**Re: Summer 2018 City Shops Bank Management Area Maintenance Inspection  
Area of Concern 4, Former DuPont Waynesboro Plant  
Waynesboro, Virginia  
EPA ID# VAD003114832**

## Memorandum

To	Michael Liberati, DuPont CRG Ralph Stahl, DuPont CRG	Page	1 of 2
CC	Nancy Grosso, DuPont CRG Ceil Mancini, AECOM		
Subject	Summer 2018 City Shops BMA Maintenance Inspection Former DuPont Waynesboro Site, Area of Concern 4		
From	Andrew Miano, AECOM Joshua Collins, AECOM		
Date	December 3, 2018

This memorandum summarizes the Summer 2018 Maintenance Inspection (inspection) of the City Shops Bank Management Area (BMA) conducted June 21<sup>st</sup> 2018. It was the first post-construction inspection following completion of construction in February 2018, and followed the scope described in the Maintenance Plan included as Appendix M of the Basis of Design Report, Phase 1A BMAs, South River AOC 4 (Anchor QEA et al., 2016). The purpose of the post-construction inspection is to set identify potential BMA maintenance needs, focusing on vegetative growth, bank stability, and the integrity of the installed bank remediation features. Additional attachments to this memorandum include:

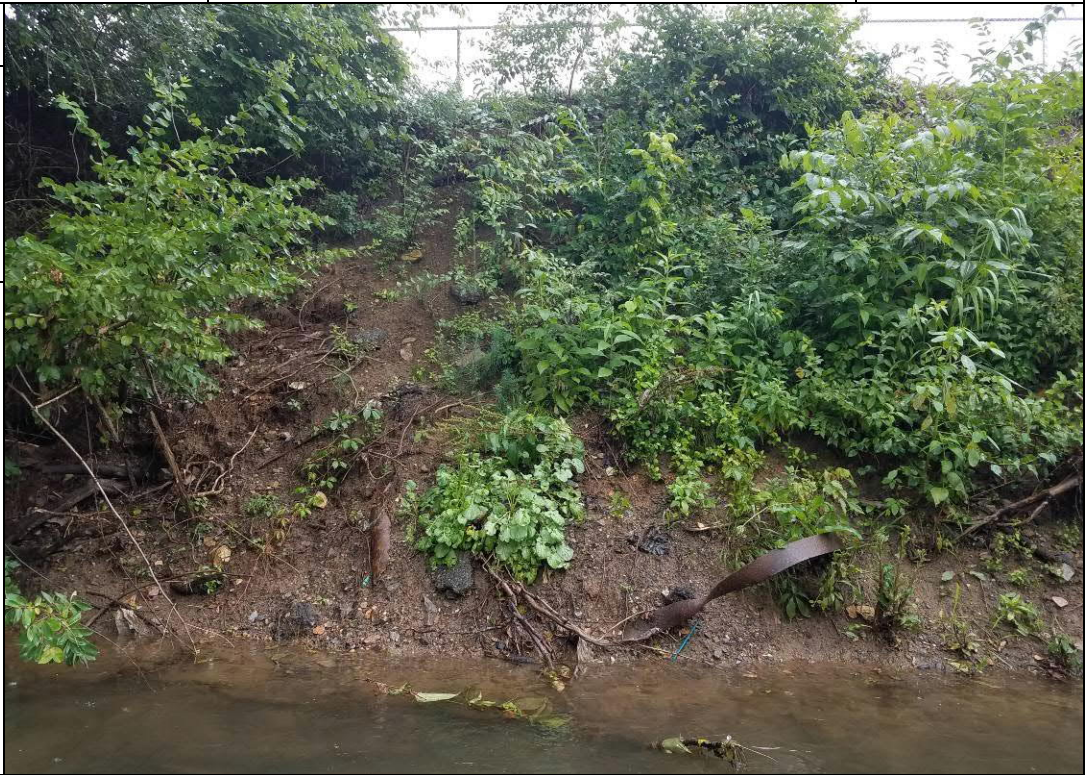
**Photo No.**  
1

Station 00 – 25'

~85 degree bank angle;  
at risk trees present;  
scour present; 95%  
vegetated.

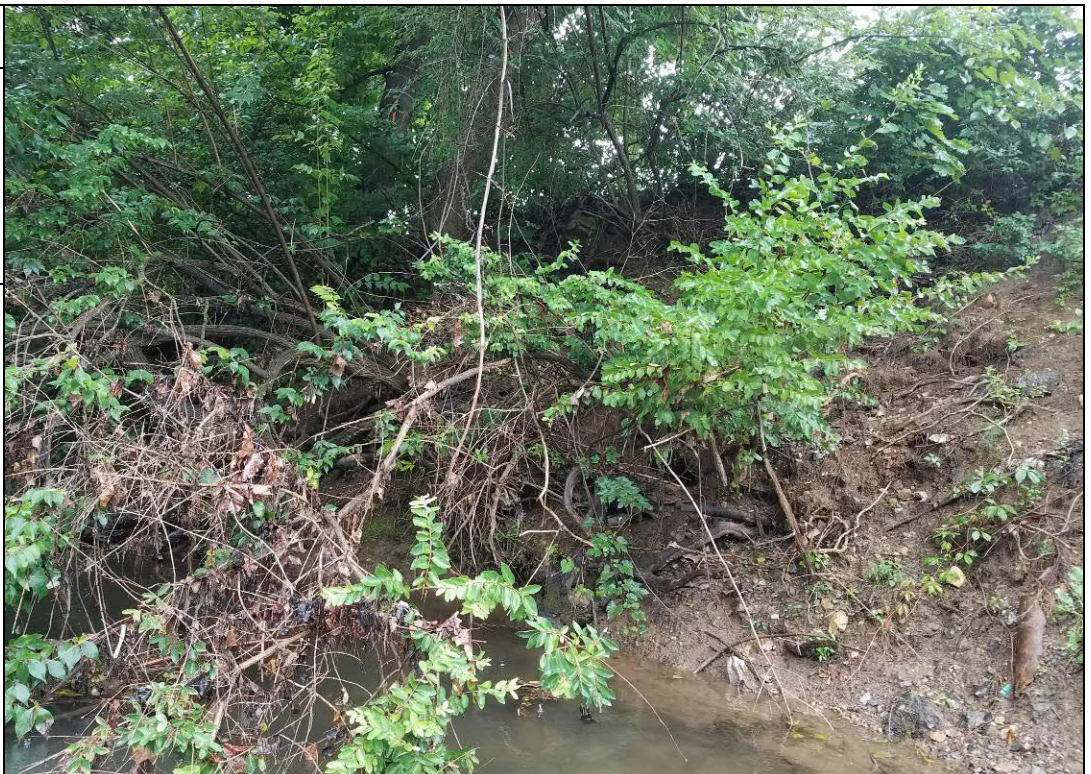
**Photo No.**  
2

Station 00 – 25'

Looking upstream from  
location 00-25'; high  
quantity of exposed  
roots on the bank; at  
risk trees present;  
scour present; 95%  
vegetated.

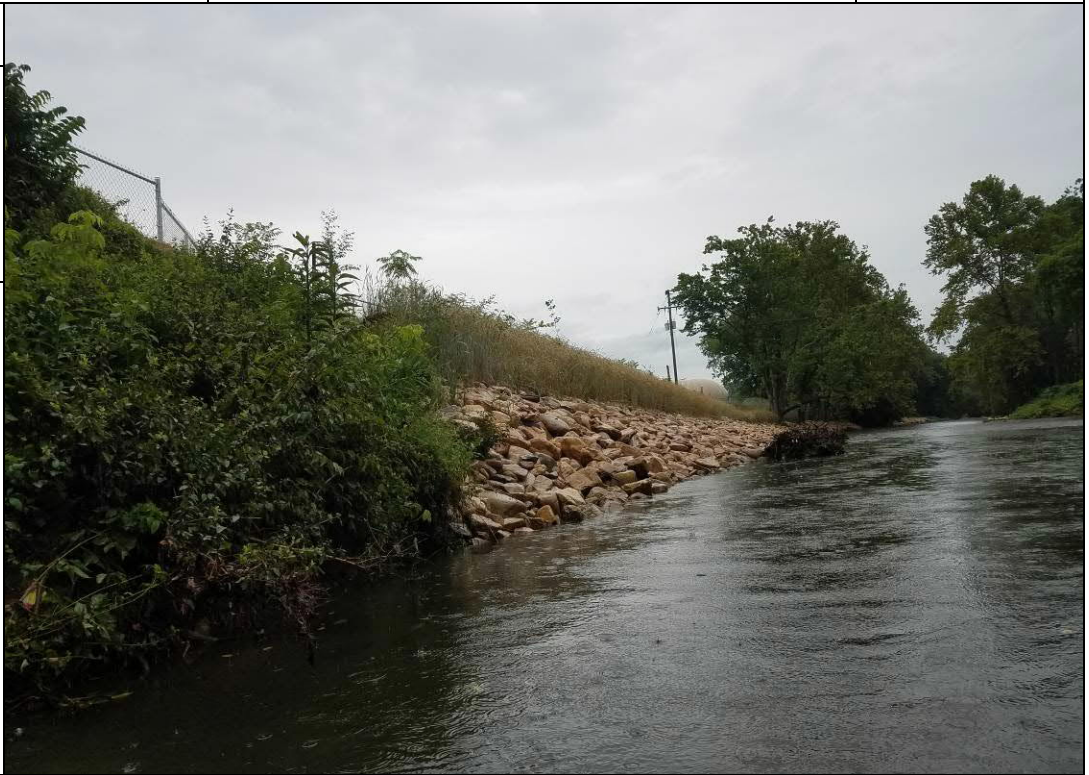
<b>Photo No.</b> 3	<b>Date:</b> 6/21/2018
-----------------------	---------------------------

Station 00 – 25'

View looking downstream from location 00-25'; high quantity of exposed roots on the bank and scour present until beginning of rock toe.

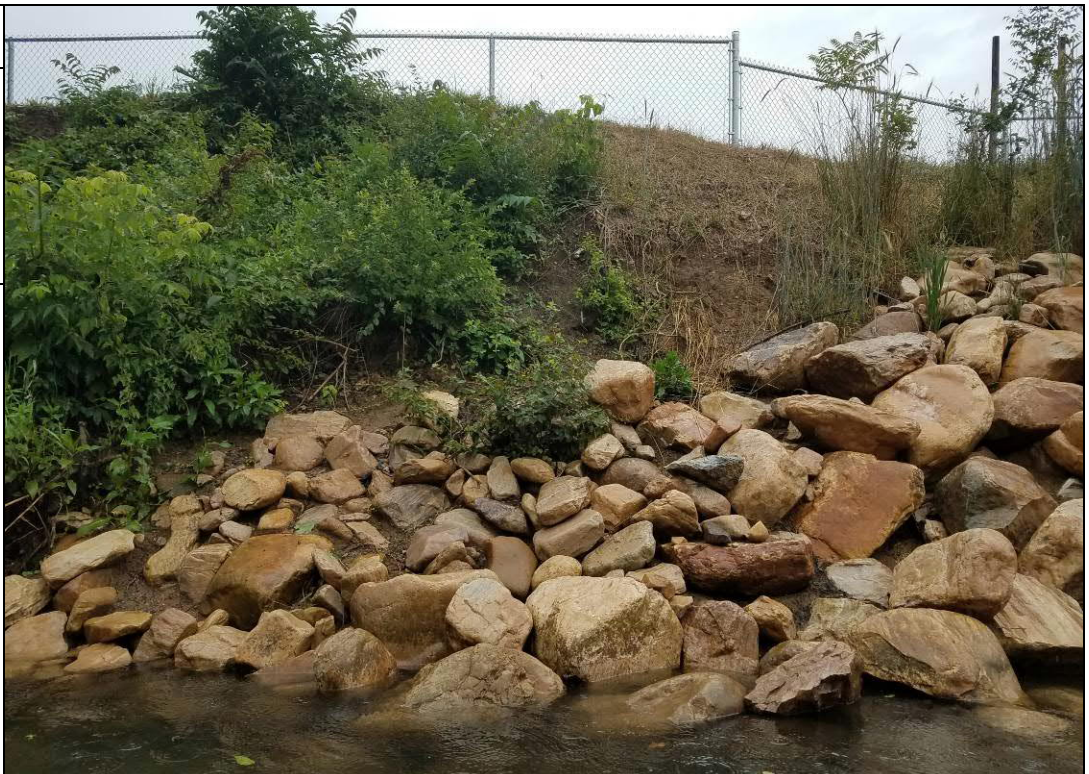
<b>Photo No.</b> 4	<b>Date:</b> 6/21/2018
-----------------------	---------------------------

Station 00 + 00'

~60-80 degree bank angle; no at-risk trees present; no exposed roots; some scour present at edge of remediation; installed rock toe intact.

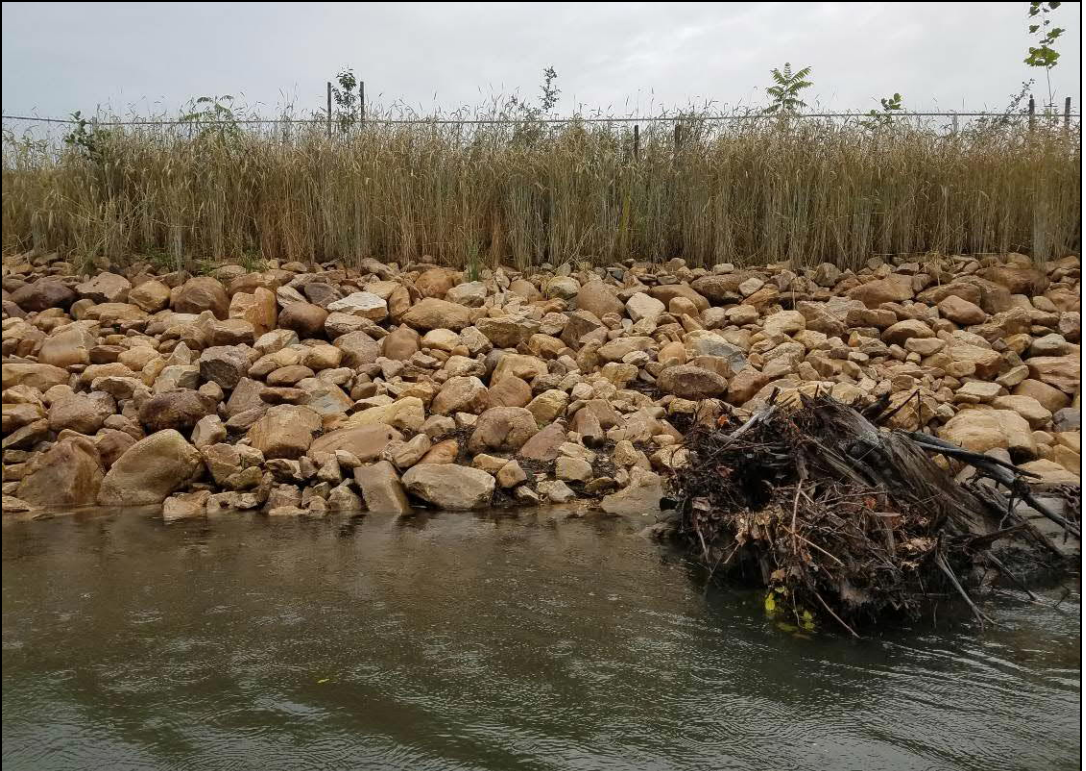
<b>Direction Photo Taken:</b> Northwest			
<b>Description:</b> Station 00 + 50'  ~45 degree bank angle; no scour present; installed rock toe intact; vegetation consists of planted rye grasses and native container plants; LWD intact.

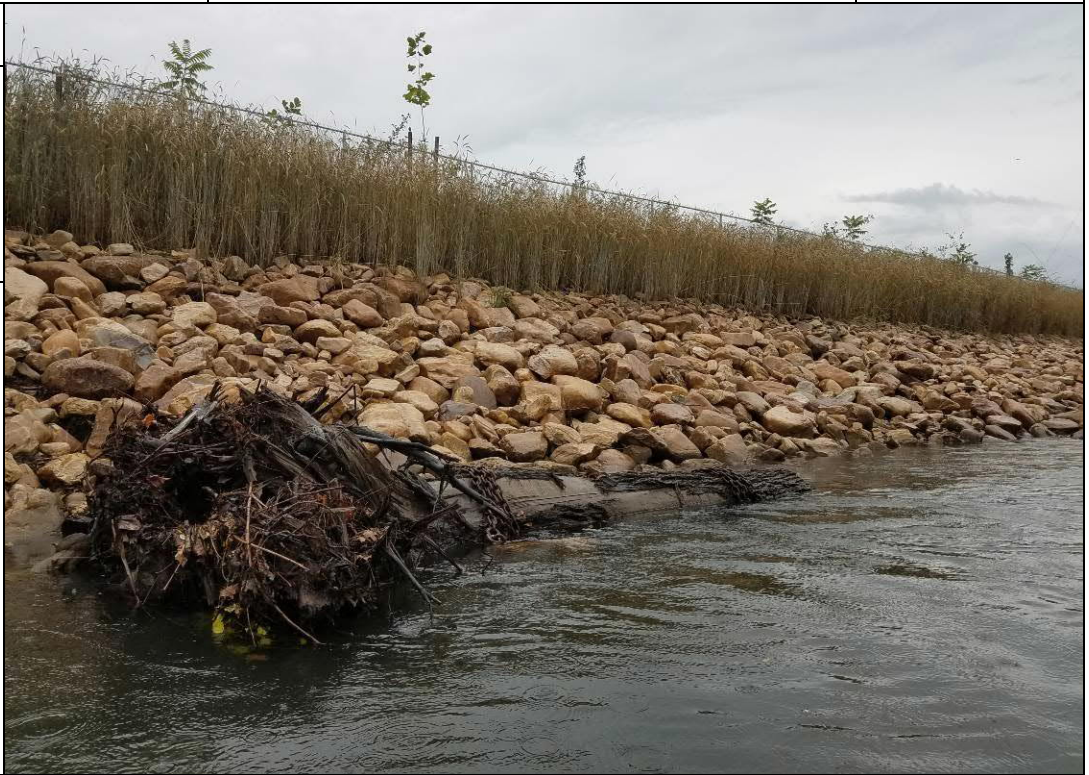
<b>Photo No.:</b> 7	<b>Date:</b> 6/21/2018
------------------------	---------------------------

Station 00 + 50'

Downstream view of 00 + 50' location; Installed rock toe intact; LWD intact.

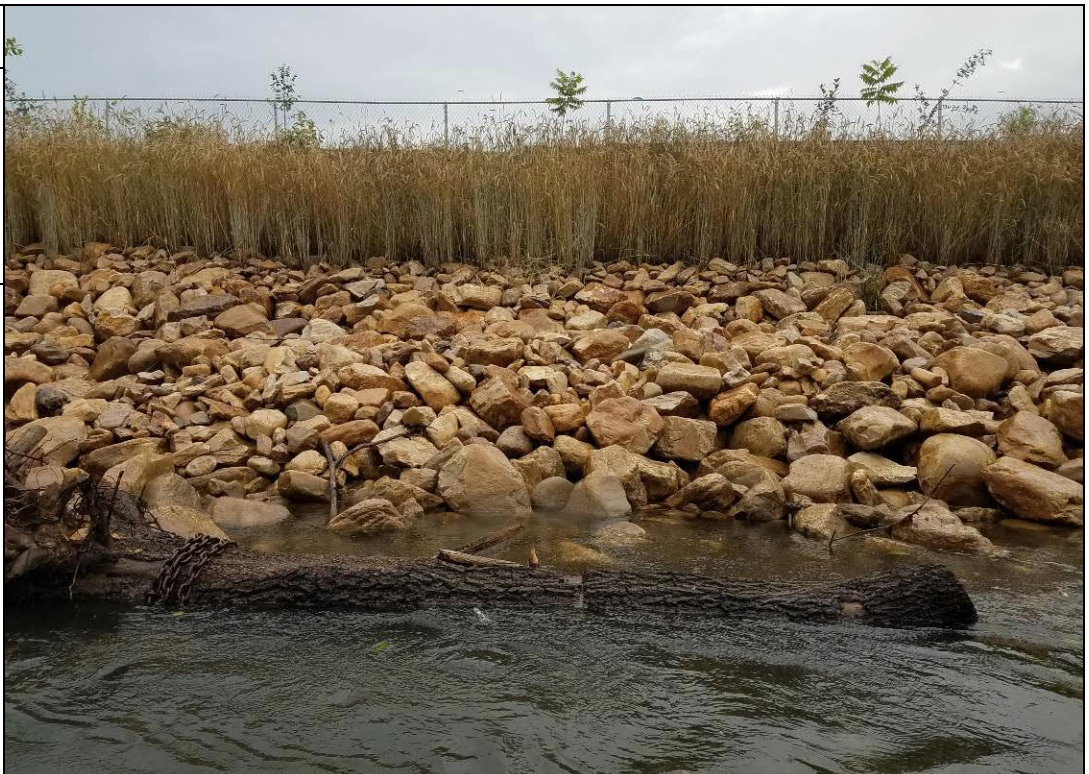
<b>Photo No.:</b> 8	<b>Date:</b> 6/21/2018
------------------------	---------------------------

Station 00 + 100'

~45 degree bank angle; no scour present; installed rock toe intact; vegetation consists of planted rye grasses and saplings on top of bank; LWD intact.

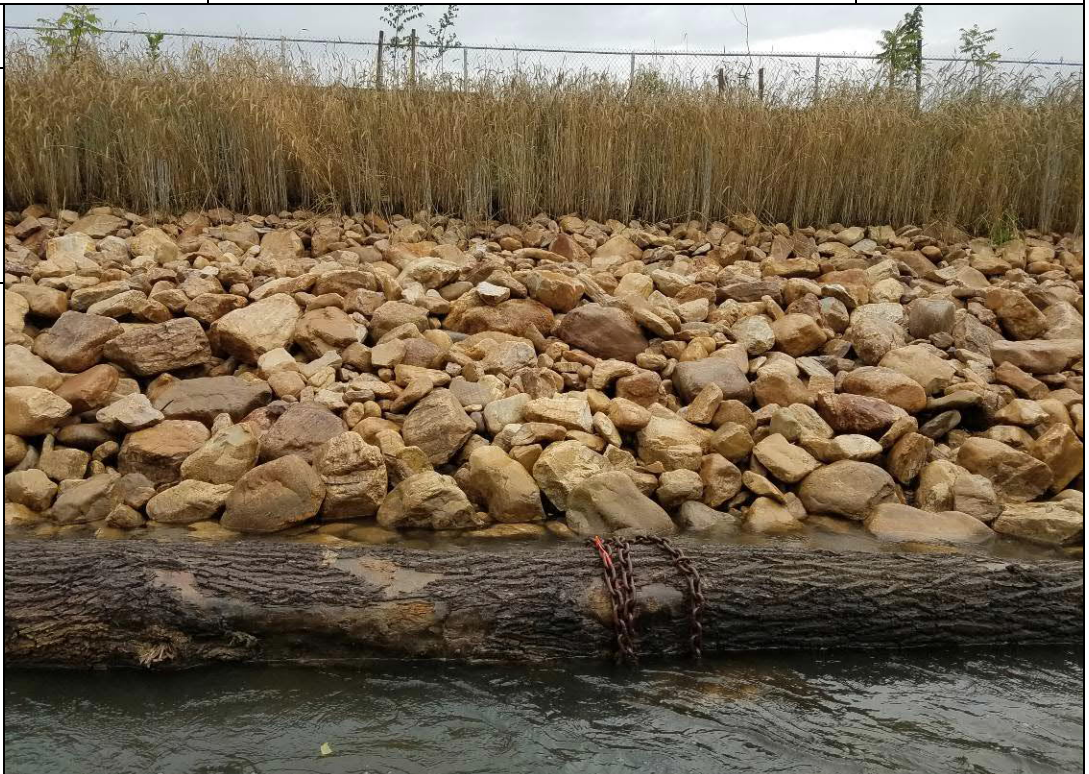
<b>Photo No.:</b> 9	<b>Date:</b> 6/21/2018
------------------------	---------------------------

Station 00 + 150'

~45 degree bank angle;  
no scour present;  
installed rock toe intact;  
vegetation consists of  
rye grasses and  
planted saplings on top  
of bank; LWD intact.

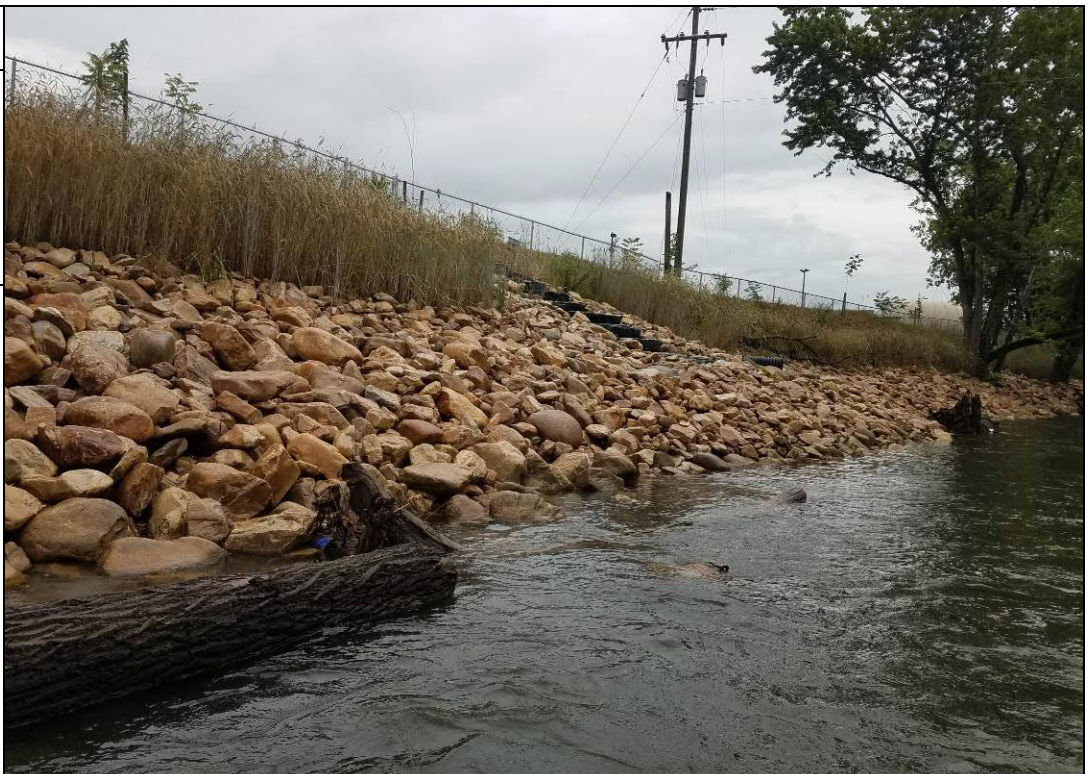
<b>Photo No.:</b> 10	<b>Date:</b> 6/21/2018
-------------------------	---------------------------

Station 00 + 150'

Downstream view of 00  
+ 150'; installed rock  
toe and LWD intact.

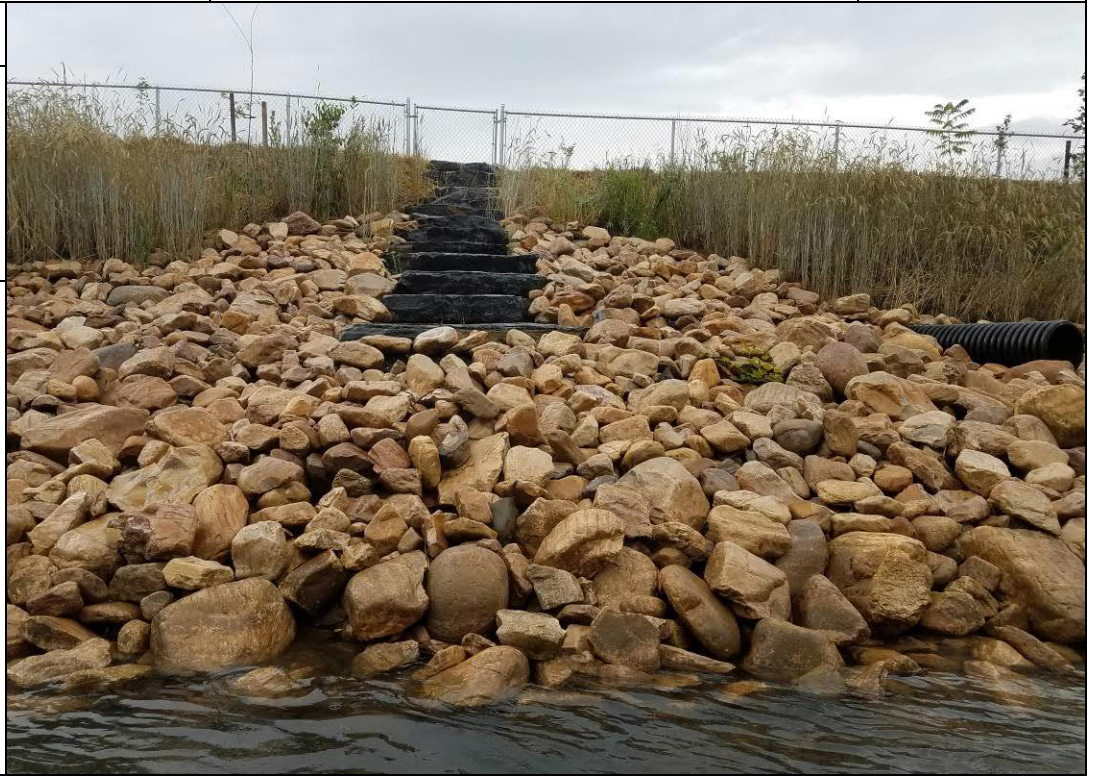
**Photo No.**  
11

Station 00 + 200'

~45 degree bank angle;  
no scour present;  
installed rock toe intact;  
staircase / gate access  
present and intact.

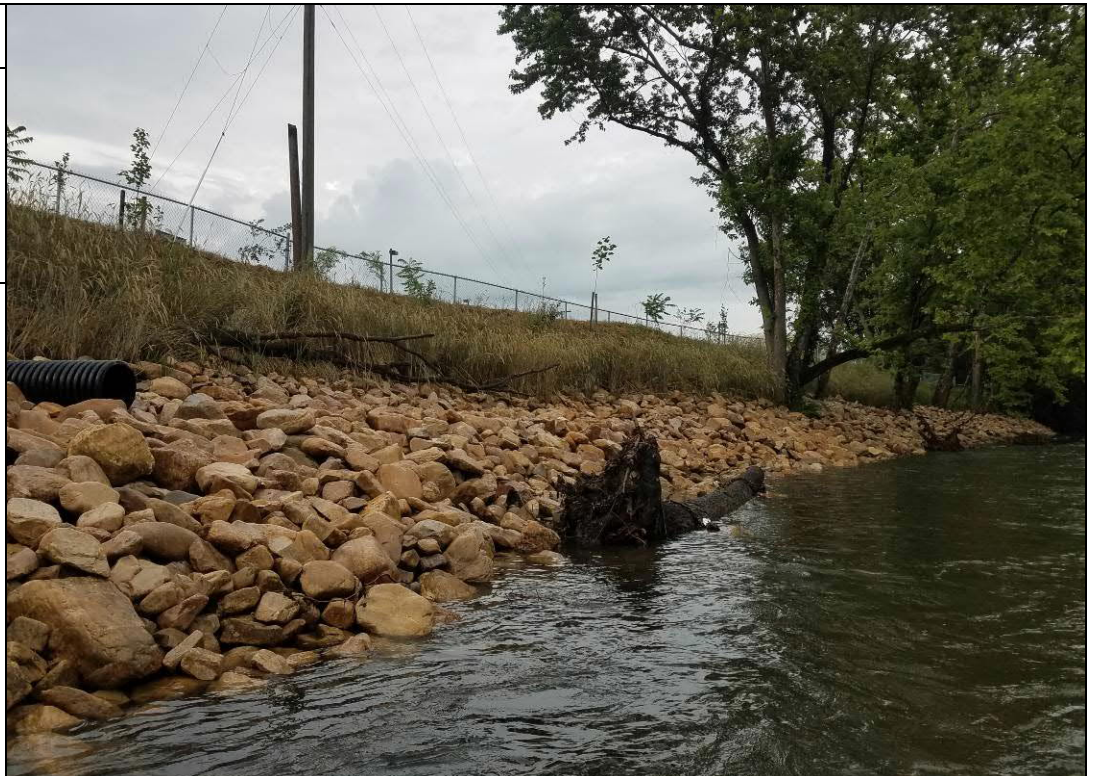
**Photo No.**  
12

Station 00 + 200'

Downstream view of 00 + 200'; vegetation consists of planted rye grasses and saplings; outfall pipe present within rock toe. Note presence wrack line with large branches deposited at top of rock toe during high flow events.

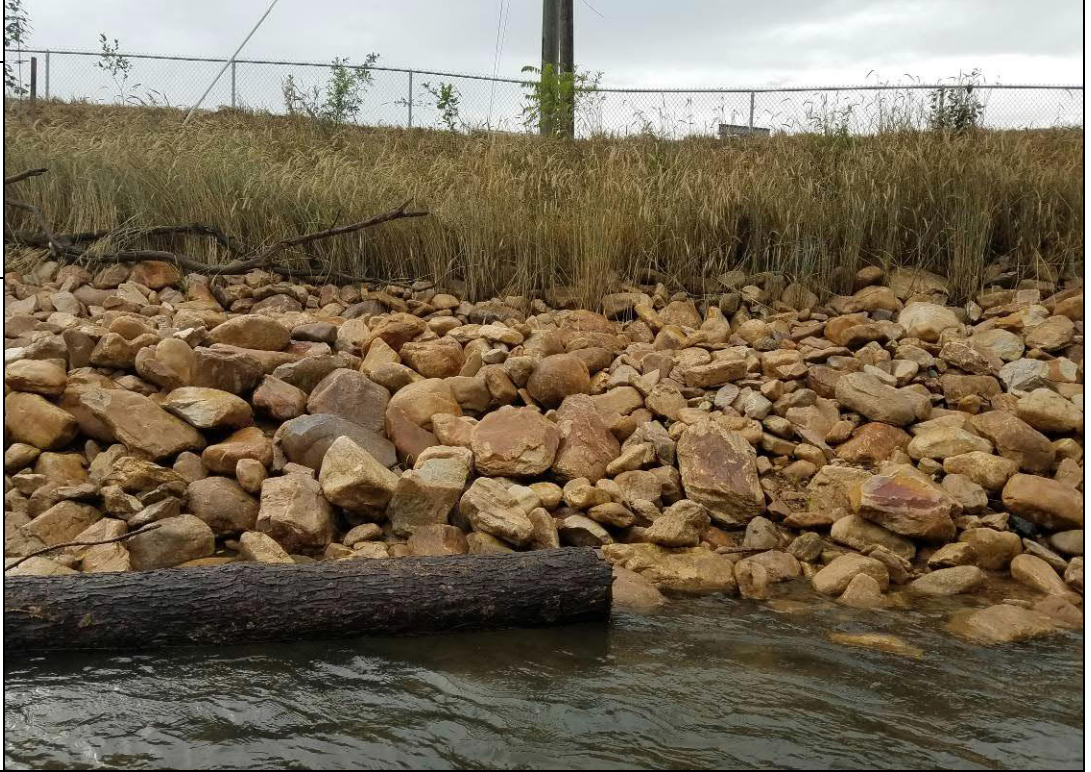
**Photo No.:**  
13

Station 00 + 250'

~45 degree bank angle;  
no scour present;  
installed rock toe intact;  
vegetation consists of  
planted rye grasses  
and saplings; LWD  
intact.

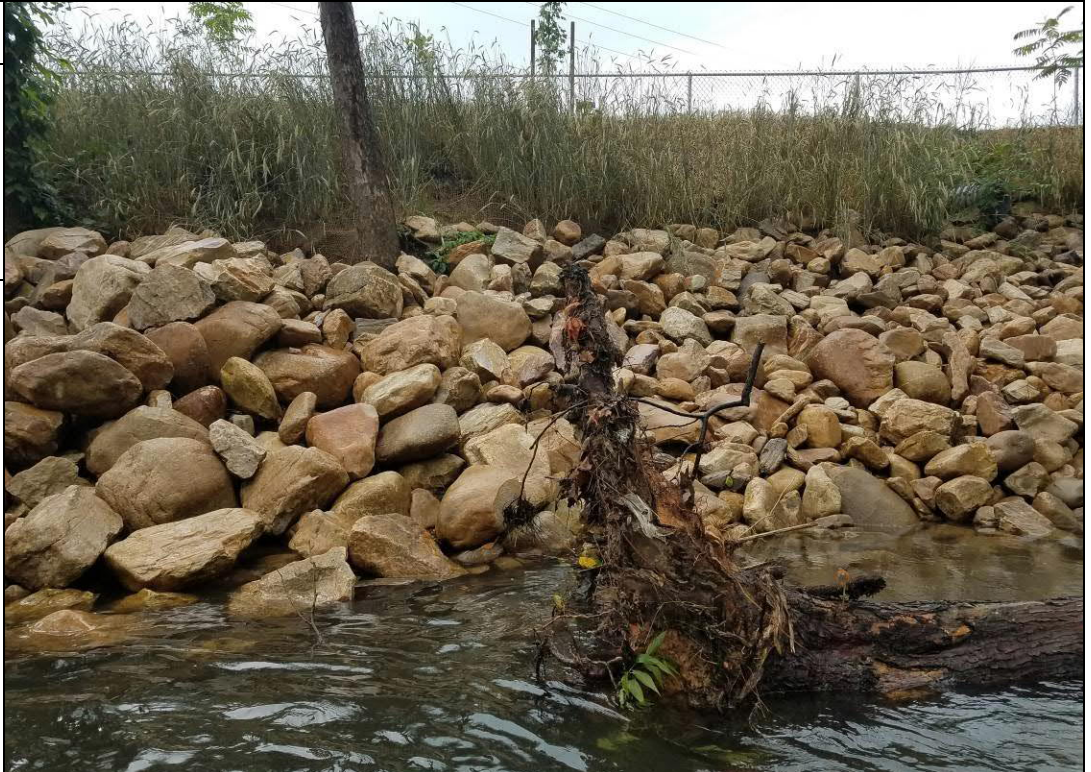
**Photo No.:**  
14

Station 00 + 300'

~45 degree bank angle;  
no scour present;  
installed rock toe intact;  
vegetation consists of  
planted rye grasses  
and saplings; LWD  
intact; no at risk trees  
present; some erosion  
control fabric exposed  
around tree base.

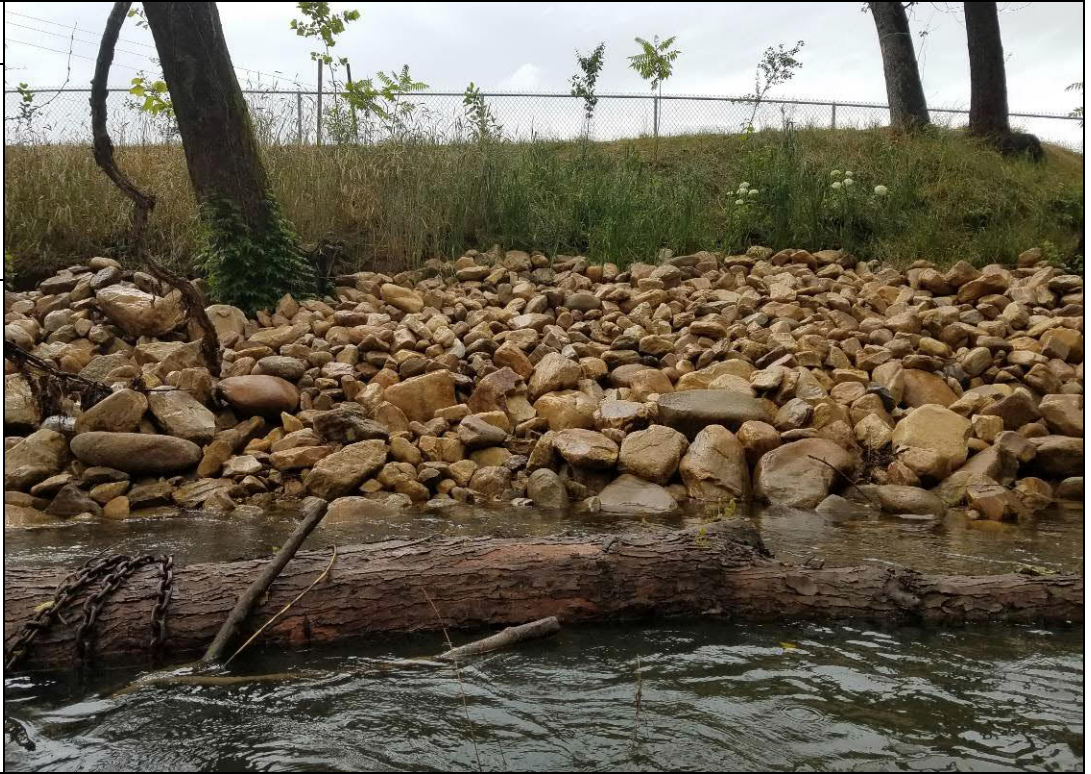
**Photo No.:**  
15

Station 00 + 350'

~45 degree bank angle;  
no scour present;  
installed rock toe intact;  
vegetation consists of  
rye grasses, planted  
saplings and mature  
sycamore trees; LWD  
intact; some erosion  
control fabric exposed  
around tree base; no at  
risk trees present.

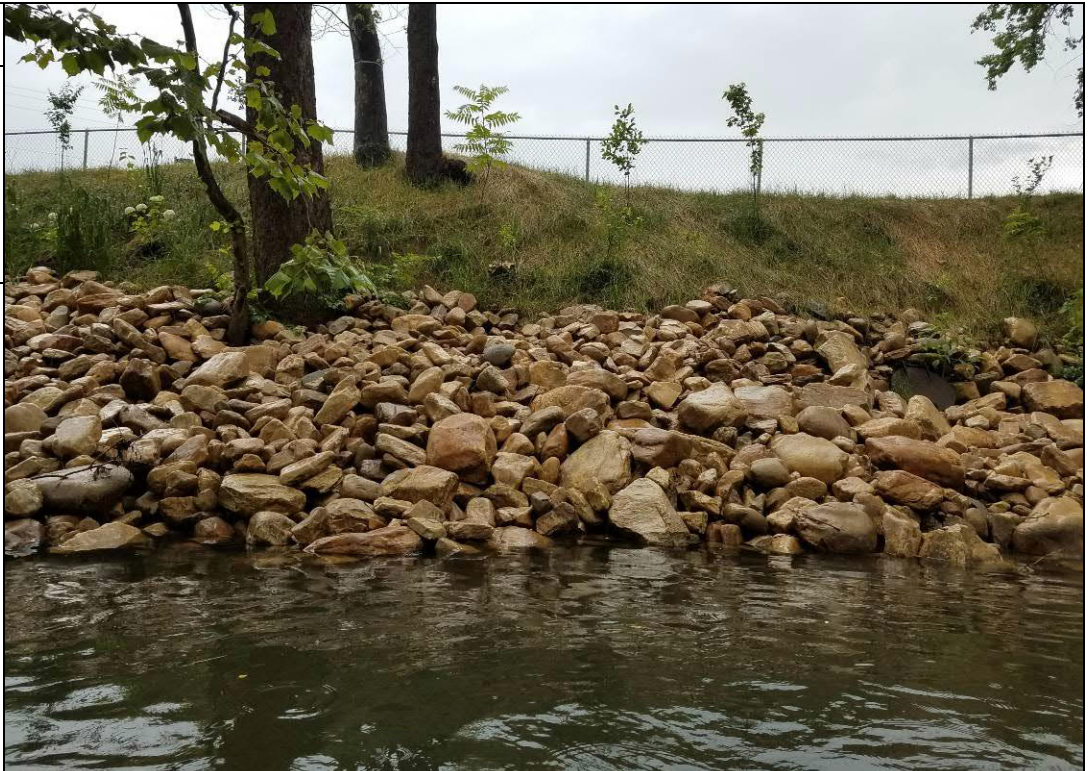
**Photo No.:**  
16

Station 00 + 400'

~45 degree bank angle;  
slight scour present;  
installed rock toe intact;  
vegetation consists of  
rye grasses and mature  
trees; LWD intact; no at  
risk trees present.

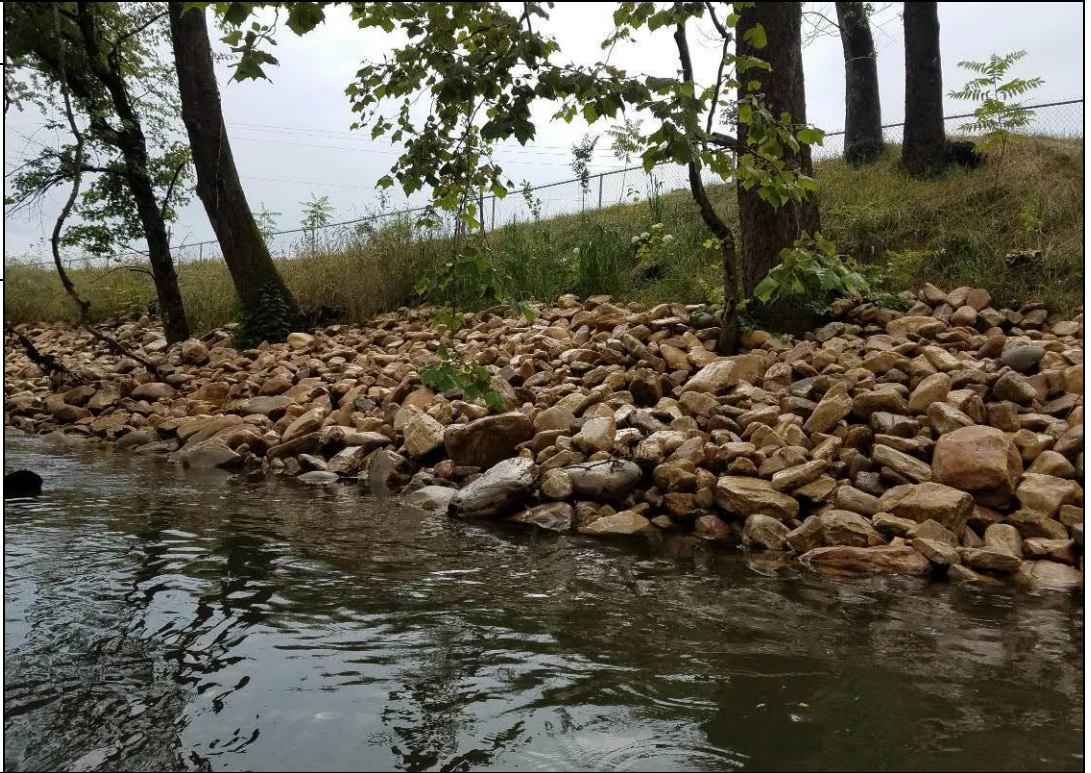
**Photo No.**  
17

Station 00 + 400'

~45 degree bank angle;  
slight scour present;  
installed rock toe intact;  
vegetation consists of  
rye grasses and trees;  
LWD intact; no at risk  
trees present.

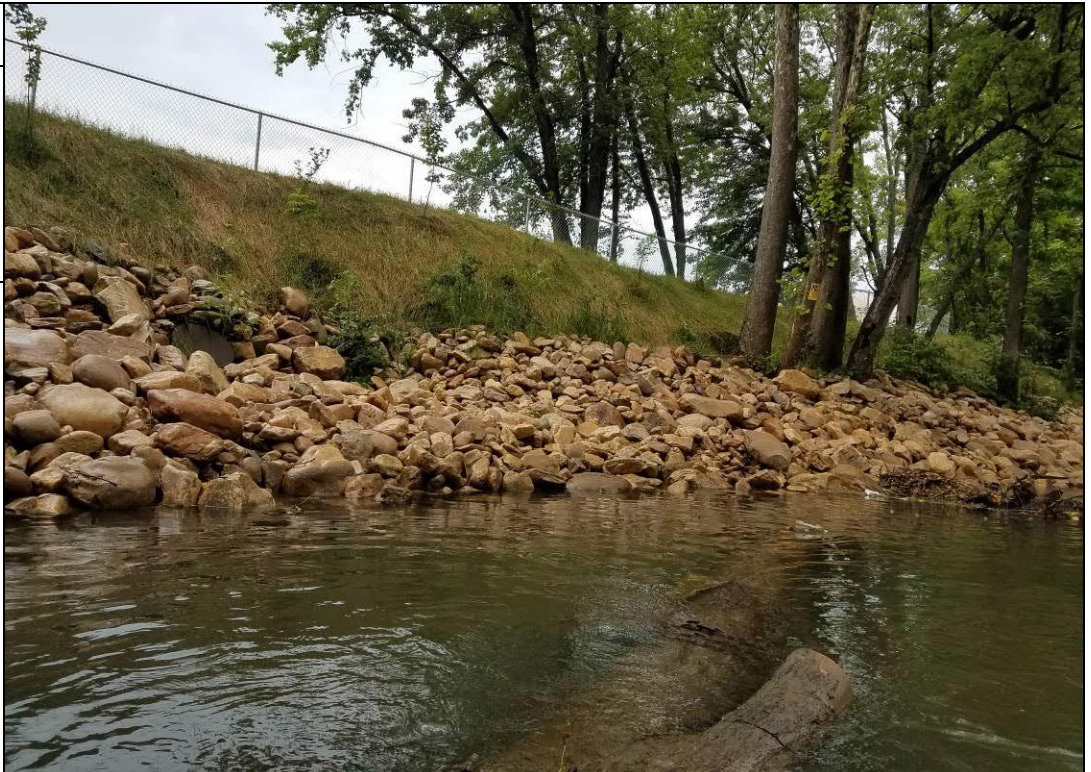
**Photo No.**  
18

Station 00 + 400'

~45 degree bank angle;  
slight scour present;  
installed rock toe intact;  
vegetation consists of  
rye grasses and mature  
trees; LWD intact; two  
outfall pipes present  
within rock toe.

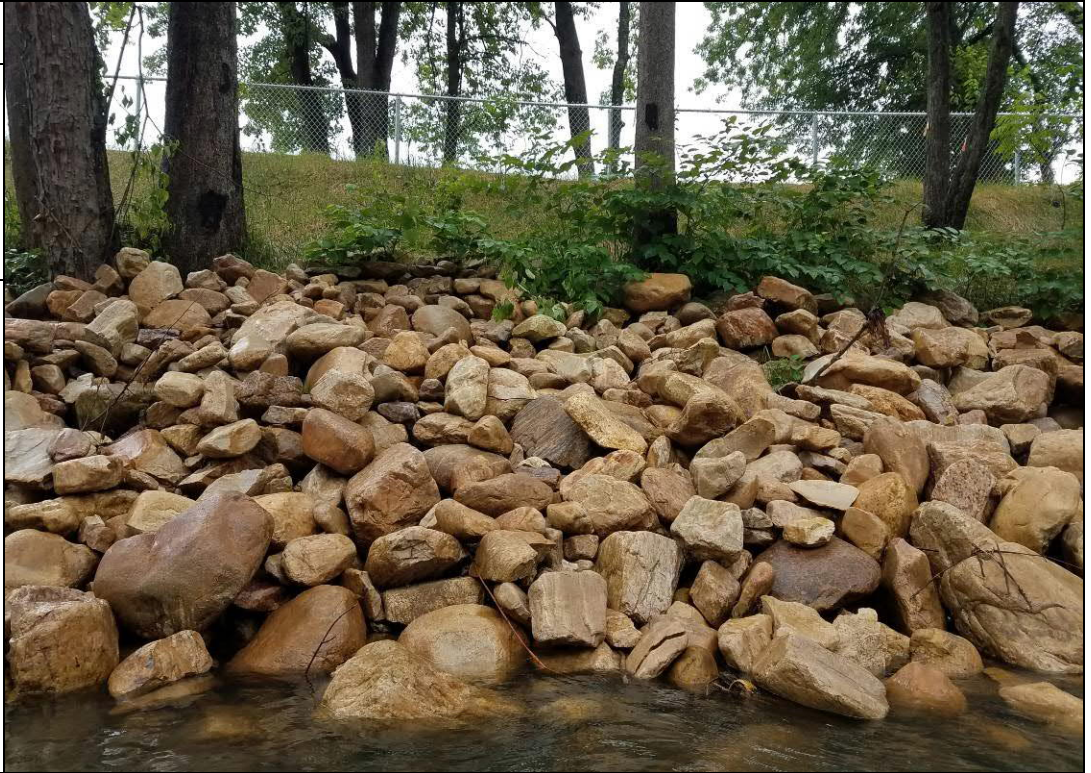
**Photo No.**  
19

Station 00 + 450'

~45 degree bank angle;  
no scour present;  
installed rock toe intact;  
vegetation consists of  
rye grasses and mature  
trees.

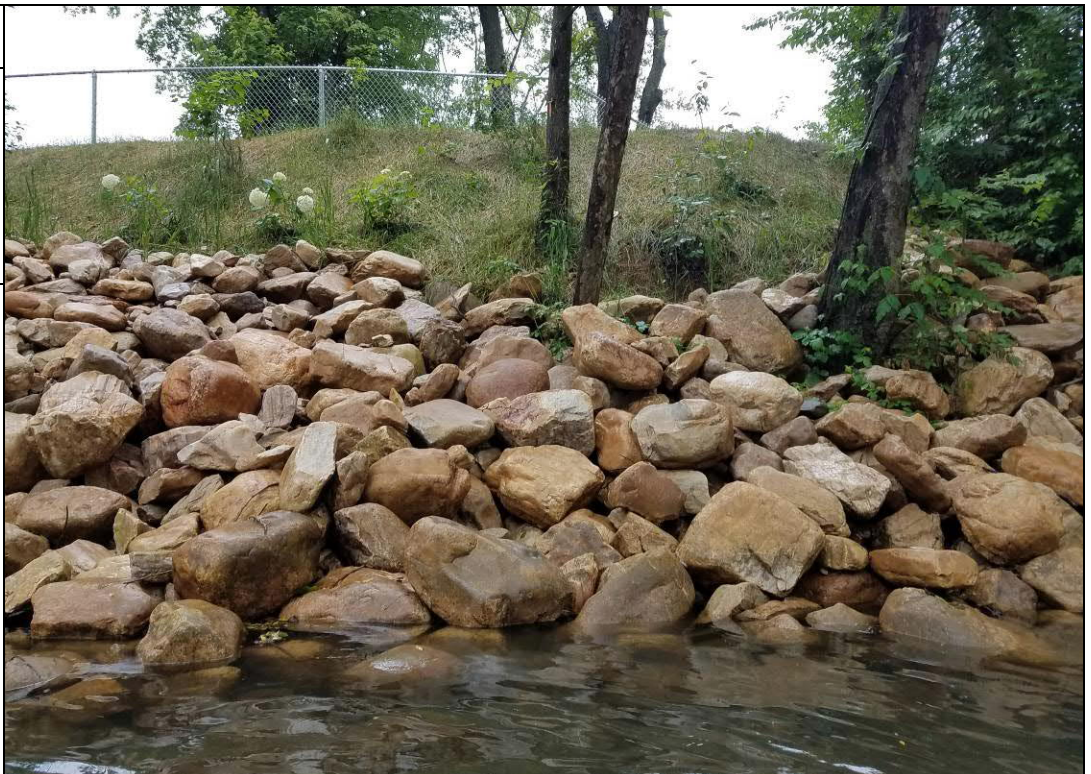
**Photo No.**  
20

Station 00 + 500'

~45 degree bank angle;  
no scour present;  
installed rock toe intact;  
vegetation consists of  
rye grasses,  
hydrangeas, and  
mature sycamore trees.

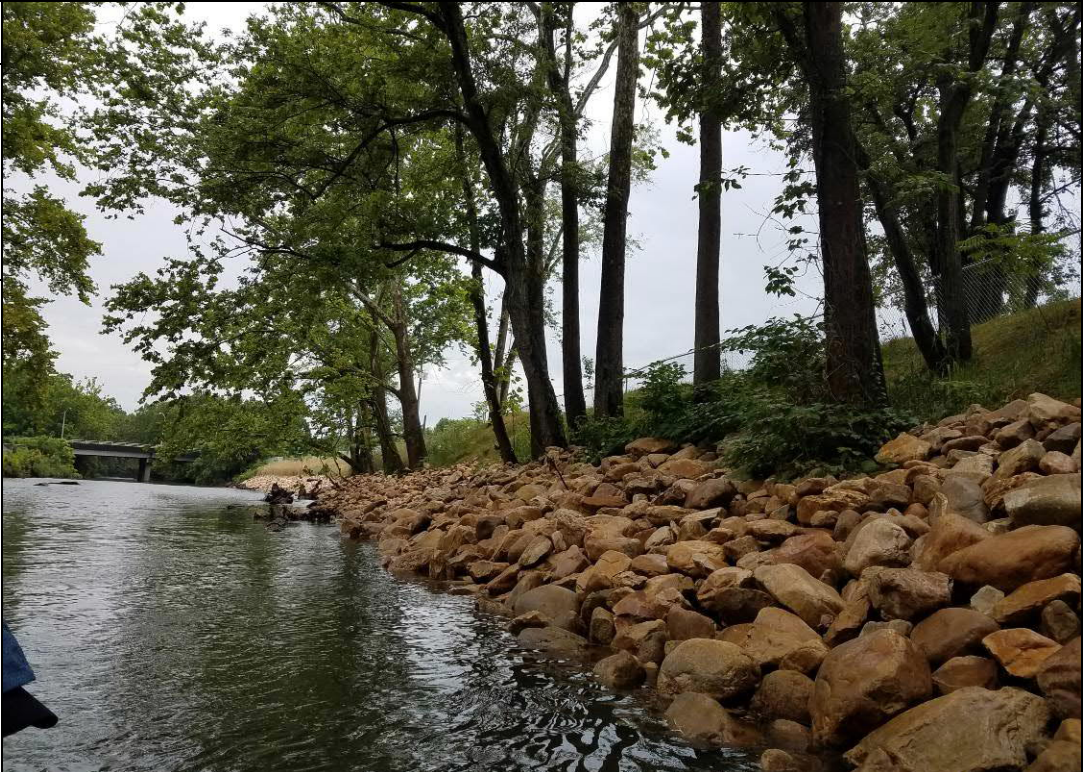
<b>Photo No.:</b> 21	<b>Date:</b> 6/21/2018
-------------------------	---------------------------

<b>Description:</b>  Station 00 + 500'  Upstream view of 00+500' ~no scour present; installed rock toe intact; vegetation consists of rye grasses and mature trees; no at risk trees present.
---

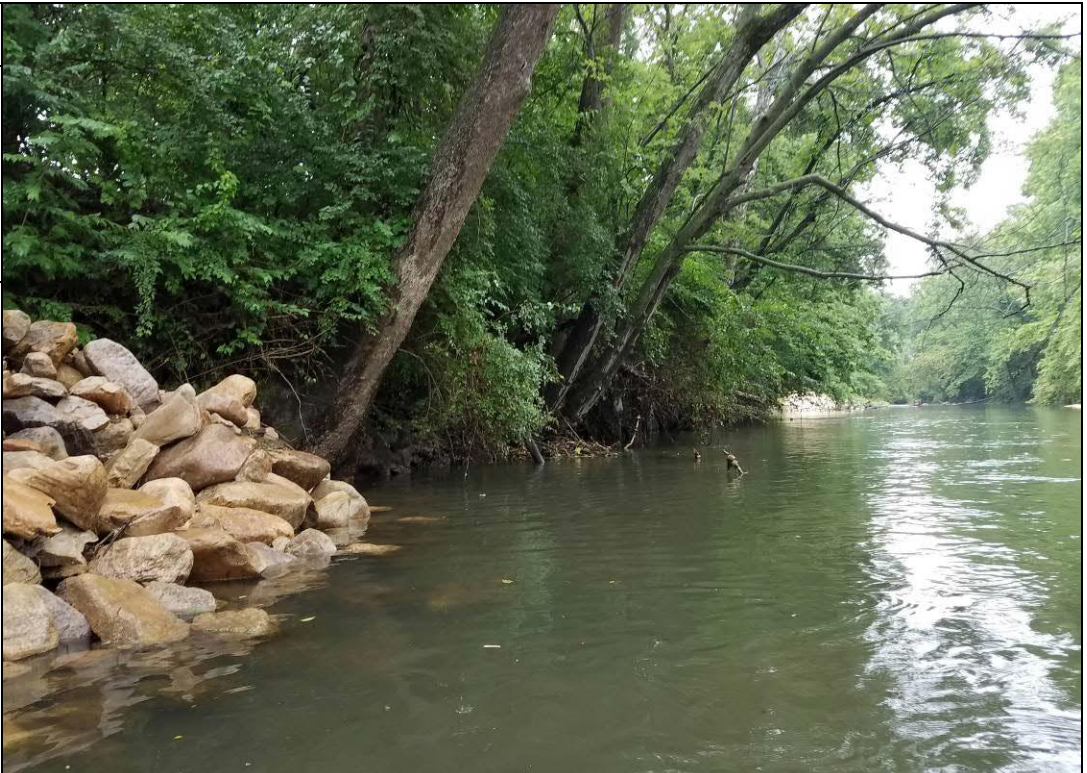
<b>Photo No.:</b> 22	<b>Date:</b> 6/21/2018
-------------------------	---------------------------

<b>Description:</b>  Station 00 + 500'  Downstream view of 00 + 500' immediately before the end of the rock toe; no scour present; installed rock toe intact.
---

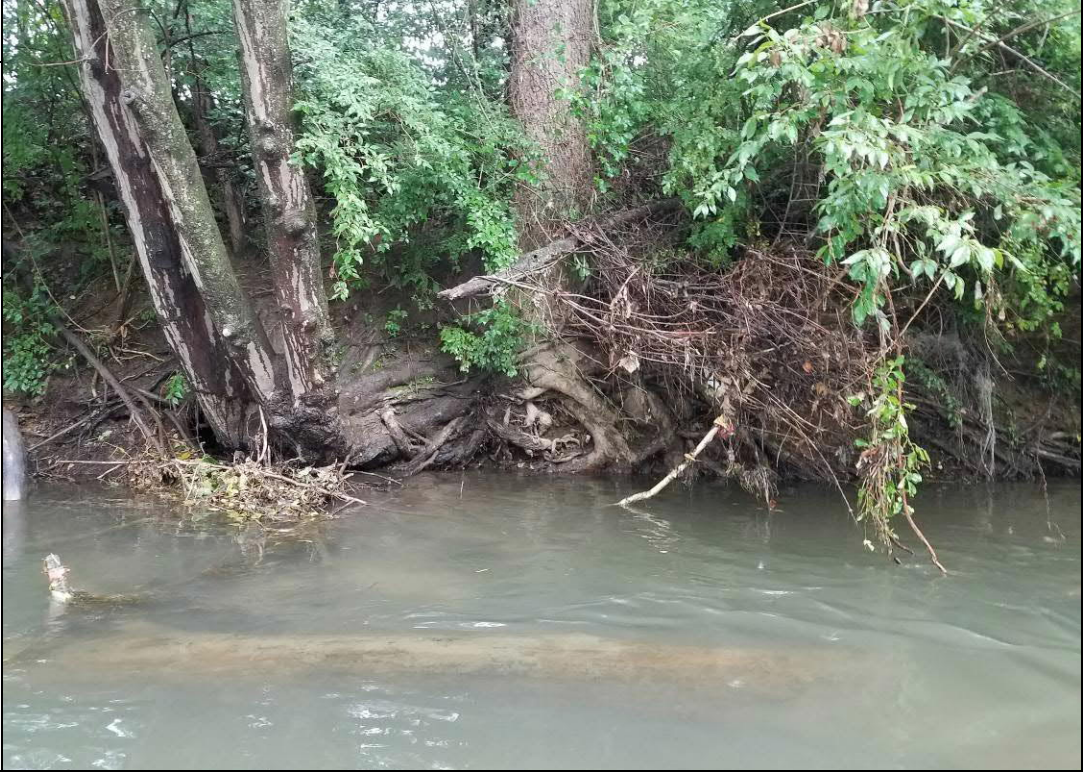
**Photo No.**  
23

Station 00 + 550' (non-remediated transect)

~70 degree bank angle; high quantity of exposed roots; at risk trees present; scour present; LWD present.

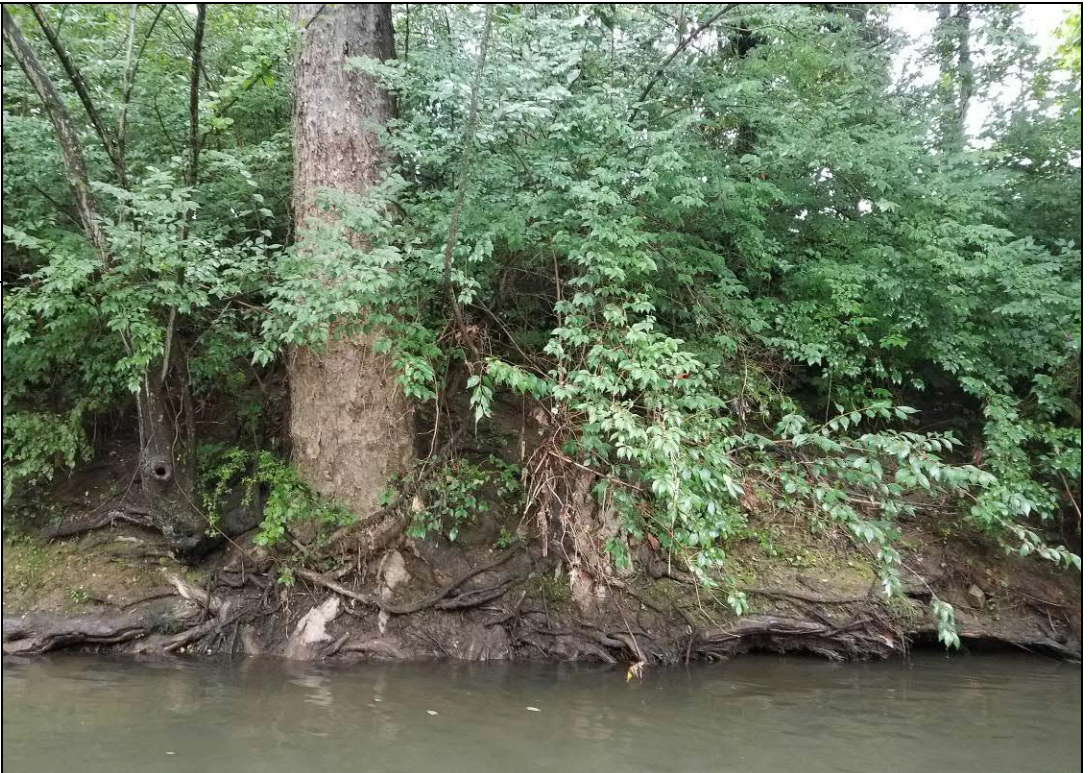
**Photo No.**  
24

Station 00 + 600' (non-remediated transect)

~75 degree bank angle; high quantity of exposed roots; at risk trees present; scour present.

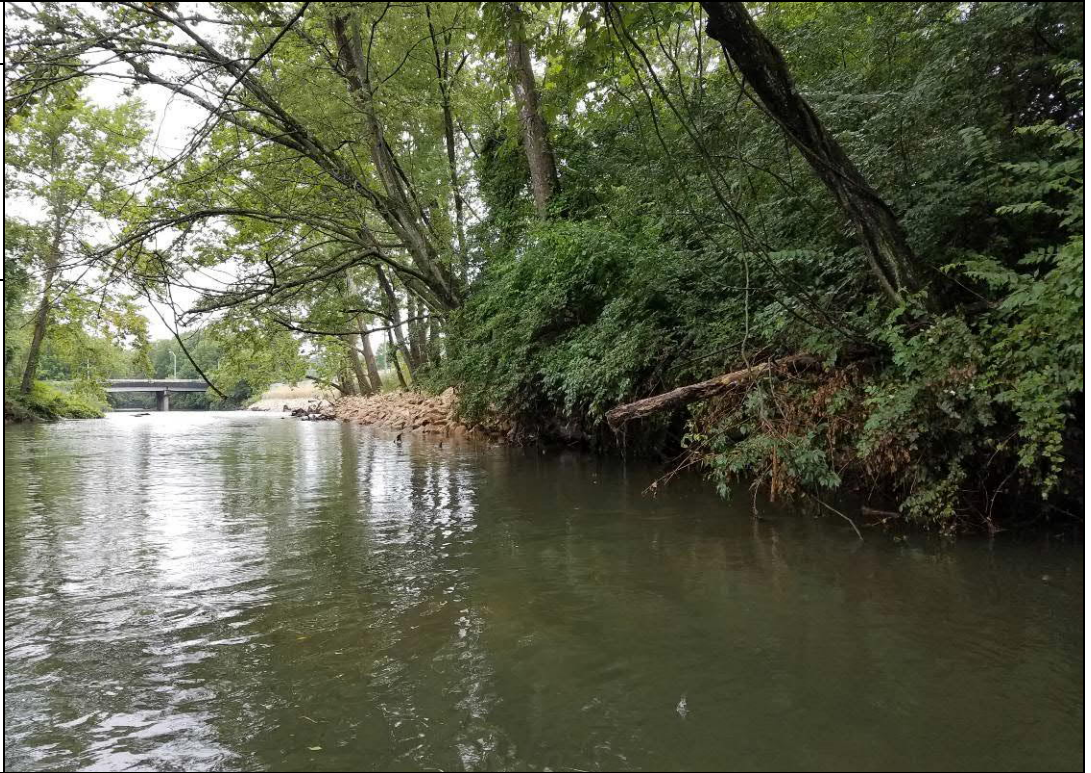
**Photo No.**  
25

Station 00 + 600' (non-remediated transect)

Upstream view of 00 + 600'; high quantity of exposed roots; at risk trees present.

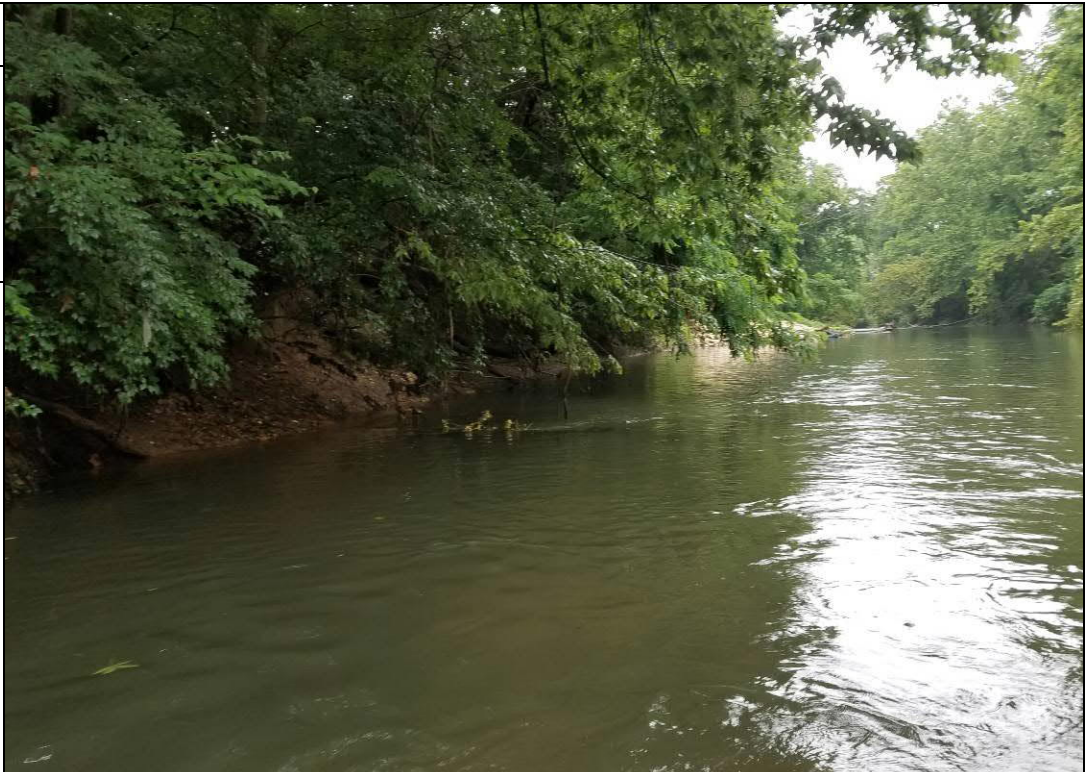
**Photo No.**  
26

Station 00 + 600' (non-remediated transect)

Downstream view of 00 + 600'; high quantity of exposed roots; at risk trees present; scour present.
