**Re: Summer 2018 City Shops Bank Management Area Maintenance Inspection  
Area of Concern 4, Former DuPont Waynesboro Plant  
Waynesboro, Virginia  
EPA ID# VAD003114832**

## Memorandum

To	Michael Liberati, DuPont CRG Ralph Stahl, DuPont CRG	Page	1 of 2
CC	Nancy Grosso, DuPont CRG Ceil Mancini, AECOM		
Subject	Summer 2018 City Shops BMA Maintenance Inspection Former DuPont Waynesboro Site, Area of Concern 4		
From	Andrew Miano, AECOM Joshua Collins, AECOM		
Date	December 3, 2018

This memorandum summarizes the Summer 2018 Maintenance Inspection (inspection) of the City Shops Bank Management Area (BMA) conducted June 21<sup>st</sup> 2018. It was the first post-construction inspection following completion of construction in February 2018, and followed the scope described in the Maintenance Plan included as Appendix M of the Basis of Design Report, Phase 1A BMAs, South River AOC 4 (Anchor QEA et al., 2016). The purpose of the post-construction inspection is to set identify potential BMA maintenance needs, focusing on vegetative growth, bank stability, and the integrity of the installed bank remediation features. Additional attachments to this memorandum include:

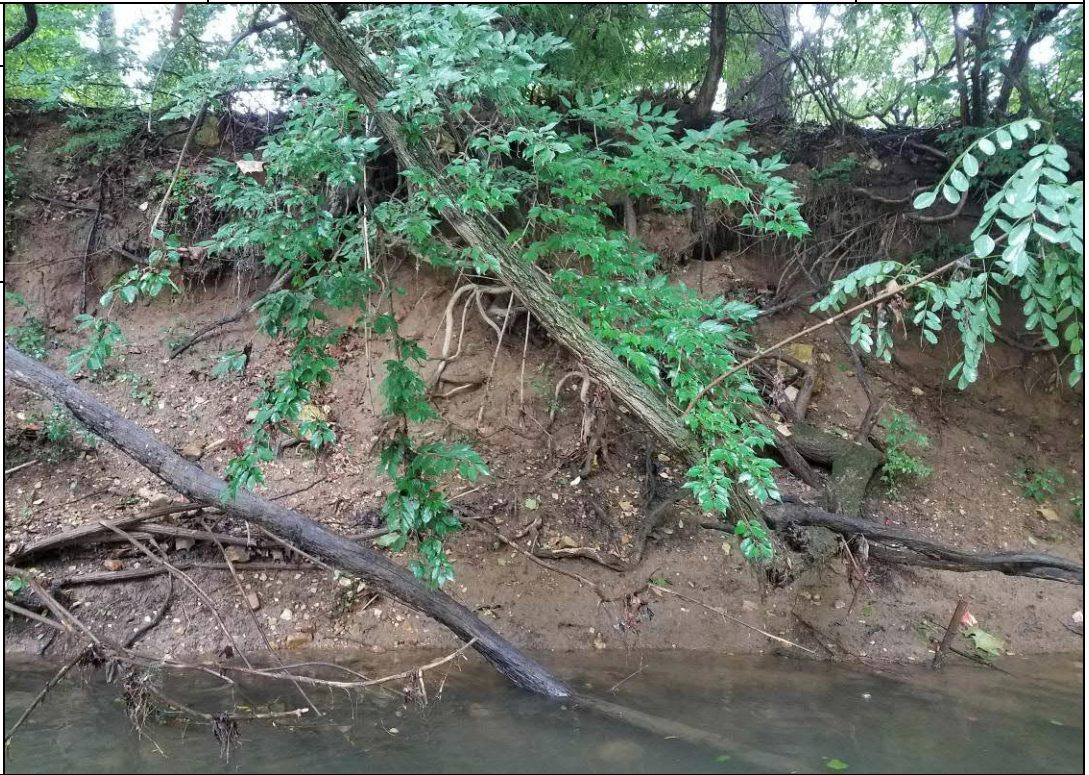
<b>Photo No.</b> 27	<b>Date:</b> 6/21/2018
------------------------	---------------------------

<b>Description:</b>  Station 00 + 650' (non-remediated transect)  ~80 degree bank angle; high quantity of exposed roots; at risk trees present; scour present.
--

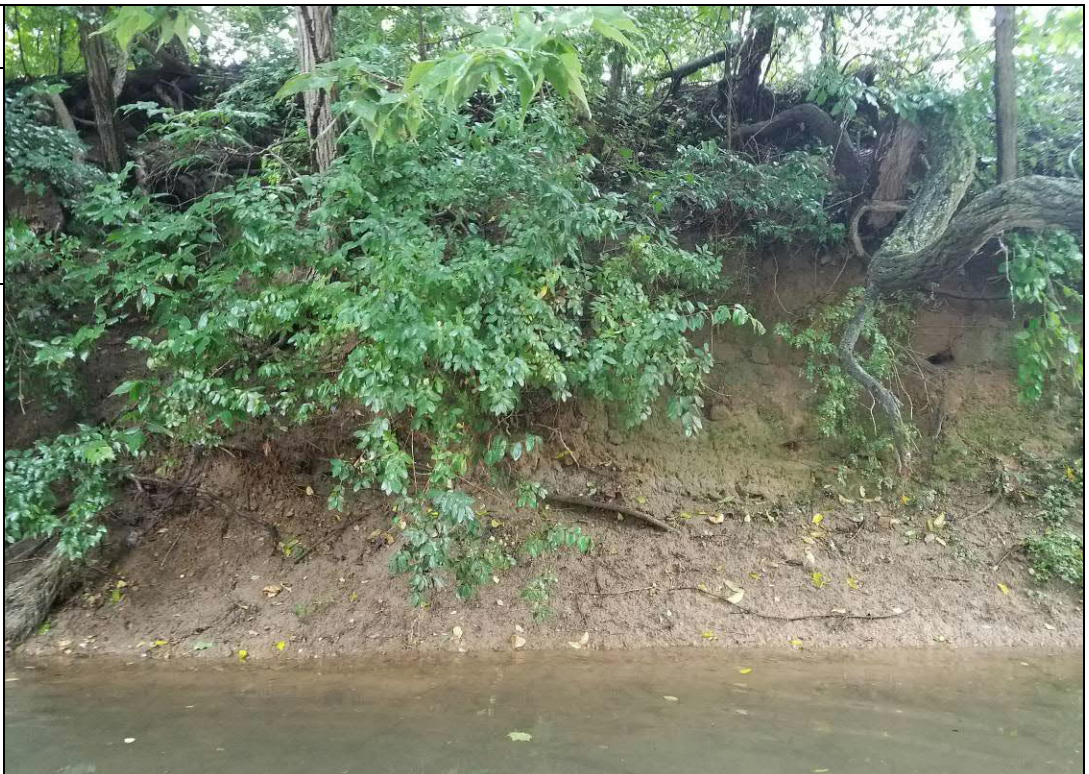
<b>Photo No.</b> 28	<b>Date:</b> 6/21/2018
------------------------	---------------------------

<b>Description:</b>  Station 00 + 700' (non-remediated transect)  ~90 degree bank angle; high quantity of exposed roots; at risk trees present; scour present.
--

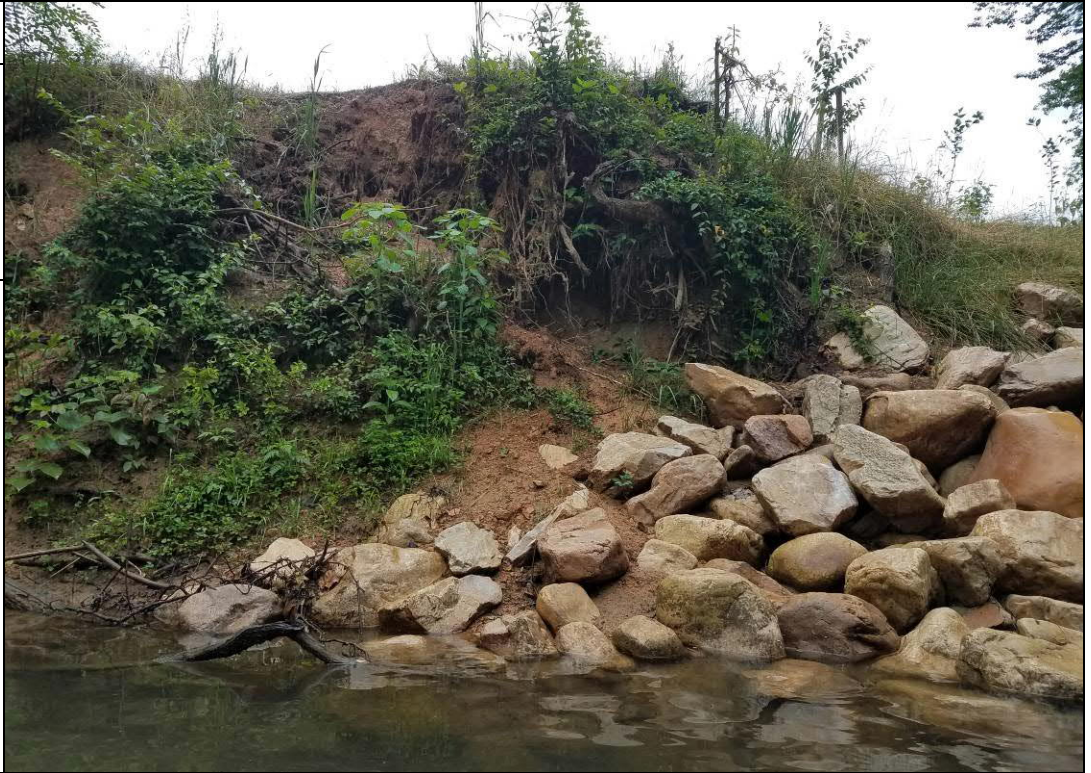
**Photo No.**  
29

- Erosion at the upstream transition of the Primary BMA B area.
- Stability of the LWD at location 00+850' (most downstream LWD) that was shifted during late spring/summer high flow events.

Station 00 + 750'

~90 degree bank angle; high quantity of exposed roots; scour present upstream of bank restoration

The following conditions documented during this inspection will be closely monitored during the winter, leaf-off inspection to identify the need for corrective action:

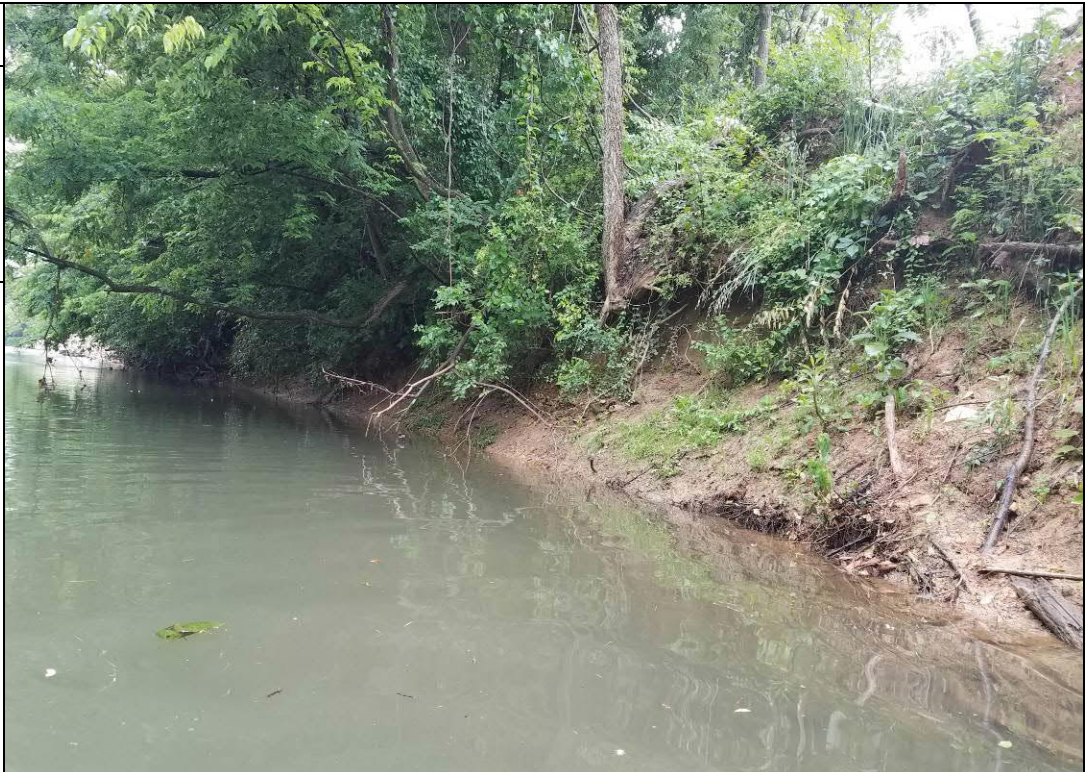
**Photo No.**  
30

Station 00 + 750'

Upstream view of 00 + 750'; high quantity of exposed roots; scour present; at risk trees present upstream and outside of remedial footprint.

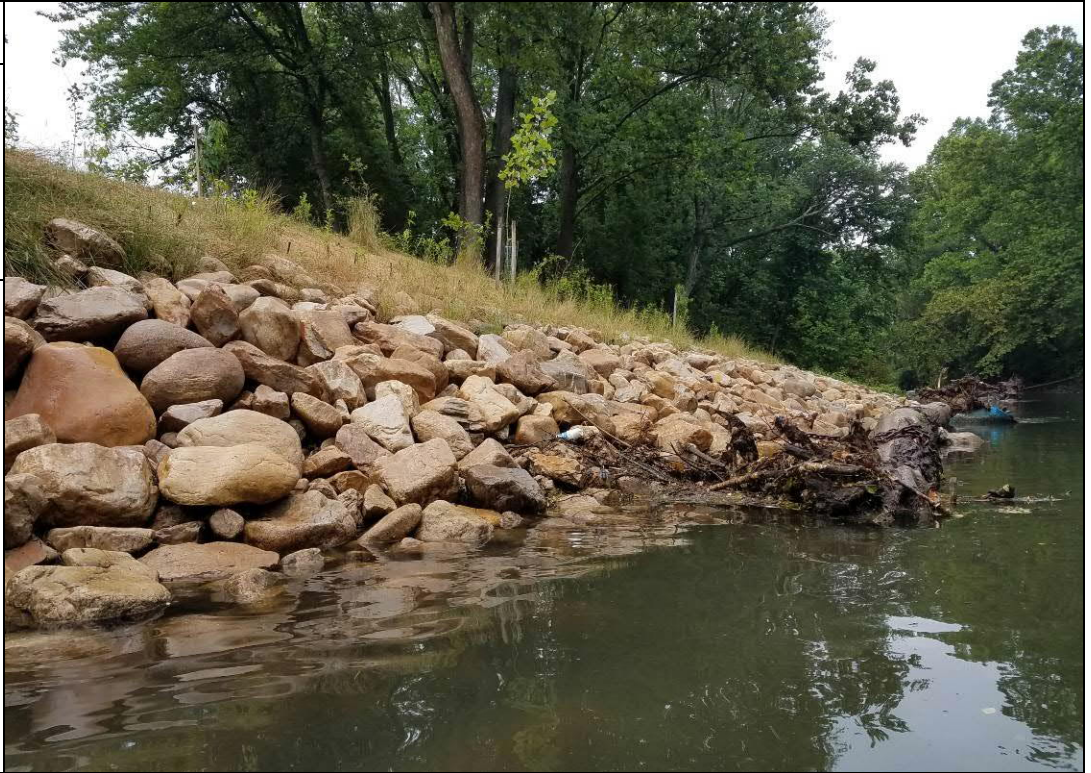
**Photo No.**  
31

Station 00 + 750'

Downstream view of 00 + 750' showing the beginning of the rock toe.

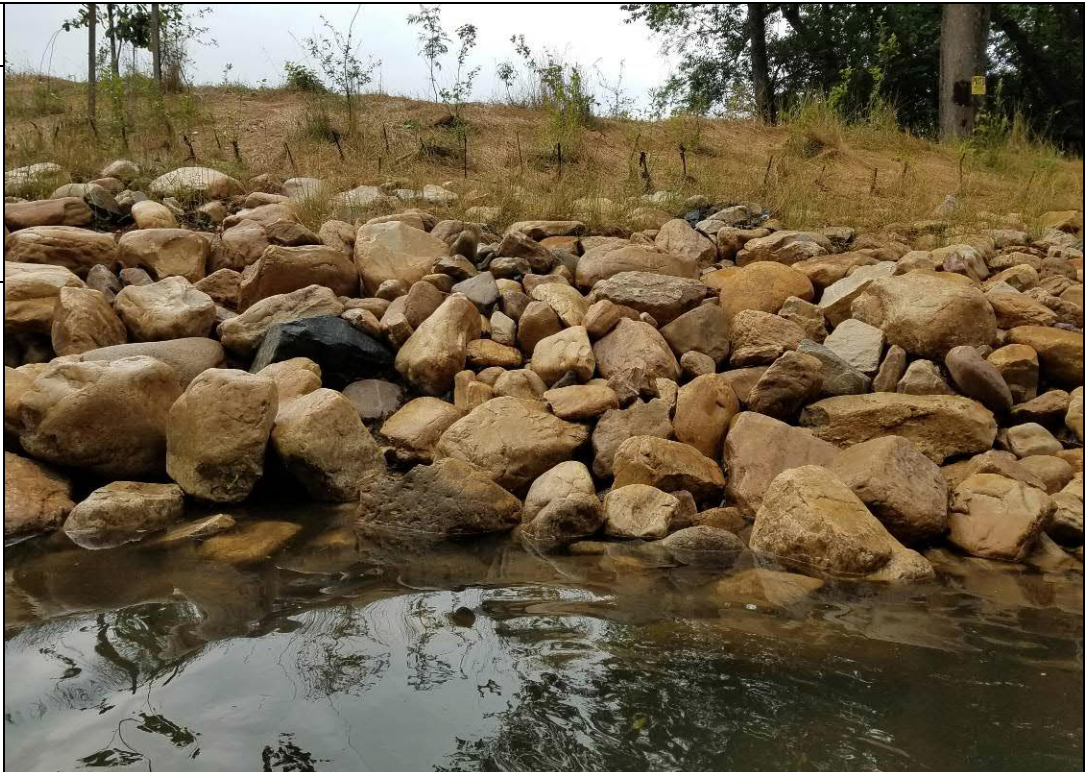
**Photo No.**  
32

Station 00 + 800'

~40 degree bank angle; no scour present; installed rock toe intact; vegetation consists of planted rye grasses and live stakes/saplings.

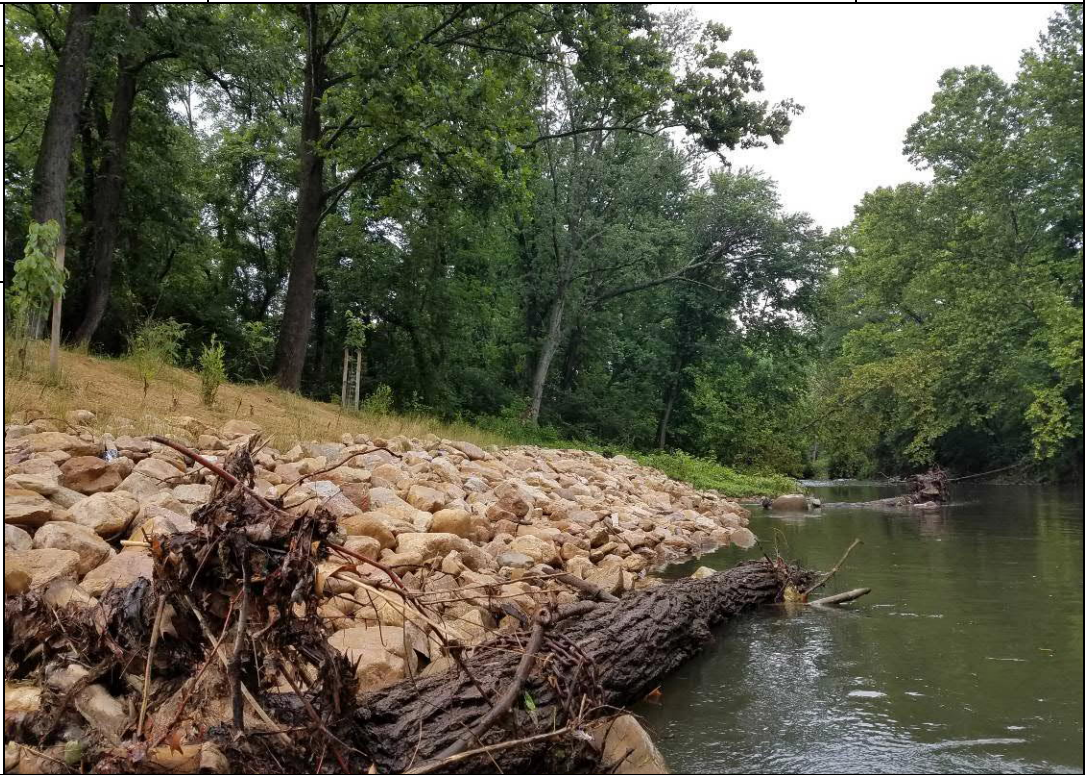
<b>Photo No.</b> 33	<b>Date:</b> 6/21/2018
------------------------	---------------------------

<b>Description:</b>  Station 00 + 800'  Downstream view of 00 + 800'; no scour present; installed rock toe intact; LWD intact.
--

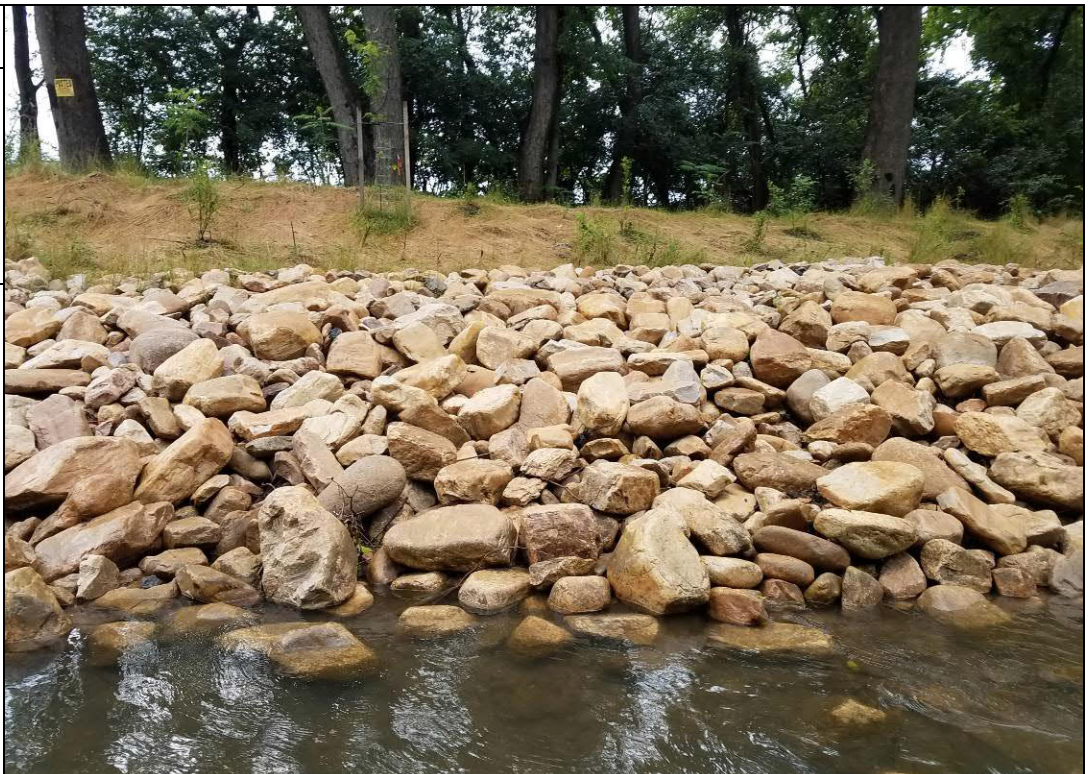
<b>Photo No.</b> 34	<b>Date:</b> 6/21/2018
------------------------	---------------------------

- The installed rock toe was intact and are starting to show evidence of desired sediment deposition in some locations.
- The furthest downstream piece of installed large woody debris (LWD; location 00+850') has shifted due to spring/summer high flows and is now projecting into the stream channel at an angle; all other LWD features were stable and anchor chains were intact.
- Geocell and erosion control fabric were intact and showed no sign of wear.
- No scour was documented at the toe of slope within the remediated portions of the BMA.

<b>Description:</b>  Station 00 + 850'  ~25-30 degree bank angle; no scour present; installed rock toe intact; vegetation consists of planted grasses and live stakes/samplings. LWD moved from original position.
--

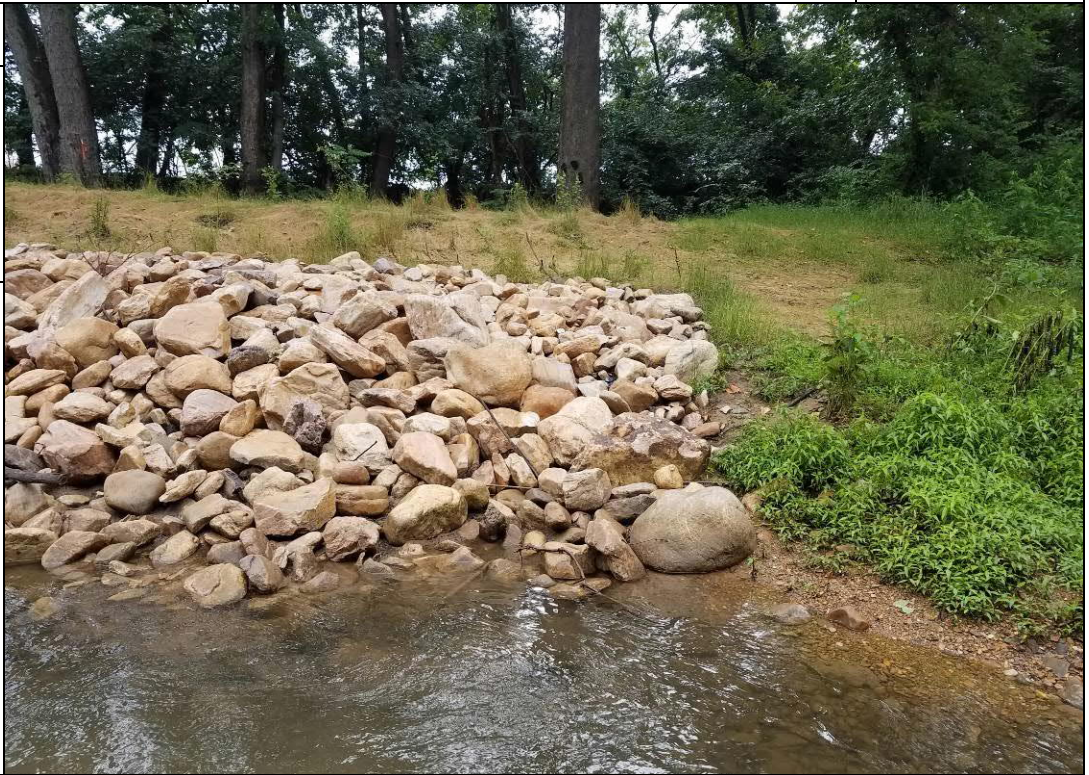
<b>Photo No.</b> 37	<b>Date:</b> 6/21/2018
------------------------	---------------------------

<b>Description:</b>  Station 00 + 880'  ~20 degree bank angle; no scour present; installed rock toe intact; vegetation consists of grasses, trees and live stakes; some erosion control fabric exposed at top of slope where herbaceous vegetation has died back.
--

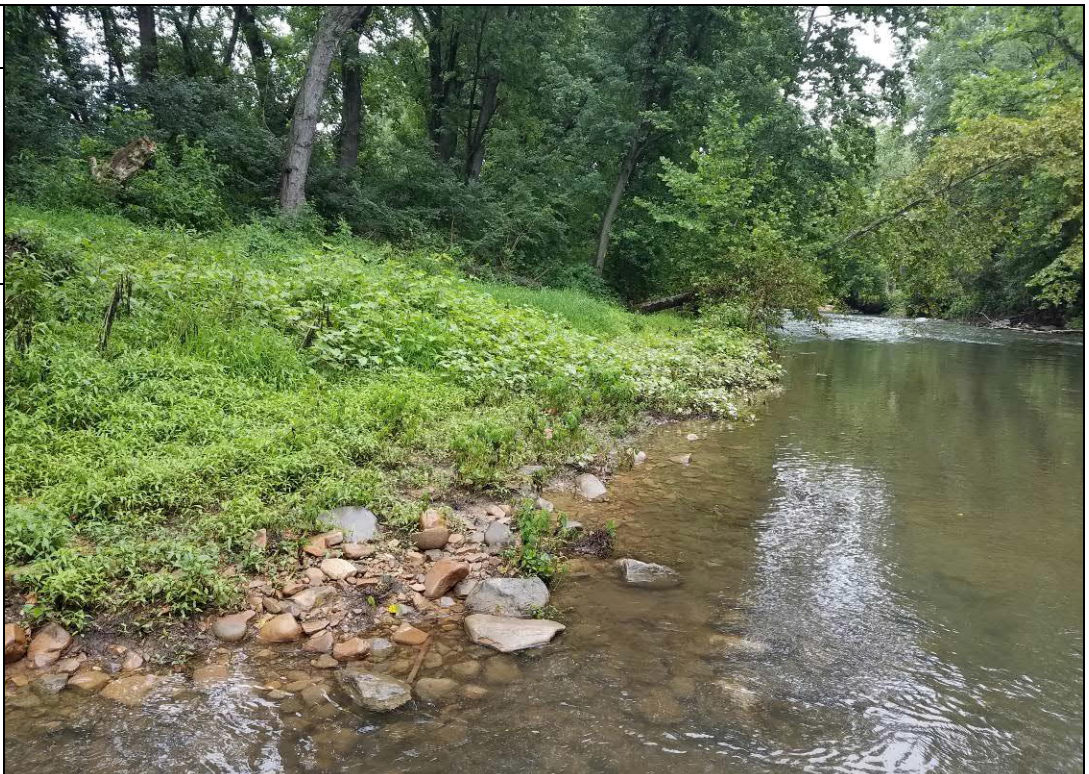
<b>Photo No.</b> 38	<b>Date:</b> 6/21/2018
------------------------	---------------------------

<b>Description:</b>  Station 00 + 880'  Downstream view of 00 + 880' at the end of the remedial footprint.
--
