**Re: Constitution Park and Allied Ready Mix Bank Management Area  
Post-Construction Bank Repair Memo  
South River AOC 4, Waynesboro, Virginia  
EPA ID# VAD003114832**

**Project name:**  
Former DuPont Waynesboro Site  
Area of Concern 4

**Subject:** Constitution Park and Allied Ready Mix Bank Management Area  
Post-Construction Bank Repair Memo

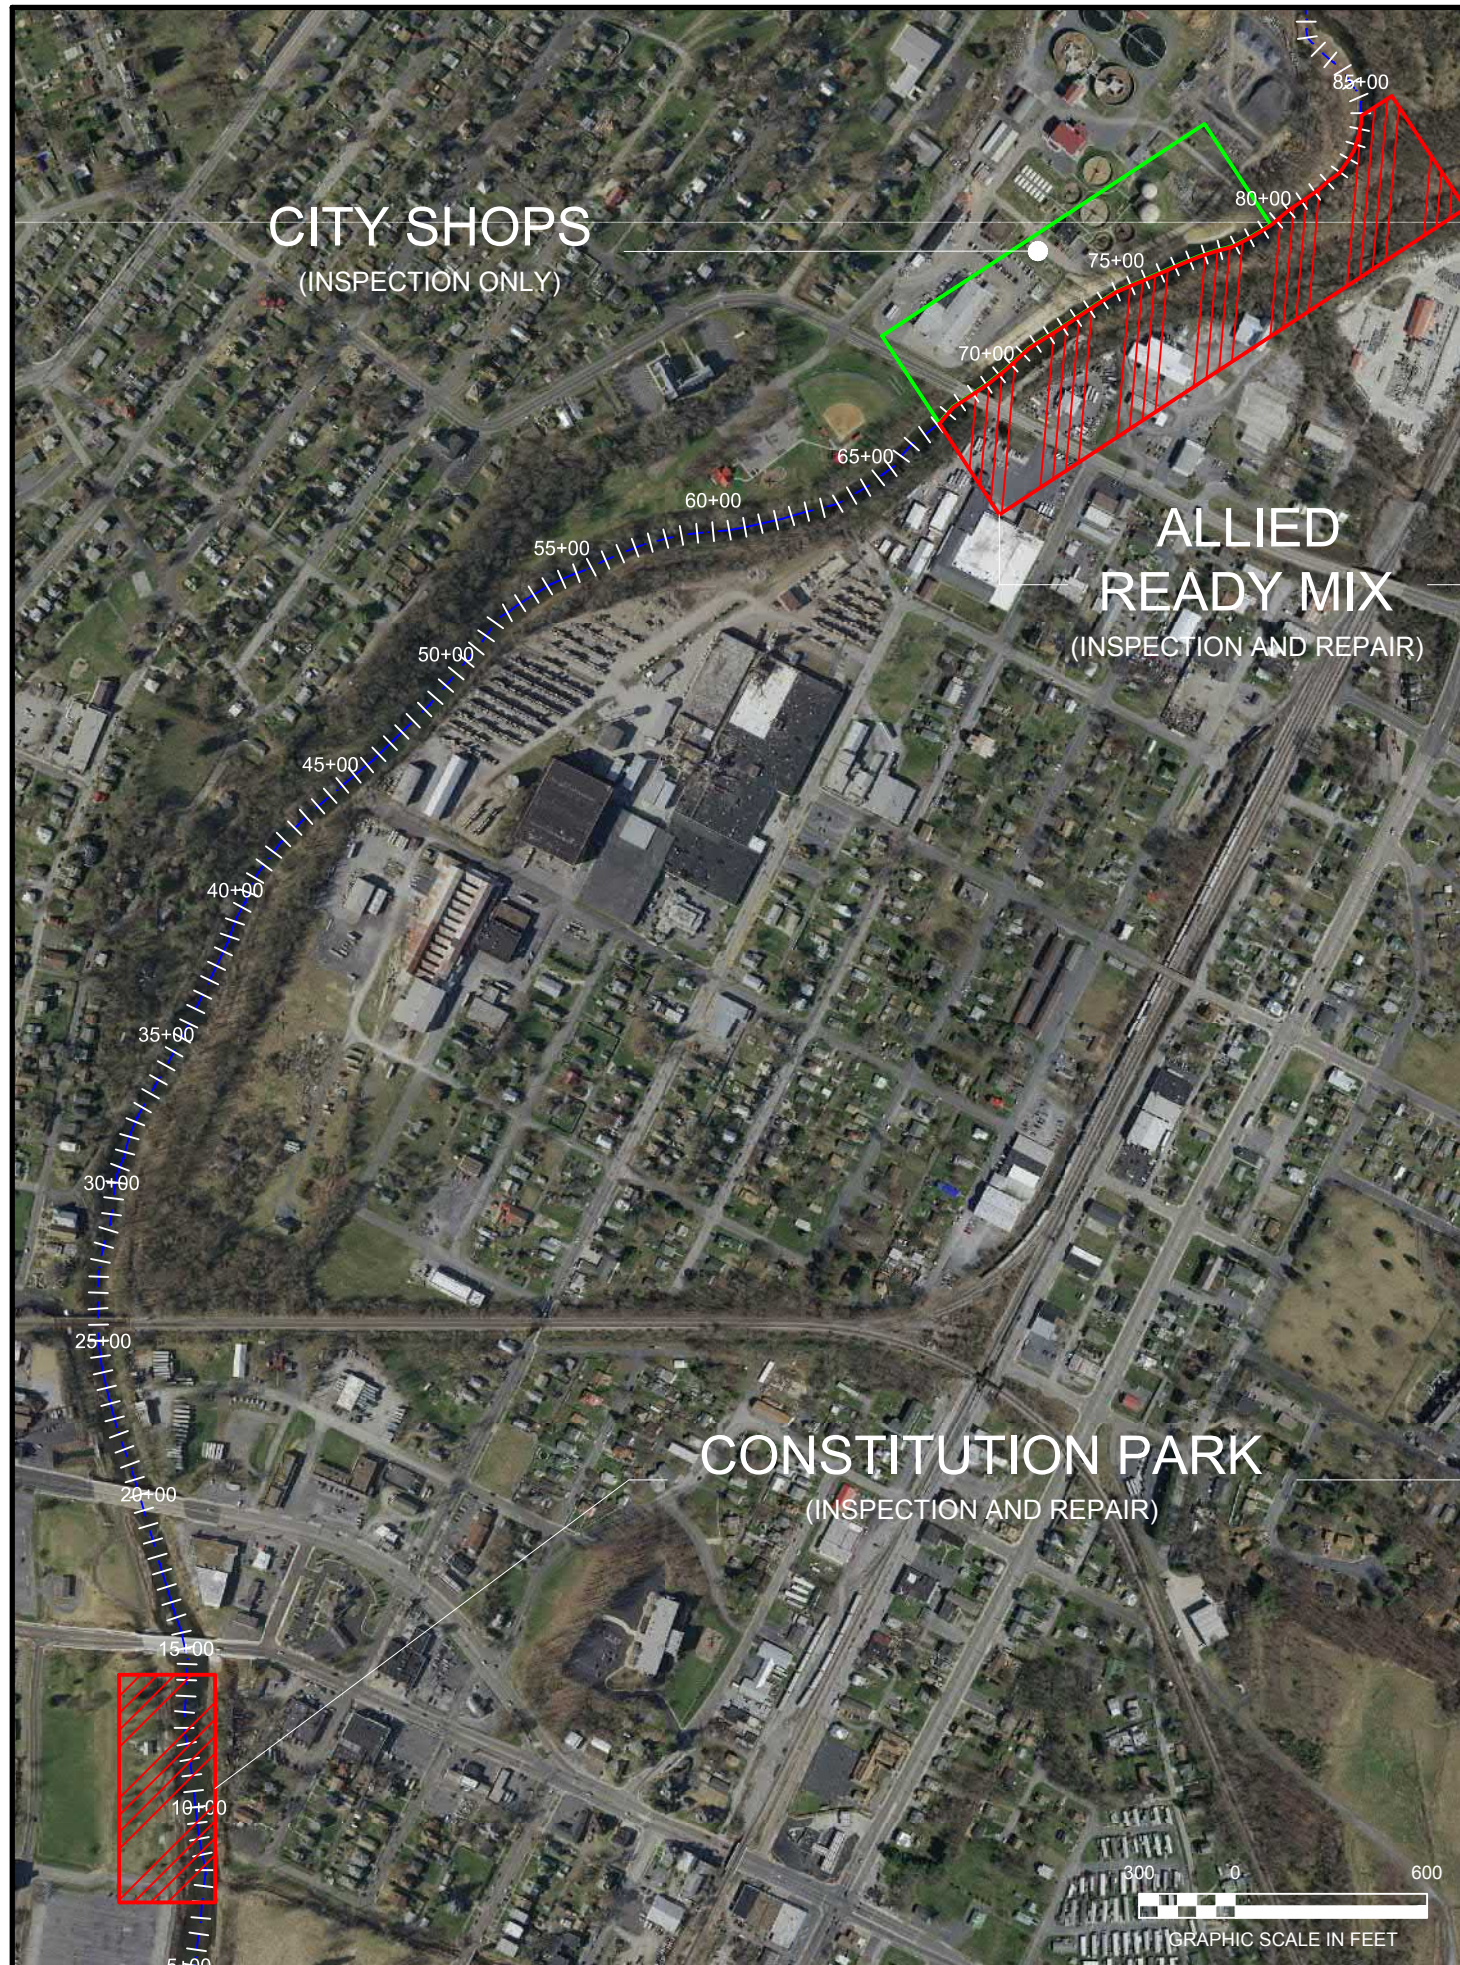
**FIGURE 1 - 2018/2019 POST-CONSTRUCTION INSPECTION AND BANK REPAIR AREAS**  
**SOUTH RIVER - ACO 4 - FORMER DUPONT WAYNESBORO SITE**  
DUPONT, WAYNESBORO, VA  
PROJECT NUMBER: 60594242

This memorandum documents Bank Management Area (BMA) repair activities completed at the Constitution Park (CP) and Allied Ready Mix (ARM) BMAs in April and May 2019. The need for corrective action was identified during the Winter 2018/2019 Leaf-off inspections that were conducted in accordance with the Maintenance Plan included as Appendix M of the Basis of Design Report, Phase 1A BMAs, South River AOC 4 (Anchor QEA et al., 2016). Corrective actions included backfilling soil into geocells, replacement of worn erosion control fabric, and planting of native vegetation. This memo will briefly describe the inspection findings, and summarize the design, and construction of the corrective actions performed at CP and ARM BMAs.

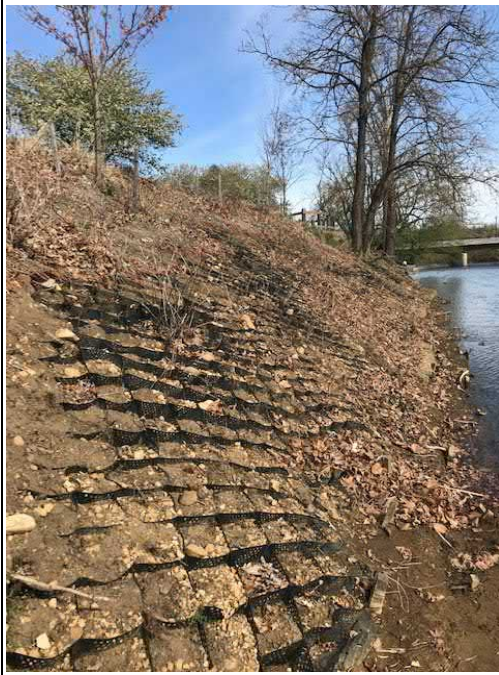
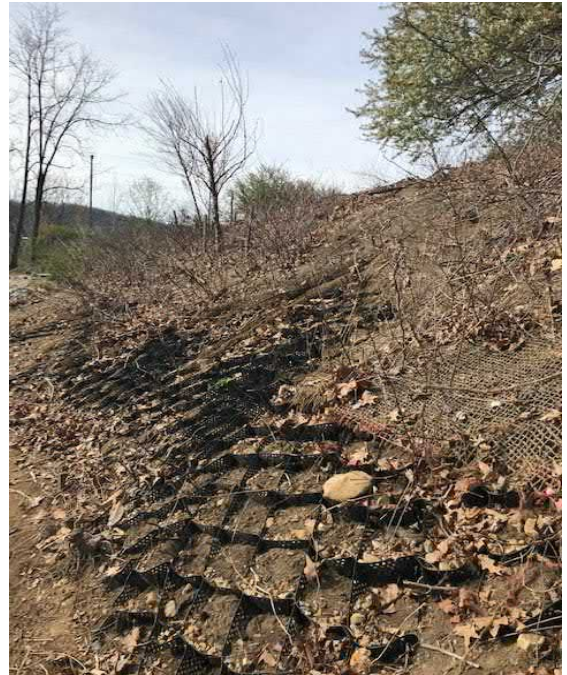
Removal of the old coir matting along slope at Constitution Park

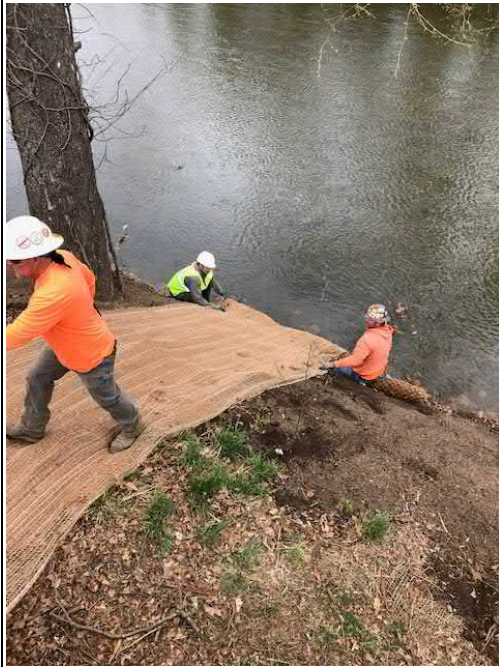
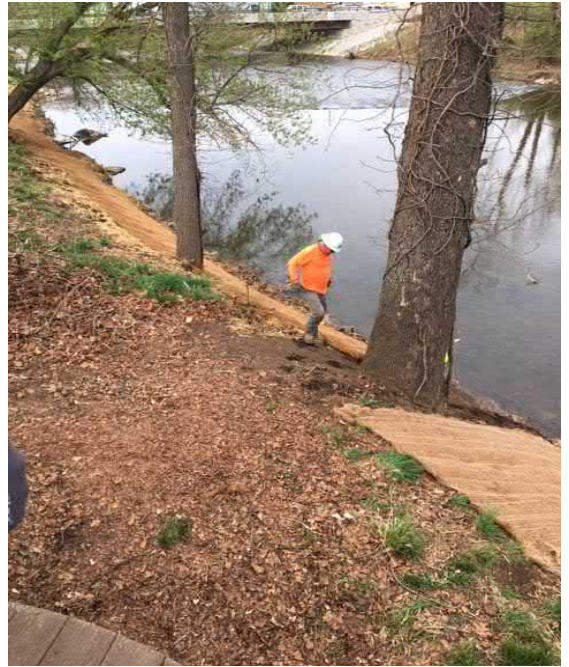
Placing the erosion control blanket over the areas backfilled and seeded.

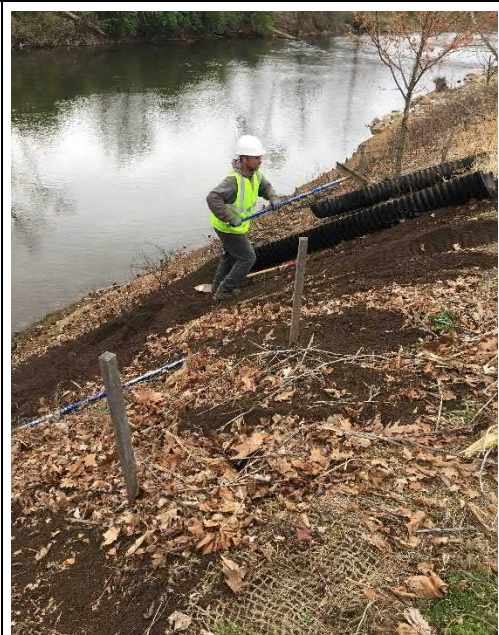
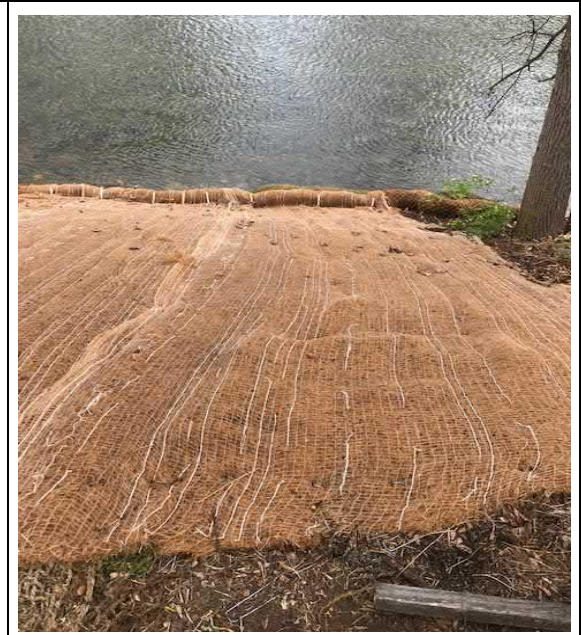
Title: Constitution Park  
 Date: 4/12/2019  
 Description:  
 Placing planting substrate material in geocell.  
 Erosion control jute mat installed on slopes.

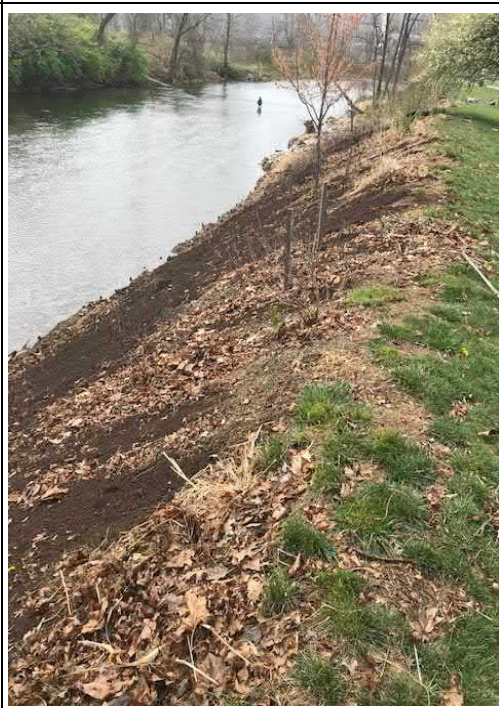
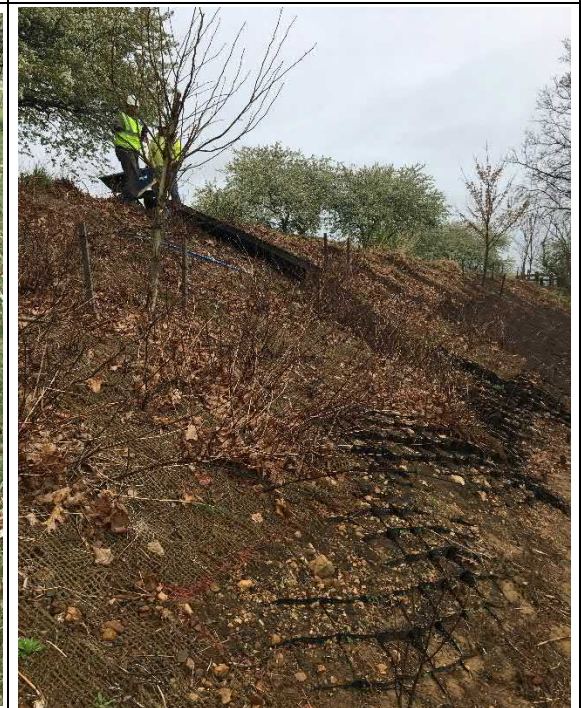
Title: Constitution Park  
 Date: 4/12/2019  
 Description:  
 Planting substrate mix backfilled in exposed geocell.  
 Summit placing planting substrate in geocell along slope.

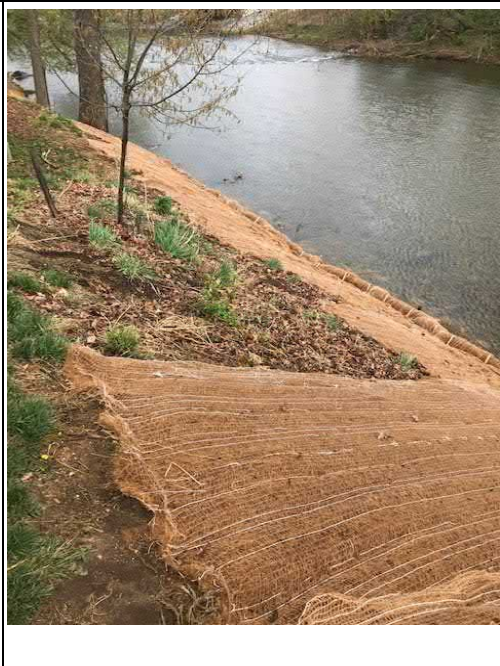
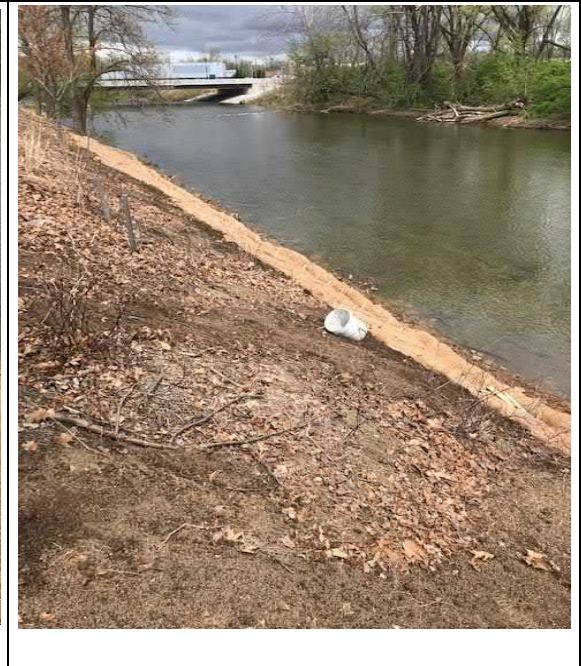
Title: Constitution Park  
 Date: 4/12/2019  
 Description:  
 Areas along slope covered with Erosion control matting after backfilled with planting substrate material, fertilizer, and seed.

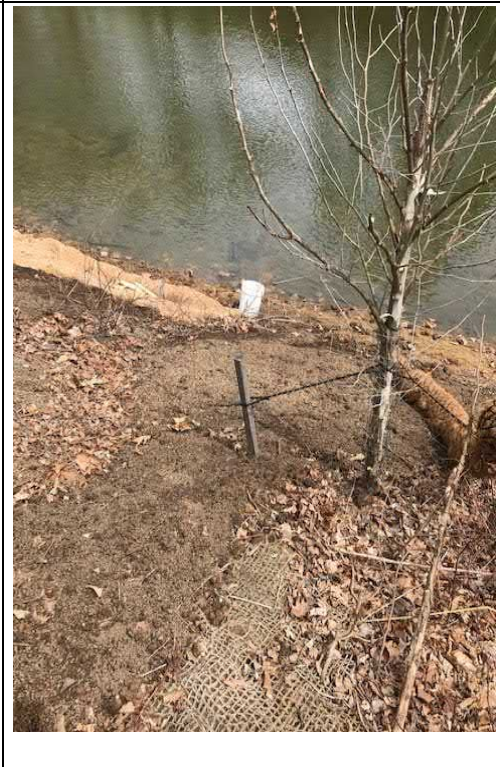
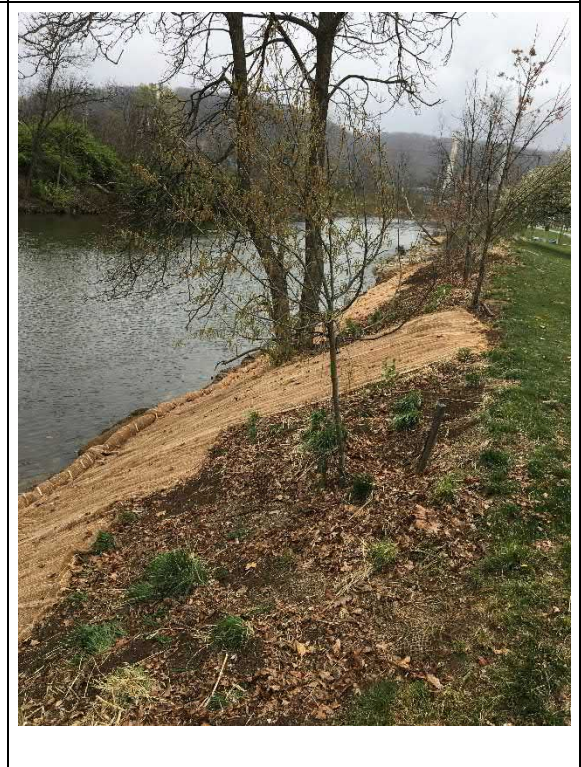
Title: Constitution Park.  
 Date: 4/12/2019  
 Description:  
 Erosion control blanket over the areas backfilled and seeded.

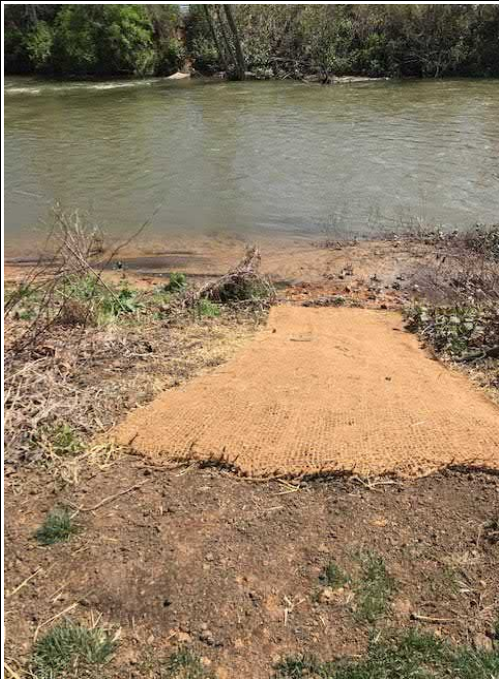
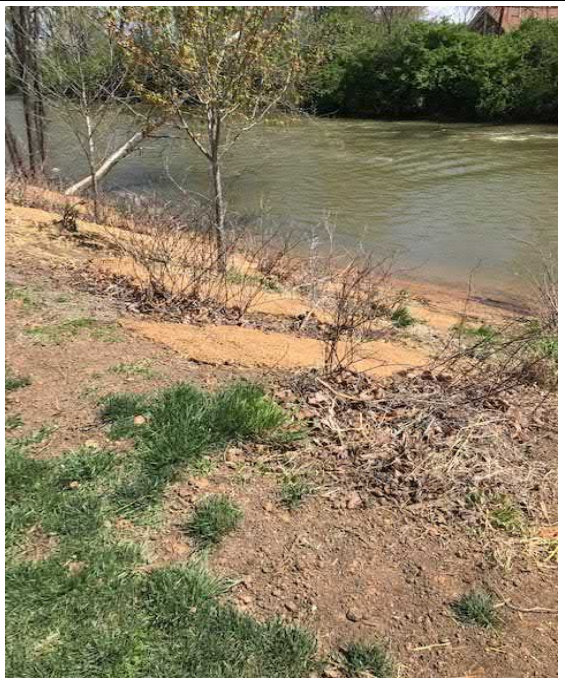
Title: Constitution Park  
 Date: 4/15/2019  
 Description:  
 Area south of the stone stairs.

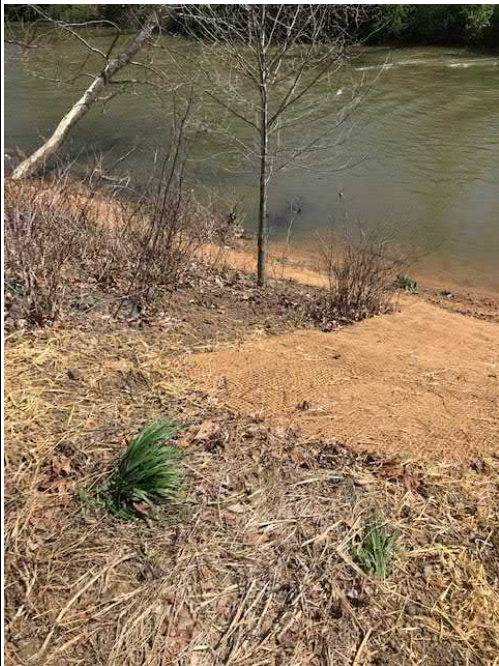
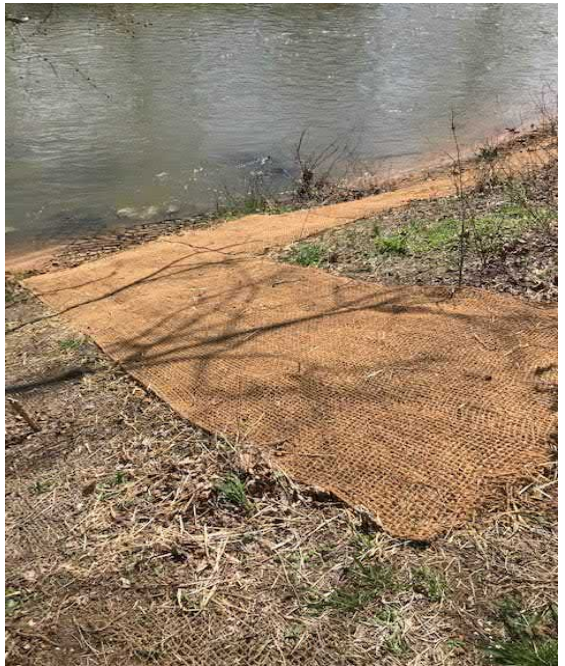
Title: Constitution Park  
 Date: 4/15/2019  
 Description:  
 Areas completed south of stone stairs.

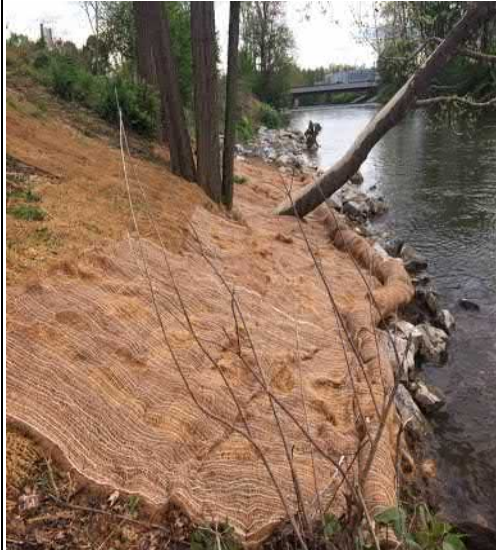
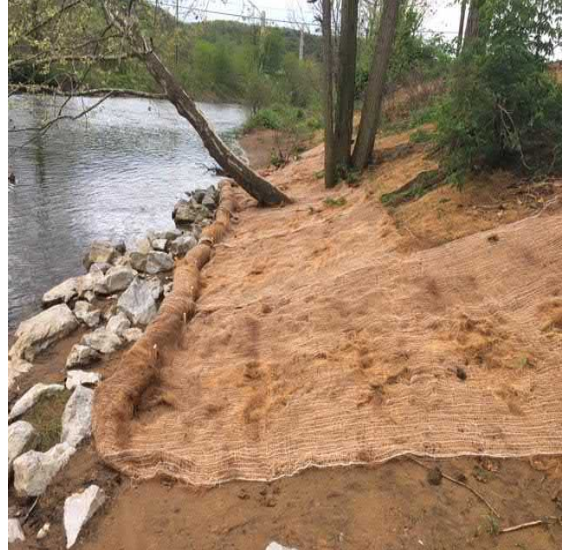
Completed repairs to bottom of slope south of the stone stairs in the southern area of Constitution Park.

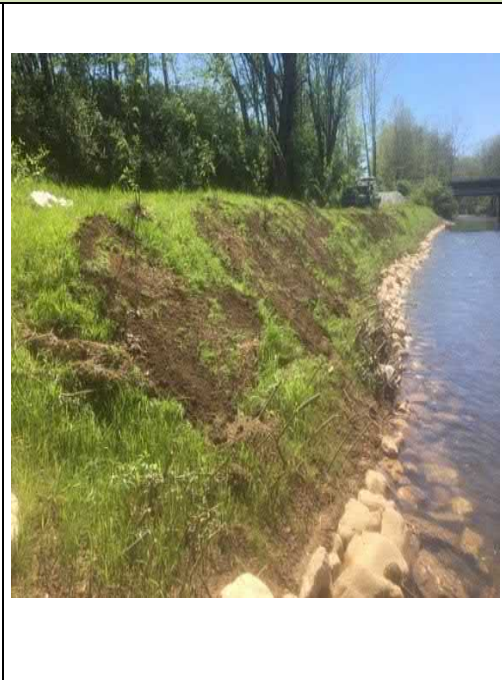
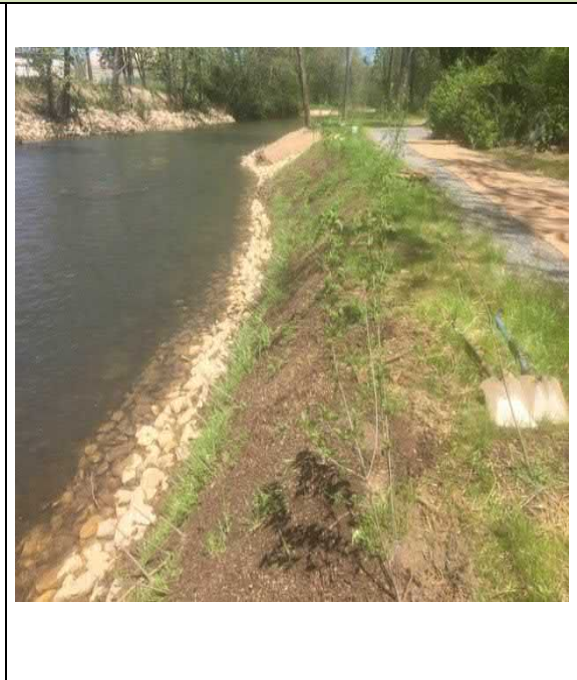
Title: ARM Site  
 Date: 4/27/2019  
 Description:  
 Completed Repair to critical slope reduction area. Removed old coir matting from slope, backfilled geocell with planting substrate and seeded.

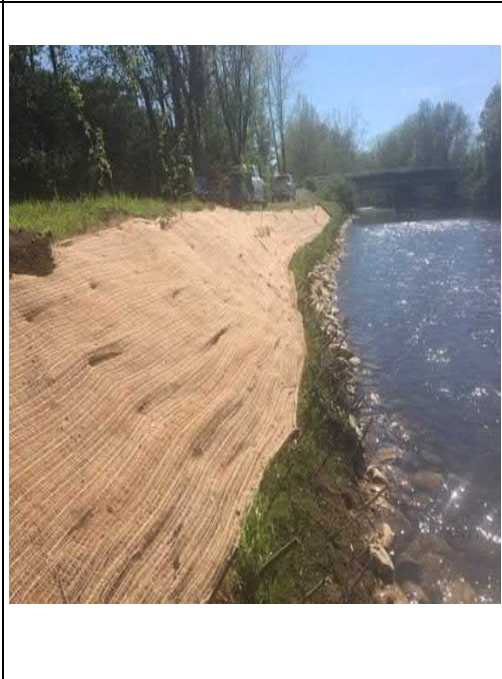
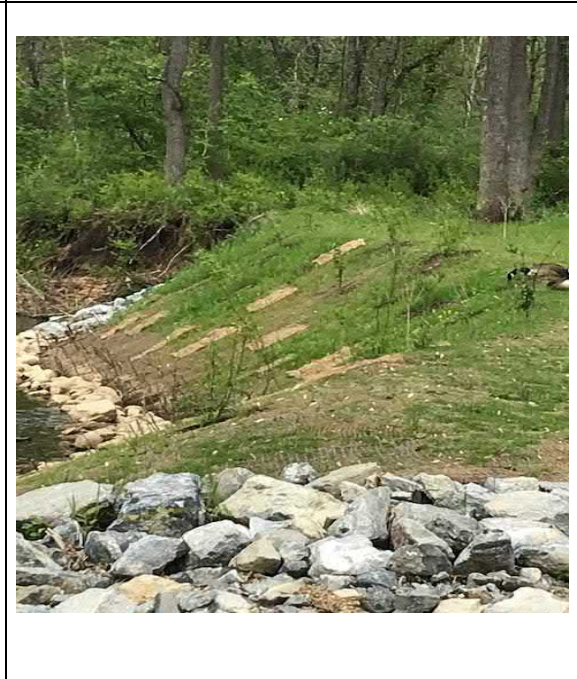
Title: ARM Site  
 Date: 4/27/2019  
 Description:  
 Critical slope reduction area covered with new coir matting (Erosion control blanket).  
 Areas patched in Primary BMA B.

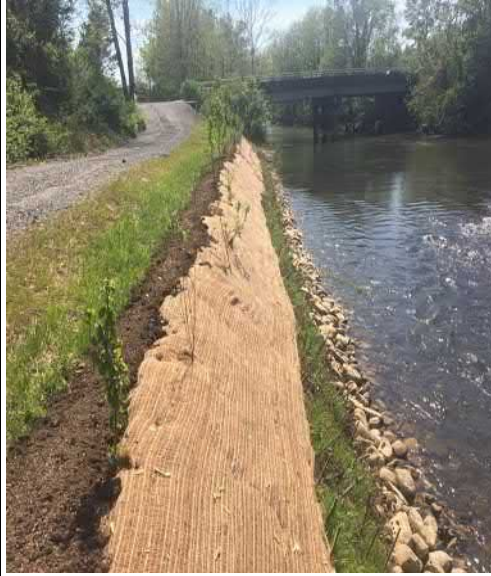
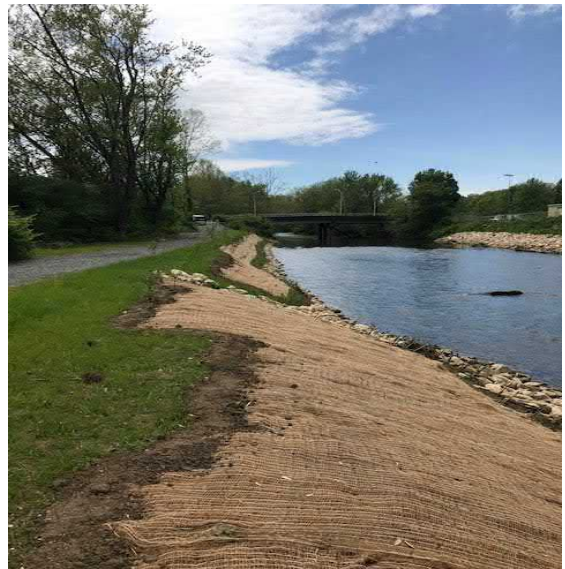
Title: ARM Site  
Date: 4/29/2019  
Description:  
Completed repairs at ARM site.

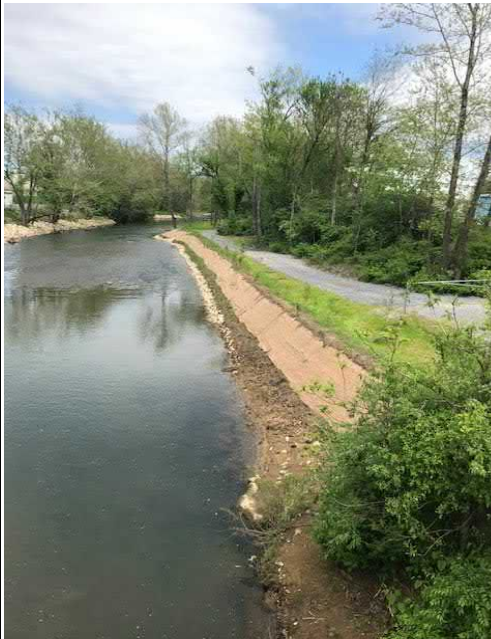
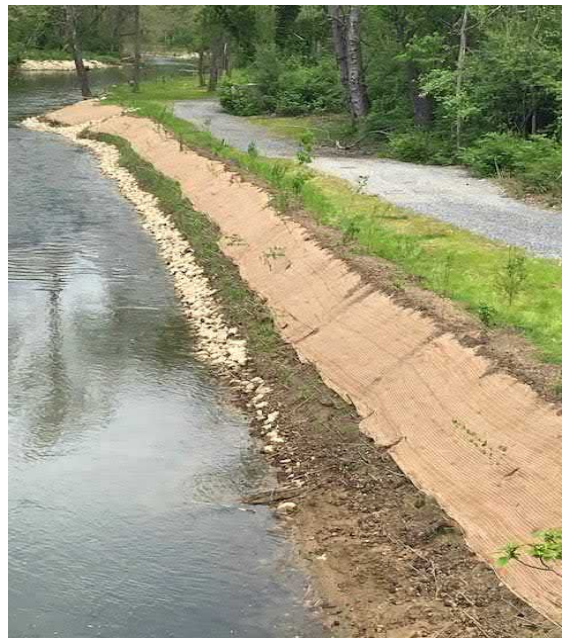
Title: ARM Site  
Date: 4/27/2019  
Description:  
Critical slope reduction area completed

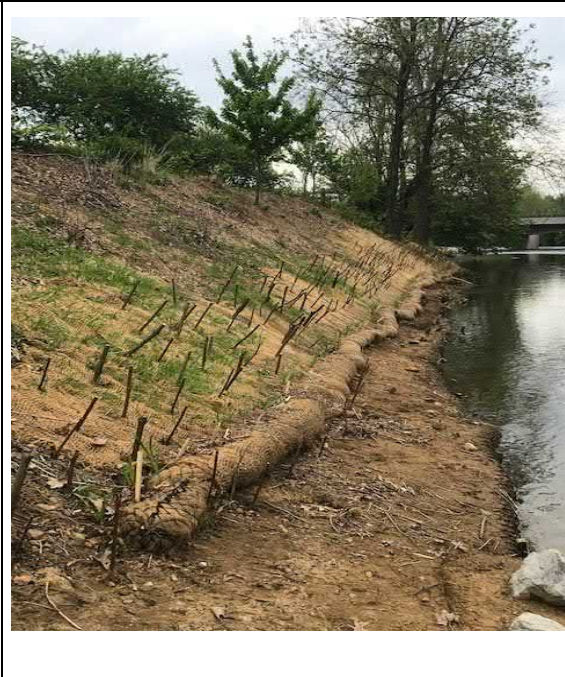
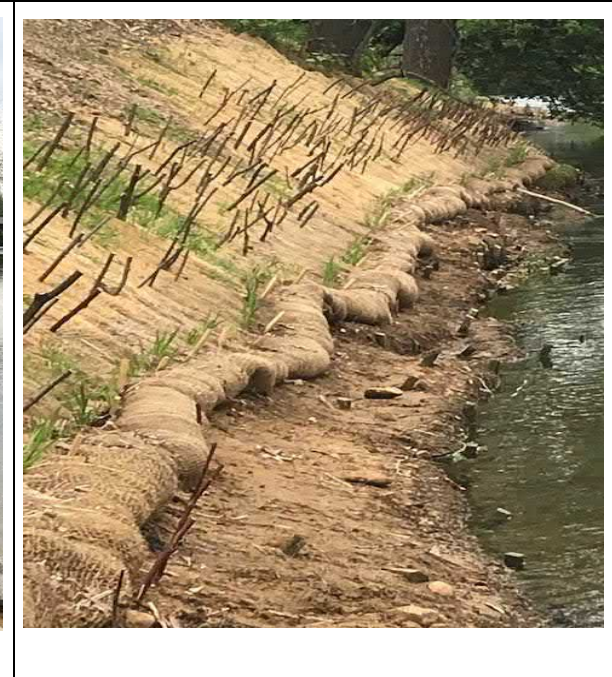
Title: Constitution Park  
 Date: 4/30/2019  
 Description: Live stakes and plugs installed

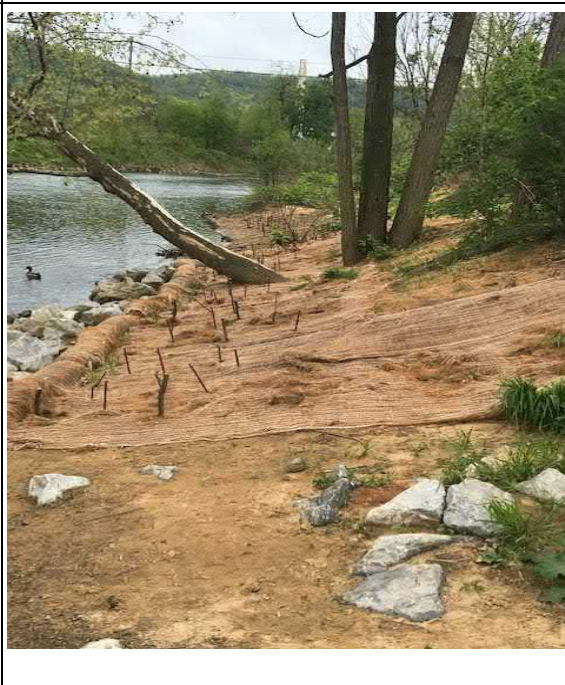
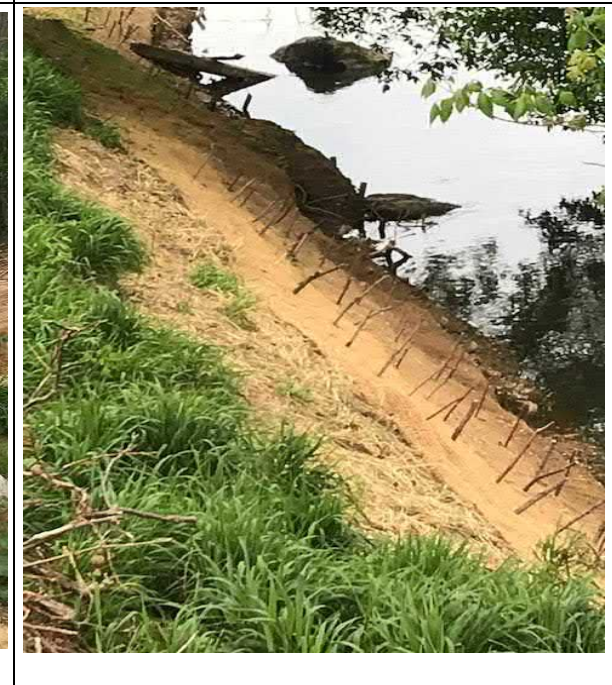
Title: Constitution Park  
 Date: 4/30/2019  
 Description: Live Stakes and Plugs installed.

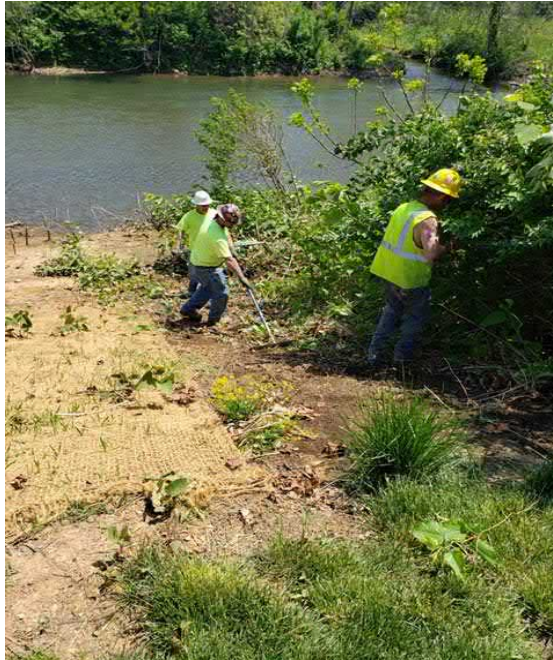
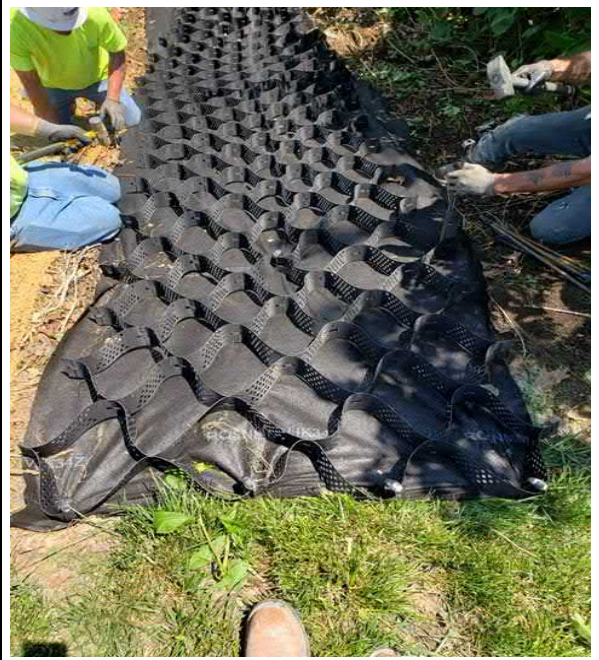
Description: Summit clearing area for access path to river for fisherman.

Non-woven geotextile and 3" geocell placed down slope and anchored in place with rebar.

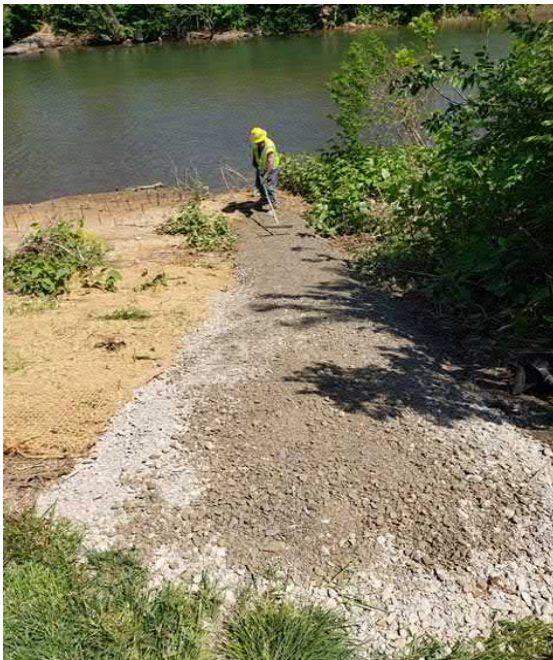
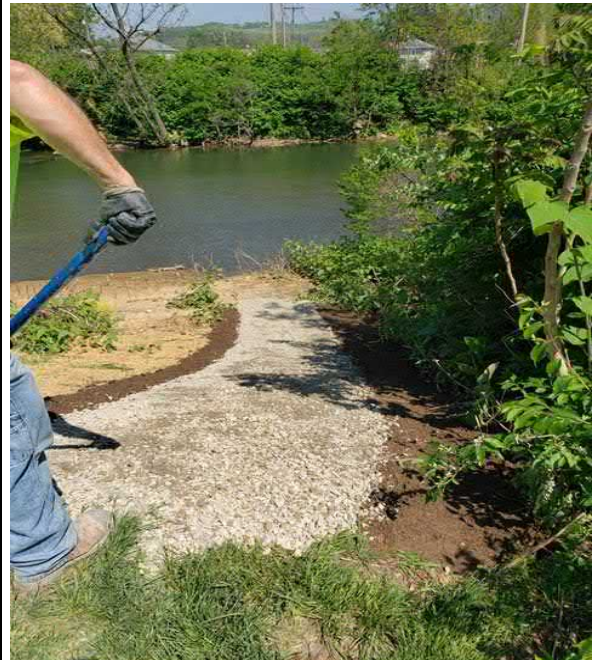
Description: Crush-n-run stone placed in geocell.

Planting substrate added to both sides of geocell.

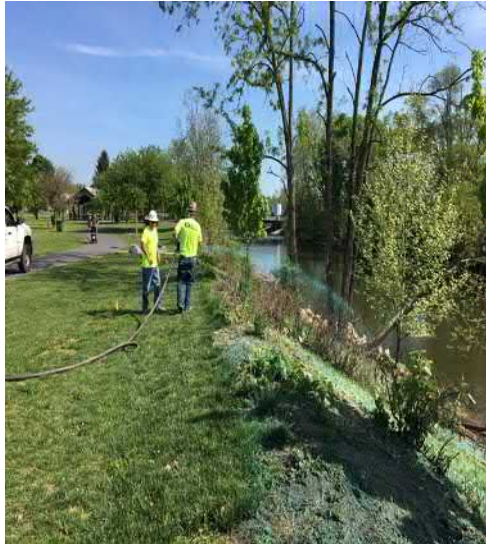
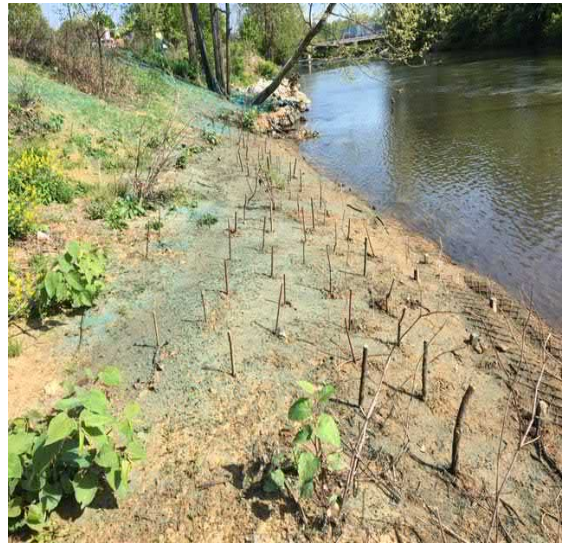
Hydroseeding the slopes after repairs made

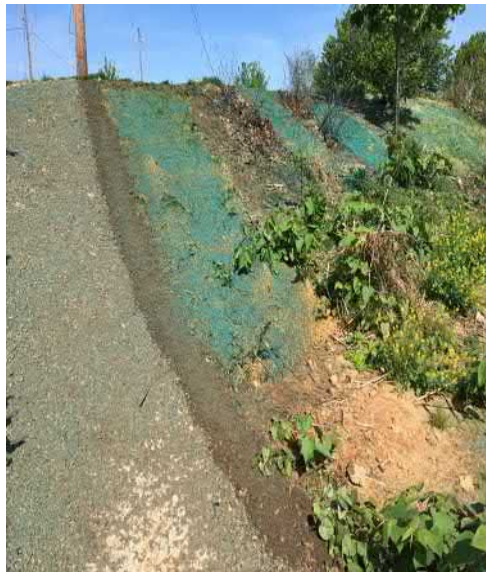
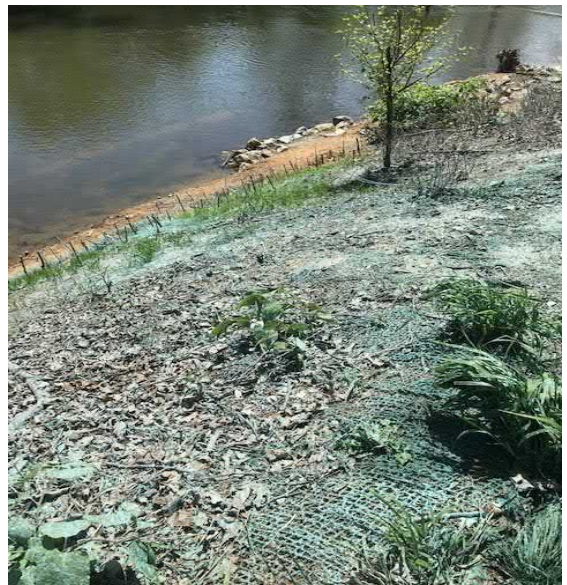
Areas hydroseeded.

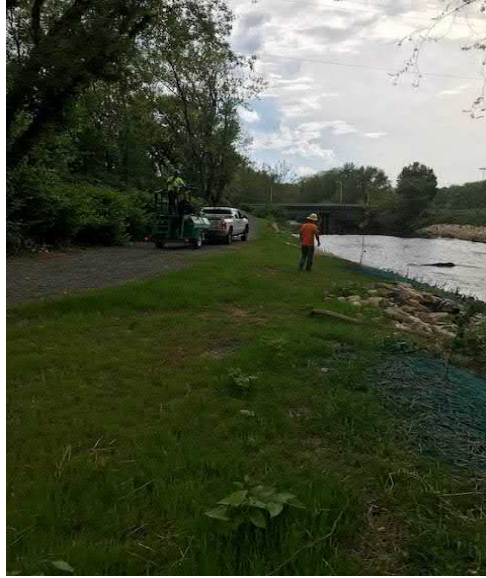
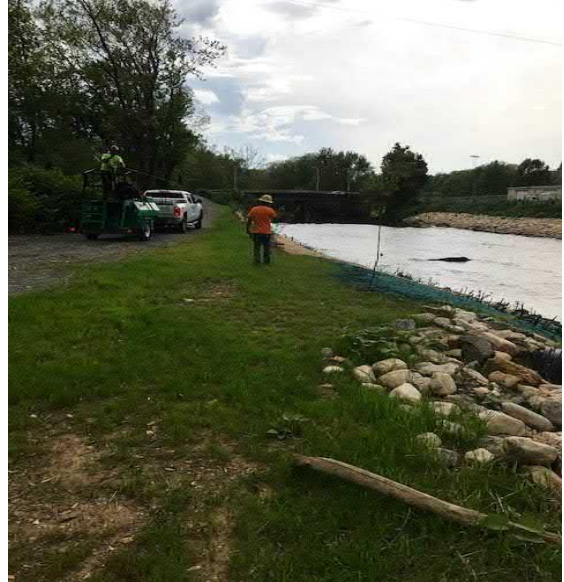
Title: ARM Site  
 Date: 5/2/2019  
 Description:  
 Summit Hydroseeding  
 the Critical Slope  
 Reduction area.

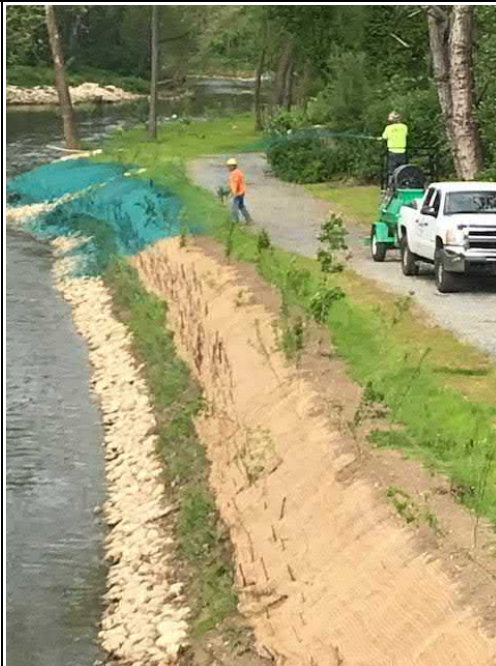
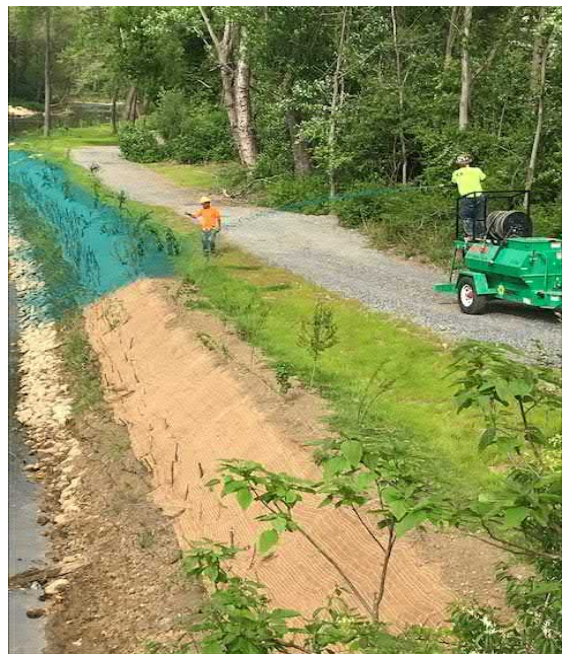
Title: ARM Site  
 Date: 5/2/2019  
 Description: Summit  
 Hydroseeding the  
 Critical Slope  
 Reduction area.

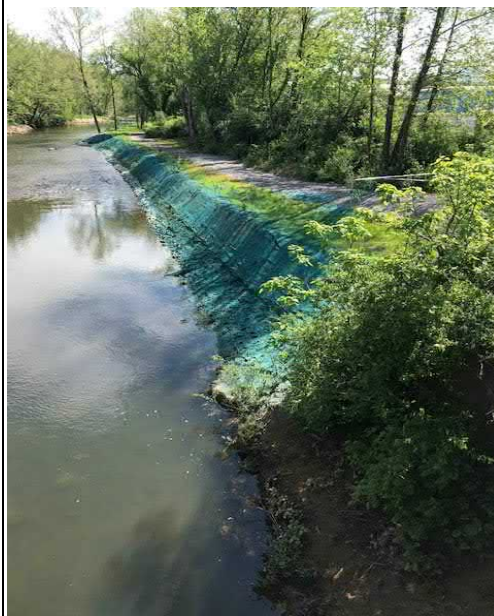
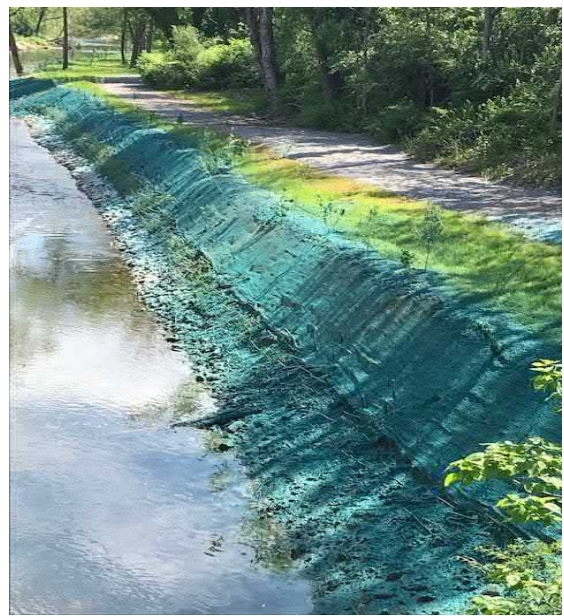
Title: ARM Site  
Date: 5/3/2019  
Description:  
Hydroseeding the slopes after repairs made

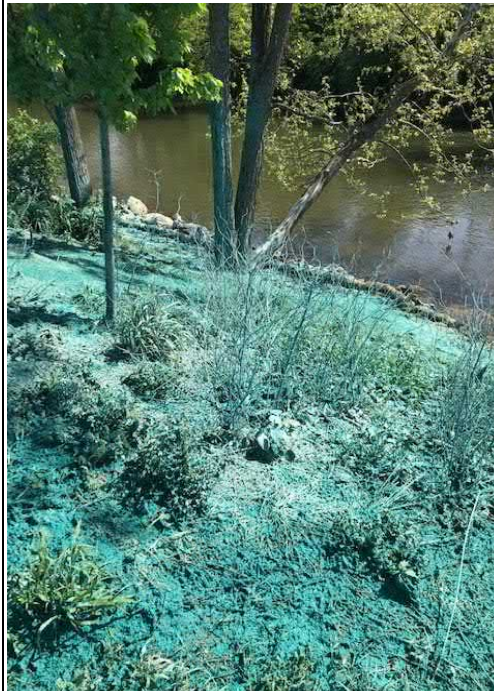
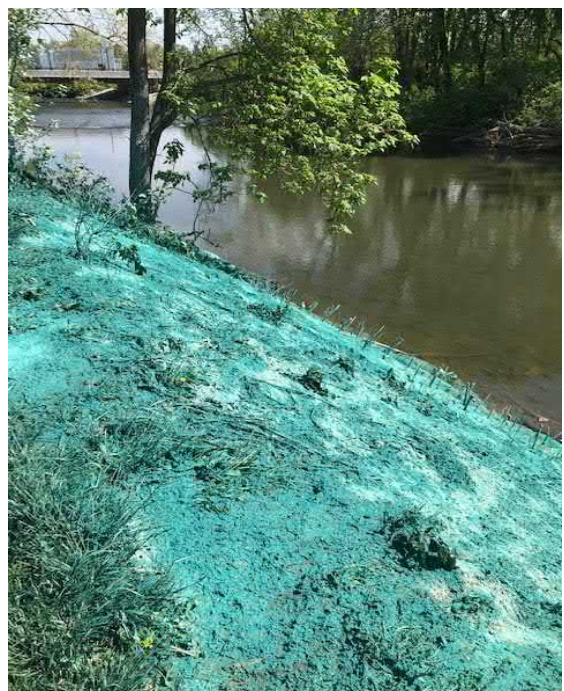
Title: Constitution Park  
Date: 5/3/2019  
Description:  
Areas hydroseeded.
