**Re: 2019 Leaf-on Maintenance Inspection Reports for Allied Ready Mix, City Shops and Constitution Park BMAs
Former DuPont Waynesboro Site, Area of Concern 4
Waynesboro, Virginia
EPA ID# VAD003114832**

To	Michael Liberati, Corteva Environmental Remediation Nancy Grosso, Corteva Environmental Remediation	Page 1 of 3
CC	Cameron Dixon, AECOM Kristy Hoffman, AECOM	
Subject	Constitution Park BMA - 2019 Leaf-on Maintenance Inspection Former DuPont Waynesboro Site, Area of Concern 4	
From	Andrew Miano, AECOM Joshua Collins, AECOM	
Date	August 19, 2019

This memorandum summarizes the 2019 Leaf-on Maintenance Inspection (inspection) of the Constitution Park Bank Management Area (BMA) conducted on June 13th, 2019. Inspection activities were conducted in compliance with the scope described in the Maintenance Plan included as Appendix M of the Basis of Design Report, Phase 1A BMAs, South River AOC 4 (Anchor QEA et al., 2016). The purpose of the maintenance inspection is to identify potential BMA maintenance needs, focusing on vegetative development, bank stability, and the integrity of the installed bank remediation features. This inspection also focused on performance of the repair work com

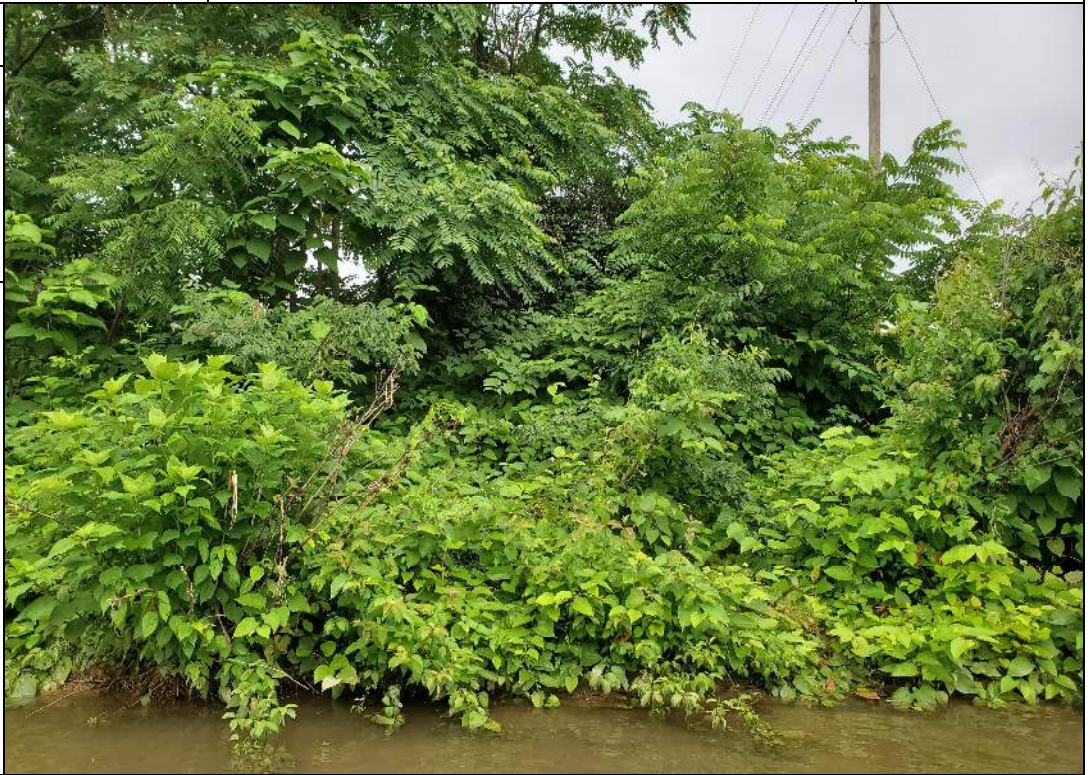
Photo No.
1

Station 00 – 25'

~20 degree lower bank angle; ~55 degree upper bank angle; no at-risk trees present; both native and invasive vegetation present.

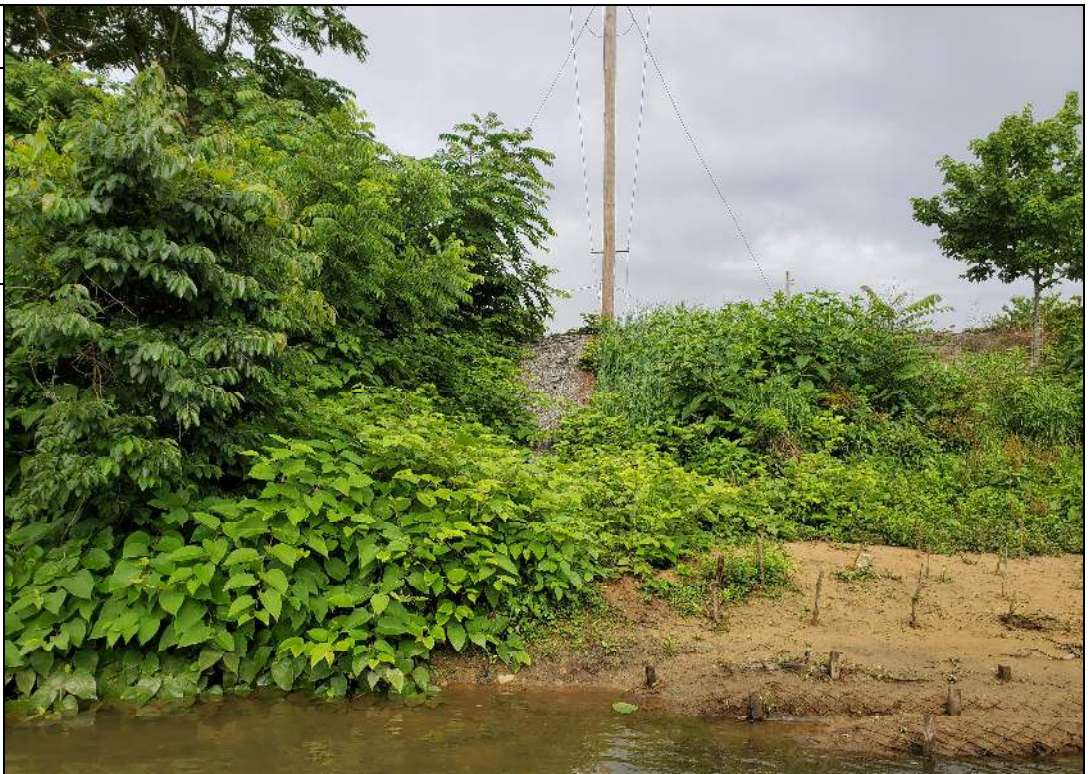
Photo No.
2

Station 00 + 00'

~30 degree lower bank angle; ~55 degree upper bank angle; patches of invasive and native vegetation; coir logs intact; newly installed live stakes ~50% established; evidence of foot traffic along slope; exposed geocell below newly installed gravel path.

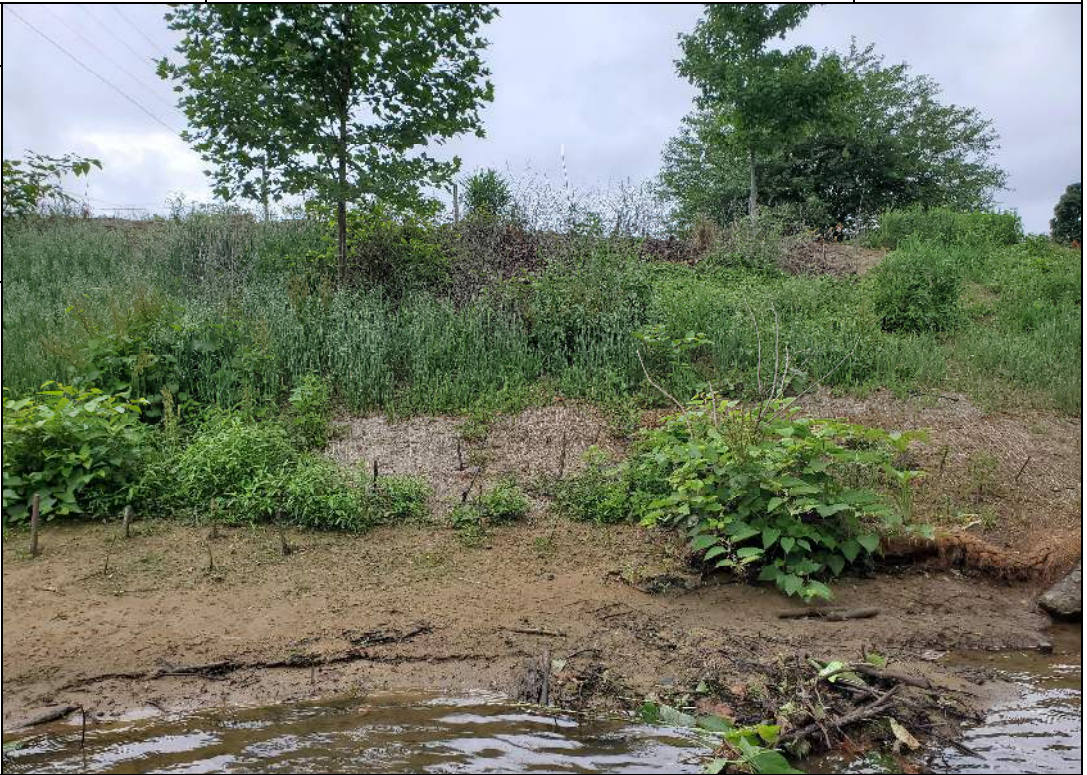
Photo No.: 3	Date: 6/13/2019
------------------------	---------------------------

Description: Station 00 + 50' ~ 45 degree bank angle present; no at-risk trees or exposed roots present; installation of new fabric present and 30% exposed; native vegetation is dominant with patches of invasives; coir logs intact; geocell intact; no scour observed; evidence of foot traffic along toe; planted live stakes 50% established.
--

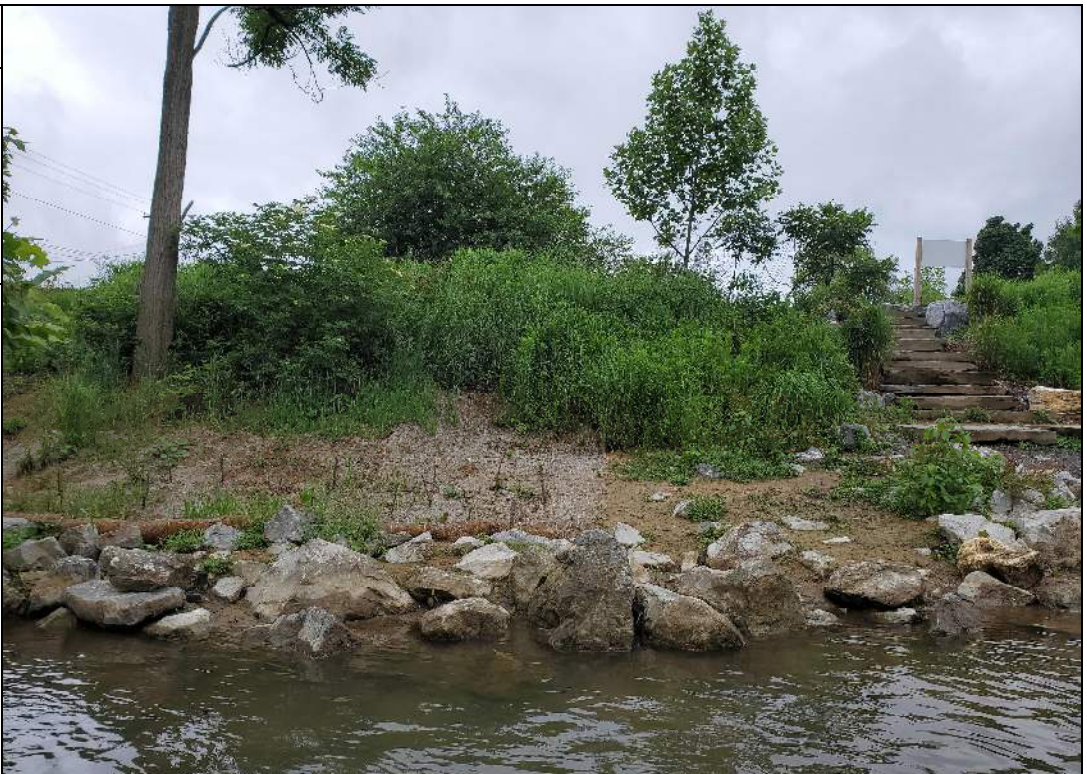
Photo No.: 4	Date: 6/13/2019
------------------------	---------------------------

Description: Station 00 + 100' ~40 degree bank angle; no at-risk trees or exposed roots present; native vegetation is dominant, patches of invasive vegetation present; no scour observed; installed rock toe intact, with evidence of sediment deposition; installed fabric 40% exposed; planted live stakes 50% established.

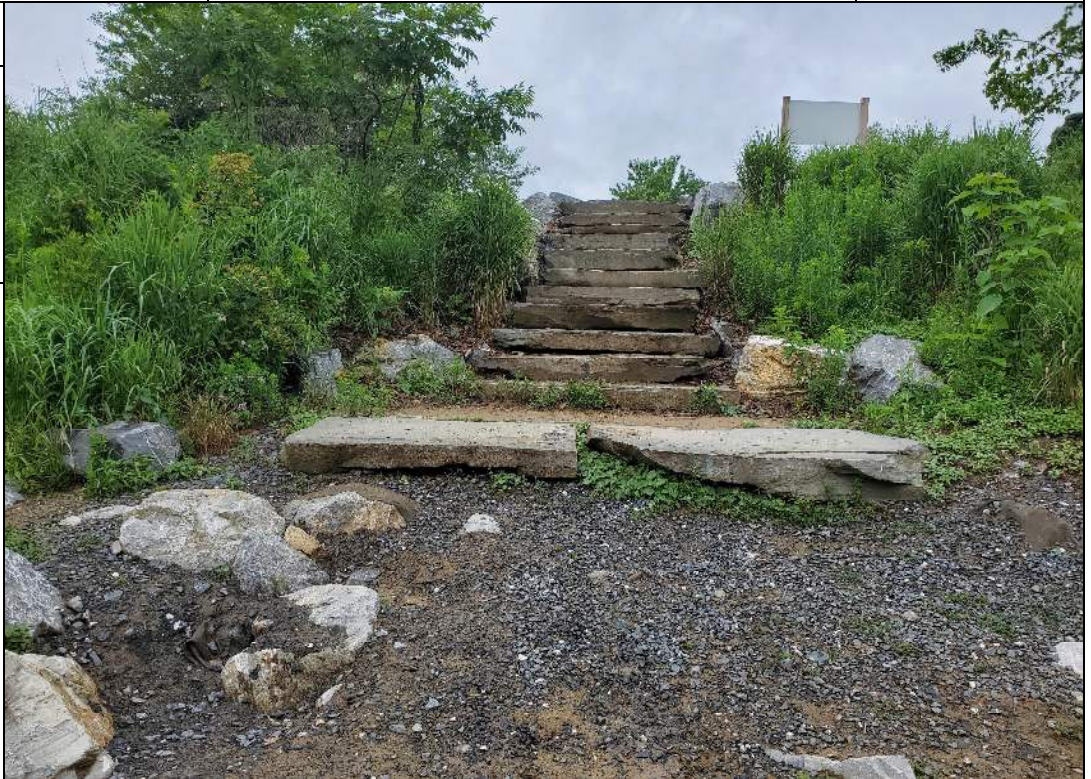
Photo No.
5

Station 00 + 100'

Installed river access steps intact; evidence of disturbance behind installed rock toe, at base of steps; disturbance is possibly due to groundhog or human activities; some fabric exposed in area of disturbance.

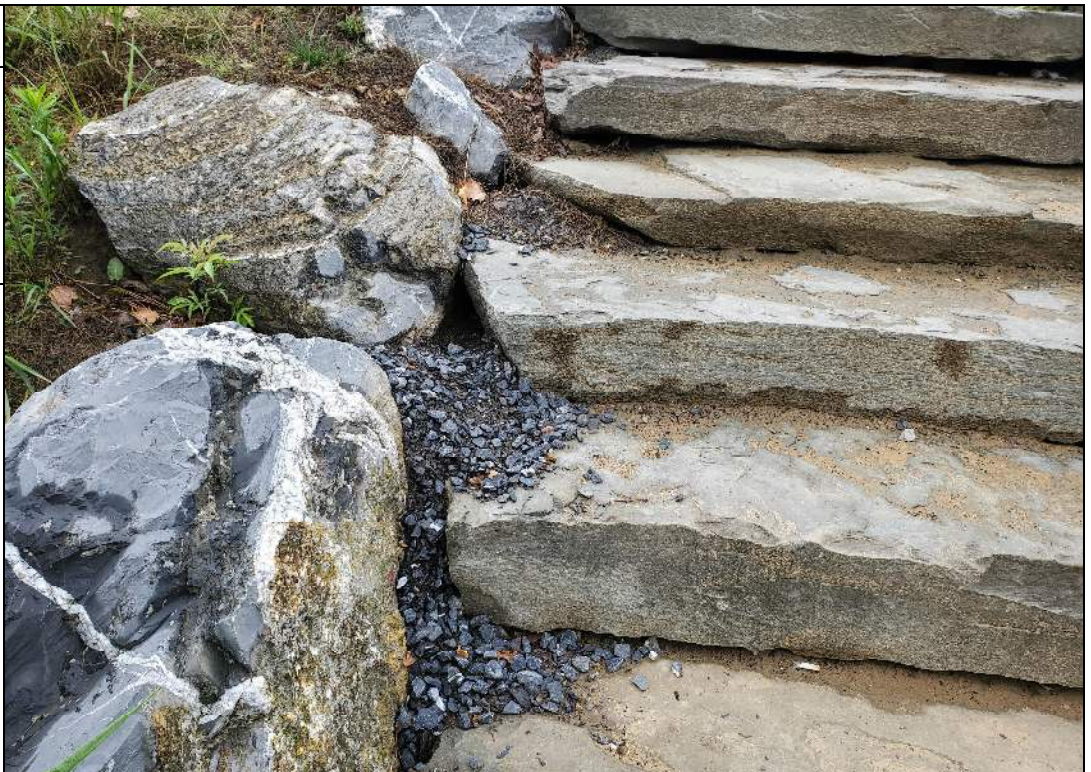
Photo No.
6

Station 00 + 100'

Exposed gravel due to a groundhog burrow adjacent to installed river access steps.

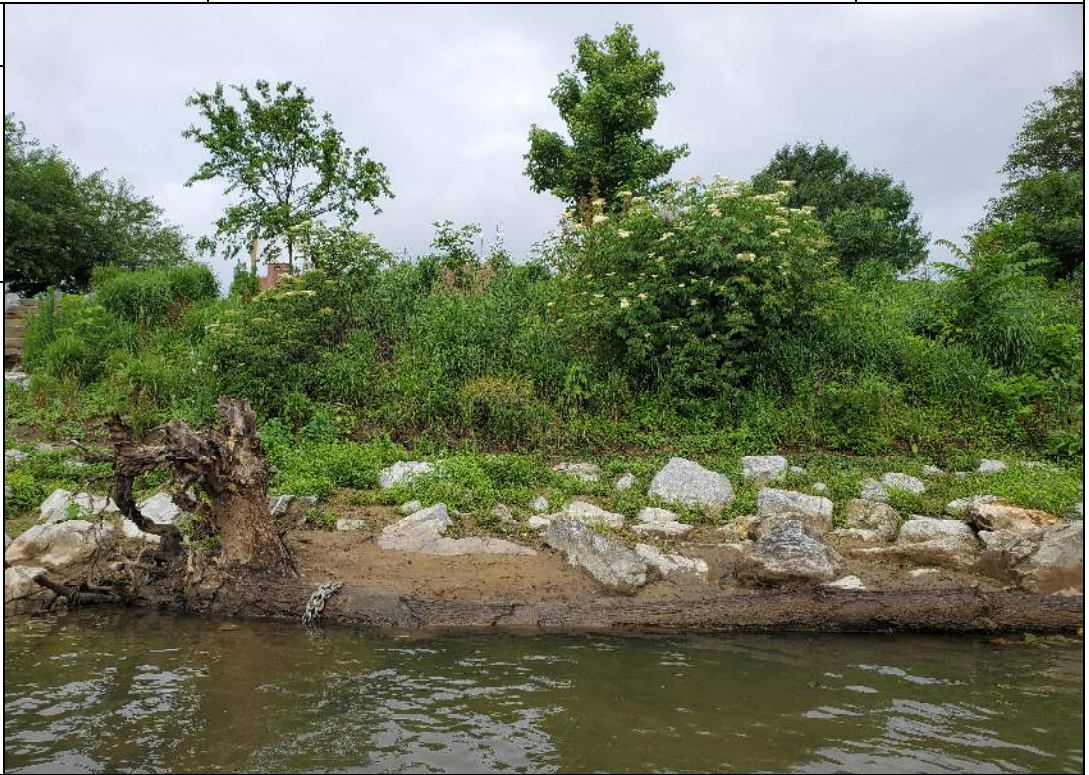
Photo No.: 7	Date: 6/13/2019
------------------------	---------------------------

Description: Station 00 + 150 ~45 degree bank angle; no at-risk trees or exposed roots present; well established native vegetation; no scour observed; installed rock toe and large woody debris (LWD) intact; installed geocell and erosion control fabric intact; evidence of sediment deposition behind LWD.
--

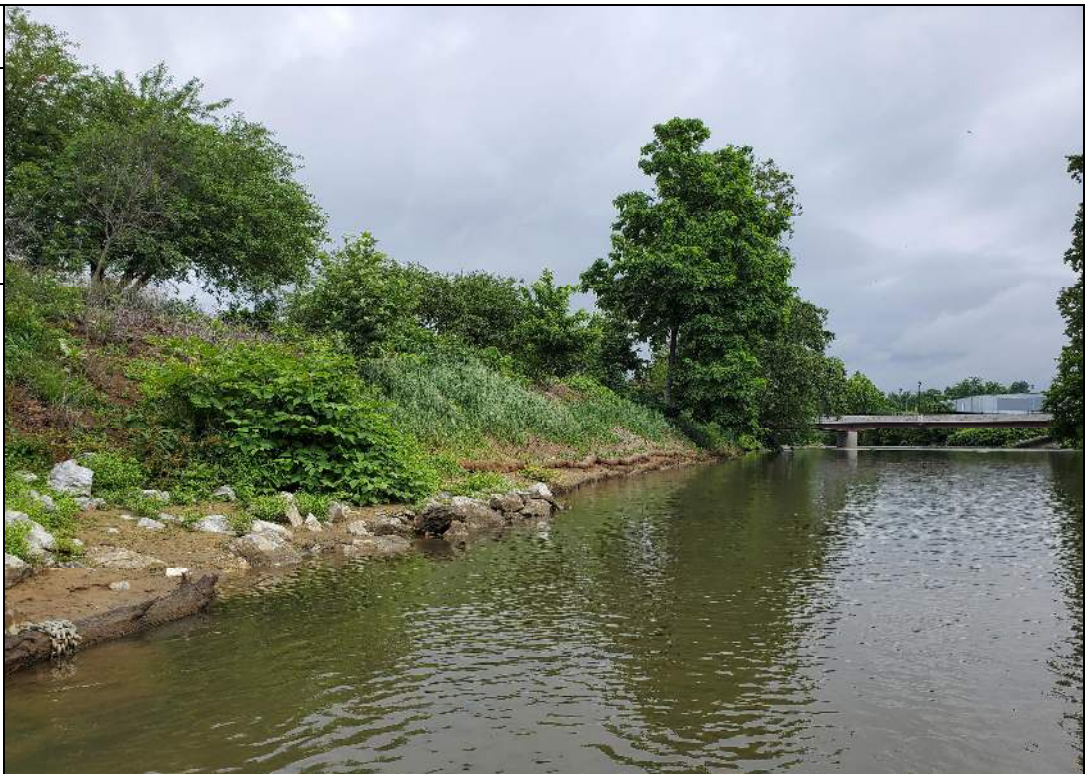
Photo No.: 8	Date: 6/13/2019
------------------------	---------------------------

Description: Station 00 + 150' Installed rock toe intact with evidence of sediment deposition; patches of the invasive knotweed present; increasing establishment of native vegetation

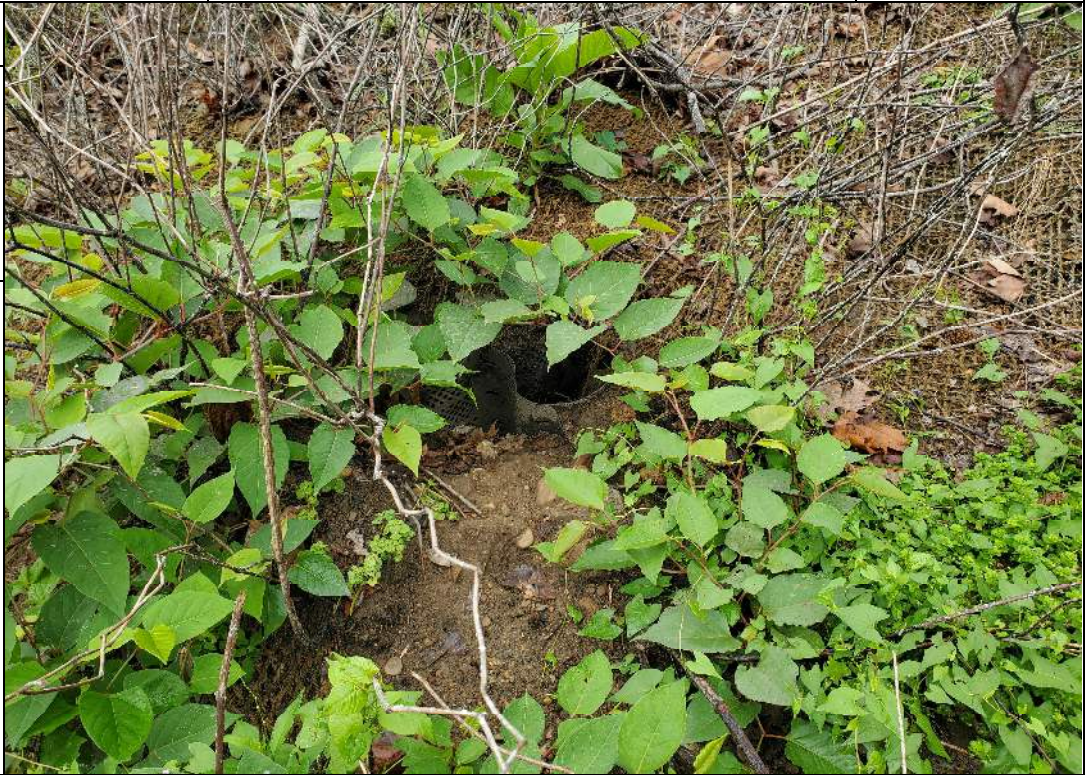
Photo No.:
9

Station 00 + 150'

Groundhog burrow downstream of 00 + 150'; exposed geocell around groundhog burrow.

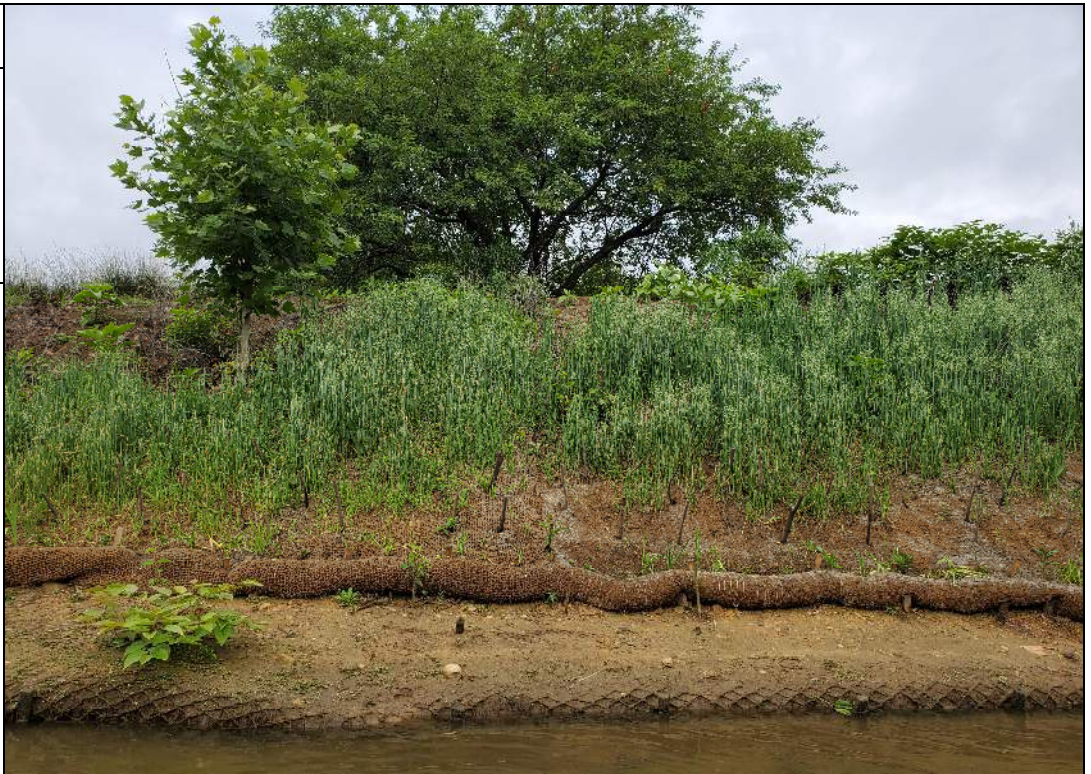
Photo No.:
10

Station 00 + 200'

~55 degree bank angle; increased native grass cover with small patches of invasive vegetation; installed live stakes 50% established; 2" plug plantings remain healthy; no scour observed; erosion control fabric 30% exposed; foot path along coir logs; newly installed coir logs intact.

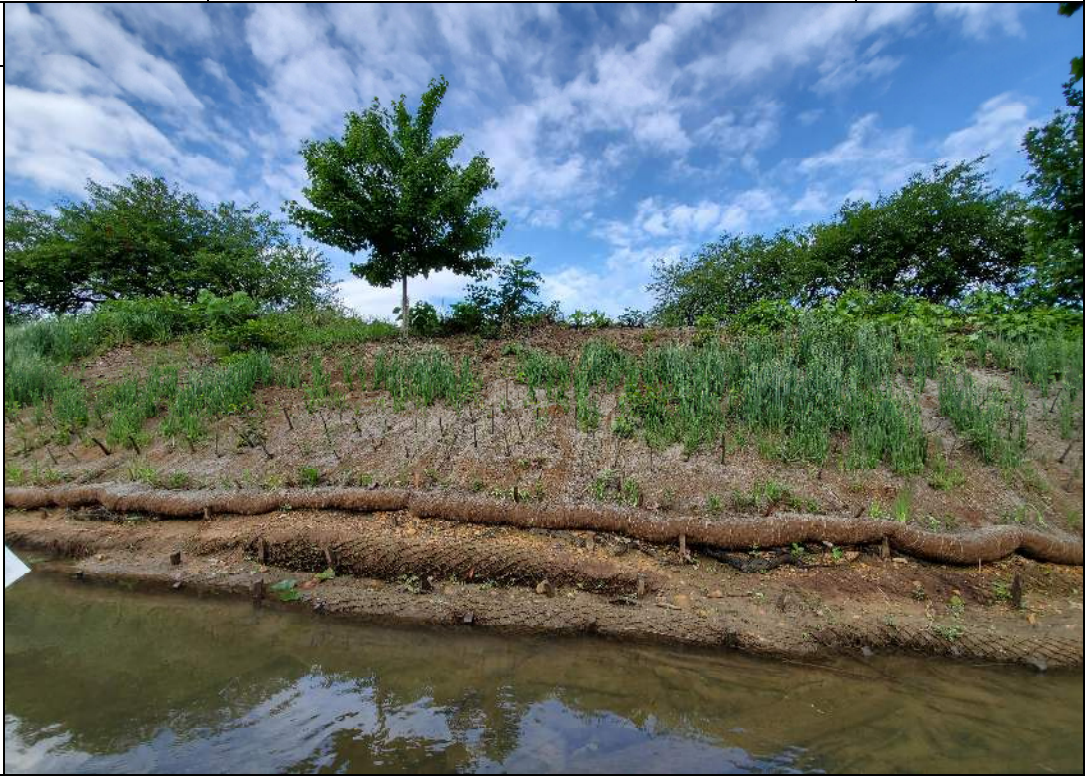
Photo No.:
11

Station 00 + 250'

~55 degree consistent uniform bank angle; no exposed roots; small patches of invasive vegetation present; installed live stakes 20% established; newly installed coir logs intact; erosion control fabric 50% exposed.

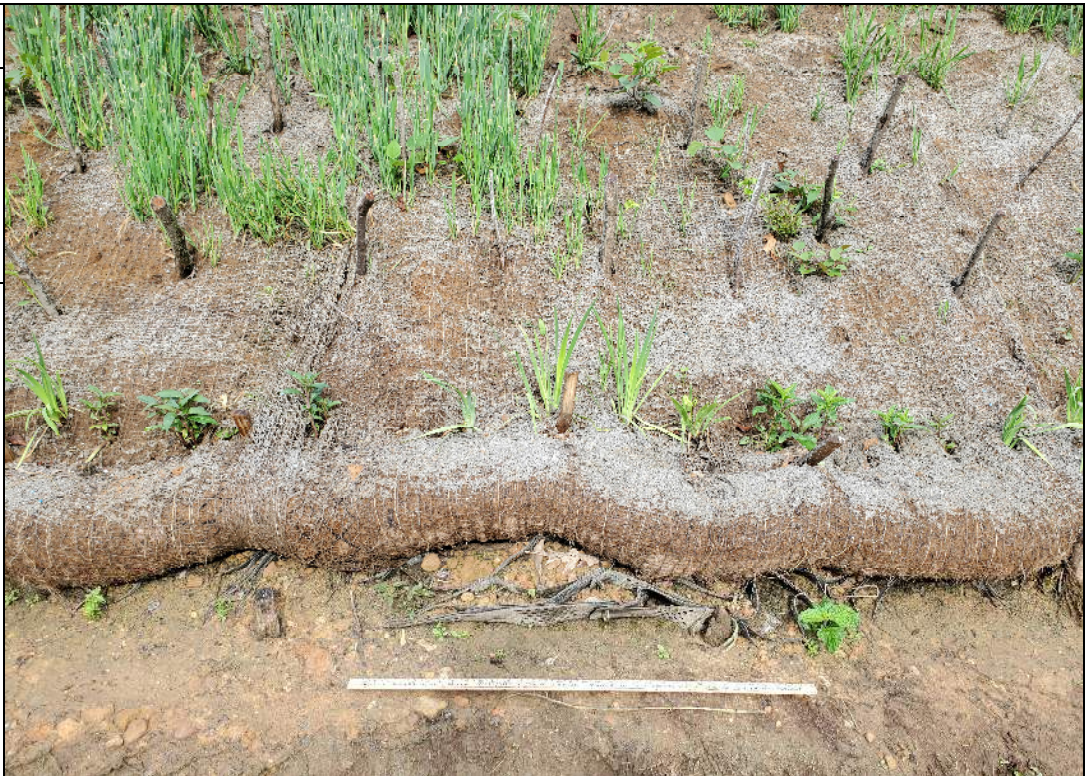
Photo No.:
12

Station 00 + 250'

Newly installed coir logs intact; 2" plug plantings remain healthy; small areas of scour and exposed geocell at toe of slope, below newly installed fabric.

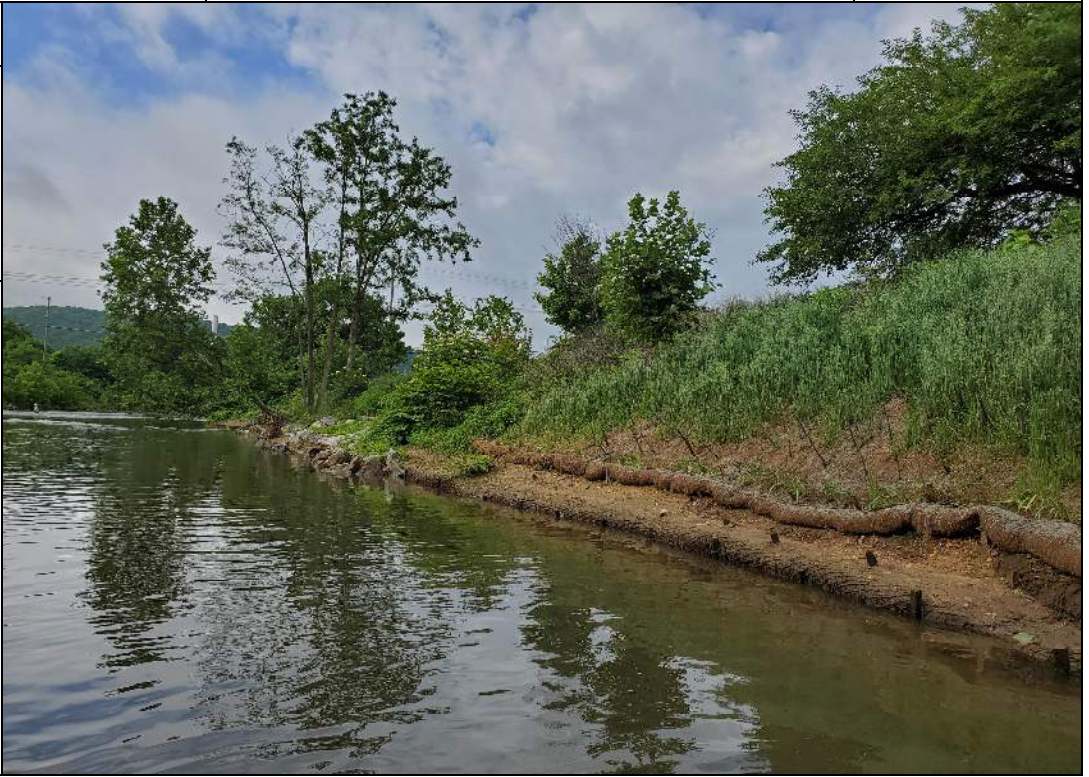
Photo No.
13

Station 00 + 250'

Small patches of invasive vegetation present; increased cover of native grasses; live stakes installed; evidence of foot traffic along coir logs; geocell intact; newly installed coir logs intact.

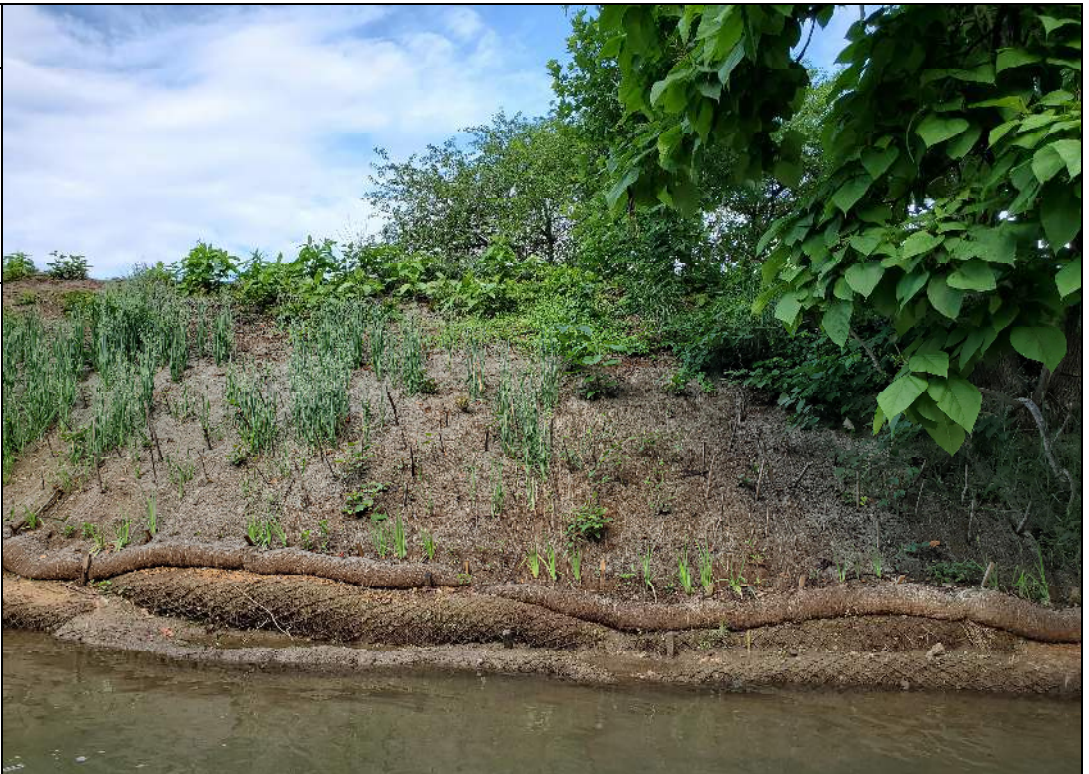
Photo No.
14

Station 00 + 300'

~70 degree uniform bank angle; no exposed roots or at-risk trees; no scour observed; increased vegetation cover; erosion control fabric 75% exposed; geocell and installed coir logs intact; installed live stakes 20% established; 2" plug plantings remain healthy.

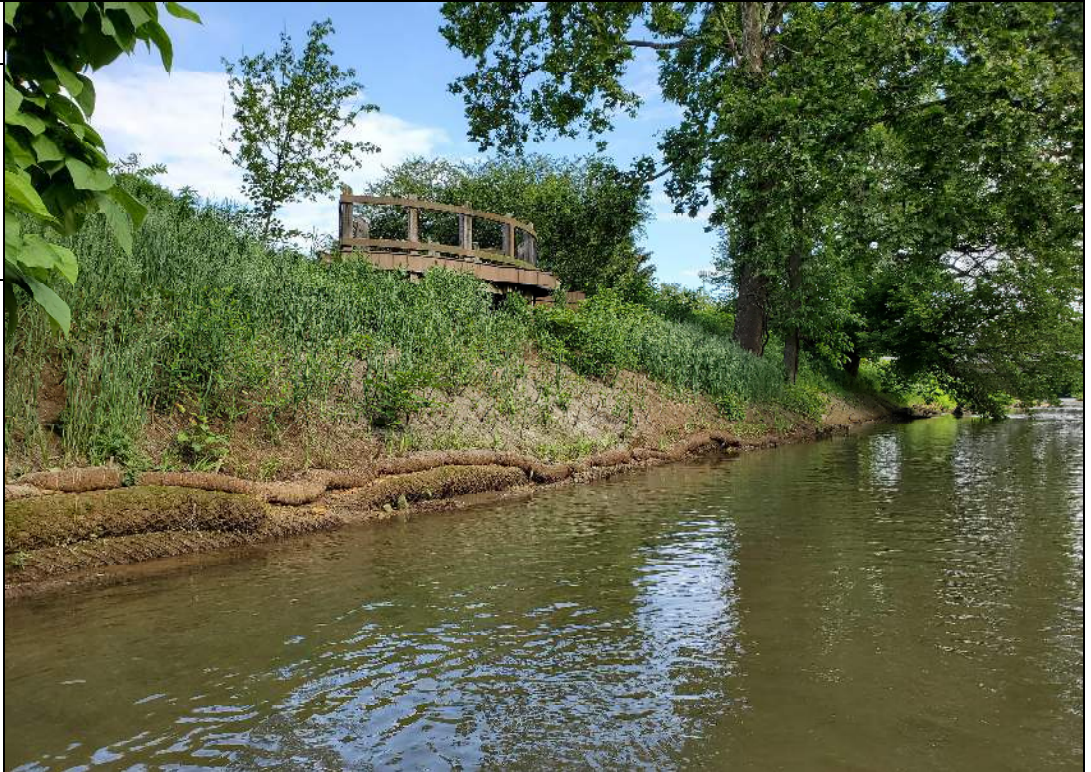
Photo No.
15

Station 00 + 300'

Predominantly native vegetation present; live stakes installed at toe of slope; erosion control fabric exposed near toe of slope; geocell and installed coir logs intact.

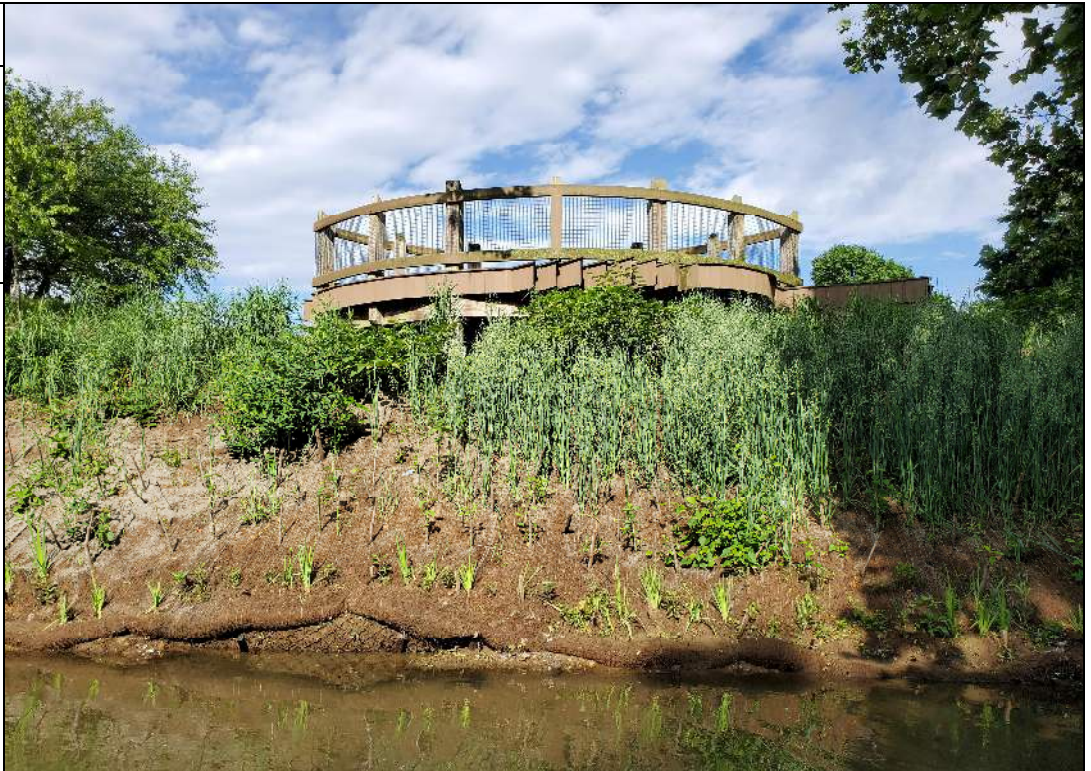
Photo No.
16

Station 00 + 350'

~70 degree bank angle; no exposed roots or at-risk trees; no scour observed; native vegetation with small patches of the invasive knotweed present; live stakes 40% established; geocell and installed coir logs intact; newly installed erosion control fabric 50% exposed; 2" plug plantings remain healthy.

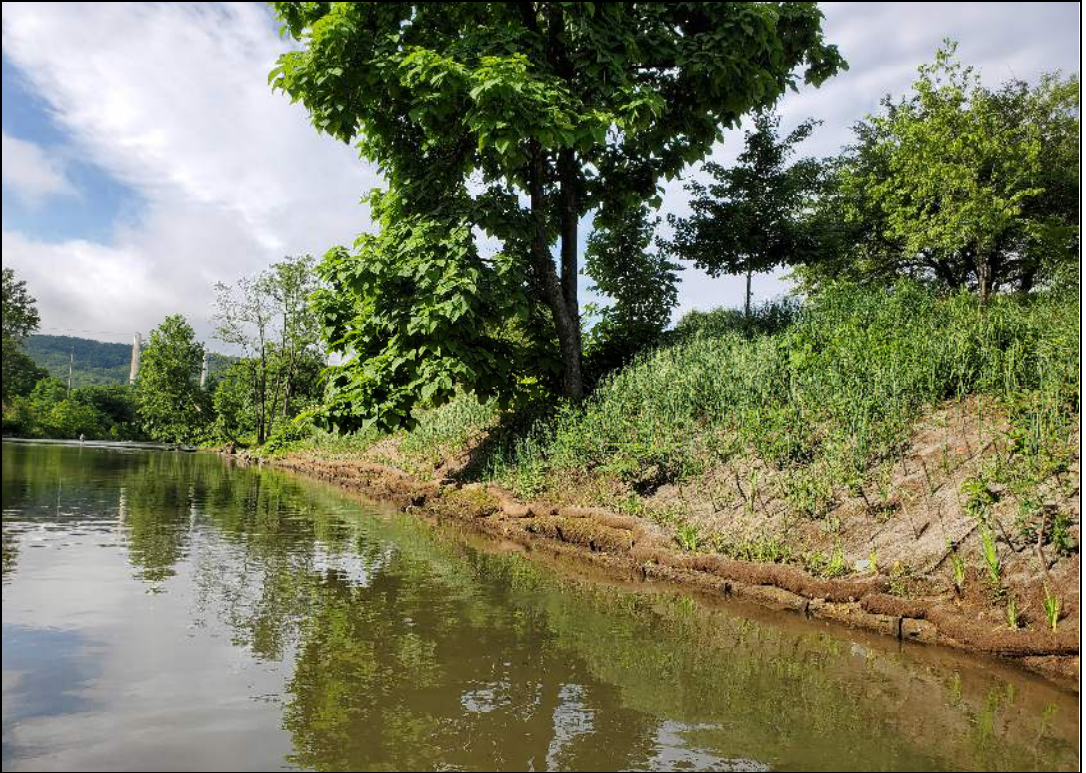
Client Name: Corteva		Site Location: Constitution Park BMA	Project No.: 60594242
Photo No.: 17	Date: 6/13/2019

Direction Photo Taken: Southwest			
Description: Station 00 + 350' Increased vegetative cover, including native grasses; installed erosion control fabric 50% exposed; installed coir logs intact.

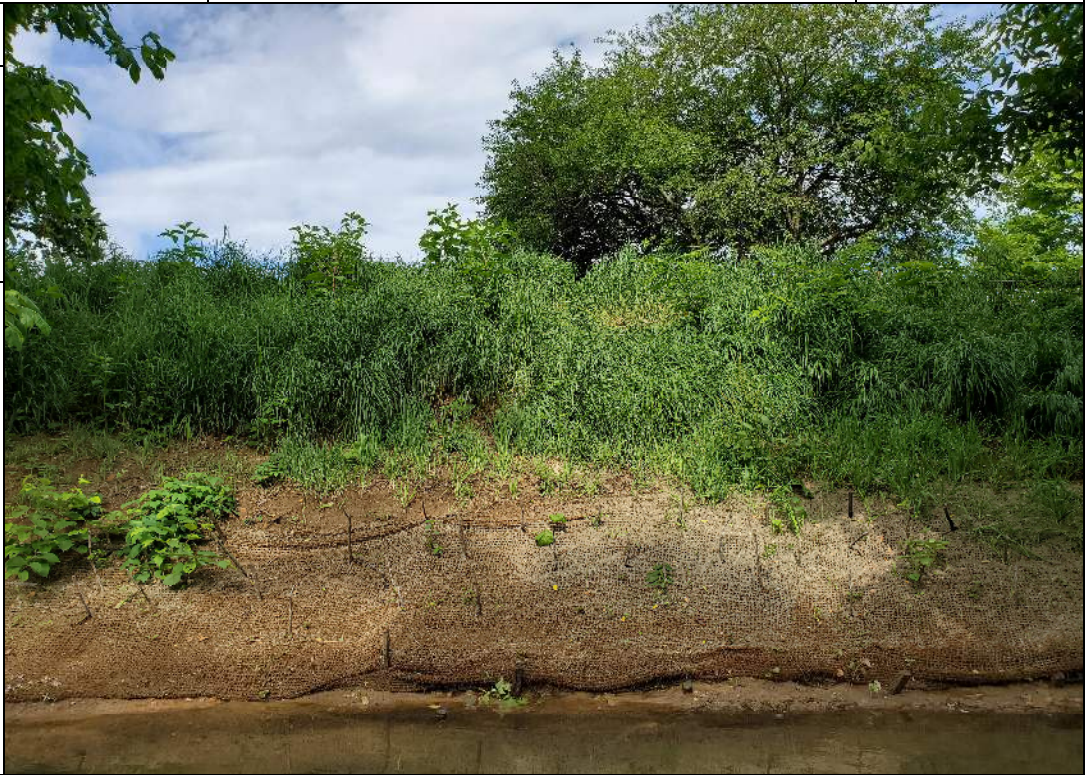
Photo No.: 19	Date: 6/13/2019
-------------------------	---------------------------

Station 00 + 400'

~60 degree bank angle; predominantly native vegetation present along top of bank with small patches of invasive knotweed at toe of slope; no exposed roots; no at-risk trees; no scour present; installed live stakes 20% established.

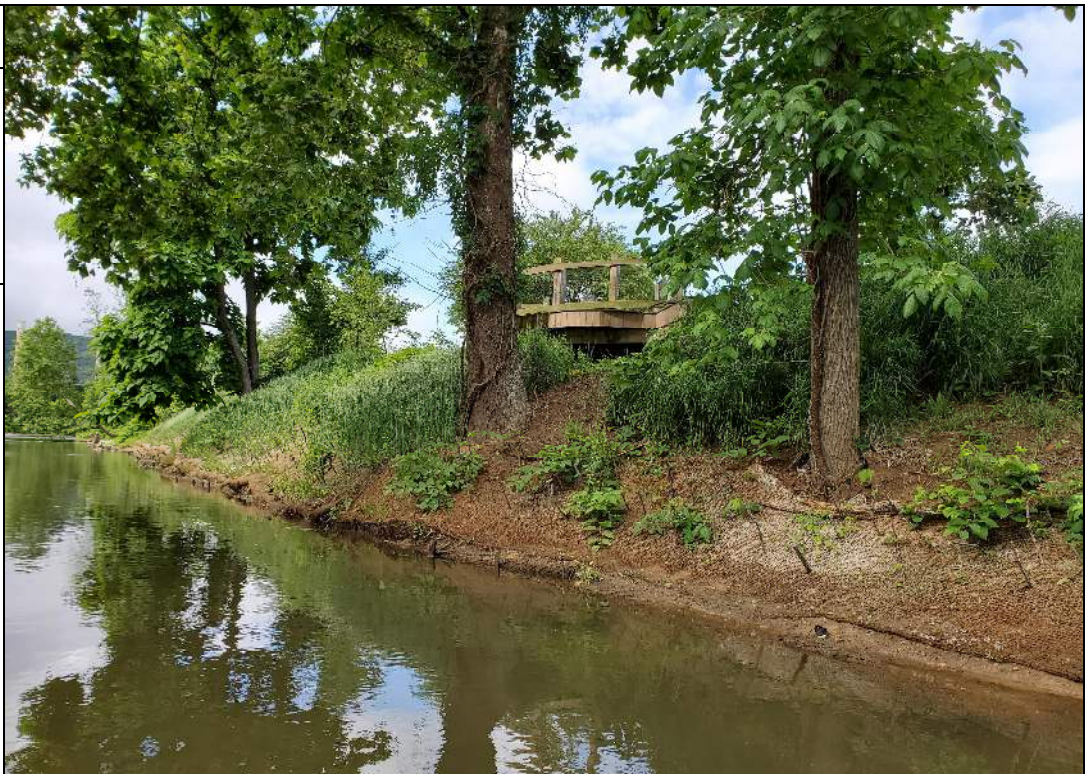
Photo No.: 20	Date: 6/13/2019
-------------------------	---------------------------

Station 00 + 400'

Installed coir logs intact; limited vegetation present at bottom of bank; geocell exposed around base of black walnut tree; installed erosion control fabric 50% exposed.

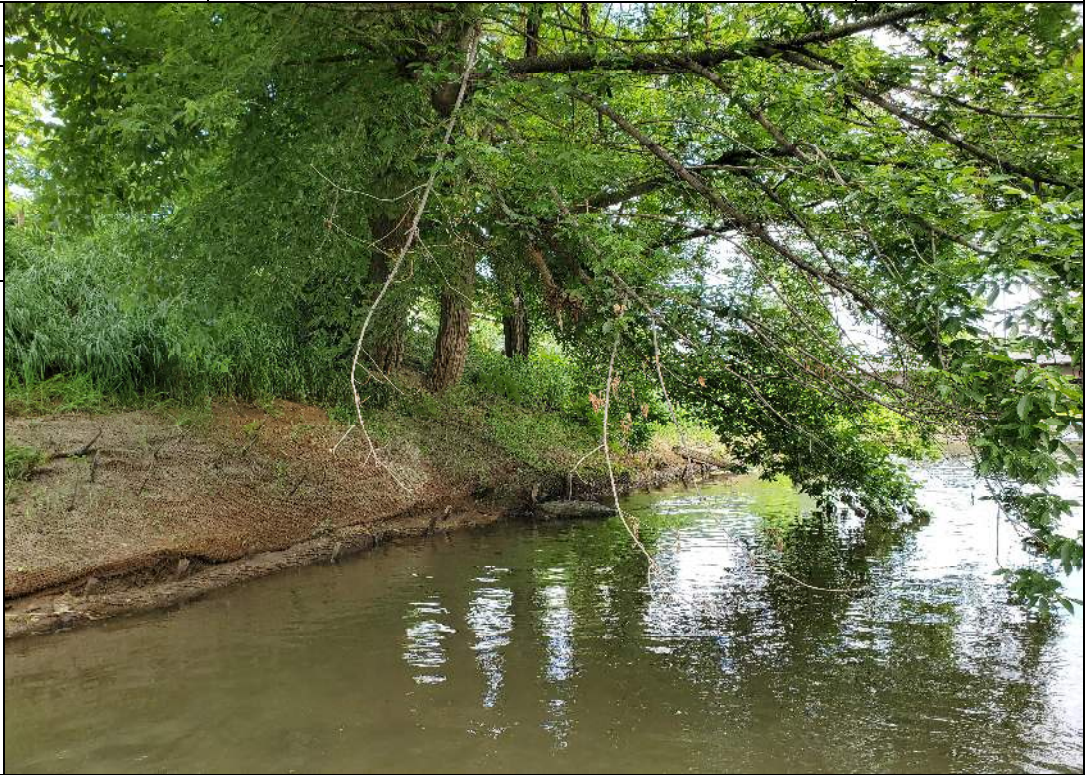
Photo No.
21

Station 00 + 400'

Installed coir logs intact; erosion control fabric exposed near toe of bank; installed live stakes 20% established.

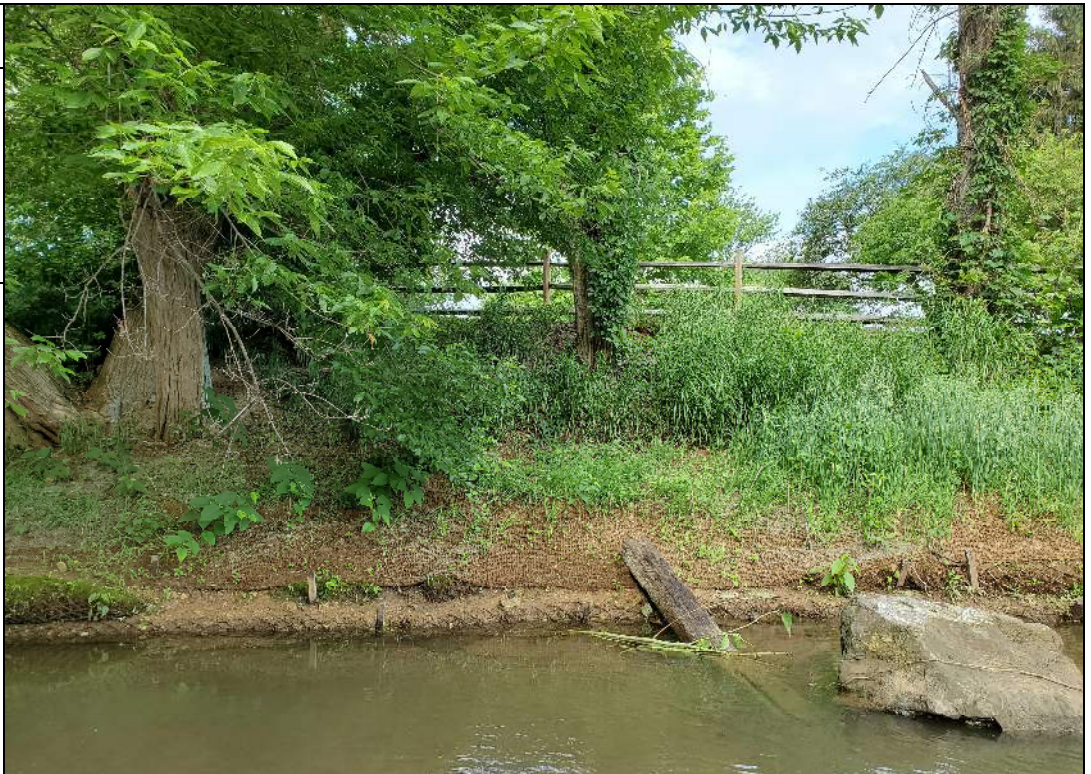
Photo No.
22

Station 00 + 450'

~50 degree bank angle; no exposed roots or at-risk trees; no scour observed; predominant native vegetation cover with patches of invasive vegetation present; erosion control fabric 30% exposed, particularly near toe of bank; installed live stakes 50% established; 2" plug plantings remain healthy.

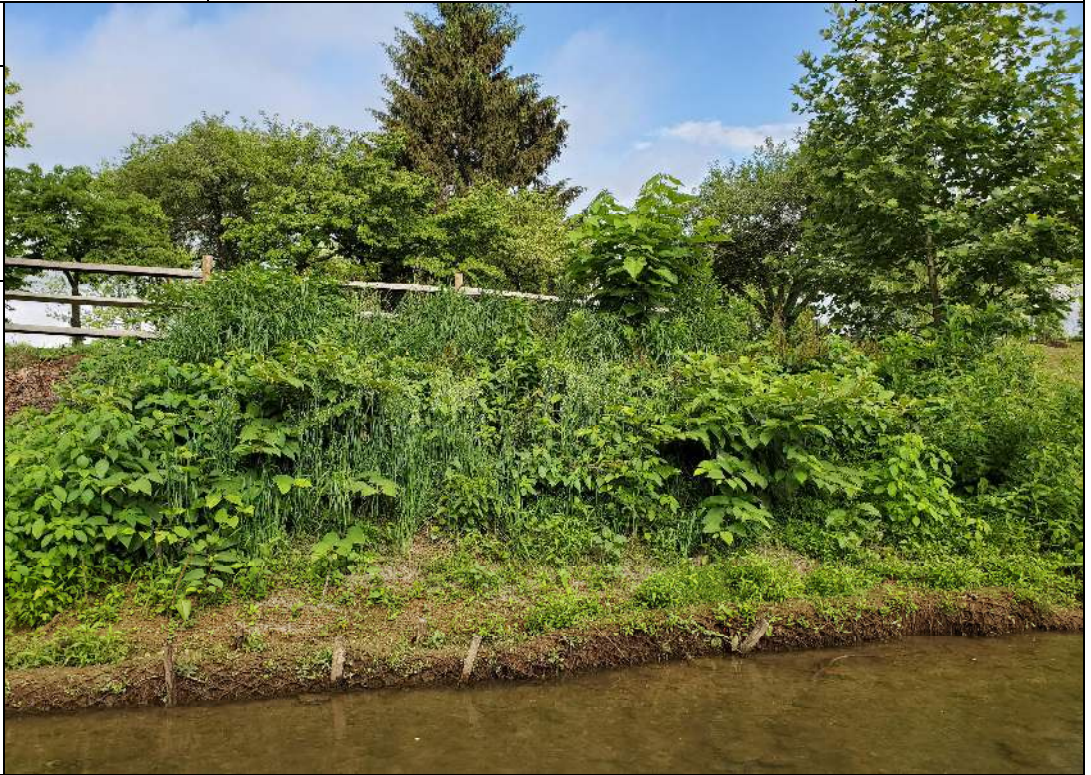
Photo No.:
23

Station 00 + 500'

~40 degree bank angle; no exposed roots or at-risk trees; no scour observed; native vegetative present but with patches of the invasive knotweed; installed live stakes 30% established. Erosion control fabric 30% exposed, particularly at toe of slope.

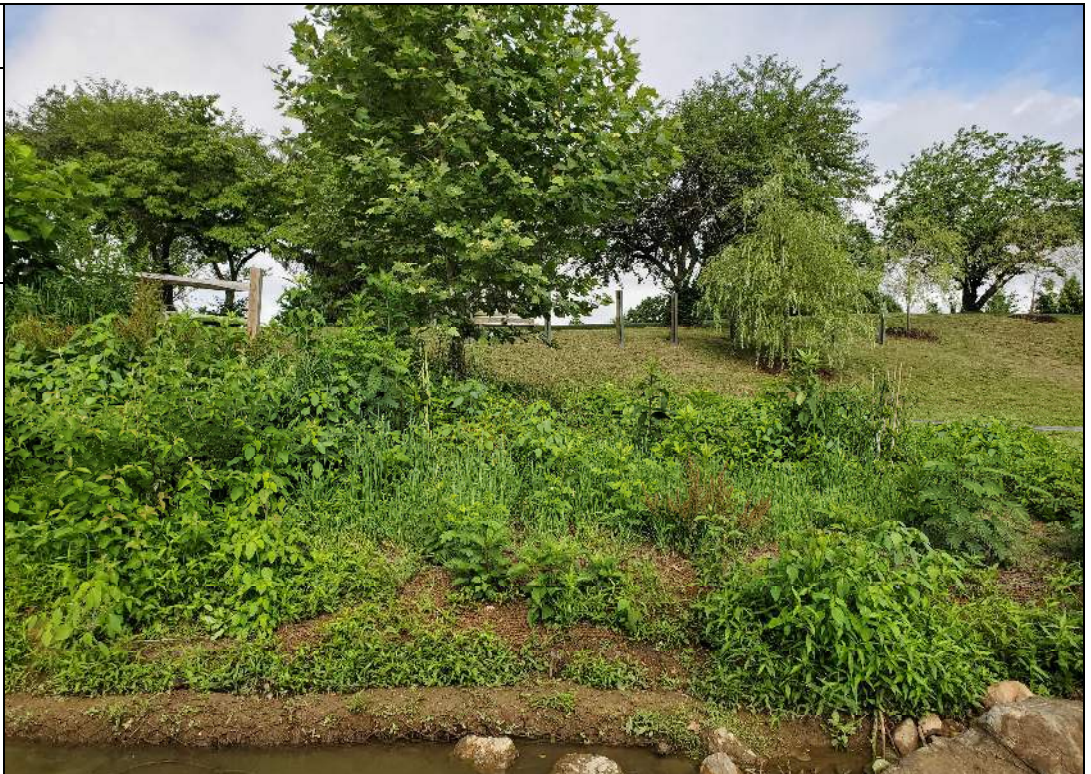
Photo No.:
24

Station 00 + 525'

~15 degree bank angle; no exposed roots or at-risk trees; no scour observed; erosion control fabric 30% exposed with predominantly native vegetation cover.
