**Re: 2019 Leaf-on Maintenance Inspection Reports for Allied Ready Mix, City Shops and Constitution Park BMAs
Former DuPont Waynesboro Site, Area of Concern 4
Waynesboro, Virginia
EPA ID# VAD003114832**

To	Michael Liberati, Corteva Environmental Remediation Nancy Grosso, Corteva Environmental Remediation	Page 1 of 3
CC	Cameron Dixon, AECOM Kristy Hoffman, AECOM	
Subject	City Shops BMA - 2019 Leaf-on Maintenance Inspection Former DuPont Waynesboro Site, Area of Concern 4	
From	Andrew Miano, AECOM Joshua Collins, AECOM	
Date	August 19, 2019

Table 1
2019 Leaf-on Maintenance Inspection Log
Qty Shops BMA
Former DuPont Waynesboro Site, Area of Concern 4

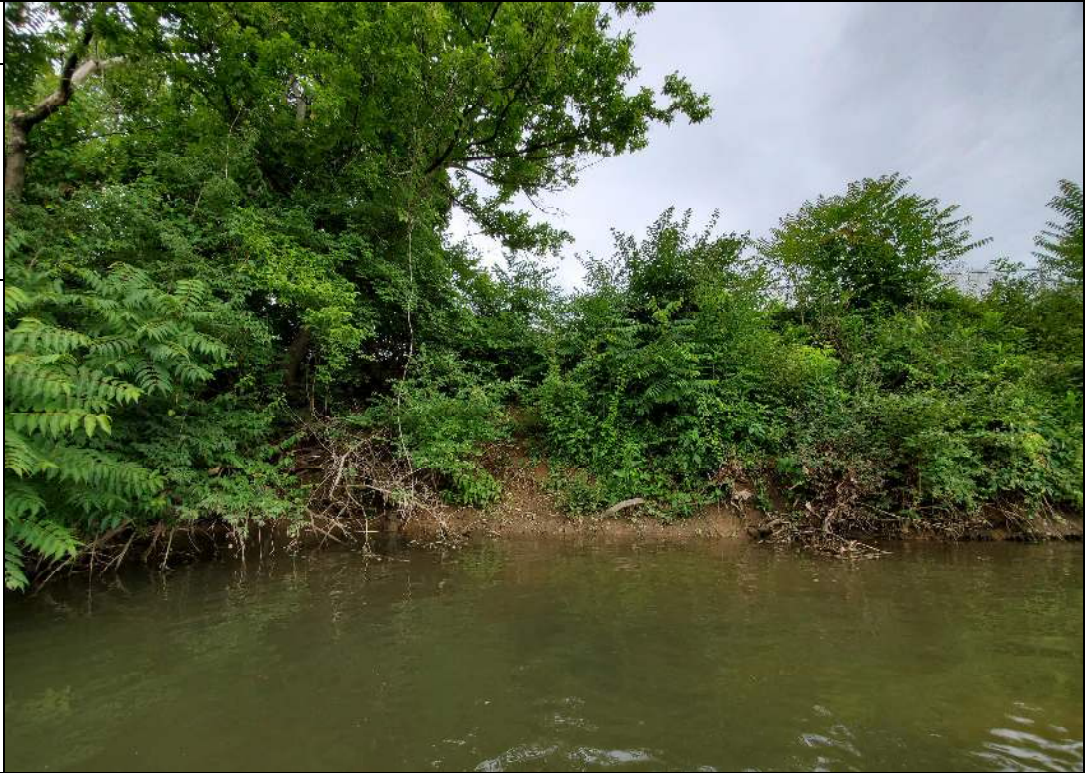
Photo No.
1

Station 00 – 25'

~85 degree bank angle;
at risk trees present;
scour present; 95%
vegetated.

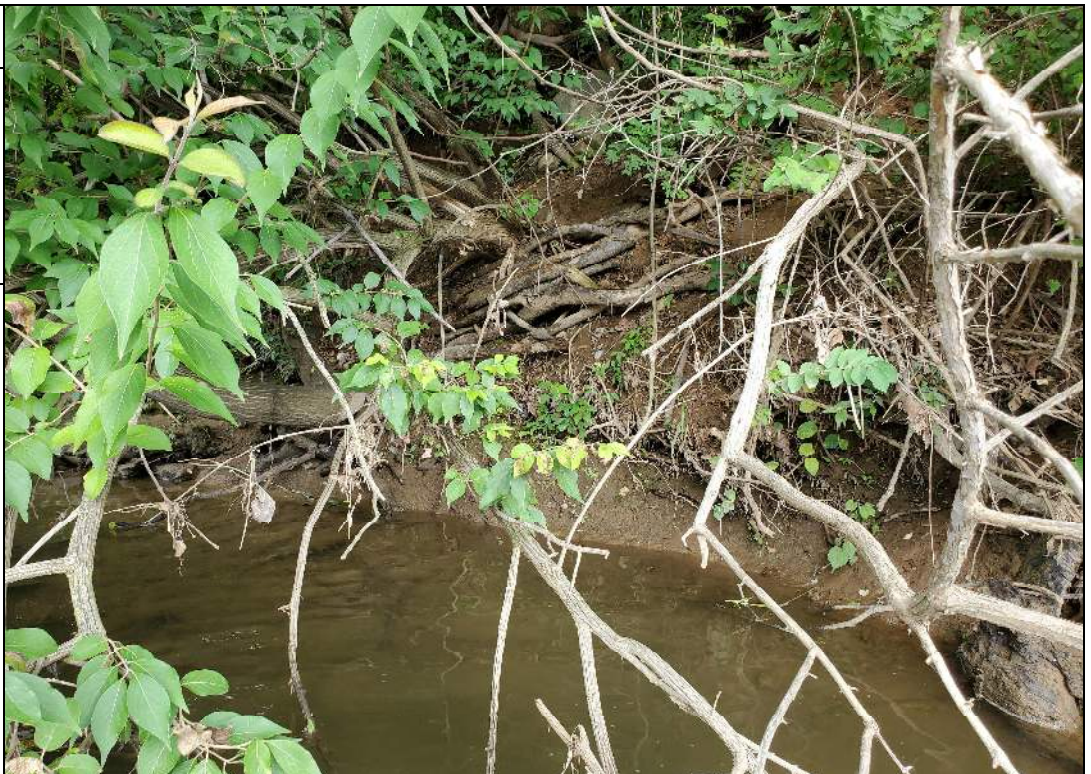
Photo No.
2

Station 00 – 25'

Upstream view from
location 00-25'; high
quantity of exposed
roots on the bank; at
risk trees present;
scour present; 95%
vegetated.

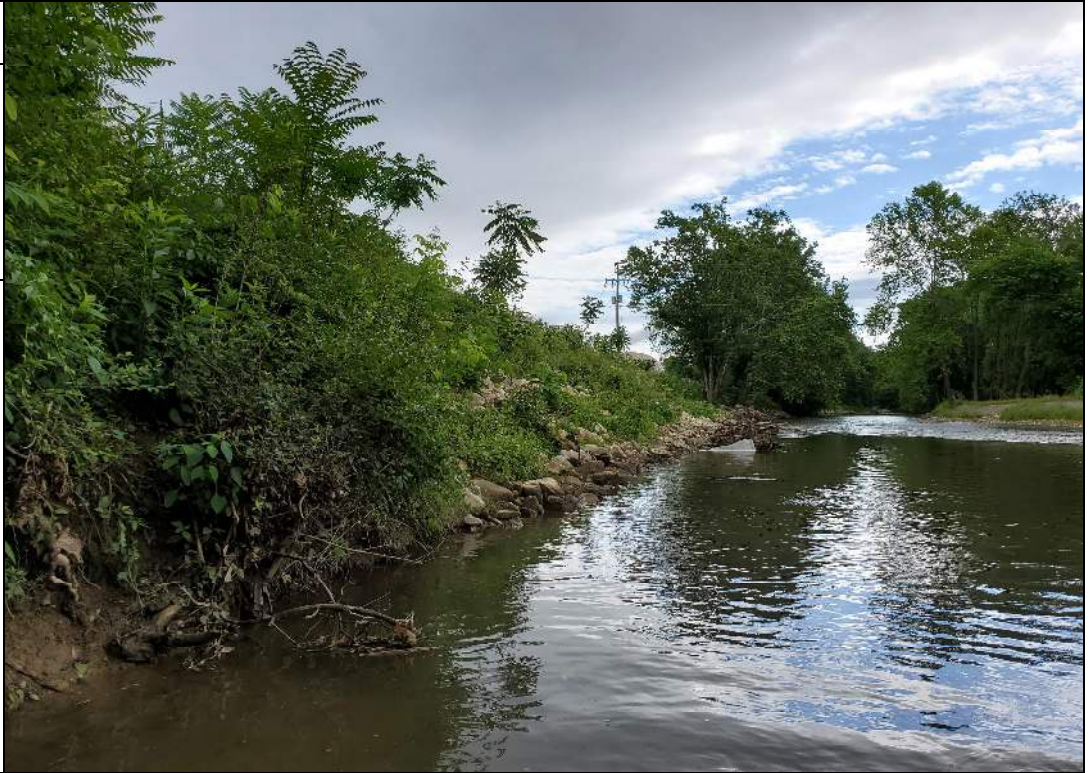
Photo No.
3

Station 00 – 25'

Downstream view from location 00-25'; high quantity of exposed roots on the bank and scour present upstream of remediation.

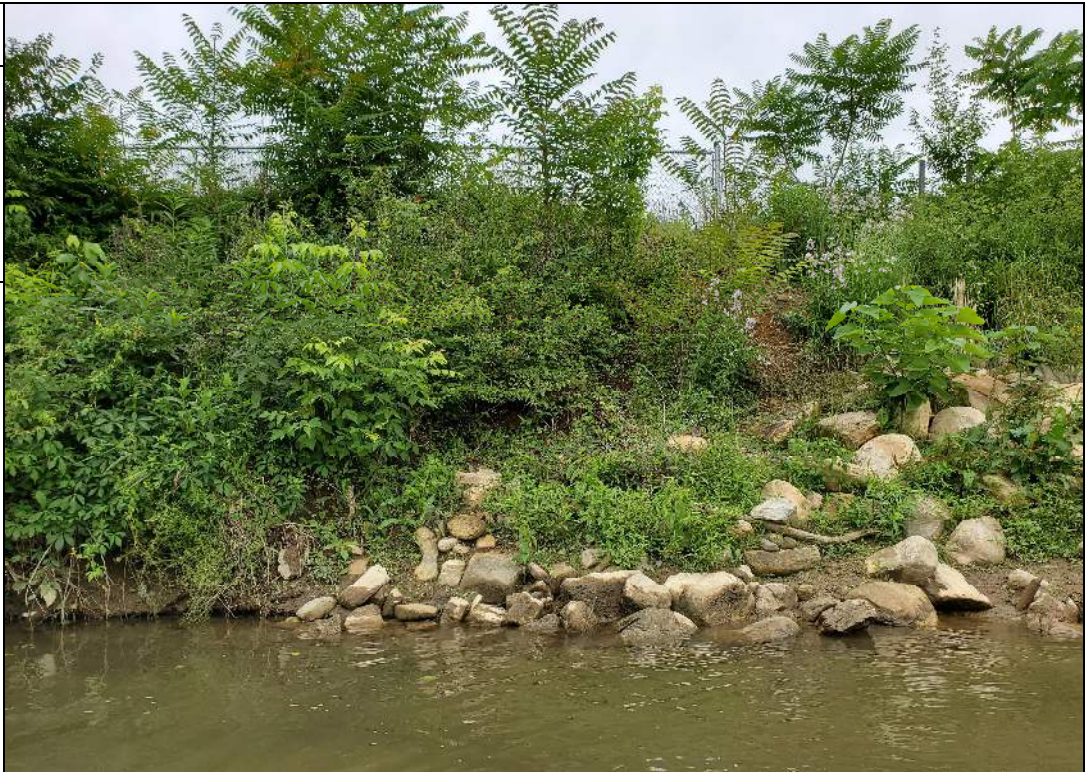
Photo No.
4

Station 00 + 00'

~60-80 degree bank angle; no at-risk trees present, no exposed roots; evidence of scour throughout; installed rock toe intact.

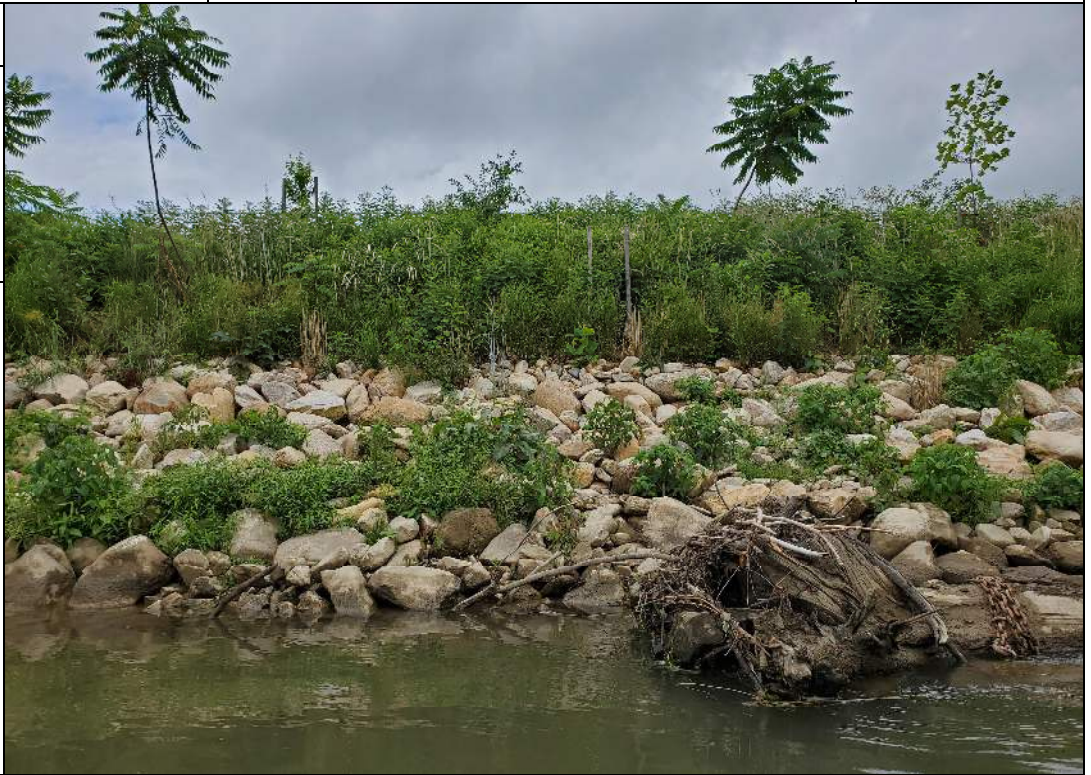
Photo No.
5

Station 00 + 50'

~45 degree bank angle;
no scour present;
installed rock toe intact;
native vegetation above
rock toe; LWD intact.

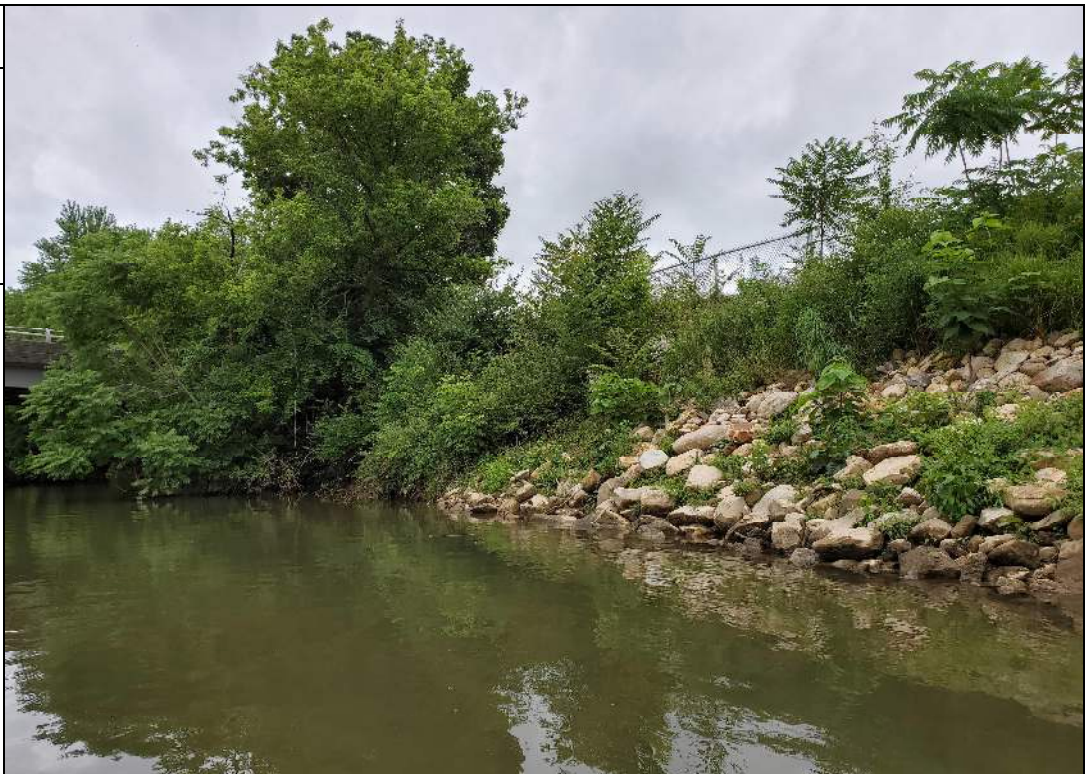
Photo No.
6

Station 00 + 50'

Upstream view of 00 +
50' location; no scour
present; installed rock
toe intact.

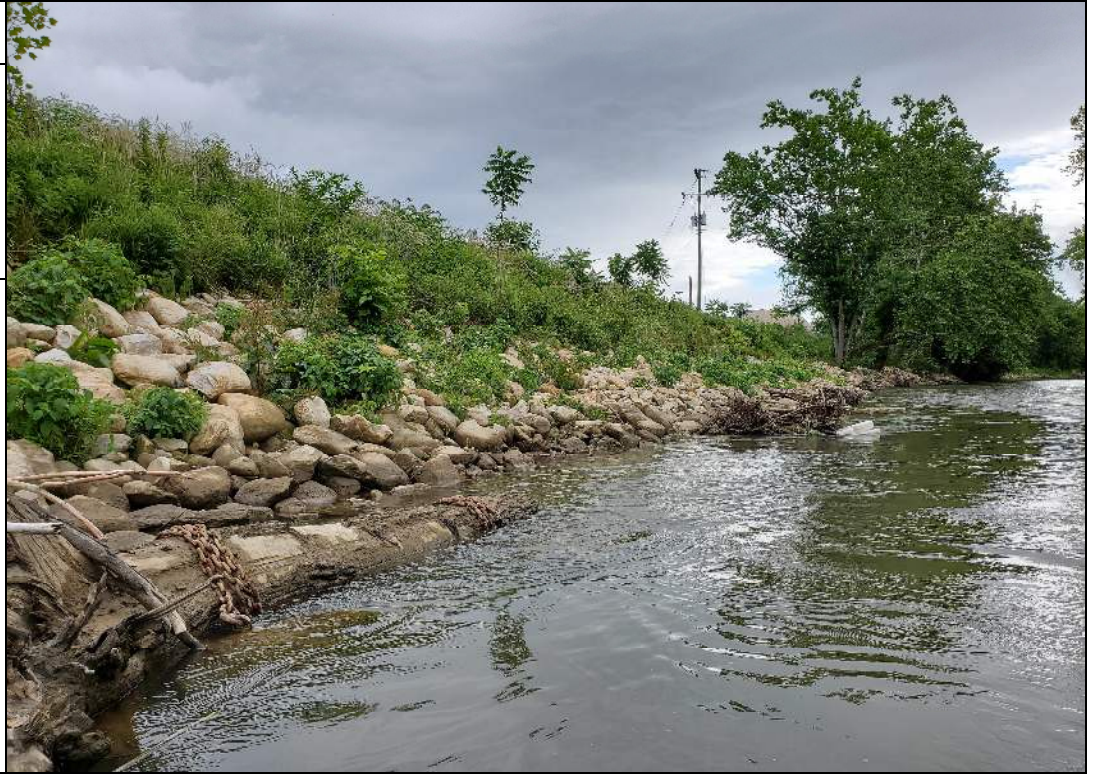
Photo No.
7

Station 00 + 50'

Downstream view of 00 + 50' location; installed rock toe intact; LWD intact.

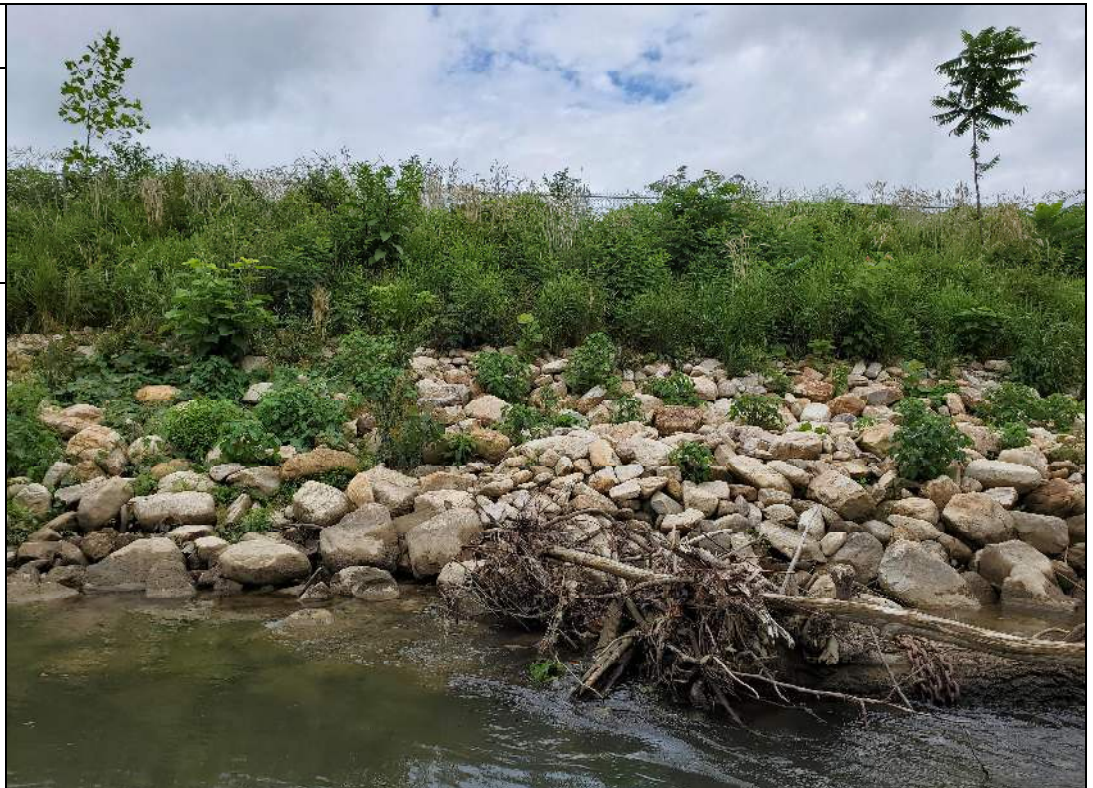
Photo No.
8

Station 00 + 100'

~45 degree bank angle; no scour present; installed rock toe intact; native vegetation above rock toe with small patches of the invasive knotweed present; LWD intact.

- Japanese knotweed was documented in limited areas of the BMA and in the areas that were not remediated; these areas will be monitored and treated (if necessary) to prevent their spread in the restored portions of the BMA.

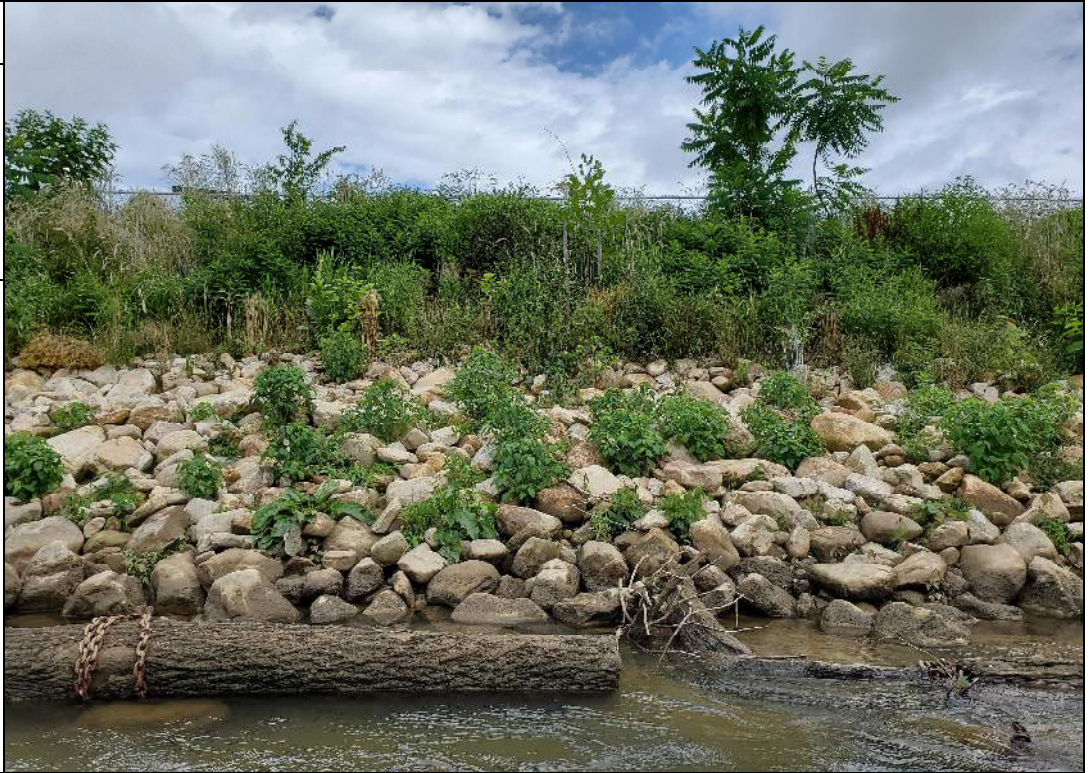
Photo No.
9

Station 00 + 150'

~45 degree bank angle;
no scour present;
installed rock toe intact;
native vegetation above
rock toe; LWD intact.

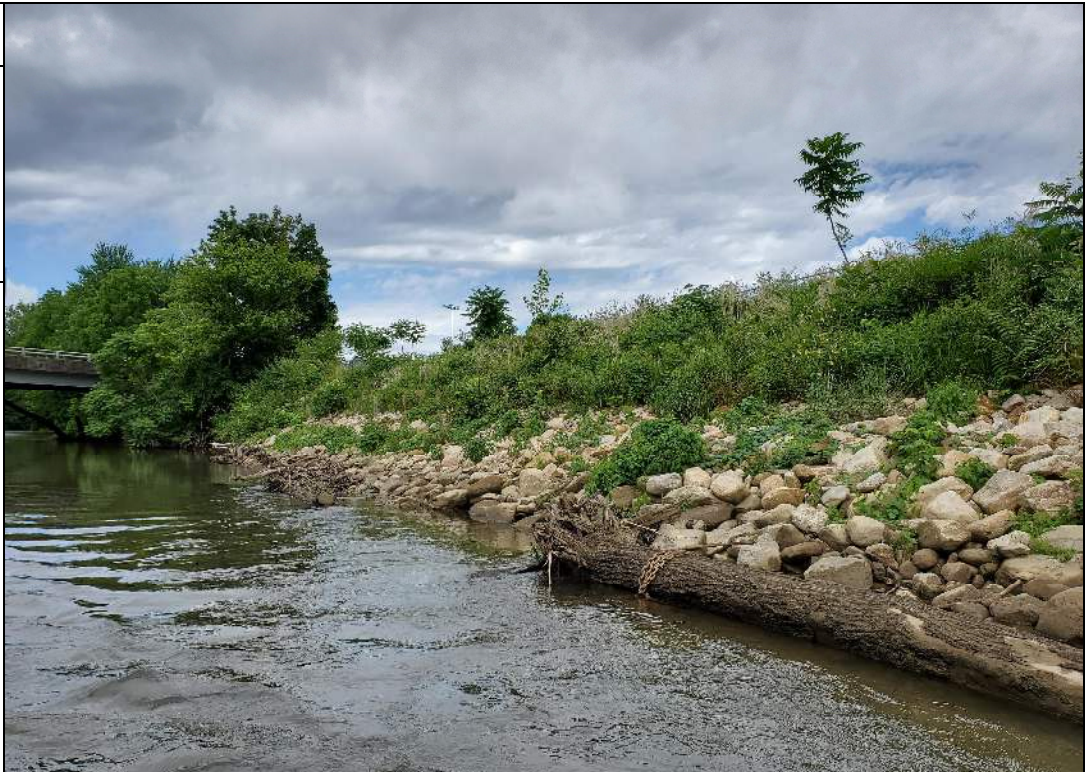
Photo No.
10

Station 00 + 150'

Upstream view from 00
+ 150'; installed rock
toe and LWD intact.

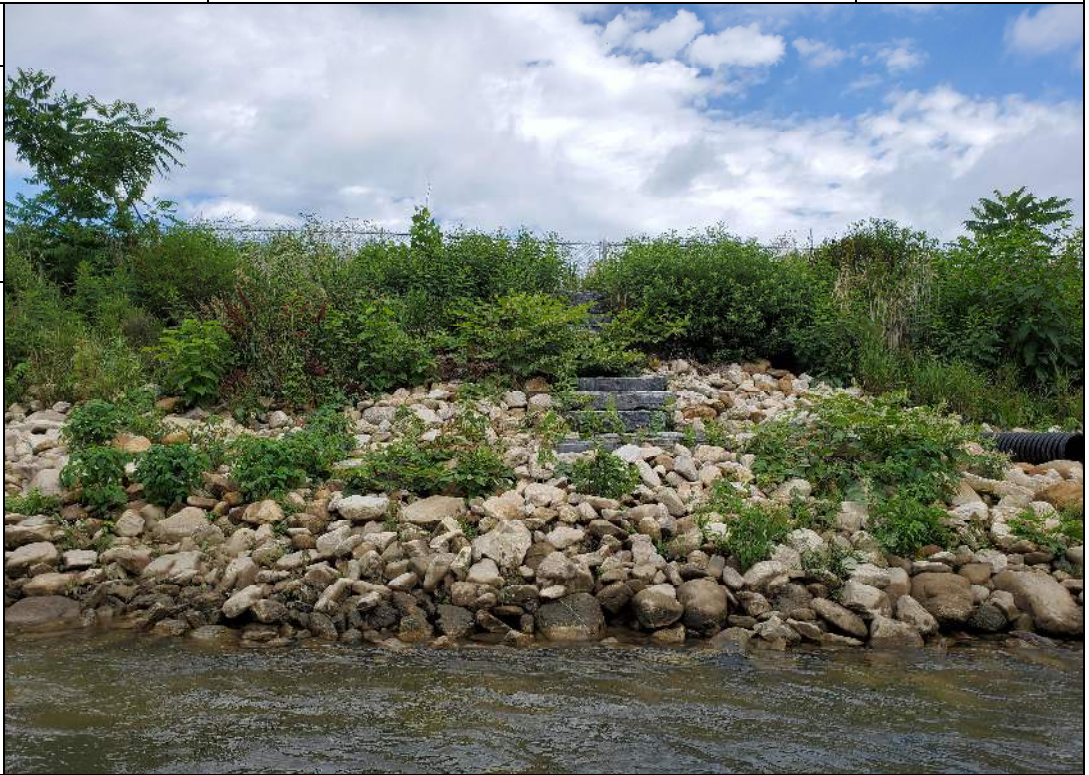
Photo No. 11	Date: 6/13/2019
------------------------	---------------------------

Description: Station 00 + 200' ~45 degree bank angle; no scour present; installed rock toe intact; staircase / gate access present and intact; native vegetation above rock toe.

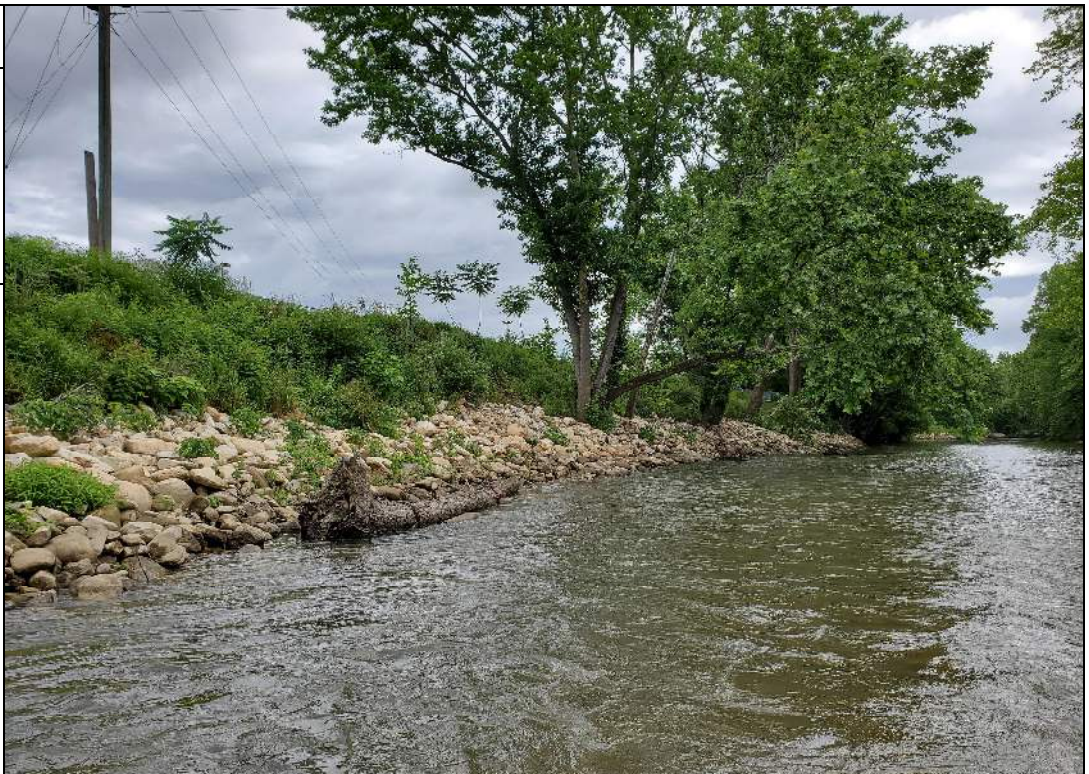
Photo No. 12	Date: 6/13/2019
------------------------	---------------------------

Description: Station 00 + 200' Downstream view of 00 + 200' LWD is intact; Native vegetation is dominant.
--

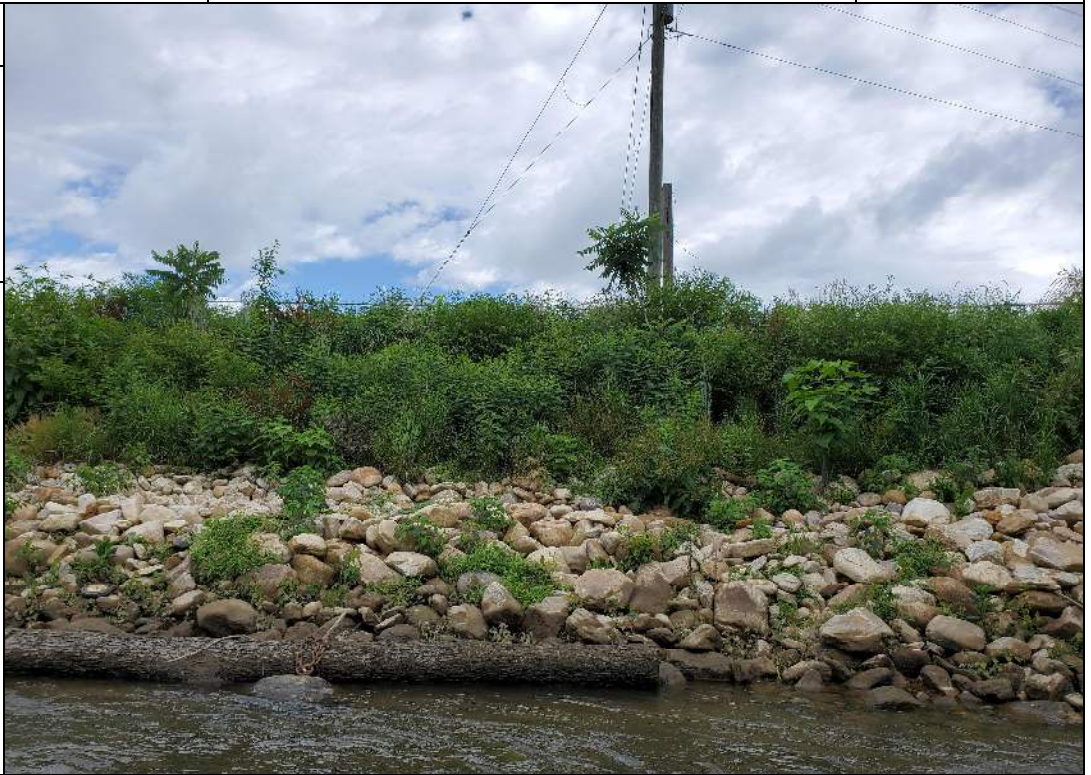
Photo No.
13

Station 00 + 250'

~45 degree bank angle;
no scour present;
installed rock toe intact;
native vegetation above
rock toe; LWD intact.

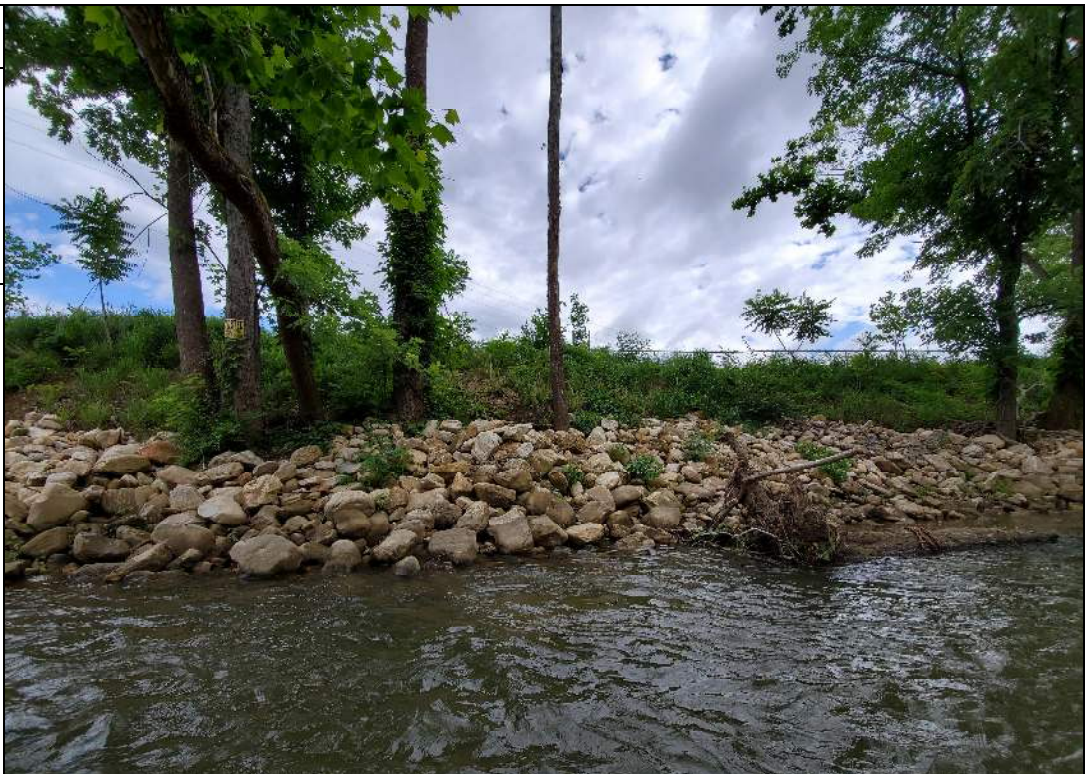
Photo No.
14

- Larger trees left in place during remediation along the BMA are healthy and show no sign of stress, with the exception of one sycamore tree at 00+300. VDEQ identified minor scour at the junction of trees left in place and the placed geocell during recent site visits. This condition was evaluated and at the time of the inspection, no areas of scour were identified due to extensive herbaceous vegetation. This condition will be re-evaluated during the 2019 leaf-off inspection.

Station 00 + 300'

~45 degree bank angle;
no scour present;
installed rock toe intact;
native vegetation above
rock toe; tree located in
center of photo is dead;
LWD intact; some
erosion control fabric
exposed around tree
bases towards top of
bank.

- Erosion at the upstream transition of the Primary BMA B area.
- The health and stability of the one sycamore tree at 00+300.
- Evaluate the junctions of trees left in place during construction and the placed geocell for signs of scour.
- Stability of the LWD located at 00+400 and 00+850' that shifted in 2018. At this time, no corrective actions are proposed as both pieces of LWD appear to be stable and are not impacting bank stability.

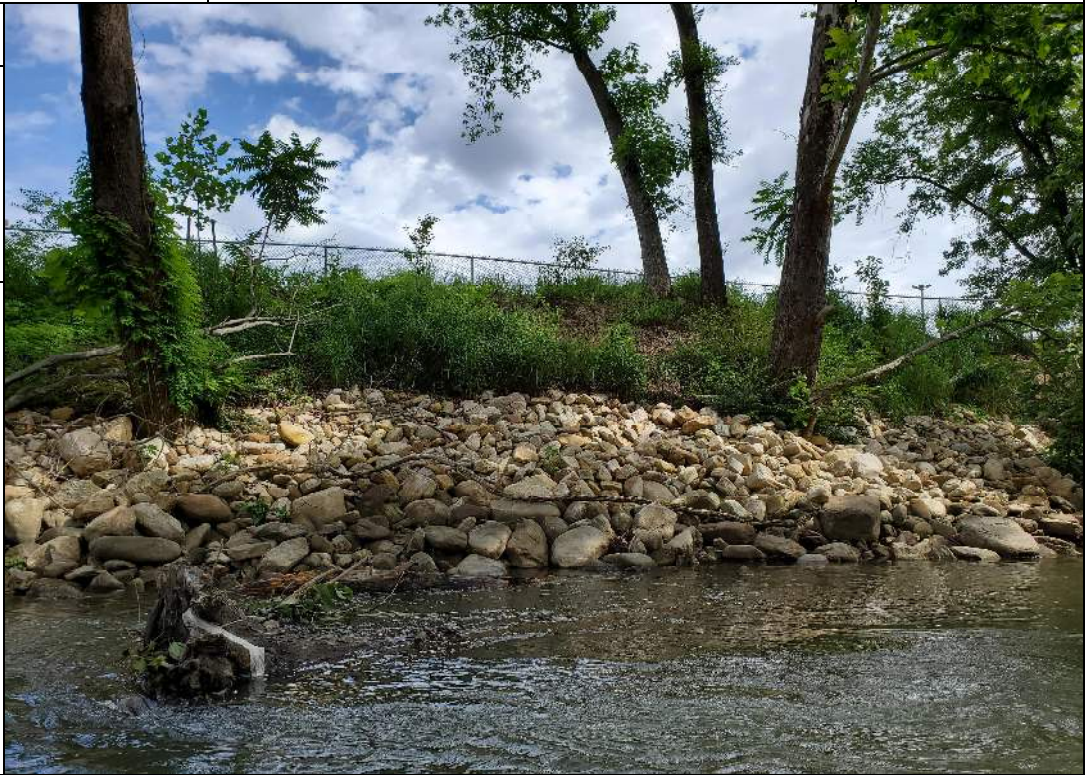
Photo No.: 15	Date: 6/13/2019
-------------------------	---------------------------

Description: Station 00 + 350' ~45 degree bank angle; no scour present; installed rock toe intact; native vegetation above rock toe consists of grasses, planted saplings, and mature sycamore trees; LWD intact; some erosion control fabric exposed around tree base; no at risk trees present.

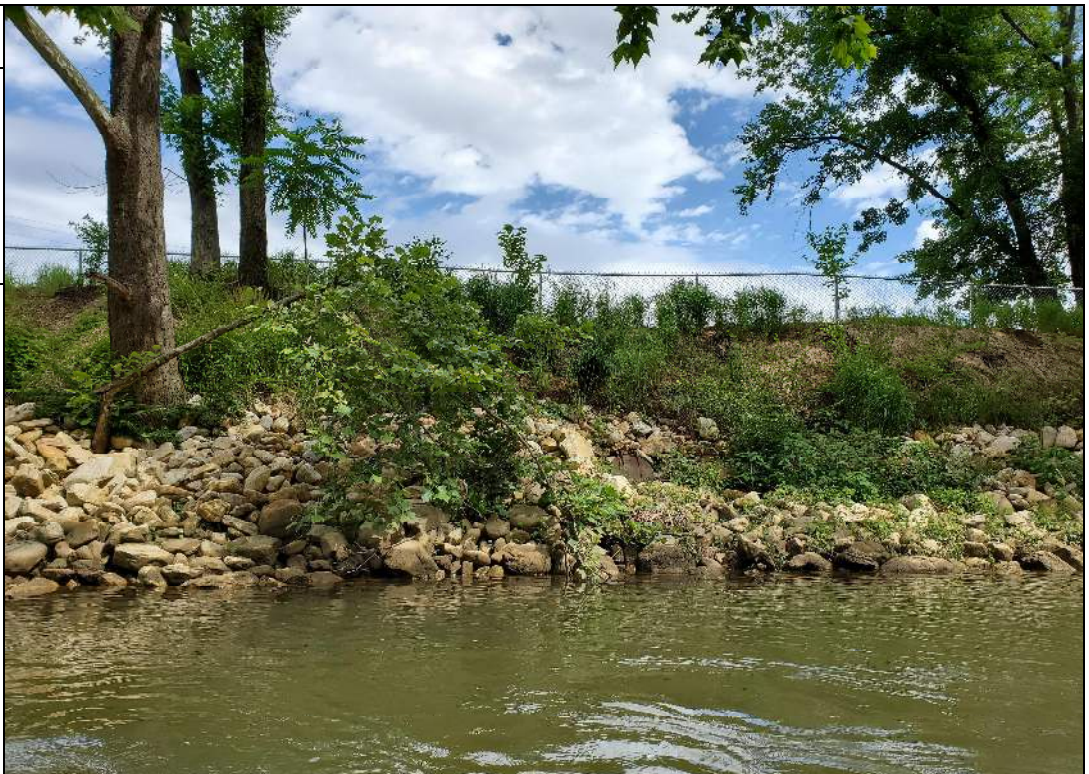
Photo No.: 16	Date: 6/13/2019
-------------------------	---------------------------

Description: Station 00 + 400' ~45 degree bank angle; slight scour present; installed rock toe intact; Installed large woody debris (LWD) has shifted downstream; native vegetation above rock toe; no at risk trees present; some erosion control fabric exposed at top of bank.
--

Comments: LWD shifted downstream at 400' and 880'

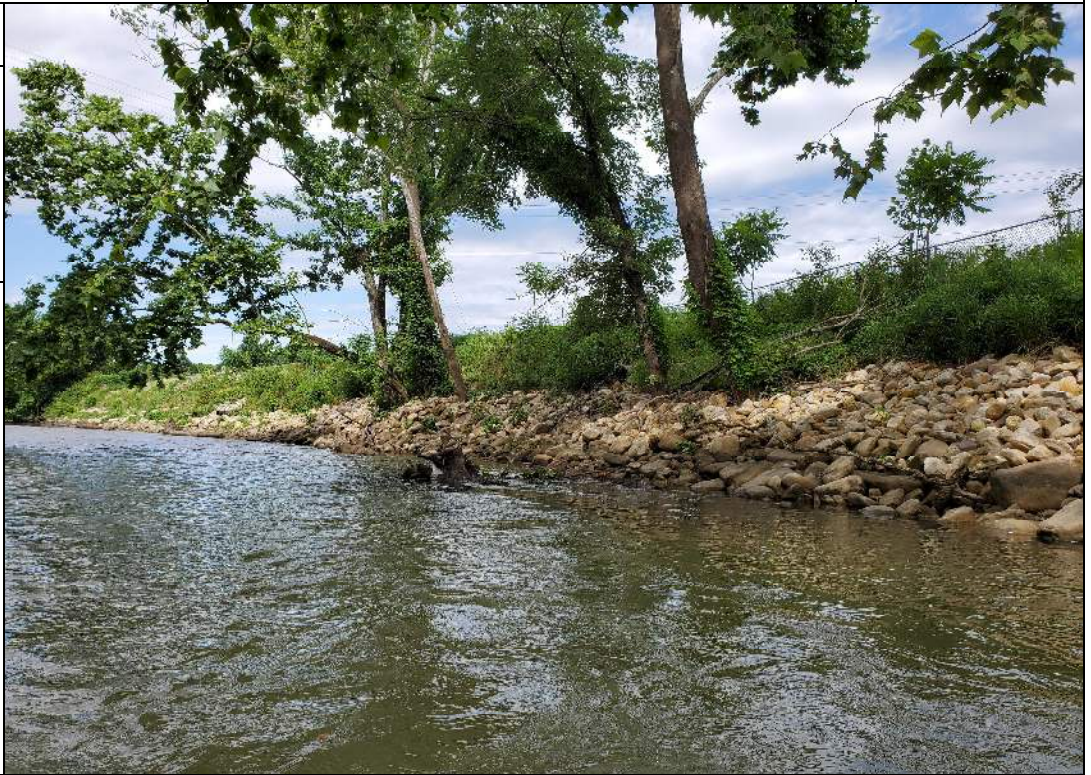
Photo No.
17

Station 00 + 400'

~45 degree bank angle; installed rock toe intact; native vegetation above rock toe; no at risk trees present.

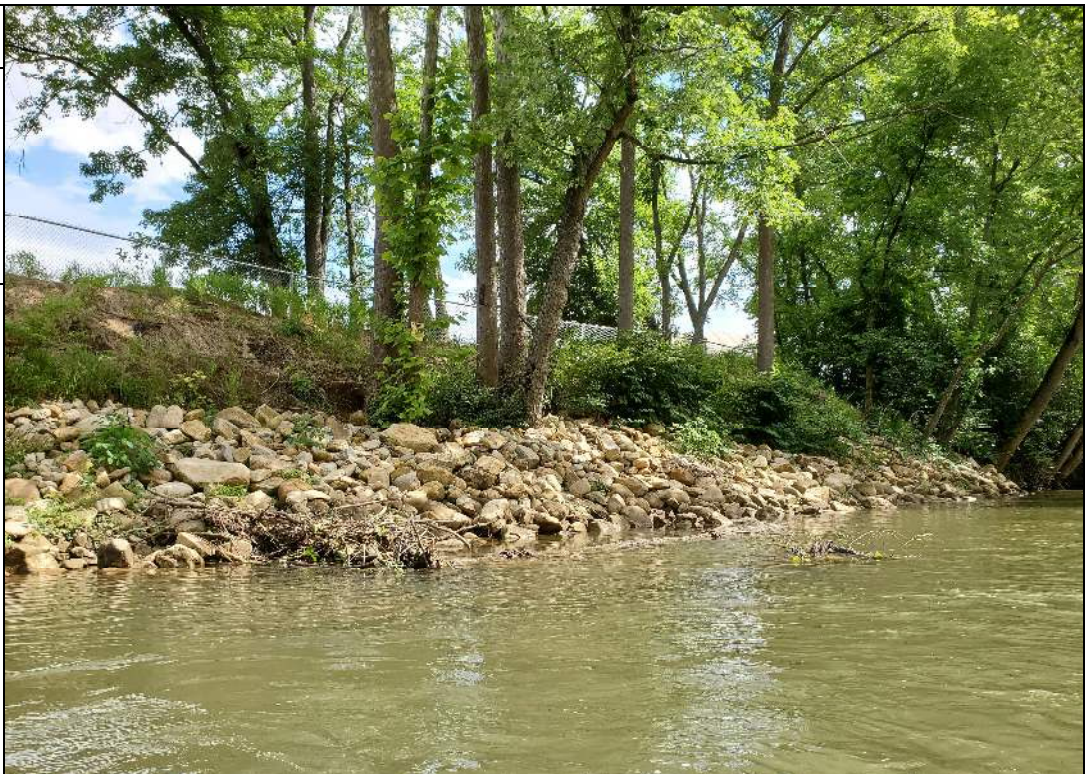
Photo No.
18

Station 00 + 400'

~45 degree bank angle; slight scour present; erosion control fabric exposed at top of bank and around tree bases; installed rock toe intact; Upstream LWD has shifted and is parallel with another piece of installed LWD downstream of 00 +400'.

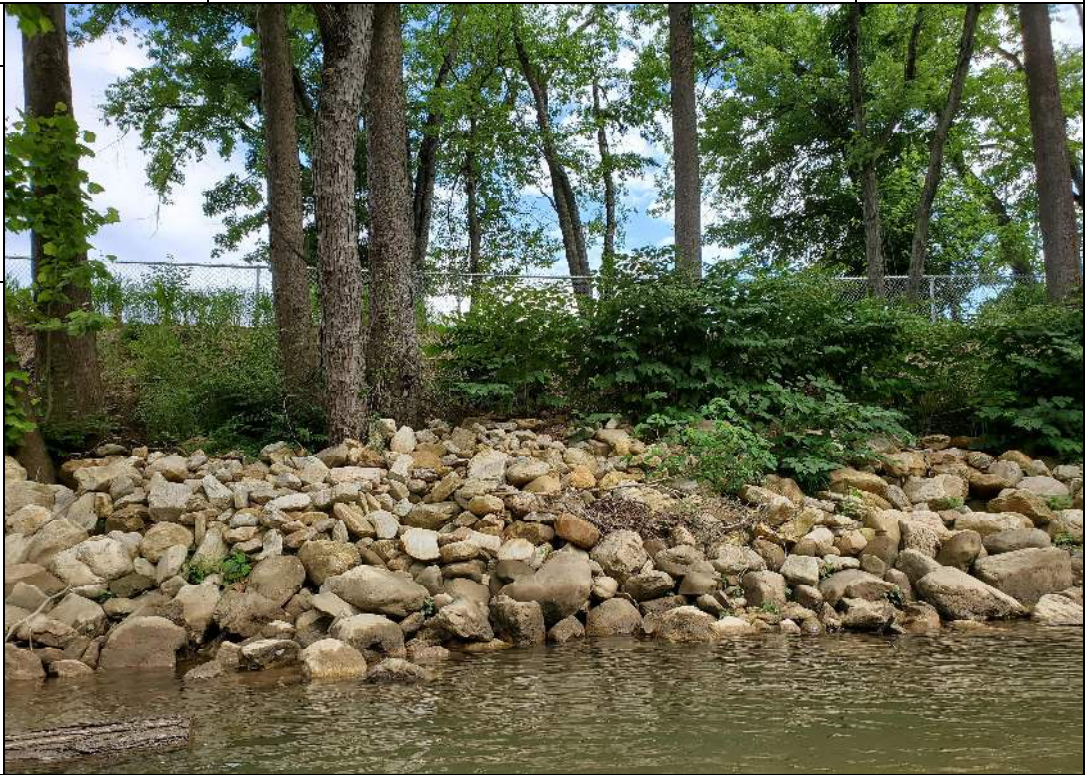
Photo No.: 19	Date: 6/13/2019
-------------------------	---------------------------

Description: Station 00 + 450' ~45 degree bank angle; no scour present; installed rock toe intact; native vegetation above rock toe; some erosion control fabric exposed at top of bank and around tree bases.
--

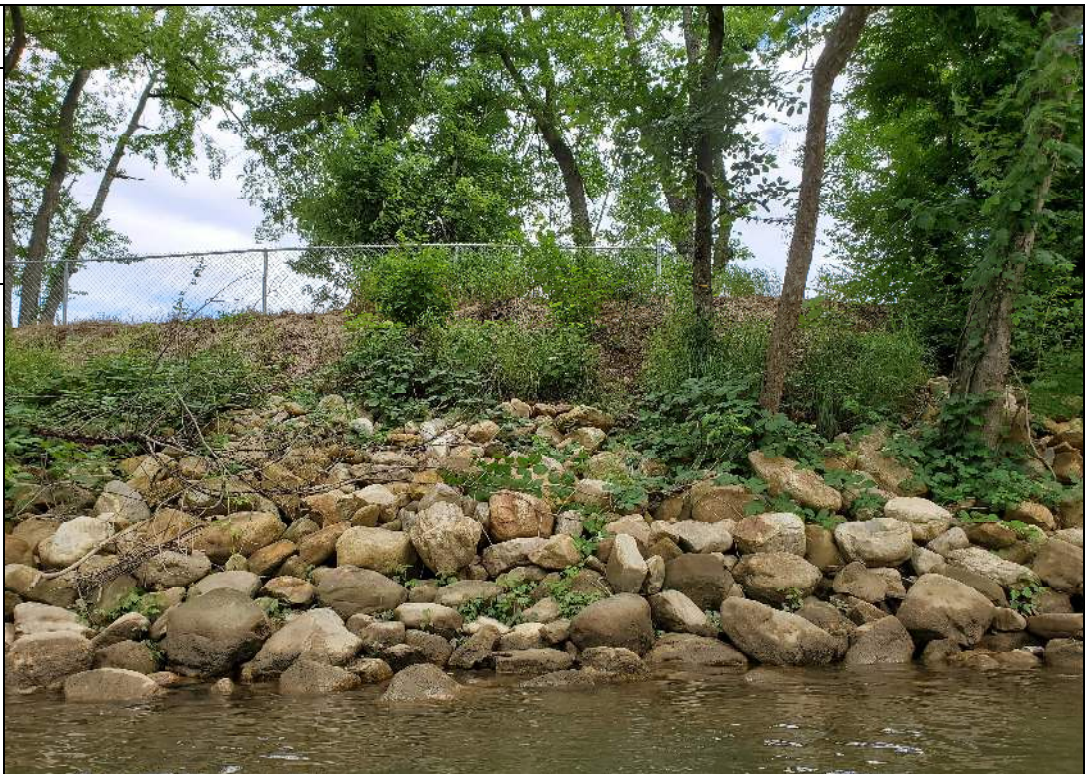
Photo No.: 20	Date: 6/13/2019
-------------------------	---------------------------

Description: Station 00 + 500' ~45 degree bank angle; no scour present; installed rock toe intact; vegetation consists of grasses, hydrangeas, and mature sycamore trees; some erosion control fabric exposed along top of bank.

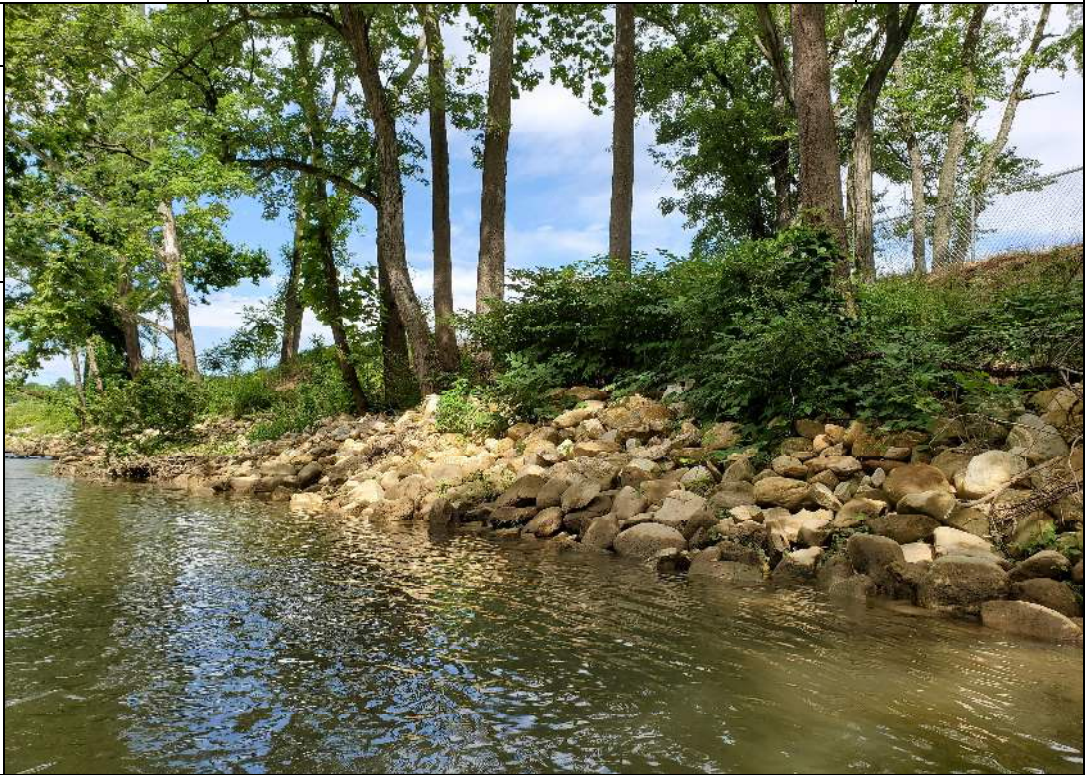
Photo No.
21

Station 00 + 500'

Upstream view of 00+500' ~no scour present; installed rock toe intact; predominantly native vegetation at top of bank; no at risk trees present; some erosion control fabric exposed along top of bank.

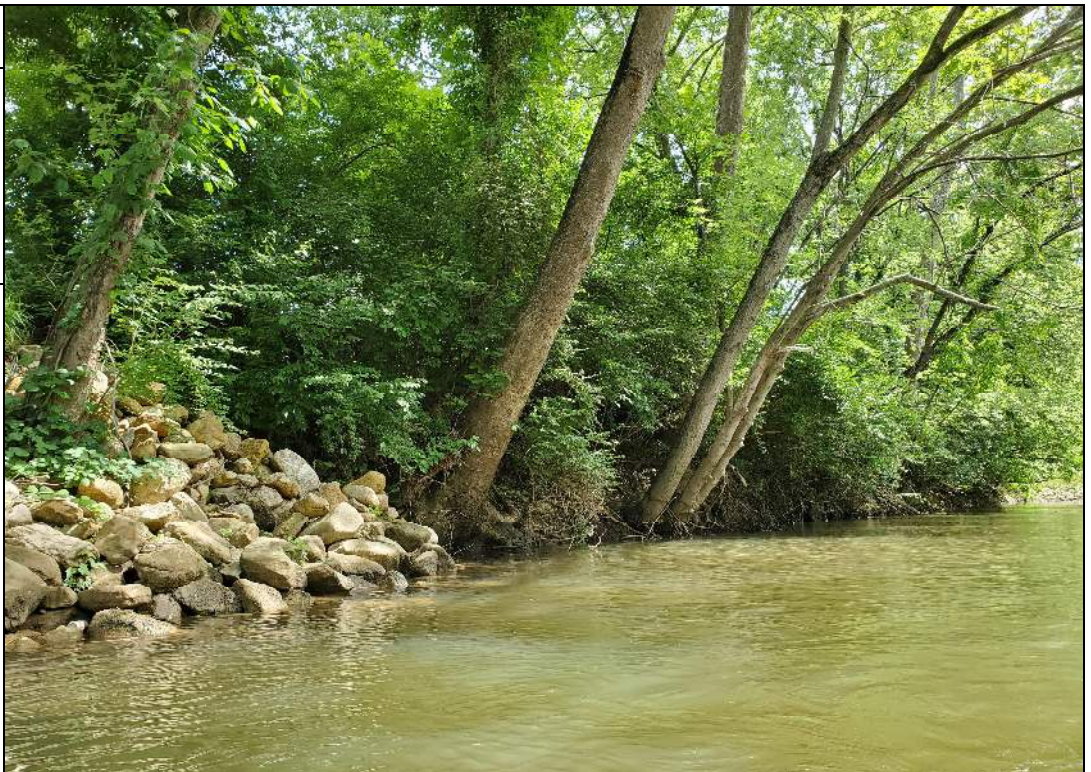
Photo No.
22

Station 00 + 500'

Downstream view of 00 + 500' immediately before the end of the rock toe; no scour present; installed rock toe intact.

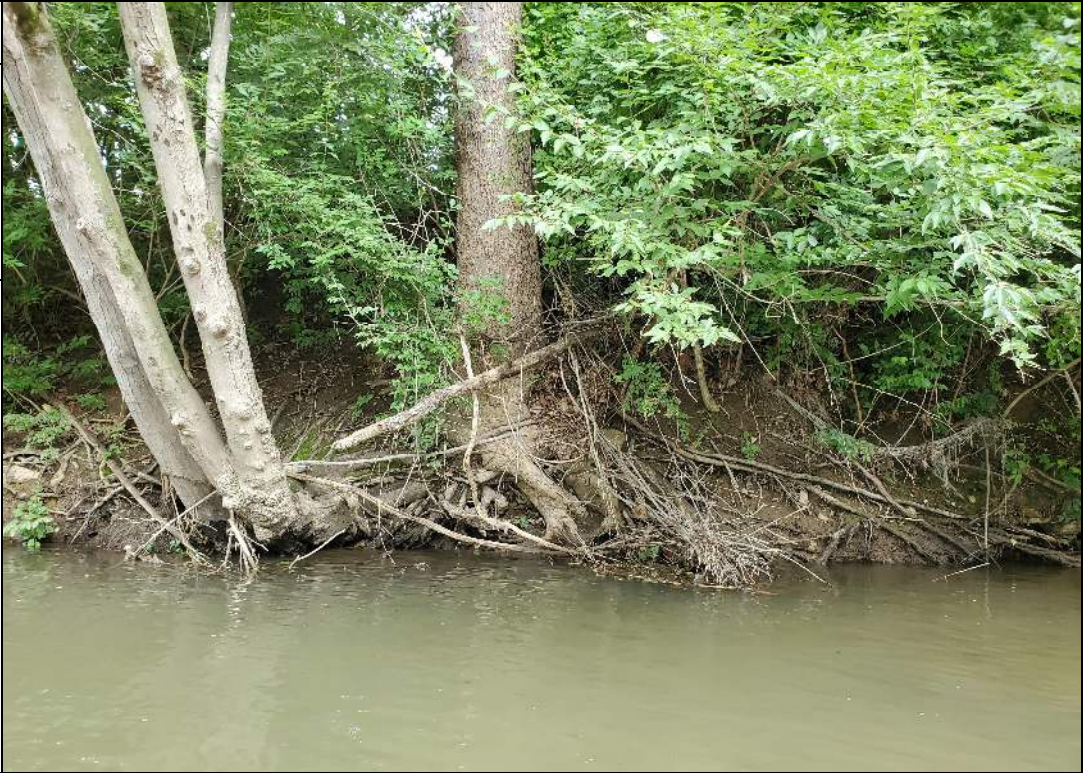
Photo No.
23

Station 00 + 550' (non-remediated transect)

~70 degree bank angle; high quantity of exposed roots; at risk trees present; scour present.

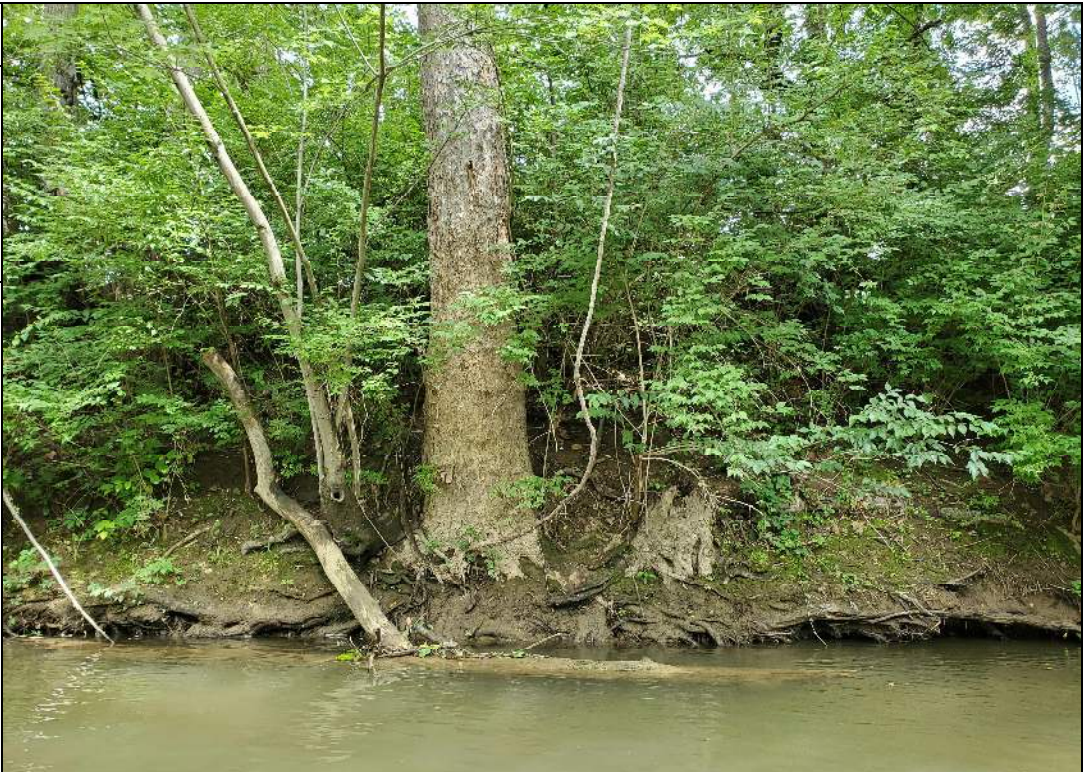
Photo No.
24

Station 00 + 600' (non-remediated transect)

~75 degree bank angle; high quantity of exposed roots; at risk trees present; scour present.

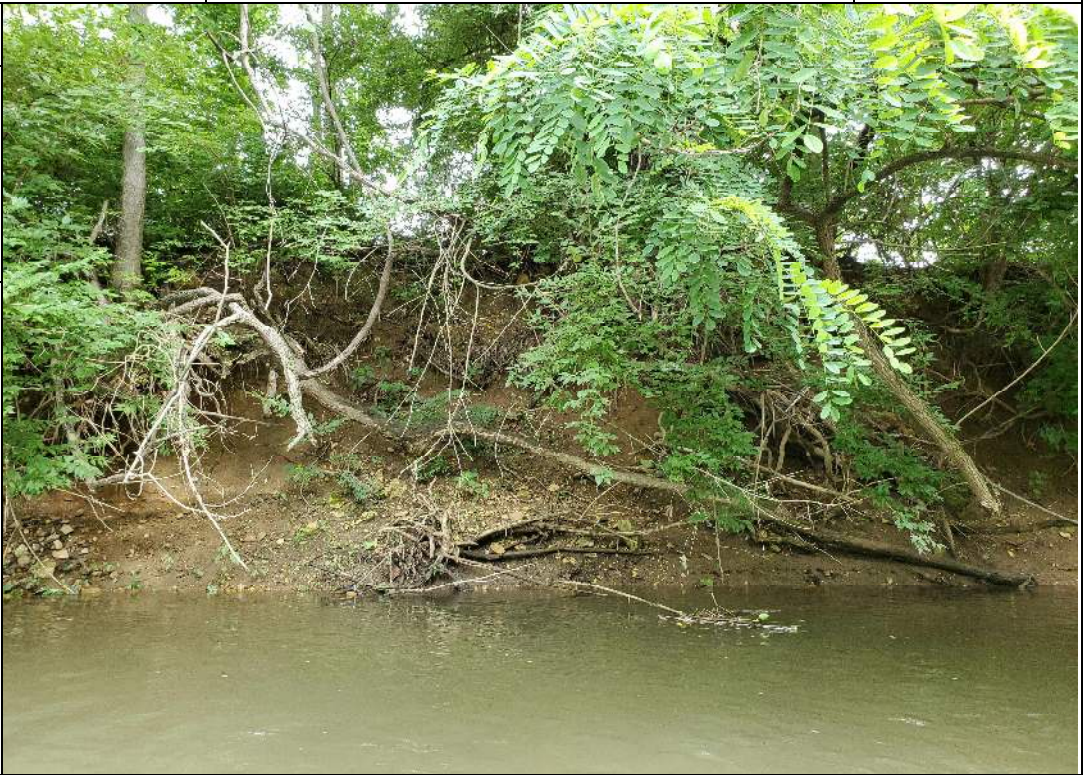
Photo No. 25	Date: 6/13/2019
------------------------	---------------------------

Station 00 + 650' (non-remediated transect)

~85 degree bank angle; high quantity of exposed roots; at risk trees present; scour continues to advance up the bank.
