**Re: 2019 Leaf-on Maintenance Inspection Reports for Allied Ready Mix, City Shops and Constitution Park BMAs
Former DuPont Waynesboro Site, Area of Concern 4
Waynesboro, Virginia
EPA ID# VAD003114832**

To	Michael Liberati, Corteva Environmental Remediation Nancy Grosso, Corteva Environmental Remediation	Page 1 of 3
CC	Cameron Dixon, AECOM Kristy Hoffman, AECOM	
Subject	City Shops BMA - 2019 Leaf-on Maintenance Inspection Former DuPont Waynesboro Site, Area of Concern 4	
From	Andrew Miano, AECOM Joshua Collins, AECOM	
Date	August 19, 2019

Table 1
2019 Leaf-on Maintenance Inspection Log
Qty Shops BMA
Former DuPont Waynesboro Site, Area of Concern 4

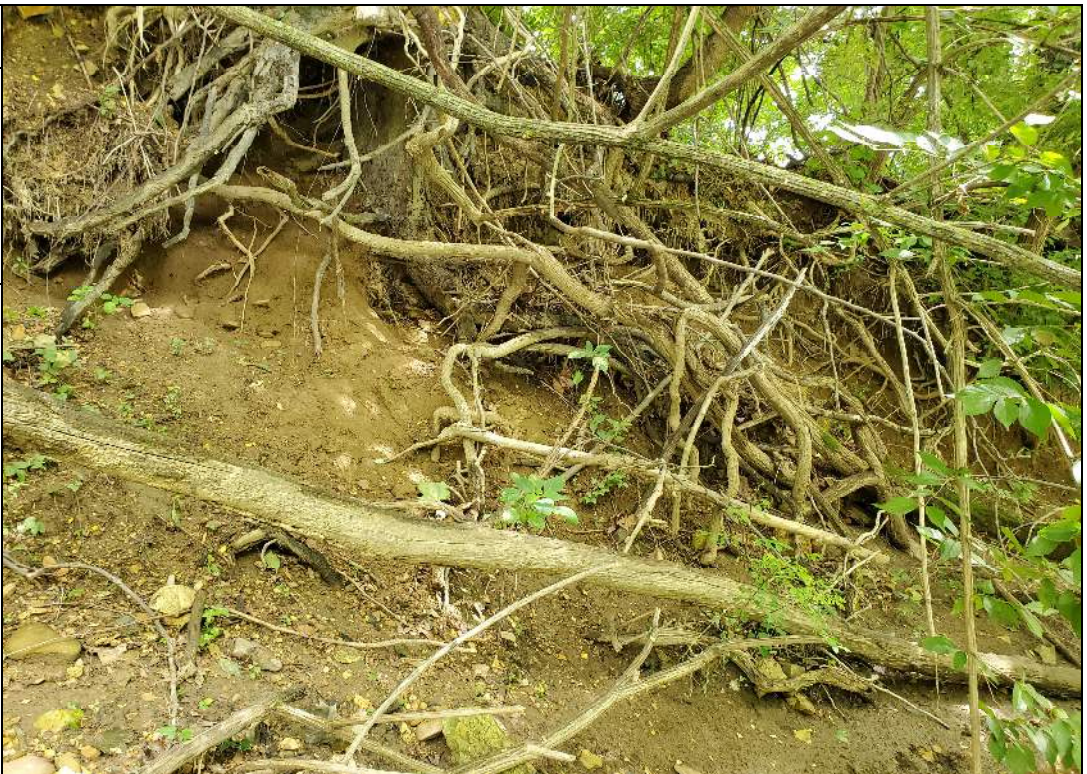
Photo No. 26	Date: 6/13/2019
------------------------	---------------------------

Station 00 + 650' (non-remediated transect)

~85 degree bank angle; high quantity of exposed roots; at risk trees present; scour advancing under root masses of at risk trees.

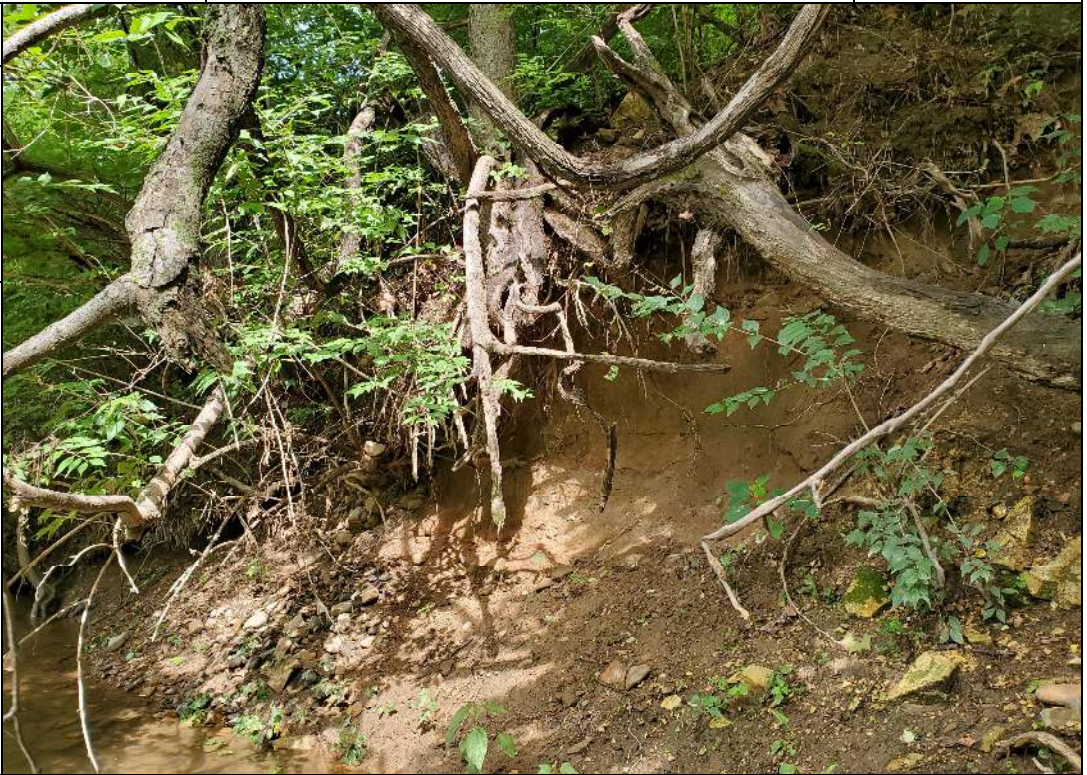
Photo No.: 27	Date: 6/13/2019
-------------------------	---------------------------

Description: Station 00 + 650' (non-remediated transect) ~85 degree bank angle; high quantity of exposed roots; several at risk trees present.

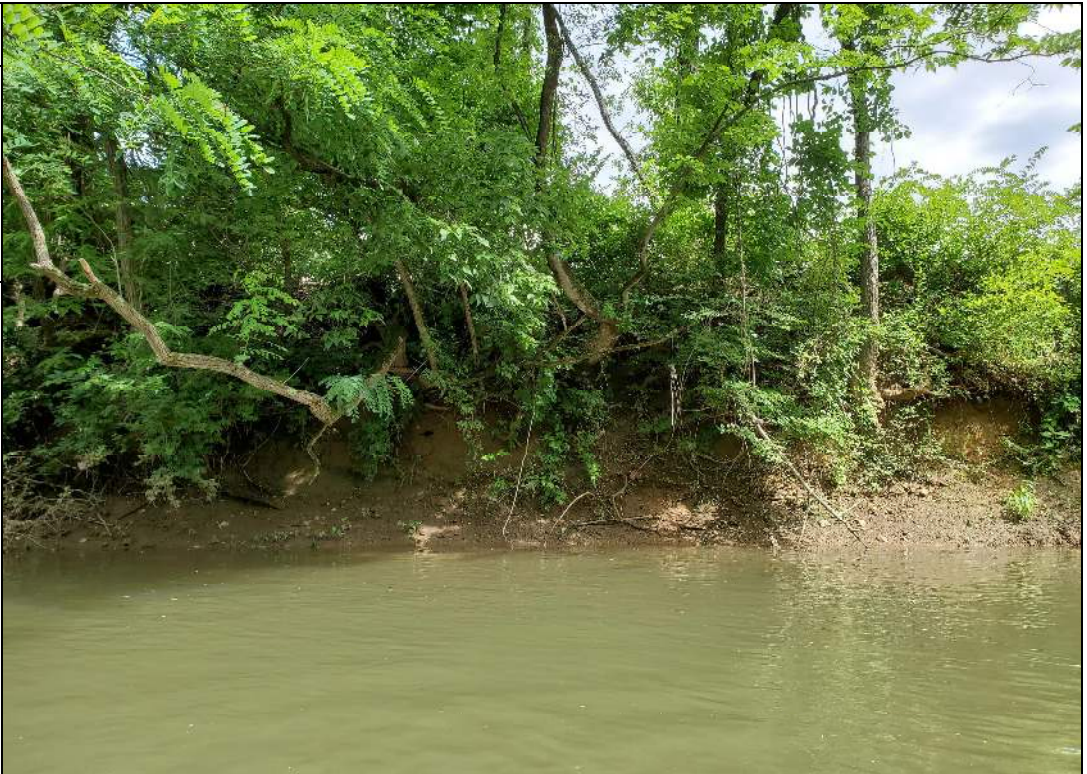
Photo No.: 28	Date: 6/13/2019
-------------------------	---------------------------

Description: Station 00 + 700' (non-remediated transect) ~90 degree bank angle; high quantity of exposed roots; at risk trees present; scour advancing towards toe of slope.

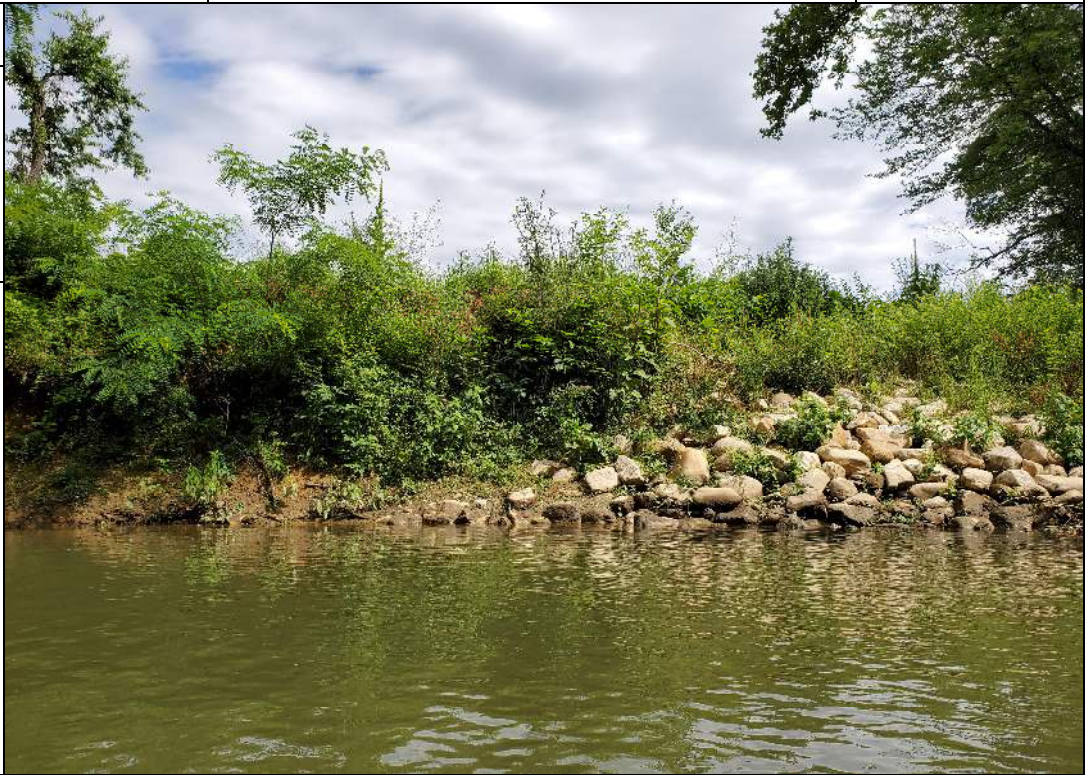
Photo No.
29

Station 00 + 750'

~90 degree bank angle;
high quantity of
exposed roots; scour
present upstream of
bank restoration.

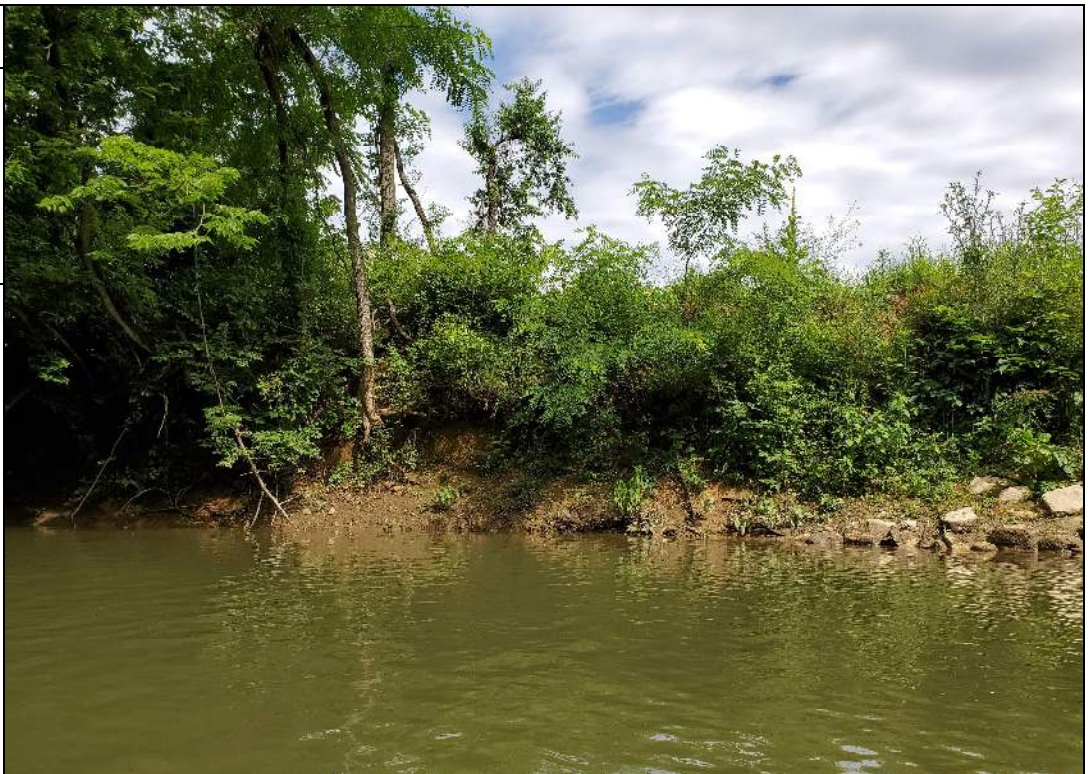
Photo No.
30

Station 00 + 750'

Upstream view of 00 +
750'; high quantity of
exposed roots; scour
present; at risk trees
present upstream
outside of remedial
footprint.

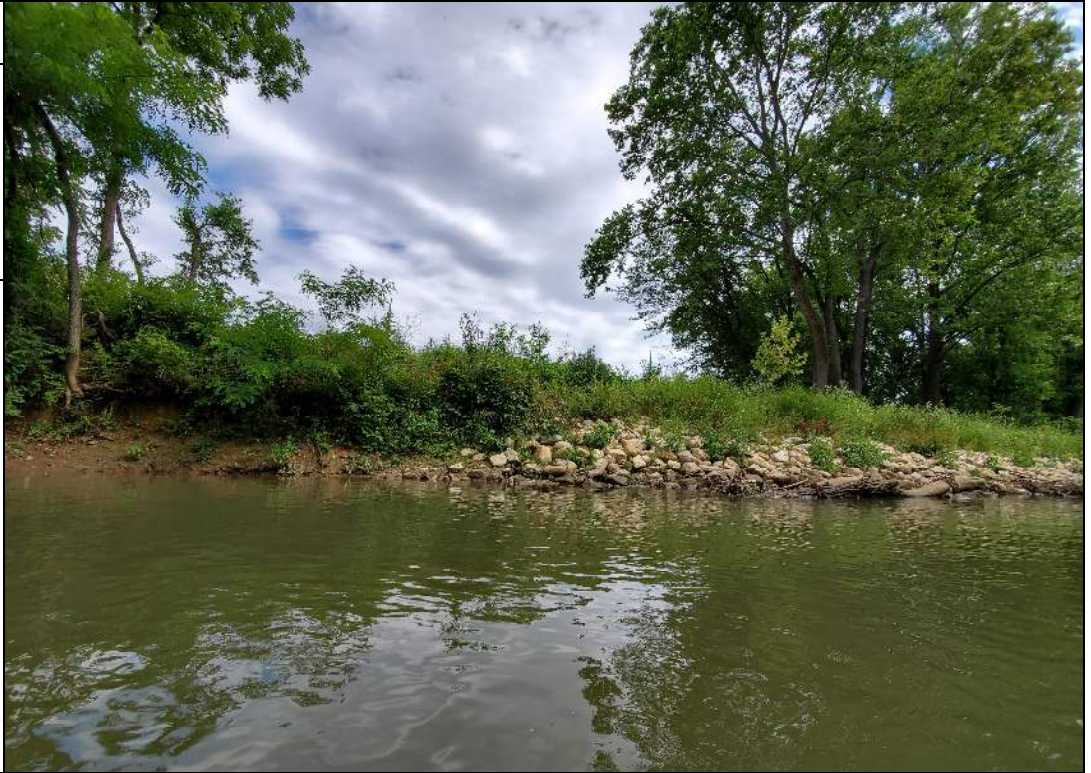
Photo No.
31

Station 00 + 750'

Additional upstream view of 00 + 750' showing the beginning of the rock toe.

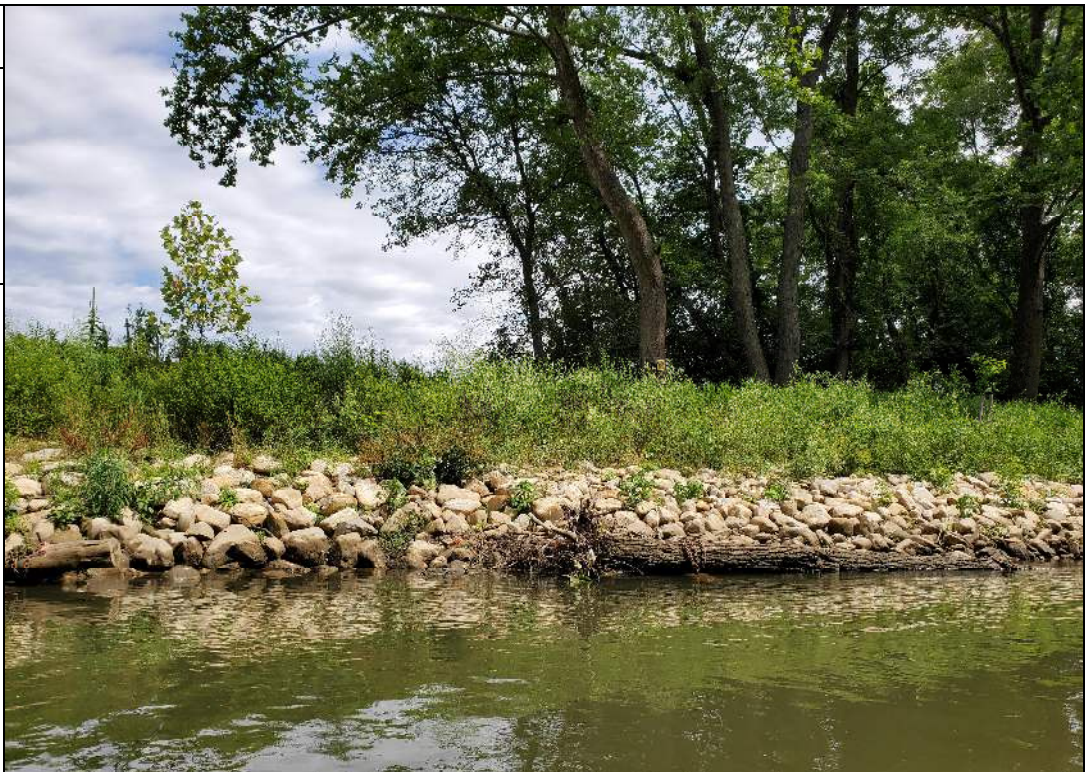
Photo No.
32

Station 00 + 800'

~40 degree bank angle; no scour present; installed rock toe intact; vegetation consists of planted grasses and live stakes/saplings; erosion control fabric primarily covered in vegetation.

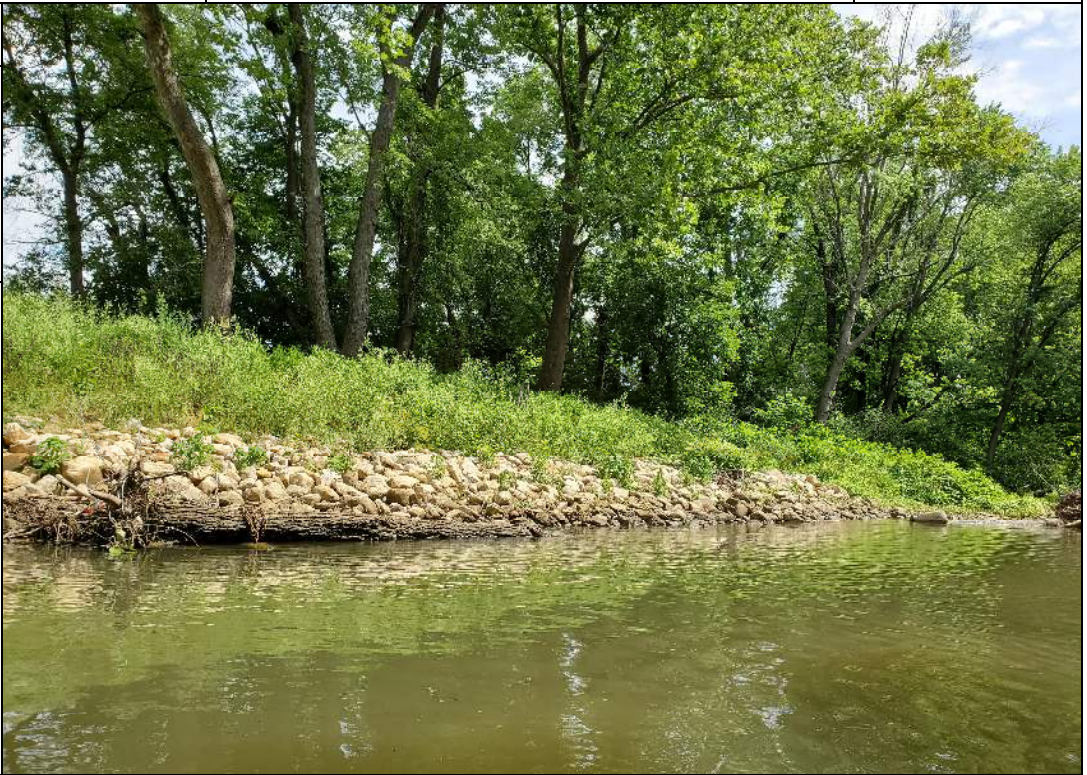
Photo No. 33	Date: 6/13/2019
------------------------	---------------------------

Description: Station 00 + 800' Downstream view of 00 + 800'; no scour present; installed rock toe intact; erosion control fabric primarily covered in vegetation.
--

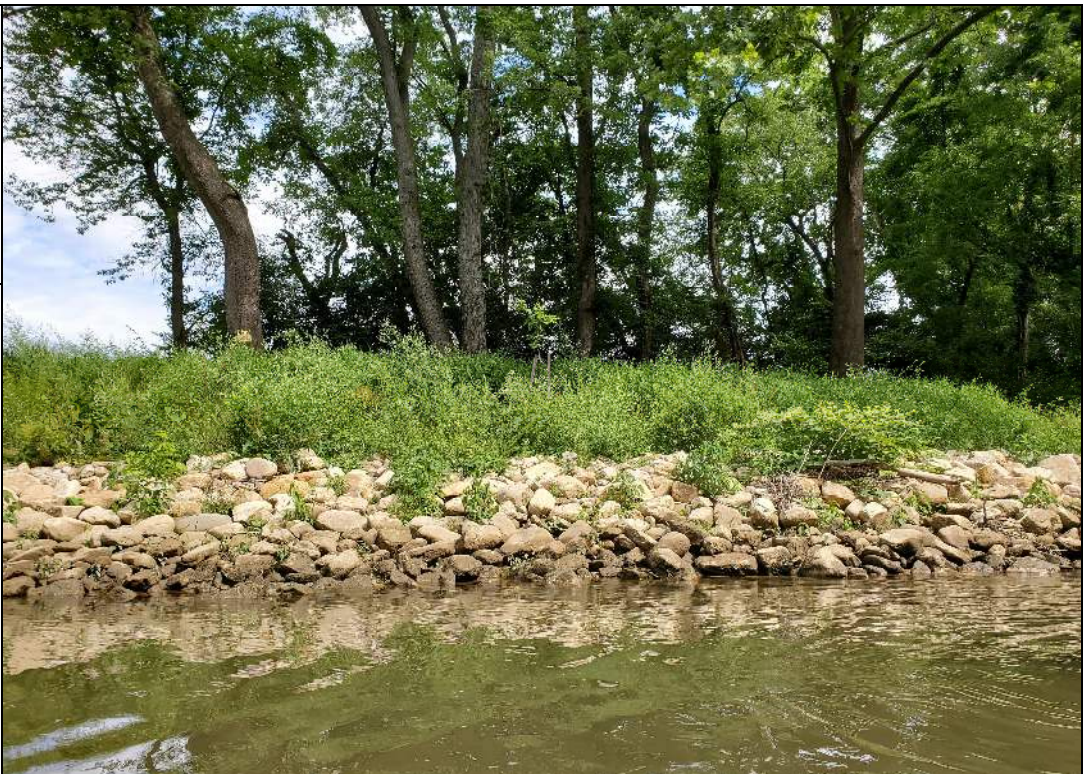
Photo No. 34	Date: 6/13/2019
------------------------	---------------------------

Description: Station 00 + 850' ~25-30 degree bank angle; no scour present; installed rock toe intact; vegetation consists of planted grasses and live stakes/samplings; erosion control fabric primarily covered in vegetation.
--

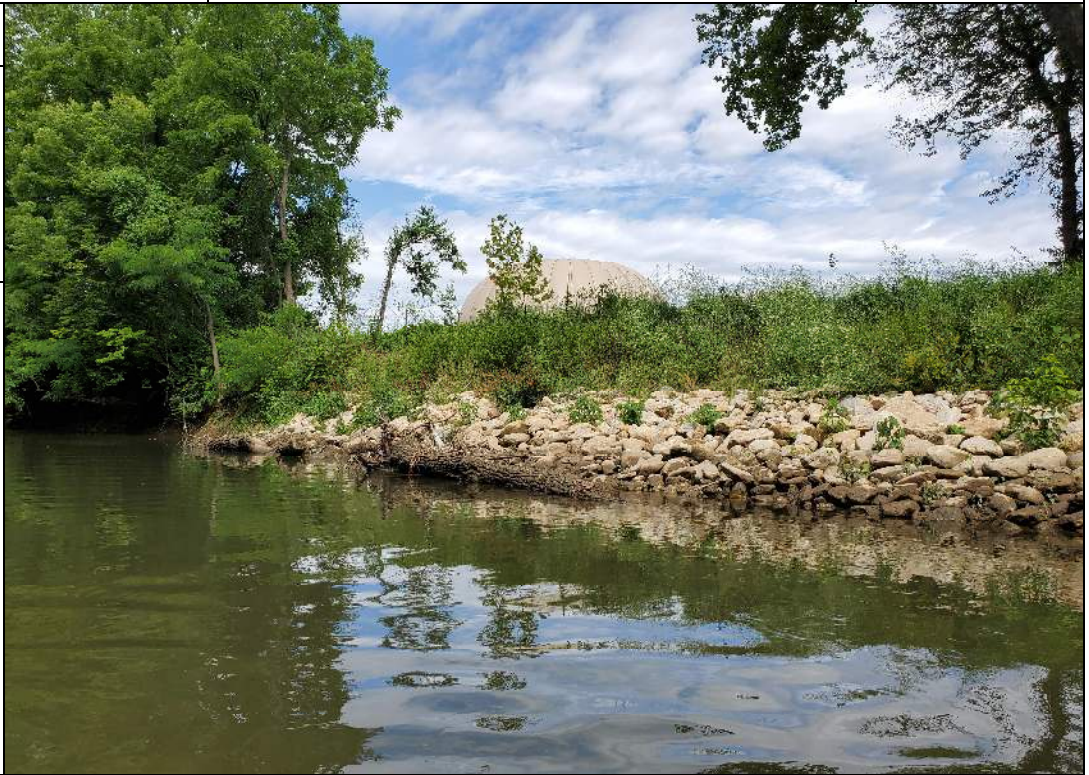
Photo No.: 35	Date: 6/13/2019
-------------------------	---------------------------

Description: Station 00 + 850' Upstream view of 00 + 850'; no scour present along installed rock toe; planted vegetation present and healthy.
--

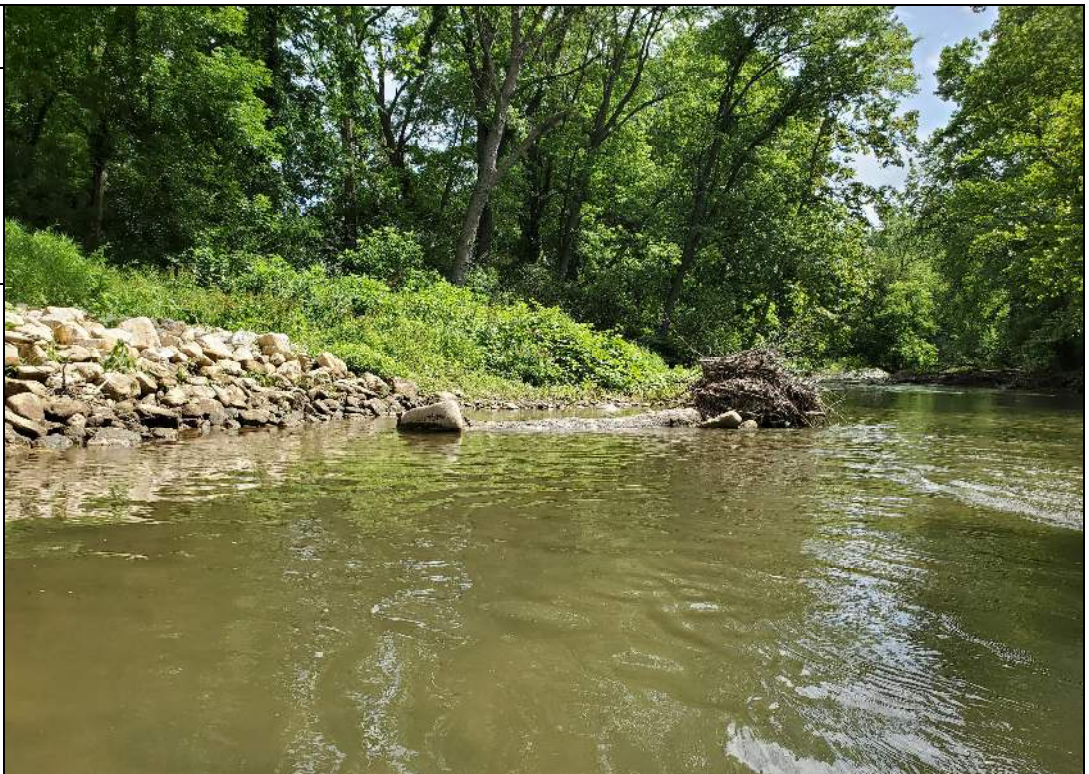
Photo No.: 36	Date: 6/13/2019
-------------------------	---------------------------

Description: Station 00 + 850' Downstream view of 00 + 850'; LWD moved from its installed position. The root ball side of the installed LWD has pivoted downstream.
--

Comments: LWD shifted downstream at 400' and 880'

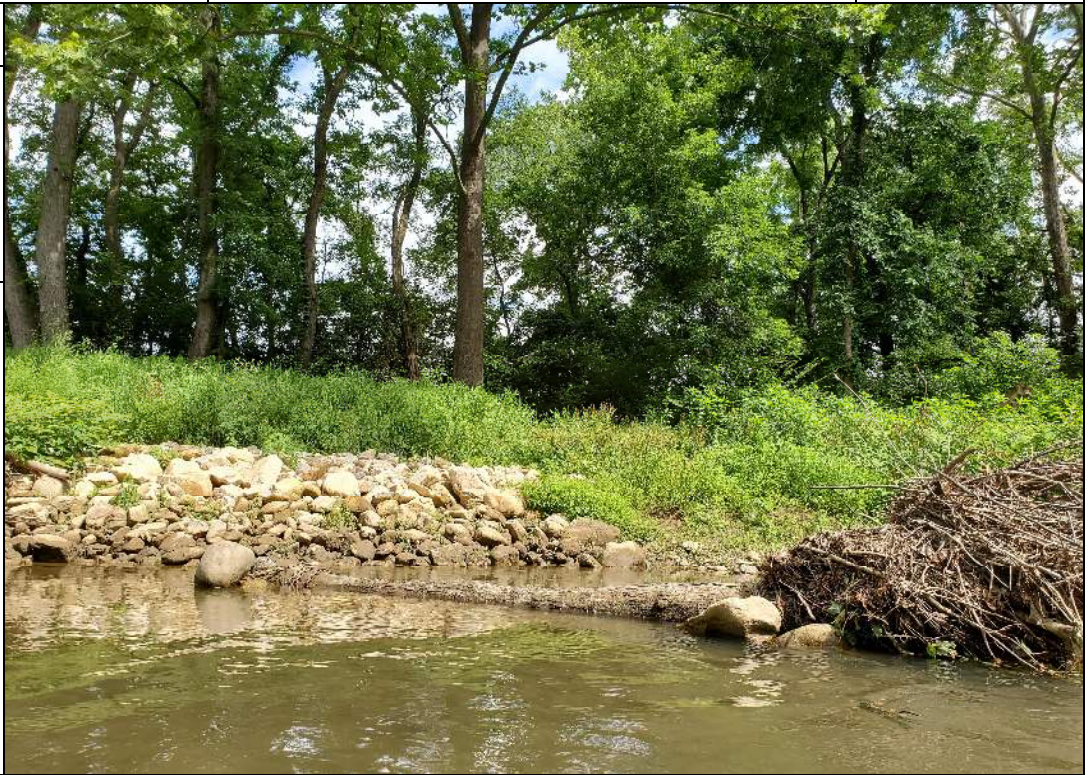
Photo No. 37	Date: 6/13/2019
------------------------	---------------------------

Station 00 + 880'

~20 degree bank angle;
no scour present;
installed rock toe intact;
vegetation consists of
grasses, trees and live
stakes; erosion control
fabric primarily covered
in vegetation.

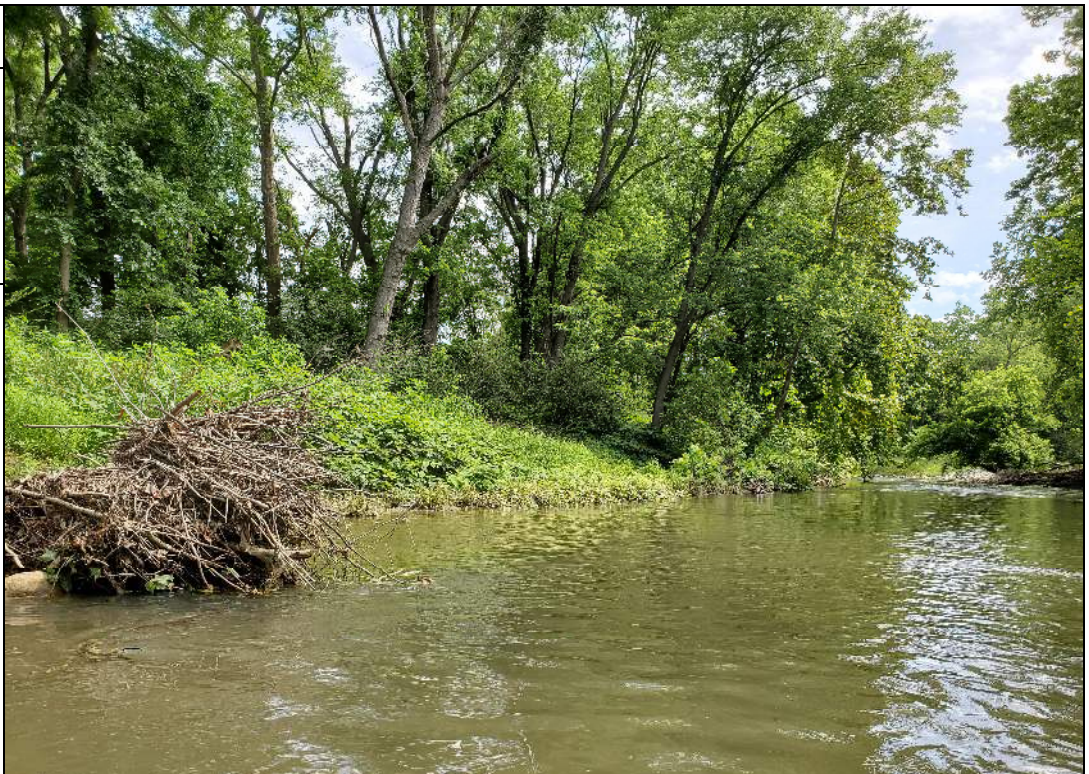
Photo No. 38	Date: 6/13/2019
------------------------	---------------------------

Station 00 + 880'

Downstream view of 00 + 880' at the end of the remedial footprint.
