**Re: 2019 Leaf-on Maintenance Inspection Reports for Allied Ready Mix, City Shops and Constitution Park BMAs
Former DuPont Waynesboro Site, Area of Concern 4
Waynesboro, Virginia
EPA ID# VAD003114832**

To	Michael Liberati, Corteva Environmental Remediation Nancy Grosso, Corteva Environmental Remediation	Page 1 of 3
CC	Cameron Dixon, AECOM Kristy Hoffman, AECOM	
Subject	Allied Ready Mix BMA – 2019 Leaf-on Maintenance Inspection Former DuPont Waynesboro Site, Area of Concern 4	
From	Andrew Miano, AECOM Joshua Collins, AECOM	
Date	August 19, 2019

This memorandum summarizes the 2019 Leaf-on Maintenance Inspection (inspection) of the Allied Ready Mix Bank Management Area (BMA) conducted in June 2019. The inspection constitutes the second maintenance inspection following completion of interim measures construction activities in November 2018. Inspection activities followed the scope described in the Maintenance Plan included as Appendix M of the Basis of Design Report, Phase 1A BMAs, South River AOC 4 (Anchor QEA et al., 2016). The purpose of the maintenance inspection is to identify potential BMA maintenance needs, focusing on vegetative development, bank stability, and the integrity

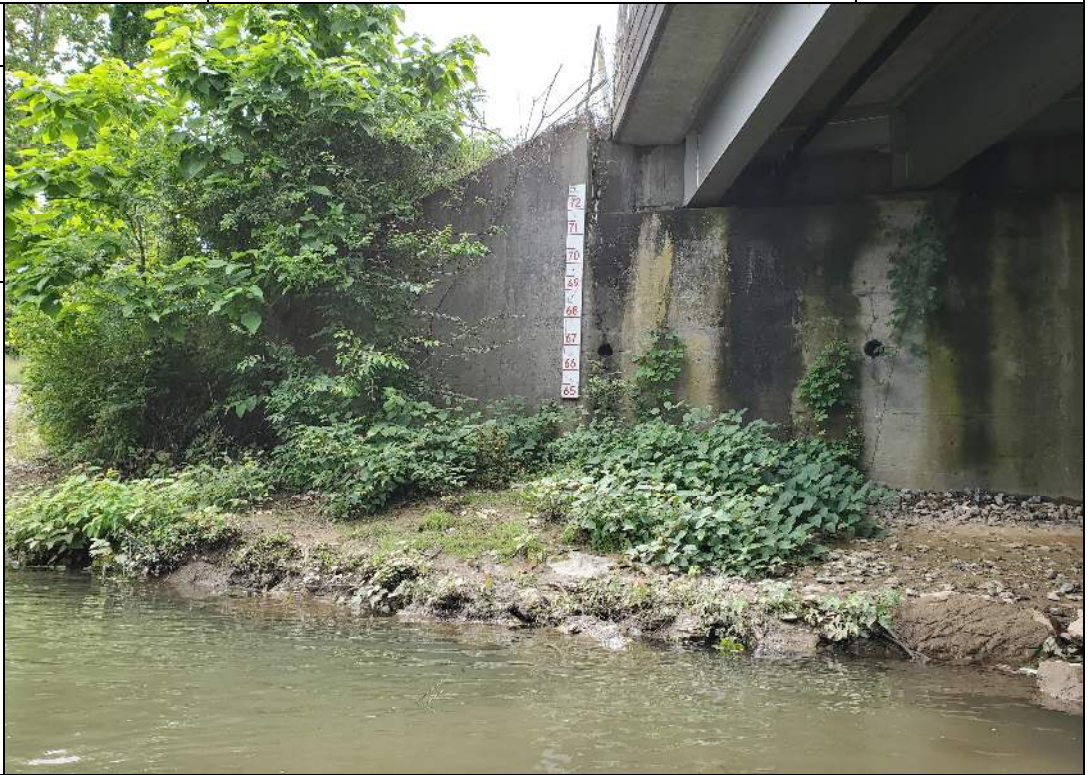
Photo No. 1	Date: 6/13/2019
-----------------------	---------------------------

Description: Station 00 – 20' (non-remediated transect under 2 nd Street overpass) ~20 degree bank angle; no at risk trees present; patches of invasive knotweed are present at the toe of slope; some scour associated with foot traffic along bank. Red maple saplings are establishing at the toe of slope.

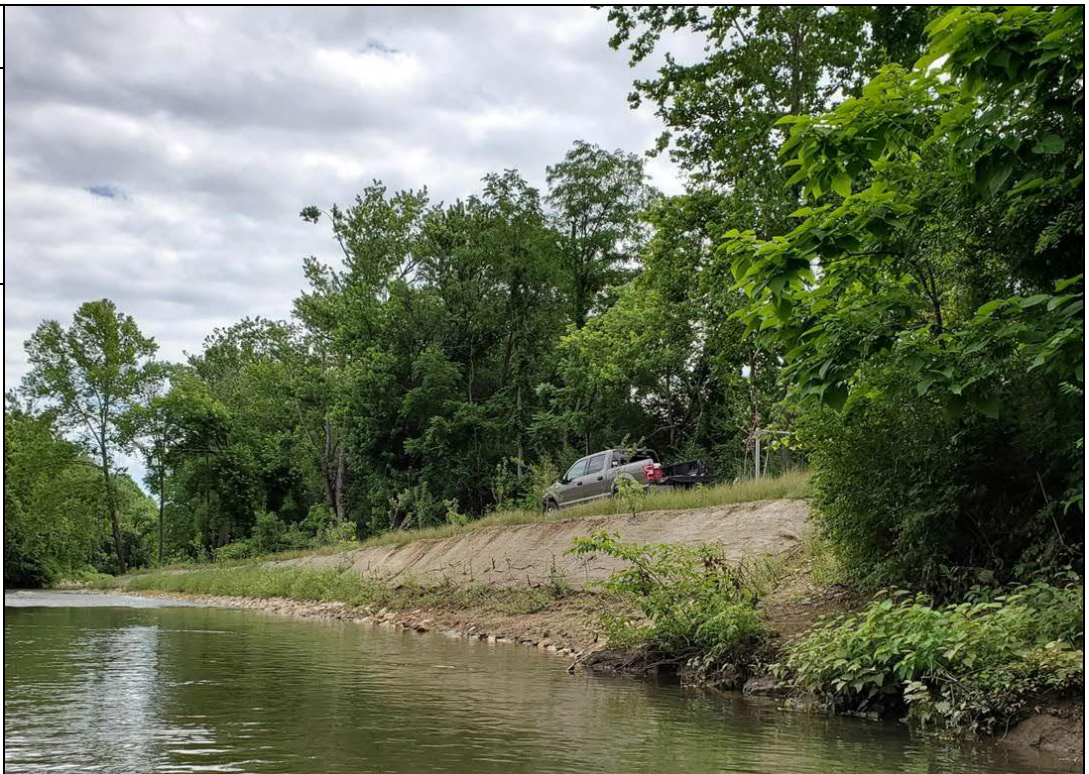
Photo No. 2	Date: 6/13/2019
-----------------------	---------------------------

Description: Station 00 – 20' (non-remediated transect under 2 nd Street overpass) ~20 degree bank angle; no at risk trees present; sand deposition above rock toe; improvised access point located downstream.

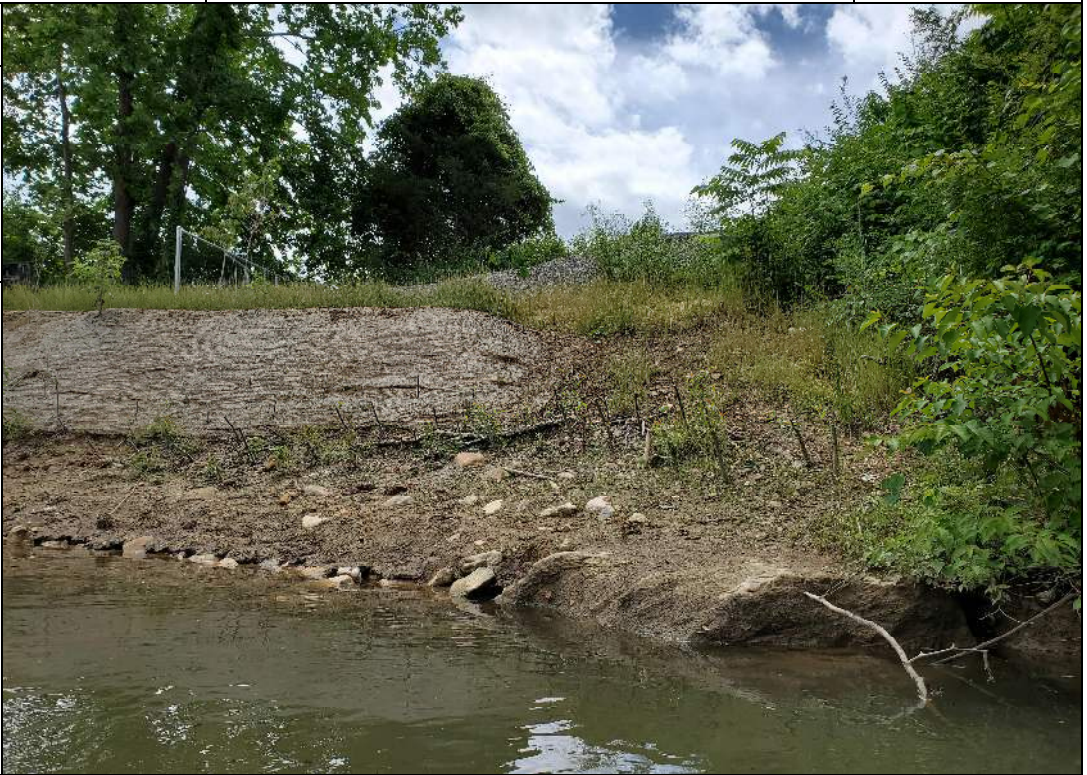
Photo No.: 3	Date: 6/13/2019
------------------------	---------------------------

Description: Station 00 + 00' ~45 degree bank angle; installed rock toe intact; sand deposition above rock toe; live stakes planted on lower bank 60% established; saplings planted on upper bank; 80% of erosion control fabric exposed; improvised access point present. Red maple saplings establishing at toe of slope.

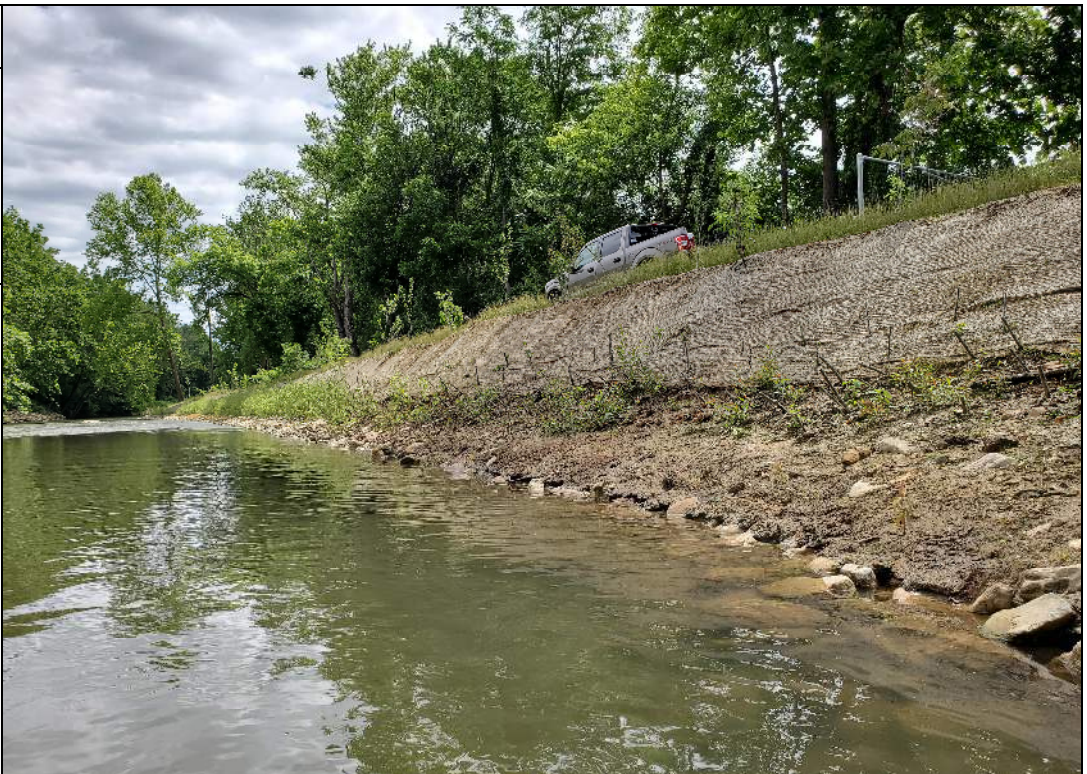
Photo No.: 4	Date: 6/13/2019
------------------------	---------------------------

Description: Station 00 + 00' ~45 degree bank angle; installed rock toe intact; live stakes planted on lower bank; red maple saplings establishing at toe of slope; saplings planted on upper bank show new growth; sand deposition observed above rock toe; no geocell exposed.

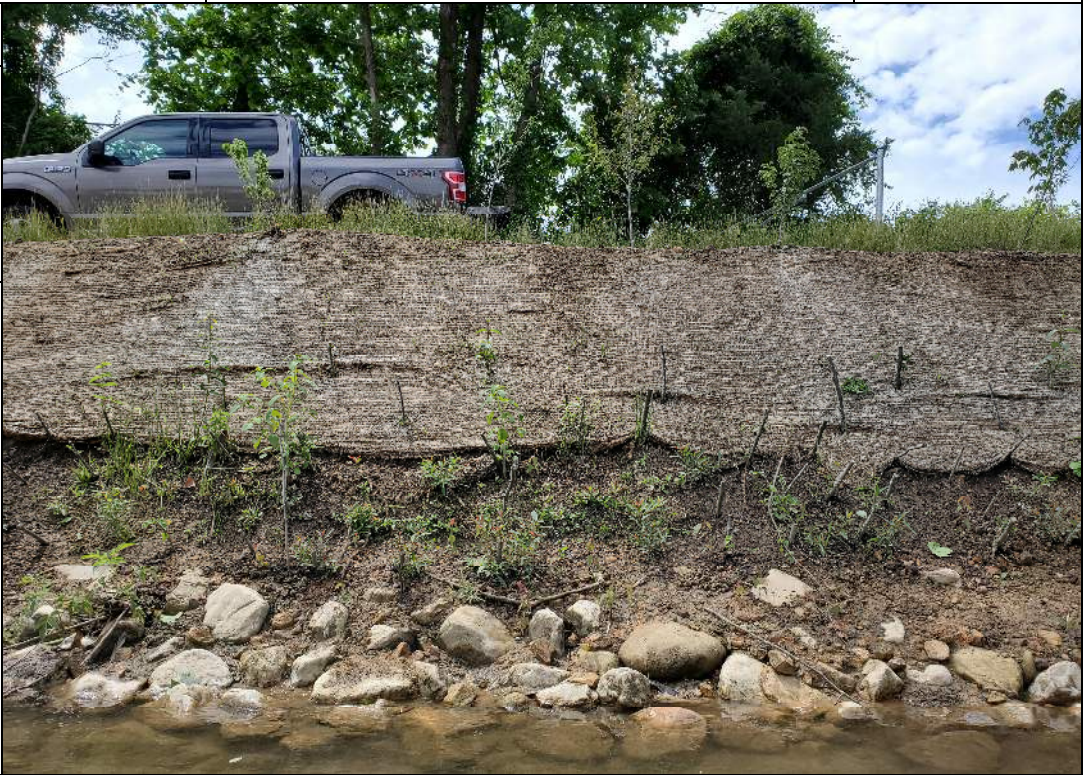
Photo No. 5	Date: 6/13/2019
-----------------------	---------------------------

Description: Station 00 + 50' ~50 degree bank angle; installed rock toe intact; live stakes planted on lower bank; red maple saplings establishing at toe of slope; saplings planted on upper bank; erosion control fabric exposed throughout; no geocell exposed.

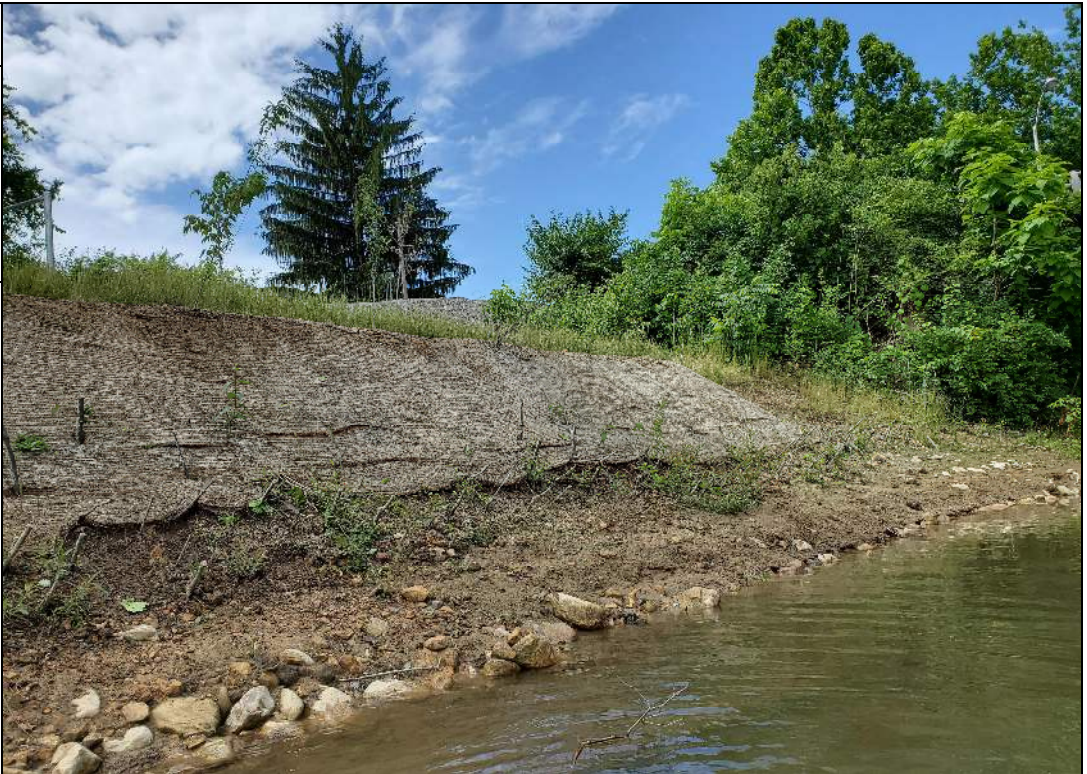
Photo No. 6	Date: 6/13/2019
-----------------------	---------------------------

Description: Station 00 + 50' Sand deposition above rock toe; erosion control fabric 80% exposed; Live stakes 60% established; red maple saplings are establishing at the toe of slope; sand deposition is present above rock toe.

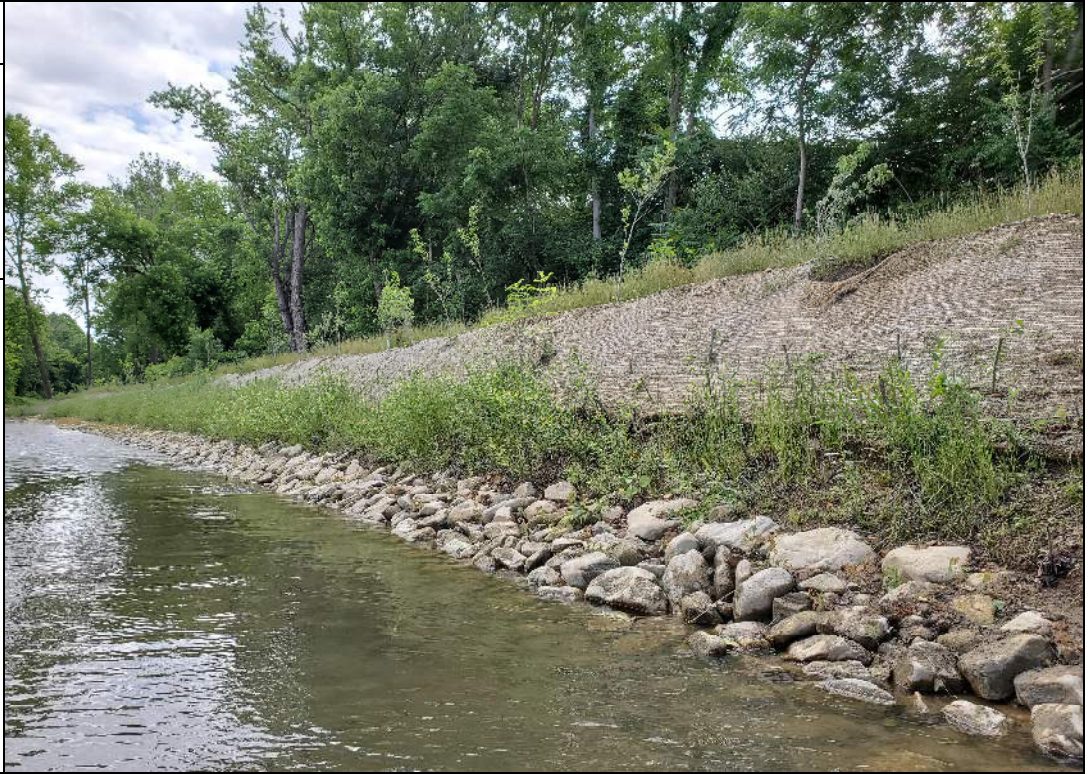
Photo No.
7

Installed rock toe intact; live stakes planted on lower bank are 60% established; saplings planted on upper bank show new growth; 80% of erosion control fabric exposed; a small tear in the erosion control fabric was observed at the top of slope.

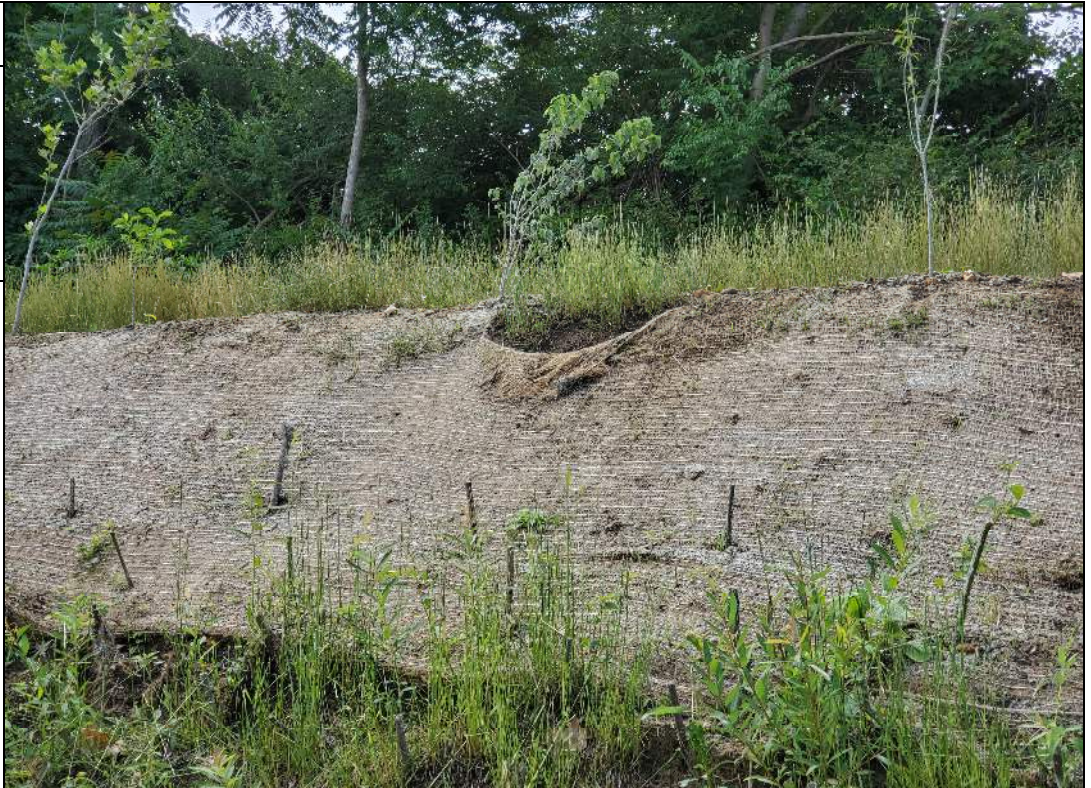
Photo No.
8

- River bank angles remained unchanged and maintain a consistent bank angle throughout the BMA as designed (Table 1).
- Localized scour was only observed at the top of the slope at 00+50' where fabric is torn; no geocell is exposed.
- There were no "at-risk" trees (e.g. trees that may no longer be stable due to erosion) within the remediated portions of the BMA.
- Although the remediated BMA remained stable, there continues to be heavy erosion present in the non-remediated downstream area of the second BMA section.

Tear in the erosion control fabric observed at the top of slope; scour is present where fabric is torn; geocell is not exposed.

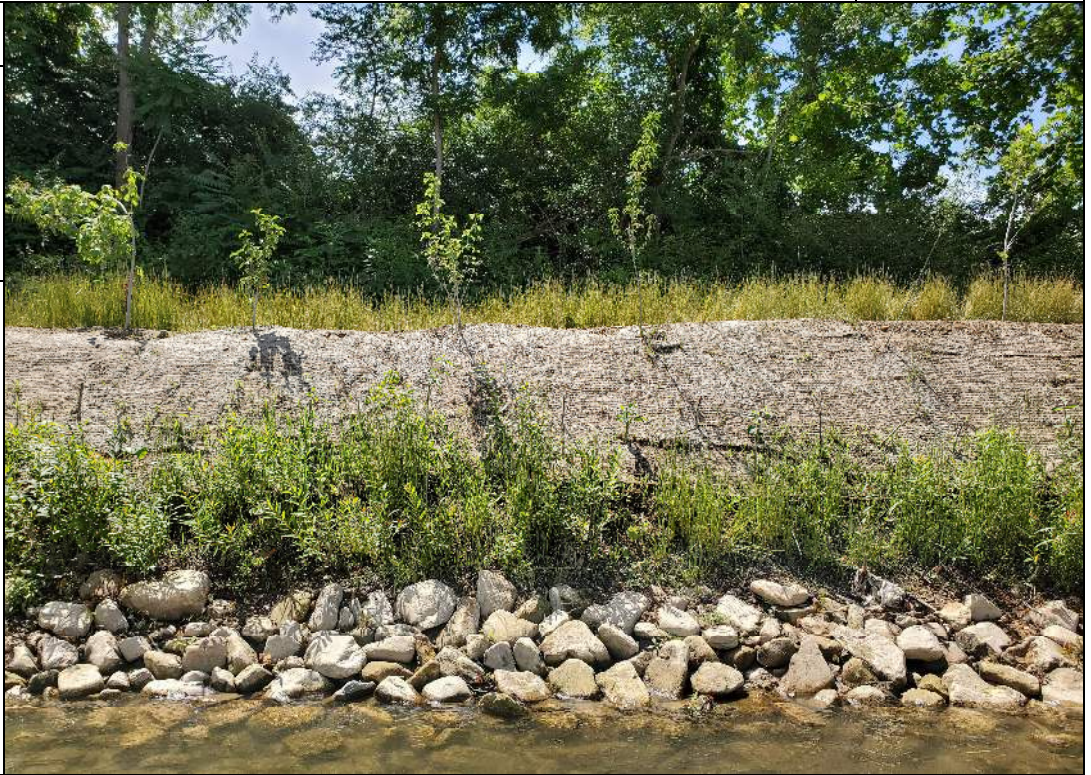
Photo No.:
9

~50 degree bank angle; installed rock toe intact; live stakes planted on lower bank are 60% established; saplings planted on upper bank show new growth; 50% of erosion control fabric exposed; no exposed geocell.

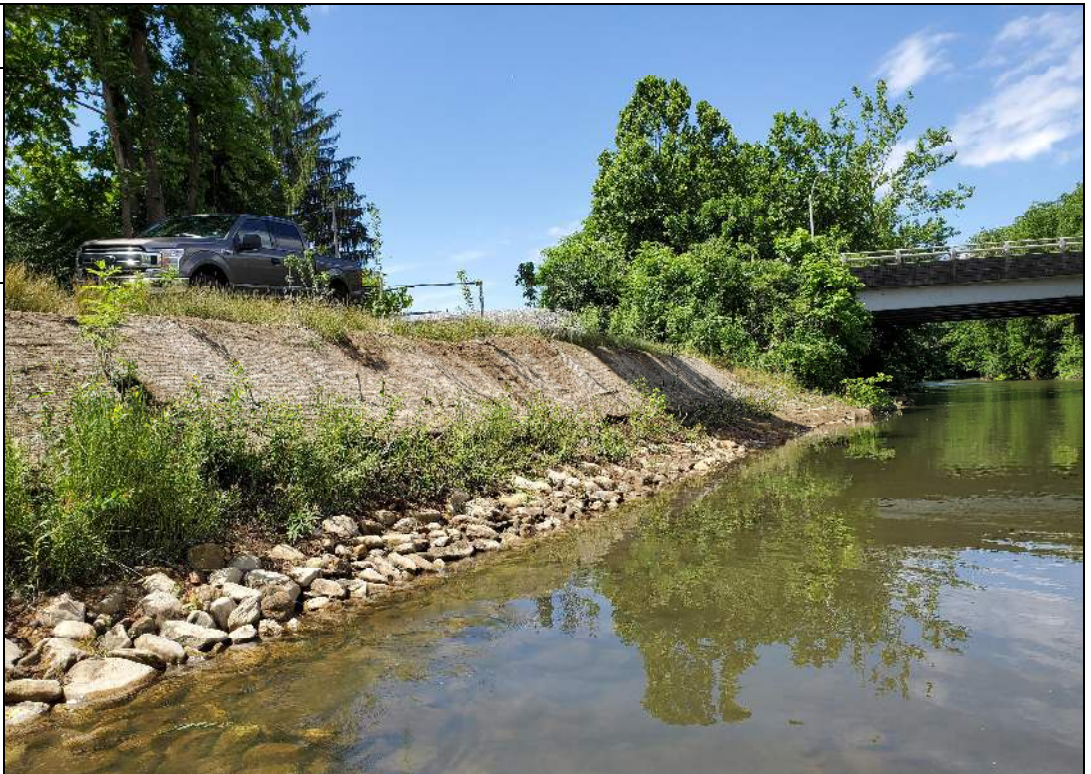
Photo No.:
10

Installed rock toe intact; sand deposition above rock toe; 50% of the erosion control fabric is exposed.

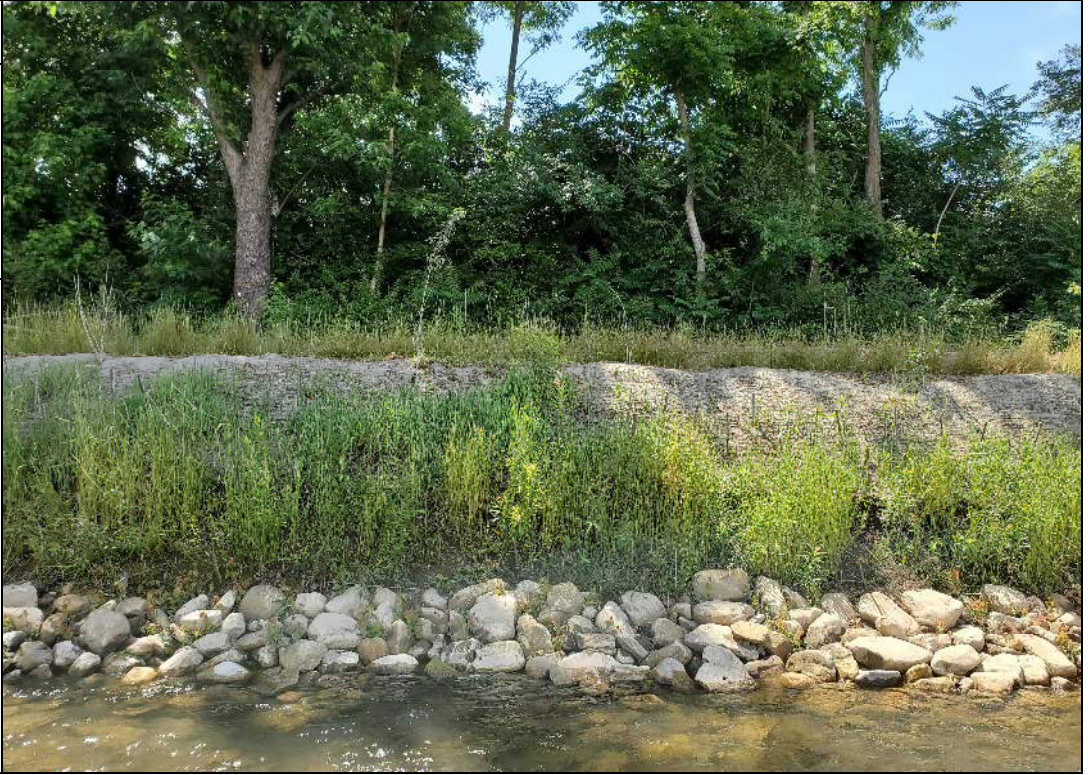
Photo No.:
11

~50 degree bank angle; installed rock toe intact; live stakes planted on lower bank are 70% established; saplings planted on upper bank show new growth; erosion control fabric 60% exposed; no exposed geocell; red maple saplings and grasses establishing at toe of slope.

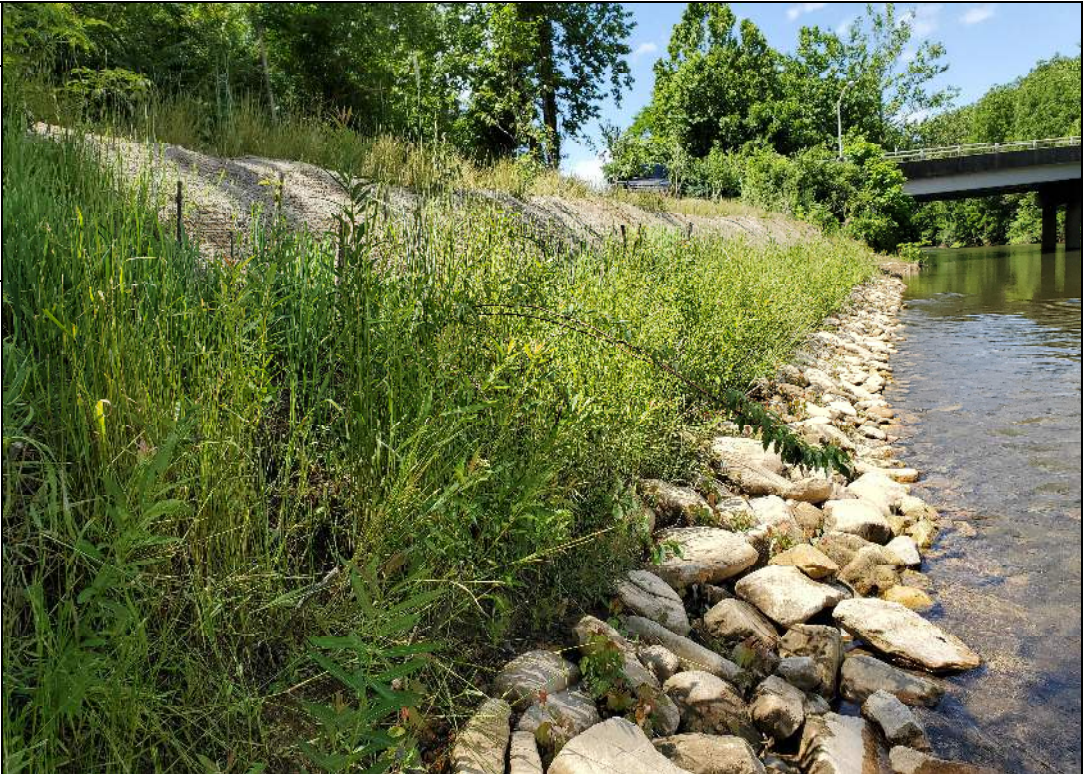
Photo No.:
12

Installed live stakes upstream of 00 + 150' show new growth. erosion control fabric 60% exposed; grasses beginning to establish on lower bank; no exposed geocell.

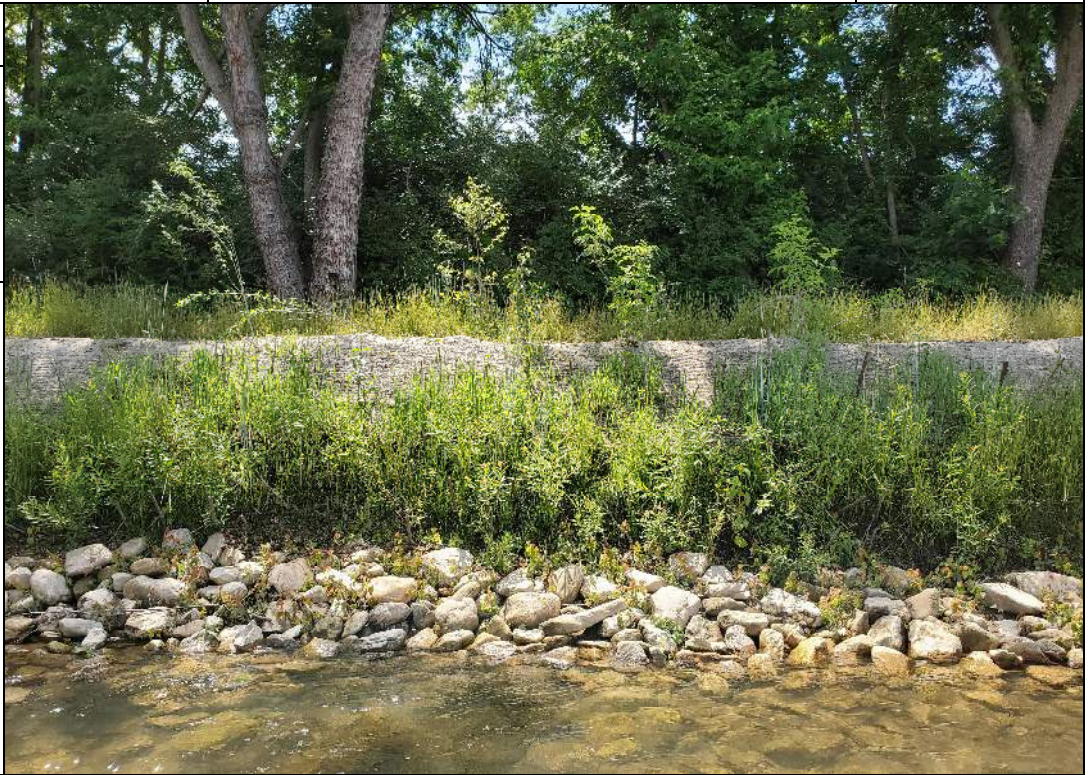
Photo No.
13

~50 degree bank angle; installed rock toe intact; live stakes 70% established; saplings planted on upper bank show new growth; 50% of erosion control fabric exposed; no exposed geocell; red maple saplings and grasses establishing at toe of slope.

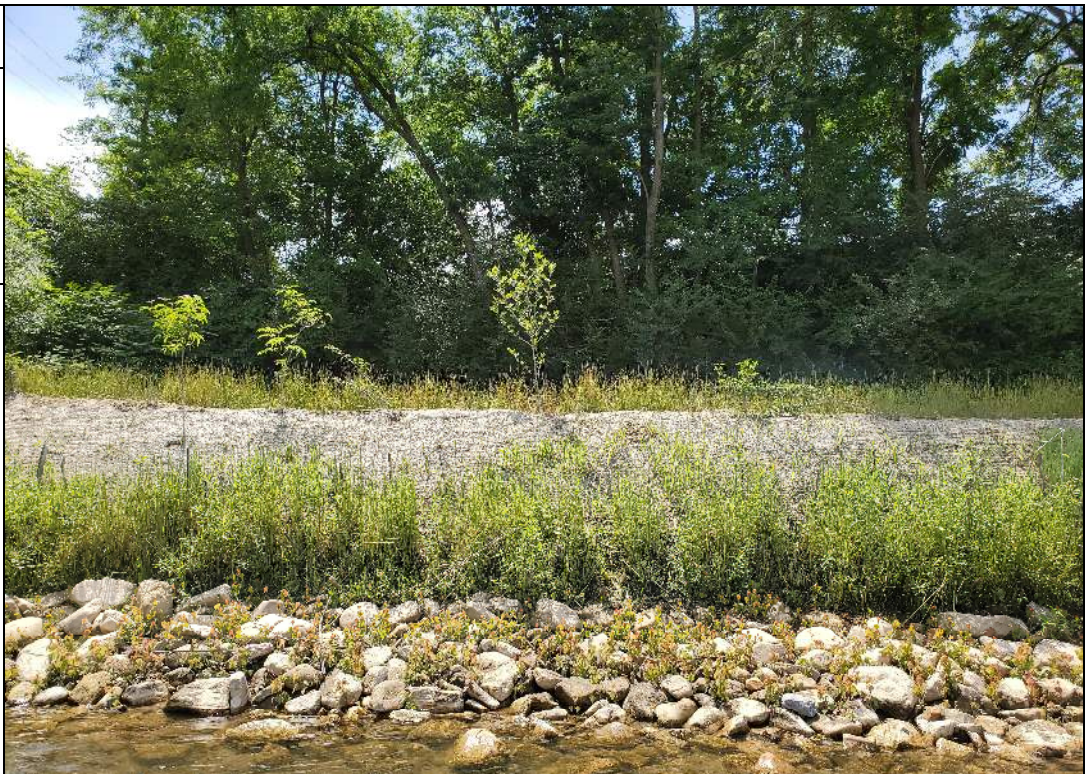
Photo No.
14

~50 degree bank angle; installed rock toe intact; live stakes 60% established; saplings planted on upper bank show new growth; 50% of erosion control fabric exposed. no exposed geocell; red maple saplings and grasses establishing at toe of slope.

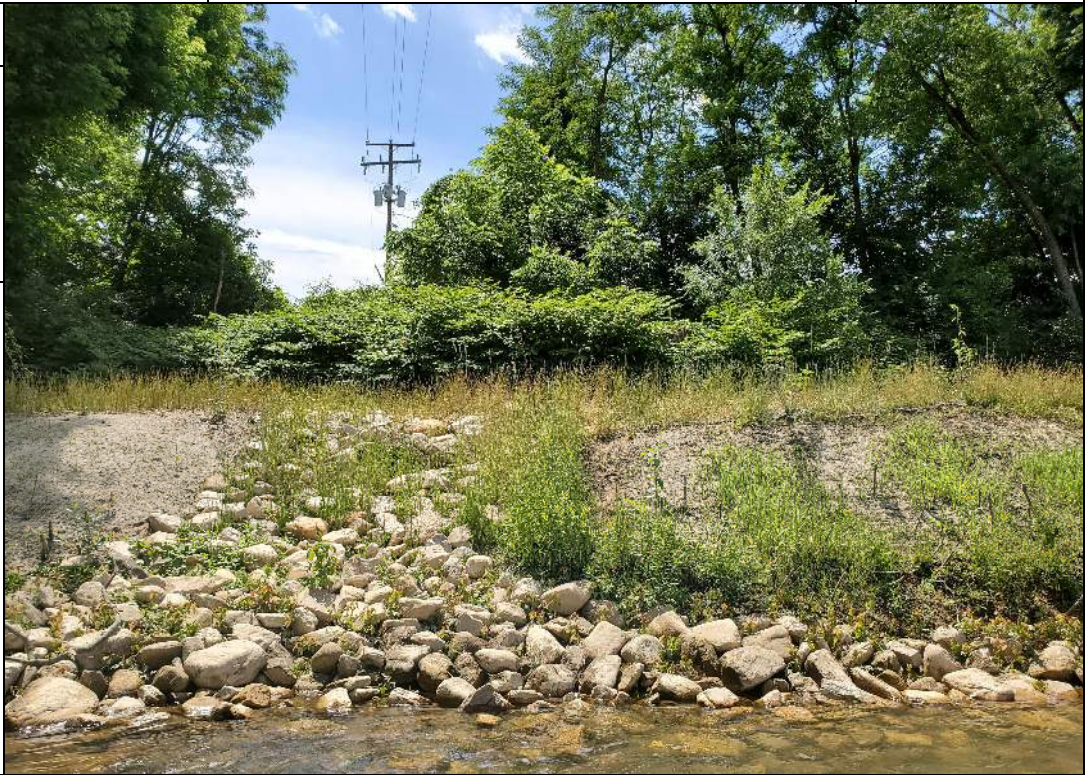
Photo No.
15

~40 degree bank angle; installed rock toe intact; outfall and drainage structure intact; live stakes 50% established; saplings planted on upper bank show new growth, 80% of erosion control fabric exposed throughout.

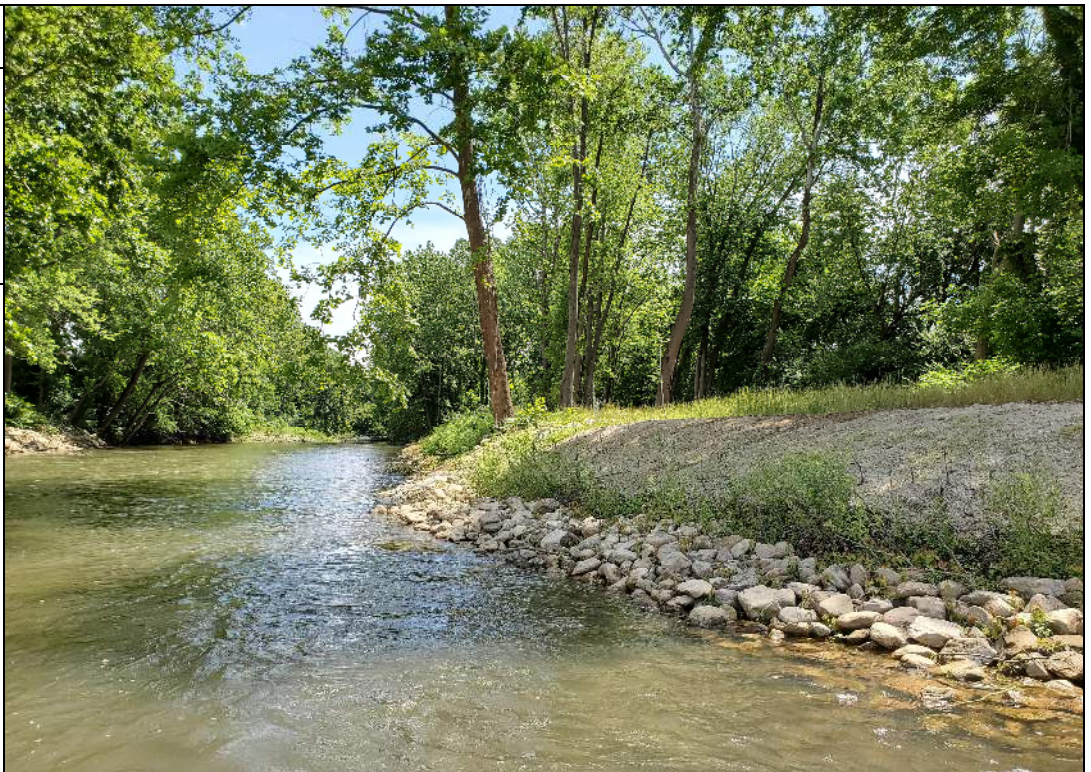
Photo No.
16

Downstream view of live stake growth and exposed erosion control fabric.

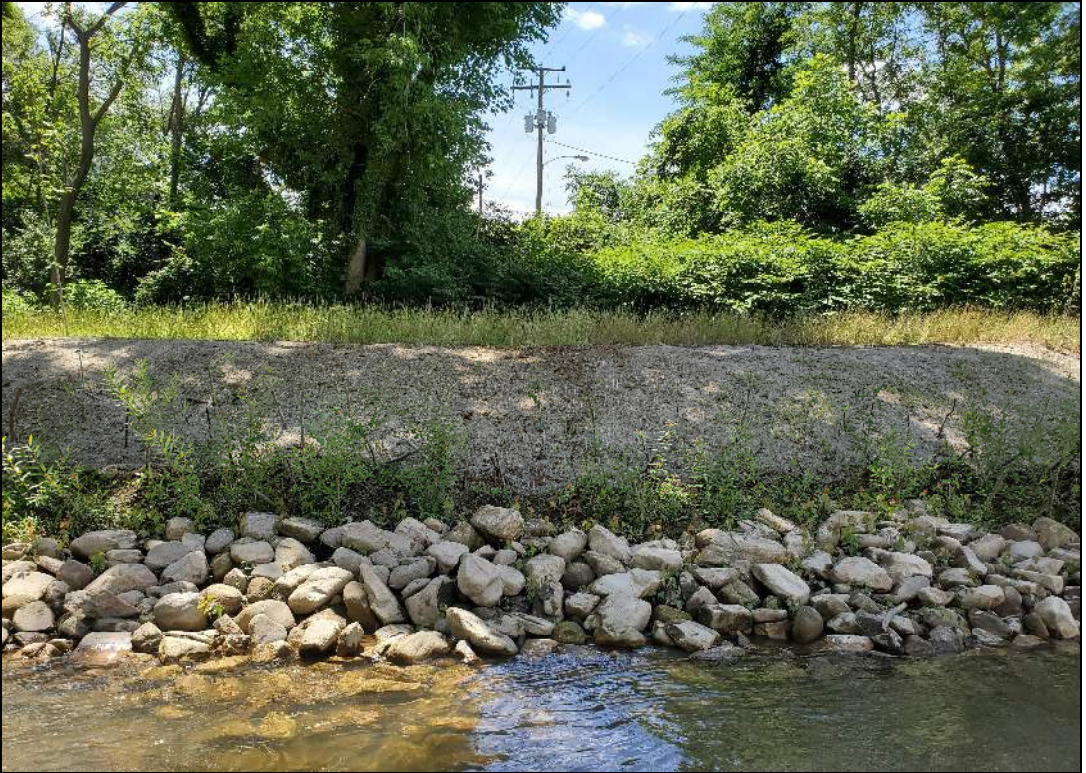
Direction Photo Taken: Southeast			
Description: Station 00 + 350' ~40 degree bank angle; installed rock toe intact; live stakes 50% established; red maple saplings establishing at toe of slope; 80% of erosion control fabric exposed.

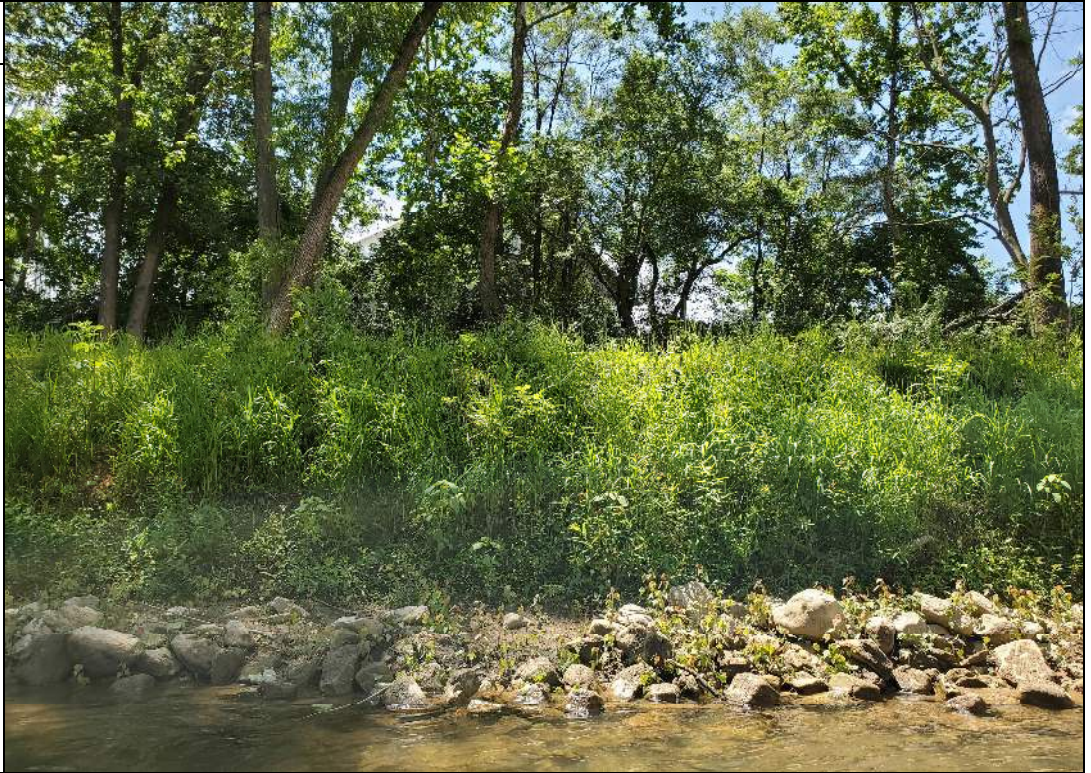
~50 degree bank angle; installed rock toe intact; grasses establishing at throughout bank; live stakes 50% established; 30% of erosion control fabric exposed from mid-bank towards the rock toe; sand deposition occurring above rock toe; red maple saplings establishing at toe of slope

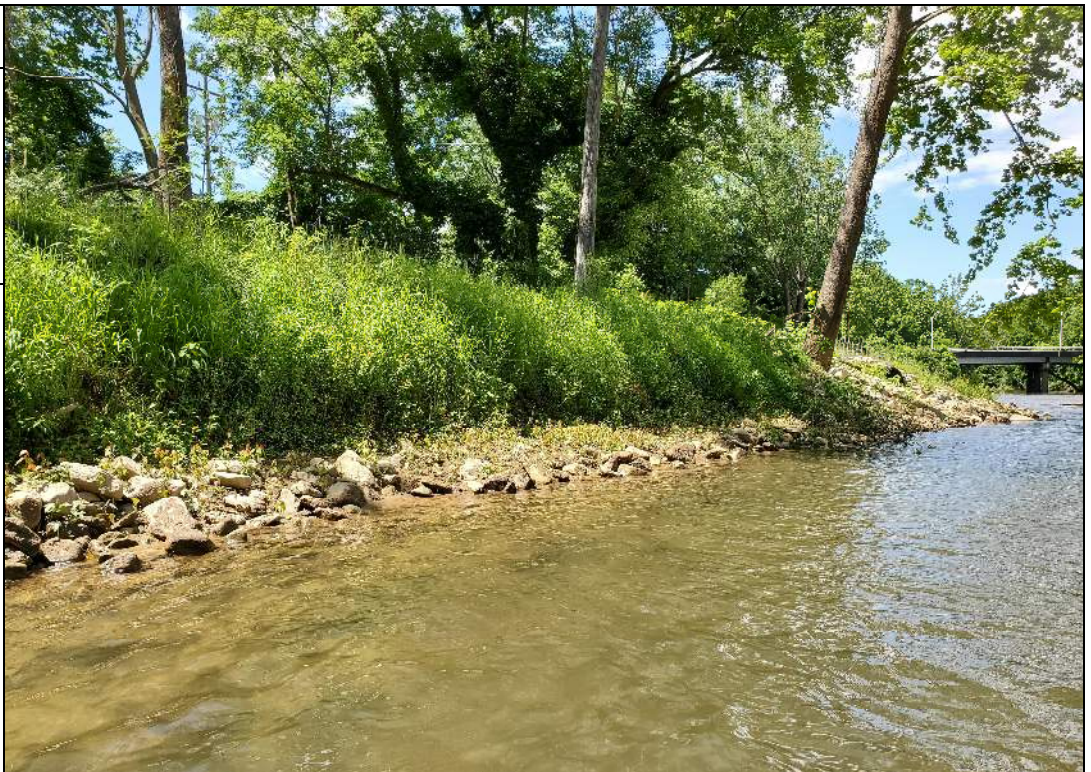
Photo No.
20

Upstream view of installed vegetation and live stakes; significant native vegetation cover with few invasives; red maple saplings are establishing at the toe of slope.

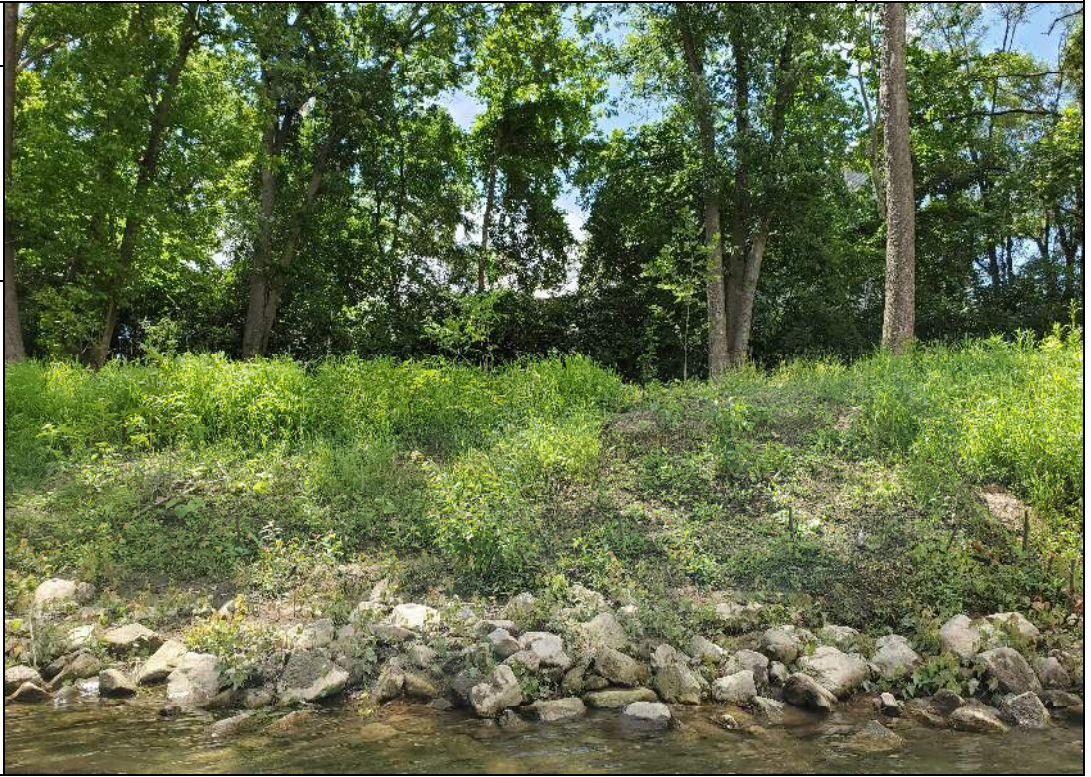
~40 degree bank angle; installed rock toe intact; grasses establishing throughout bank; live stakes 50% established; erosion control fabric 40% exposed; sand deposition occurring above rock toe; red maple saplings establishing at toe of slope.

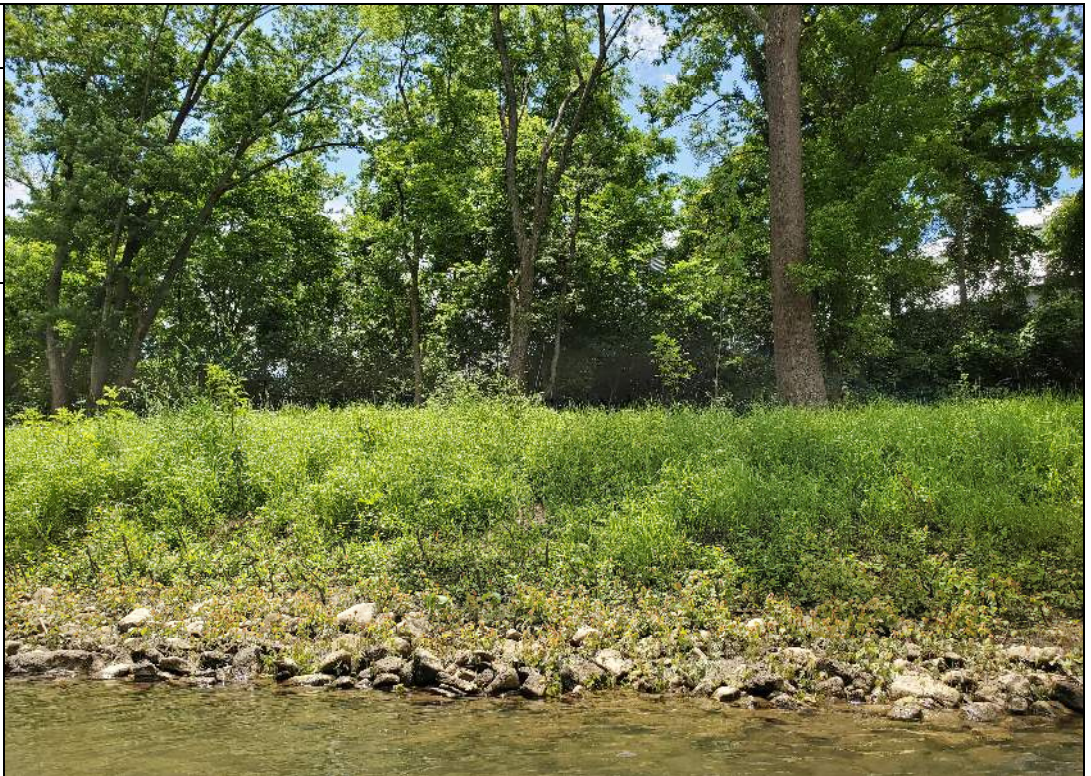
Photo No.
22

~30 degree bank angle; installed rock toe intact; grasses establishing throughout bank; sand deposition occurring above rock toe; red maple saplings establishing at toe of slope; bank 80% covered in vegetation.

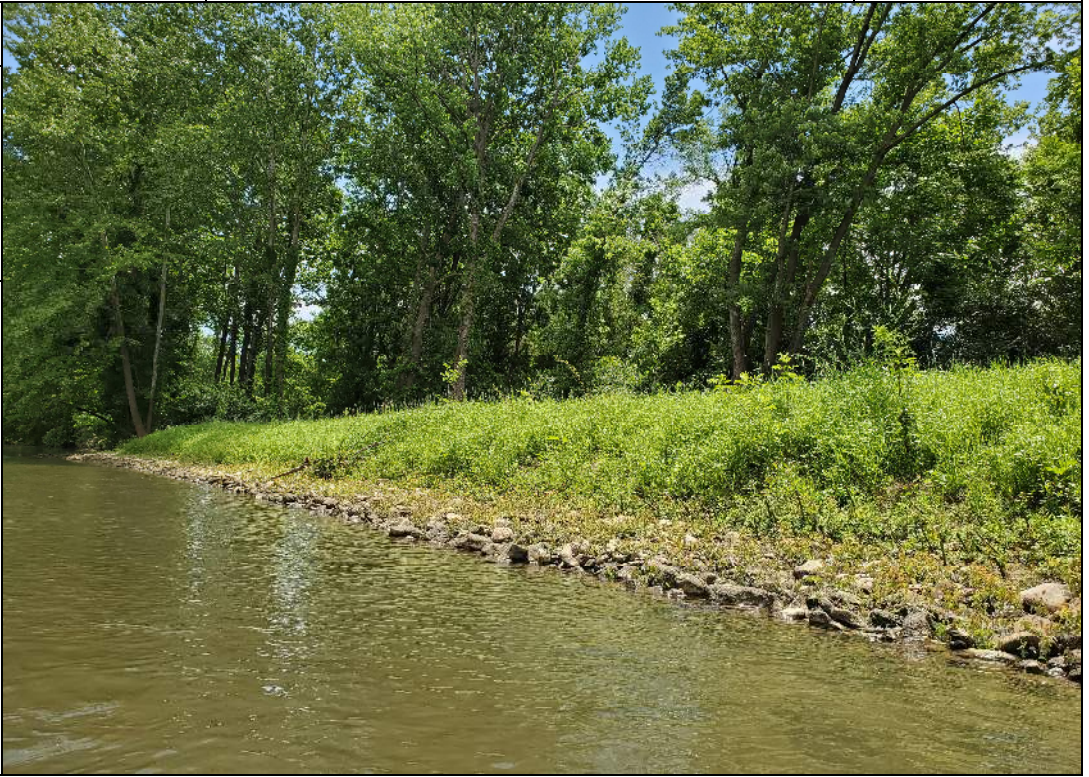
Downstream view from 00 + 550' and installed live stakes; downstream mid-bank plantings continue to exhibit healthy growth; red maple saplings are establishing at the toe of slope; native grasses established throughout bank; live stakes 50% established.

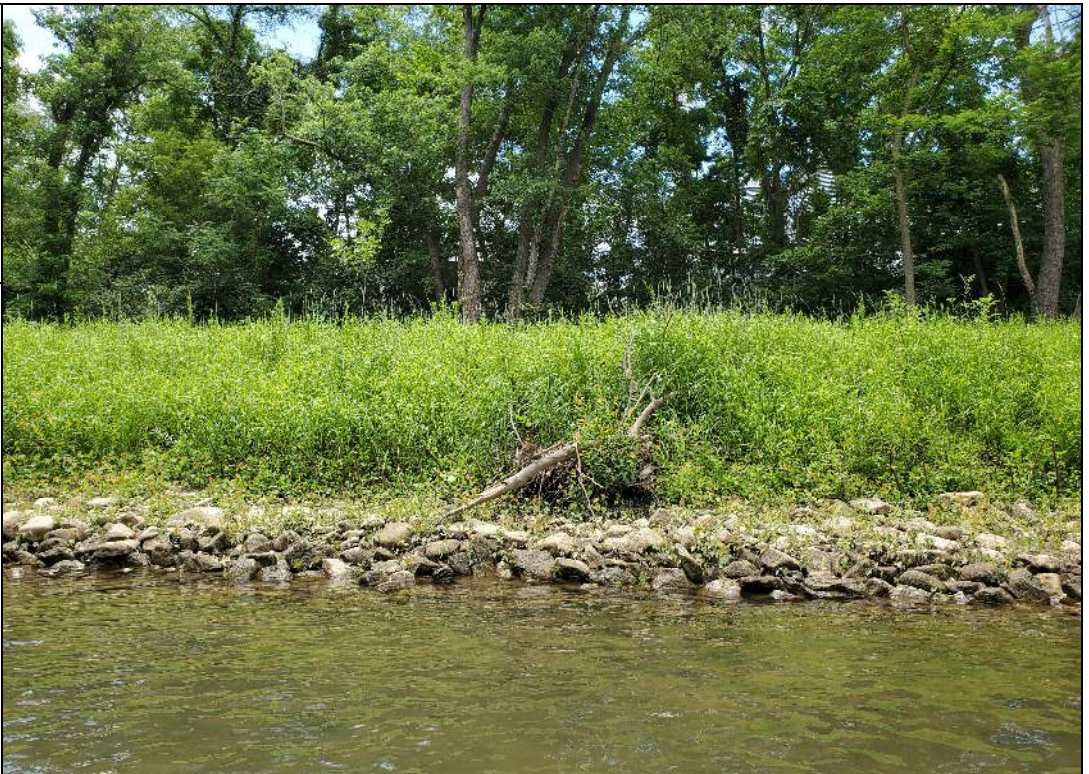
Photo No.:
24

~30 degree bank angle; installed rock toe intact; grasses establishing throughout bank; live stakes 50% established; erosion control fabric completely covered with native vegetation; sand deposition occurring above rock toe; red maple saplings establishing at the toe of slope.

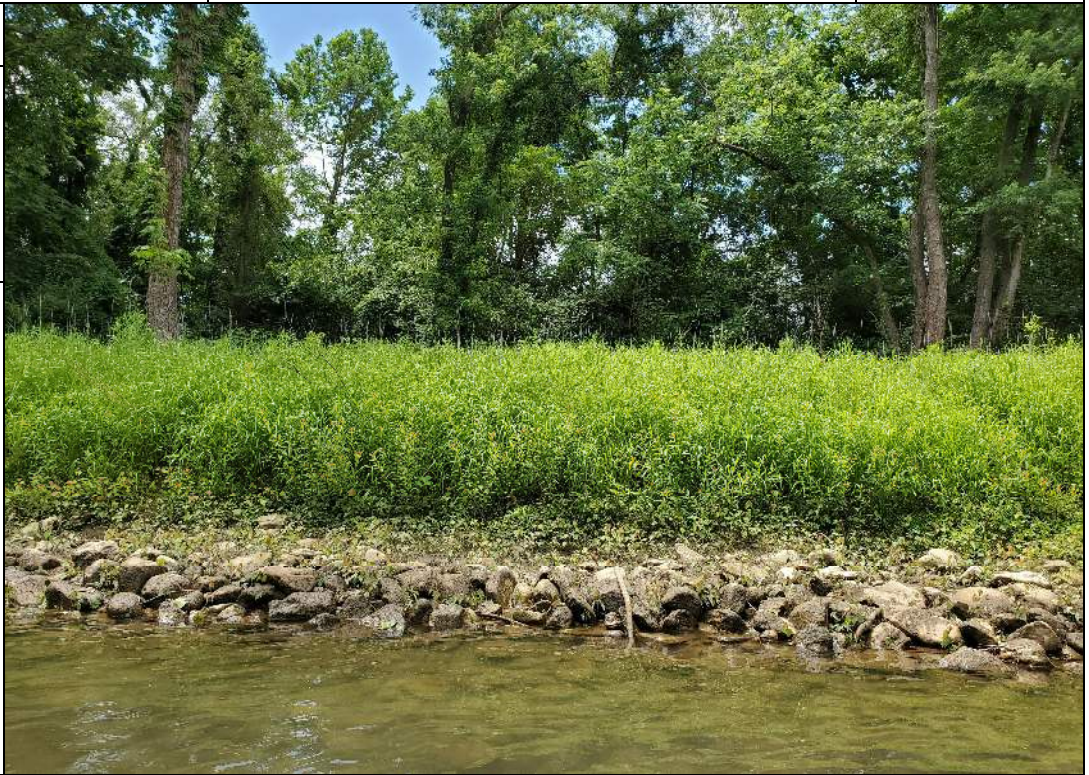
Description: Station 00 + 650' ~30 degree bank angle; installed rock toe intact; grasses establishing throughout bank; live stakes 50% established; erosion control fabric completely covered with native vegetation; sand deposition occurring above rock toe; red maple saplings establishing at the toe of slope.
