**Re: 2019 Leaf-on Maintenance Inspection Reports for Allied Ready Mix, City Shops and Constitution Park BMAs
Former DuPont Waynesboro Site, Area of Concern 4
Waynesboro, Virginia
EPA ID# VAD003114832**

To	Michael Liberati, Corteva Environmental Remediation Nancy Grosso, Corteva Environmental Remediation	Page 1 of 3
CC	Cameron Dixon, AECOM Kristy Hoffman, AECOM	
Subject	Allied Ready Mix BMA – 2019 Leaf-on Maintenance Inspection Former DuPont Waynesboro Site, Area of Concern 4	
From	Andrew Miano, AECOM Joshua Collins, AECOM	
Date	August 19, 2019

This memorandum summarizes the 2019 Leaf-on Maintenance Inspection (inspection) of the Allied Ready Mix Bank Management Area (BMA) conducted in June 2019. The inspection constitutes the second maintenance inspection following completion of interim measures construction activities in November 2018. Inspection activities followed the scope described in the Maintenance Plan included as Appendix M of the Basis of Design Report, Phase 1A BMAs, South River AOC 4 (Anchor QEA et al., 2016). The purpose of the maintenance inspection is to identify potential BMA maintenance needs, focusing on vegetative development, bank stability, and the integrity

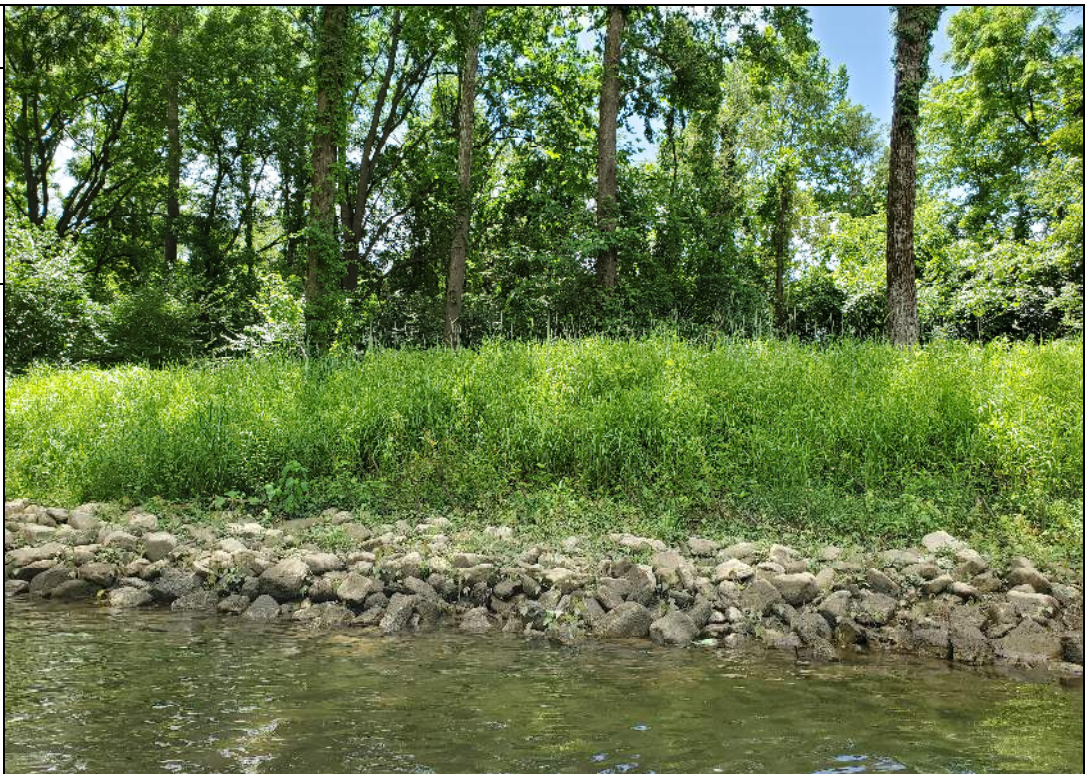
Description: Station 00 + 700' ~30 degree bank angle; installed rock toe intact; grasses establishing throughout bank; live stakes 50% established; erosion control fabric completely covered with native vegetation; sand deposition occurring above rock toe; red maple saplings establishing at the toe of slope.

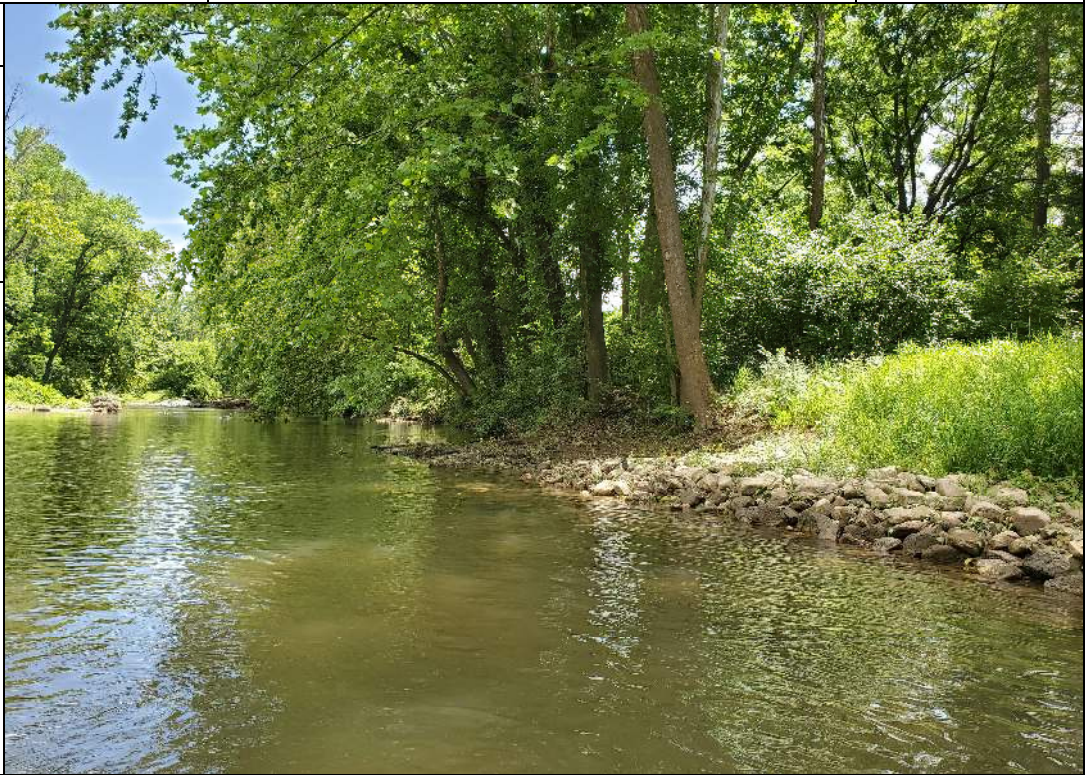
Description: Station 00 + 700' Downstream view of 00 + 700' showing the end of the first remediated section.

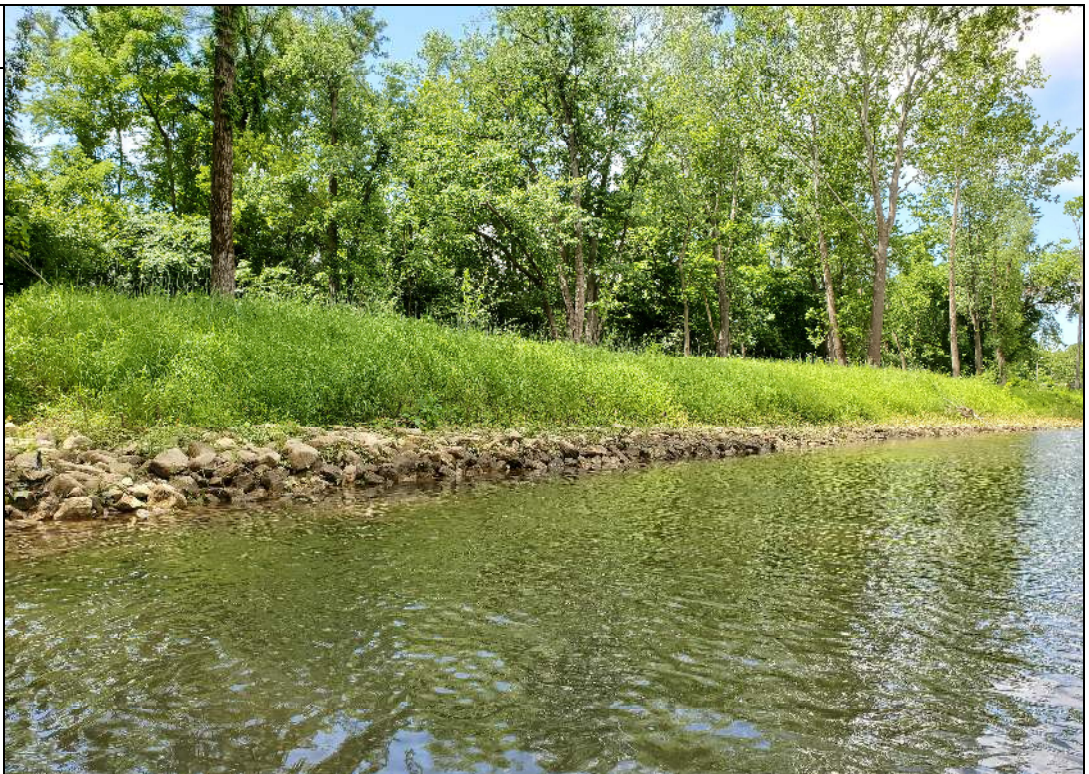
Description: Station 00 + 700' Upstream view of 00 + 700'; live stakes and rock toe intact; red maple saplings are establishing at toe of slope; erosion control fabric completely covered in native vegetation.

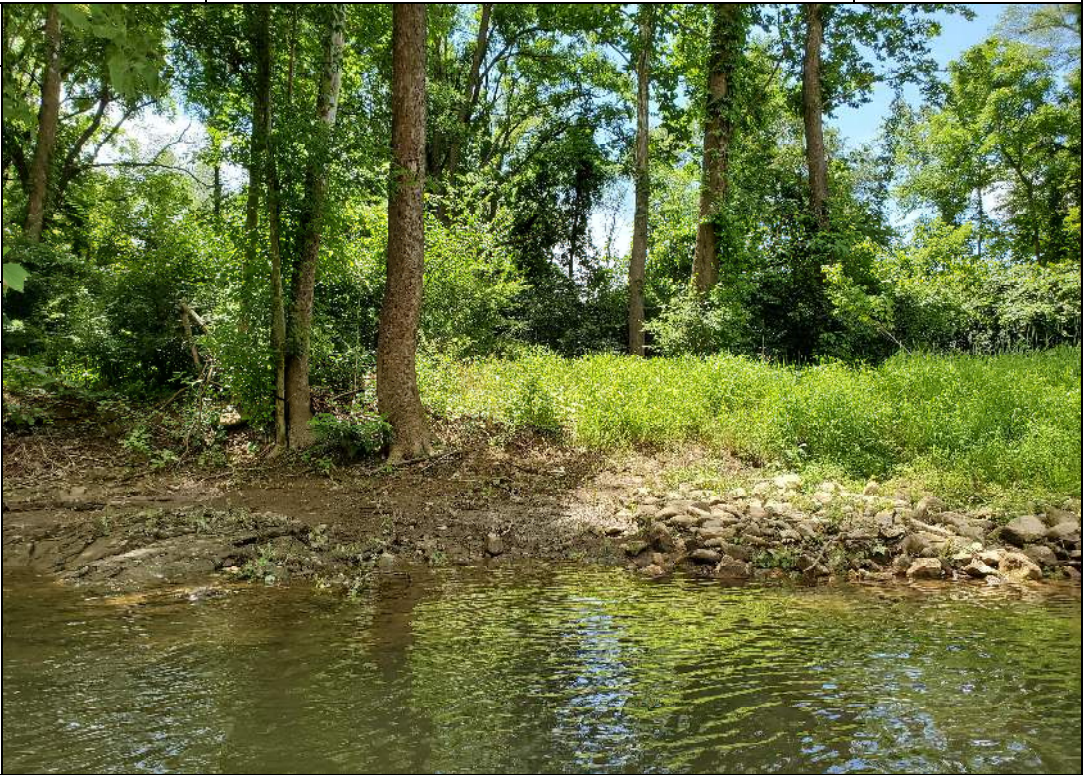
Description: Station 00 + 750' ~30 degree bank angle; installed rock toe intact; partially exposed roots downstream of BMA; no at risk trees; grasses establishing at top of bank; red maple saplings establishing at the toe of slope; live stakes 50% established; erosion control fabric completely covered in native vegetation.

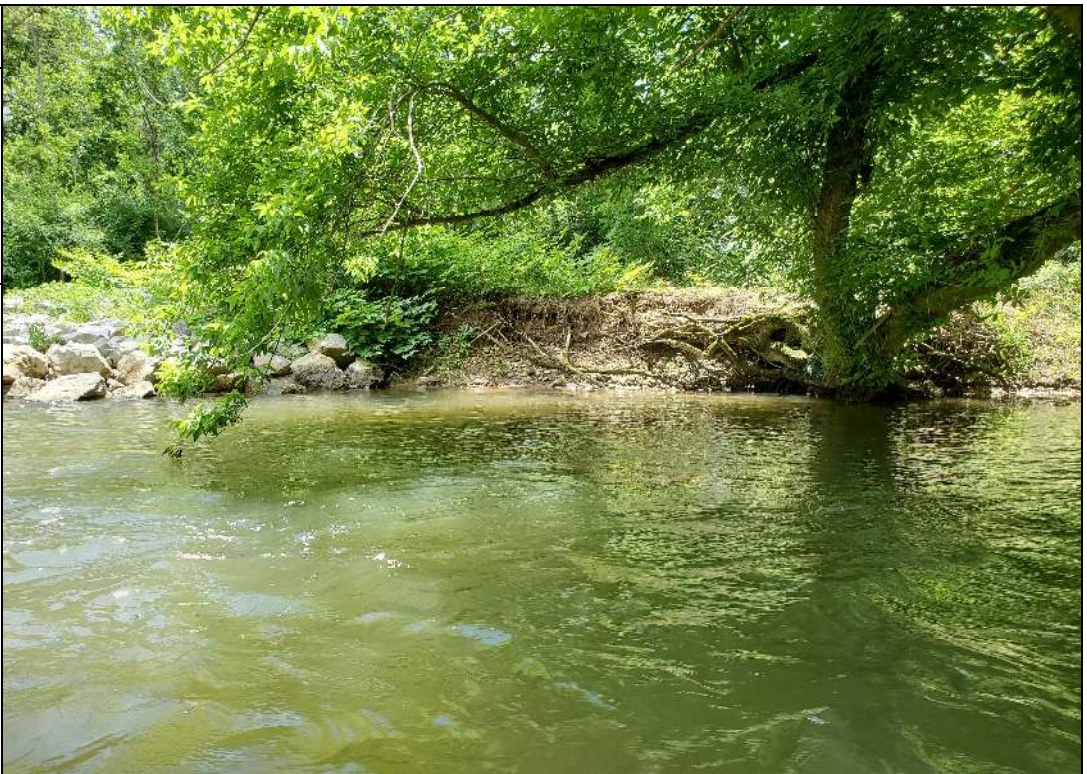
Description: Station 00 + 1250' ~40 degree bank angle (non-remediated 80); exposed roots of large at risk tree are present upstream of remediation, evidence of heavy scour around roots; no scour present along rock toe of remediation.

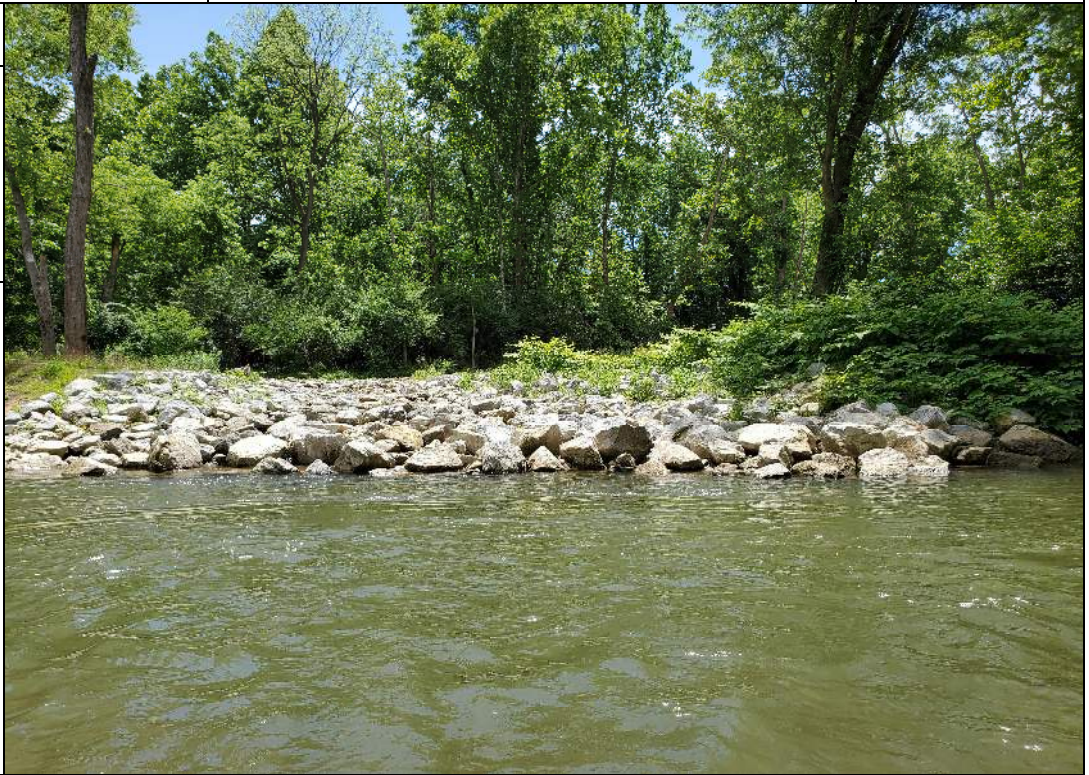
Description: Station 00 + 1300' ~20 degree bank angle; rip rap fortified tributary channel; no exposed roots; no at risk trees; no fabric or geocell installed; no live stakes or trees planted.

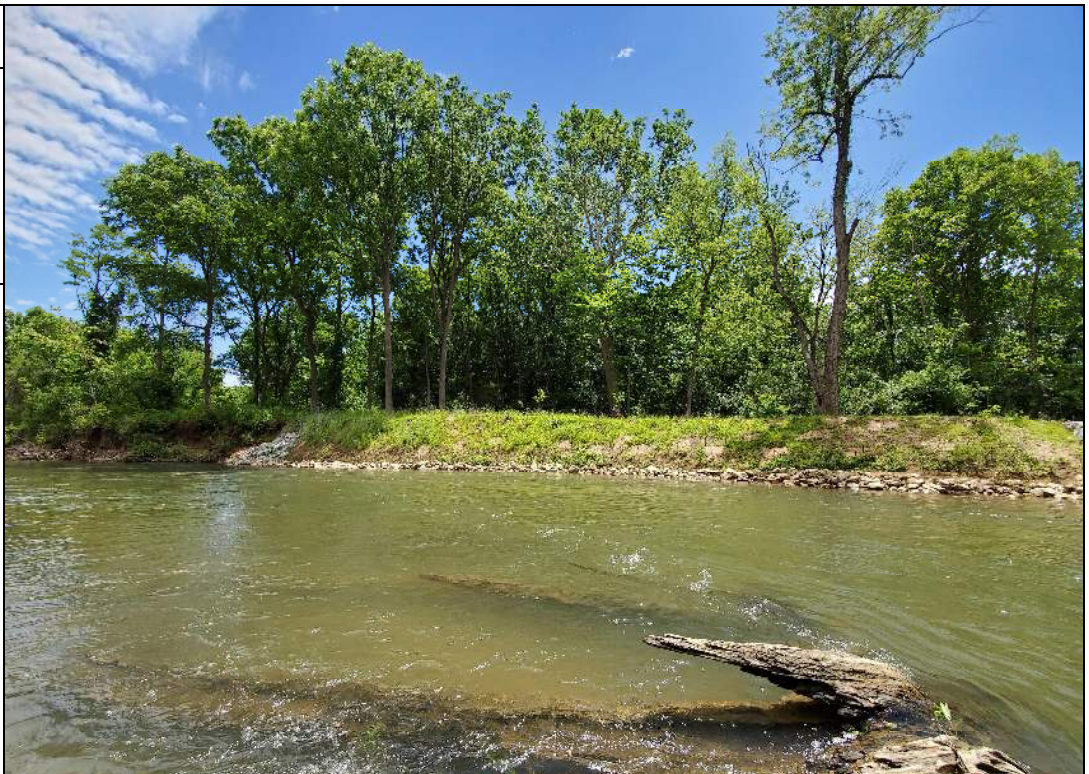
Description: Station 00 + 1300' Looking downstream from 00 + 1300'; live stakes and rock toe intact; live stakes 50% established; erosion control fabric partially exposed throughout; sand deposition above rock toe.

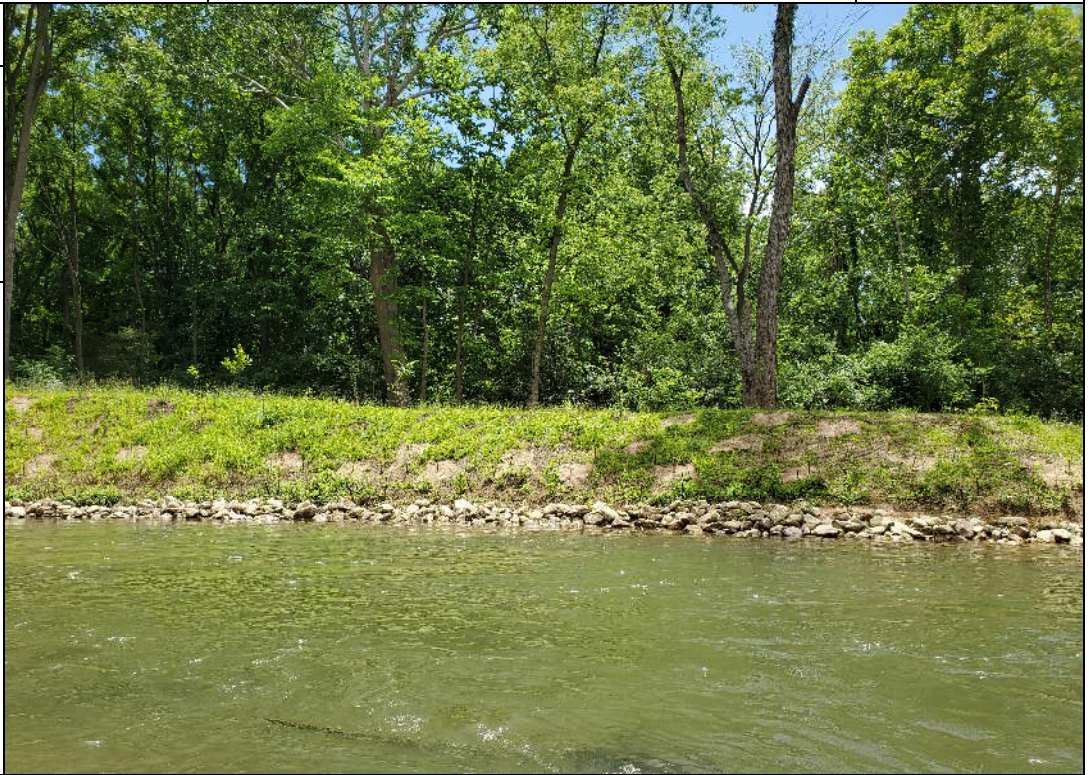
~50 degree bank angle; no exposed roots; no at risk trees; live stakes 50% established; red maple saplings establishing at toe of slope; erosion control fabric 50% exposed; no scour present.

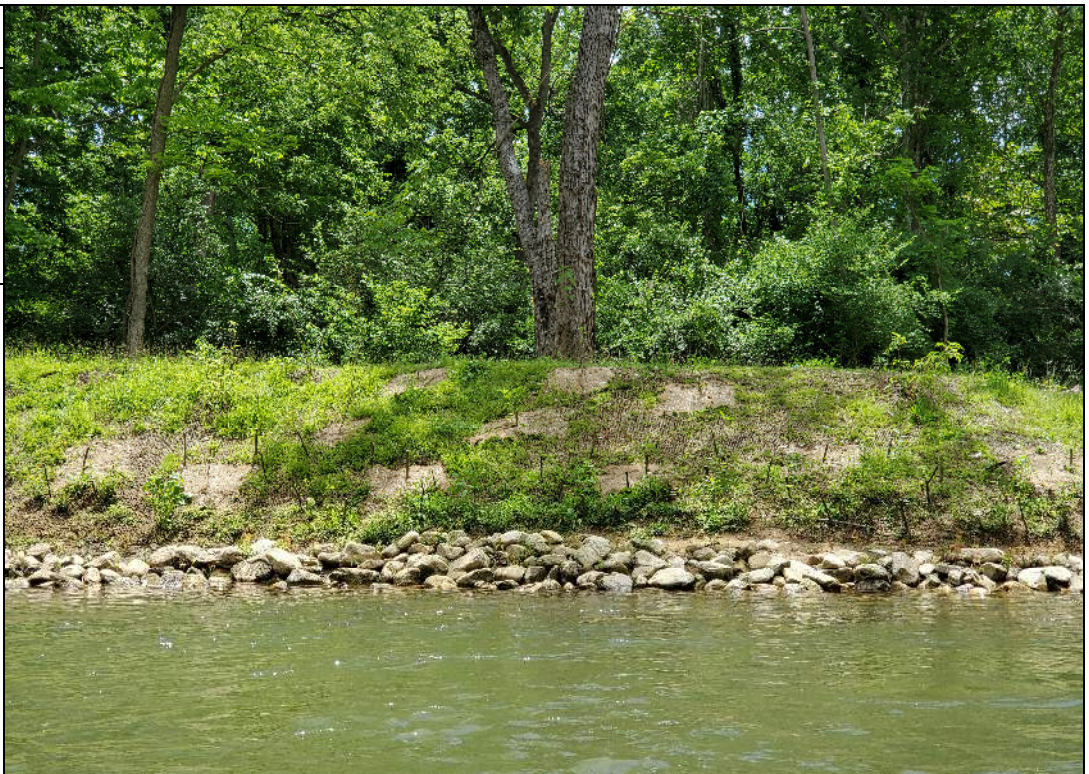
Photo No. 34	Date: 6/13/2019
------------------------	---------------------------

Erosion control fabric repairs are intact and 50% exposed; no scour present; live stakes 50% established.

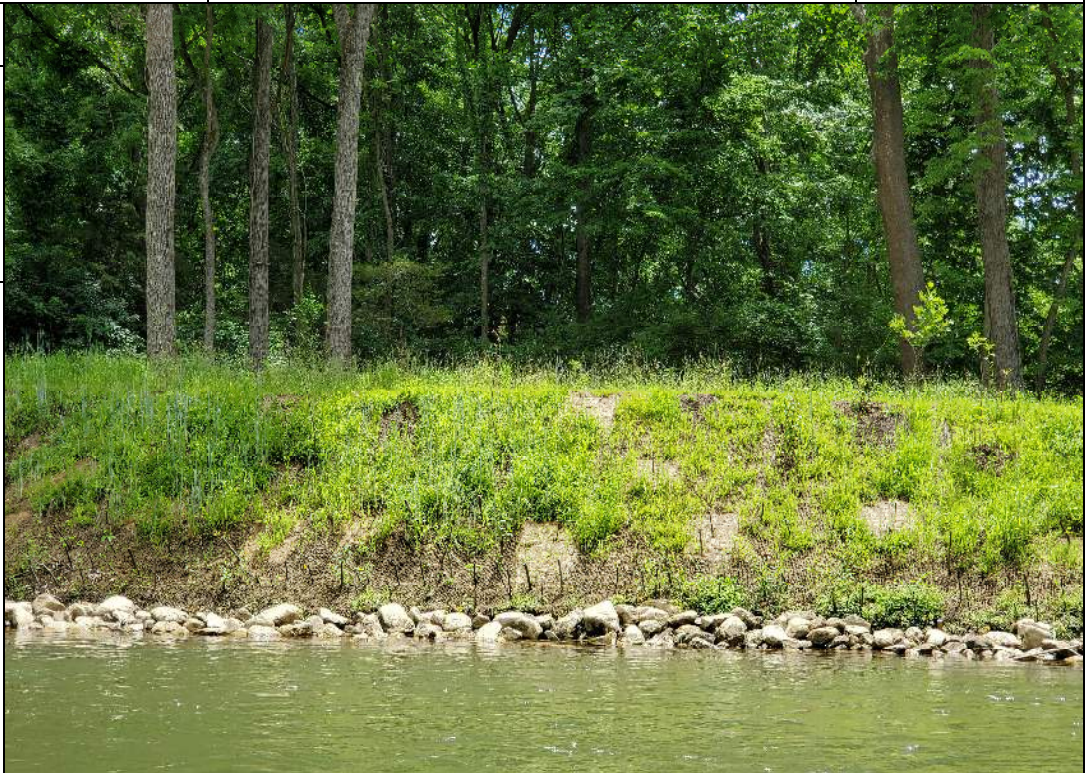
~50 degree bank angle; no exposed roots; no at risk trees; live stakes 50% established; planted saplings show new growth; newly installed erosion control fabric 50% exposed; no scour present.

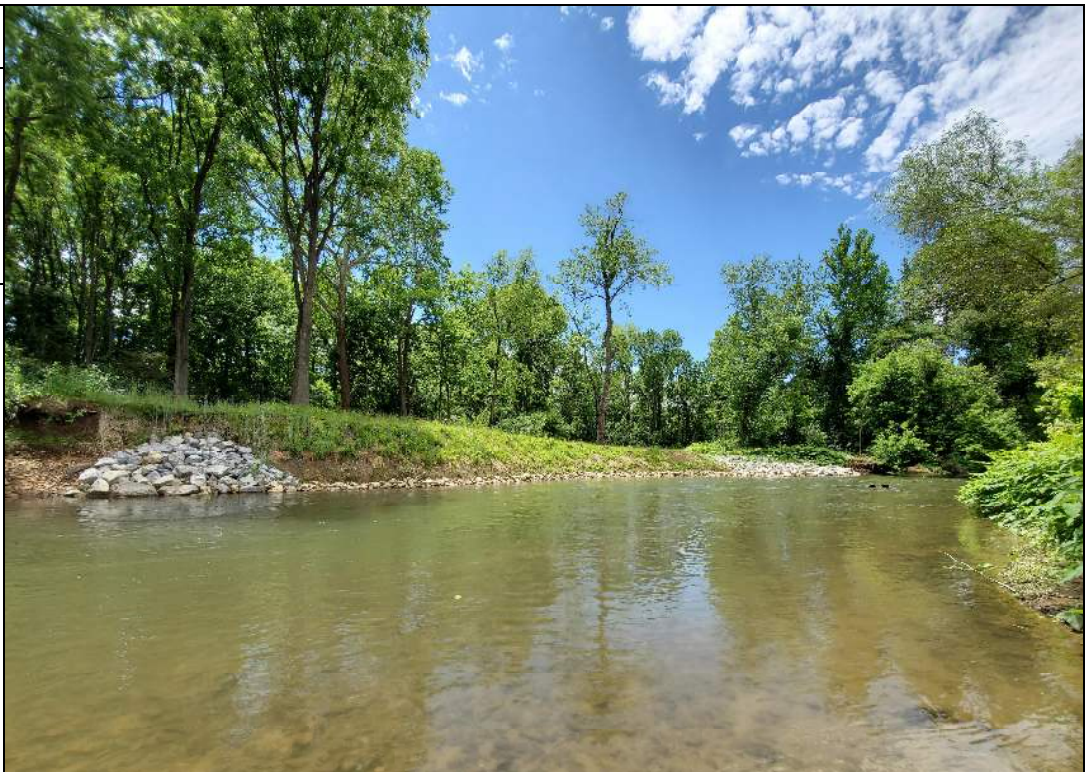
Photo No.
36

Upstream view of 00 + 1450' showing entire BMA; no exposed roots; no at risk trees; live stakes planted on lower bank above rock toe show new growth and are 50% established; saplings planted throughout rest of bank display new growth; red maple saplings at toe of slope; installed rock toe intact.

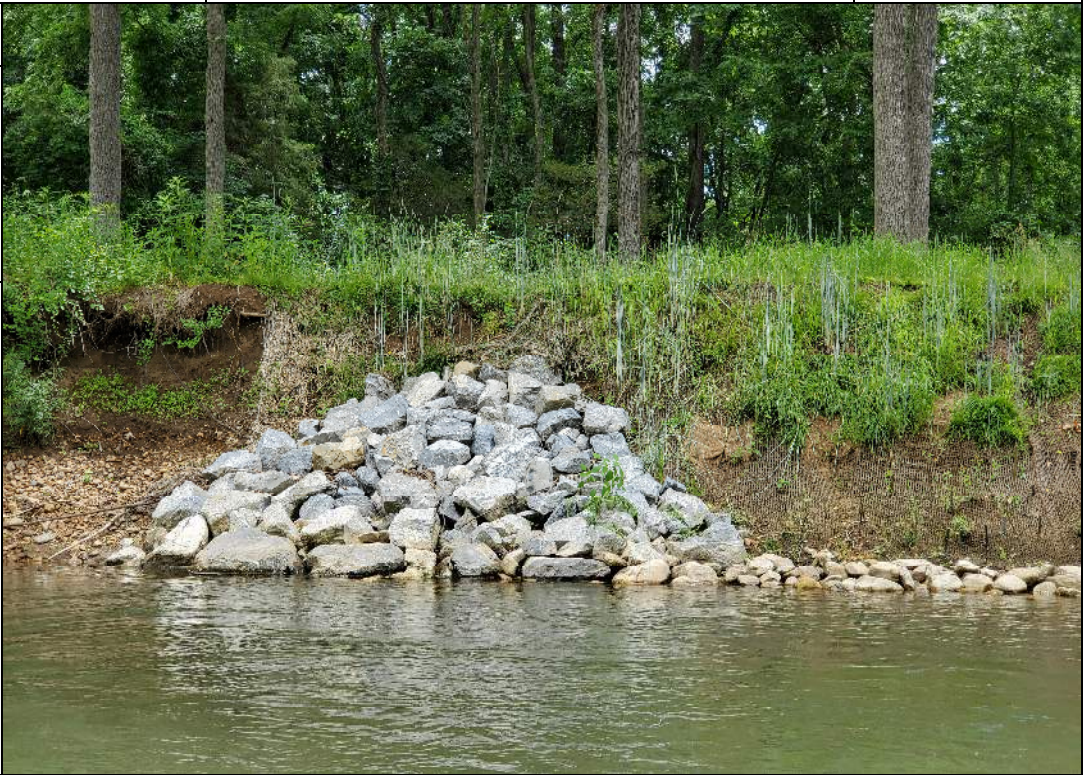
Description: Station 00 + 1450' ~50 degree bank angle; no exposed roots; no at risk trees; Rip rap fortified bank abutment intact with heavy erosion present immediately downstream of remediated BMA.

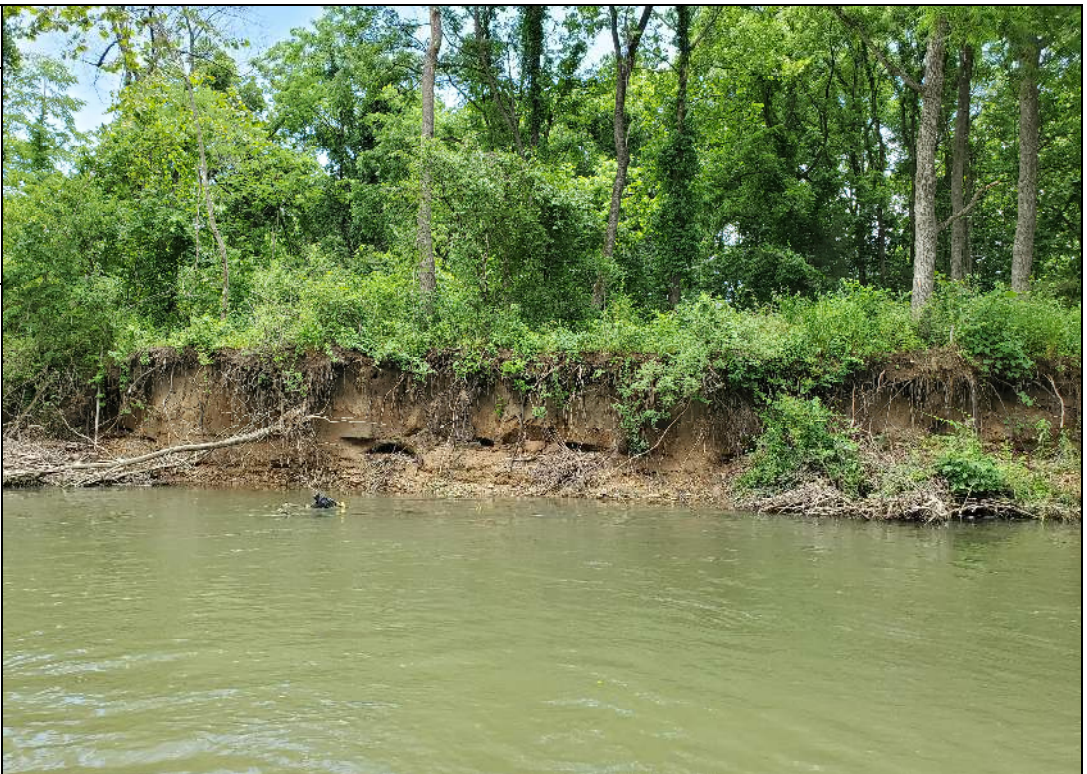
Description: Station 00 + 1500' ~90 degree bank angle; heavy erosion present downstream of remediated BMA; severe root exposure and high density of at risk trees due to undercut bank.
