**To:**  
Michael Liberati, Corteva**CC:**  
Joshua Collins, AECOM  
Kevin Suter, AECOM  
Matt Pritchett, Summit**Project name:**  
South River AOC 4**From:**  
Cameron Dixon, PE, AECOM**Date:**  
September 1, 2020

# Memo

**Subject:** Shiloh Baptist Church Bank Erosion

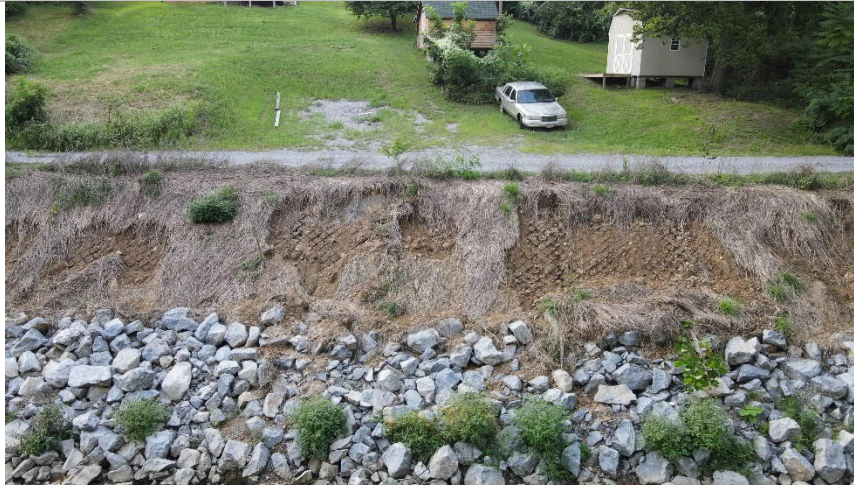
On August 26, 2020, an inspection of the bank stabilization measures at the Shiloh Baptist Church identified a section of bank where significant erosion of the bank was observed with sloughing of the surface soils down the bank into the rip-rap toe exposing the geocell below. This erosion extended along approximately 140 linear feet from relative river mile (RRM) 0.60 to 0.63, where excavation was conducted during the remedial activities. The erosion covered approximately 75% of the area from 2' feet below the top of bank to the top of the rip-rap toe (Photos 1-3).

Photo 1 - Extent of Bank Erosion

In order to address this erosion and prevent future sloughing of materials, the existing soil above the geocell should be removed from the riprap toe to the top of the bank. Then a thin layer of planting substrate should be used to fill in any voids in the geocell pockets and cover the geocell, with no more than 1"-2" of material placed over the geocell, to match the Typical Primary B Restoration Cross Section on Sheet X-102 of the Shiloh Baptist Church Design Drawings and the restoration details on D-201 and D-202. The planting substrate should be seeded with an erosion control mix and covered with an erosion control blanket that is properly anchored at the top of the bank per the details in the construction drawings. The repaired area should be watered as needed between storms through the end of the fall growth season. In the spring, the area should be hydroseeded with the design bank mixture and shrubs re-planted as needed. Watering should be maintained through the summer as needed to fully establish vegetated growth, per specification 32 90 00 Planting and Habitat Restoration.

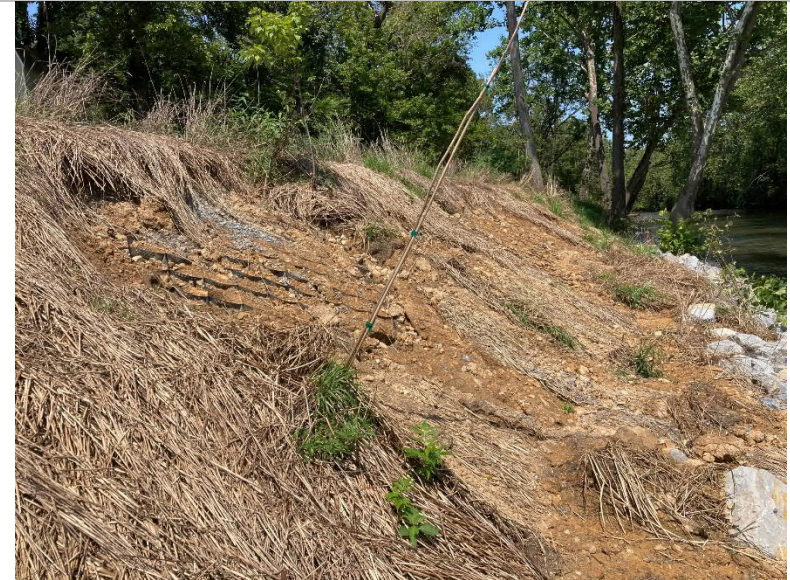
Photo 2 - Bank Erosion at Top of Bank

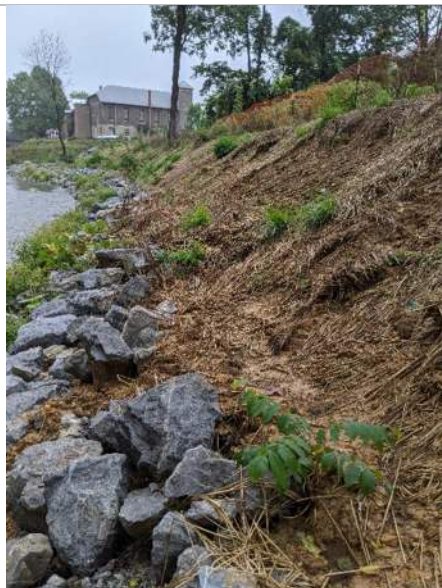
Photo 3 - Sloughed Material on Stone Toe

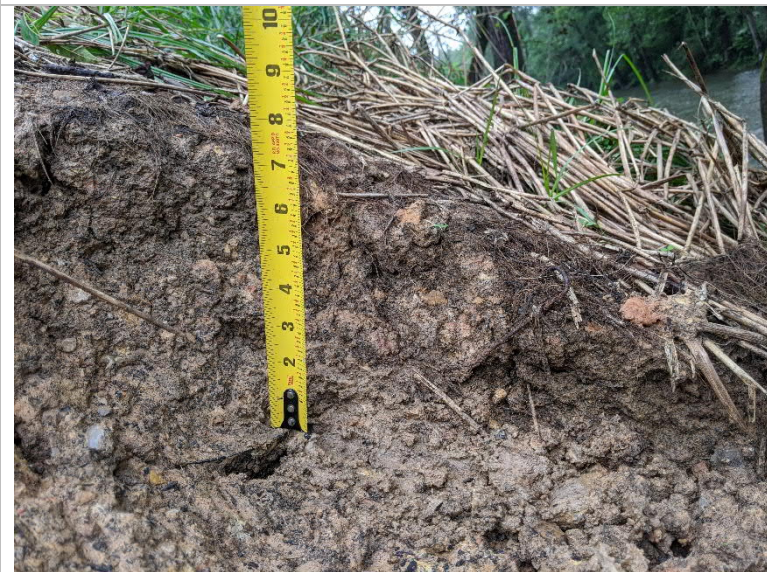
In the eroded areas where there was undisturbed material there was approximately 6-8" of soil placed above the face of the geocell (Photo 4). This excess soil slid along the face of the geocell until it formed a buttress at the bottom of the slope against the stone toe, likely resulting from storm events that eroded the buttressing soils at the bottom of the bank which led to the material sliding down the face of the bank. Areas along the top of the slope where erosion occurred exhibited cracking from the loss of structural support on the face of the bank. The cracking appears to be a trailing indicator; rather than appearing before the erosion occurs, it forms after the bank materials slid down the face of the bank.

Photo 4 - Material above Geocell

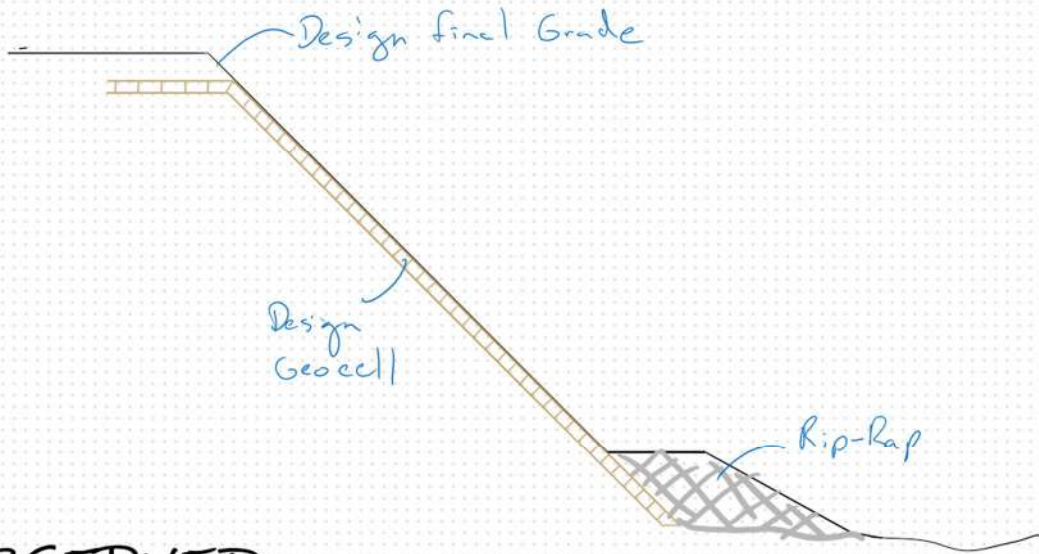
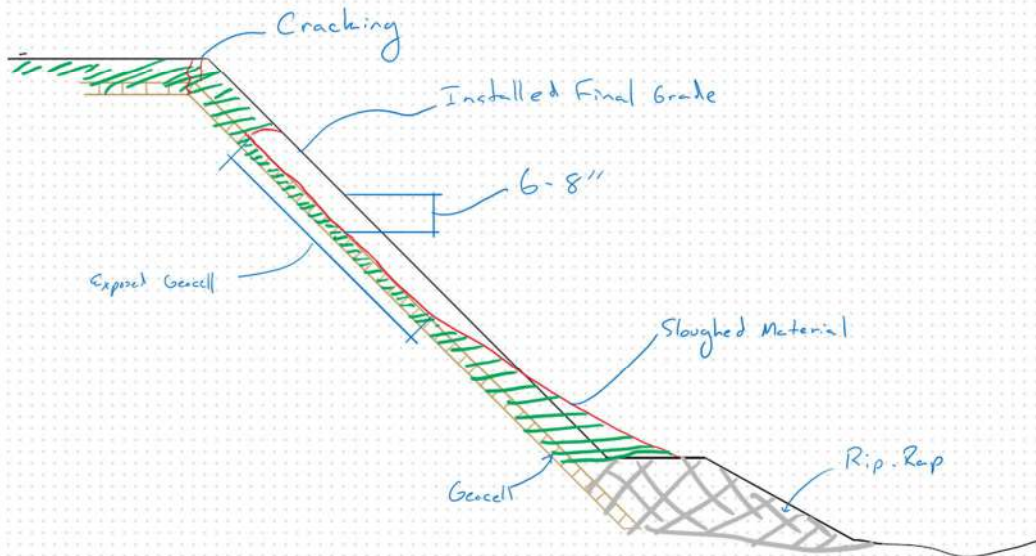
**Figure 1 – Typical Markup Bank Sections**

AECOM conducted a site visit to inspect the areas of erosion on August 28, 2020. The erosion is restricted to the surface soils above the geocell, and there were no overall bank stability issues identified. Figure 1 is a typical schematic of the bank in these areas. Where the geocell was exposed, there was no evidence of erosion of the soil within the geocells, subsidence of the subgrade below the geocell, or overall sloughing of the geocell. There was little coverage of living vegetation in this area, with the surface cover on the bank face largely consisting of dead annual rye grass from the stabilization mixture; the permanent seed mixture had not become established.

# DESIGN

# OBSERVED
