**Re: 2020 Post-Construction Bank Management Area Repairs
Former DuPont Waynesboro Site AOC 4
Waynesboro, Virginia
EPA ID# VAD003114832**

Project name:
Former DuPont Waynesboro Site
Area of Concern 4

Memo

Subject: 2020 Post-Construction Bank Management Area Repairs

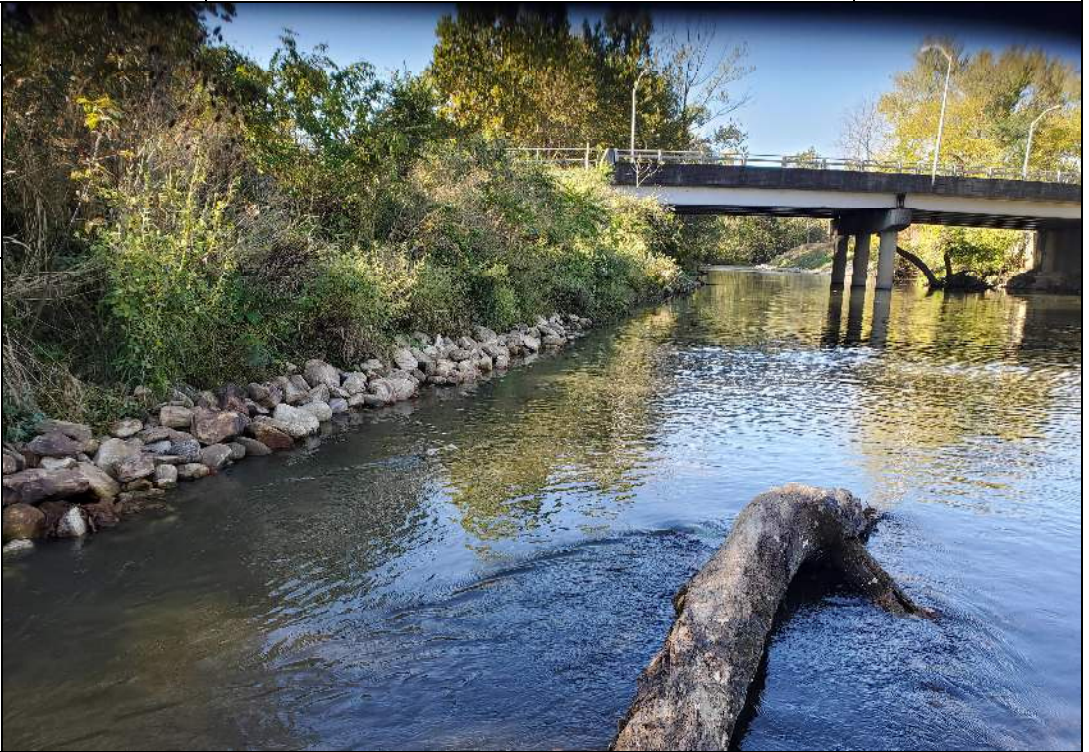
Photo No.
1

The 2019 Leaf-off BMA inspection identified an improvised weir structure had been constructed by unknown parties along a portion of the upstream BMA from Station 00+50 to Station 00+100 (AECOM, 2019). High water conditions during spring months limited the ability to fully assess the condition of the embedded stone toe at the toe of slope until late in the summer of 2020. Upon inspection it was determined that while the moved stone to did not structurally affect the stability of the slope, it was creating increased scour at the downstream end of the weir where the flow was being directed at the toe of slope. Corrective actions were recommended to replace the moved toe rock back to the toe of slope as it was originally placed to limit potential for future scour. Summit Environmental mobilized to the ARM BMA the week of September 21st, 2020 to conduct the repairs. Laborers manually moved the stone toe rock back to the toe of slope and blended it in with the existing stone toe (See Appendix A; Photo 1 and Photo 2).

Station 00 + 50'

Rocks that were moved by unidentified members of the public from the remediated bank into the stream channel were placed back along the stone toe. Vegetation cover is established along remediated bank.

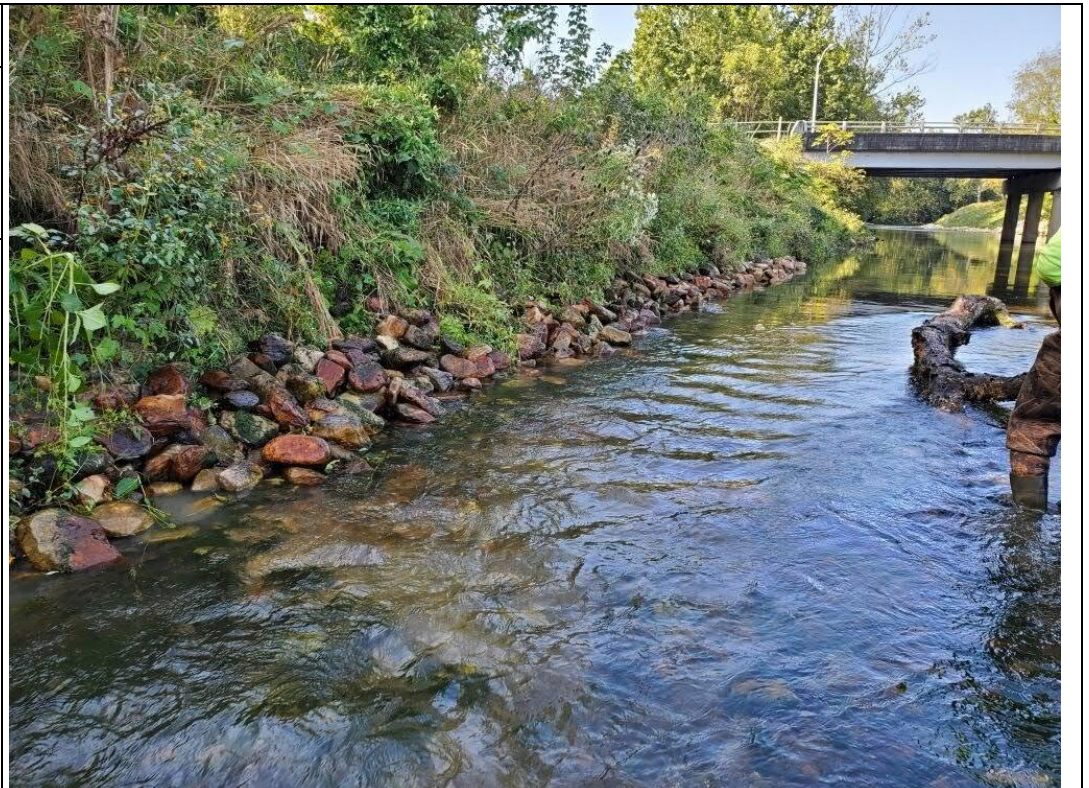
Photo No.
2

Station 00 + 100'

Rocks that were moved into the stream channel to form an improvised weir were placed back along the stone toe to stop the potential for scour to occur. Vegetation cover is established along remediated bank.

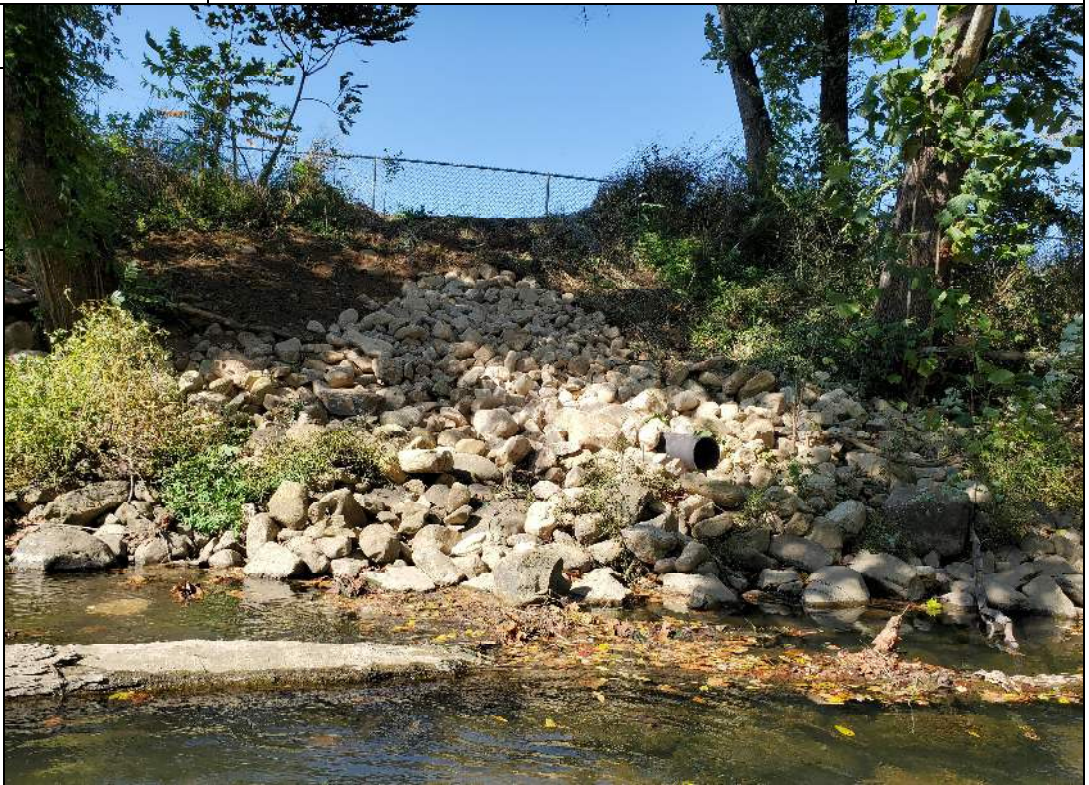
Photo No.: 3	Date: 10/14/2020
------------------------	----------------------------

The City of Waynesboro daylighted a 12-inch stormwater outfall which had been covered during the remediation at the City Shops BMA. The outfall located at Station 00+350, was identified during the 2019 Leaf-off inspection (AECOM, 2020a). During the daylighting of the outfall, portions of the stone toe were removed and sections of geocell were cut creating areas of localized scour along the bank. AECOM and Summit discussed the condition

Description:
Station 00 + 350'
Remediated bank disturbed by the City of Waynesboro Public Works Department to daylight an existing stormwater outfall pipe was repaired. Daylighted outfall was extended and rocks were added to stabilize the remediated bank and limit bank erosion.

of the bank and outfall with the City Shops maintenance staff and it was determined that the outfall needed to remain operational and that it should be extended to direct flow away from the bank face. Summit Environmental mobilized to the City Shops BMA during the week of October 7, 2020 to complete the repair. In order to minimize the potential for scour, the 12-inch outfall pipe was extended to the toe of slope. Damaged geocell was then repaired and/or replaced as necessary and additional natural stone armoring was placed above the extended outfall with a gradual transition to the existing grade on the upstream and downstream transitions (See Appendix A – Photo 3 and Photo 4).

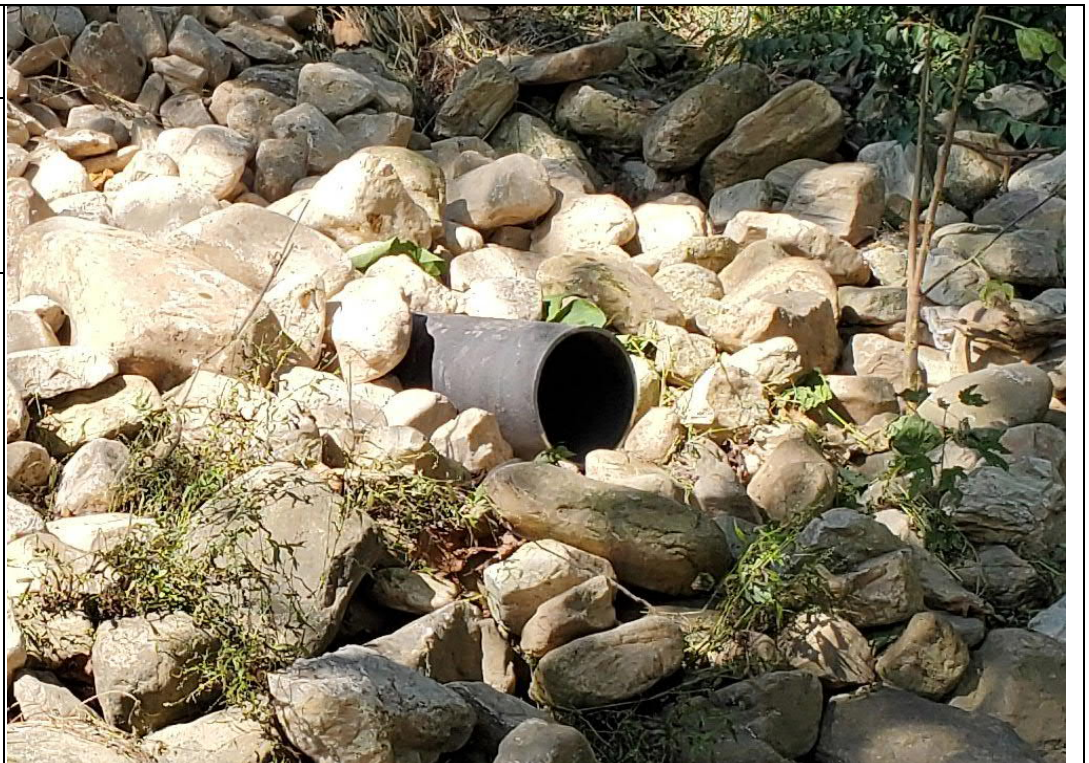
Photo No.: 4	Date: 10/14/2020
------------------------	----------------------------

Description:
Station 00 + 350'
Closeup photo of the daylighted outfall that was extended during bank repairs.

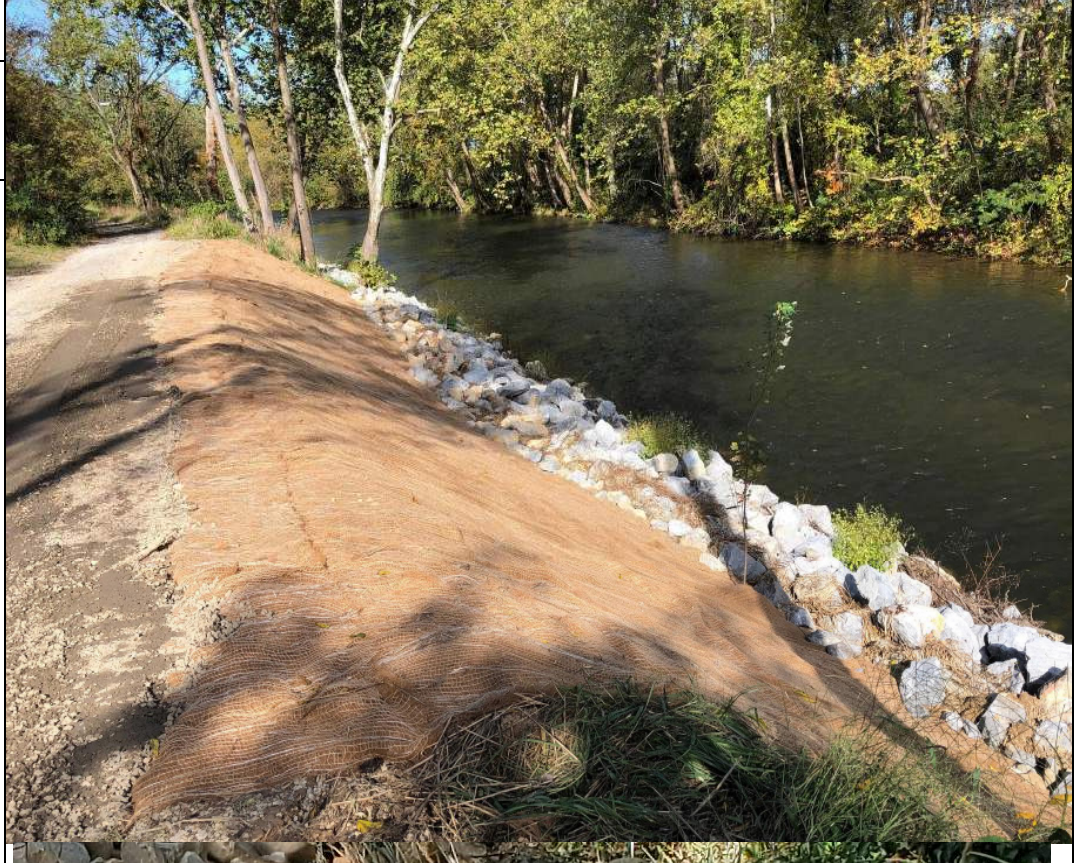
Photo No.
5

Repairs of a section the Shiloh Baptist Church remediated bank at Station 00+450 were required after a sloughing of excess planting substrate was identified over approximately 140 linear feet in the late summer/fall 2020. Summit Environmental mobilized to the site the week of October 13, 2020 to complete the repairs as outlined in the Post Construction Erosion – Corrective Action Memorandum (AECOM 2020b). The bank was repaired by removing damaged erosion control fabric and excess topsoil so that only 1-2" of planting substrate was above the geocell. Next, the bank was seeded with an erosion control planting mix and new erosion control fabric was placed and secured to the repaired bank and native seed was broadcast throughout the repaired area. Focused monitoring on the scour and vegetation establishment will continue to determine if additional corrective actions are required for the Shiloh Baptist Church BMA.

Station 00 + 450'

Bank repair at the Shiloh Baptist Church BMA. In order to repair the damaged section of the bank, the damaged coir mat was removed, topsoil was replaced to an appropriate depth, and a new coir mat was installed and seeded.

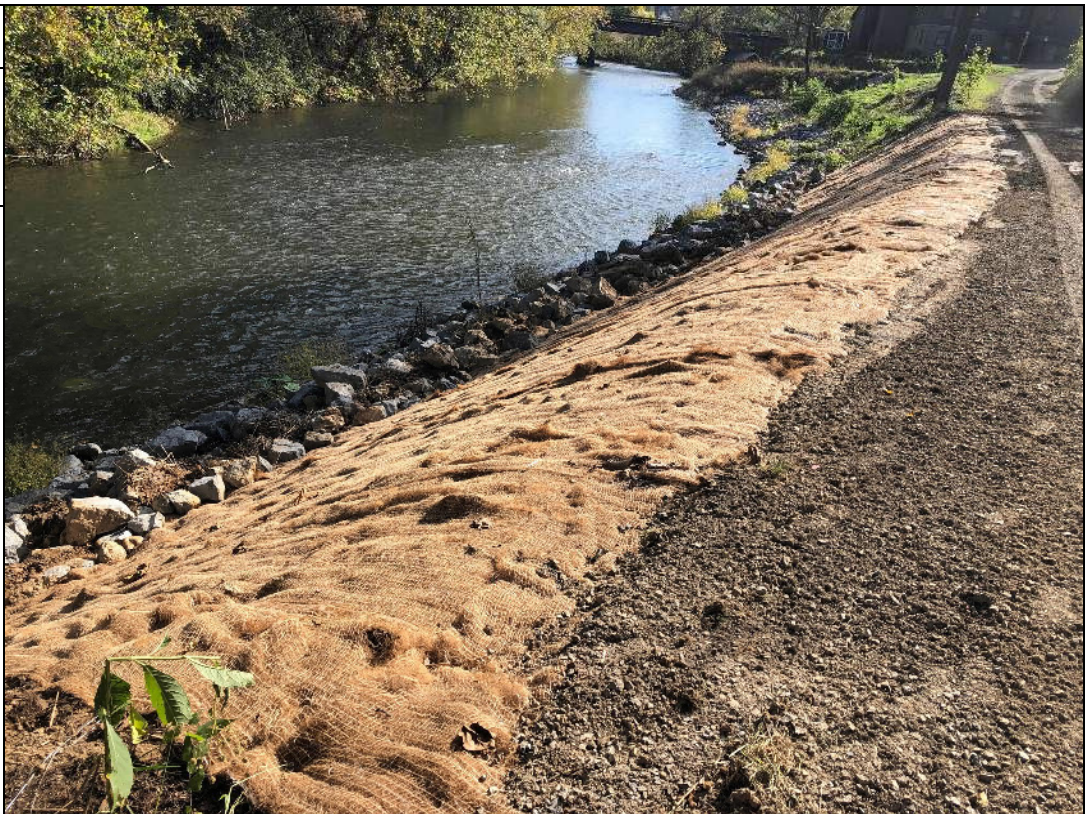
Photo No.
6

Station 00 + 450'

Additional view of the bank repair that occurred at the Shiloh Baptist Church BMA.
