**Re: 2020 Leaf-on and 2020-2021 Leaf-off Maintenance Inspections
Former DuPont Waynesboro Site AOC 4
Waynesboro, Virginia
EPA ID# VAD003114832**

Subject 2020-2021 Phase 1 BMA Leaf-Off Maintenance Inspection
Former DuPont Waynesboro Site, Area of Concern 4

Date March 24, 2021

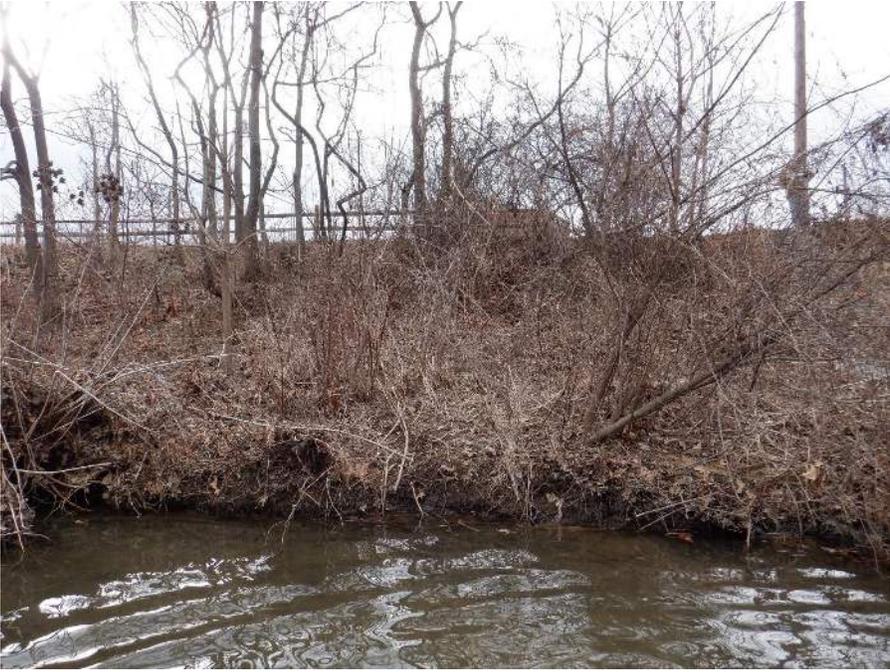
<p>Location: 00-25'</p> <hr/> <p>Photo Number: Date: 1 1/18/2021</p> <hr/> <p>Direction Photo Taken: West</p> <hr/> <p>Description: ~20 degree lower bank angle and 55 degree upper bank angle; no at risk trees present; some erosion at water's edge with minimal scour</p>

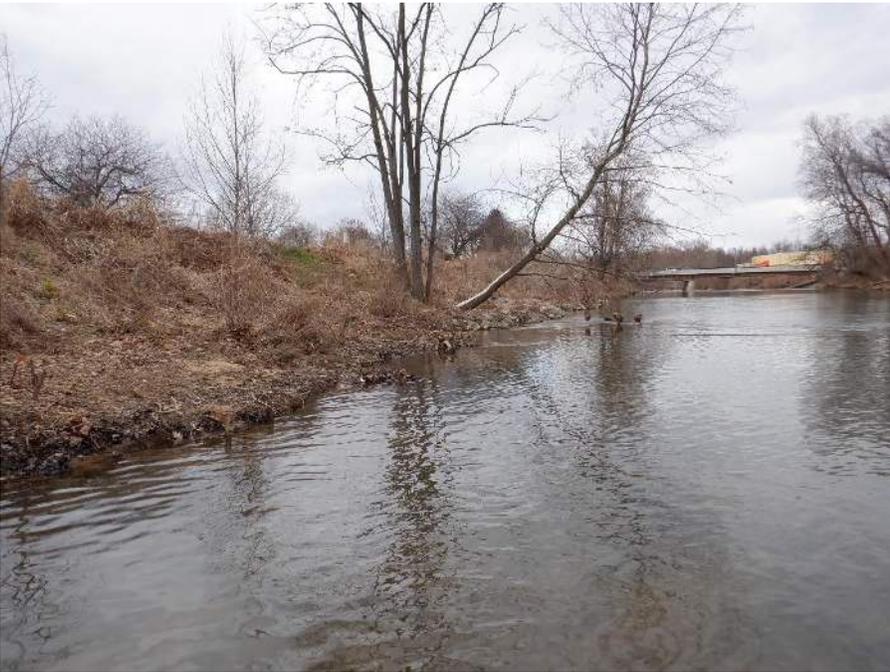
<p>Location: 00-25'</p> <hr/> <p>Photo Title: Date: 2 1/18/2021</p> <hr/> <p>Direction Photo Taken: Northwest</p> <hr/> <p>Description: Start of remediated bank; evidence of foot traffic along toe of slope; some coir logs damaged and some geocell exposed; some erosion control fabric exposed</p>

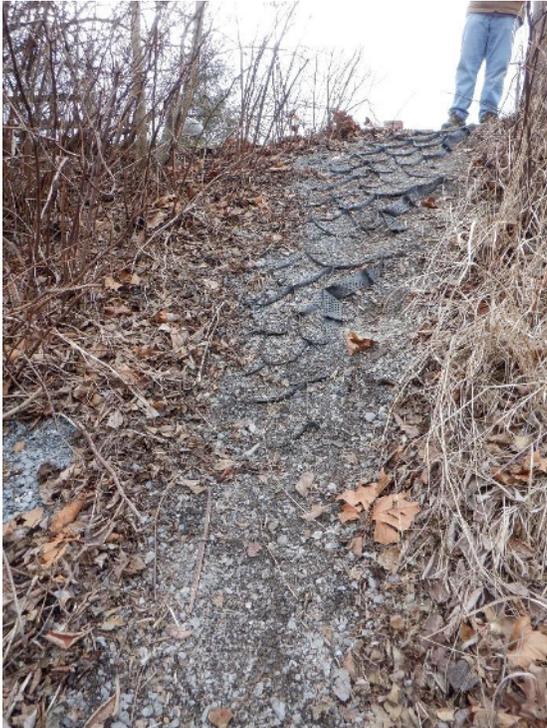
<p>Location: 00+00'</p> <hr/> <p>Photo Title: Date: 4 1/18/2021</p> <hr/> <p>Direction Photo Taken: West</p> <hr/> <p>Description: Exposed geocell along constructed river access path</p>

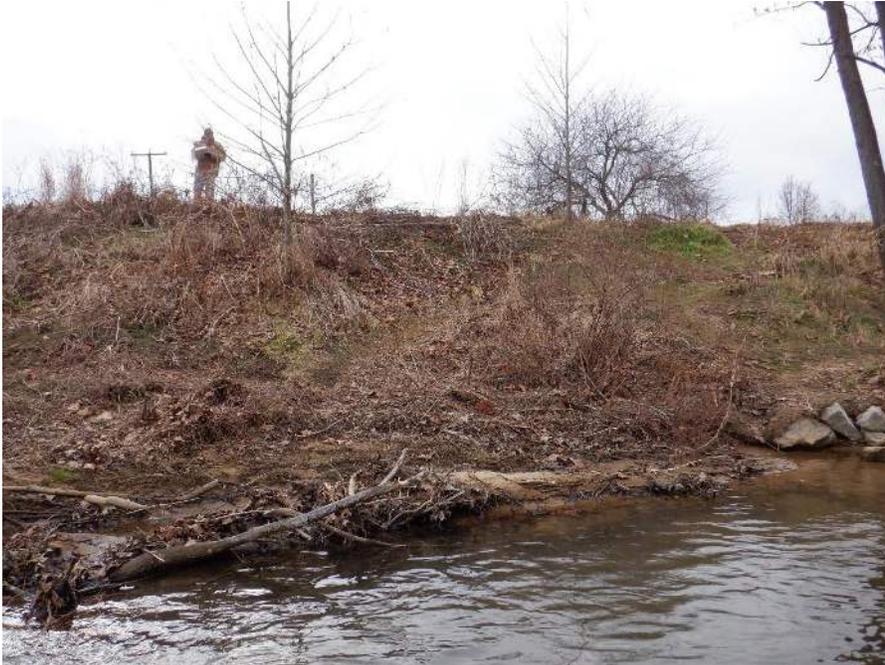
<p>Location: 00+50'</p> <hr/> <p>Photo Number: Date: 5 1/18/2021</p> <hr/> <p>Direction Photo Taken: West</p> <hr/> <p>Description: ~45 degree bank angle; no exposed roots; lives takes and plantings establishing; vegetation established; coir logs show wear from foot traffic along toe of slope; erosion control fabric deteriorated; geocell exposed above toe; sediment deposition along toe of slope</p>

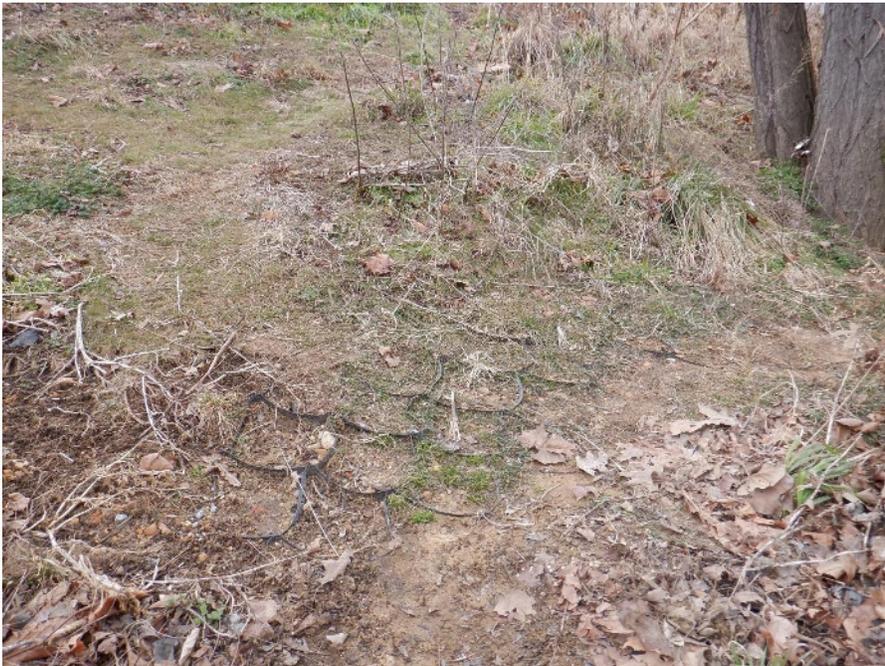
<p>Location: 00+50'</p> <hr/> <p>Photo Title: Date: 6 1/18/2021</p> <hr/> <p>Direction Photo Taken: West</p> <hr/> <p>Description: Exposed geocell above toe of bank; erosion control fabric deteriorated</p>

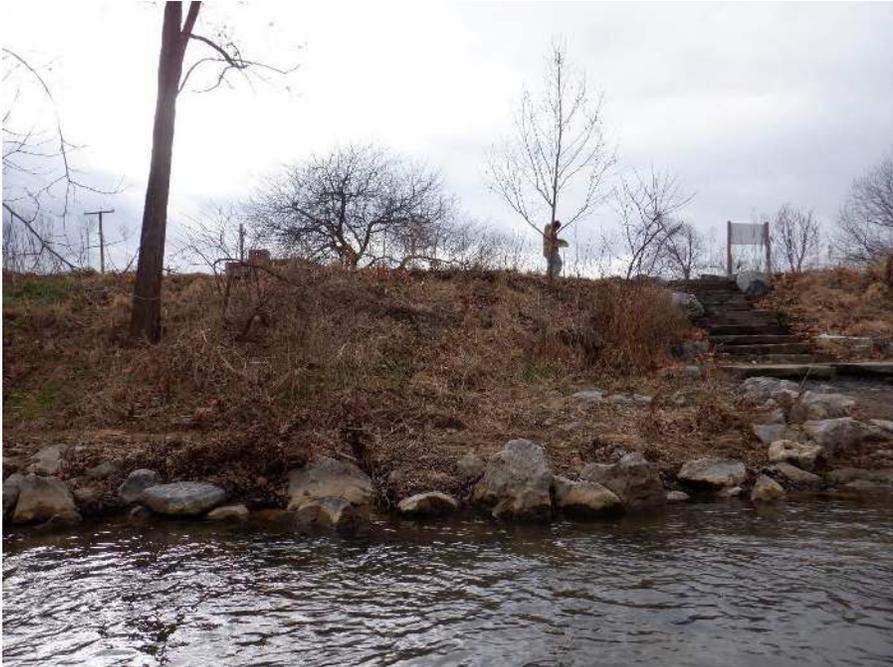
<p>Location: 00+100'</p> <hr/> <p>Photo Number: Date: 7 1/18/2021</p> <hr/> <p>Direction Photo Taken: West</p> <hr/> <p>Description: ~45 degree bank angle; live stakes not visible; plantings establishing; vegetation established; staircase intact; sediment deposition around rock toe; installed rock toe intact</p>

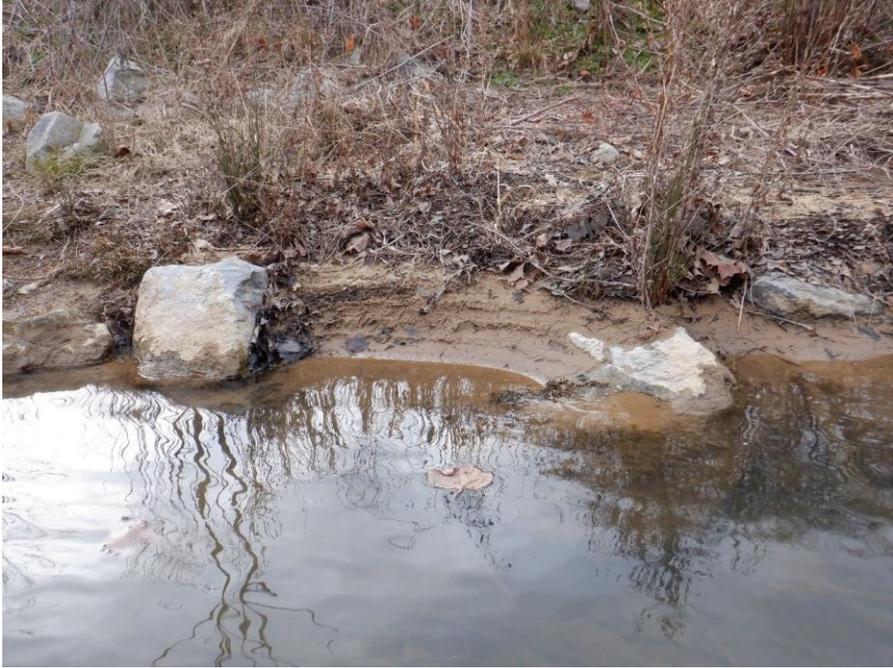
<p>Location: 00+150'</p> <hr/> <p>Photo Number: 13 Date: 1/18/2021</p> <hr/> <p>Direction Photo Taken: West</p> <hr/> <p>Description: Scour along toe of slope</p>

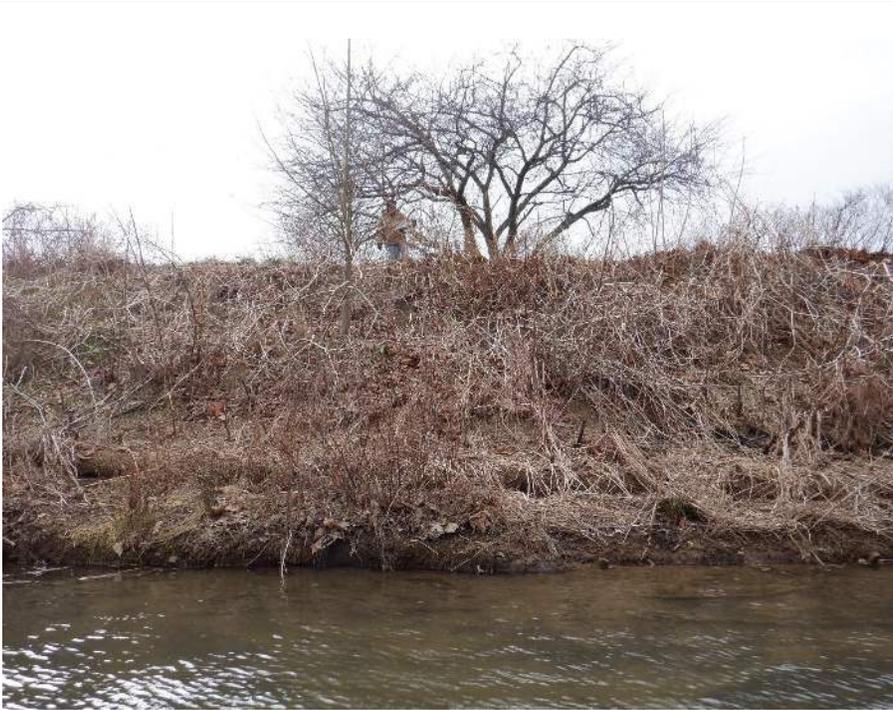
<p>Location: 00+200'</p> <hr/> <p>Photo Title: 14 Date: 1/18/2021</p> <hr/> <p>Direction Photo Taken: West</p> <hr/> <p>Description: ~55 degree bank angle; lives stakes and plantings establishing; vegetation established mid to upper bank; erosion control fabric deteriorated; large sections of geocell exposed extending approximately 3-4' depth by 40-50' length above the toe of slope above coir logs; minimal scour</p>

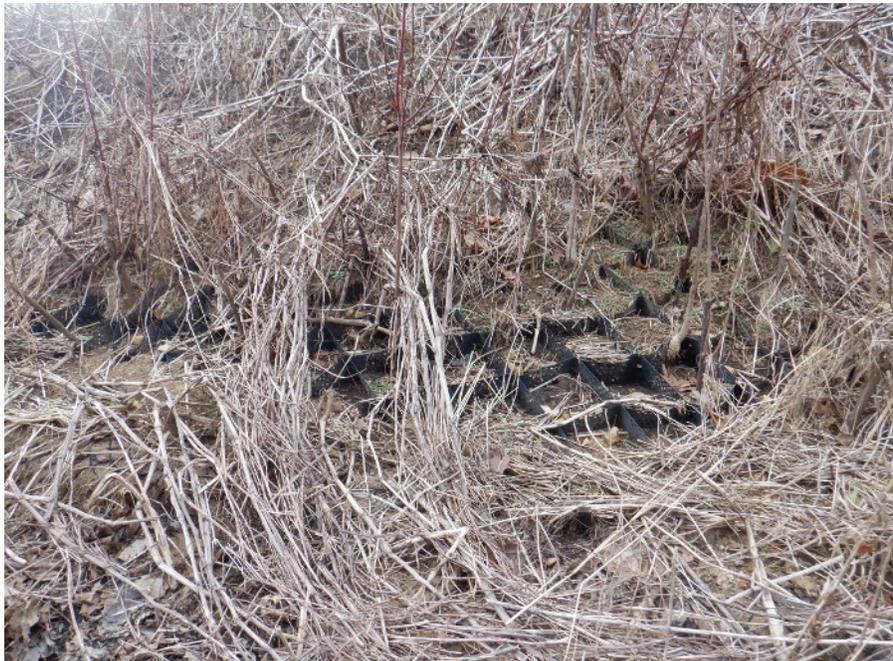
<p>Location: 00+200'</p> <hr/> <p>Photo Number: 15 Date: 1/18/2021</p> <hr/> <p>Direction Photo Taken: West</p> <hr/> <p>Description: Large section of exposed geocell 3-4' depth extending 40-50' left to right after recent high water events; erosion control fabric deteriorated</p>

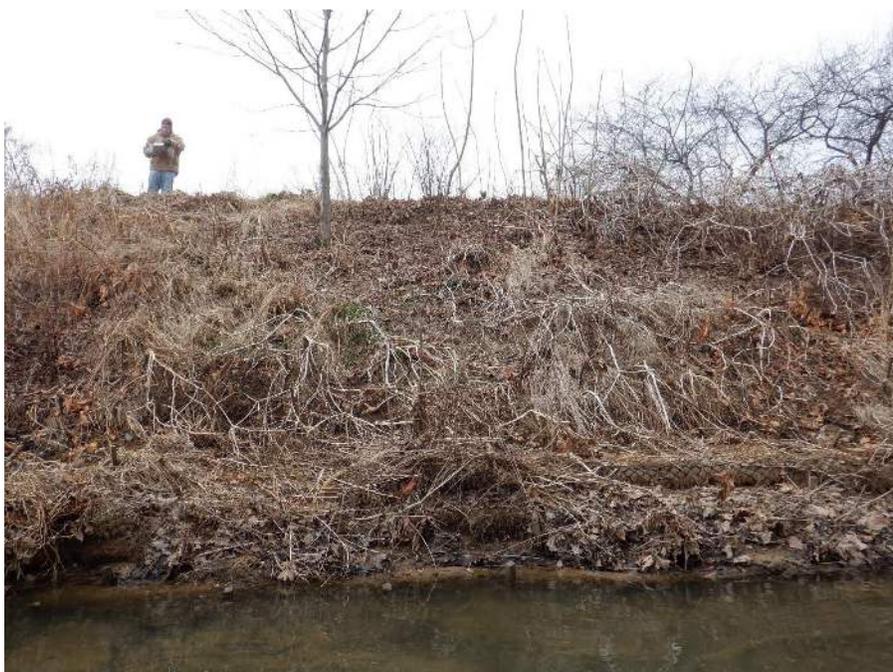
<p>Location: 00+250'</p> <hr/> <p>Photo Title: 16 Date: 1/18/2021</p> <hr/> <p>Direction Photo Taken: West</p> <hr/> <p>Description: ~55 degree bank angle; vegetation establishing mid to upper bank; live stakes and plantings establishing; erosion control fabric deteriorated; geocell exposed above toe of slope above coir logs in large sections extending lengthwise across the bank; scour present along exposed geocell</p>

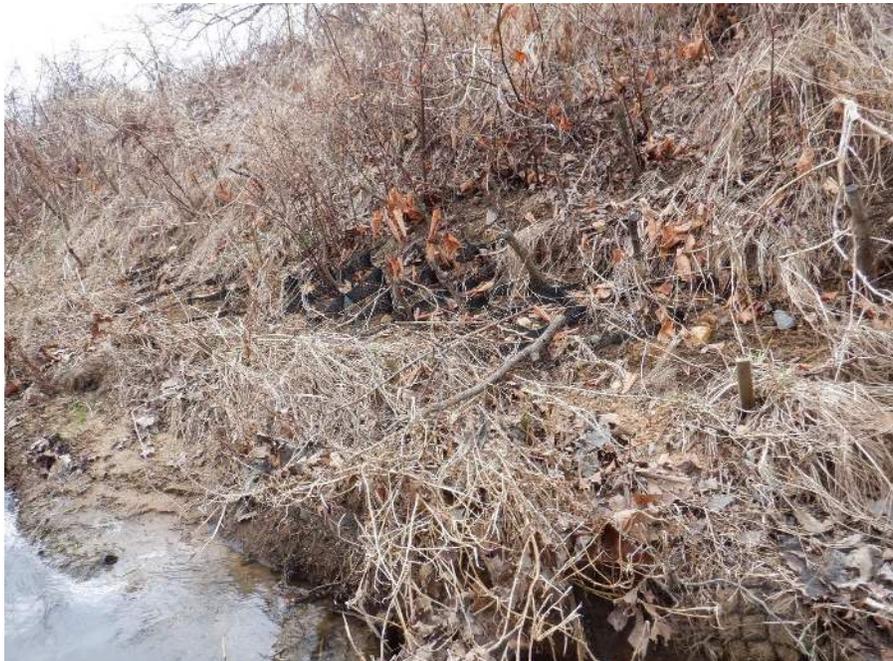
<p>Location: 00+250'</p> <hr/> <p>Photo Number: 17 Date: 1/18/2021</p> <hr/> <p>Direction Photo Taken: West</p> <hr/> <p>Description: Large section of geocell exposed extending lengthwise across bank; erosion control fabric deteriorated</p>

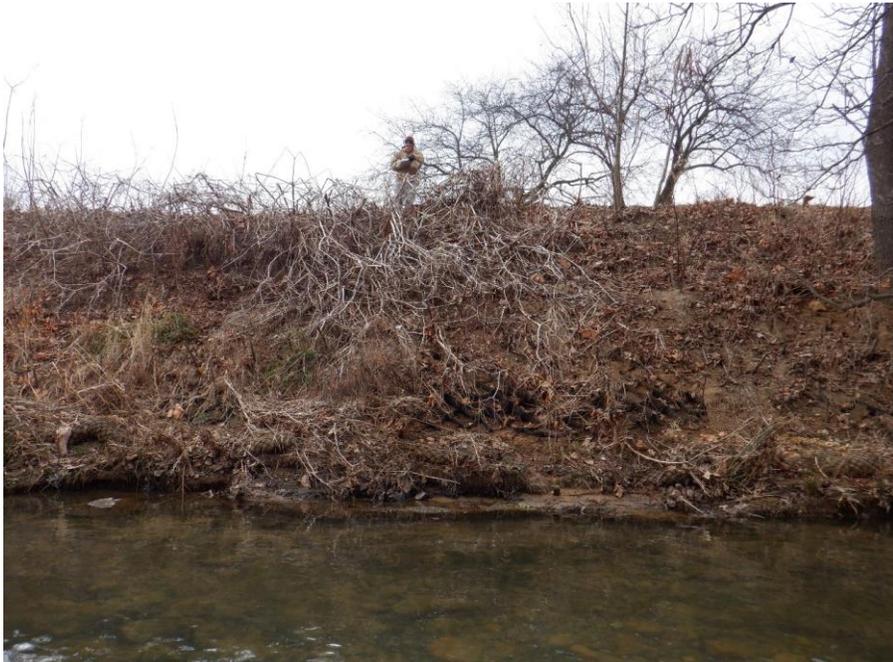
<p>Location: 00+300'</p> <hr/> <p>Photo Title: 18 Date: 1/18/2021</p> <hr/> <p>Direction Photo Taken: West</p> <hr/> <p>Description: ~70 degree bank angle; vegetation establishing mid to upper bank; lives stakes and plantings establishing; large section of geocell exposed along bank at 3-5' depth and about 100' continuously lengthwise across bank above toe and coir logs; erosion control fabric deteriorated</p>

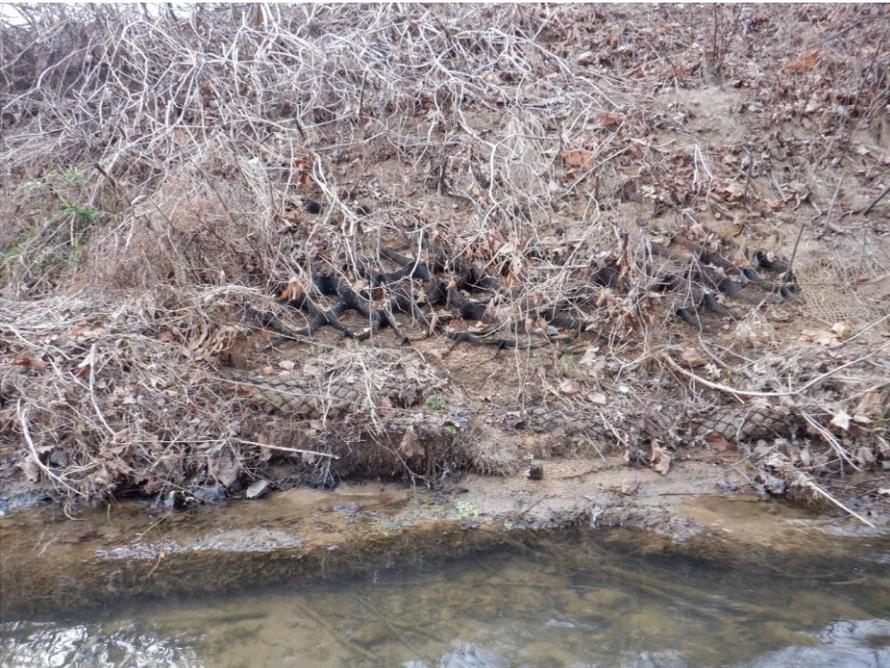
<p>Location: 00+300'</p> <hr/> <p>Photo Title: Date: 20 1/18/2021</p> <hr/> <p>Direction Photo Taken: West</p> <hr/> <p>Description: Exposed geocell above coir logs extending lengthwise throughout bank</p>

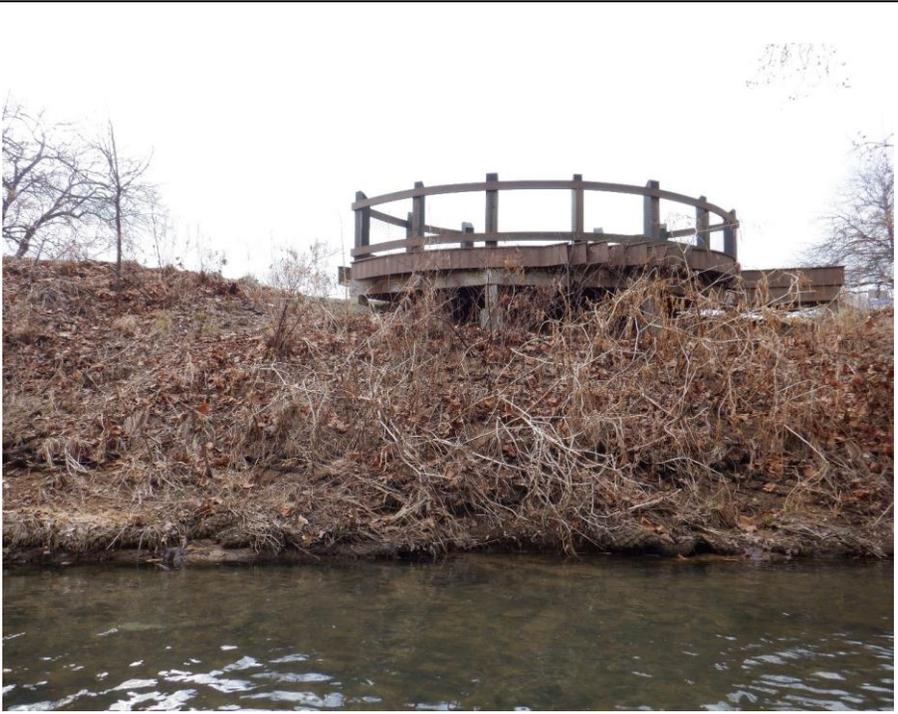
<p>Location: 00+350'</p> <hr/> <p>Photo Number: Date: 21 1/18/2021</p> <hr/> <p>Direction Photo Taken: West</p> <hr/> <p>Description: ~70 degree bank angle; vegetation establishing; bank 40% exposed; live stakes and plantings establishing; large sections of geocell exposed above toe of bank; erosion control fabric deteriorated</p>

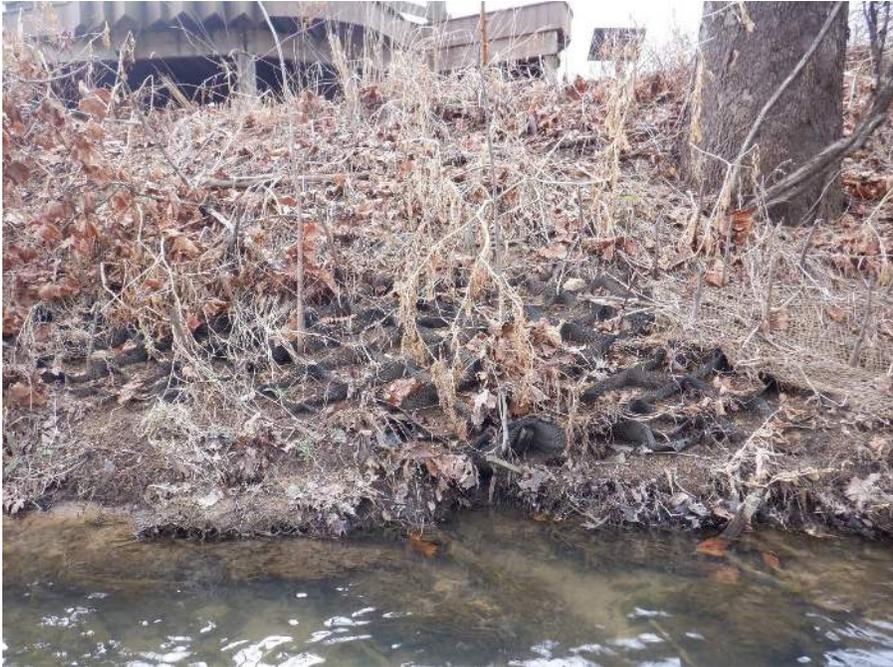
<p>Location: 00+350'</p>

<p>Photo Number: 23 Date: 1/18/2021</p>	
<p>Direction Photo Taken: West</p>	
<p>Description: Large section of geocell exposed above toe of bank approximately 5' depth extending 30-40' in length; erosion control fabric deteriorated</p>

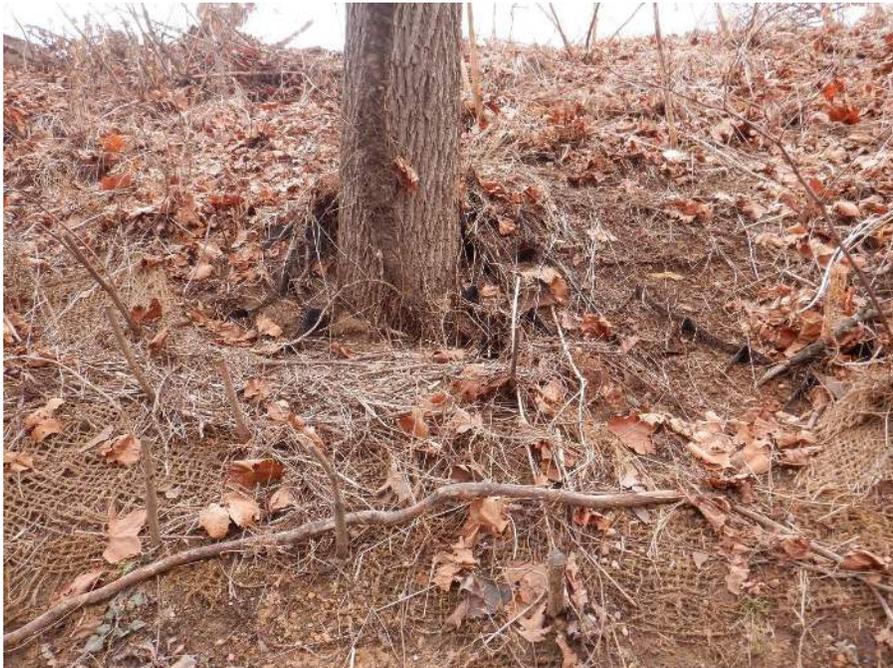
<p>Photo Title: 24 Date: 1/18/2021</p>	
<p>Direction Photo Taken: West</p>	
<p>Description: Bank largely exposed; erosion control fabric 80% exposed; fabric deteriorating; geocell exposed around tree</p>

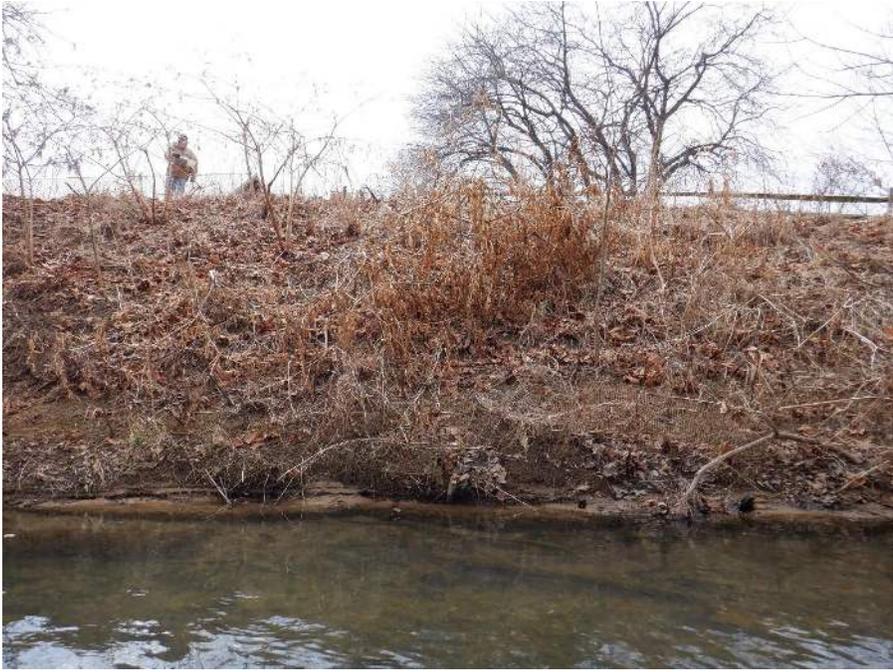
<p>Location: 00+400'</p>

<p>Photo Number: 25 Date: 1/18/2021</p>	
<p>Direction Photo Taken: West</p>	
<p>Description: ~60 degree bank angle; vegetation establishing mid to upper bank; live stakes and plantings establishing; coir logs deteriorating; erosion control fabric deteriorating; lower bank slope 75% exposed; undercutting at toe of slope; small patches of geocell exposed</p>

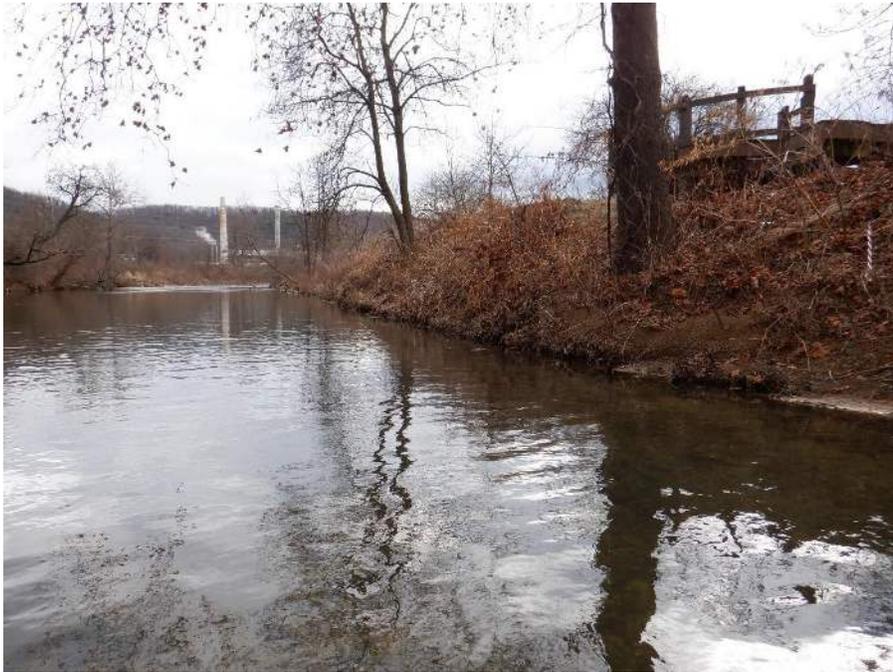
<p>Photo Title: 26 Date: 1/18/2021</p>	
<p>Direction Photo Taken: Southwest</p>	
<p>Description: Upstream view of remediated bank; undercutting along toe of slope; large sections of geocell exposed</p>

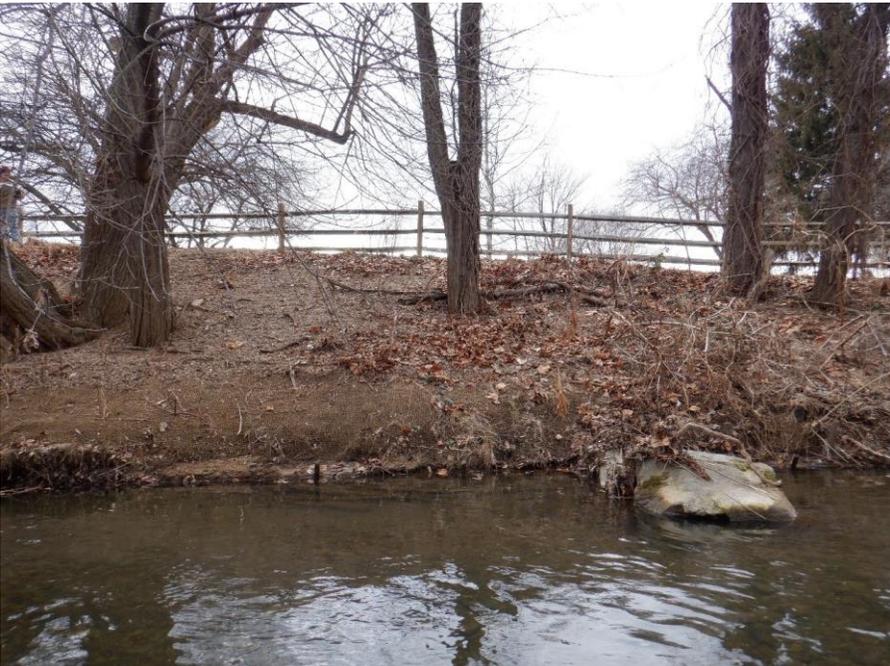
<p>Location: 00+450'</p> <hr/> <p>Photo Title: 28 Date: 1/18/2021</p> <hr/> <p>Direction Photo Taken: West</p> <hr/> <p>Description: ~50 degree bank angle; vegetation minimally established; erosion control fabric and bank 90% exposed; erosion control fabric deteriorating; small amount of geocell exposed at toe; scour along coir logs</p>

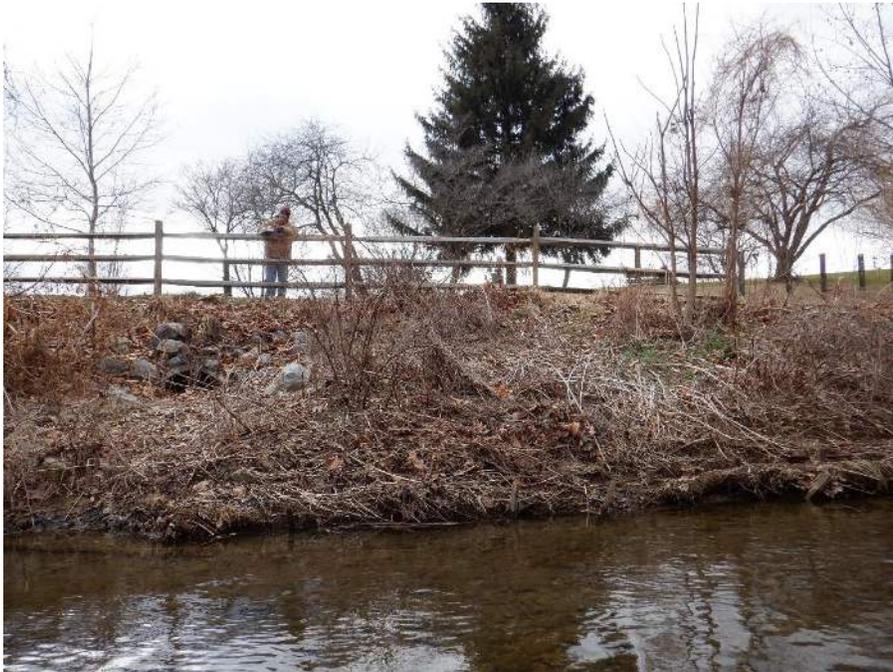
<p>Location: 00+500'</p> <hr/> <p>Photo Title: 30 Date: 1/18/2021</p> <hr/> <p>Direction Photo Taken: West</p> <hr/> <p>Description: ~40 degree bank angle; live stakes and plantings establishing; vegetation establishing; coir logs deteriorating and slumping into river; small patches of geocell exposed; erosion control fabric deteriorated; undercutting along toe</p>

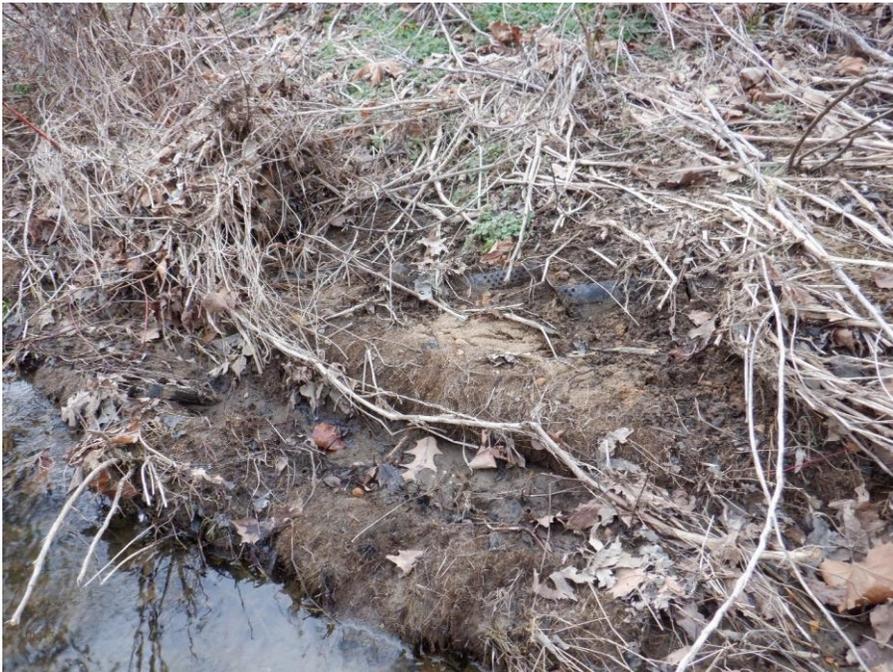
<p>Location: 00+525'</p> <hr/> <p>Photo Title: Date: 34 1/18/2021</p> <hr/> <p>Direction Photo Taken: West</p> <hr/> <p>Description: Small patch of geocell exposed; coir log deteriorating; undercutting at toe of slope</p>

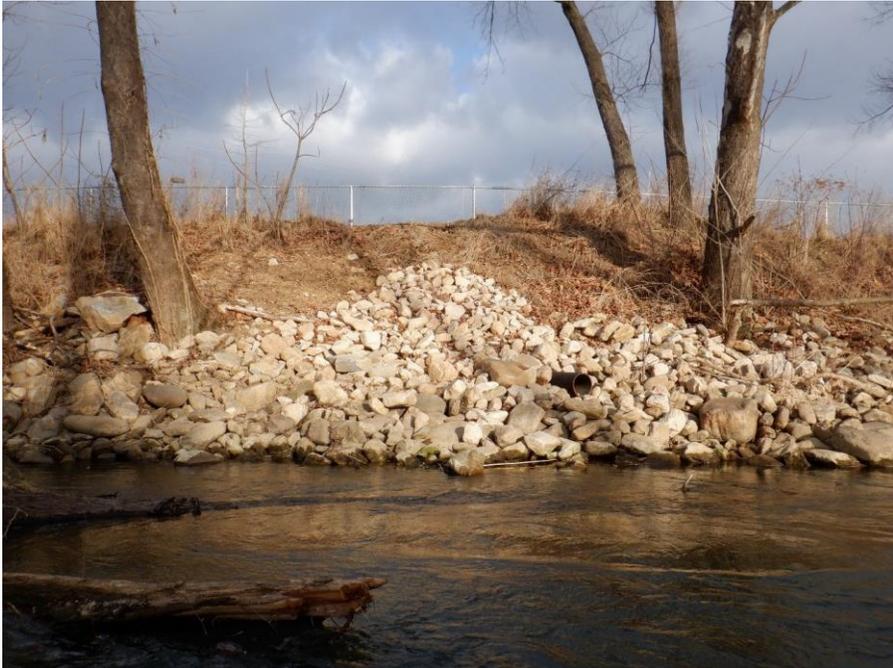
<p>Location: 00+350'</p> <hr/> <p>Photo Title: Date: 14 1/20/2021</p> <hr/> <p>Direction Photo Taken: Northwest</p> <hr/> <p>Description: ~45 degree bank angle; installed rock toe intact; daylighted outfall pipe and stone repaired; minimal vegetation established due to outfall pipe repair in fall of 2020; LWD intact; vegetation established outside of repair</p>

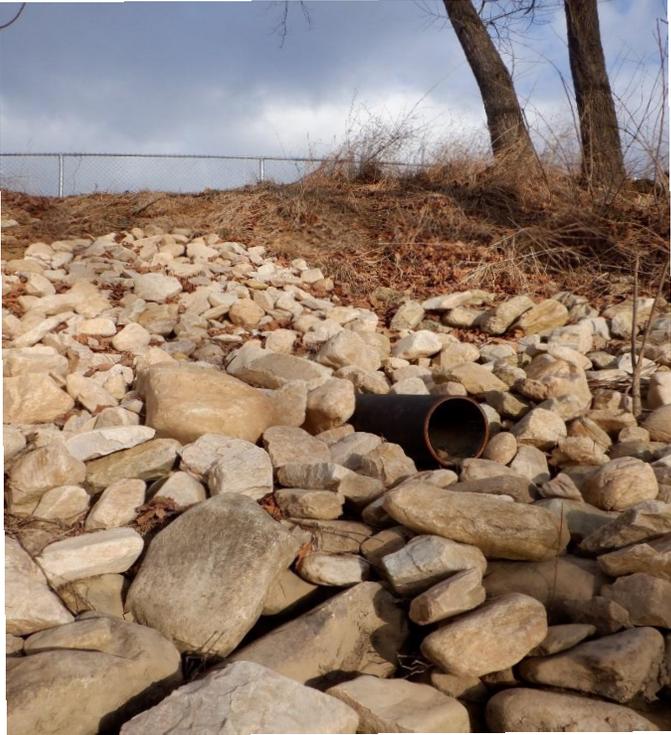
<p>Location: 00+350'</p> <hr/> <p>Photo Number: Date: 17 1/20/2021</p> <hr/> <p>Direction Photo Taken: Northwest</p> <hr/> <p>Description: Outfall pipe of 12" inside diameter and stone that was repaired after previous outfall pipe was daylighted and stones were removed; vegetation establishing around repair</p>

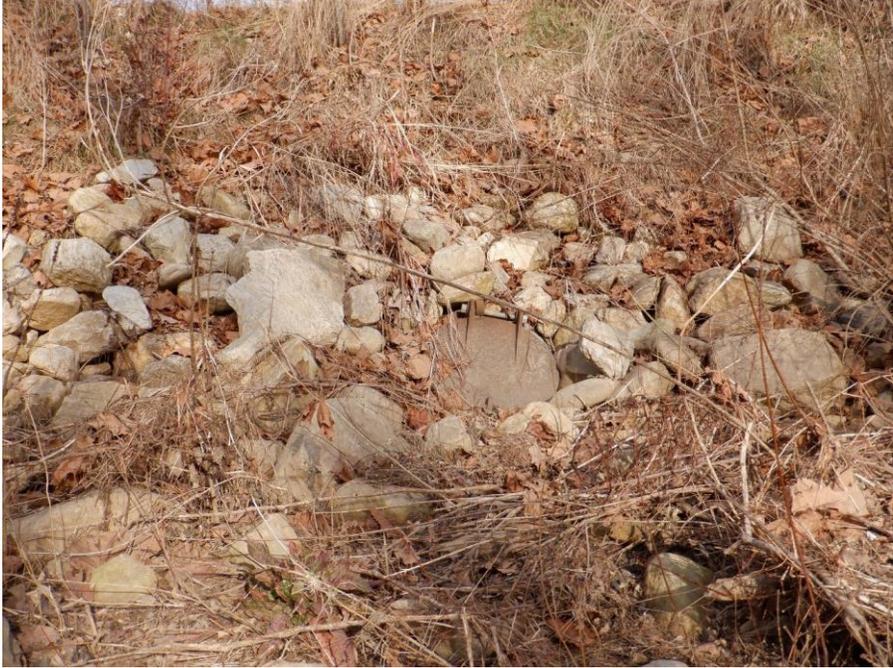
- There are two stormwater overflow pipes located at 00+400'. One overflow pipe has a broken hinge and the other may be blocked by stone and/or vegetation. This will continue to be monitored; however, these outfalls are not associated with the remediation and any required maintenance/repairs are the responsibility of the City of Waynesboro. .

<p>Location: 00+400'</p> <hr/> <p>Photo Number: Date: 19 1/20/2021</p> <hr/> <p>Direction Photo Taken: Northwest</p> <hr/> <p>Description: Outfall pipe with damaged hinge; vegetation established, installed rock toe intact</p>

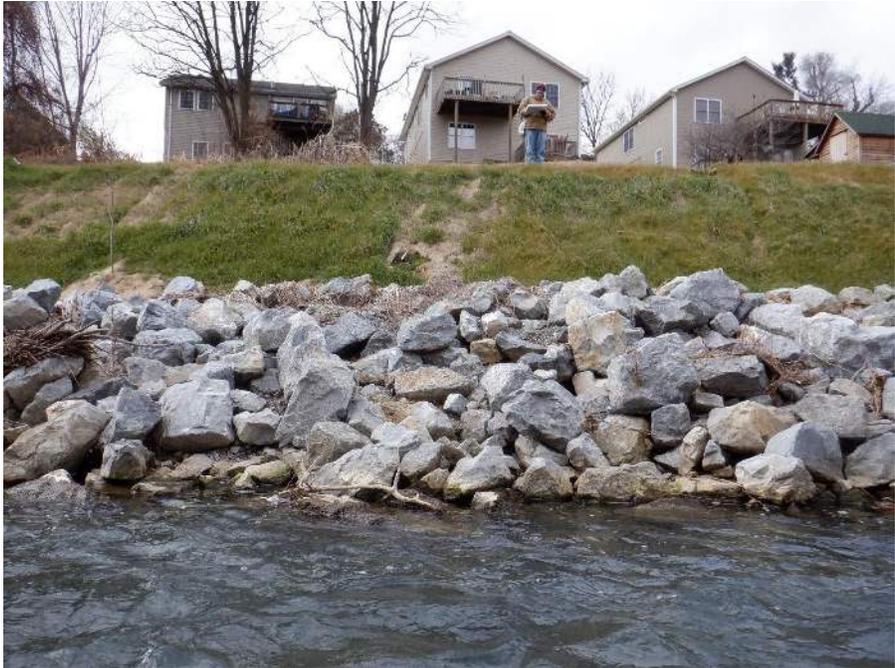
<p>Photo Number: 23 Date: 1/18/2021</p>	
<p>Direction Photo Taken: West</p>	
<p>Description: ~70 degree upper bank angle and 60 degree lower bank angle; portion of the bank that failed over the summer has been repaired; grasses establishing along repaired portion of bank; installed rock toe intact; erosion control fabric 40% exposed in repaired area</p>

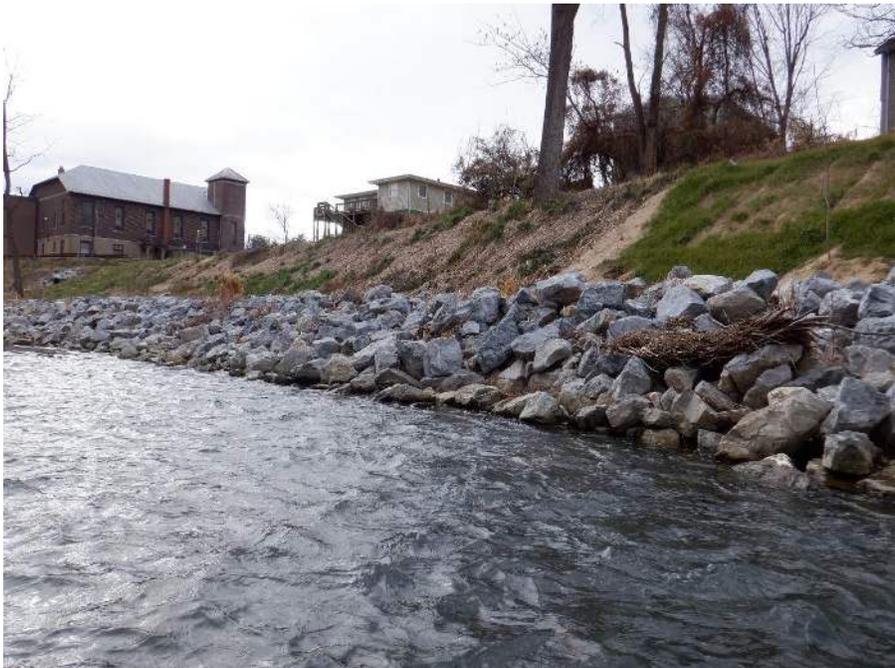
<p>Photo Title: 24 Date: 1/18/2021</p>	
<p>Direction Photo Taken: Southwest</p>	
<p>Description: Upstream portion of failed bank that was repaired fall of 2020; grasses establishing on repaired bank; erosion control fabric 40% exposed in repaired area</p>
