**Re: 2021 Leaf-on and Leaf-off Maintenance Inspections  
Former DuPont Waynesboro Site AOC 4  
Waynesboro, Virginia  
EPA ID# VAD003114832**

## Memorandum

Subject 2021 Leaf-on Maintenance Inspection  
Former DuPont Waynesboro Site, Area of Concern 4

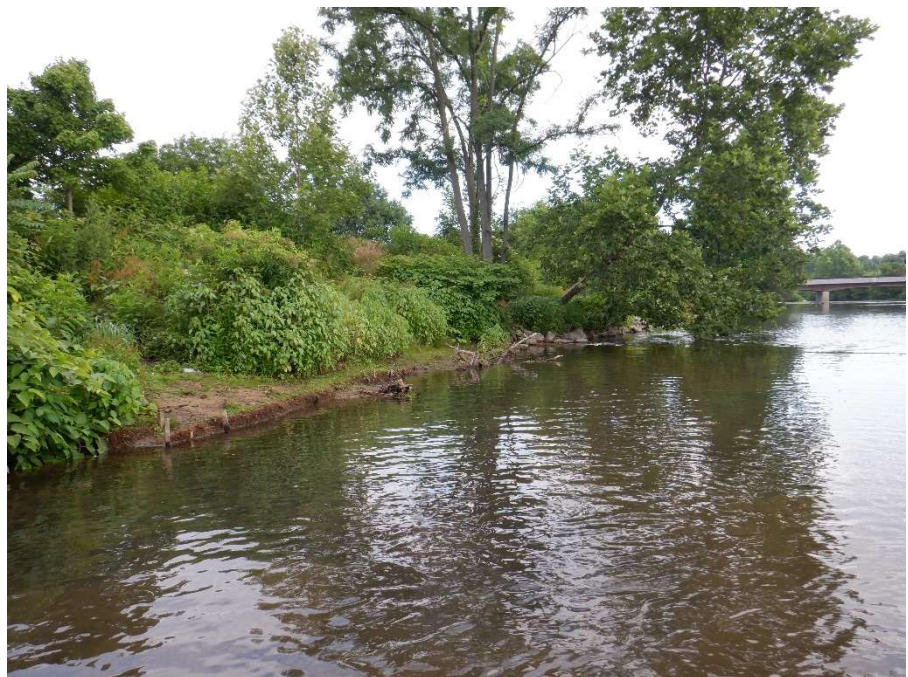
**Description:**  
Start of remediated bank; No evidence of foot traffic along toe of slope; coir logs decomposed.

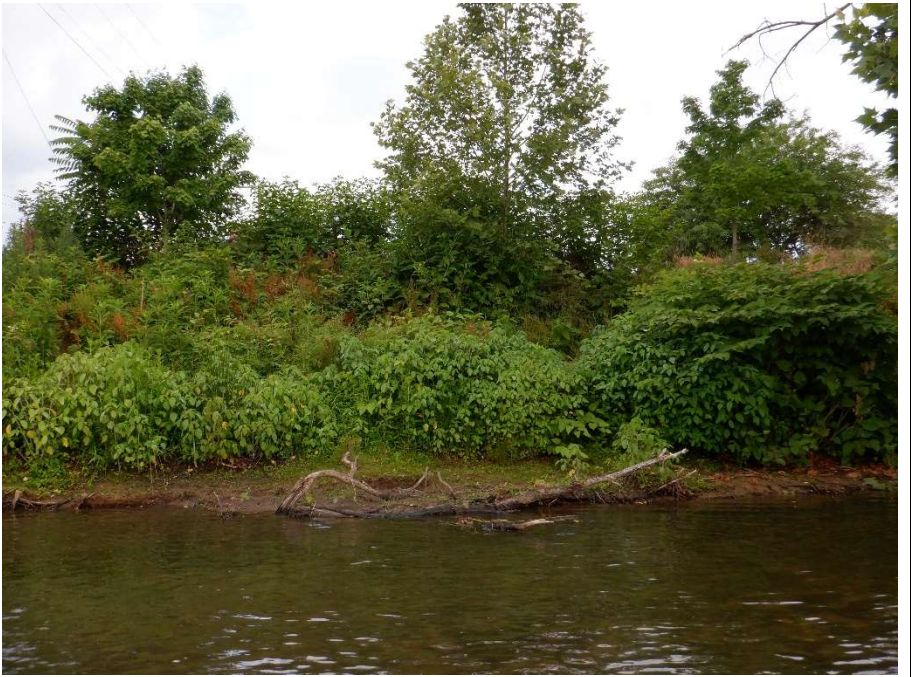
<b>Location:</b> 00+50'

<b>Photo Number:</b> 5 <b>Date:</b> 6/22/2021	
<b>Direction Photo Taken:</b> West	
<b>Description:</b> ~45 degree bank angle; no exposed roots; No live stakes have established; native vegetation established-jewelweed 50% cover, invasive knotweed 50% cover; coir logs have decomposed along toe of slope; erosion control fabric deteriorated; No geocell observed; sediment deposition along toe of slope.

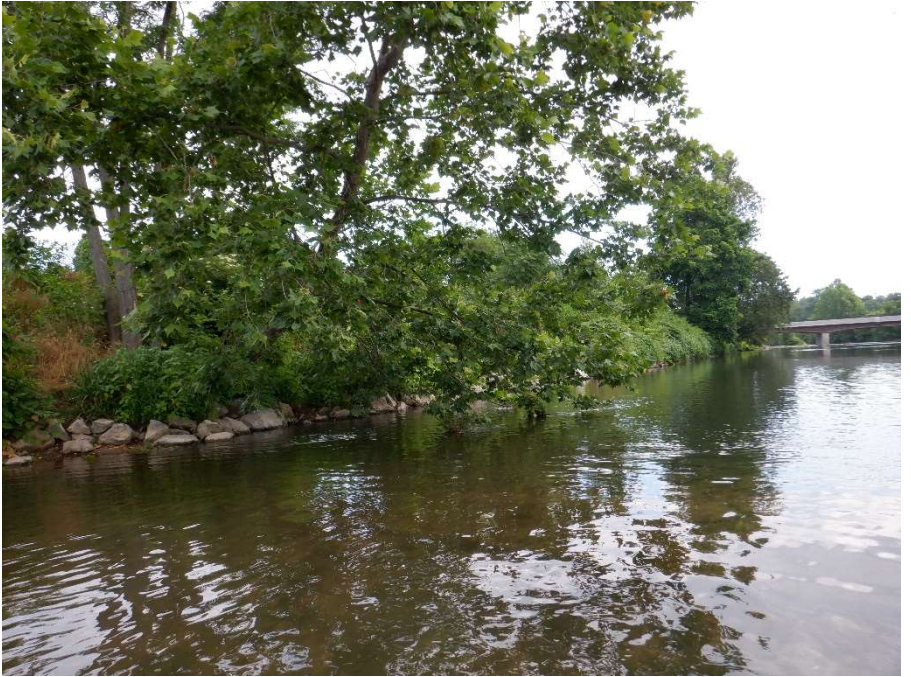
<b>Location:</b> 00+50'

<b>Photo Title:</b> 6 <b>Date:</b> 6/22/2021	
<b>Direction Photo Taken:</b> Northwest	
<b>Description:</b> Evidence of foot traffic at toe of slope; erosion control fabric deteriorated.

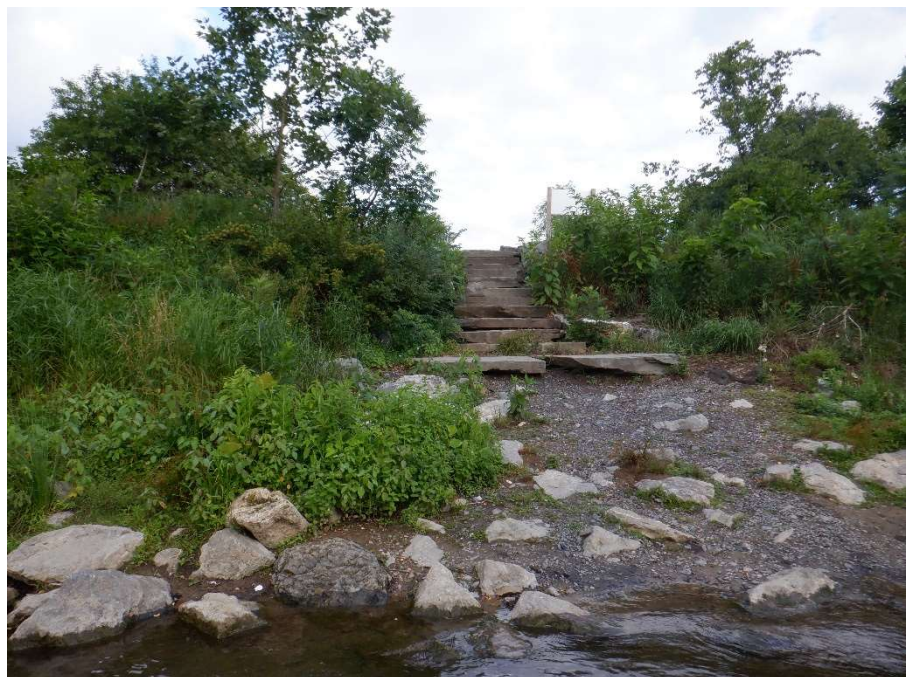
**Description:**  
Staircase intact; undercutting under bottom stone slab steps likely occurring during high water events.

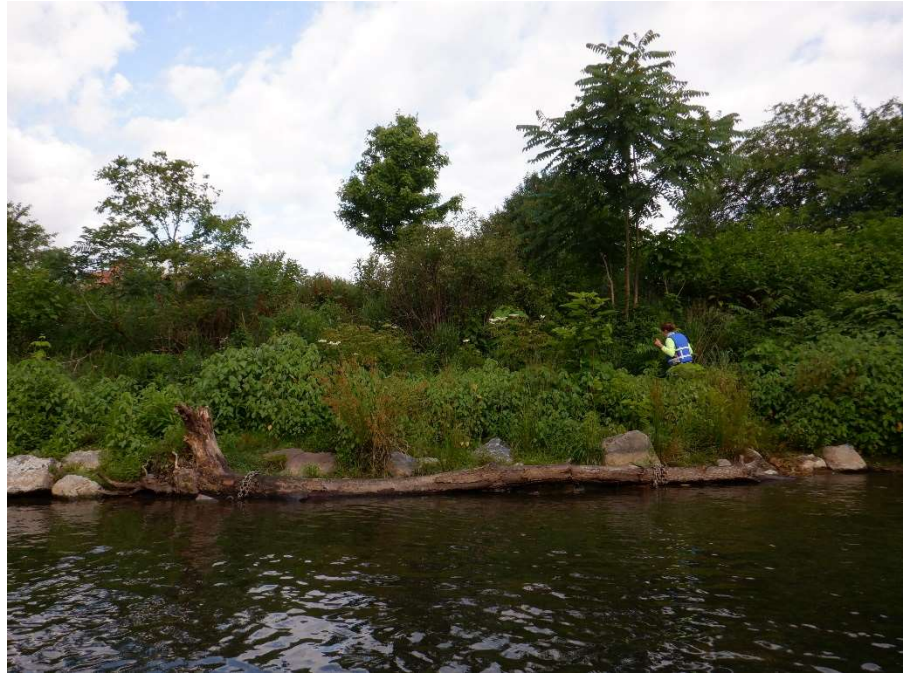
**Description:**  
~45 degree bank angle; no exposed roots; live stakes not visible; native vegetation has established- softrush, elderberry, sumac; invasive ailanthus saplings observed; evidence of foot traffic along slope; scour at toe of bank; LWD intact; sediment deposition behind LWD.

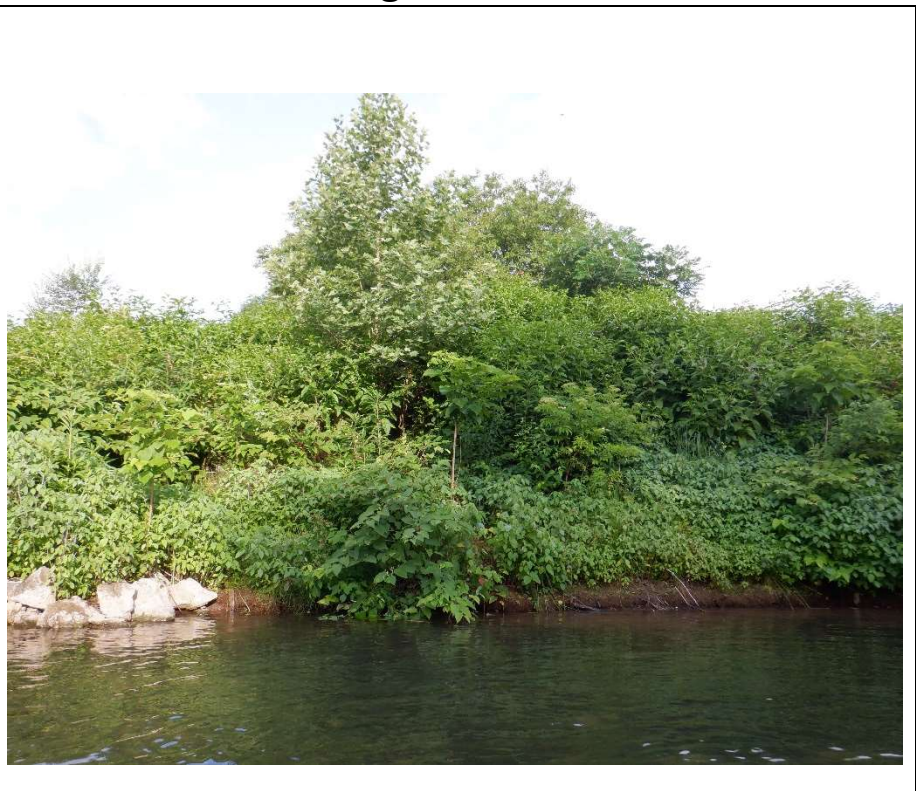
<p><b>Location:</b> 00+200'</p> <hr/> <p><b>Photo Number:</b>      <b>Date:</b> 11                              6/22/2021</p> <hr/> <p><b>Direction Photo Taken:</b> West</p> <hr/> <p><b>Description:</b> ~55 degree bank angle; no evidence of lives stakes observed; isolated patched of invasive knotweed; native vegetation establishing- elderberry, sumac, pokeberry, sycamore and catalpa saplings; vegetation established mid to upper bank; erosion control fabric deteriorated; no geocell exposed; minimal scour.</p>

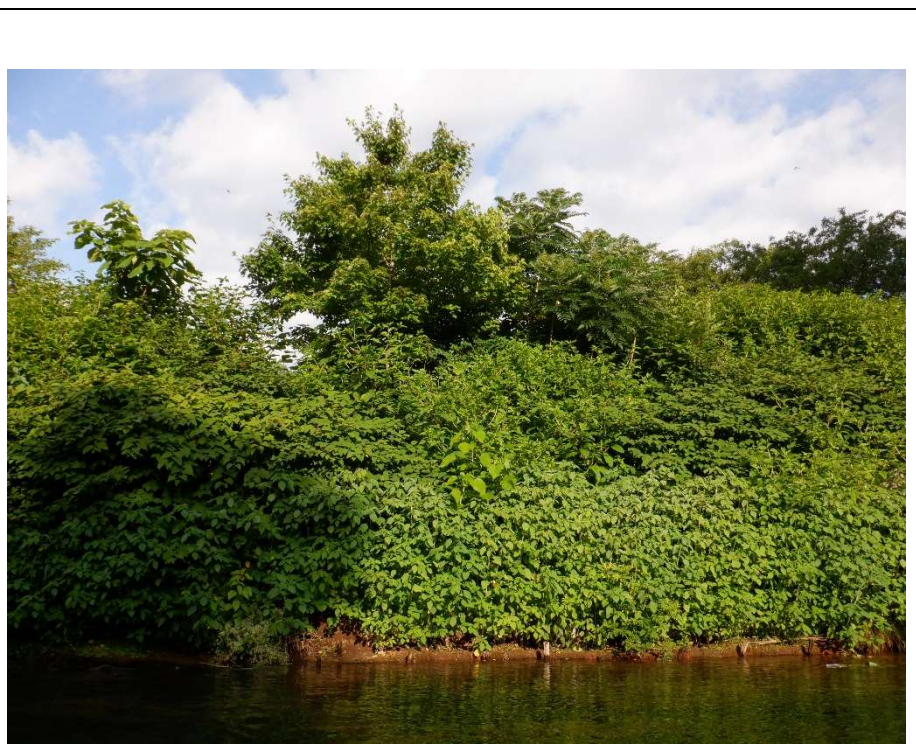
<p><b>Location:</b> 00+250'</p> <hr/> <p><b>Photo Title:</b>              <b>Date:</b> 12                              6/22/2021</p> <hr/> <p><b>Direction Photo Taken:</b> West</p> <hr/> <p><b>Description:</b> ~55 degree bank angle; vegetation establishing mid to upper bank; no live stakes observed; native vegetation established- jewelweed, catalpa saplings; erosion control fabric deteriorated; no geocell exposed a; coir logs visible at toe of slope; no scour observed.</p>

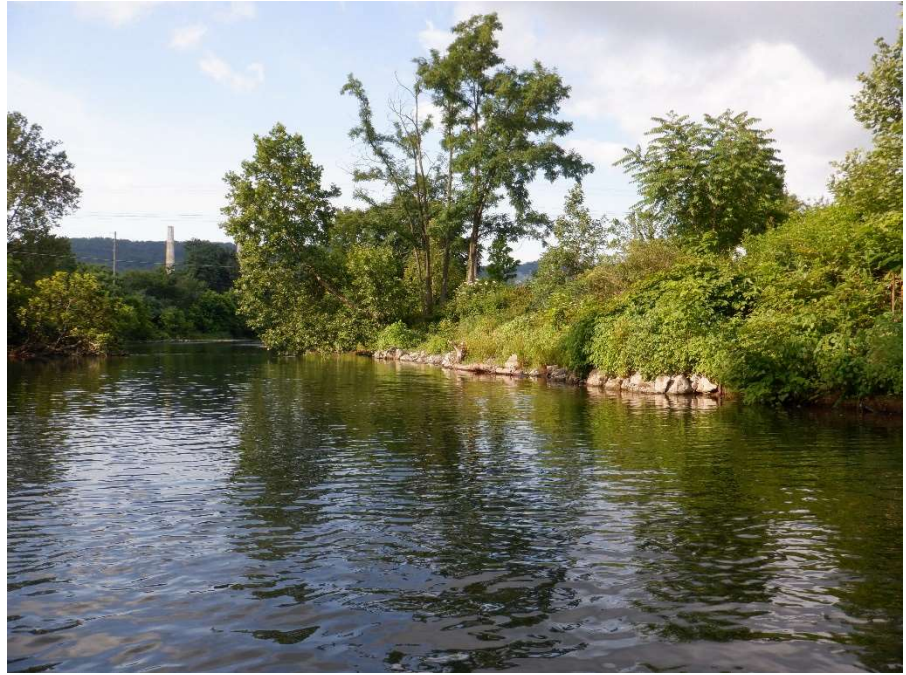
**Description:**  
Small patches of invasive knotweed observed; no at risk trees present; coir logs have degraded; no foot traffic evident at water's edge.

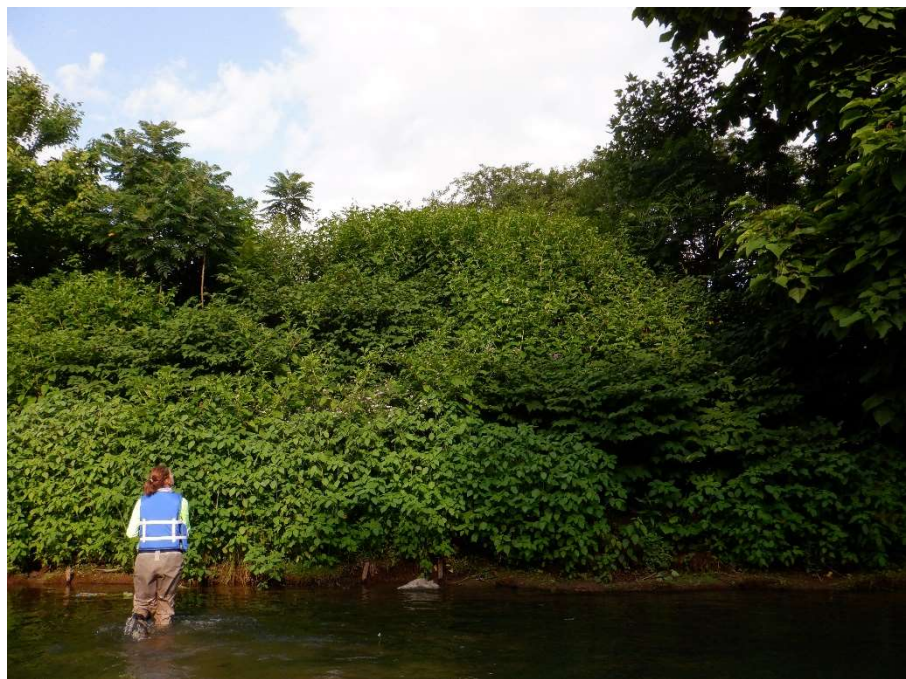
**Description:**  
~70 degree bank angle; vegetation established mid to upper bank; no live stakes observed; erosion control fabric deteriorated; no geocell; no evidence of foot traffic; native vegetation established- staghorn sumac, jewelweed; invasive knotweed ~ 25% cover.

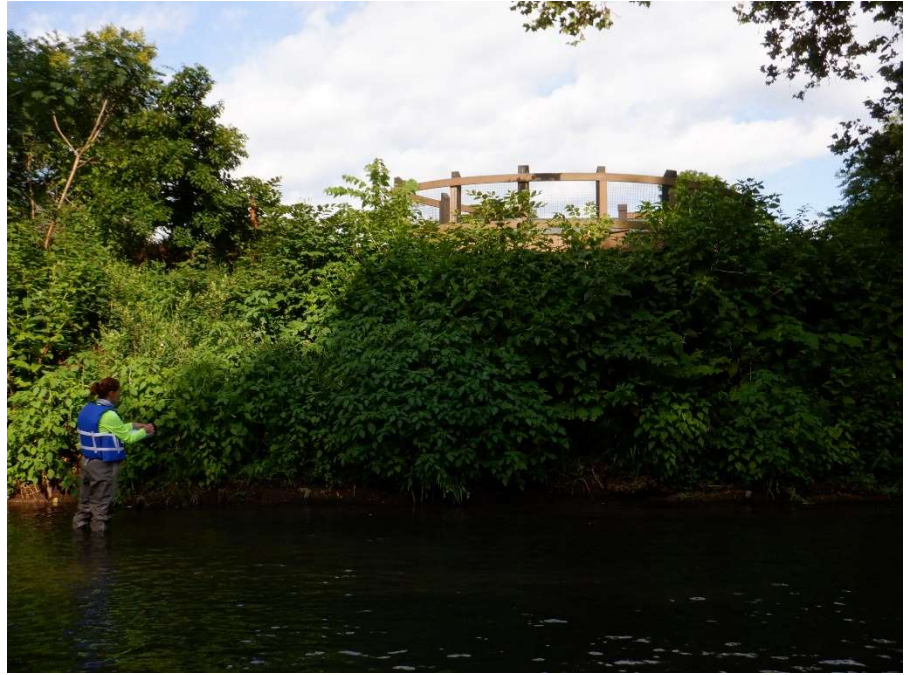
**Description:**  
~70 degree bank angle;  
vegetation establishing;  
invasive knotweed ~70%  
cover; live stakes ~ 30%  
established; erosion control  
fabric deteriorated; sycamore  
tree previously listed as  
dead, is alive and growing;  
minimal scour present at toe  
of slope.

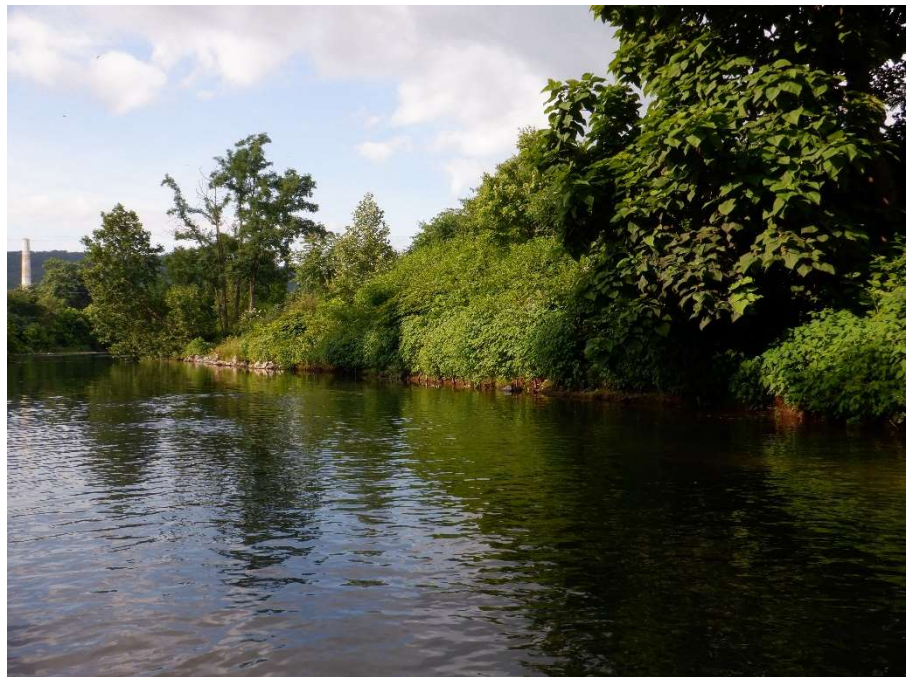
**Description:**  
Upstream view of  
remediated bank; minimal  
scour overall; coir logs have  
degraded; no evidence of  
foot traffic observed;  
increased native vegetation  
established.

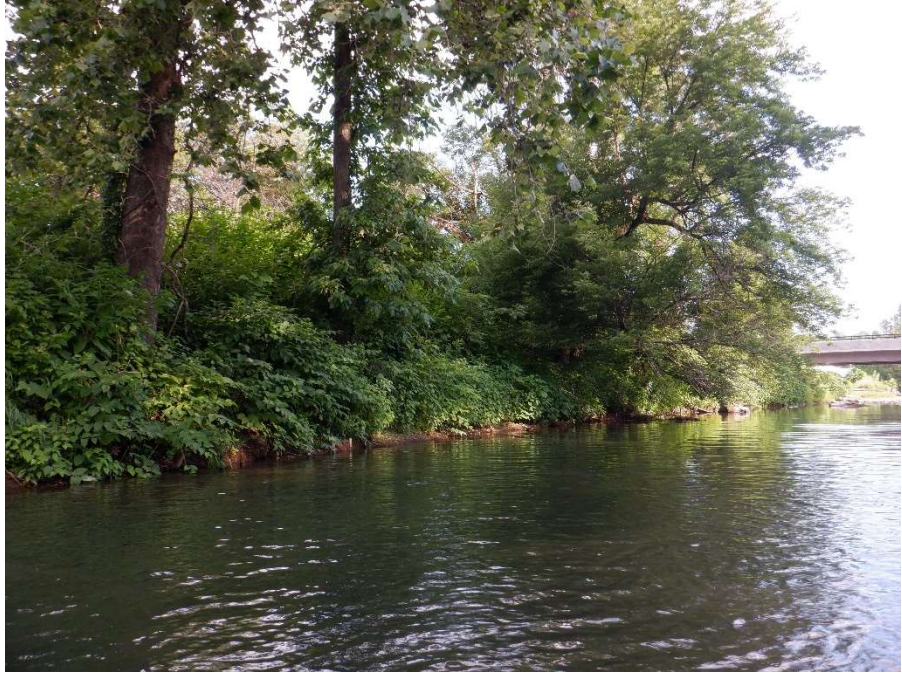
<p><b>Location:</b> 00+350'</p>

<p><b>Photo Number:</b> 17      <b>Date:</b> 6/22/2021</p>	
<p><b>Direction Photo Taken:</b> Northwest</p>	
<p><b>Description:</b> Downstream view; increased cover of invasive knotweed; no live stakes observed; no exposed geocell or erosion control fabric observed.</p>

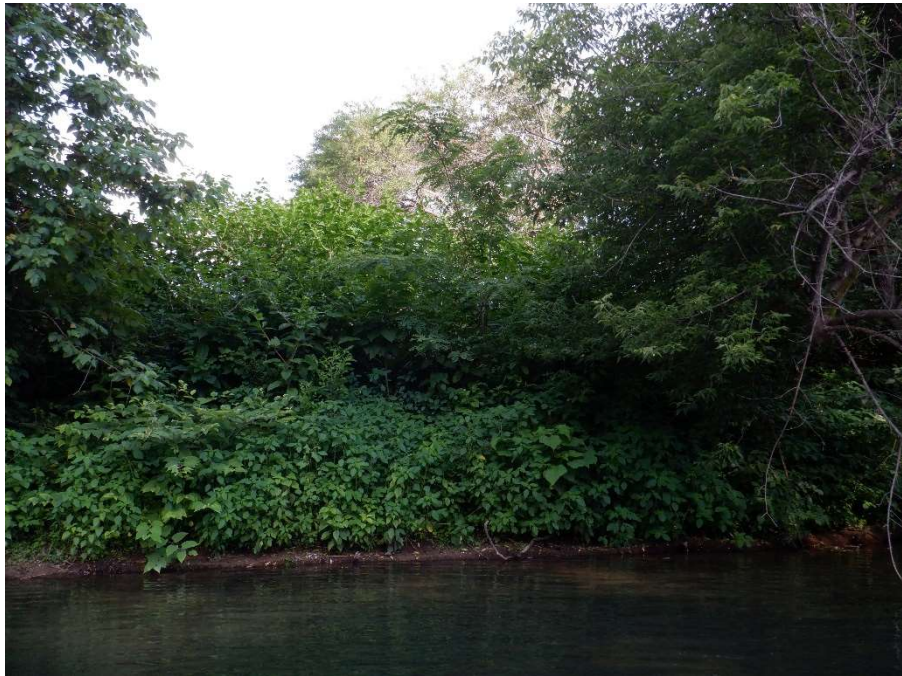
<p><b>Location:</b> 00+400'</p>

<p><b>Photo Title:</b> 18      <b>Date:</b> 6/22/2021</p>	
<p><b>Direction Photo Taken:</b> West</p>	
<p><b>Description:</b> ~60 degree bank angle; vegetation establishing mid to upper bank; No live stakes observed; coir logs deteriorating; no erosion control fabric observed; lower bank soils no longer exposed; invasive knotweed ~10% cover; native vegetation includes- black walnut, jewelweed, pokeberry, box elder, poison ivy and catalpa saplings.</p>

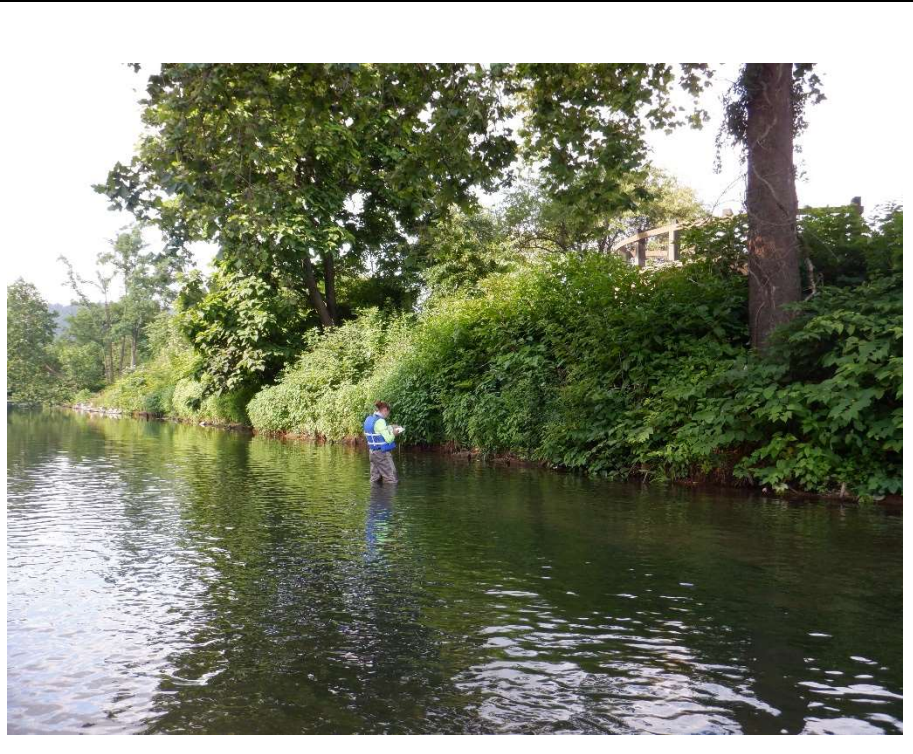
**Description:**  
Upstream view showing remediated section; no exposed roots or at-risk trees present; no scour; coir logs have decomposed; increase in cover of invasive knotweed.

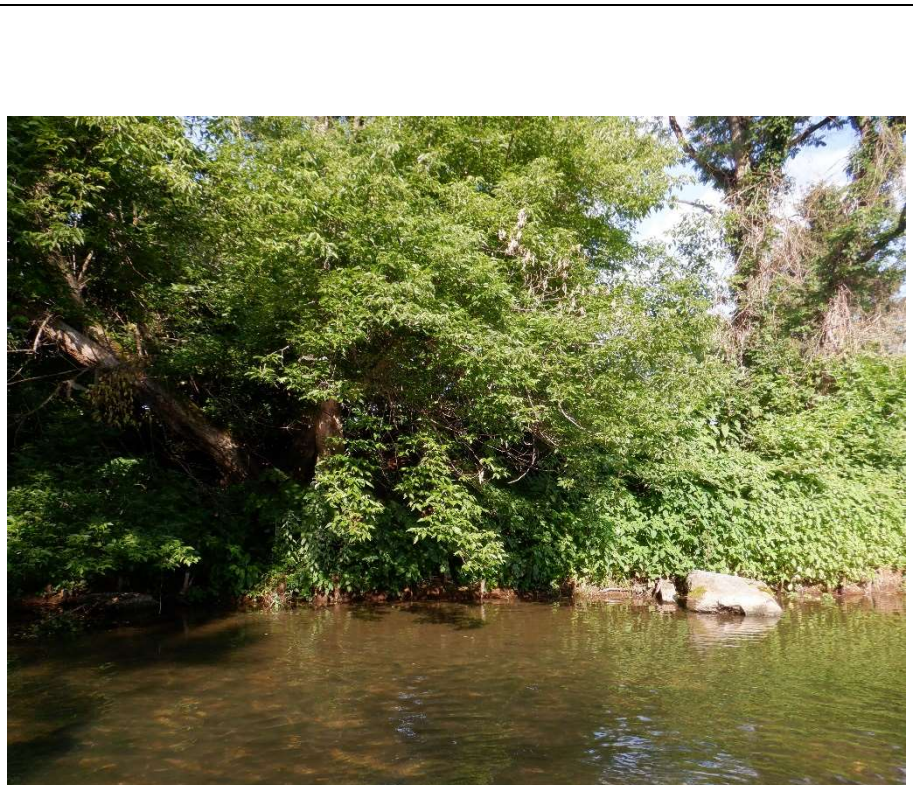
**Description:**  
~50 degree bank angle; vegetation established; no erosion control fabric exposed; banks soils covered with vegetation (mostly jewelweed); invasive knotweed ~5% cover; native vegetation includes- jewelweed, box elder, locust, curly dock, pokeberry; box elder is an at-risk tree; erosion control fabric decomposed; coir logs decomposed, stakes remain at toe of slope.

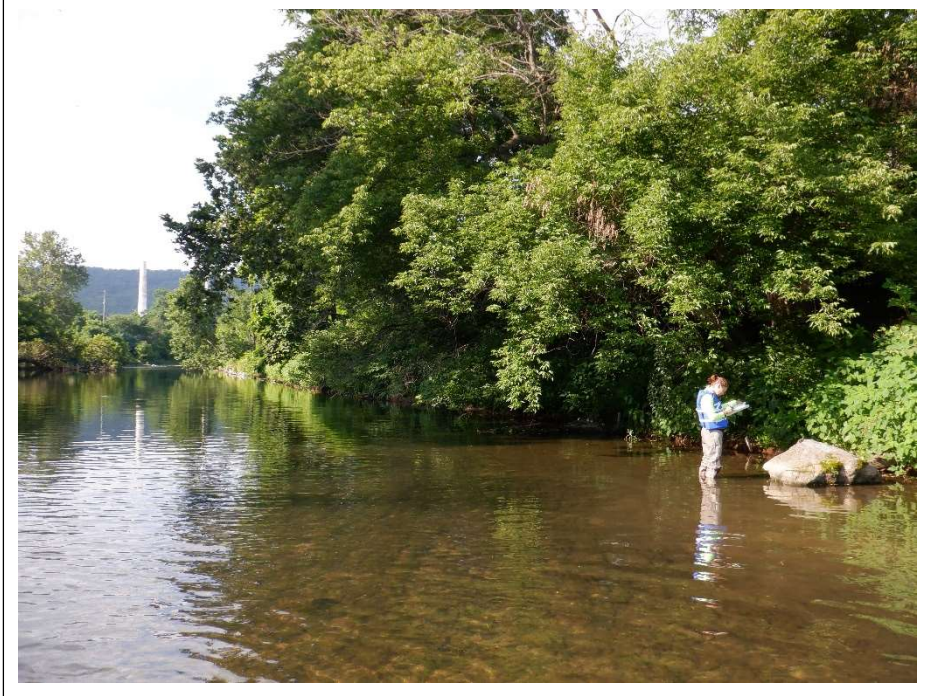
<p><b>Location:</b> 00+500'</p> <hr/> <p><b>Photo Title:</b>              <b>Date:</b> 22                              6/22/2021</p> <hr/> <p><b>Direction Photo Taken:</b> Southwest</p> <hr/> <p><b>Description:</b> Upstream view- at risk box elder at 00+450; no scour, no exposed roots.</p>

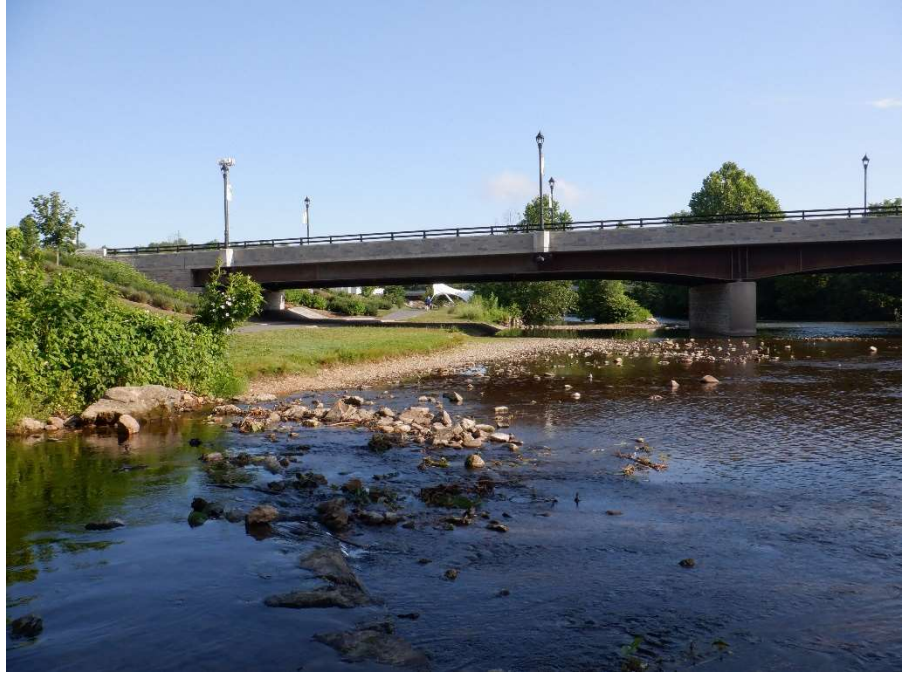
Downstream view- patches of invasive knotweed observed.

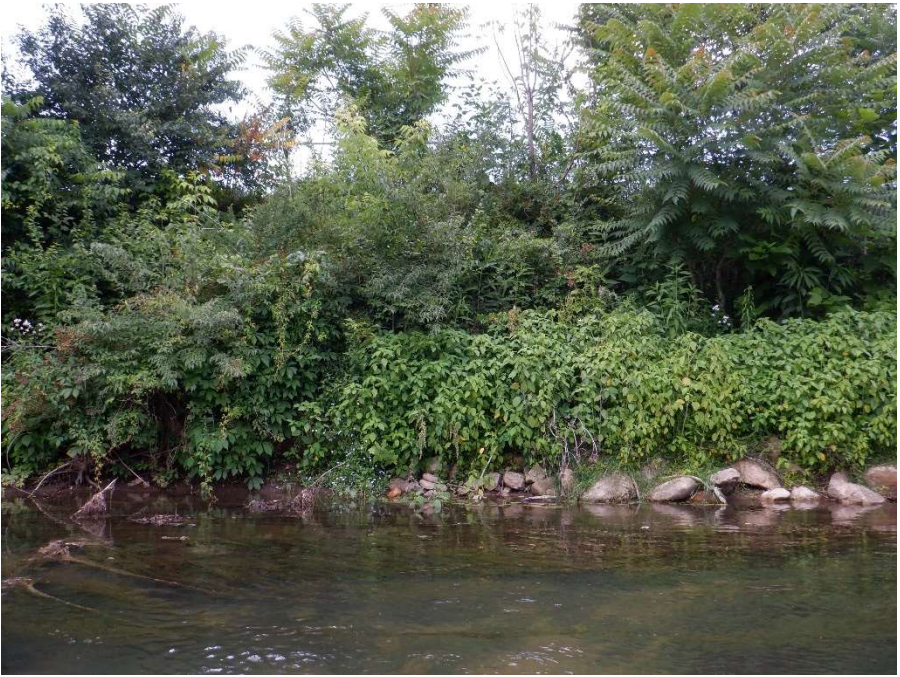
<p><b>Location:</b> Station 00-00'</p> <hr/> <p><b>Photo Number:</b>      <b>Date:</b> 3                              6/22/2021</p> <hr/> <p><b>Direction Photo Taken:</b> Northwest</p> <hr/> <p><b>Description:</b> 70 degree bank angle; lower bank - 60 degrees, upper bank - 80 degrees. No exposed roots, catalpa tree at toe of slope. No woody plants adjacent to edge of water; some scour present from rock toe to mid bank upstream of remediation.</p>

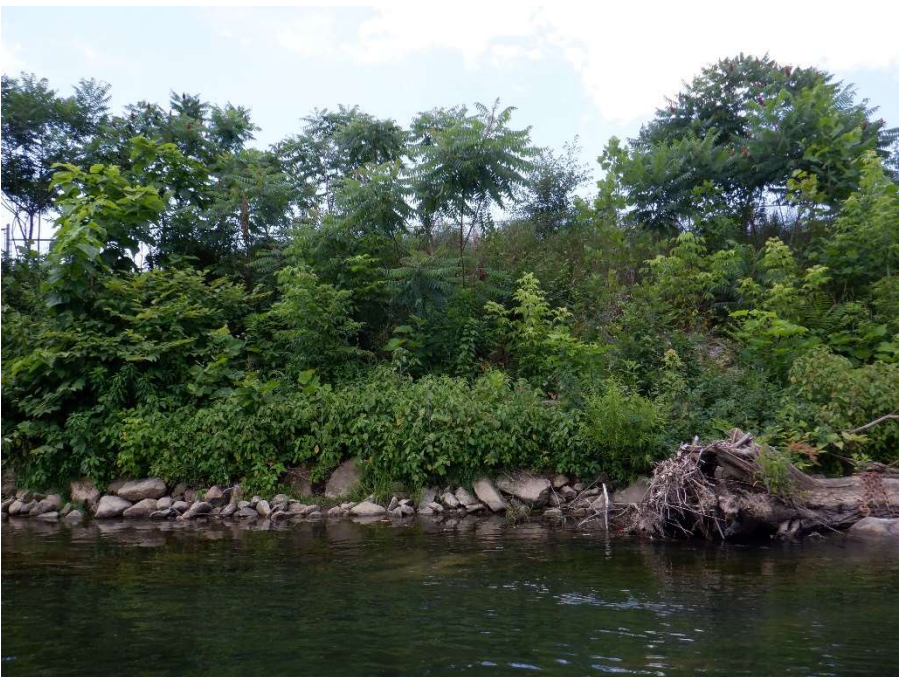
<p><b>Location:</b> Station 00-50'</p> <hr/> <p><b>Photo Title:</b>              <b>Date:</b> 4                              6/22/2021</p> <hr/> <p><b>Direction Photo Taken:</b> Northwest</p> <hr/> <p><b>Description:</b> 45 degree bank angle; predominantly native vegetation along top of rock toe- catalpa and sycamore saplings. Overall sumacs - 60% cover, no knotweed observed; no woody plants adjacent to edge of water; No geocell or erosion control fabric exposed. LWD intact; sediment filling behind LWD.</p>

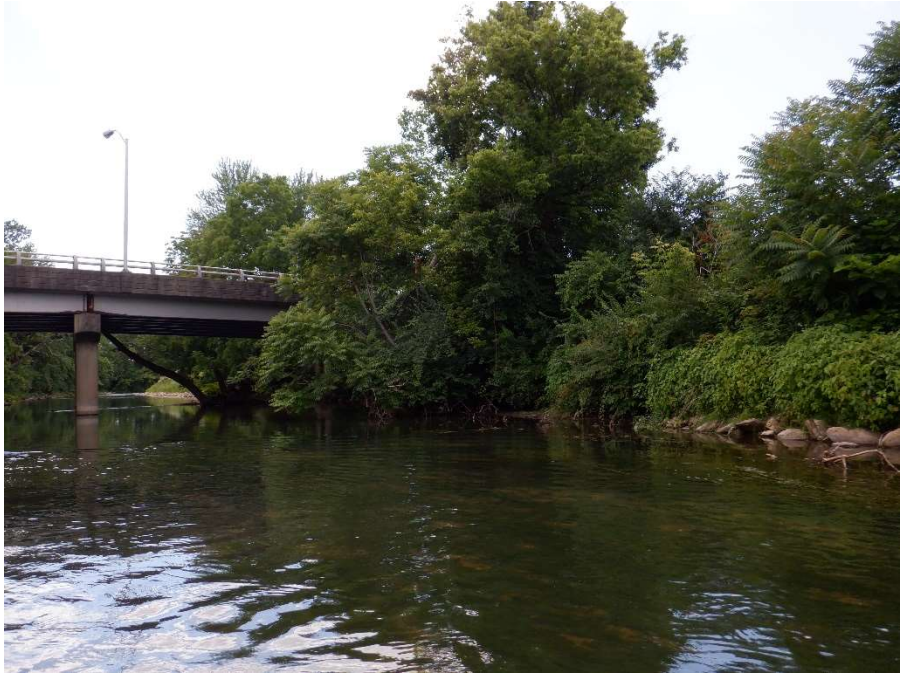
<p><b>Location:</b> Station 00-50'</p> <hr/> <p><b>Photo Number:</b>      <b>Date:</b> 5                              6/22/2021</p> <hr/> <p><b>Direction Photo Taken:</b> West</p> <hr/> <p><b>Description:</b> Upstream view of location; installed rock toe intact; No geocell or erosion control fabric exposed; predominantly native vegetation along top of rock toe- catalpa and sycamore saplings. Overall sumacs - 60% cover, no knotweed observed.</p>

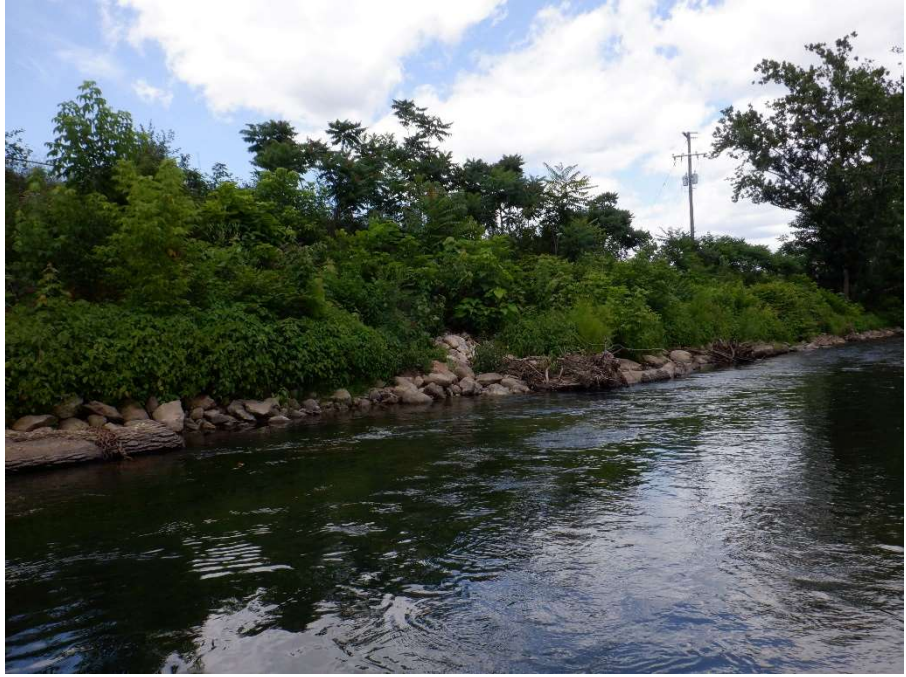
<p><b>Location:</b> Station 00-50'</p> <hr/> <p><b>Photo Title:</b>              <b>Date:</b> 6                                  6/22/2021</p> <hr/> <p><b>Direction Photo Taken:</b> North</p> <hr/> <p><b>Description:</b> Downstrea view of location; installed rock toe intact; No geocell or erosion control fabric exposed; predominantly native vegetation along top of rock toe- catalpa and sycamore saplings. Overall sumacs - 60% cover, no knotweed observed.</p>

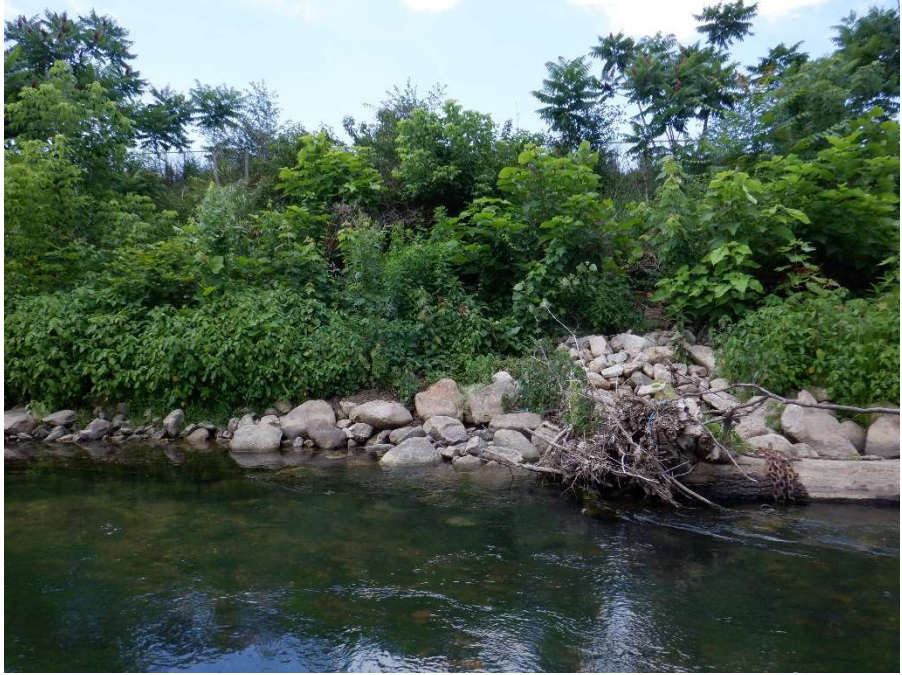
<p><b>Location:</b> Station 00-100'</p> <hr/> <p><b>Photo Number:</b>      <b>Date:</b> 7                              6/22/2021</p> <hr/> <p><b>Direction Photo Taken:</b> Northwest</p> <hr/> <p><b>Description:</b> 45 degree bank angle; predominantly native vegetation along top of rock toe- sumac 60% cover, grasses, no knotweed. Sycamore saplings at toe; No woody plants adjacent to edge of water; No geocell observed. ~5% erosion control fabric exposed on upper bank. LWD intact. No scour present along rock toe.</p>

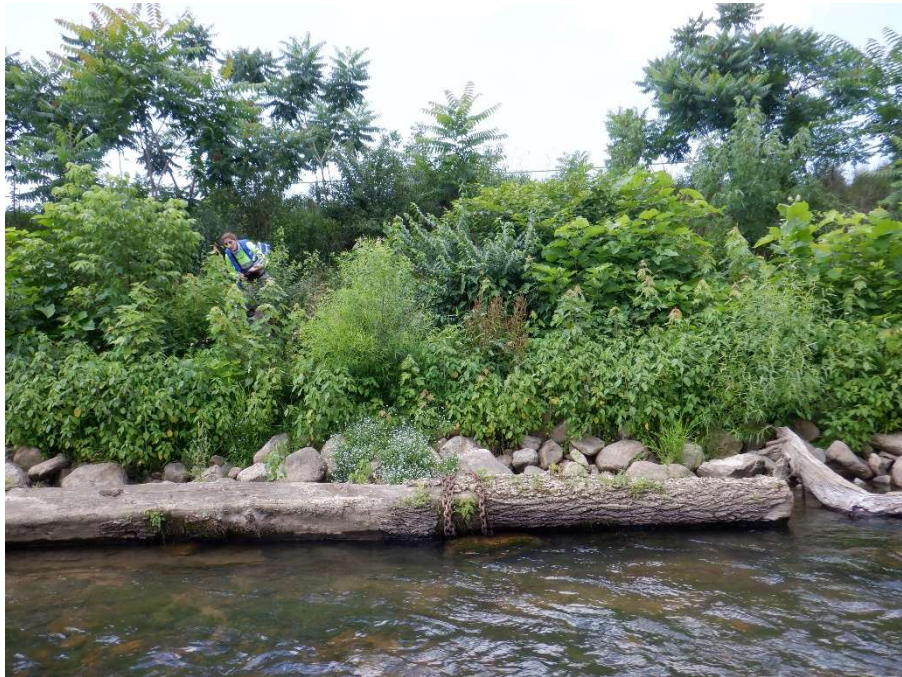
<p><b>Location:</b> Station 00-150'</p> <hr/> <p><b>Photo Title:</b>              <b>Date:</b> 8                                  6/22/2021</p> <hr/> <p><b>Direction Photo Taken:</b> Northwest</p> <hr/> <p><b>Description:</b> 45 degree bank angle; Predominantly native vegetation along top of rock toe- sycamore saplings, dogwoods, sumac, jewelweed at toe, physocarpus; invasive knotweed present; No woody plants adjacent to edge of water; No geocell observed. ~5% erosion control fabric exposed on upper bank. LWD intact; No scour present along rock toe.</p>

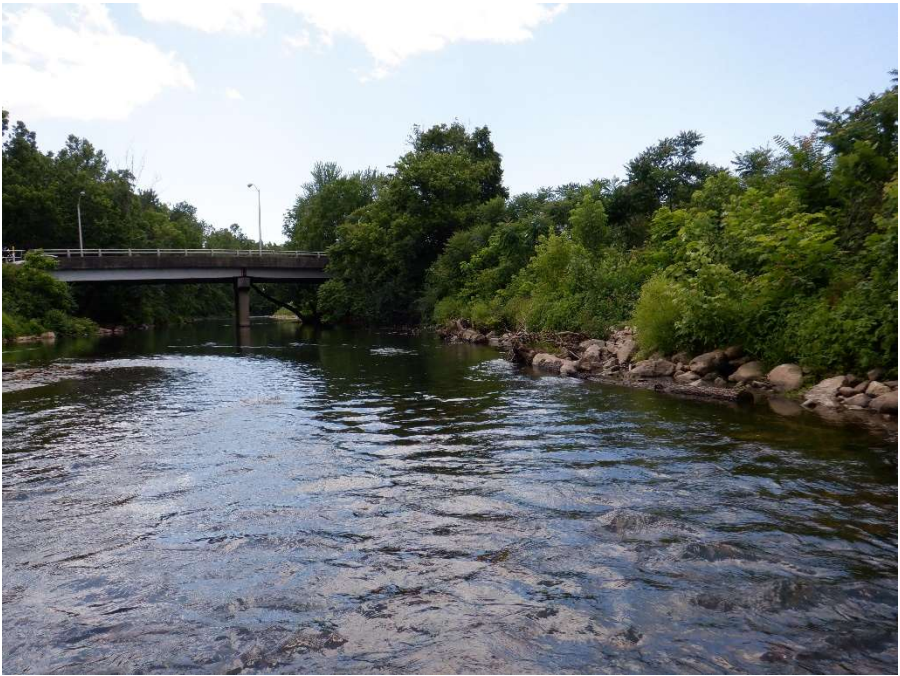
<p><b>Location:</b> Station 00-150'</p> <hr/> <p><b>Photo Number:</b>      <b>Date:</b> 9                              6/22/2021</p> <hr/> <p><b>Direction Photo Taken:</b> West</p> <hr/> <p><b>Description:</b> Upstream view of location; predominantly native vegetation along top of rock toe; no geocell observed. ~5% erosion control fabric exposed on upper bank. LWD intact; No scour present along rock toe.</p>

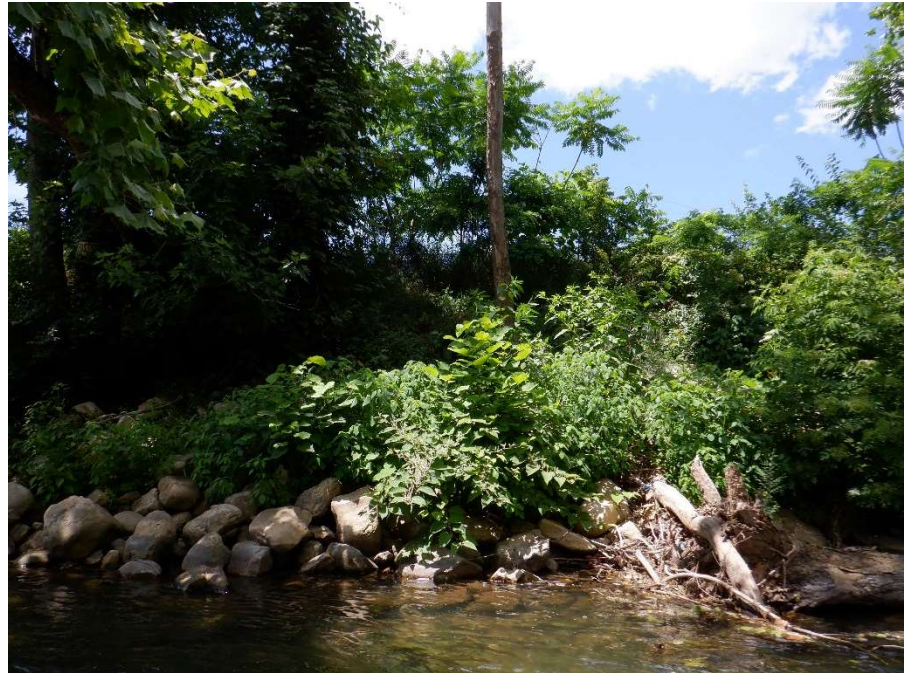
**Description:**  
45 degree bank angle;  
Predominantly native vegetation along top of rock toe- elderberry ~80% cover, periwinkle ~25%; no knotweed observed; smallest old growth sycamore dead with top 1/2 snapped off creating natural log dam at water's edge; no fabric exposed; no geocell exposed; LWD intact; no scour present along rock toe.

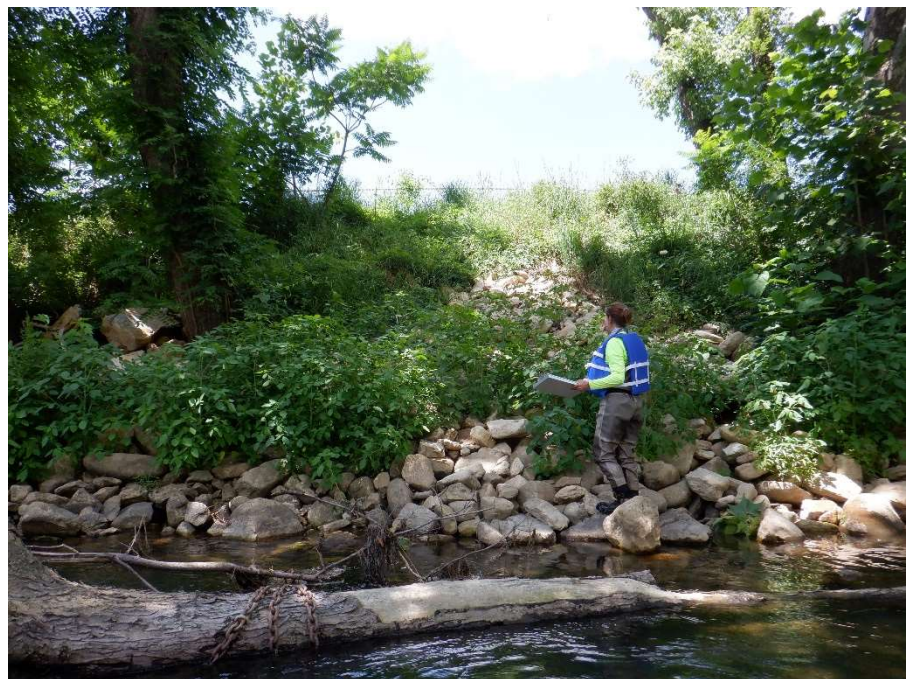
**Description:**  
45 degree bank angle;  
Predominantly native vegetation along top of rock toe- sumac, jewelweed ~80% cover, catalpa saplings; no erosion control fabric exposed; some geocell exposed; rock exposed on bank; LWD intact; no additional stabilization or remediation of exposed outfall pipe in regards to cut geocell, movement of rock toe has taken place; rock toe above outfall that was daylighted is beginning to collapse; scour present from storm drain disturbance.

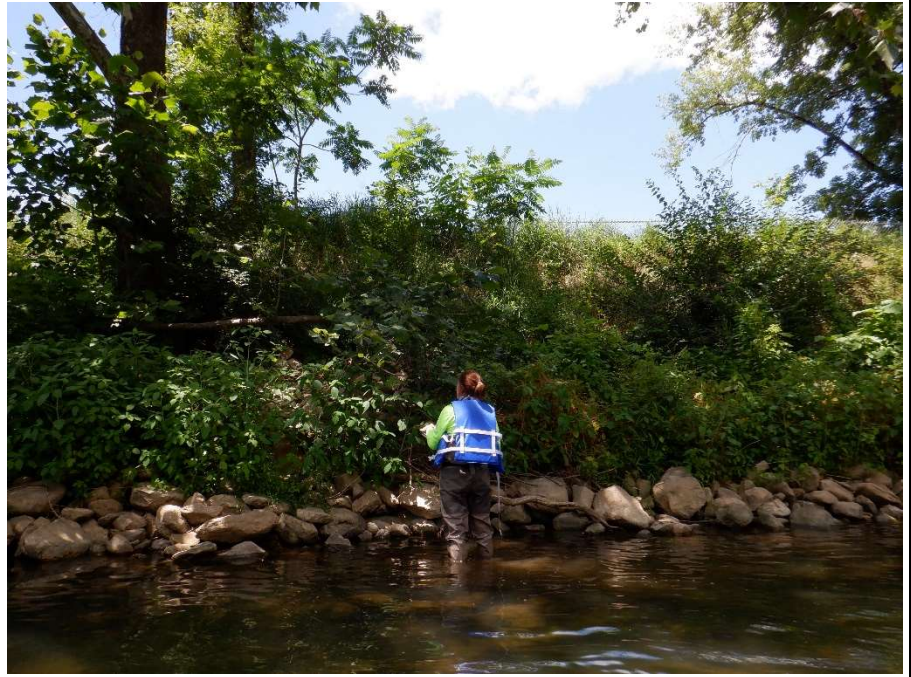
<p><b>Location:</b> Station 00-400'</p> <hr/> <p><b>Photo Number:</b>      <b>Date:</b> 15                              6/22/2021</p> <hr/> <p><b>Direction Photo Taken:</b> Northwest</p> <hr/> <p><b>Description:</b> 45 degree bank angle; predominantly native vegetation along top of rock toe- small sycamores at toe of slope, invasive honeysuckle present, jewelweed and grasses are dominant; no at risk trees present; erosion control fabric exposed on upper bank; 1st outfall pipe has broken hinge on door; 2nd outfall pipe appears to be blocked from opening and is covered by vegetation; no scour present along rock toe; two outfall pipes present within rock toe.</p>

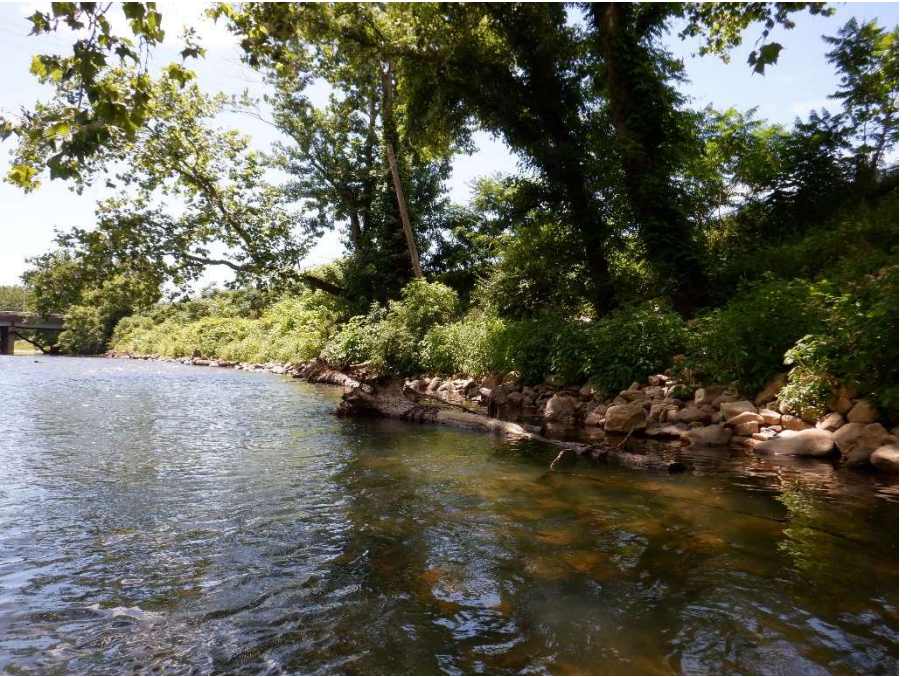
<p><b>Location:</b> Station 00-400'</p> <hr/> <p><b>Photo Title:</b>              <b>Date:</b> 16                              6/22/2021</p> <hr/> <p><b>Direction Photo Taken:</b> West</p> <hr/> <p><b>Description:</b> Upstream view of location; predominantly native vegetation along top of rock toe, no at risk trees present; erosion control fabric exposed on upper bank; upstream LWD has shifted and is parallel with another piece of installed LWD downstream of 00 +400'; no scour present along rock toe.</p>

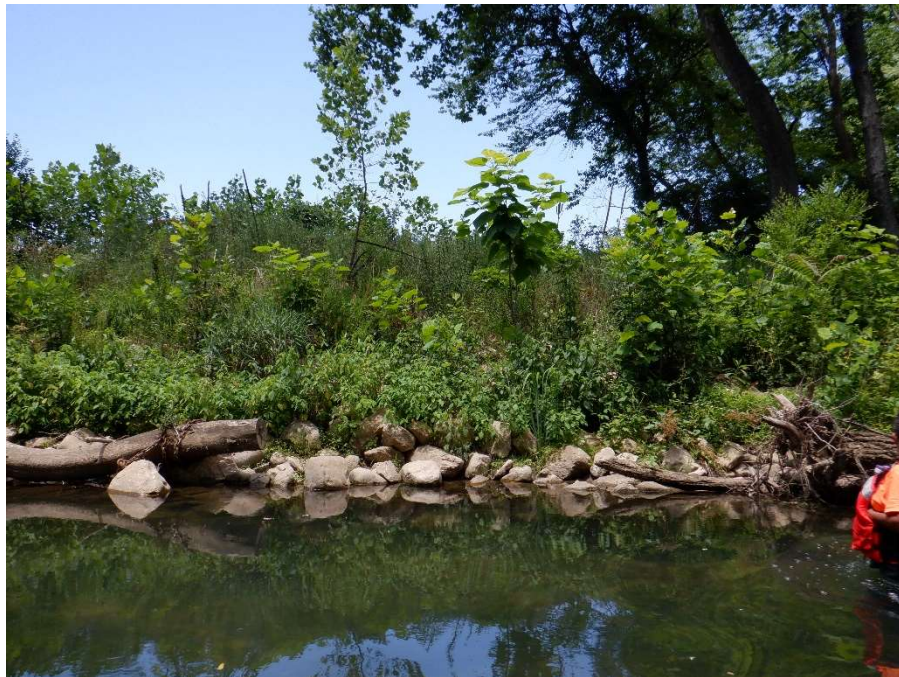
<p><b>Location:</b> Station 00-800'</p> <hr/> <p><b>Photo Title:</b>              <b>Date:</b> 30                      6/22/2021</p> <hr/> <p><b>Direction Photo Taken:</b> Northwest</p> <hr/> <p><b>Description:</b> 40 degree bank angle; planted vegetation well established above rock toe- no invasive knotweed observed. elms ~15% cover, sycamore sapling at toe, wingstem and grasses also observed; no at risk trees present; no geocell exposed; no erosion control fabric exposed; LWD intact; no scour present along rock toe.</p>

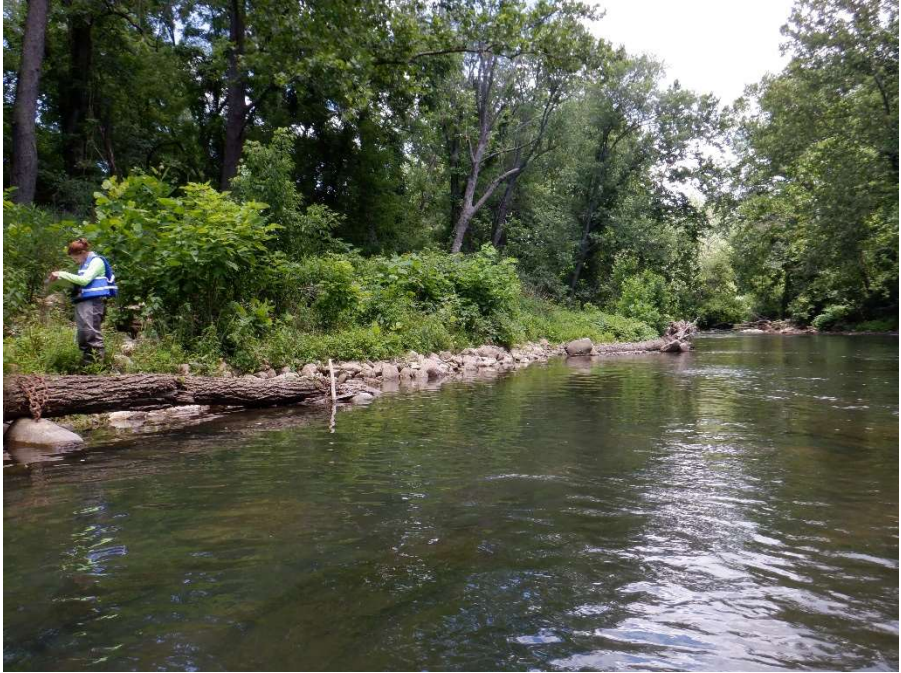
<p><b>Location:</b> Station 00-800'</p> <hr/> <p><b>Photo Number:</b>      <b>Date:</b> 31                              6/22/2021</p> <hr/> <p><b>Direction Photo Taken:</b> North</p> <hr/> <p><b>Description:</b> Downstream view of location; planted vegetation well established above rock toe; no at risk trees present; no geocell exposed; no erosion control fabric exposed; LWD intact; no scour present along rock toe.</p>

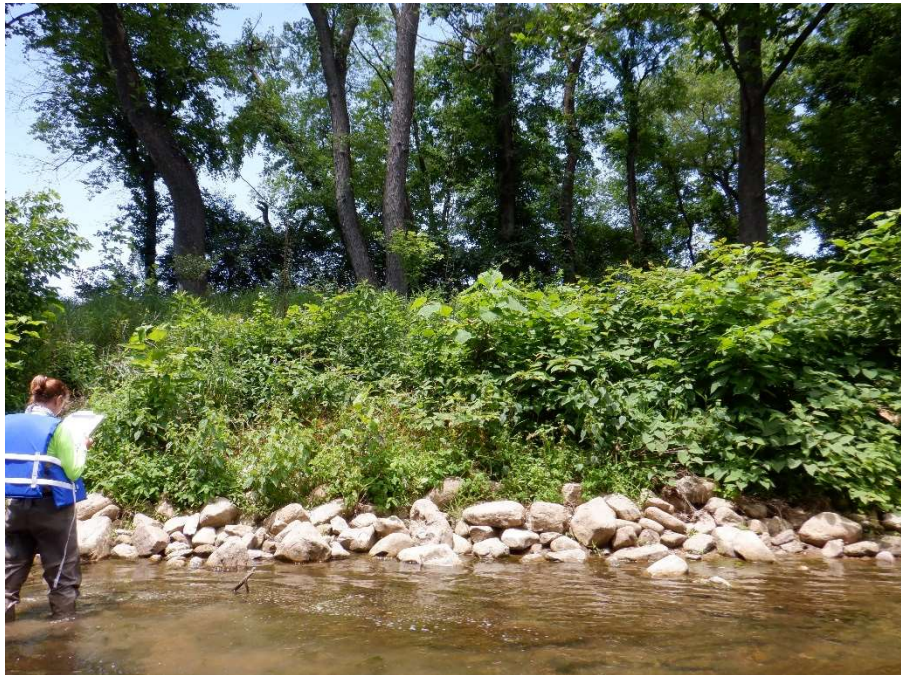
<p><b>Location:</b> Station 00-850'</p> <hr/> <p><b>Photo Title:</b>              <b>Date:</b> 32                              6/22/2021</p> <hr/> <p><b>Direction Photo Taken:</b> Northwest</p> <hr/> <p><b>Description:</b> 25 degree bank angle; lower bank; ~25 degrees, ~upper bank; ~30 degrees, box elder and red maple saplings, invasive ailanthus sapling observed. Jewelweed becoming established; no at risk trees present; erosion control fabric primarily covered in vegetation; LWD moved from its installed position. The root ball side of the installed LWD has pivoted downstream from its original position and is now angled into the river. No scour present along rock toe.</p>
