**Re: 2021 Leaf-on and Leaf-off Maintenance Inspections  
Former DuPont Waynesboro Site AOC 4  
Waynesboro, Virginia  
EPA ID# VAD003114832**

## Memorandum

Subject 2021 Leaf-on Maintenance Inspection  
Former DuPont Waynesboro Site, Area of Concern 4

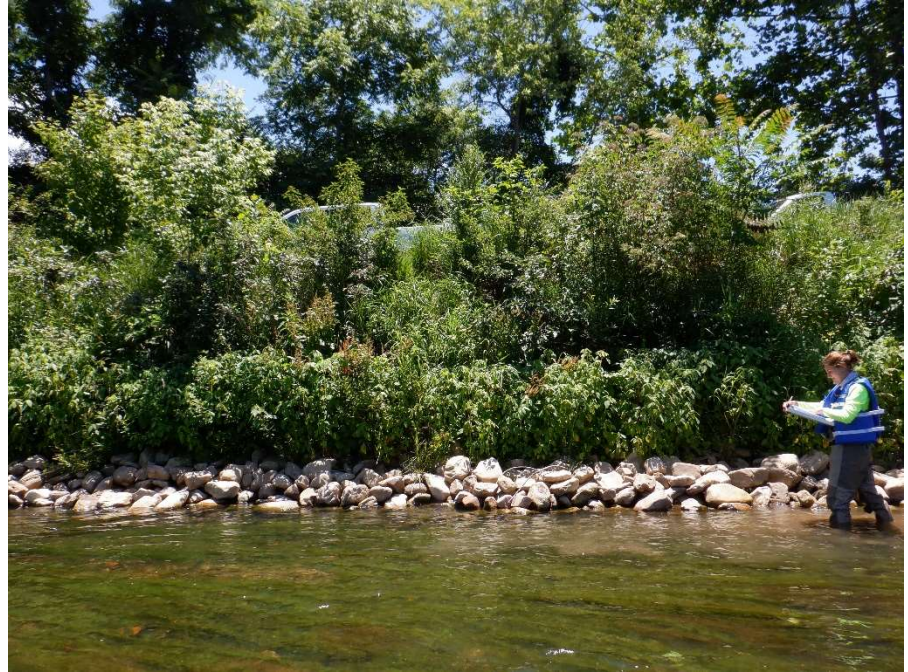
**Description:**  
~ 50 degree bank angle; slope hydroseeded Spring 2020; native herbaceous vegetation adjacent to water; live stakes 30% established; also observed was box elder, jewelweed at toe ~25% cover, invasive ailanthus sapling, silver maples, willows, dogwoods ~15% cover, and grasses making up the remaining cover; no at-risk trees present; improvised weir that was previously present has been removed; scour at rock toe.

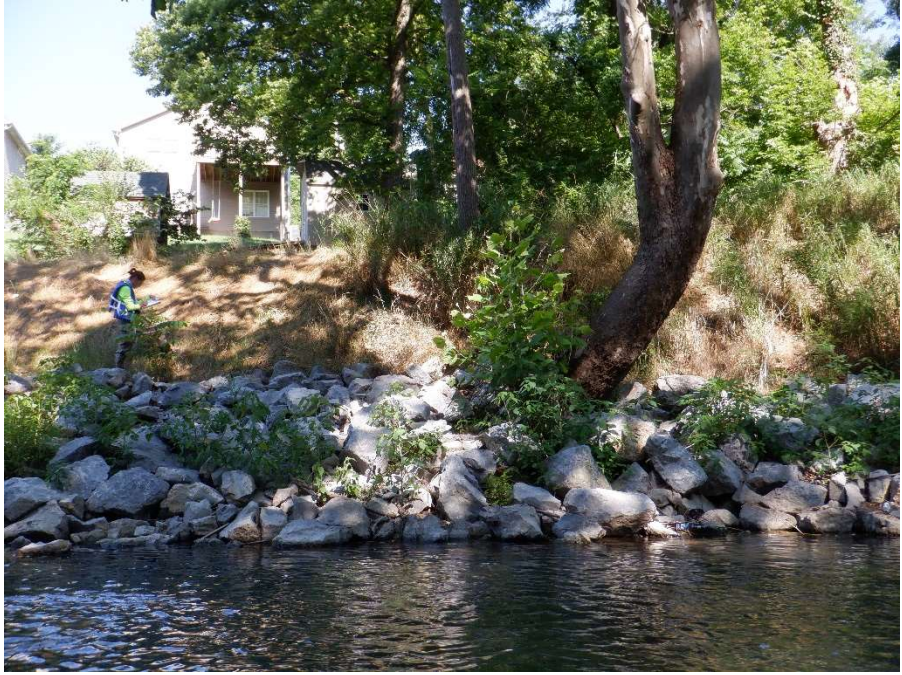
<p><b>Location:</b> 00+650'</p> <hr/> <p><b>Photo Number:</b>      <b>Date:</b> 25                              6/23/2021</p> <hr/> <p><b>Direction Photo Taken:</b> West</p> <hr/> <p><b>Description:</b> ~ 65 degree bank angle; Lower bank; ~60 degrees Upper bank; ~70 degrees; Dense herbaceous vegetation establishing; saplings and shrub plantings intact and establishing; growth observed on willow livestakes; sparse knotweed in rock toe; cherry sapling; 2 sycamore trees; jewelweed and grasses dominant; At risk Sycamore tree; No erosion control fabric or geocell exposed due to dense herbaceous vegetation cover.</p>

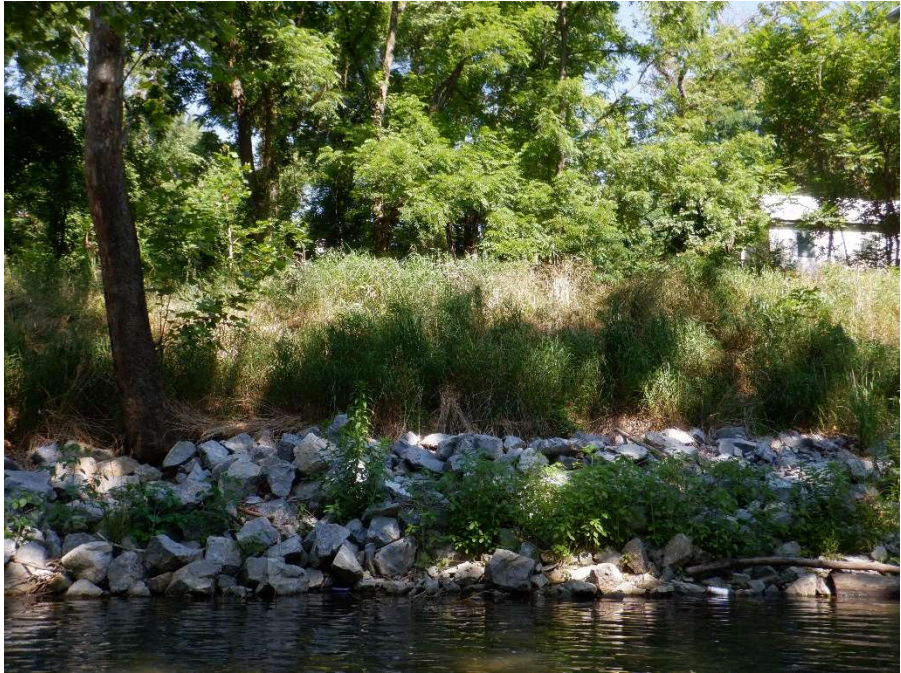
<p><b>Location:</b> 00+750'</p> <hr/> <p><b>Photo Number:</b>      <b>Date:</b> 29                      6/23/2021</p> <hr/> <p><b>Direction Photo Taken:</b> West</p> <hr/> <p><b>Description:</b> ~ 60 degree bank angle; Dense herbaceous vegetation established; grasses are dominant ~95% cover; Jewelweed and elderberry; no livestake growth; saplings and shrub plantings intact and establishing; Sycamore possibly at future risk; No erosion control fabric or geocell exposed due to dense herbaceous vegetation cover; rock toe intact; Evidence of sediment deposition</p>

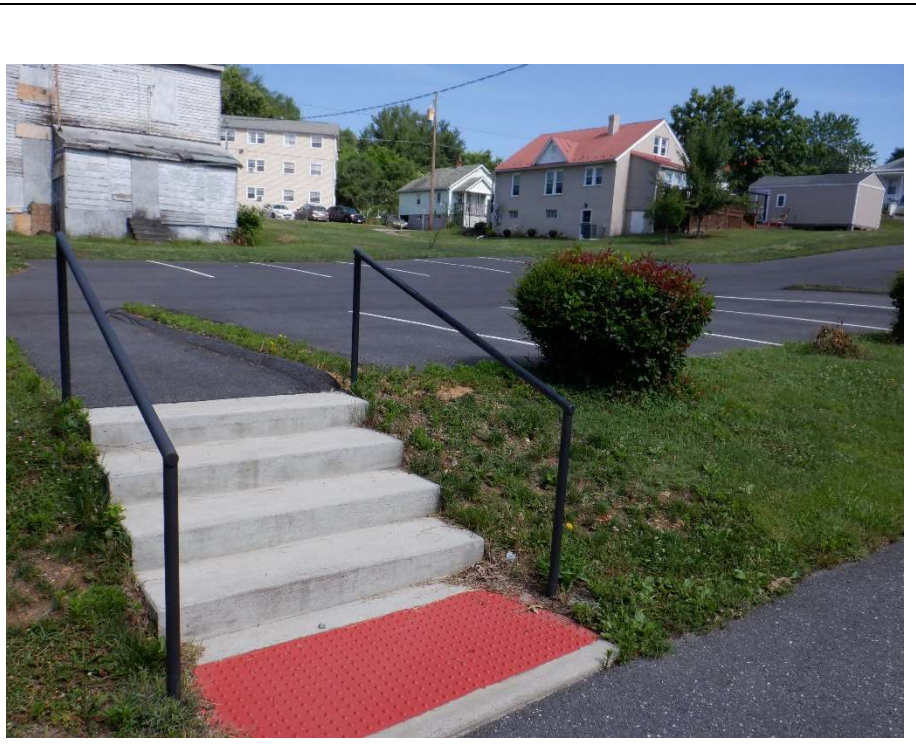
<p><b>Location:</b> Greenway</p>	 
<p><b>Photo Number:</b> 39      <b>Date:</b> 6/23/2021</p>	
<p><b>Direction Photo Taken:</b> West</p>	
<p><b>Description:</b> Exposed drainage pipe along GW trail. Good herbaceous cover adjacent to trail. May need future maintenance to ensure overhanging vegetation is trimmed.</p>

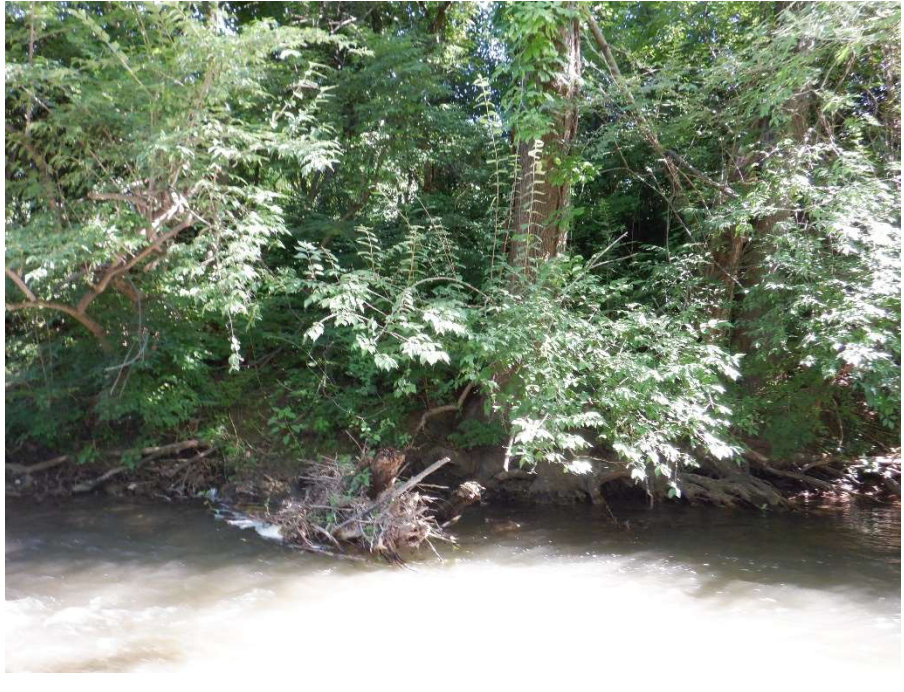
**Description:**  
~ 65 degree bank angle;  
unremediated section;  
exposed roots; sycamore,  
silver maple; exposed roots;  
scour present at toe of slope.
