**VIRGINIA DEPARTMENT OF ENVIRONMENTAL QUALITY**

**Re: 2021 Leaf-on and Leaf-off Maintenance Inspections  
Former DuPont Waynesboro Site AOC 4  
Waynesboro, Virginia  
EPA ID# VAD003114832**

Subject South River BMA - 2021 Leaf-Off Maintenance Inspection  
Former DuPont Waynesboro Site, Area of Concern 4

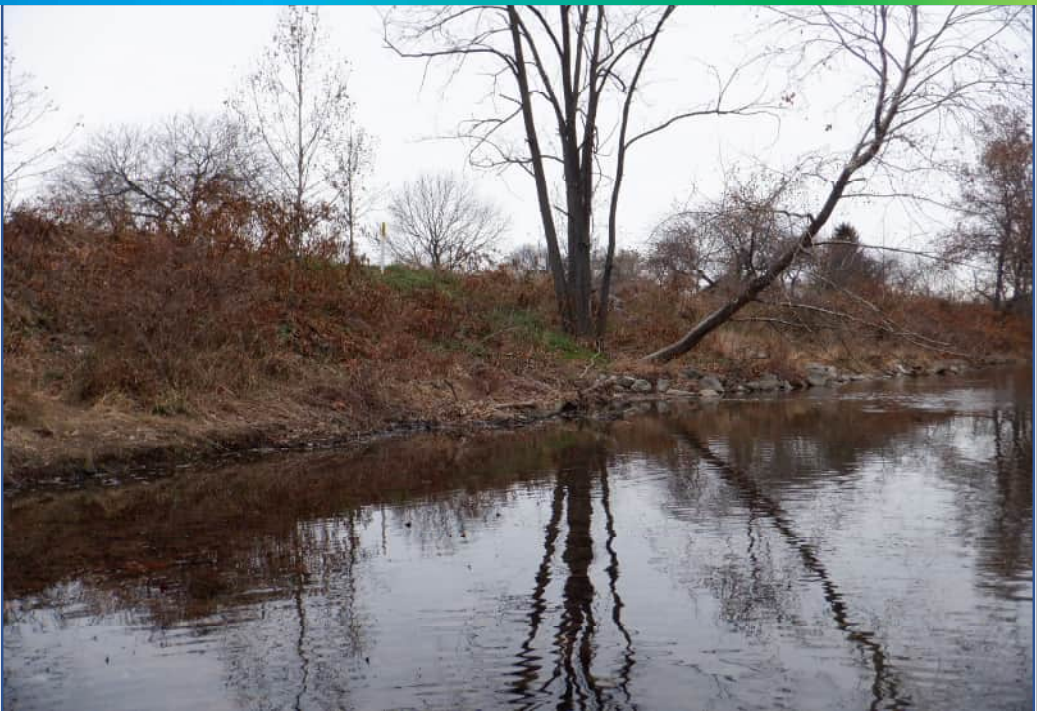
<b>Direction:</b> Northwest			
<b>Description:</b> Start of remediated bank - geocell exposed along foot path; some scour upstream of 00 – 25'.

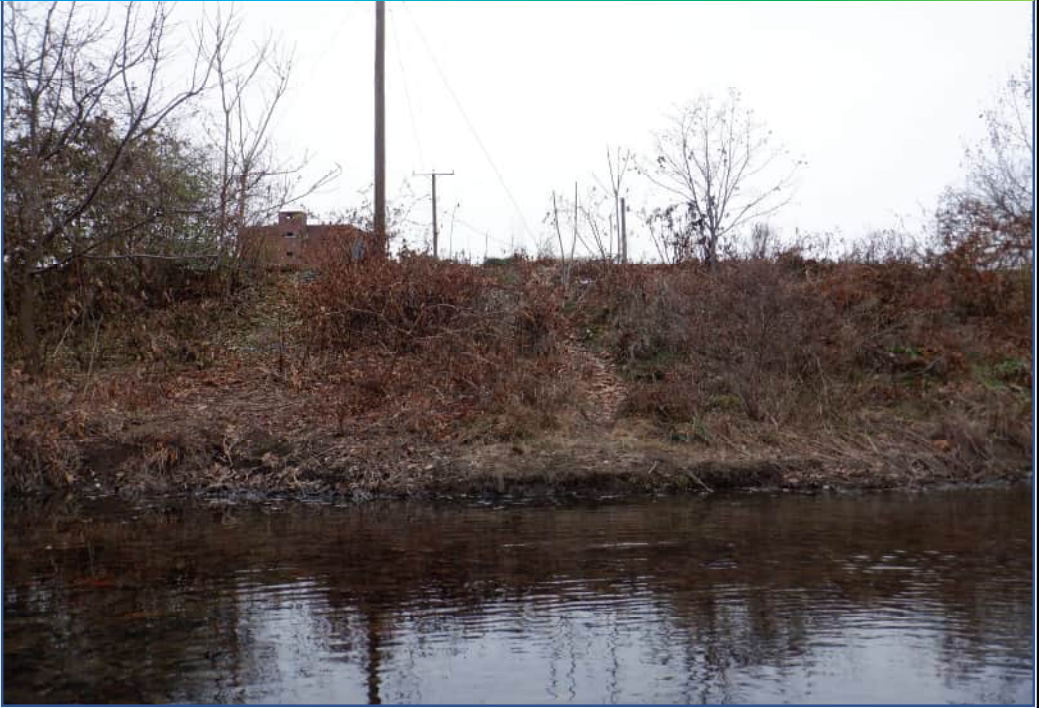
<b>Direction:</b> West			
<b>Description:</b> Lower bank ~30°; upper bank ~55°; live stakes not visible; 40% vegetation cover; no trees adjacent to edge of water; coir logs deteriorated; no erosion control fabric visible; moderate erosion mid to lower bank; new footpath; undercutting present.

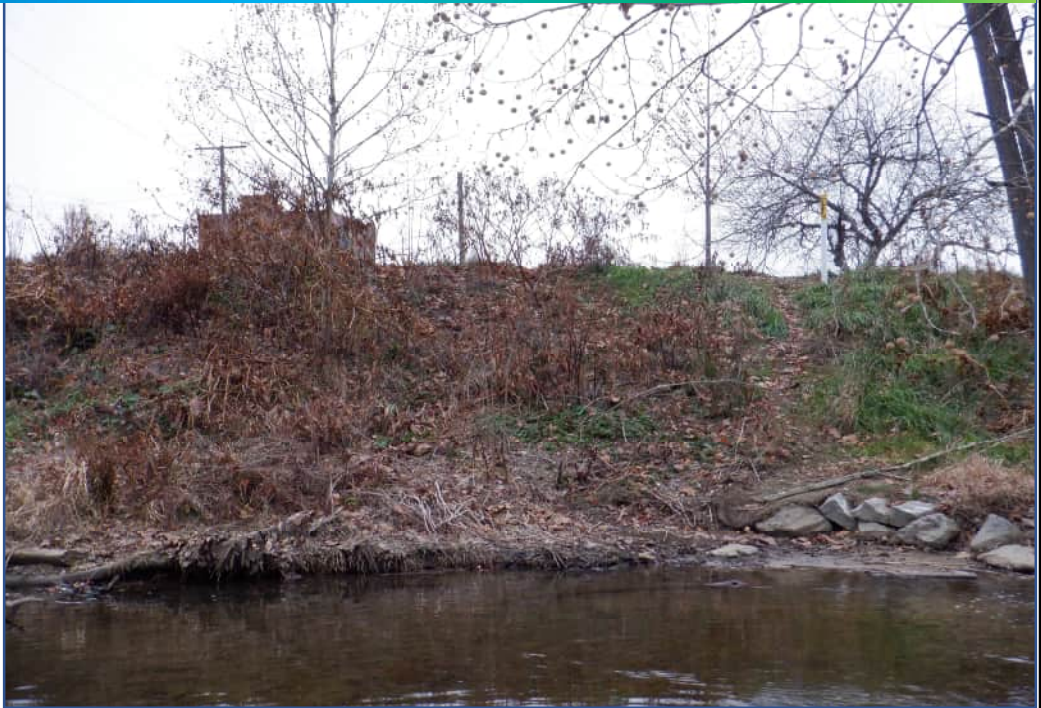
<b>Direction:</b> West			
<b>Description:</b> ~45° lower 3' of bank toe level; 20-30% invasive species cover; 50% vegetation cover; no trees adjacent to edge of water; at-risk sycamore 20 feet downstream.

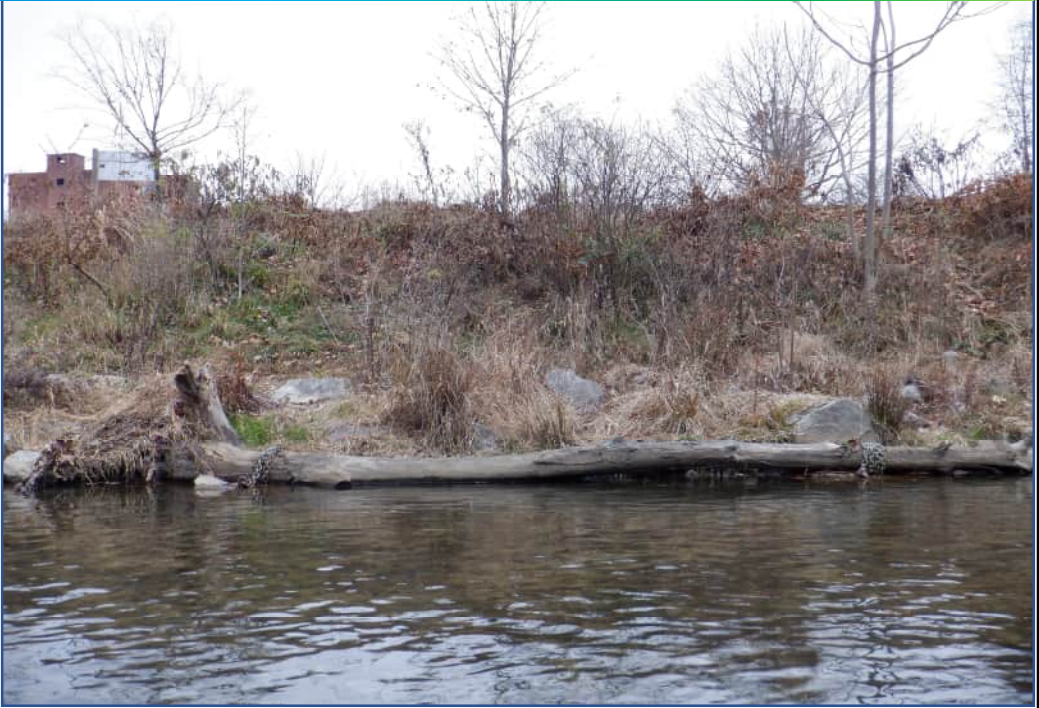
<b>Direction:</b> West			
<b>Description:</b> Lower bank ~5°; upper bank ~45°; native vegetation predominantly present; live stakes not visible; 95% vegetation cover; no trees adjacent to edge of water; new footpath present.

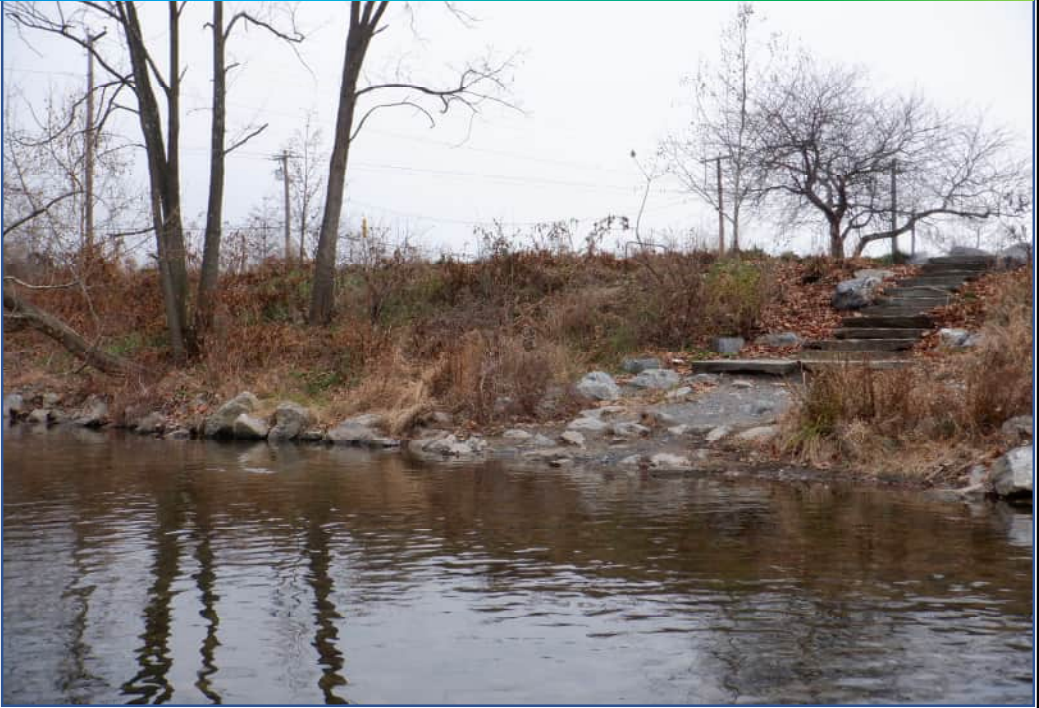
<b>Direction:</b> Southwest			
<b>Description:</b> Upstream view of bank remediation; silt filling in rock toe; some scour at toe of bank.

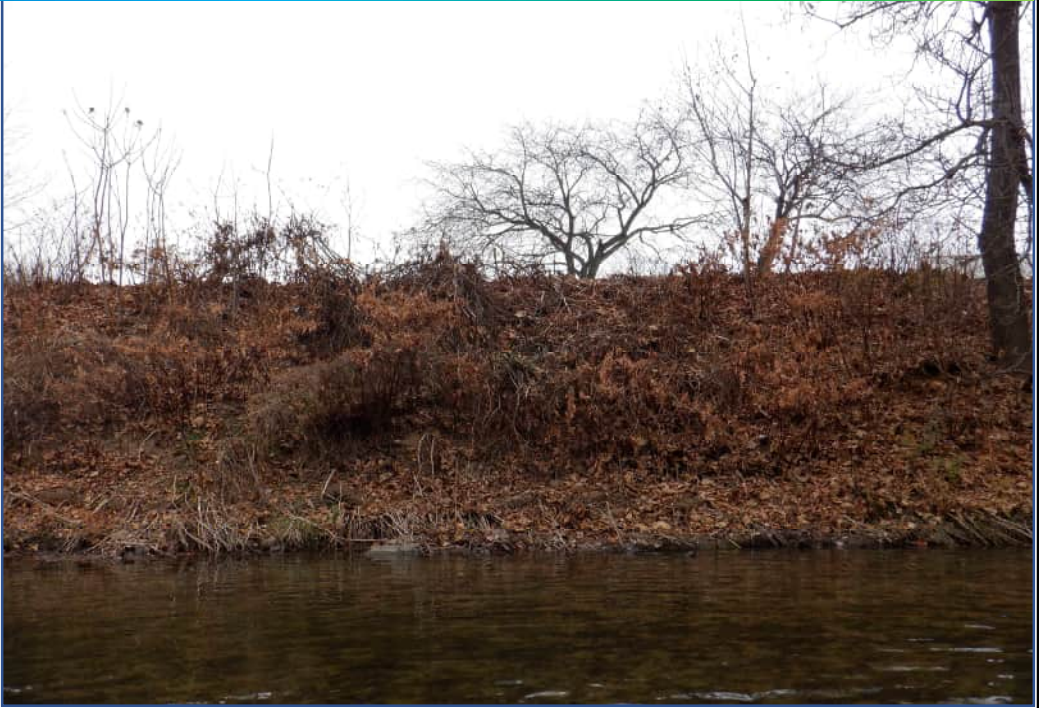
<b>Direction:</b> West		
<b>Description:</b> ~70° bank angle; minimal vegetation present; live stakes 30% established; 40% vegetation cover; geocell partially exposed along lower half of bank; localized scour at toe.

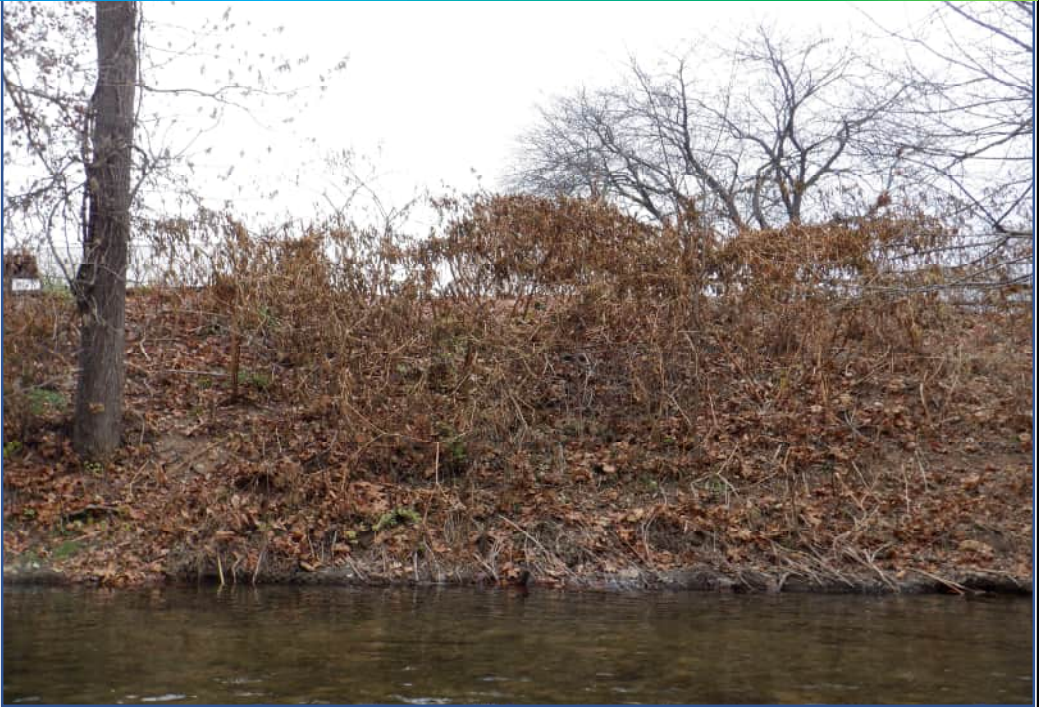
<b>Direction:</b> West			
<b>Description:</b> ~60° bank angle; native vegetation present along top of bank with small patches of invasive knotweed at toe of slope; live stakes 20% established; 40% vegetation cover; erosion control fabric exposed around tree and degraded; slight scour present.

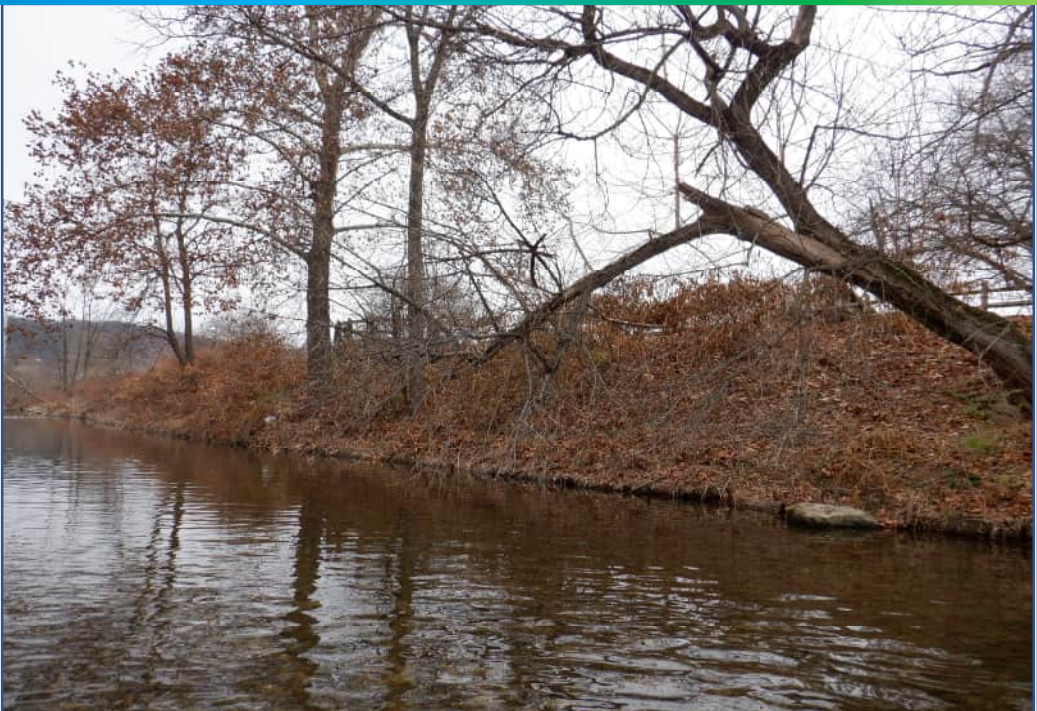
<b>Direction:</b> Southwest			
<b>Description:</b> Upstream view of bank remediation; at-risk tree present, bark stripped from portion of trunk; moderate undercutting at toe.

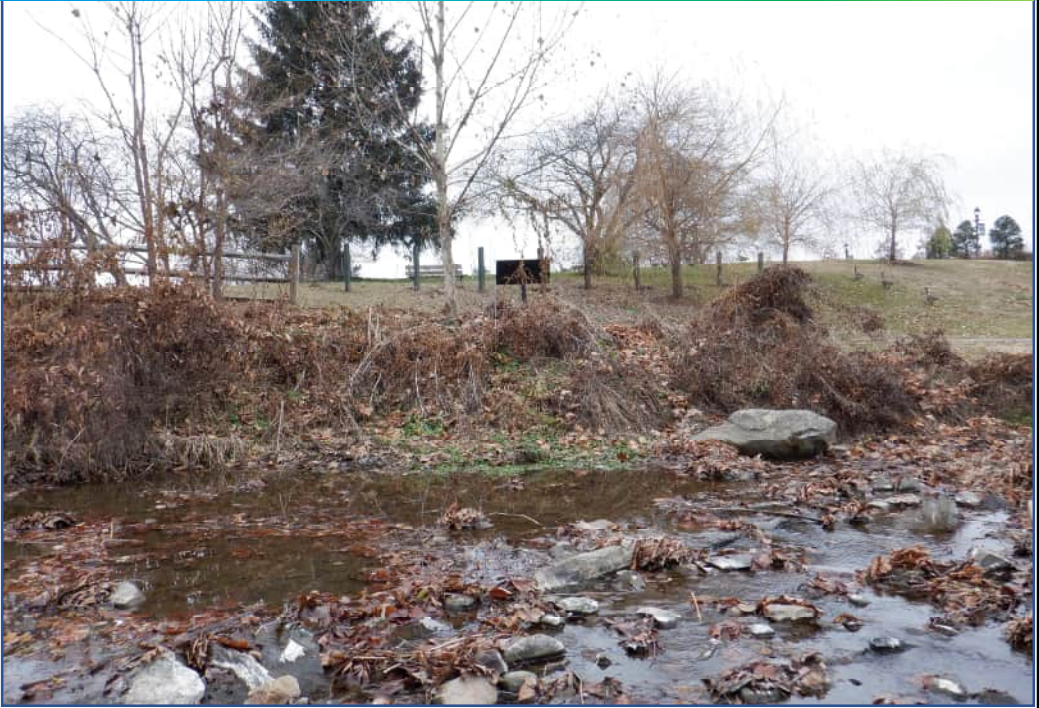
<b>Direction:</b> West			
<b>Description:</b> ~15° bank angle; predominantly native vegetation cover; live stakes 30% established; 60% vegetation cover; no trees adjacent to edge of water.

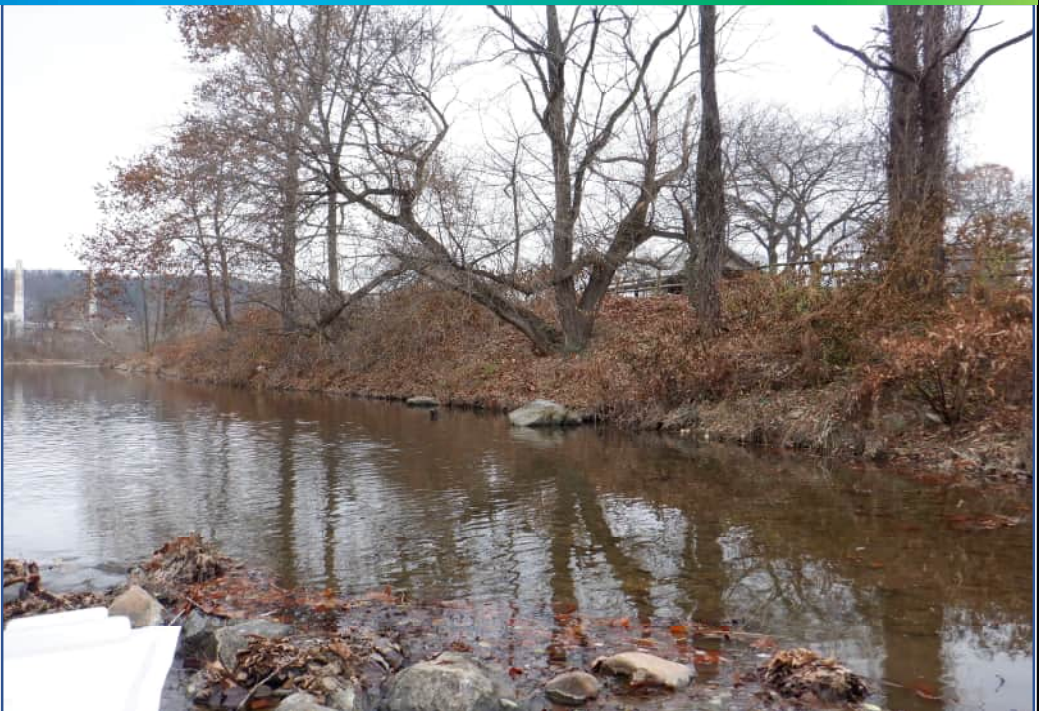
<b>Direction:</b> Southwest			
<b>Description:</b> Upstream view of bank remediation; geocell minimally exposed near toe of bank; erosion control fabric degraded.

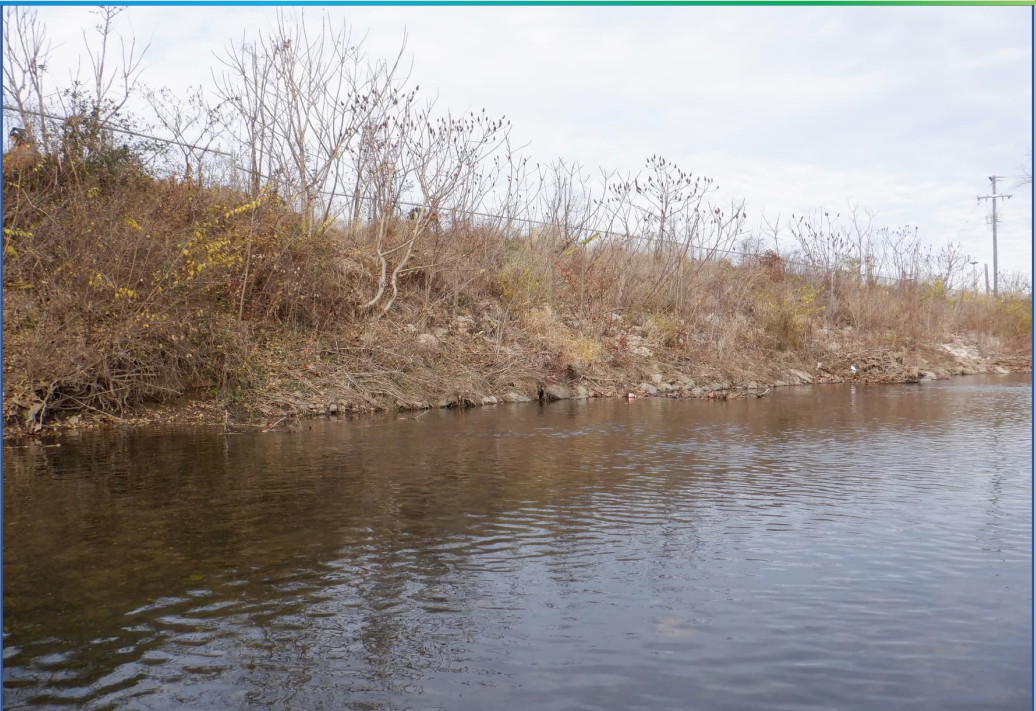
Photo Number: 02		Location: 00-25'	
Date: 12/7/2021

Direction: Northeast			
Description: Downstream view of start of remediated area; grasses establishing by rock toe; at risk trees present; scour present at toe.

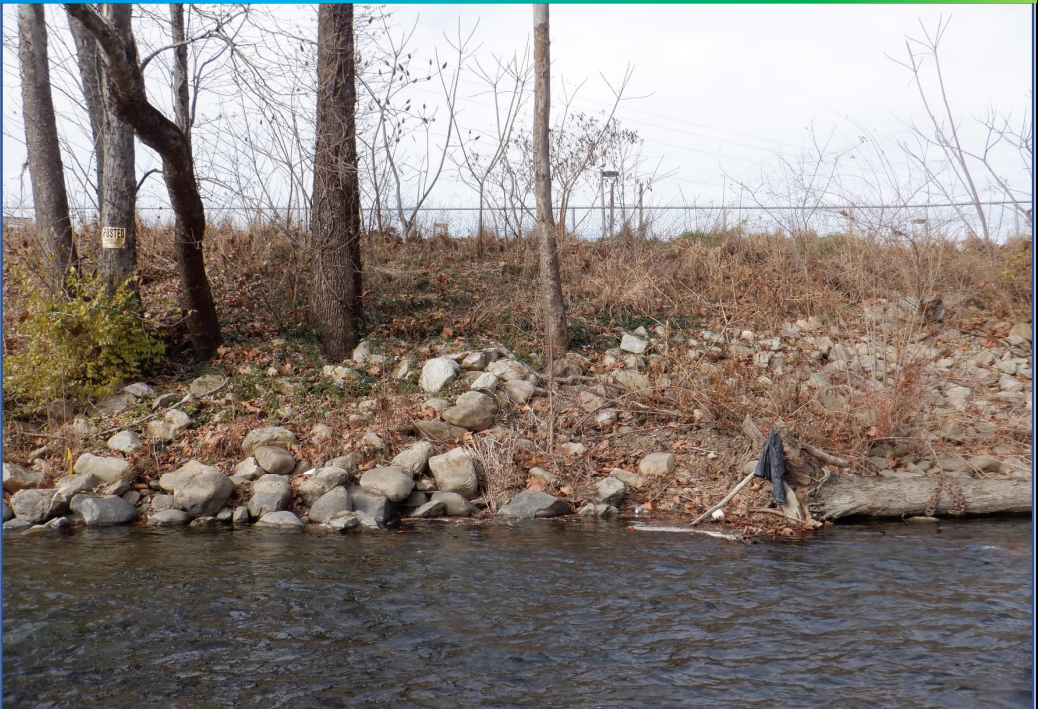
Direction: Northwest			
<p><b>Description:</b> ~45° bank angle; predominantly native vegetation; flood debris along top of rock toe; vegetation fully established and grasses establishing in rock toe; smallest old growth sycamore appears dead; at risk tree present; rock toe intact; LWD intact.</p>

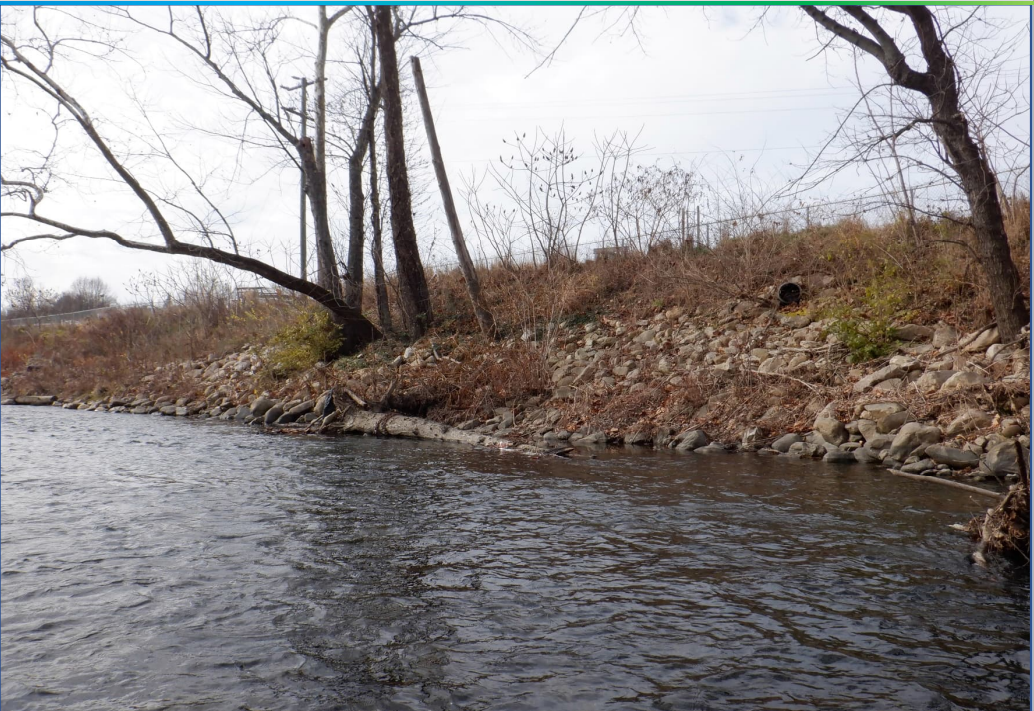
Direction: Southwest			
Description: Upstream view of bank remediation; sparse vegetation; no at-risk trees present.

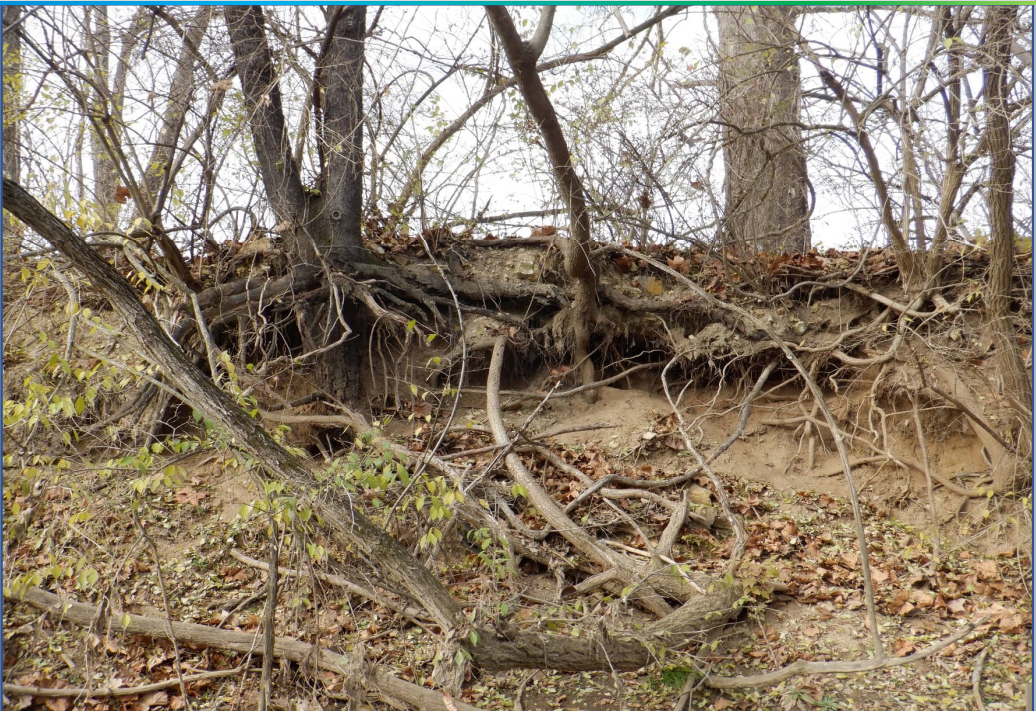
Direction: Northwest			
Description: Non-remediated area; significant bank erosion and undercutting; high density of exposed roots; at-risk trees present along the upper bank.

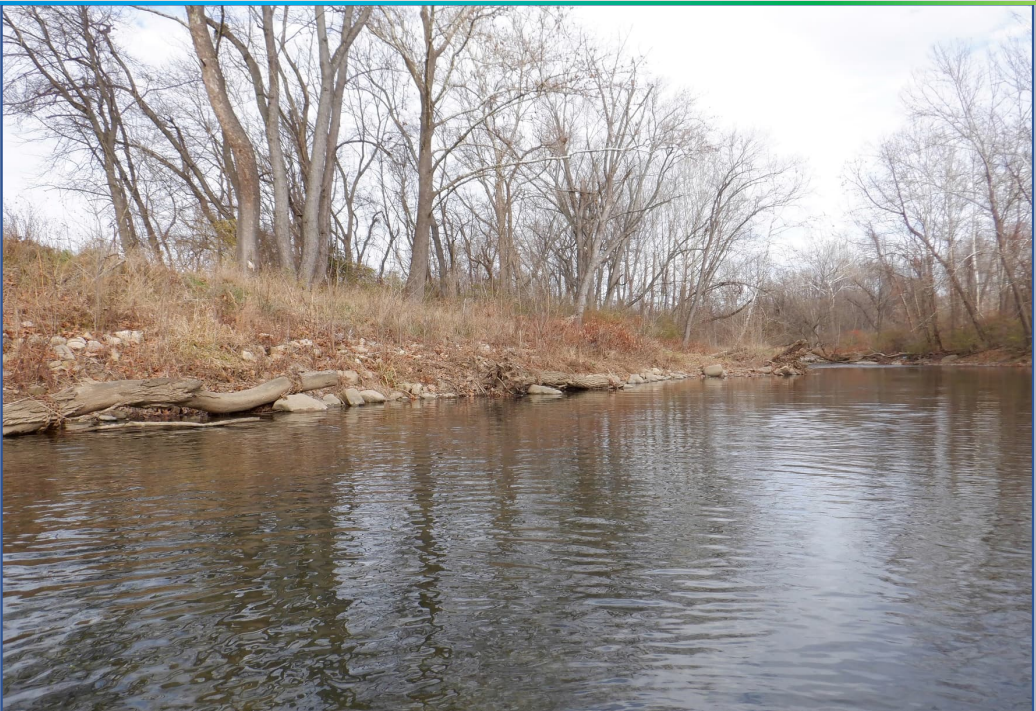
Direction: Northeast			
Description: Downstream view of the start of the 2 <sup>nd</sup> remediated section; LWD intact; rock toe intact; scour above rock toe.

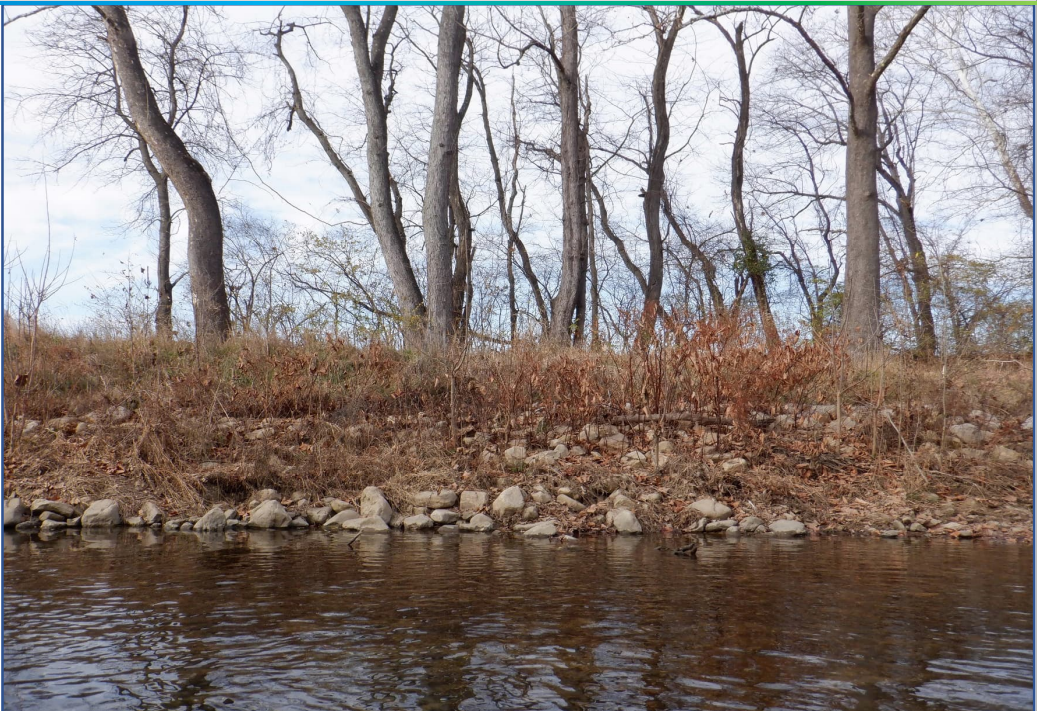
Direction: Northwest			
Description: lower bank ~25°; upper bank ~30°; vegetation established above rock toe; no at-risk trees present.

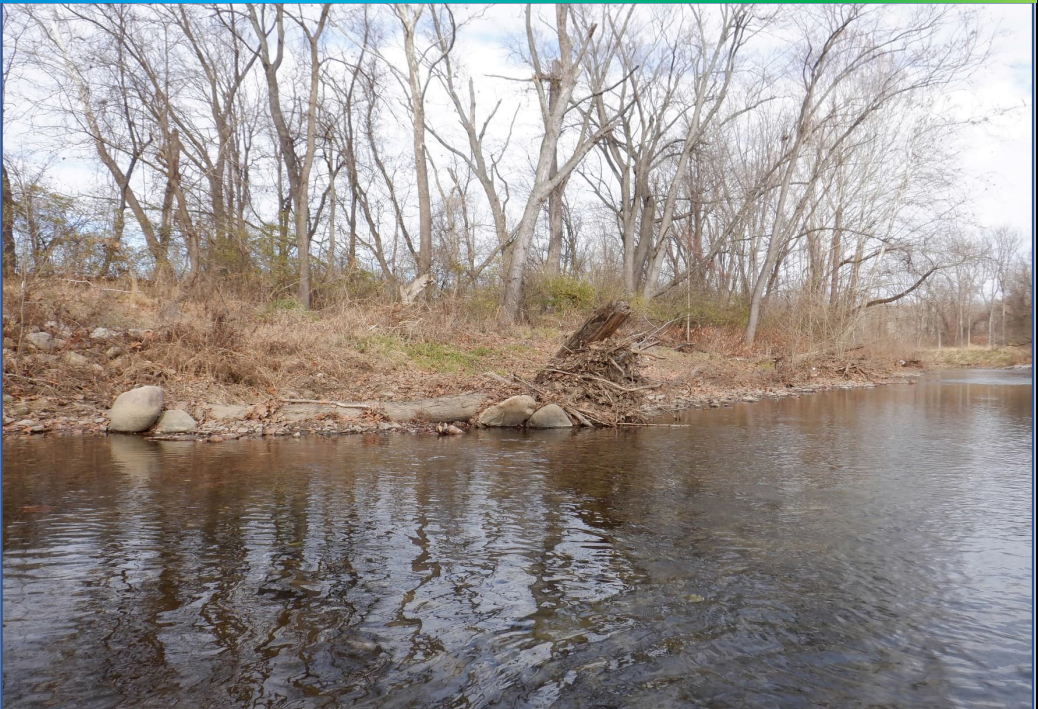
Direction: Northeast	
Description: Downstream view of remediated bank; rock toe intact; LWD shifted downstream from its original position and is angled into the river.

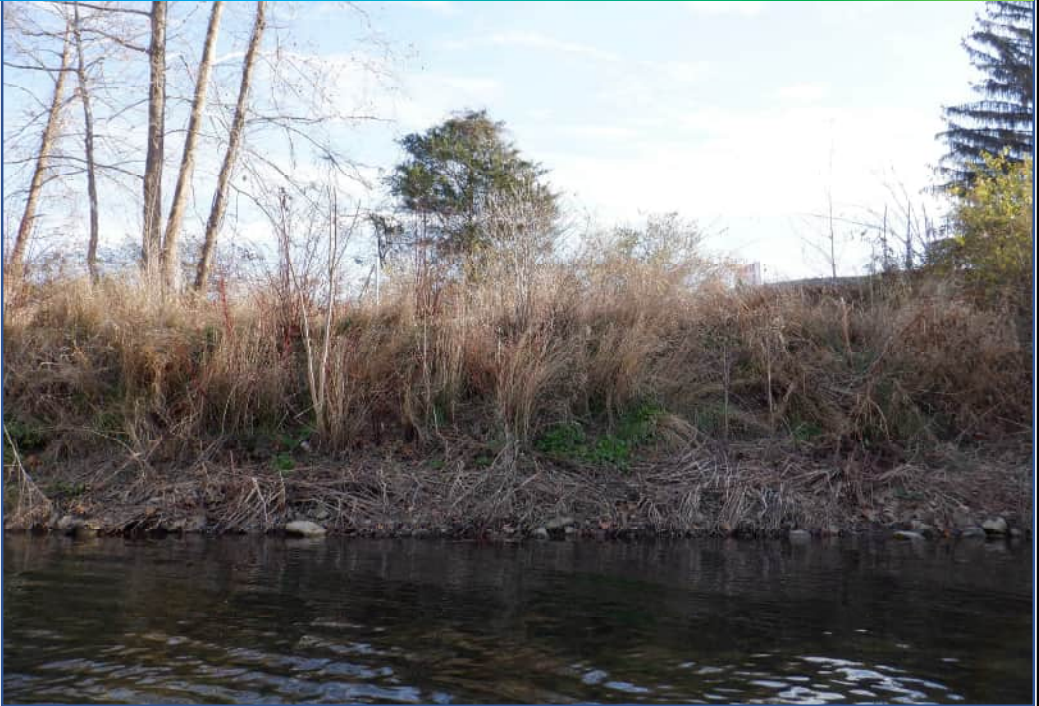
<b>Direction:</b> Southeast	
<b>Description:</b> ~45° bank angle; start of remediated bank; few live stakes observed; native vegetation fully established; no at-risk trees present; rock toe intact with sand deposition; trampled vegetation associated with foot traffic along bank.

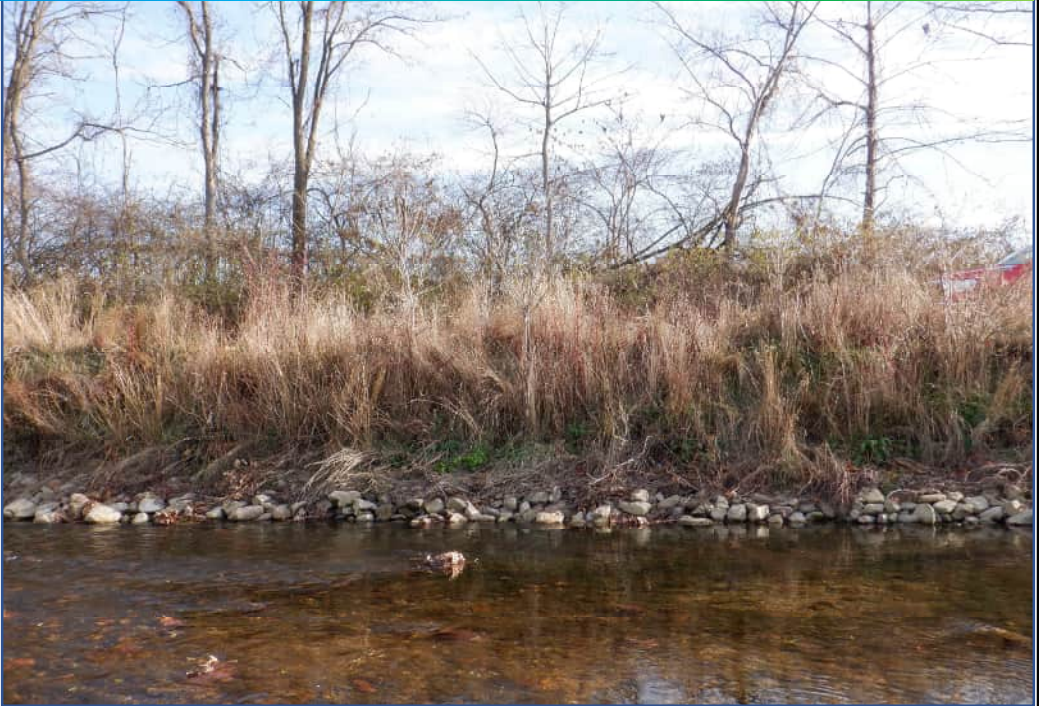
<b>Direction:</b> Southeast			
<b>Description:</b> ~50° bank angle; few live stakes observed; herbaceous vegetation fully established; no at-risk trees present; rock toe intact.

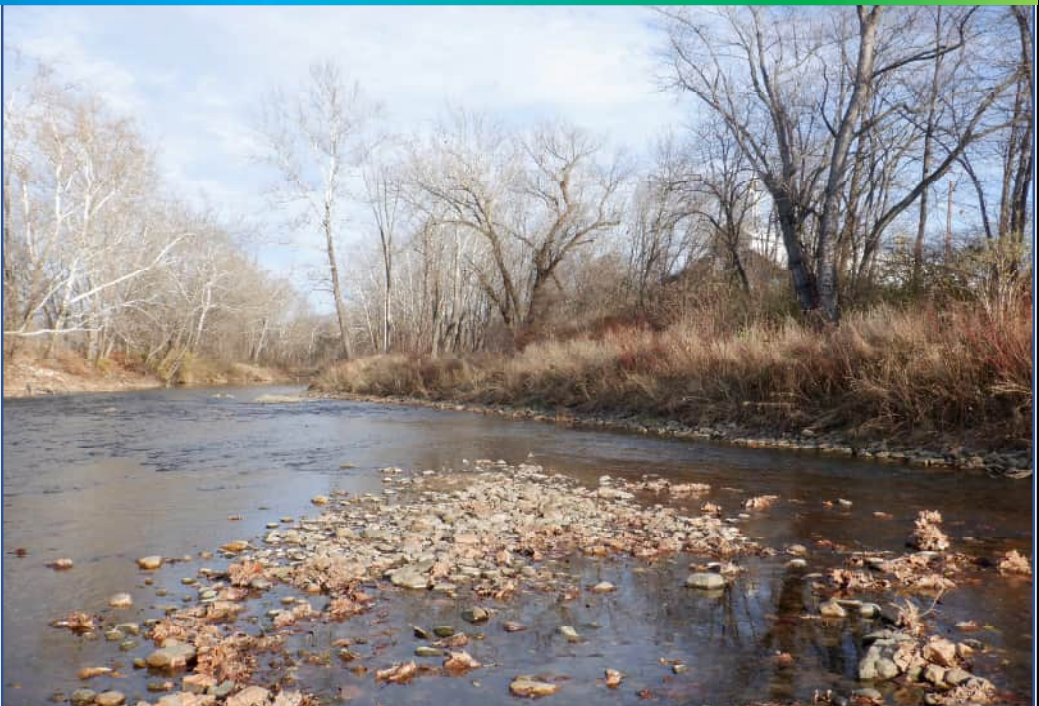
<b>Direction:</b> East			
<b>Description:</b> Downstream view of remediated bank; vegetation fully established; no at-risk trees present.

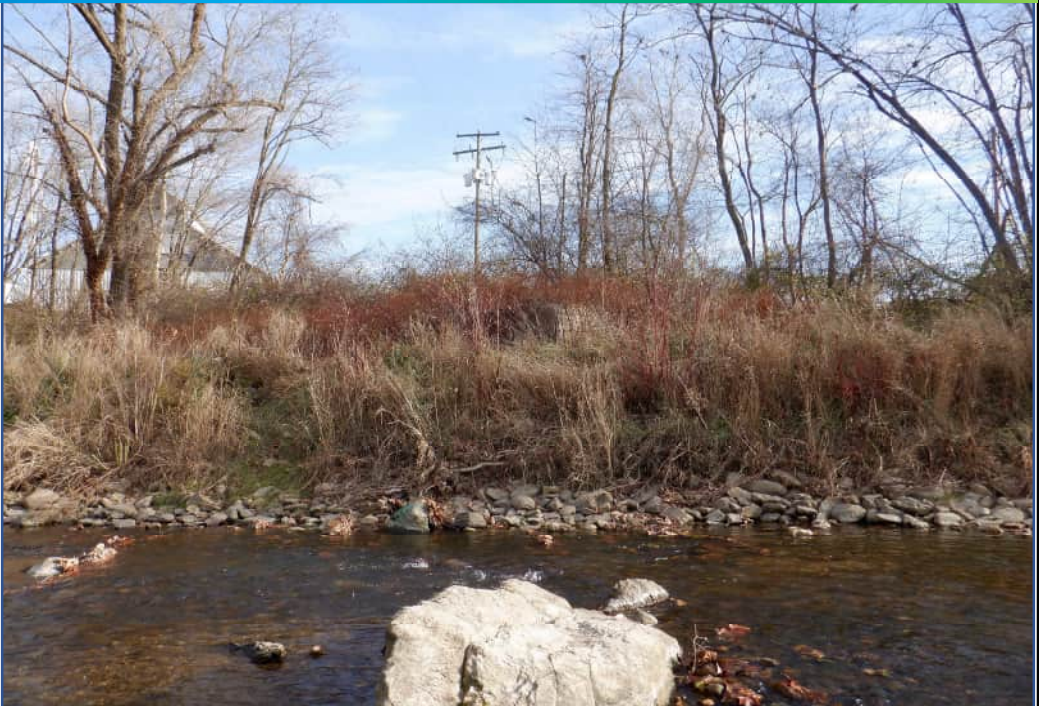
<b>Direction:</b> Southeast			
<b>Description:</b> ~40° bank angle; few live stakes observed; herbaceous vegetation fully established; no at-risk trees present; rock toe intact; footpath present; sand deposition at toe of bank.

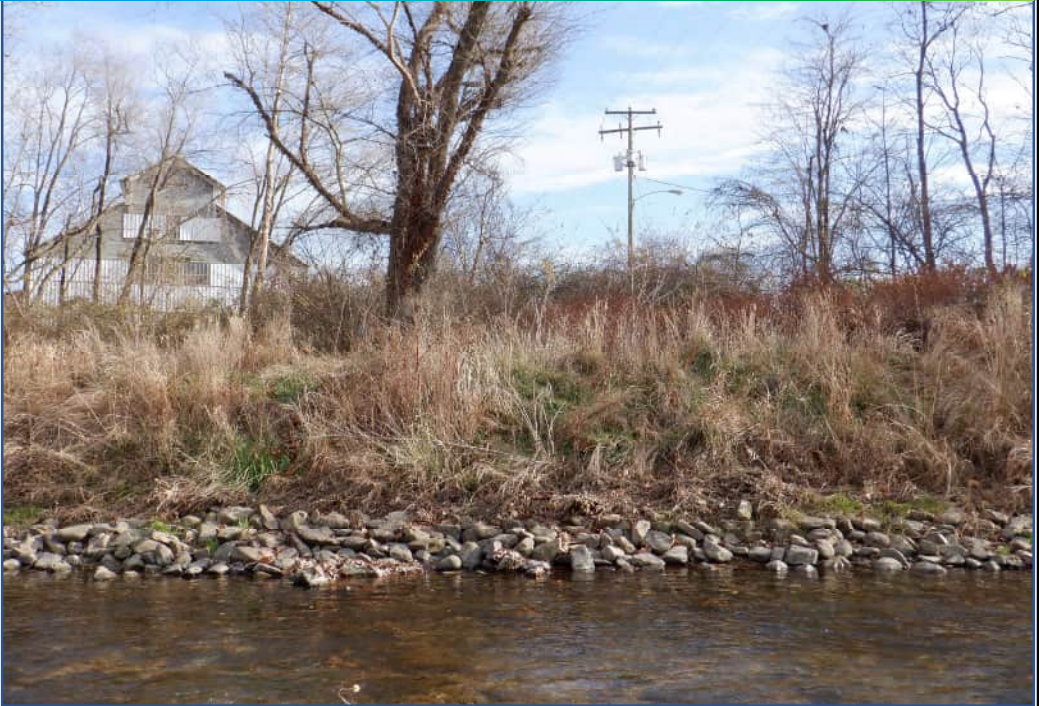
<b>Direction:</b> Southeast	
<b>Description:</b> ~40° bank angle; no live stakes observed; herbaceous vegetation fully established; no at-risk trees present; rock toe intact; sand deposition at toe of bank.

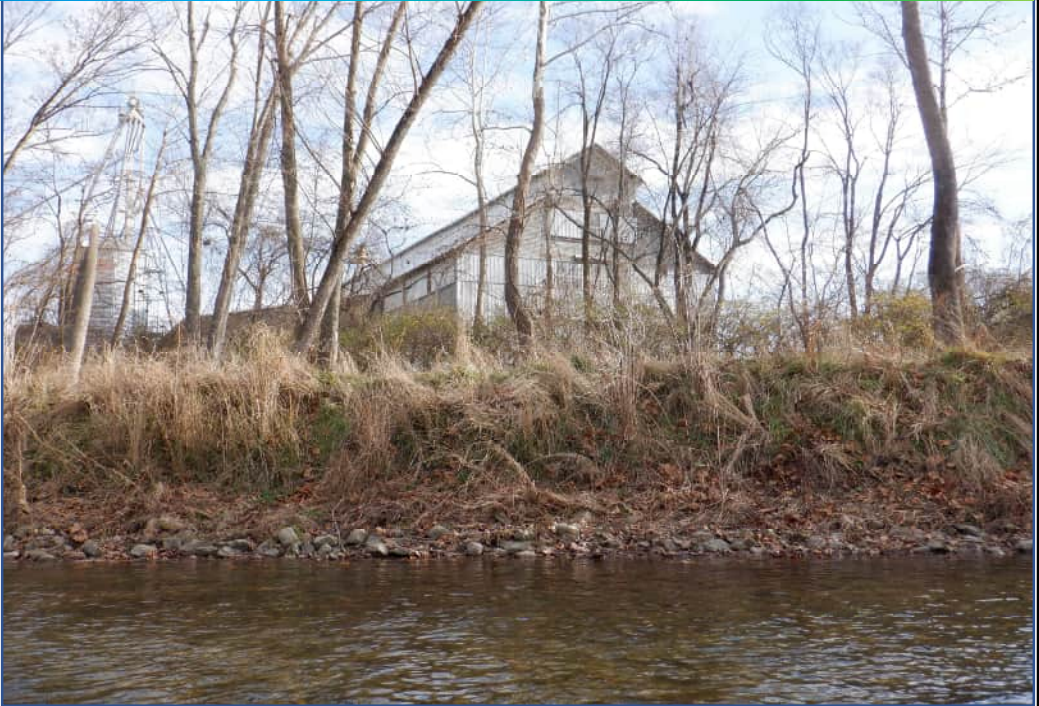
<b>Direction:</b> Southeast			
<b>Description:</b> ~50° bank angle; no live stakes observed; herbaceous vegetation fully established; no at-risk trees present; sand deposition at toe of bank.

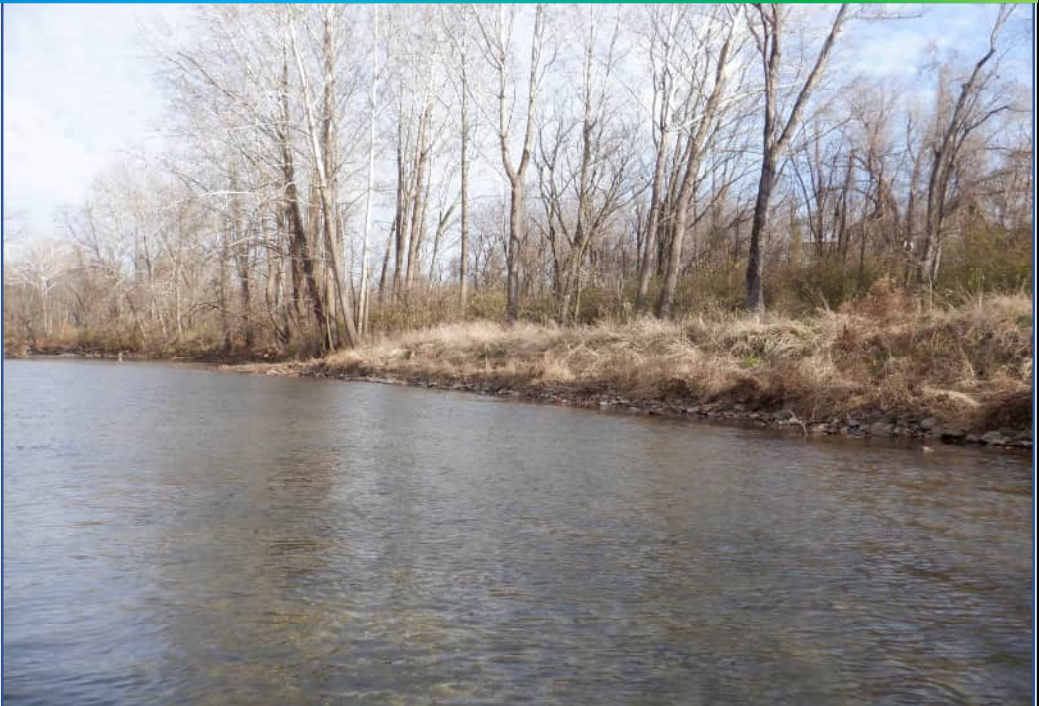
<b>Direction:</b> East			
<b>Description:</b> Downstream view of remediated bank; debris on plateau above rock toe due to flooding; plateau above rock toe becoming more pronounced.

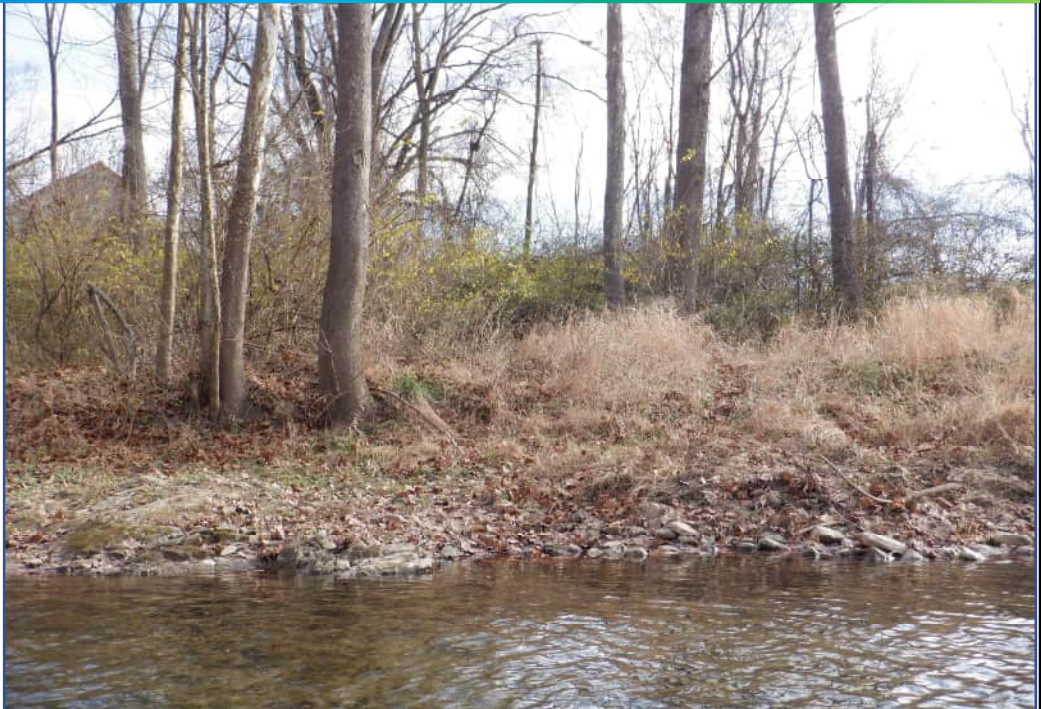
<b>Direction:</b> Southeast			
<b>Description:</b> End of 1 <sup>st</sup> remediated section; lower bank ~20°; upper bank ~40°; no live stakes observed; herbaceous vegetation fully established; no at-risk trees in remediated area; rock toe intact; sediment deposition at toe of bank.

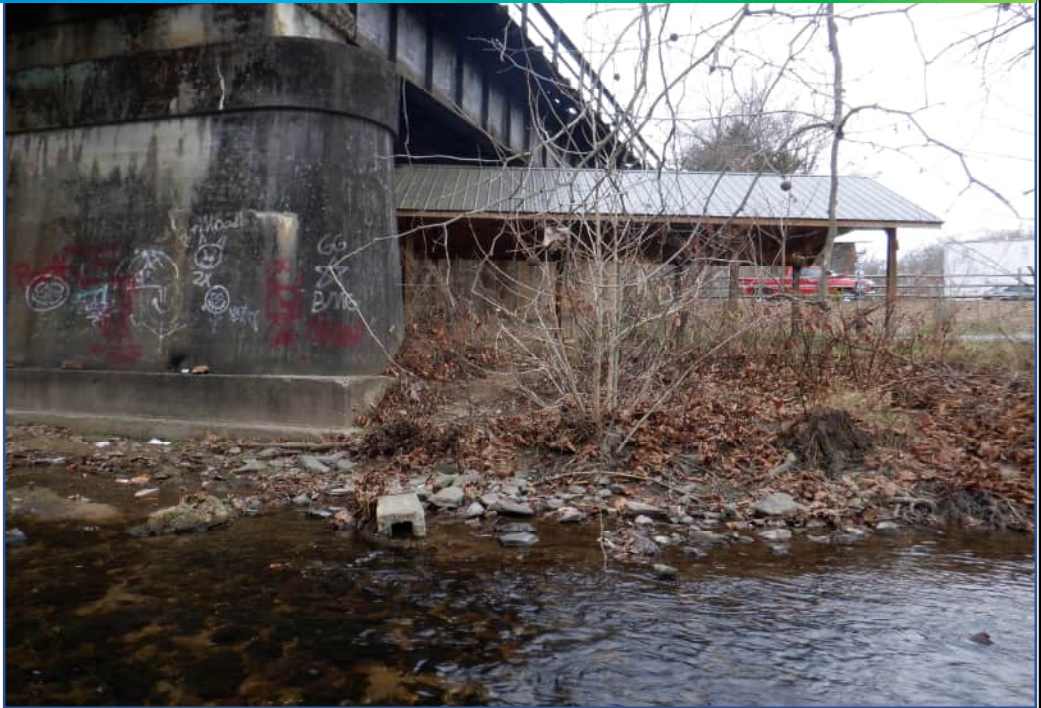
<b>Direction:</b> West	
<b>Description:</b> Upstream of remediation; ~ 30° bank angle; moderate vegetation, 50% cover; exposed roots along bank; access pathways present; no at-risk trees present; minimal scour present.

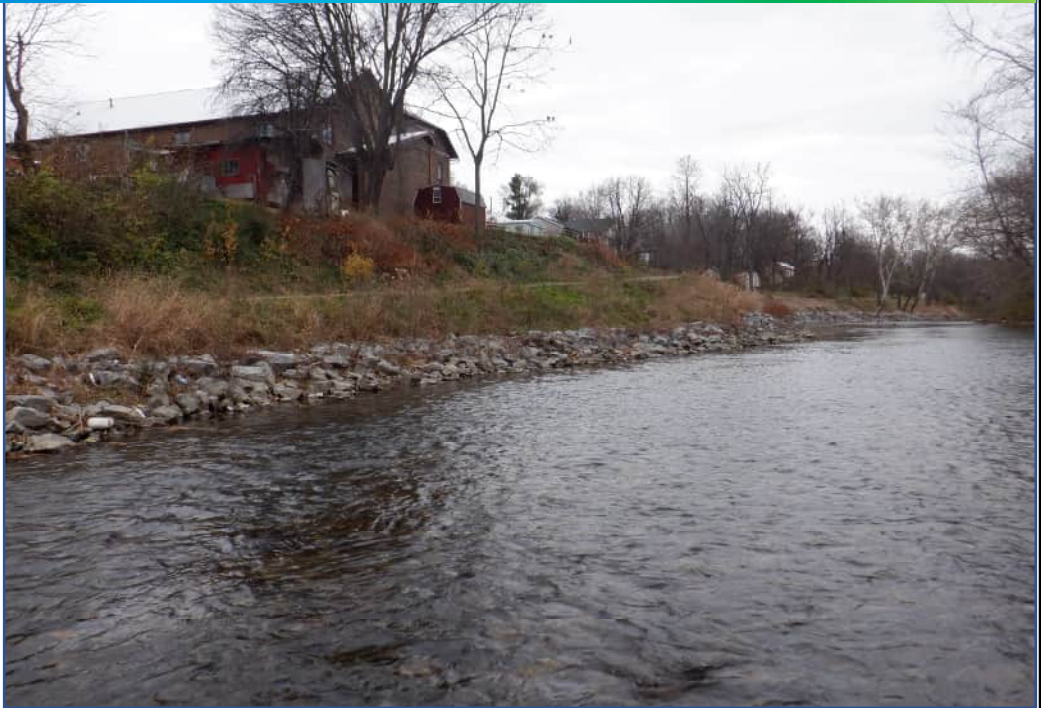
<b>Direction:</b> North			
<b>Description:</b> Downstream view of remediated bank; rock toe intact; herbaceous vegetation establishing.

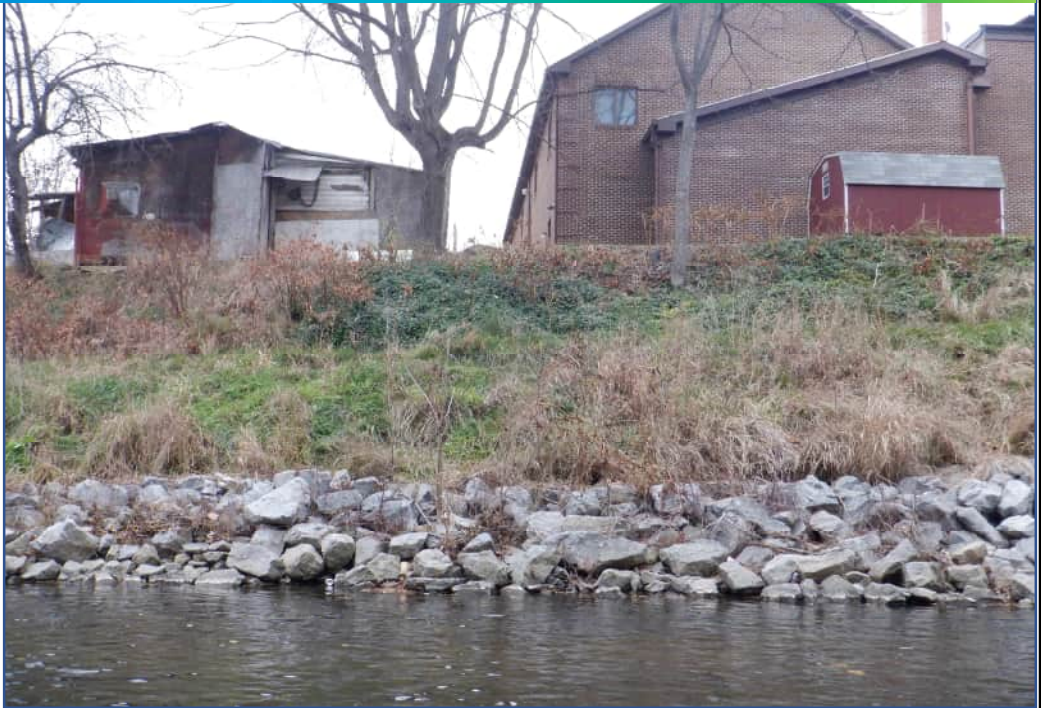
<b>Direction:</b> West			
<b>Description:</b> lower bank ~40°; upper bank ~60°; above greenway ~60°; vegetation establishing, 95% cover; footpath present; rock toe intact; plastic corrugated pipe exposed on bank above greenway; sediment deposition in rock toe.

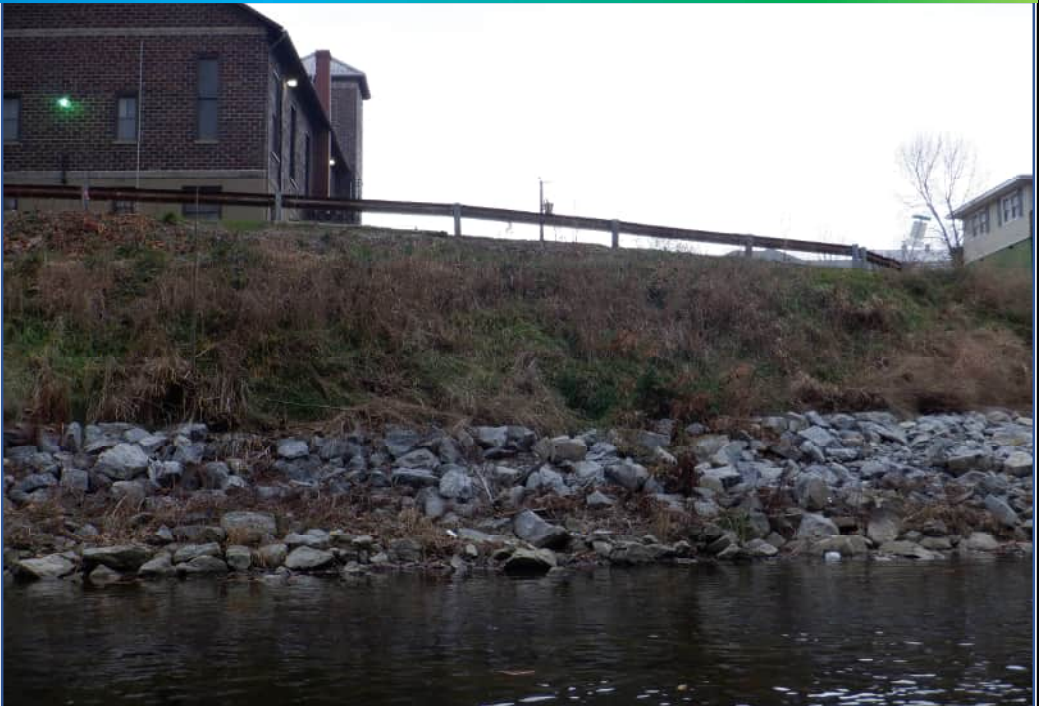
<b>Direction:</b> West	
<p><b>Description:</b> lower bank ~45°; upper bank ~80°; above greenway ~70°; plantings intact; live stakes not established; vegetation establishing, 90% cover; erosion control fabric and geocell exposed above greenway; corrugated pipe above greenway damaged; rock toe intact with sediment deposition.</p>
