**VIRGINIA DEPARTMENT OF ENVIRONMENTAL QUALITY**

**Re: 2021 Leaf-on and Leaf-off Maintenance Inspections  
Former DuPont Waynesboro Site AOC 4  
Waynesboro, Virginia  
EPA ID# VAD003114832**

Subject South River BMA - 2021 Leaf-Off Maintenance Inspection  
Former DuPont Waynesboro Site, Area of Concern 4

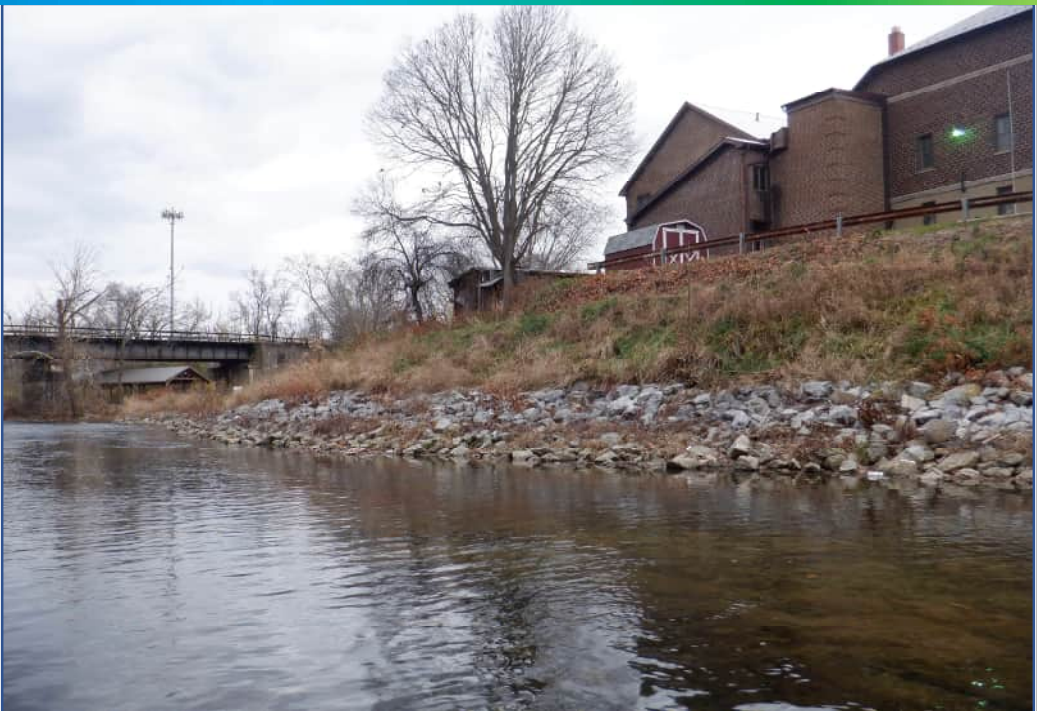
<b>Direction:</b> South			
<b>Description:</b> Upstream view of remediated bank; vegetation establishing; rock toe intact.

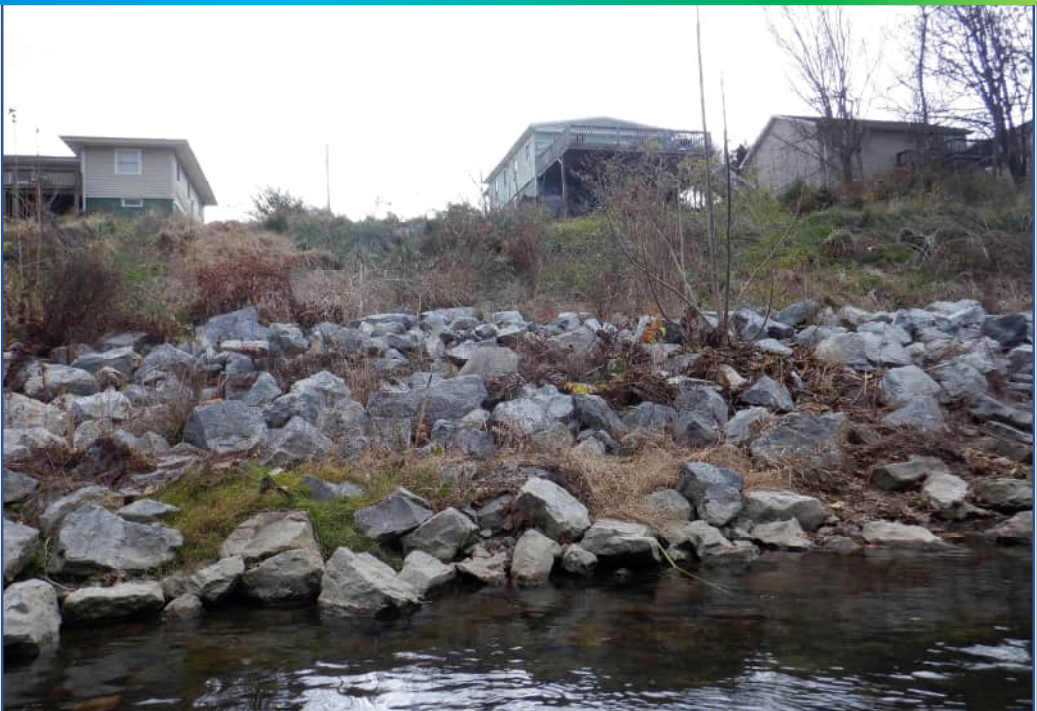
<b>Direction:</b> West			
<b>Description:</b> Some evidence of erosion from runoff from Riverside Drive; sediment deposition in rock toe; sapling and grasses establishing in rock toe.

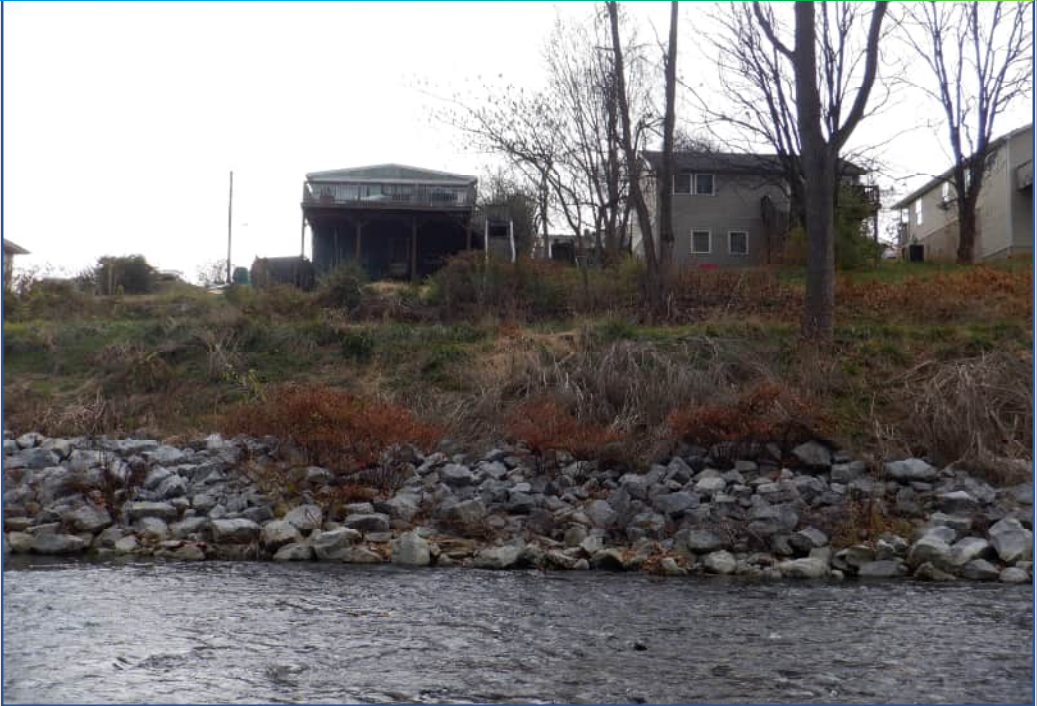
<p><b>Photo Number:</b> 20 <span style="float: right;"><b>Location:</b> 00+550'</span></p>	
<p><b>Date:</b> 12/6/2021</p> <hr/> <p><b>Direction:</b> West</p> <hr/> <p><b>Description:</b> lower bank; ~60°; upper bank; ~70°; reseeded grasses not establishing on repaired bank section; vegetation 20% cover; no trees adjacent to edge of water; rock toe intact; repaired bank intact; sediment deposition in rock toe.</p>

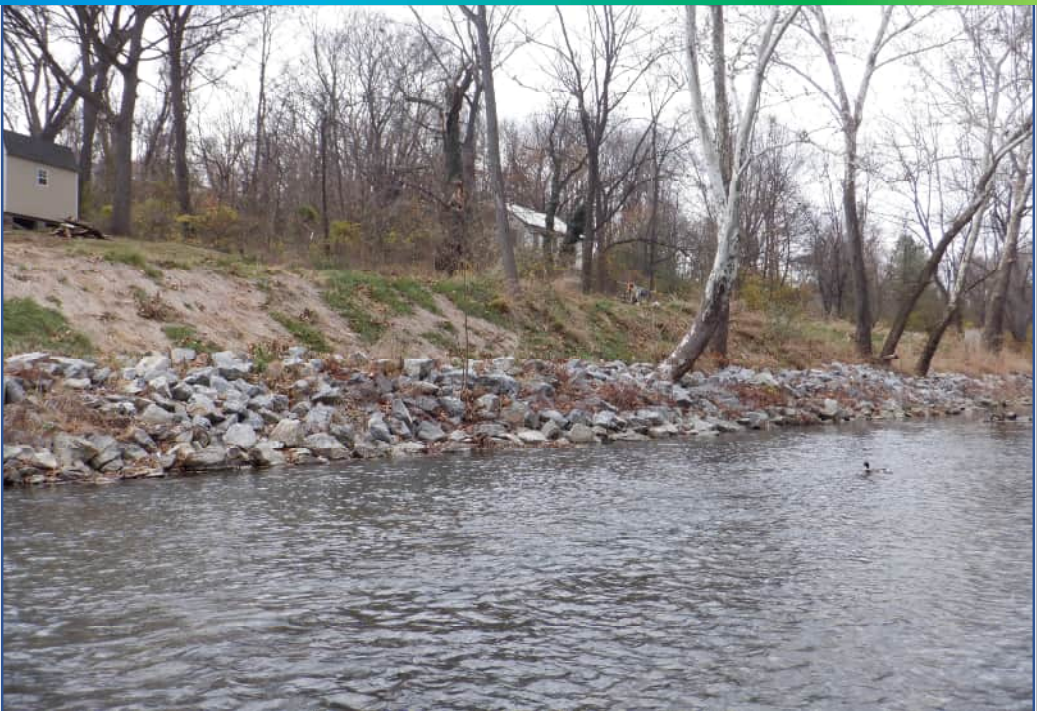
<b>Direction:</b> North	
<b>Description:</b> Downstream view of remediated bank; reseeded grasses not establishing repaired bank section; vegetation 20% cover; rock toe intact.

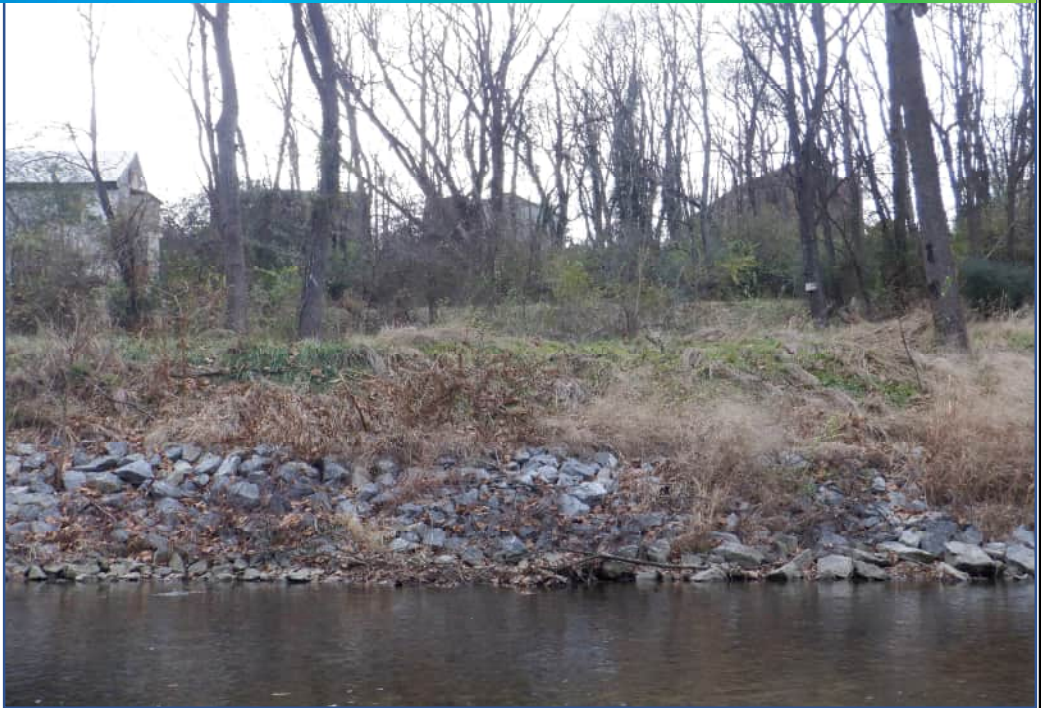
<b>Direction:</b> West			
<b>Description:</b> ~ 70° bank angle; live stakes and plantings not established; 75% vegetation cover; no trees adjacent to edge of water; rock toe intact; sediment deposition in rock toe.

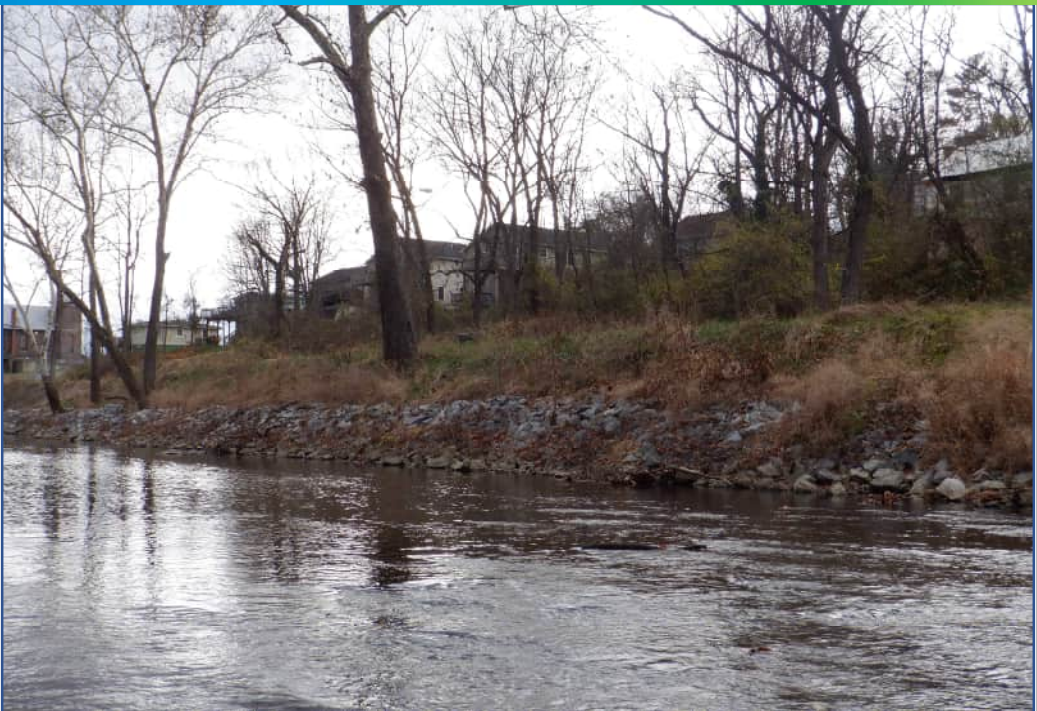
<b>Direction:</b> South			
<b>Description:</b> Upstream view of remediated bank; grasses establishing; rock toe intact.

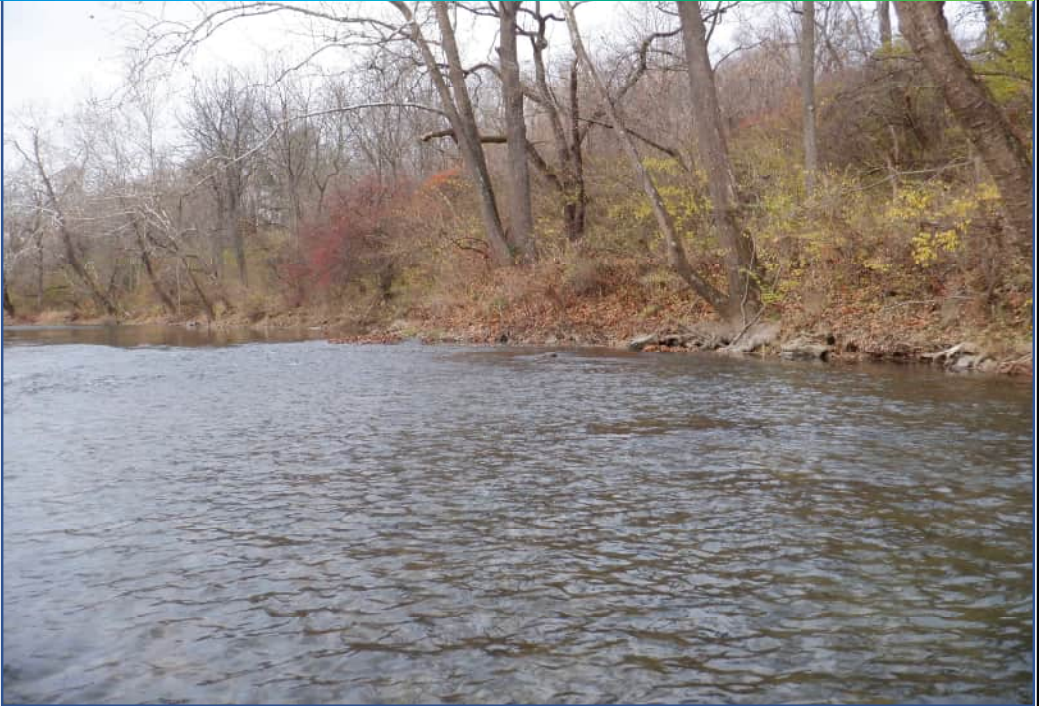
<b>Direction:</b> West	
<b>Description:</b> Upstream view of non-remediated bank; undercut bank with exposed roots; upstream of remediation; minimal scour present; bank undercut.

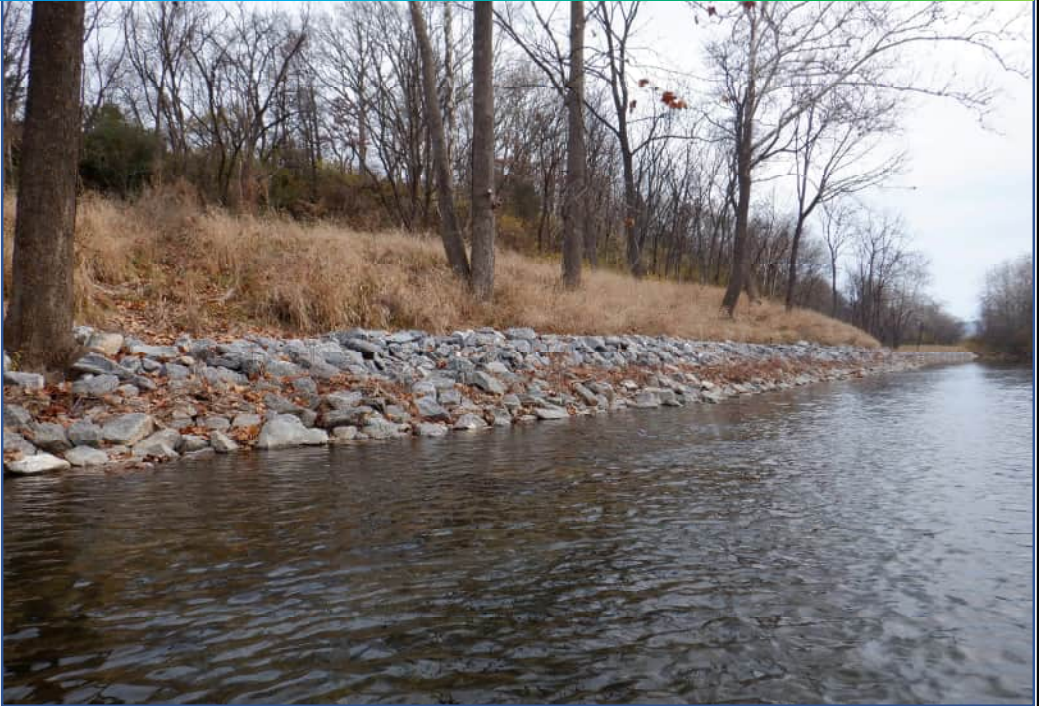
<b>Direction:</b> North	
<b>Description:</b> Downstream view of 1 <sup>st</sup> remediated section; rock toe intact; coir logs deteriorated; minimal sediment deposition; vegetation establishing.

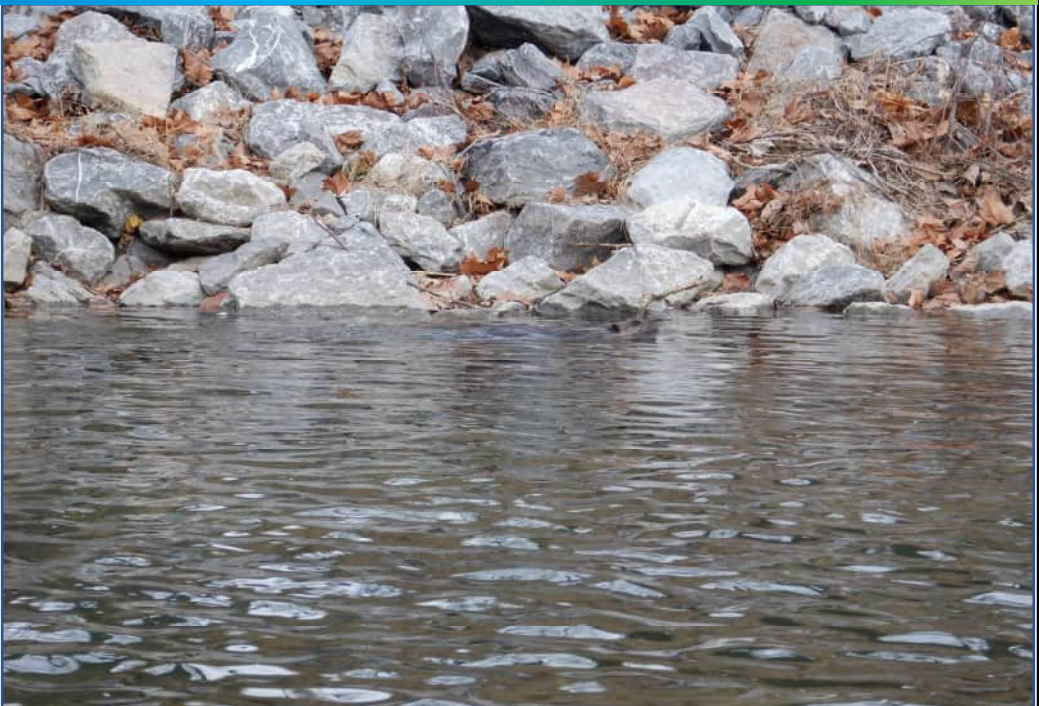
<b>Direction:</b> Northwest	
<b>Description:</b> Rock toe intact; minimal sediment deposition; beaver swimming along rock toe.

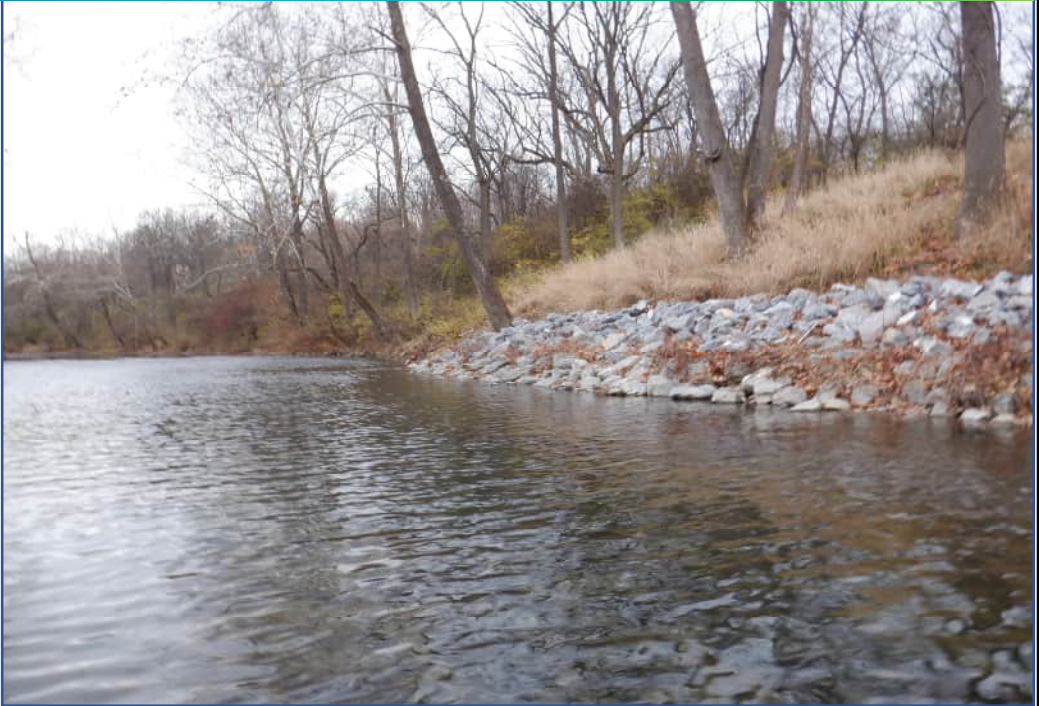
<b>Direction:</b> West			
<b>Description:</b> Upstream view of remediated area; erosion control fabric minimally exposed and deteriorating; rock toe intact; coir logs deteriorated; moderate sediment deposition; vegetation establishing.

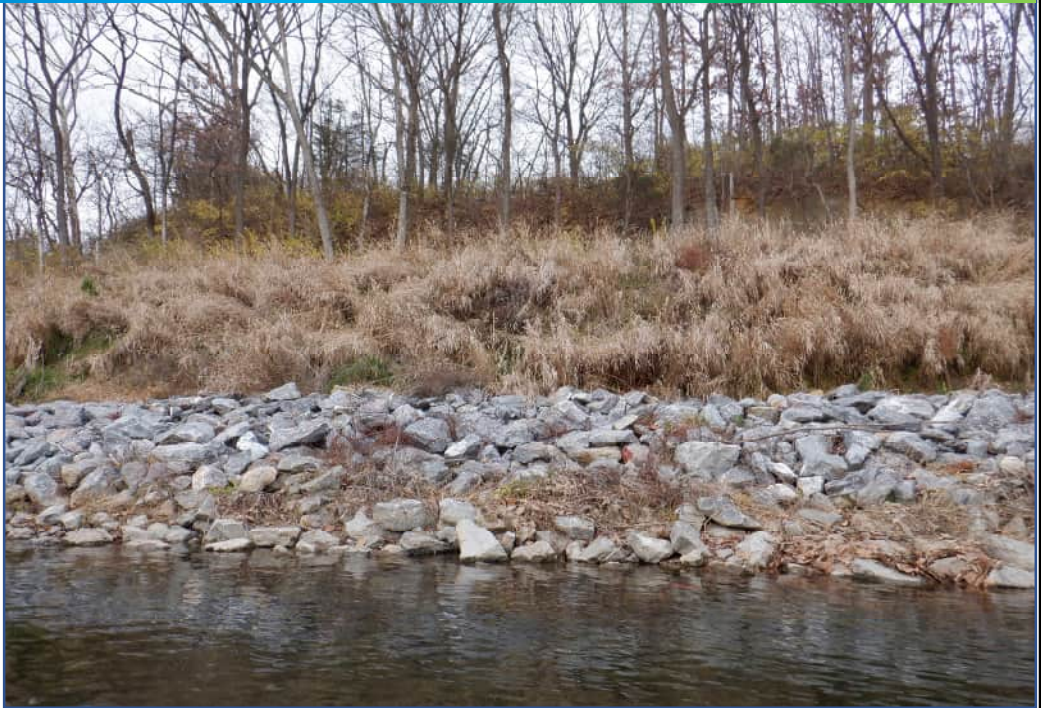
<b>Direction:</b> Northwest	
<b>Description:</b> ~ 60° bank angle; live stakes and plantings not established; 90% vegetation cover; no at-risk trees present; rock toe intact; coir log deteriorated; minimal sediment deposition; vegetation establishing.

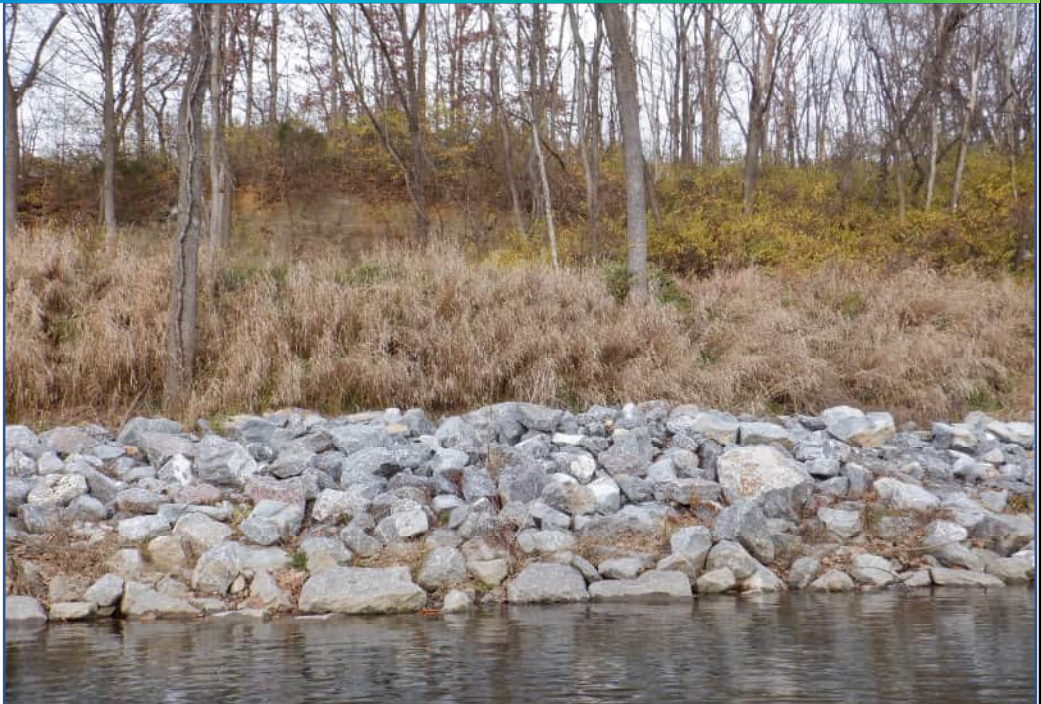
<b>Direction:</b> Northwest	
<b>Description:</b> ~ 70° bank angle; live stakes and plantings not established; 95% vegetation cover; no at-risk trees present; rock toe intact; coir log deteriorated; minimal sediment deposition; vegetation establishing.

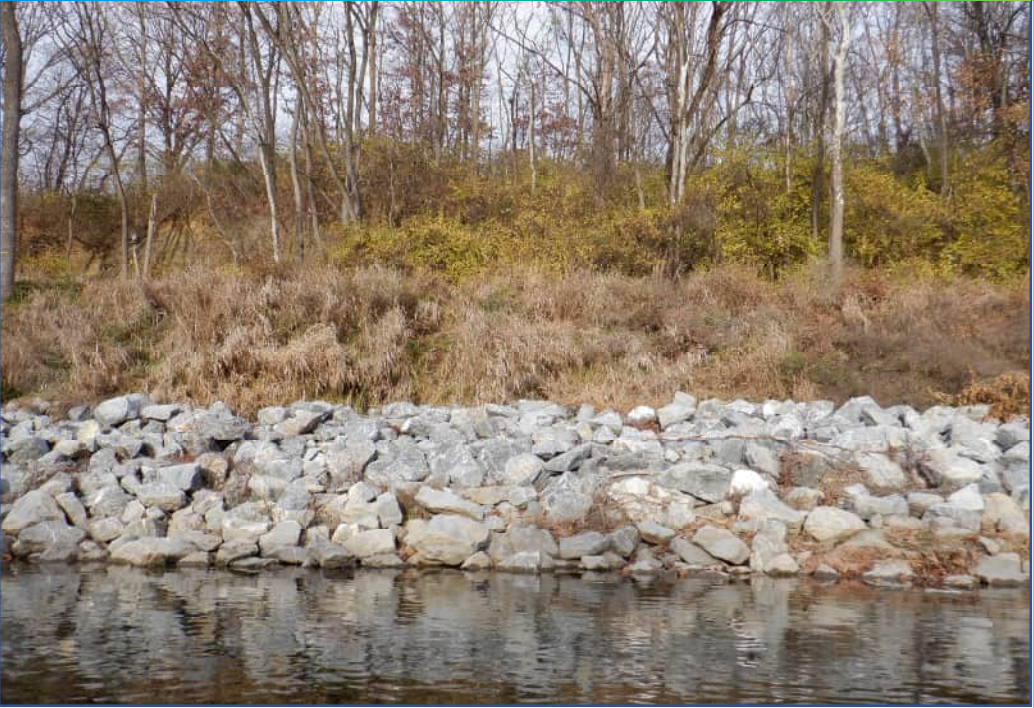
<b>Direction:</b> Northwest	
<b>Description:</b> ~ 65° bank angle; no woody vegetation; live stakes and plantings not established; 70% vegetation cover; no at-risk trees present; rock toe intact; coir log deteriorated; minimal sediment deposition; vegetation establishing.

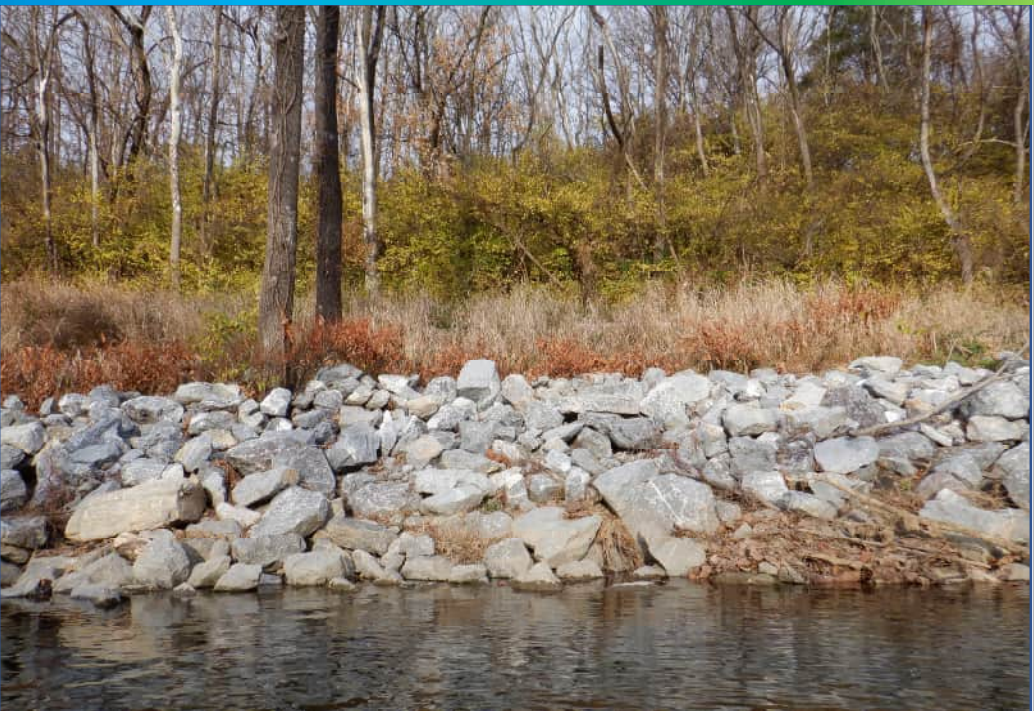
<b>Direction:</b> Northwest	
<b>Description:</b> ~ 40° bank angle; live stakes and plantings not established; 80% vegetation cover; trees near rock toe in good condition; rock toe intact; coir log deteriorated; minimal sediment deposition; vegetation establishing.

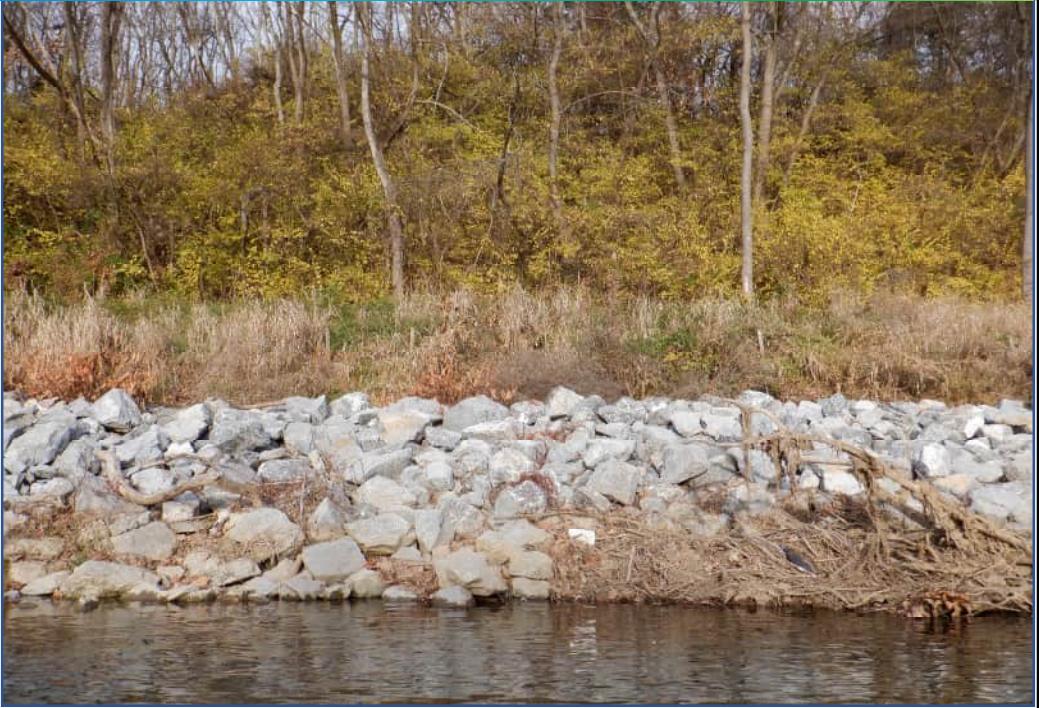
<b>Direction:</b> Northwest	
<b>Description:</b> ~ 40° bank angle; live stakes and plantings not established; 70% vegetation cover; no at-risk trees present; erosion control fabric 15% exposed and deteriorating; rock toe intact; coir log deteriorated; minimal sediment deposition; vegetation establishing.

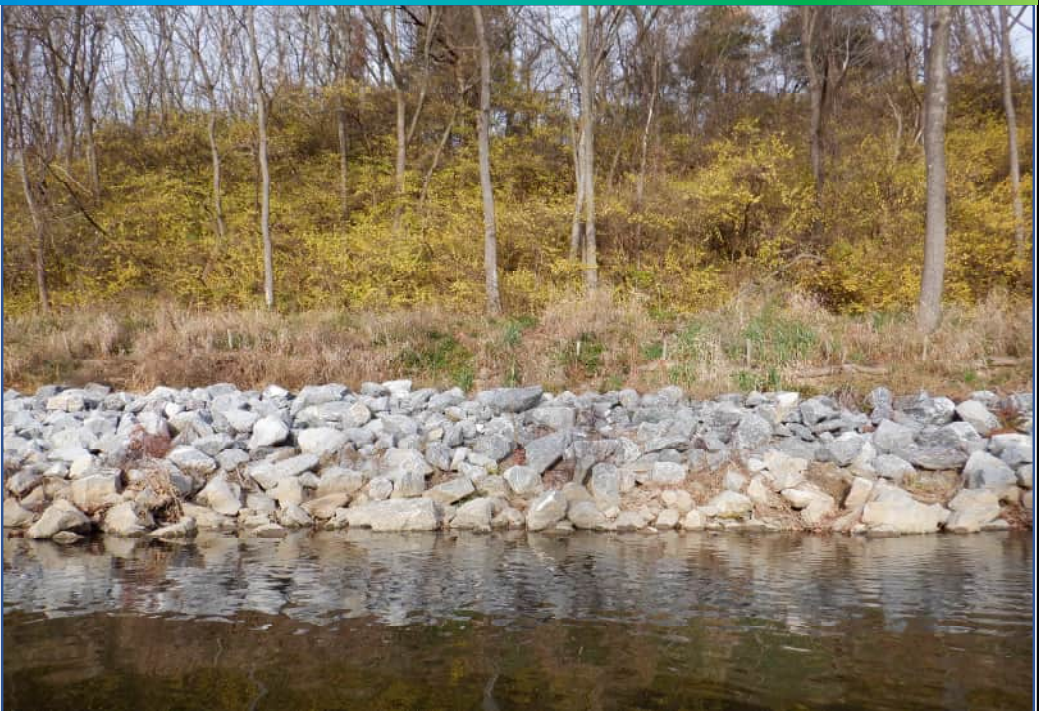
<b>Direction:</b> Northwest	
<b>Description:</b> ~ 50° bank angle; live stakes and plantings not established; 60% vegetation cover; no at-risk trees present; erosion control fabric 30% exposed and deteriorating; rock toe intact; coir log deteriorated; minimal sediment deposition; vegetation establishing.

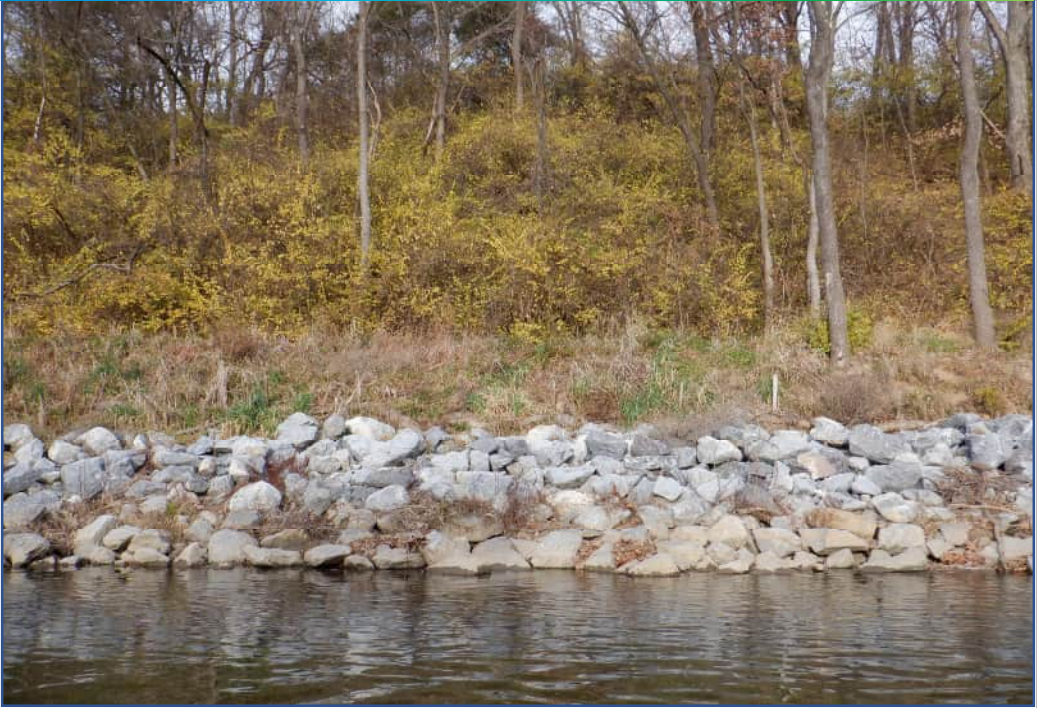
<b>Direction:</b> Northwest	
<b>Description:</b> ~ 50° bank angle; live stakes and plantings not established; 60% vegetation cover; no at-risk trees present; erosion control fabric 20% exposed and deteriorating; rock toe intact; coir logs deteriorated; minimal sediment deposition; vegetation establishing.

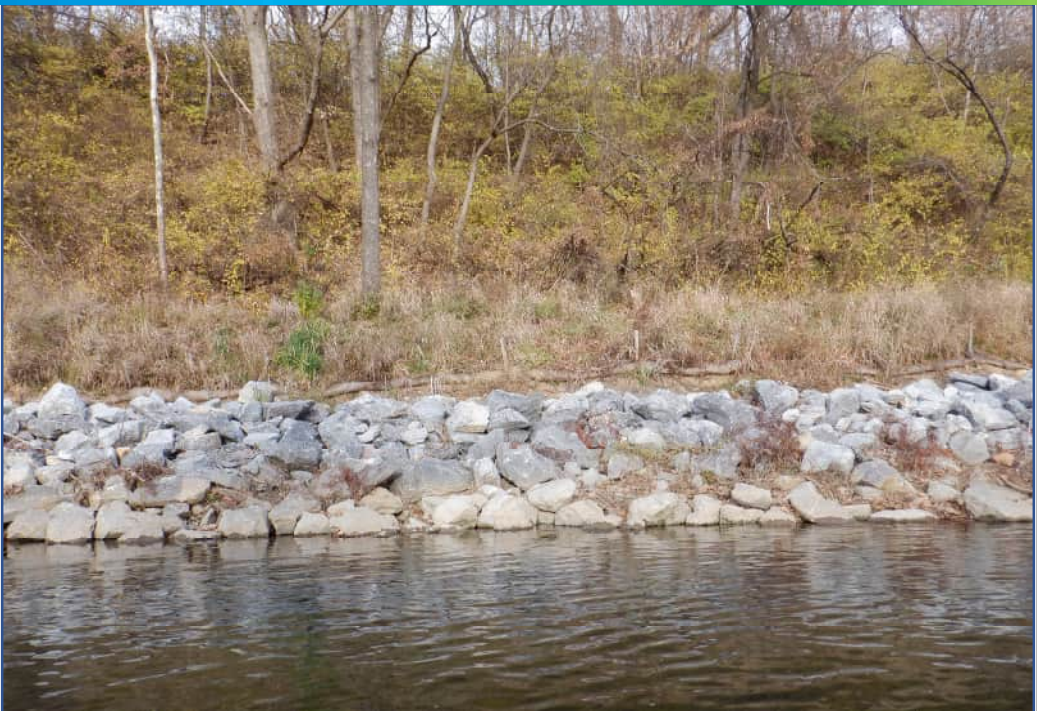
<b>Direction:</b> Northwest	
<b>Description:</b> ~ 60° bank angle; live stakes and plantings not established; 70% vegetation cover; tree present in good condition; erosion control fabric 10% exposed; significant erosion between coir log and top of intact rock toe; minimal sediment deposition; vegetation establishing.

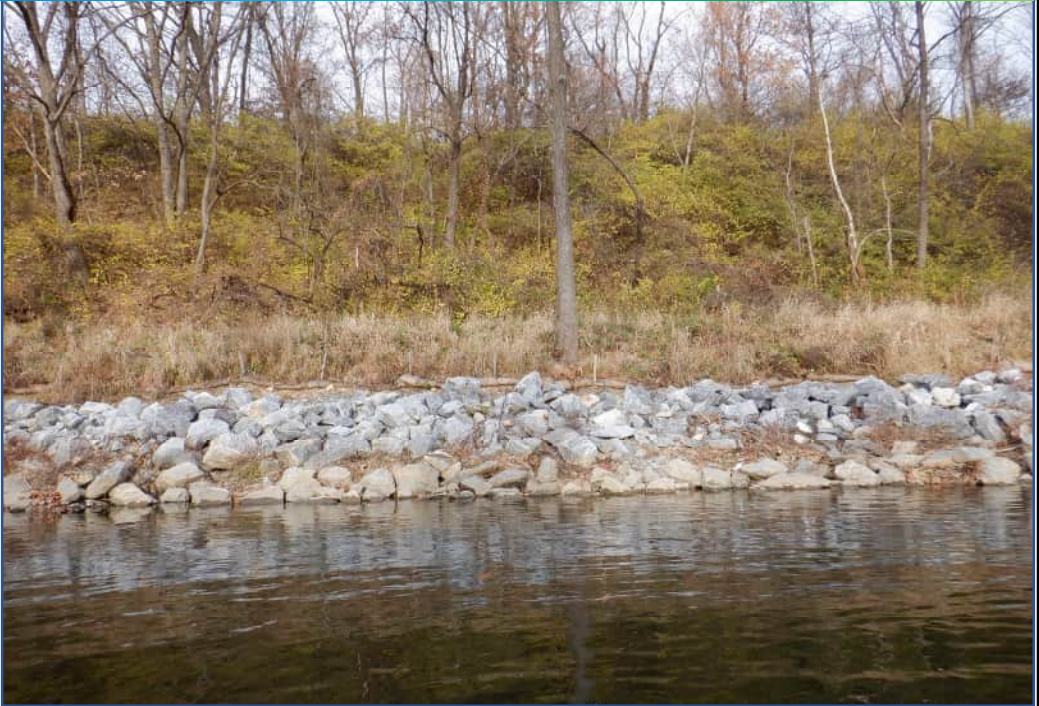
<b>Direction:</b> Northwest			
<b>Description:</b> ~ 50° bank angle; live stakes and plantings not established; significant erosion and no vegetation below coir log; 60% vegetation cover; one tree above rock toe in good condition; minimal sediment deposition; vegetation establishing.

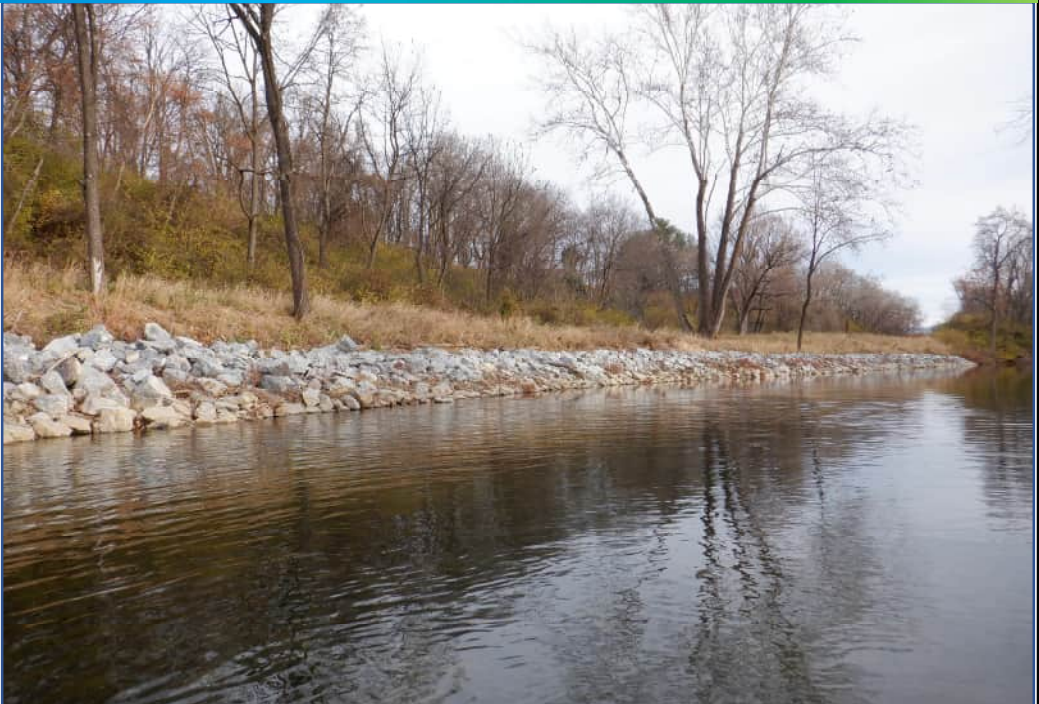
<b>Direction:</b> North			
<b>Description:</b> Downstream view of remediated bank; rock toe intact; vegetation establishing.

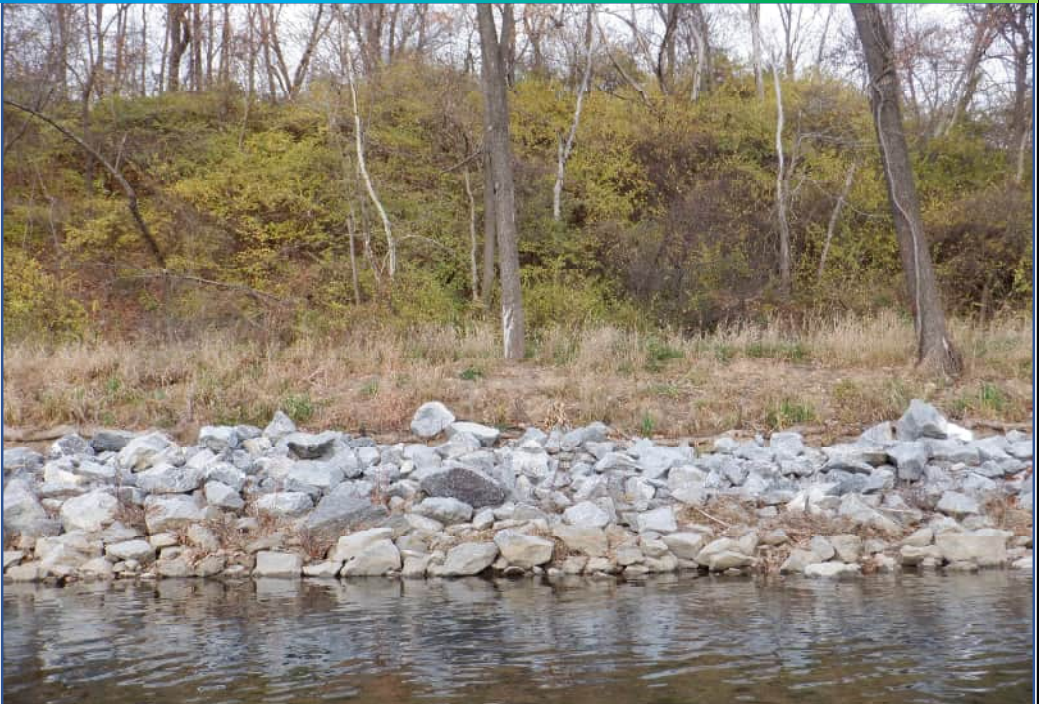
<b>Direction:</b> Northwest		
<b>Description:</b> ~ 50° bank angle; significant erosion and no vegetation below deteriorated coir log; 30% vegetation cover; tree near greenway has damaged bark; erosion control fabric deteriorating; rock toe intact; minimal sediment deposition.

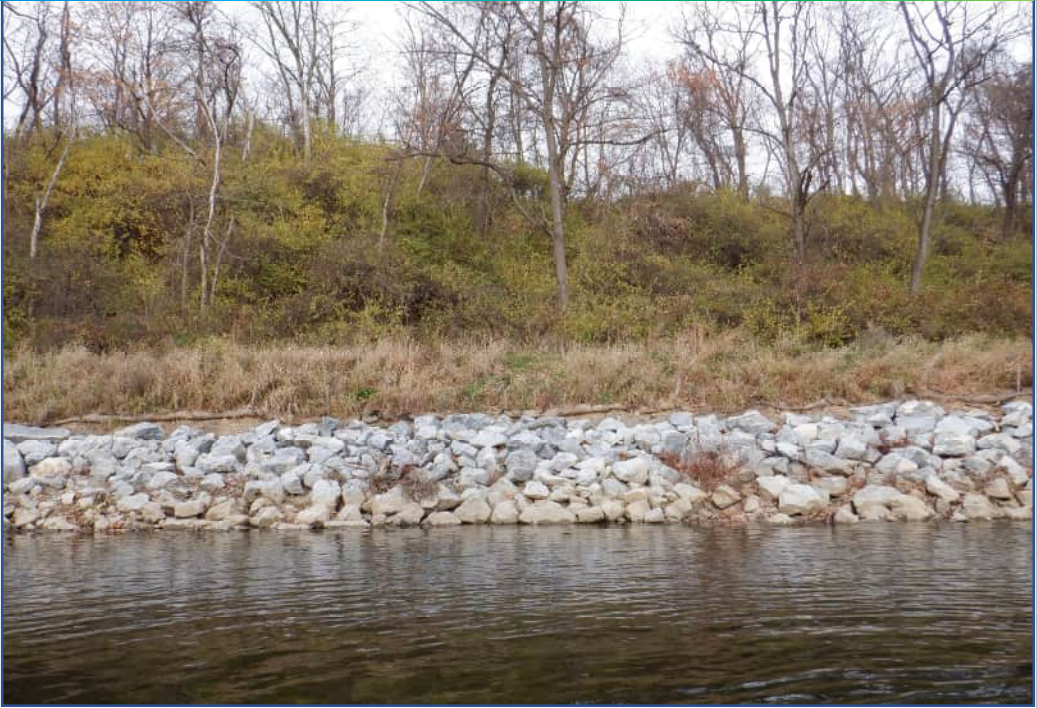
<b>Direction:</b> Northwest			
<b>Description:</b> ~ 40° bank angle; live stakes and plantings not established; significant erosion and no vegetation below coir log; 60% vegetation cover; no at-risk trees present; erosion control fabric 10% exposed and deteriorating; minimal sediment deposition; vegetation establishing.

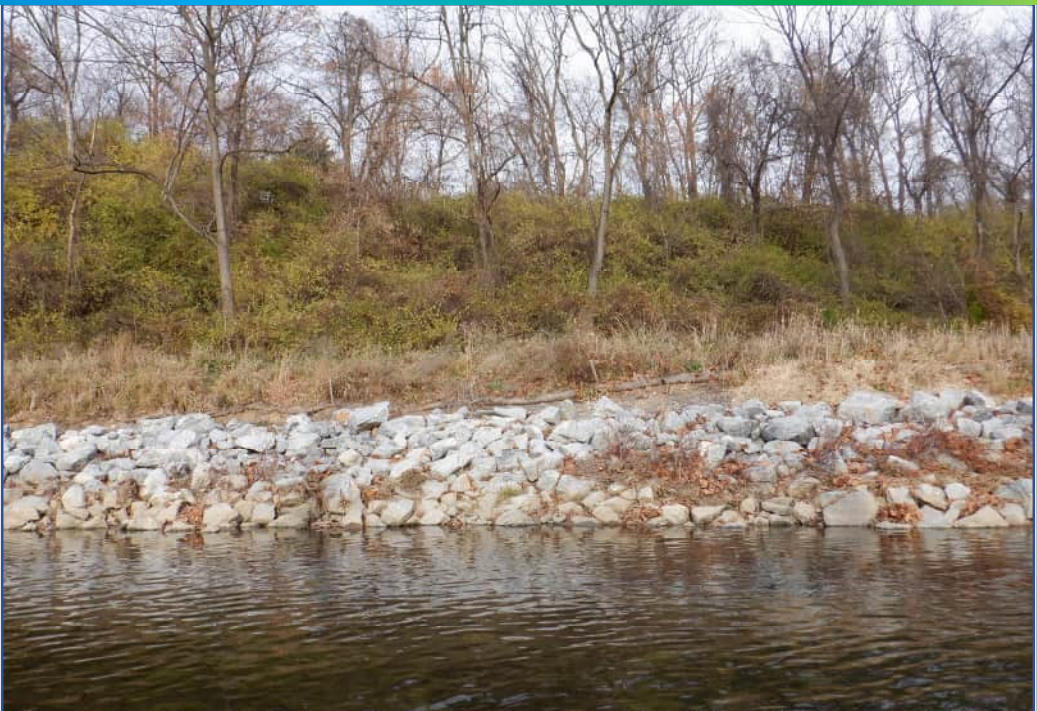
<b>Direction:</b> Northwest			
<b>Description:</b> ~ 50° bank angle; live stakes and plantings not established; significant erosion and no vegetation below deteriorated coir log; 40% vegetation cover; no at-risk trees present; erosion control fabric 10% exposed and deteriorating; rock toe intact; minimal sediment deposition.

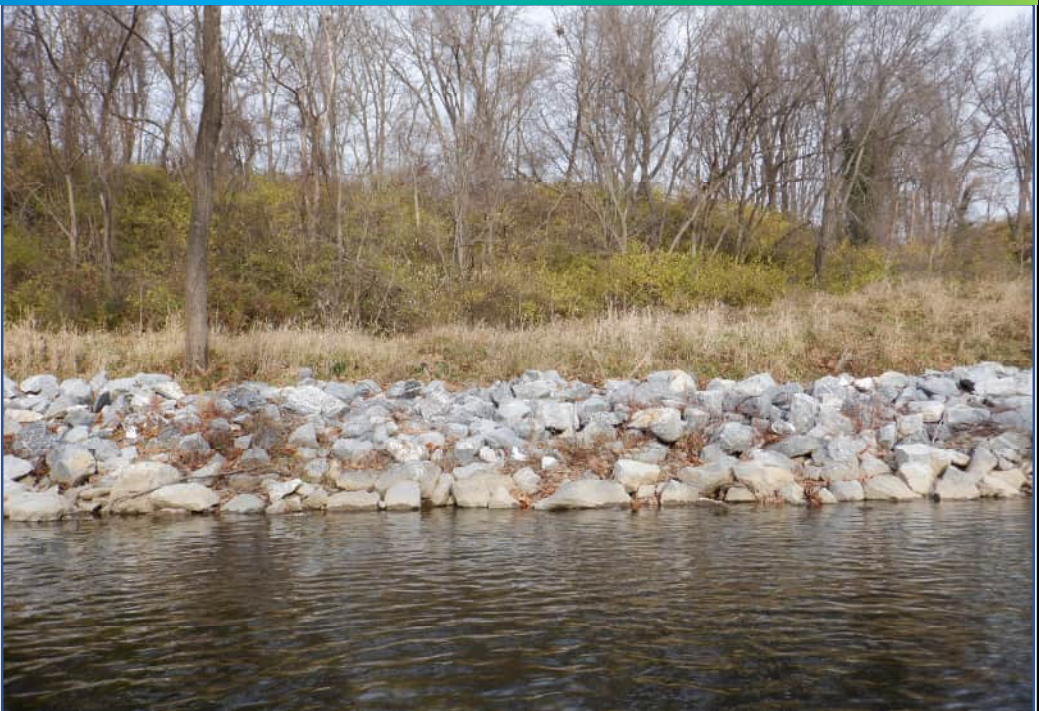
<b>Direction:</b> Northwest			
<b>Description:</b> ~ 20° bank angle; live stakes and plantings not established; 80% vegetation cover; no at-risk trees; rock toe intact; coir log deteriorated; minimal sediment deposition; vegetation establishing.

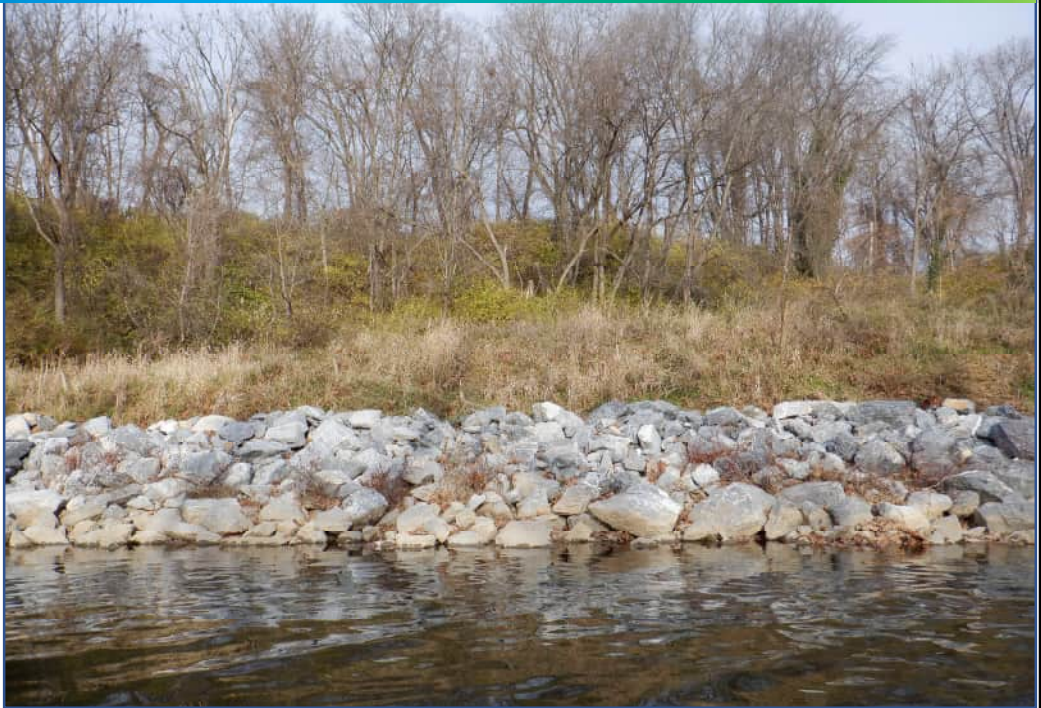
<b>Direction:</b> Northwest	
<b>Description:</b> ~ 30° bank angle; live stakes and plantings not established; 90% vegetation cover; no at-risk trees present; rock toe intact; coir log deteriorated; minimal sediment deposition; vegetation establishing.

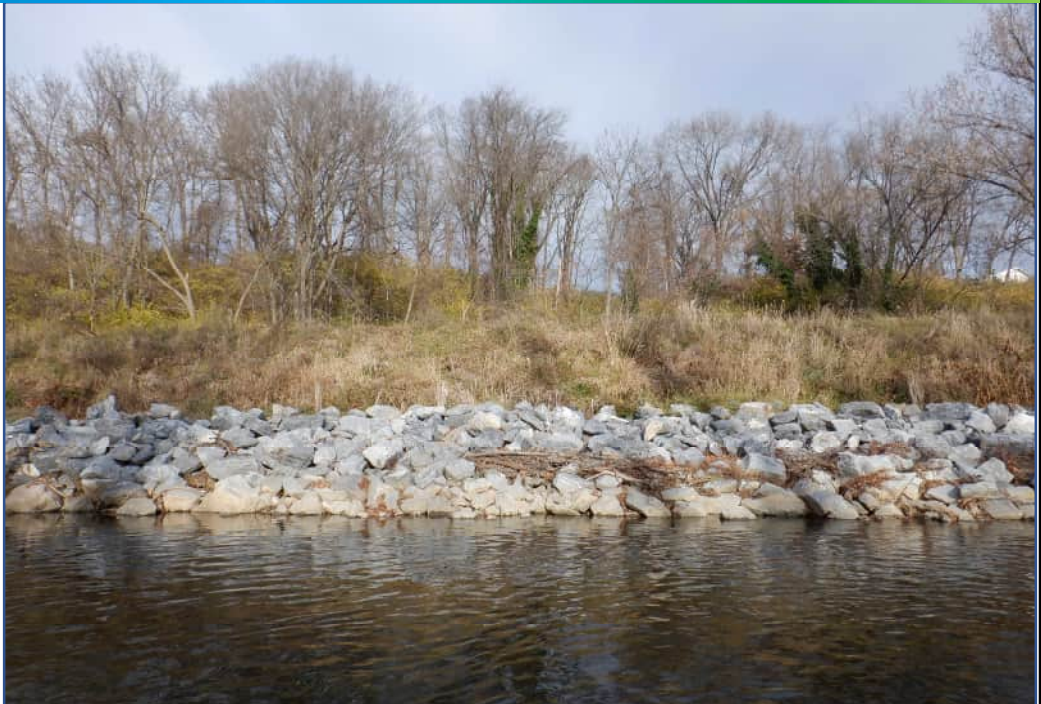
<b>Direction:</b> Northwest	
<b>Description:</b> ~ 30° bank angle; live stakes and plantings not established; 90% vegetation cover; no at-risk trees present; rock toe intact; coir log deteriorated; minimal sediment deposition; vegetation establishing.

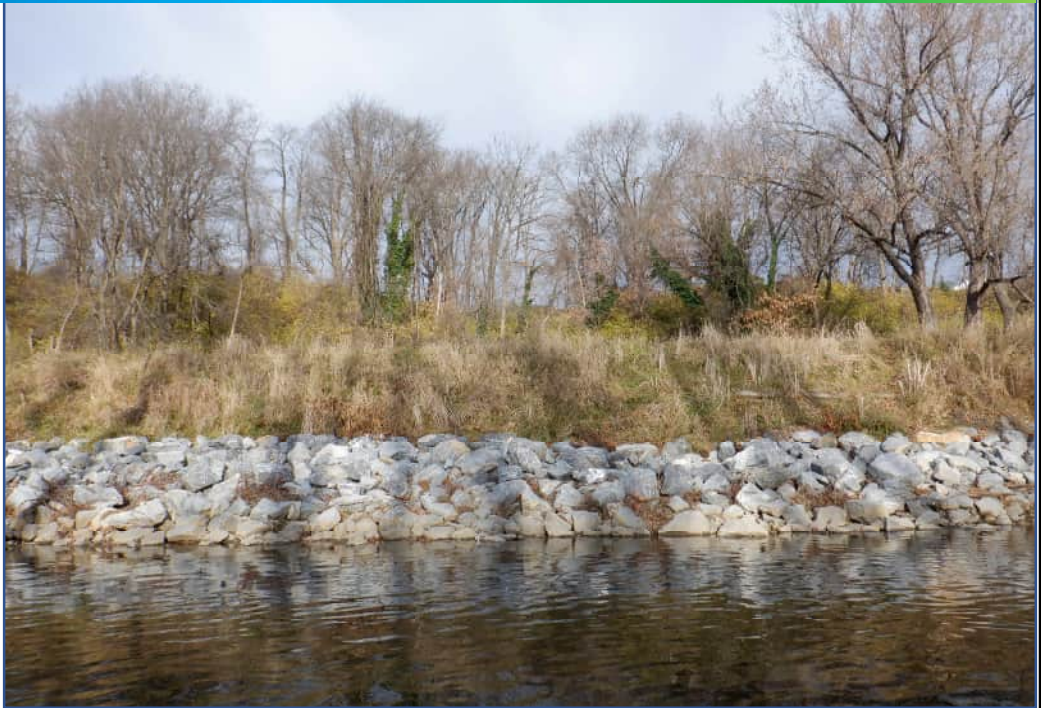
<b>Direction:</b> Northwest		
<b>Description:</b> ~ 45° bank angle; end of 1 <sup>st</sup> remediated section; live stakes and plantings not established; 90% vegetation cover; no at-risk trees present; rock toe intact; coir logs deteriorated; minimal sediment deposition; vegetation establishing.

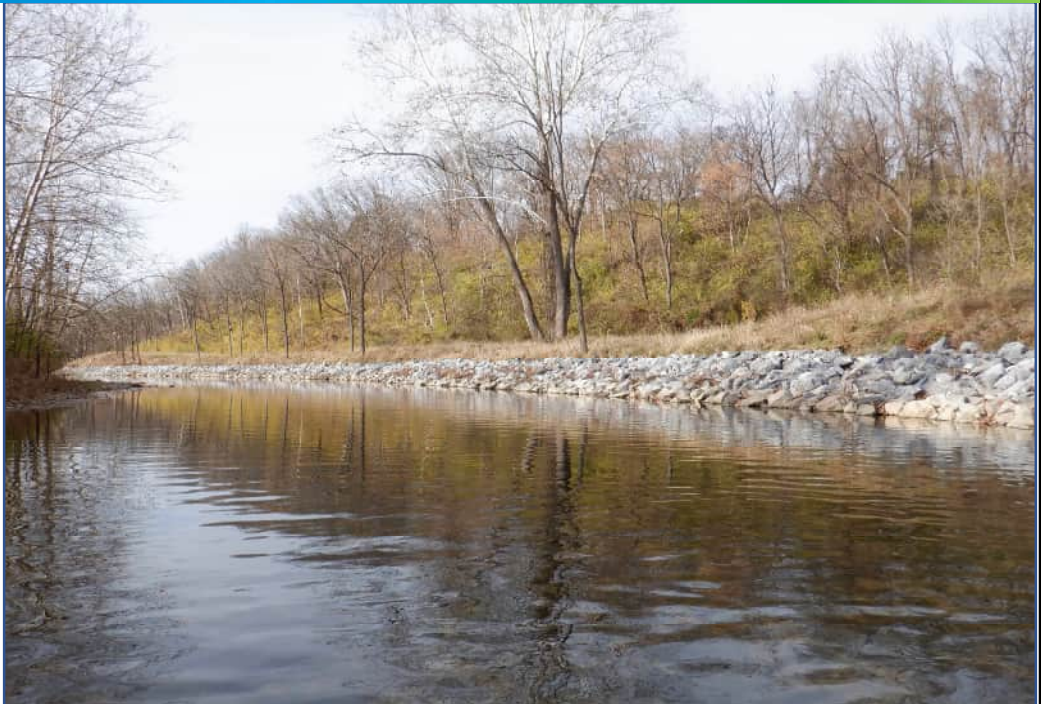
<b>Direction:</b> West		
<b>Description:</b> Upstream view of remediated bank; live stakes and plantings not established; no at-risk trees present; vegetation establishing.
