RE: 2022 Leaf-off, 2022 Leaf-on and 2023 Leaf-on BMA Inspection Memos
Former DuPont Waynesboro Site AOC 4
Waynesboro, Virginia
EPA ID# VAD003114832

Subject South River BMA - 2022 Leaf-off Maintenance Inspection
Former DuPont Waynesboro Site, Area of Concern 4

South River Photo Log
 City Shops BMA
 2022 Leaf-off Inspection

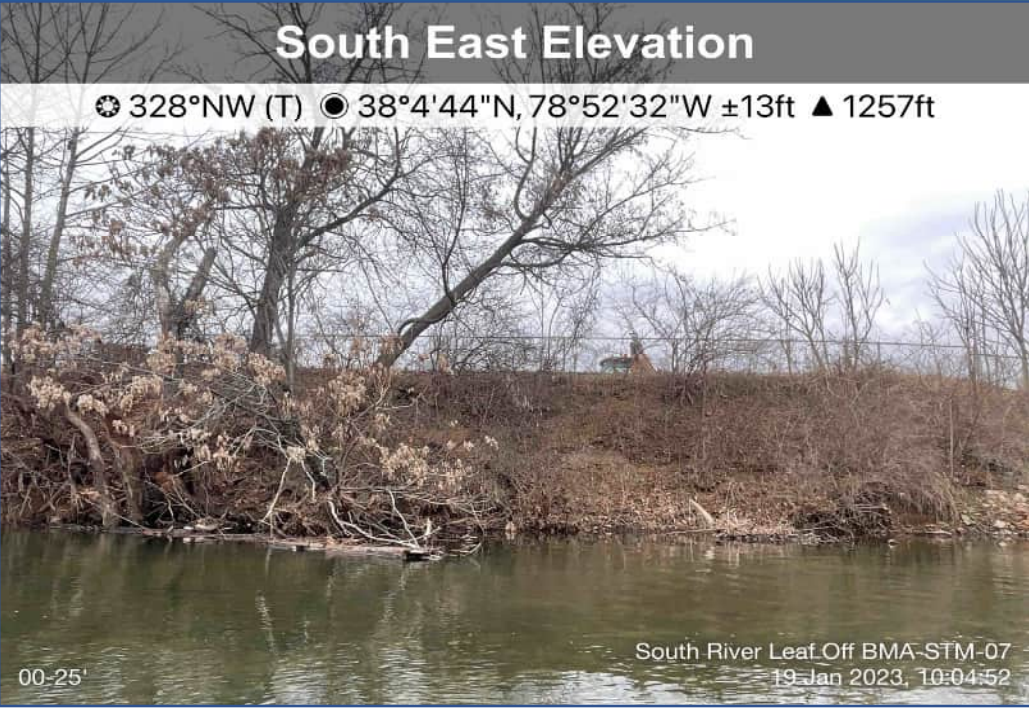
Photo Number: 01	Location: 00 - 25'
Date: 01/19/2023	<div style="background-color: #cccccc; padding: 5px;">South East Elevation</div> <div style="background-color: #e0e0e0; padding: 5px;"> 📍 328°NW (T) 📍 38°4'44"N, 78°52'32"W ±13ft ▲ 1257ft </div>

Direction: Northwest	
Description: Upstream of remediated area; ~85° bank angle; high quantity of exposed roots on the bank; 25% vegetated; scour present throughout	
00-25'	South River Leaf Off BMA-STM-07 19 Jan 2023, 10:04:52

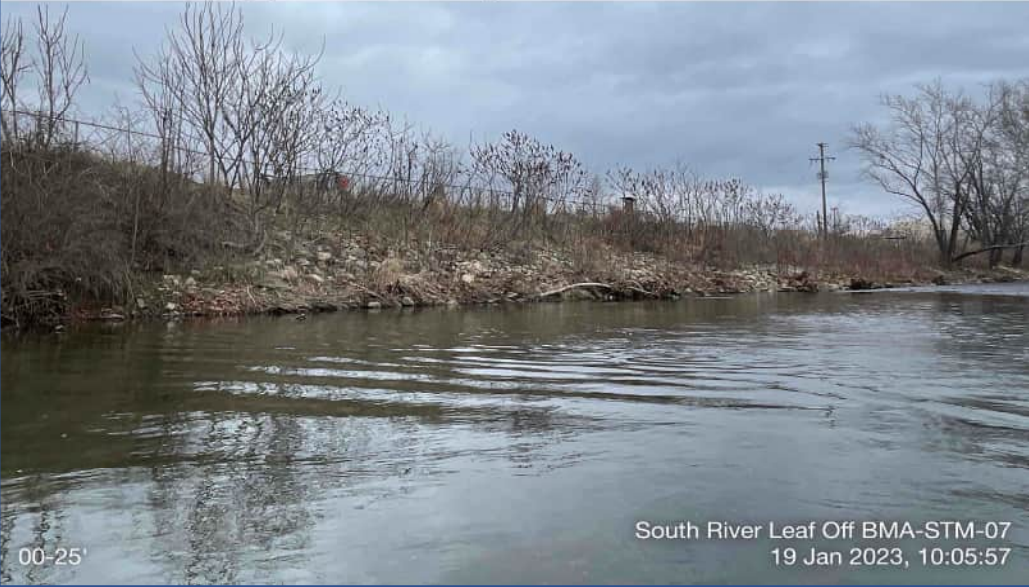
Photo Number: 02	Location: 00 - 25'
Date: 01/19/2023	<div style="background-color: #cccccc; padding: 5px;">South Elevation</div> <div style="background-color: #e0e0e0; padding: 5px;"> 📍 20°N (T) 📍 38°4'44"N, 78°52'32"W ±13ft ▲ 1263ft </div>

Direction: North	
Description: Downstream view of start of remediated area; grasses establishing by rock toe base; at risk trees present; scour present throughout	
00-25'	South River Leaf Off BMA-STM-07 19 Jan 2023, 10:05:57

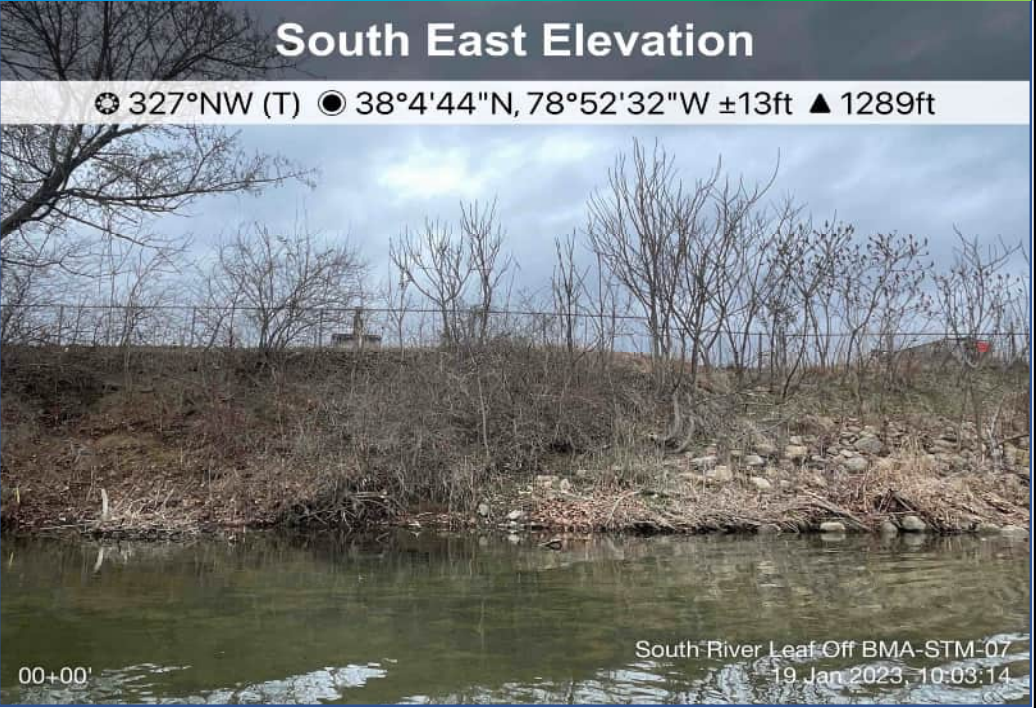
Photo Number: 03	Location: 00 + 00'
Date: 01/19/2023	<h2 style="margin: 0;">South East Elevation</h2> <p style="margin: 0;">☉ 327°NW (T) ● 38°4'44"N, 78°52'32"W ±13ft ▲ 1289ft</p>

<p style="margin: 0; font-size: small;">00+00' South River Leaf Off BMA-STM-07 19 Jan 2023, 10:03:14</p>
Direction: Northwest	
<p>Description: Beginning of 1st remediation area; lower bank ~50°; upper bank ~70°; no woody plants adjacent to edge of water; vegetation fully established and grasses establishing by rock toe base; some scour present from rock toe to mid bank upstream of remediation</p>

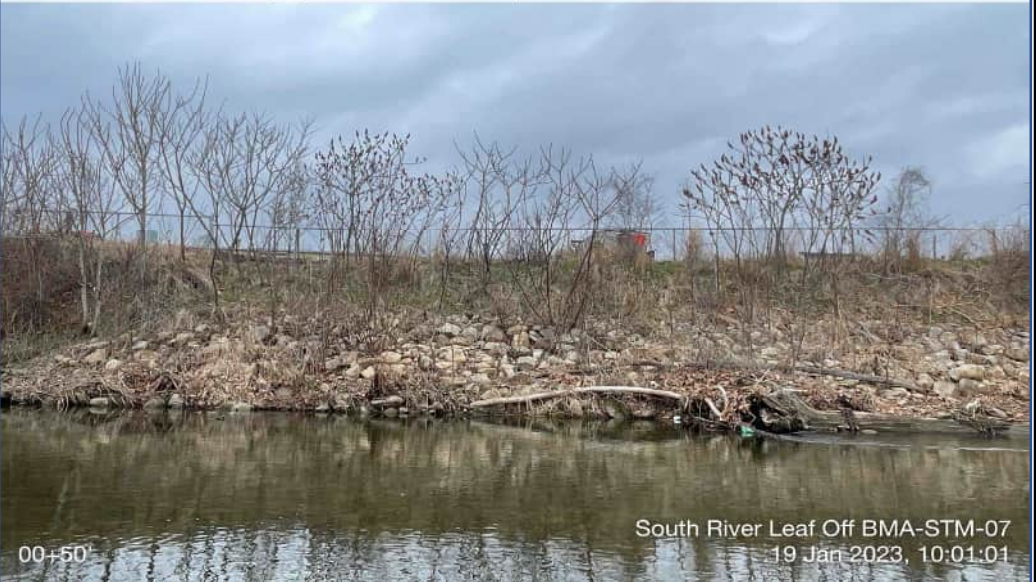
Photo Number: 04	Location: 00 + 50'
Date: 01/19/2023	<h2 style="margin: 0;">South East Elevation</h2> <p style="margin: 0;">☉ 324°NW (T) ● 38°4'44"N, 78°52'31"W ±13ft ▲ 1275ft</p>

<p style="margin: 0; font-size: small;">00+50' South River Leaf Off BMA-STM-07 19 Jan 2023, 10:01:01</p>
Direction: Northwest	
<p>Description: ~45° bank angle; predominantly native vegetation along top of rock toe; vegetation fully established; grasses establishing by rock toe base; no woody plants adjacent to edge of water, drift lines present on rip rap, minimal exposed geocell</p>

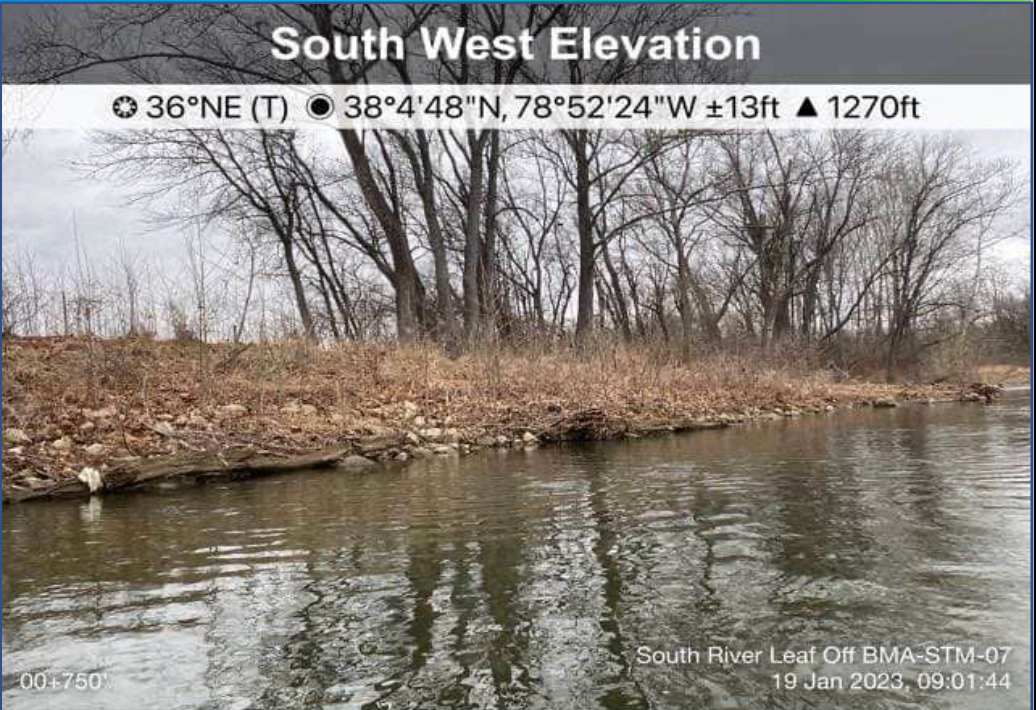
<p>Photo Number: 29</p>	<p>Location: 00 + 750'</p>
<p>Date: 01/19/2023</p>	<div style="text-align: center;"> <p>South West Elevation</p> <p>☀ 36°NE (T) ● 38°4'48"N, 78°52'24"W ±13ft ▲ 1270ft</p>

</div>
<p>Direction: Northeast</p>	
<p>Description: Downstream view of the beginning of the remediation area; rock toe intact, LWD intact</p>	
<p>00+750' South River Leaf Off BMA-STM-07 19 Jan 2023, 09:01:44</p>

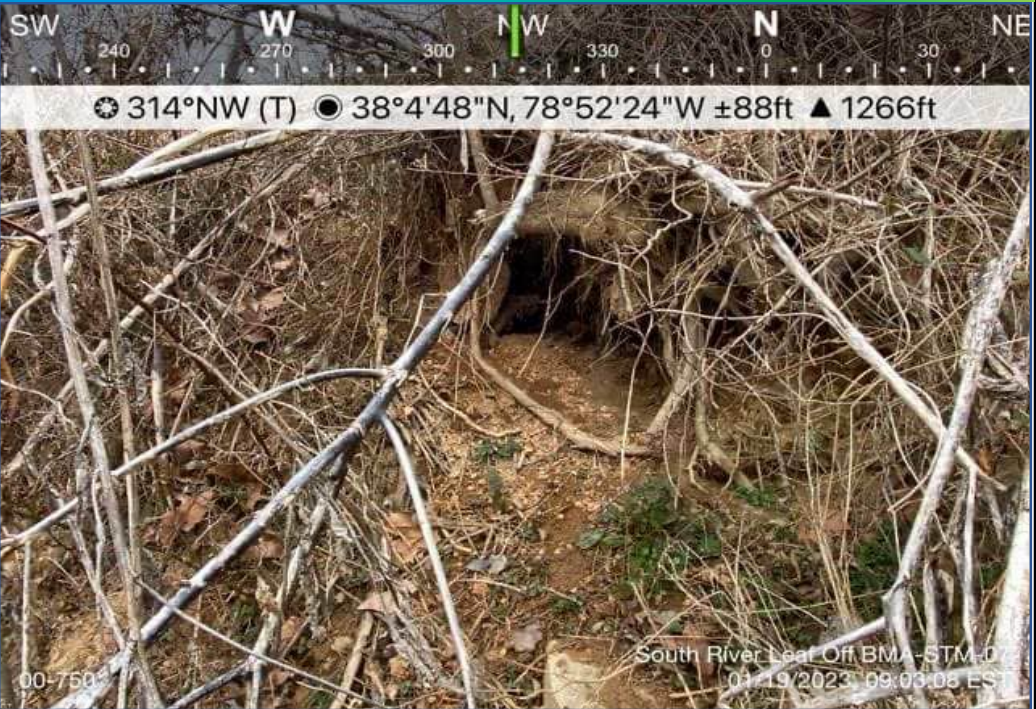
<p>Photo Number: 30</p>	<p>Location: 00 + 750'</p>
<p>Date: 01/19/2023</p>	<div style="text-align: center;"> <p>SW W NW N NE</p> <p>240 270 300 330 0 30</p> <p>☀ 314°NW (T) ● 38°4'48"N, 78°52'24"W ±88ft ▲ 1266ft</p>

</div>
<p>Direction: Northwest</p>	
<p>Description: Upper bank upstream of start of remediated section is undercut by an animal burrow</p>	
<p>00-750' South River Leaf Off BMA-STM-07 01/19/2023, 09:03:05 EST</p>

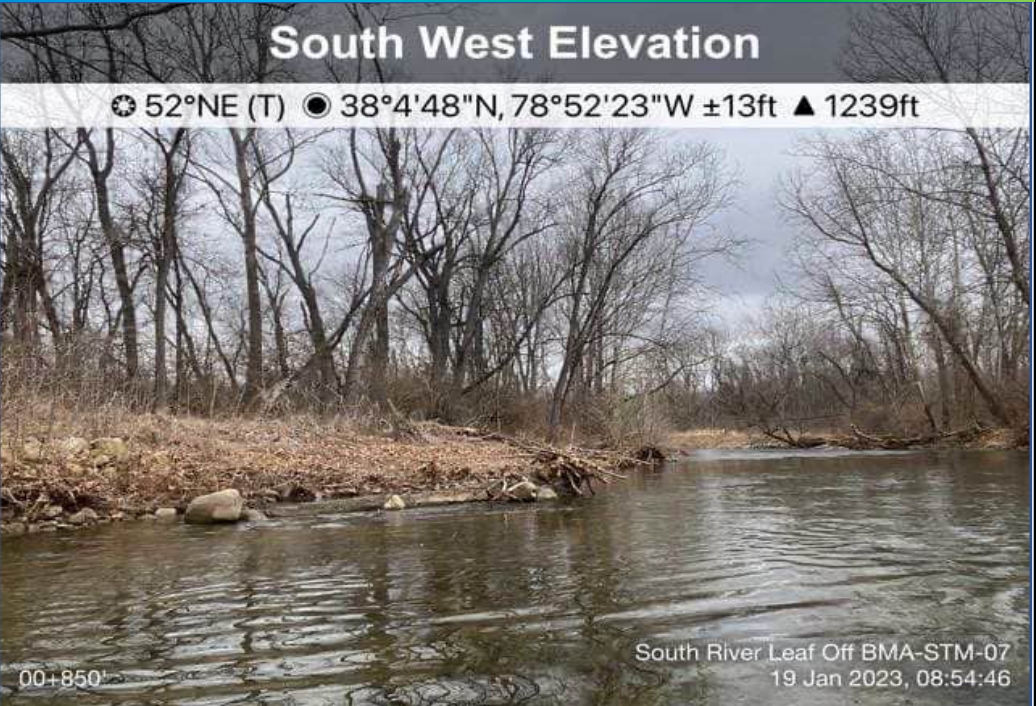
Photo Number: 34	Location: 00 + 850'
Date: 01/19/2023	<h2 style="margin: 0;">South West Elevation</h2> <p style="margin: 0;"> 📍 52°NE (T) 📍 38°4'48"N, 78°52'23"W ±13ft ▲ 1239ft </p>

Direction: Northeast	
<p>Description: Downstream view of remediated bank; rock toe intact; Previously installed LWD remains in place downstream from its original position and is closer to 00+880'; no scour present along rock toe</p>	
00+850'	South River Leaf Off BMA-STM-07 19 Jan 2023, 08:54:46

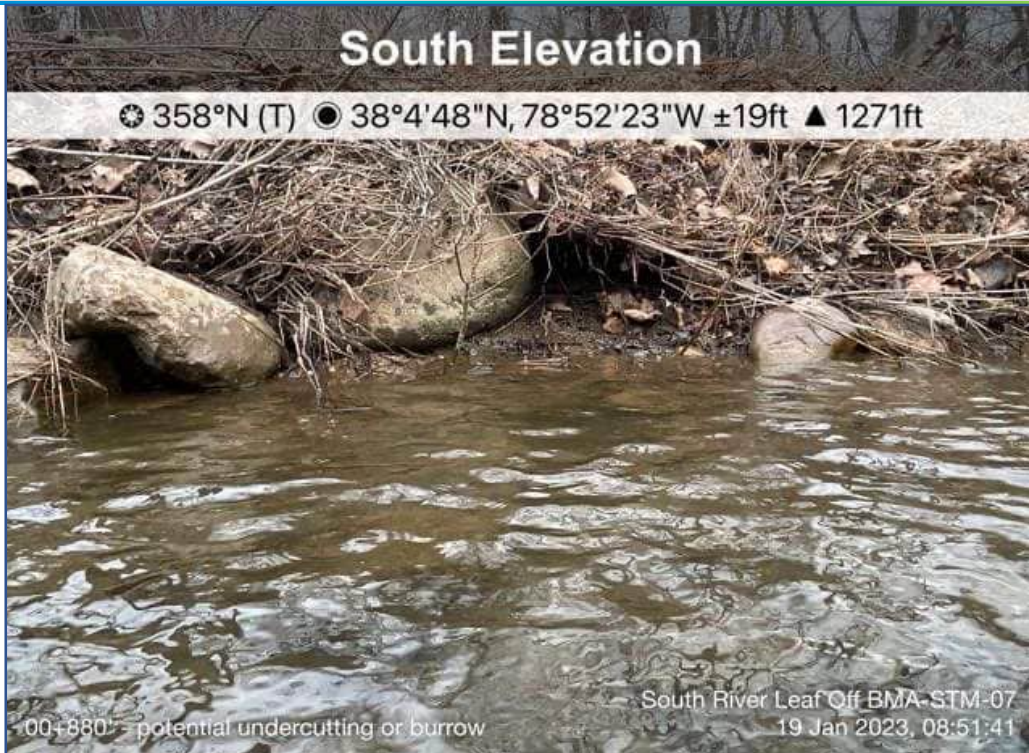
Photo Number: 37	Location: 00 + 880'
Date: 01/19/2023

<p>South Elevation</p> <p>☉ 358°N (T) ● 38°4'48"N, 78°52'23"W ±19ft ▲ 1271ft</p> <p>00+880' - potential undercutting or burrow</p> <p>South River Leaf Off BMA-STM-07 19 Jan 2023, 08:51:41</p>
Direction: North	
Description: Minor bank undercutting along shoreline

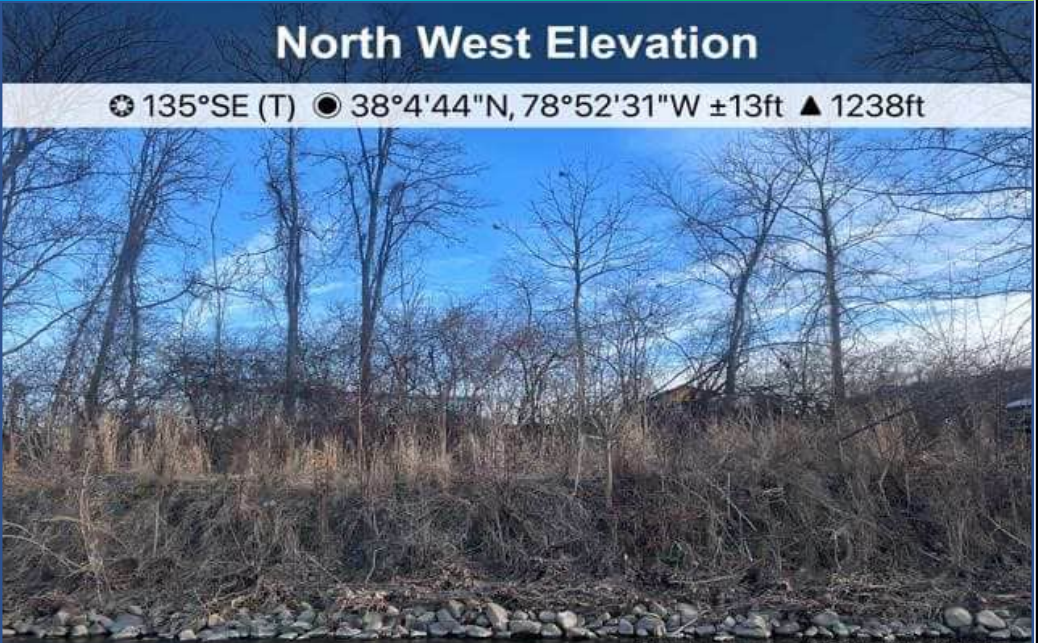
Photo Number: 05	Location: 00 + 100'
Date: 01/18/2023	<h3 style="margin: 0;">North West Elevation</h3> <div style="background-color: #e0e0e0; padding: 2px; margin: 2px 0;"> ☀ 135°SE (T) ● 38°4'44"N, 78°52'31"W ±13ft ▲ 1238ft </div>

<div style="display: flex; justify-content: space-between; margin-top: 5px;"> 00+100' South River Leaf Off BMA-STM-08 18 Jan 2023, 15:57:35 </div>
Direction: Southeast	
Description: ~50° bank angle; few live stakes observed; herbaceous vegetation fully established; no at-risk trees present; rock toe intact, no improvised weir observed, minimal geocell exposed

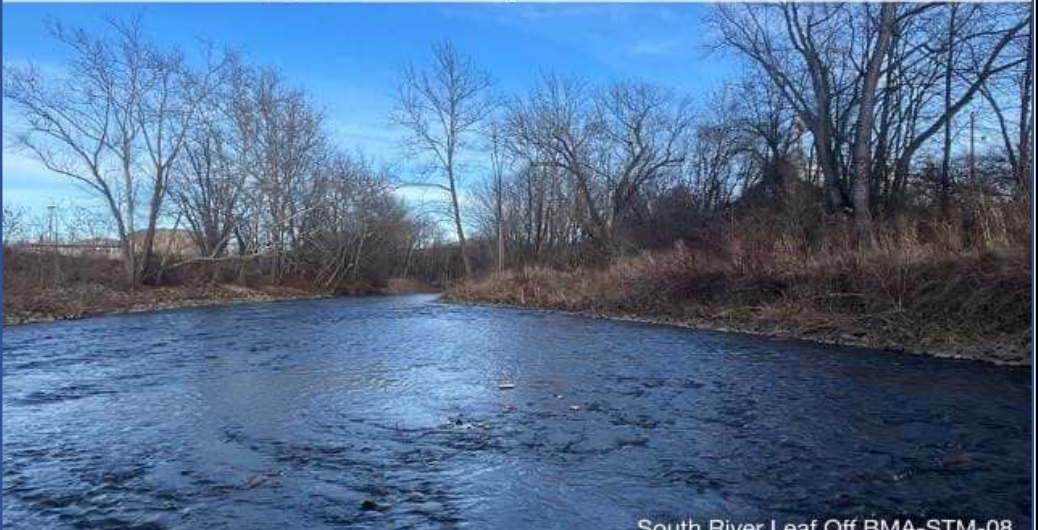
Photo Number: 06	Location: 00 + 100'
Date: 01/18/2023	<h3 style="margin: 0;">South West Elevation</h3> <div style="background-color: #e0e0e0; padding: 2px; margin: 2px 0;"> ☀ 64°NE (T) ● 38°4'44"N, 78°52'31"W ±9ft ▲ 1239ft </div>

<div style="display: flex; justify-content: space-between; margin-top: 5px;"> 00+100' South River Leaf Off BMA-STM-08 18 Jan 2023, 15:57:31 </div>
Direction: Northeast	
Description: Downstream view of remediated bank; vegetation fully established; no at-risk trees present.

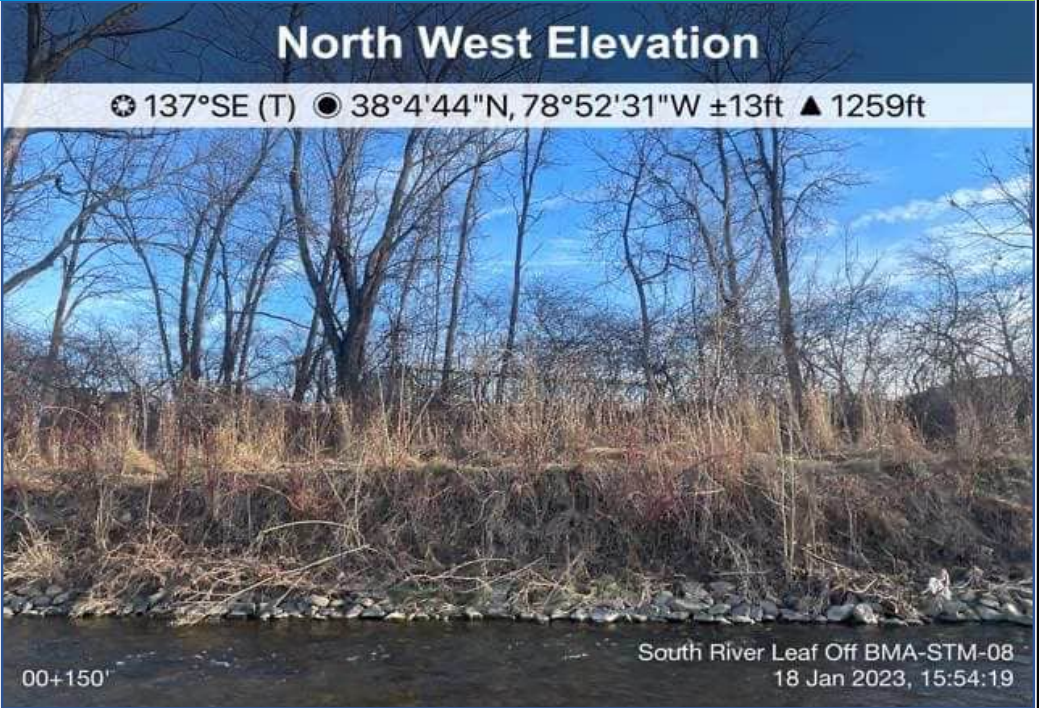
Photo Number: 07	Location: 00 + 150'
Date: 01/18/2023

<p>North West Elevation ☀ 137°SE (T) ● 38°4'44"N, 78°52'31"W ±13ft ▲ 1259ft</p> <p>00+150' South River Leaf Off BMA-STM-08 18 Jan 2023, 15:54:19</p>
Direction: Southeast	
Description: ~50° bank angle; live stakes 60% established; herbaceous vegetation mostly established; no at-risk trees present; rock toe intact; sand deposition at toe of bank, minimal geocell exposed.

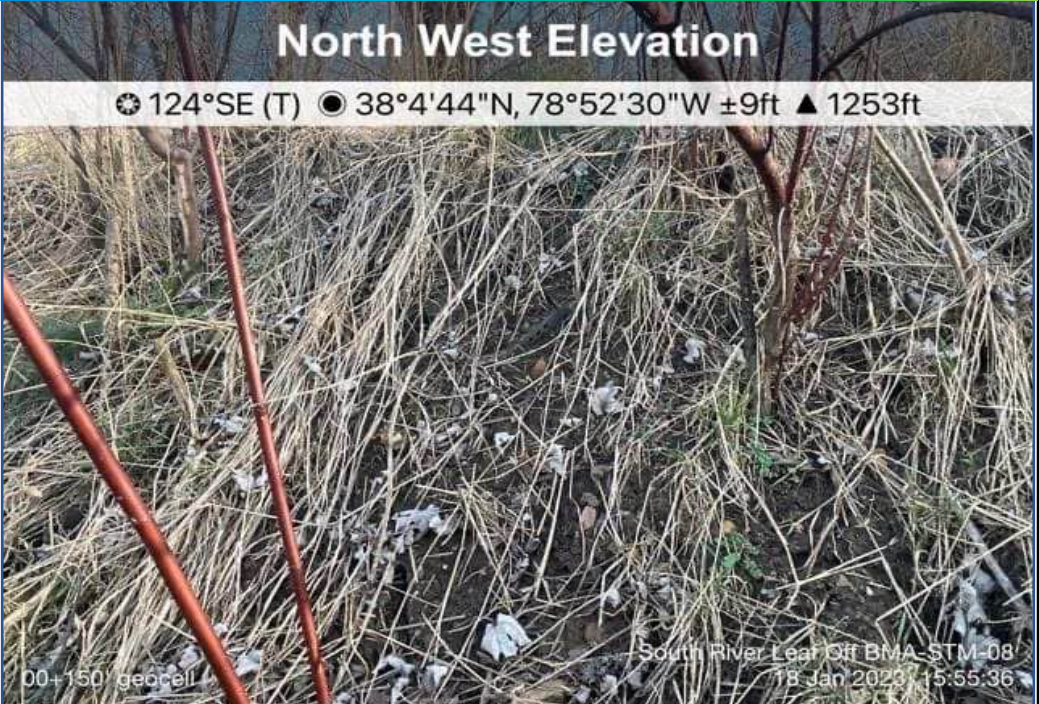
Photo Number: 08	Location: 00 + 150'
Date: 01/18/2023

<p>North West Elevation ☀ 124°SE (T) ● 38°4'44"N, 78°52'30"W ±9ft ▲ 1253ft</p> <p>00+150' geocell South River Leaf Off BMA-STM-08 18 Jan 2023, 15:55:36</p>
Direction: Southeast	
Description: Minimal geocell exposed, vegetation mostly established.

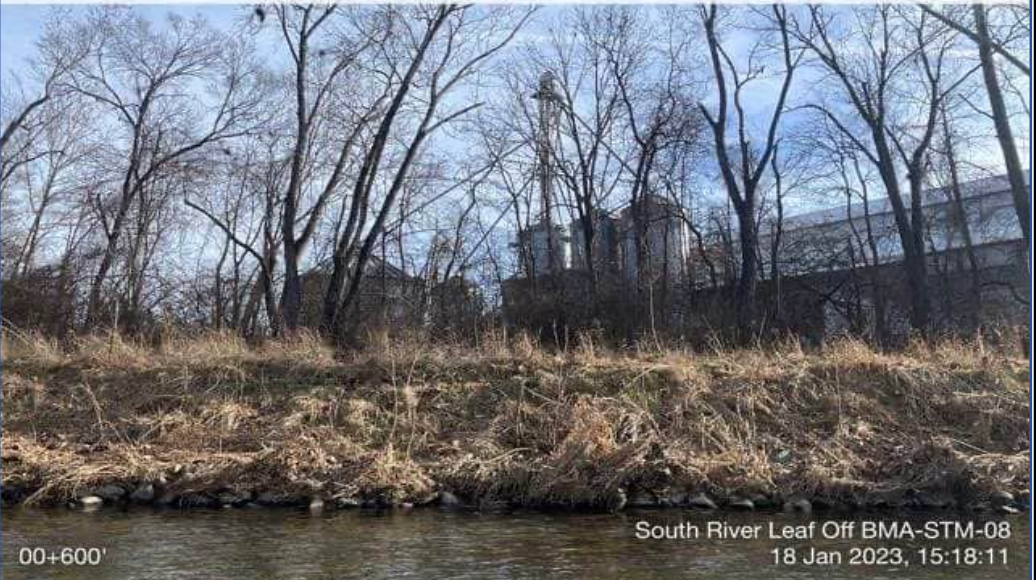
Photo Number: 22	Location: 00 + 600'
Date: 01/18/2023	<h3 style="margin: 0;">North West Elevation</h3> <div style="background-color: #e0e0e0; padding: 5px; margin: 5px 0;"> ☀ 151°SE (T) ● 38°4'47"N, 78°52'26"W ±13ft ▲ 1257ft </div>

Direction: Southeast	
<p>Description: Lower bank ~20°; upper bank ~40°; no live stakes observed; herbaceous vegetation fully established; no at-risk trees present; rock toe intact.</p>	
00+600'	South River Leaf Off BMA-STM-08 18 Jan 2023, 15:18:11

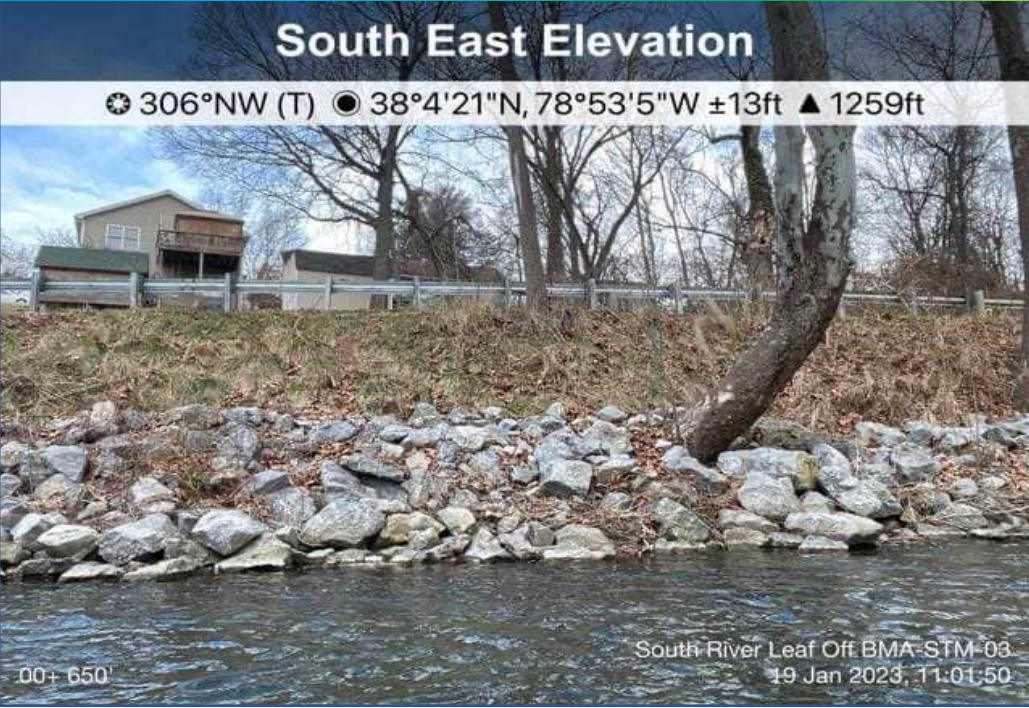
<p>Photo Number: 27</p>	<p>Location: 00 + 650'</p>
<p>Date: 01/19/2023</p>	<div style="text-align: center;"> <h3>South East Elevation</h3> <p>☼ 306°NW (T) ● 38°4'21"N, 78°53'5"W ±13ft ▲ 1259ft</p>

<p style="font-size: small;">00+ 650' South River Leaf Off BMA-STM-03 19 Jan 2023, 11:01:50</p> </div>
<p>Direction: Northwest</p>	
<p>Description: End of repaired section; vegetation 80% cover with sparse patches of exposed soil. Rock toe in good condition. Sycamore tree is firmly rooted in rock toe.</p>

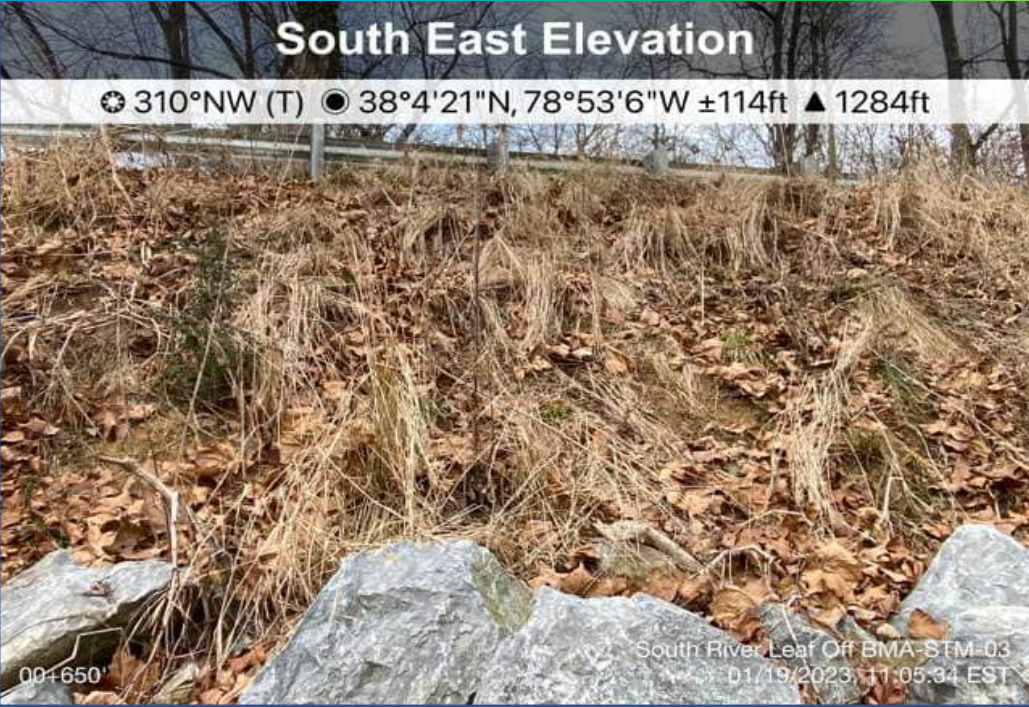
<p>Photo Number: 28</p>	<p>Location: 00 + 650'</p>
<p>Date: 01/19/2023</p>	<div style="text-align: center;"> <h3>South East Elevation</h3> <p>☼ 310°NW (T) ● 38°4'21"N, 78°53'6"W ±114ft ▲ 1284ft</p>

<p style="font-size: small;">00+650' South River Leaf Off BMA-STM-03 01/19/2023, 11:05:34 EST</p> </div>
<p>Direction: Northwest</p>	
<p>Description: Small patches of exposed soil present along upper bank.</p>

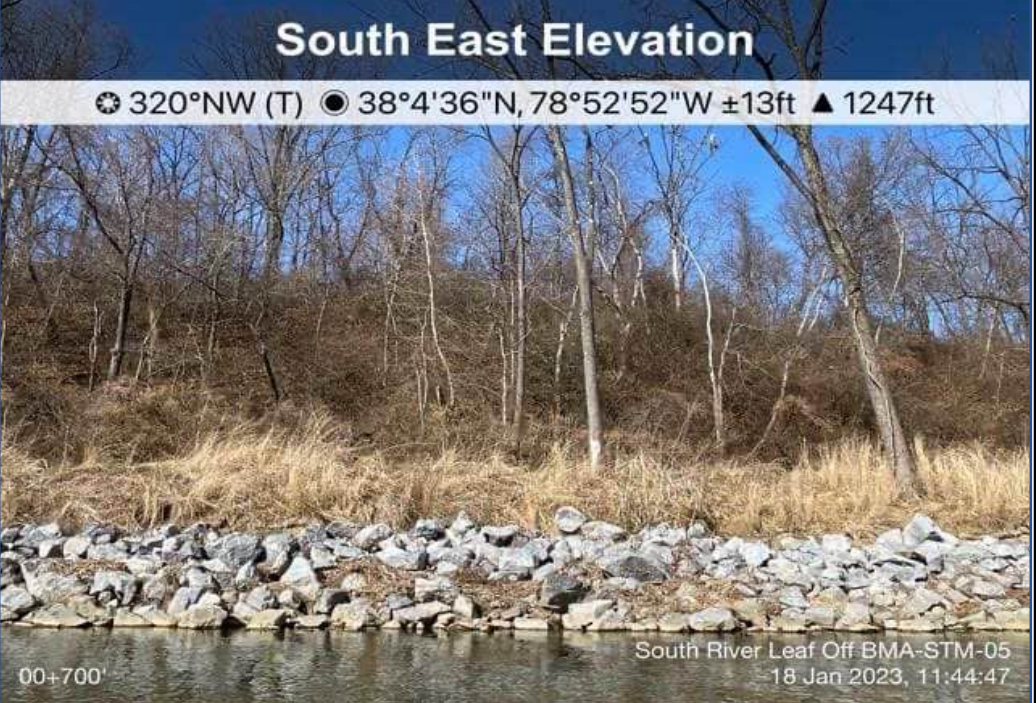
Photo Number: 34	Location: 00 + 700'
Date: 01/18/2023	<h3 style="color: white; background-color: #003366; padding: 5px;">South East Elevation</h3> <div style="background-color: #cccccc; padding: 5px; font-weight: bold;"> ☀ 320°NW (T) ● 38°4'36"N, 78°52'52"W ±13ft ▲ 1247ft </div>

Direction: Northwest	
<p>Description: ~40° bank angle; vegetation 80% cover; two trees near the greenway have damaged bark but are stable. Geocell is exposed just above rock toe with some exposed/eroded soil; erosion control fabric has mostly deteriorated.</p>	
00+700'	South River Leaf Off BMA-STM-05 18 Jan 2023, 11:44:47

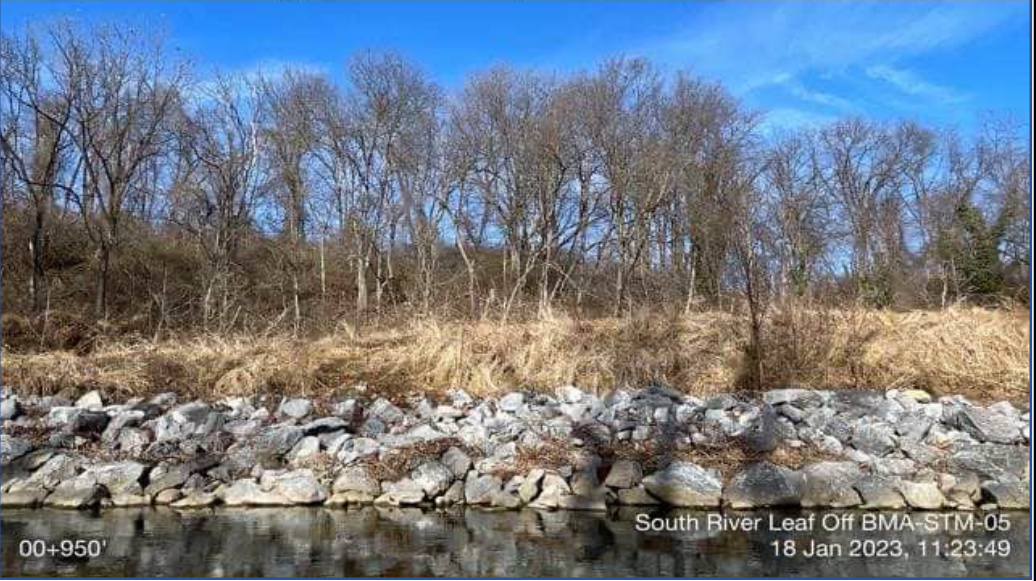
Photo Number: 41	Location: 00 + 950'
Date: 01/18/2023	<h3>South East Elevation</h3> <p>☼ 333°NW (T) ● 38°4'37"N, 78°52'49"W ±13ft ▲ 1275ft</p>

<p style="font-size: small; text-align: right;">South River Leaf Off BMA-STM-05 18 Jan 2023, 11:23:49</p>
Direction: Northwest	
<p>Description: ~30° bank angle; vegetation is well established (95% cover); no at-risk trees present; rock toe intact.</p>	
00+950'

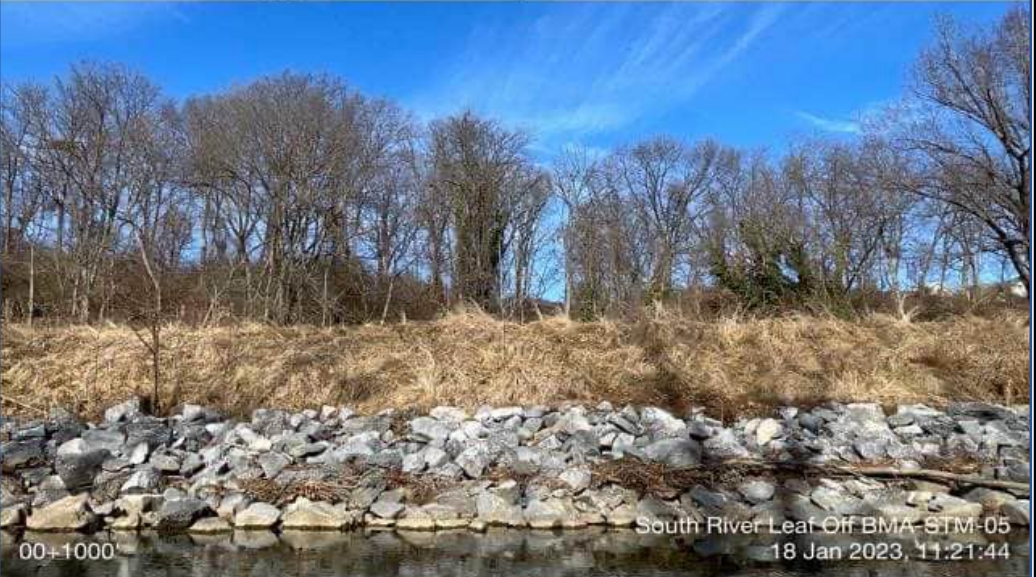
Photo Number: 42	Location: 00 + 1000'
Date: 01/18/2023	<h3>South East Elevation</h3> <p>☼ 336°NW (T) ● 38°4'38"N, 78°52'48"W ±13ft ▲ 1266ft</p>

<p style="font-size: small; text-align: right;">South River Leaf Off BMA-STM-05 18 Jan 2023, 11:21:44</p>
Direction: Northwest	
<p>Description: ~30° bank angle; a few saplings have established; 95% vegetation cover; no at-risk trees present; rock toe intact.</p>	
00+1000'

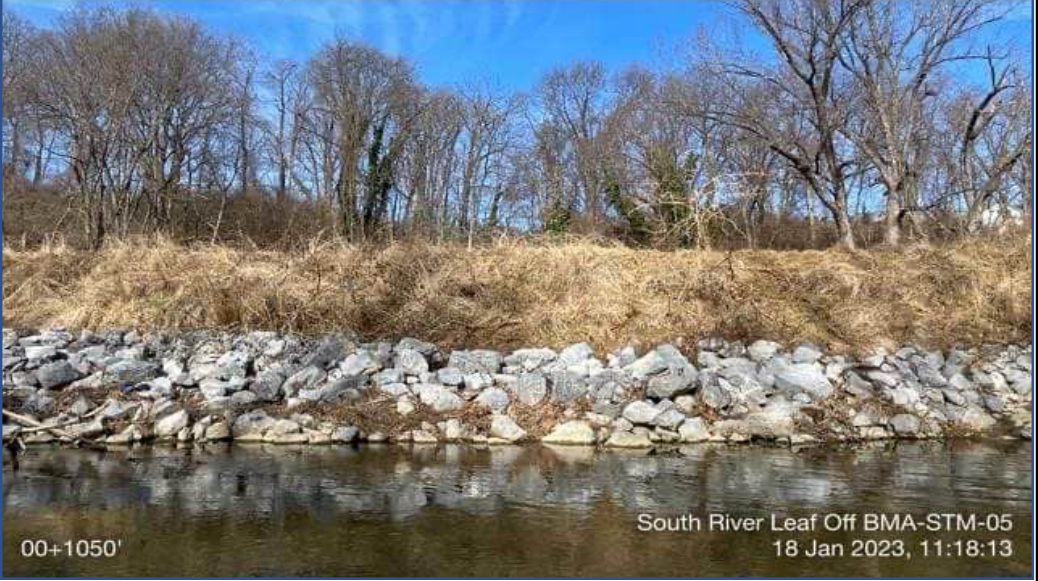
Photo Number: 43	Location: 00 + 1050'
Date: 01/18/2023	<h3>South East Elevation</h3> <p>☼ 331°NW (T) ● 38°4'38"N, 78°52'48"W ±13ft ▲ 1260ft</p>

<p style="text-align: right; font-size: small;">South River Leaf Off BMA-STM-05 18 Jan 2023, 11:18:13</p>
Direction: Northwest	
<p>Description: ~35° bank angle; end of 1st remediated section; 90% vegetation cover; plastic mesh netting from coir logs is exposed in a few areas.</p>	
00+1050'

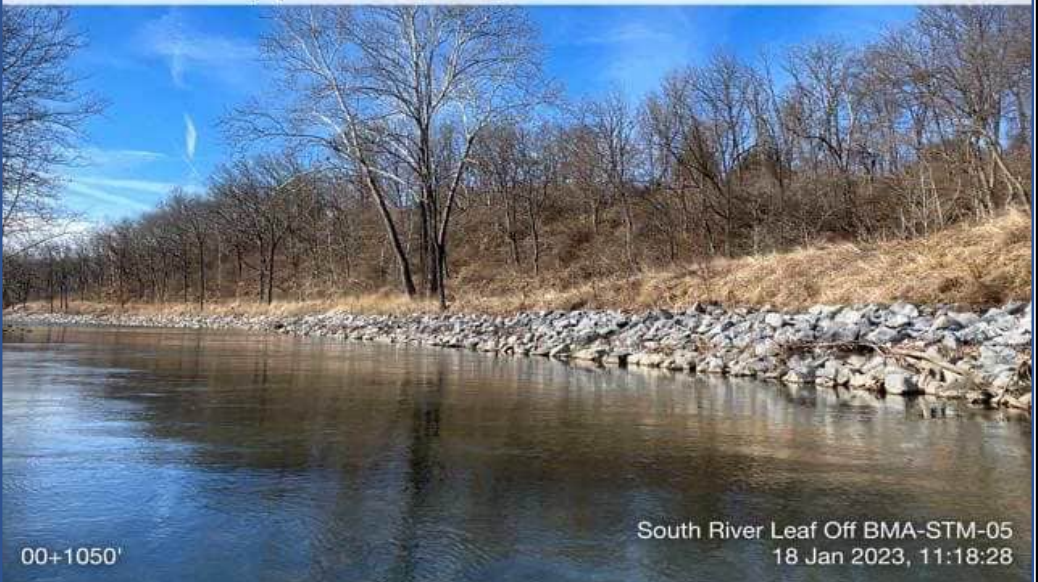
Photo Number: 44	Location: 00 + 1050'
Date: 01/18/2023	<h3>East Elevation</h3> <p>☼ 261°W (T) ● 38°4'38"N, 78°52'48"W ±13ft ▲ 1266ft</p>

<p style="text-align: right; font-size: small;">South River Leaf Off BMA-STM-05 18 Jan 2023, 11:18:28</p>
Direction: West	
<p>Description: Upstream view of remediated bank; live stakes and plantings not established; no at-risk trees present; vegetation establishing.</p>	
00+1050'

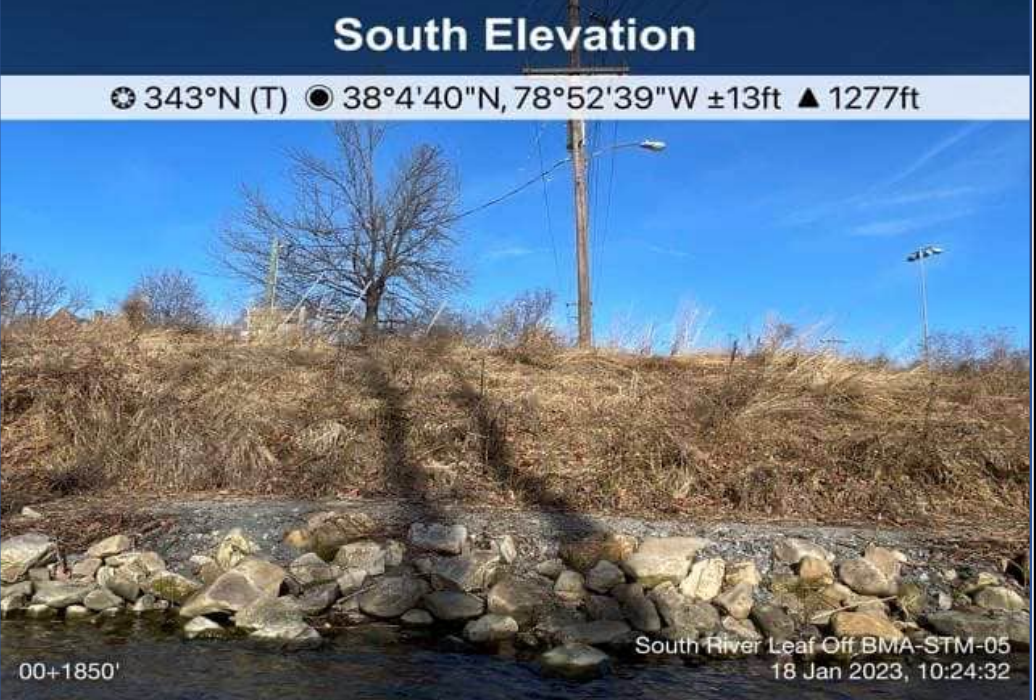
Photo Number: 72	Location: 00 + 1850'
Date: 01/18/2023	<h2 style="margin: 0;">South Elevation</h2> <p style="margin: 0;">☀ 343°N (T) ● 38°4'40"N, 78°52'39"W ±13ft ▲ 1277ft</p>

Direction: North	
Description: ~30° bank angle; 95% vegetation cover; no at-risk trees present; rock toe and gravel intact and walking path in good condition.	
00+1850'	South River Leaf Off BMA-STM-05 18 Jan 2023, 10:24:32

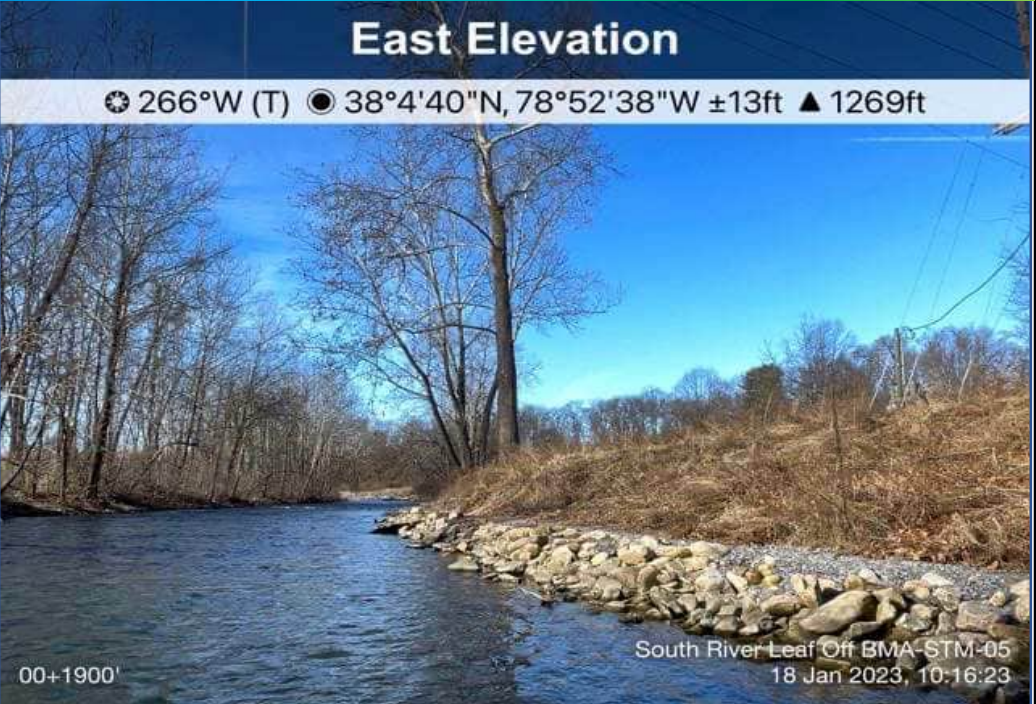
Photo Number: 74	Location: 00 + 1900'
Date: 01/18/2023	<h3 style="color: white; background-color: #003366; padding: 5px;">East Elevation</h3> <div style="background-color: #cccccc; padding: 2px;"> ☀ 266°W (T) ● 38°4'40"N, 78°52'38"W ±13ft ▲ 1269ft </div>

<div style="display: flex; justify-content: space-between; font-size: 0.8em; margin-top: 5px;"> 00+1900' South River Leaf Off BMA-STM-05 18 Jan 2023, 10:16:23 </div>
Direction: West	
<p>Description: Upstream view of remediated bank; vegetation is well established; rock toe and walking path are intact.</p>

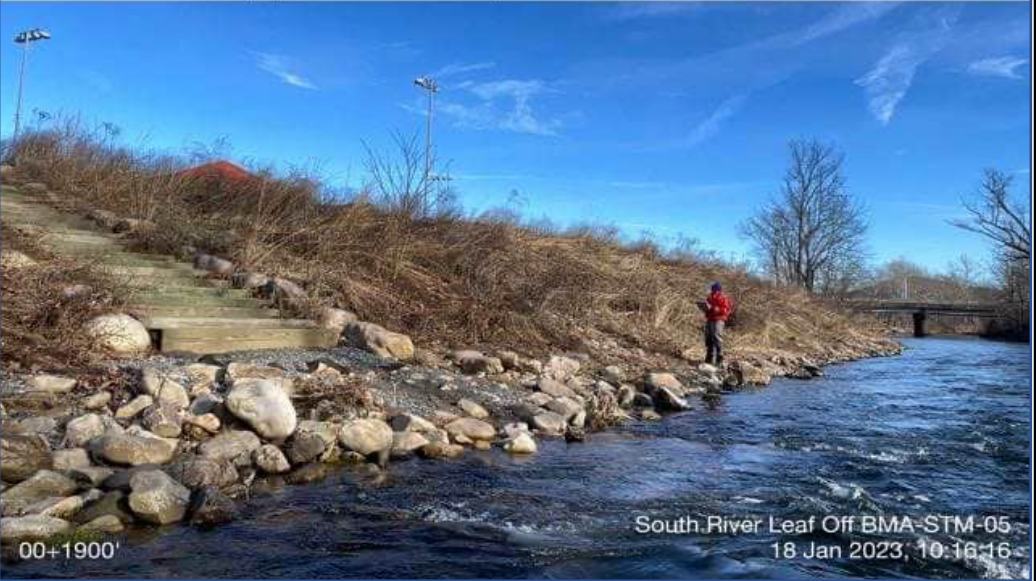
Photo Number: 75	Location: 00 + 1900'
Date: 01/18/2023	<h2 style="background-color: #003366; color: white; padding: 5px;">South West Elevation</h2> <p style="background-color: #cccccc; padding: 2px;">☉ 29°NE (T) ☉ 38°4'40"N, 78°52'38"W ±13ft ▲ 1268ft</p>

<p style="font-size: small; text-align: right;">South River Leaf Off BMA-STM-05 18 Jan 2023, 10:16:16</p>
Direction: Northeast	
<p>Description: Downstream view of remediated bank.</p>	
00+1900'

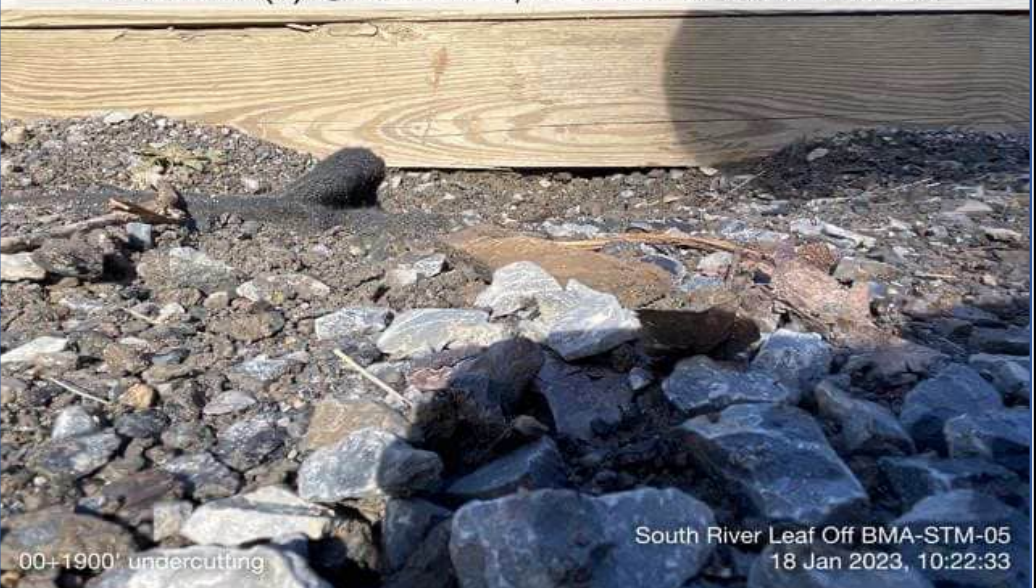
Photo Number: 76	Location: 00 + 1900'
Date: 01/18/2023	<h2 style="background-color: #003366; color: white; padding: 5px;">South East Elevation</h2> <p style="background-color: #cccccc; padding: 2px;">☉ 326°NW (T) ☉ 38°4'40"N, 78°52'38"W ±13ft ▲ 1282ft</p>

<p style="font-size: small; text-align: right;">South River Leaf Off BMA-STM-05 18 Jan 2023, 10:22:33</p>
Direction: Northwest	
<p>Description: Last stair is slightly undercut with some exposed erosion control fabric.</p>	
00+1900' undercutting
