RE: 2022 Leaf-off, 2022 Leaf-on and 2023 Leaf-on BMA Inspection Memos
Former DuPont Waynesboro Site AOC 4
Waynesboro, Virginia
EPA ID# VAD003114832

Memorandum

Subject 2022 Leaf-on Maintenance Inspection
Former DuPont Waynesboro Site, Area of Concern 4

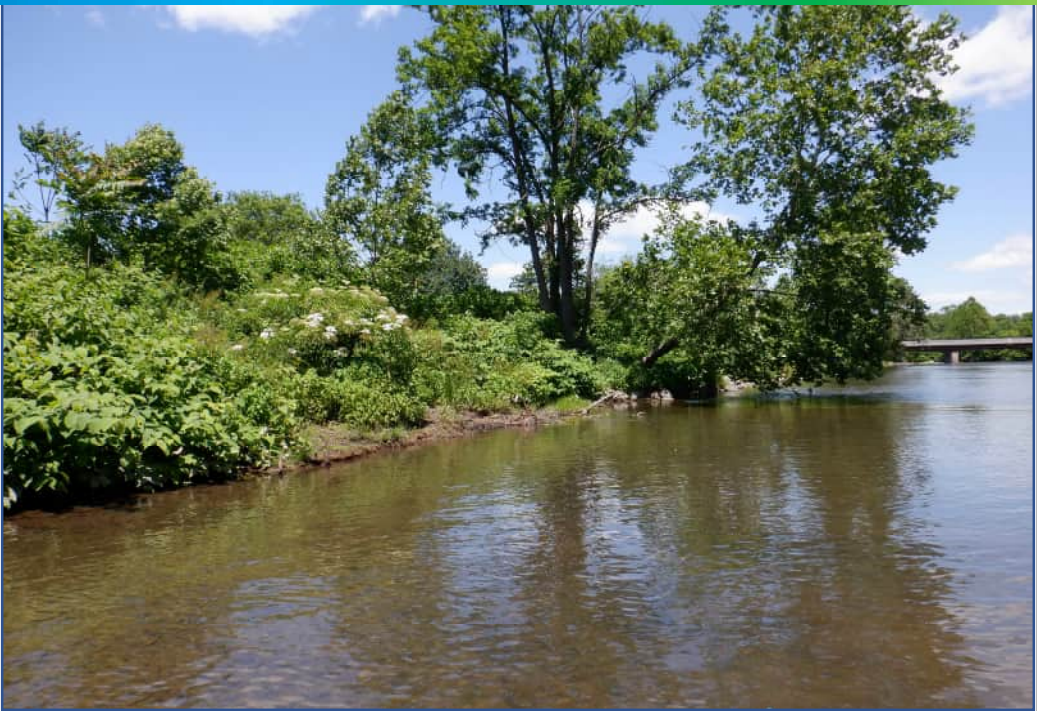
Direction: Northwest			
Description: View from upstream of remediated bank; low presence of scour 5' upstream of 00 – 25'; slight erosion at waters edge.

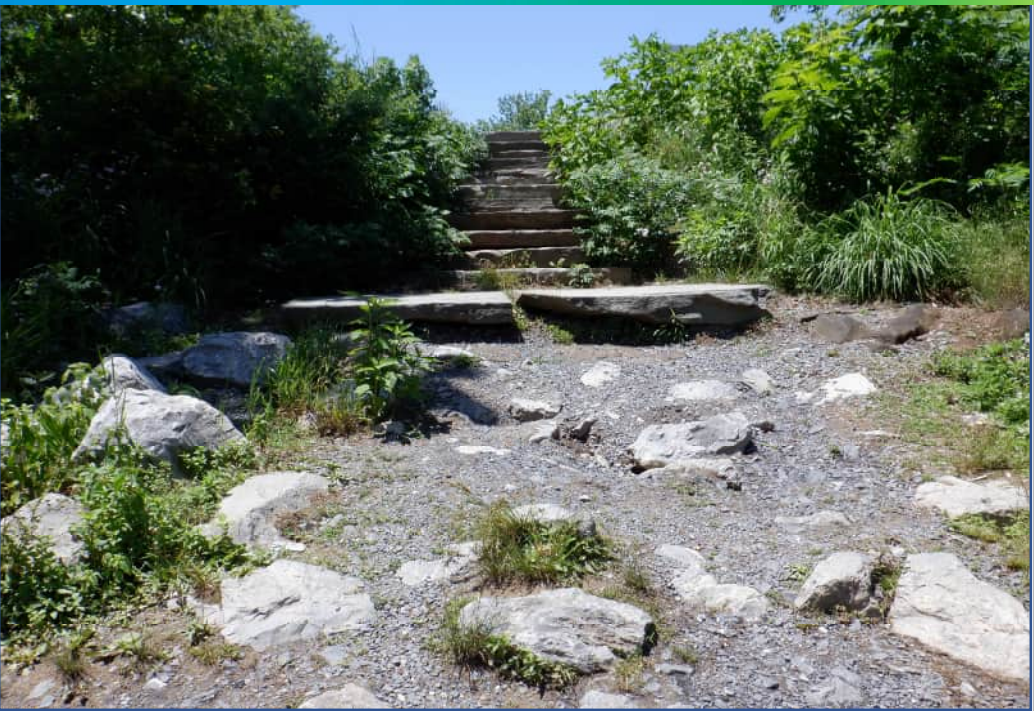
Direction: West			
Description: Rock toe along bank and constructed river access stairs intact, but continues to deteriorate; erosion from high water and human activity has caused several holes and divots on the path at the bottom of the stairs

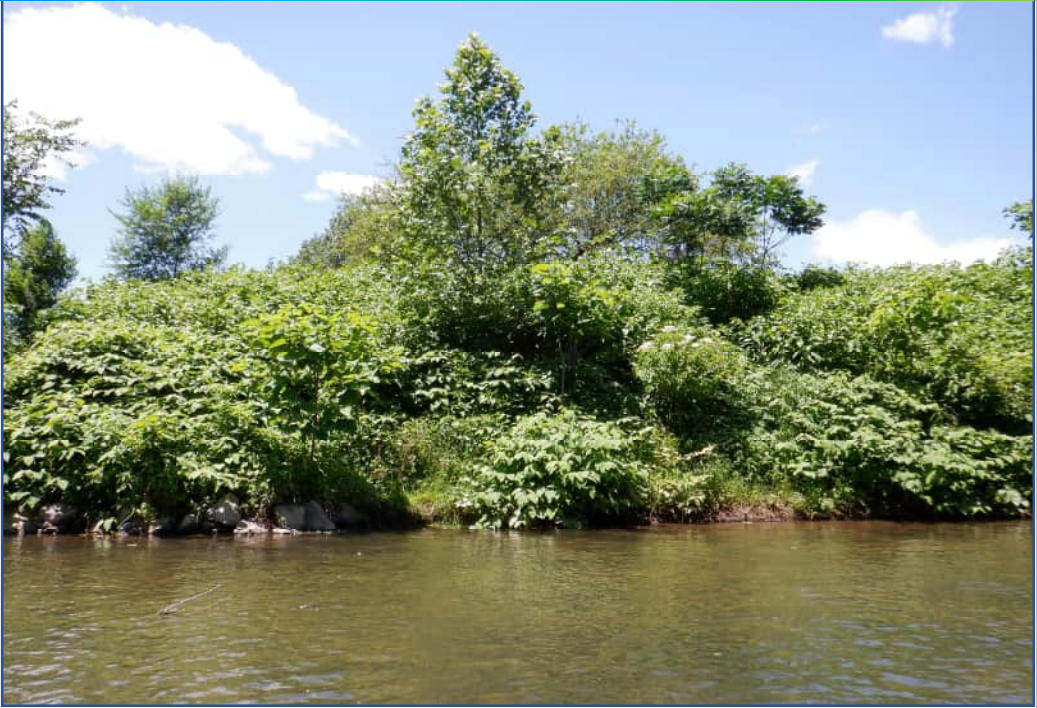
Direction: Southwest			
Description: ~55° bank angle; large patches of invasive knotweed ~50% cover; coir logs deteriorated, but stakes that held logs visibly protruding from water; evidence of foot traffic along the toe of slope and coir logs; minimal scour along toe.

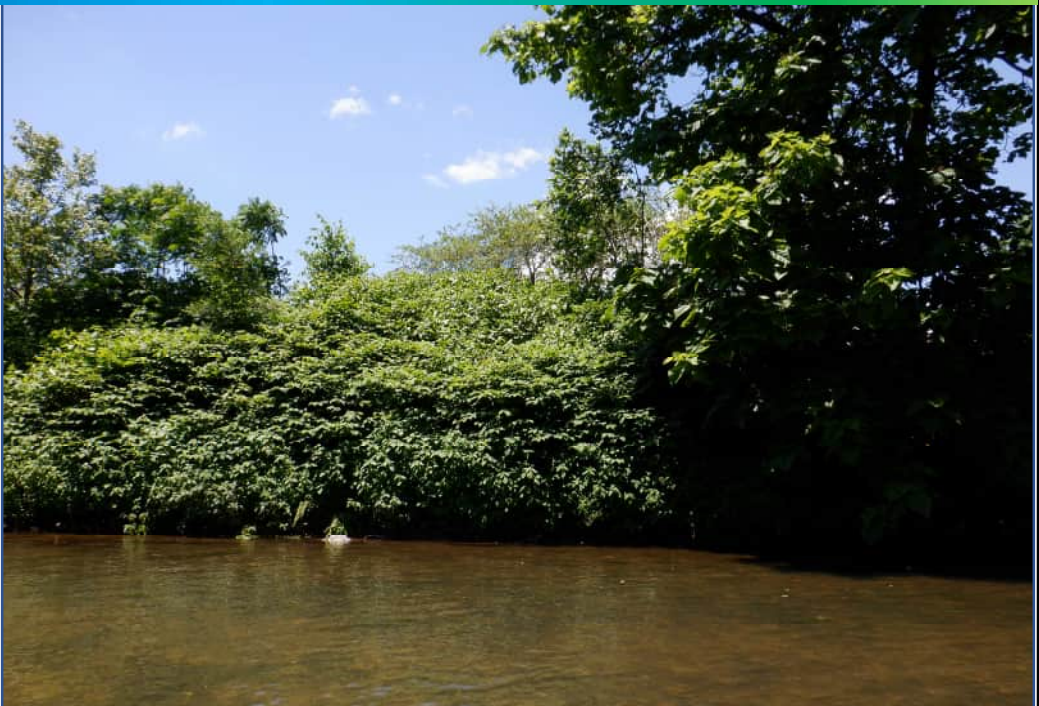
Direction: West	
Description: ~70° bank angle; few live stakes established; large patches of invasive knotweed 50% cover; no geocell or erosion control visible; coir logs deteriorated, but stakes that held logs visibly protruding from water.

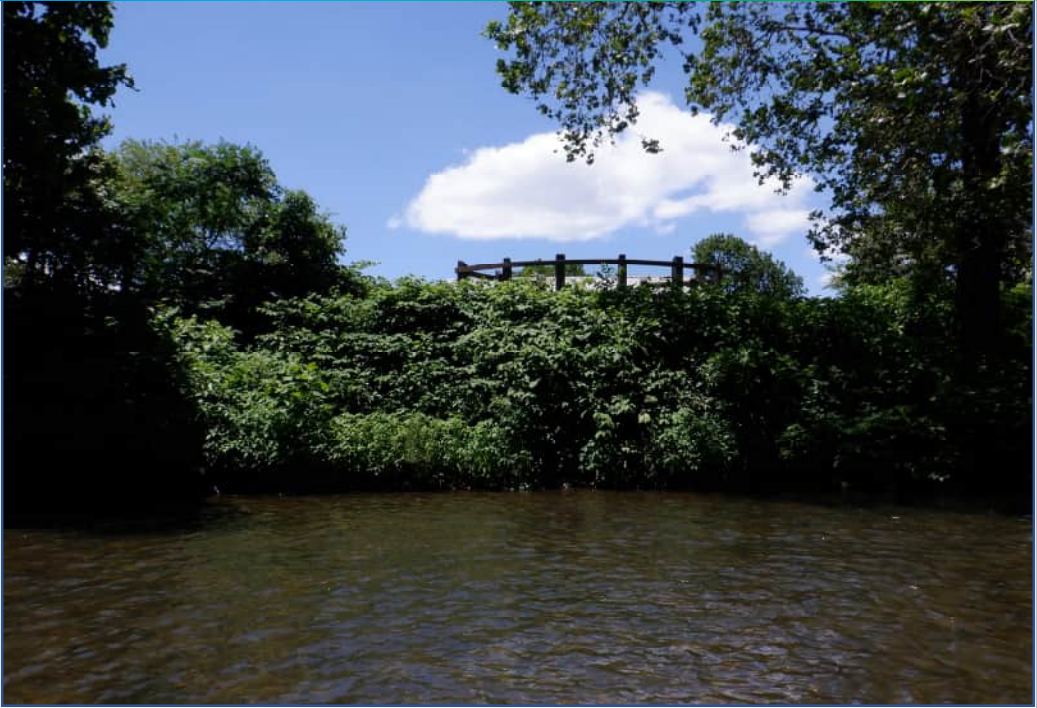
Direction: West	
Description: ~70° bank angle; no live stakes visible; Large patches of invasive knotweed ~70% cover; coir logs deteriorated, but stakes that held logs visibly protruding from water; lookout deck above bank on greenway.

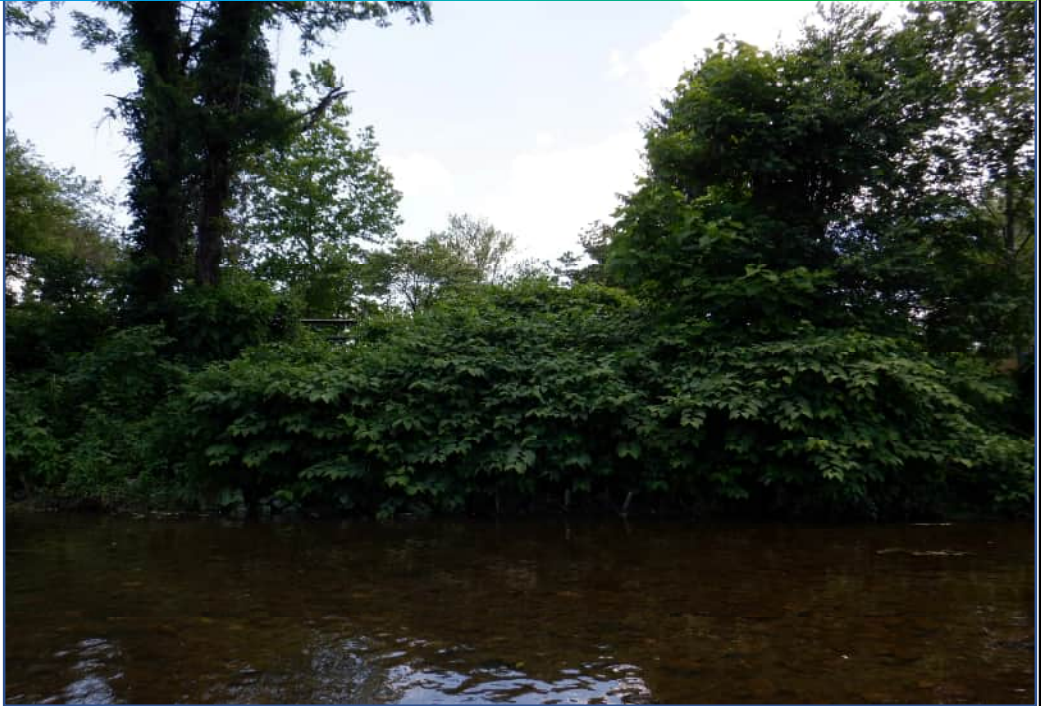
Direction: West			
Description: ~40° bank angle; no live stakes visible Large patch of invasive knotweed 60% cover; coir logs deteriorated, but stakes that held logs visibly protruding from water.

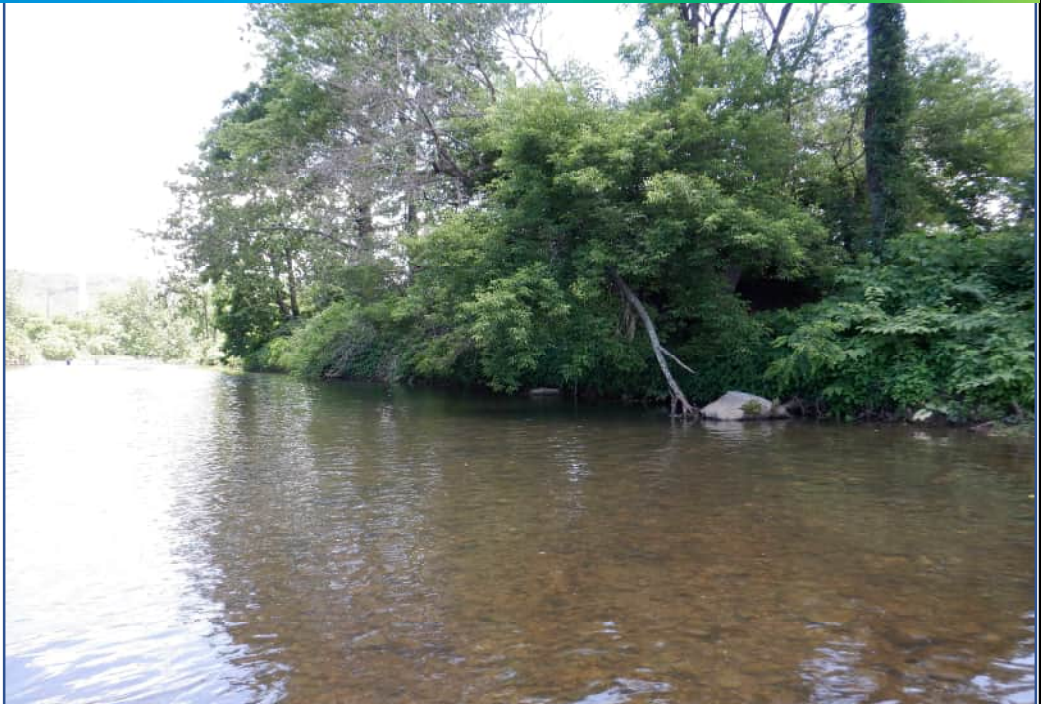
Direction: Southwest			
Description: Upstream view of bank remediation; at-risk tree present leaning over water, bark stripped from portion of trunk; undercutting.

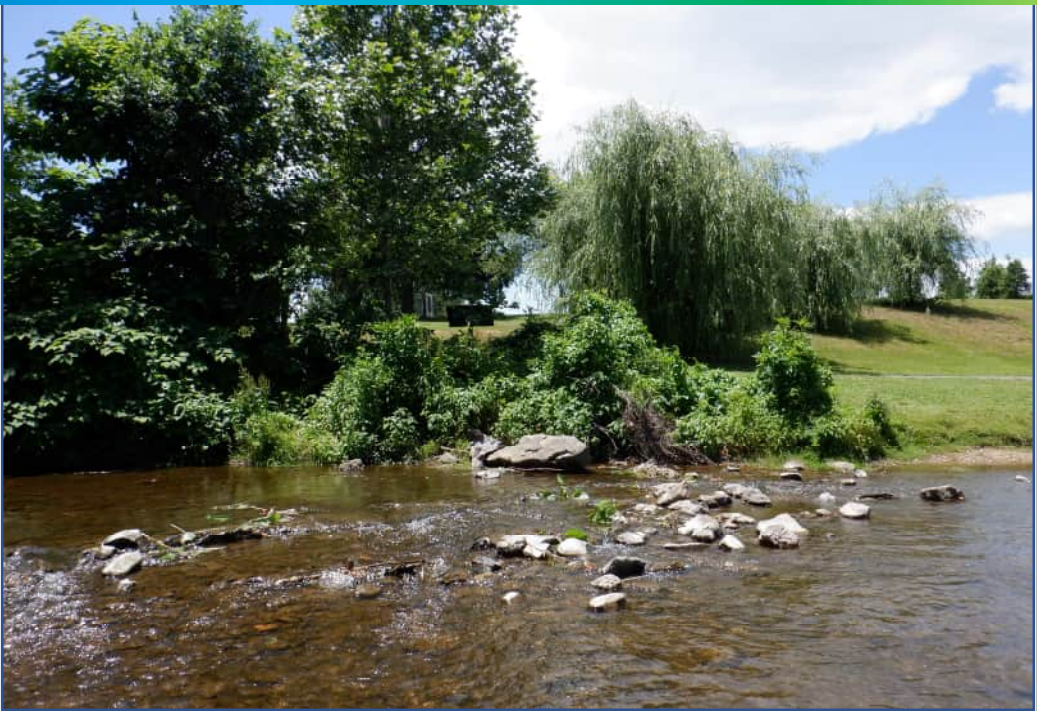
Direction: Northwest			
Description: End of remediated section and beginning of non-remediated section; ~45° bank angle; bank is only 3 ft in height; no live stakes; small patch of invasive knotweed; mostly native vegetation.

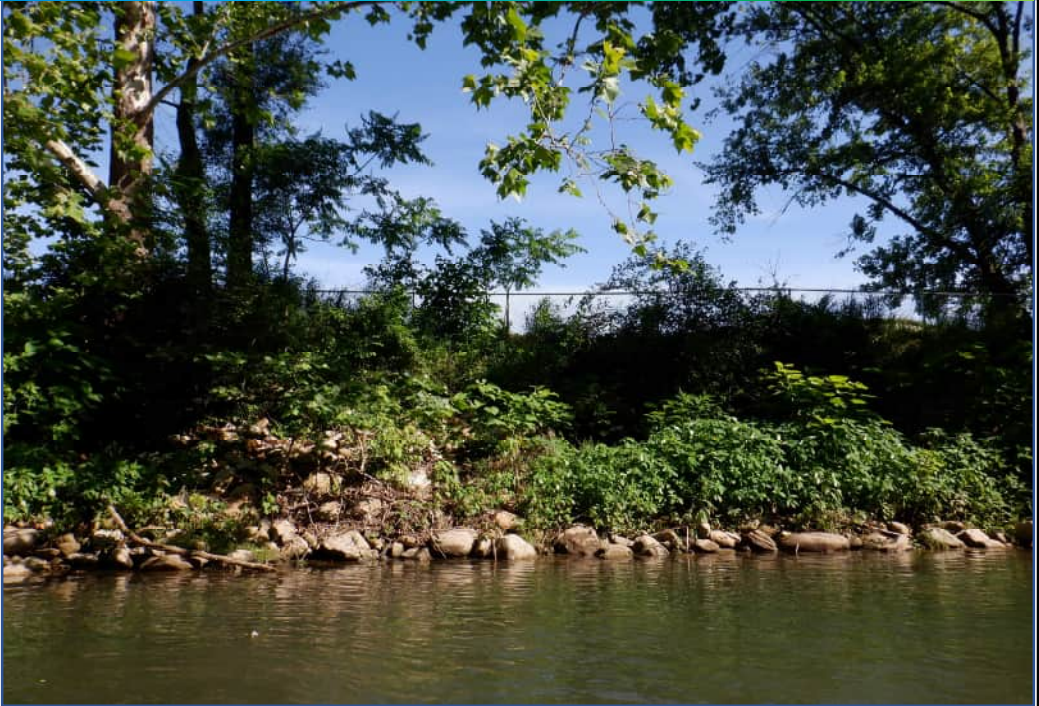
Direction: Northwest	
Description: ~45° bank angle; native vegetation fully established; some large trees present; LWD has shifted downstream; rock toe intact; no scour present along rock toe; 1st outfall pipe has broken hinge on door; 2nd outfall pipe has blocked opening and is covered by vegetation.

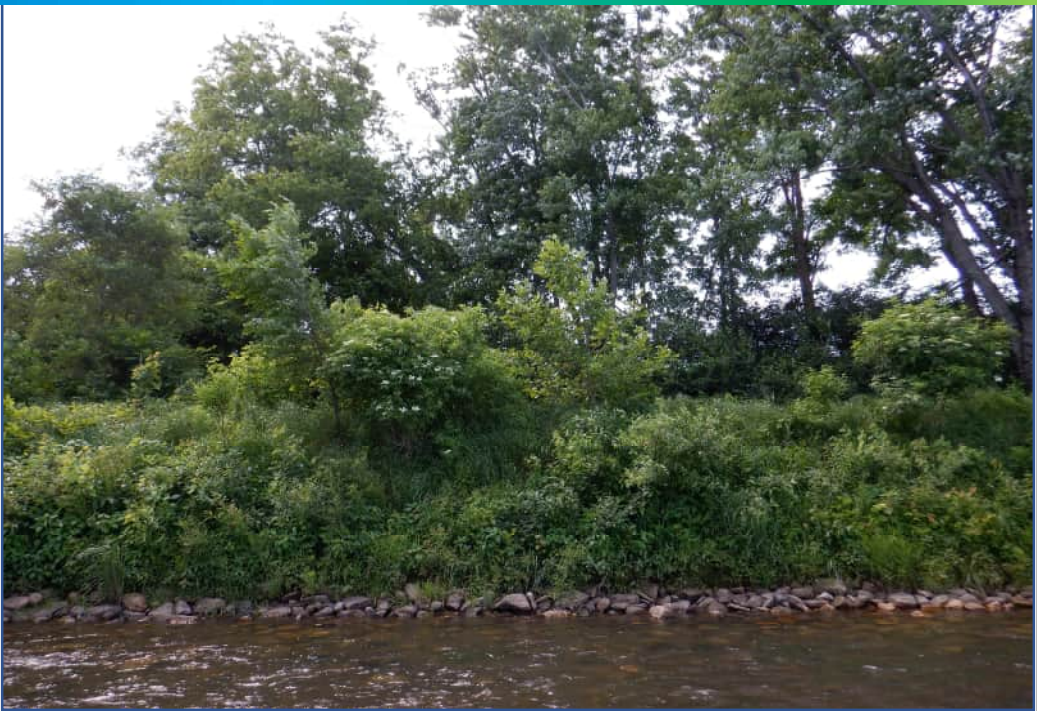
Direction: Southeast			
Description: ~50° bank angle; live stakes 50% established; native herbaceous vegetation fully established; no at-risk trees present; rock toe intact; sand deposition at toe of bank; erosion control fabric no longer exposed.

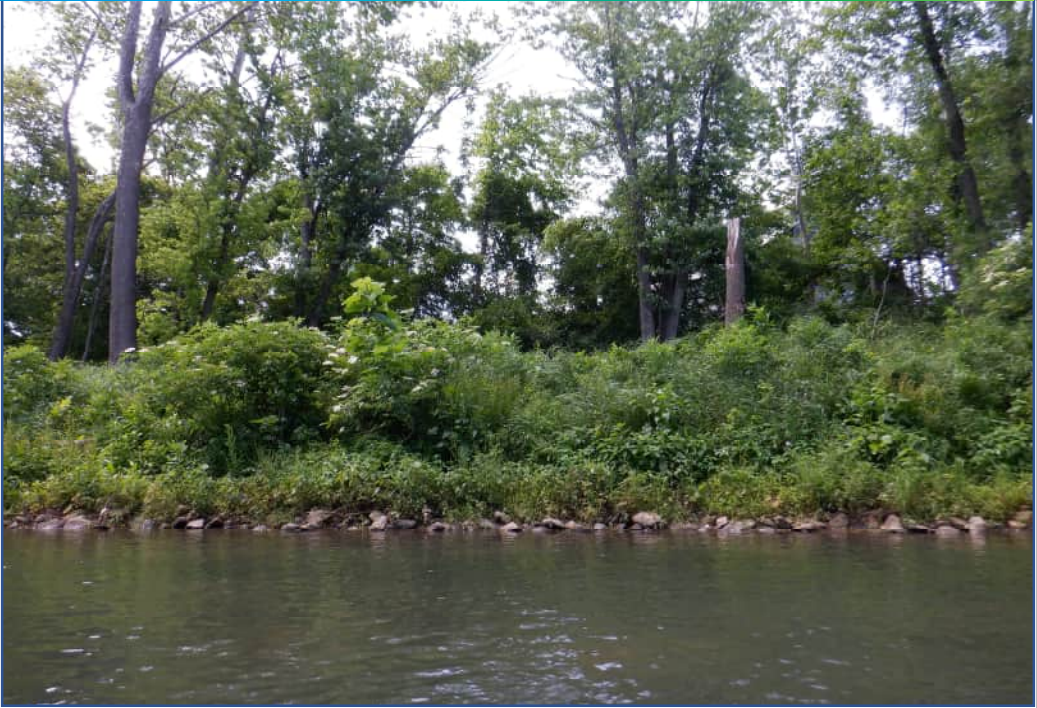
Direction: Southeast			
Description: ~60° bank angle; no live stakes observed; native herbaceous vegetation fully established; no at-risk trees present; new LWD downstream from tree on upper bank snapping in half; rock toe intact; sand deposition at toe of bank and above rock toe.

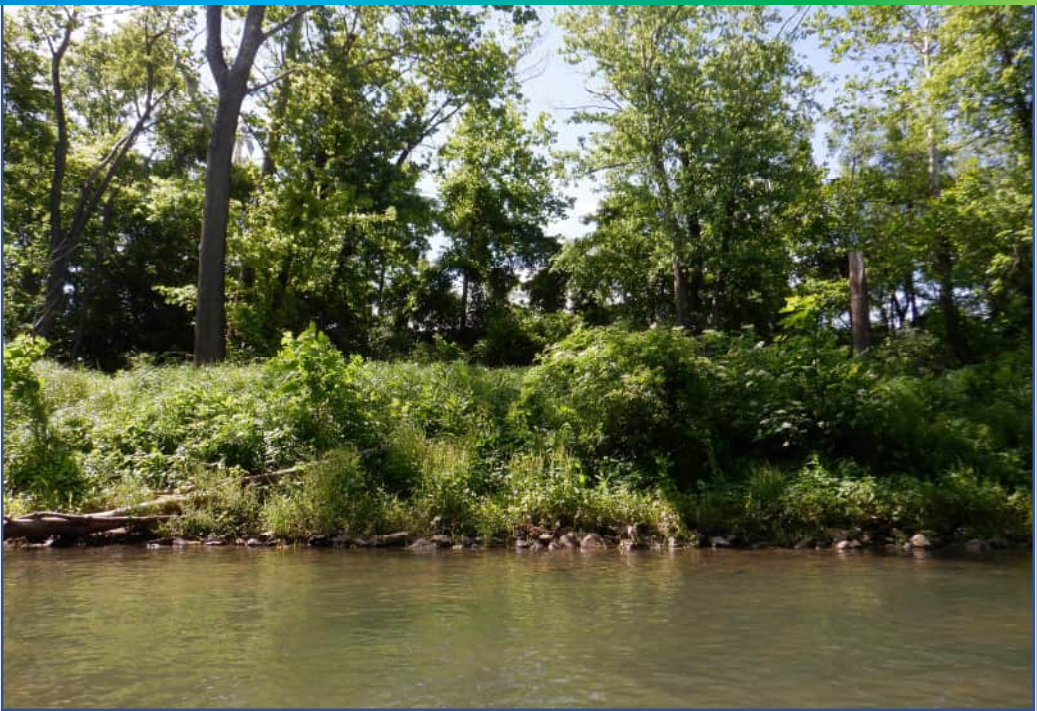
Direction: Southeast			
Description: Lower bank ~30°; upper bank ~50°; no live stakes observed; native herbaceous vegetation fully established; no at-risk trees present; new LWD from tree at top of bank at 00+500 snapping in half; rock toe intact; sand deposition at toe of bank.

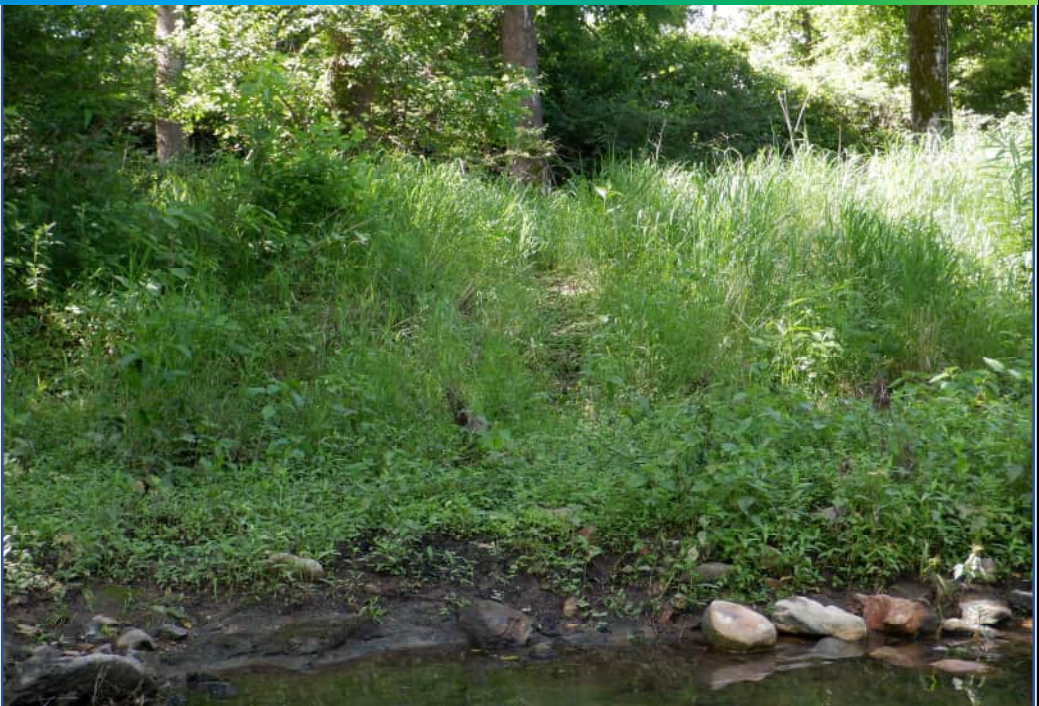
Direction: East	
Description: View of trampled grasses caused by improvised footpath at end of first remediated section.

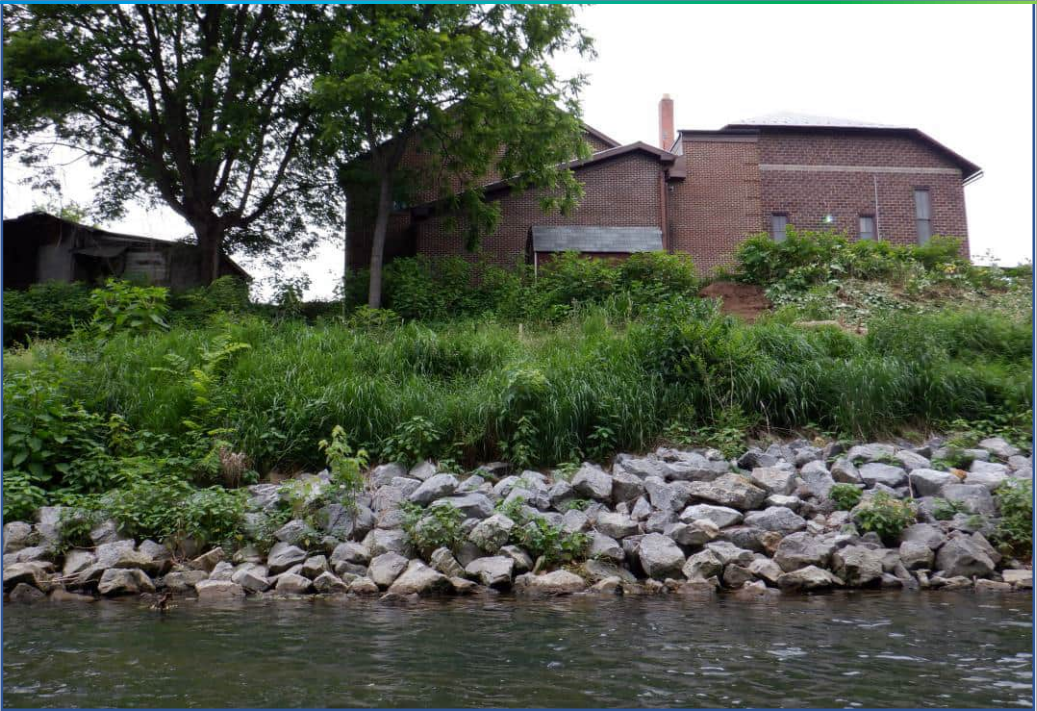
Direction: West	
Description: ~ 65° bank angle; lower bank ~40°; upper bank ~60°; Above GW ~70°; vegetation 95% cover; maple and elm saplings adjacent to edge of water; rock toe intact; evidence of sediment deposition in rock toe.

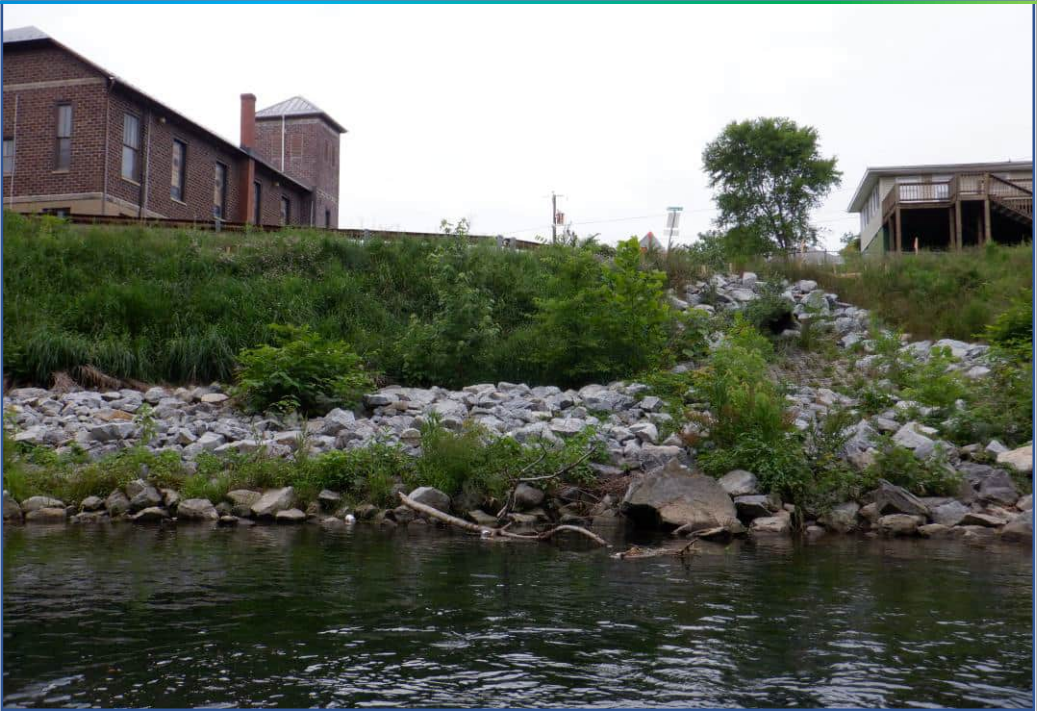
Direction: West			
Description: ~ 65° bank angle; vegetation 95% cover; small patch of invasive knotweed 2% cover; several saplings growing in and around rock toe; entirely riprap; large plastic corrugated pipe and Armorflex mat below outfall intact; gravel deposition at outfall.

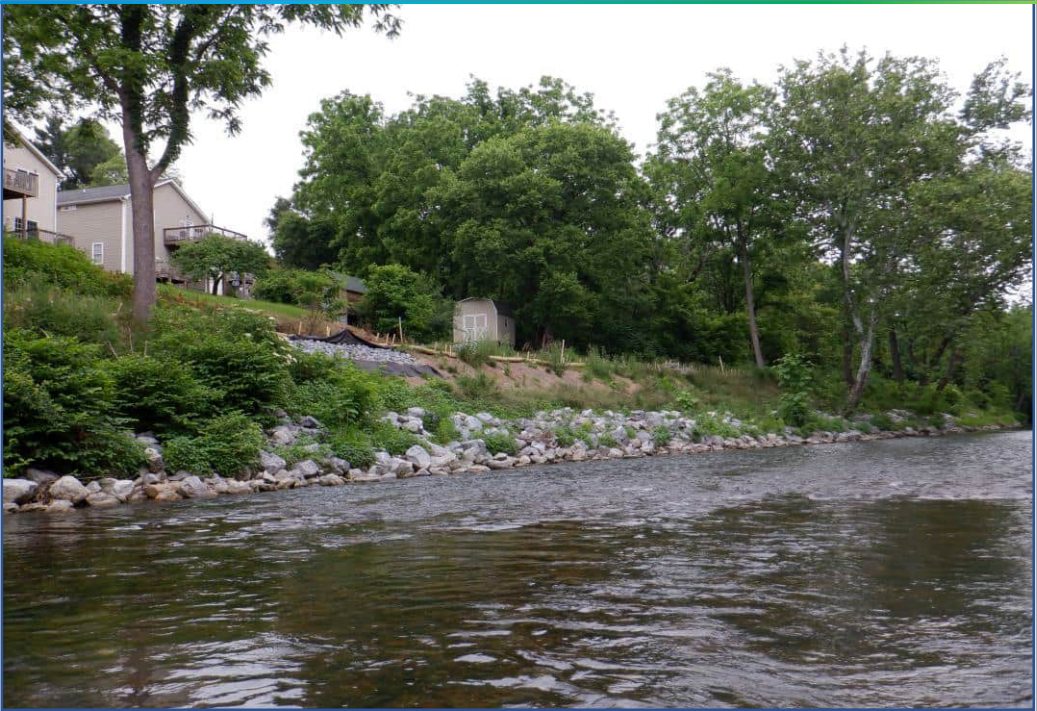
Direction: North			
Description: Downstream view of remediated bank, including section of previously failed bank now covered in dead grass.

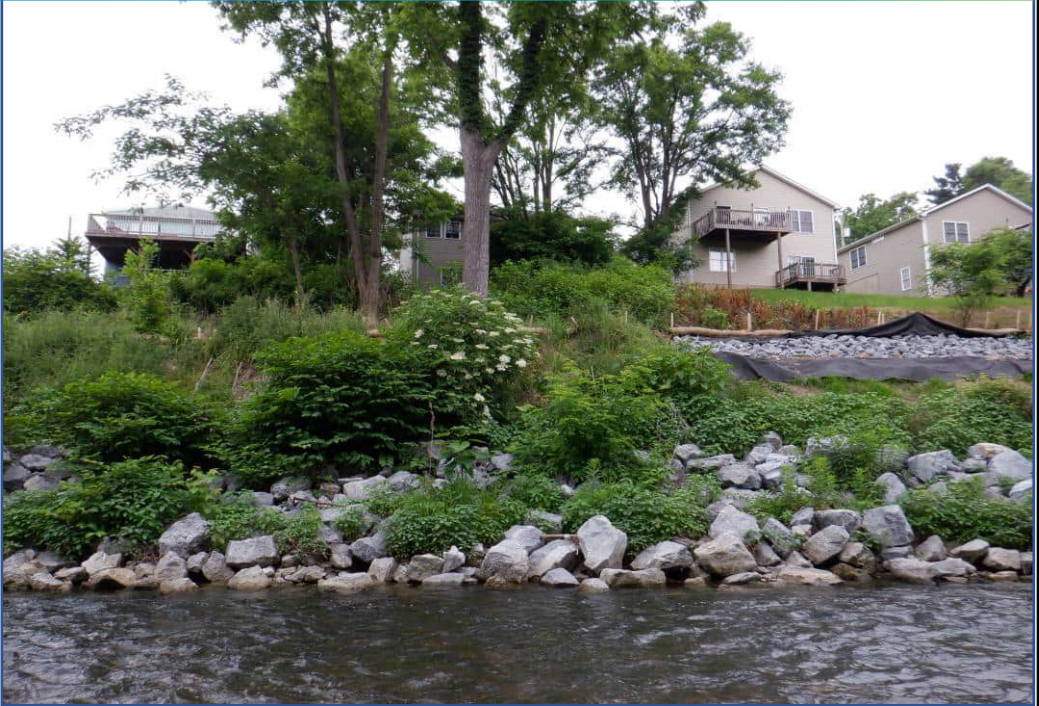
Photo Number: 24 Location: 00+500'	
<p>Date: 6/7/2022</p> <hr/> <p>Direction: Northwest</p> <hr/> <p>Description: Downstream view of remediated bank, including the section that was repaired due to construction damage. Grass did not establish on previously restored bank, few herbaceous vegetation growing in its place.</p>

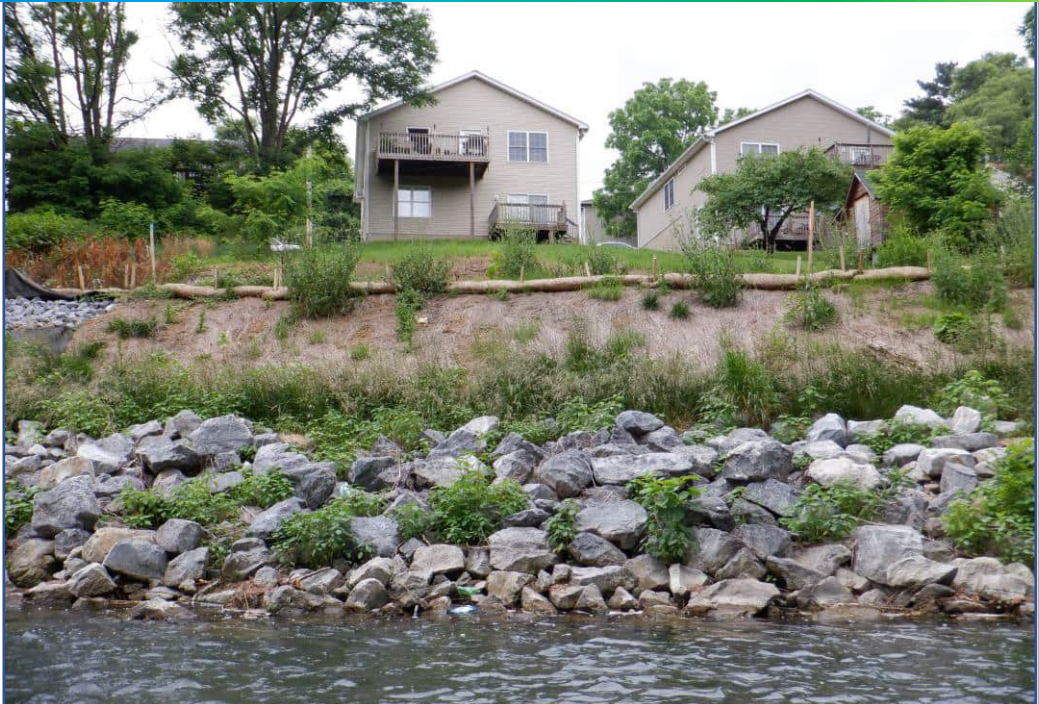
Direction: West		
Description: ~ 65° bank angle; lower bank; ~60°; upper bank; ~70°; reseeded grasses not establishing on restored bank section; vegetation 20% cover, 80% dead grass; repaired bank intact; no trees adjacent to edge of water; rock toe intact; evidence of sediment deposition in rock toe.

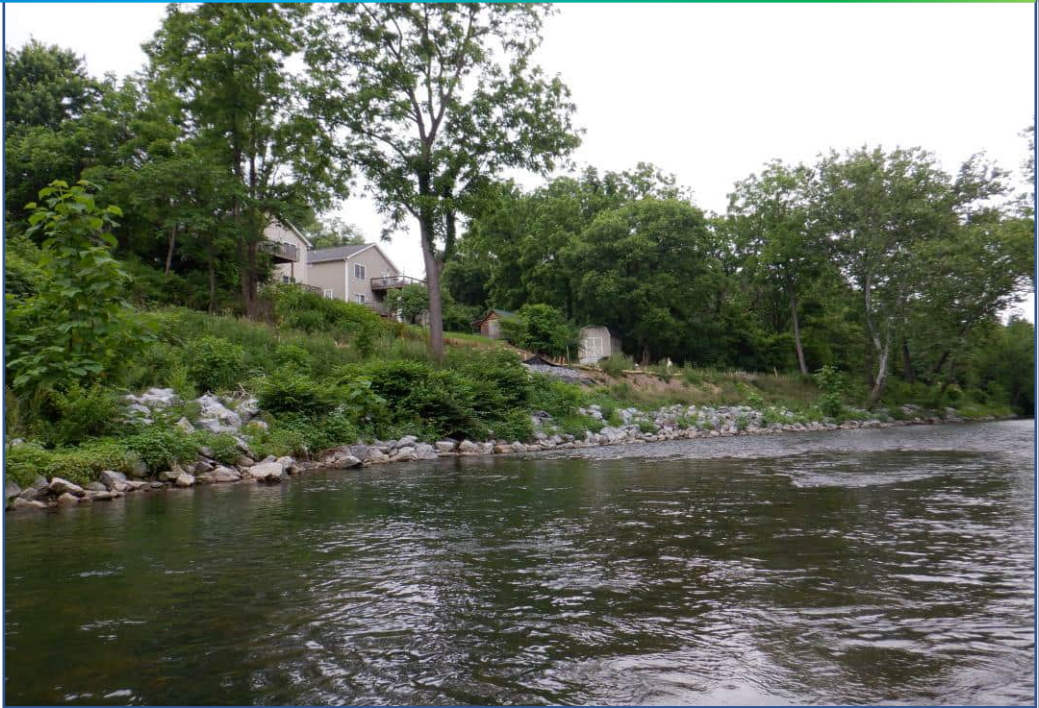
Direction: North			
Description: Downstream view of remediated bank; no trees adjacent to edge of water; rock toe intact; repaired bank intact; evidence of sediment deposition in rock toe.

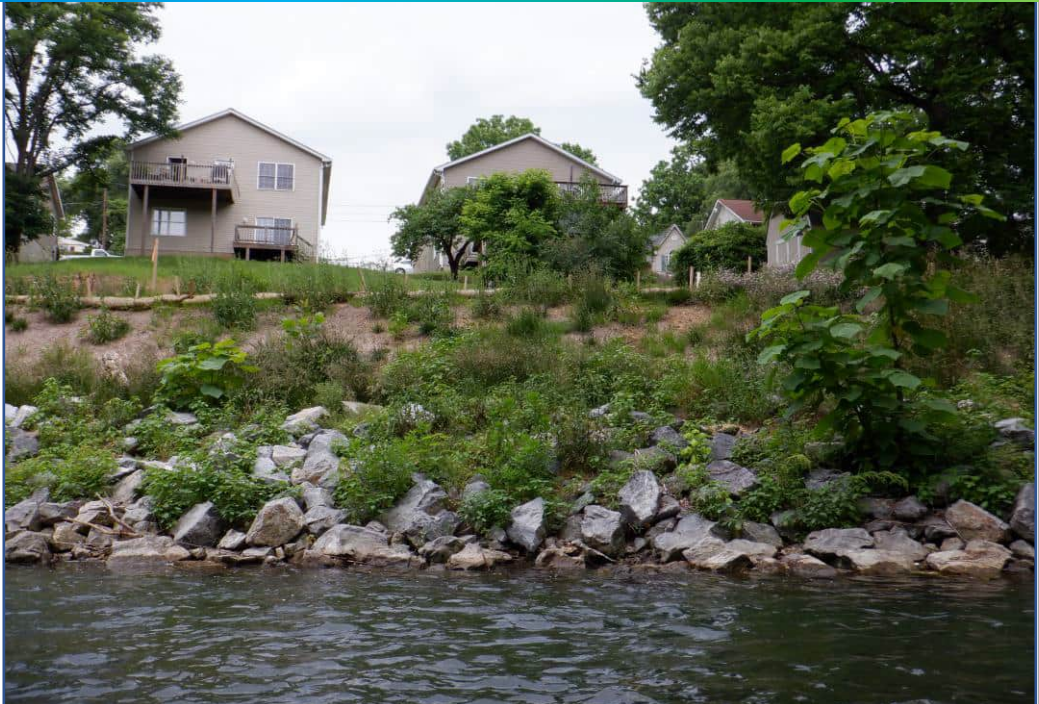
Direction: West			
Description: ~ 55° bank angle; reseeded grasses not establishing on restored bank section; vegetation 40% cover, 60% dead grass; repaired bank intact; no trees adjacent to edge of water; rock toe intact;

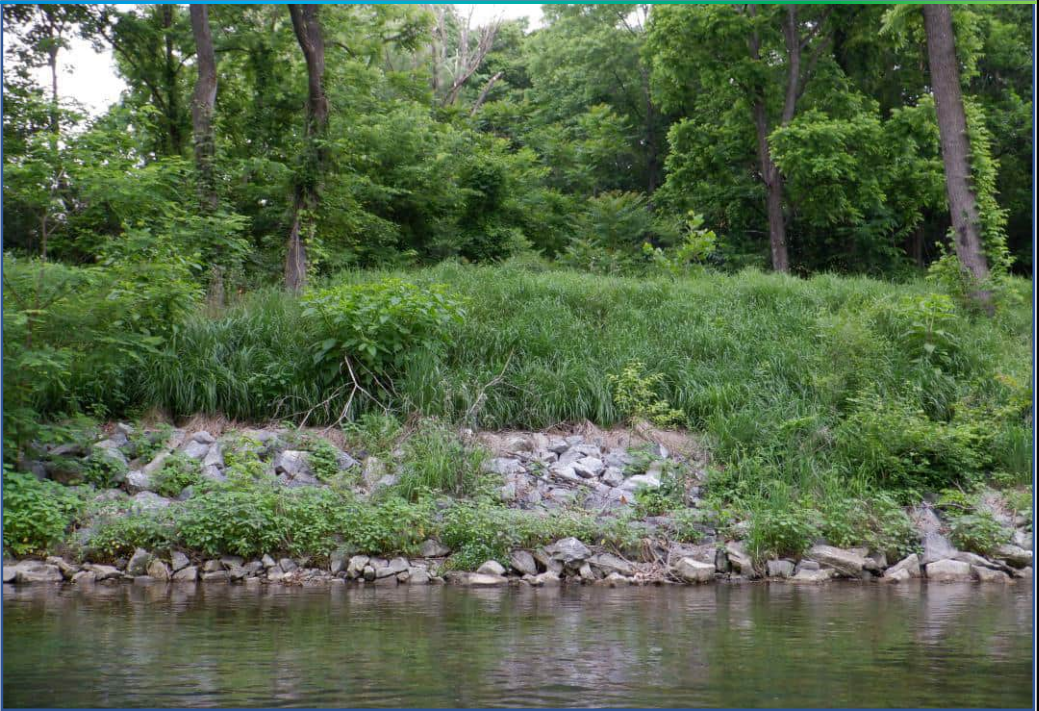
Direction: West			
Description: ~ 70° bank angle; grasses and herbaceous vegetation established; vegetation 90% cover; no trees adjacent to edge of water; rock toe intact; evidence of sediment deposition in rock toe

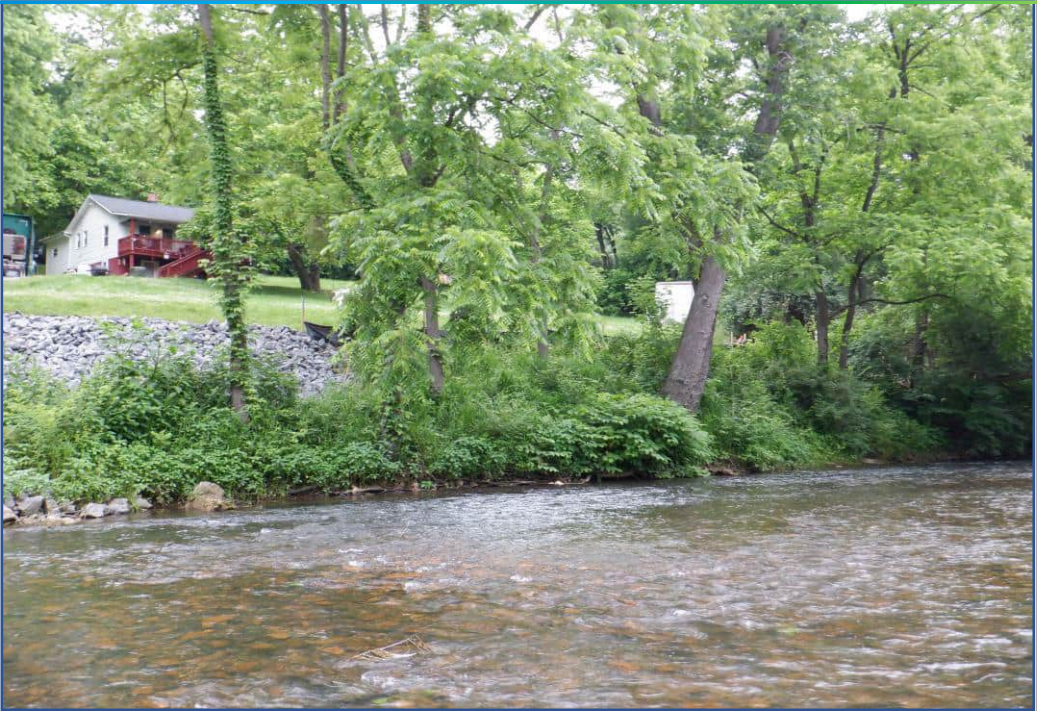
Direction: Northwest			
Description: View of the non-remediated bank immediately following remediated area; new cobble added for GW construction.

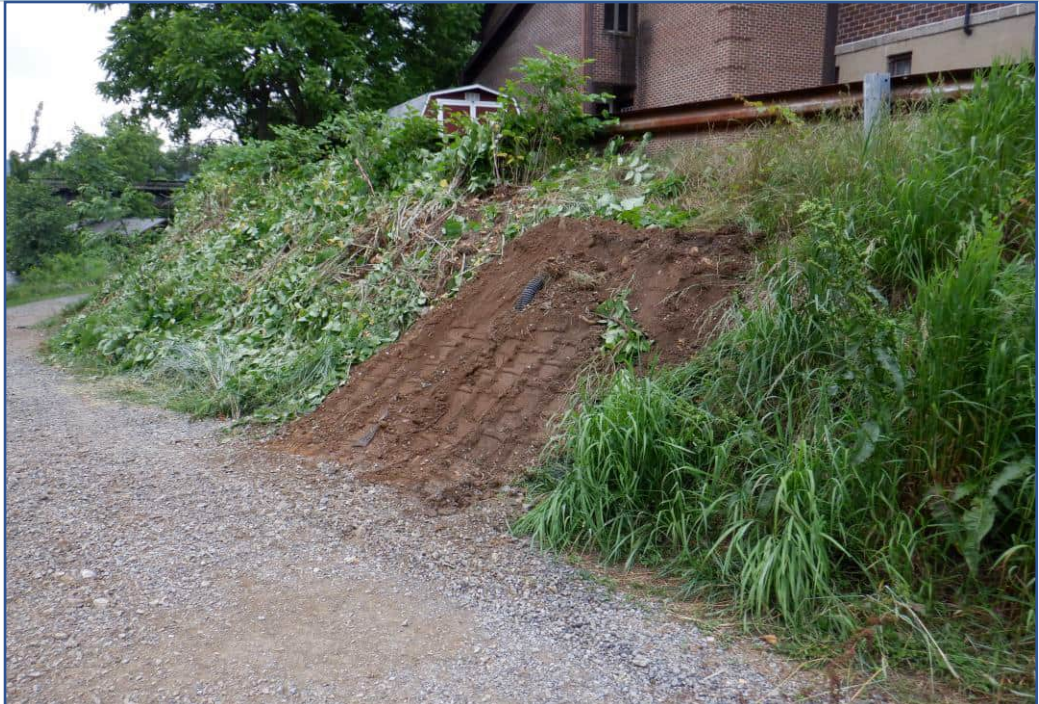
Direction: West	
Description: Bank with replaced drainage pipe above GW; vegetation on bank above GW impacted by construction of GW.

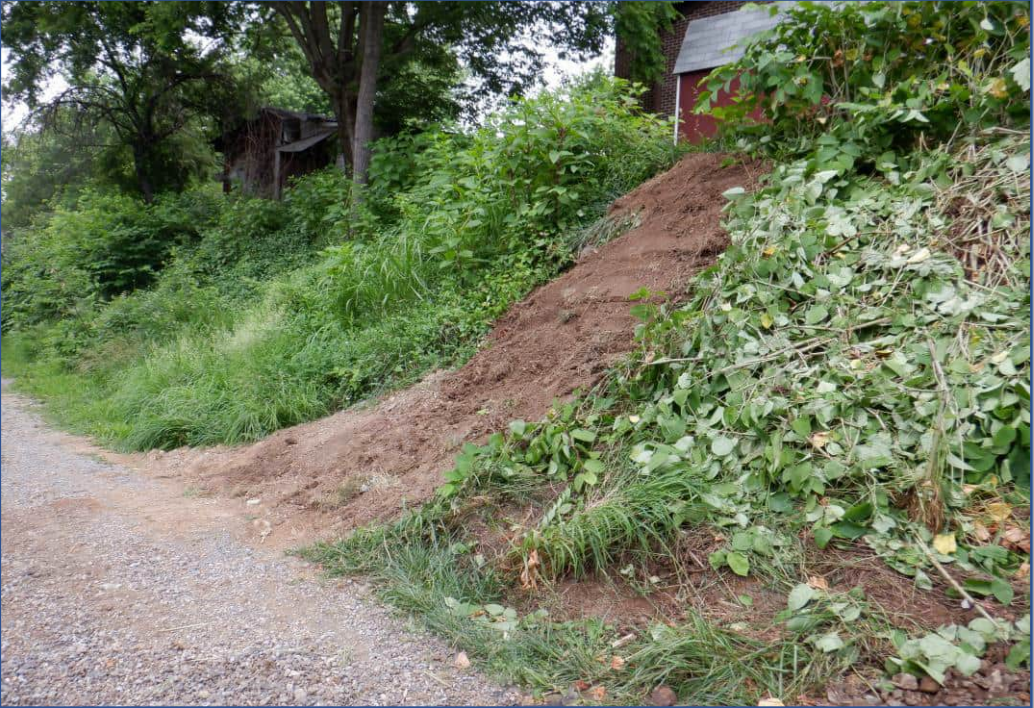
Direction: West	
Description: Bank with replaced drainage pipe above GW; vegetation on bank above GW impacted by construction of GW.

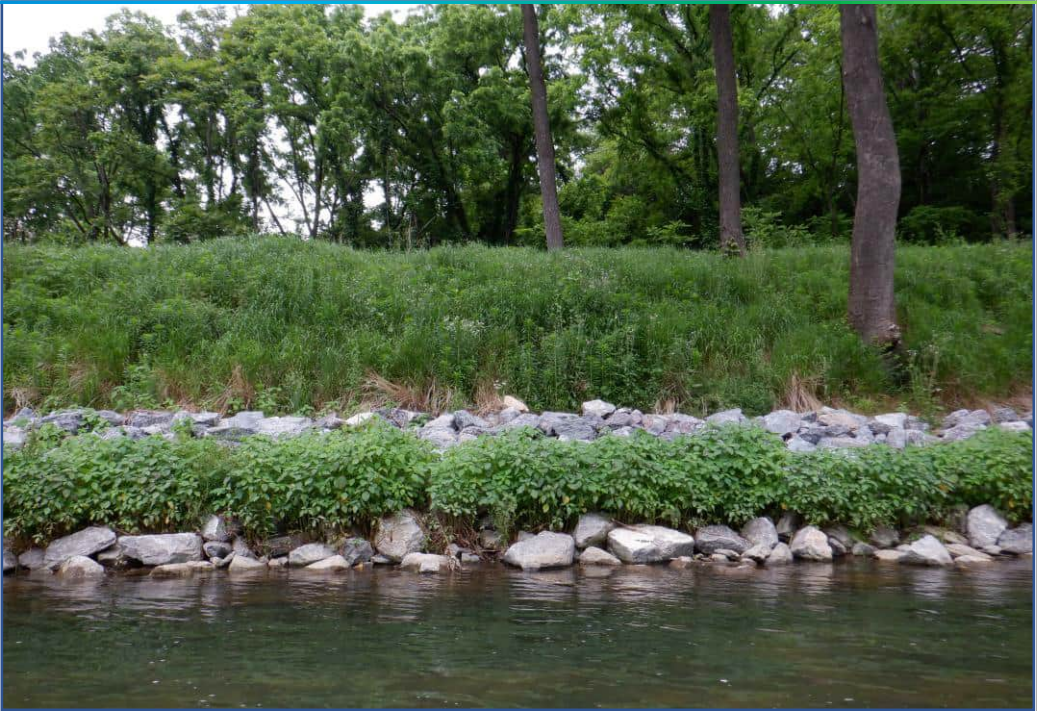
Direction: Northwest	
Description: ~ 60° bank angle vegetation 90% cover; no at-risk trees present; vegetation growing in rock toe;.

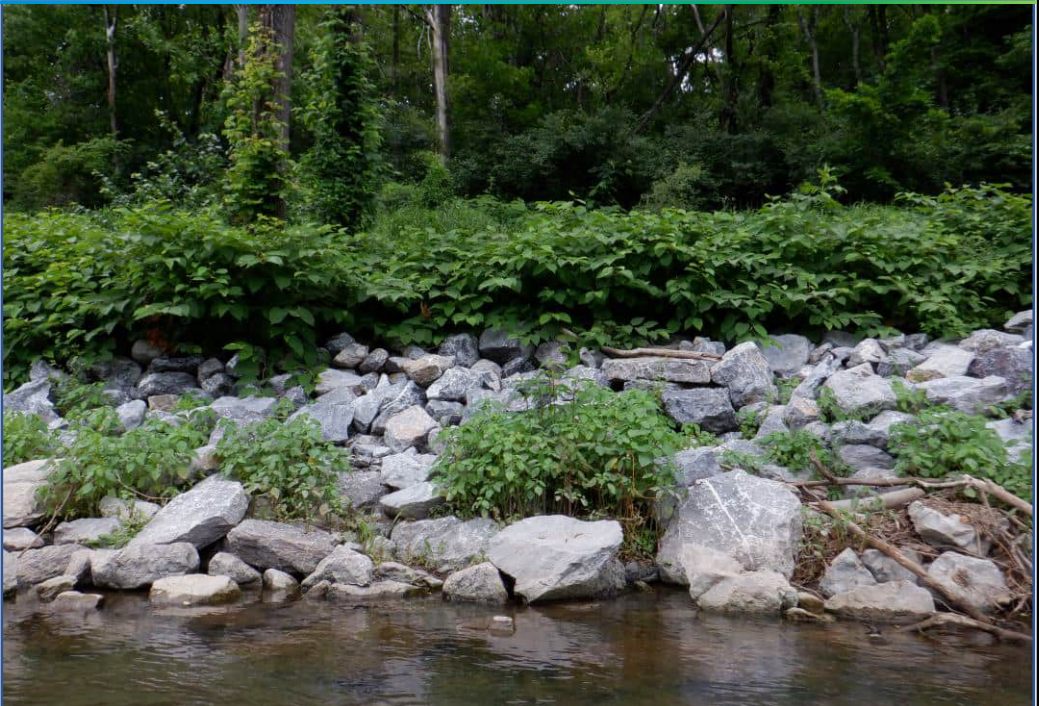
Direction: Northwest	
Description: ~ 70° bank angle; vegetation 95% cover; large patches of invasive knotweed 50% cover; trees near rock toe in good condition; rock toe intact, plants establishing in rock toe; minimal sediment deposition.

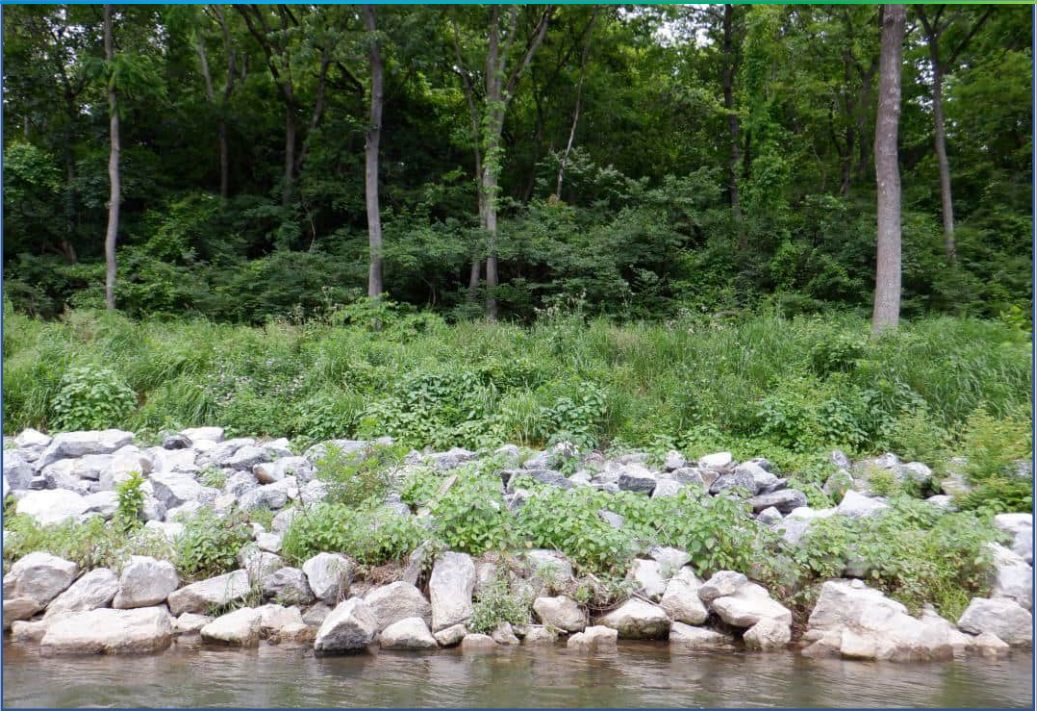
Direction: Northwest	
Description: ~ 60° bank angle; vegetation 95% cover; rock toe intact; jewelweed establishing in rock toe; minimal sediment deposition.

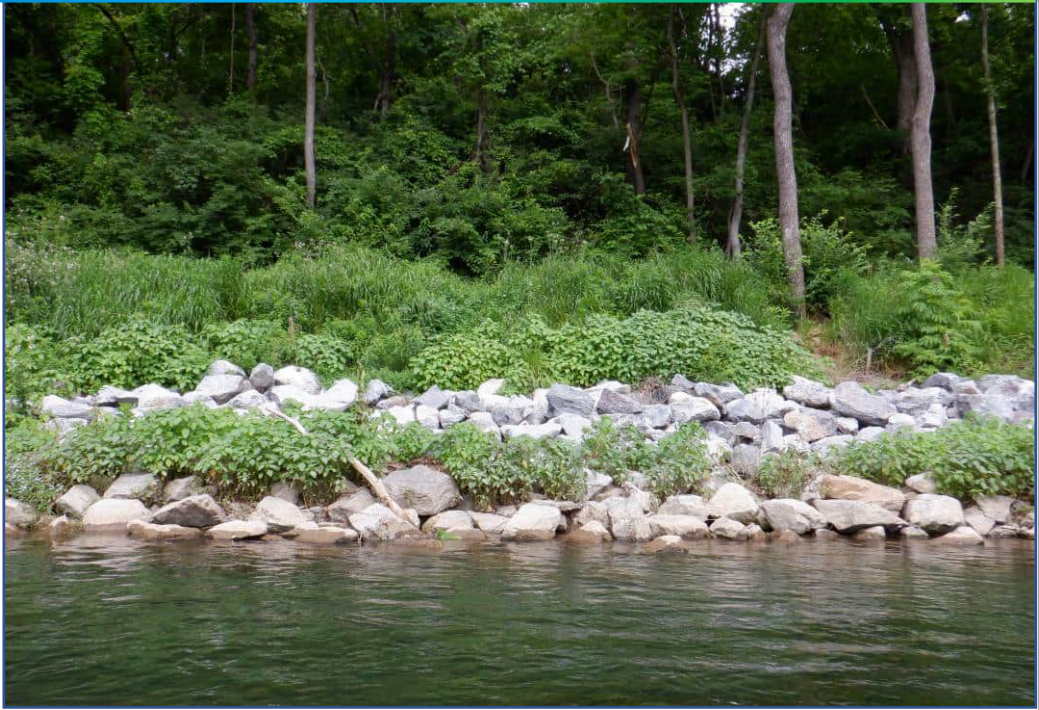
Direction: Northwest	
Description: ~ 50° bank angle; vegetation 60% cover; improvised access leading to bare soil around black walnut trees; rock toe intact; minimal sediment deposition; plants established.

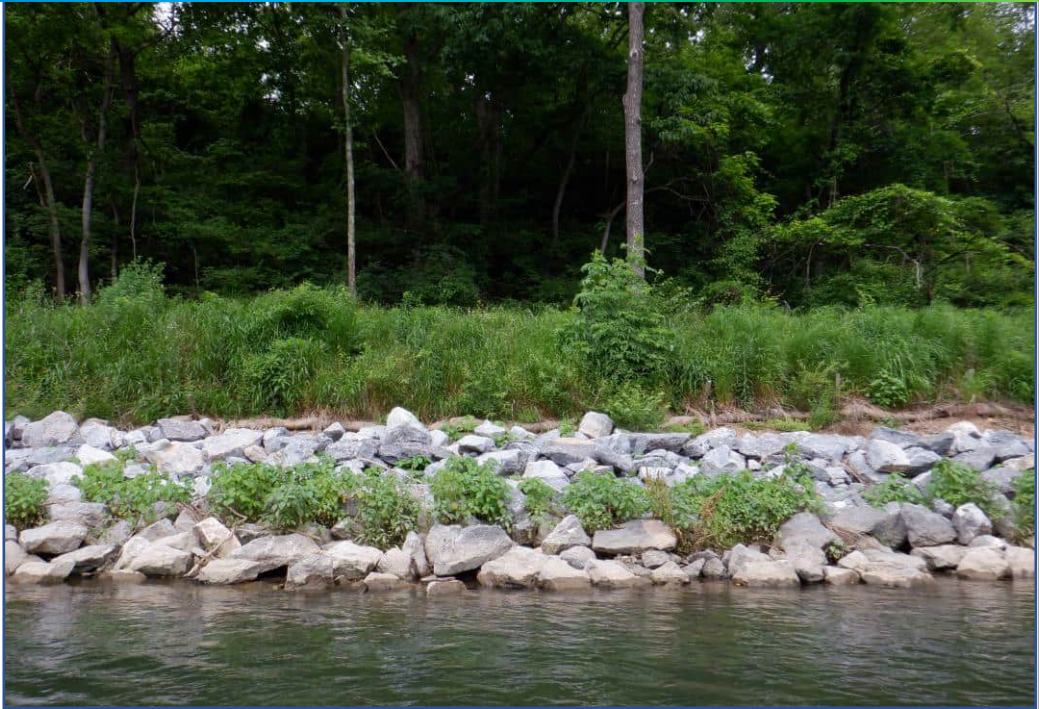
Direction: Northwest	
Description: ~ 60° bank angle; vegetation 85% cover; coir logs degrading but exposed, significant erosion between coir log and top of intact rock toe; rock toe intact, jewelweed establishing in toe; minimal sediment deposition;
