RE: 2022 Leaf-off, 2022 Leaf-on and 2023 Leaf-on BMA Inspection Memos
Former DuPont Waynesboro Site AOC 4
Waynesboro, Virginia
EPA ID# VAD003114832

Memorandum

Subject 2022 Leaf-on Maintenance Inspection
Former DuPont Waynesboro Site, Area of Concern 4

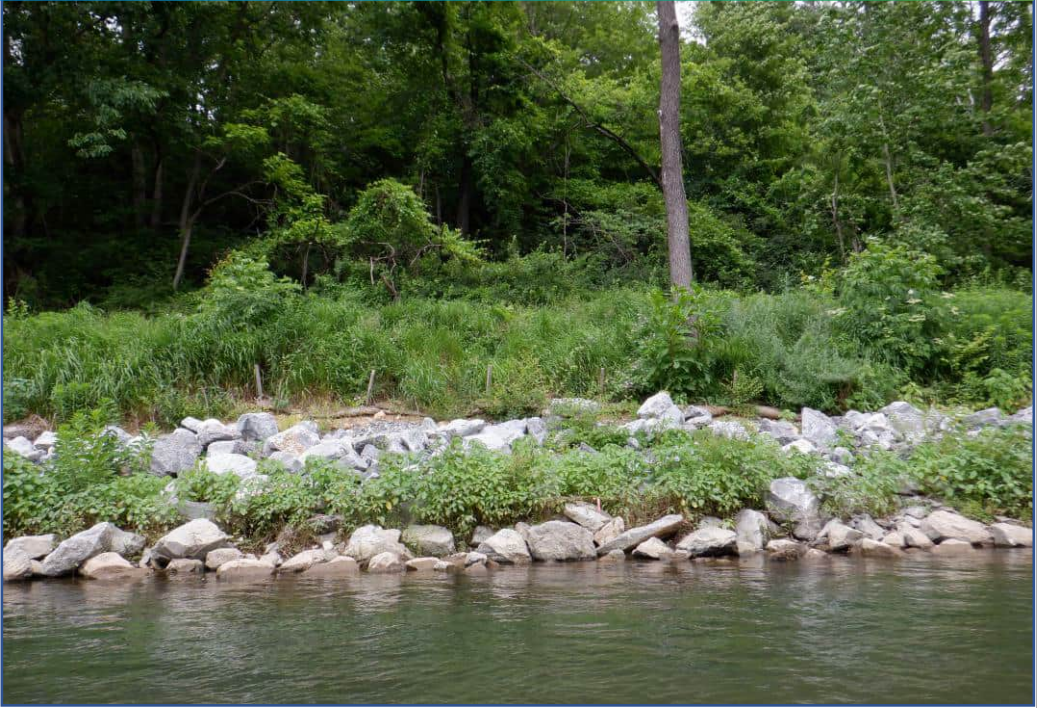
Direction: Northwest	
Description: ~ 60° bank angle; vegetation 75% cover; coir logs degrading but exposed, erosion and no vegetation between coir logs and rock toe; rock toe intact, jewelweed establishing in rock toe; minimal sediment deposition.

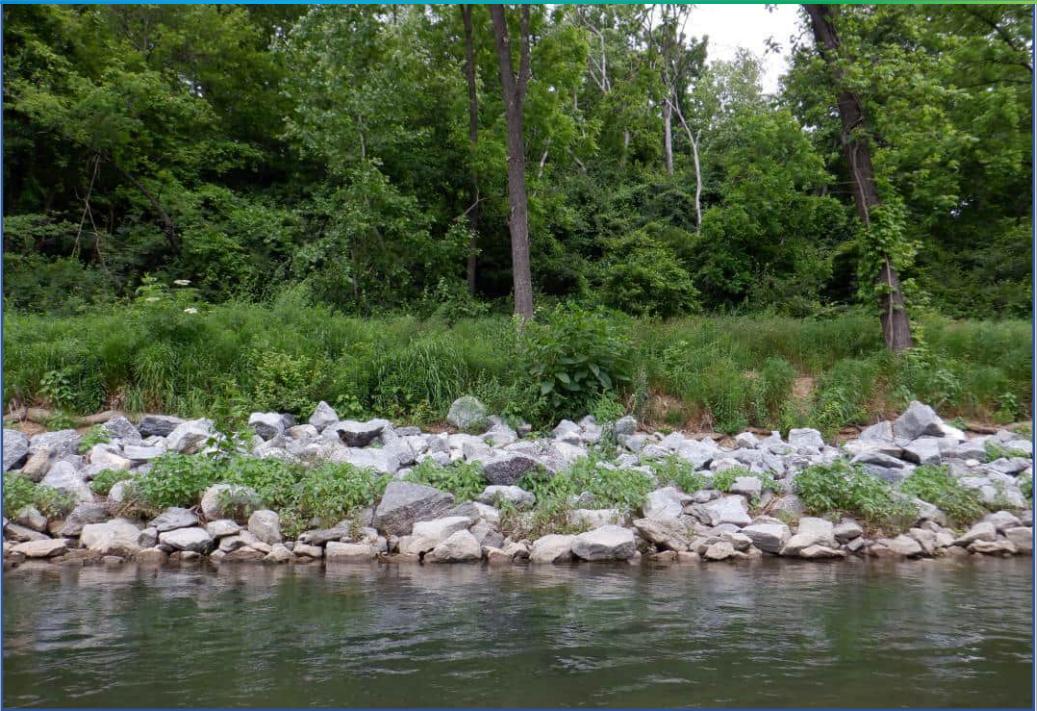
Direction: Northwest	
Description: ~ 50° bank angle; vegetation 75% cover; coir logs degrading but exposed, erosion and no vegetation between coir logs and rock toe; rock toe intact, jewelweed establishing in rock toe; minimal sediment deposition.

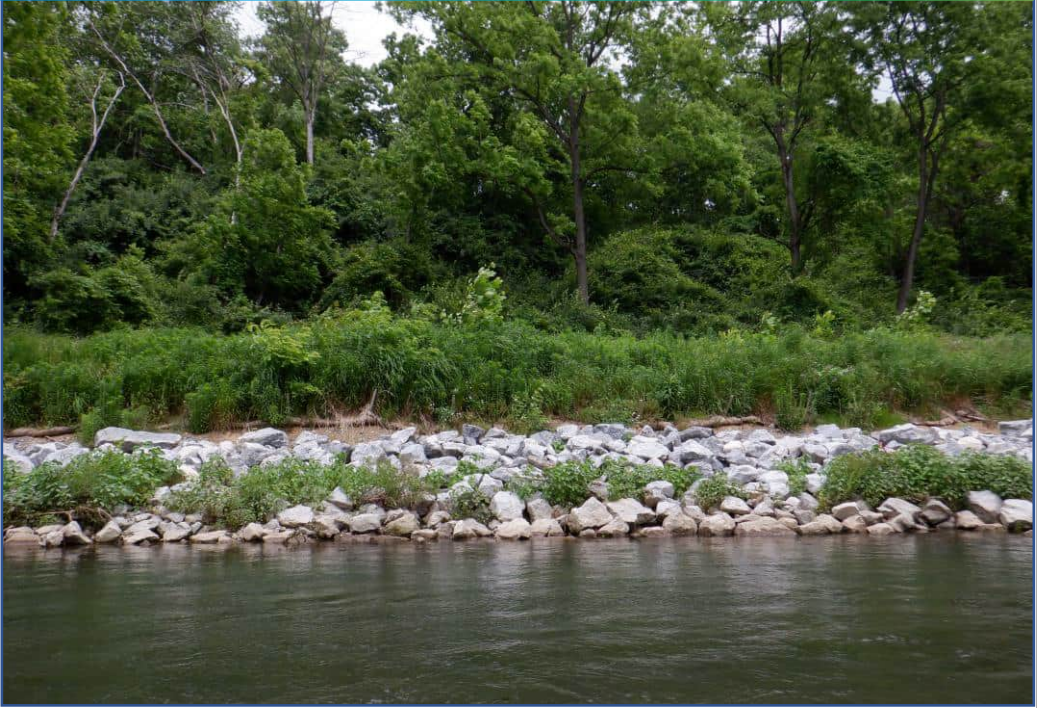
Direction: Northwest	
Description: ~ 50° bank angle; vegetation 75% cover; coir logs degrading but exposed, erosion and no vegetation between coir logs and rock toe; rock toe intact, jewelweed establishing in rock toe; minimal sediment deposition.

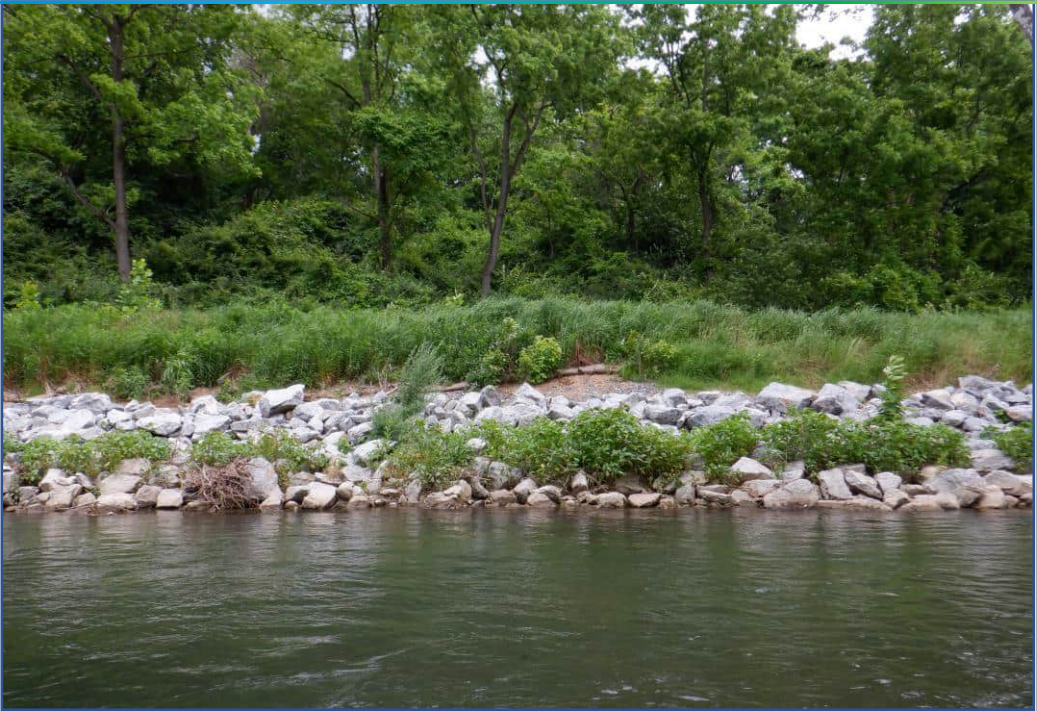
Direction: Northwest	
Description: ~ 50° bank angle; vegetation 75% cover; coir logs degrading but exposed, erosion and no vegetation between coir logs and rock toe; rock toe intact, jewelweed establishing in rock toe; minimal sediment deposition.

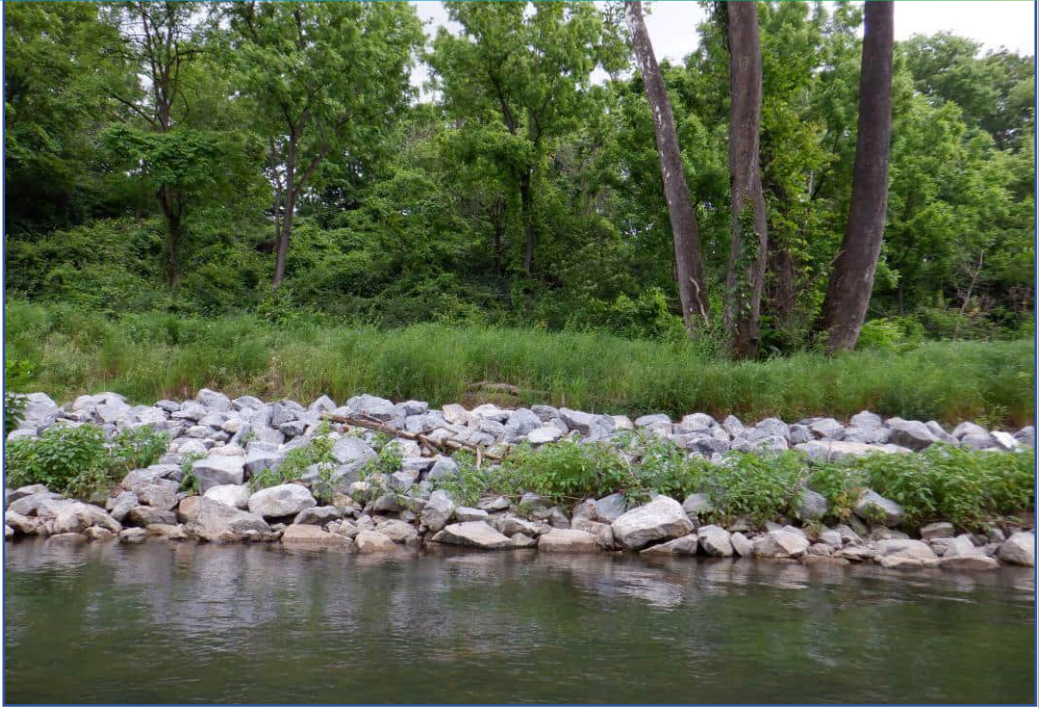
Direction: Northwest	
Description: ~ 45° bank angle; vegetation 80% cover; group of 4 trees near top of bank in good condition; coir log deteriorated but still visible; rock toe intact, jewelweed establishing in rock toe; minimal sediment deposition.

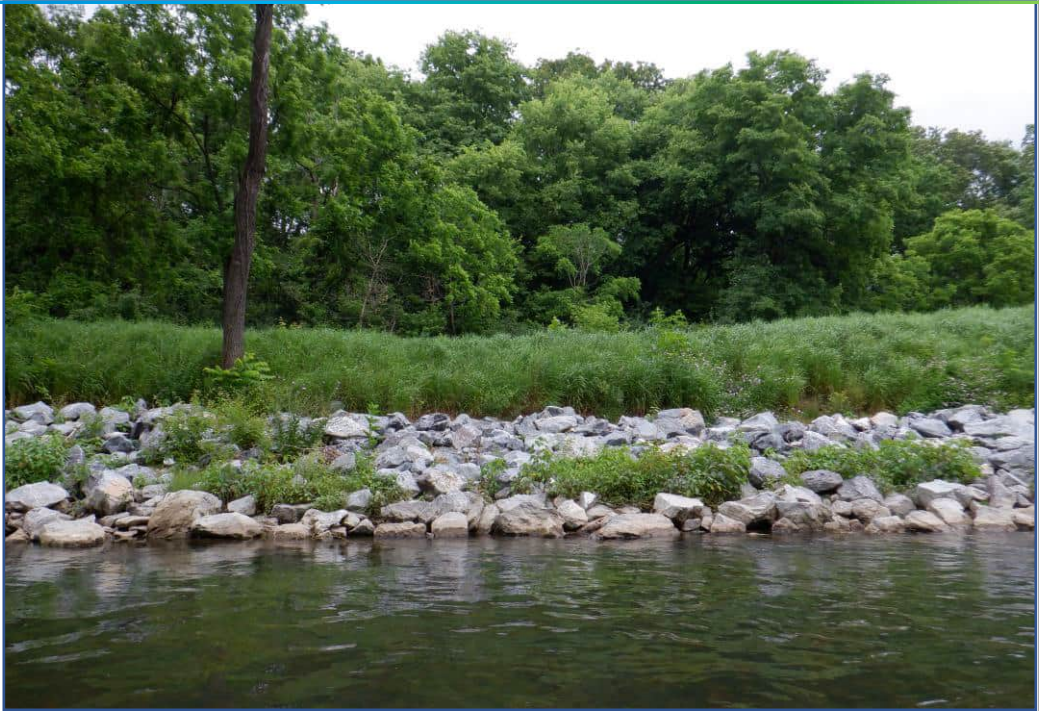
Direction: Northwest	
Description: ~ 50° bank angle; vegetation 80% cover; tree in good condition; rock toe intact, jewelweed establishing in rock toe; coir log deteriorated; minimal sediment deposition.

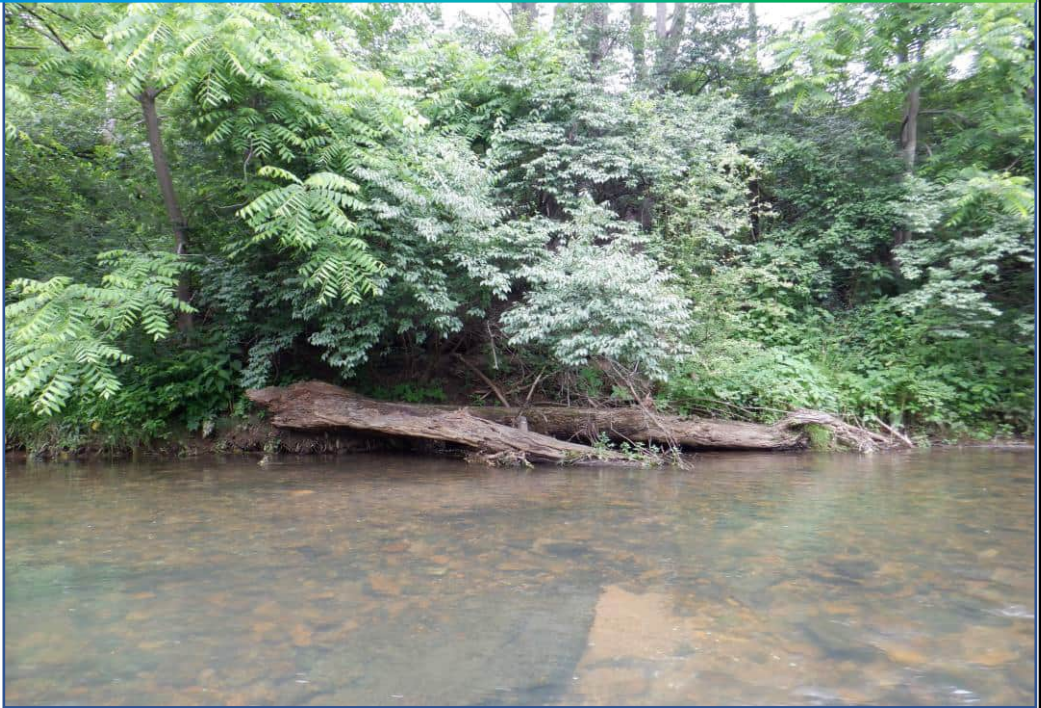
Direction: North			
Description: Non-remediated section; ~ 50° bank angle; vegetation 95% cover; 3 trees mid bank in good condition; minimal undercutting and scour at toe of bank; exposed roots; LWD present.

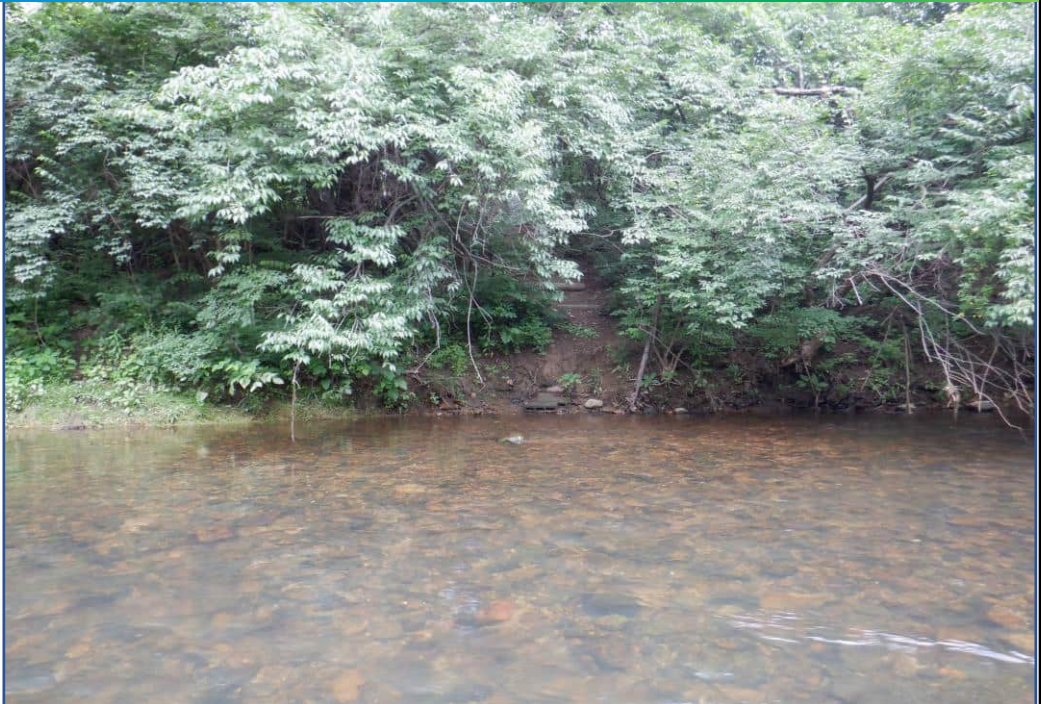
Direction: North			
Description: Non-remediated section; ~ 65° bank angle; access path with improvised stairs; vegetation on mid and upper bank; vegetation 30% cover; one tree mid bank in good condition; scour and erosion evident at base of access path.

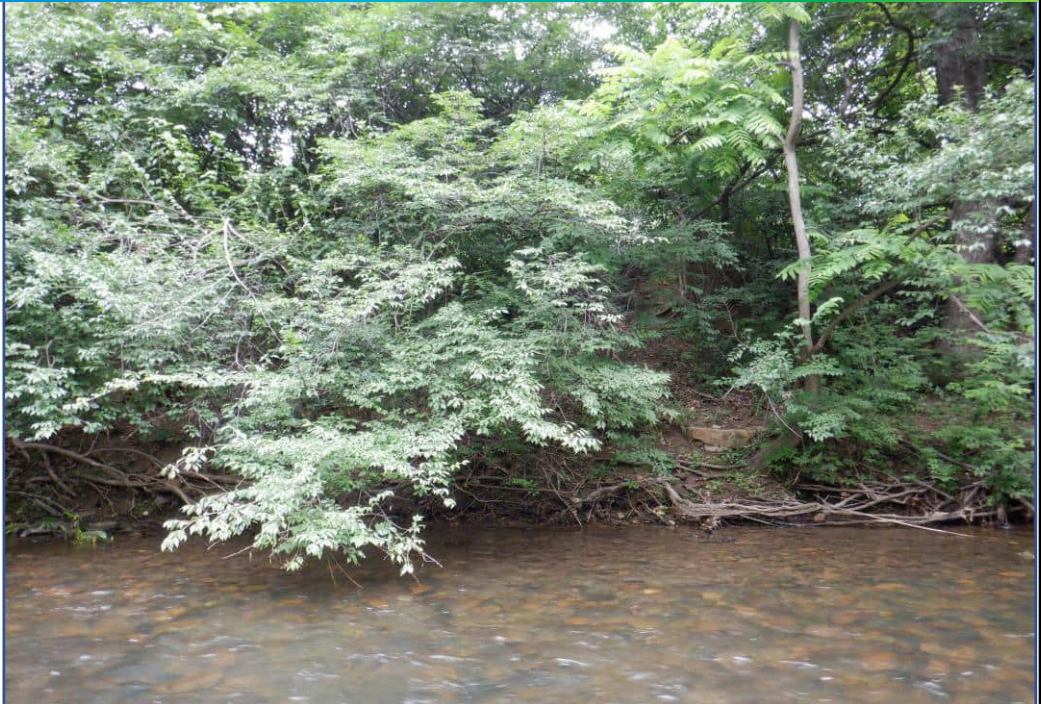
Direction: North			
Description: Non-remediated section; ~ 45° bank angle; highly exposed roots throughout bank; vegetation 40% cover; improvised access oath present; one tree mid bank in good condition; bank undercutting at base of toe; no scour.

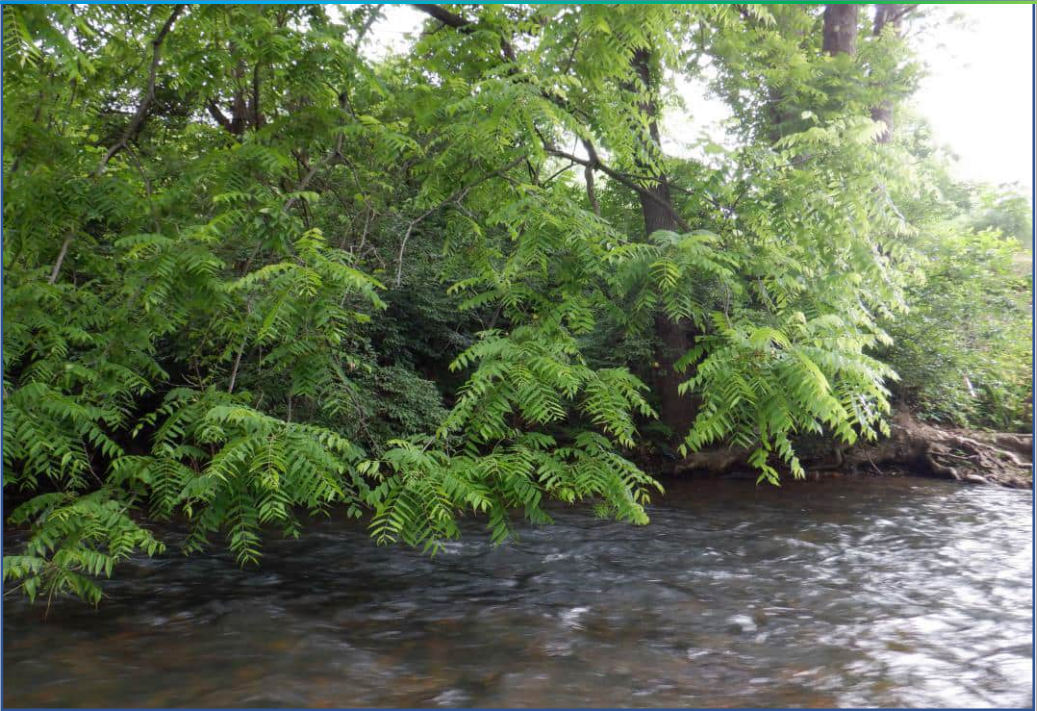
Direction: North			
Description: End of non-remediated section; ~ 60° bank angle; vegetation 70% cover; 1 tree at toe and 1 on upper bank in good condition; footpath; minimal undercutting at tree roots at toe of bank; minimal scour at exposed tree roots at toe.

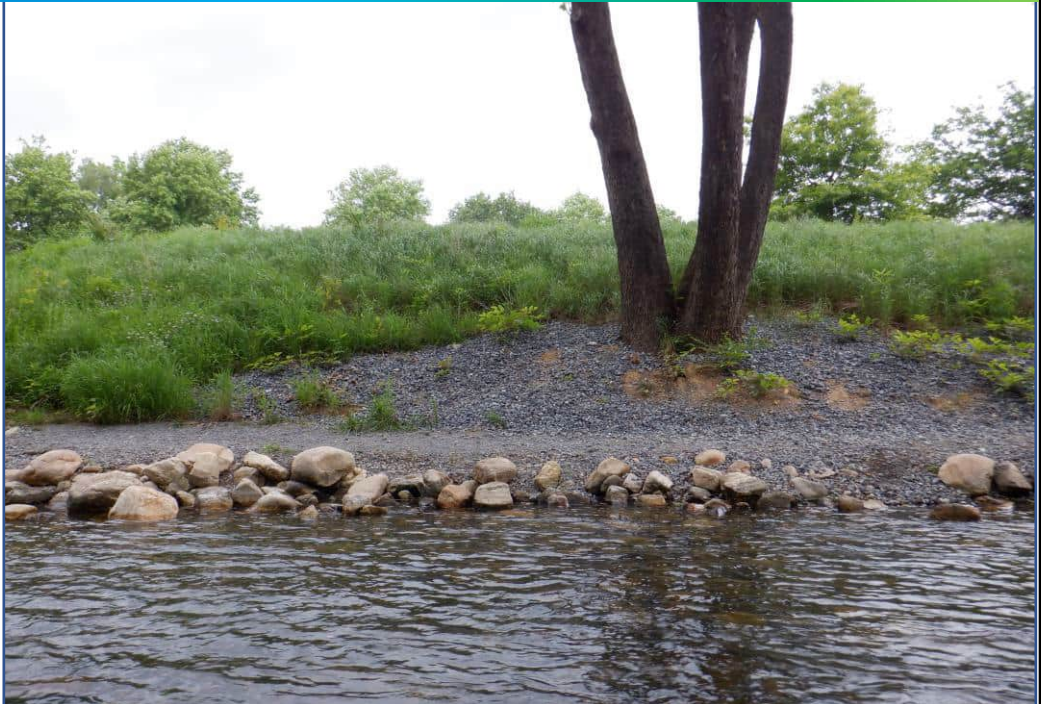
Direction: North	
Description: ~ 50° bank angle; vegetation 95% cover; group of 4 trees above gravel walking path in good condition; rock toe intact; walking path above rock toe starting to slant due to erosion; small boulders tumbled into water.

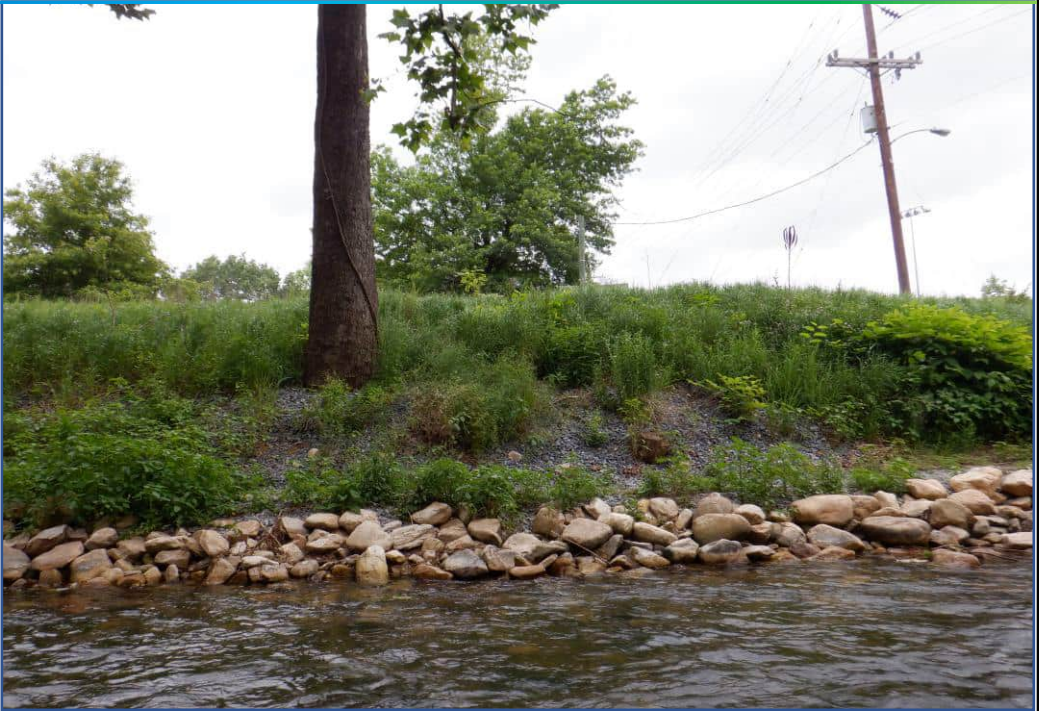
Direction: North			
Description: ~ 65° bank angle; vegetation 95% cover; rock toe intact; walking path above rock toe; path slanted, gravel dust eroded away revealing larger blue gravel, small boulders tumbled into water.

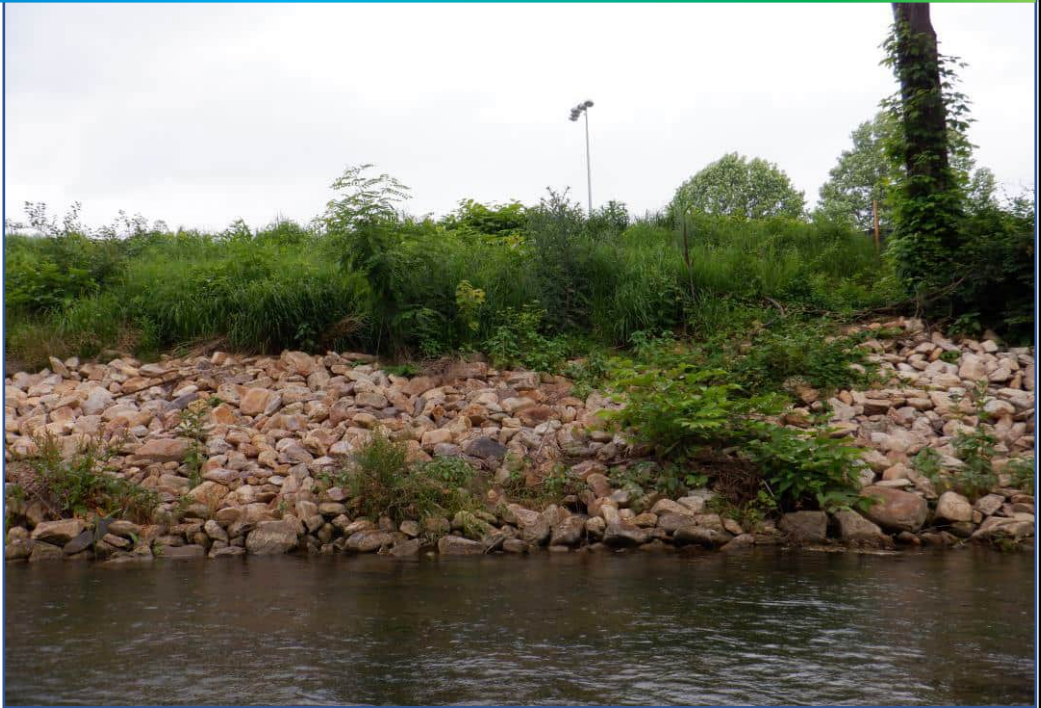
Direction: Northwest			
Description: ~ 65° bank angle; end of 2 nd remediated section; vegetation 95% cover; 1 tree mid bank in good condition; footpath at end of remediation; higher intact rock toe in this section.

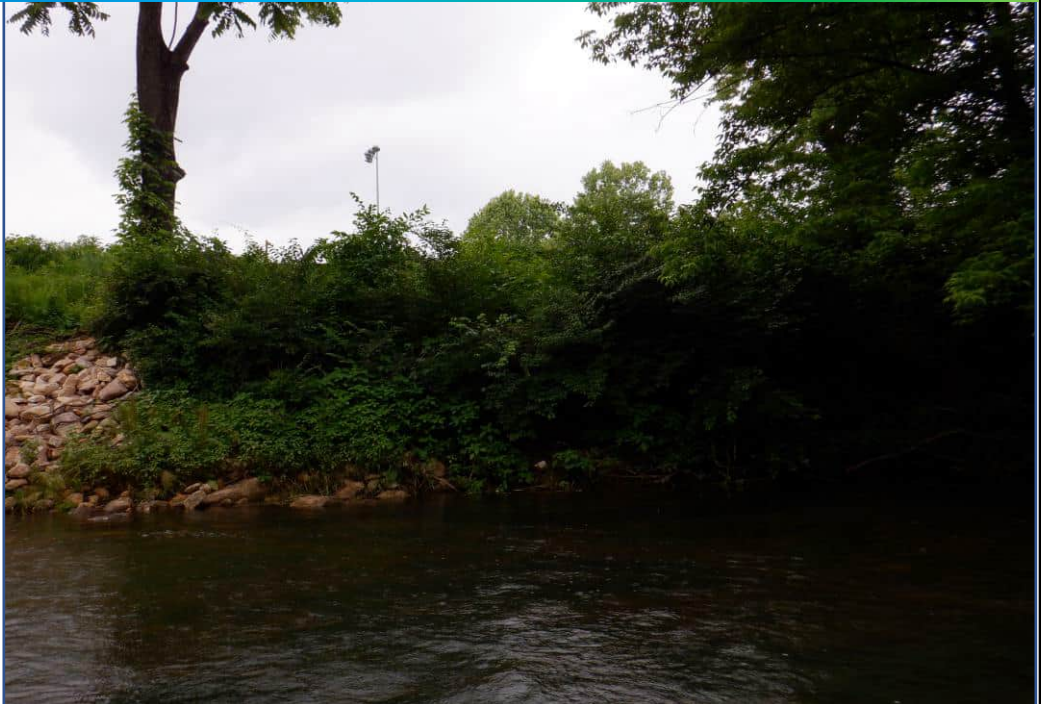
Direction: Northwest			
Description: Start of non-remediated section; ~60° bank angle; woody vegetation throughout bank; medium exposed roots mid to lower bank; Box Elder Tree at-risk; sparse vegetation; bank undercutting; no scour.

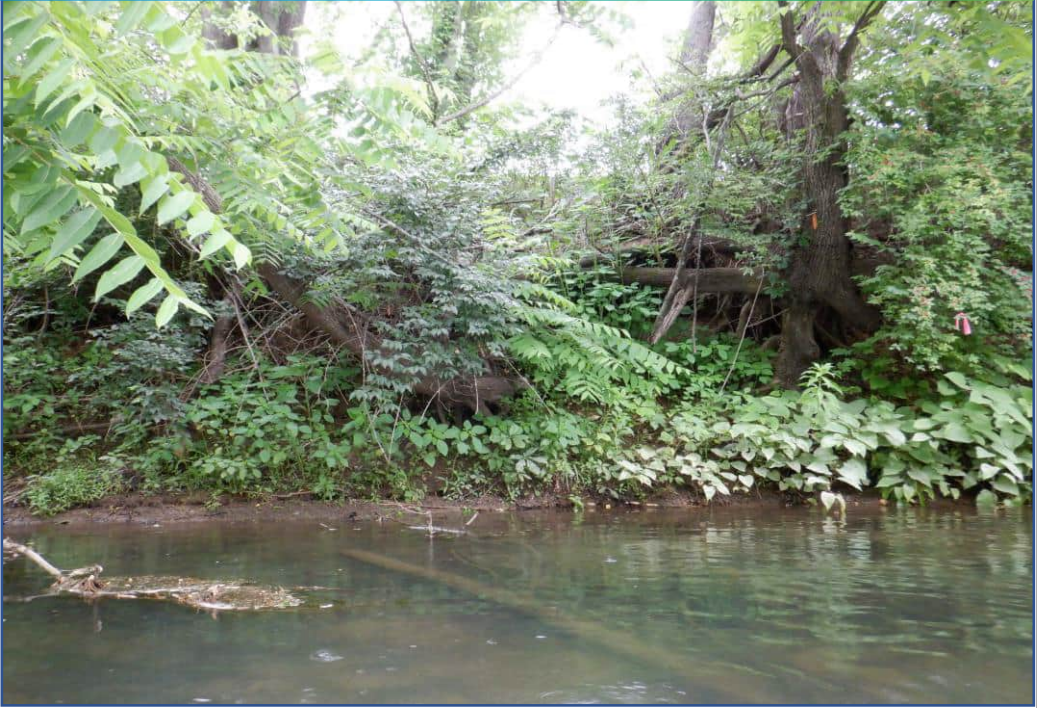
Direction: Northwest	
Description: ~ 65° bank angle; woody vegetation mid to upper bank; highly exposed roots; no vegetation established adjacent to water's edge; several trees on upper bank in good condition, trees at risk leaning above rock toe.

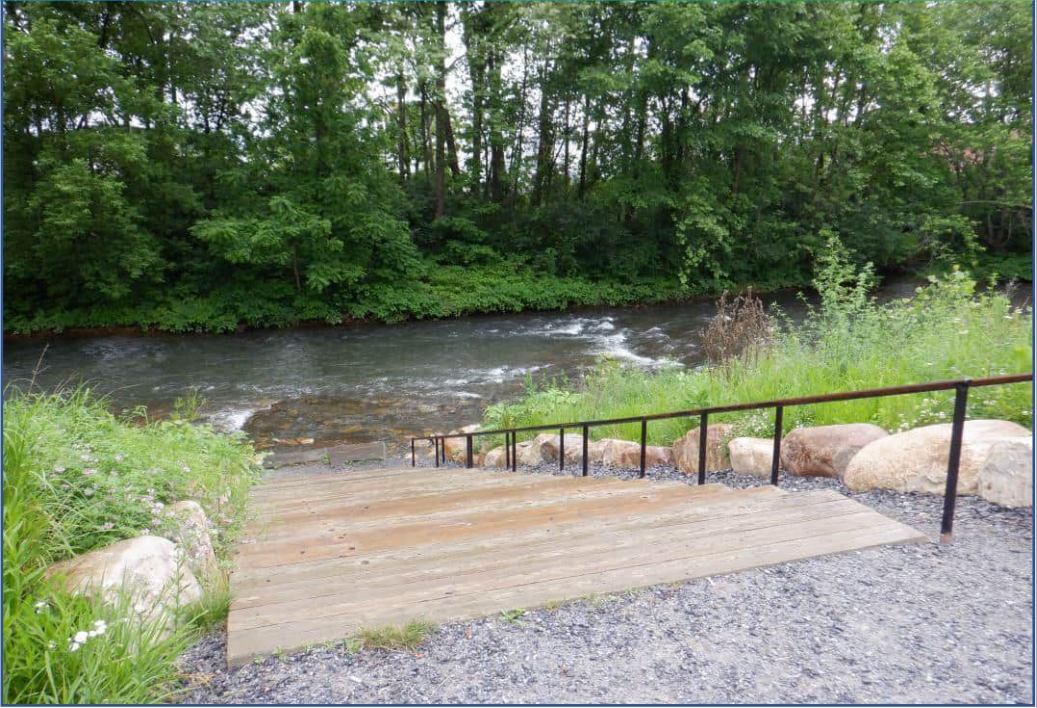
Direction: South			
Description: Public river access; wooden stairs and kayak rail. Stairs in good condition
