RE: 2022 Leaf-off, 2022 Leaf-on and 2023 Leaf-on BMA Inspection Memos
Former DuPont Waynesboro Site AOC 4
Waynesboro, Virginia
EPA ID# VAD003114832

Subject 2023 Leaf-on Maintenance Inspection
Former DuPont Waynesboro Site, Area of Concern 4

Constitution Park BMA 2023 Leaf-on Inspection

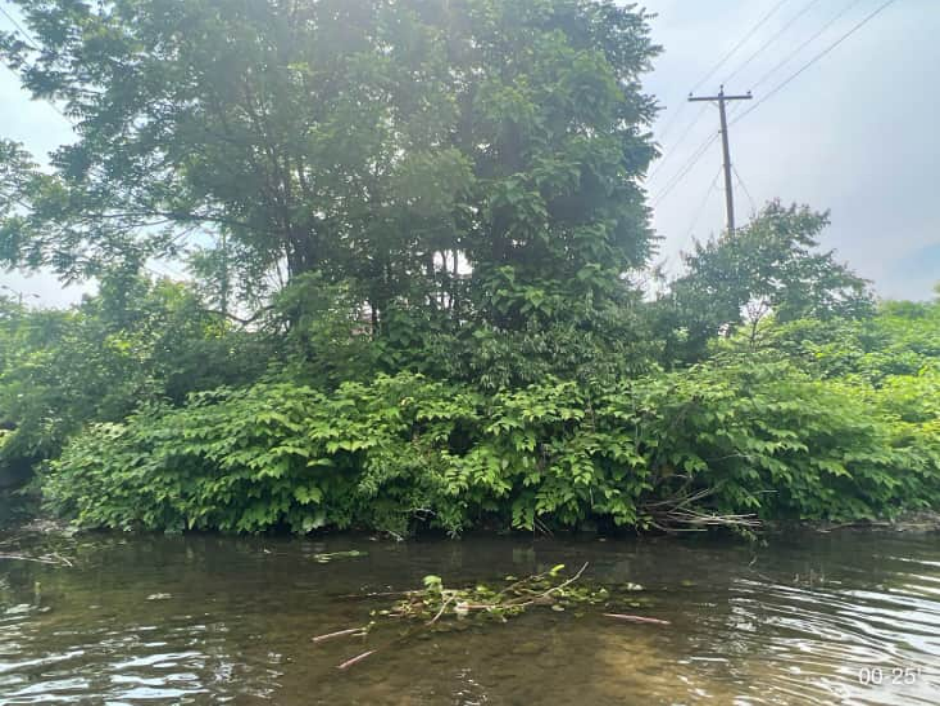
Photo Number: 1	Location: 00 – 25'
Date: 6/5/2023

Direction: West	
Description: Lower bank ~20°; Upper bank ~55° No woody plants or trees adjacent to edge of water; large patch of invasive knotweed along water's edge

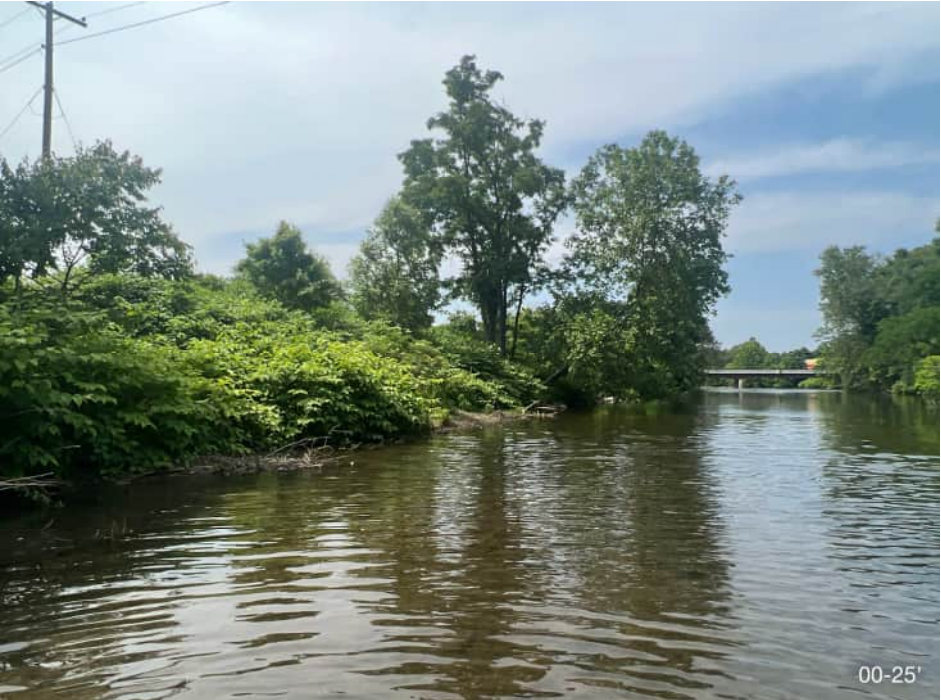
Photo Number: 2	Location: 00 – 25'
Date: 6/5/2023

Direction: Northwest	
Description: View from upstream of remediated bank; low presence of scour 5' upstream of 00 – 25'; slight erosion at water's edge

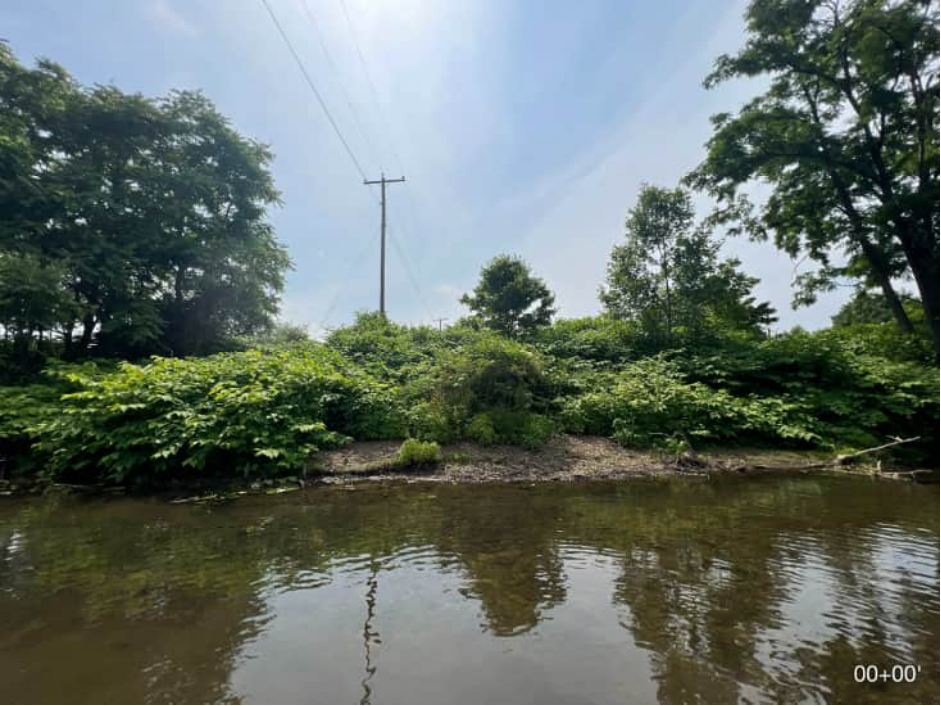
Photo Number: 3	Location: 00 + 00'
<p>Date: 6/5/2023</p> <hr/> <p>Direction: West</p> <hr/> <p>Description:</p> <p>Lower bank ~30°; Upper bank ~55°</p> <p>Invasive Japanese knotweed cover ~65%; coir logs deteriorated; slight scour and undercutting along toe</p>

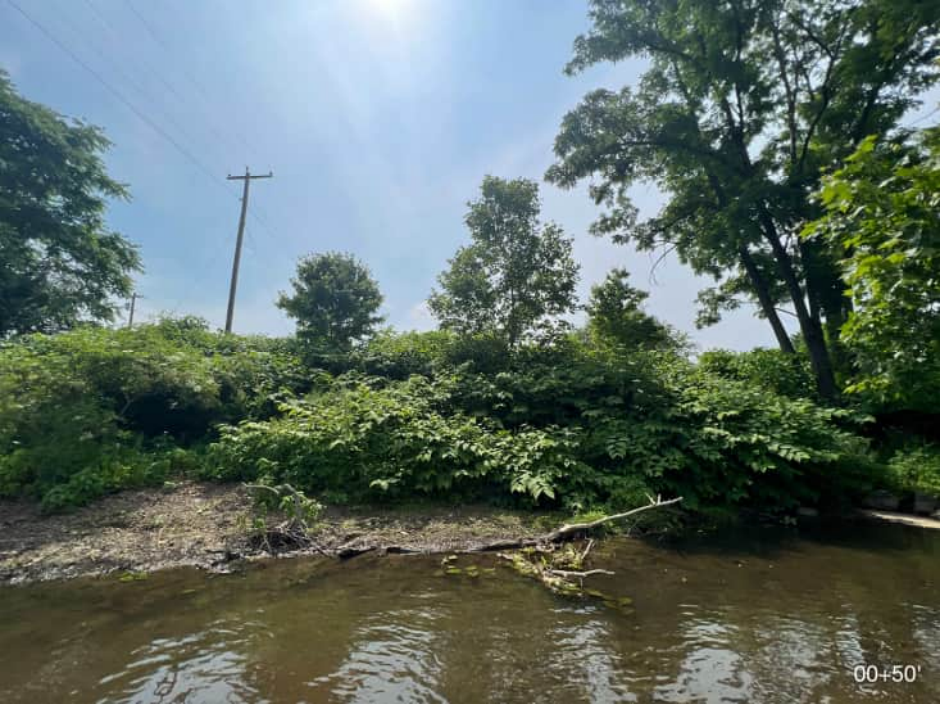
Photo Number: 5	Location: 00 + 50'
Date: 6/5/2023

Direction: West	
Description: ~45° consistent bank angle; 3' of bank toe is level; 65% invasive knotweed cover; at-risk adjacent sycamore 20 feet downstream

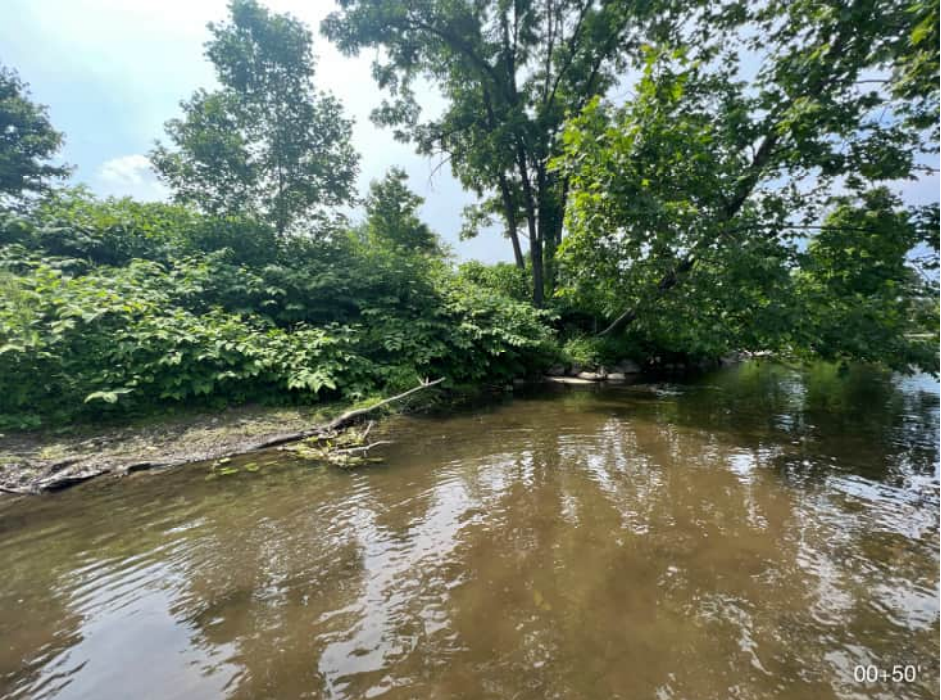
Photo Number: 6	Location: 00 + 50'
Date: 6/5/2023

Direction: Northwest	
Description: Downstream view of at-risk adjacent sycamore at 00+70'

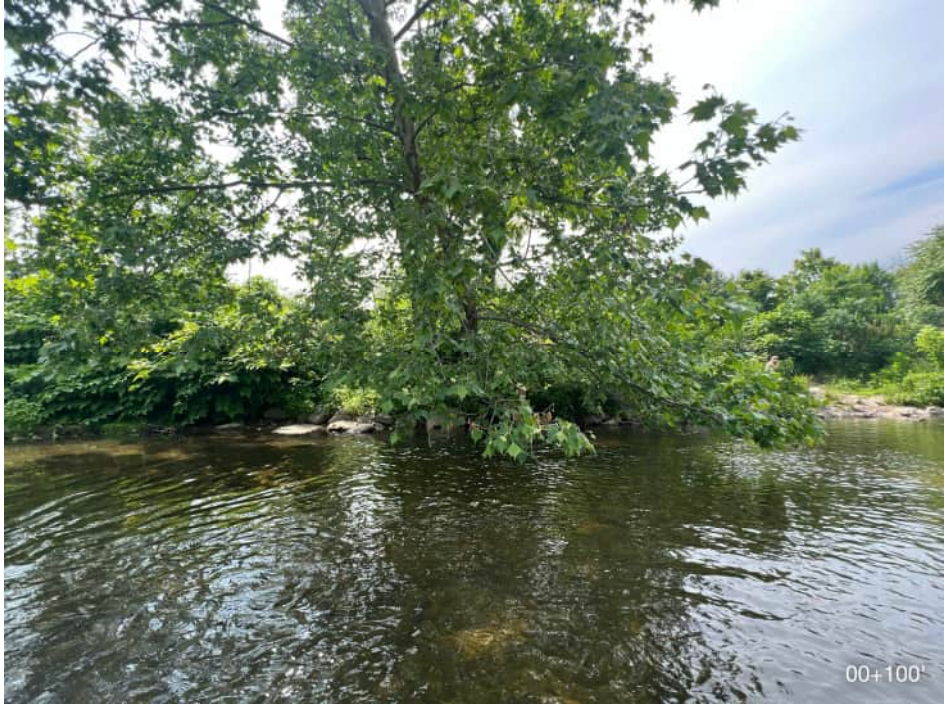
Photo Number: 7	Location: 00 + 100'
<p>Date: 6/5/2023</p> <hr/> <p>Direction: West</p> <hr/> <p>Description:</p> <p>Upper bank ~50° Lower bank ~20° (rock toe)</p> <p>At-risk trees sycamore upstream at 00+70'; sediment deposition adjacent to rock toe boulders</p>

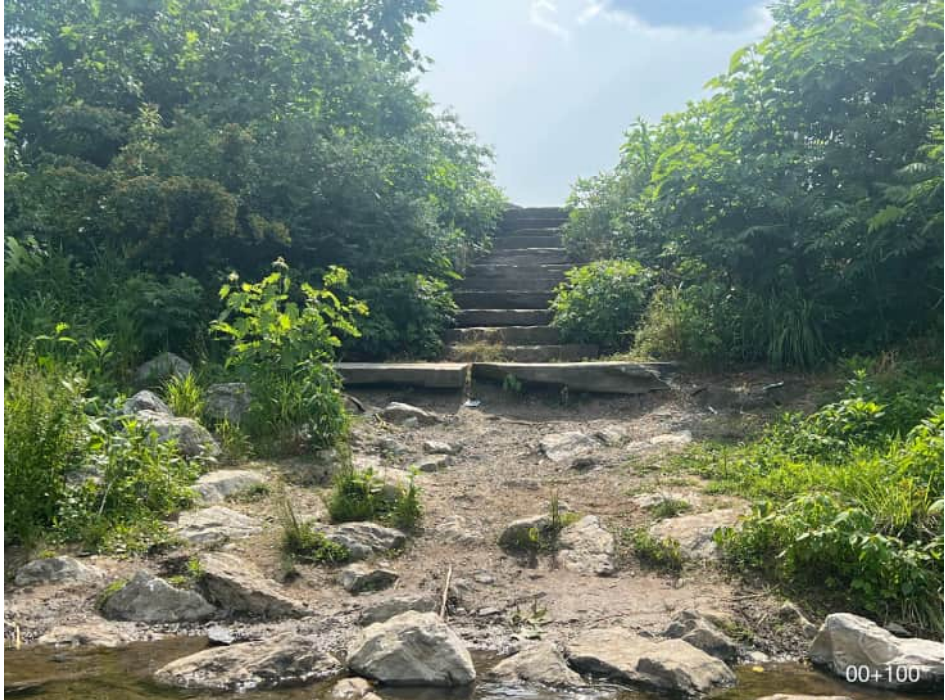
Photo Number: 8	Location: 00 + 100'
<p>Date: 6/5/2023</p> <hr/> <p>Direction: West</p> <hr/> <p>Description:</p> <p>Rock toe along bank and constructed river access stairs remain intact; erosion from high water and human activity has caused several holes and divots on the path at the bottom of the stairs</p>

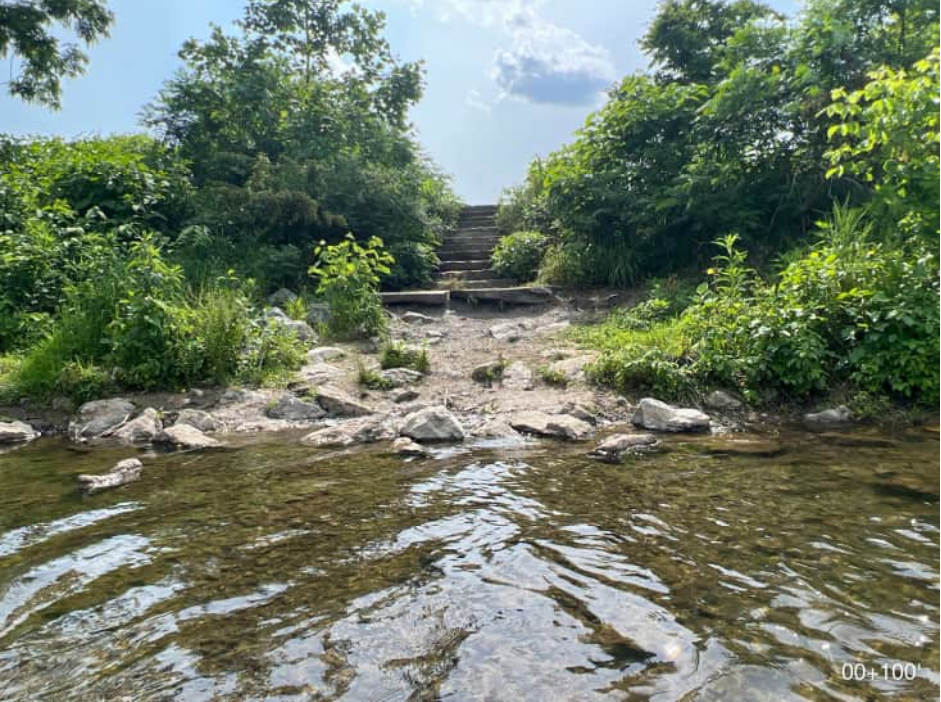
Photo Number: 9	Location: 00 + 100'
Date: 6/5/2023

Direction: West	
Description: Zoomed out view of river access stairs; stairs are slightly overgrown by vegetation but remain accessible

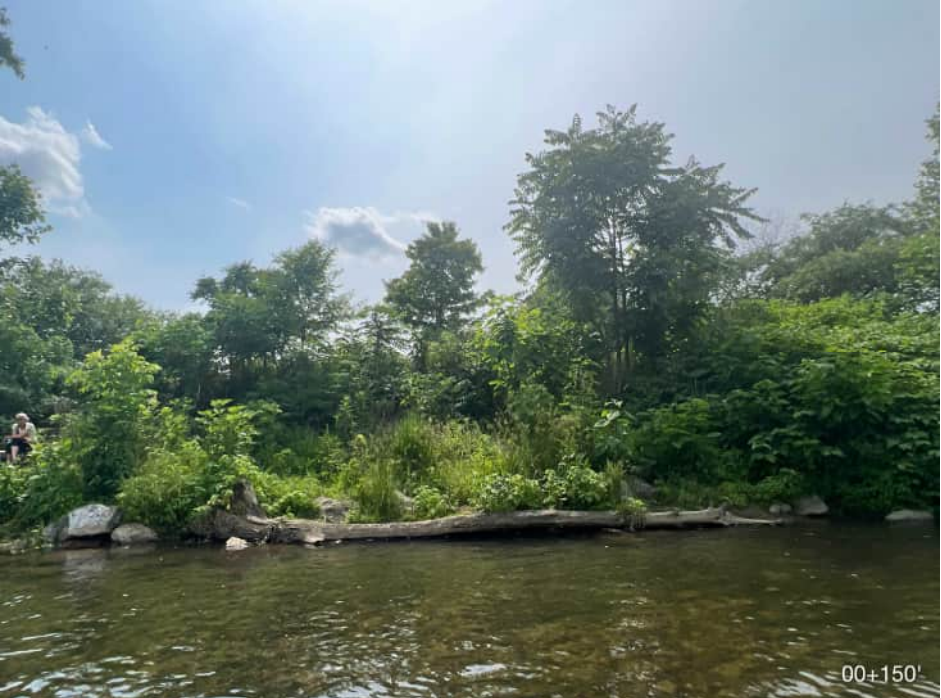
Photo Number: 10	Location: 00 + 150'
Date: 6/5/2023

Direction: West	
Description: Upper bank ~45°; Lower bank 15° (rock toe) Native vegetation dominant; small patch of invasive ailanthus saplings and some knotweed present

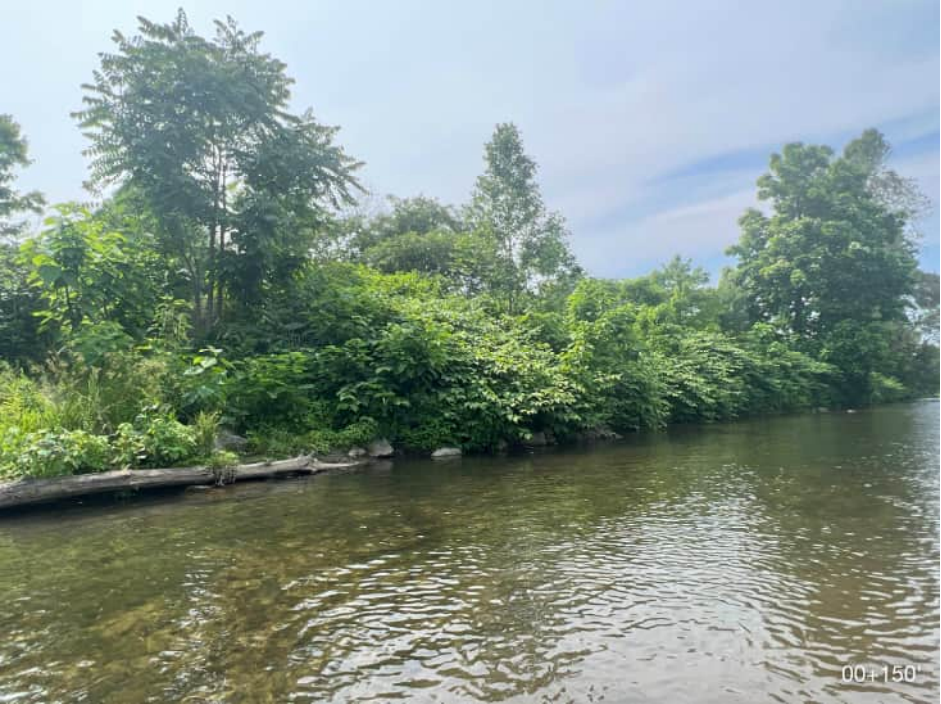
Photo Number: 11	Location: 00 + 150'
Date: 6/5/2023

Direction: Northwest	
Description: Downstream view of bank remediation A continuous line of Japanese knotweed is present

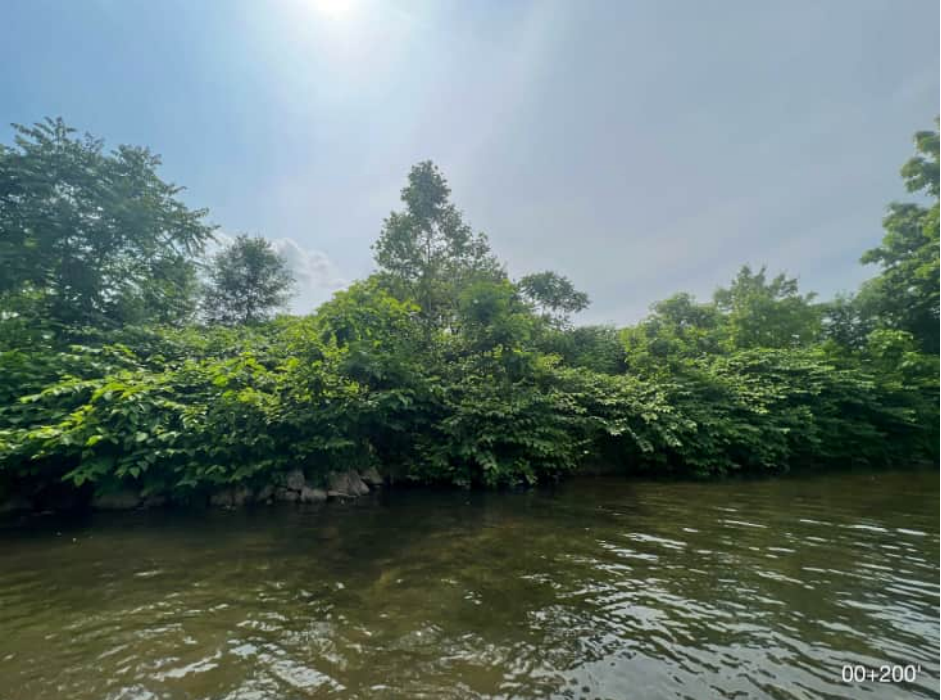
Photo Number: 12	Location: 00 + 200'
Date: 6/5/2023

Direction: West	
Description: ~55° bank angle (rock toe visible) Invasive knotweed ~90% cover; coir logs deteriorated, but stakes that held logs visibly protruding from water; minimal scour along toe; princess tree adjacent

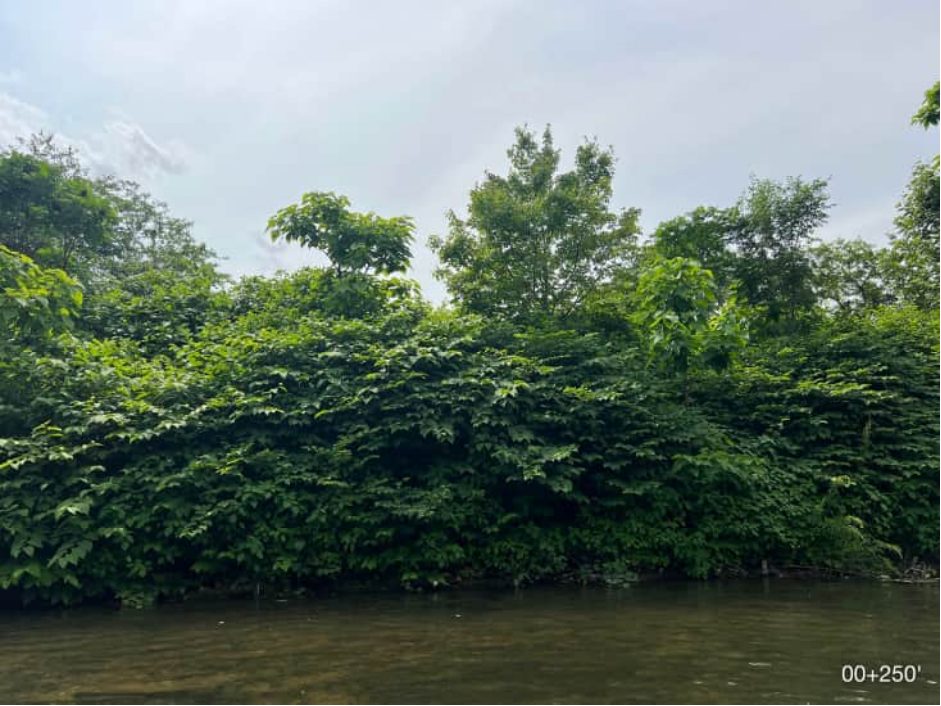
Photo Number: 13	Location: 00 + 250'
Date: 6/5/2023

Direction: West	
Description: ~55° bank angle Significant line of continuous Japanese knotweed cover ~90%; slight undercutting along toe

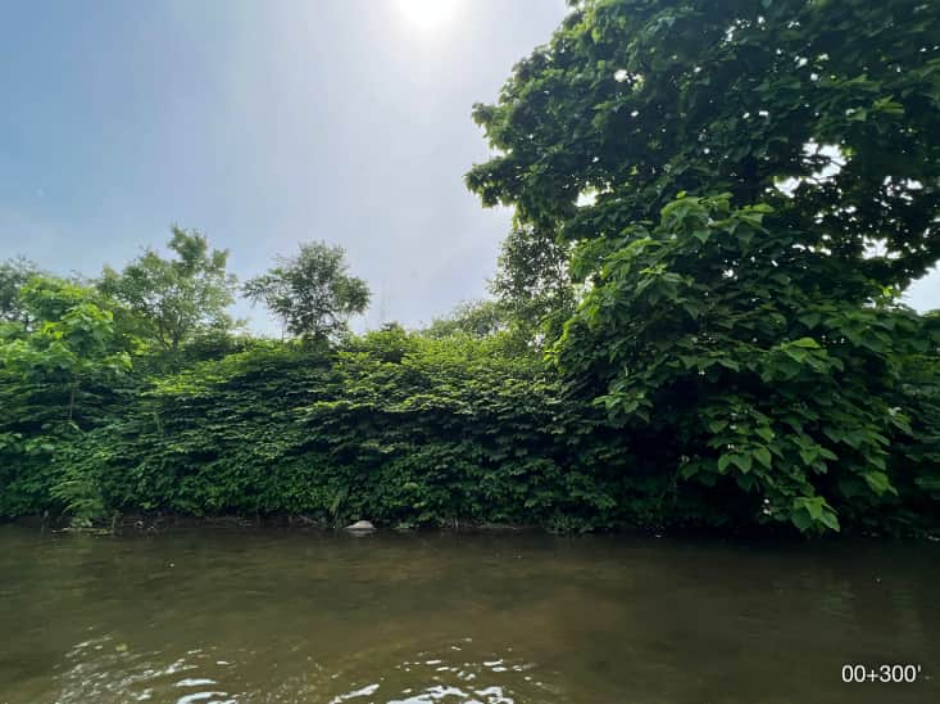
Photo Number: 15	Location: 00 + 300'
Date: 6/5/2023

Direction: West	
Description: ~70° bank angle Large patches of invasive knotweed ~90% cover; large Catalpa tree adjacent to edge of water in good condition

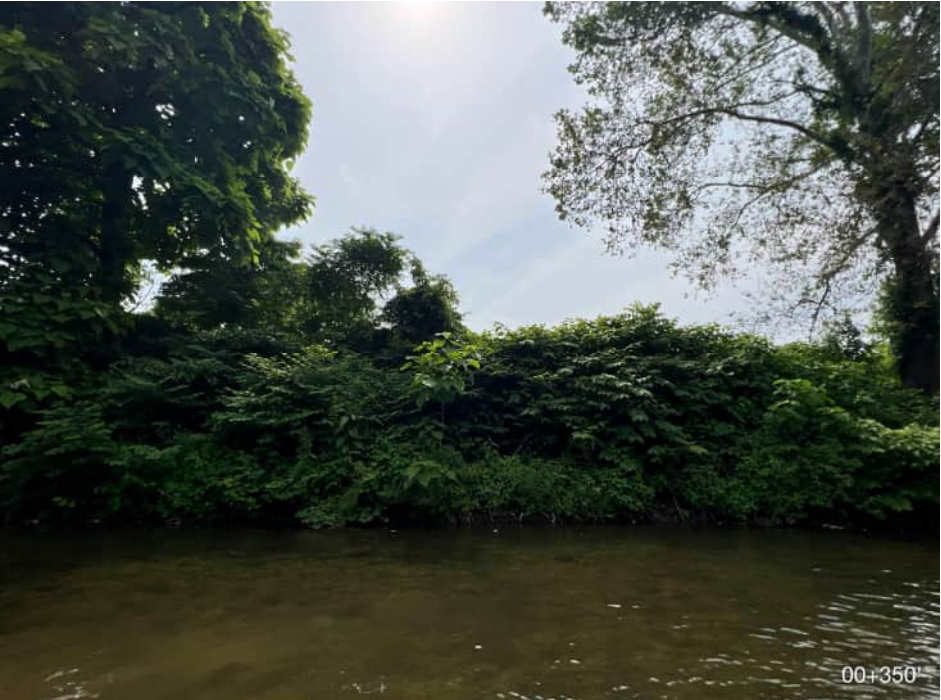
Photo Number: 16	Location: 00 + 350'
Date: 6/5/2023

Direction: West	
Description: ~70° bank angle Large patches of invasive knotweed present: ~80% cover; large adjacent tree possibly dying

- Recommended herbicide treatment of Japanese knotweed in late summer/early fall.
- Recommended stabilization of eroded and undercut geocell at 00+350'.

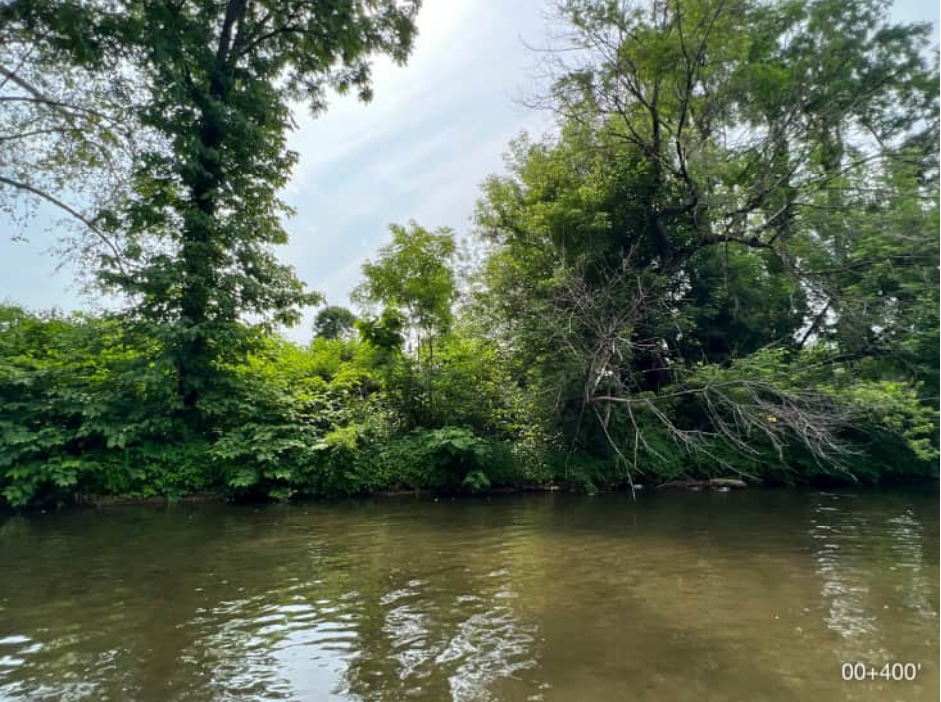
Photo Number: 19	Location: 00 + 400'
Date: 6/5/2023

Direction: West	
Description: ~60° bank angle Small patch of invasive knotweed ~30%; mostly native vegetation along bank; dead tree limbs hanging over river

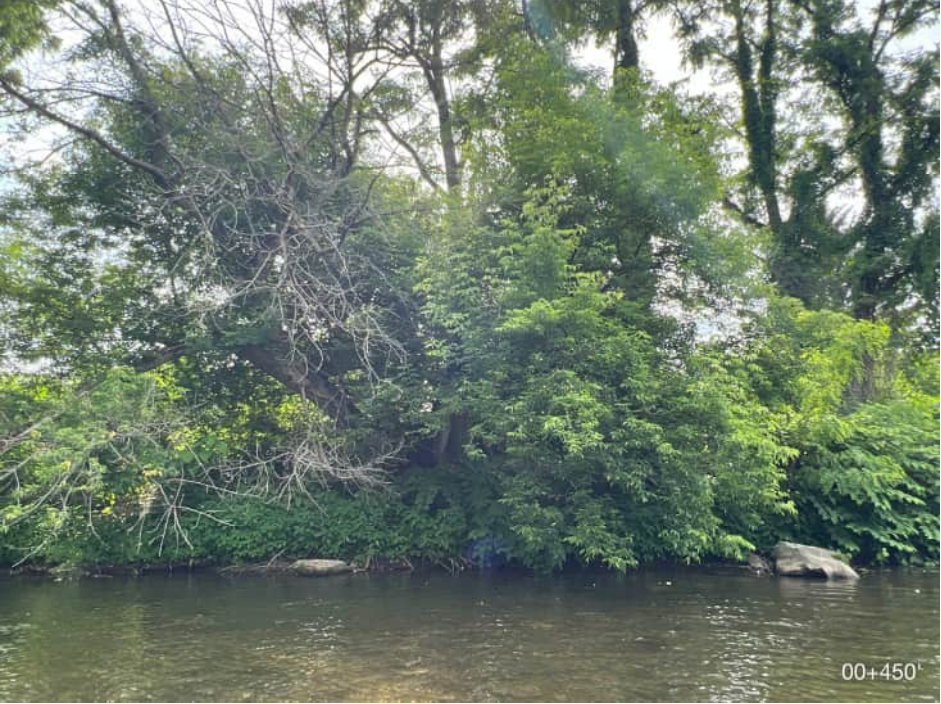
Photo Number: 21	Location: 00 + 450'
Date: 6/5/2023

Direction: West	
Description: ~50° bank angle Native vegetation present along top of bank with small patches of invasive knotweed at toe of slope; at-risk Box Elder tree with several dead limbs hanging over water

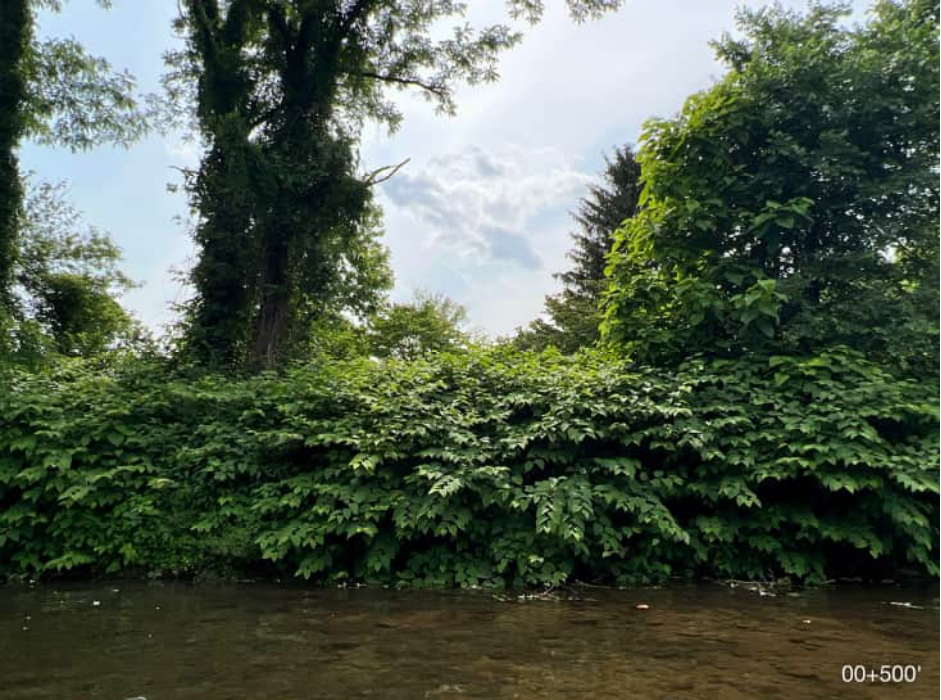
Photo Number: 22	Location: 00 + 500'
Date: 6/5/2023

Direction: West	
Description: ~40° bank angle Significant growth of invasive knotweed 95% cover

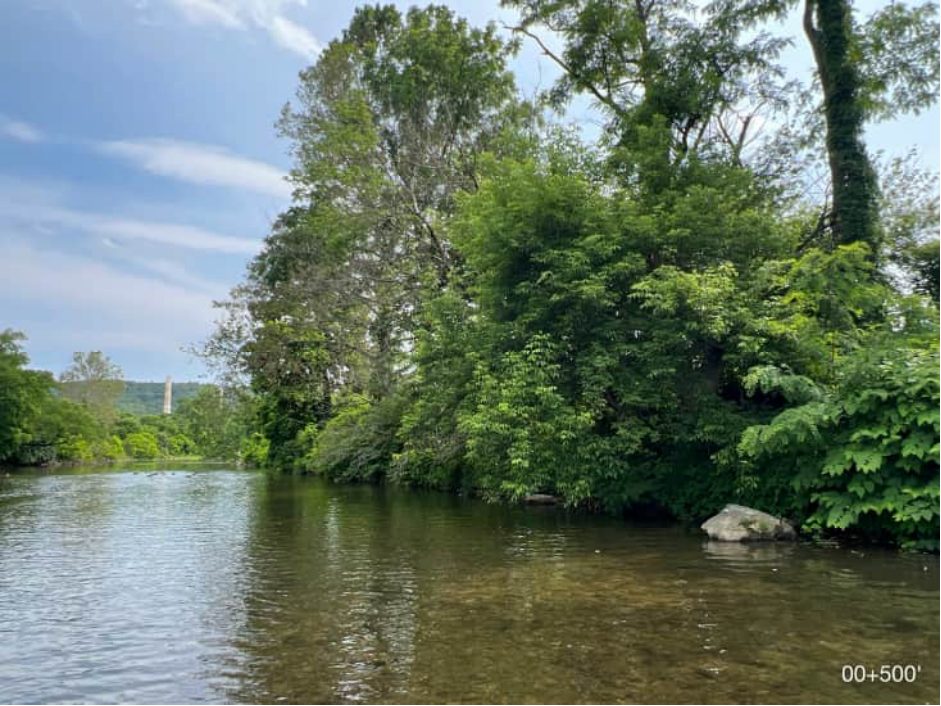
Photo Number: 23	Location: 00 + 500'
Date: 6/5/2023

Direction: Southwest	
Description: Upstream view of bank remediation; at-risk tree present leaning over water, bark stripped from portion of trunk; slight undercutting observed

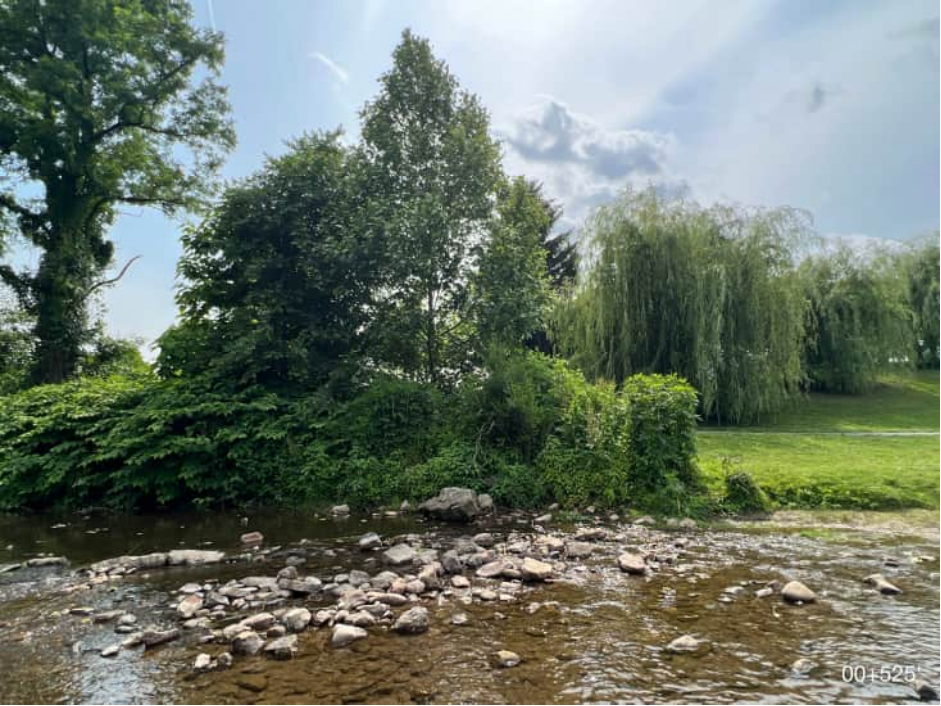
Direction: West	
Description: End of remediated section and beginning of non-remediated section ~45° bank angle Bank is only ~3 ft in height; small patch of invasive knotweed; increased lush native growth; some cobbles are exposed due to low water level

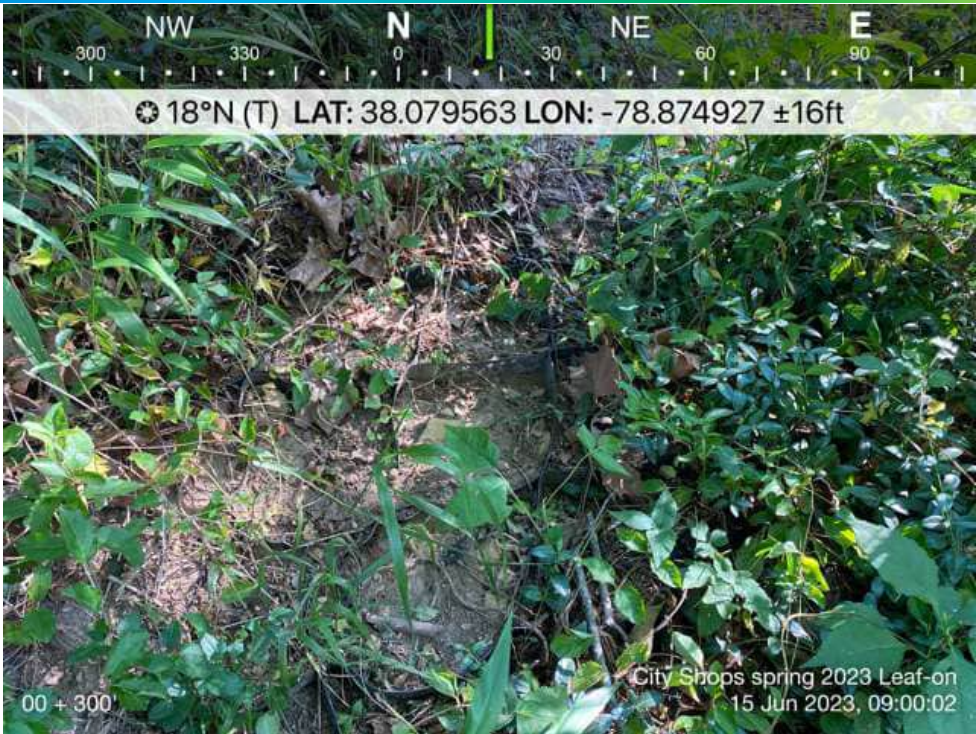
Direction: North	
Description: Small patch of bare soil and exposed geocell along upper bank

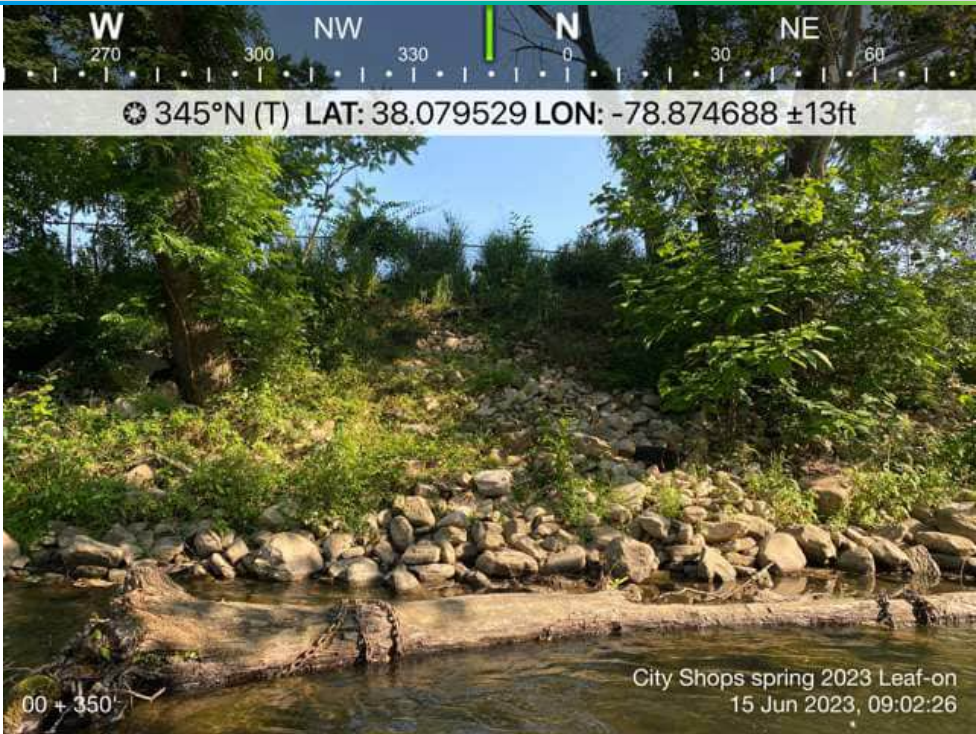
Direction: North	
Description: ~45° bank angle Predominantly native vegetation; intact rock toe; vegetation fully established; geocell minimally exposed along upper bank

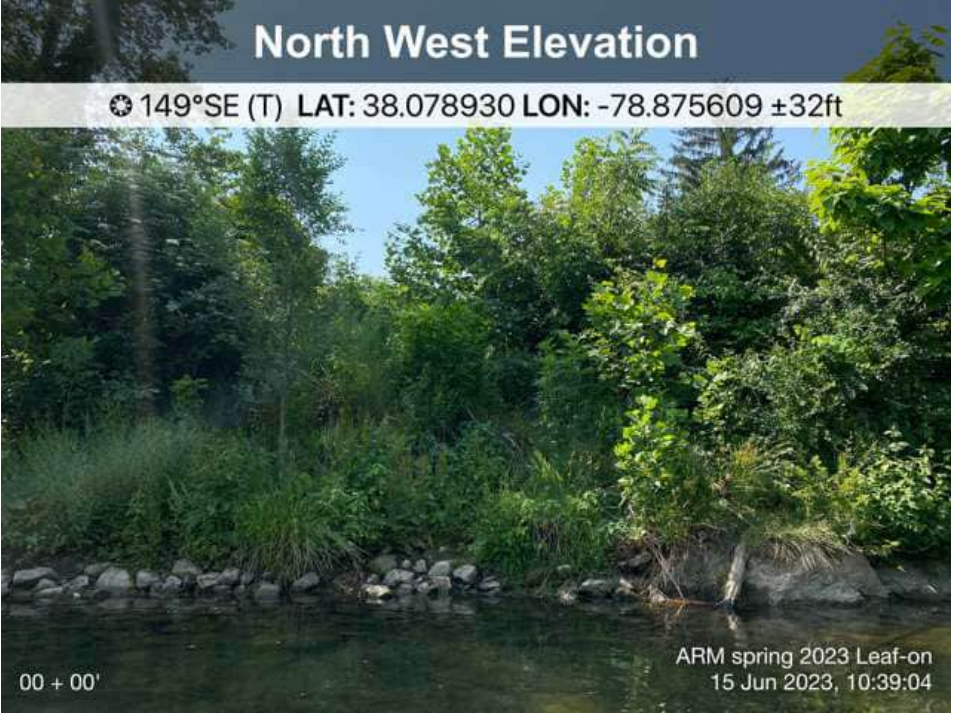
Direction: Southeast	☉ 149°SE (T) LAT: 38.078930 LON: -78.875609 ±32ft		
Description: Start of 1 st remediation section Herbaceous vegetation fully established; invasive ailanthus saplings, knotweed coverage ~5%; rock toe intact with sand deposition; geocell minimally exposed along upper bank	ARM spring 2023 Leaf-on 15 Jun 2023, 10:39:04

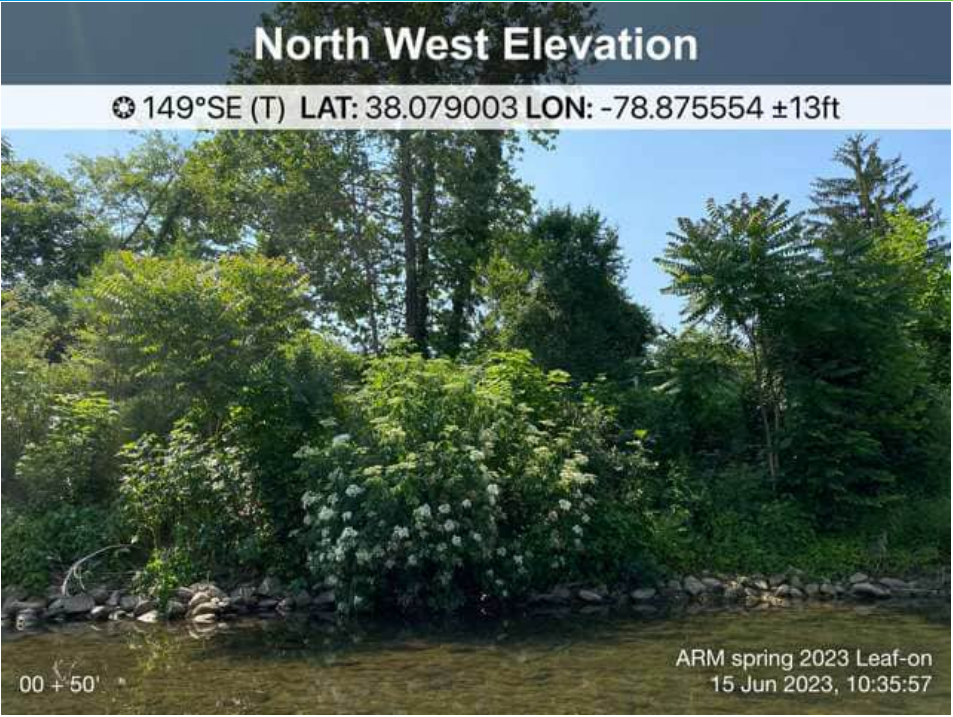
Direction: Southeast	
Description: ~50° bank angle Native herbaceous vegetation fully established; woody vegetation adjacent to water; no at-risk trees present; rock toe intact; geocell minimally exposed; sand deposition along rock toe

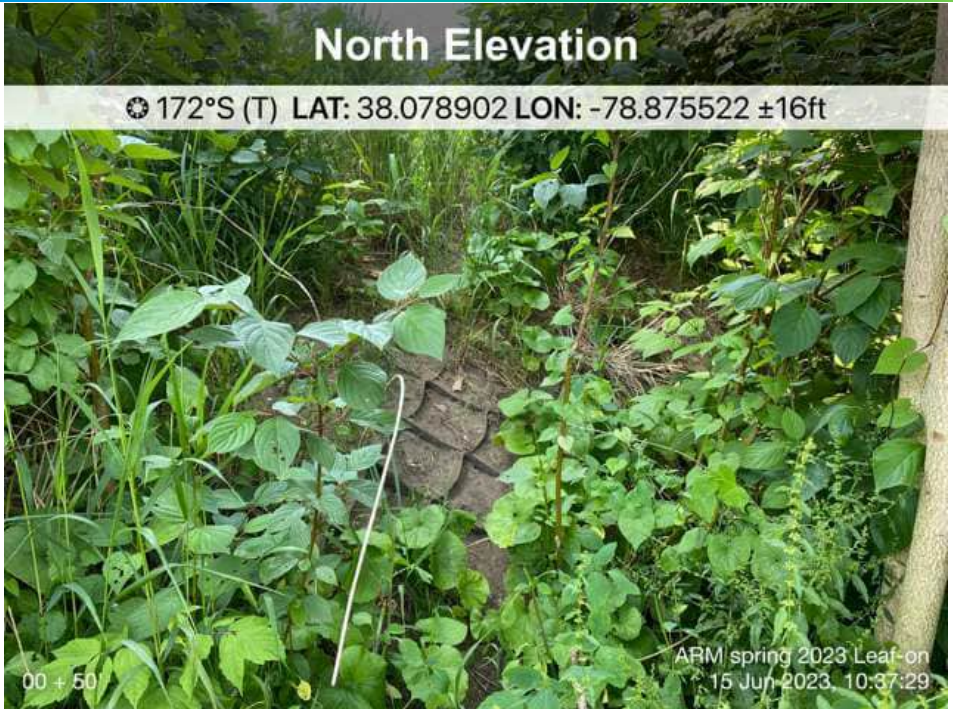
Direction: South	
Description: Geocell along upper bank is minimally exposed

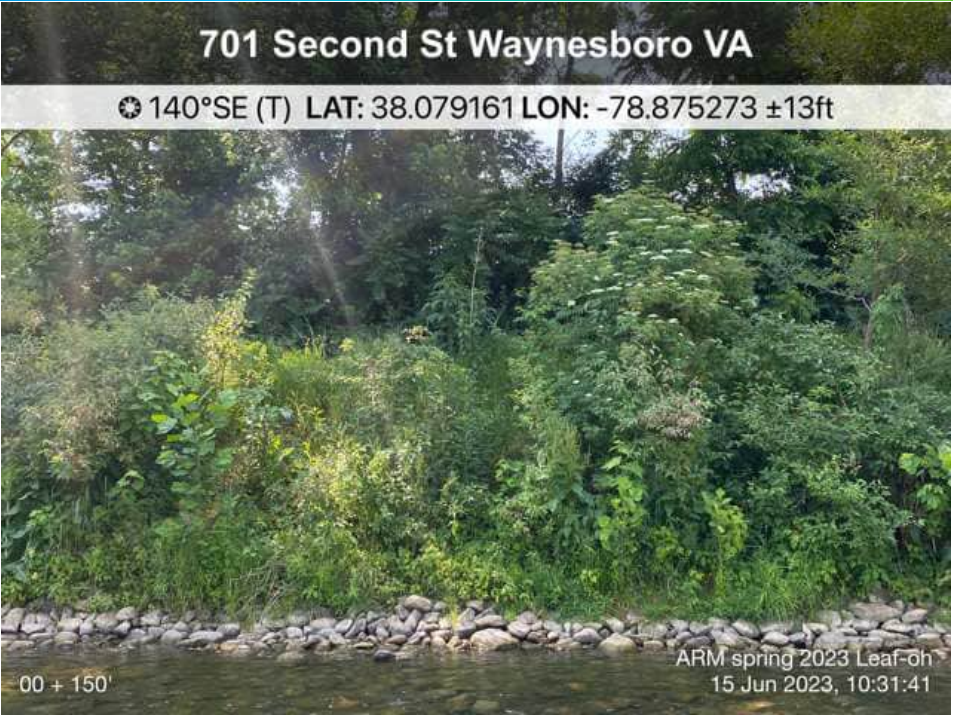
Direction: Southeast	
Description: ~50° bank angle Native herbaceous vegetation fully established; no at-risk trees present; rock toe intact; geocell exposed

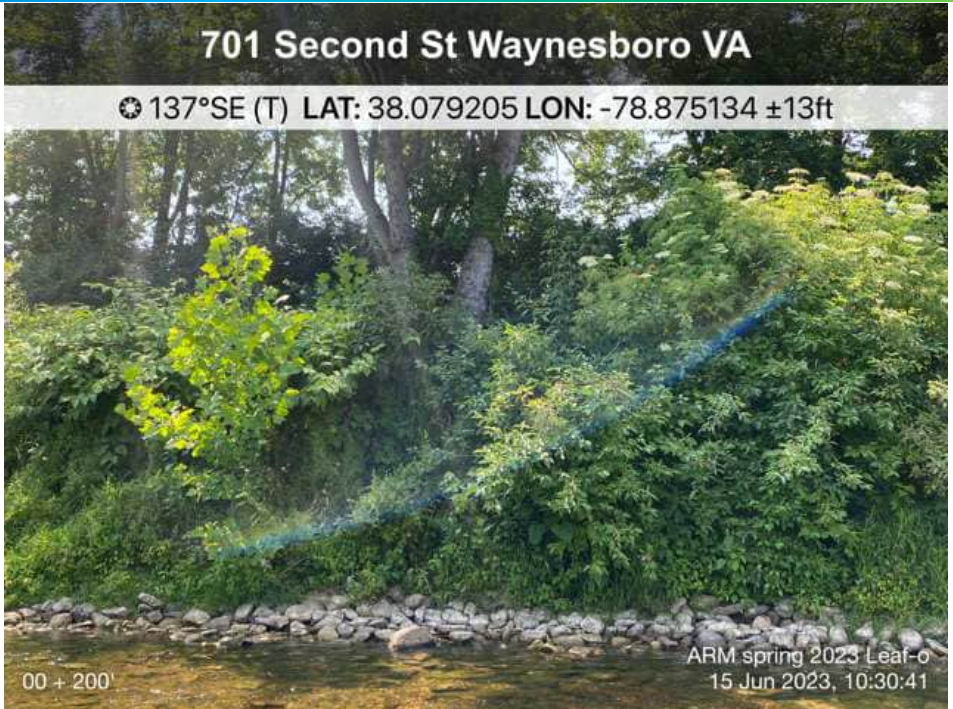
Direction: Southeast	
Description: ~50° bank angle Native herbaceous vegetation fully established; Invasive knotweed present ~2%; no at-risk trees present; rock toe intact; sand deposition at toe of bank; geocell minimally exposed along upper bank

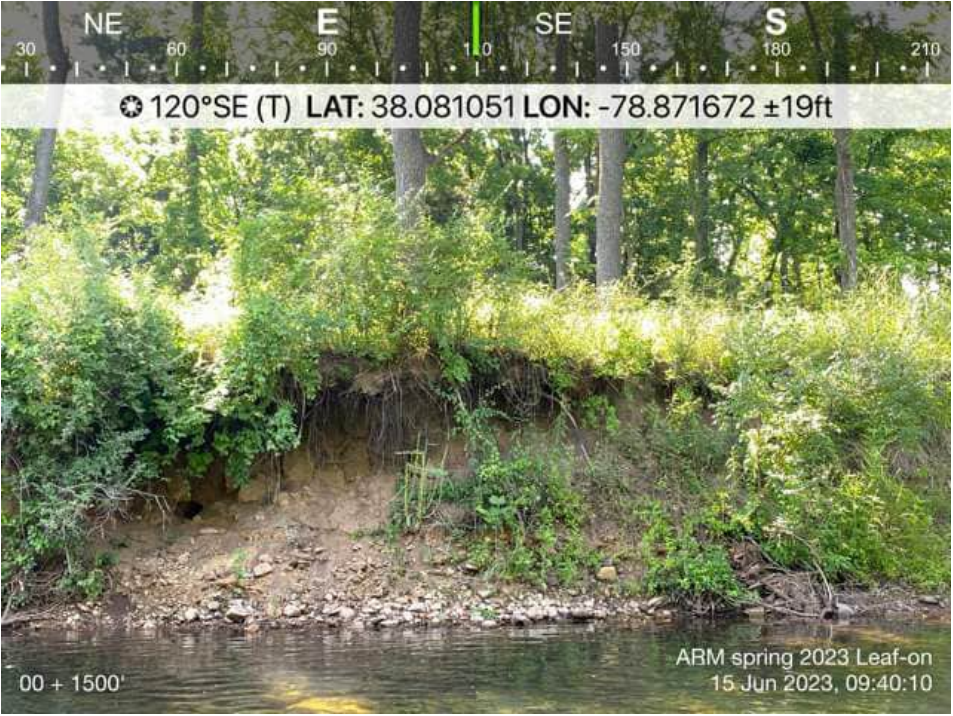
Direction: Southeast	
Description: ~90° bank angle Non-remediated section downstream of BMA; severe erosion, root exposure, and undercutting present

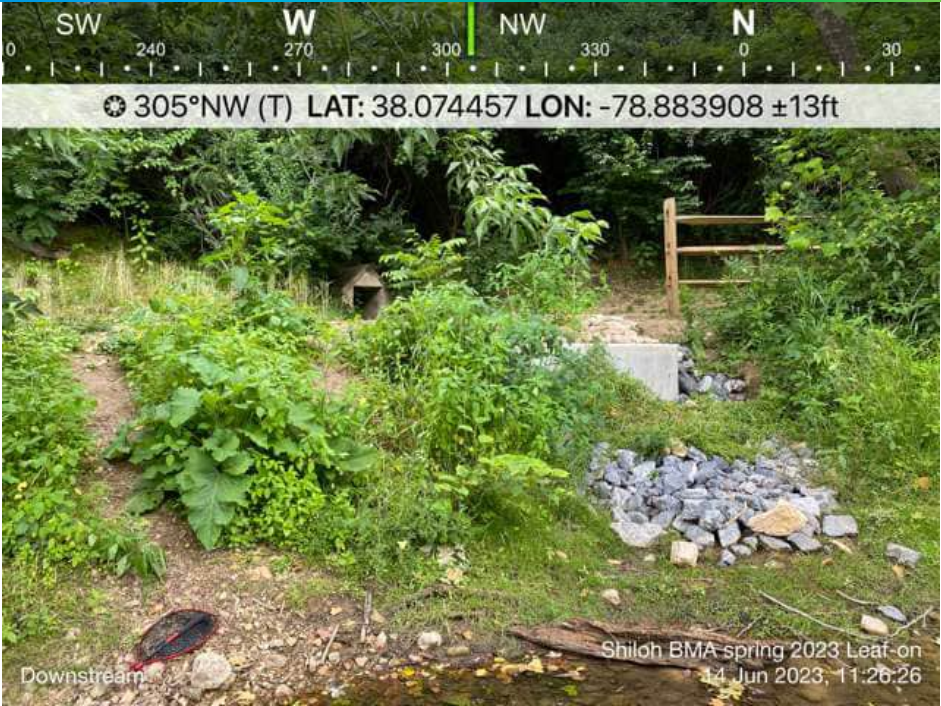
Direction: Northwest	
Description: Newly installed drainage swale and rip rap are in good condition

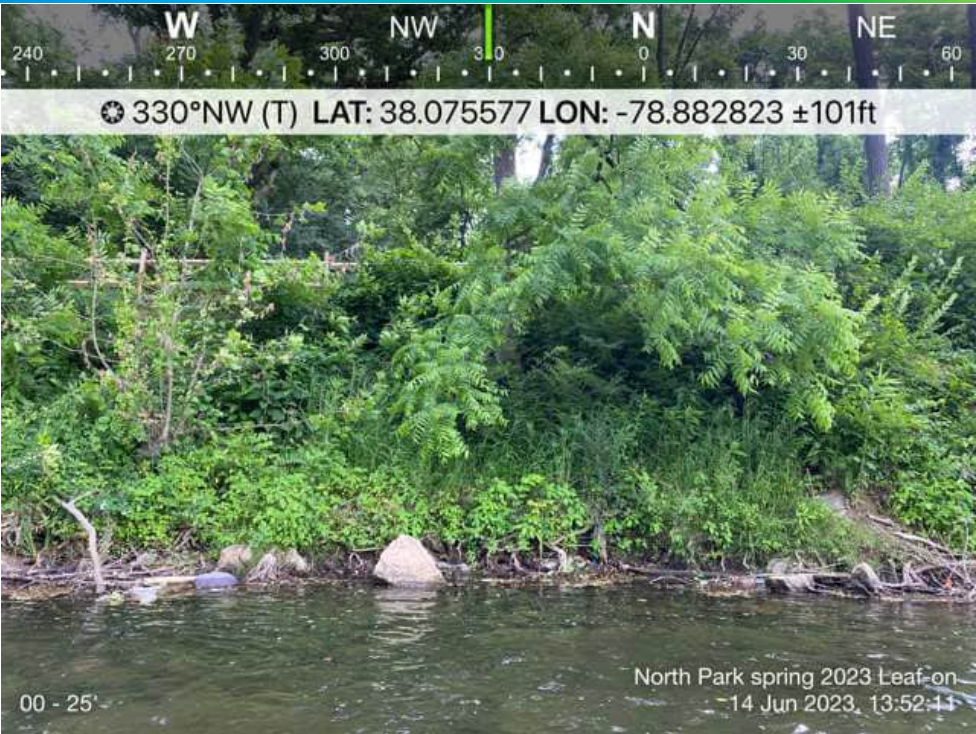
Direction: Northwest	
Description: Upstream of remediation; ~80° lower bank; ~60° upper bank Vertical drop at toe; exposed roots throughout bank; minimal scour present along toe

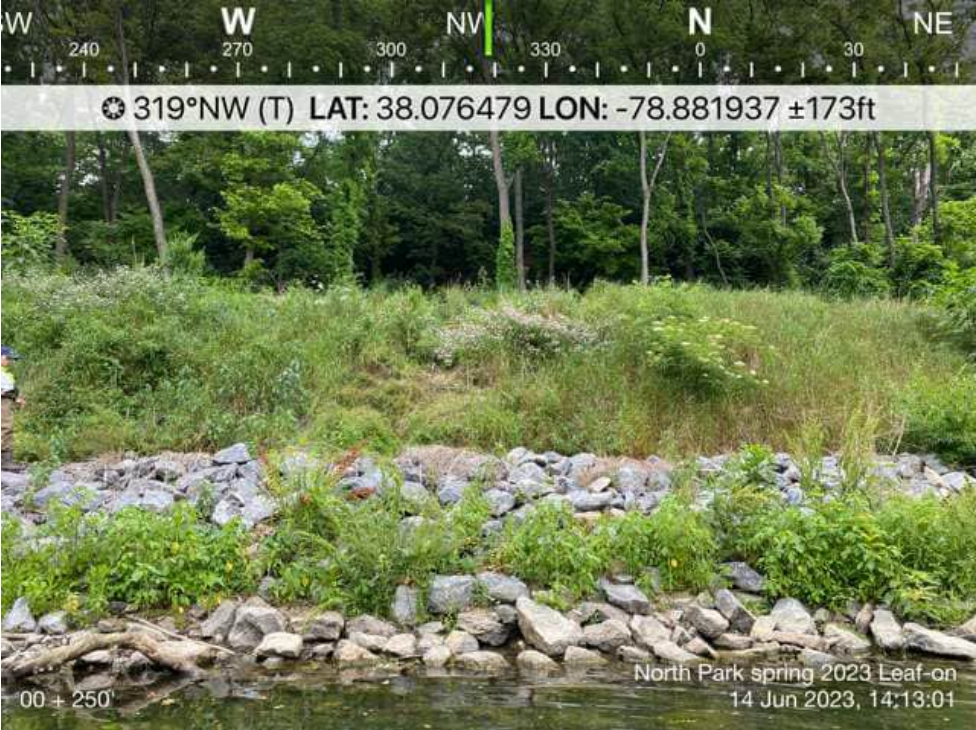
Direction: Northwest	
Description: ~45° lower bank; ~70° upper bank Vegetation 90% cover; rock toe intact; increased sediment deposition in rock toe; geocell is minimally exposed

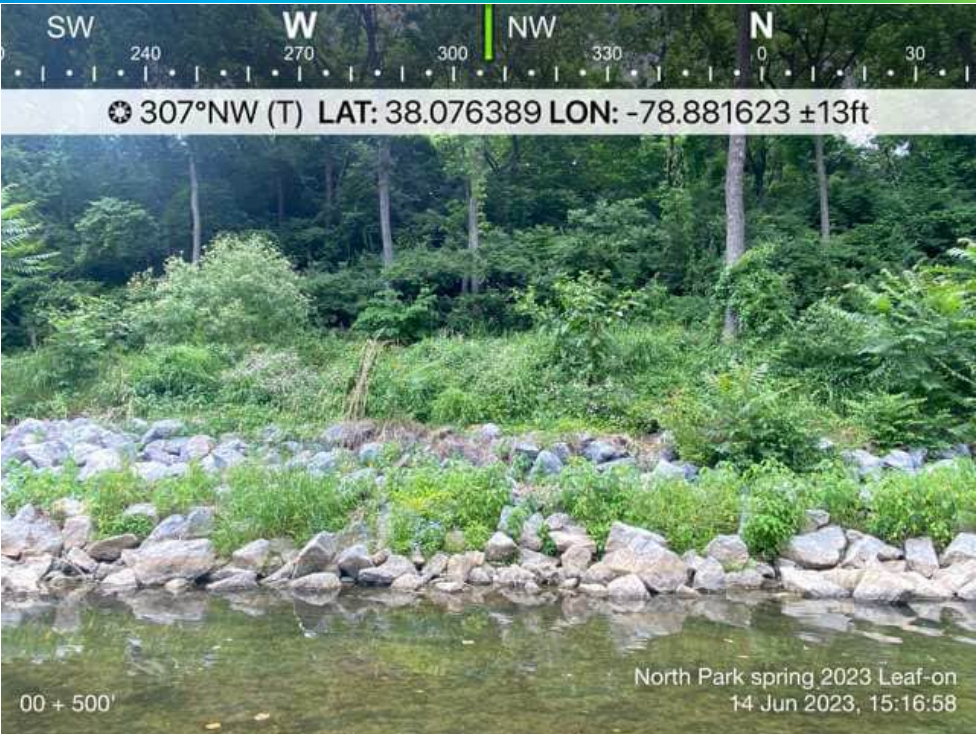
Direction: Northwest	
Description: ~45° lower bank; ~60° upper bank Vegetation ~95% cover with herbaceous and woody plants well established rock toe intact; geocell exposed along top of bank
