RE: 2022 Leaf-off, 2022 Leaf-on and 2023 Leaf-on BMA Inspection Memos
Former DuPont Waynesboro Site AOC 4
Waynesboro, Virginia
EPA ID# VAD003114832

Subject 2023 Leaf-on Maintenance Inspection
Former DuPont Waynesboro Site, Area of Concern 4

Constitution Park BMA 2023 Leaf-on Inspection

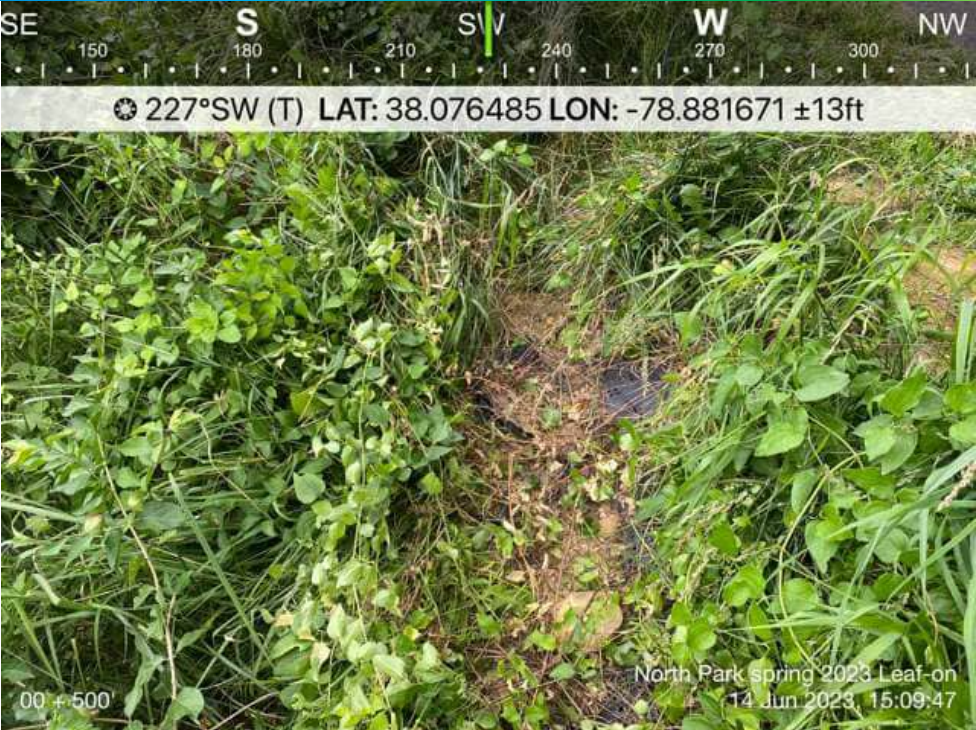
Direction: Southwest	
Description: Geocell protruding from the shallow trench along the top of bank, adjacent to the greenway path
