**Re: Fall 2017 Constitution Park Maintenance Inspection Memorandum  
Former DuPont Waynesboro Plant, On-Site  
Waynesboro, Virginia  
EPA ID# VAD003114832**

| Subject | Fall 2017 Constitution Park BMA Maintenance Inspection<br>Former DuPont Waynesboro Site, Area of Concern 4 | | |

Table 1  
BMA Inspection Log  
Fall 2017 Constitution Park BMA Maintenance Inspection Memorandum  
Former DuPont Waynesboro Site, Area of Concern 4

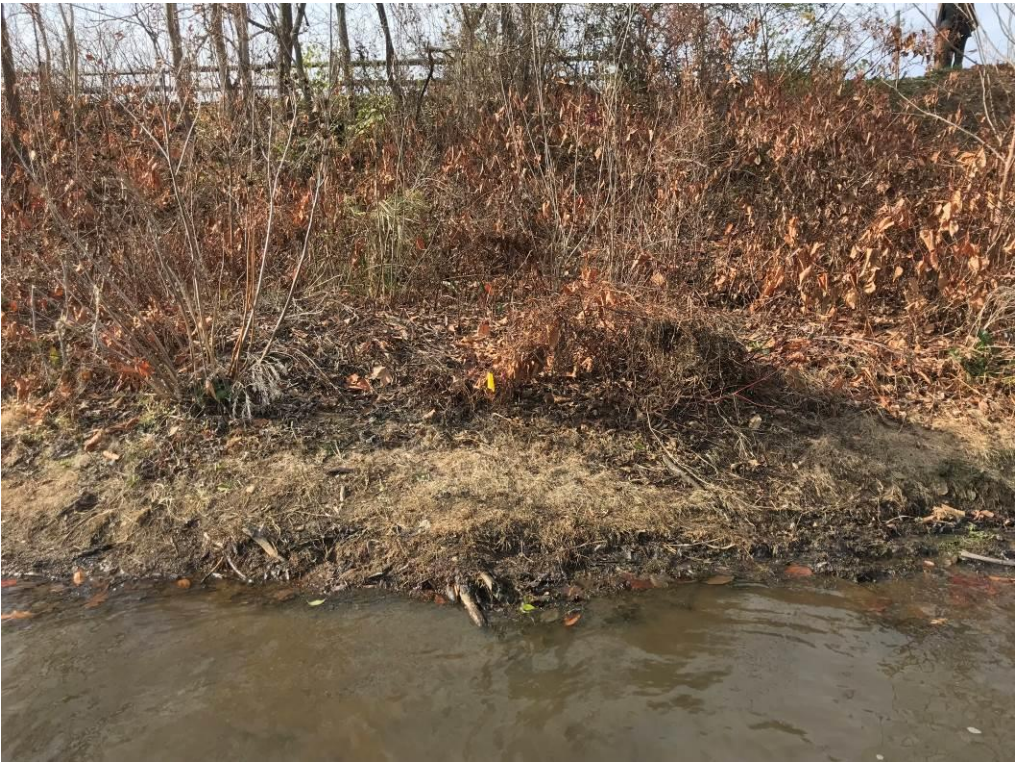
| <b>Photo No.</b><br>1 | <b>Date:</b><br>12/6/2017 | | |

| <b>Description:</b><br><br>Station 00 – 25'<br><br>~30 degree bank angle;<br>no at-risk trees present;<br>both native and<br>invasive vegetation<br>present. | | | |

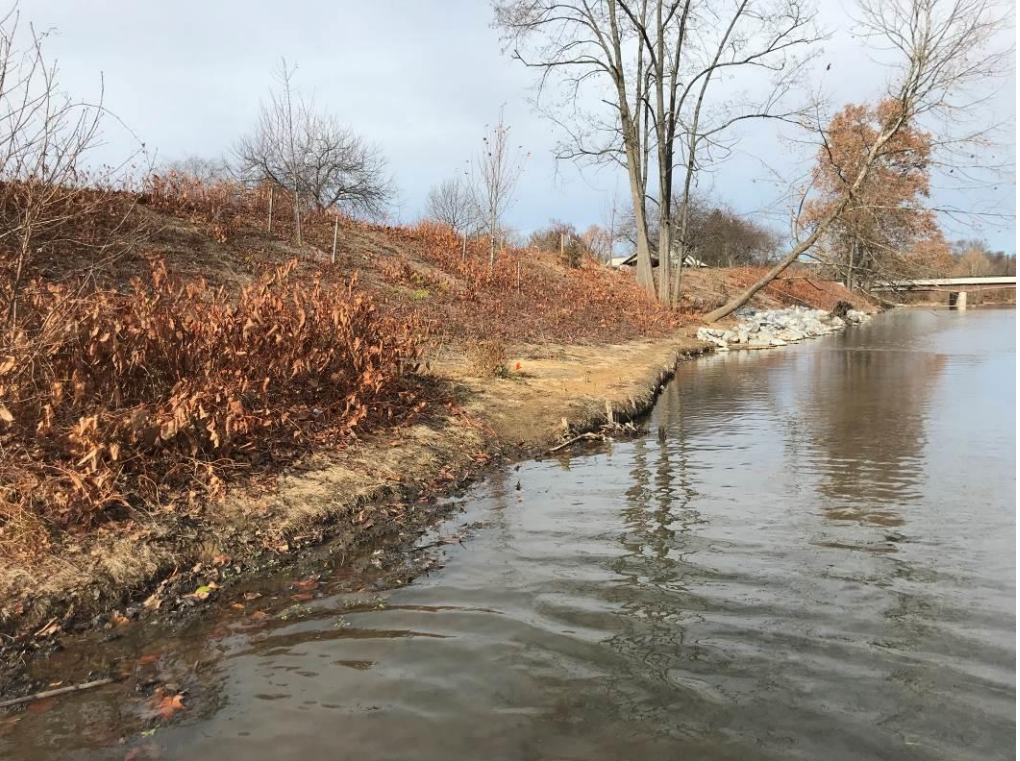
| <b>Photo No.</b><br>2 | <b>Date:</b><br>12/6/2017 | |

| <b>Description:</b><br><br>Station 00 – 25'<br><br>No woody plants<br>adjacent to river with<br>exposed roots<br>observed; however,<br>invasive vegetation is<br>present. | | |

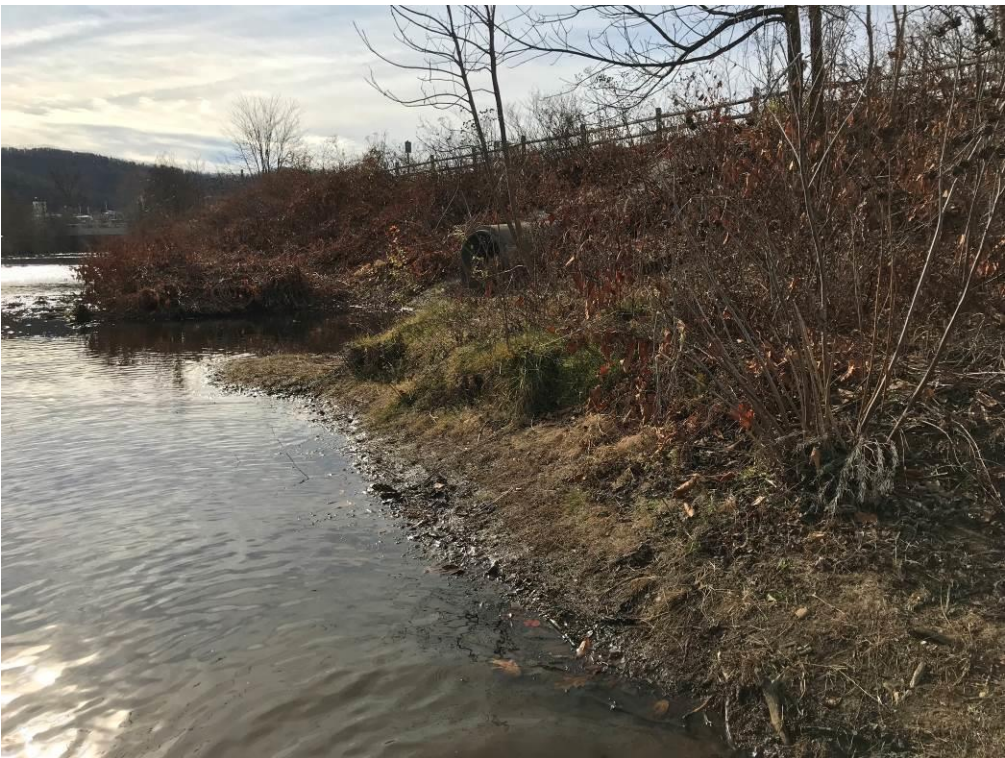
| <b>Photo No.</b><br>3 | <b>Date:</b><br>12/6/2017 | | |

| <b>Description:</b><br><br>Station 00 – 25'<br><br>Low presence of scour<br>~5' upstream of inspection point. | | | |

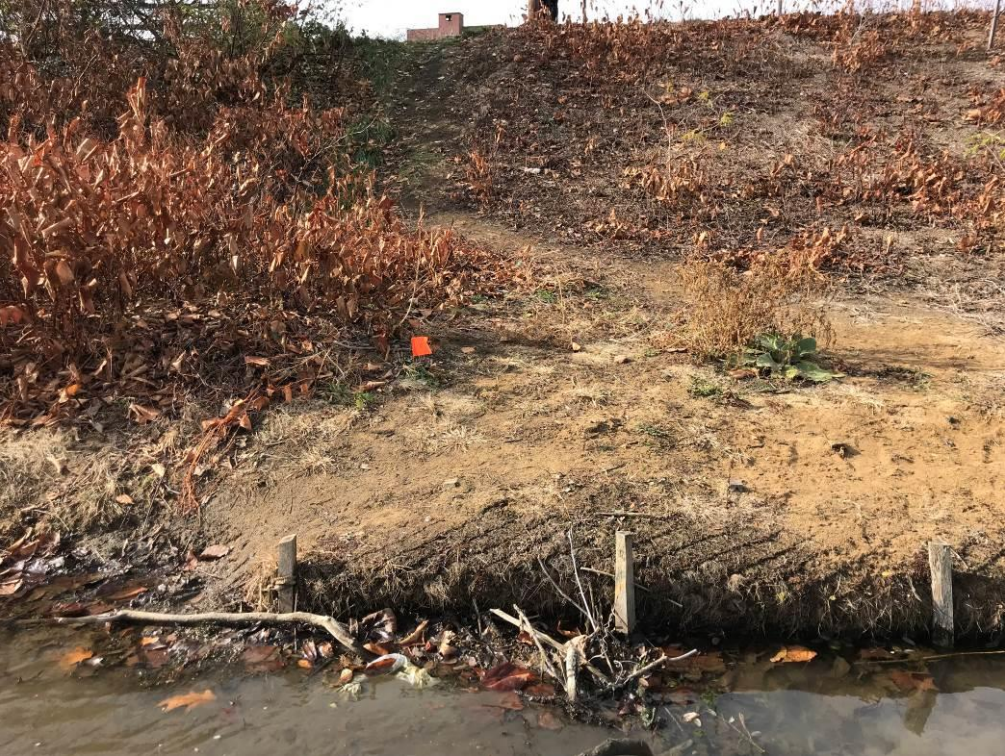
| <b>Photo No.</b><br>4 | <b>Date:</b><br>12/6/2017 | |

| <b>Description:</b><br><br>Station 00 + 00'<br><br>~40 degree bank angle;<br>patches of invasive<br>vegetation present; coir<br>logs intact; no scour<br>present; heavy foot<br>traffic down the bank<br>and along coir logs. | | |

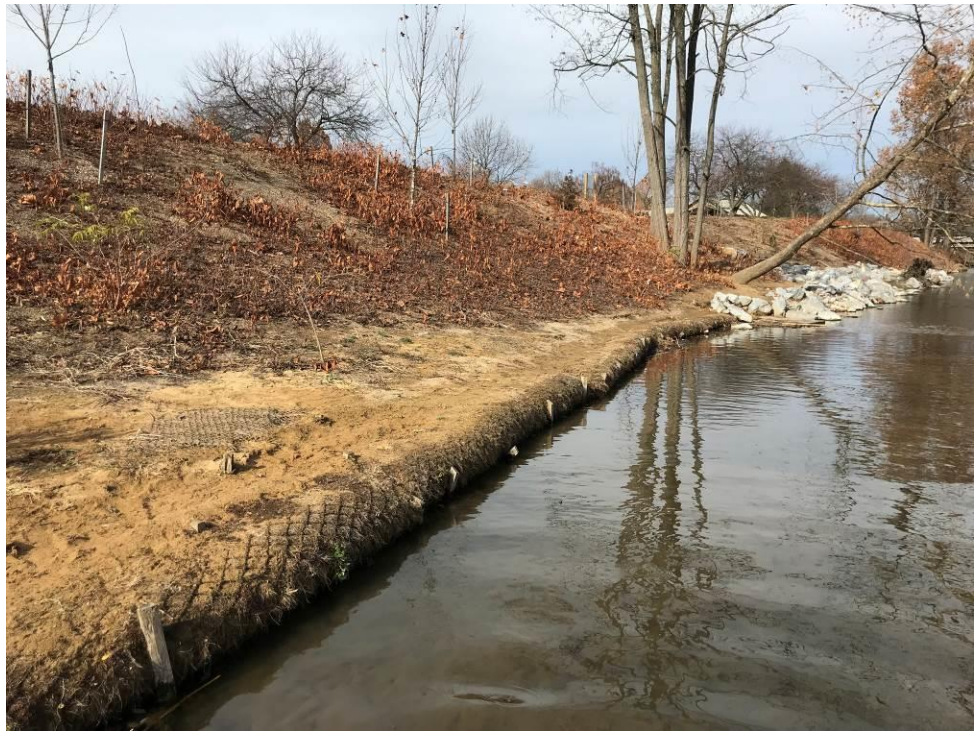
| <b>Photo No.</b><br>5 | <b>Date:</b><br>12/6/2017 |

| <b>Description:</b><br><br>Station 00 + 00'<br><br>No at-risk trees present; limited native vegetation present with patches of invasive vegetation; coir logs intact; minimal scour present; foot traffic along toe of slope evident; edge of erosion control fabric is exposed along toe of slope. |

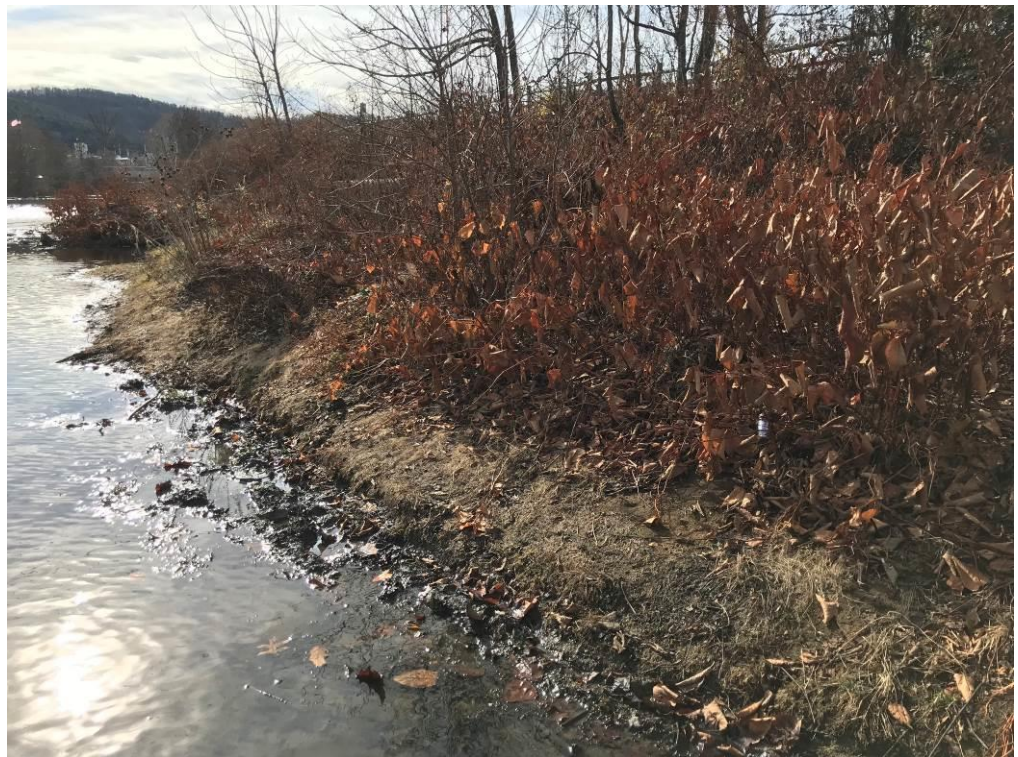
| <b>Photo No.</b><br>6 | <b>Date:</b><br>12/6/2017 |

| <b>Description:</b><br><br>Station 00 + 00'<br><br>Invasive vegetation present with limited patches of native vegetation; minimal foot traffic along toe of slope; minimal scour present. |

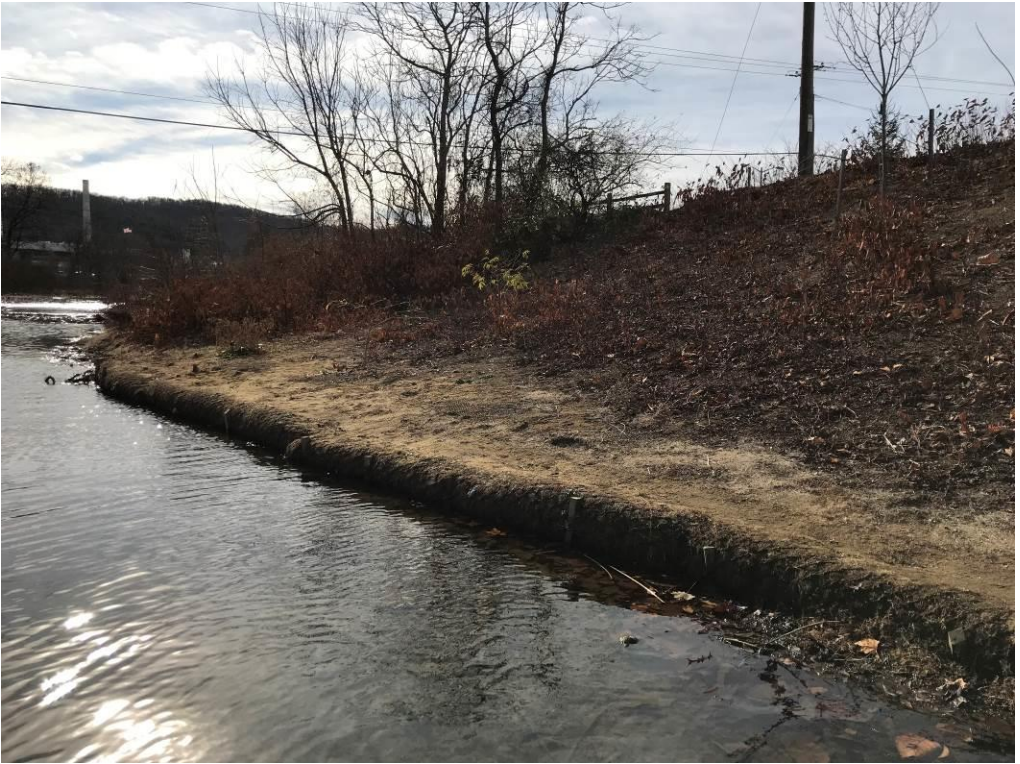
| <b>Description:</b><br><br>Between station 00 + 00' and 00 + 50'<br><br>Installed erosion control fabric intact, but some exposed; heavy foot traffic along toe of slope; evidence of knotweed vegetation maintenance along bank; geocell intact, but beginning to be exposed near the toe of the slope. | | | |

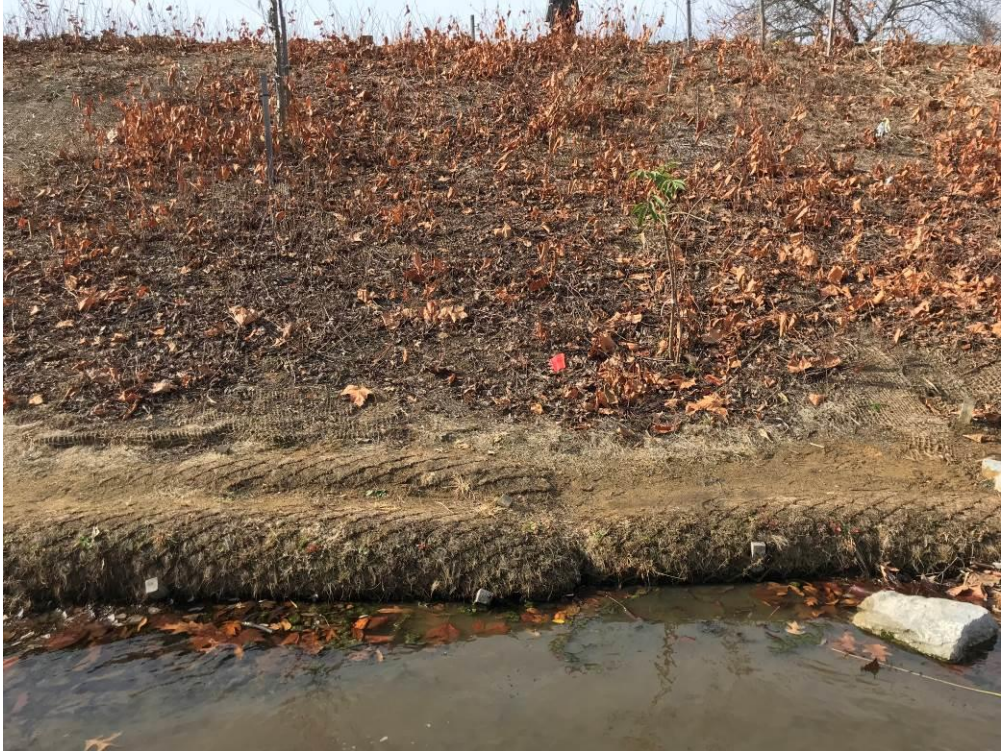
| <b>Description:</b><br><br>Station 00 + 50'<br><br>~45 degree consistent bank angle; no at-risk trees present; no exposed roots; coir logs intact; no scour present; evidence of foot traffic along toe of slope, along coir logs; evidence of recent invasive vegetation maintenance. | | |

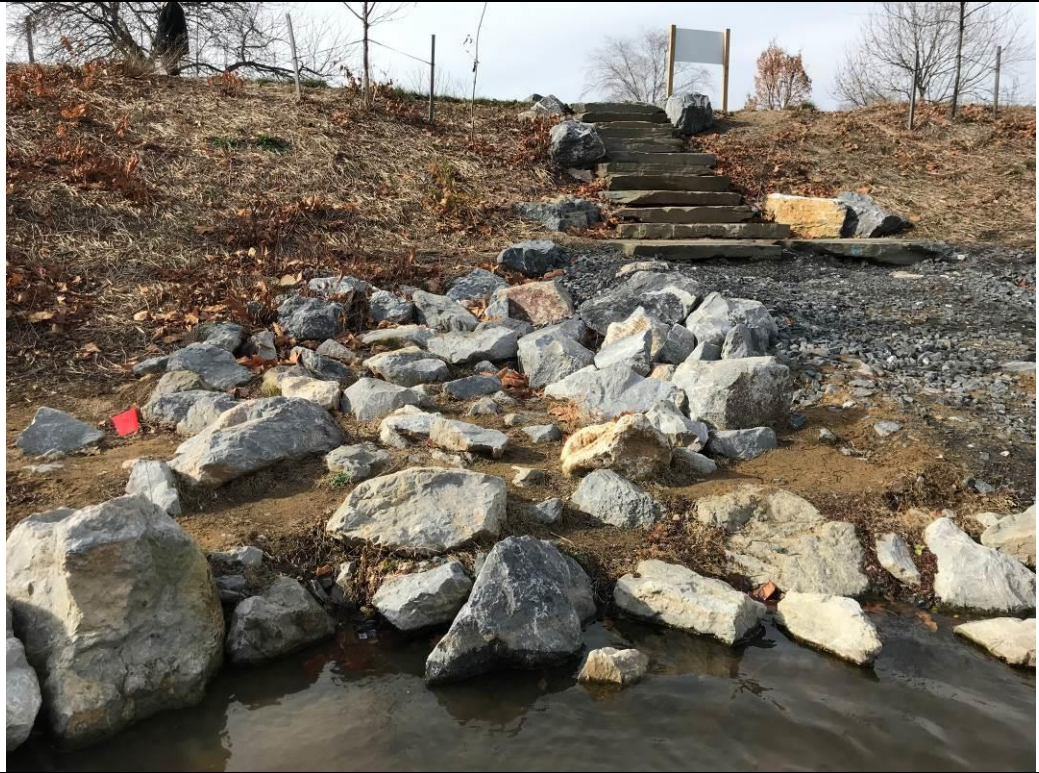
**Photo No.**  
9**Date:**  
12/6/2017**Direction Photo  
Taken:**

Station 00 + 100'

~40 degree bank angle;  
no at-risk trees present;  
no exposed roots; no  
scour present; installed  
rock toe intact with  
evidence of sediment  
deposition; installed  
river access steps  
intact.

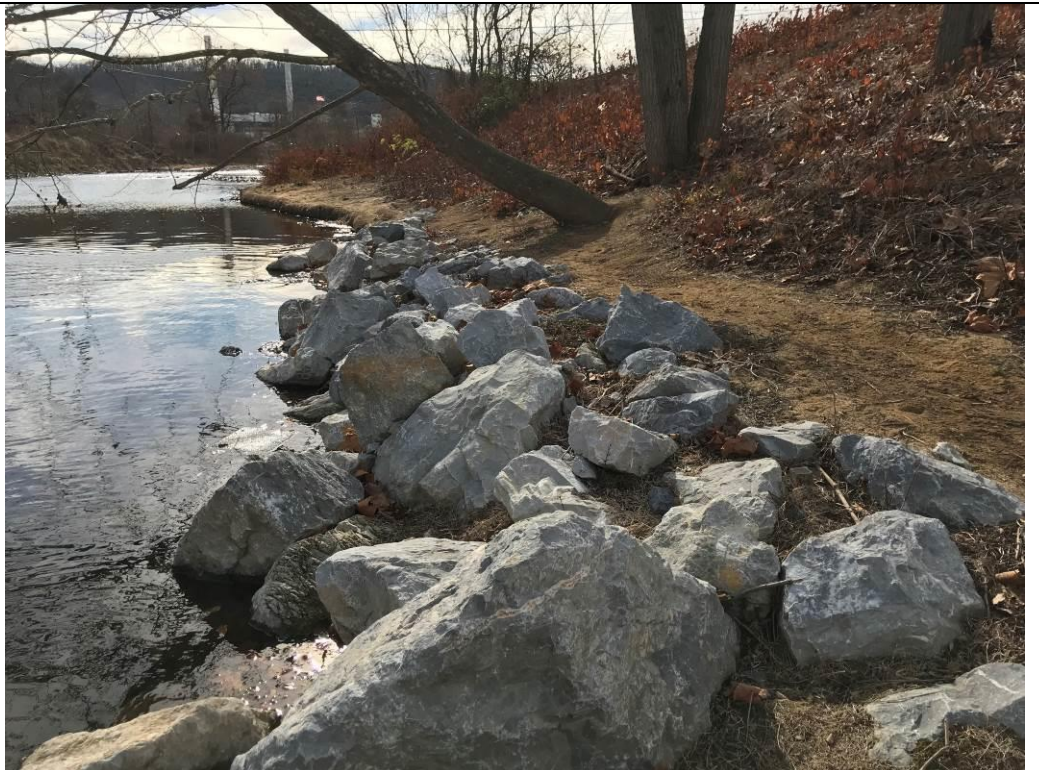
**Photo No.**  
10**Date:**  
12/6/2017**Direction Photo  
Taken:**

Station 00 + 100'

No at-risk trees  
present; no exposed  
roots; no scour present;  
installed rock toe intact  
with evidence of  
sediment deposition;  
evidence  
of foot traffic along toe  
of slope, along coir  
logs.

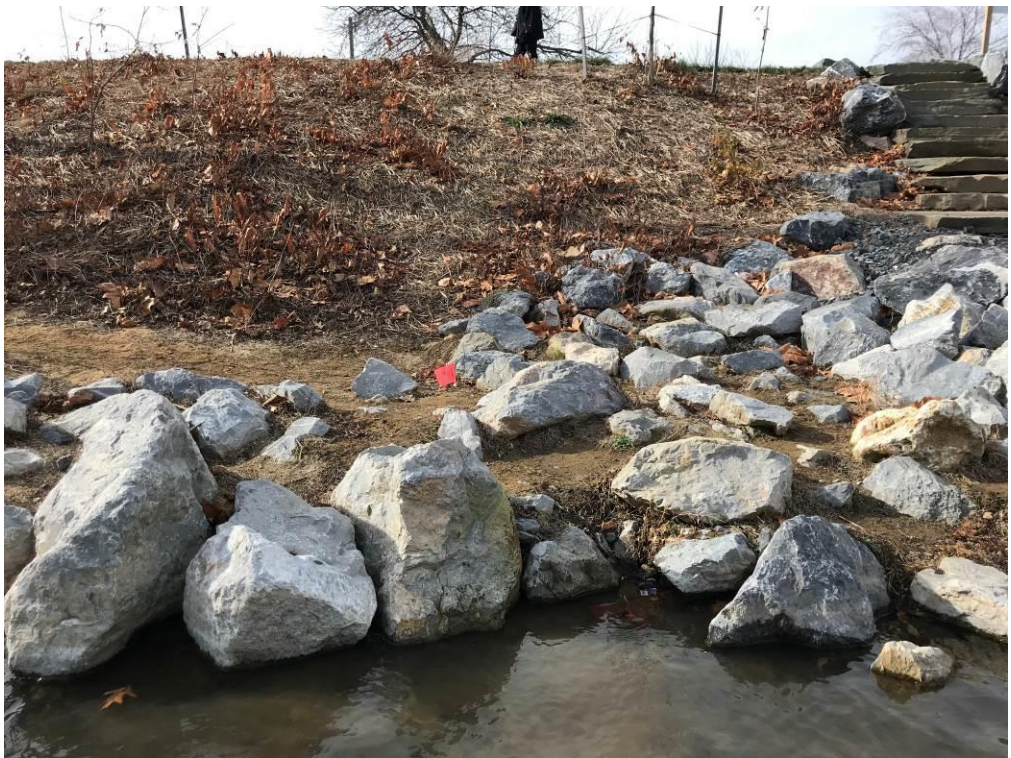
| <b>Photo No.</b><br>11 | <b>Date:</b><br>12/6/2017 | | |

| <b>Description:</b><br><br>Station 00 + 100'<br><br>Sediment deposition adjacent to rock toe boulders; evidence of recent invasive vegetation maintenance on slope. | | | |

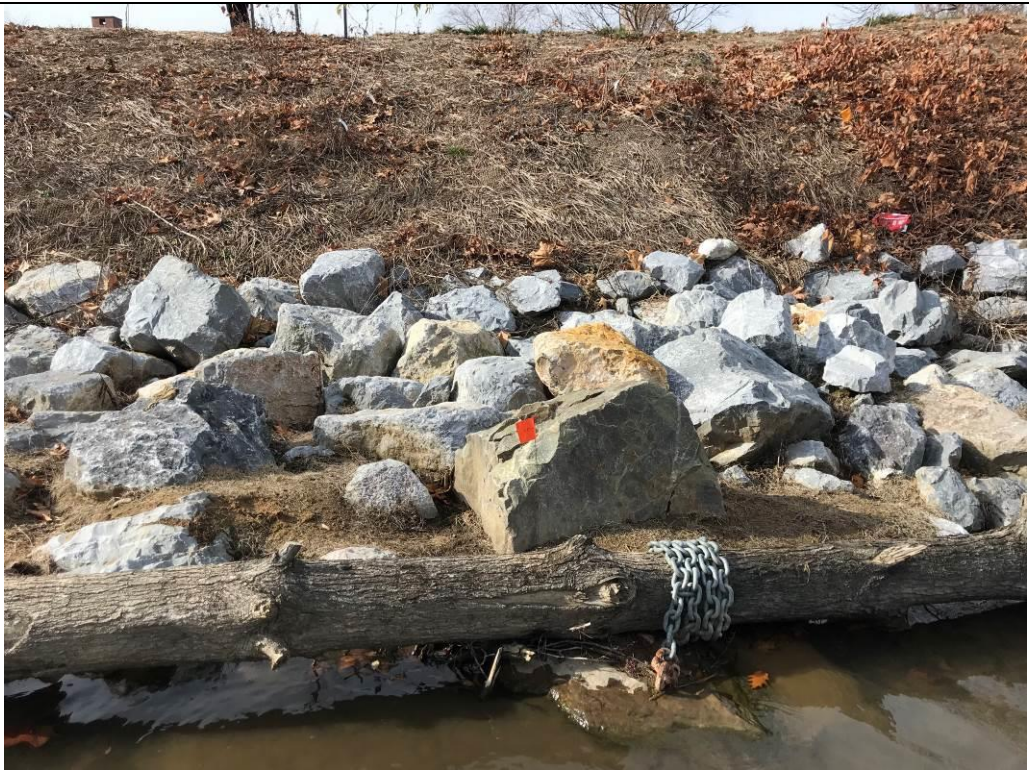
| <b>Description:</b><br><br>Station 00 + 150'<br><br>~45 degree bank angle; no at-risk trees present; no exposed roots; no scour present; installed rock toe and large woody debris (LWD) intact; installed geocell and erosion control fabric intact; evidence of sediment deposition. | | |

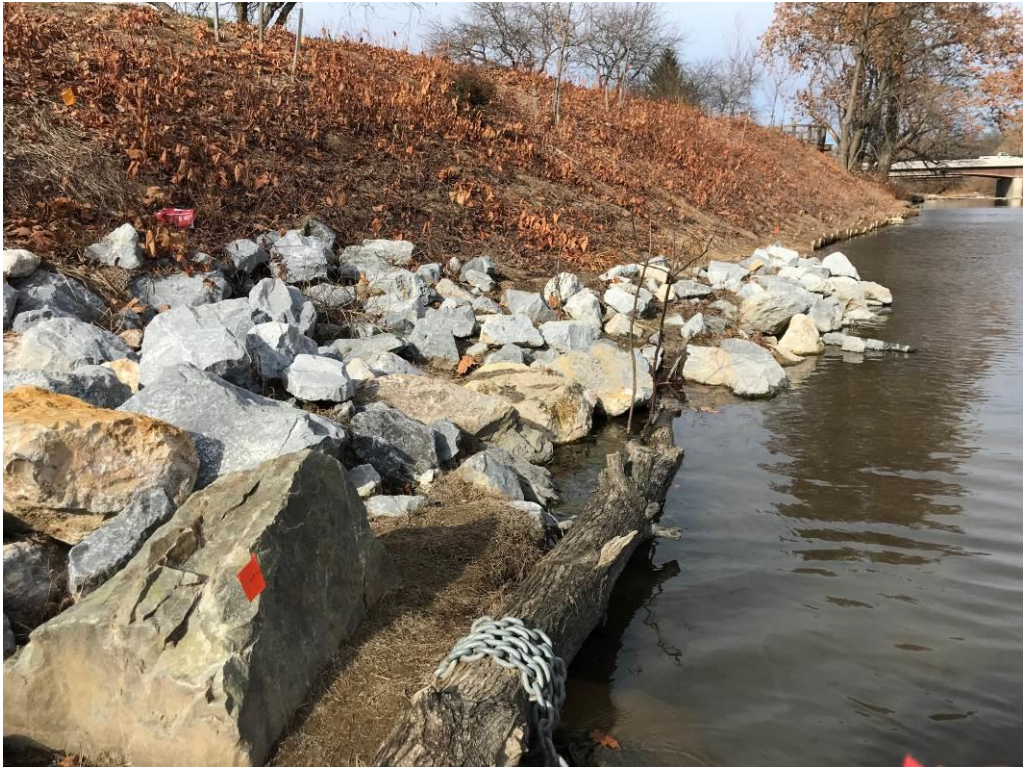
| <b>Description:</b><br>Station 00 + 150'<br><br>Installed rock toe intact with evidence of sediment deposition; evidence of invasive vegetative maintenance. | | | |

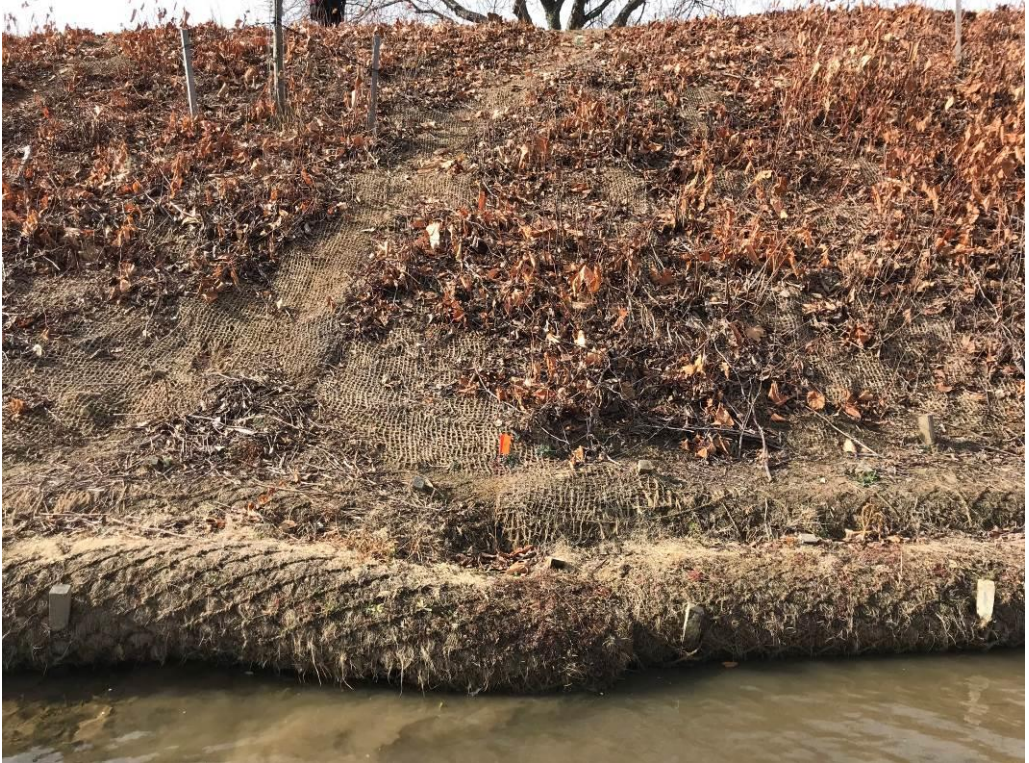
| <b>Description:</b><br>Station 00 + 200'<br><br>~55 degree consistent bank angle; no exposed roots; no scour present; exposed erosion control fabric; foot path present down bank and along coir logs; evidence of recent invasive vegetation maintenance; installed coir logs, geocell and erosion fabric intact. | | |

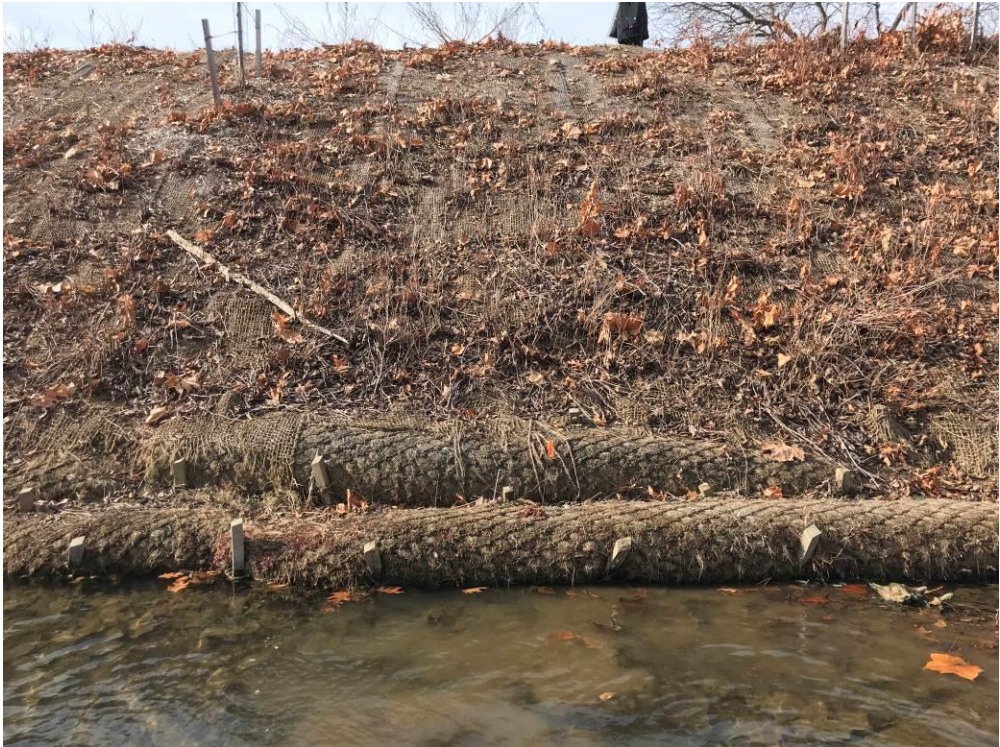
| <b>Description:</b><br><br>Station 00 + 250'<br><br>~55 degree consistent bank angle; no exposed roots; no scour present; evidence of recent vegetation maintenance, including removal of deceased shrub; installed coir logs and geocell intact; edge of erosion control fabric exposed near toe of slope. | | | |

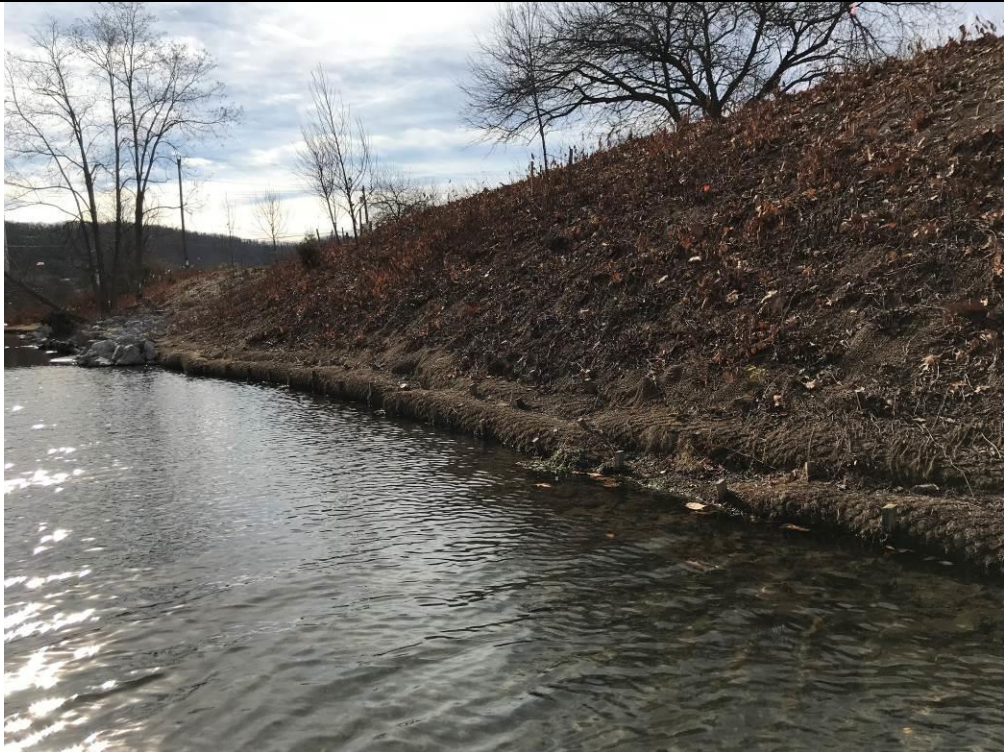
| <b>Photo No.</b><br>16 | <b>Date:</b><br>12/6/2017 | |

| <b>Description:</b><br><br>Station 00 + 250'<br><br>Evidence of recent vegetative maintenance; evidence of foot traffic along coir logs; geocells and installed coir logs intact. | | |

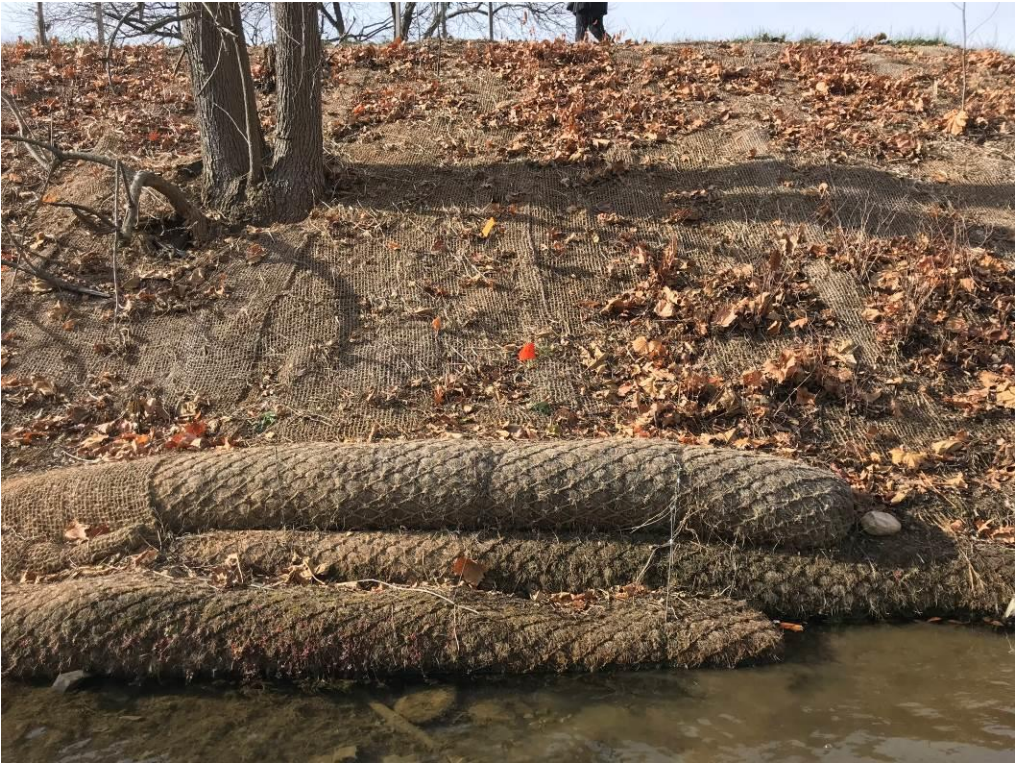
| <b>Description:</b><br>Station 00 + 300'<br><br>~70 degree consistent bank angle; no exposed roots; no at-risk trees; no scour present;; minimal vegetation present; erosion control fabric exposed near toe of slope; geocell and installed coir logs intact. | | | |

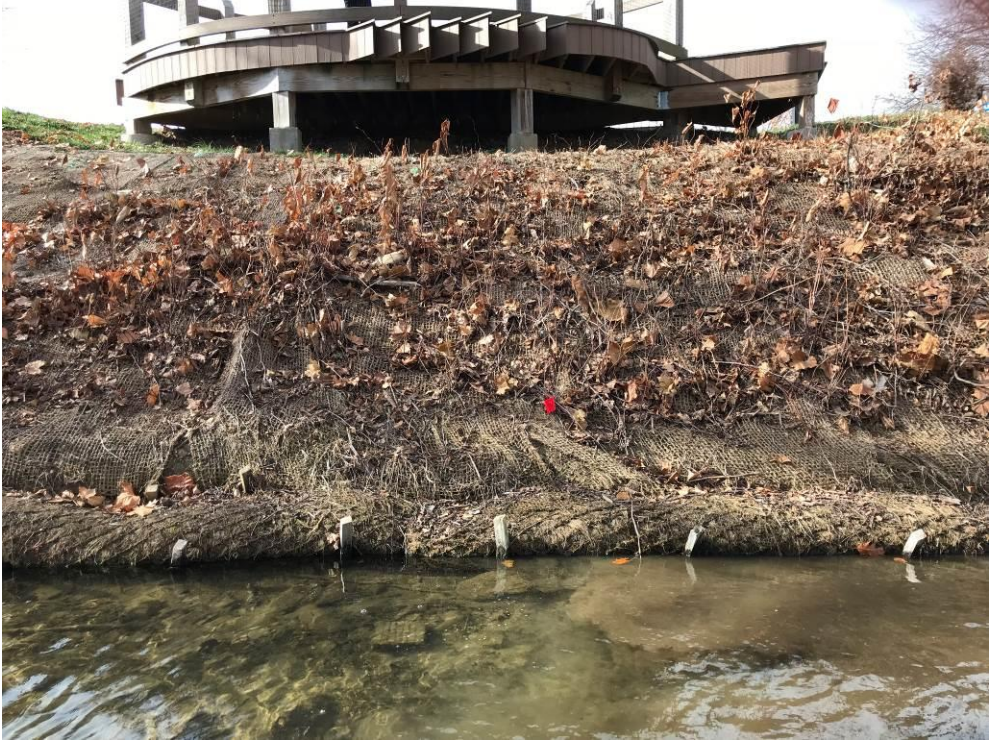
| <b>Description:</b><br>Station 00 + 350'<br><br>~70 degree consistent bank angle; no exposed roots; no at-risk trees; recent vegetative maintenance, exposed erosion control fabric throughout; installed coir logs intact, but showing signs of wear and potential for scour. | | |

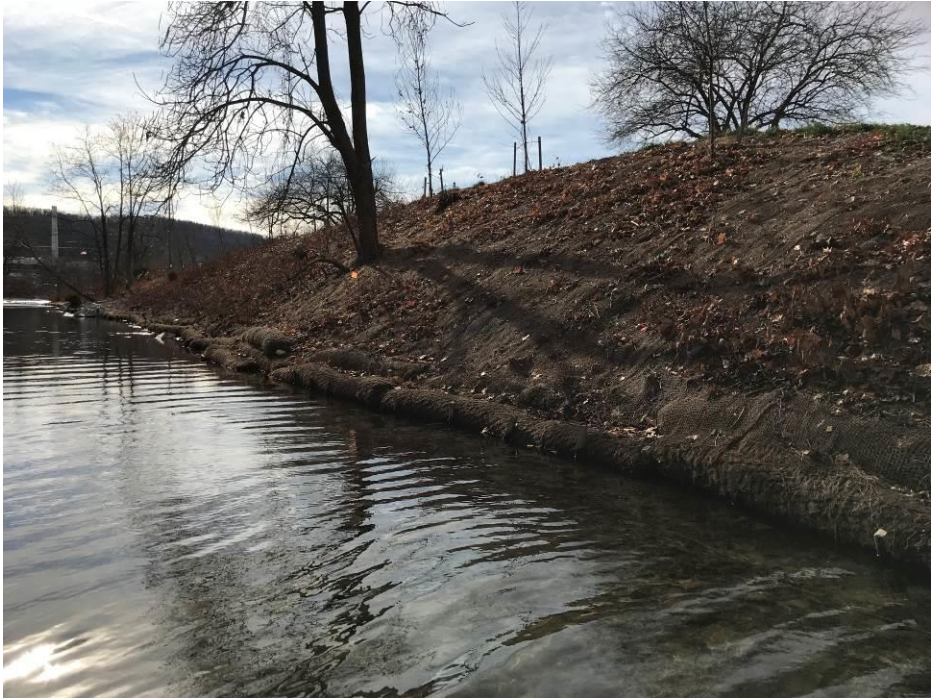
| <b>Photo No.</b><br>19 | <b>Date:</b><br>12/6/2017 | | |

| <b>Description:</b><br><br>Station 00 + 350'<br><br>Edge of installed erosion control fabric exposed; installed coir logs intact. | | | |

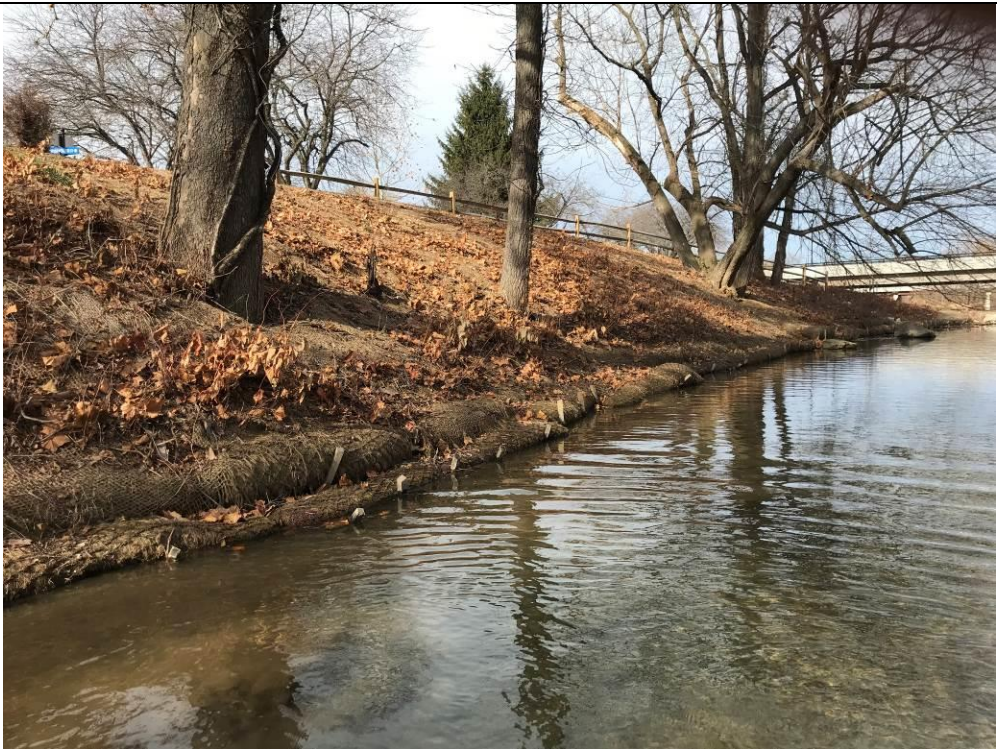
| <b>Photo No.</b><br>20 | <b>Date:</b><br>12/6/2017 | |

| <b>Description:</b><br><br>Station 00 + 350'<br><br>Edge of installed erosion control fabric exposed along toe of slope; installed coir logs intact, but showing signs of wear and potential for scour. | | |

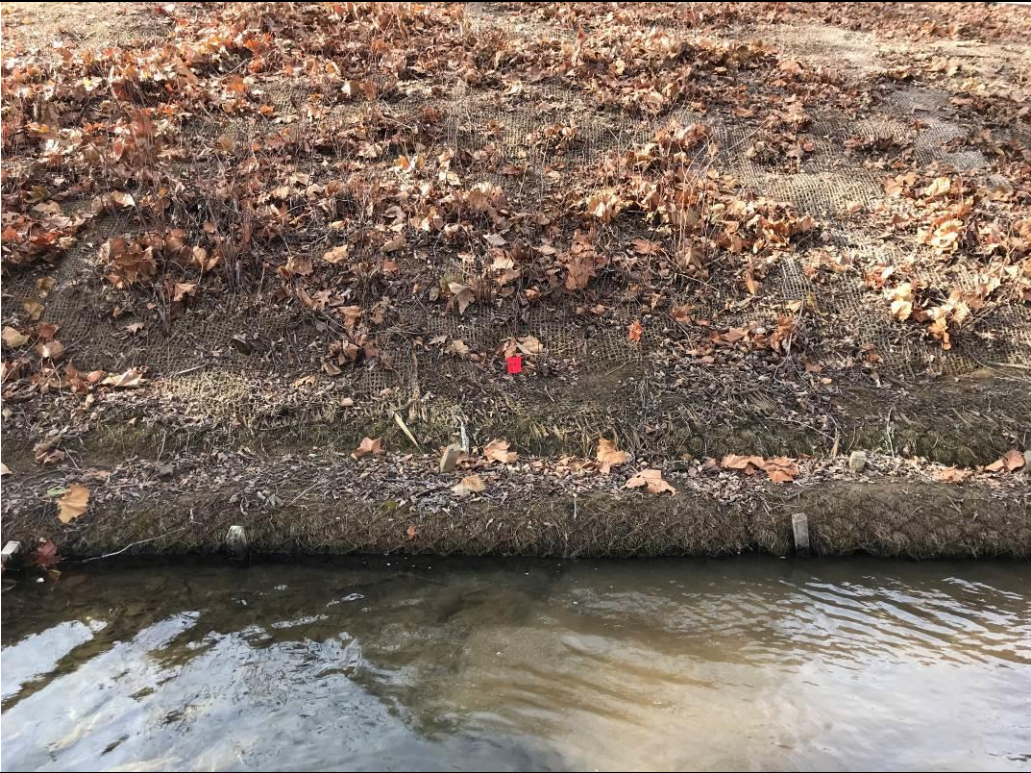
| <b>Photo No.</b><br>21 | <b>Date:</b><br>12/6/2017 | | |

| <b>Description:</b><br><br>Station 00 + 400'<br><br>~60 degree consistent bank angle; no exposed roots; no at-risk trees; no scour present; minimal vegetation present; erosion control fabric exposed near toe of slope. | | | |

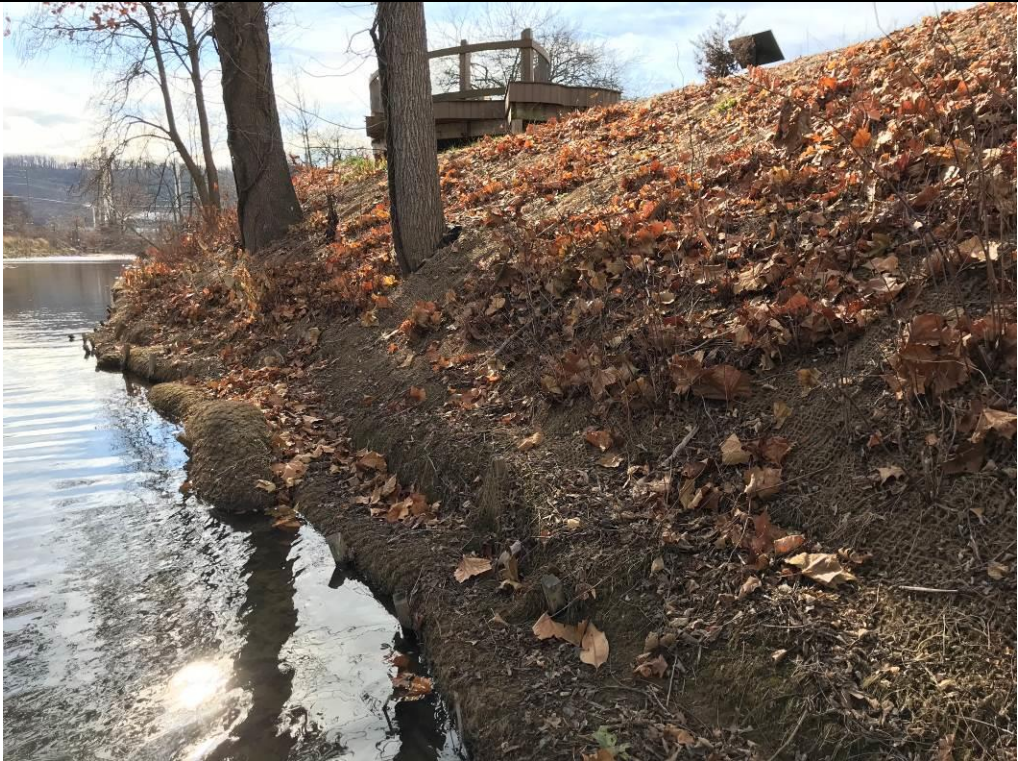
| <b>Photo No.</b><br>22 | <b>Date:</b><br>12/6/2017 | |

| <b>Description:</b><br><br>Station 00 + 400'<br><br>Installed coir logs intact; erosion control fabric exposed near bottom of bank; some geocell and erosion control fabric exposed around base of black walnut tree. | | |

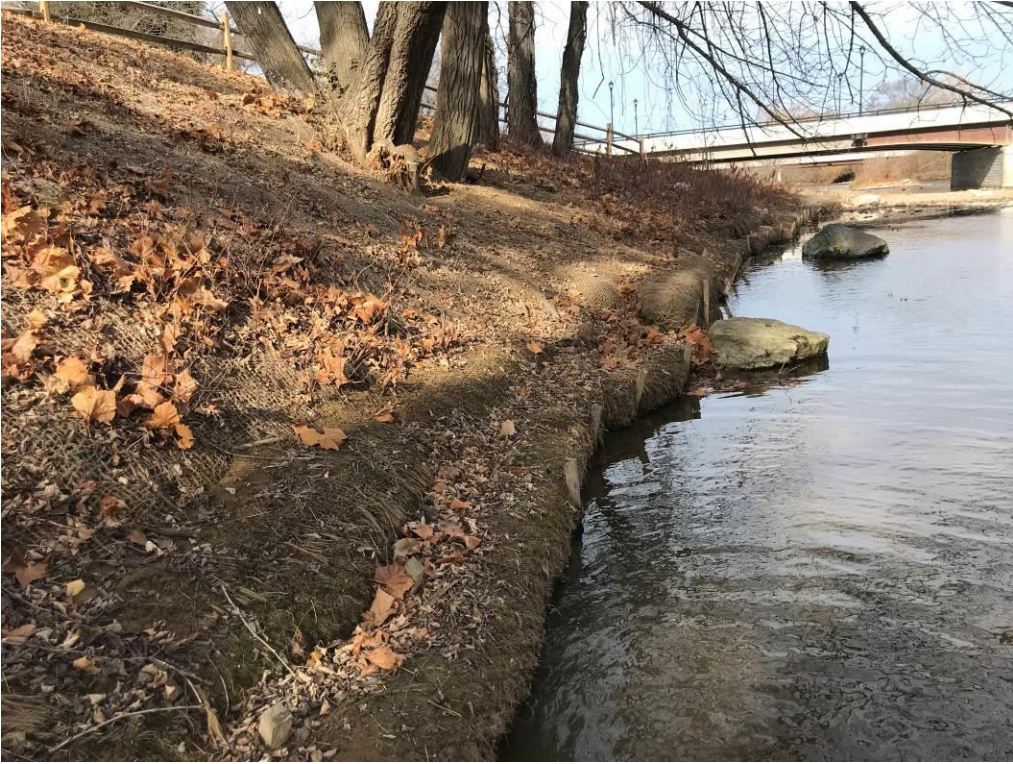
| <b>Photo No.</b><br>23 | <b>Date:</b><br>12/6/2017 | | |

| <b>Description:</b><br><br>Station 00 + 400'<br><br>Installed coir logs intact; erosion control fabric exposed throughout, particularly near bottom of bank. | | | |

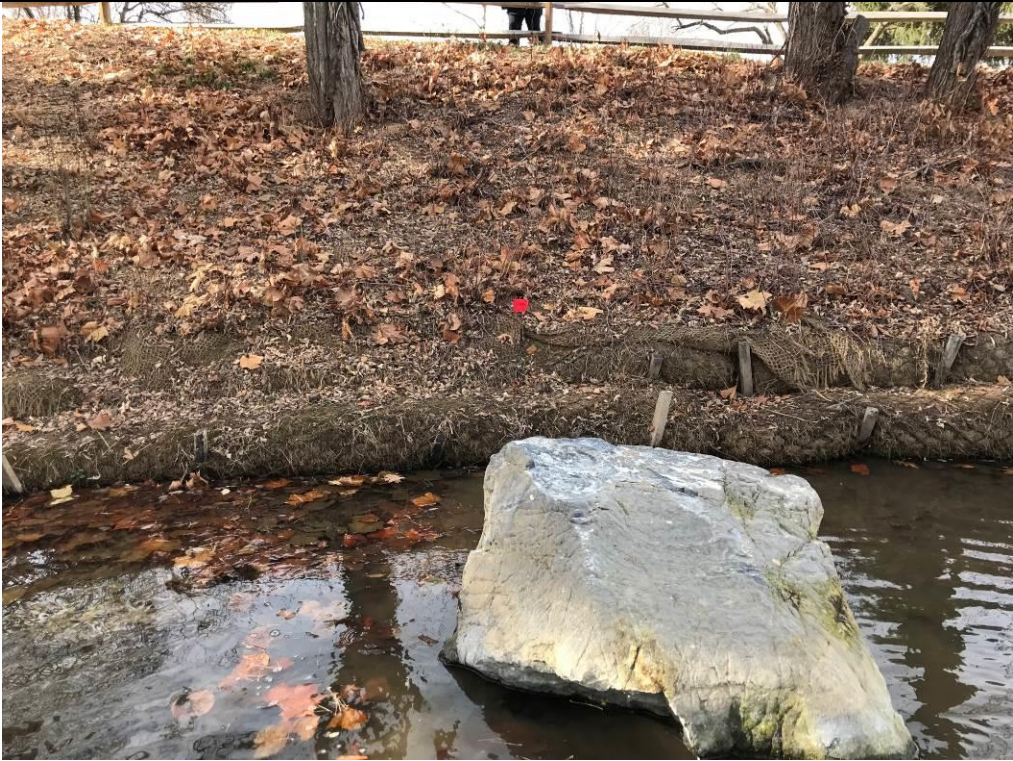
| <b>Photo No.</b><br>24 | <b>Date:</b><br>12/6/2017 | |

| <b>Description:</b><br><br>Station 00 + 450'<br><br>~50 degree consistent bank angle; no exposed roots; no at-risk trees; no scour present; established herbaceous vegetation at top of bank; erosion control fabric exposed near bottom of bank. | | |

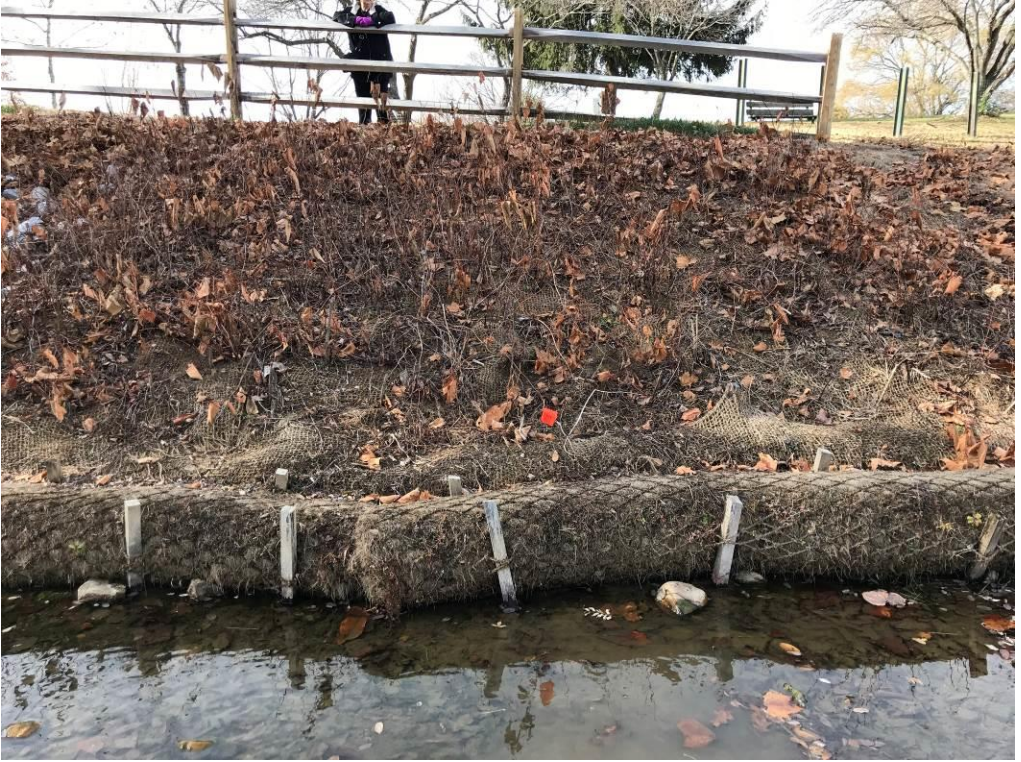
| <b>Description:</b><br><br>Station 00 + 500'<br><br>~40 degree consistent bank angle; no exposed roots; no at-risk trees; no scour present; evidence of vegetative maintenance including removal of a small dead planted tree; invasive knotweed present; erosion fabric exposed near toe of bank. | | | |

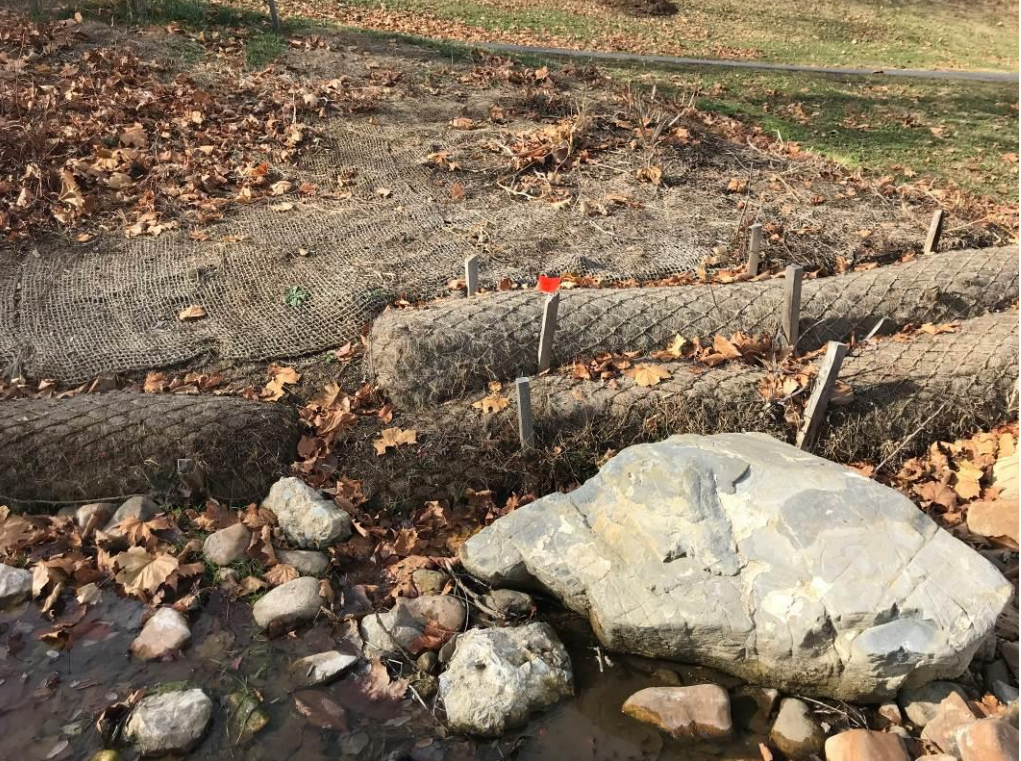
| <b>Photo No.</b><br>26 | <b>Date:</b><br>12/6/2017 | |

| <b>Description:</b><br><br>Station 00 + 525'<br><br>~15 degree consistent bank angle; no exposed roots; no at-risk trees; no scour present; majority of erosion control fabric exposed and not vegetated. | | |

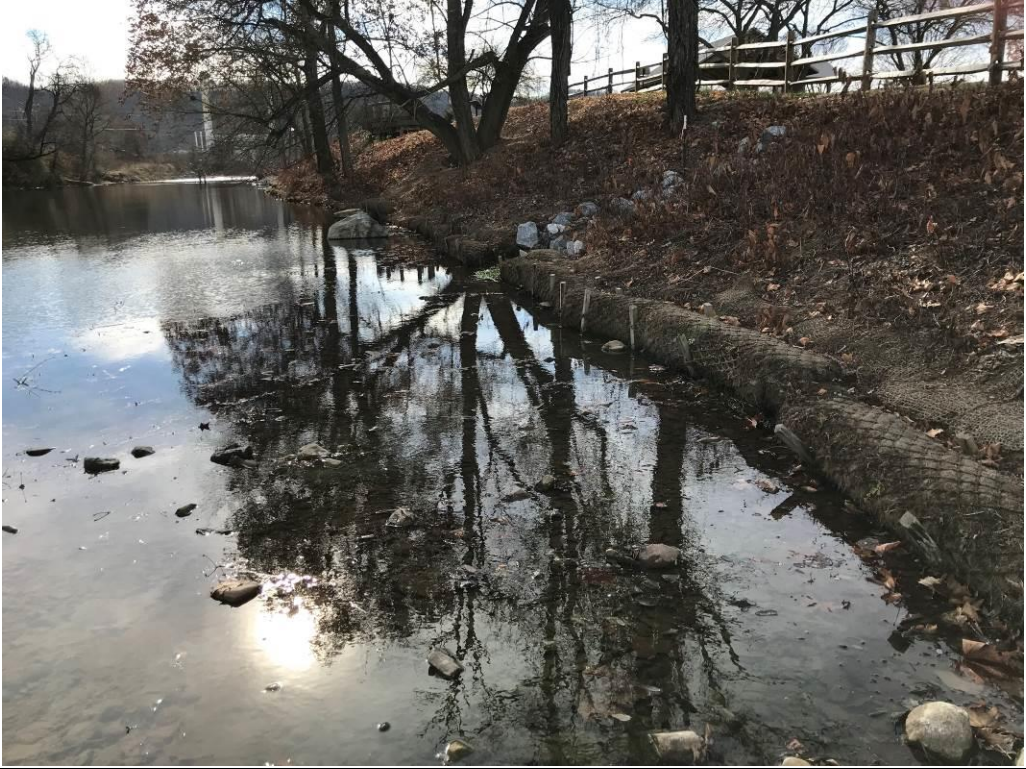
| <b>Description:</b><br>Station 00 + 525'<br><br>No exposed roots; no at-risk trees; no scour present; previously repaired stabilization features intact; limited areas of invasive vegetation present; majority of erosion control fabric is not vegetated. | | | |
