**Re: Fall 2017 Constitution Park Maintenance Inspection Memorandum  
Former DuPont Waynesboro Plant, On-Site  
Waynesboro, Virginia  
EPA ID# VAD003114832**

| Subject | Fall 2017 Constitution Park BMA Maintenance Inspection<br>Former DuPont Waynesboro Site, Area of Concern 4 | | |

Table 1  
BMA Inspection Log  
Fall 2017 Constitution Park BMA Maintenance Inspection Memorandum  
Former DuPont Waynesboro Site, Area of Concern 4

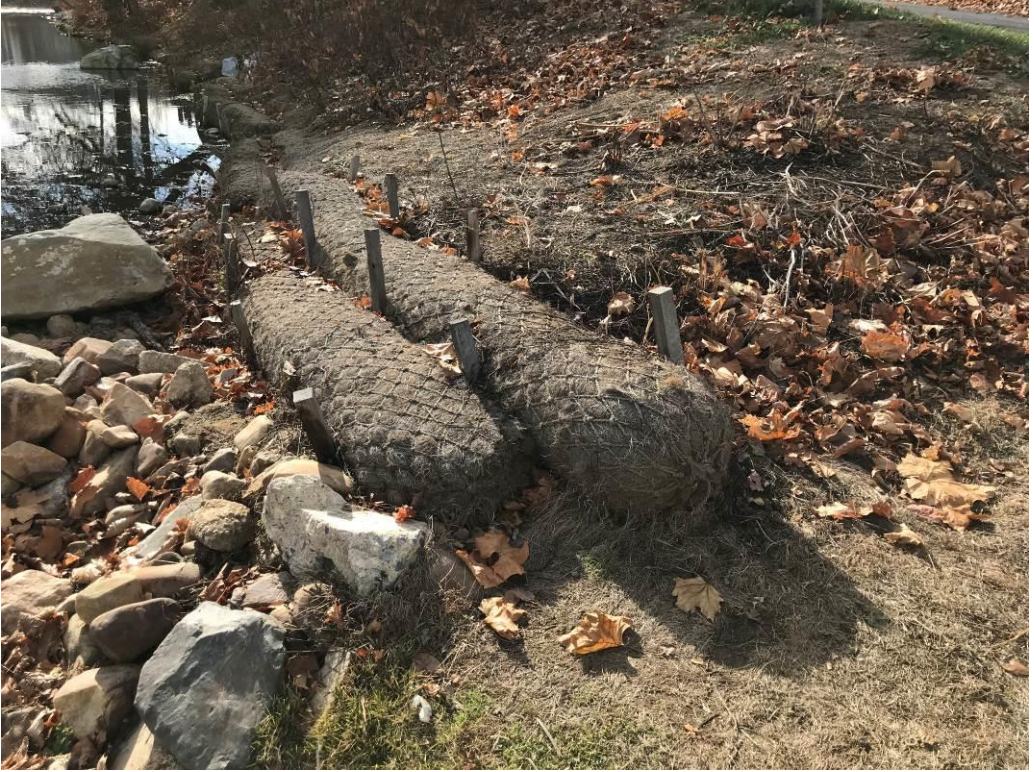
| <b>Photo No.</b><br>28 | <b>Date:</b><br>12/6/2017 | |

| <b>Description:</b><br>Station 00 + 525'<br><br>No exposed roots; no at-risk trees; no scour present; majority of erosion control fabric exposed and not vegetated. | | |
