## Memorandum

| Subject | Spring 2017 Short-term Monitoring Field Summary Memo<br>Former DuPont Waynesboro Site, Area of Concern 4 | |
| Date | August 31, 2017 | |

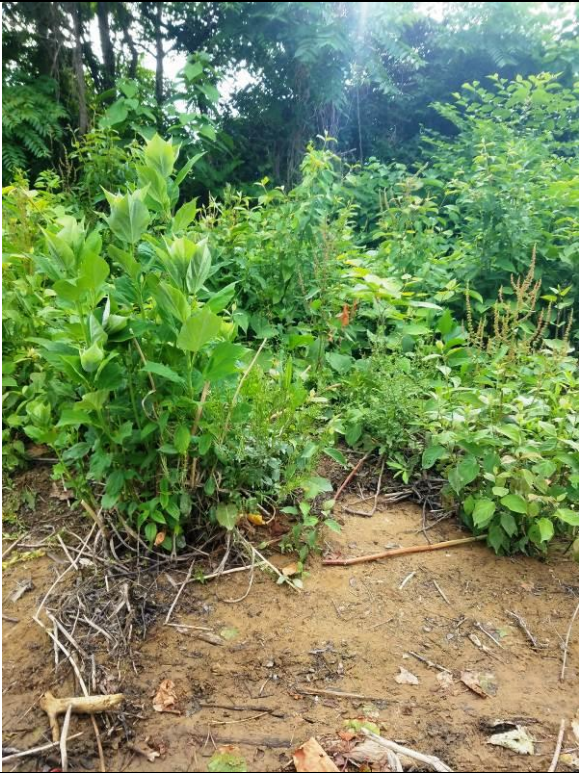
| <b>Photo No.</b><br>1 | <b>Date:</b><br>6/8/2017 | | |

| <b>Description:</b><br><br>Station 00 – 25'<br><br>~30 degree bank angle;<br>no at-risk trees present | | | |

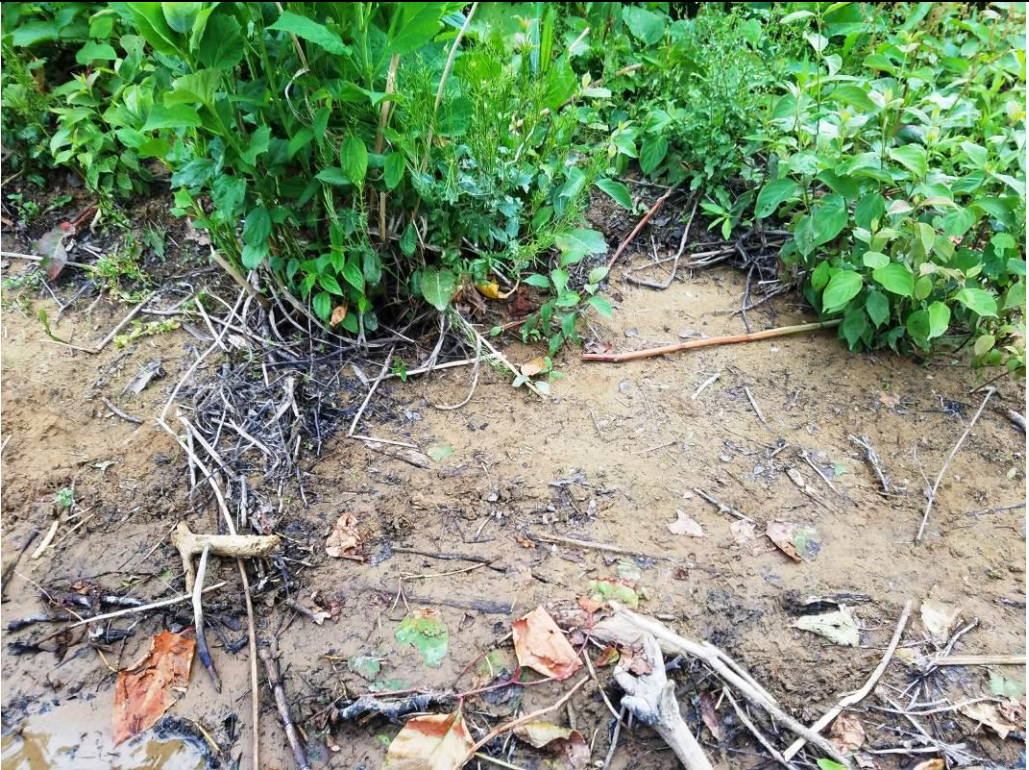
| <b>Photo No.</b><br>2 | <b>Date:</b><br>6/8/2017 | |

| <b>Description:</b><br><br>Station 00 – 25'<br><br>Minimal exposed roots<br>observed; however, no<br>woody plants adjacent<br>to river | | |

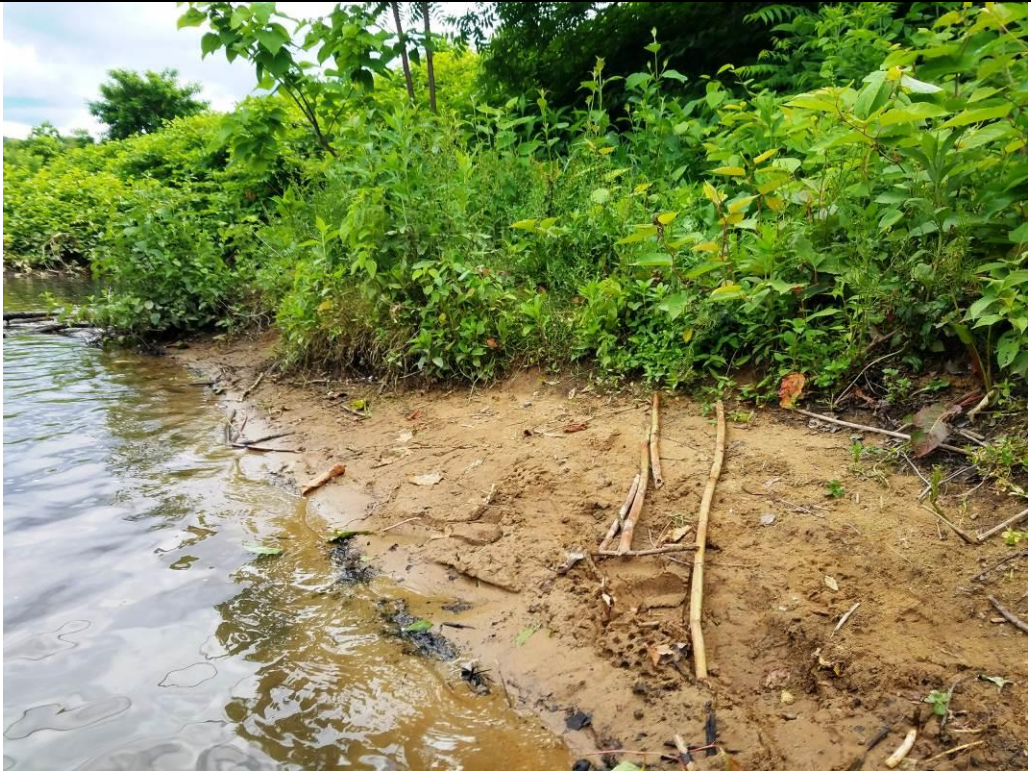
| <b>Photo No.</b><br>3 | <b>Date:</b><br>6/8/2017 | | |

| <b>Description:</b><br><br>Station 00 – 25'<br><br>Low presence of scour<br>~5' upstream of inspection point | | | |

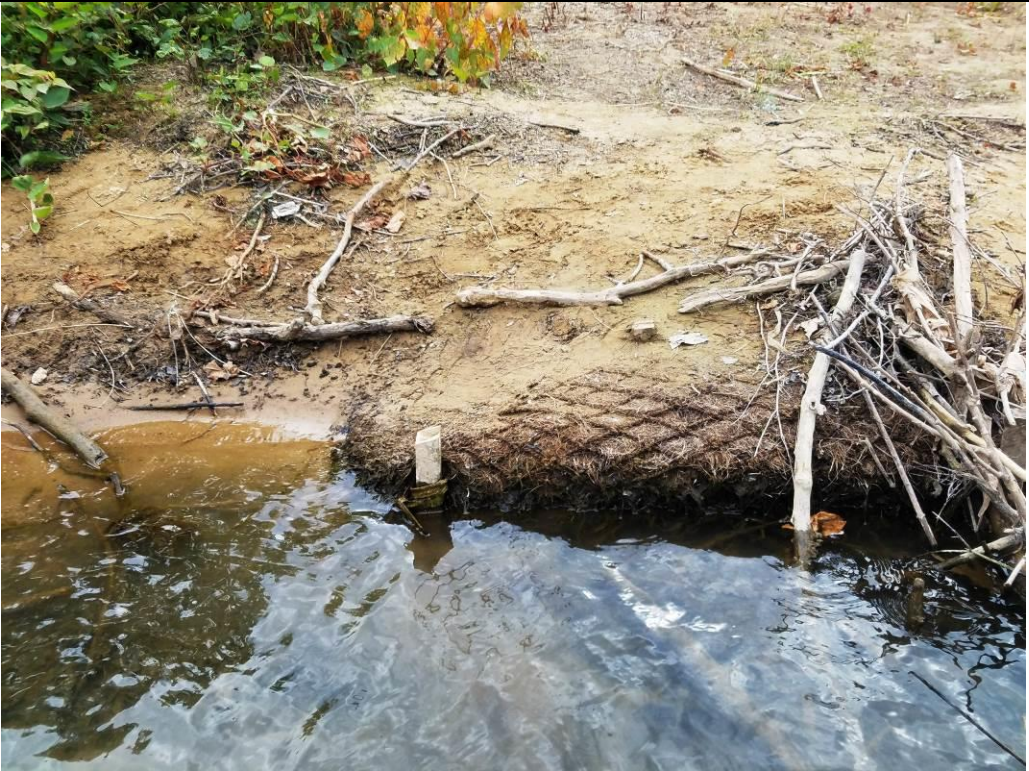
| <b>Photo No.</b><br>5 | <b>Date:</b><br>6/8/2017 | | |

| <b>Description:</b><br>Station 00 + 00'<br><br>No woody plants adjacent to edge of river; no exposed roots; coir logs intact; no scour present | | | |

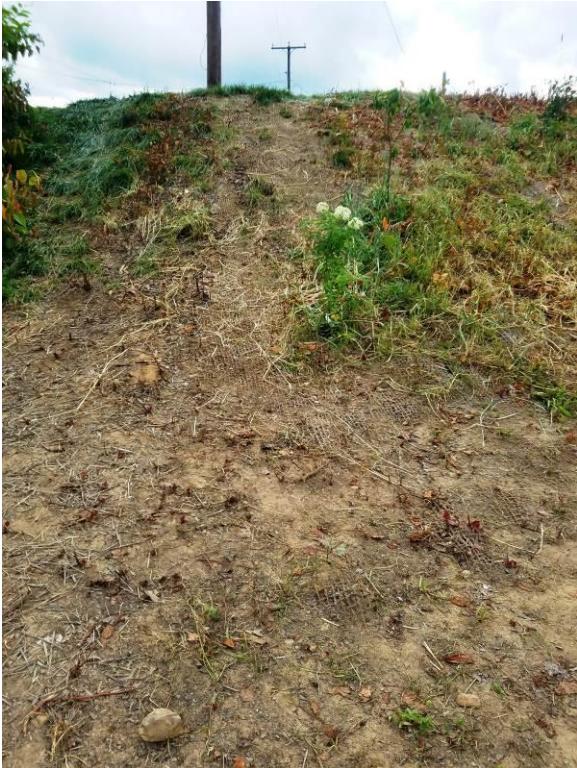
| <b>Photo No.</b><br>6 | <b>Date:</b><br>6/8/2017 | |

| <b>Description:</b><br>Station 00 + 00'<br><br>Installed geocell and erosion control fabric intact; potential river access observed at edge of bank treatment | | |

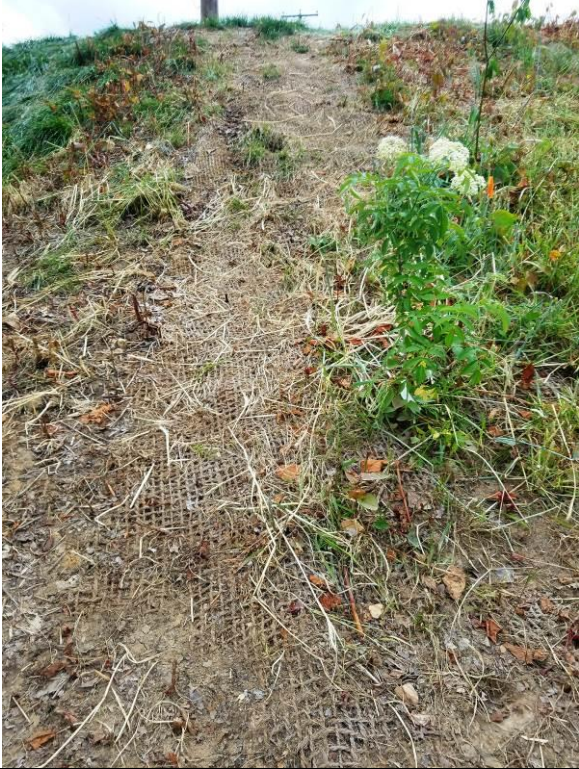
| <b>Photo No.</b><br>7 | <b>Date:</b><br>6/8/2017 | | |

| <b>Description:</b><br><br>Station 00 + 00'<br><br>Installed geocell and erosion control fabric intact; potential river access observed | | | |

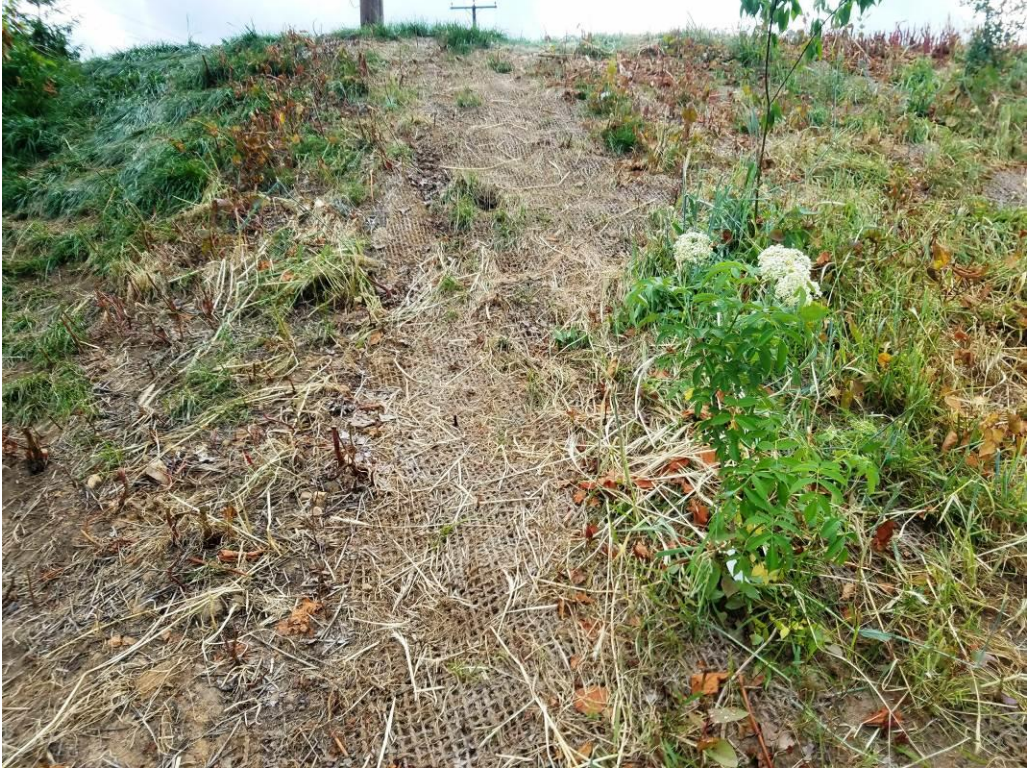
| <b>Photo No.</b><br>8 | <b>Date:</b><br>6/8/2017 | |

| <b>Description:</b><br><br>Station 00 + 00'<br><br>Installed geocell and erosion control fabric intact; potential river access observed | | |

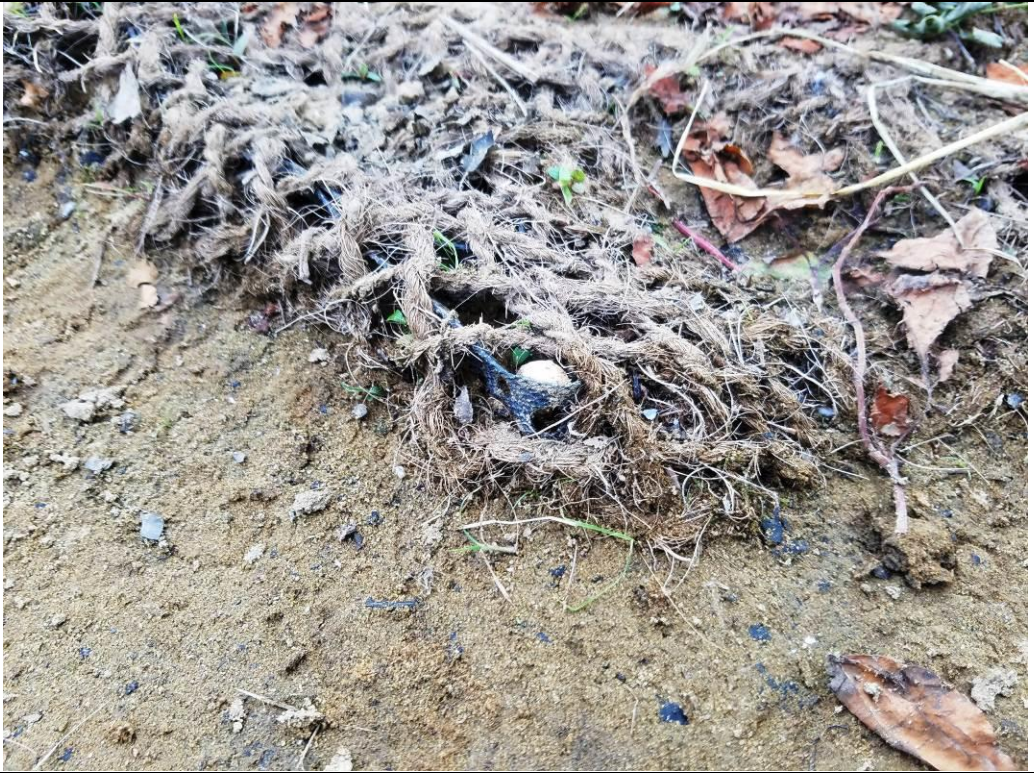
| <b>Photo No.</b><br>9 | <b>Date:</b><br>6/8/2017 | | |

| <b>Description:</b><br><br>Between station 00 + 00' and 00 + 50'<br><br>Installed geocell intact, but beginning to be exposed near the toe of the slope; installed erosion control fabric intact, but exposed | | | |

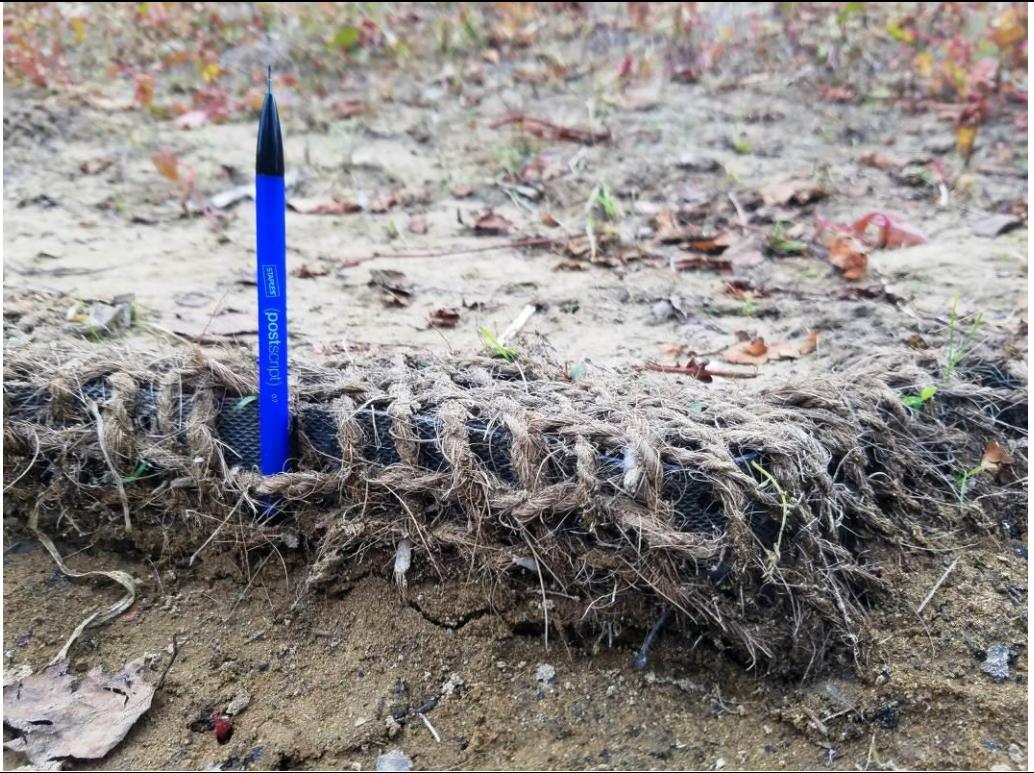
| <b>Photo No.</b><br>11 | <b>Date:</b><br>6/8/2017 | | |

- Installed coir logs were intact following completion of recent maintenance activities; however, there were a few areas of wear associated with foot traffic along the toe of the slope (i.e., 00 + 50').

| <b>Description:</b><br><br>Station 00 + 50'<br><br>Installed geocell intact, but beginning to be exposed near the toe of the slope; installed erosion control fabric intact, but exposed | | | |

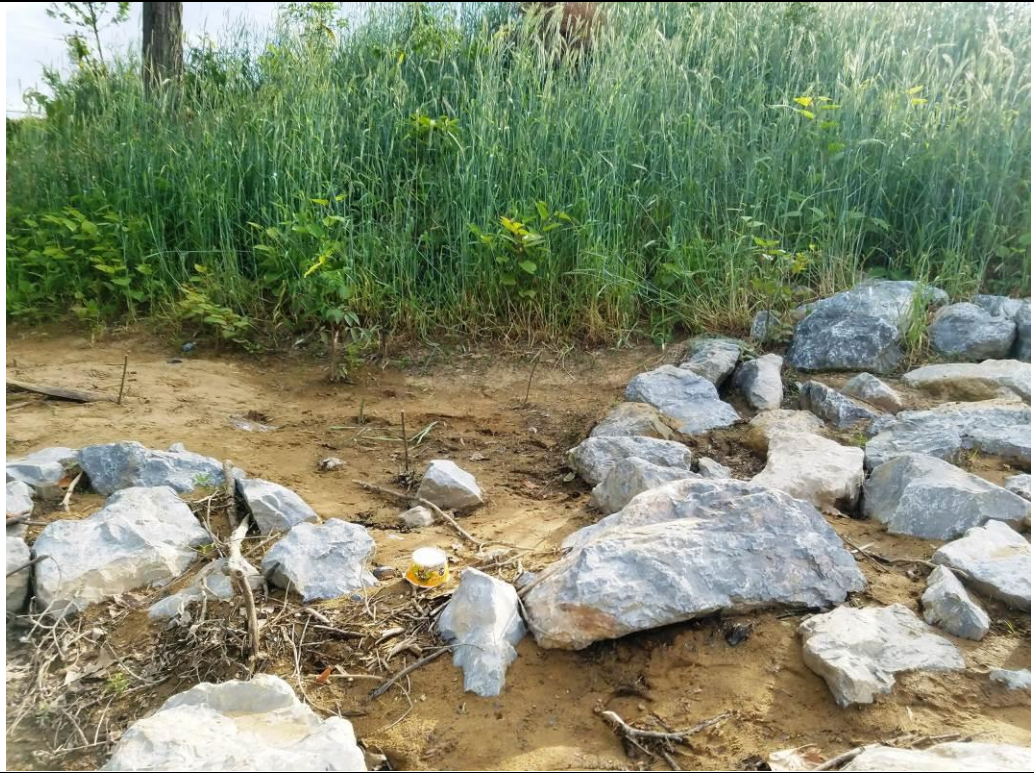
Depression adjacent to  
rock toe boulders, likely  
related to recent  
sediment deposition;  
well-established  
planted rye grass on  
bank

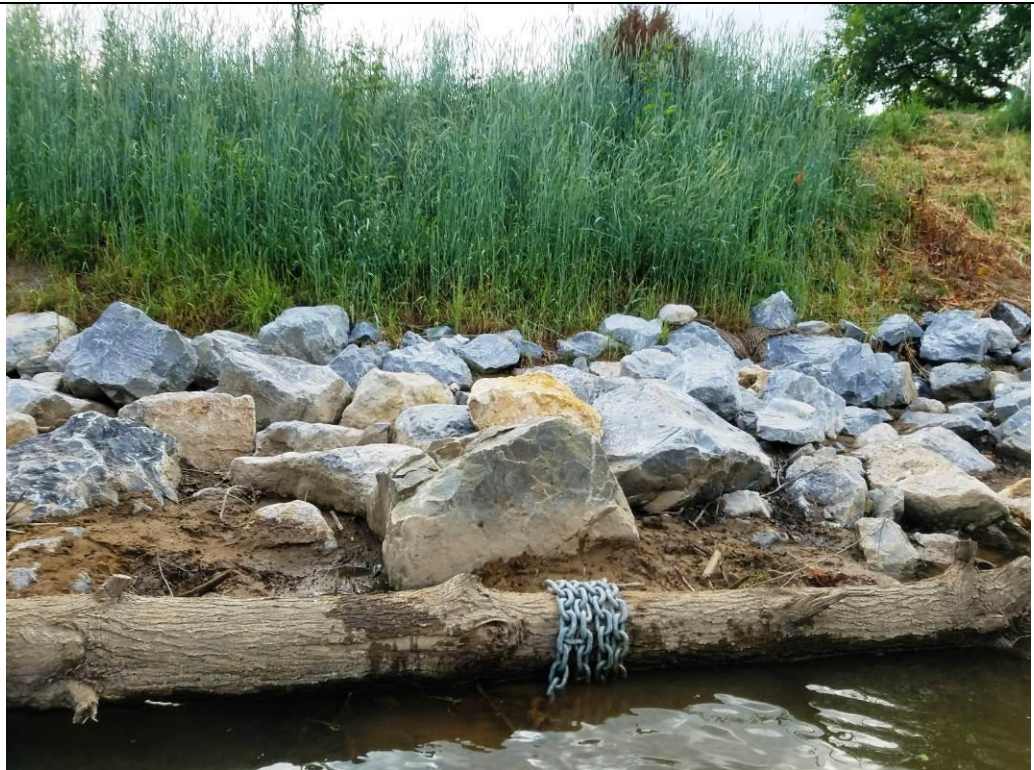
**Photo No.**  
14**Date:**  
6/8/2017**Direction Photo  
Taken:**

~45 degree bank angle;  
no at-risk trees present;  
no exposed roots; no  
scour present; installed  
rock toe and large  
woody debris (LWD)  
intact; installed geocell  
and erosion control  
fabric intact; well-  
established planted rye  
grass on bank

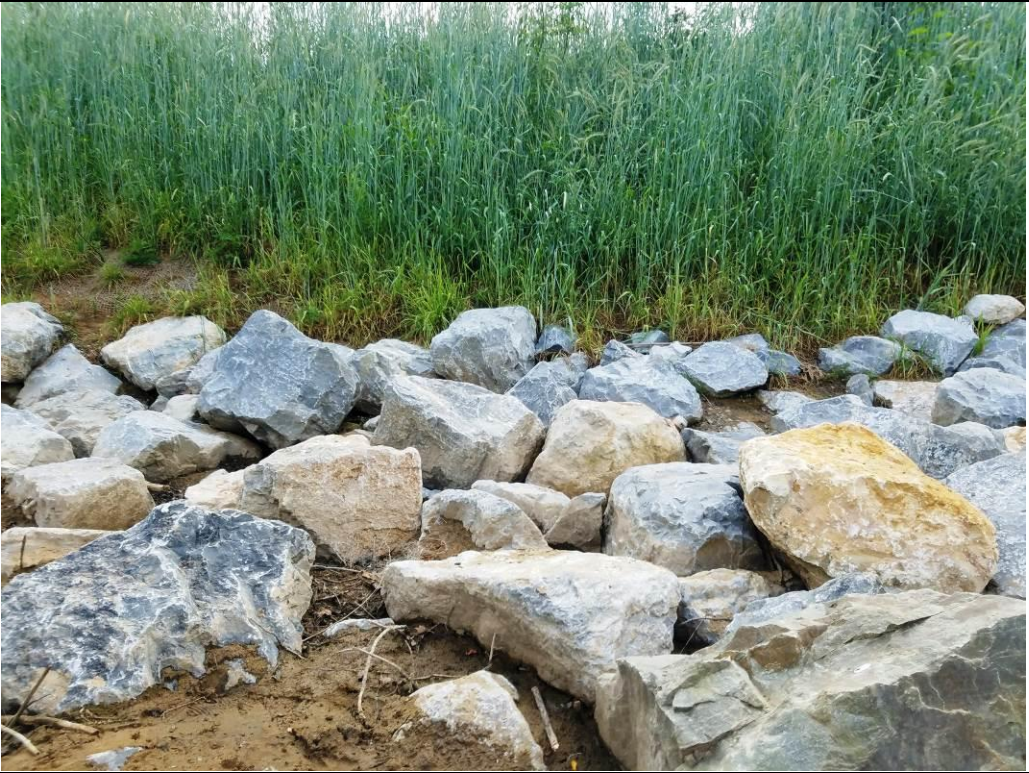
| <b>Photo No.</b><br>15 | <b>Date:</b><br>6/8/2017 | | |

| <b>Description:</b><br><br>Station 00 + 150'<br><br>Installed rock toe intact with evidence of sediment deposition; well-established planted rye grass on bank | | | |

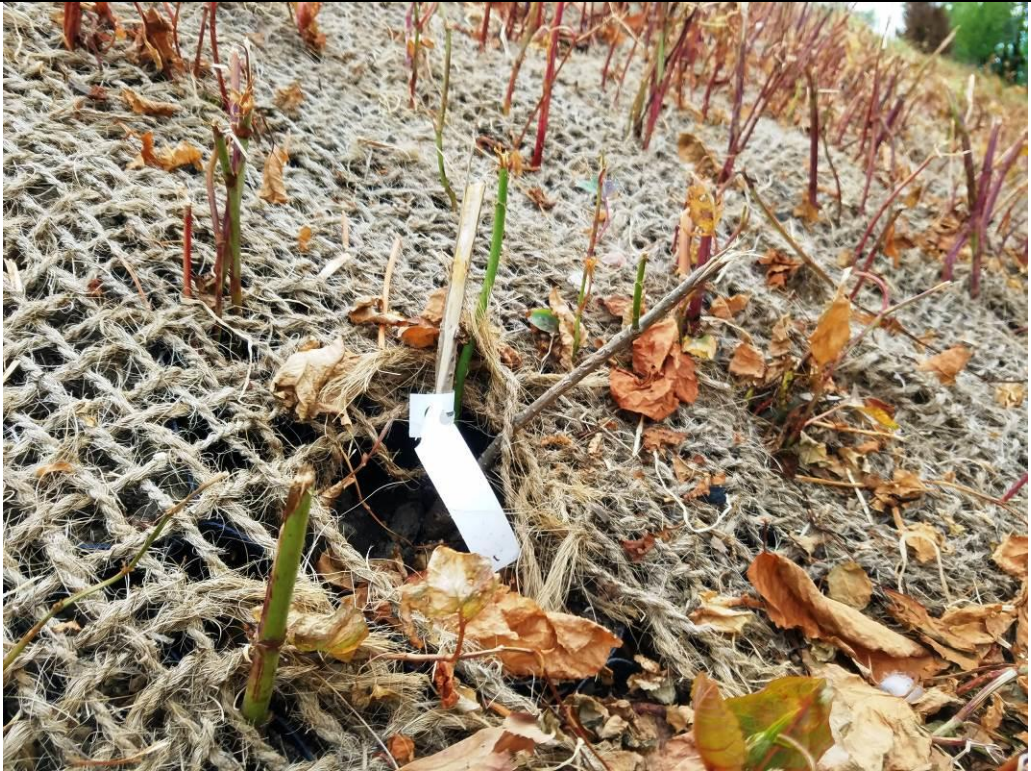
| <b>Photo No.</b><br>17 | <b>Date:</b><br>6/8/2017 | | |

| <b>Description:</b><br>Station 00 + 200'<br><br>Evidence of recent vegetative maintenance, including cut stakings; exposed erosion control fabric | | | |

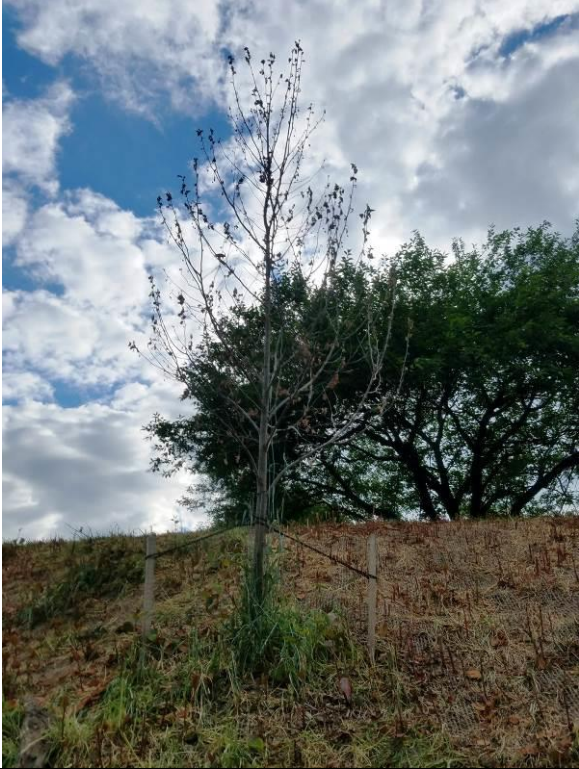
| <b>Photo No.</b><br>19 | <b>Date:</b><br>6/8/2017 | | |

| <b>Description:</b><br><br>Station 00 + 200'<br><br>Evidence of recent vegetative maintenance, including cut stakings and dead sycamore sapling | | | |

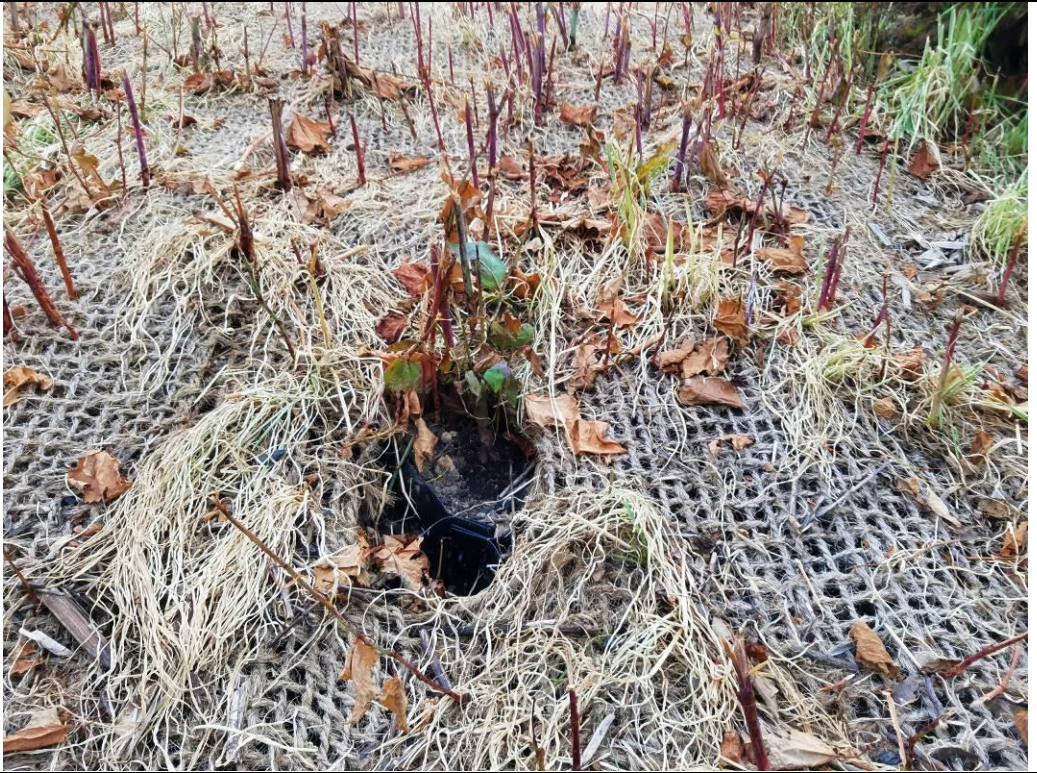
| <b>Photo No.</b><br>21 | <b>Date:</b><br>6/8/2017 | | |

| <b>Description:</b><br><br>Station 00 + 250'<br><br>Evidence of recent vegetative maintenance, including cut stakings; minimal exposed geocell around planted vegetation | | | |

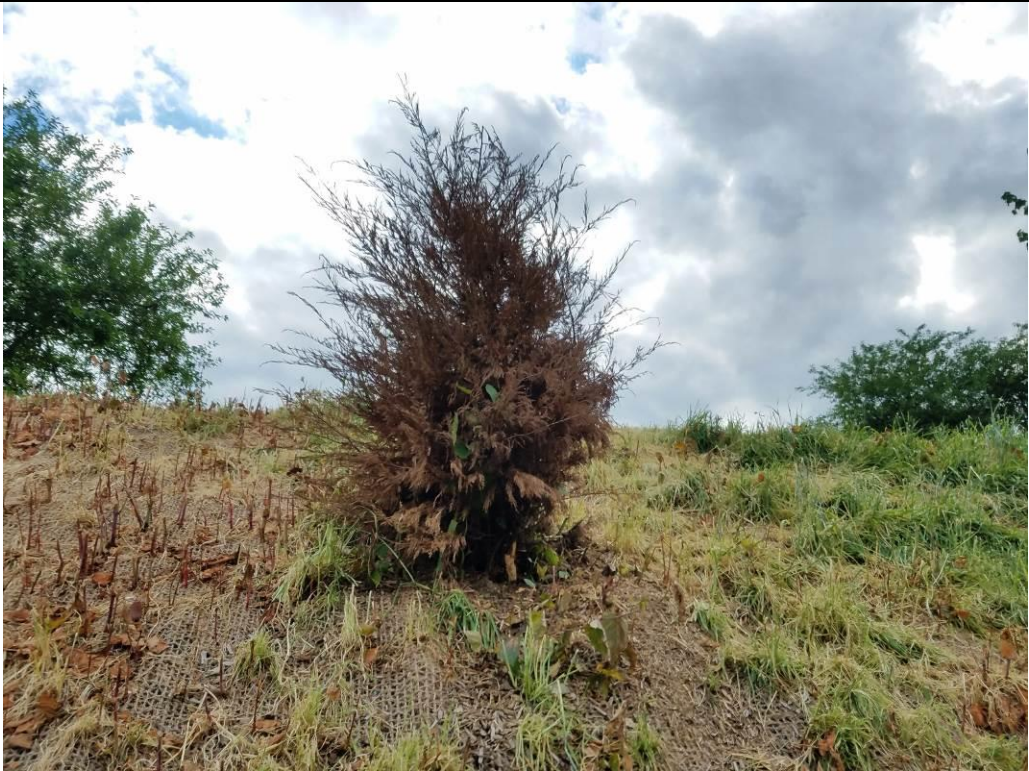
| <b>Photo No.</b><br>23 | <b>Date:</b><br>6/8/2017 | | |

| <b>Description:</b><br><br>Station 00 + 250'<br><br>Evidence of recent vegetative maintenance, including cut stakings; dead shrub to be replaced | | | |

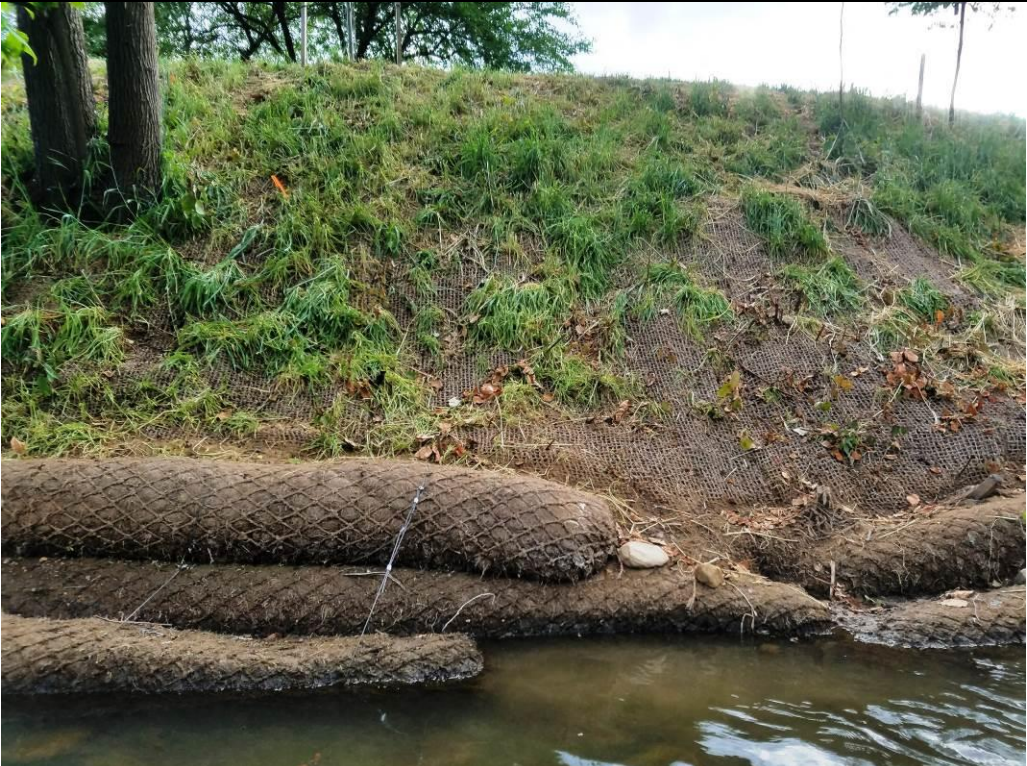
| <b>Description:</b><br><br>Station 00 + 300'<br><br>~70 degree consistent bank angle; no exposed roots; no at-risk trees; no scour present; established herbaceous vegetation on river bank; minimal evidence of cut stakings; installed coir logs, erosion control fabric, and geocell intact | | | |

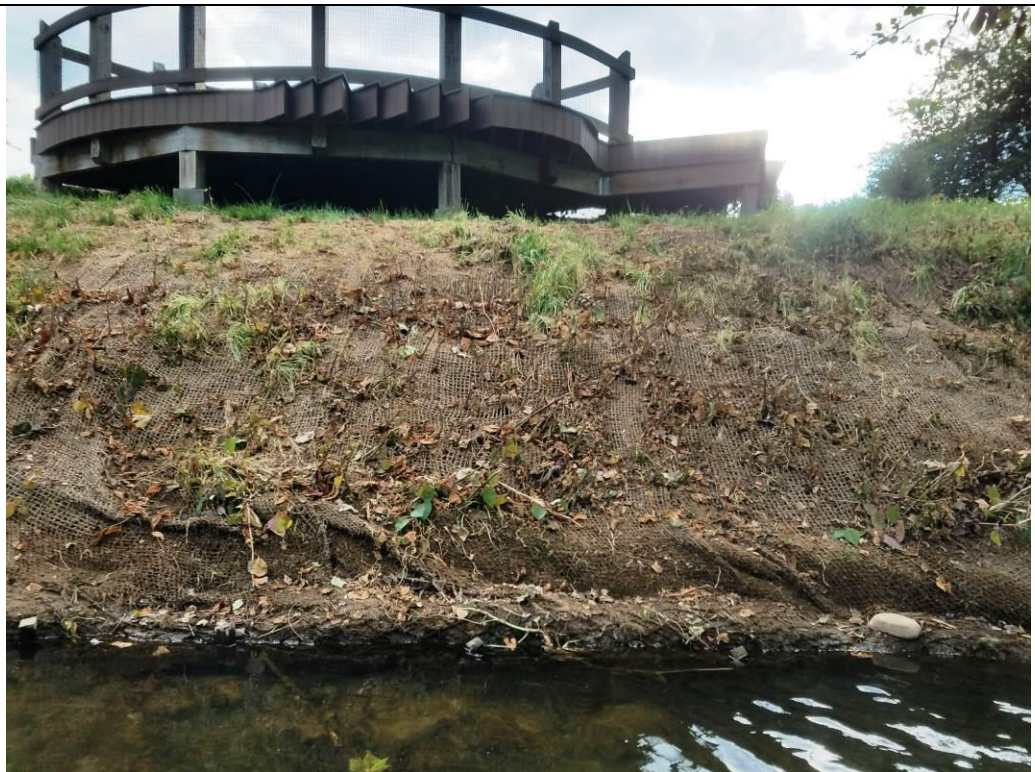
- There was no evidence of local scour, however, coir logs at Station 00 + 350' showed signs of wear and potential for future scouring.

| <b>Description:</b><br><br>Station 00 + 350'<br><br>~70 degree consistent bank angle; no exposed roots; no at-risk trees; recent vegetative maintenance, exposing erosion control fabric throughout; installed coir logs intact, but showing signs of wear and potential for scour | | |

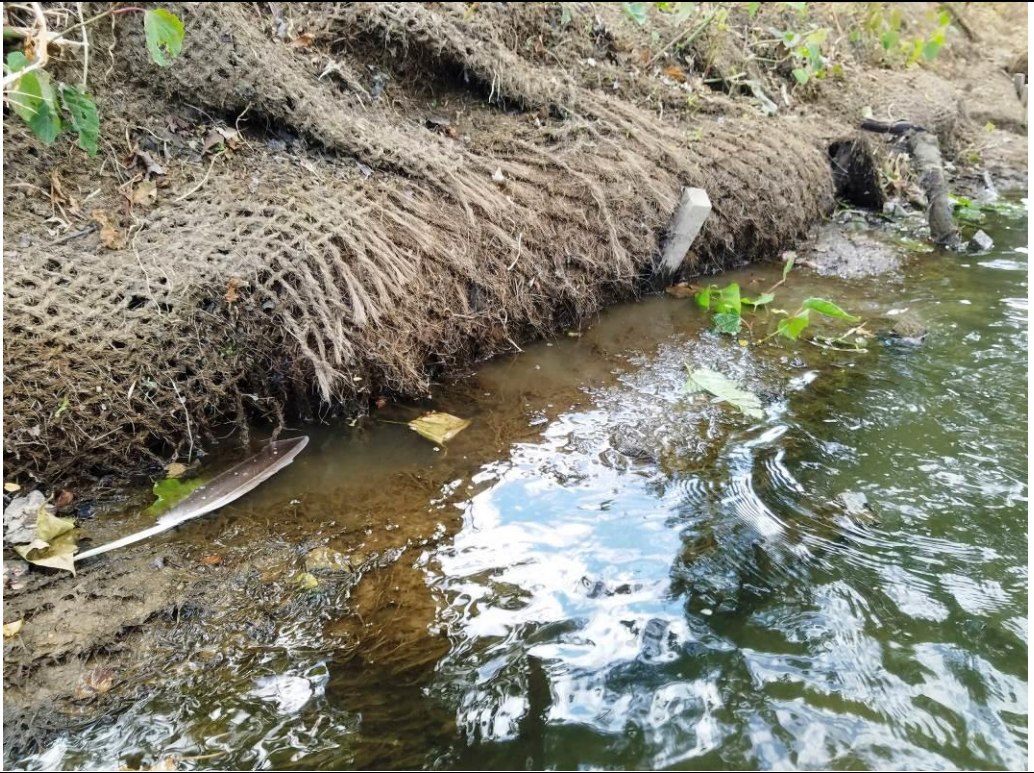
| <b>Photo No.</b><br>27 | <b>Date:</b><br>6/8/2017 | | |

| <b>Description:</b><br><br>Station 00 + 350'<br><br>Edge of installed erosion control fabric exposed along toe of slope; installed coir logs intact, but showing signs of wear and potential for scour | | | |

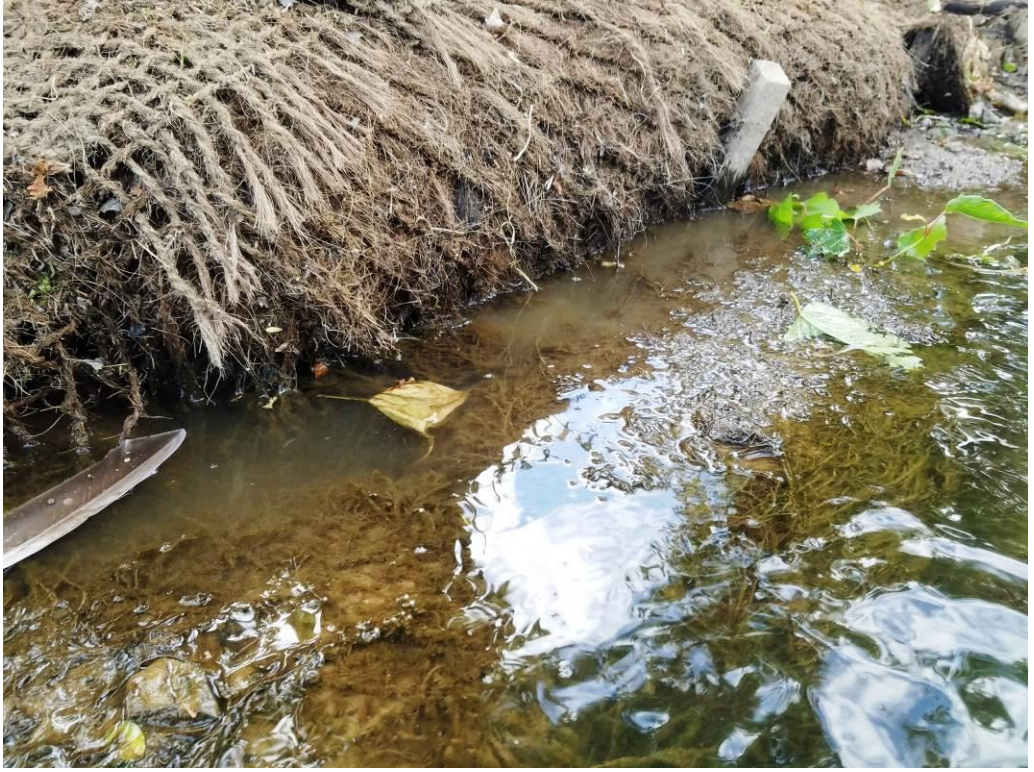
| <b>Photo No.</b><br>28 | <b>Date:</b><br>6/8/2017 | |

| <b>Description:</b><br><br>Station 00 + 350'<br><br>Edge of installed erosion control fabric exposed along toe of slope; installed coir logs intact, but showing signs of wear and potential for scour | | |

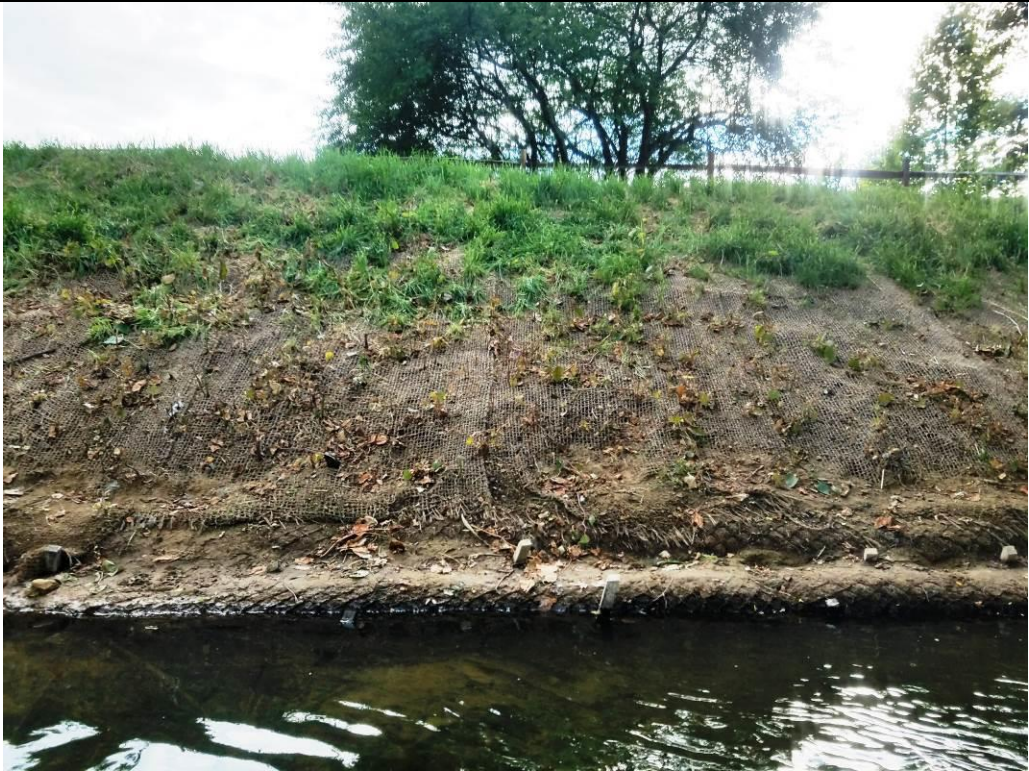
| <b>Description:</b><br>Station 00 + 400'<br><br>~60 degree consistent bank angle; no exposed roots; no at-risk trees; no scour present; established herbaceous vegetation at top of bank; evidence of vegetative maintenance near bottom of bank | | | |

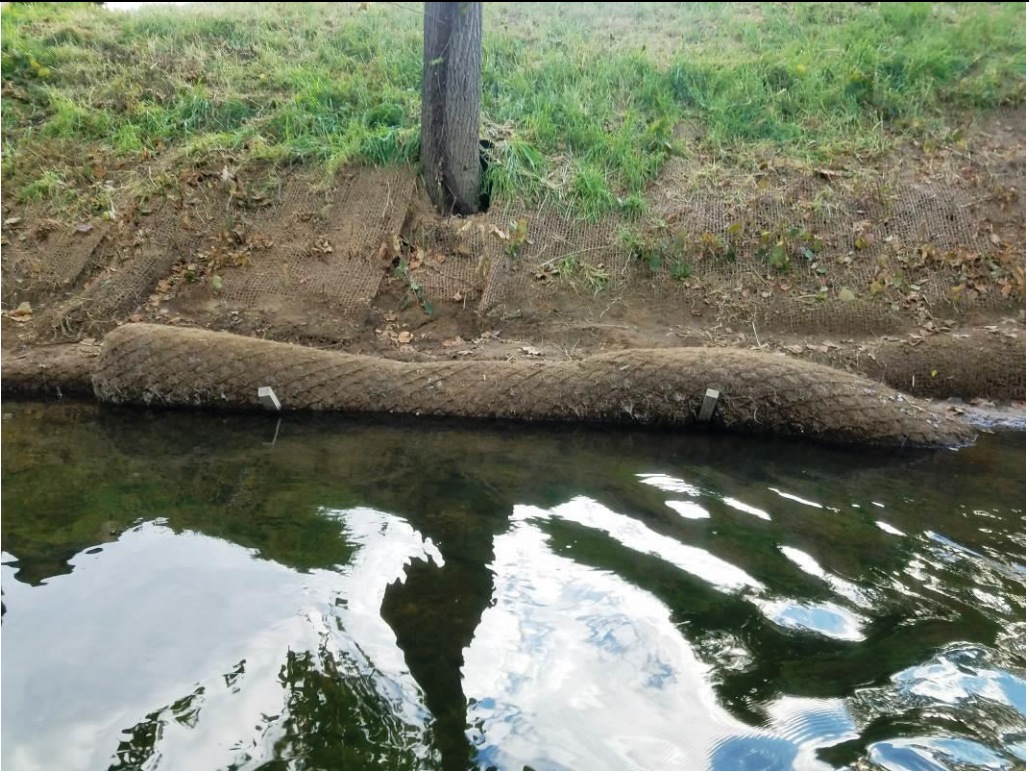
| <b>Photo No.</b><br>31 | <b>Date:</b><br>6/8/2017 | | |

| <b>Description:</b><br>Station 00 + 400'<br><br>Installed coir logs intact; erosion control fabric exposed near bottom of bank | | | |

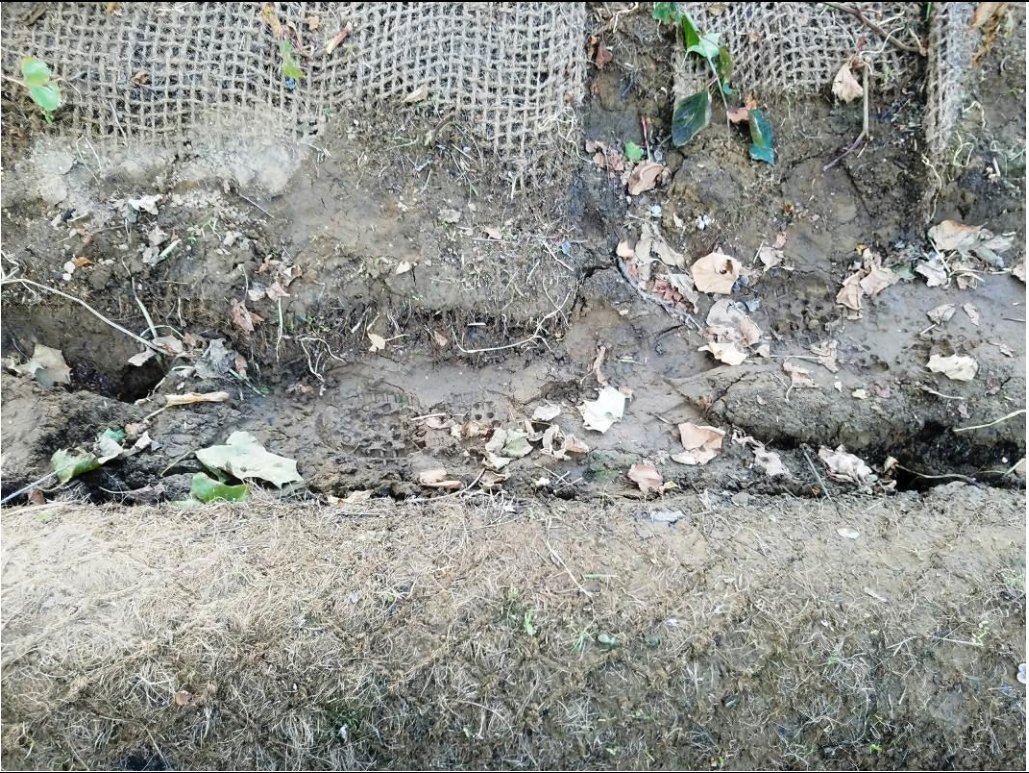
| <b>Photo No.</b><br>33 | <b>Date:</b><br>6/8/2017 | | |

| <b>Description:</b><br>Station 00 + 400'<br><br>Edge of erosion control fabric exposed near bottom of bank | | | |

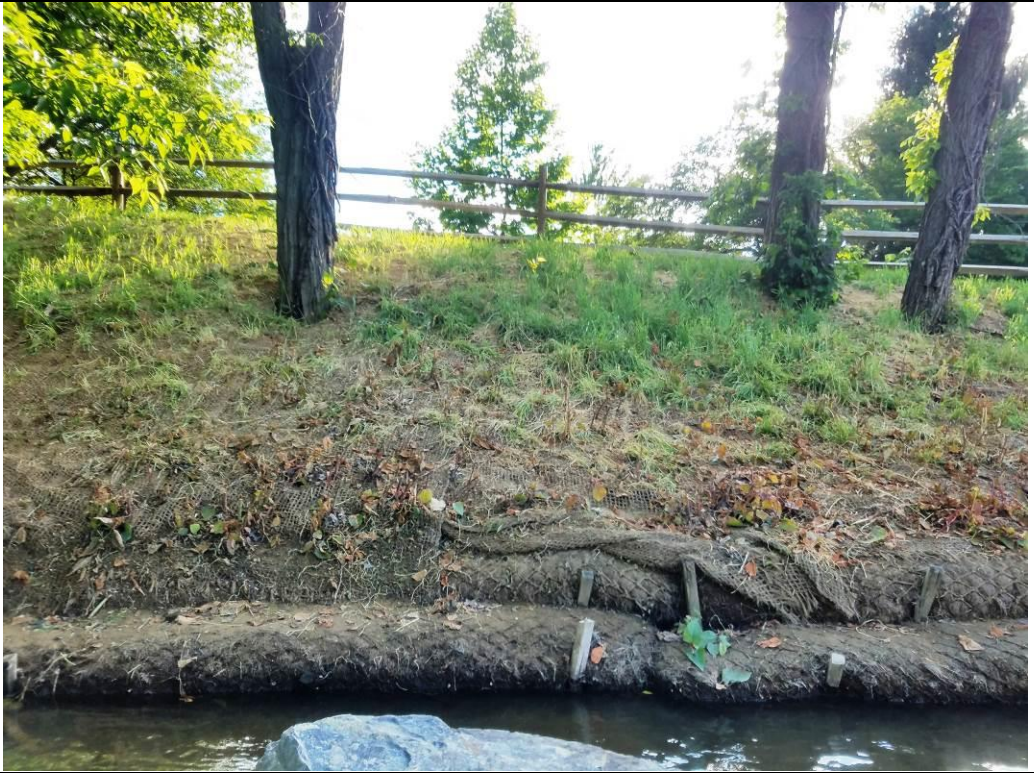
| <b>Description:</b><br>Station 00 + 450'<br><br>~50 degree consistent bank angle; no exposed roots; no at-risk trees; no scour present; established herbaceous vegetation at top of bank; evidence of vegetative maintenance near bottom of bank | | | |

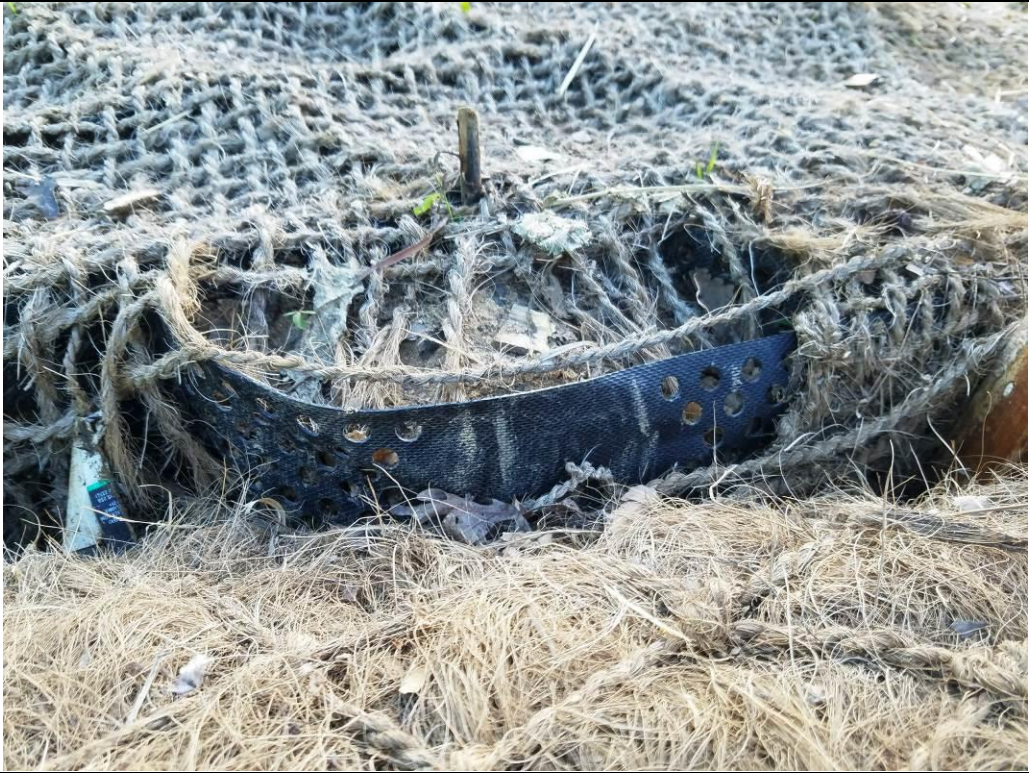
| <b>Photo No.</b><br>37 | <b>Date:</b><br>6/8/2017 | | |

| <b>Description:</b><br>Station 00 + 500'<br><br>Evidence of recent vegetative maintenance, including cut stakings; minimal exposed geocell and erosion control fabric around some planted vegetation | | | |

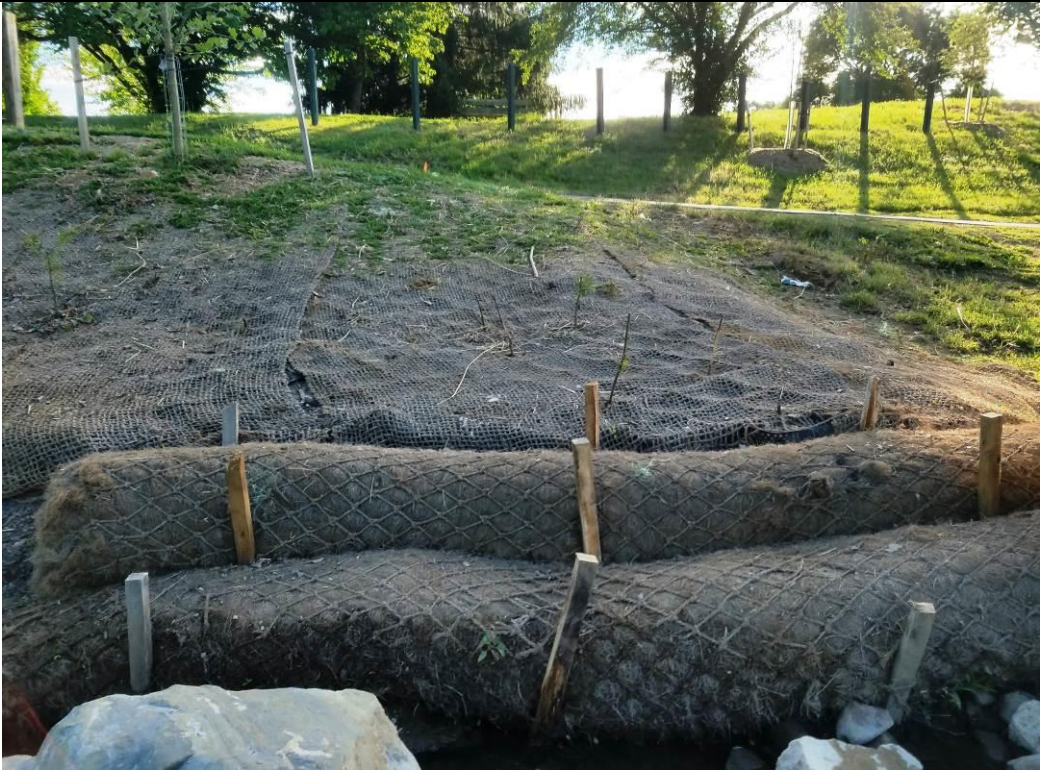
| <b>Photo No.</b><br>38 | <b>Date:</b><br>6/8/2017 | |

| <b>Description:</b><br>Station 00 + 525'<br><br>~15 degree consistent bank angle; no exposed roots; no at-risk trees; no scour present; installed stabilization features recently repaired; majority of erosion control fabric unvegetated | | |

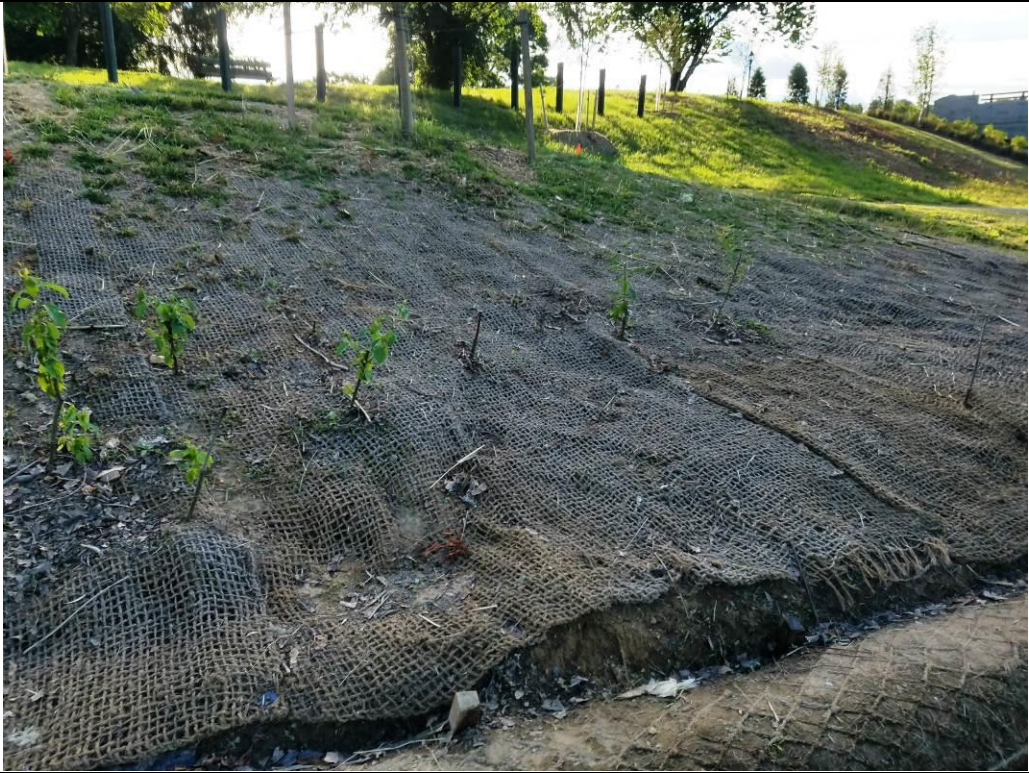
| <b>Description:</b><br>Station 00 + 525'<br><br>No exposed roots; no at-risk trees; no scour present; installed stabilization features recently repaired; planted stakings appear to be healthy; majority of erosion control fabric nonvegetated | | | |

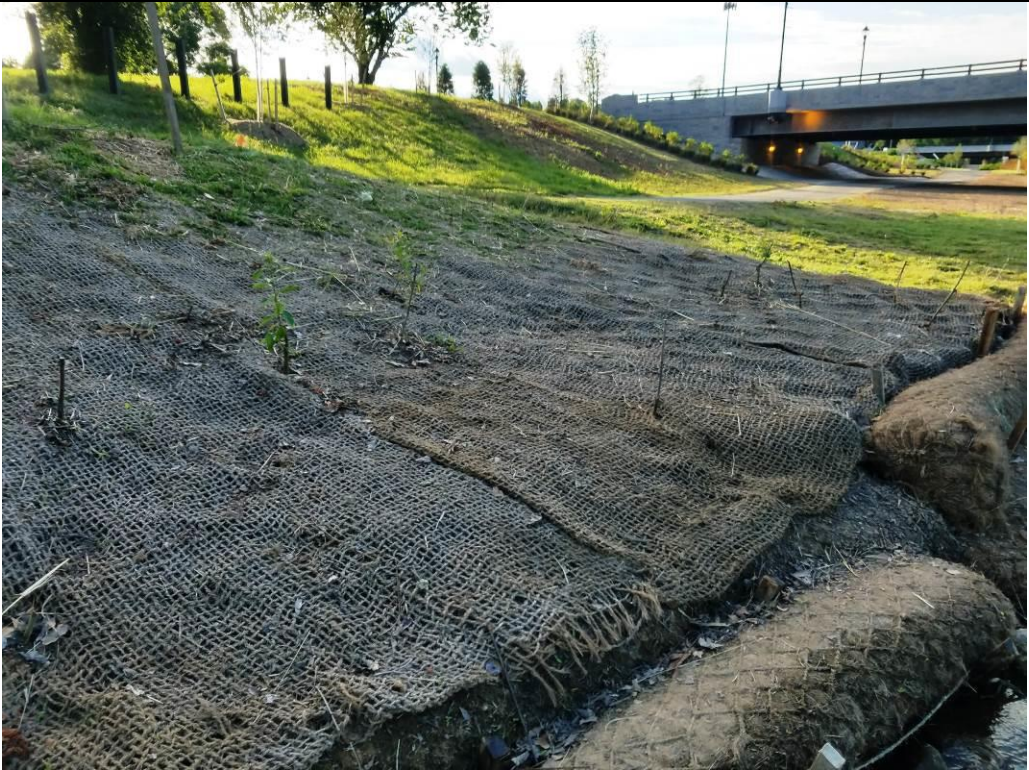
| <b>Photo No.</b><br>40 | <b>Date:</b><br>6/8/2017 | |

| <b>Description:</b><br>Station 00 + 525'<br><br>No exposed roots; no at-risk trees; no scour present; installed stabilization features recently repaired; planted stakings appear to be healthy; majority of erosion control fabric unvegetated | | |
