## Memorandum

| Subject | Spring 2017 Short-term Monitoring Field Summary Memo<br>Former DuPont Waynesboro Site, Area of Concern 4 | |
| Date | August 31, 2017 | |

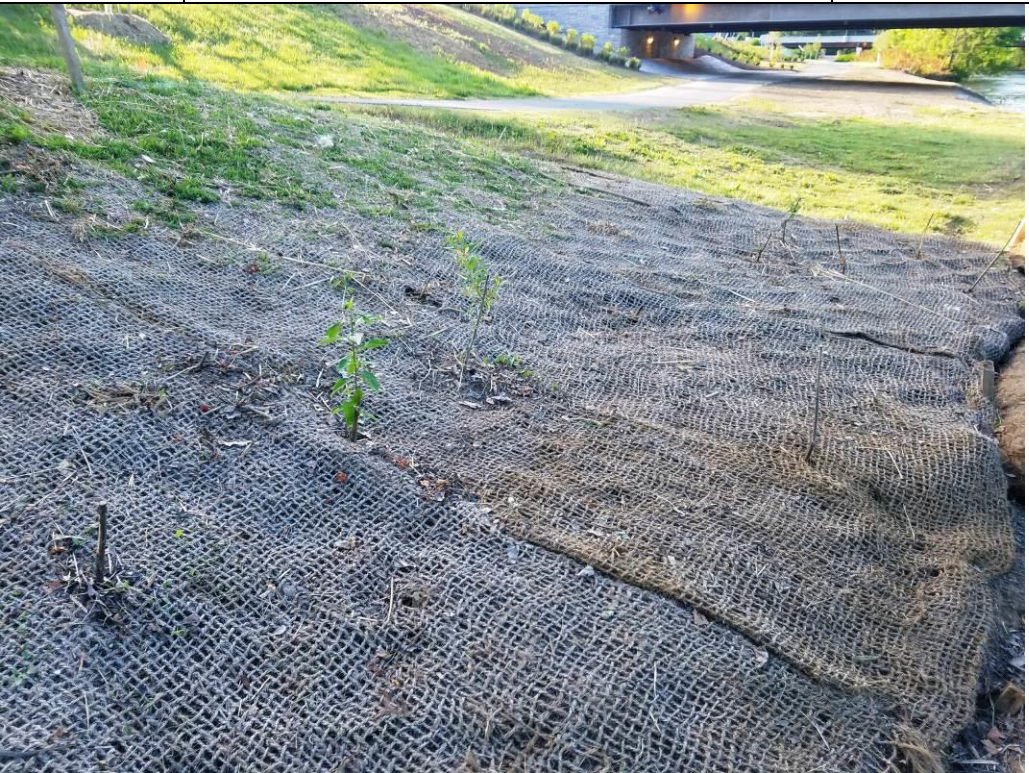
| <b>Description:</b><br>Station 00 + 525'<br><br>No exposed roots; no at-risk trees; no scour present; installed stabilization features recently repaired; planted stakings appear to be healthy; majority of erosion control fabric unvegetated | | | |

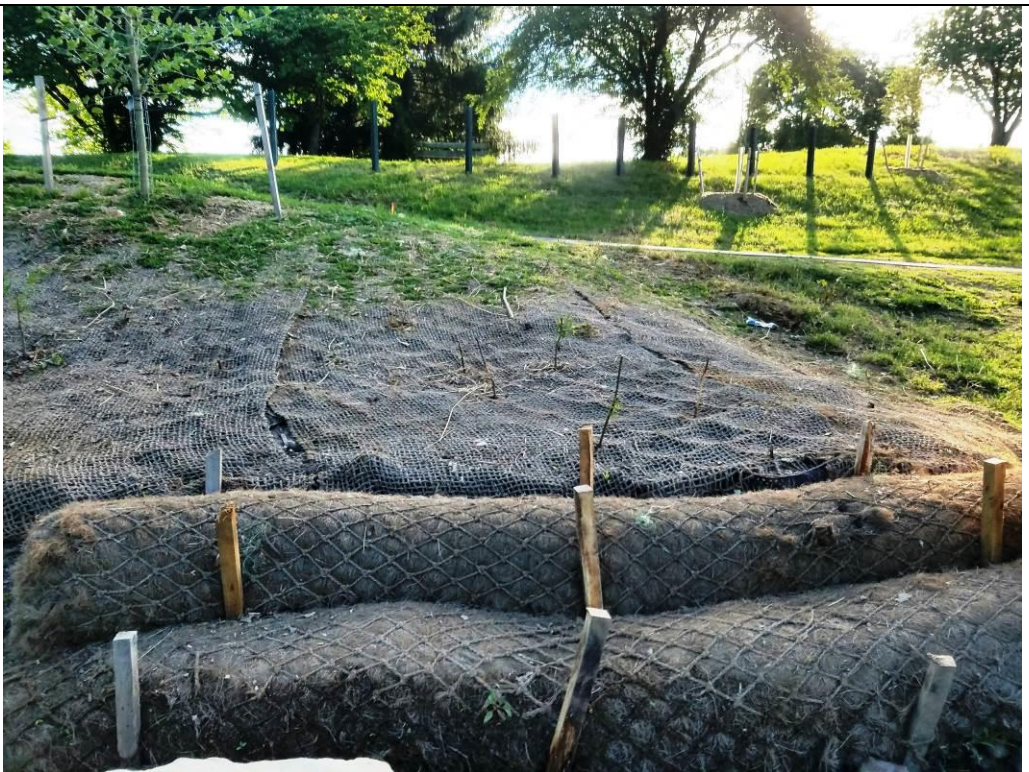
| <b>Photo No.</b><br>42 | <b>Date:</b><br>6/8/2017 | |

| <b>Description:</b><br>Station 00 + 525'<br><br>~15 degree consistent bank angle; no exposed roots; no at-risk trees; no scour present; installed stabilization features recently repaired; majority of erosion control fabric unvegetated | | |

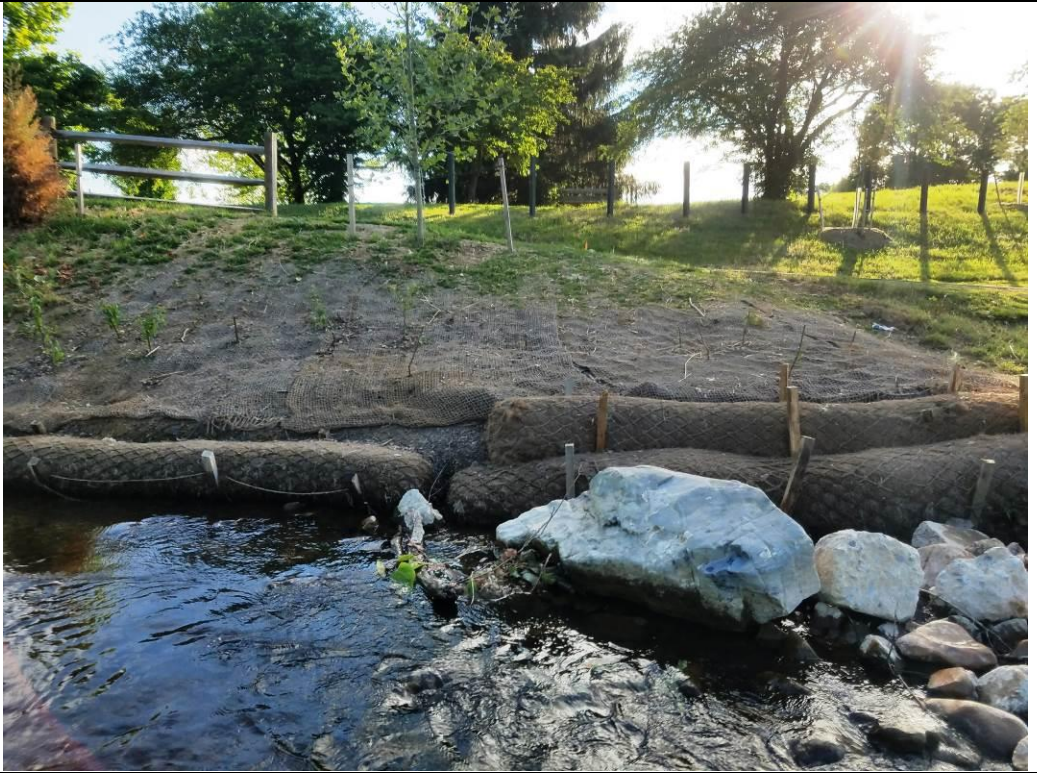
| <b>Description:</b><br>Station 00 + 525'<br><br>~15 degree consistent bank angle; no exposed roots; no at-risk trees; no scour present; installed stabilization features recently repaired; majority of erosion control fabric unvegetated along bank | | | |

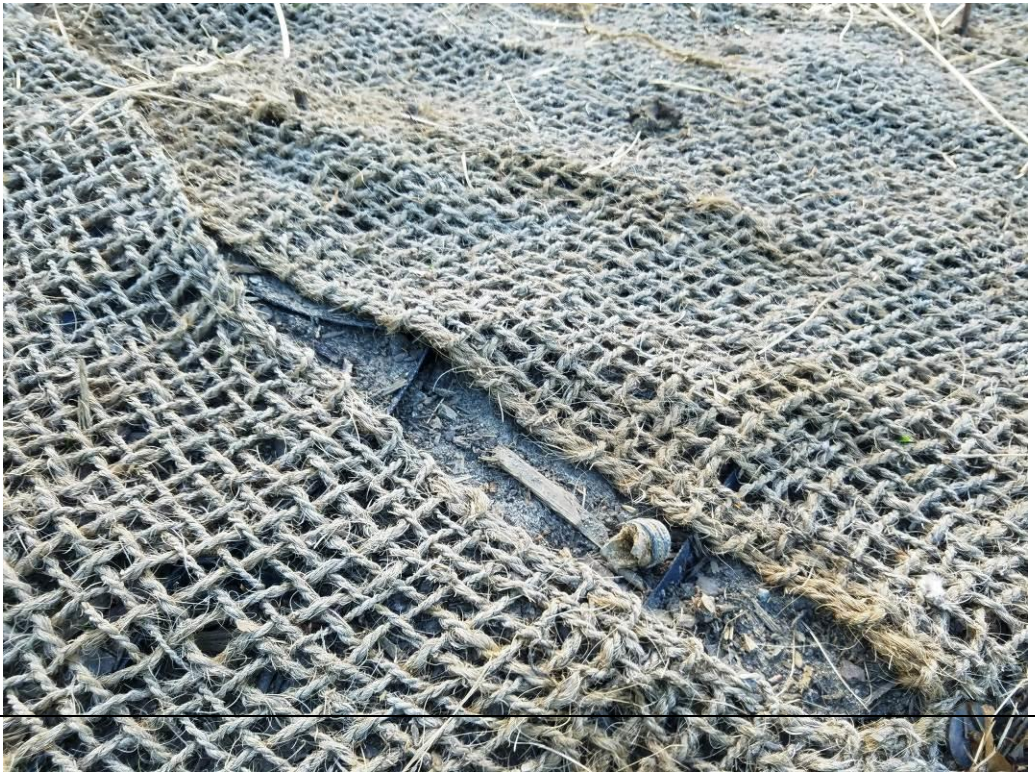
| <b>Photo No.</b><br>44 | <b>Date:</b><br>6/8/2017 | |

| <b>Description:</b><br>Station 00 + 525'<br><br>Installed stabilization features recently repaired; majority of erosion control fabric exposed along bank; minor amount of geocell unvegetated near bottom of bank | | |

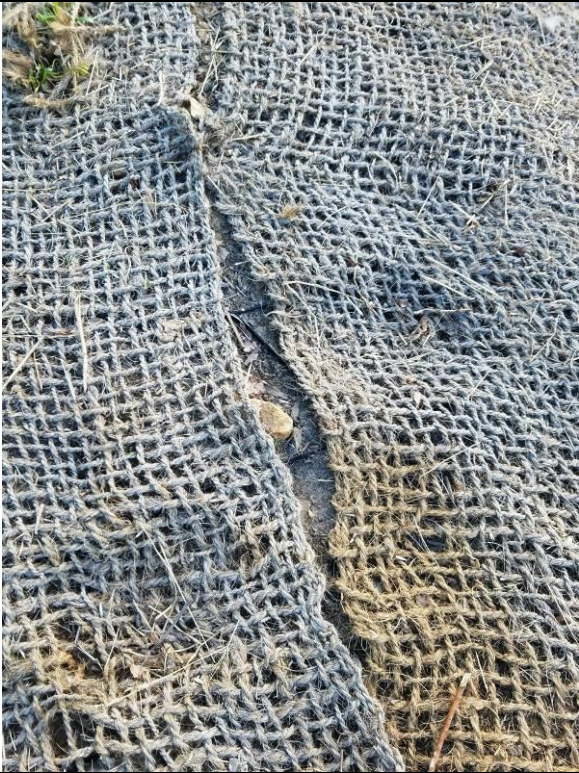
| <b>Photo No.</b><br>45 | <b>Date:</b><br>6/8/2017 | | |

| <b>Description:</b><br>Station 00 + 525'<br><br>Installed stabilization features recently repaired; majority of erosion control fabric unvegetated along bank; minor amount of geocell exposed near bottom of bank | | | |

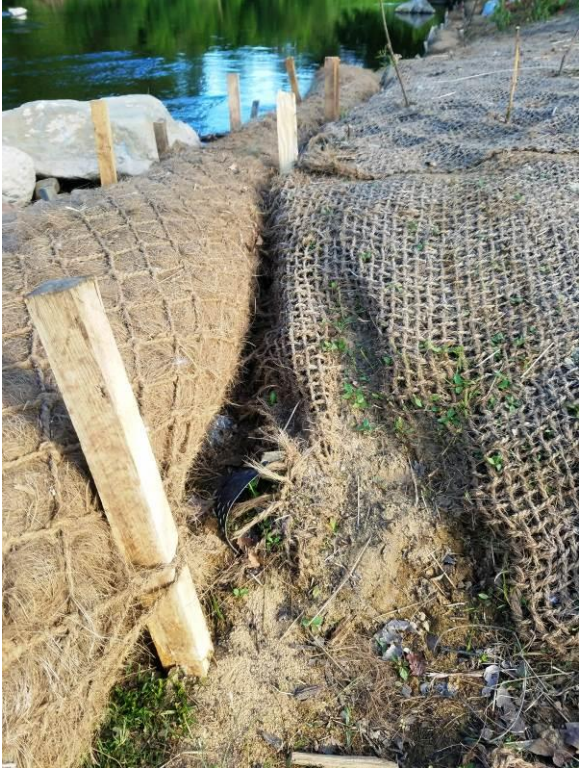
| <b>Photo No.</b><br>46 | <b>Date:</b><br>6/8/2017 | | |

| <b>Description:</b><br>Station 00 + 525'<br><br>Installed stabilization features recently repaired; edge of erosion control fabric exposed along bottom of bank, near intact coir logs | | | |
