**Re: Summer 2018 Constitution Park Bank Management Area Maintenance Inspection  
Area of Concern 4, Former DuPont Waynesboro Plant  
Waynesboro, Virginia  
EPA ID# VAD003114832**

| Subject | Summer 2018 Constitution Park BMA Maintenance Inspection<br>Former DuPont Waynesboro Site, Area of Concern 4 | | |

Table 1  
Summer 2018 Constitution Park BMA Maintenance Inspection  
Former DuPont Waynesboro Site, Area of Concern 4

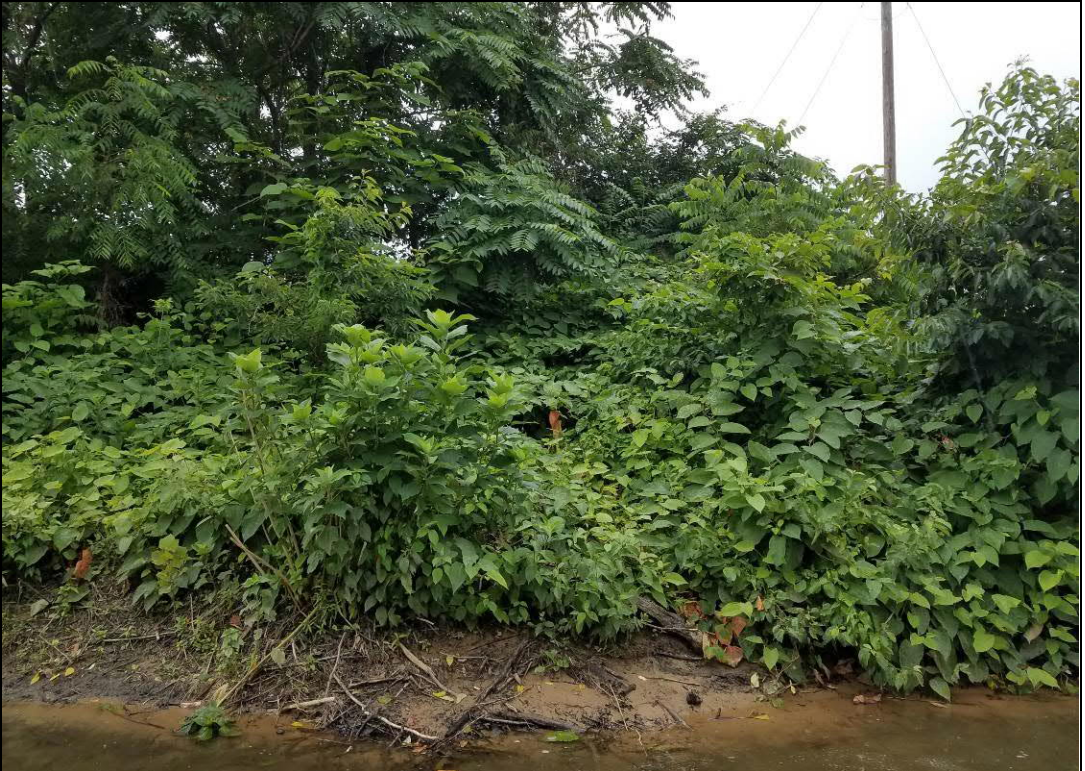
| <b>Photo No.</b><br>1 | <b>Date:</b><br>6/21/2018 | | |

| Station (ft) <sup>1</sup> | Undercutting | | | | Exposed Roots | | | At Risk Trees | | | Installed Stabilization Features/Intact | | | | | | Local Scour | | | Overall Change Since Previous Inspection (Y/N) |
|---|---|---|---|---|---|---|---|---|---|---|---|---|---|---|---|---|---|---|---|---|
| 00 - 25 | 30 | N (see notes) | Lower bank: ~30 degrees<br>Upper bank: ~55 degrees | 1 | L | No woody plants adjacent to edge of water | 1 | Y | No woody plants adjacent to edge of water | 1 | NA | NA | NA | | 1 | Y | Low presence of scour 5' upstream of 00 - 25 | 1 | N | |

| <b>Description:</b><br><br>Station 00 – 25'<br><br>~30 degree bank angle;<br>no at-risk trees present;<br>both native and<br>invasive vegetation<br>present; limited scour 5'<br>upstream. | | | |

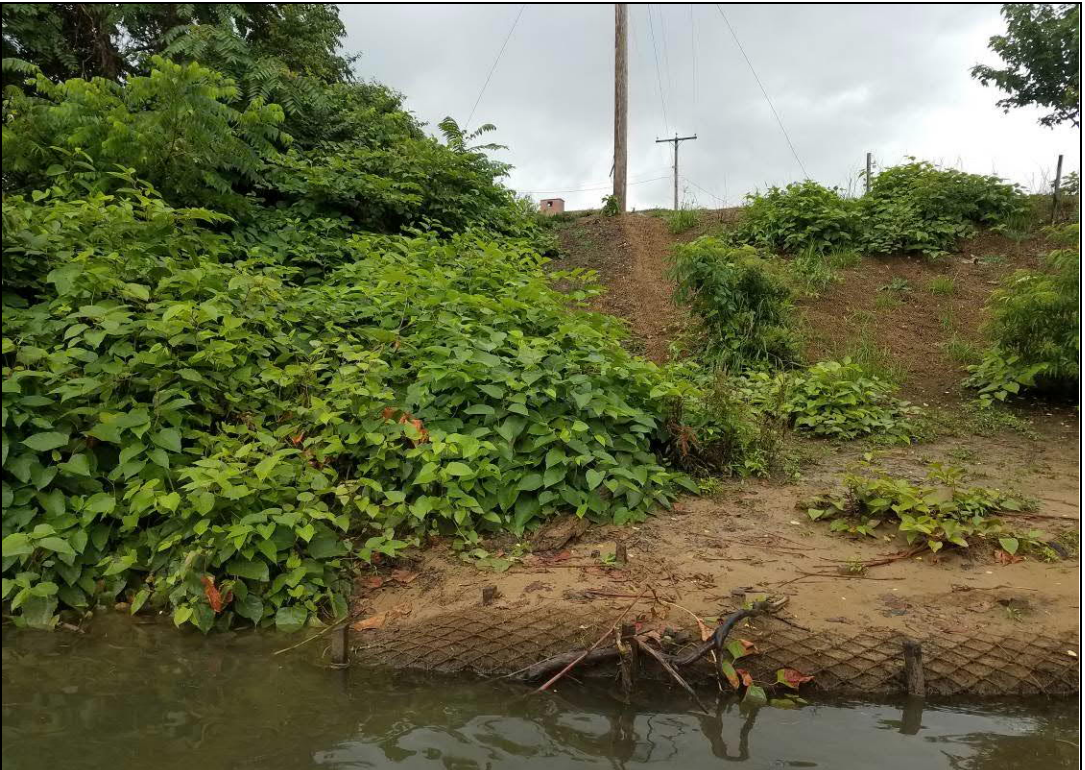
| <b>Photo No.</b><br>2 | <b>Date:</b><br>6/21/2018 | |

| Station (ft) <sup>1</sup> | Undercutting | | | | Exposed Roots | | | At Risk Trees | | | Installed Stabilization Features/Intact | | | | | | Local Scour | | | Overall Change Since Previous Inspection (Y/N) |
|---|---|---|---|---|---|---|---|---|---|---|---|---|---|---|---|---|---|---|---|---|
| 00 + 00 | 40 | N (see notes) | Lower bank: ~30 degrees<br>Upper bank: ~55 degrees | 2 | N | No woody plants adjacent to edge of water; minimal vegetation present on bank | 2 | N | No woody plants adjacent to edge of water | 2 | NA | Y | Y | Cair logs intact, some erosion control fabric is visible | 2 | N | Potential river access point observed; evidence of foot traffic along the toe of slope, along cair logs | 2 | Y | |

| <b>Description:</b><br><br>Station 00 + 00'<br><br>~40 degree bank angle;<br>patches of invasive and<br>native vegetation<br>present; coir logs intact;<br>no scour observed;<br>heavy foot traffic down<br>the bank and along coir<br>logs. | | |

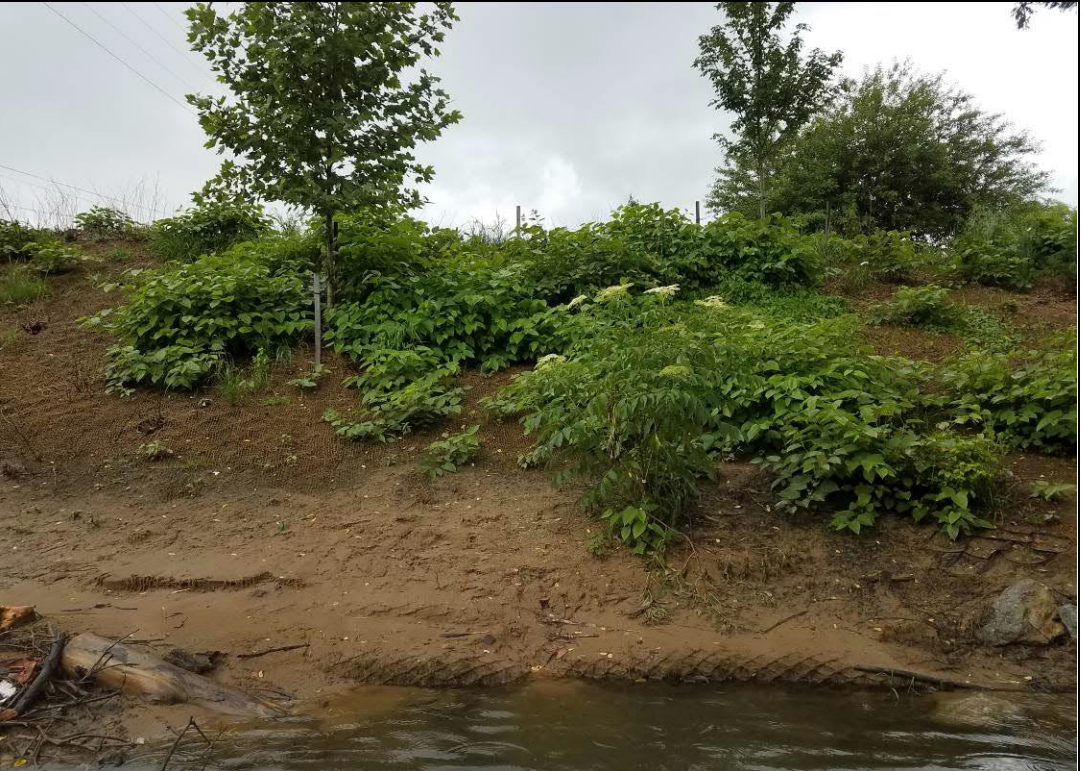
| Station (ft) <sup>1</sup> | Undercutting | | | | Exposed Roots | | | At Risk Trees | | | Installed Stabilization Features/Intact | | | | | | Local Scour | | | Overall Change Since Previous Inspection (Y/N) |
|---|---|---|---|---|---|---|---|---|---|---|---|---|---|---|---|---|---|---|---|---|
| 00 + 50 | 45 | Y | | 3 | N | No woody plants adjacent to edge of water; 30-40% invasive species cover | 3 | N | No woody plants adjacent to edge of water | 3 | NA | Y (beginning to be exposed at toe of slope) | Y (exposed throughout) | Geocell intact, but beginning to be exposed near the toe of the slope between 00 + 00 and 00 + 50 | 3 | N | Evidence of foot traffic along the toe of slope | 3 | Y | |

| <b>Description:</b><br><br>Station 00 + 50'<br><br>~ 45 degree bank angle present; no at-risk trees or exposed roots present; patches of invasive and native vegetation present; coir logs intact; geocell intact and slightly exposed; no scour observed; evidence of foot traffic along toe of slope, along coir logs. | | | |

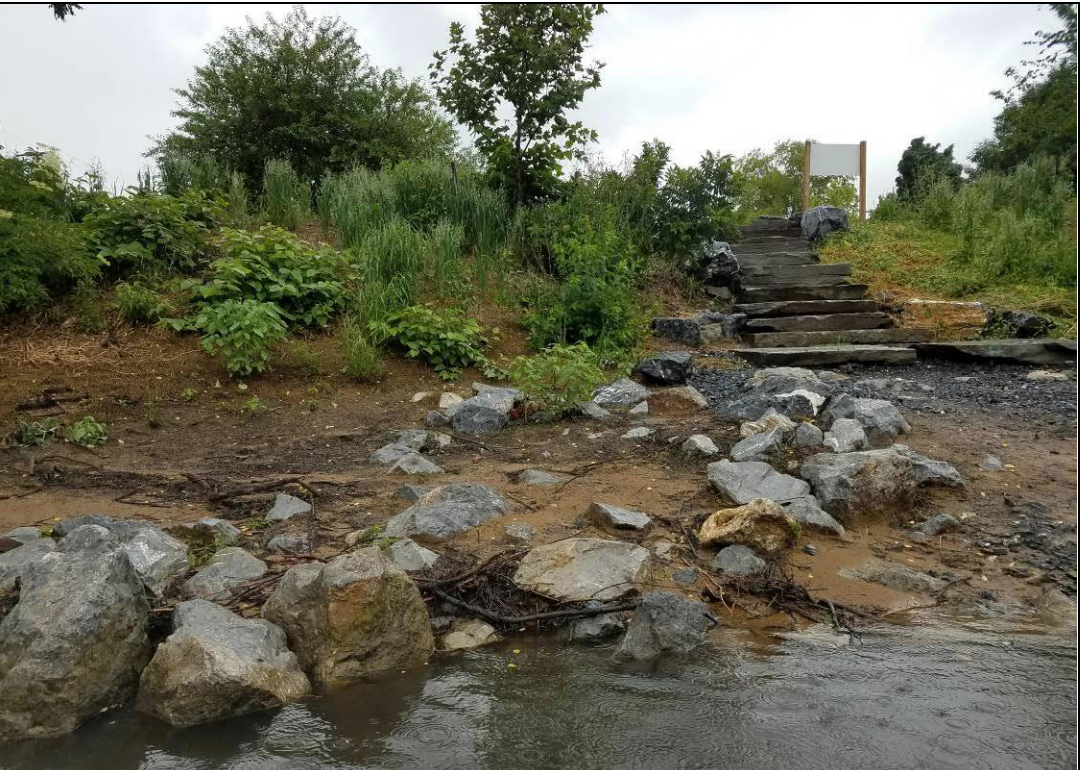
| Station (ft) <sup>1</sup> | Undercutting | | | | Exposed Roots | | | At Risk Trees | | | Installed Stabilization Features/Intact | | | | | | Local Scour | | | Overall Change Since Previous Inspection (Y/N) |
|---|---|---|---|---|---|---|---|---|---|---|---|---|---|---|---|---|---|---|---|---|
| 00 + 100 | 40 | N (see notes) | Lower bank ~10 degrees (rock toe);<br>Upper bank ~45 degrees | 4,5 | NA | No woody plants adjacent to edge of water | 4,5,6 | N | No at-risk trees present; no exposed roots | 4,5,6 | Y (rock toe) | Y | Y (small exposed section of cair fabric) | Rock toe along bank and constructed river access steps intact | 4 | N | Sediment deposition adjacent to rock toe boulders | 4 | Y | |

| <b>Description:</b><br><br>Station 00 + 100'<br><br>~40 degree bank angle; no at-risk trees or exposed roots present; patches of invasive and native vegetation present; no scour observed; installed rock toe intact, with evidence of sediment deposition; installed river access steps intact. | | |

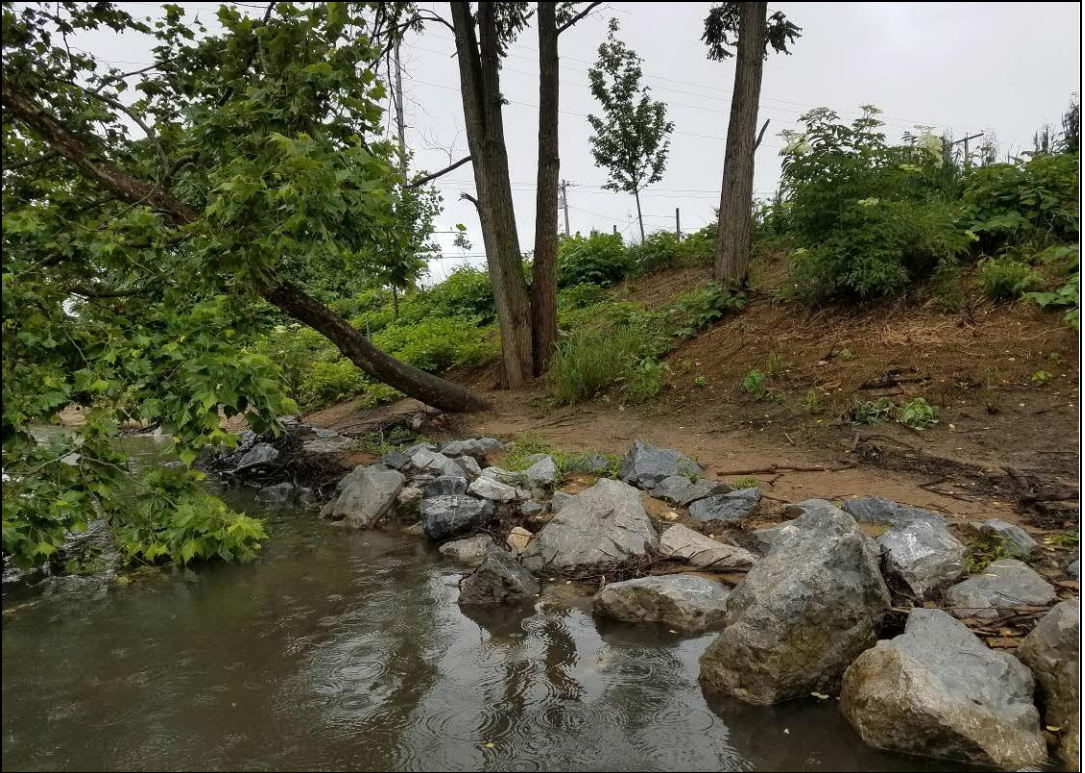
| <b>Description:</b><br>Station 00 + 100'<br><br>No at-risk trees or exposed roots present; no scour observed; installed rock toe intact, with evidence of sediment deposition; evidence of foot traffic along toe of slope, along coir logs. | | | |

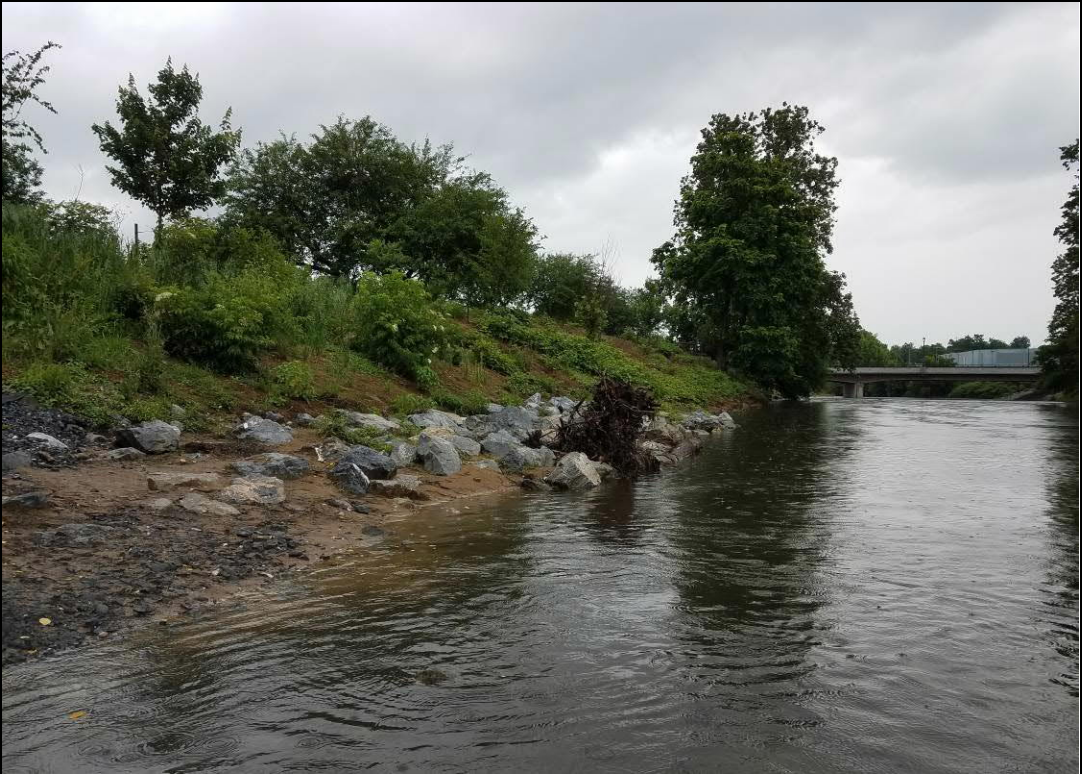
| <b>Photo No.</b><br>6 | <b>Date:</b><br>6/21/2018 | |

| <b>Description:</b><br>Station 00 + 100'<br><br>Sediment deposition adjacent to rock toe boulders; invasive and native vegetation present. | | |

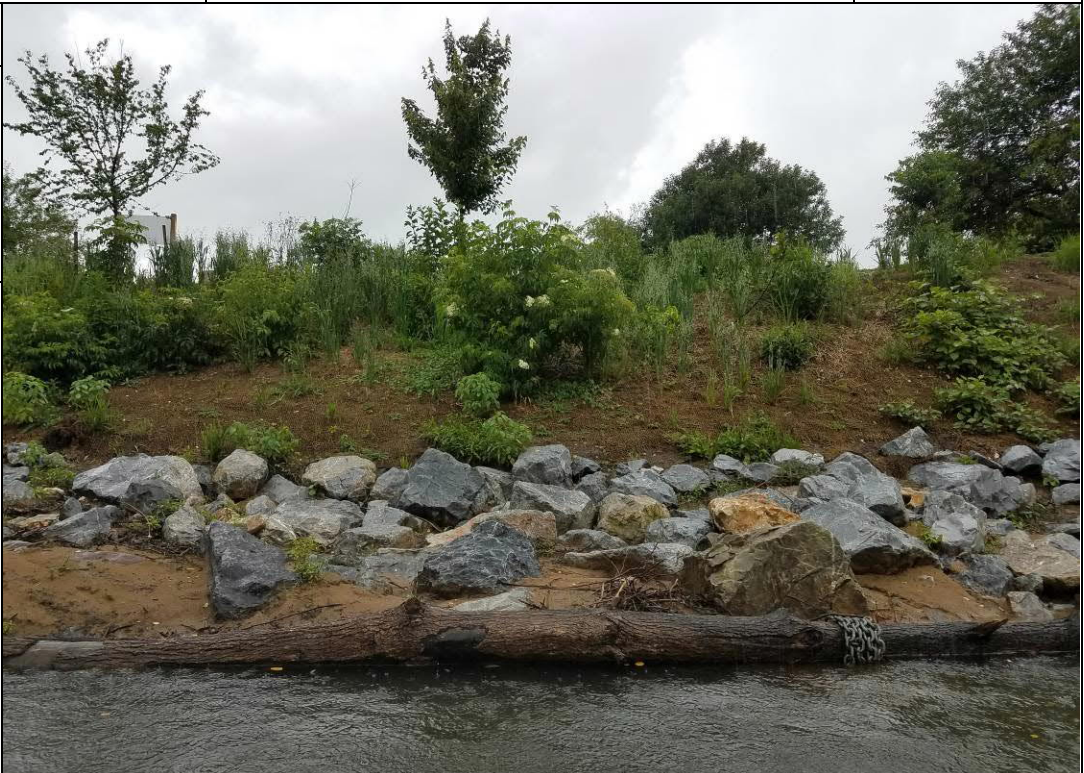
| Station (ft) <sup>1</sup> | Undercutting | | | | Exposed Roots | | | At Risk Trees | | | Installed Stabilization Features/Intact | | | | | | Local Scour | | | Overall Change Since Previous Inspection (Y/N) |
|---|---|---|---|---|---|---|---|---|---|---|---|---|---|---|---|---|---|---|---|---|
| 00 + 150 | 45 | N (see notes) | Lower bank ~5 degrees (rock toe);<br>Upper bank ~45 degrees | 7 | NA | Native vegetation predominantly present; no woody plants adjacent to edge of water | 7,8,9 | N | No woody plants adjacent to edge of water | 7,8,9 | Y (LWD and Rock toe) | Y | Y | Installed geocell and erosion control fabric intact | 7,9 | N | Silt filling in behind LWD and in boulders | 7,9 | Y | |

| <b>Description:</b><br>Station 00 + 150<br><br>~45 degree bank angle; no at-risk trees or exposed roots present; well established native vegetation; no scour observed; installed rock toe and large woody debris (LWD) intact; installed geocell and erosion control fabric intact; evidence of sediment deposition. | | | |

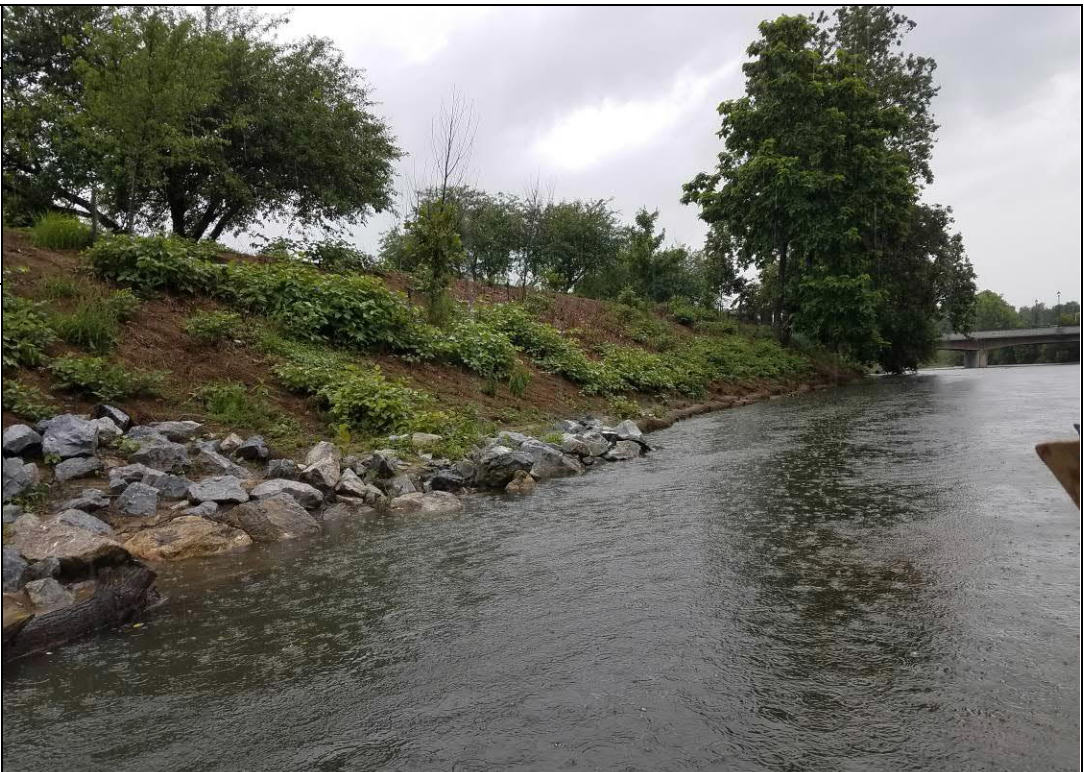
| <b>Photo No.</b><br>8 | <b>Date:</b><br>6/21/2018 |

| <b>Description:</b><br><br>Station 00 + 150'<br><br>Installed rock toe intact with evidence of sediment deposition: small patches of the invasive knotweed present. | |

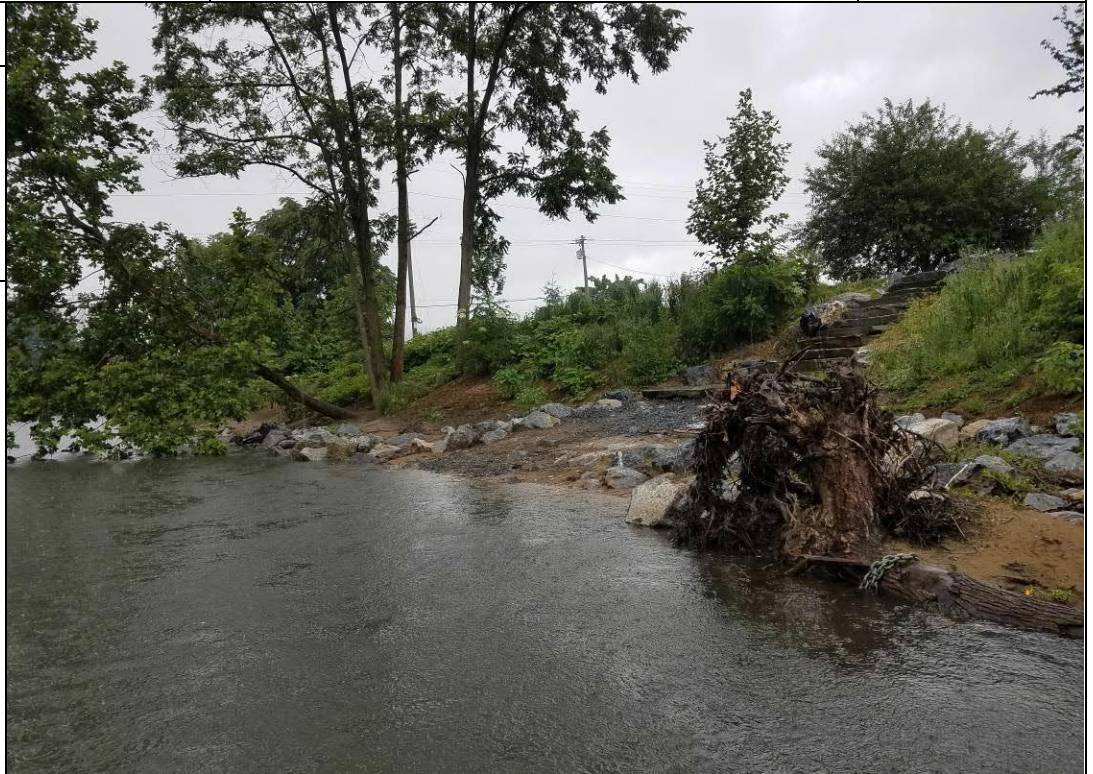
| <b>Photo No.</b><br>9 | <b>Date:</b><br>6/21/2018 |

Station 00 + 150'

Installed rock toe and LWD intact, with evidence of sediment deposition.

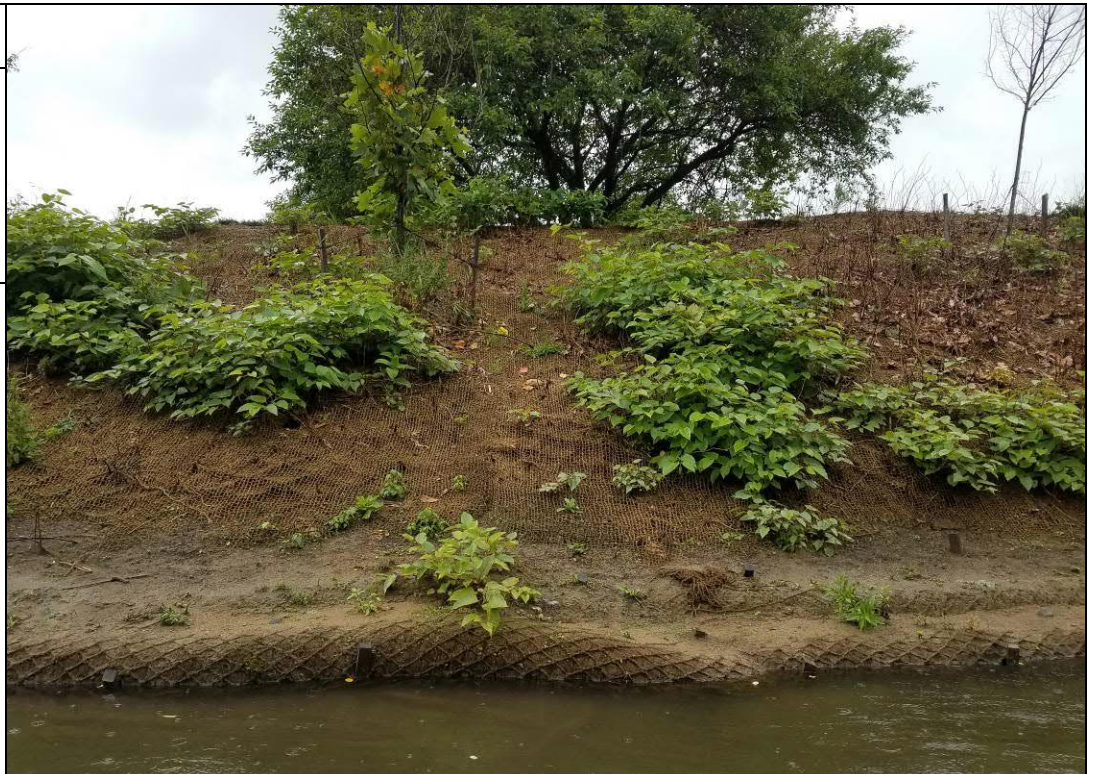
| <b>Photo No.</b><br>10 | <b>Date:</b><br>6/21/2018 |

| Station (ft) <sup>1</sup> | Undercutting | | | | Exposed Roots | | | At Risk Trees | | | Installed Stabilization Features/Intact | | | | | | Local Scour | | | Overall Change Since Previous Inspection (Y/N) |
|---|---|---|---|---|---|---|---|---|---|---|---|---|---|---|---|---|---|---|---|---|
| 00 + 200 | 55 | Y | | 10 | NA | Patches of invasive vegetation present; no woody plants adjacent to edge of water | 10 | N | No woody plants adjacent to edge of water | 10 | NA | Y | Y (exposed throughout) | installed cair logs, geocell and erosion fabric intact | 10 | N | Evidence of foot traffic along the toe of slope, along cair logs | 10 | Y | |

Station 00 + 200'

~55 degree bank angle; patches of invasive vegetation present; no exposed roots; no scour observed; exposed erosion control fabric; foot path present down bank and along coir logs; installed coir logs, geocell and erosion fabric intact.

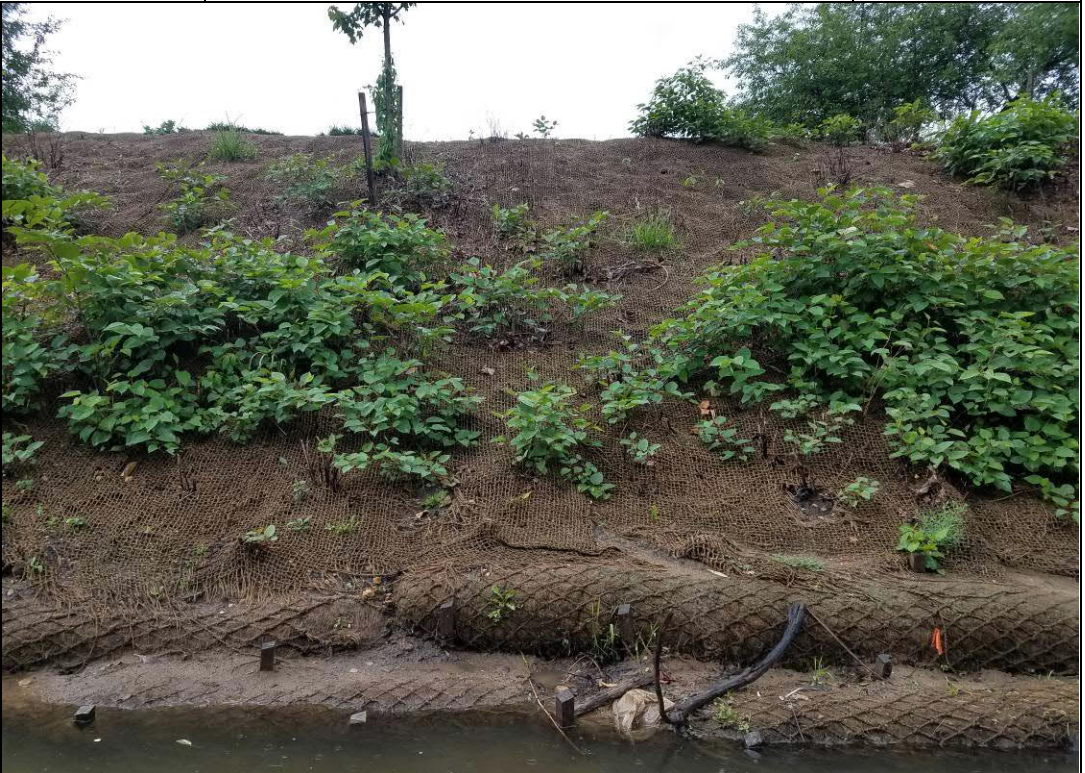
| Station (ft) <sup>1</sup> | Undercutting | | | | Exposed Roots | | | At Risk Trees | | | Installed Stabilization Features/Intact | | | | | | Local Scour | | | Overall Change Since Previous Inspection (Y/N) |
|---|---|---|---|---|---|---|---|---|---|---|---|---|---|---|---|---|---|---|---|---|
| 00 + 250 | 55 | Y | | 11,12 | NA | Patches of invasive vegetation present; no woody plants adjacent to edge of water | 11 | N | No woody plants adjacent to edge of water | 11,12 | NA | Y | Y (exposed throughout) | Geocell intact; edge of erosion control fabric exposed throughout | 11,12 | N | | 11 | Y | |

| <b>Description:</b><br><br>Station 00 + 250'<br><br>~55 degree consistent uniform bank angle; no exposed roots; no scour present; patches of invasive vegetation present; installed coir logs and geocell intact; edge of erosion control fabric exposed near toe of slope. | | | |

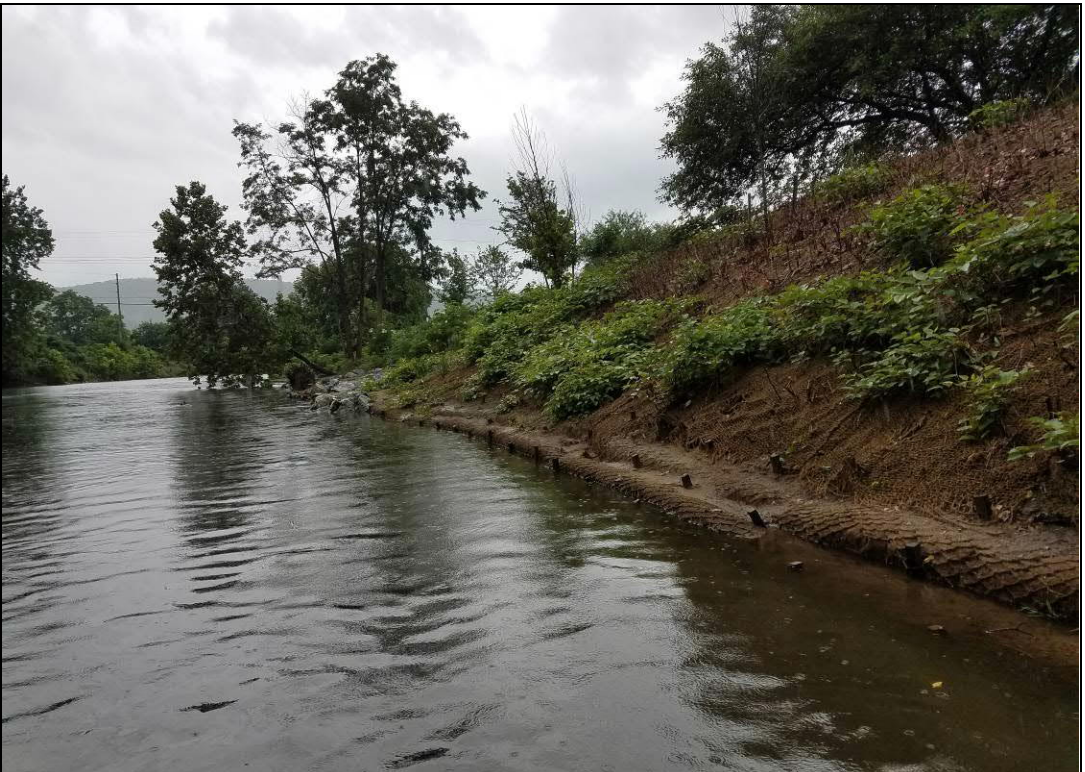
| <b>Photo No.</b><br>12 | <b>Date:</b><br>6/21/2018 | |

| <b>Description:</b><br><br>Station 00 + 250'<br><br>Patches of invasive vegetation present; evidence of foot traffic along coir logs; geocell and installed coir logs intact. | | |

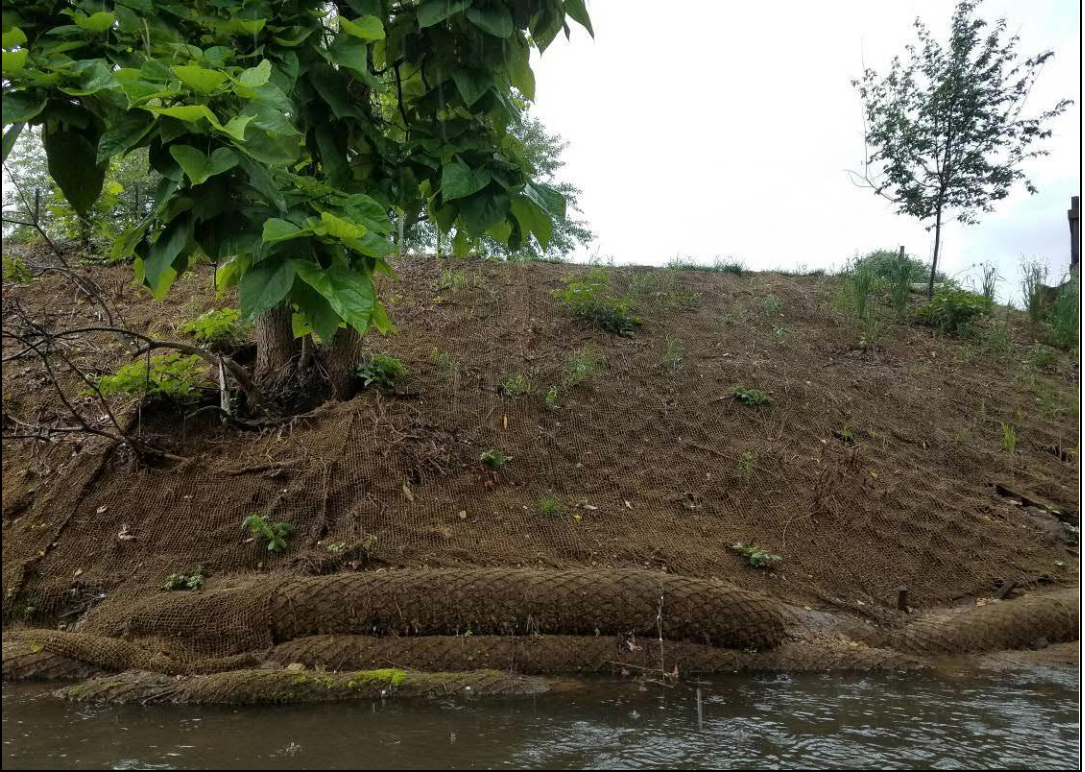
| Station (ft) <sup>1</sup> | Undercutting | | | | Exposed Roots | | | At Risk Trees | | | Installed Stabilization Features/Intact | | | | | | Local Scour | | | Overall Change Since Previous Inspection (Y/N) |
|---|---|---|---|---|---|---|---|---|---|---|---|---|---|---|---|---|---|---|---|---|
| 00 + 300 | 70 | Y | | 13 | NA | Minimal vegetation present; no woody plants adjacent to edge of water | 13 | N | No exposed roots; no at-risk trees | 13 | NA | Y | Y (50% exposed) | Erosion control fabric 50% exposed; geocells and installed cair logs intact | 13,14,15 | N | | 13 | Y | |

| <b>Description:</b><br><br>Station 00 + 300'<br><br>~70 degree uniform bank angle; no exposed roots or at-risk trees; no scour observed; minimal vegetation present; erosion control fabric exposed near toe of slope; geocell and installed coir logs intact. | | | |

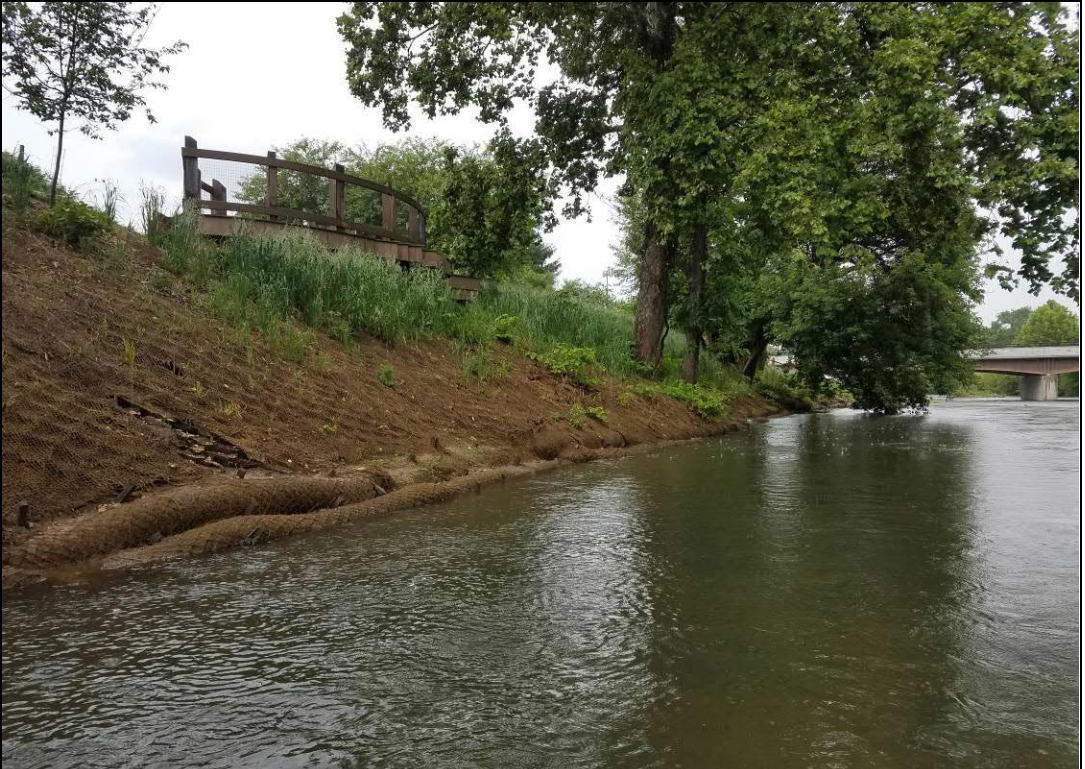
| <b>Photo No.</b><br>14 | <b>Date:</b><br>6/21/2018 | |

| <b>Description:</b><br><br>Station 00 + 300'<br><br>Minimal vegetation present; erosion control fabric exposed near toe of slope; geocell and installed coir logs intact. | | |

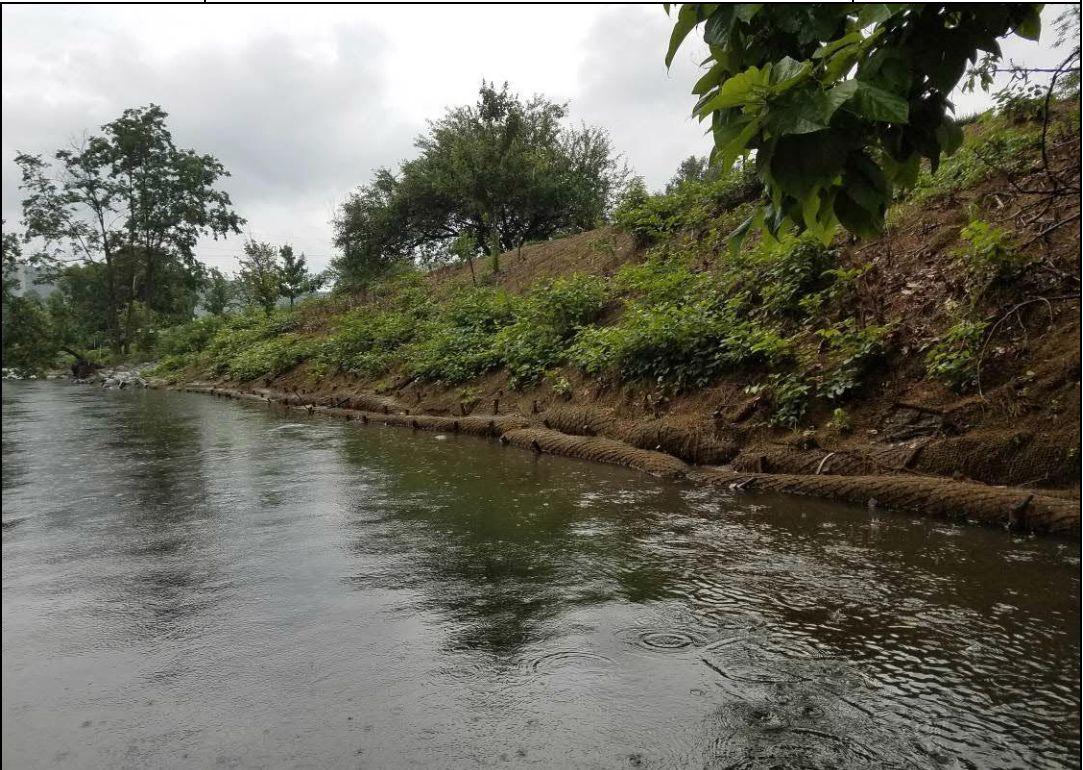
| <b>Photo No.</b><br>15 | <b>Date:</b><br>6/21/2018 | | |

| <b>Description:</b><br><br>Station 00 + 300'<br><br>Patches of invasive vegetation present upstream of the inspection point; erosion control fabric exposed near toe of slope; geocell and installed coir logs intact. | | | |

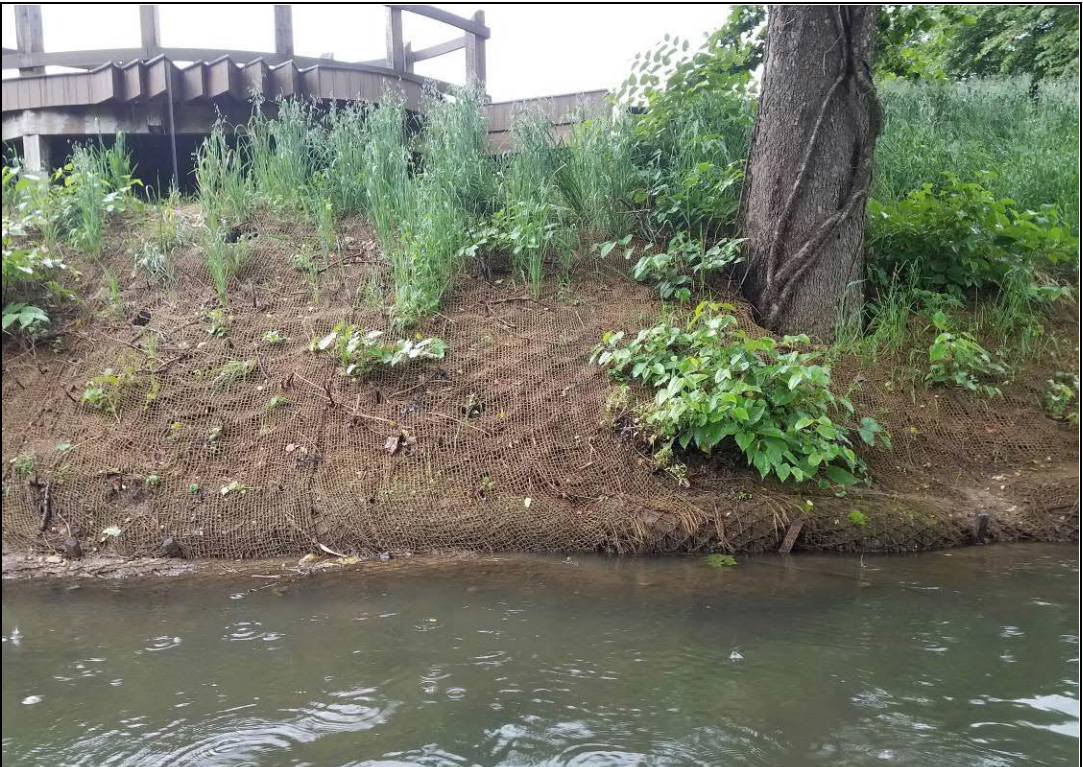
| Station (ft) <sup>1</sup> | Undercutting | | | | Exposed Roots | | | At Risk Trees | | | Installed Stabilization Features/Intact | | | | | | Local Scour | | | Overall Change Since Previous Inspection (Y/N) |
|---|---|---|---|---|---|---|---|---|---|---|---|---|---|---|---|---|---|---|---|---|
| 00 + 350 | 70 | Y | | 16 | NA | Native vegetation present along top of bank with small patches of the invasive knotted plant present | 16,18 | N | No woody plants adjacent to edge of water | 16,17,18 | NA | Y (some geocell exposed below observation platform) | Y (exposed throughout) | Cair log 5' downstream slightly loose and appears to have shifted towards the stream; | 16,17,18 | N | Installed cair logs intact, but showing signs of wear and potential for scour | 18 | Y | |

| <b>Description:</b><br><br>Station 00 + 350'<br><br>~70 degree bank angle;<br>no exposed roots or at-risk trees; no scour observed; native vegetation present along top of bank, with small patches of the invasive knotweed present; geocell and installed coir logs intact. | | |

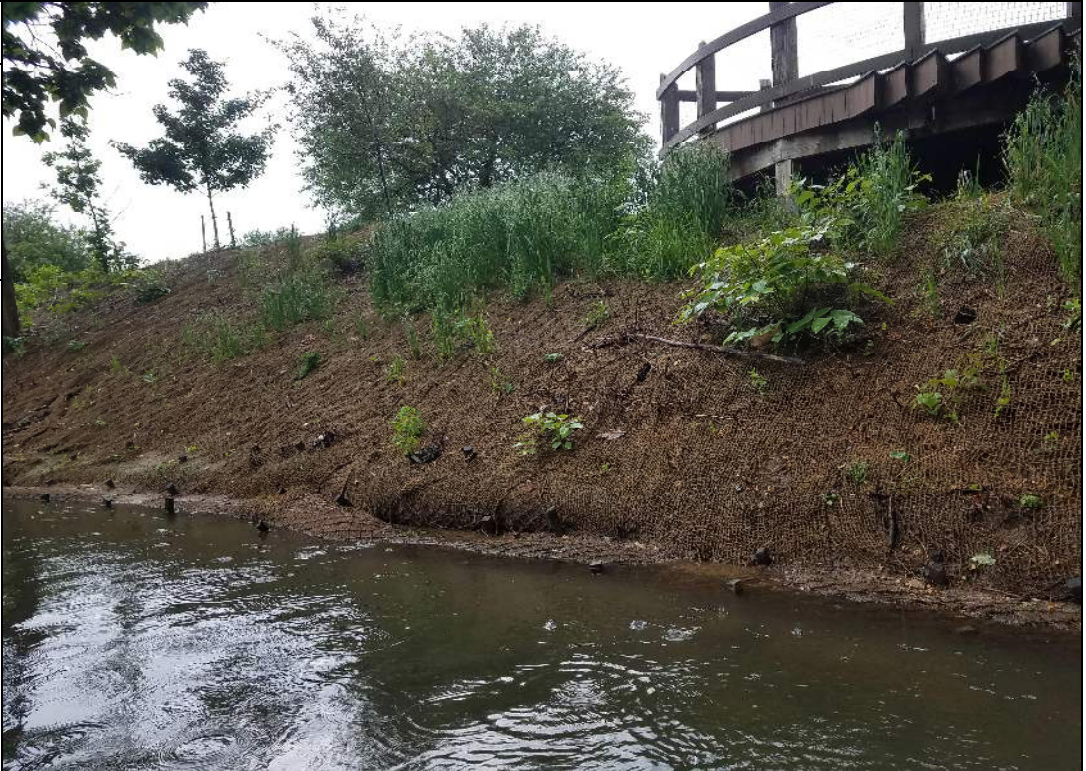
| <b>Photo No.</b><br>17 | <b>Date:</b><br>6/21/2018 | | |

| <b>Description:</b><br><br>Station 00 + 350'<br><br>Limited vegetative cover; edge of installed erosion control fabric exposed; installed coir logs intact. | | | |

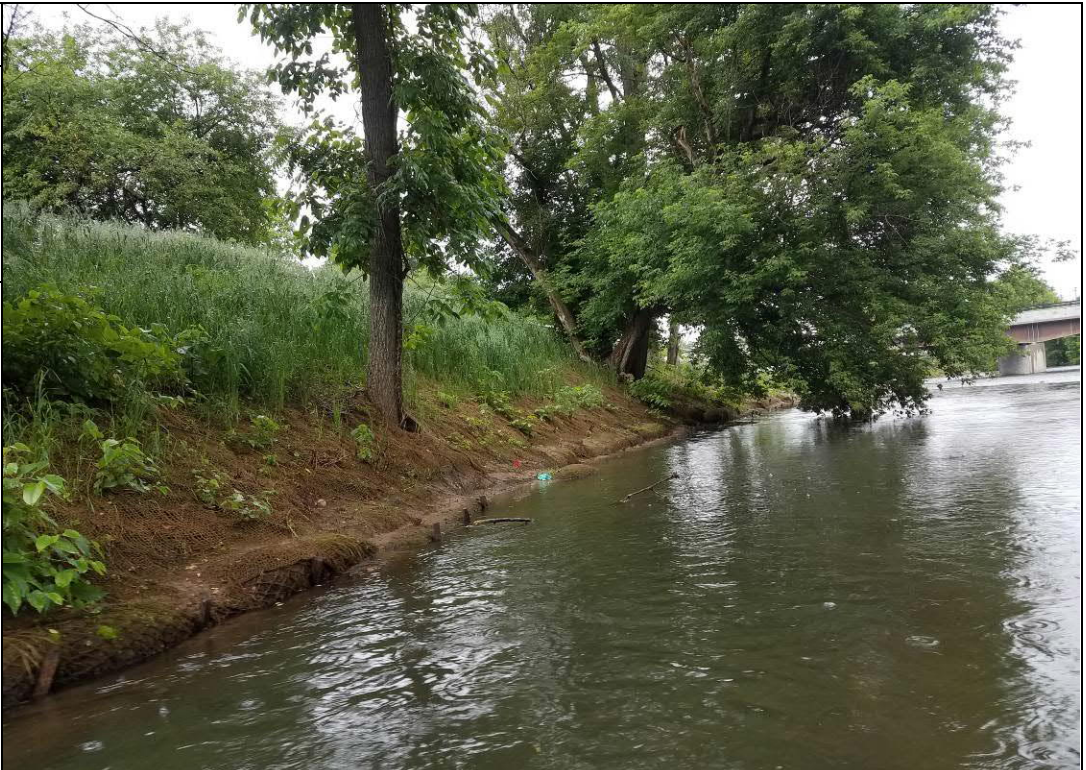
| <b>Photo No.</b><br>18 | <b>Date:</b><br>6/21/2018 | |

| <b>Description:</b><br><br>Station 00 + 350'<br><br>Edge of installed erosion control fabric exposed along toe of slope; installed coir logs intact, but showing signs of wear; predominantly native vegetation present covering much of bank. | | |

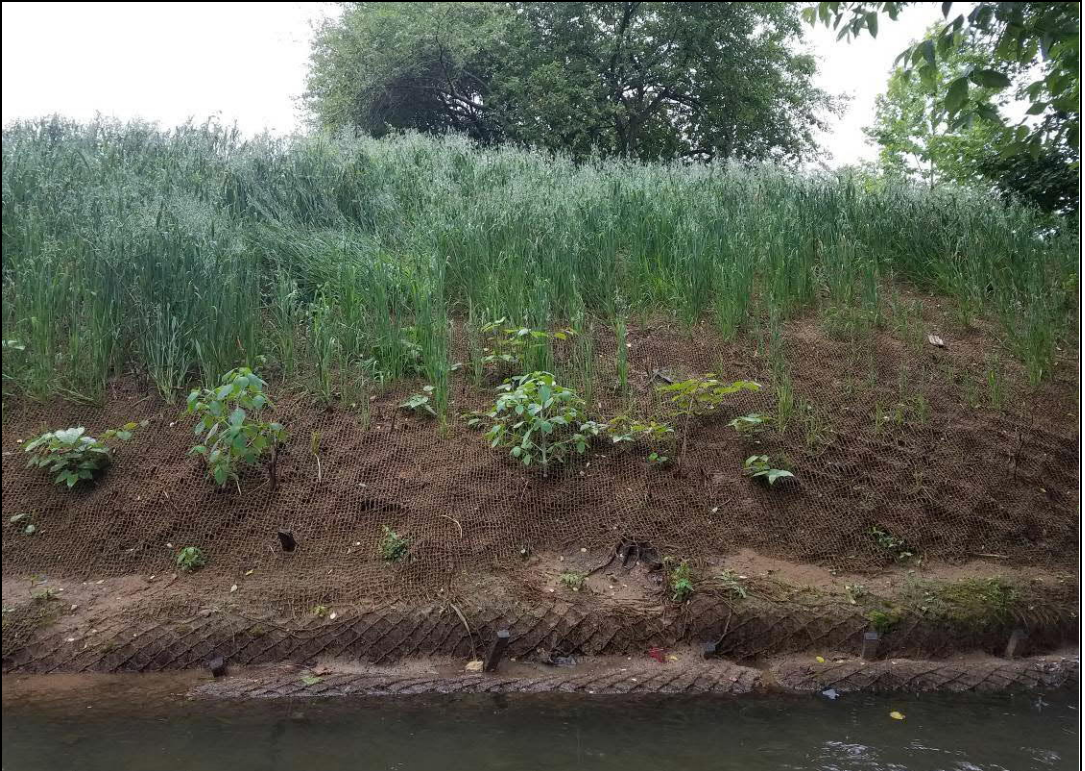
| <b>Photo No.</b><br>19 | <b>Date:</b><br>6/21/2018 | | |

| Station (ft) <sup>1</sup> | Undercutting | | | | Exposed Roots | | | At Risk Trees | | | Installed Stabilization Features/Intact | | | | | | Local Scour | | | Overall Change Since Previous Inspection (Y/N) |
|---|---|---|---|---|---|---|---|---|---|---|---|---|---|---|---|---|---|---|---|---|
| 00 + 400 | 60 | Y | | 19,20,21 | NA | Predominantly native vegetation present; no woody plants adjacent to edge of water | 19,20,21 | N | No exposed roots; no at-risk trees | 19,20,21 | NA | Y (small amount exposed upstream around black walnut) | Y (60% exposed) | limited geocell exposed around base of black walnut tree; erosion control fabric exposed throughout, particularly near bottom of bank; cair log looks out of place | 19,20,21 | N | | 19 | Y | |

| <b>Description:</b><br><br>Station 00 + 400'<br><br>~60 degree bank angle; predominantly native vegetation present with the exception of at toe of slope; no exposed roots; no at-risk trees; no scour present. | | | |

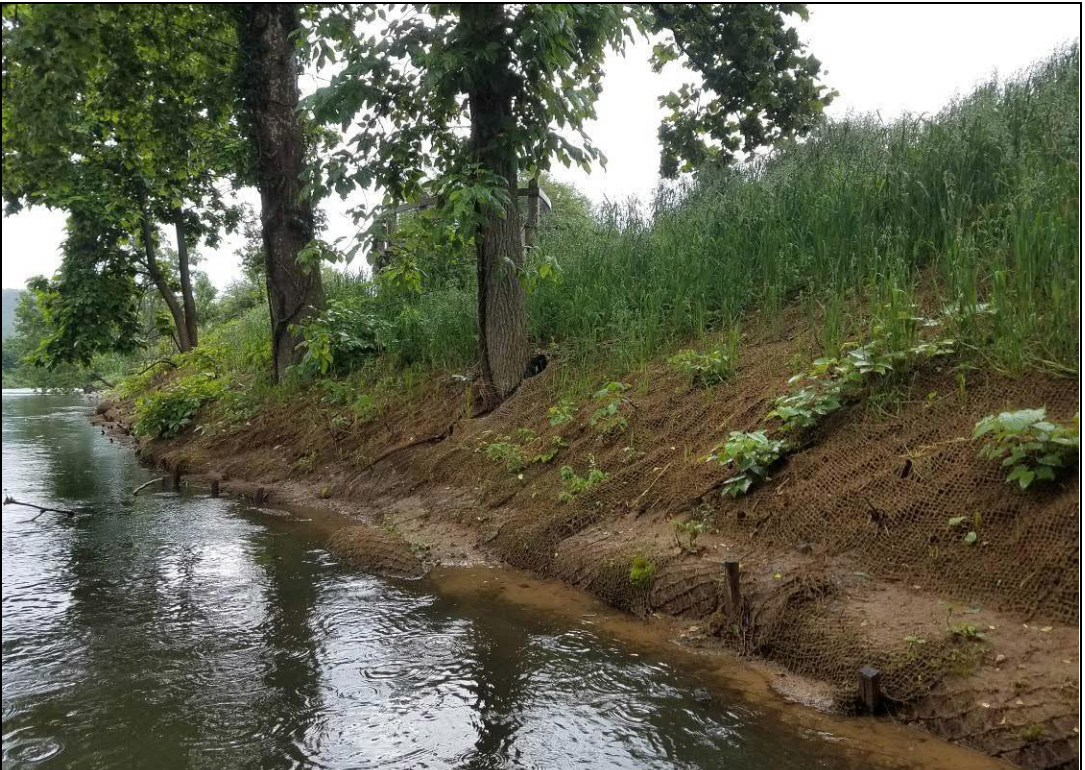
| <b>Photo No.</b><br>20 | <b>Date:</b><br>6/21/2018 | |

| <b>Description:</b><br><br>Station 00 + 400'<br><br>Installed coir logs intact; limited vegetation present at bottom of bank; limited geocell exposed around base of black walnut tree. | | |

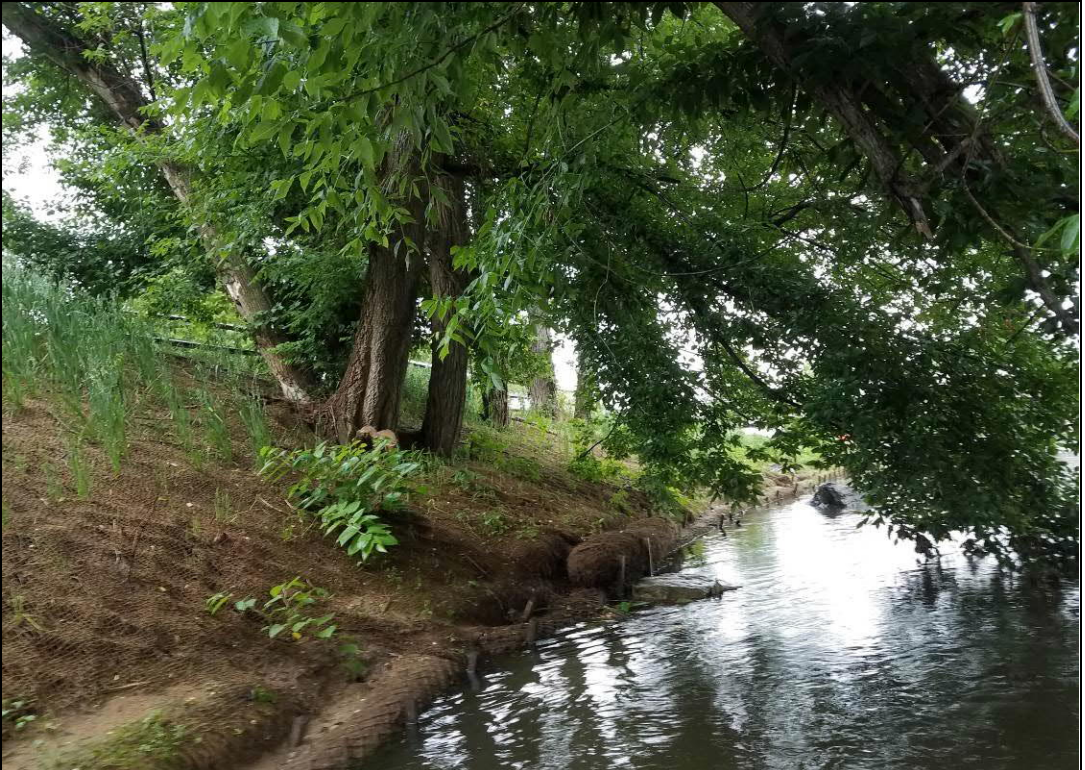
| <b>Photo No.</b><br>21 | <b>Date:</b><br>6/21/2018 | | |

| <b>Description:</b><br>Station 00 + 400'<br><br>Installed coir logs intact; extensive bare areas present, particularly near toe of the bank. | | | |

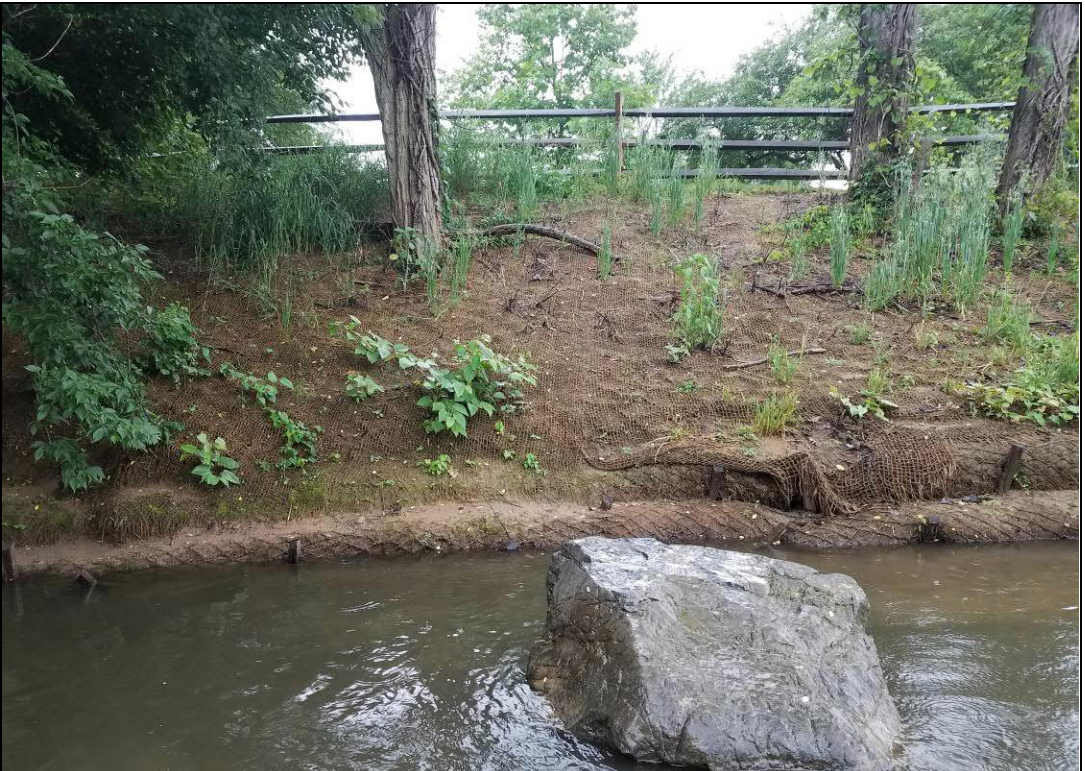
| <b>Photo No.</b><br>22 | <b>Date:</b><br>6/21/2018 | |

| Station (ft) <sup>1</sup> | Undercutting | | | | Exposed Roots | | | At Risk Trees | | | Installed Stabilization Features/Intact | | | | | | Local Scour | | | Overall Change Since Previous Inspection (Y/N) |
|---|---|---|---|---|---|---|---|---|---|---|---|---|---|---|---|---|---|---|---|---|
| 00 + 450 | 50 | Y | | 22 | NA | Patches of native and invasive vegetation present; no woody plants adjacent to edge of water | 22 | N | No exposed roots; no at-risk trees | 22 | NA | Y | Y (exposed throughout) | Erosion control fabric exposed throughout | 22 | Y | Minimal scour present near cair log | 22 | Y | |

| <b>Description:</b><br>Station 00 + 450'<br><br>~50 degree bank angle; no exposed roots or at-risk trees; minimal scour observed; patches of native and invasive vegetation present; with areas of bare erosion control fabric visible near toe of bank. | | |
