**Re: Summer 2018 Constitution Park Bank Management Area Maintenance Inspection  
Area of Concern 4, Former DuPont Waynesboro Plant  
Waynesboro, Virginia  
EPA ID# VAD003114832**

| Subject | Summer 2018 Constitution Park BMA Maintenance Inspection<br>Former DuPont Waynesboro Site, Area of Concern 4 | | |

Table 1  
Summer 2018 Constitution Park BMA Maintenance Inspection  
Former DuPont Waynesboro Site, Area of Concern 4

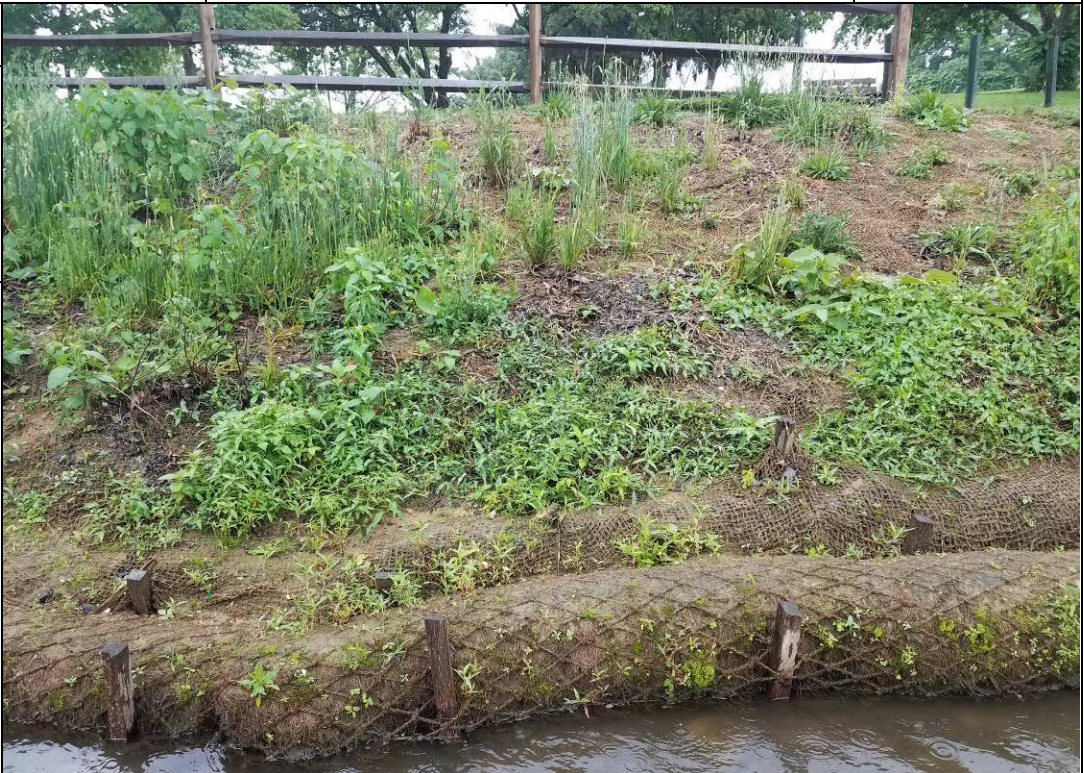
| <b>Photo No.</b><br>23 | <b>Date:</b><br>6/21/2018 | | |

| Station (ft) <sup>1</sup> | Undercutting | | | | Exposed Roots | | | At Risk Trees | | | Installed Stabilization Features/Intact | | | | | | Local Scour | | | Overall Change Since Previous Inspection (Y/N) |
|---|---|---|---|---|---|---|---|---|---|---|---|---|---|---|---|---|---|---|---|---|
| 00 + 500 | 40 | Y | Decreased vertical bank height (~6') | 23 | NA | Native vegetation predominantly present; no woody plants adjacent to edge of water | 23 | N | No woody plants adjacent to edge of water | 23 | NA | Y | Y (30% exposed) | Erosion fabric exposed near toe of bank | 23 | N | | 23 | Y | |

| <b>Description:</b><br><br>Station 00 + 500'<br><br>~40 degree bank angle;<br>no exposed roots or at-risk trees; no scour observed; native approximately 50% vegetative cover ,<br>predominantly comprised of native species. | | | |

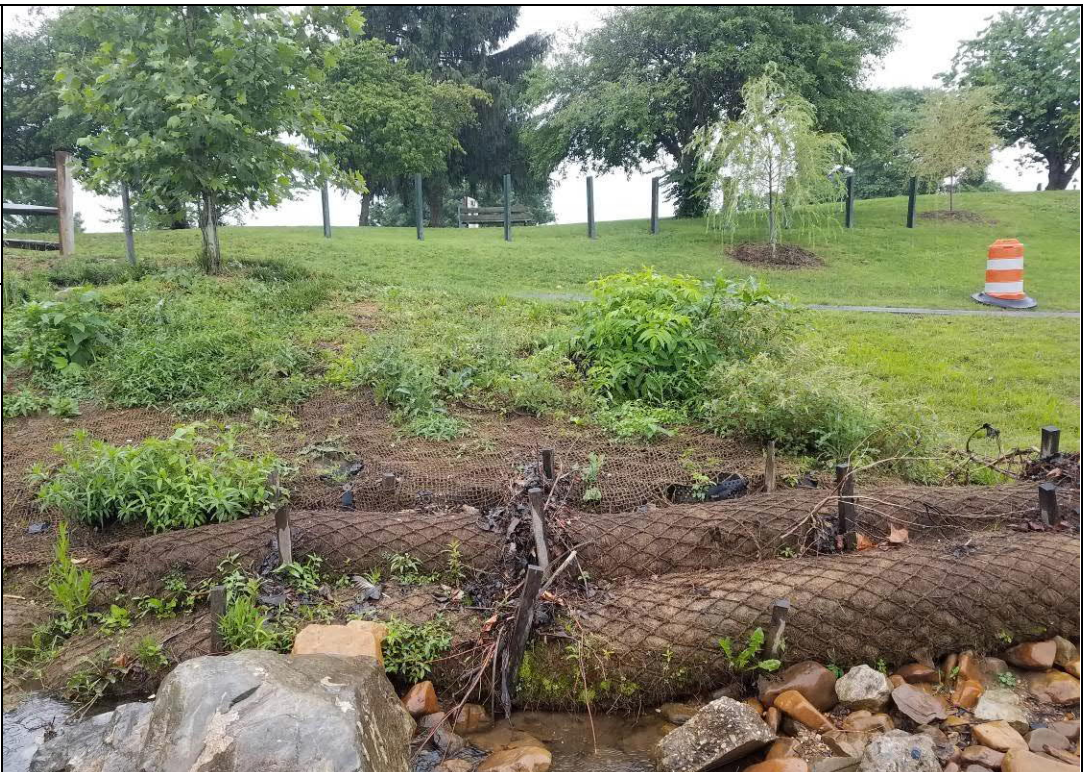
| <b>Photo No.</b><br>24 | <b>Date:</b><br>6/21/2018 | |

| Station (ft) <sup>1</sup> | Undercutting | | | | Exposed Roots | | | At Risk Trees | | | Installed Stabilization Features/Intact | | | | | | Local Scour | | | Overall Change Since Previous Inspection (Y/N) |
|---|---|---|---|---|---|---|---|---|---|---|---|---|---|---|---|---|---|---|---|---|
| 00 + 525 | 15 | Y | | 24,25 | NA | Scattered native vegetation; no woody plants adjacent to edge of water | 24 | N | No woody plants adjacent to edge of water | 24 | NA | Y (small amount exposed along cair log and edge of remediation) | Y (60% exposed) | Erosion control fabric exposed near toe of bank | 24 | N | | 24,25,26 | Y | |

| <b>Description:</b><br><br>Station 00 + 525'<br><br>~15 degree bank angle;<br>no exposed roots or no at-risk trees; no scour observed; extensive bare erosion control fabric present with limited native vegetation. | | |
