**Re: 2018/2019 Constitution Park Bank Management Area - Leaf-off Maintenance Inspection  
Area of Concern 4, Former DuPont Waynesboro Plant  
Waynesboro, Virginia  
EPA ID# VAD003114832**

| Subject | 2018/2019 Constitution Park BMA - Leaf-off Maintenance Inspection<br>Former DuPont Waynesboro Site, Area of Concern 4 | |

Table 1  
Winter 2018/2019 Constitution Park BMA Leaf-off Maintenance Inspection  
Former DuPont Waynesboro Site, Area of Concern 4

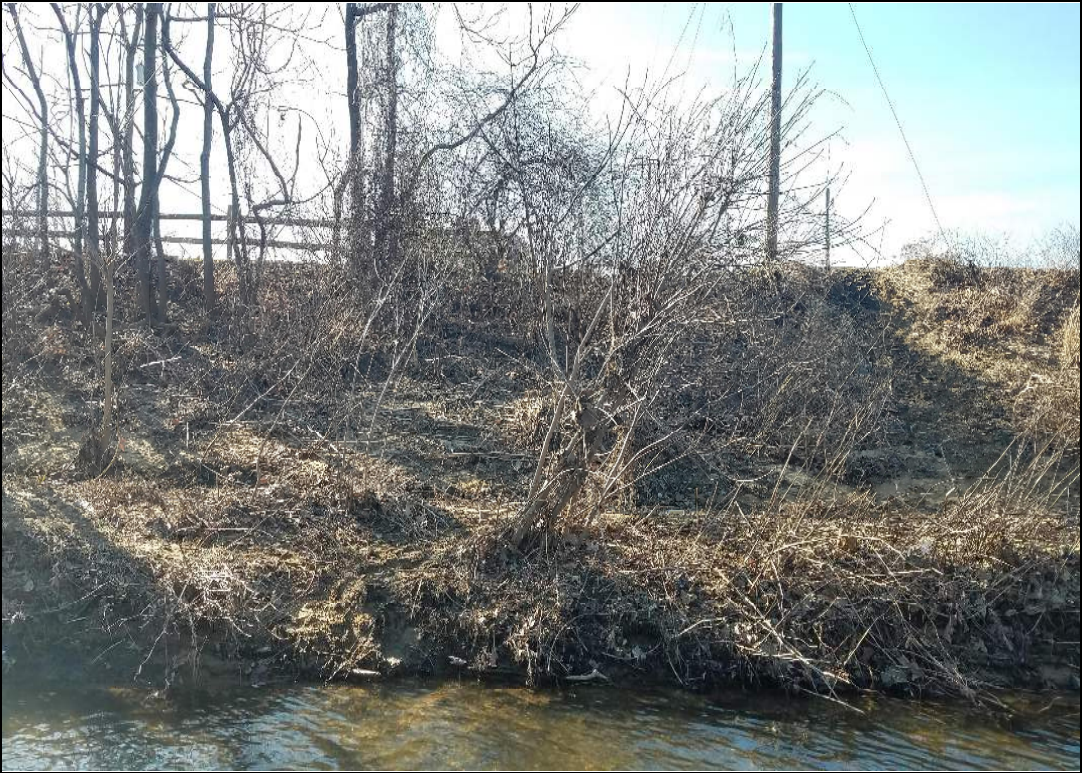
| <b>Photo No.</b><br>1 | <b>Date:</b><br>2/04/2019 | | |

| Station (ft) <sup>1</sup> | Undercutting | | | | Exposed Roots | | | At Risk Trees | | | Installed Stabilization Features Intact | | | | | | Local Scour | | | Overall Change Since Previous Inspection (Y/N) |
|---|---|---|---|---|---|---|---|---|---|---|---|---|---|---|---|---|---|---|---|---|
| 00 - 25 | 30 | N (see notes) | Lower bank; ~20 degrees<br>Upper bank; ~55 degrees | 1 | L | No woody plant sadjacent to edge of water | 1 | N | No woody plant sadjacent to edge of water | 1 | NA | NA | NA | | 1 | Y | Low presence of scour 5' upst ream of 00 - 25 | 1 | Y | |

| <b>Description:</b><br><br>Station 00 – 25'<br><br>~20 degree lower bank angle; ~55 degree upper bank angle; no at-risk trees present; both native and invasive vegetation present. | | | |

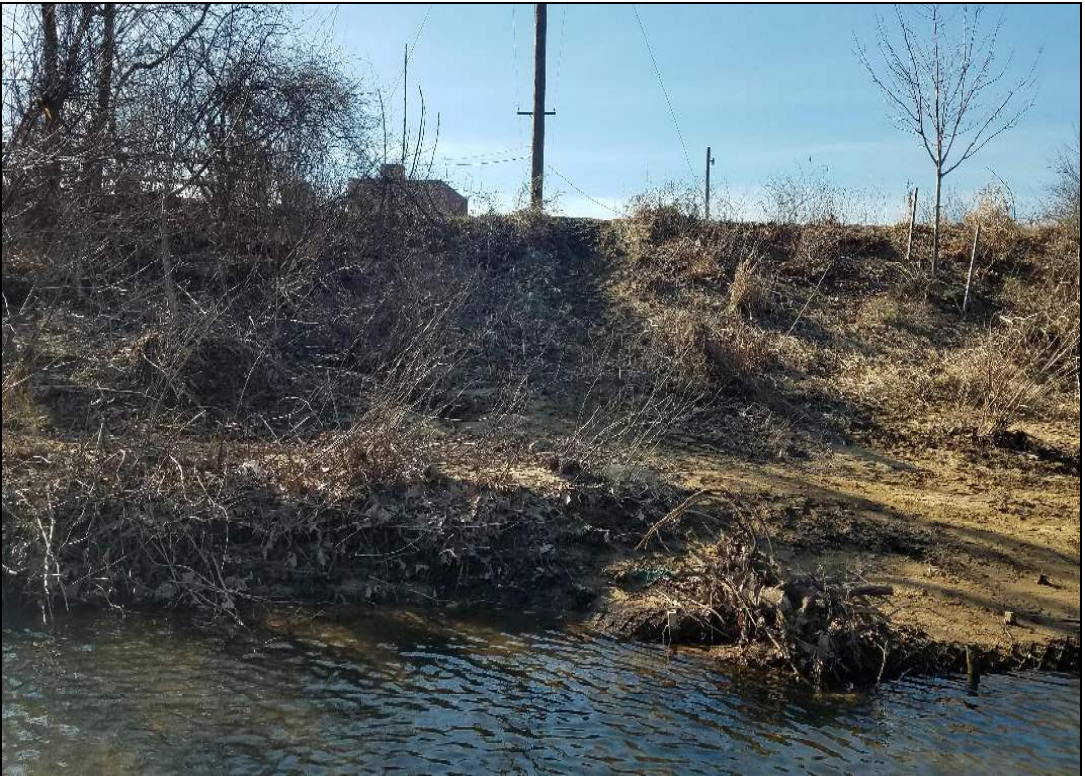
| <b>Photo No.</b><br>2 | <b>Date:</b><br>2/04/2019 | |

| Station (ft) <sup>1</sup> | Undercutting | | | | Exposed Roots | | | At Risk Trees | | | Installed Stabilization Features Intact | | | | | | Local Scour | | | Overall Change Since Previous Inspection (Y/N) |
|---|---|---|---|---|---|---|---|---|---|---|---|---|---|---|---|---|---|---|---|---|
| 00 + 00 | 40 | N (see notes) | Lower bank; ~30 degrees<br>Upper bank; ~55 degrees | 2 | NA | No woody plant sadjacent to edge of water; minimal vegetation present on bank | 2 | N | No woody plant sadjacent to edge of water | 2 | NA | Y | Y | Coir logs intact, some erosion control fabric is visible | 2 | N | Potential river access point observed; evidence of foot traffic along the toe of slope, along coir logs | 2 | Y | |

| <b>Description:</b><br><br>Station 00 + 00'<br><br>~20 degree lower bank angle; ~55 degree upper bank angle; patches of invasive and native vegetation present; coir logs intact; no scour present; evidence of heavy foot traffic at base of bank and along coir logs. | | |

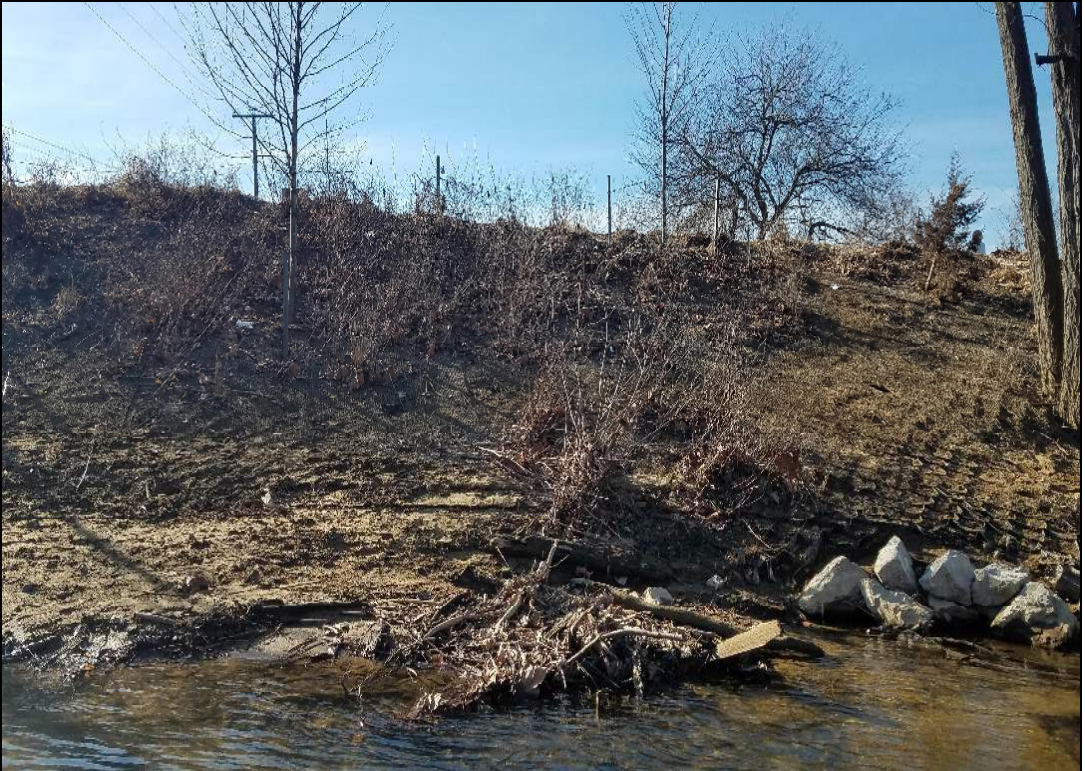
| Station (ft) <sup>1</sup> | Undercutting | | | | Exposed Roots | | | At Risk Trees | | | Installed Stabilization Features Intact | | | | | | Local Scour | | | Overall Change Since Previous Inspection (Y/N) |
|---|---|---|---|---|---|---|---|---|---|---|---|---|---|---|---|---|---|---|---|---|
| 00 + 50 | 45 | Y | | 3 | NA | No woody plant sadjacent to edge of water; 30-40% invasive species cover | 3 | N | No woody plant sadjacent to edge of water | 3 | NA | Y (exposed at tow of slope) | Y (exposed throughout) | Geocell intact, but beginning to be exposed near the toe of the slope | 3 | N | Evidence of foot traffic along the toe of slope | 3 | N | |

| <b>Description:</b><br><br>Station 00 + 50'<br><br>~45 degree consistent bank angle; no at-risk trees present; no exposed roots; coir logs intact; geocell intact and exposed near toe of slope; no scour present; evidence of foot traffic along toe of slope, along coir logs. | | | |

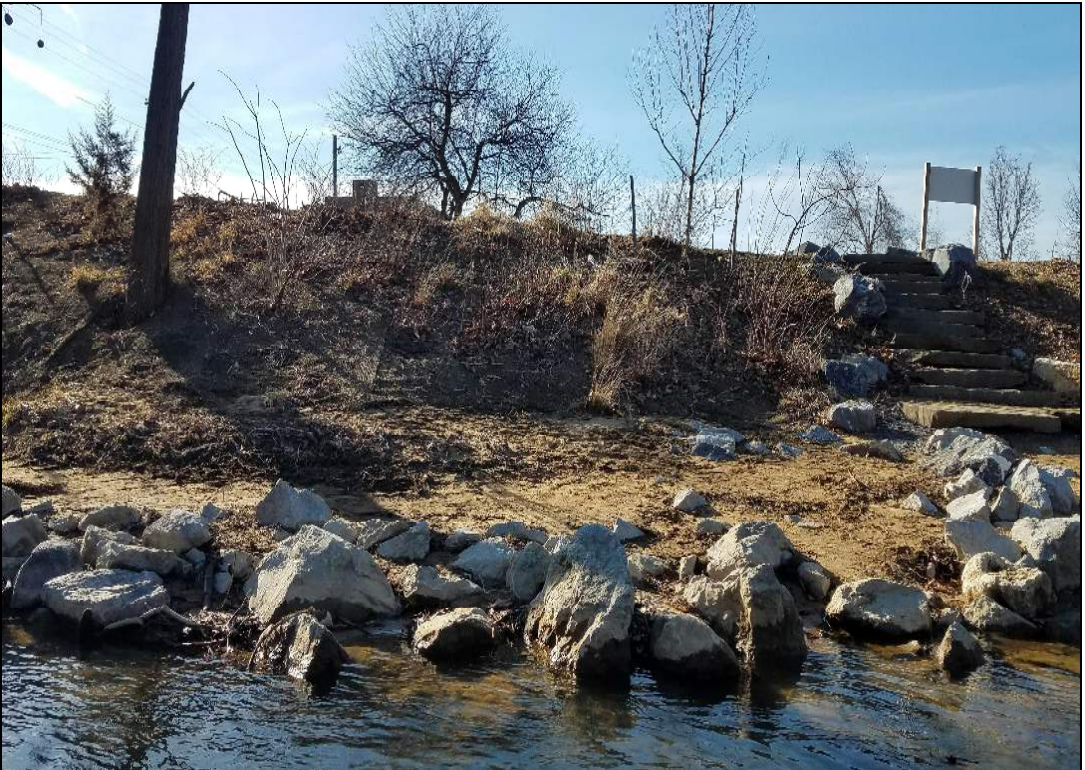
| Station (ft) <sup>1</sup> | Undercutting | | | | Exposed Roots | | | At Risk Trees | | | Installed Stabilization Features Intact | | | | | | Local Scour | | | Overall Change Since Previous Inspection (Y/N) |
|---|---|---|---|---|---|---|---|---|---|---|---|---|---|---|---|---|---|---|---|---|
| 00 + 100 | 40 | N (see notes) | Lower bank ~10 degrees (rock toe);<br>Upper bank ~45 degrees | 4 | NA | No woody plant sadjacent to edge of water | 4,5,6 | N | No at-risk trees present; no exposed roots | 4,5,6 | Y (rock toe) | Y | Y (exposed throughout) | Rock toe along bank and constructed river access steps intact | 4,5,6 | N | Sediment deposition adjacent to rock toe boulders | 4,5,6 | N | |

| <b>Description:</b><br><br>Station 00 + 100'<br><br>~40 degree bank angle; no at-risk trees present; patches of invasive and native vegetation present; no exposed roots; no scour present; installed rock toe intact with evidence of sediment deposition; installed river access steps intact. | | |

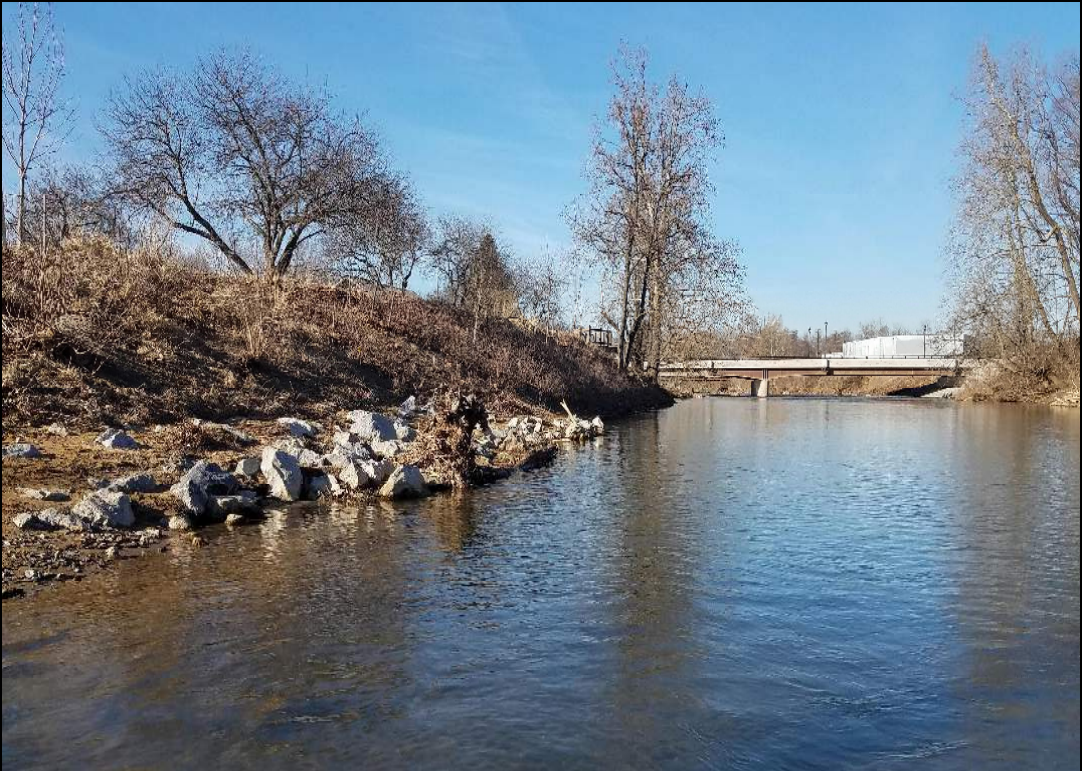
| <b>Photo No.</b><br>5 | <b>Date:</b><br>2/04/2019 | | |

| <b>Description:</b><br>Station 00 + 100'<br><br>Sediment deposition adjacent to rock toe boulders; invasive and native vegetation present. | | | |

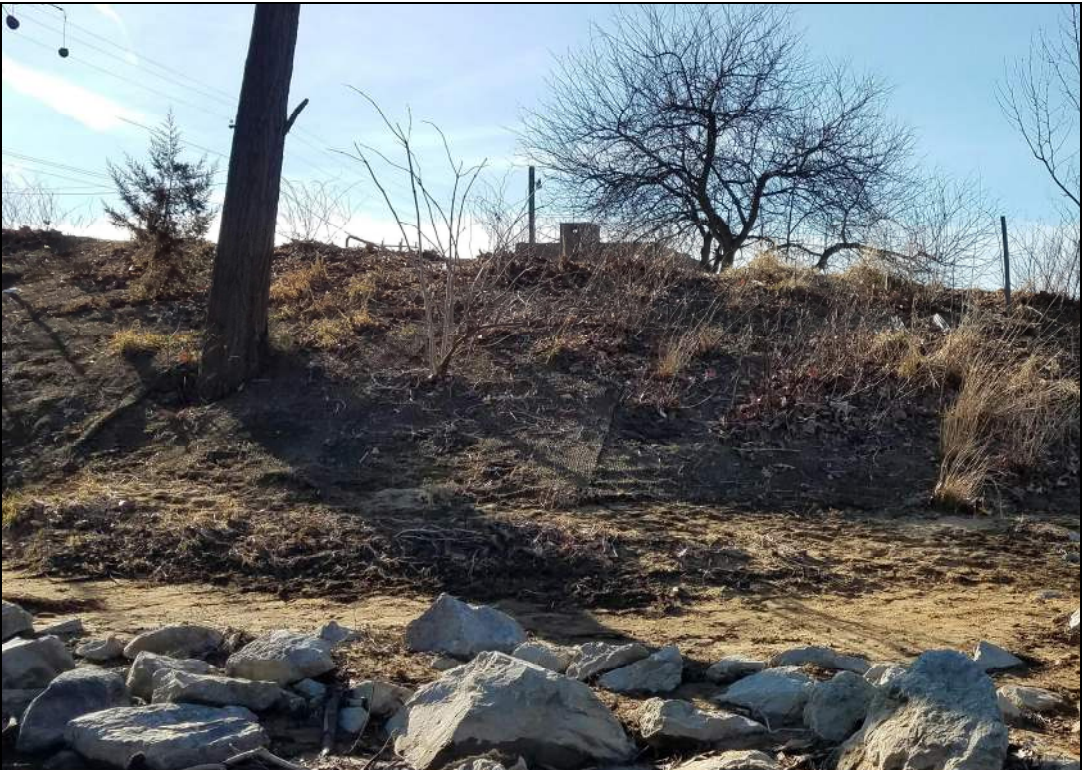
| <b>Photo No.</b><br>6 | <b>Date:</b><br>2/04/2019 | |

| <b>Description:</b><br>Station 00 + 100'<br><br>Sedimentation near rock toe boulders, foot traffic evident above rock toe line, erosion control fabric exposed along upper portion of bank. | | |

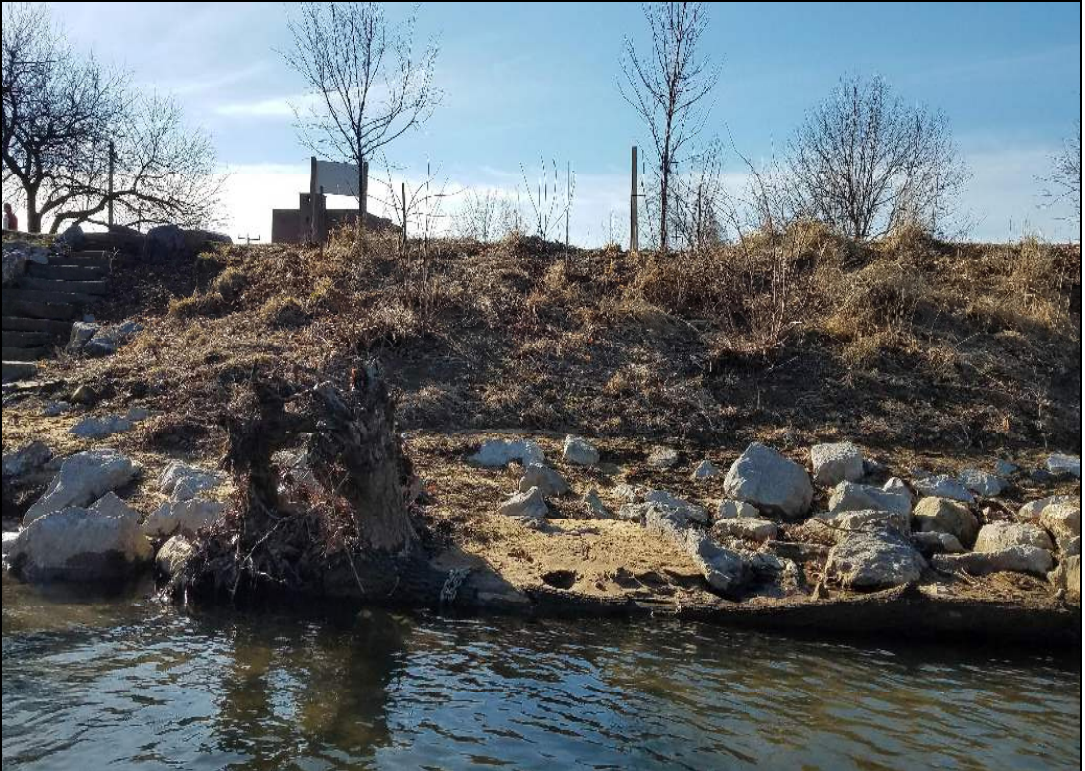
| Station (ft) <sup>1</sup> | Undercutting | | | | Exposed Roots | | | At Risk Trees | | | Installed Stabilization Features Intact | | | | | | Local Scour | | | Overall Change Since Previous Inspection (Y/N) |
|---|---|---|---|---|---|---|---|---|---|---|---|---|---|---|---|---|---|---|---|---|
| 00 + 150 | 45 | N (see notes) | Lower bank <5 degrees (rock toe);<br>Upper bank ~45 degrees | 7 | NA | Native vegetation predominantly present; no woody plant sadjacent to edge of water | 7,8,9 | N | No woody plant sadjacent to edge of water | 7,8,9 | Y (LWD and Rock toe) | Y | Y | Installed geocell and erosion control fabric intact | 7,8,9 | N | Silt filling in behind LWD and in boulders | 7,8,9 | N | |

| <b>Description:</b><br><br>Station 00 + 150'<br><br>~45 degree bank angle; no at-risk trees present; no exposed roots; no scour present; installed rock toe and large woody debris (LWD) intact; installed geocell and erosion control fabric intact; evidence of sediment deposition. | | | |

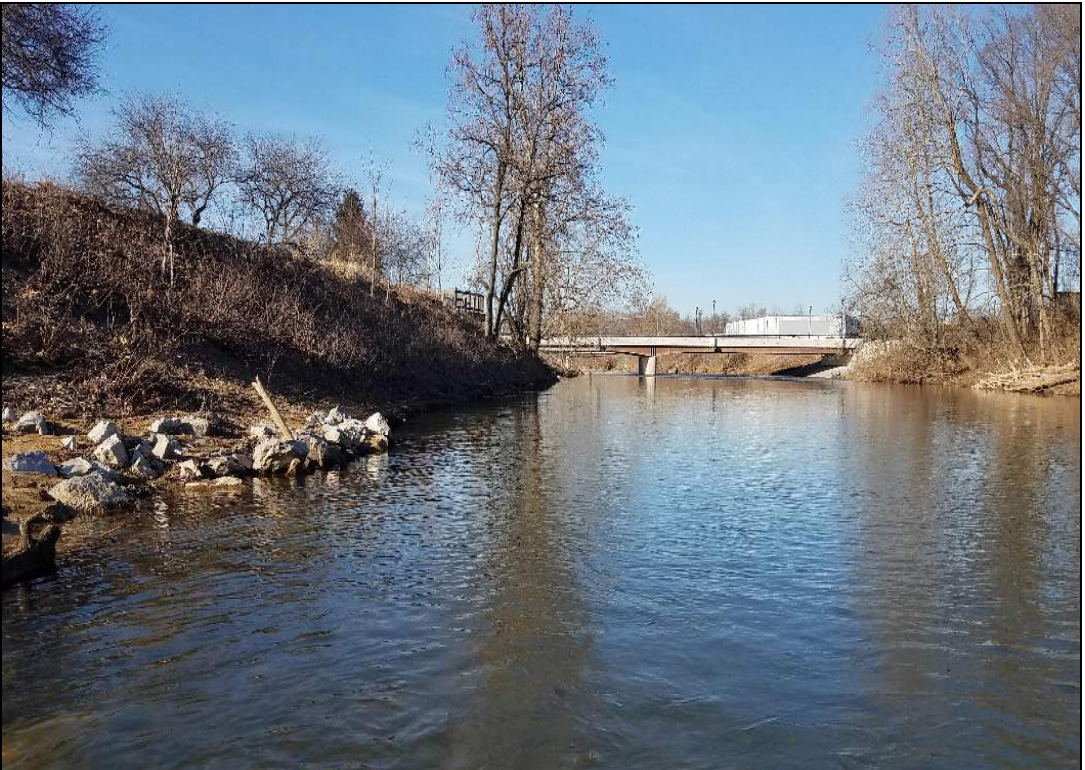
| <b>Photo No.</b><br>8 | <b>Date:</b><br>2/04/2019 | |

| <b>Description:</b><br><br>Station 00 + 150'<br><br>Installed rock toe intact with evidence of sediment deposition; patches of the invasive Japanese knotweed present. | | |

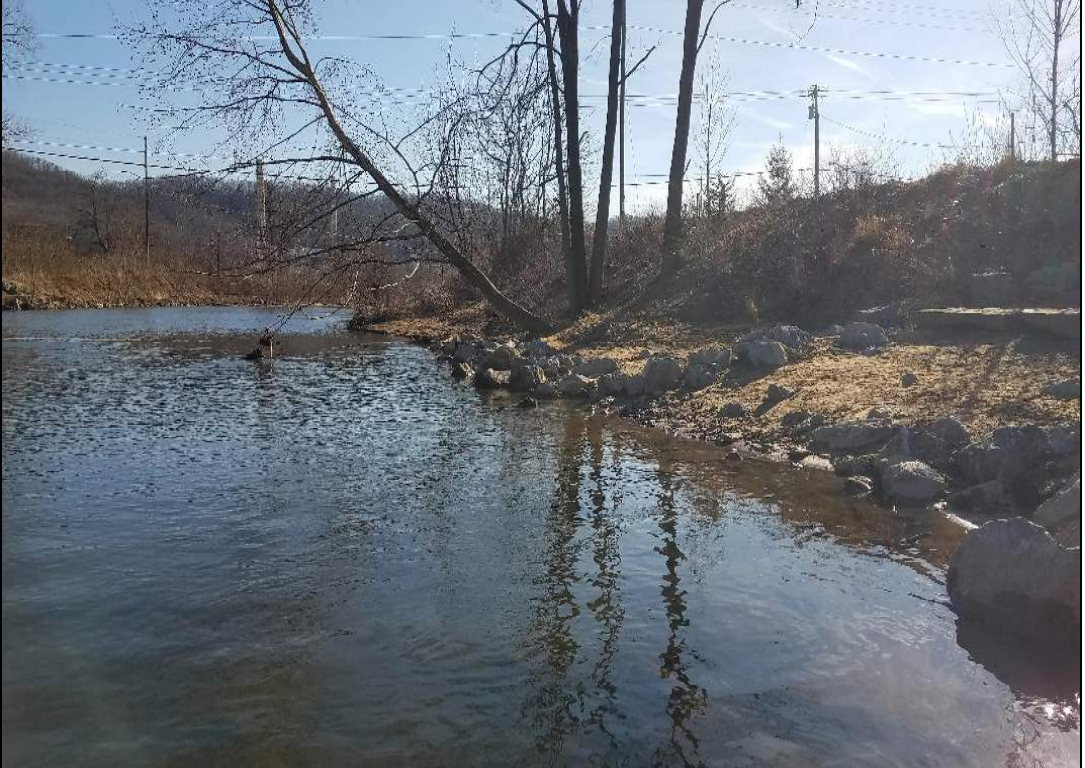
| <b>Photo No.</b><br>9 | <b>Date:</b><br>2/04/2019 | | |

| <b>Description:</b><br><br>Station 00 + 150'<br><br>Installed rock toe and LWD intact with evidence of sediment deposition. | | | |

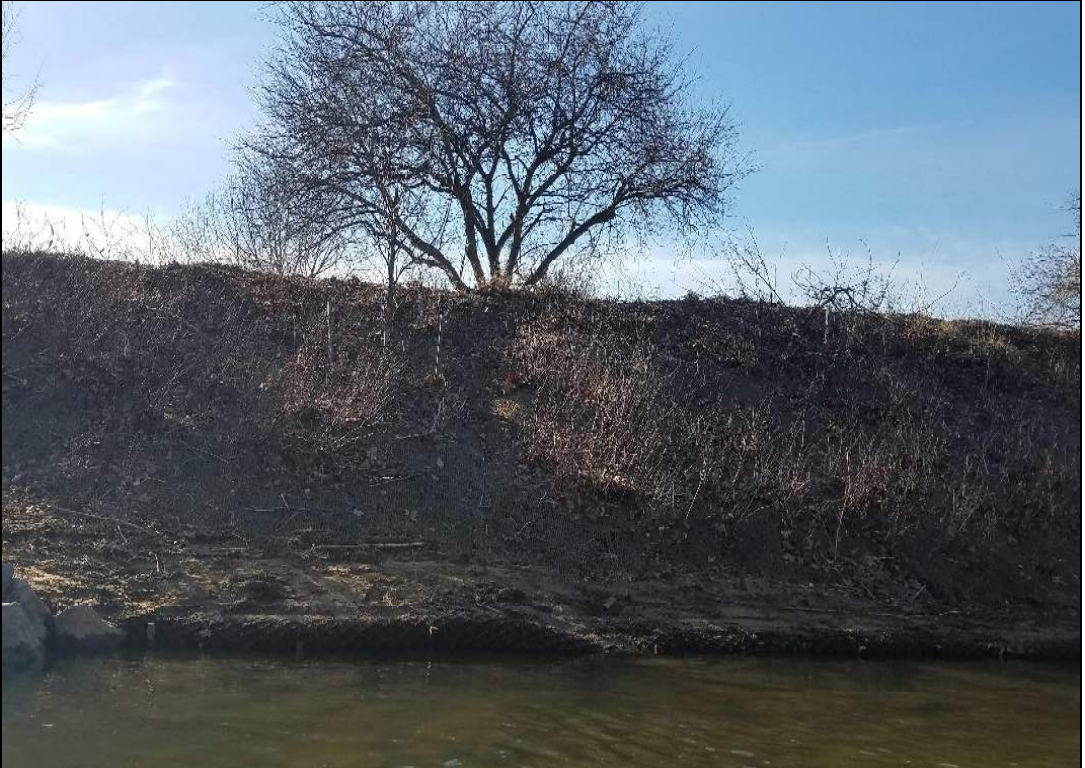
| Station (ft) <sup>1</sup> | Undercutting | | | | Exposed Roots | | | At Risk Trees | | | Installed Stabilization Features Intact | | | | | | Local Scour | | | Overall Change Since Previous Inspection (Y/N) |
|---|---|---|---|---|---|---|---|---|---|---|---|---|---|---|---|---|---|---|---|---|
| 00 + 200 | 55 | Y | | 10 | NA | Patches of invasive vegetation present; no woody plant sadjacent to edge of water | 10 | N | No woody plant sadjacent to edge of water | 10 | NA | Y | Y (exposed throughout) | Installed coir logs, geocell and erosion fabric intact | 10 | N | Evidence of foot traffic along the toe of slope, along coir logs | 10 | N | |

| <b>Description:</b><br><br>Station 00 + 200'<br><br>~55 degree consistent bank angle; patches of invasive vegetation present; no exposed roots; no scour present; exposed erosion control fabric; foot path present along coir logs; installed coir logs, geocell, and erosion fabric intact. | | |

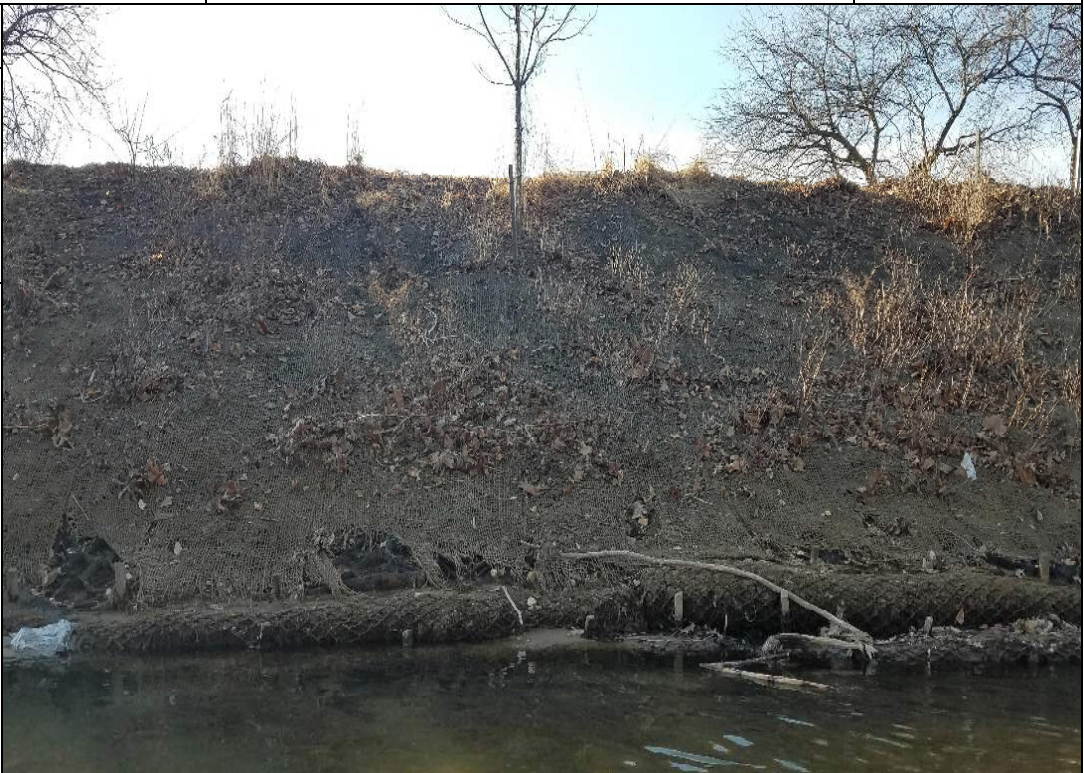
| Station (ft) <sup>1</sup> | Undercutting | | | | Exposed Roots | | | At Risk Trees | | | Installed Stabilization Features Intact | | | | | | Local Scour | | | Overall Change Since Previous Inspection (Y/N) |
|---|---|---|---|---|---|---|---|---|---|---|---|---|---|---|---|---|---|---|---|---|
| 00 + 250 | 55 | Y | | 11 | NA | Patches of invasive vegetation present; no woody plant sadjacent to edge of water | 11 | N | No woody plant sadjacent to edge of water | 11 | NA | Y (geocell exposed at toe) | Y (exposed throughout) | Geocell intact; erosion control fabric exposed throughout; fabric torn at toe near exposed geocell | 11,12 | Y | Small patches of scour present around exposed geocell. | 11,12 | Y | |

| <b>Description:</b><br><br>Station 00 + 250'<br><br>~55 degree consistent bank angle; no exposed roots; patches of invasive vegetation present; installed coir logs and geocell intact; geocell exposed at toe of slope; erosion control fabric exposed throughout with small torn patches at the bottom of the bank. | | |

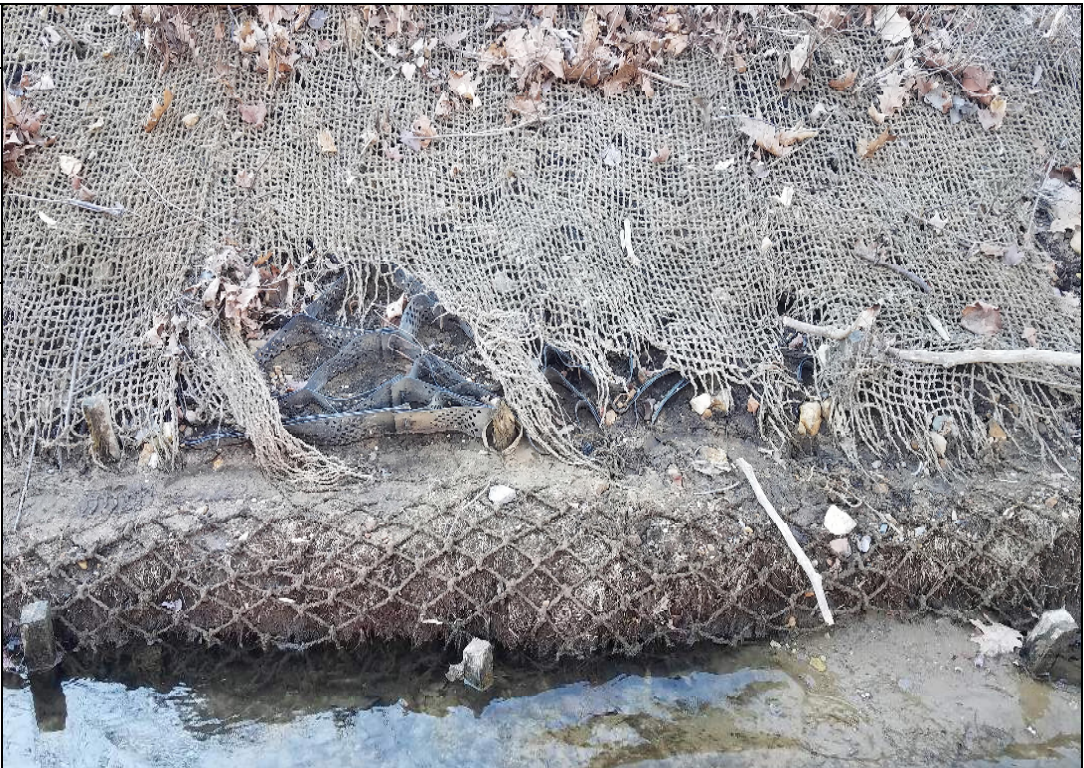
| <b>Photo No.</b><br>12 | <b>Date:</b><br>2/04/2019 | |

| <b>Description:</b><br><br>Station 00 + 250'<br><br>Evidence of foot traffic along coir logs; erosion control fabric torn at toe of slope where geocell is exposed. Small patches of scour present around exposed geocell. | | |

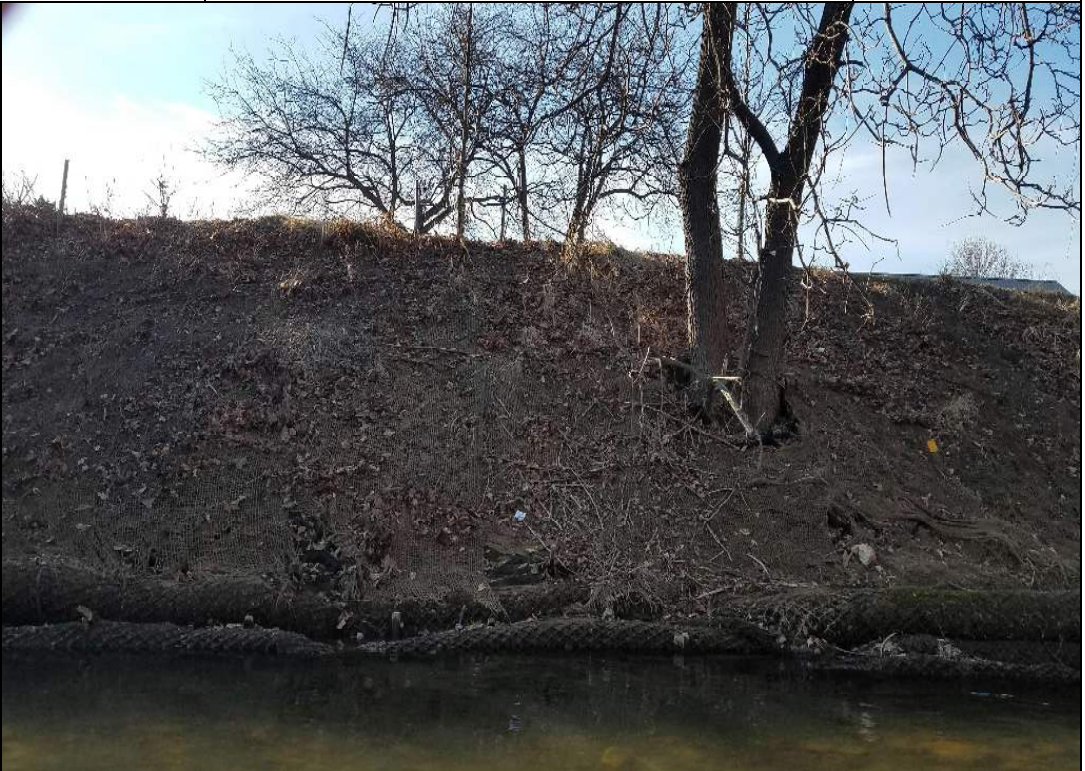
| Station (ft) <sup>1</sup> | Undercutting | | | | Exposed Roots | | | At Risk Trees | | | Installed Stabilization Features Intact | | | | | | Local Scour | | | Overall Change Since Previous Inspection (Y/N) |
|---|---|---|---|---|---|---|---|---|---|---|---|---|---|---|---|---|---|---|---|---|
| 00 + 300 | 70 | Y | | 13 | NA | Minimal vegetation present; no woody plant sadjacent to edge of water | 13 | N | No exposed roots; no at-risk trees | 13 | NA | Y (geocell exposed at toe) | Y (exposed throughout) | Erosion control fabric exposed; geocell and installed coir logs intact. | 13 | N | | 13 | Y | |

| <b>Description:</b><br><br>Station 00 + 300'<br><br>~70 degree consistent bank angle; no exposed roots; no at-risk trees; no scour present; minimal vegetation present; erosion control fabric exposed throughout; geocell and installed coir logs intact; geocell exposed near toe of slope. | | | |

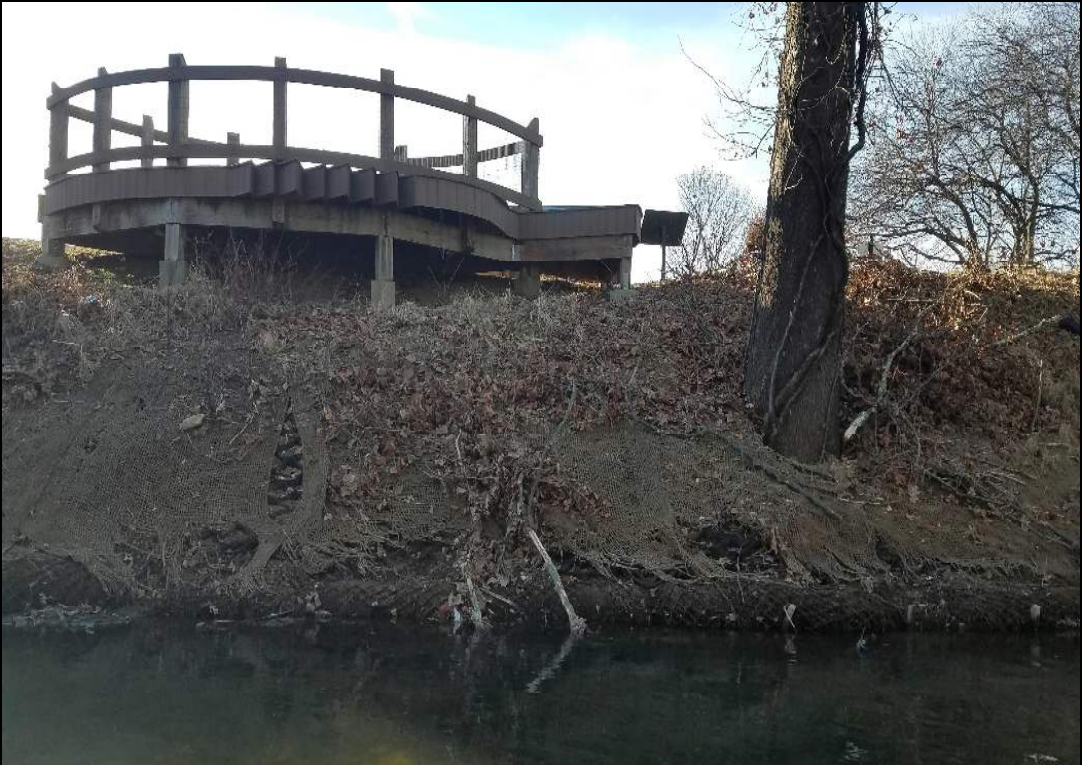
| Station (ft) <sup>1</sup> | Undercutting | | | | Exposed Roots | | | At Risk Trees | | | Installed Stabilization Features Intact | | | | | | Local Scour | | | Overall Change Since Previous Inspection (Y/N) |
|---|---|---|---|---|---|---|---|---|---|---|---|---|---|---|---|---|---|---|---|---|
| 00 + 350 | 70 | Y | | 14 | NA | Native vegetation present along top of bank with small patches of the invasive knotweed plant present | 14 | N | No woody plant sadjacent to edge of water | 14 | NA | Y (some geocell exposed below observation platform) | Y (exposed throughout) | Coir log 5' downst ream slightly loose and appears to have shifted; fabric torn at toe | 14,15,16 | Y | Installed coir logs intact; minimal scour at toe of slope | 14,15,16 | Y | |

| <b>Description:</b><br><br>Station 00 + 350'<br><br>~70 degree consistent bank angle; no exposed roots; no at-risk trees; vegetation present along top of bank; geocell and installed coir logs intact; erosion control fabric exposed throughout and torn near exposed geocell at toe of slope. | | |

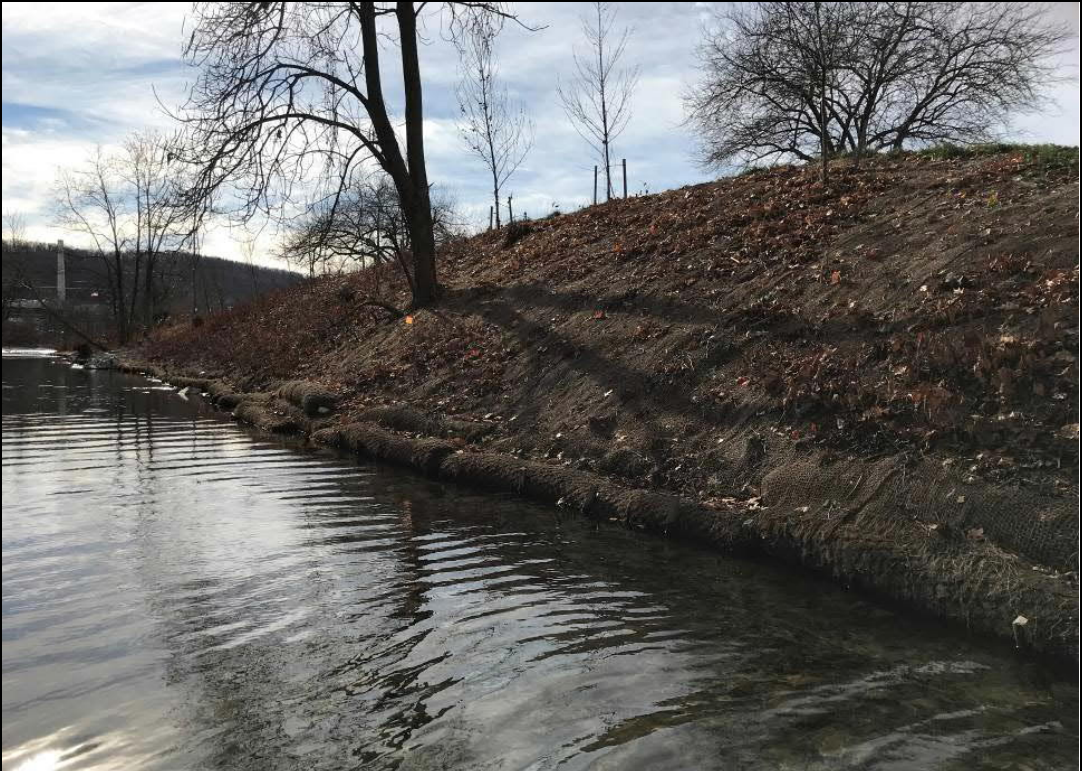
| <b>Photo No.</b><br>15 | <b>Date:</b><br>2/04/2019 | | |

| <b>Description:</b><br><br>Station 00 + 350'<br><br>Installed erosion control fabric exposed throughout; installed coir logs intact; minimal scour at toe upstream of 00 + 350'. | | | |

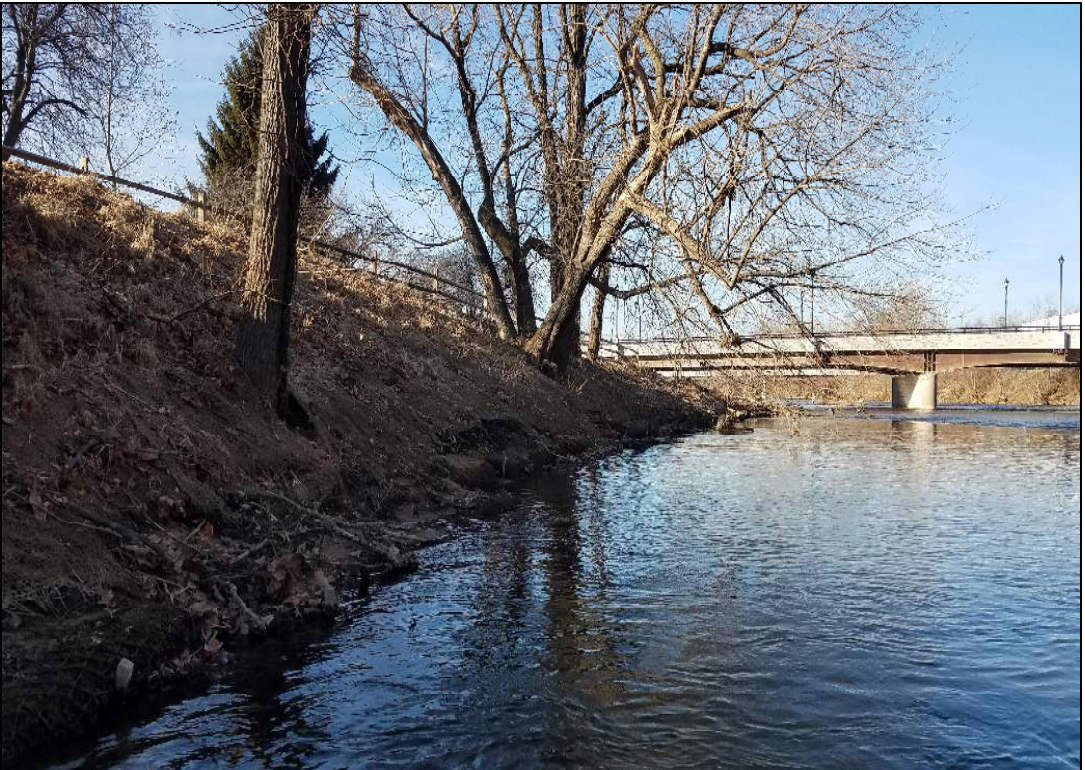
| <b>Photo No.</b><br>16 | <b>Date:</b><br>2/04/2019 | |

| <b>Description:</b><br><br>Station 00 + 350'<br><br>Installed erosion control fabric exposed along toe of slope; installed coir logs intact, but showing signs of wear and potential for scour. | | |

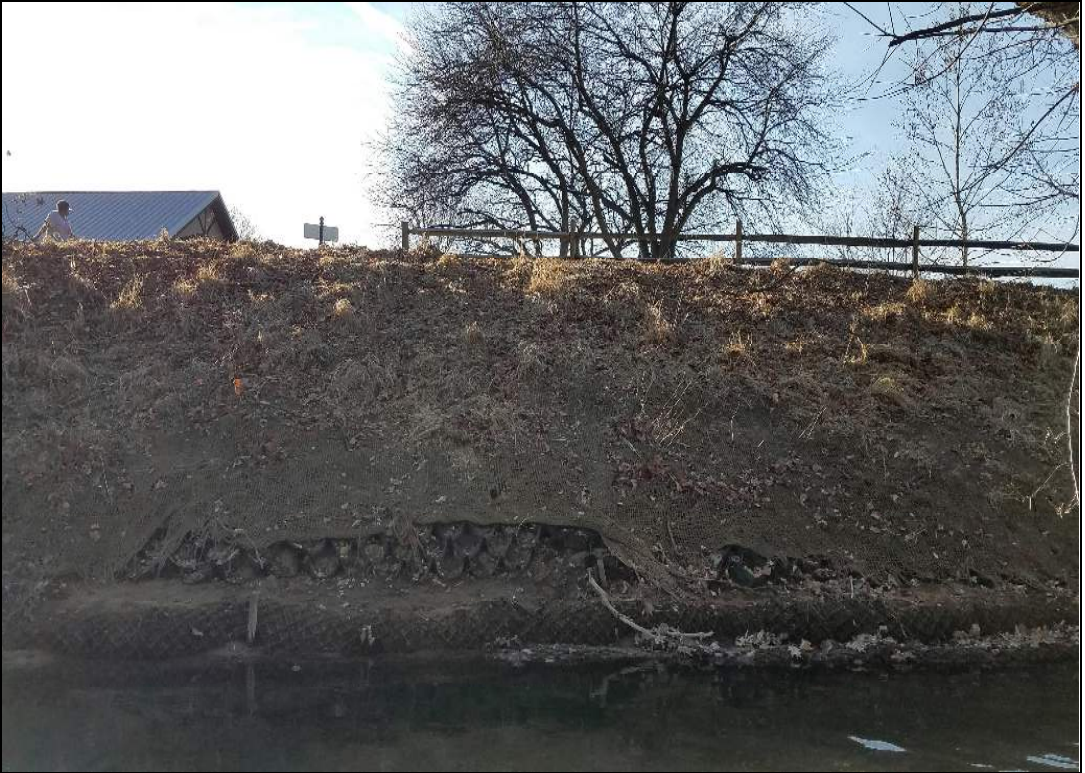
| Station (ft) <sup>1</sup> | Undercutting | | | | Exposed Roots | | | At Risk Trees | | | Installed Stabilization Features Intact | | | | | | Local Scour | | | Overall Change Since Previous Inspection (Y/N) |
|---|---|---|---|---|---|---|---|---|---|---|---|---|---|---|---|---|---|---|---|---|
| 00 + 400 | 60 | Y | | 17,18,19 | NA | Predominantly native vegetation present; no woody plant sadjacent to edge of water | 17,18,19 | N | No exposed roots; no at-risk trees | 17,18,19 | NA | Y (exposed upst ream around black walnut and at toe of slope) | Y (60% exposed) | Limited geocell exposed around base of black walnut tree; erosion control fabric exposed throughout, particularly near bottom of bank; coir log may have shifted; tear in fabric along toe near exposed geocell | 17,18,19 | Y | Scour present along toe | 17,18,19 | Y | |

| <b>Description:</b><br><br>Station 00 + 400'<br><br>~60 degree consistent bank angle; vegetation present at top of bank; no exposed roots; no at-risk trees; erosion control fabric exposed throughout and torn at toe of slope where geocell is exposed; some scour present along toe of slope near exposed geocell. | | | |

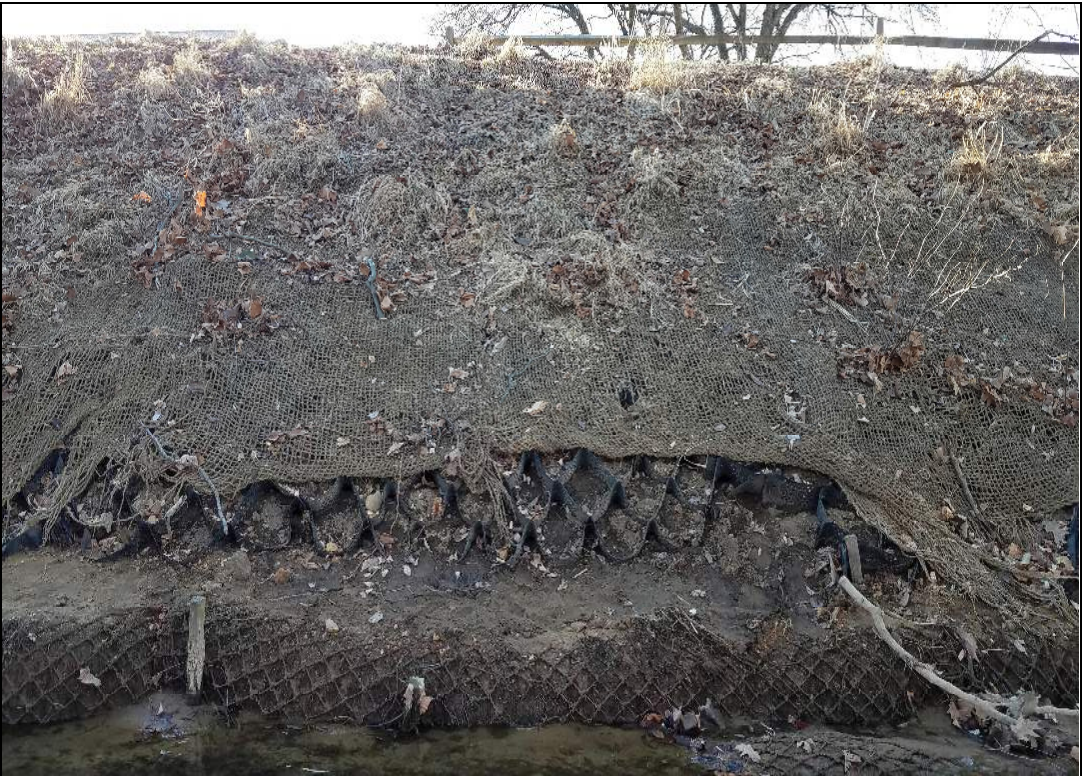
| <b>Photo No.</b><br>18 | <b>Date:</b><br>2/04/2019 | |

| <b>Description:</b><br><br>Station 00 + 400'<br><br>Erosion control fabric exposed and torn near bottom of bank; geocell exposed; some scour present at toe of slope around exposed geocell; evidence of foot traffic along toe of slope; installed coir logs intact. | | |

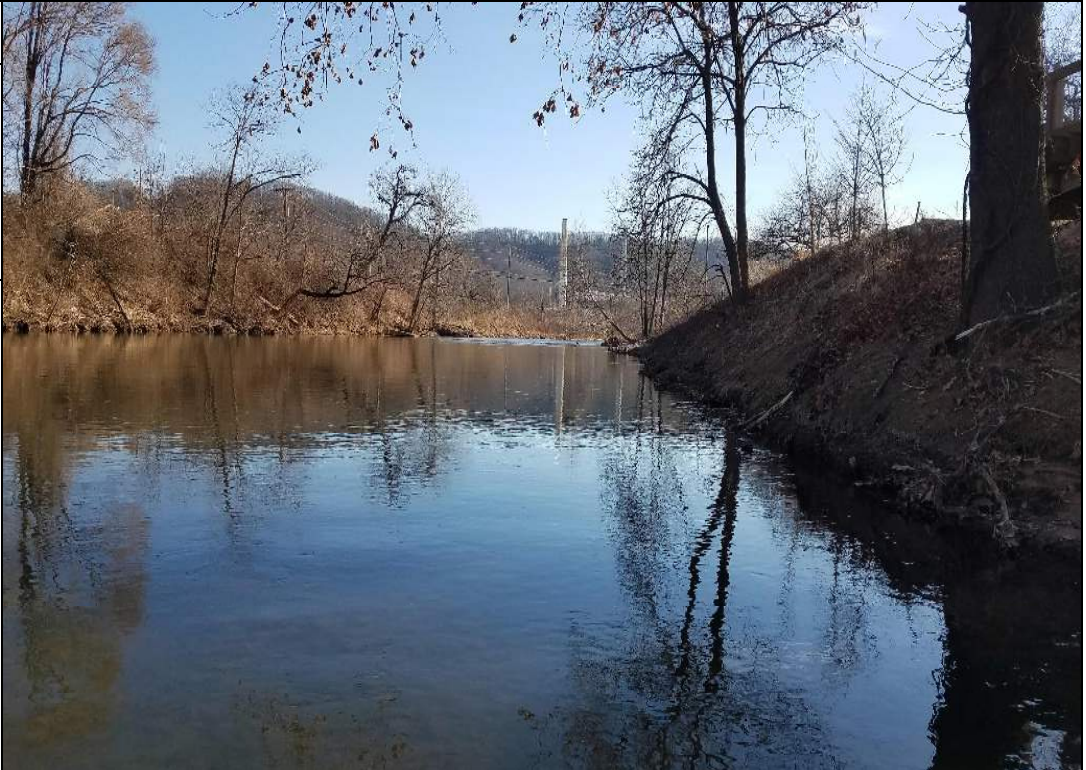
| <b>Description:</b><br><br>Station 00 + 400'<br><br>Installed coir logs intact; limited geocell exposed around base of black walnut tree; erosion control fabric exposed near bottom of bank; some scour present upstream of 00+ 400' at toe of slope. | | | |

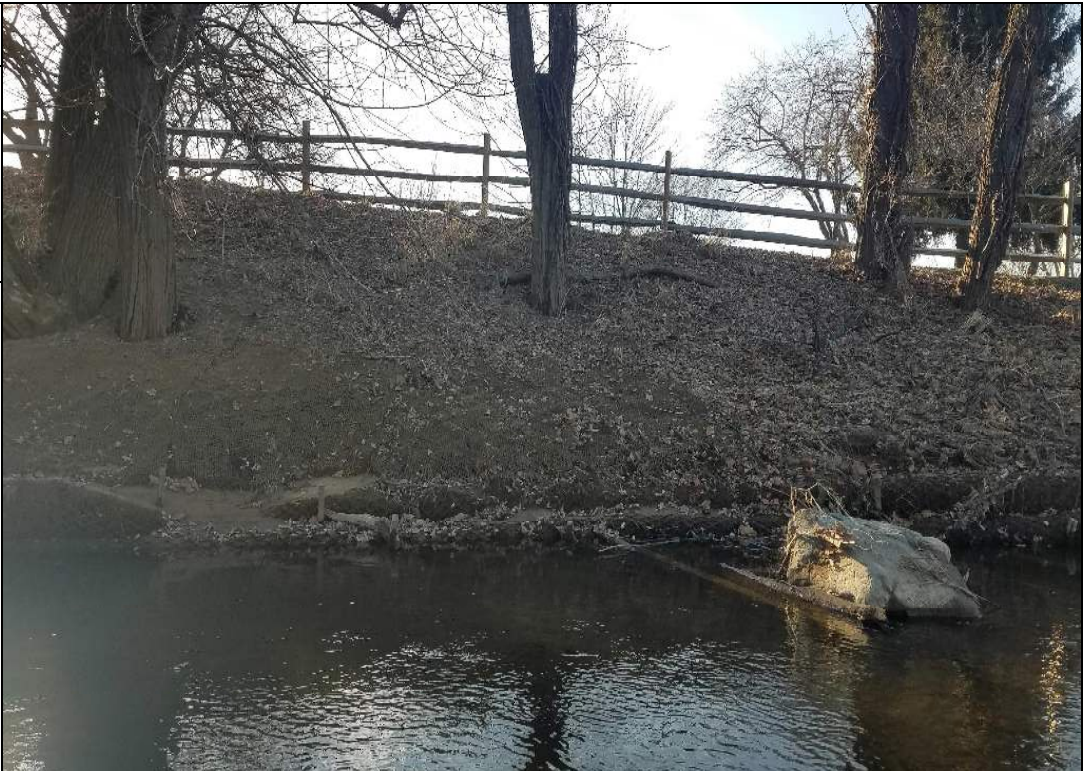
| <b>Photo No.</b><br>20 | <b>Date:</b><br>2/04/2019 | |

| Station (ft) <sup>1</sup> | Undercutting | | | | Exposed Roots | | | At Risk Trees | | | Installed Stabilization Features Intact | | | | | | Local Scour | | | Overall Change Since Previous Inspection (Y/N) |
|---|---|---|---|---|---|---|---|---|---|---|---|---|---|---|---|---|---|---|---|---|
| 00 + 450 | 50 | Y | | 20 | NA | Patches of native and invasive vegetation present; no woody plant sadjacent to edge of water | 20 | N | No exposed roots; no at-risk trees | 20 | NA | Y | Y (exposed throughout) | Erosion control fabric exposed throughout | 20 | Y | Minimal scour present near coir log | 20 | Y | |

| <b>Description:</b><br><br>Station 00 + 450'<br><br>~50 degree consistent bank angle; no exposed roots; no at-risk trees; some scour present along toe of slope; established herbaceous vegetation at top of bank; erosion control fabric exposed throughout. | | |

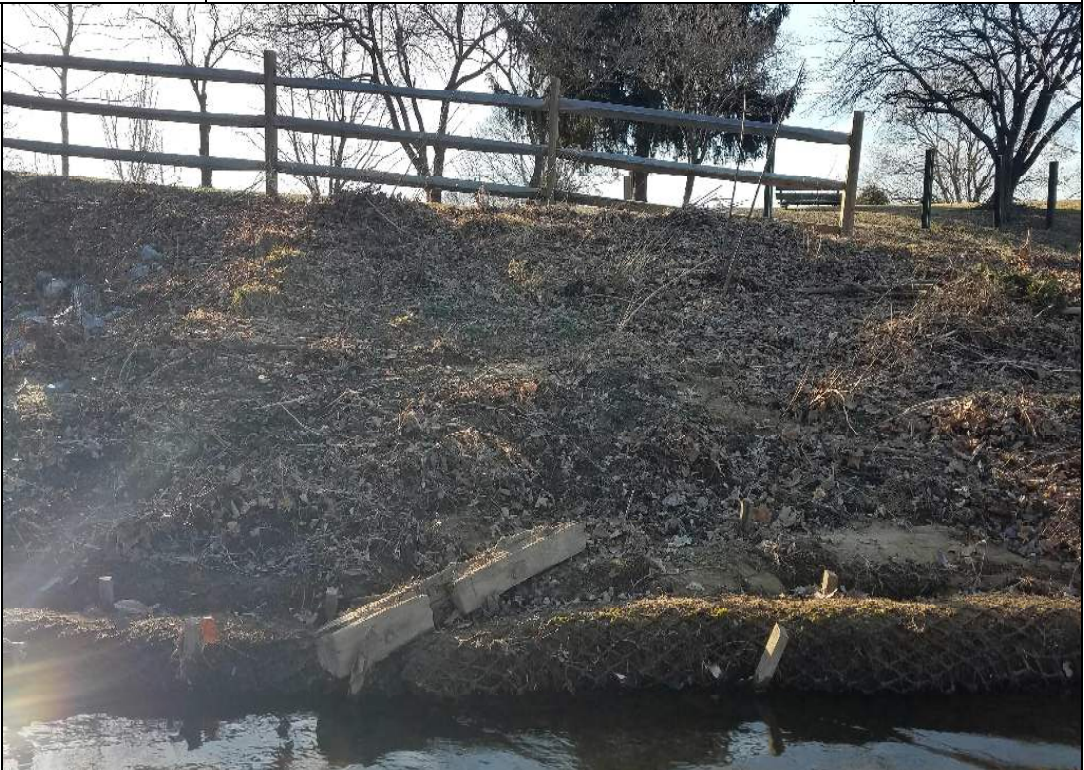
| <b>Photo No.</b><br>21 | <b>Date:</b><br>2/04/2019 | | |

| Station (ft) <sup>1</sup> | Undercutting | | | | Exposed Roots | | | At Risk Trees | | | Installed Stabilization Features Intact | | | | | | Local Scour | | | Overall Change Since Previous Inspection (Y/N) |
|---|---|---|---|---|---|---|---|---|---|---|---|---|---|---|---|---|---|---|---|---|
| 00 + 500 | 40 | Y | Decreased vertical bank height (~6') | 21 | NA | Native vegetation predominantly present; no woody plant sadjacent to edge of water | 21 | N | No woody plant sadjacent to edge of water | 21 | NA | Y | Y (30% exposed) | Erosion fabric exposed near toe of bank | 21 | N | | 21 | Y | |

| <b>Description:</b><br><br>Station 00 + 500'<br><br>~40 degree consistent bank angle; no exposed roots; no at-risk trees; no scour present; native and invasive plants present; erosion fabric exposed near toe of bank. | | | |

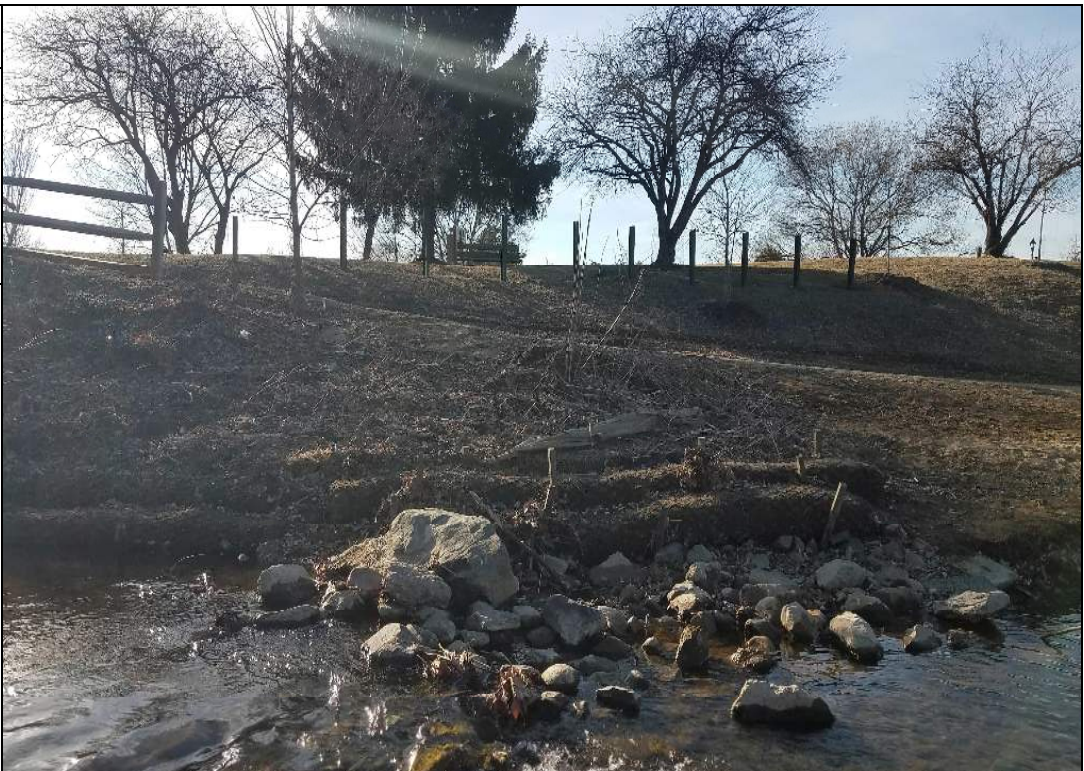
| <b>Photo No.</b><br>22 | <b>Date:</b><br>2/04/2019 | |

| Station (ft) <sup>1</sup> | Undercutting | | | | Exposed Roots | | | At Risk Trees | | | Installed Stabilization Features Intact | | | | | | Local Scour | | | Overall Change Since Previous Inspection (Y/N) |
|---|---|---|---|---|---|---|---|---|---|---|---|---|---|---|---|---|---|---|---|---|
| 00 + 525 | 15 | Y | | 22,23,24 | NA | Scattered native vegetation; no woody plant sadjacent to edge of water | 22,23,24 | N | No woody plant sadjacent to edge of water | 22,23,24 | NA | Y (small amount exposed along coir log and edge of remediation) | Y (60% exposed) | Erosion control fabric exposed near toe of bank | 22,23,24 | N | | 22,23,24 | Y | |

| <b>Description:</b><br><br>Station 00 + 525'<br><br>~15 degree consistent bank angle; no exposed roots; no at-risk trees; no scour present; majority of erosion control fabric exposed with scattered vegetation. | | |
