**Re: 2018/2019 Constitution Park Bank Management Area - Leaf-off Maintenance Inspection  
Area of Concern 4, Former DuPont Waynesboro Plant  
Waynesboro, Virginia  
EPA ID# VAD003114832**

| Subject | 2018/2019 Constitution Park BMA - Leaf-off Maintenance Inspection<br>Former DuPont Waynesboro Site, Area of Concern 4 | |

Table 1  
Winter 2018/2019 Constitution Park BMA Leaf-off Maintenance Inspection  
Former DuPont Waynesboro Site, Area of Concern 4

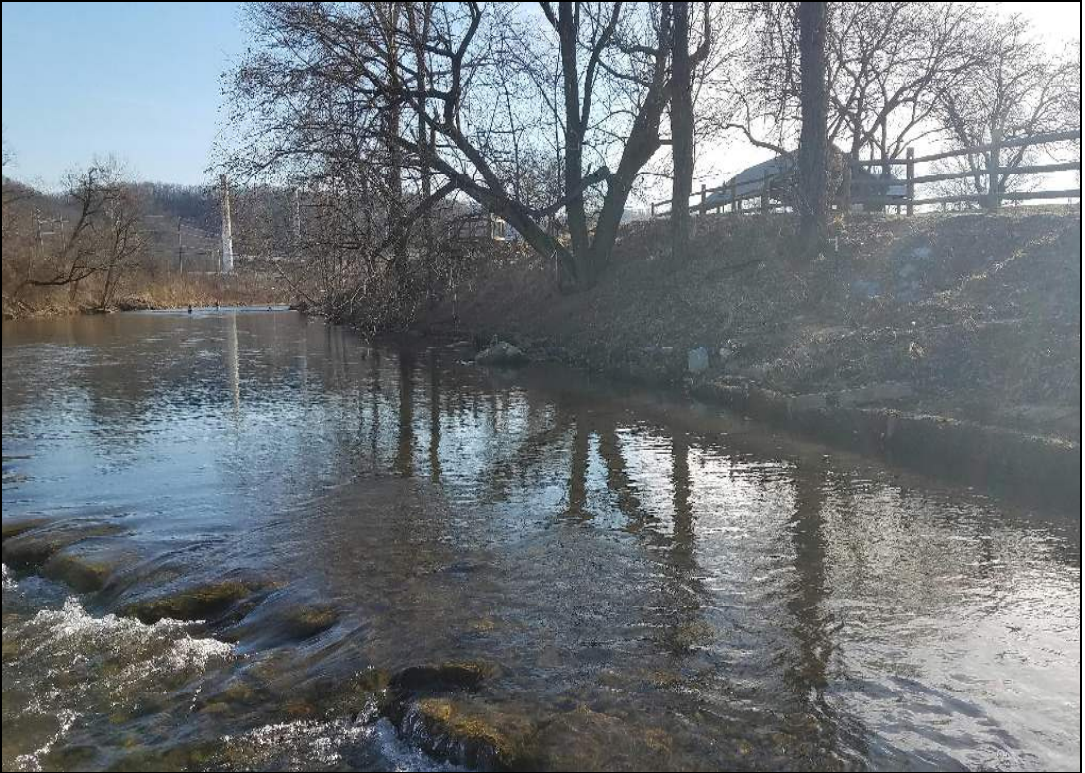
| <b>Photo No.</b><br>23 | <b>Date:</b><br>2/04/2019 | | |

| <b>Description:</b><br><br>Station 00 + 525'<br><br>No exposed roots; no at-risk trees; no scour present; limited areas of invasive vegetation present. | | | |

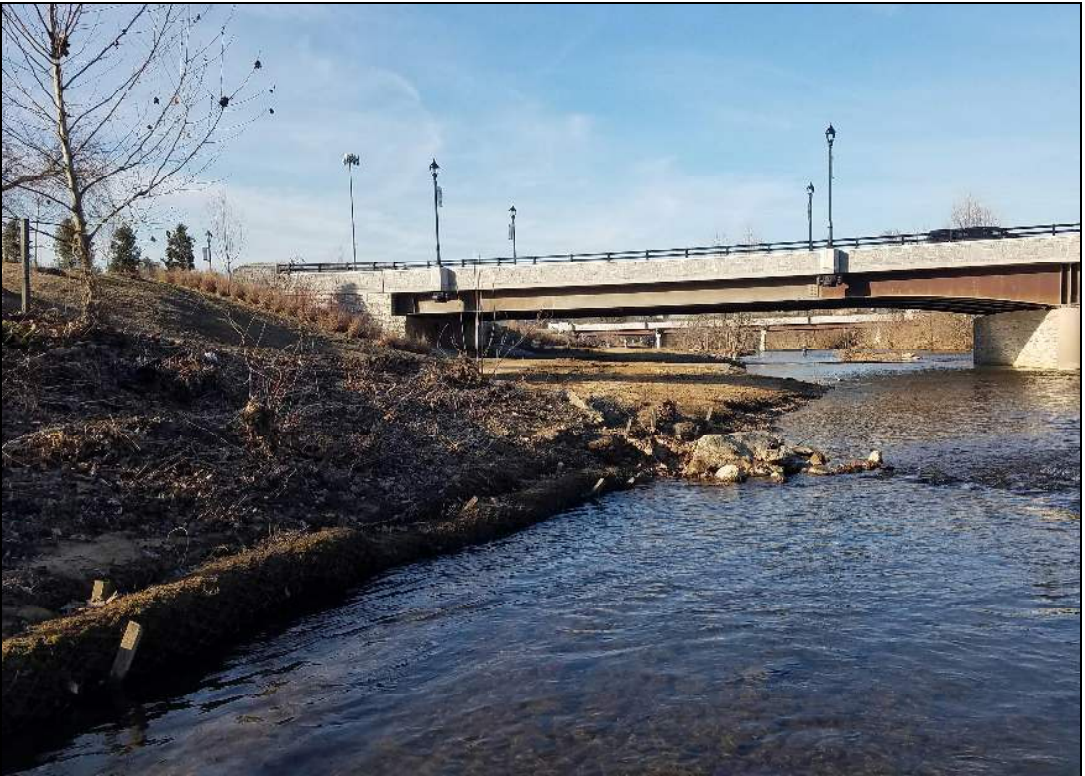
| <b>Photo No.</b><br>24 | <b>Date:</b><br>2/04/2019 | |

| <b>Description:</b><br><br>Station 00 + 525'<br><br>No exposed roots; no at-risk trees; no scour present; majority of erosion control fabric exposed and not vegetated. | | |
