# Corrective Action Program Review Waynesboro Invista Plant

July 15, 2008

# Sewer Investigation

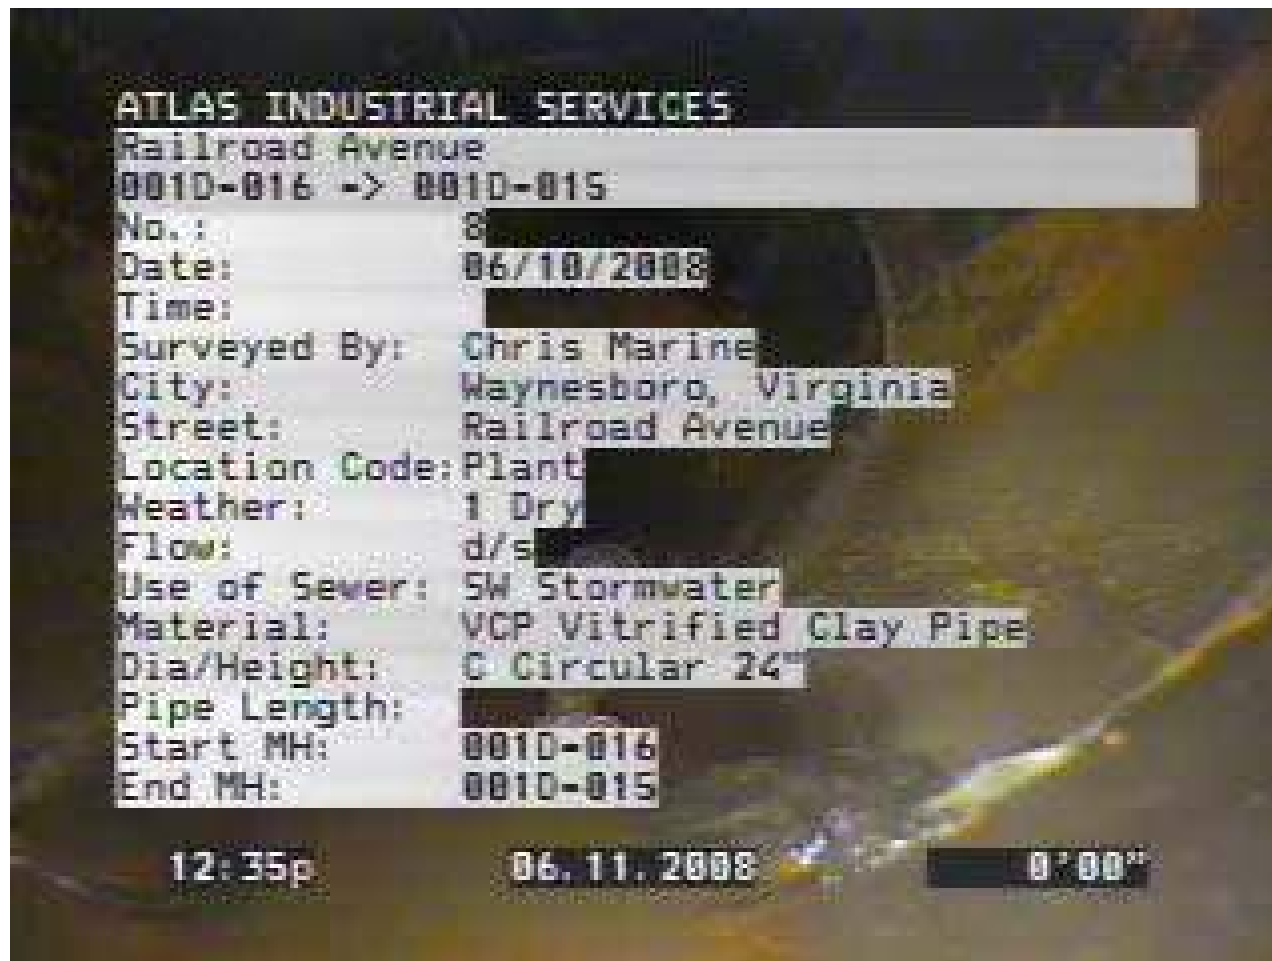
This video is from MH 001D-016 to MH 001D-015 along Railroad Ave

The camera was stopped at 8 feet due to debris but this line was successfully revisited using the larger tractor from the other direction.

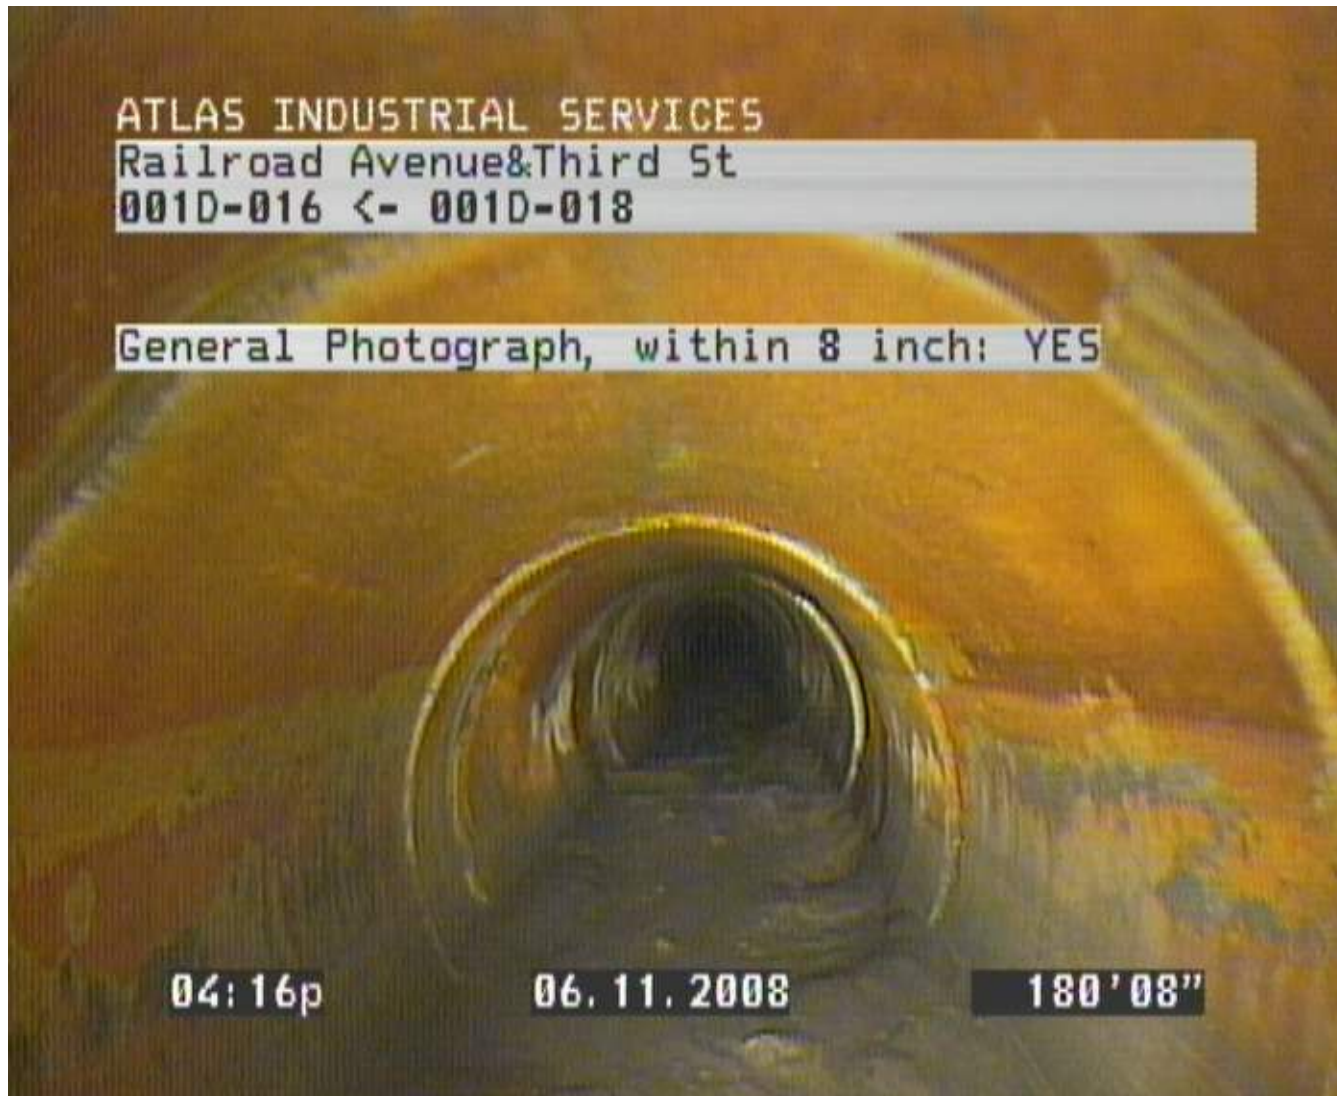
An example of sediment accumulation in the bottom of the pipe.
