Geomorphology Update

Jim Pizzuto, Geological Sciences
Michael O'Neal, Geography
and graduate students...
University of Delaware

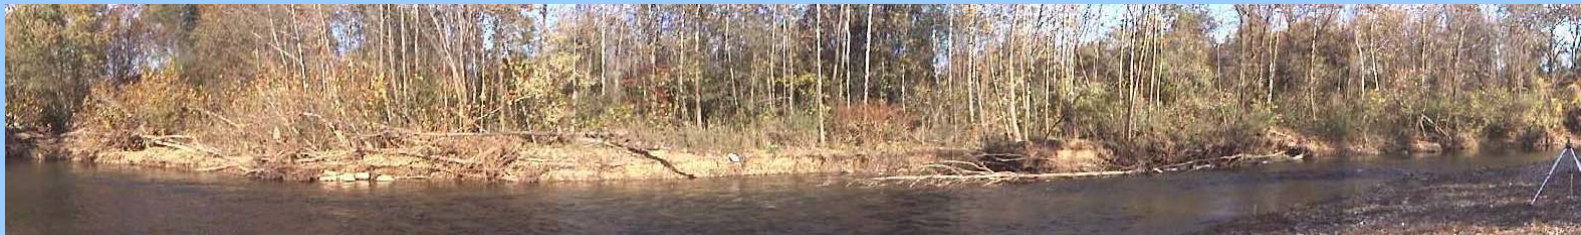
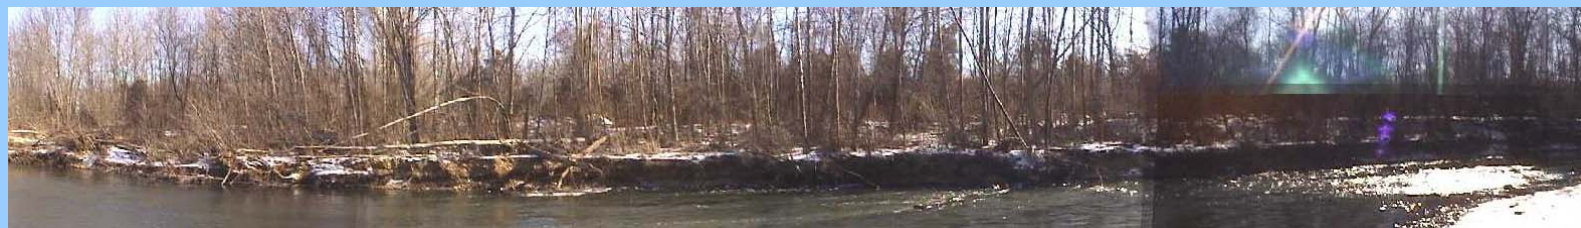
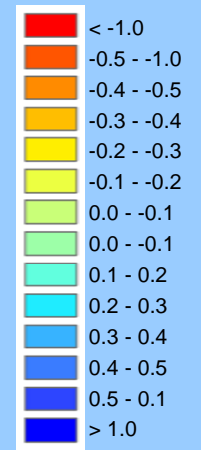
RM 1.6

Apparent deposition – an artifact of filtering

Erosion of > 1m/yr in non-cohesive gravelly bank sediments!

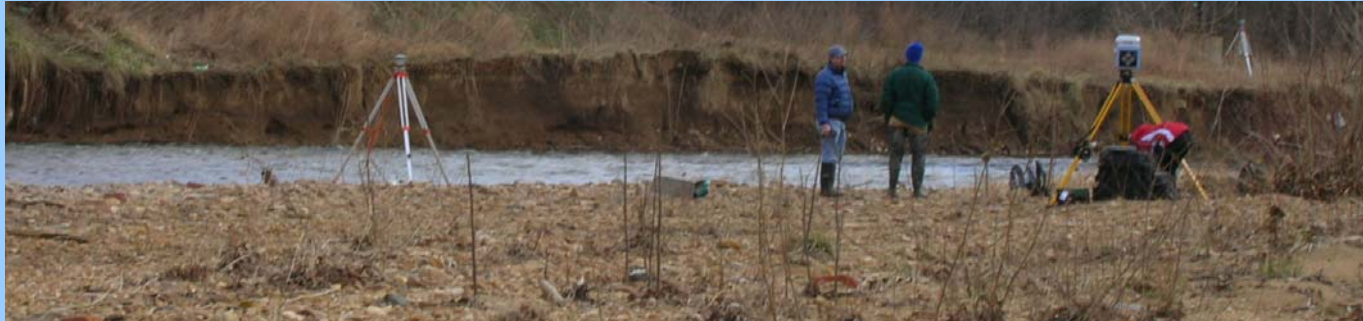
RM 1.75 (Oxbow)

Several decimeters of erosion localized in "holes"

Areas in light green (most of the bank) show no changes!!

Apparent deposition in blue tones are artifacts of data filtering!

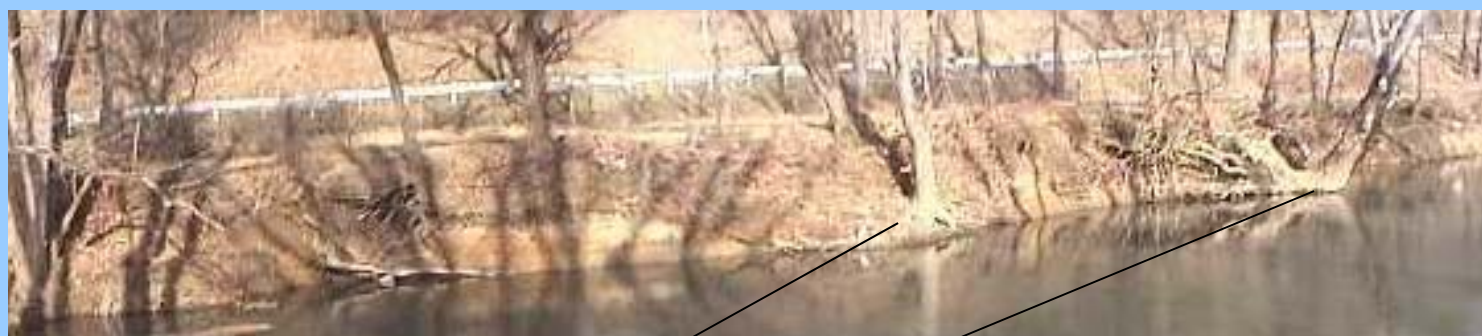
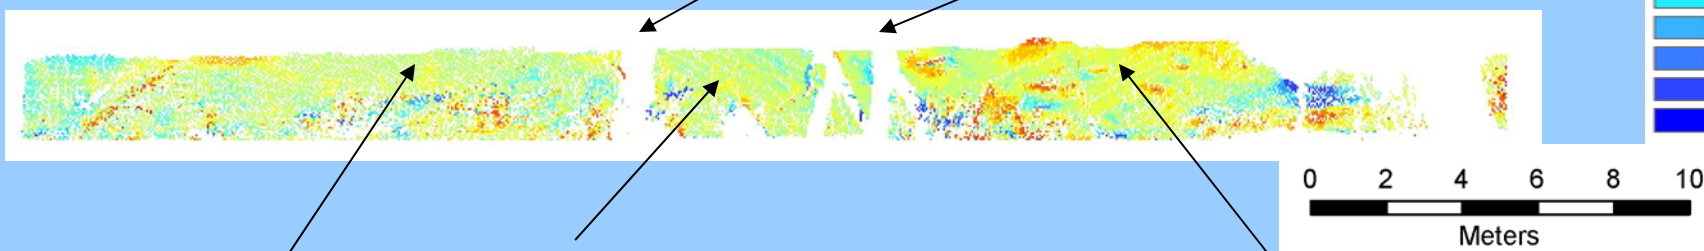
RM 2.95

Note: Erosion here is too slow to be resolved on historical aerial photographs

Small areas of erosion
(yellow and light green)

Several decimeters
of bank erosion
behind large trees

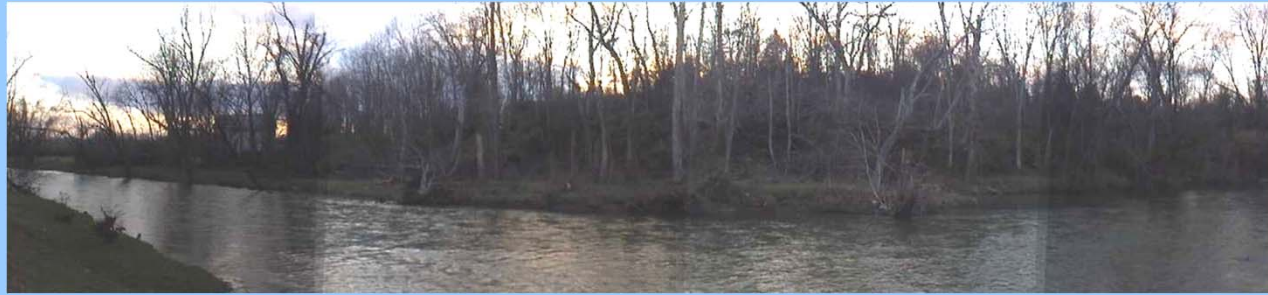
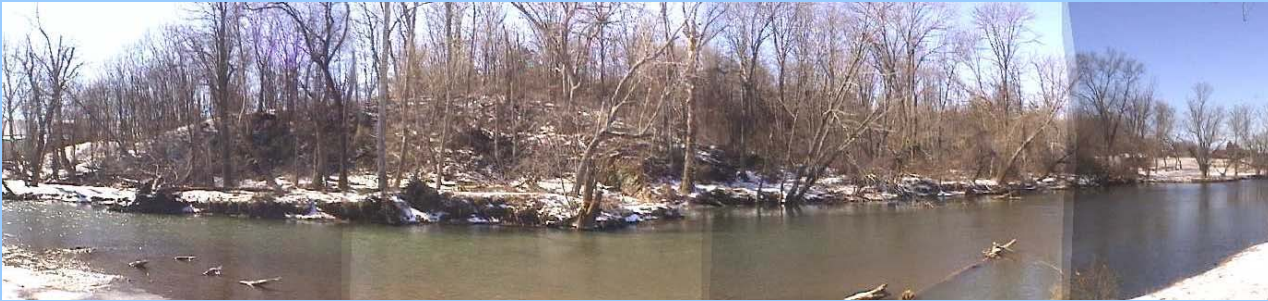
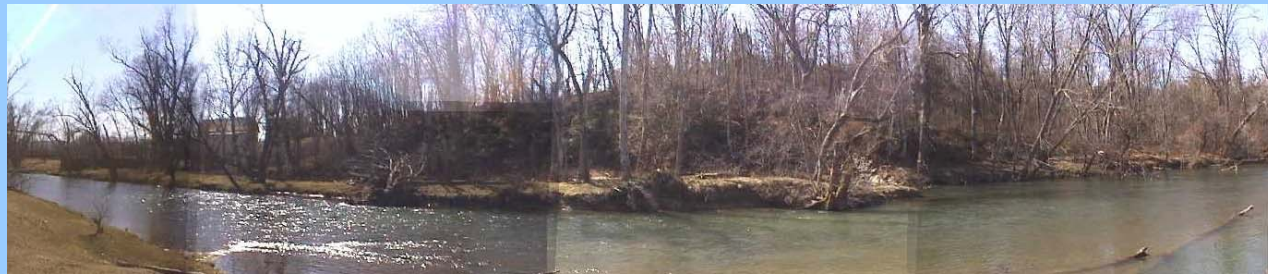
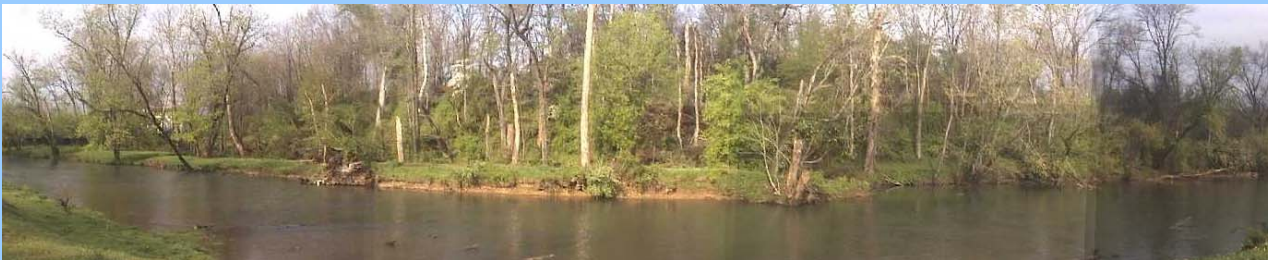
RM 5.35 (River Left)

~ Decimeter of erosion (yellow, green) or no change (green, blue green)

“Deposition” is snow!

~Decimeter of erosion of middle of bank

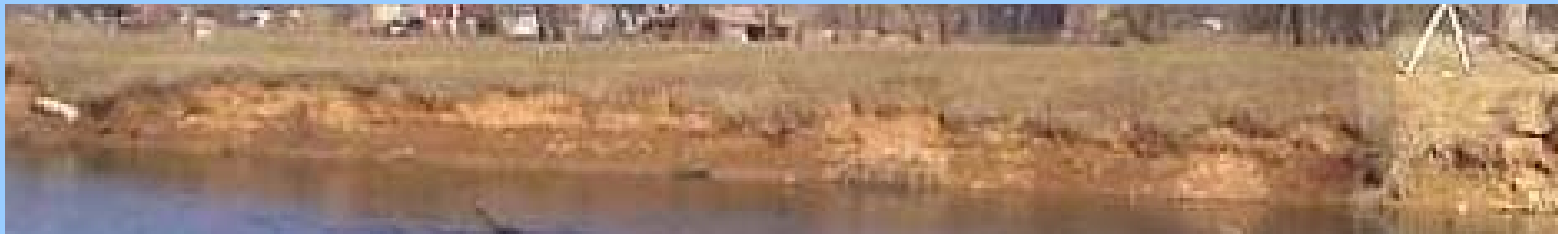
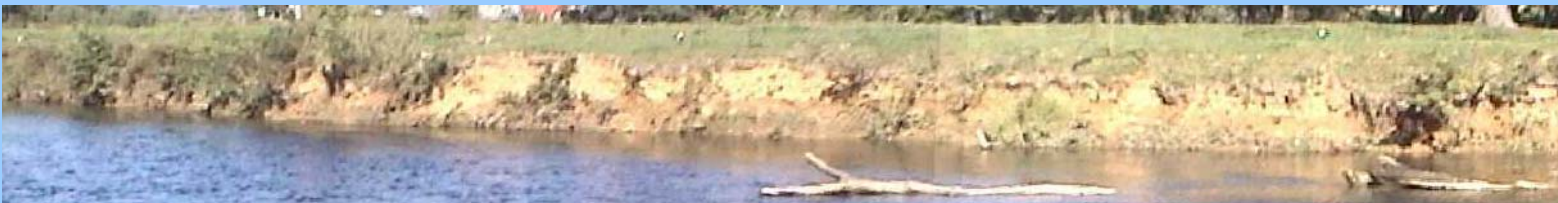
RM 5.37 (River right)

Apparent growth of shrubs (blue)

Several decimeters of erosion (yellow)

Up to 1 m of erosion on cattle path

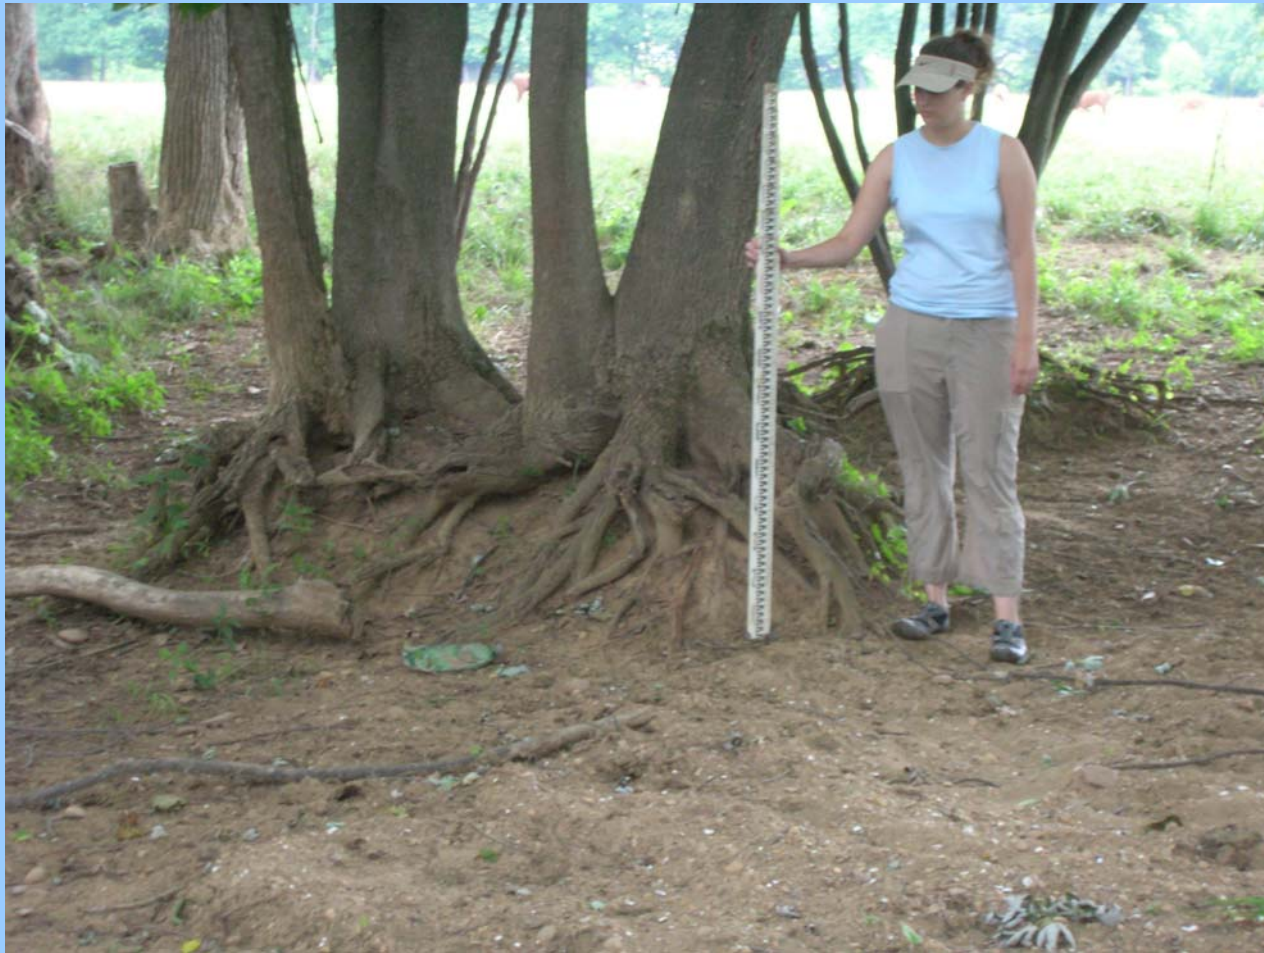
Floodplain Erosion By Cattle

Cattle erosion is equivalent to ~ 50 years of “background” bank erosion along South River
