**Re: 2018/2019 Allied Ready Mix Bank Management Area - Leaf-off Maintenance Inspection  
Area of Concern 4, Former DuPont Waynesboro Plant  
Waynesboro, Virginia  
EPA ID# VAD003114832**

| Subject | 2018/2019 Allied Ready Mix BMA – Leaf-off Maintenance Inspection<br>Former DuPont Waynesboro Site, Area of Concern 4 | | |

Table 1  
Winter 2018/2019 Allied Ready Mix BMA Maintenance Inspection  
Former DuPont Waynesboro Site, Area of Concern 4

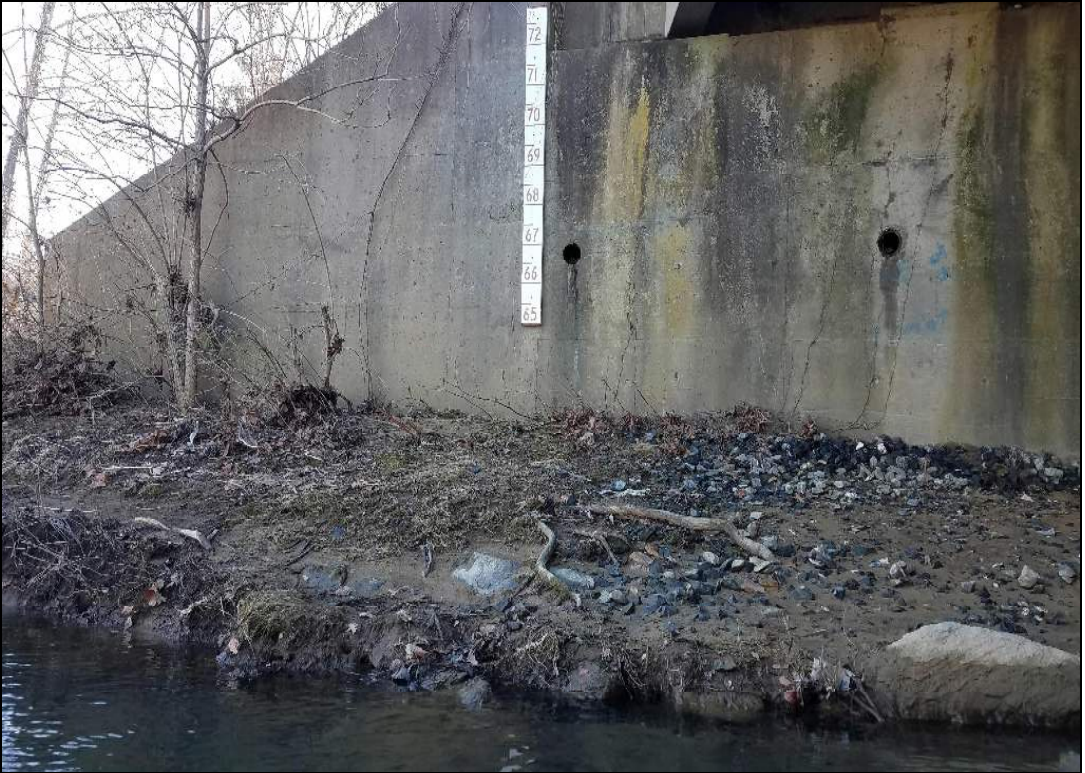
| Station (ft) <sup>1</sup> | Undercutting | | | | Exposed Roots | | | At Risk Trees | | | Installed Stabilization Features Intact | | | | | Local Scour | | | Overall Change Since Previous Inspection (Y/N) |
|---|---|---|---|---|---|---|---|---|---|---|---|---|---|---|---|---|---|---|---|
| POM1 | 20 | Y | | 1 | NA | No exposed roots | 1,2 | N | No woody plant sadjacent to edge of water | 1,2 | NA | NA | NA | No fabric or geocell installed; upstream of remediation | 1,2 | Y | Some scour associated with foot traffic along bank | 1,2 | NA |

| <b>Description:</b><br><br>Station PCM1 (non-remediated transect under 2 <sup>nd</sup> Street overpass)<br><br>~20 degree bank angle; no at risk trees present; some scour associated with foot traffic along bank. | | | |

Comments: Empty holes where planted stock was lost during high flow events will be backfilled with planting substrate and have erosion control fabric repair. Dormant live stakes (4') or similar will be installed to replace lost container stock. Monitor upstream end of BMA for signs of wear from foot traffic.

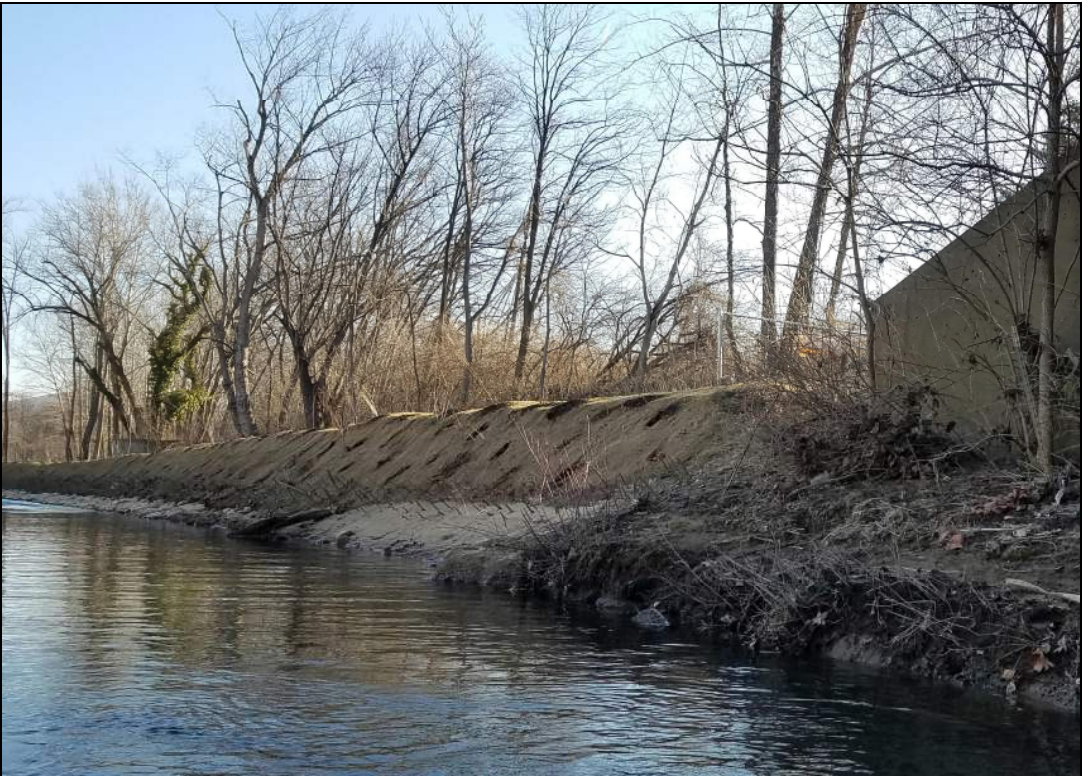
| <b>Description:</b><br><br>Station PCM1 (non-remediated transect under 2 <sup>nd</sup> Street overpass)<br><br>~20 degree bank angle; no at risk trees present; sand deposition above rock toe; improvised access point located downstream. | | |

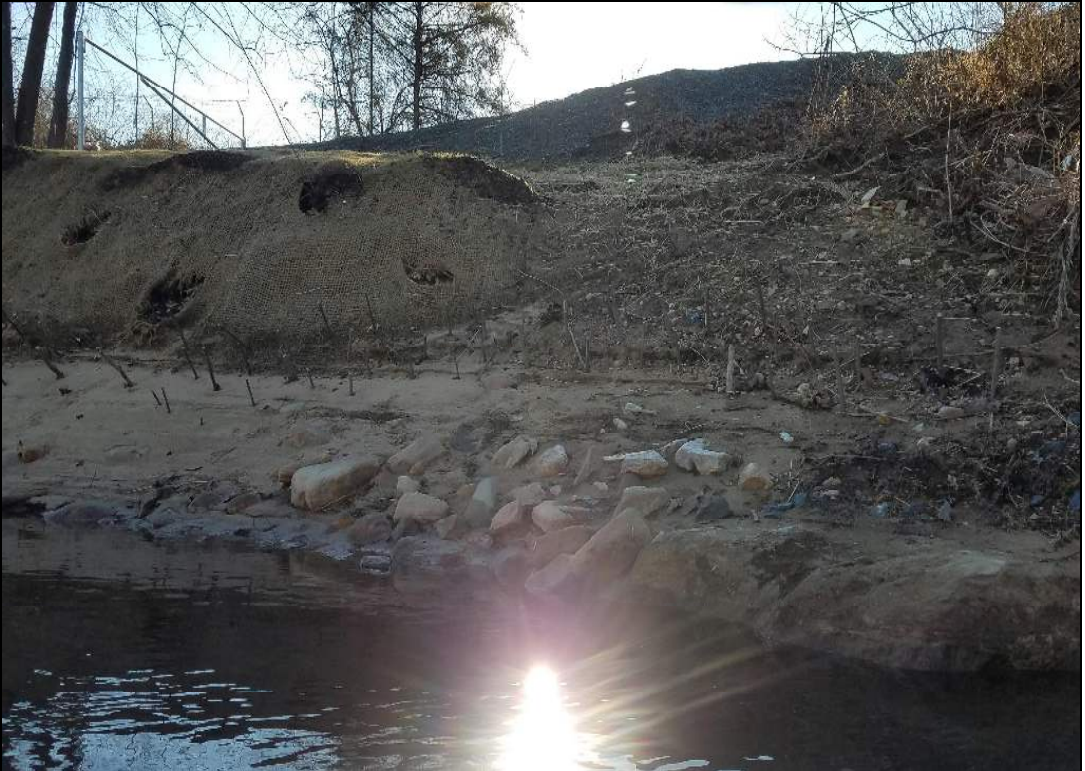
| Station (ft) <sup>1</sup> | Undercutting | | | | Exposed Roots | | | At Risk Trees | | | Installed Stabilization Features Intact | | | | | Local Scour | | | Overall Change Since Previous Inspection (Y/N) |
|---|---|---|---|---|---|---|---|---|---|---|---|---|---|---|---|---|---|---|---|
| POM2 | 45 | Y | | 3,4 | NA | No exposed roots | 3,4 | N | No woody plant sadjacent to edge of water | 3,4 | Y(Rock Toe) | Y | Y | Erosion control fabric exposed throughout, geocell exposed where plants dislodged | 3,4 | Y | Some scour associated with foot traffic along bank; sand deposition above rock toe | 3,4 | NA |

| <b>Description:</b><br>Station PCM2<br><br>~45 degree bank angle;<br>installed rock toe intact;<br>sand deposition above<br>rock toe; live stakes<br>planted on lower bank;<br>saplings planted on<br>upper bank, erosion<br>fabric exposed<br>throughout; improvised<br>access point present. | | | |

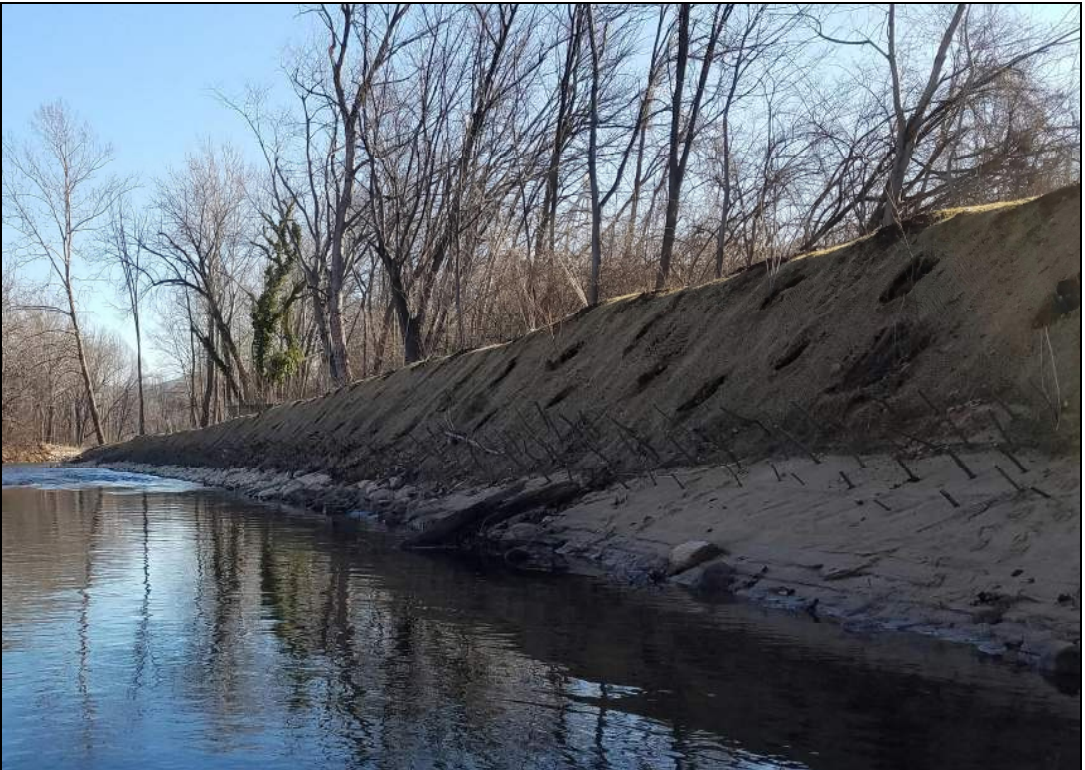
| <b>Description:</b><br>Station PCM2<br><br>~45 degree bank angle;<br>installed rock toe intact;<br>live stakes planted on<br>lower bank; saplings<br>planted on upper bank;<br>erosion control fabric<br>exposed throughout;<br>geocell exposed where<br>plants dislodged; scour<br>localized to dislodged<br>planting depressions | | |

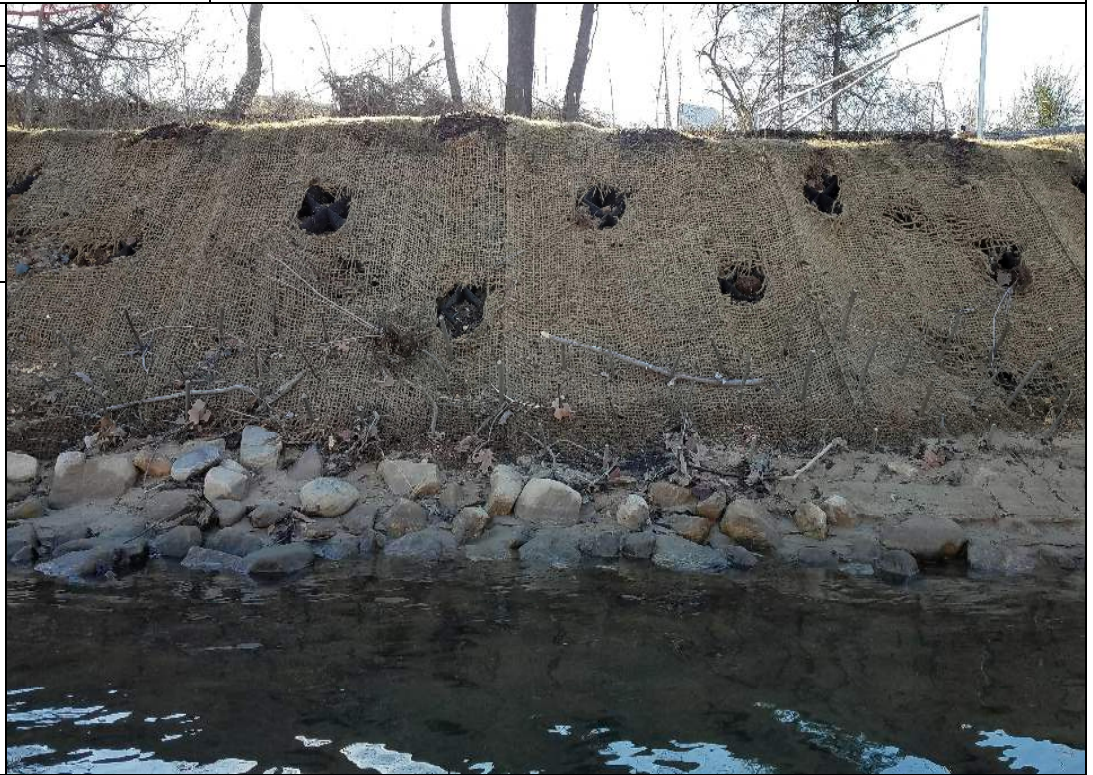
| <b>Photo No.</b><br>5 | <b>Date:</b><br>2/05/2019 |

| Station (ft) <sup>1</sup> | Undercutting | | | | Exposed Roots | | | At Risk Trees | | | Installed Stabilization Features Intact | | | | | Local Scour | | | Overall Change Since Previous Inspection (Y/N) |
|---|---|---|---|---|---|---|---|---|---|---|---|---|---|---|---|---|---|---|---|
| POM3 | 50 | Y | | 5 | NA | No exposed roots | 5,6,7 | N | No woody plant sadjacent to edge of water | 5,6,7 | Tabl | Y | Y | Erosion control fabric exposed throughout, geocell exposed where plants dislodged | 5,6,7,8 | Y | Scour localized to dislodged planting depressions; sand deposition above rock toe | 5,6,7,8 | NA |

Station PCM3

~50 degree bank angle; installed rock toe intact; live stakes planted on lower bank; saplings planted on upper bank, erosion fabric exposed throughout; geocell is exposed, fabric is torn, and scour is present where planted container stock has washed away.

- Areas of the BMA where planted container stocks were lost will be backfilled with planting substrate and the erosion control blanket will be repaired.
- Replacement plantings (i.e. 4' dormant live stakes or similar) will then be installed prior to the spring growing season.
- Continue to monitor planted saplings and live stake installations following high flow (e.g. approximately 1,000 cubic feet per second at the USGS gage in Waynesboro) to assess the effectiveness of erosion control fabric repair and replacement plantings.

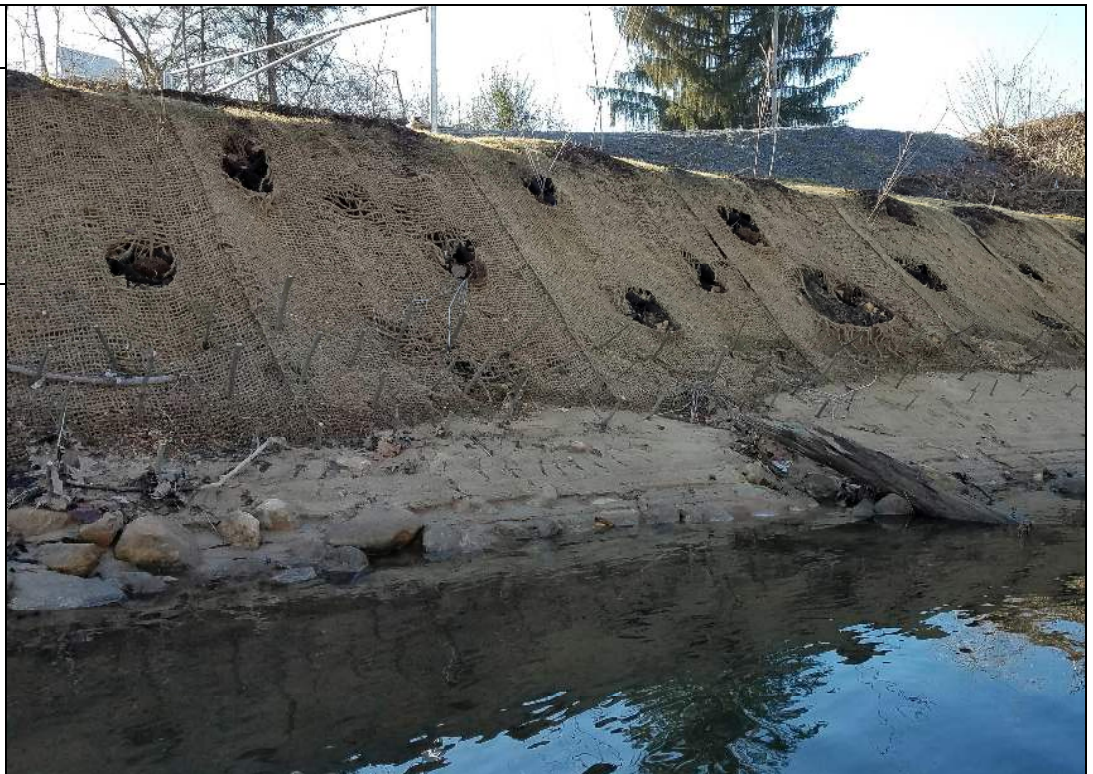
| <b>Photo No.</b><br>6 | <b>Date:</b><br>2/05/2019 |

Station PCM3

Sand deposition above rock toe; erosion fabric exposed throughout; geocell is exposed, fabric is torn, and scour is present where planted trees have washed away.

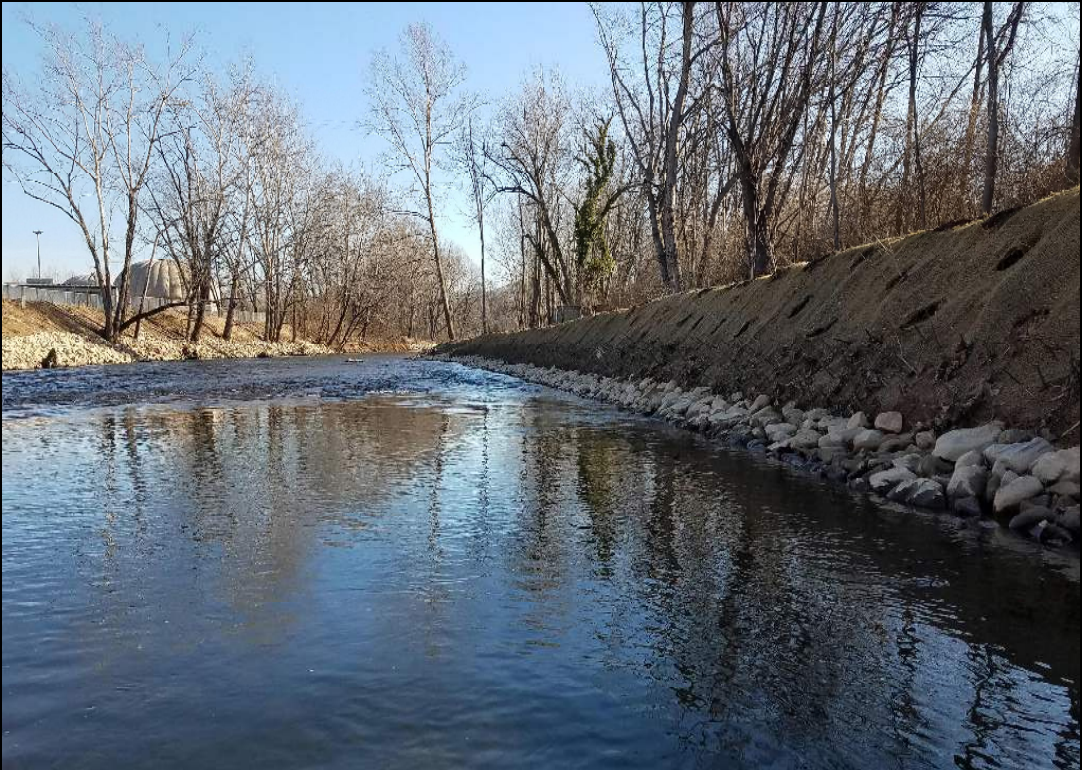
| <b>Description:</b><br><br>Station PCM3<br><br>Installed rock toe intact; live stakes planted on lower bank; saplings planted on upper bank, erosion fabric exposed throughout. | | | |

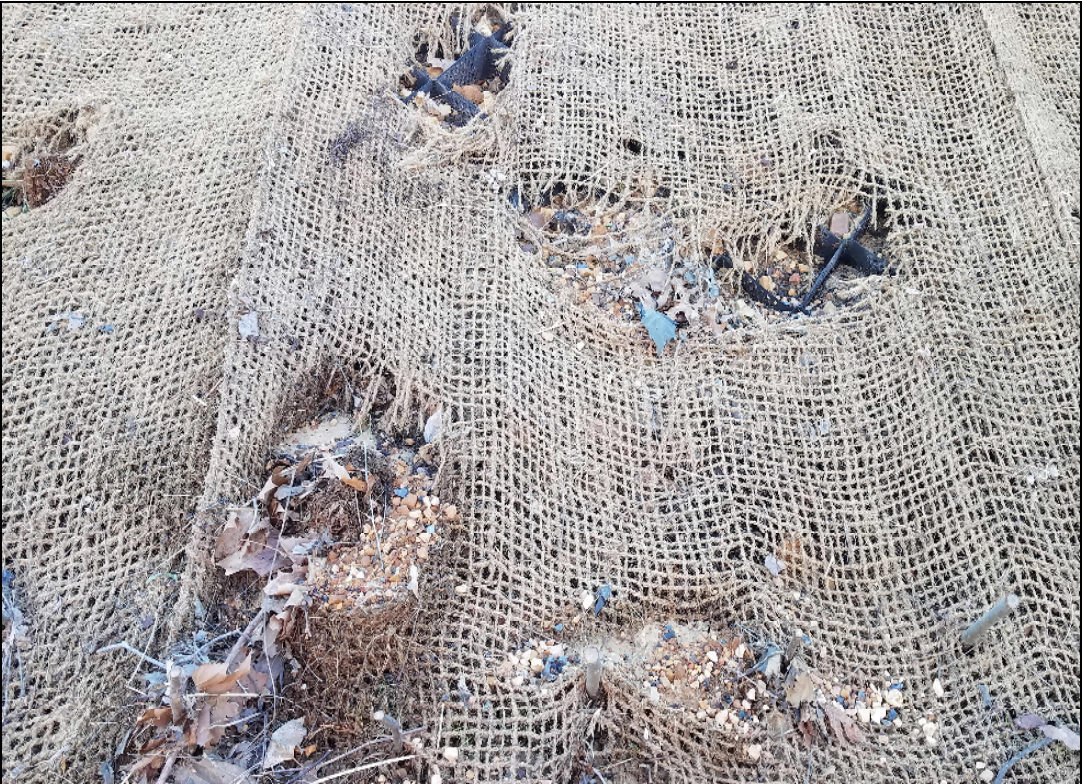
| <b>Description:</b><br><br>Station PCM3<br><br>Geocell is exposed, fabric is torn, and scour is present where planted container stock has washed away. | | |

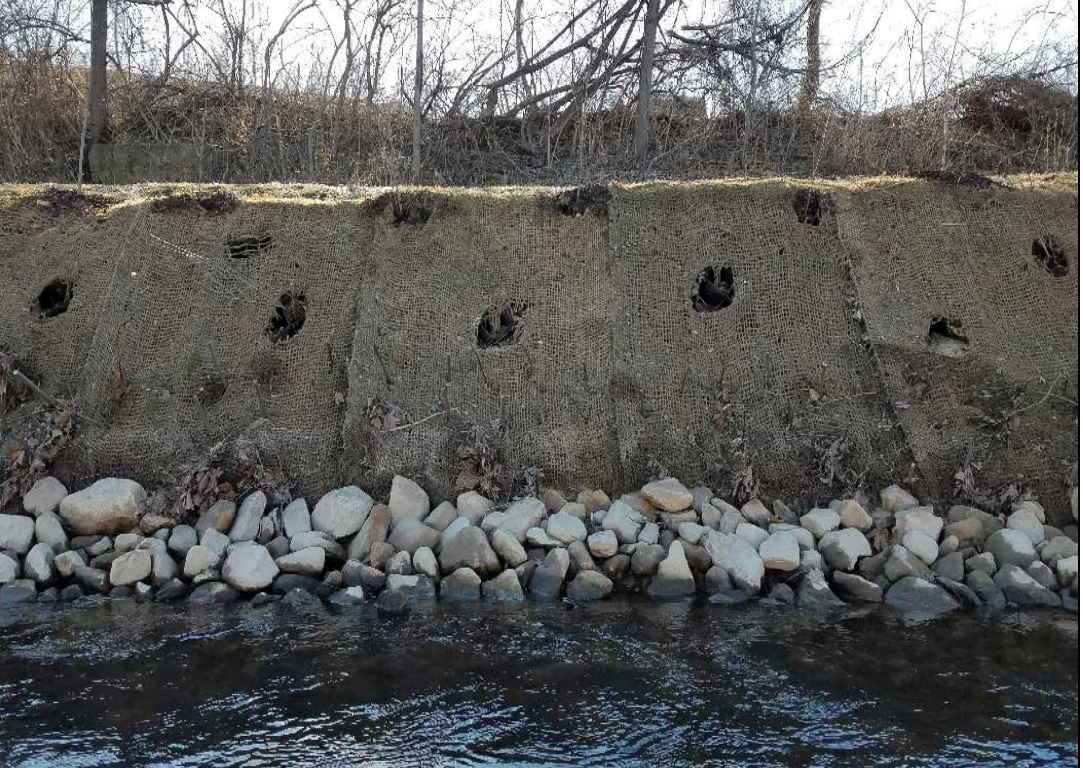
| Station (ft) <sup>1</sup> | Undercutting | | | | Exposed Roots | | | At Risk Trees | | | Installed Stabilization Features Intact | | | | | Local Scour | | | Overall Change Since Previous Inspection (Y/N) |
|---|---|---|---|---|---|---|---|---|---|---|---|---|---|---|---|---|---|---|---|
| POM4 | 50 | Y | | 9 | NA | No exposed roots | 9,10 | N | No woody plant sadjacent to edge of water | 9,10 | Y(Rock Toe) | Y | Y | Erosion control fabric exposed throughout, geocell exposed where plants dislodged | 9,10 | Y | Scour localized to dislodged planting depressions | 9,10 | NA |

| <b>Description:</b><br><br>Station PCM4<br><br>~50 degree bank angle; installed rock toe intact; live stakes planted on lower bank; saplings planted on upper bank, erosion fabric exposed throughout; geocell is exposed, fabric is torn, and scour is present where planted trees have washed away. | | | |

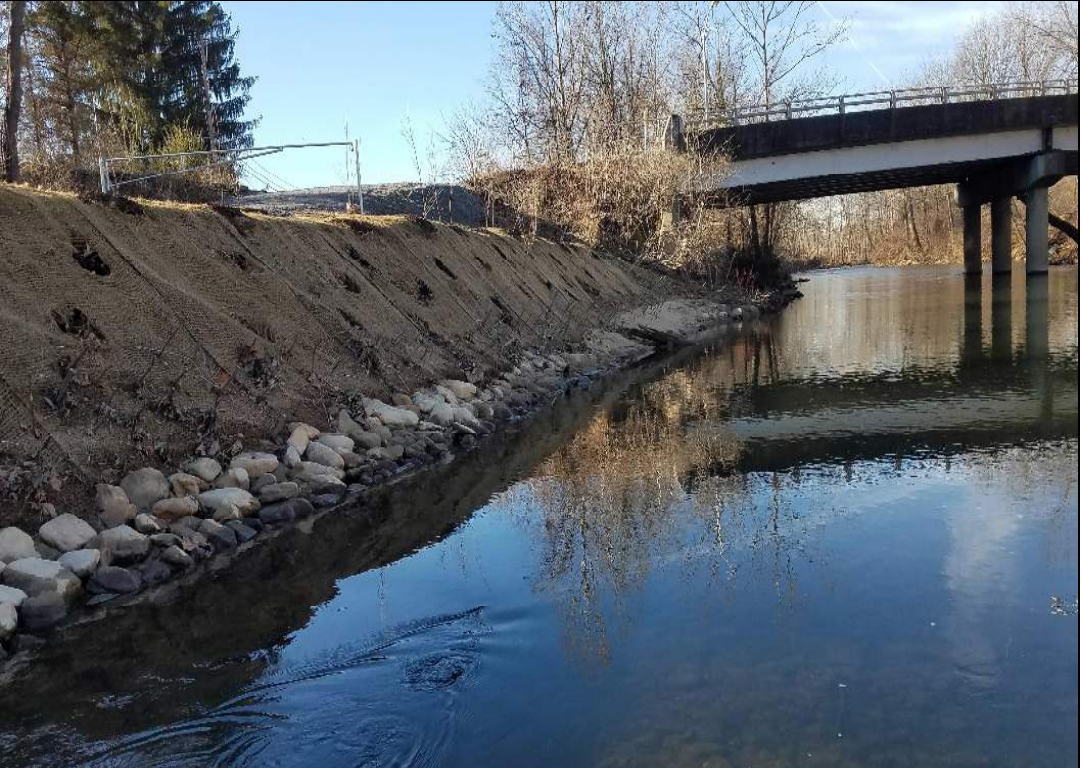
| <b>Description:</b><br><br>Station PCM4<br><br>Installed rock toe intact; sand deposition above rock toe; erosion fabric exposed throughout. | | |

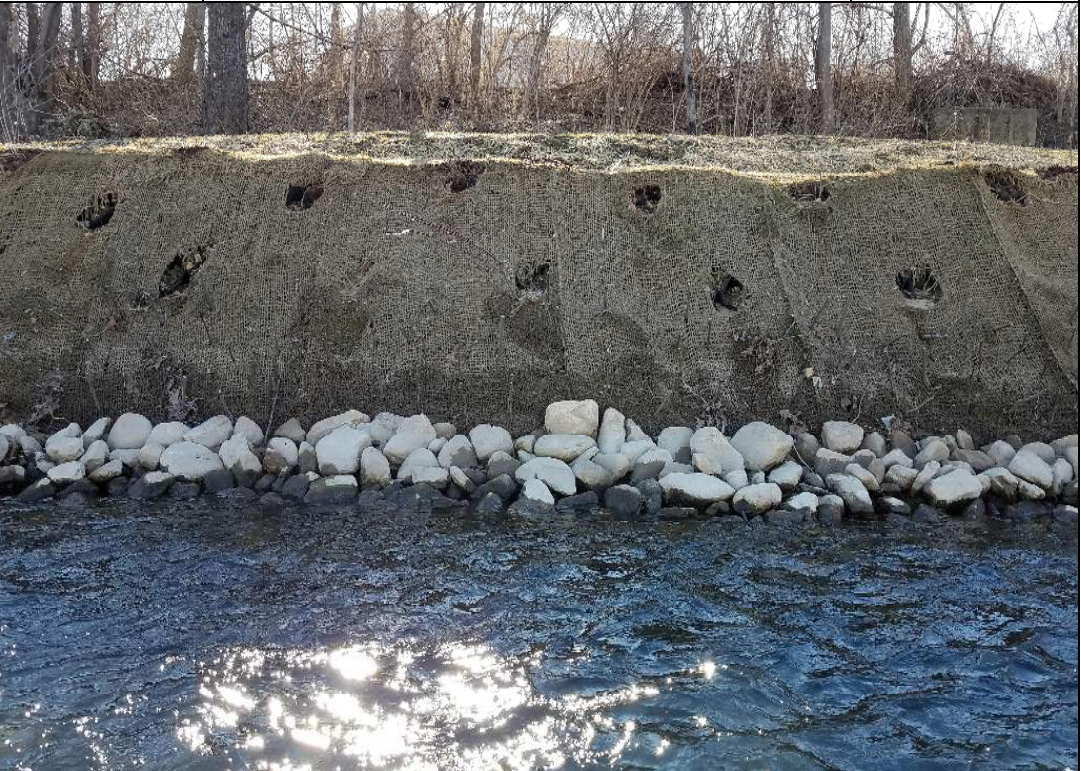
| Station (ft) <sup>1</sup> | Undercutting | | | | Exposed Roots | | | At Risk Trees | | | Installed Stabilization Features Intact | | | | | Local Scour | | | Overall Change Since Previous Inspection (Y/N) |
|---|---|---|---|---|---|---|---|---|---|---|---|---|---|---|---|---|---|---|---|
| POM5 | 50 | Y | | 11 | NA | No exposed roots | 11,12 | N | No woody plant sadjacent to edge of water | 11,12 | Y(Rock Toe) | Y | Y | Erosion control fabric exposed throughout, geocell exposed where plants dislodged | 11 | Y | Scour localized to dislodged planting depressions | 11 | NA |

| <b>Description:</b><br><br>Station PCM5<br><br>~50 degree bank angle; installed rock toe intact; live stakes planted on lower bank; saplings planted on upper bank, erosion fabric exposed throughout; geocell is exposed, fabric is torn, and scour is present where planted container stock has washed away. | | | |

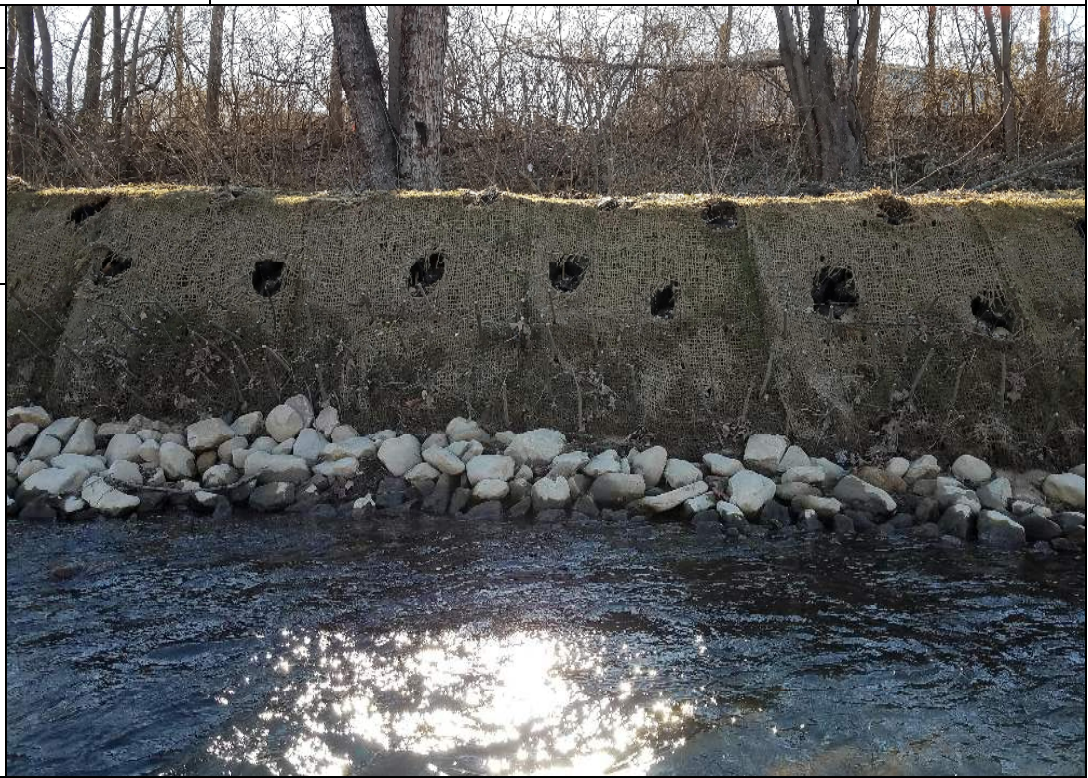
| Station (ft) <sup>1</sup> | Undercutting | | | | Exposed Roots | | | At Risk Trees | | | Installed Stabilization Features Intact | | | | | Local Scour | | | Overall Change Since Previous Inspection (Y/N) |
|---|---|---|---|---|---|---|---|---|---|---|---|---|---|---|---|---|---|---|---|
| POM6 | 50 | Y | | 13 | NA | No exposed roots | 13 | N | No woody plant sadjacent to edge of water | 13 | Y(Rock Toe) | Y | Y | Erosion control fabric exposed throughout, geocell exposed where plants dislodged | 13 | Y | Scour localized to dislodged planting depressions | 13 | NA |

| <b>Description:</b><br><br>Station PCM6<br><br>~50 degree bank angle;<br>installed rock toe intact;<br>live stakes planted on<br>lower bank; saplings<br>planted on upper bank,<br>erosion fabric exposed<br>throughout; geocell is<br>exposed, fabric is torn,<br>and scour is present<br>where planted trees<br>have washed away. | | |

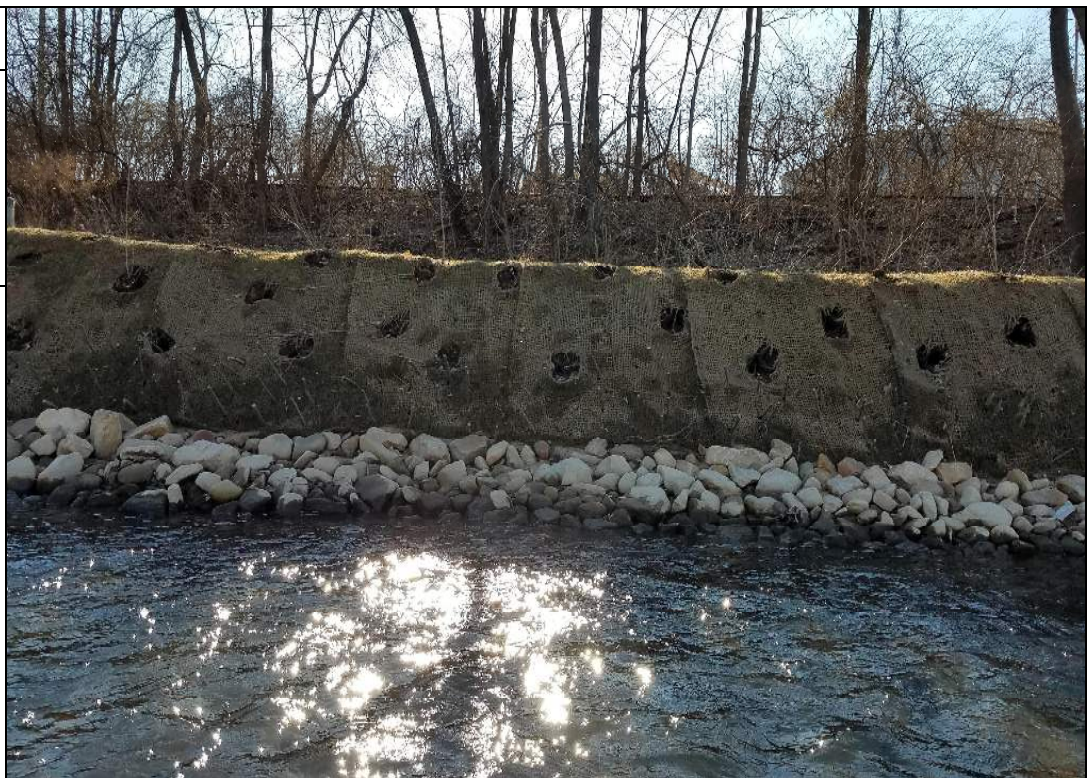
| Station (ft) <sup>1</sup> | Undercutting | | | | Exposed Roots | | | At Risk Trees | | | Installed Stabilization Features Intact | | | | | Local Scour | | | Overall Change Since Previous Inspection (Y/N) |
|---|---|---|---|---|---|---|---|---|---|---|---|---|---|---|---|---|---|---|---|
| POM7 | 50 | Y | | 14 | NA | No exposed roots | 14 | N | No woody plant sadjacent to edge of water | 14 | Y(Rock Toe) | Y | Y | Erosion control fabric exposed throughout, geocell exposed where plants dislodged | 14 | Y | Scour localized to dislodged planting depressions | 14 | NA |

| <b>Description:</b><br><br>Station PCM7<br><br>~50 degree bank angle;<br>installed rock toe intact;<br>live stakes planted on<br>lower bank; saplings<br>planted on upper bank,<br>erosion fabric exposed<br>throughout; geocell is<br>exposed, fabric is torn,<br>and scour is present<br>where planted<br>container stock has<br>washed away. | | |

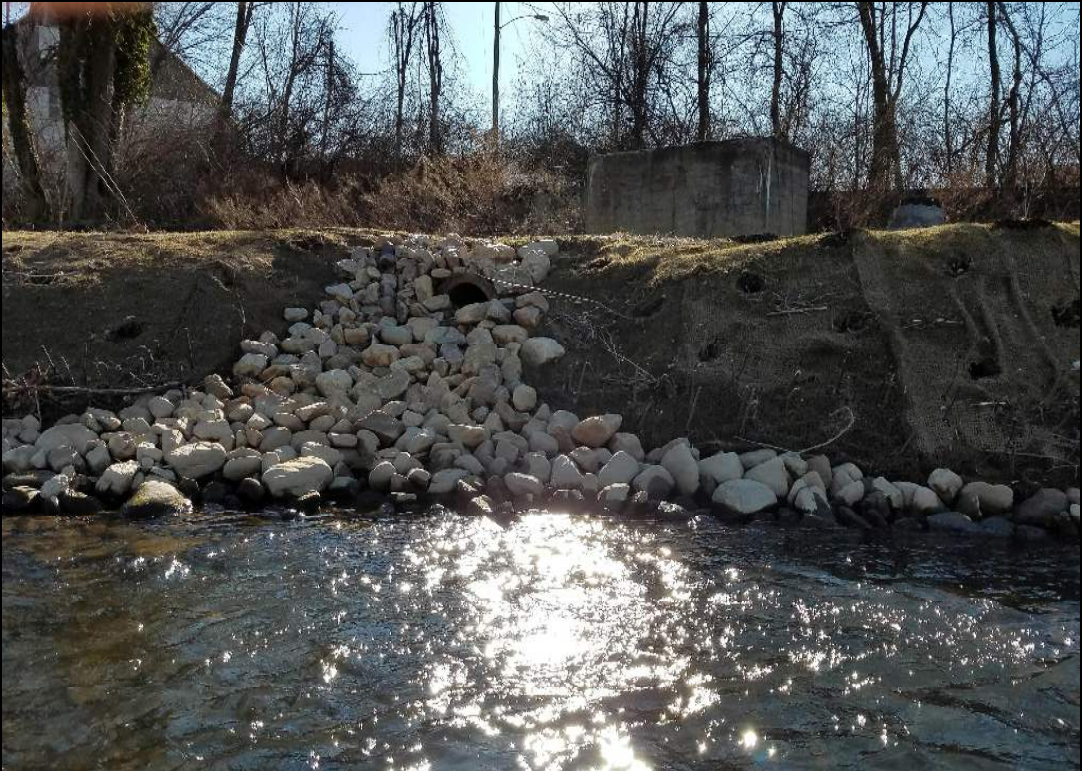
| <b>Description:</b><br>Station PCM8<br><br>~40 degree bank angle; installed rock toe intact; outfall and drainage structure intact; live stakes planted on lower bank; saplings planted on upper bank, erosion fabric exposed throughout. | | | |

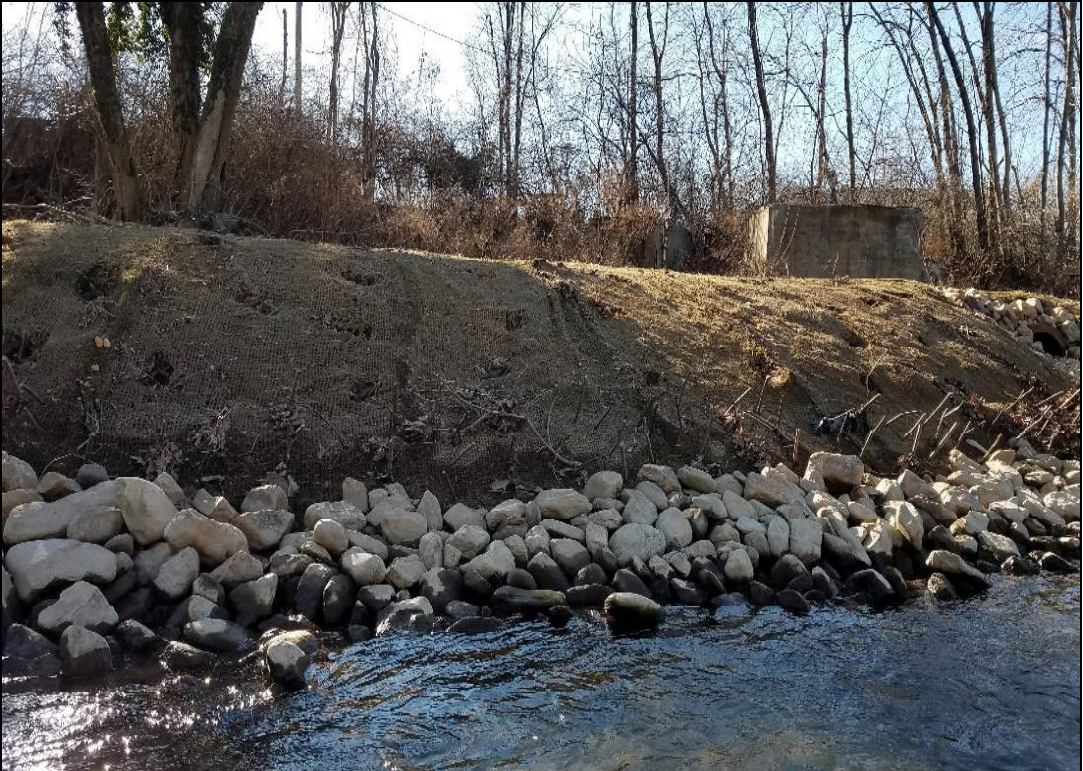
| <b>Description:</b><br><br>Station PCM9<br><br>~40 degree bank angle;<br>installed rock toe intact;<br>live stakes planted on<br>lower bank; saplings<br>planted on upper bank,<br>erosion fabric exposed<br>throughout. | | | |

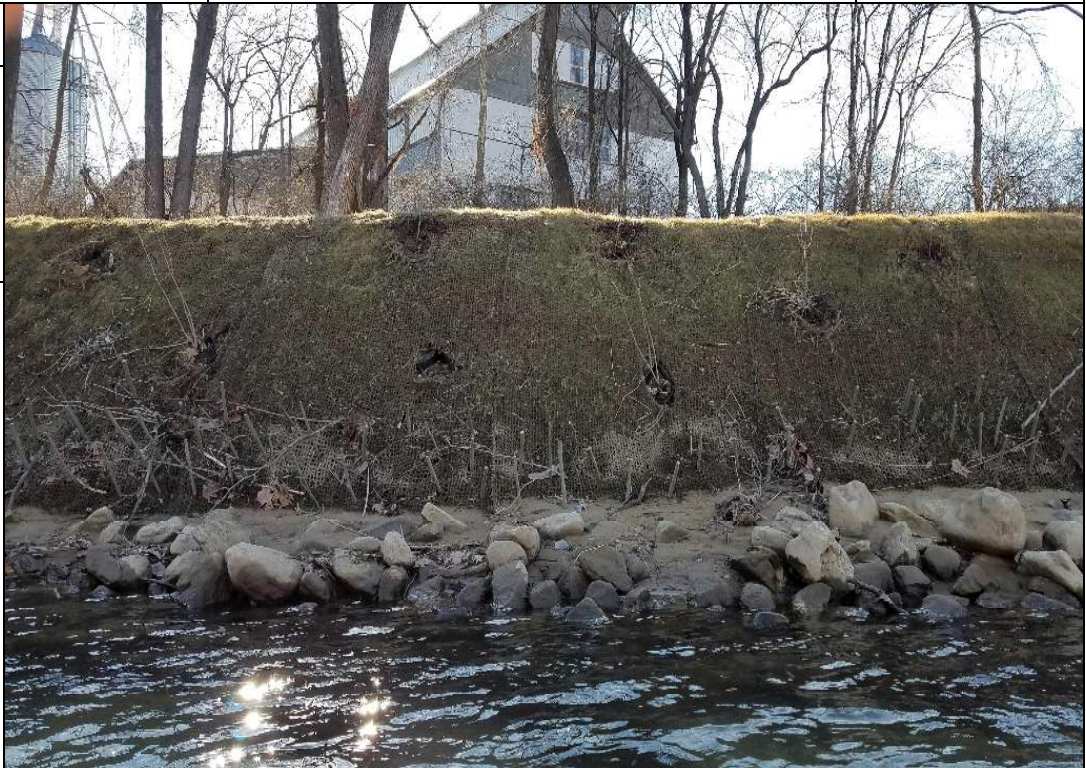
| <b>Description:</b><br><br>Station PCM11<br><br>~50 degree bank angle; installed rock toe intact; grasses establishing at top of bank; erosion fabric exposed from mid-bank towards the rock toe; sand deposition occurring above rock toe. | | | |

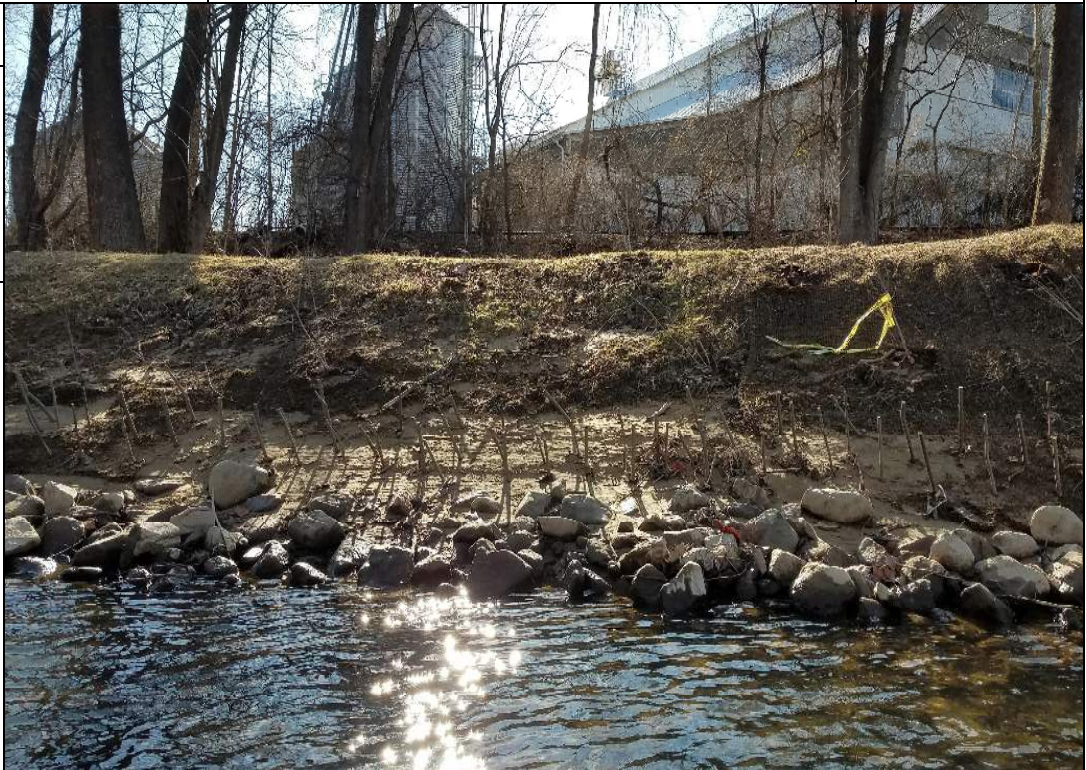
| <b>Description:</b><br><br>Station PCM12<br><br>~40 degree bank angle;<br>installed rock toe intact;<br>grasses establishing at<br>top of bank; erosion<br>fabric exposed from<br>mid-bank towards the<br>rock toe; sand<br>deposition occurring<br>above rock toe. | | | |

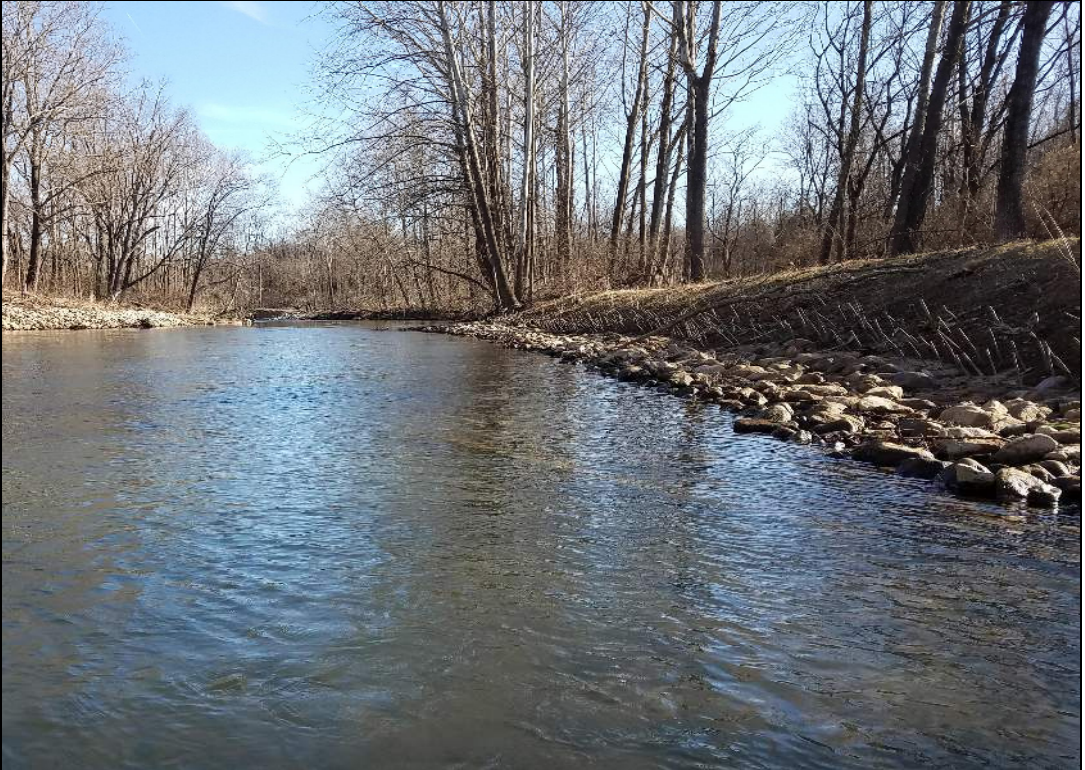
| <b>Description:</b><br><br>Station PCM13<br><br>Downstream view from PCM13 and installed live stakes; downstream mid-bank plantings were generally intact. | | | |

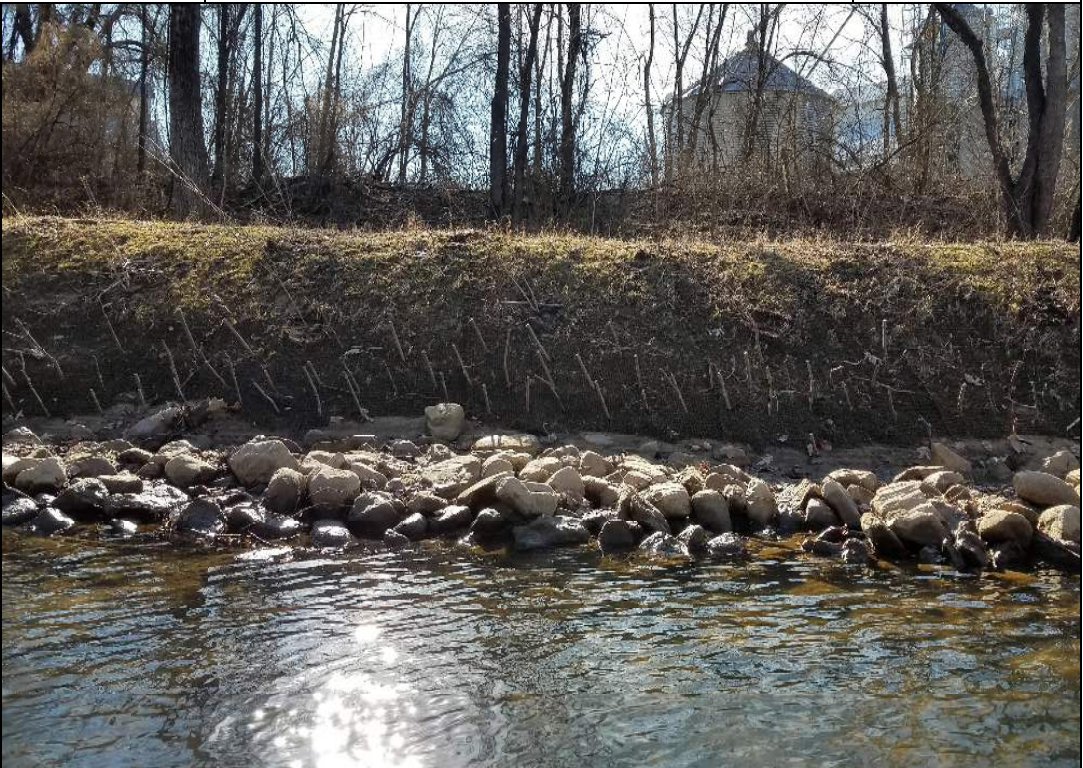
| <b>Description:</b><br><br>Station PCM15<br><br>~30 degree bank angle; installed rock toe intact; grasses establishing at top of bank; erosion fabric exposed from mid-bank towards the rock toe (~50% exposed); sand deposition occurring above rock toe. | | | |

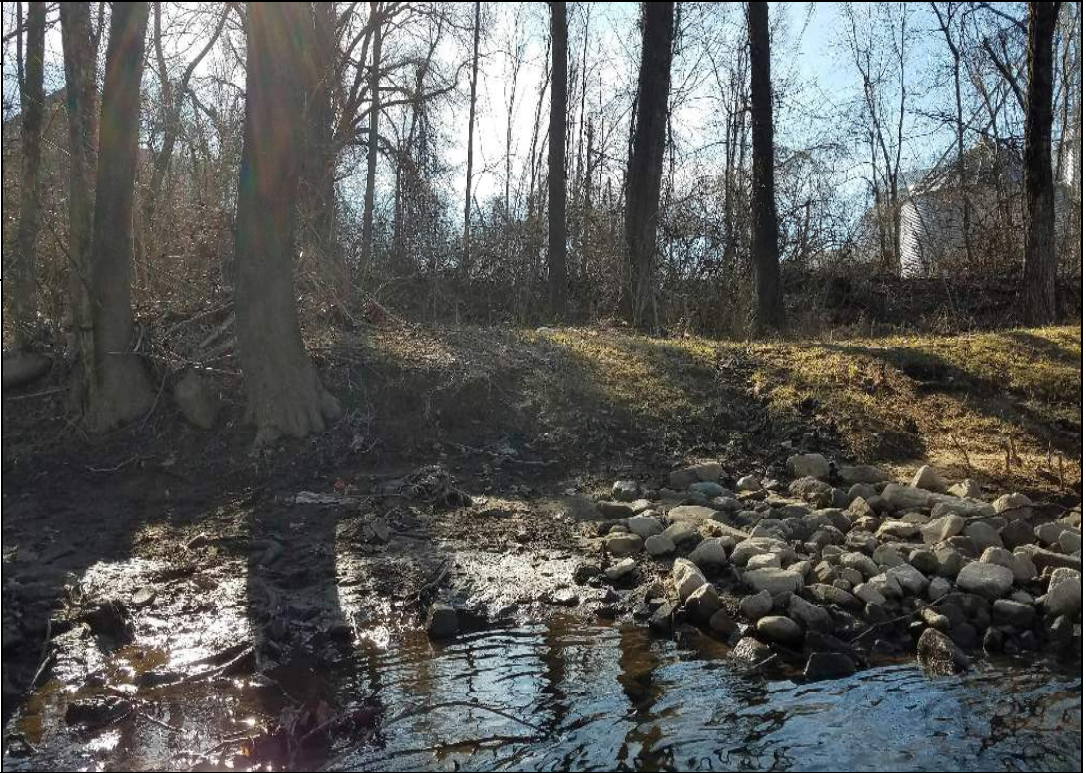
| <b>Description:</b><br>Station PCM17<br><br>~30 degree bank angle; installed rock toe intact; no exposed roots; no at risk trees; grasses establishing at top of bank; erosion fabric exposed from mid-bank towards the rock toe (~30% exposed); geocell intact and not exposed. | | | |

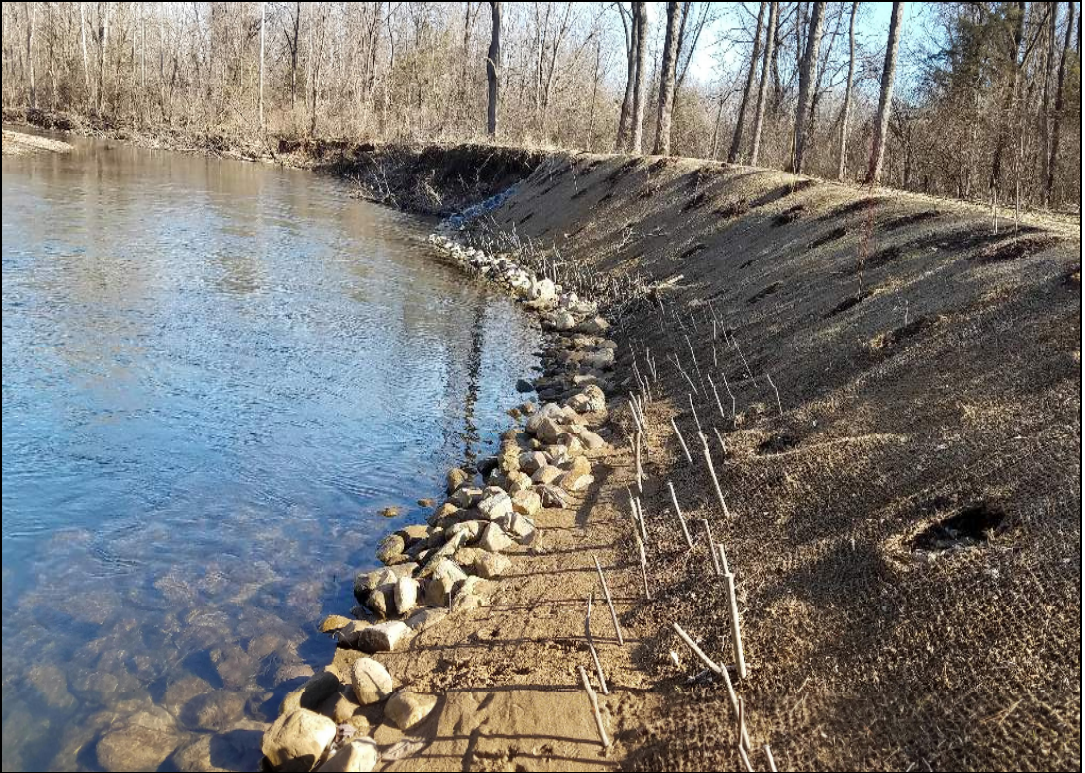
| <b>Description:</b><br><br>Station PCM19<br><br>Downstream view from PCM19; live stakes and rock toe intact; erosion control fabric exposed throughout; sand deposition above rock toe. | | | |

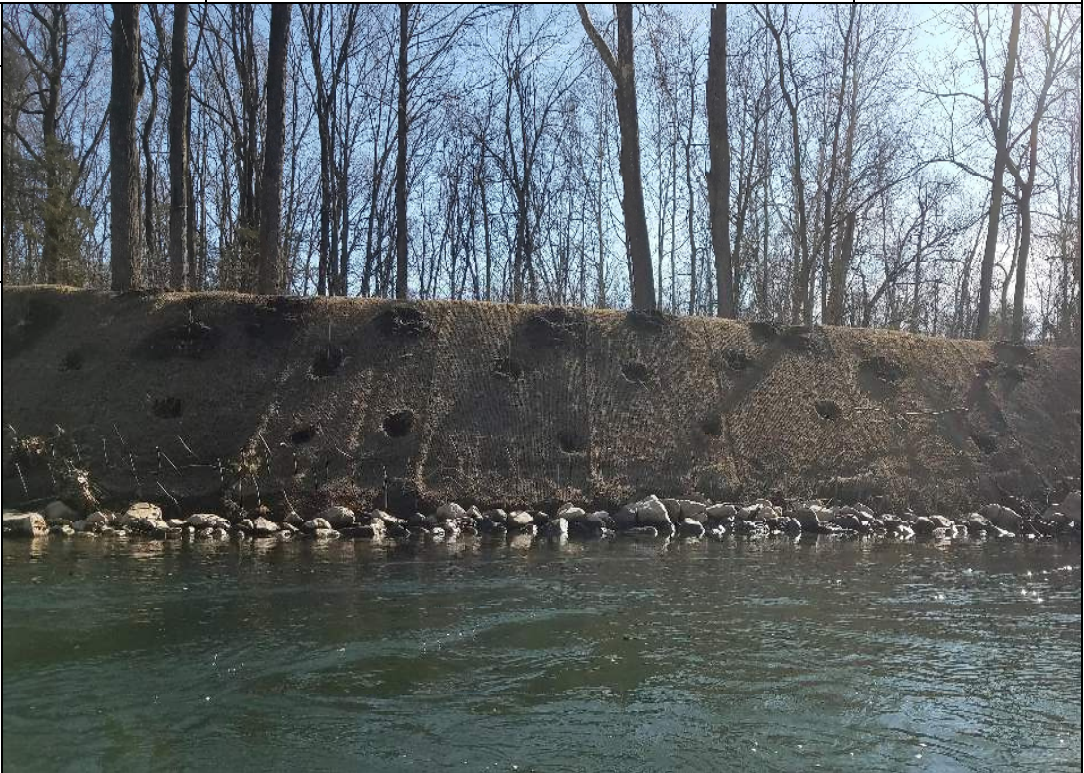
| <b>Description:</b><br><br>Station PCM21<br><br>~50 degree bank angle; no exposed roots; no at risk trees; live stakes planted on lower bank above rock toe; saplings planted throughout rest of bank; fabric is torn and scour present where mid bank planted container stock has washed away. | | | |

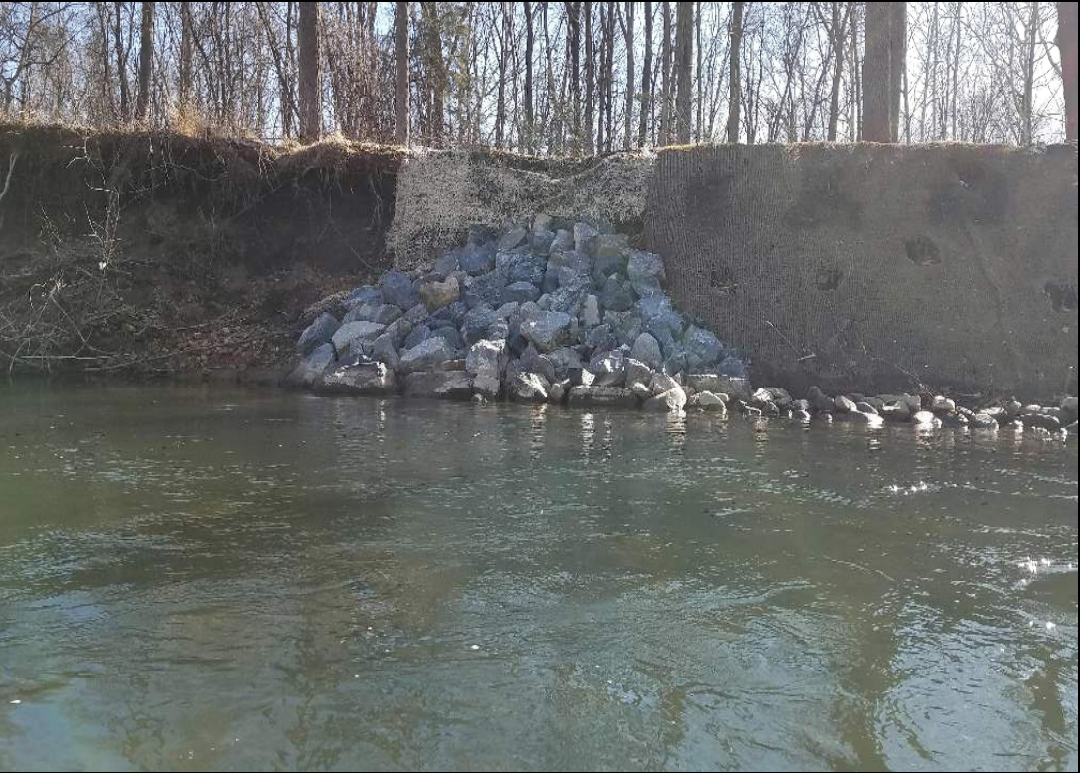
| <b>Description:</b><br><br>Station PCM22<br><br>~50 degree bank angle;<br>no exposed roots; no at risk trees; Rip rap fortified bank abutment intact with heavy erosion present immediately downstream of remediated BMA. | | | |
