**Re: Revised 2015 Short Term Monitoring Report
Former DuPont Waynesboro Site, Area of Concern 4
Waynesboro, Virginia
EPA ID# VAD003114832**

Area of Concern (AOC) 4 2015 Short-term Monitoring Report

Former DuPont Waynesboro Site, Virginia

Date: October 2016

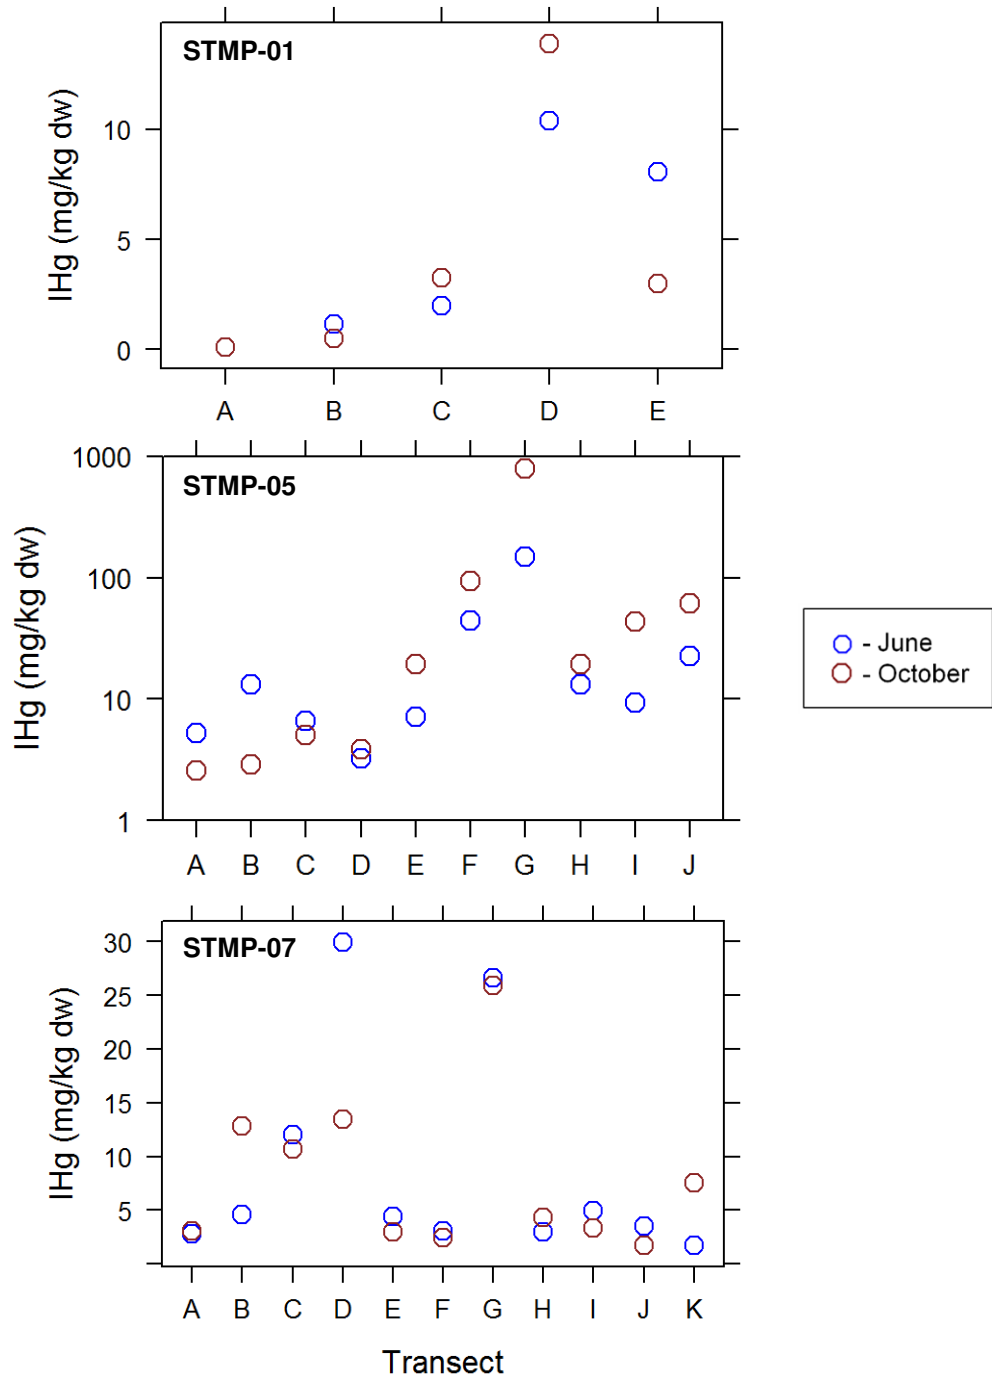
Figure 2
 Inorganic Mercury (IHg) in Sediment
 Short-Term Monitoring 2015 Annual Monitoring Report
 DuPont South River – AOC 4

Notes:
 mg/kg, Milligrams per kilogram
 dw, Dry weight

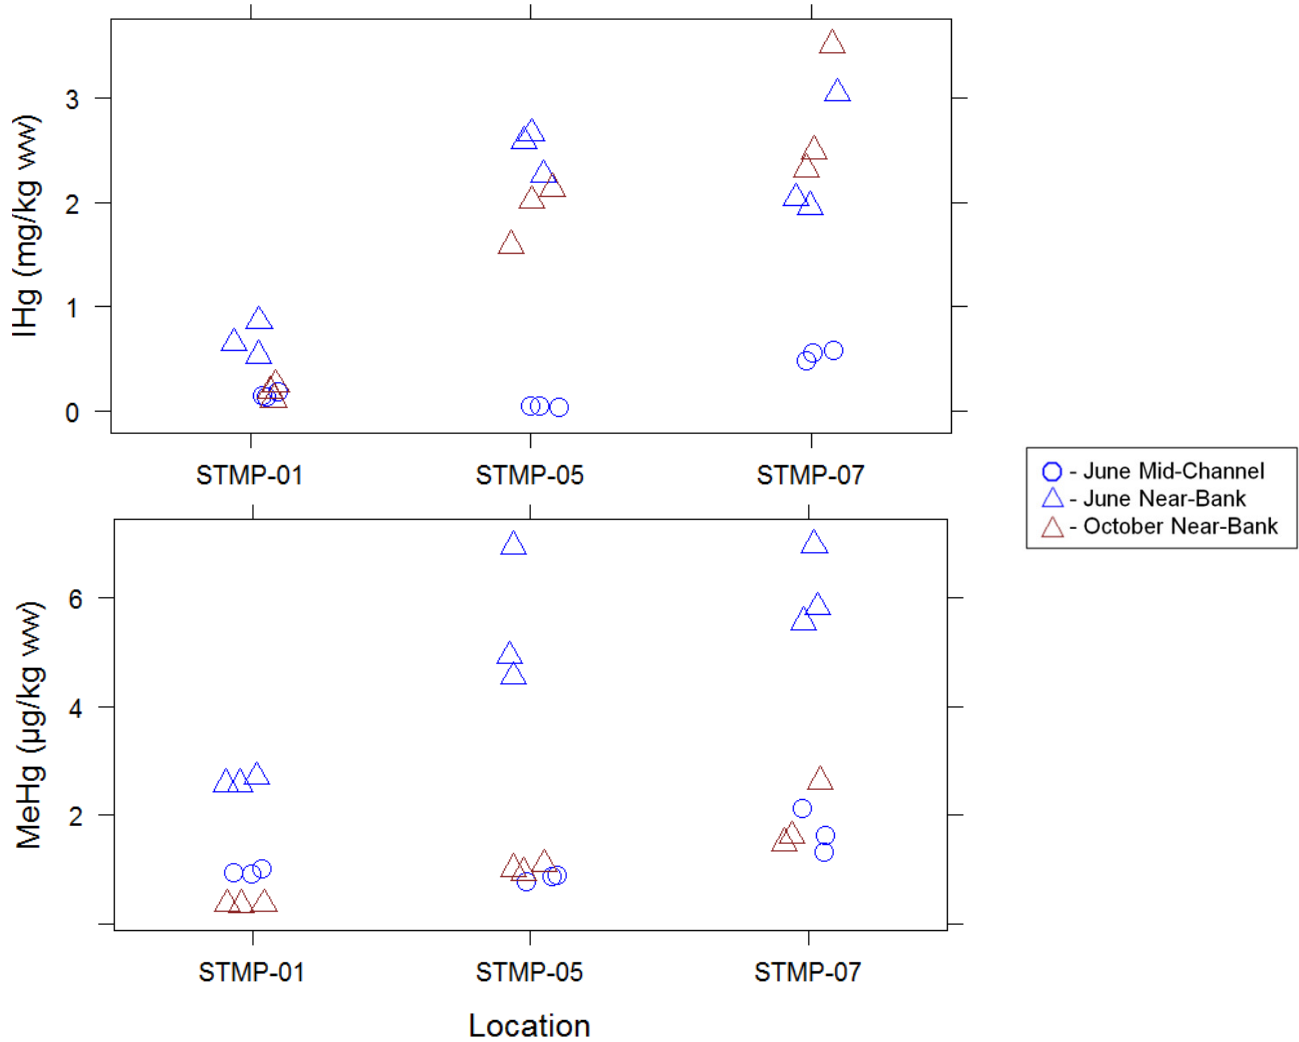
Figure 4
 Mercury Concentrations in Periphyton
 Short-Term Monitoring 2015 Annual Monitoring Report
 DuPont South River – AOC 4

Notes:
 IHg, Inorganic Mercury
 MeHg, Methylmercury
 µg/kg, Micrograms per kilogram
 Ww, Wet weight

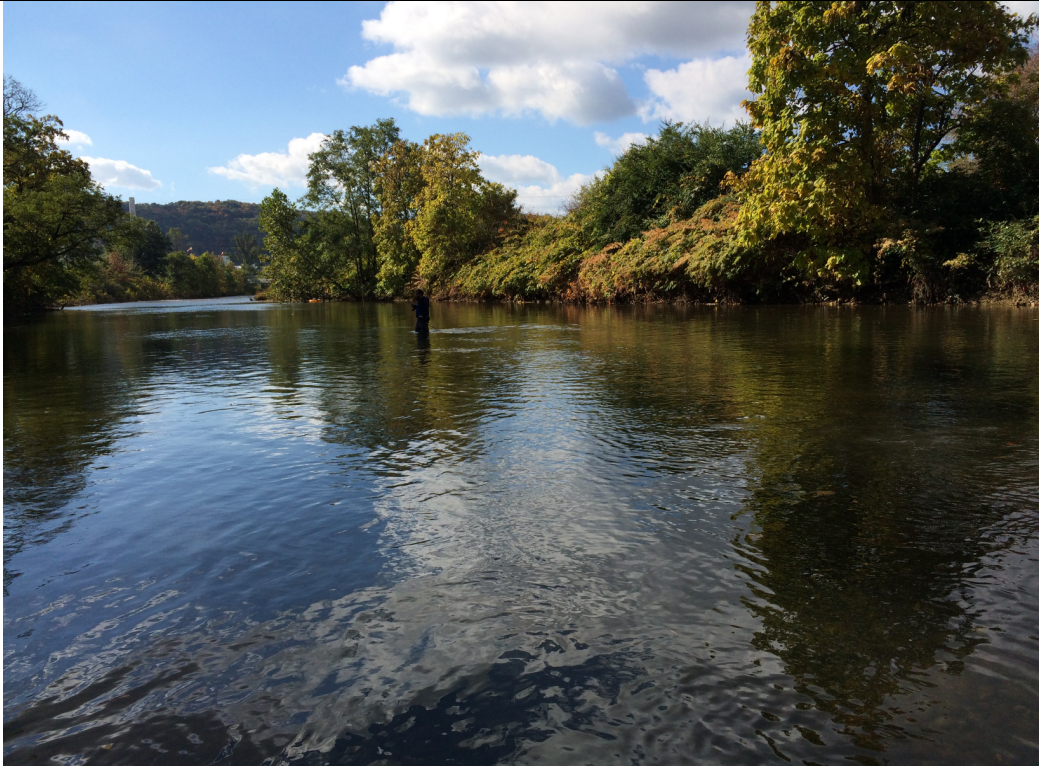
Client Name: DuPont		Site Location: South River – Short-Term Monitoring	Project No.: 60394083
Photo No.: 1	Date: 10/13/2015

Direction Photo Taken: South			
Description: Long view of STMP-01. Large area of Japanese Knotweed (<i>Fallopia japonica</i>) in middle of extent.

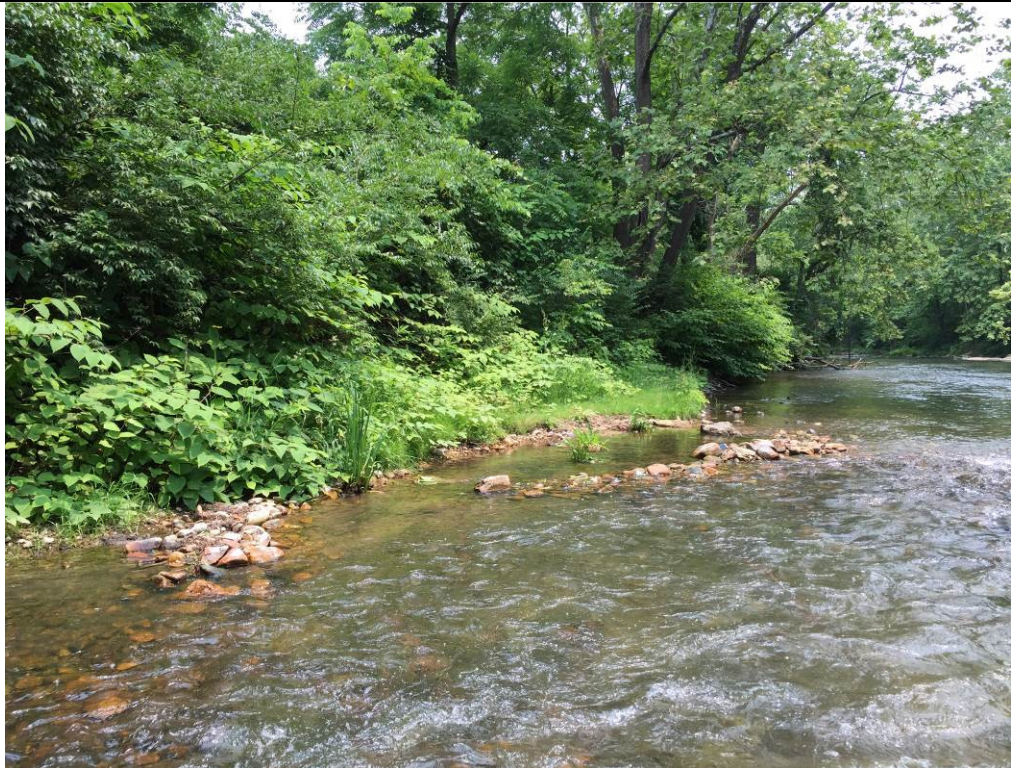
Description:
Cobble riffle at the upstream extent of STMP-07.

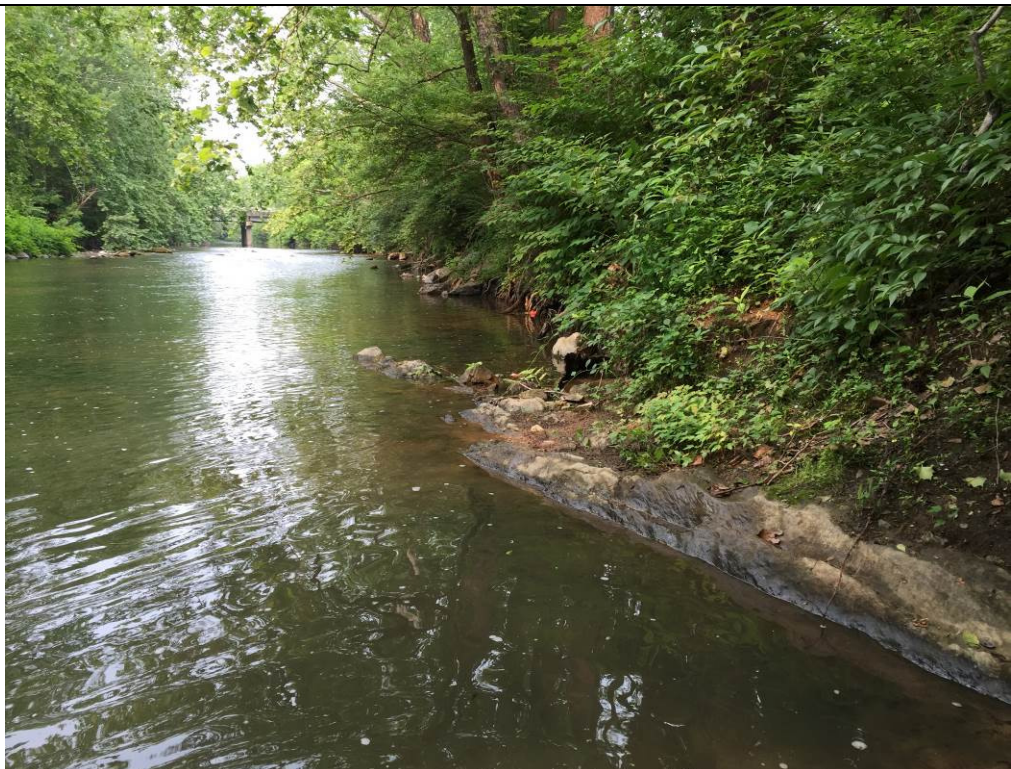
Photo No. 10	Date: 06/10/2015
------------------------	----------------------------

Description:
Exposed bedrock on the left bank of STMP-07.

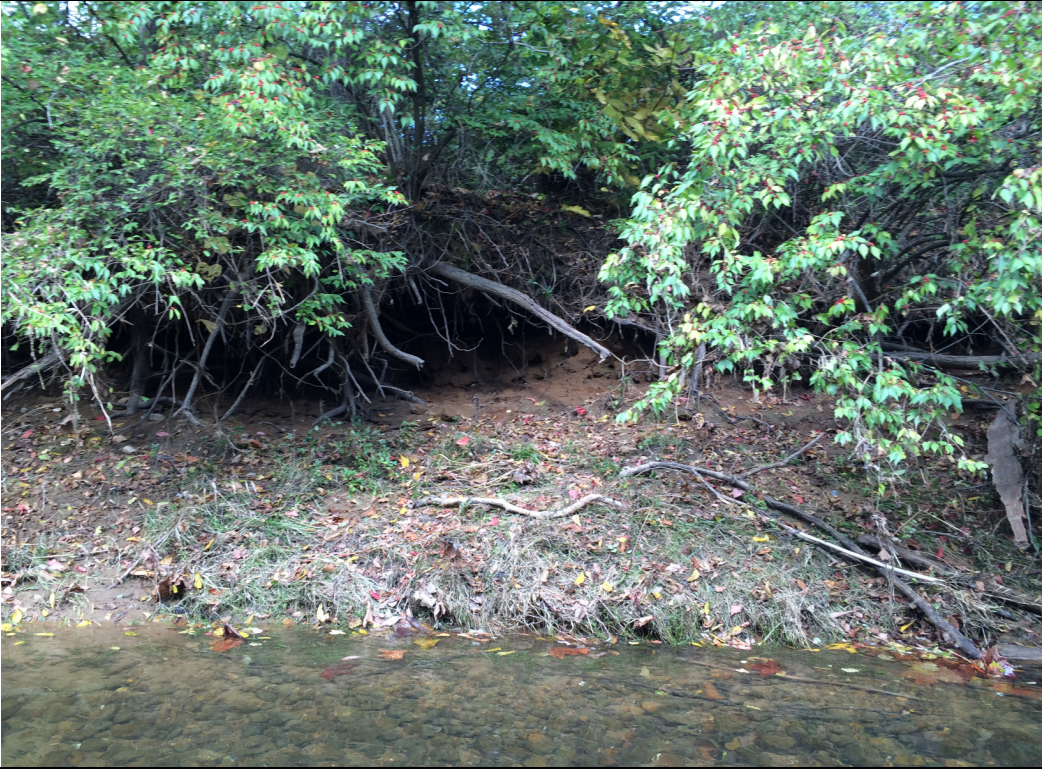
Client Name: DuPont		Site Location: South River – Short-Term Monitoring	Project No.: 60394083
Photo No.: 11	Date: 10/14/2015

Direction Photo Taken: Northwest			
Description: Erosional area with significant undercutting and exposed roots on the left bank at STMP-07.
