TechCorner: Mercury Levels in South River Fish: Why Aren't They Declining?

Univ. of Delaware Surveys Riverbank Using LIDAR

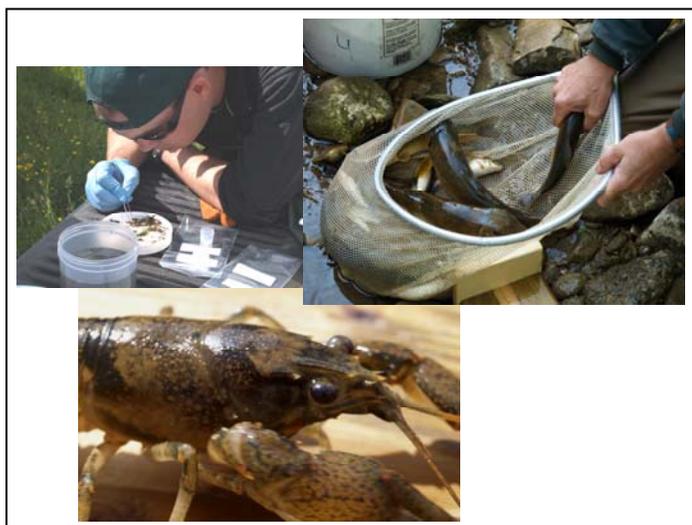
Ecological team members count critters and sample fish and crayfish to help identify where mercury may be entering the food chain.
