Geomorphology of S River Progress Report, Fall 2005

Dept. of Geology

University of Delaware

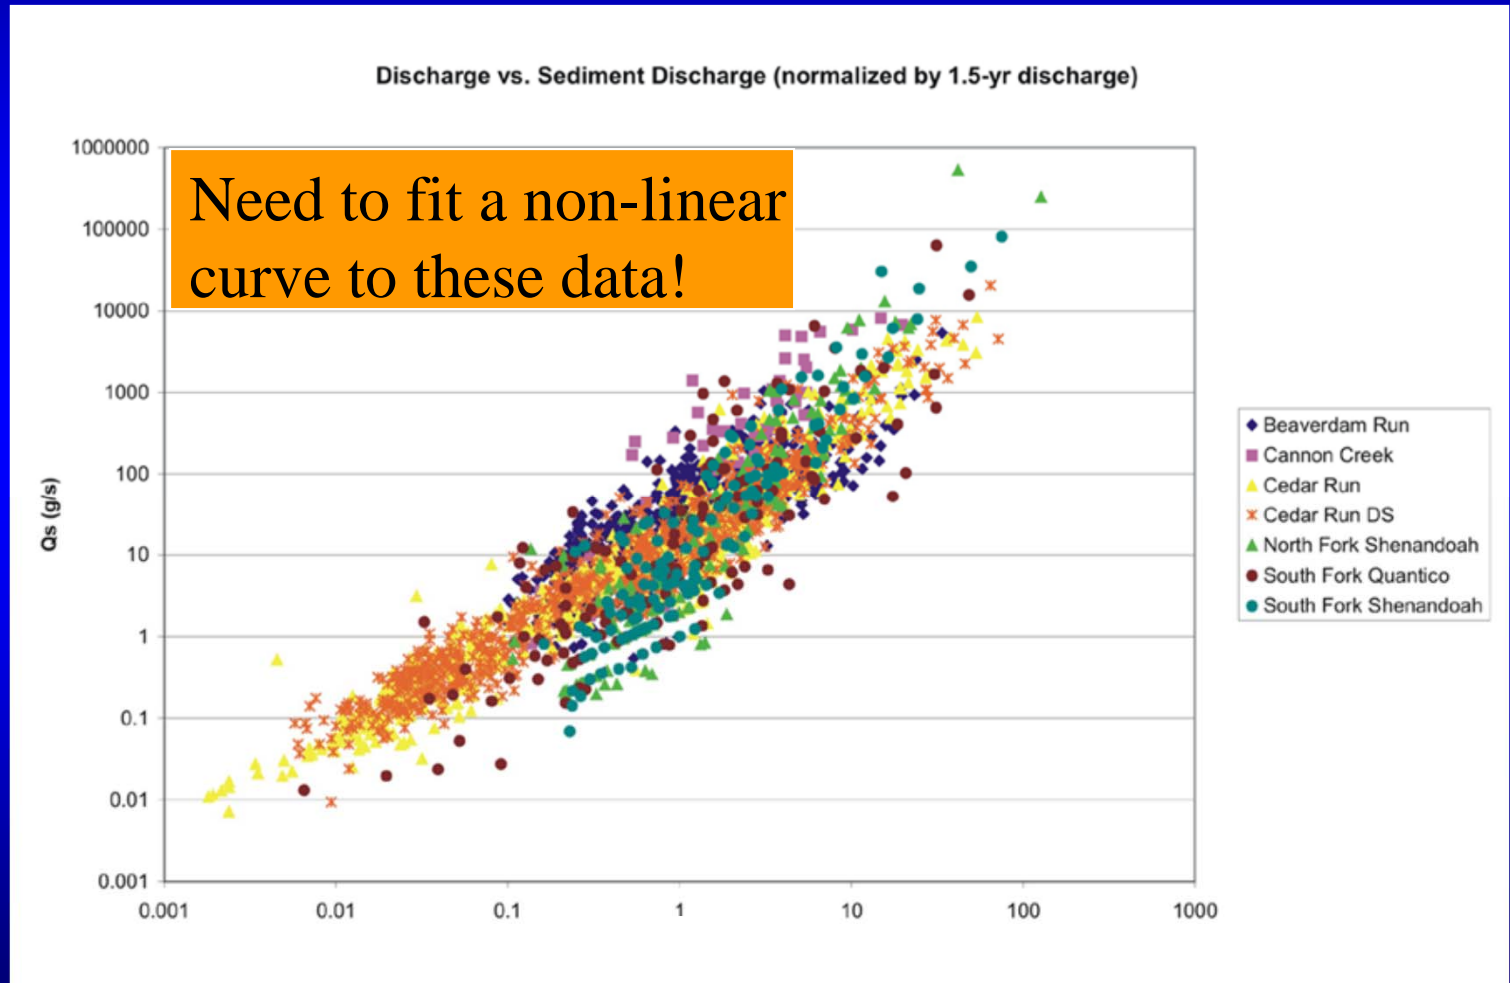
Suspended Sediment Inputs (and Outputs) Determined From A Regional Sediment Rating Curve

Sediment
Flux
(g/s)

Mean Daily Water Discharge/ 1.5 Year Water Discharge

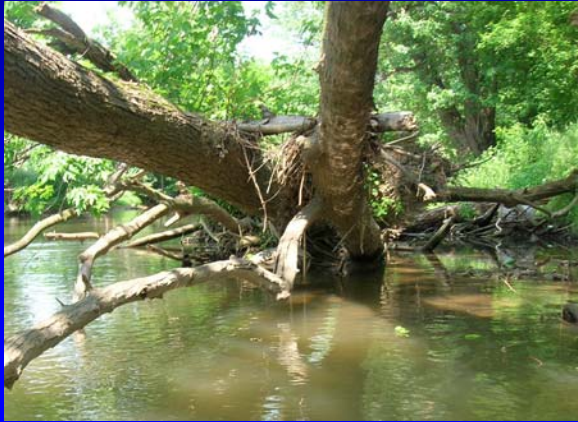
Riffles that accumulate LWD

- Mud is stored in deposits along the margins of the channel in areas of low velocity caused by:
 - Channel expansions
 - Eddies
 - Reduced slope
 - Large woody debris

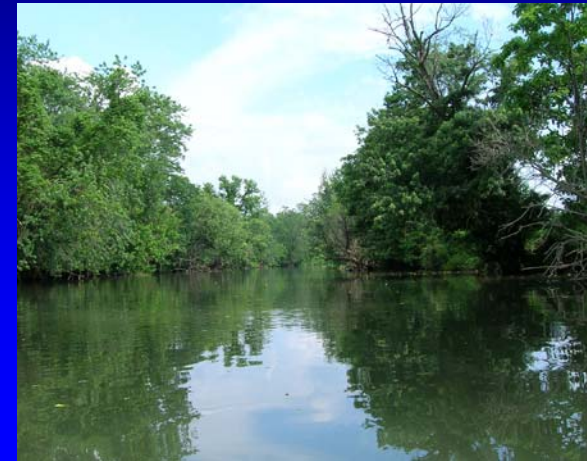
Long Pools in Areas of Low Slope

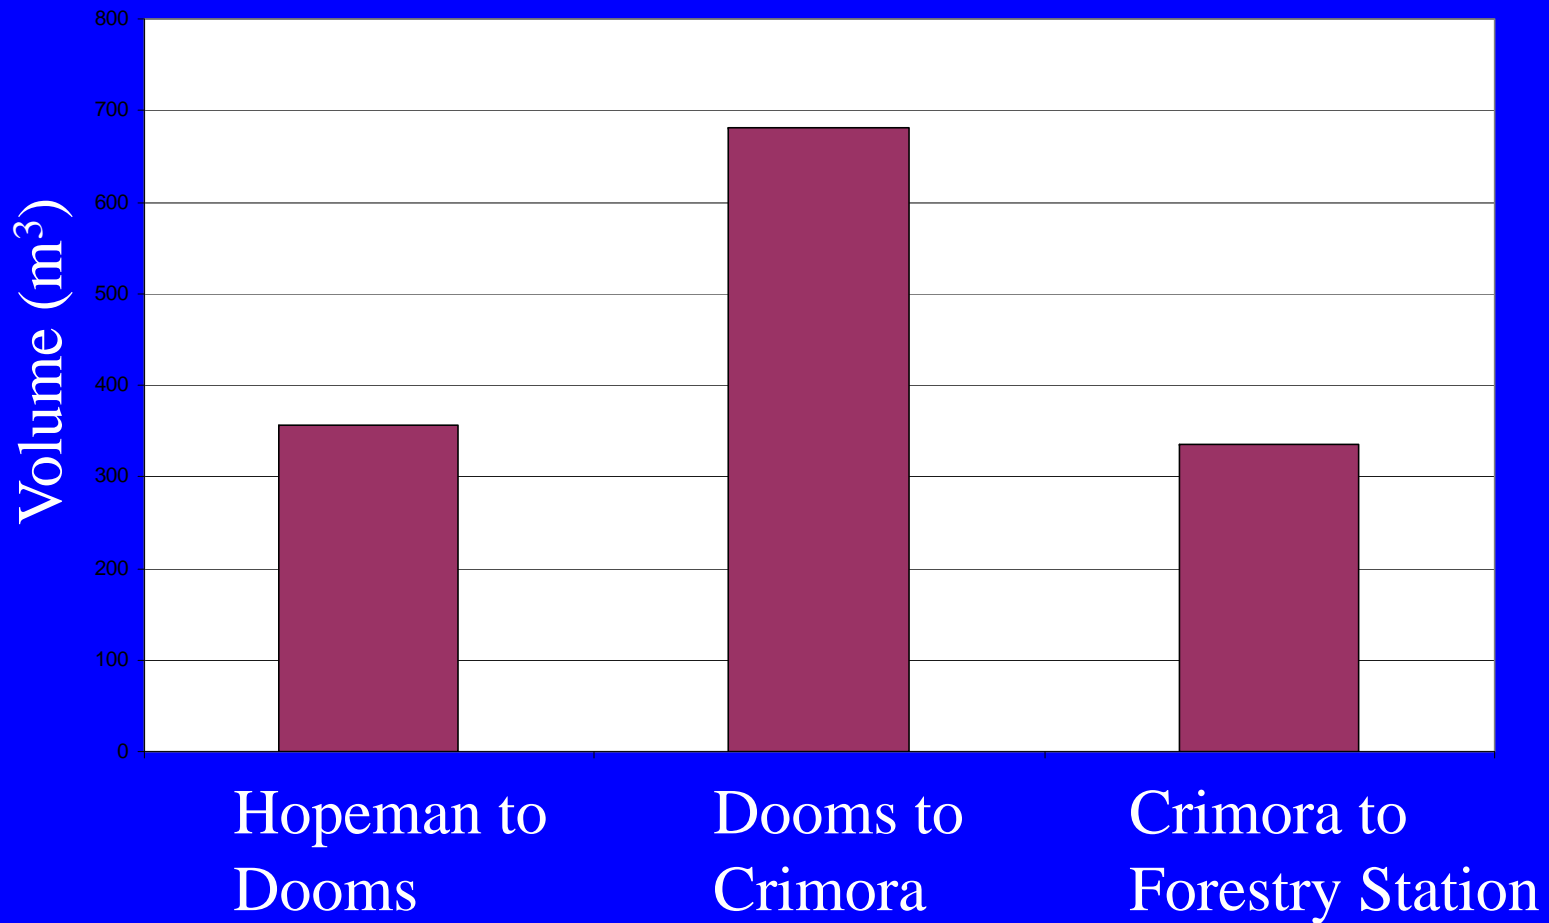
Storage Volumes by River Reach

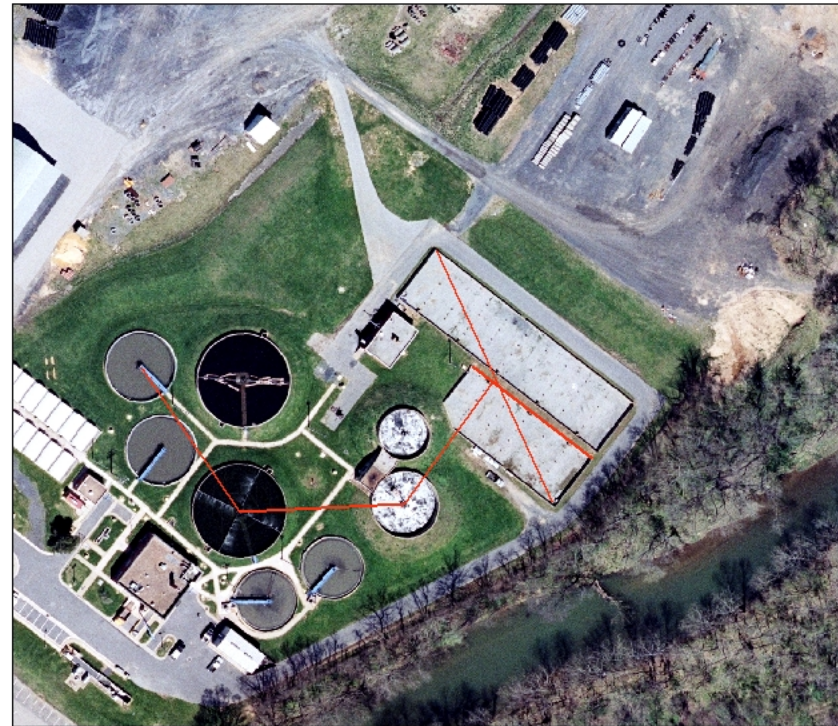
Red Lines Network Used In
Correlation Between Aerial Photos.
Lines:
Joining Center Of Tanks
Parallel With Building
Diagonal

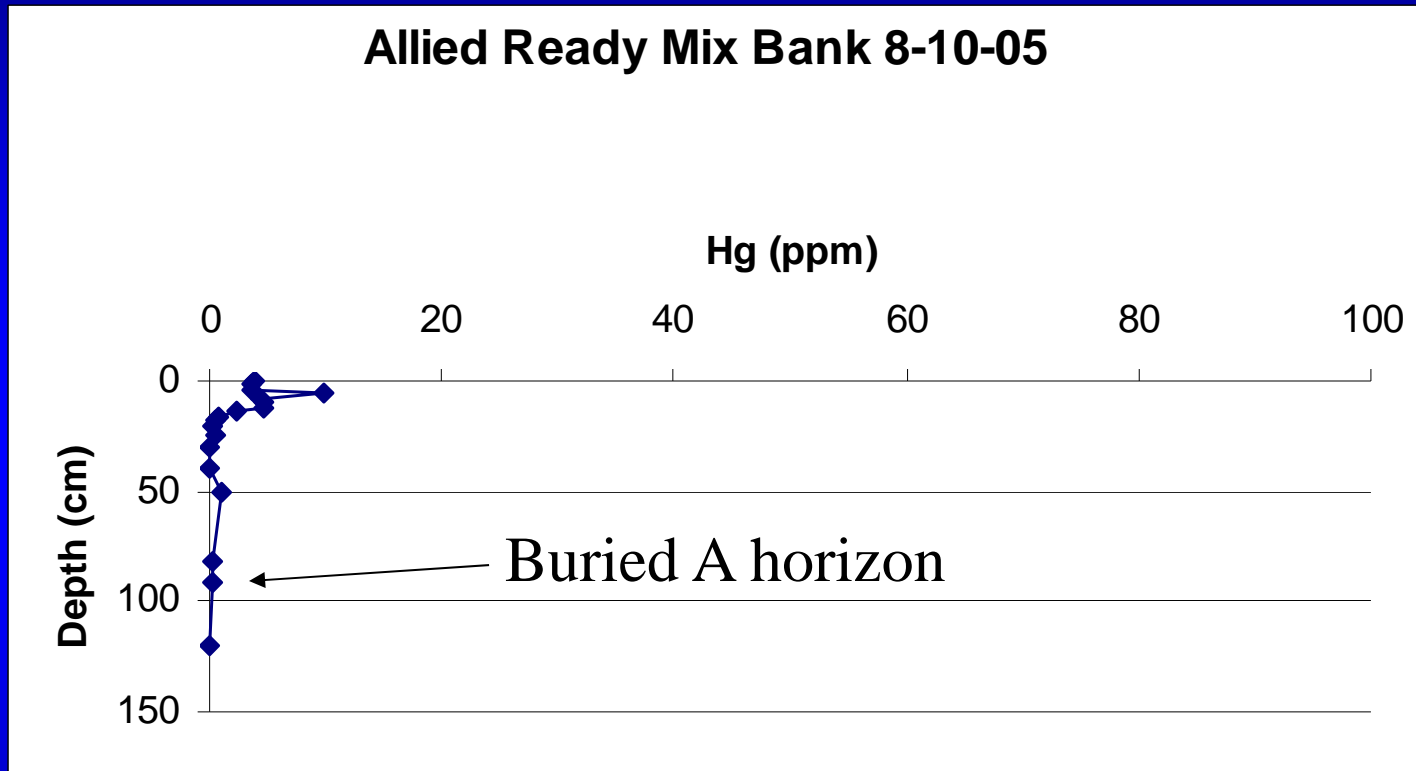
Allied Ready Mix

- Sandy sediment
- Mostly deposited far from channel ?
- Buried A horizon 81-92 cm

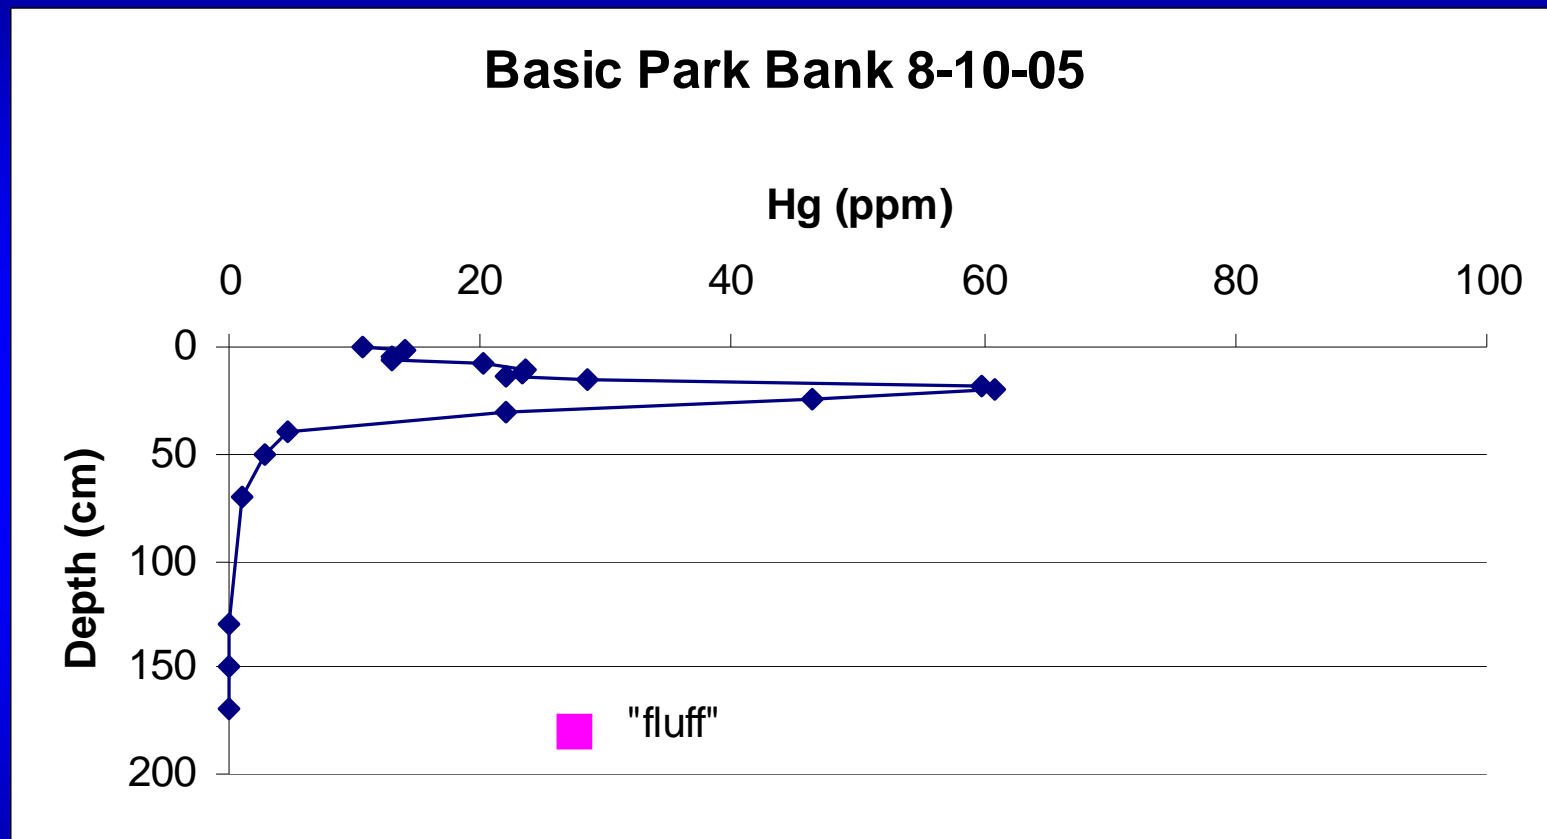
Basic Park 8-10-05

- Silty sediment
- Deposited adjacent to channel
- “Fluff” is part of a channel margin mud deposit at base of bank

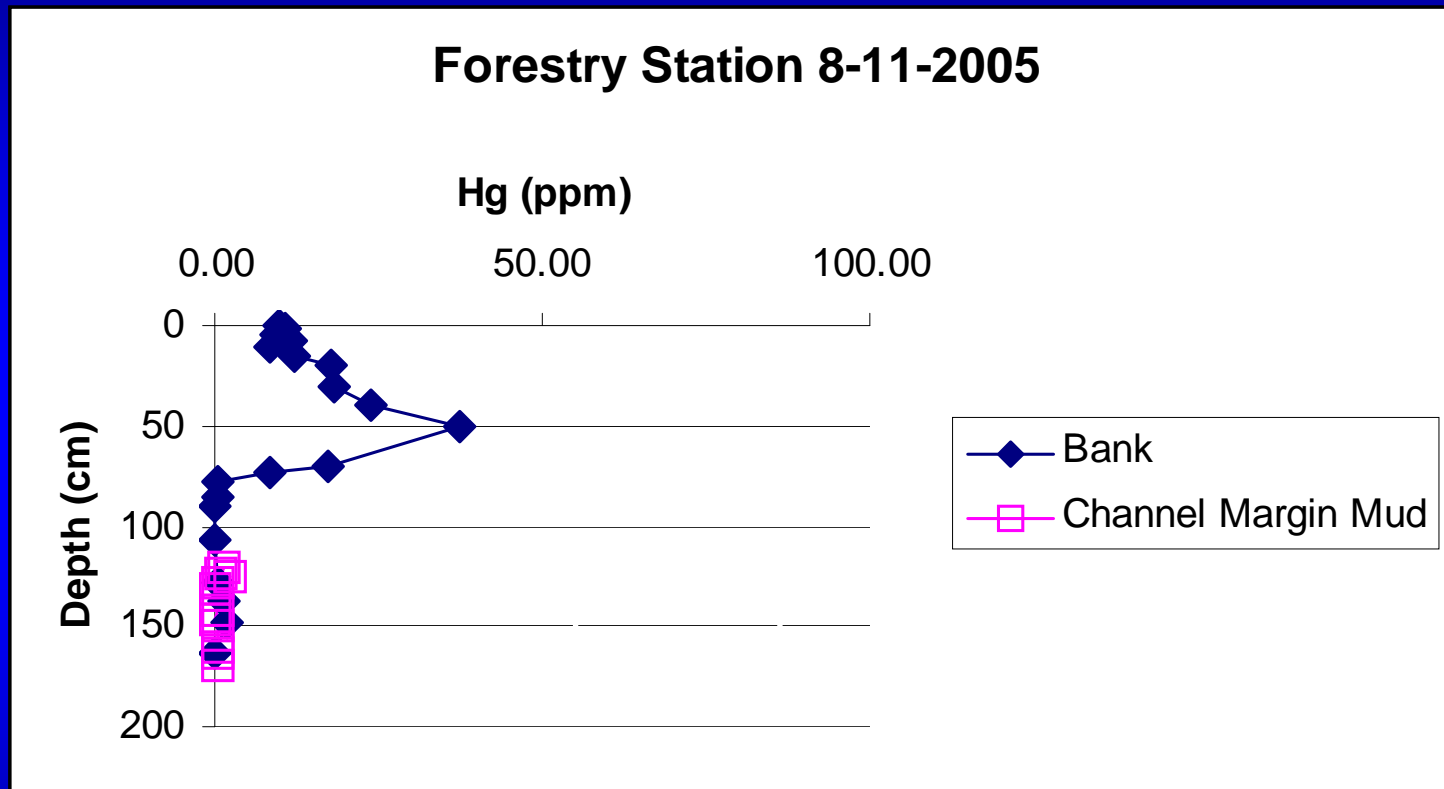
Forestry Station Eroding Bank 8-11-05

- Silty sediment
- Deposited adjacent to channel
- “Mill pond deposits” 128-144 cm
- “Channel margin mud” from adjacent bank (very low Hg not typical of most S. River transported muds)??

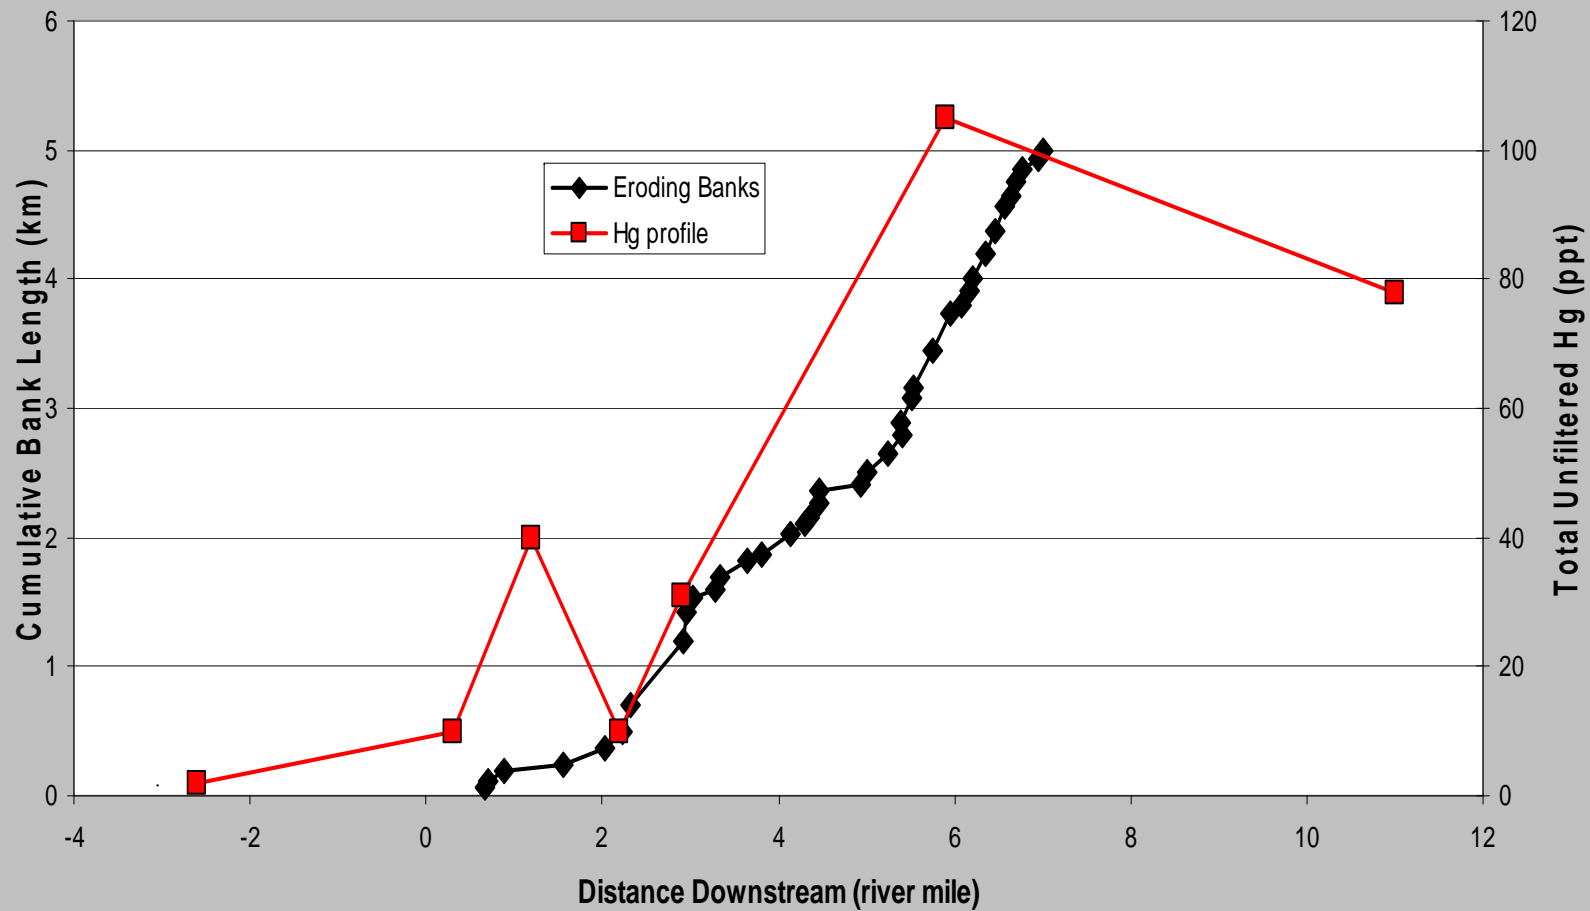
Cumulative Bank Length vs. Distance Downstream
