Geomorphological Studies

**Coring Fine Sediment
Deposits**

**Lidar Bank Erosion
Surveys, Historical
Aerial Photo Analysis**

Coring Mud Deposits

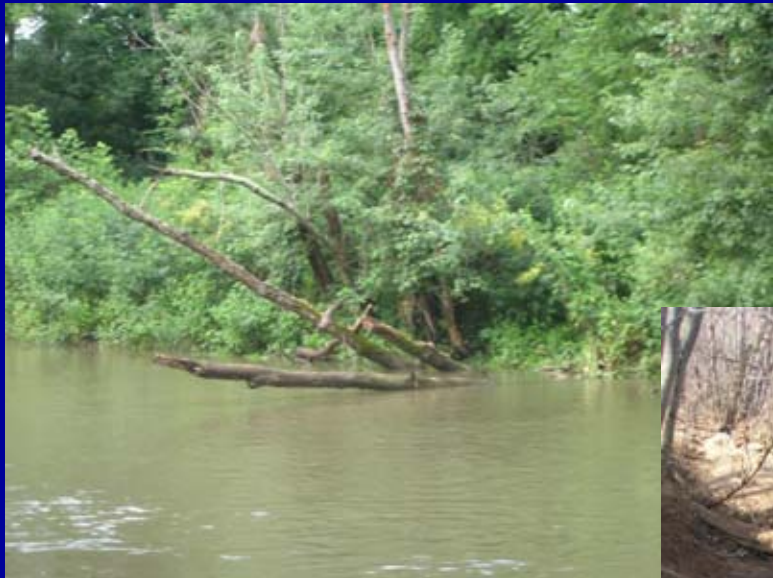
H1A

- Long pooled sections caused by bedrock or old mill dams (D5A)
- Regions downstream of riffles in channel margins with LWD accumulations (H1A, H2C)
- Bank obstructions usually caused by trees (H2A)
- Side channel backwaters where flow separates around islands (D7A)

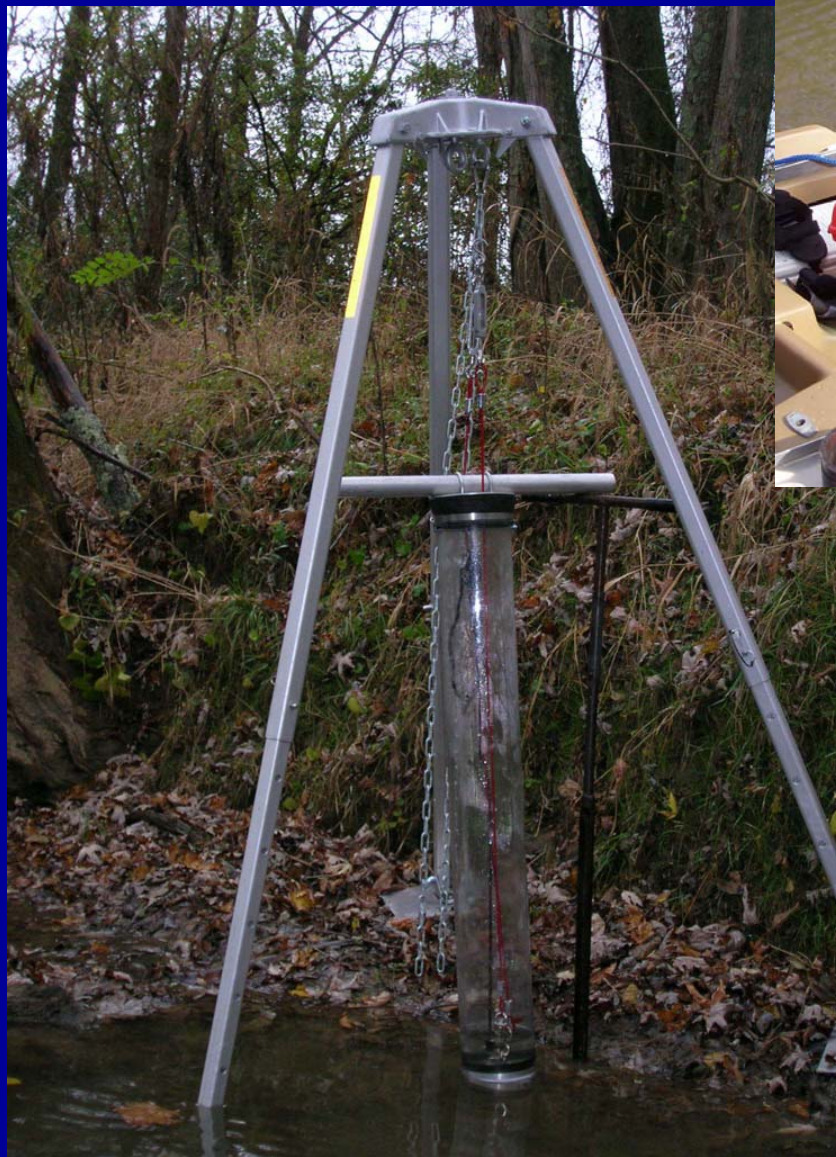
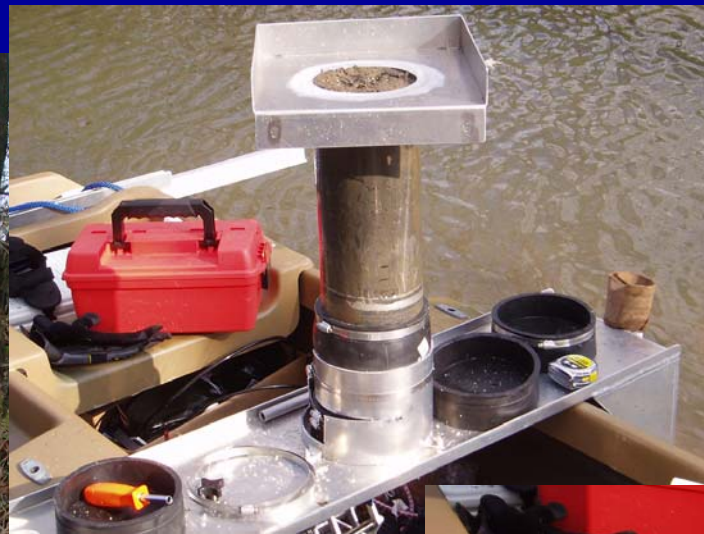
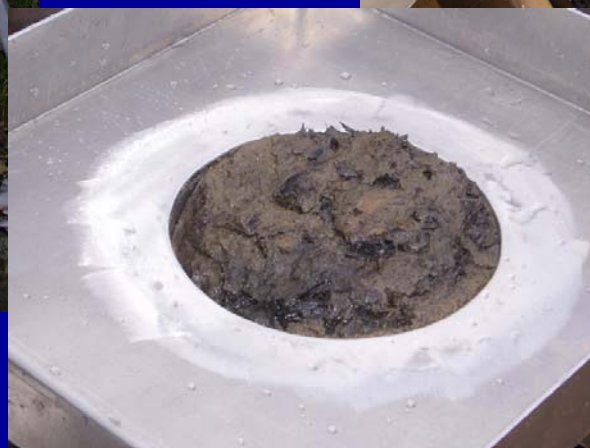
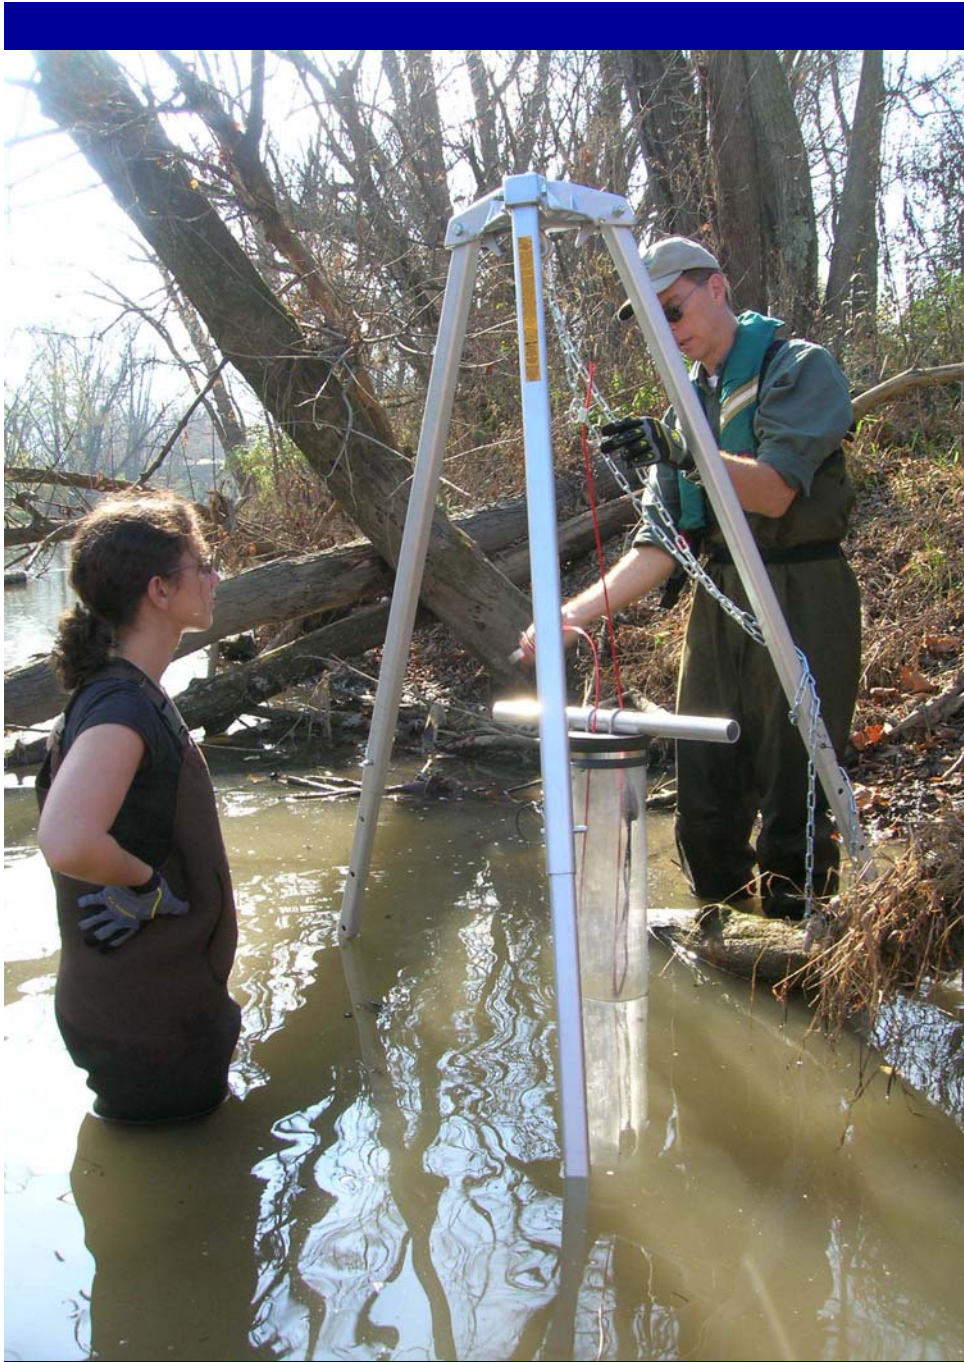
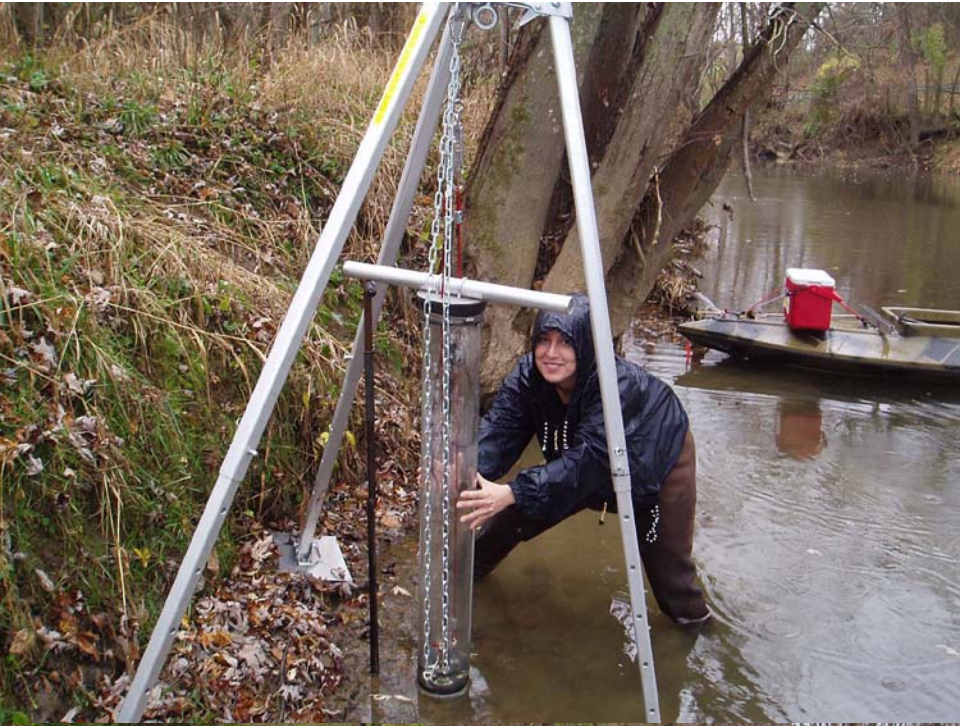
Summary of Coring Methods

- Tripod placed over mud deposit
- Core pipe (6-inch Teflon tube) attached
- Piston with valve at the top to regulate suction
- Extruded on apparatus attached to boat
- Sampled for analytes in the field and at Forestry Center

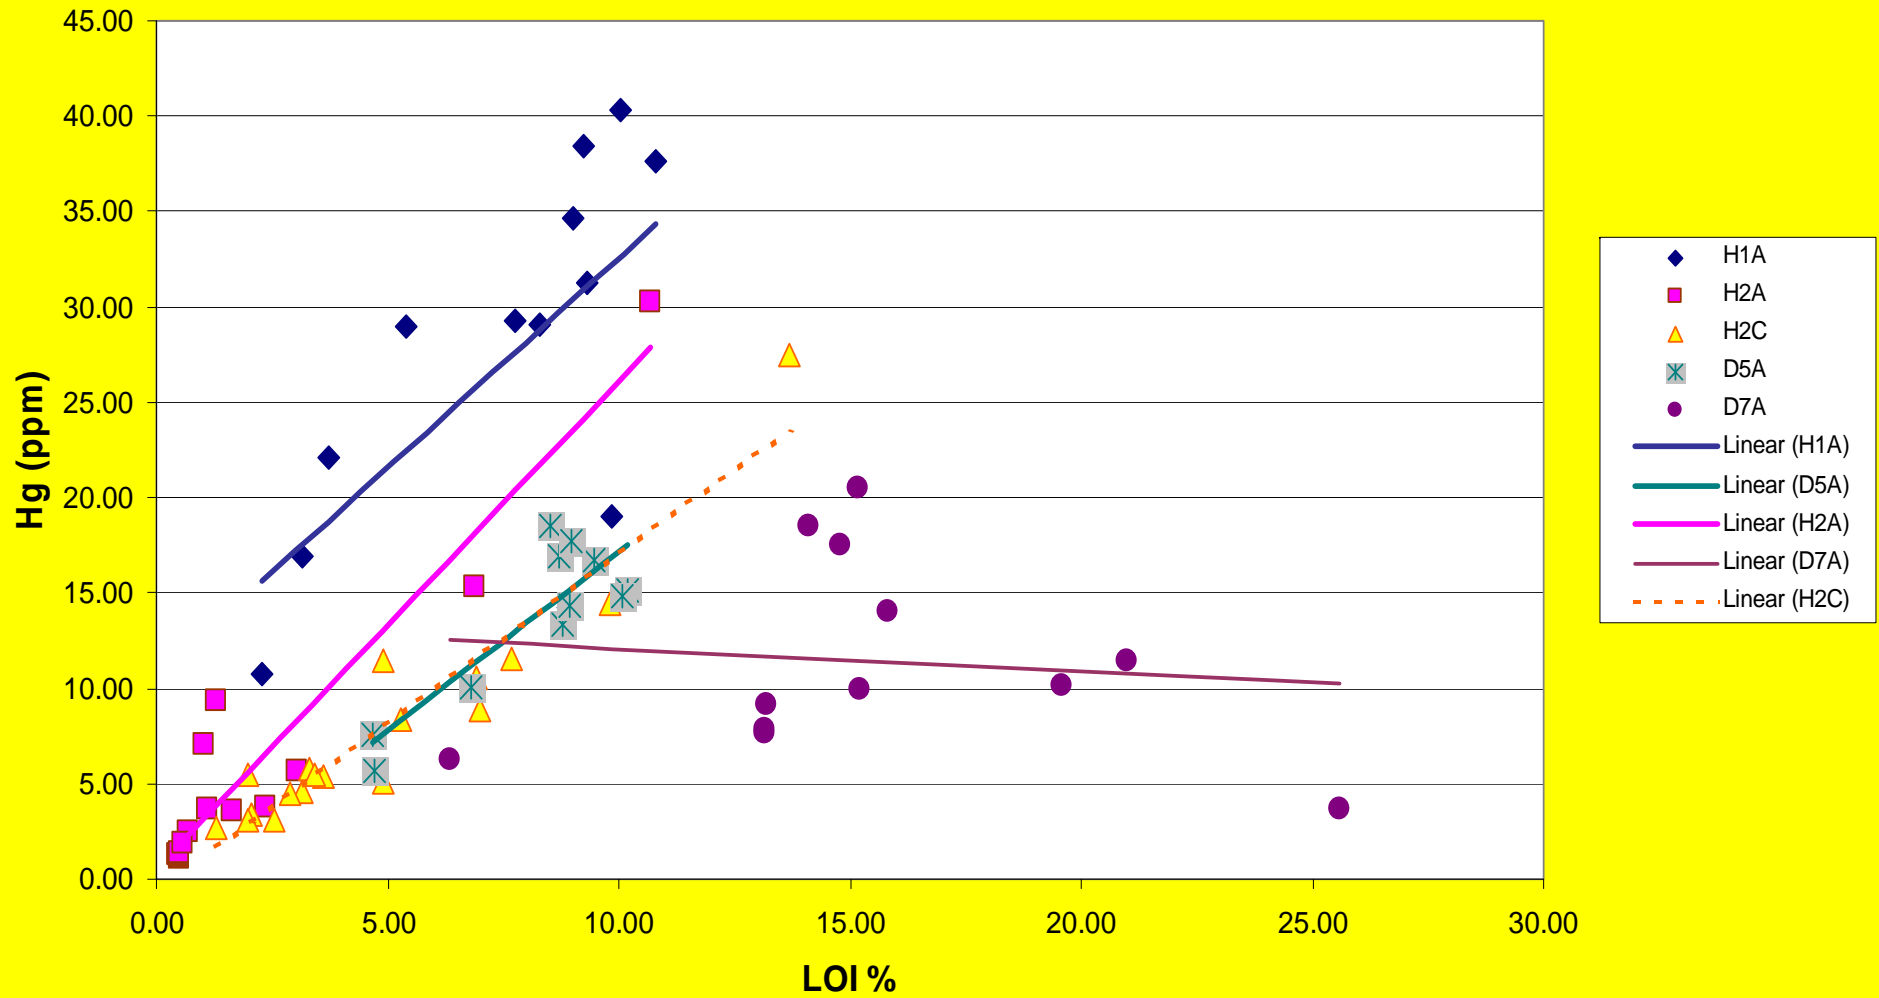
- Appears to be a good correlation with Hg and LOI and mud
- For each core, used multiple regression to obtain equations relating Hg concentrations to concentrations of mud and LOIS
- Used regression equations to estimate what Hg concentrations would likely be if sand was not present
 - Assumption: Hg associated with sand is negligible!

Hg vs LOI for Each Core...

- There is a good correlation with total Hg and LOI
- It appears that Hg concentration on LOI decreases with distance downstream from the plant
- Need to collect more cores with a wider spatial distribution to assess relationship

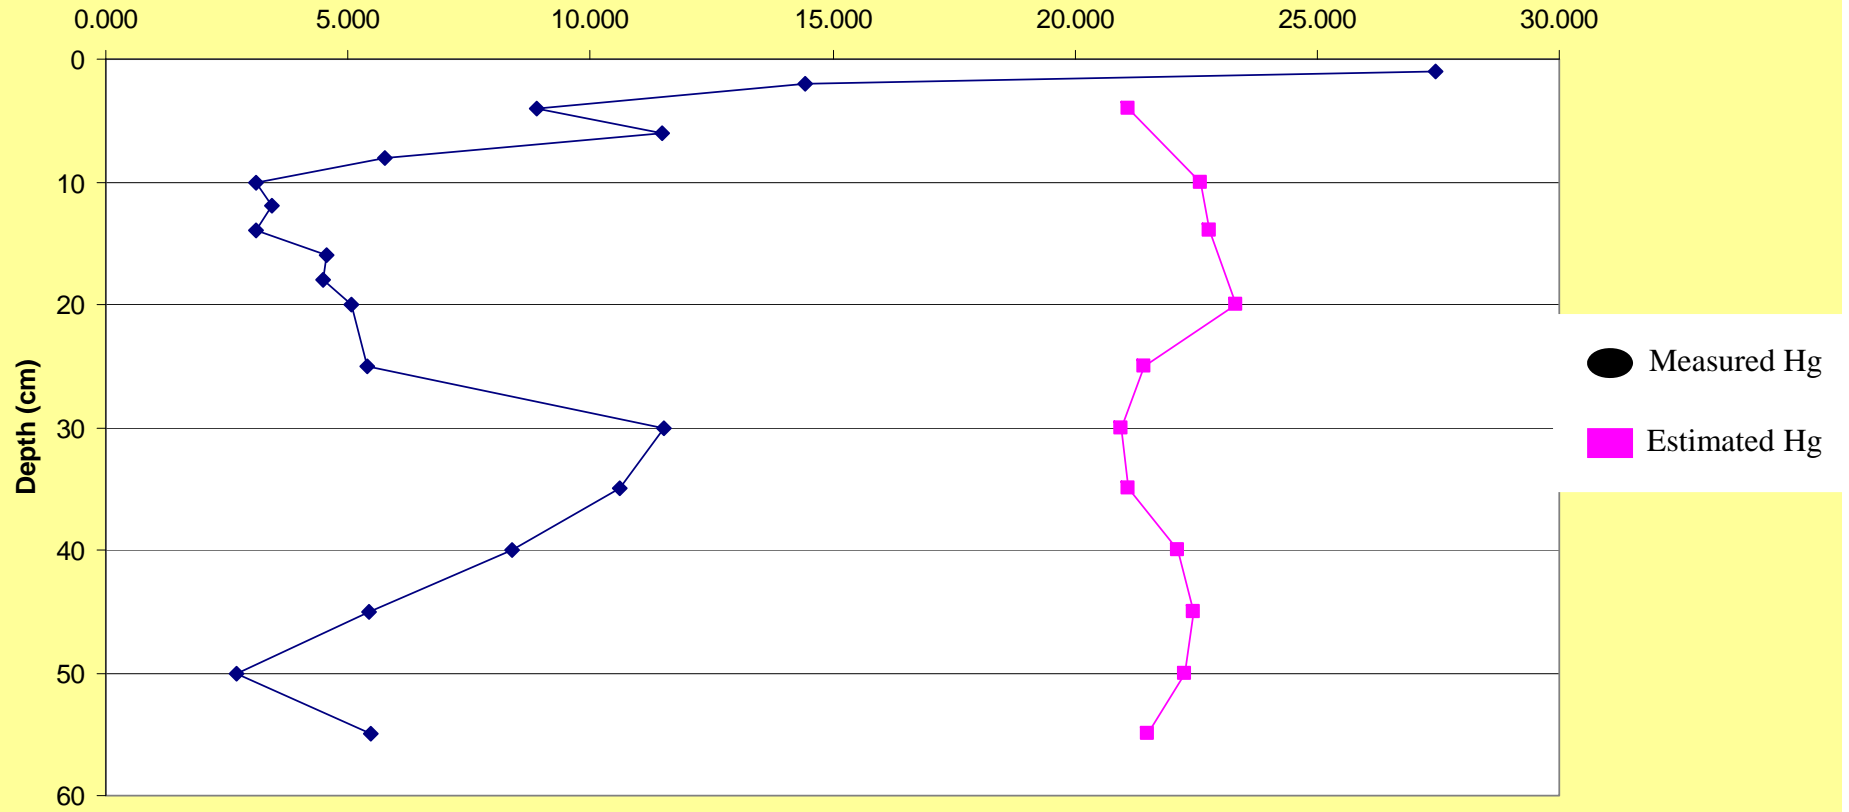
H2C

Hg (ppm)

- Measured Hg
- Estimated Hg

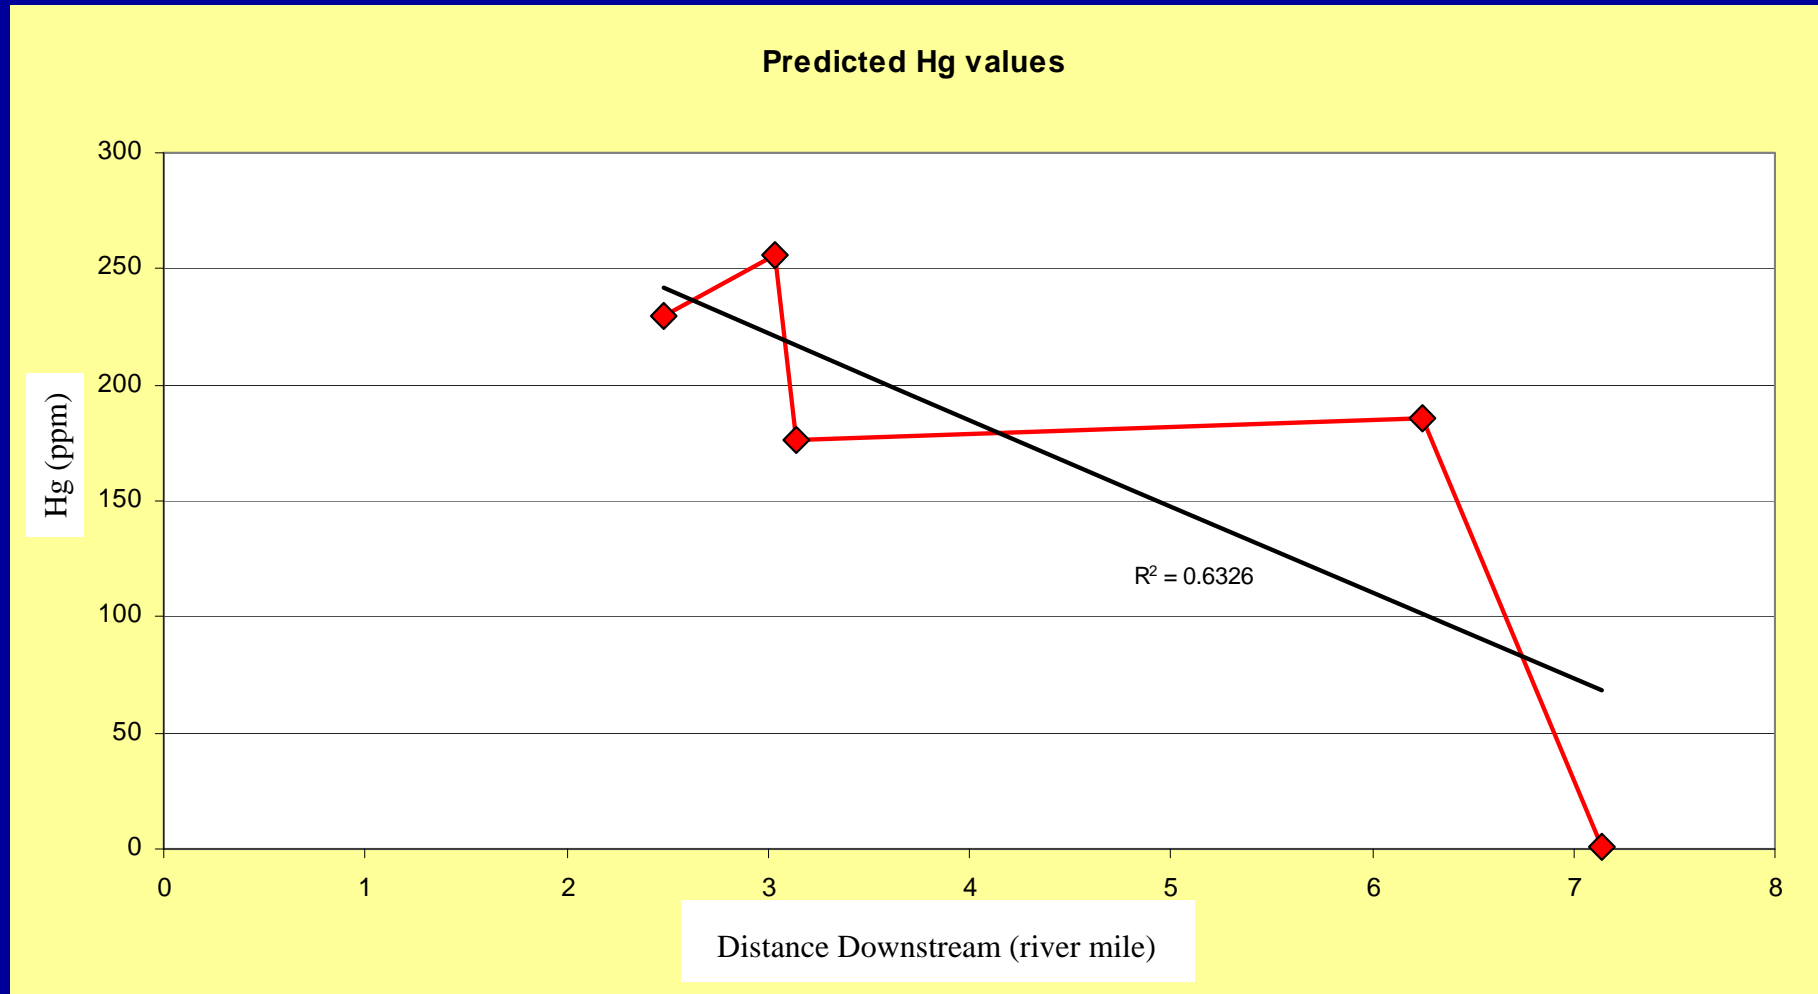
Average Hg on “LOI” (Organic Matter) vs River Mile

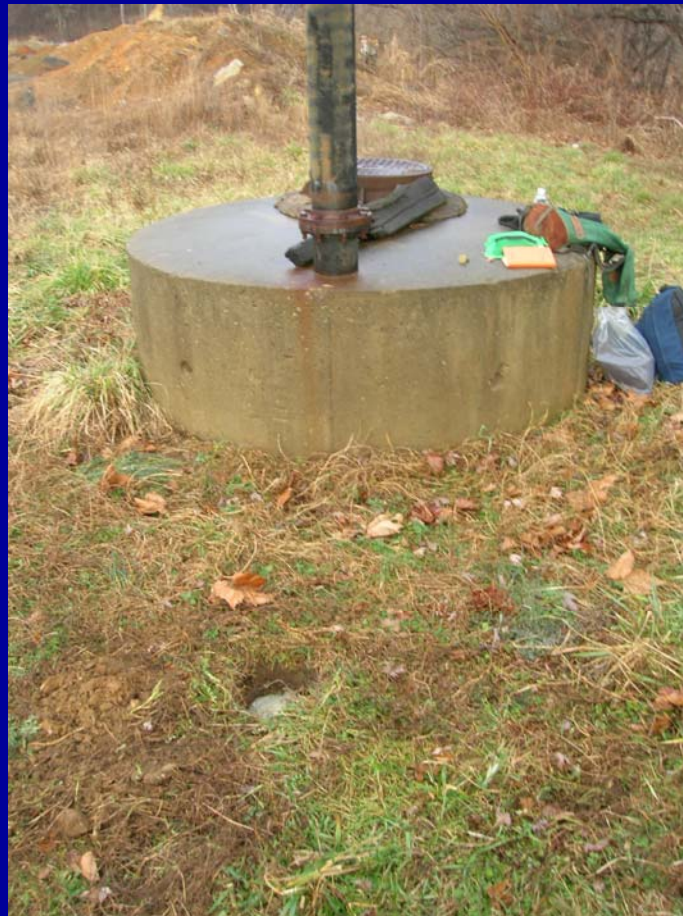
Permanent Benchmark, Wastewater Treatment Plant

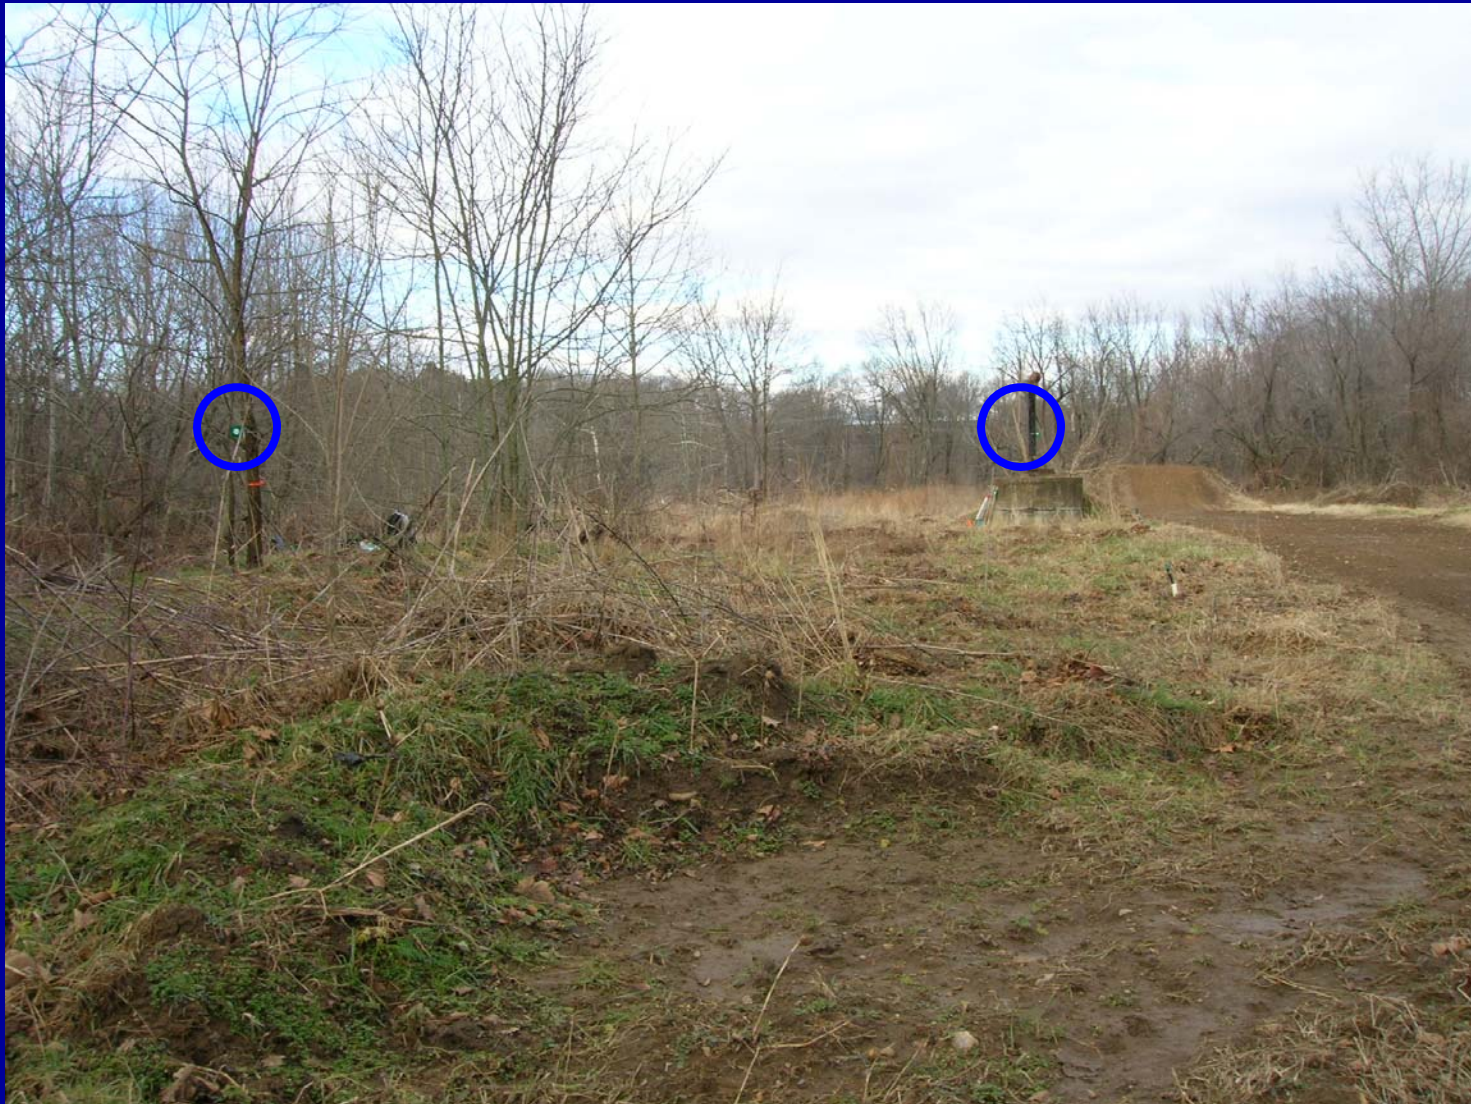
Targets on Permanent Mounts on Cutbank

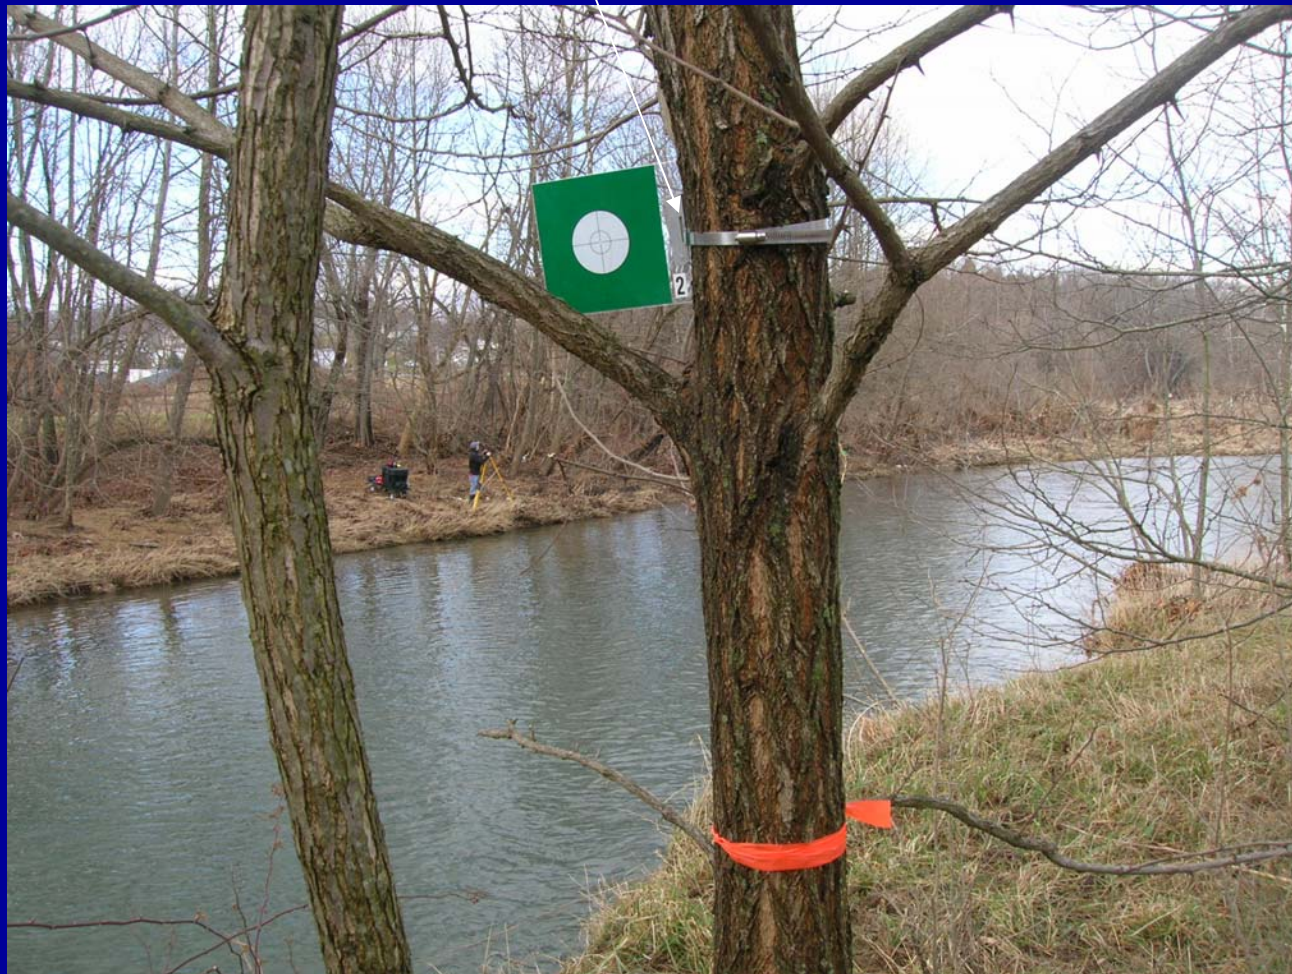
Target Closeup

Metal plate left in tree; clamp and target removed

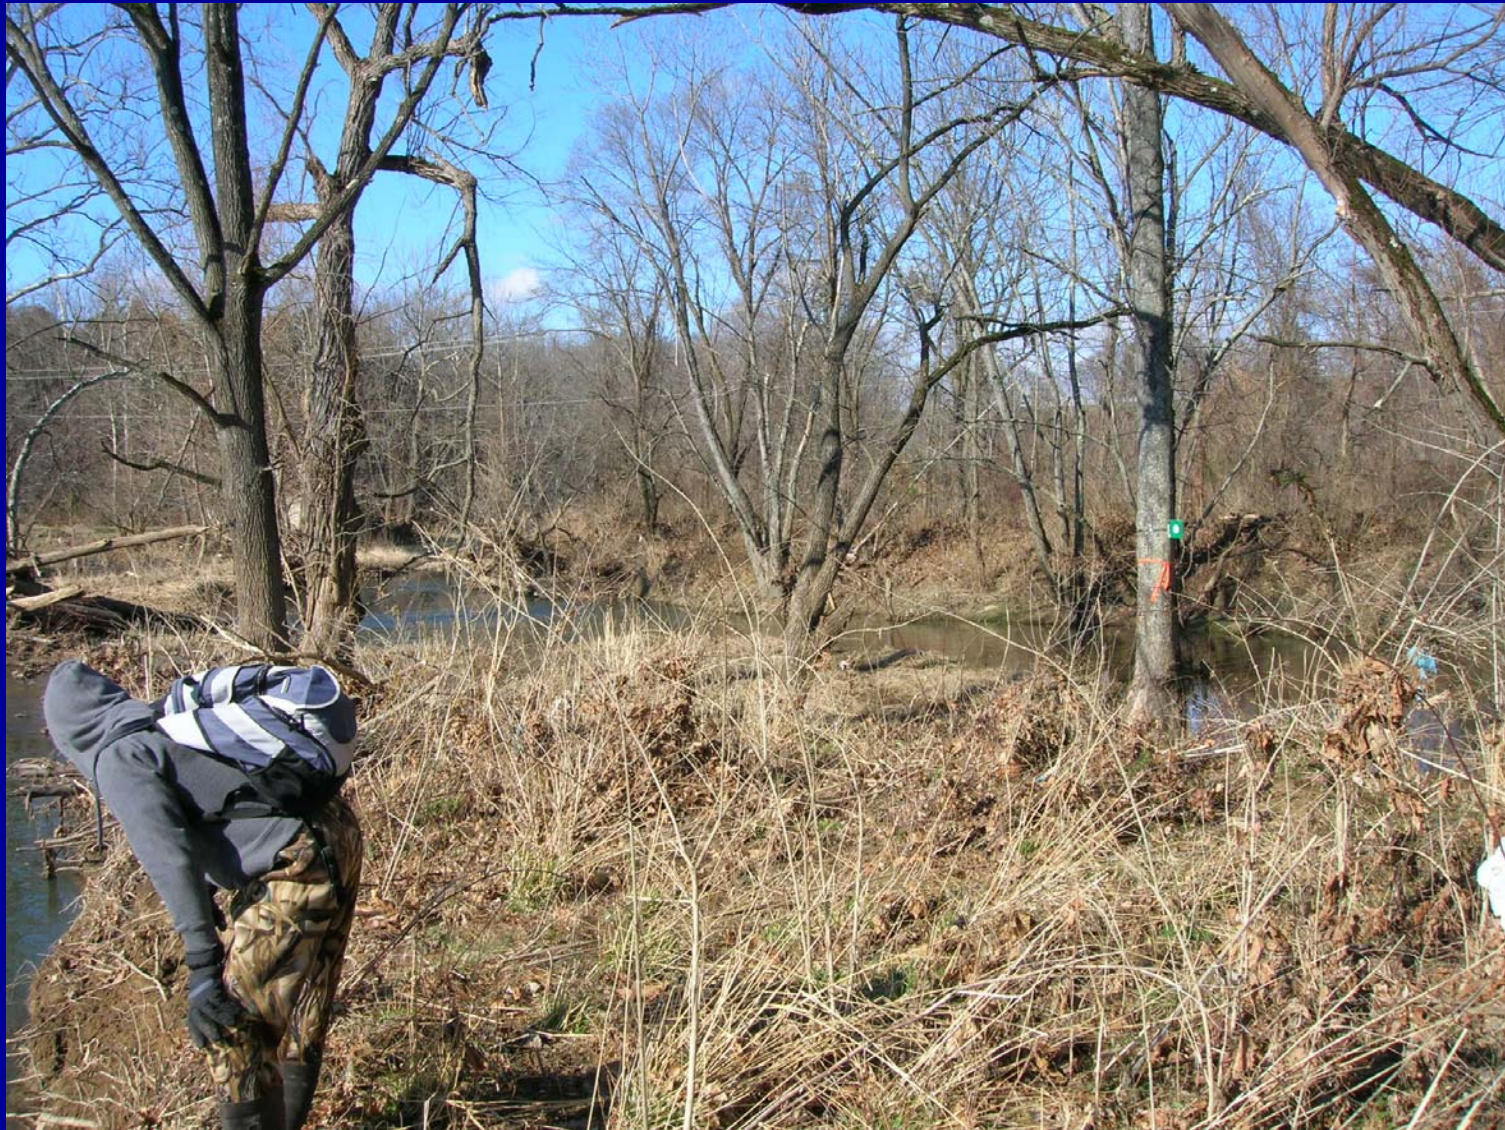
Target on tree at downstream end of bend

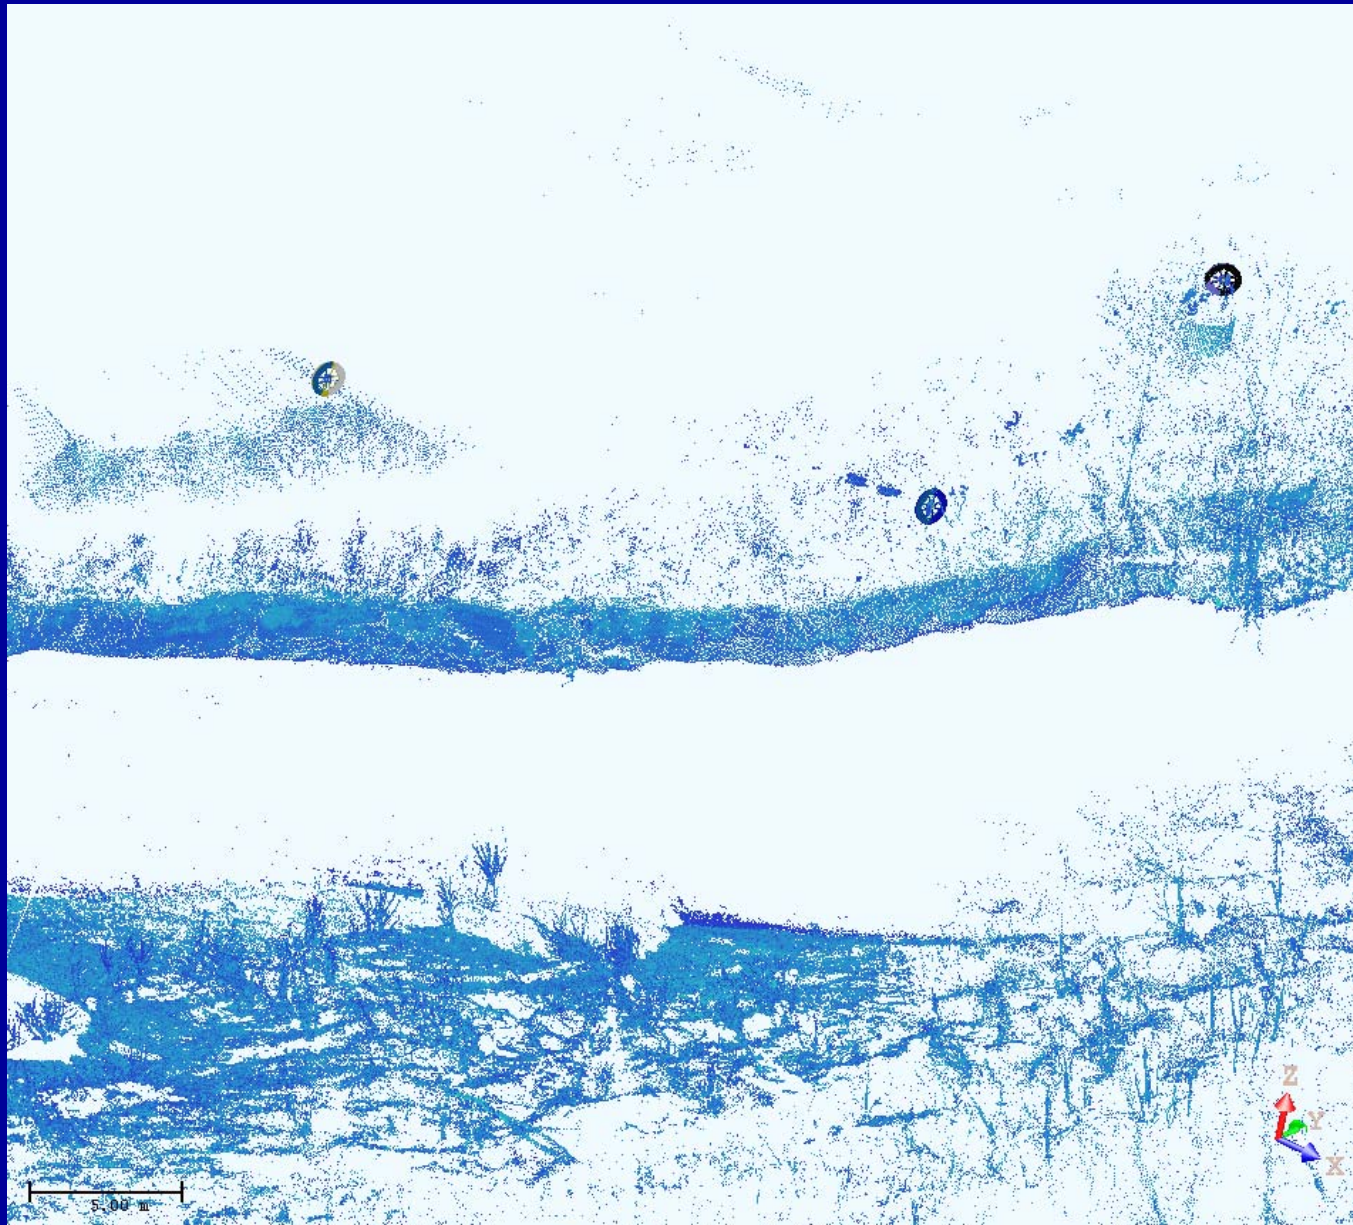
Color here is related to intensity of the returned signal..

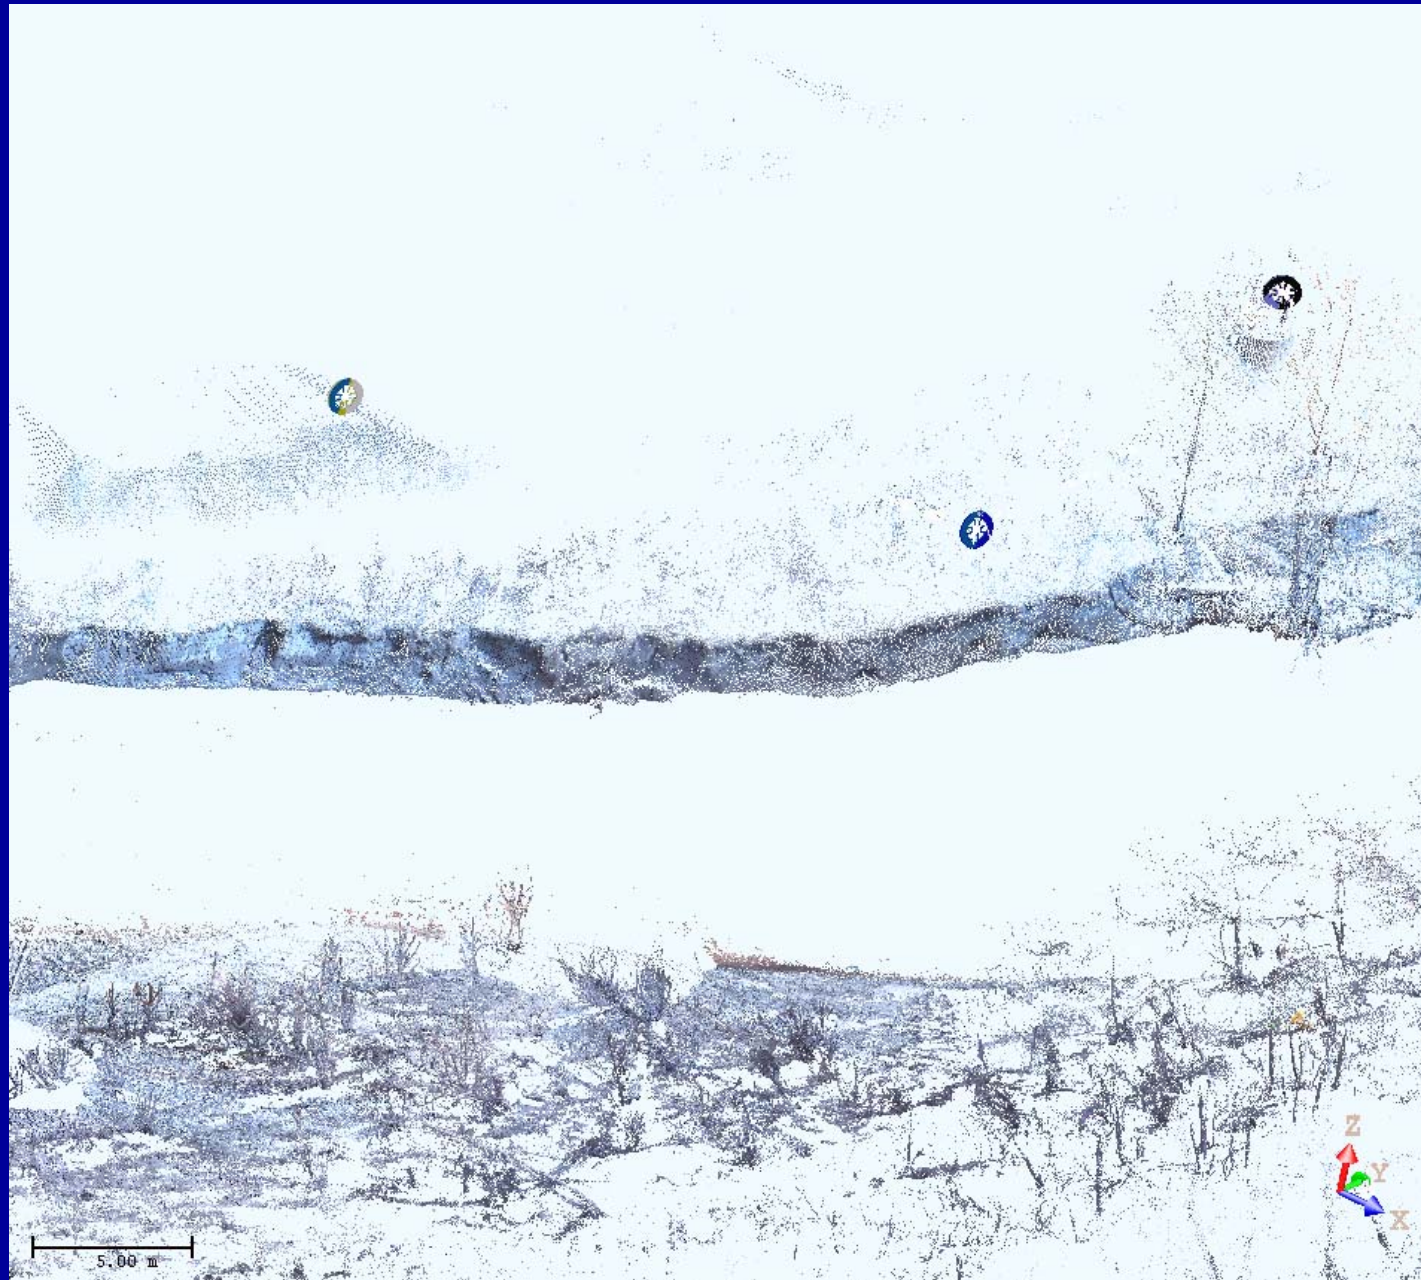
A “true color image”...

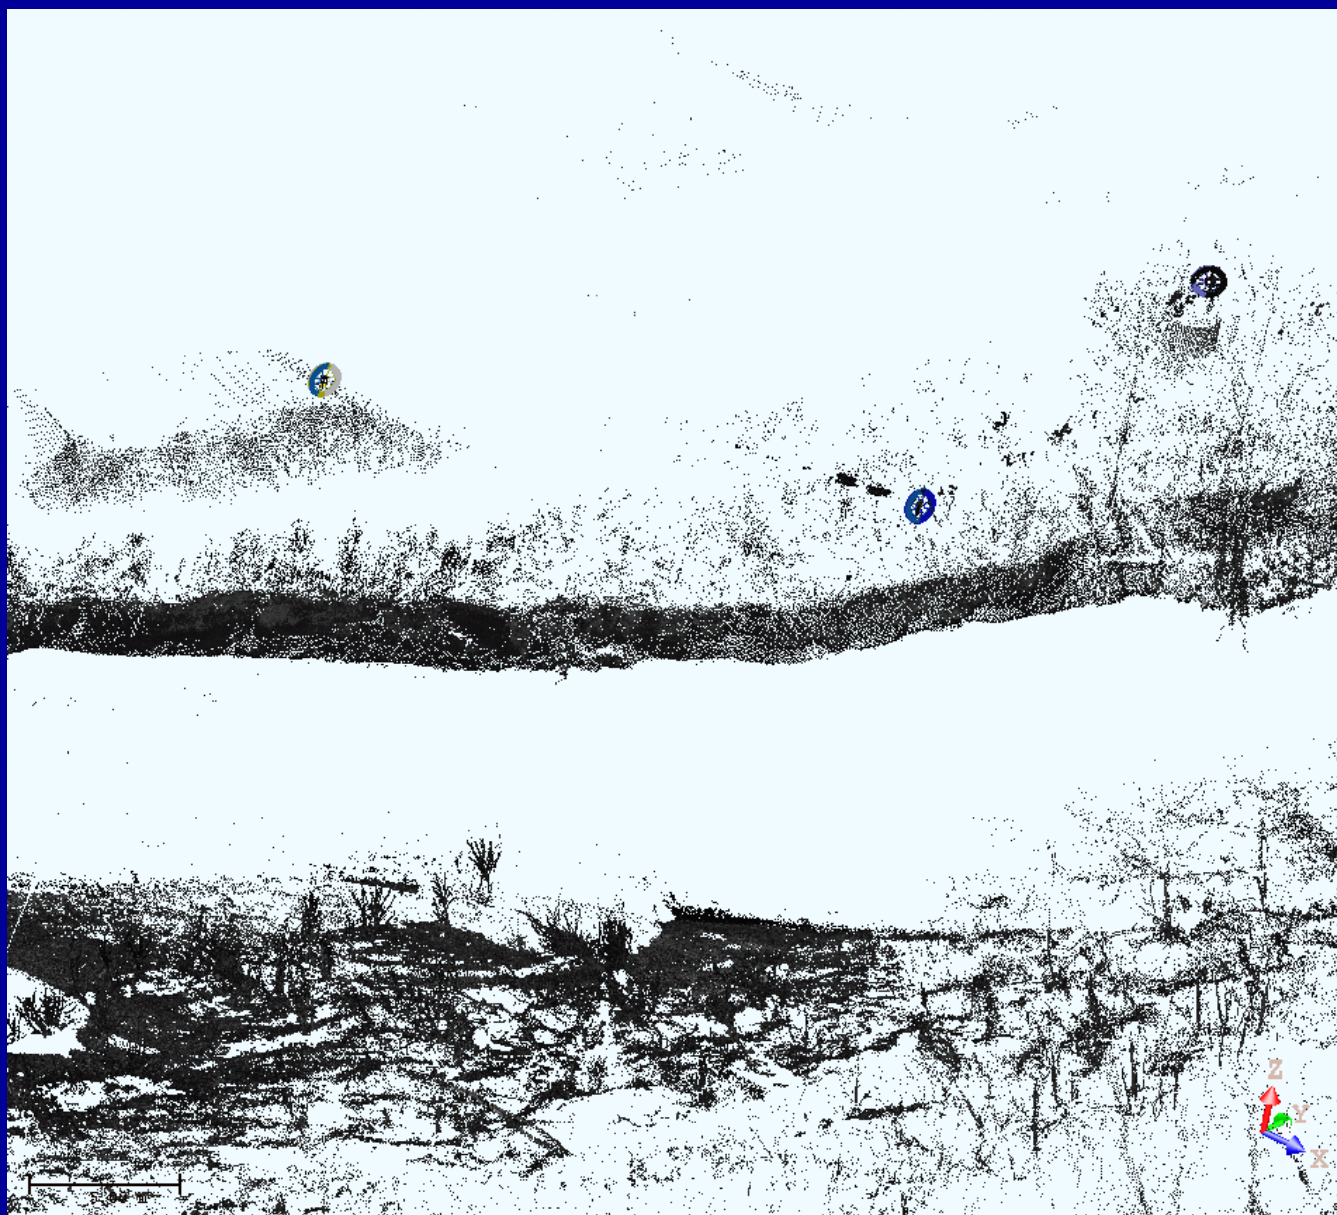
Surveyed points shown in black....

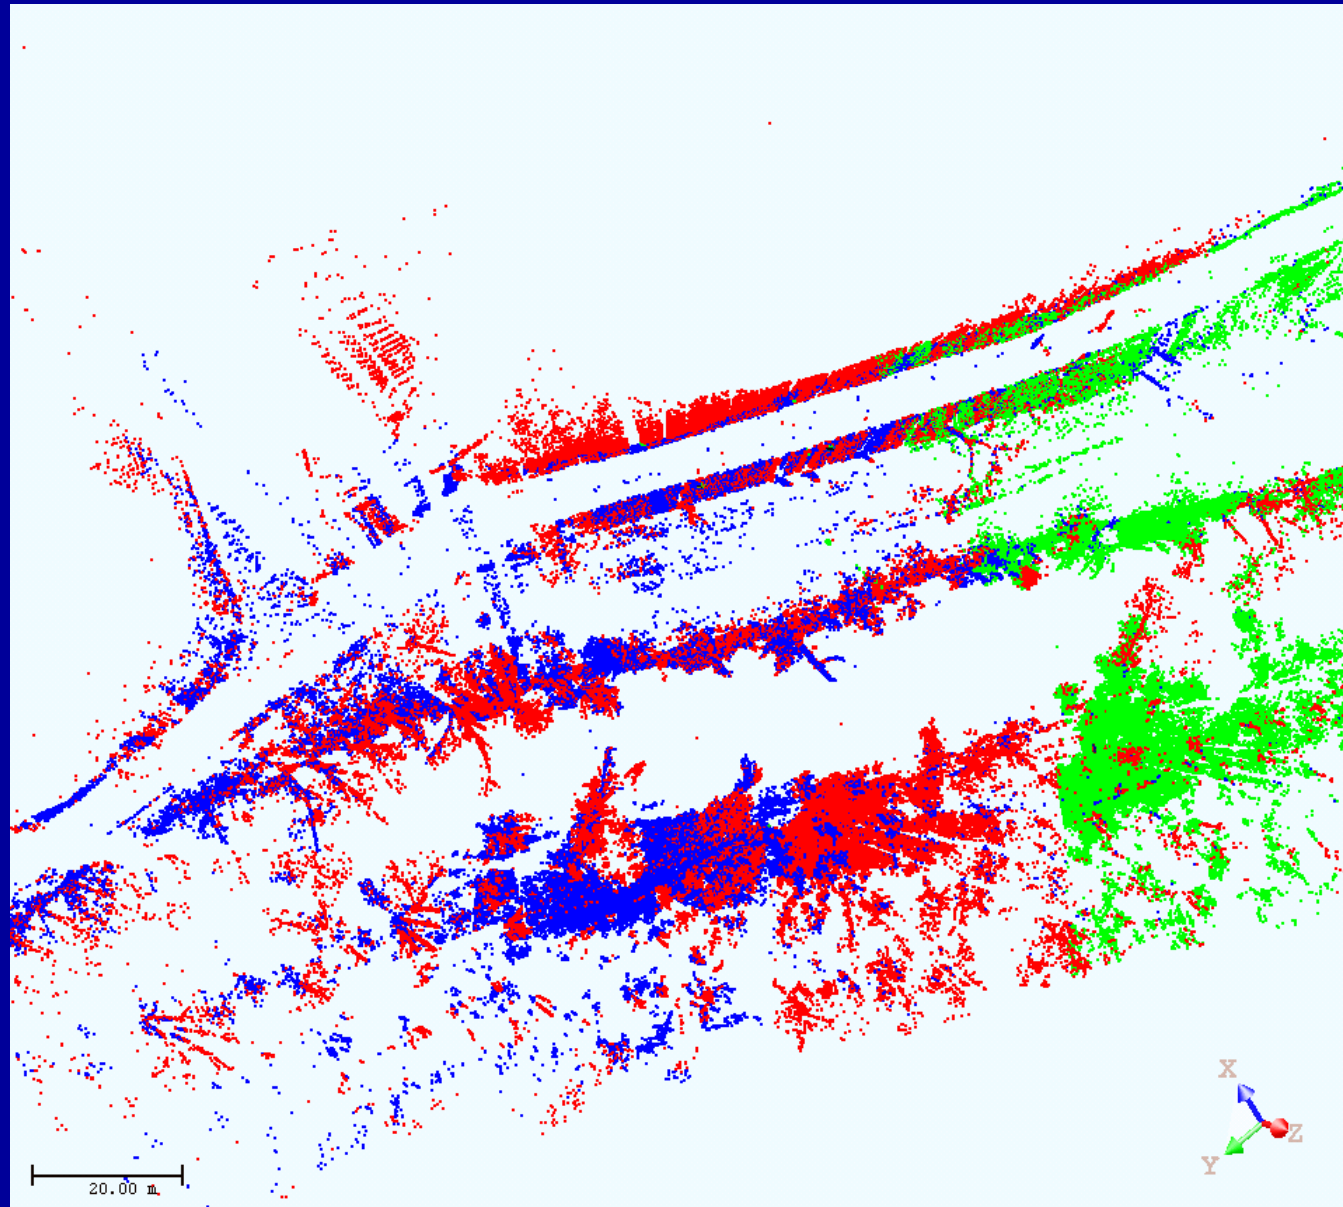
“Hopeman Bend” 2/1/06 River Mile 2.9-3.0
