Geomorphology Update

Dr. Michael O'Neal
Erica Rhoades
Dept. of Geography
U. Of Delaware

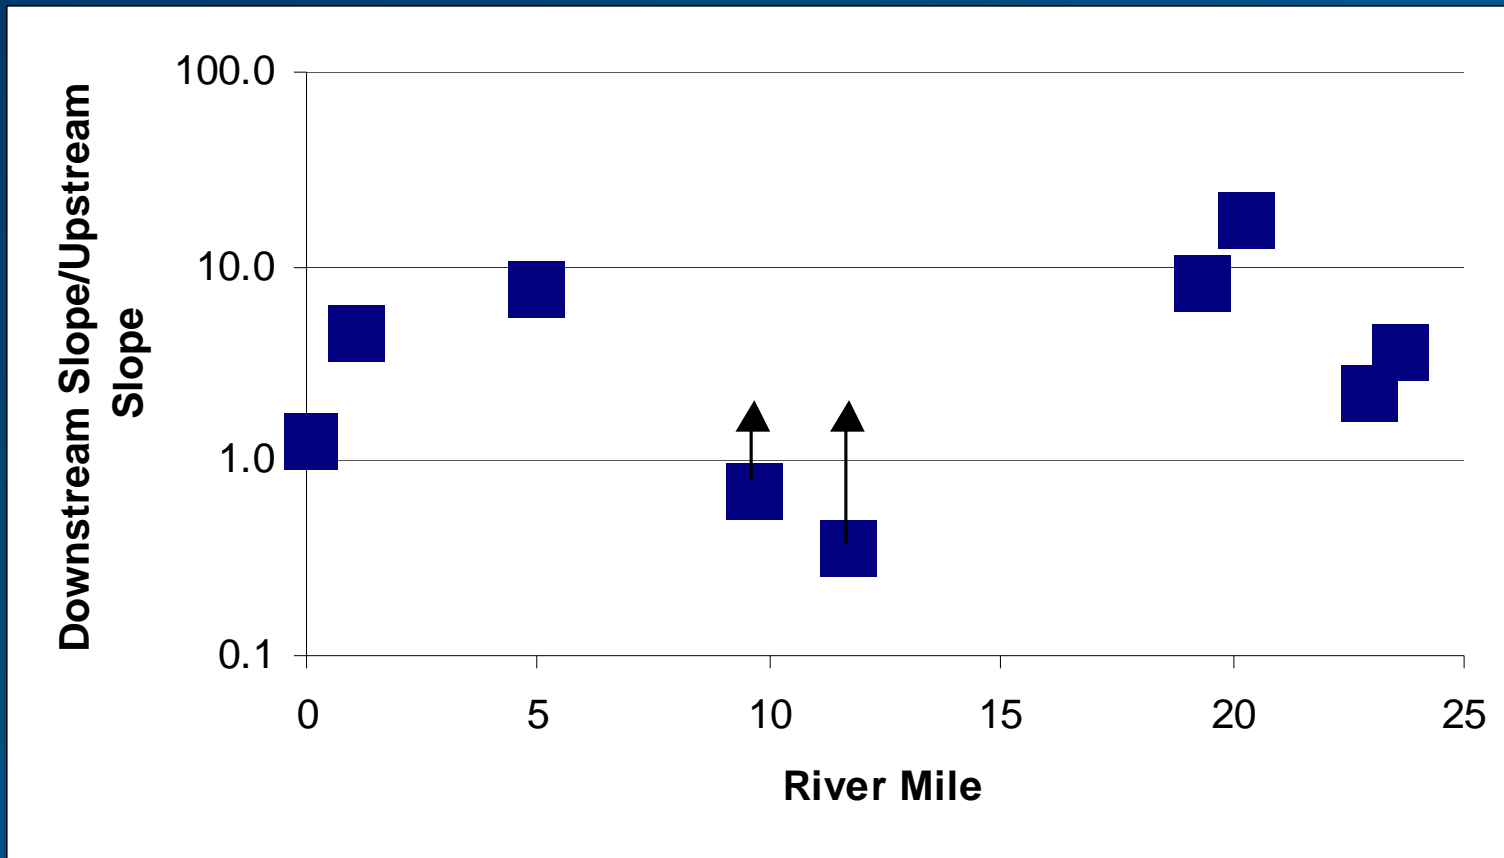
At Dam Sites, Slope is Steeper Downstream (the right place to build dams...)

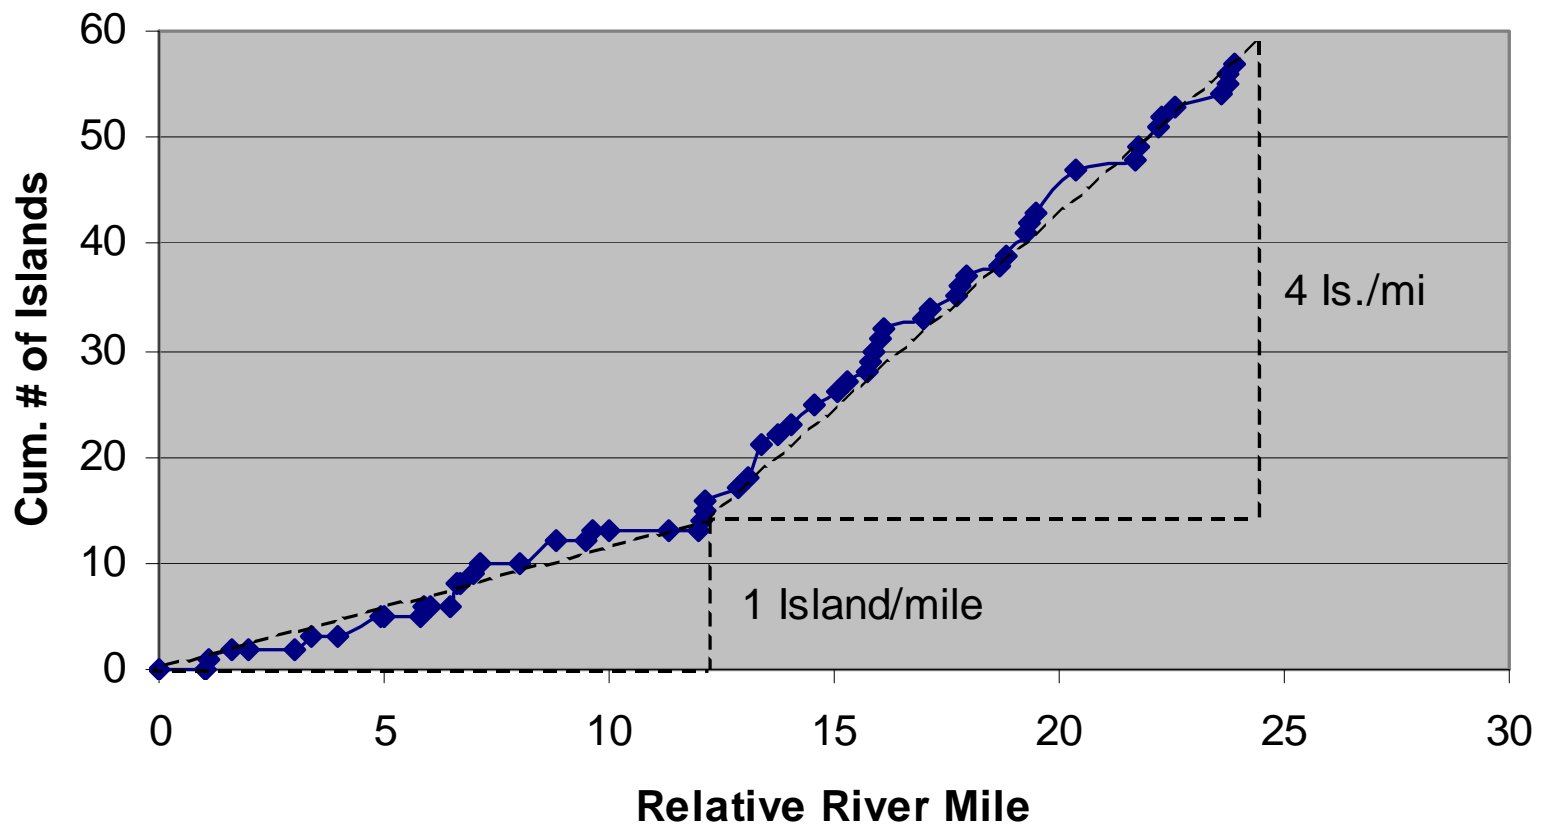
Islands – Upstream and Downstream

Downstream Section Should not be termed “anastomosing”

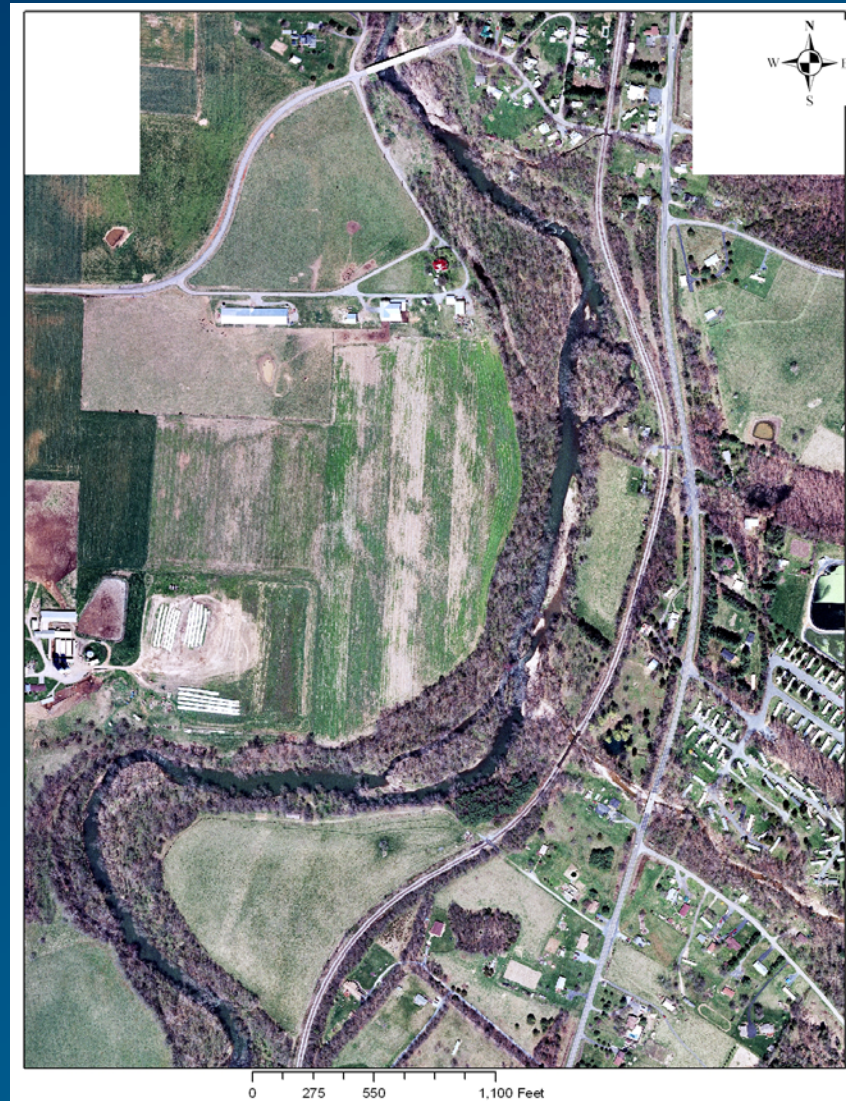
Downstream – Abundant Islands

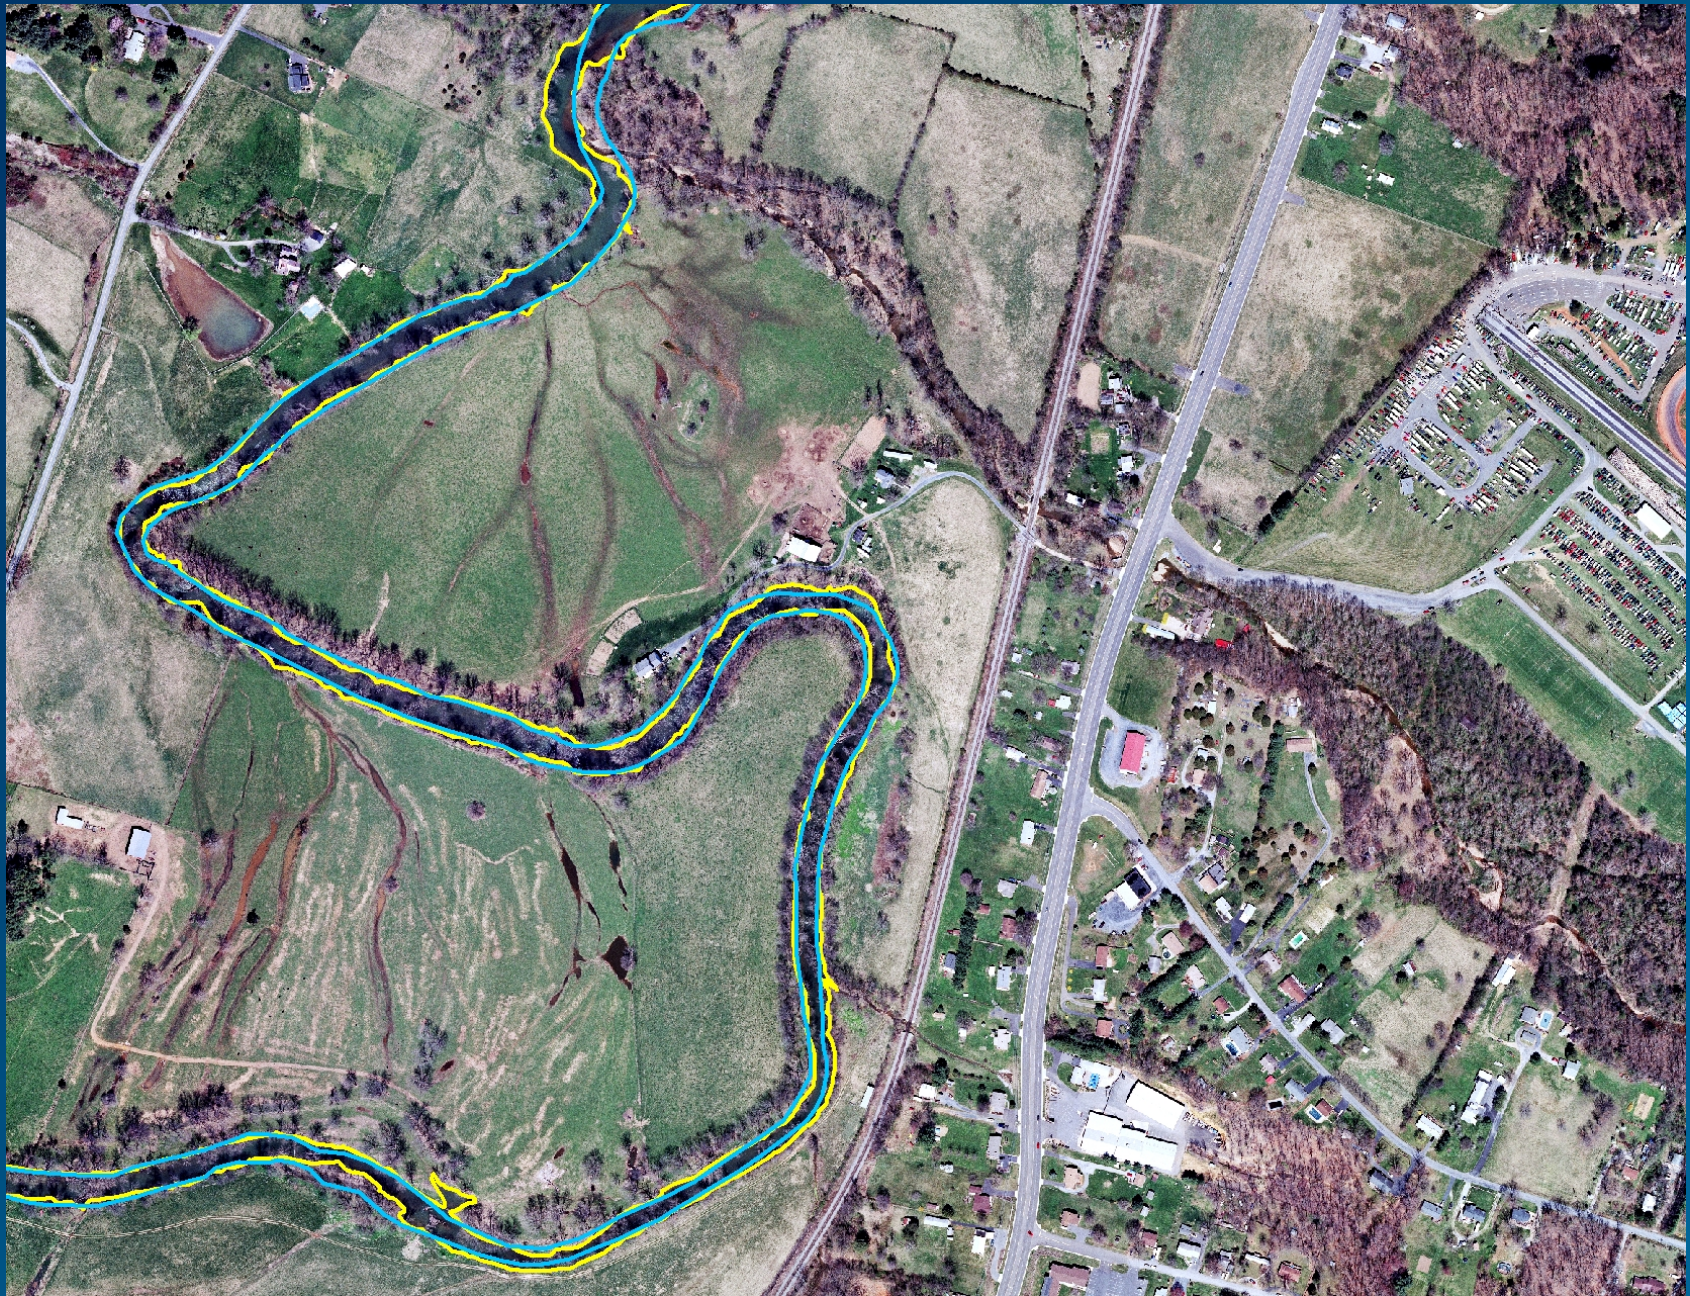
Blue – 1937, Yellow, 2005 – not much change!

- These define long term average rates of bank erosion
 - Accurate, high quality data
 - Rms errors about 1 ft in rectification
- Rates are very slow in most places
 - Many places have bank erosion rates below threshold of resolution
 - According to mapping of eroding banks, erosion is nonetheless occurring
 - Threshold of resolution is about 10 ft/(68 yrs), less than 2 inches per year
- Preliminary “look” indicates a few hotspots of rapid erosion
 - Areas without bedrock control or trees, and presence of other factors

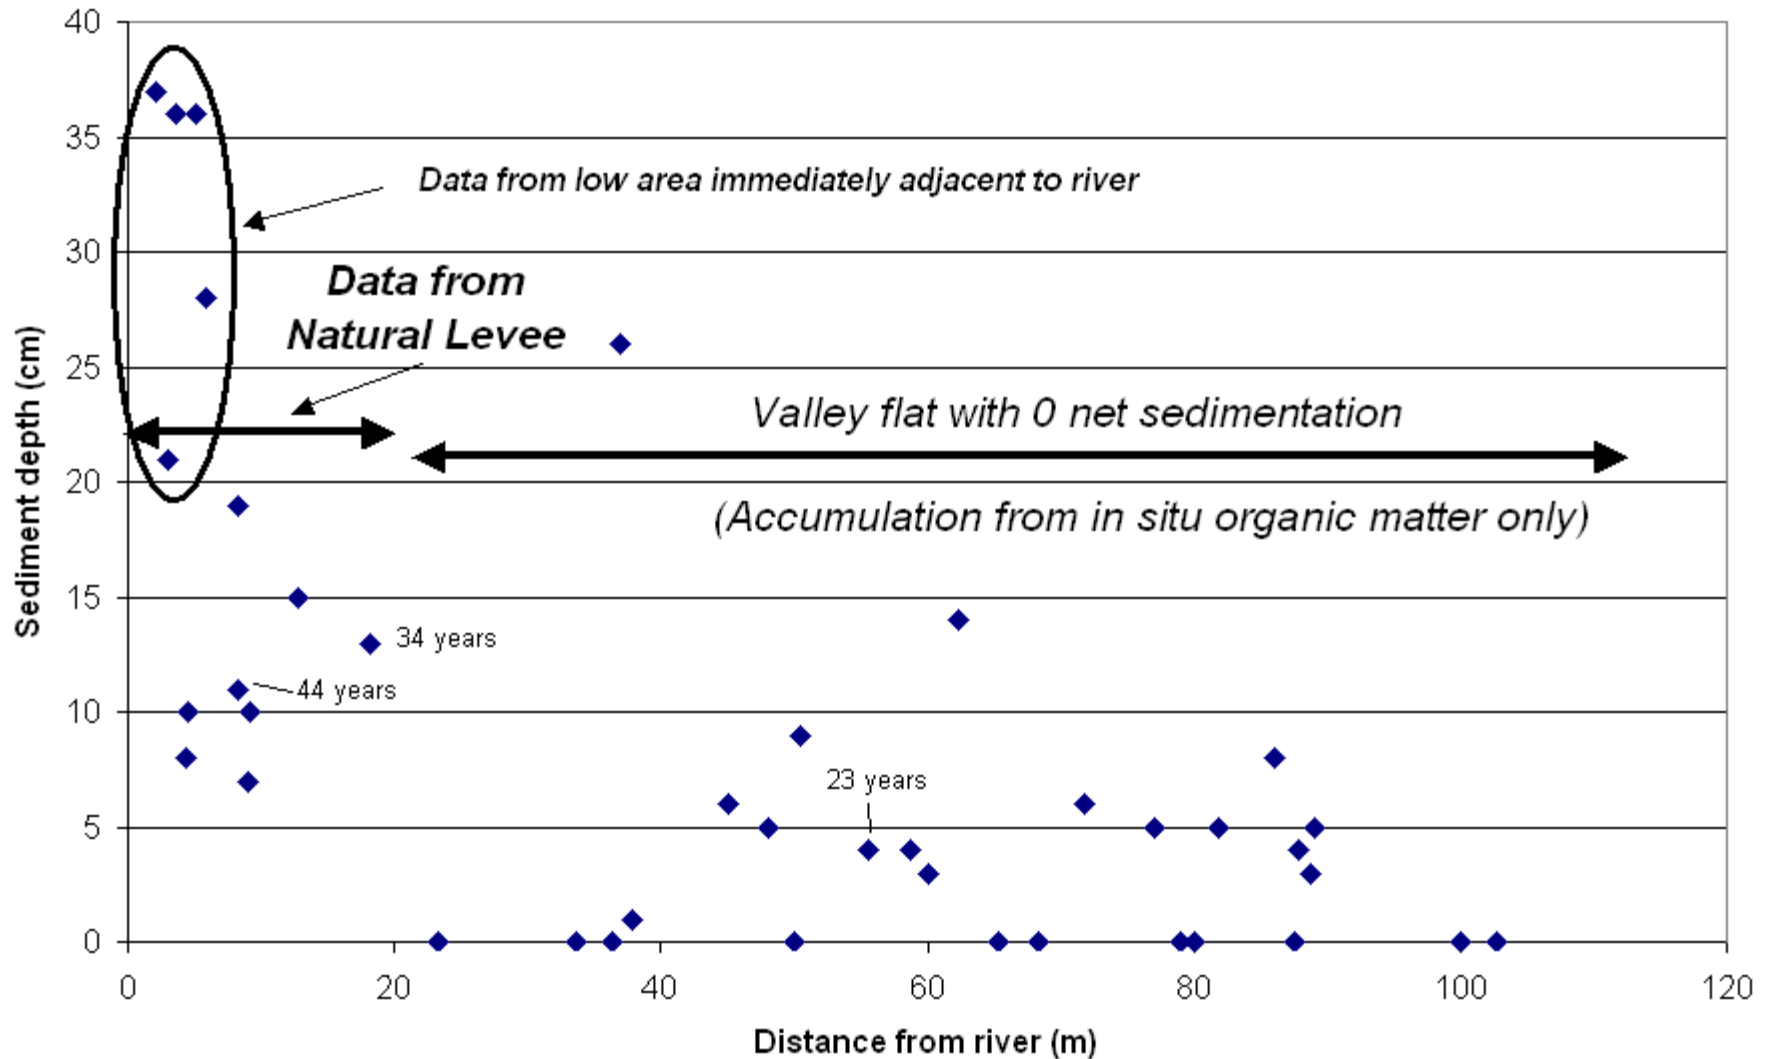
Distance from river vs. sediment accumulation

- To “first order”, accumulation on the valley flat has been negligible in recent decades
- Significant accumulation occurs on “levee areas” within a few 10s of meters of the stream channel
- We are working on dating more trees
- Grain size analysis of sediment in progress

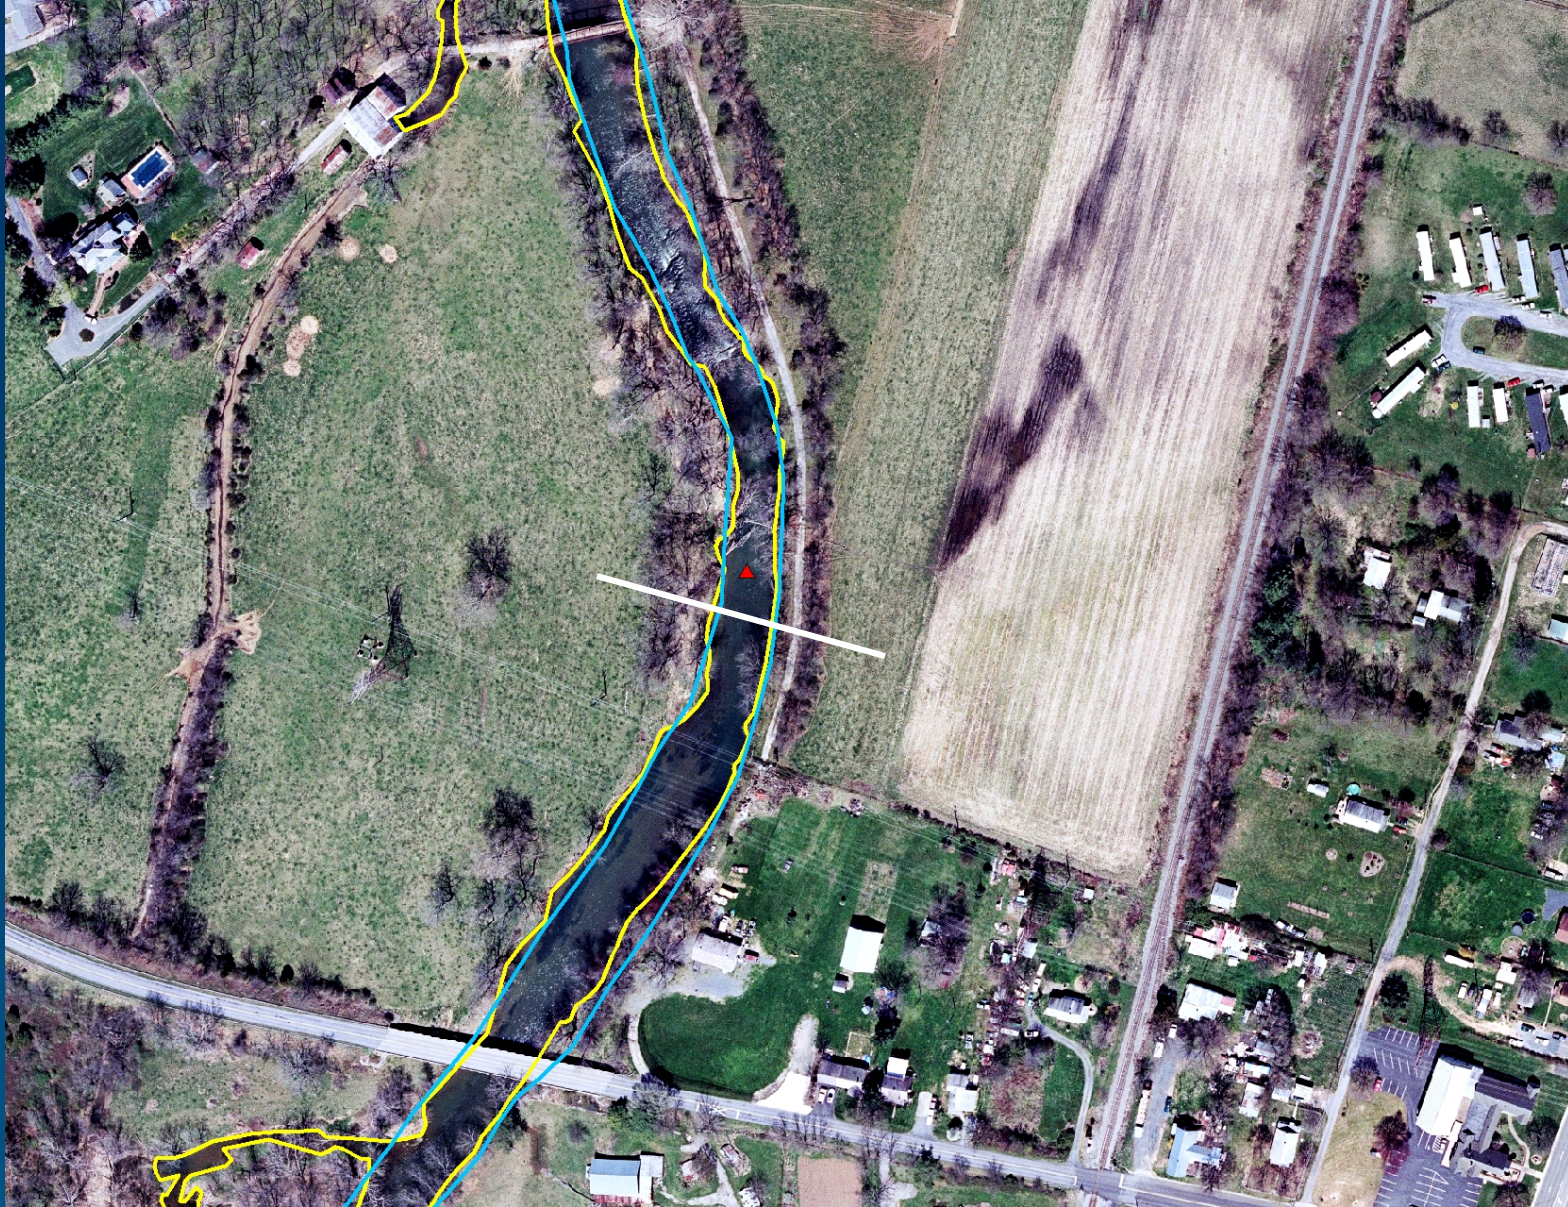
Banks have eroded here from 1937-2005 !

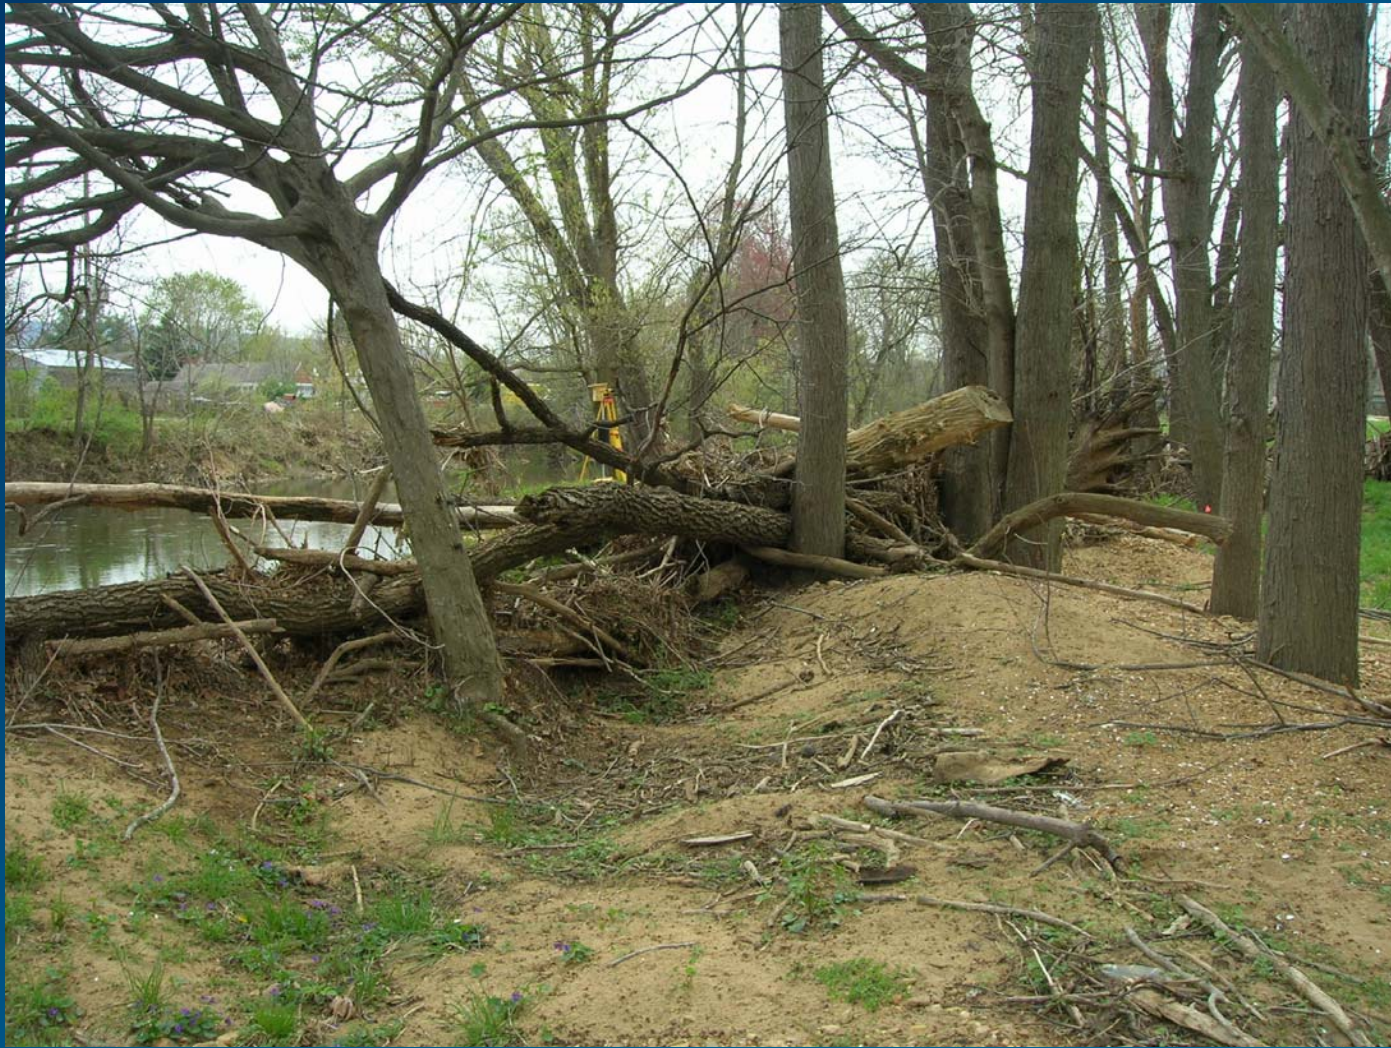
Episodic Deposition of Sand and Gravel

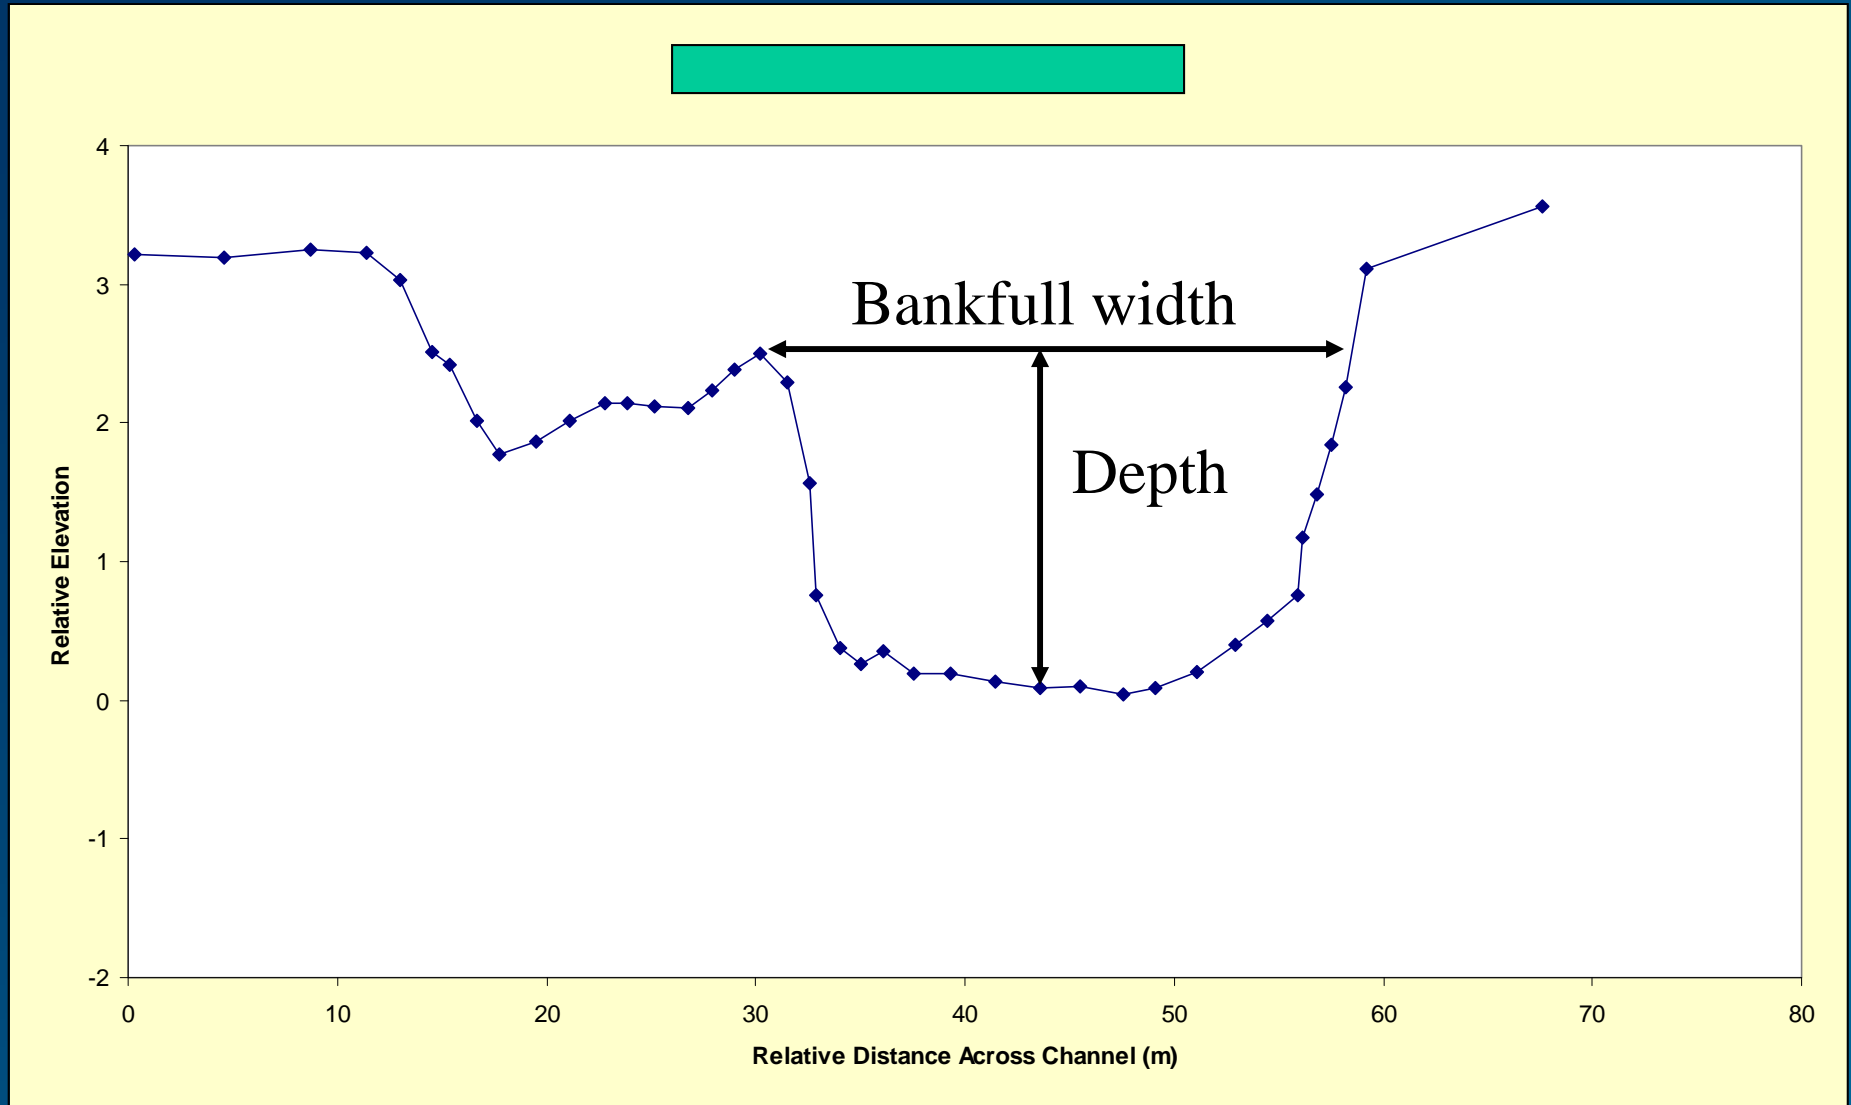
Topographic Profile (Cross-section) Below Dooms
