Geomorphology Update July 2006

- Channel bank migration and erosion, 1937-2005
 - Illustration of methods
- 5 Styles of bank erosion (1937-2005)
 - Typical patterns of channel change
- Final interpretation of Fine-Grained Channel Margin Deposit radiocarbon ages
- Summary of mud storage in Fine-Grained Channel Margin Deposits, Waynesboro-Port Republic
- Bed material size composition, upstream versus downstream
- Testing a simple box model of sediment-related Hg in the channel perimeter

Shoreline Changes 1937-2005

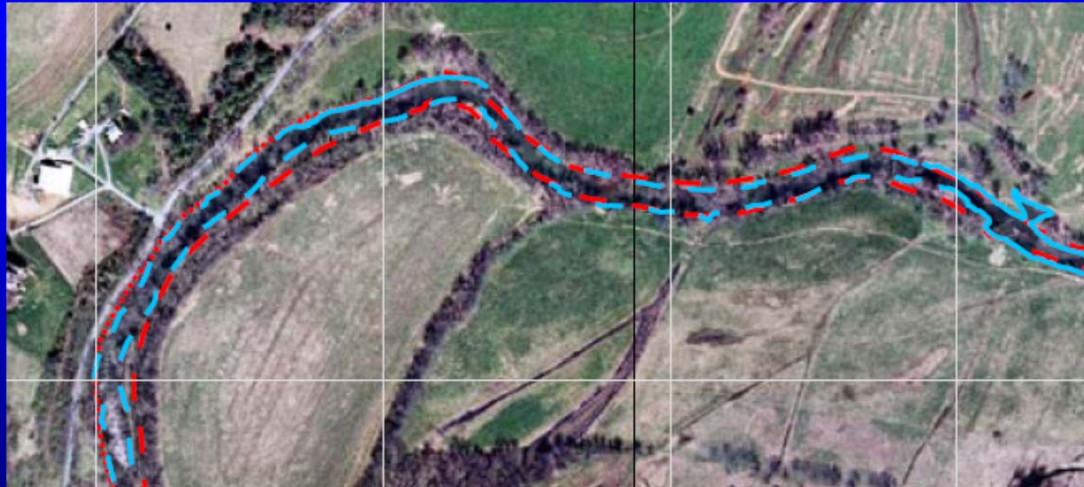
The image displays the South River between Waynesboro and Port Republic, Virginia. Red and blue lines represent stream boundaries from 1937 and 2005, respectively. The 2005 Air Photo Base Map was used in this image.

The 1937 and 2005 shorelines were split using confidence levels 1-3, with 1 designating areas where the bank is clear and 2 designating unclear bank locations. Solid lines, dashed lines, and dotted lines represent confidence levels 1 thru 3, respectively.

Positional accuracy for the airphotos is ca. 1 m based on RMSE values from the rectification process. The stream boundaries shown in the map have this error compounded by that from landscape elements masking the water-land contact and poor photo quality. As a result of these errors, a subjective confidence level is assigned to the shoreline boundary indicated by different line types for errors of 0-2 meters (solid), 2-4 (dashed), and 4-6 (dotted).

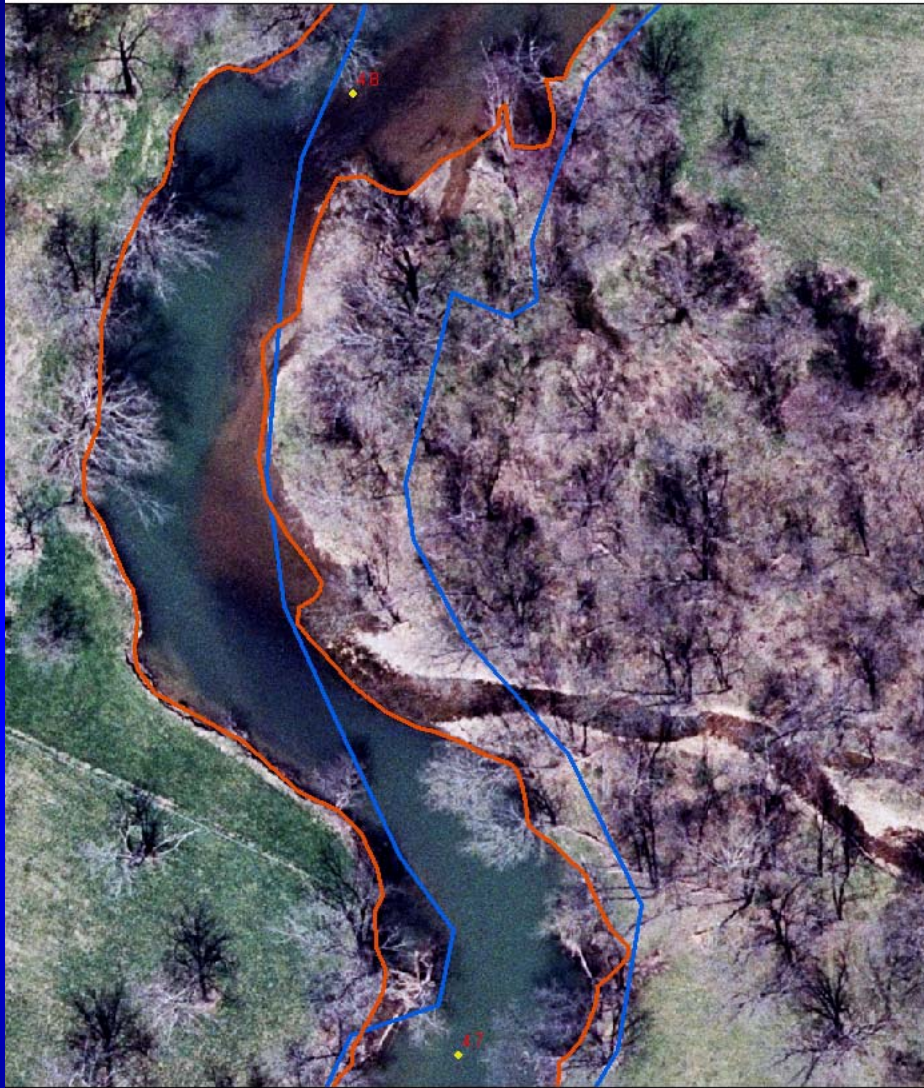
SCALE 1 : 700
RRM: 4.70 - 4.79

Classic bend migration (no bedrock
Or large trees....)

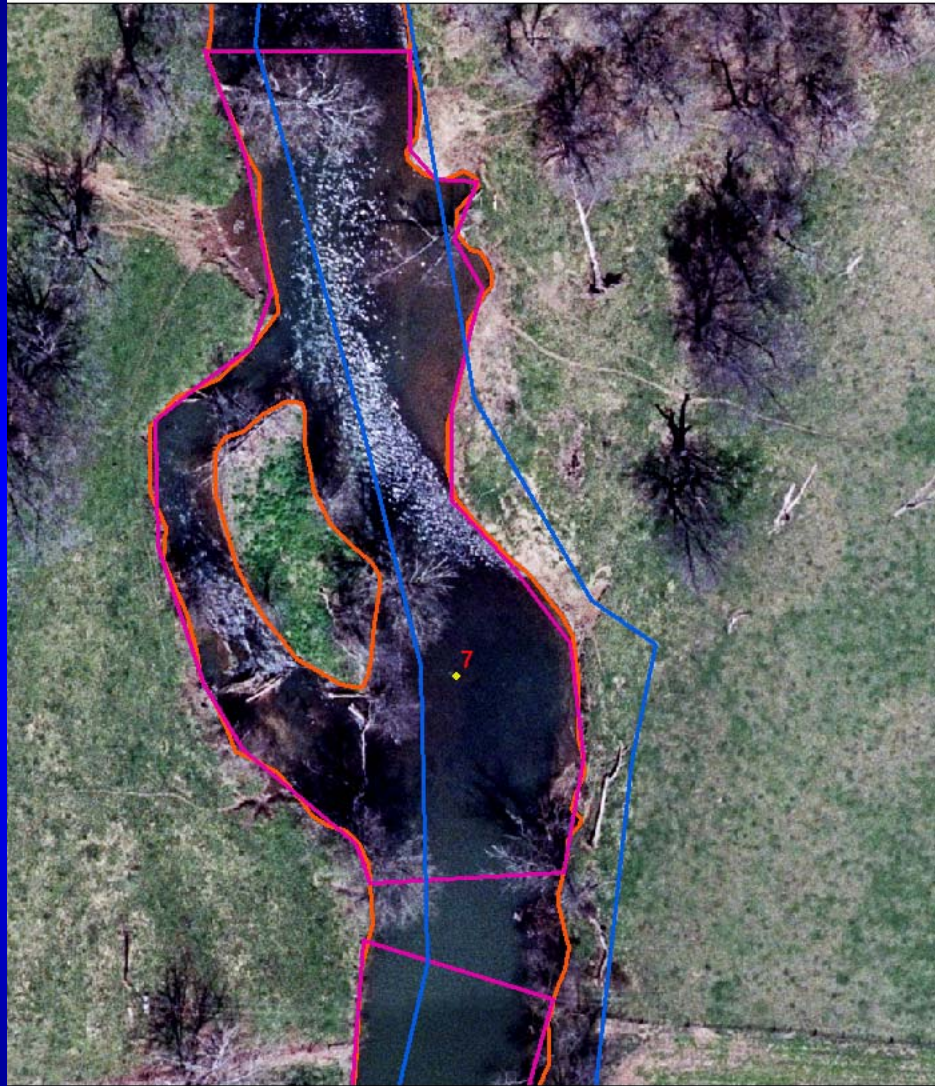
SCALE 1 : 700
RRM: 6.98 - 7.06

Island development

Tributary Sedimentation

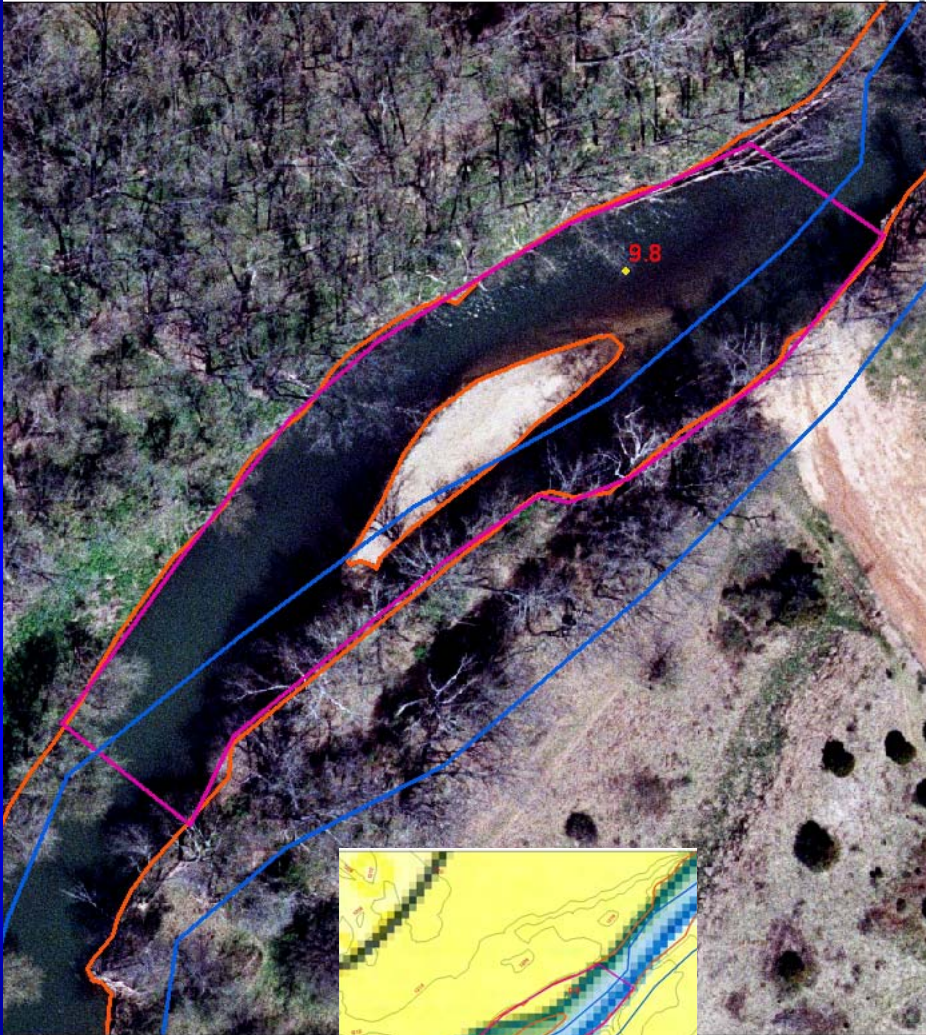
RRM: 9.73 - 9.81

Classic bend migration, or related to dams and bridges, or..?

Erosion
Occurs
On lower
Side of
floodplain

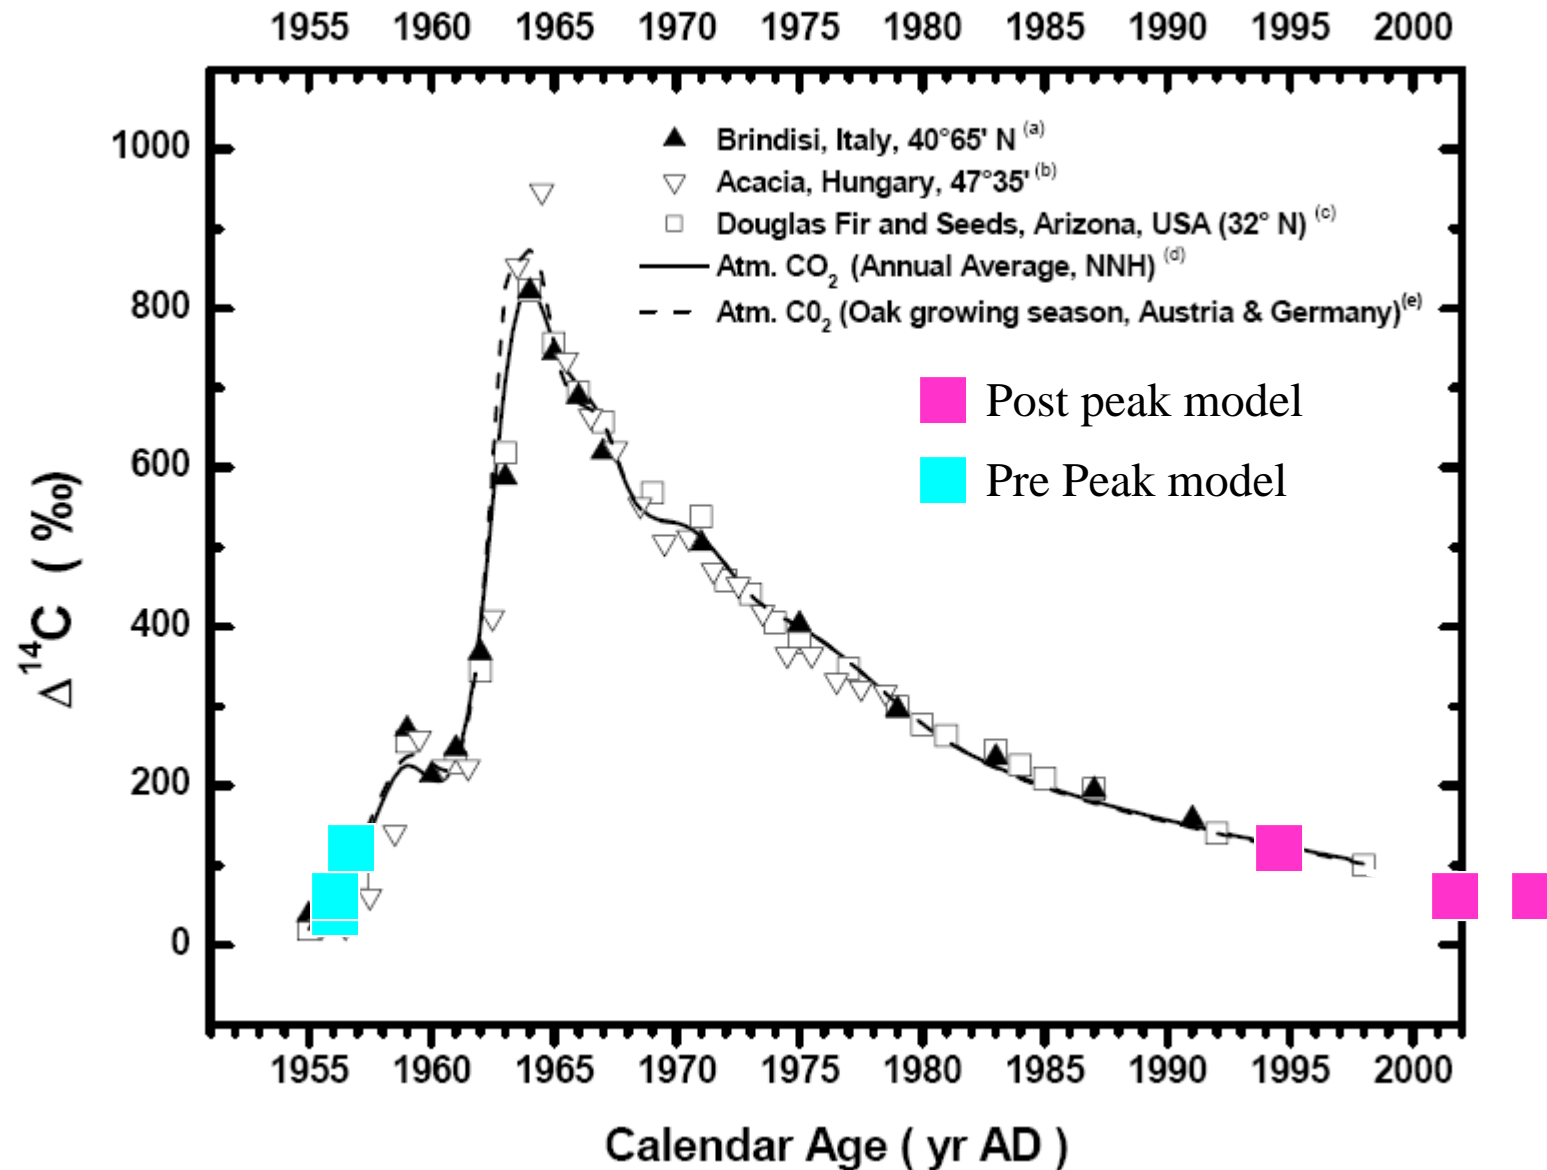
Two Possible Ages for Bomb Radiocarbon Analyses

Why we prefer the younger ages...

- Younger ages maintain stratigraphic superposition, with older deposits underlying younger deposits
- Deposit H2A is formed as a result of a bank obstruction in the form of a tree that is only 24 years old, inconsistent with an age of the deposit from the late 1950s.
- Ages in the late 1950s would require the uppermost few centimeters these deposits to have remained completely undisturbed by floods and other processes for more than 50 years, which we believe is very unlikely.
- The sediments are stratified and reflect deposition in place by the river, as opposed to mass slumping from nearby banks, etc.

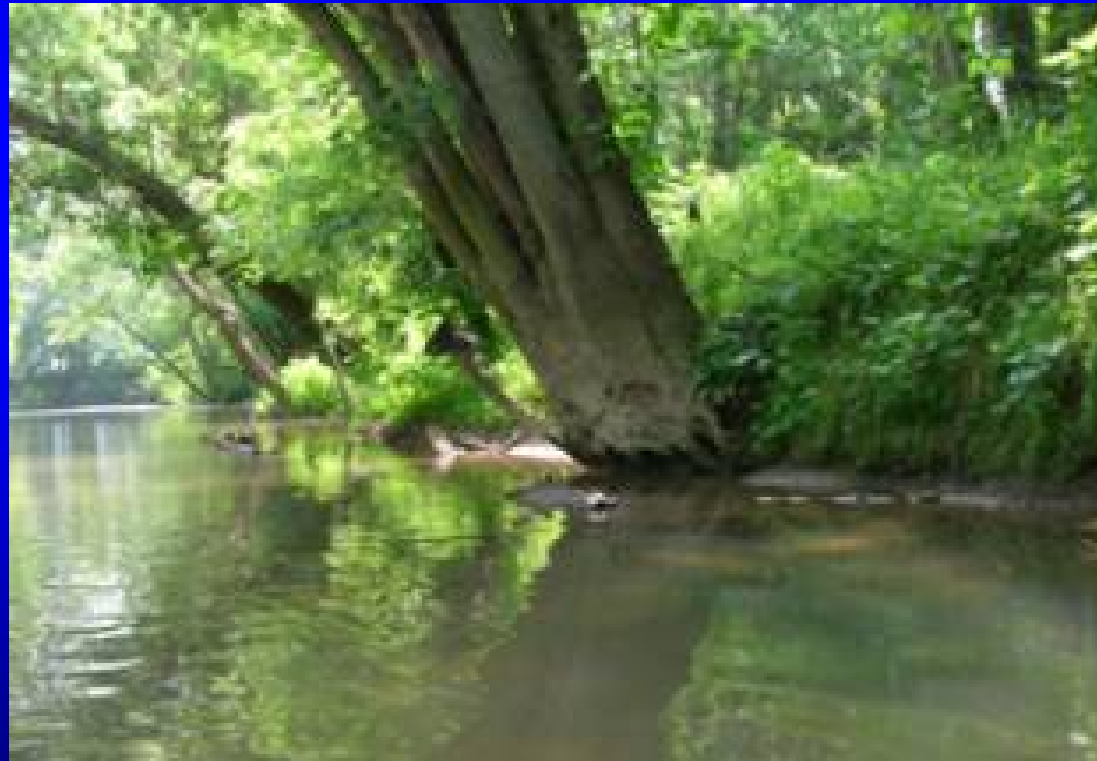
24 year old tree (Silver Maple at
Deposit H2A

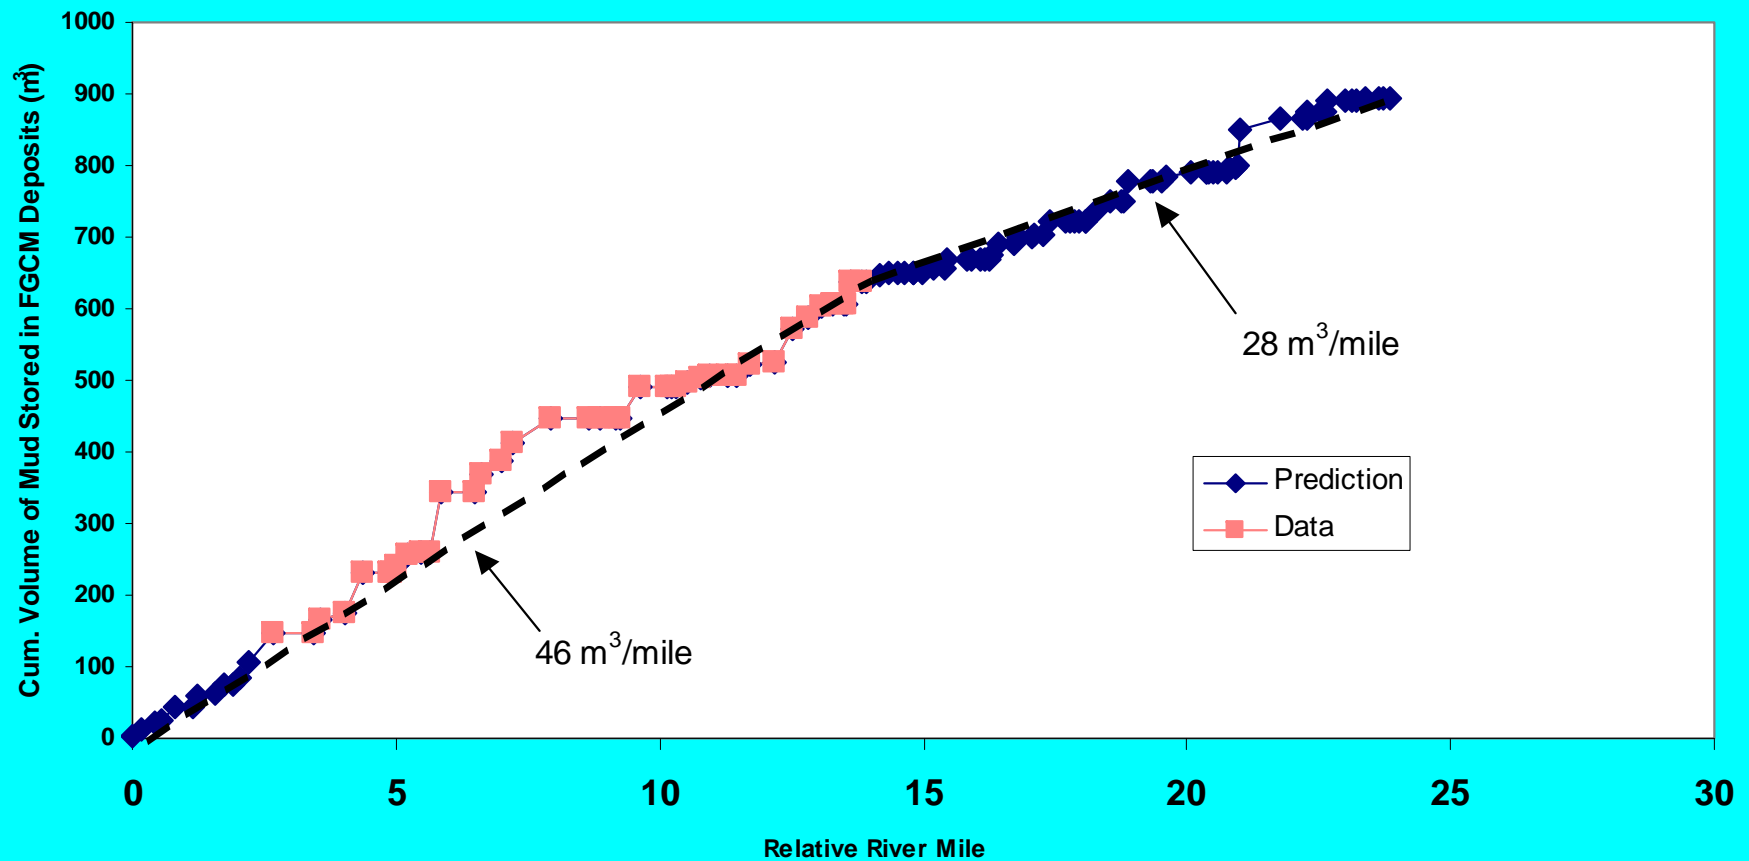
Final Estimate of Mud (silt and clay) stored in Fine-Grained Channel Margin Deposits

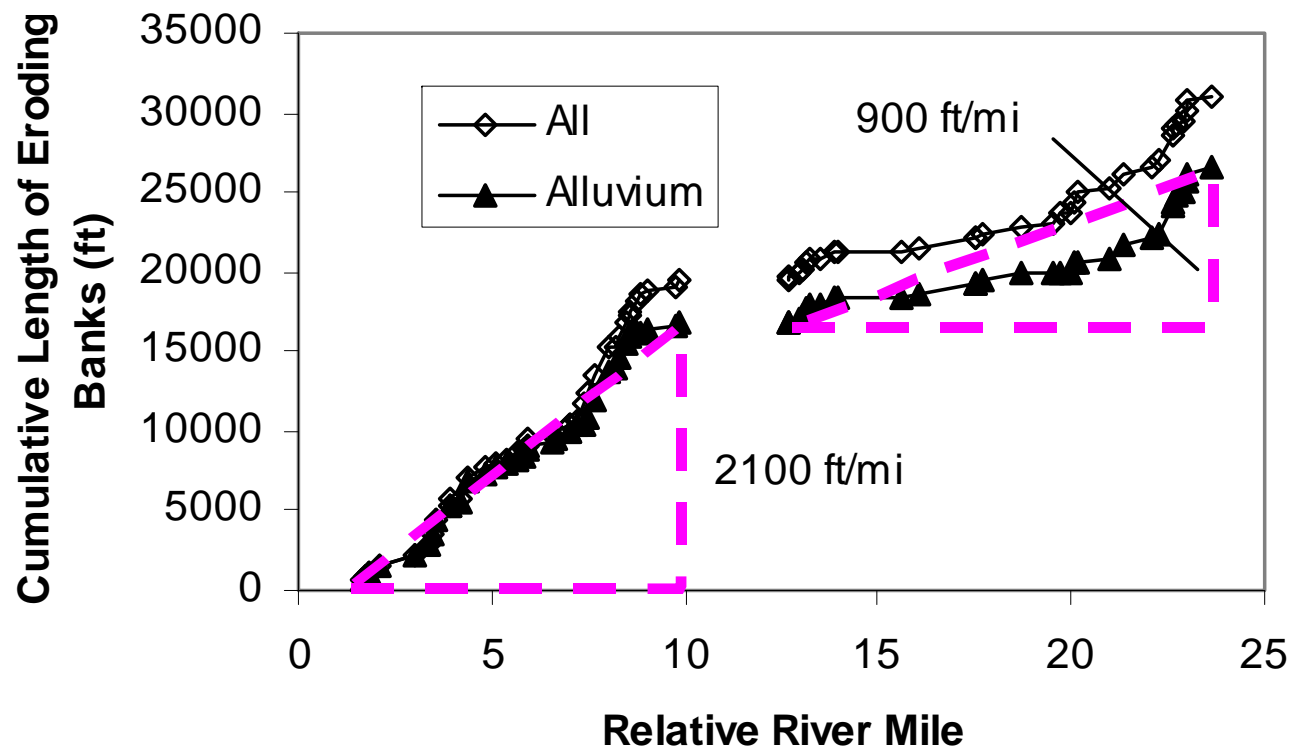
Upstream/Downstream Current Eroding Banks

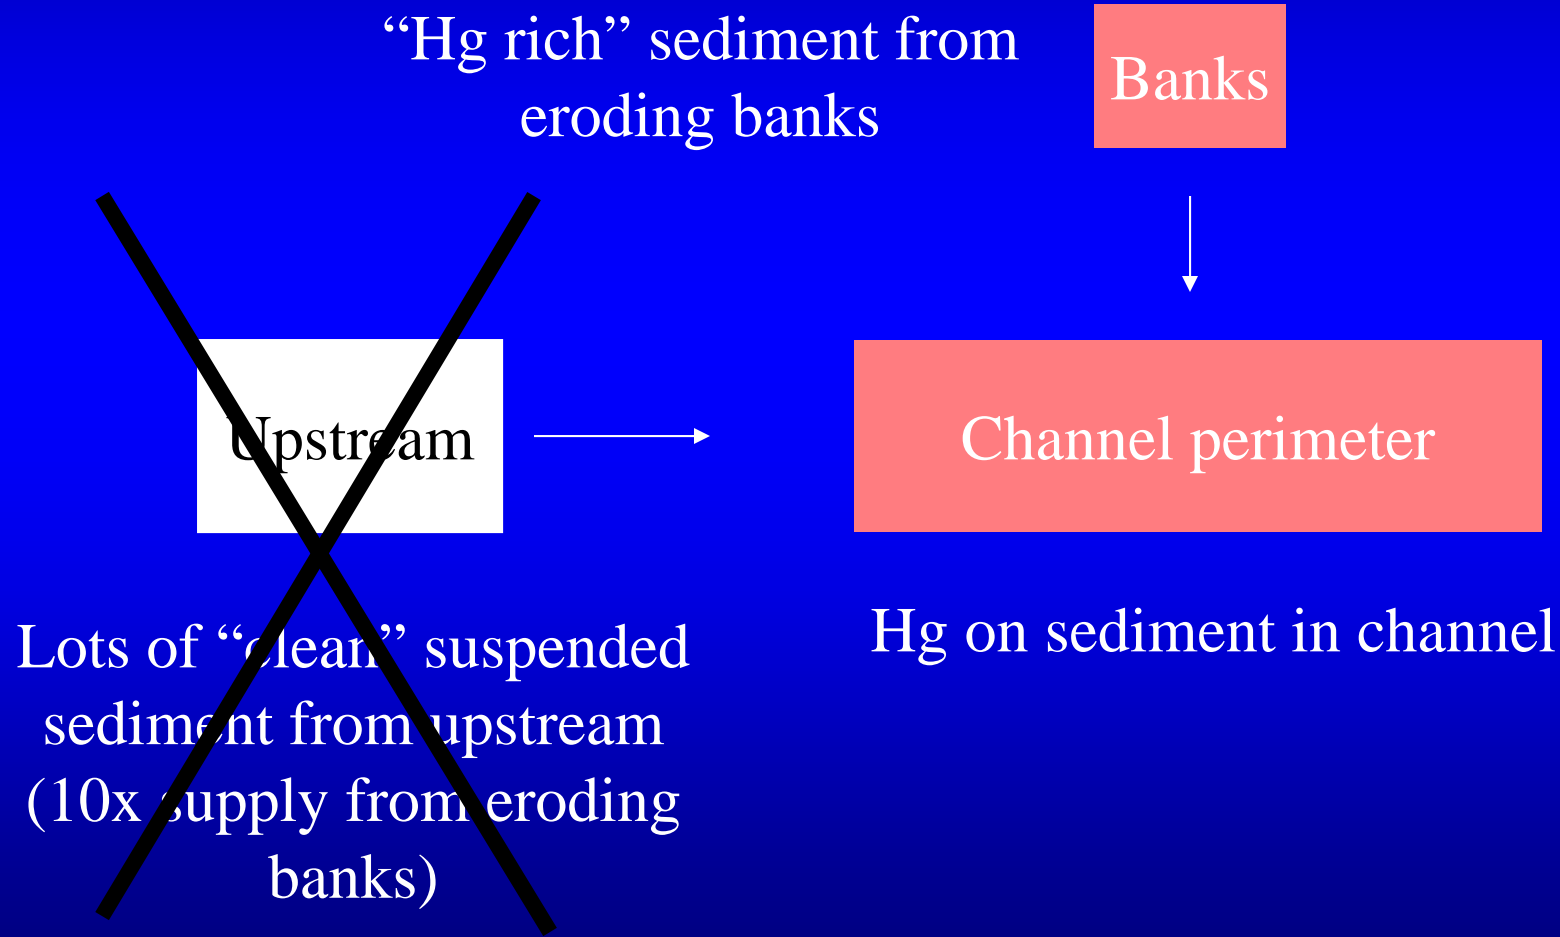
A Better Model of Sediment-Related Hg in South River Channel Perimeter

Working Hypotheses to Explain Why Channel Sediment and Eroding Bank Hg Concentrations Appear Similar

- Eroded bank sediment is directly stored in the channel without dilution
 - Bank erosion occurs at relatively lower flows when upstream supply is minimal
 - During big storms, upstream supply is moved through the study area without significant storage and therefore without diluting Hg in the channel system that is sampled between storms
- Something entirely different....
