# Phase 1 Interim Measures Update

**Former DuPont Waynesboro Site - AOC 4**

South River Science Team Spring Meeting

April 10, 2019

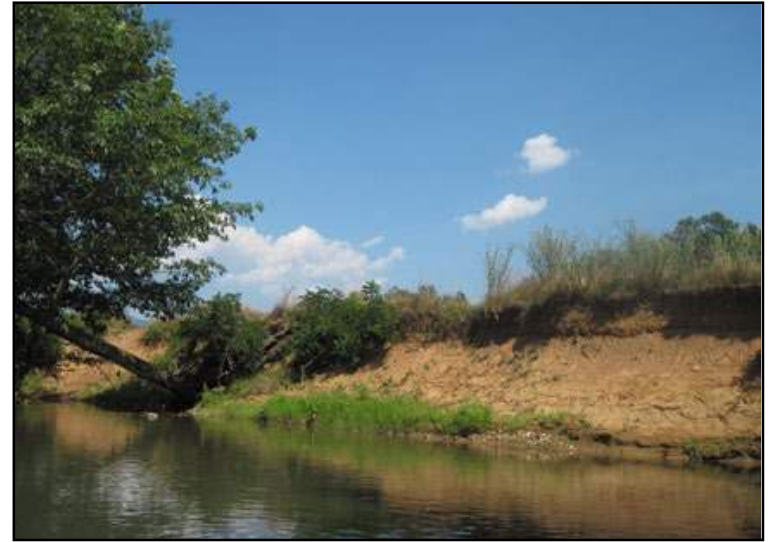
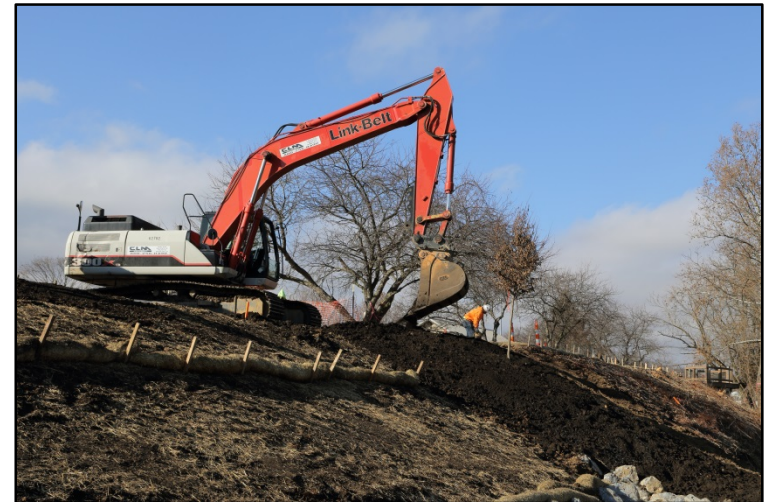
# Remedial Design Criteria

- Reduce mercury loading
- Maintain/improve habitat
- Minimize disruption
- Use proven/effective methods
- Address landowner concerns

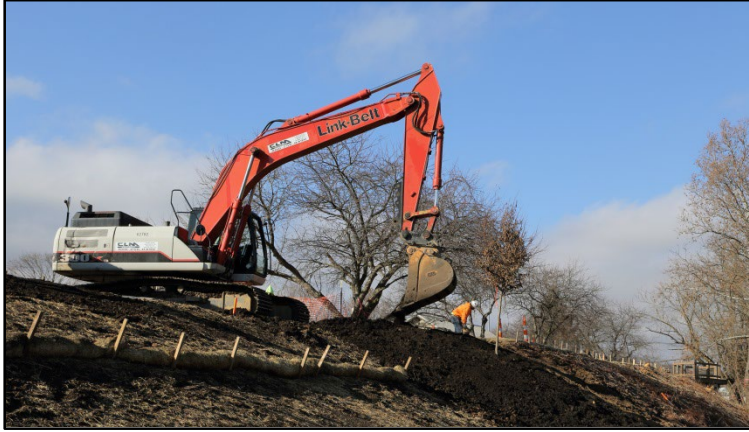
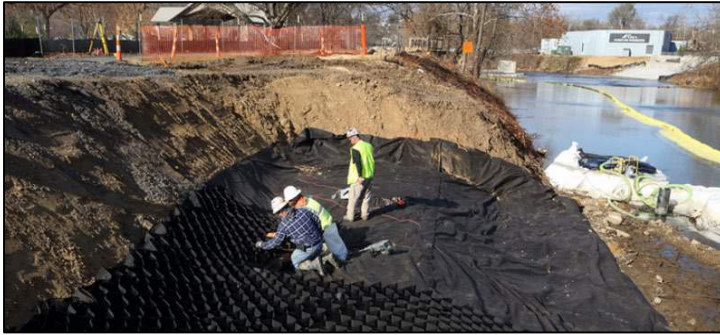
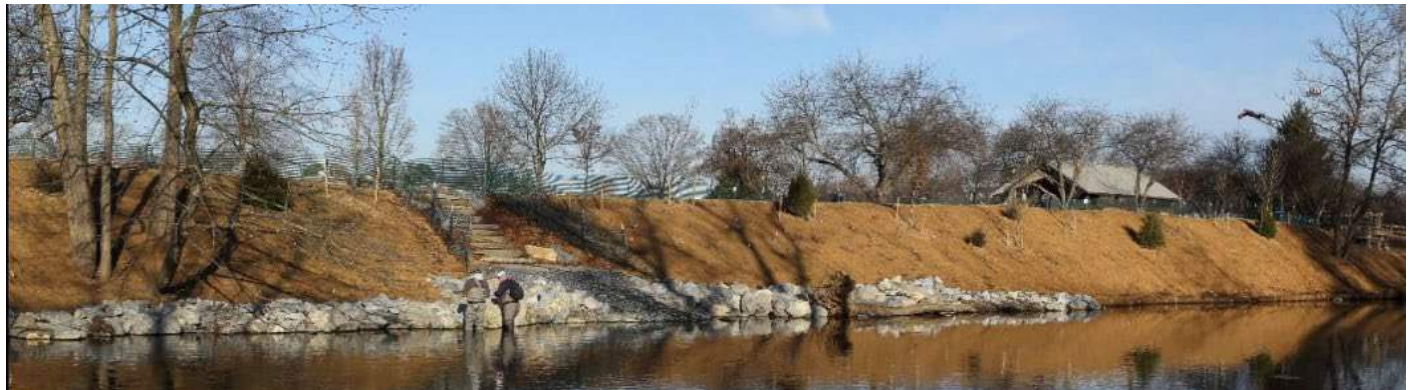
# Construction Sequence

- 1) Design implementability and safety review
- 2) Site access and clearing
- 3) Cofferdam installation
- 4) Contaminated soil removal
- 5) Bank stabilization
- 6) Site restoration (planting and habitat features)

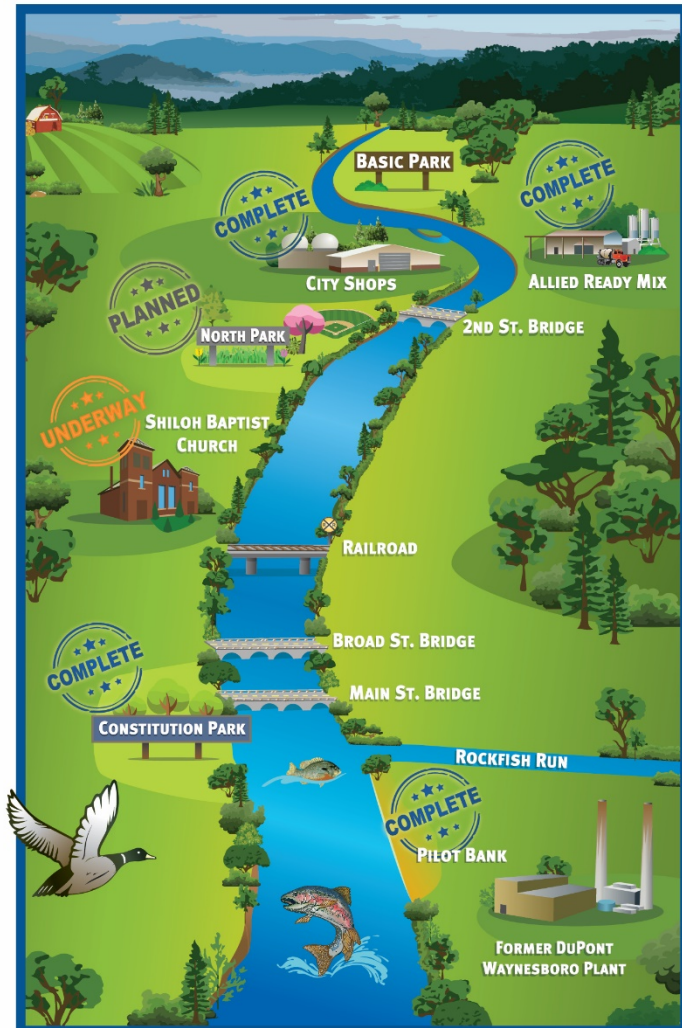
**Estimated Percent of Mercury Input Reduced to Date  
(October 2018)**

# Phase 1 Interim Measures Status

*It is estimated that the erosion of six South River riverbanks contributes appreciable mercury to the river each year. The goal of the remediation work is to stop the erosion of these riverbanks and, in doing so, reduce the mercury input into the South River by 90%.*
