# RCRA Corrective Action Program Update

Former DuPont Waynesboro Plant  
October 24, 2012

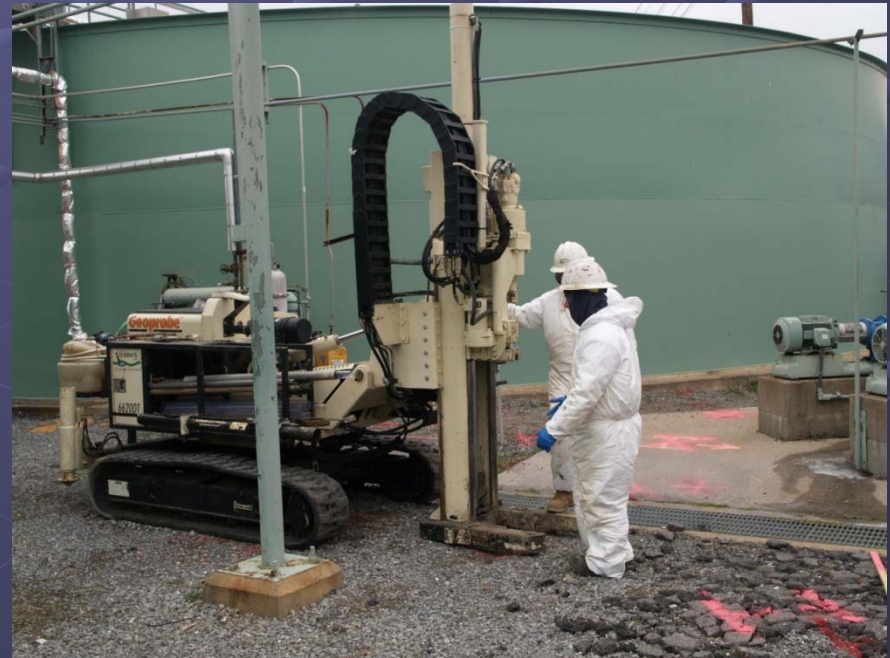
## ● RCRA Facility Investigation

- Investigated 20 SWMUs and 2 AOCs
- Identified 3 SWMUs (1,4, and 7) for Corrective Measures Study
- Recommended continued GW monitoring and sewer remediation

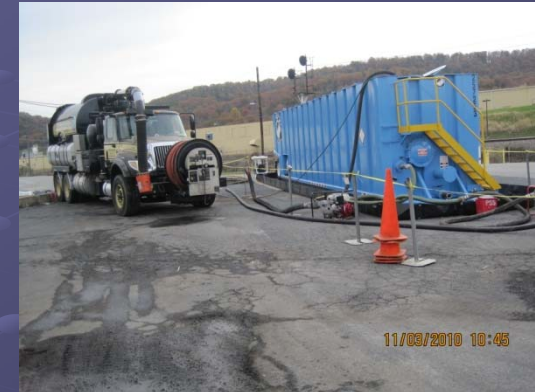
## ● Sewer Investigation

- Three phase program – mapping, CCTV, sampling and cleanout
- Sampled 85 structures, cleaned 1,967 ft of sewer, removed 27 cu yds of sediment.
- Removed approximately 521 kg (1,148 lb) Hg from sewer system
- Recommended abandonment, cleaning or re-routing impacted sections

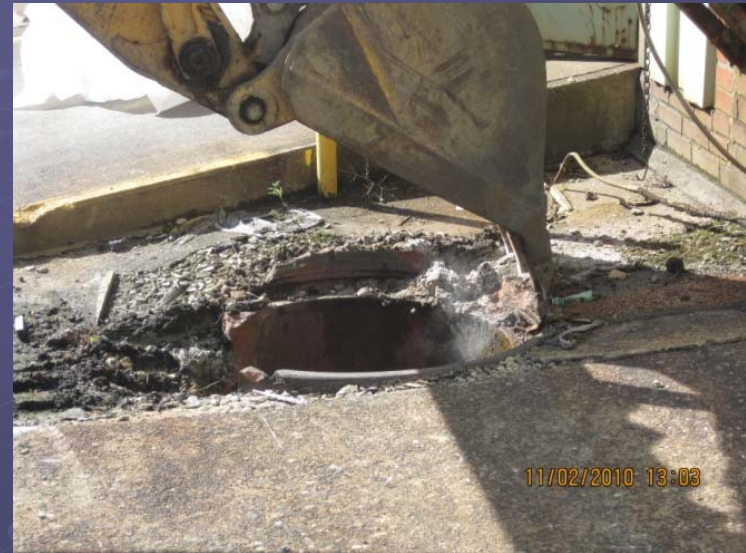
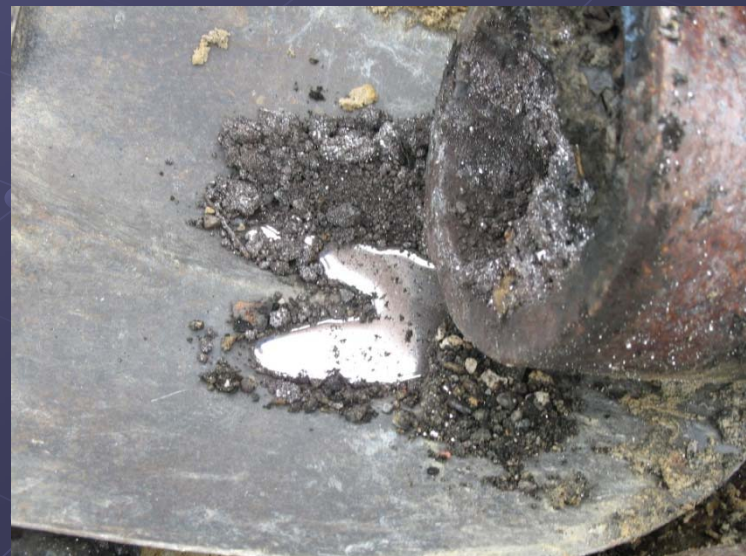
## ● Interim Measures

- Removed and abandoned Hg sources connected to sewers
- Re-routed roof drainage that flushed through impacted trenches
