# Geomorphology Update July 2006

# Shoreline Changes 1937-2005

## 1937 - 2005 Areas of Erosion and Accretion, South River, Virginia

Erica L. Rhoades and Michael A. O'Neal, University of Delaware, 2006

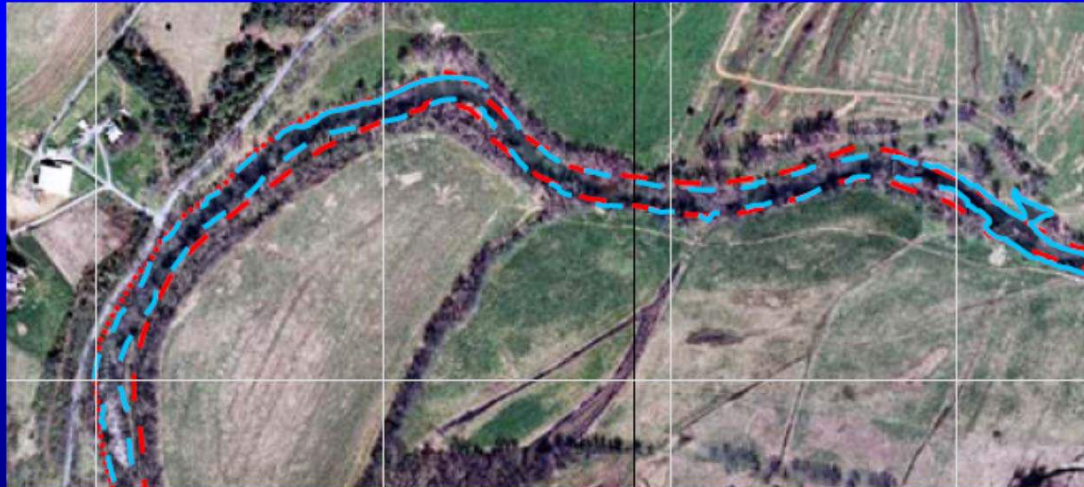
The image displays the South River between Waynesboro and Port Republic, Virginia. Red and blue lines represent stream boundaries from 1937 and 2005, respectively. The 2005 Air Photo Base Map was used in this image.

The 1937 and 2005 shorelines were split using confidence levels 1-3, with 1 designating areas where the bank is clear and 2 designating unclear bank locations. Solid lines, dashed lines, and dotted lines represent confidence levels 1 thru 3, respectively.

Positional accuracy for the airphotos is ca. 1 m based on RMSE values from the rectification process. The stream boundaries shown in the map have this error compounded by that from landscape elements masking the water-land contact and poor photo quality. As a result of these errors, a subjective confidence level is assigned to the shoreline boundary indicated by different line types for errors of 0-2 meters (solid), 2-4 (dashed), and 4-6 (dotted).

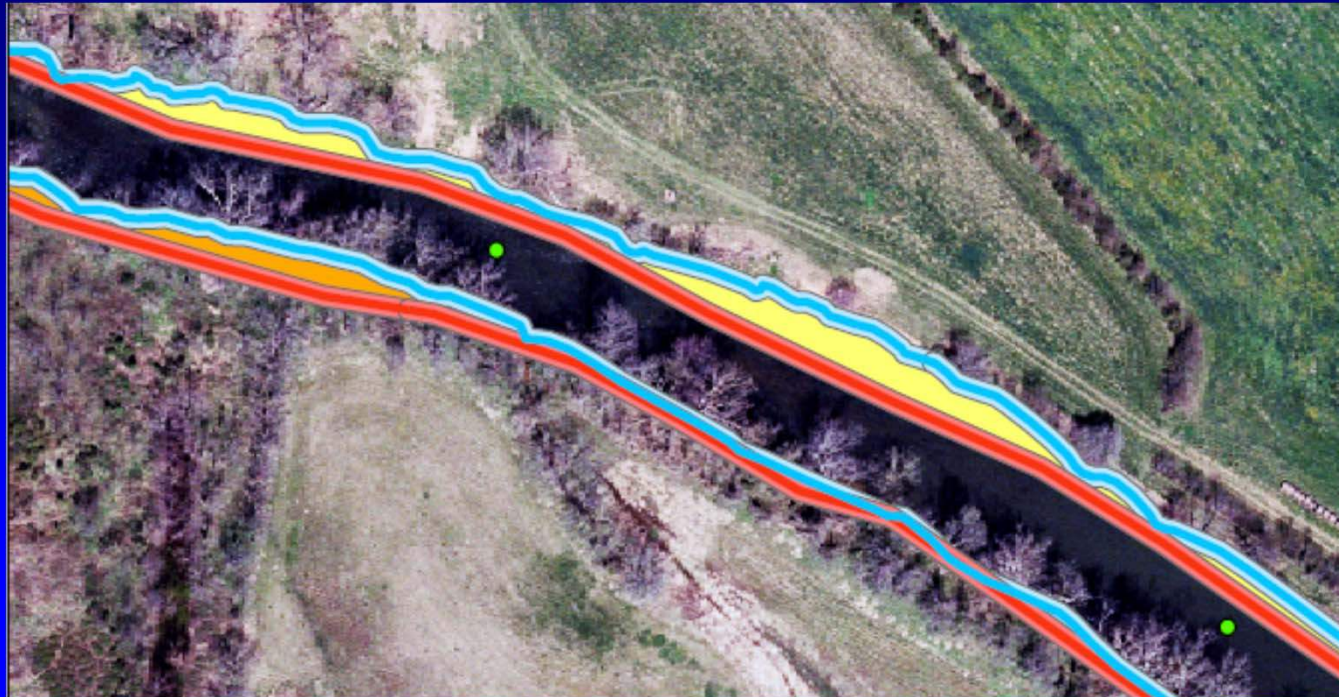
The image above displays the South River (mile markers 10.6 and 10.7), with red and blue lines representing stream boundaries from 1937 and 2005, respectively. The 2005 Air Photo Base Map was used to display areas of erosion and accretion along the river. Areas of erosion are shown in yellow and areas of accretion are shown in orange. A buffer of 2 meters was placed around each stream boundary to include the errors involved in locating the bank.

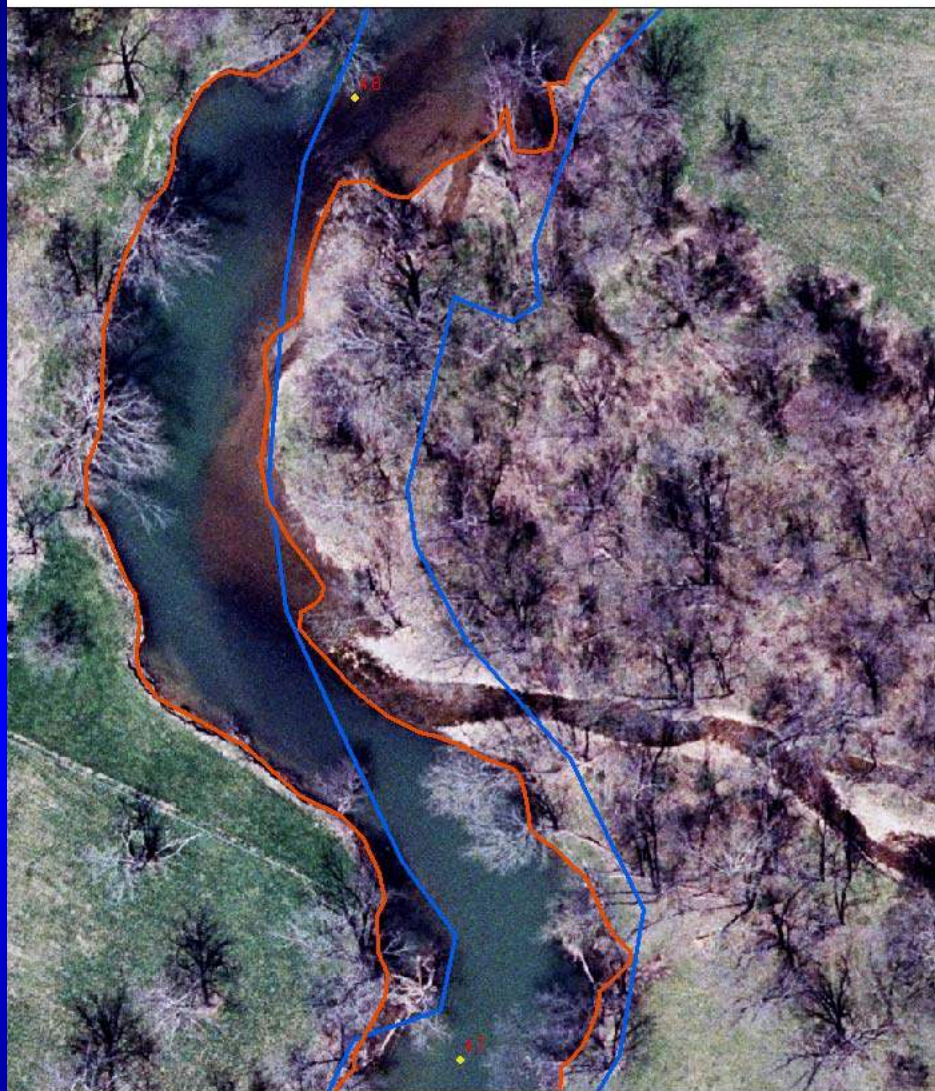
SCALE 1 : 1,000  
RRM: 3.46 - 3.57

Classic bend migration (no bedrock  
Or large trees....)

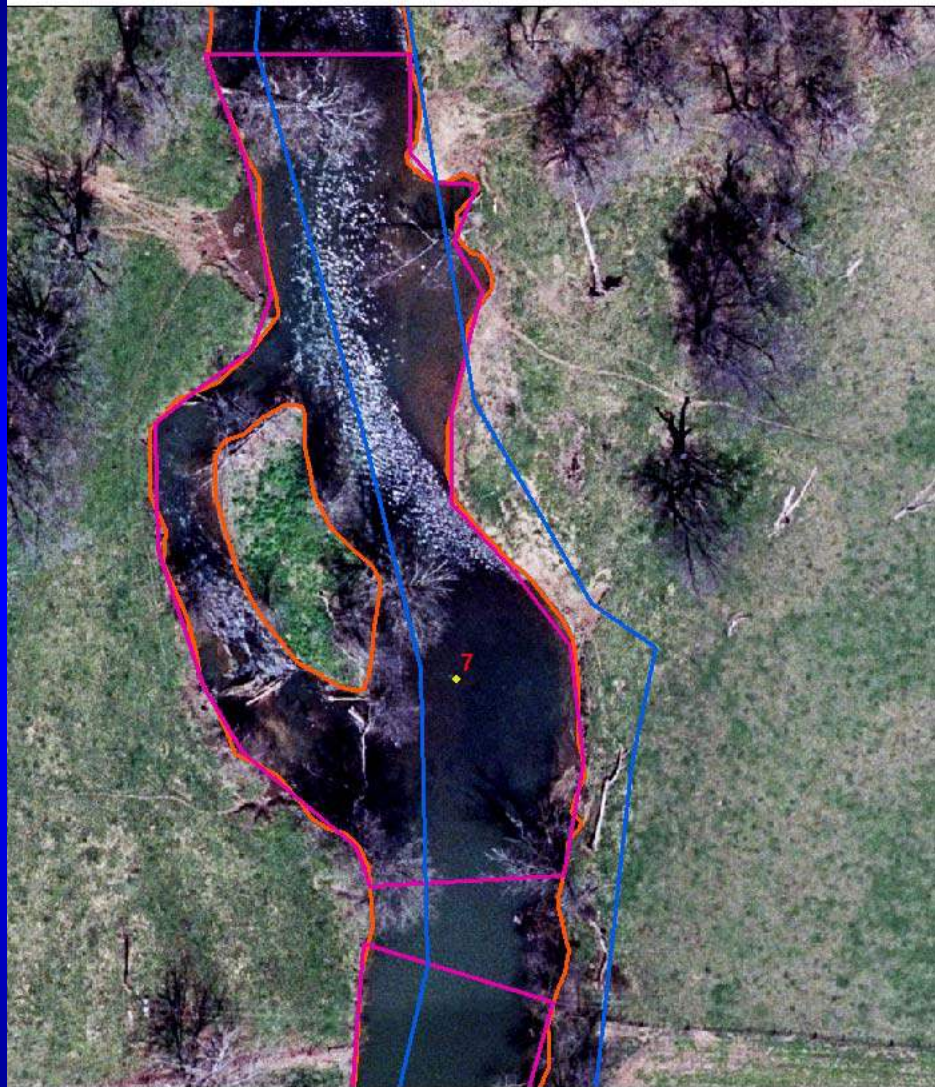
SCALE 1 : 700

Island development

# Side Channel Forms on Lower floodplain

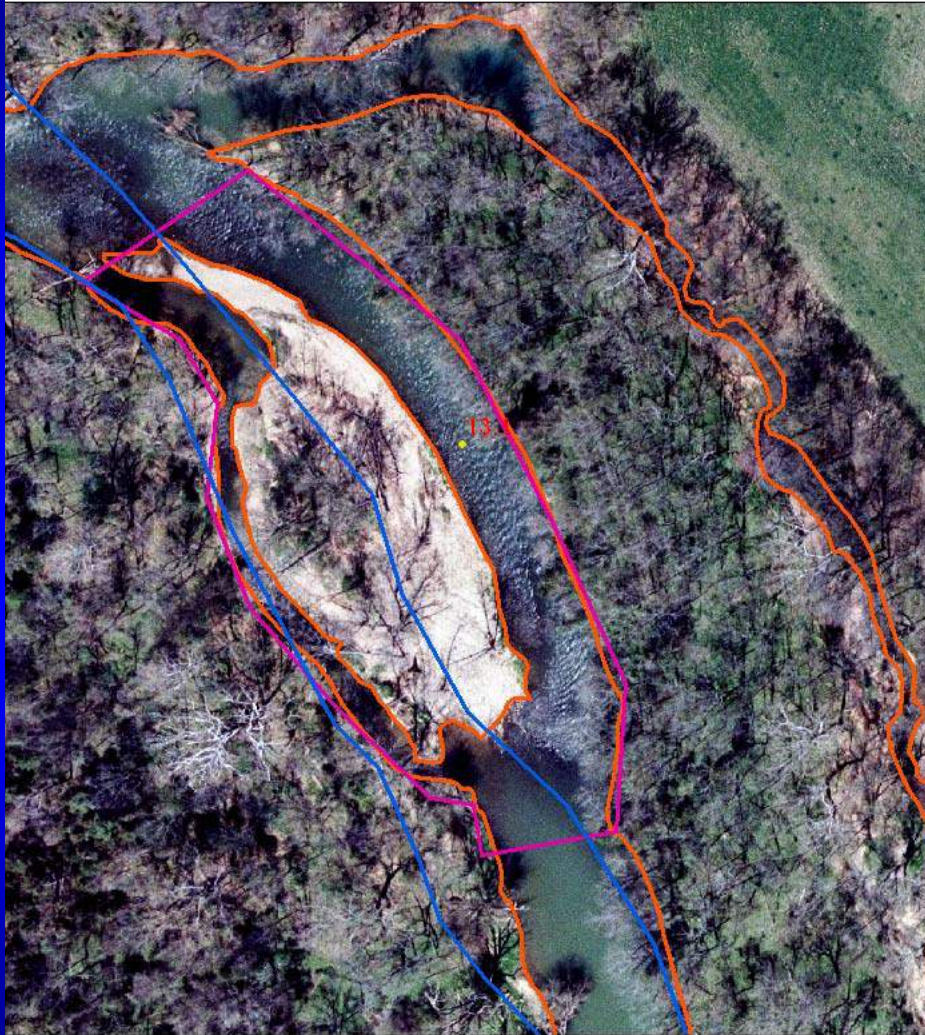
SCALE 1 : 700

ALLUVIUM  
TERRACE

Erosion  
Occurs  
On lower  
Side of  
floodplain

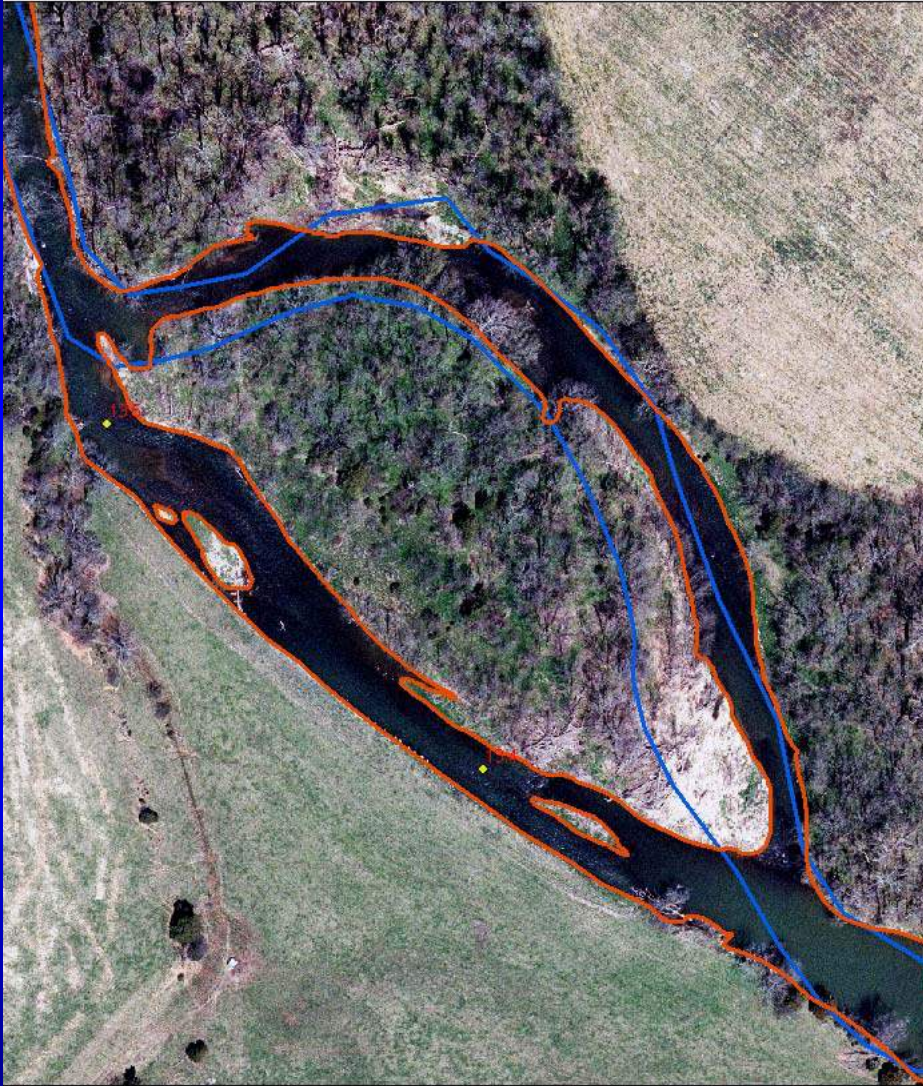
SCALE 1 : 1000

Island development

# Island development
