Re: Summer 2018 City Shops Bank Management Area Maintenance Inspection
Area of Concern 4, Former DuPont Waynesboro Plant
Waynesboro, Virginia
EPA ID# VAD003114832

Memorandum

To	Michael Liberati, DuPont CRG Ralph Stahl, DuPont CRG	Page 1 of 2
CC	Nancy Grosso, DuPont CRG Ceil Mancini, AECOM	
Subject	Summer 2018 City Shops BMA Maintenance Inspection Former DuPont Waynesboro Site, Area of Concern 4	
From	Andrew Miano, AECOM Joshua Collins, AECOM	
Date	December 3, 2018

APPENDIX A
PHOTOGRAPHIC LOG

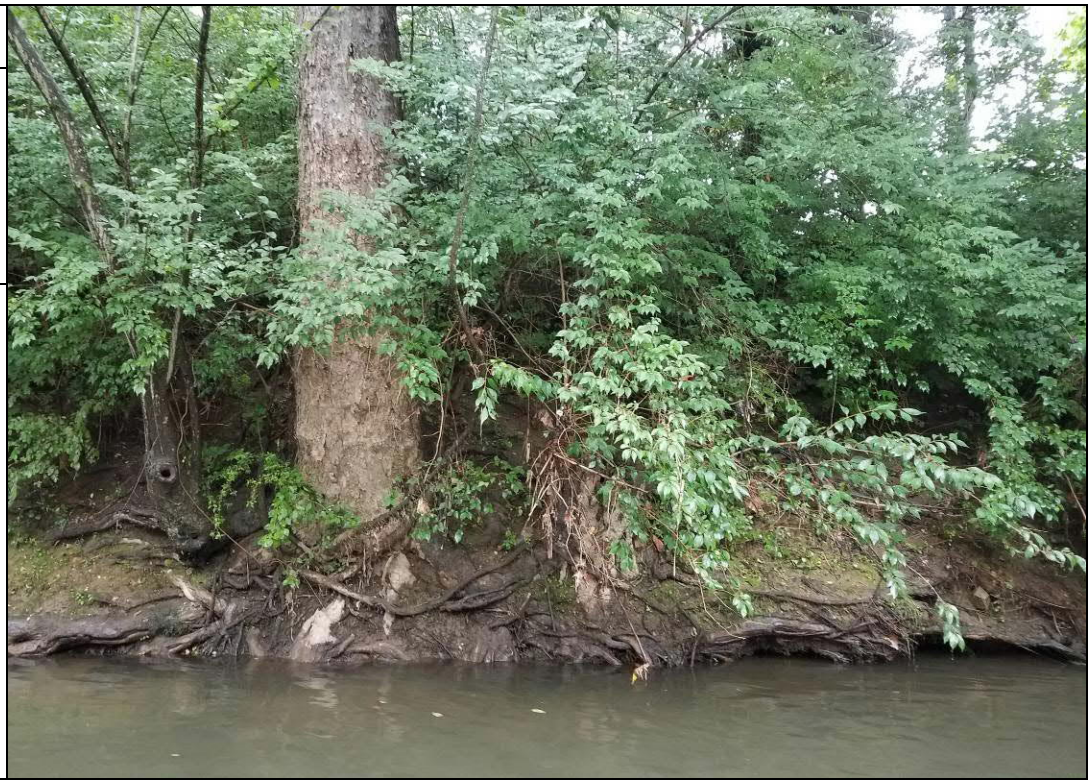
Photo No.	Date:
24	6/21/2018

Station 00 + 600' (non-remediated transect)

~75 degree bank angle; high quantity of exposed roots; at risk trees present; scour present.
