**Re: Constitution Park and Allied Ready Mix Bank Management Area  
Post-Construction Bank Repair Memo  
South River AOC 4, Waynesboro, Virginia  
EPA ID# VAD003114832**

**Project name:**  
Former DuPont Waynesboro Site  
Area of Concern 4

**Subject:** Constitution Park and Allied Ready Mix Bank Management Area  
Post-Construction Bank Repair Memo

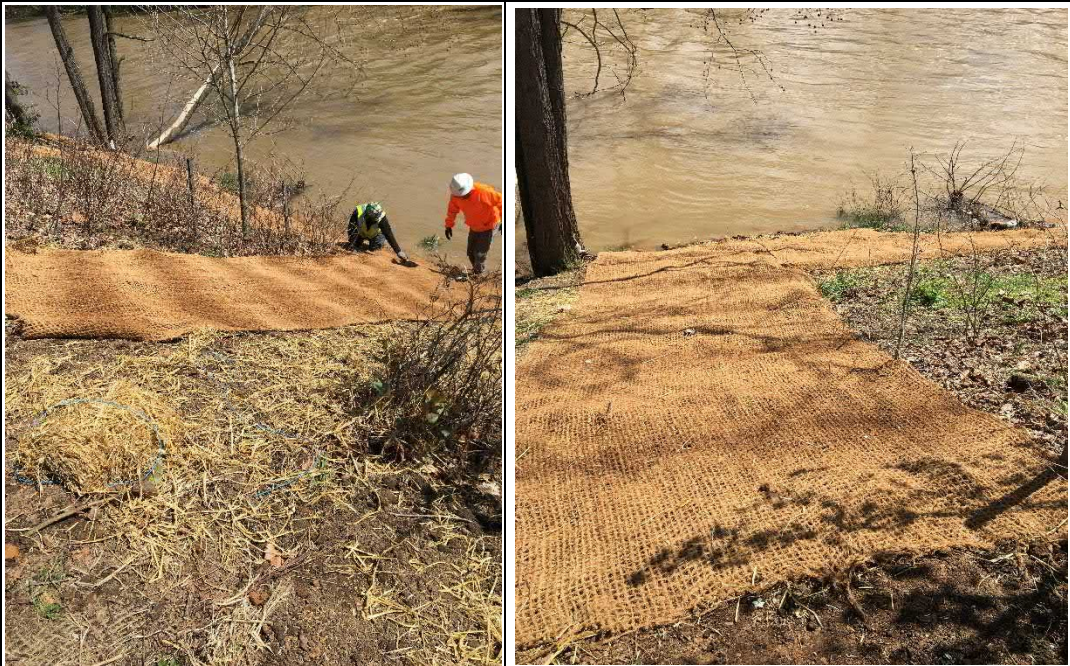
DAILY CONSTRUCTION REPORT	
<b>PROJECT:</b> South River Bank Stabilization – AOC 4 (Phase 1 Interim Measures)	<b>DATE:</b> 4/15/2019
<b>SITE PHOTOGRAPHS</b>	
<p>Title: Constitution Park</p> <p>Date: 4/15/2019</p> <p>Description:</p> <p>South of stone stairs. Summit placing coir matting over backfilled geocell, seed, fertilizer and straw.</p>
