**Re: 2020 Leaf-on and 2020-2021 Leaf-off Maintenance Inspections
Former DuPont Waynesboro Site AOC 4
Waynesboro, Virginia
EPA ID# VAD003114832**

Subject 2020-2021 Phase 1 BMA Leaf-Off Maintenance Inspection
Former DuPont Waynesboro Site, Area of Concern 4

Date March 24, 2021

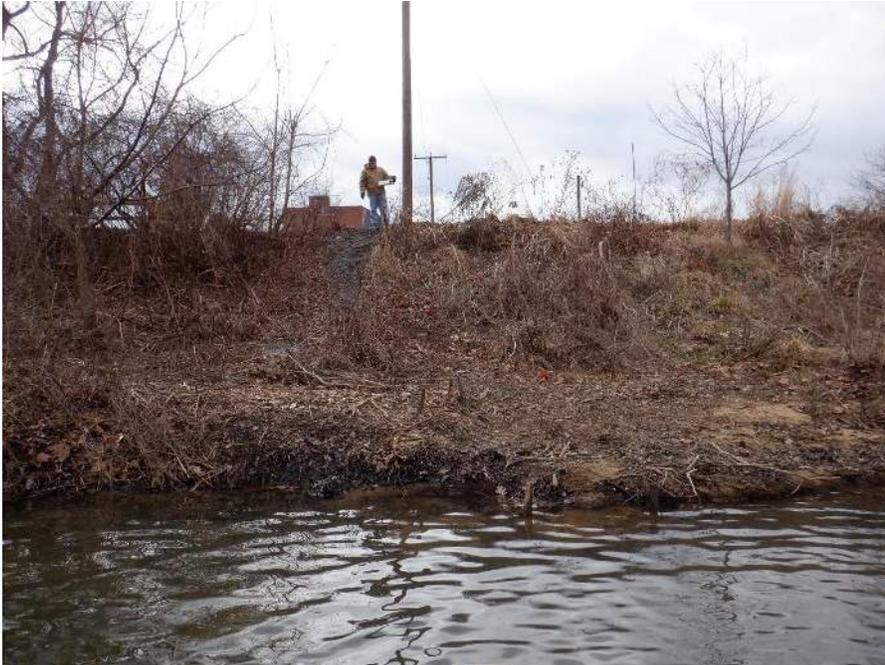
<p>Location: 00+00'</p> <hr/> <p>Photo Number: Date: 3 1/18/2021</p> <hr/> <p>Direction Photo Taken: West</p> <hr/> <p>Description: ~30 degree lower bank angle and 55 degree upper bank angle; live stakes and plantings establishing; coir logs intact; vegetation established; exposed geocell at constructed gravel access path</p>

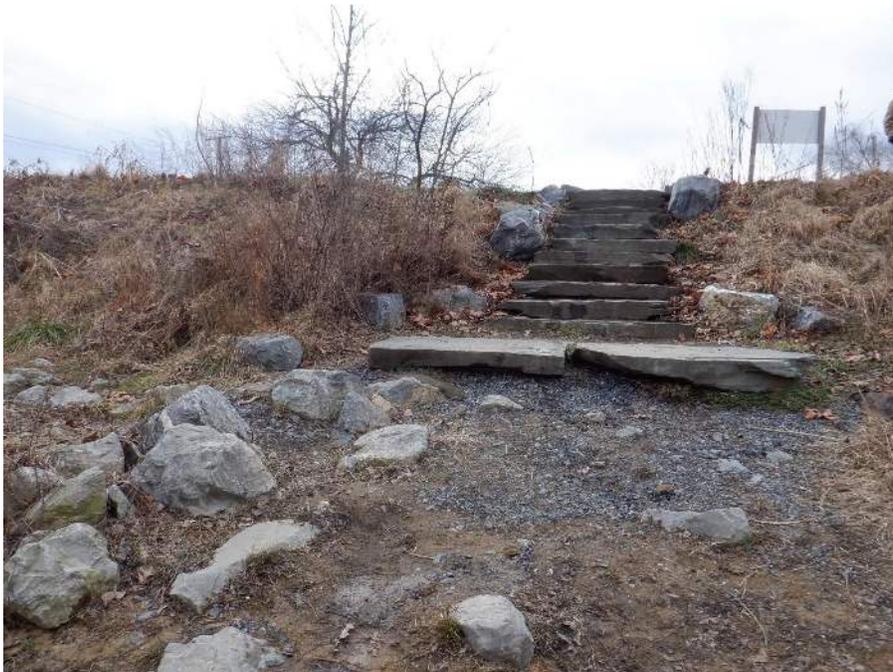
- The installed rock toe was intact and showed no indication of movement.
- The two staircases along the downstream portion of the BMA are intact with minimal erosion and scour under the bottom steps from high water. The kayak launch ramp along the first upstream staircase is intact.
- The walking path along the stone toe between the two staircases is intact with some erosion from high water events that has scoured some of the crushed stone from the path, exposing the larger grade blue stone beneath.
- Erosion control fabric was exposed and shows signs of wear in some areas. Erosion control fabric and geocell was highly exposed in the downstream portion of the BMA from 00+1700' to 00+2200'. This will continue to be monitored to determine if repairs are warranted.

<p>Location: 00+100'</p> <hr/> <p>Photo Title: Date: 8 1/18/2021</p> <hr/> <p>Direction Photo Taken: West</p> <hr/> <p>Description: Staircase intact; undercutting under bottom stone slab steps</p>

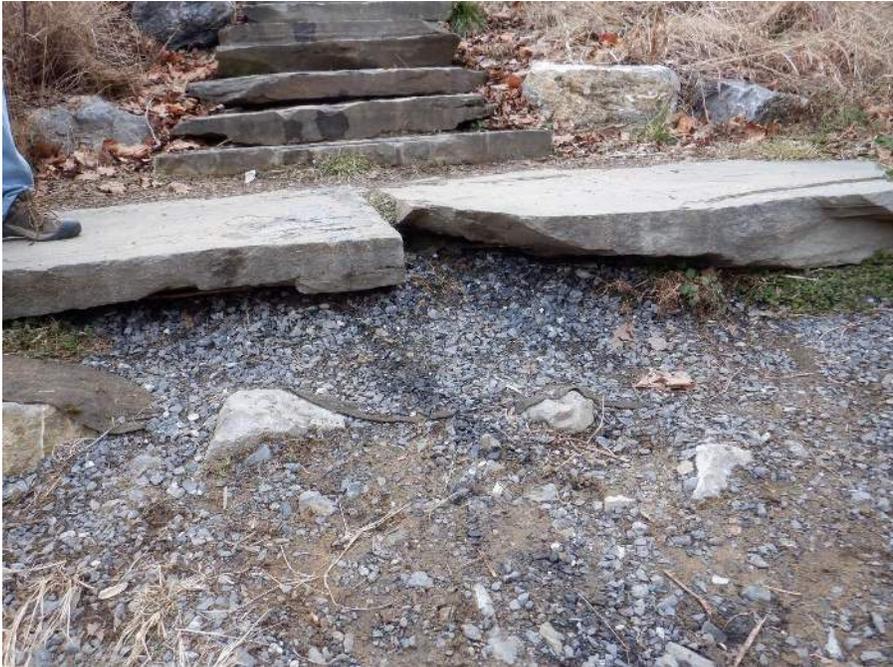
<p>Location: 00+100'</p> <hr/> <p>Photo Number: Date: 9 1/18/2021</p> <hr/> <p>Direction Photo Taken: West</p> <hr/> <p>Description: Undercutting under bottom stone slab steps from high water events</p>

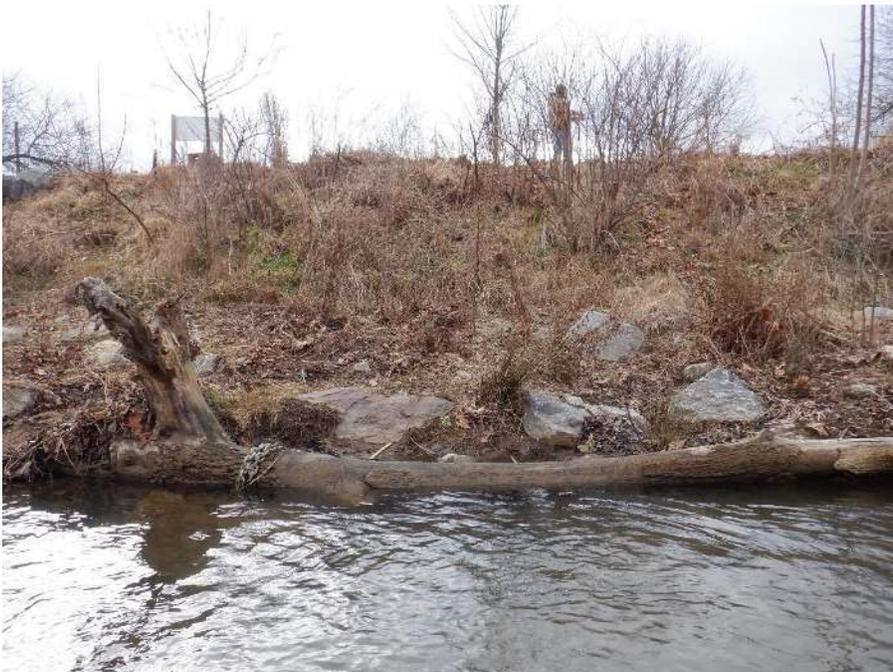
00 + 50	45	Y	Lower 3' of bank toe level	5,6	NA	20-30% invasive species cover. Live stakes not visible.	5,6	N	No trees adjacent to edge of water	5,6	NA	Y	Y (30% exposed)	Erosion control fabric torn at toe of slope and 70% exposed; geocell exposed where erosion control fabric deteriorating; Cair log damaged.	5,6	N	Evidence of foot traffic along the toe of slope	5,6	Y (new foot path down to river, erosion control fabric exposed, some geocell exposed)
00 + 100	40	N (see notes)	Lower bank ~10 degrees (rock toe); Upper bank ~45 degrees	7,8,9	NA	Live stakes not visible	7,8,9	N	No at-risk trees present	7,8,9	Y (rock toe)	Y	N	Rock toe along bank and constructed river access steps intact with undercutting under bottom steps	7,8,9	N	Sediment deposition adjacent to rock toe boulders	7,8,9	N
00 + 150	45	N (see notes)	Lower bank <5 degrees (rock toe); Upper bank ~45 degrees	10,11,12,13	NA	Native vegetation predominantly present; Live stakes not visible; new footpath present	10,11,12,13	N	No trees adjacent to edge of water	10,11,12,13	Y (LWD and Rock toe)	Y	Y	significant geocell exposure along bank (~50 feet across bank by 3-4' height)	10,11,12,13	Y	Silt filling in behind LWD and in boulders; scour at toe of bank	10,11,12,13	N

<p>Location: 00+150'</p> <hr/> <p>Photo Title: Date: 10 1/18/2021</p> <hr/> <p>Direction Photo Taken: West</p> <hr/> <p>Description: ~45 degree bank angle; no exposed roots; live stakes not visible; evidence of foot traffic along slope; scour at toe of bank; LWD intact; sediment deposition behind LWD</p>

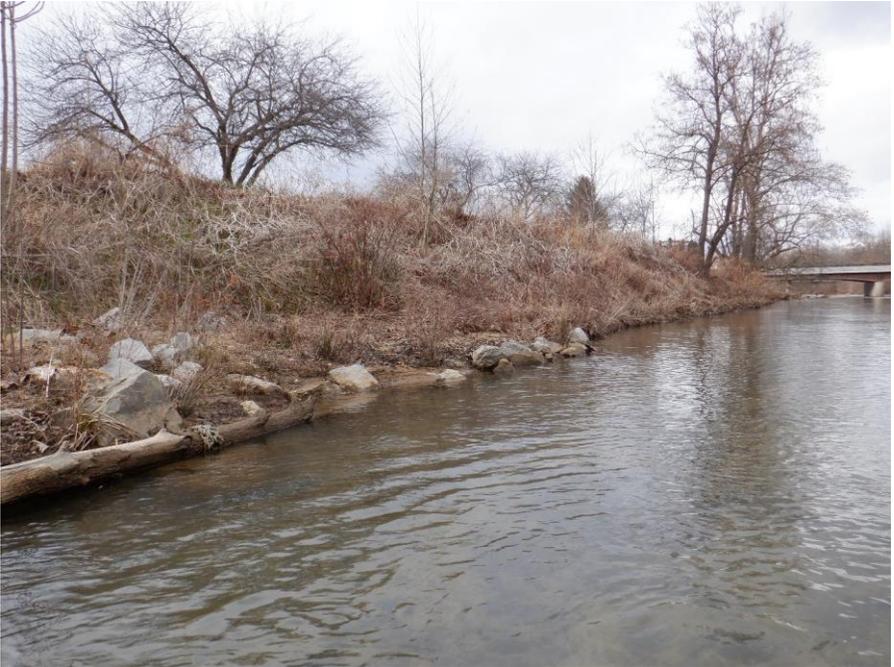
<p>Location: 00+150'</p> <hr/> <p>Photo Number: Date: 11 1/18/2021</p> <hr/> <p>Direction Photo Taken: Northwest</p> <hr/> <p>Description: Downstream view of remediated bank; vegetation established mid to upper bank; minor undercutting along slope toe at water's edge</p>

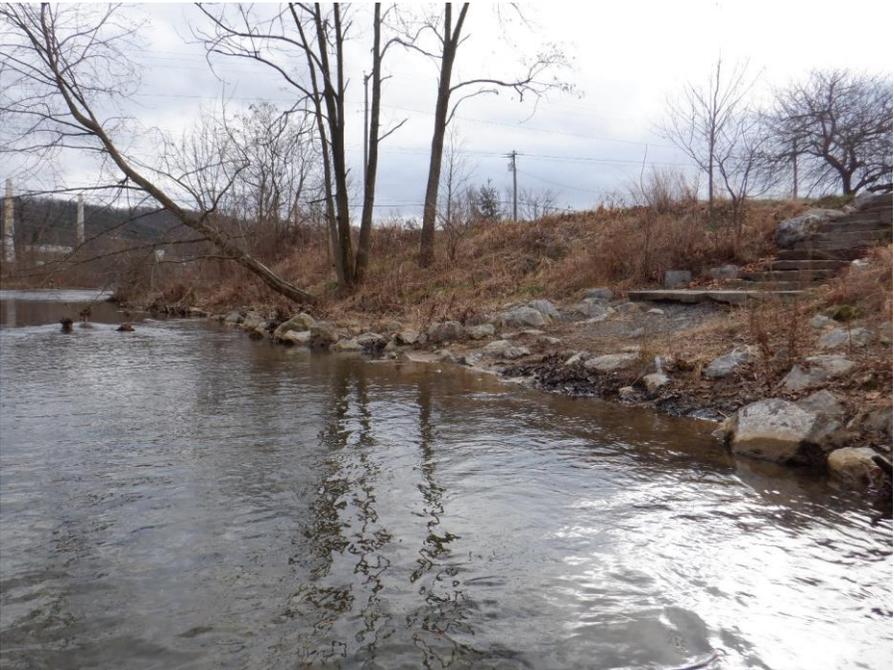
<p>Location: 00+150'</p> <hr/> <p>Photo Title: Date: 12 1/18/2021</p> <hr/> <p>Direction Photo Taken: Southwest</p> <hr/> <p>Description: Upstream view of remediated bank; vegetation established; installed rock toe intact</p>

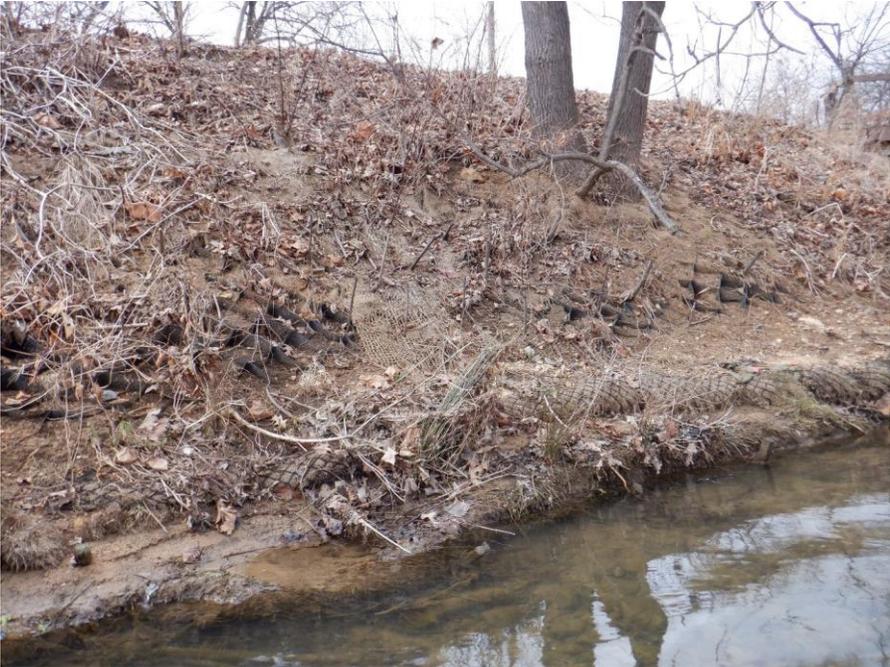
<p>Location: 00+300'</p> <hr/> <p>Photo Number: Date: 19 1/18/2021</p> <hr/> <p>Direction Photo Taken: Northwest</p> <hr/> <p>Description: Exposed geocell along bank</p>

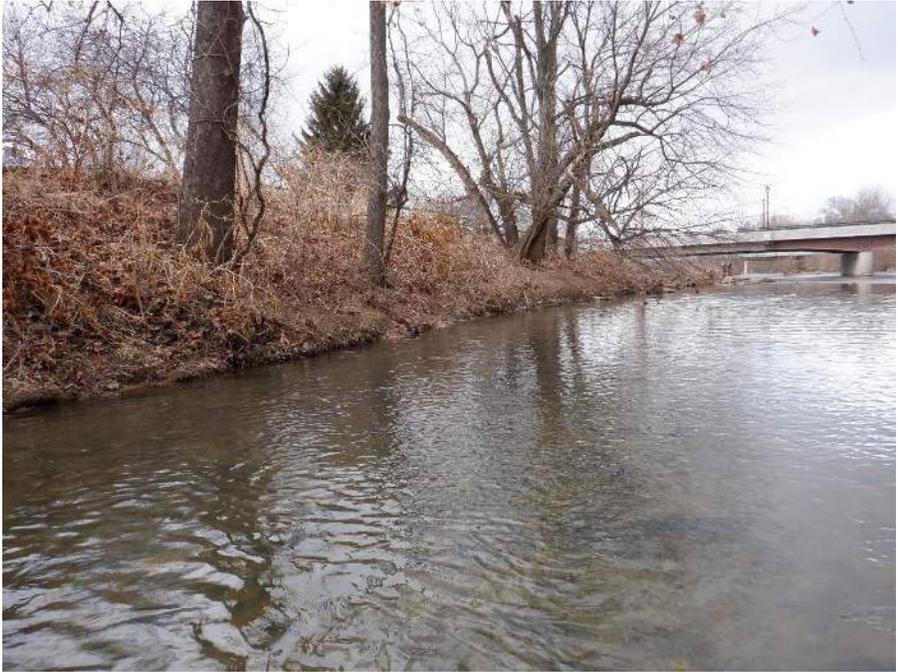
<p>Location: 00+350'</p> <hr/> <p>Photo Title: Date: 22 1/18/2021</p> <hr/> <p>Direction Photo Taken: Northwest</p> <hr/> <p>Description: Downstream view showing remediated section; geocell exposed along bank; mild undercutting along toe of bank</p>

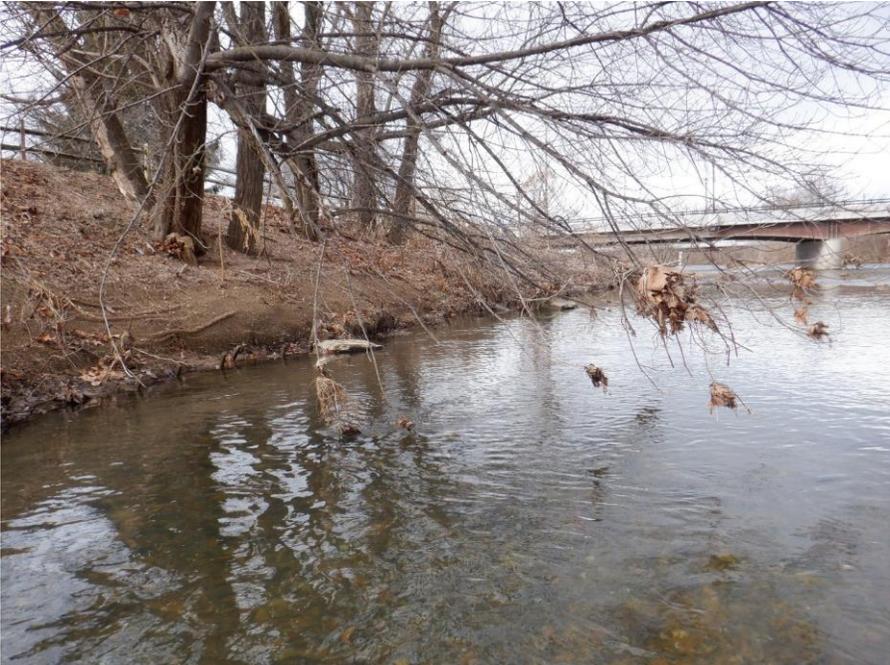
<p>Location: 00+400'</p> <hr/> <p>Photo Number: 27 Date: 1/18/2021</p> <hr/> <p>Direction Photo Taken: Northwest</p> <hr/> <p>Description: Downstream view of remediated bank; undercutting along toe of slope; minimal vegetation established</p>

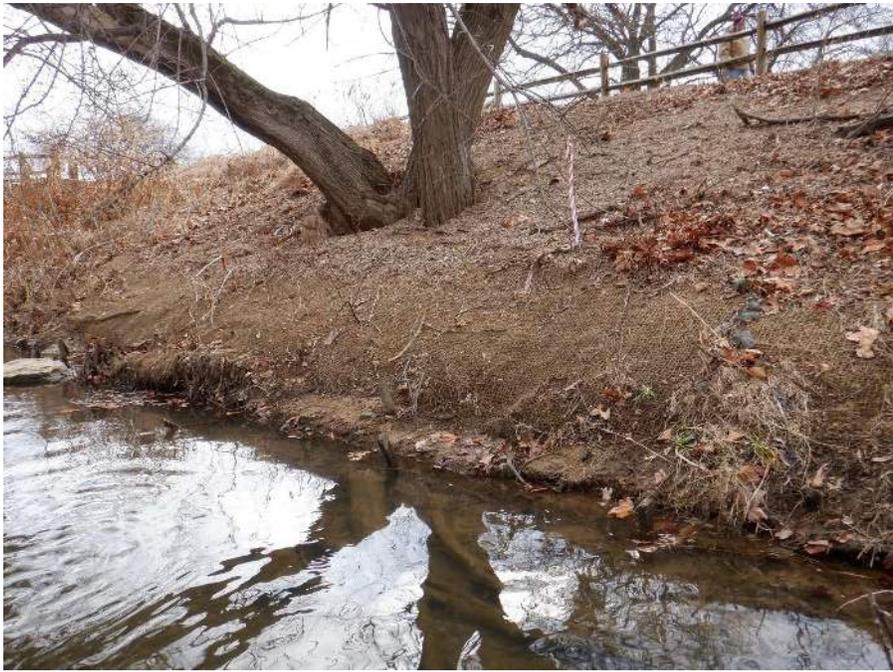
<p>Location: 00+450'</p> <hr/> <p>Photo Number: 29 Date: 1/18/2021</p> <hr/> <p>Direction Photo Taken: Southwest</p> <hr/> <p>Description: Upstream view showing exposed erosion control fabric and bank; minimal vegetation established; undercutting along toe; coir logs slumping</p>

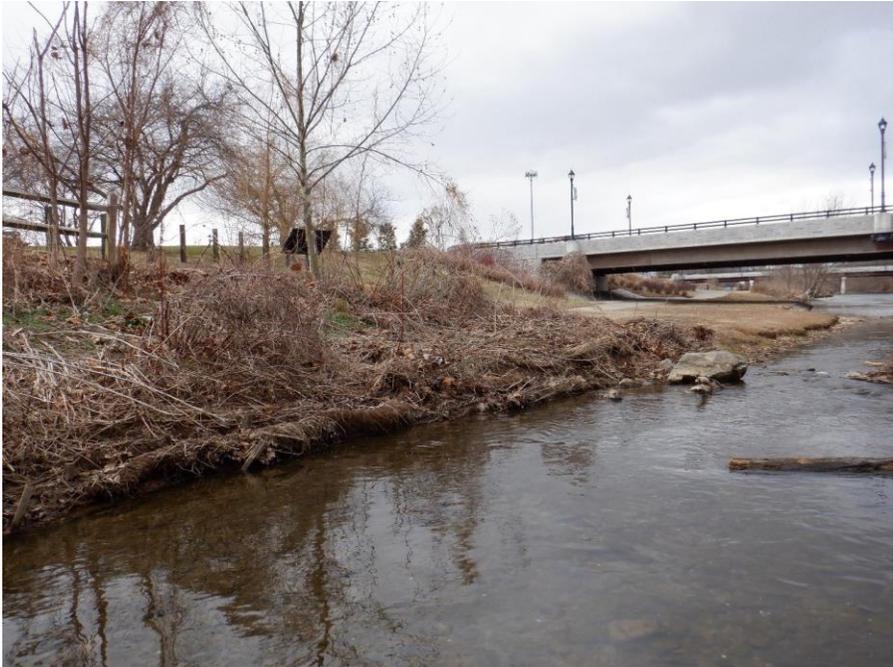
00 + 500	40	Y	The bank design has a decreased vertical bank height (~6') compared to upstream monitoring stations	30,31	NA	Native vegetative present with patches of the invasive knotweed; live stakes 30% established	30,31	N	No trees adjacent to edge of water	30,31	NA	Y	N	small amount of geocell exposed; cair log degraded and slumping into river	30,31	N		30,31	Y (cair log slumping into river)
00 + 525	15	Y		32,33,34	NA	Predominantly native vegetation cover; live stakes 30% established	32,33,34	N	No trees adjacent to edge of water	32,33,34	NA	Y	Y (fabric degraded)	Geocell minimally exposed near toe of bank	32,33,34	N		32,33,34	N

<p>Location: 00+500'</p> <hr/> <p>Photo Number: Date: 31 1/18/2021</p> <hr/> <p>Direction Photo Taken: Northwest</p> <hr/> <p>Description: Downstream showing end of bank remediation; undercutting along toe</p>

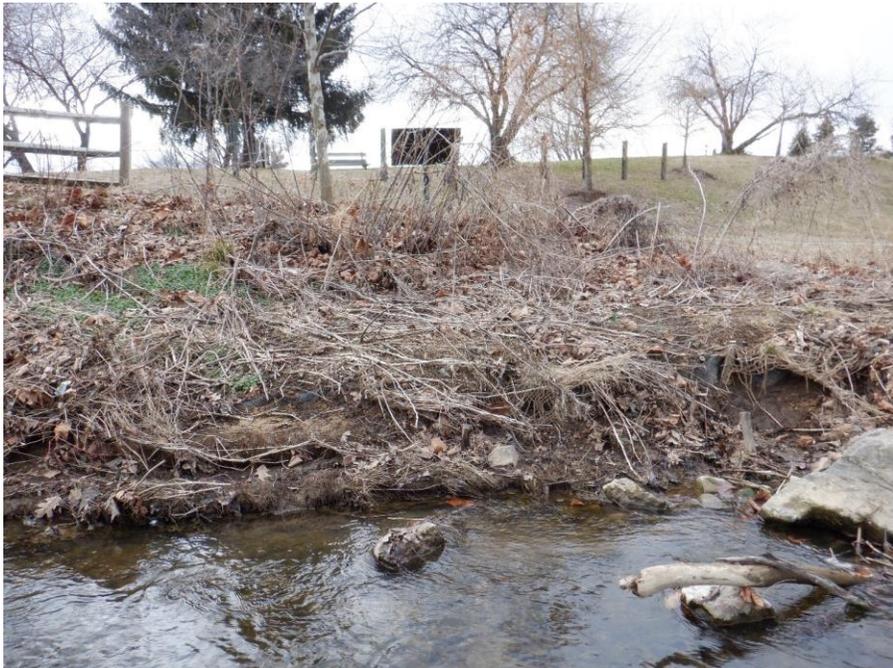
<p>Location: 00+525'</p> <hr/> <p>Photo Title: Date: 32 1/18/2021</p> <hr/> <p>Direction Photo Taken: West</p> <hr/> <p>Description: End of remediation; ~15 degree bank angle; vegetation establishing; erosion along slope toe; small patches of geocell exposed above toe; fencing intact</p>

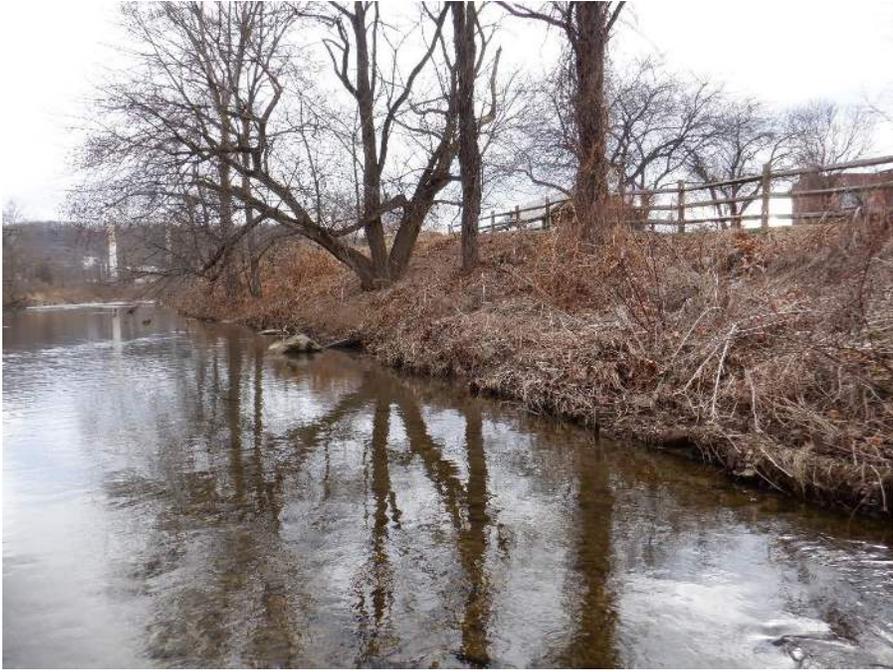
<p>Location: 00+525'</p> <hr/> <p>Photo Number: Date: 33 1/18/2021</p> <hr/> <p>Direction Photo Taken: Southwest</p> <hr/> <p>Description: Upstream view of bank remediation; undercutting along toe of slope; coir logs slumping into river</p>

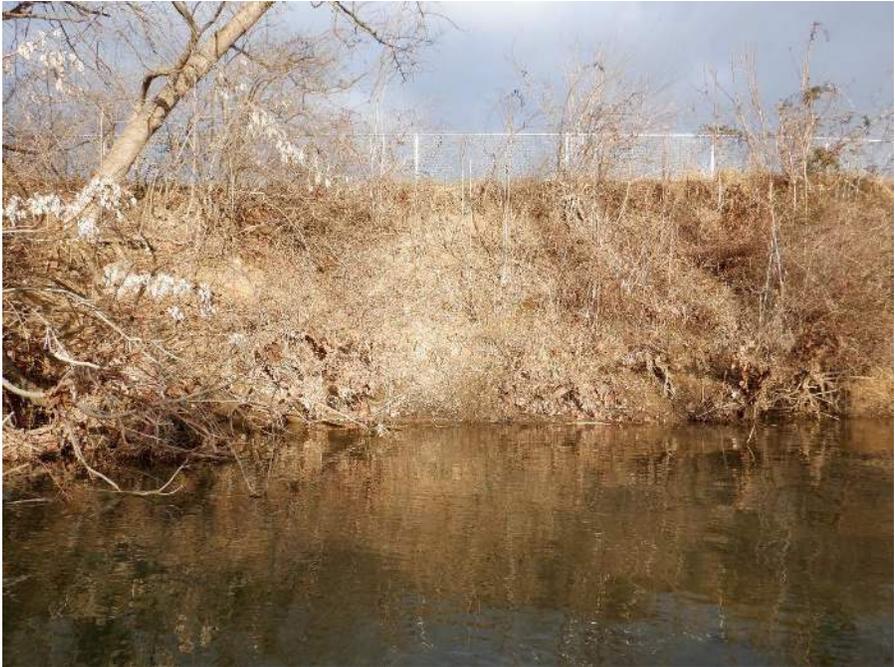
<p>Location: 00-25'</p> <hr/> <p>Photo Number: Date: 1 1/20/2021</p> <hr/> <p>Direction Photo Taken: Northwest</p> <hr/> <p>Description: ~85 degree bank angle; as risk trees present; scour present; 25% vegetated</p>

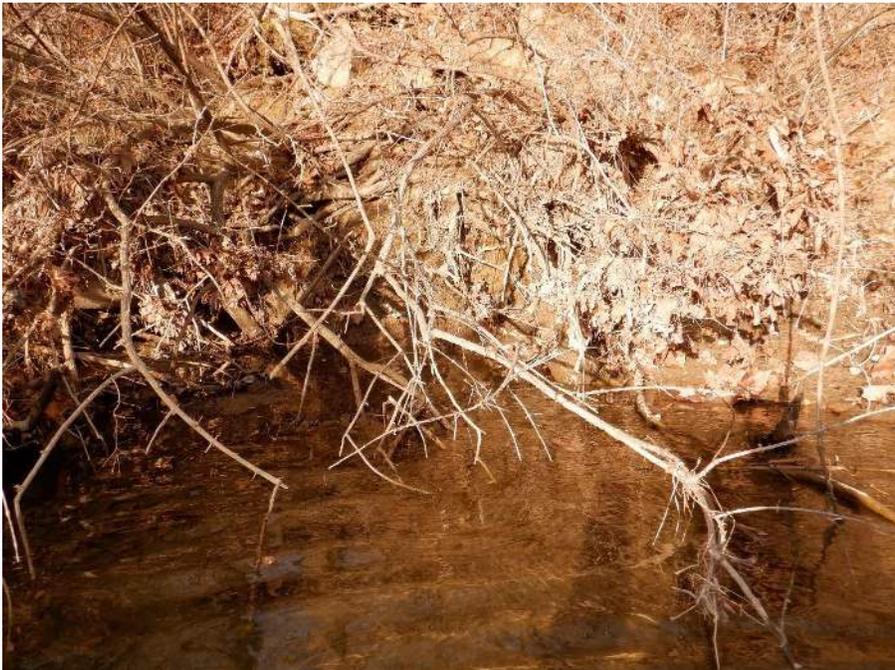
<p>Location: 00-25'</p> <hr/> <p>Photo Title: Date: 2 1/20/2021</p> <hr/> <p>Direction Photo Taken: Northwest</p> <hr/> <p>Description: Significant root exposure on bank; at risk trees present; scour present; 25% vegetated</p>

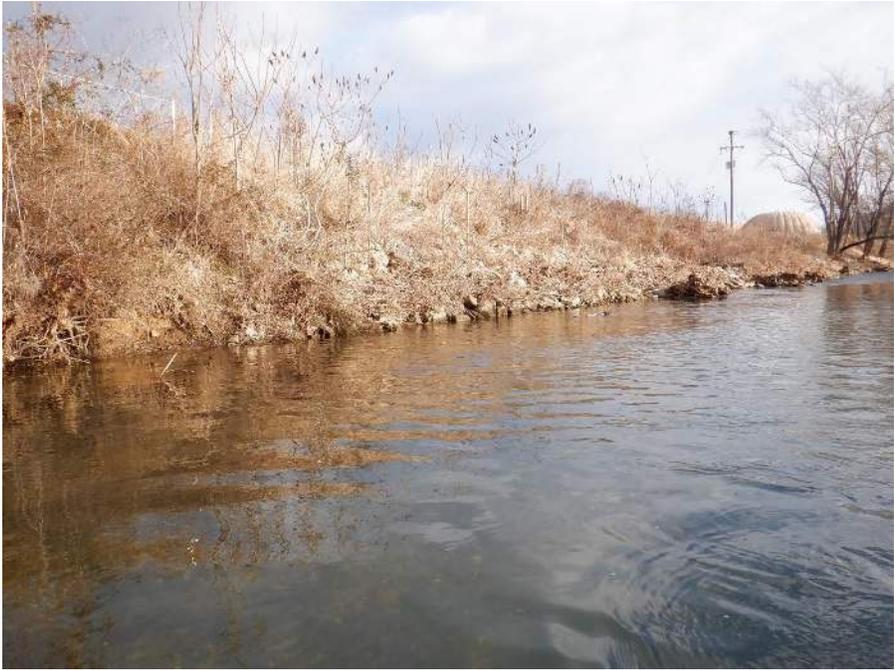
<p>Location: 00-25</p> <hr/> <p>Photo Number: Date: 3 1/20/2021</p> <hr/> <p>Direction Photo Taken: North</p> <hr/> <p>Description: Upstream extent of remediation; installed rock toe intact</p>

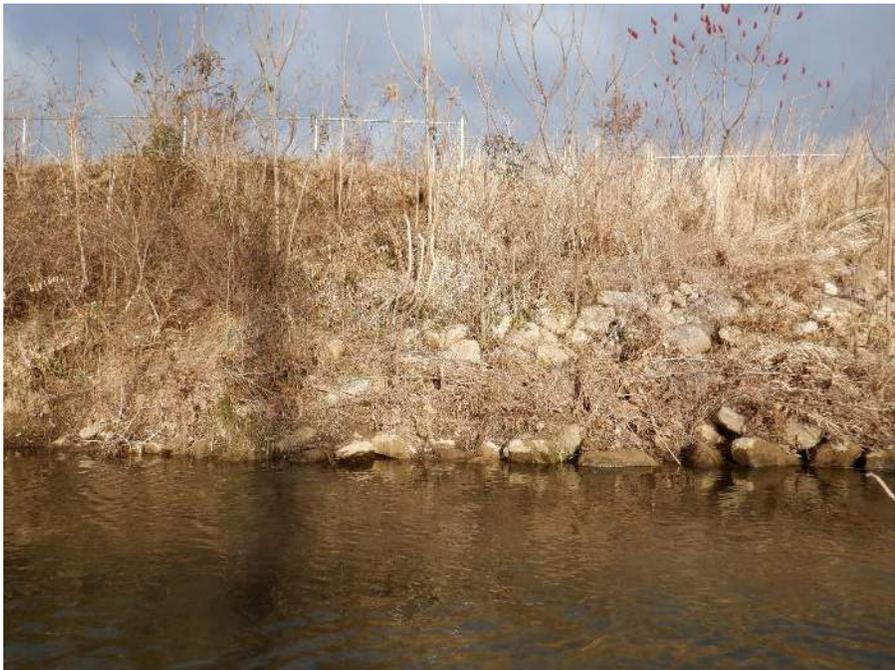
<p>Location: 00+00</p> <hr/> <p>Photo Title: Date: 4 1/20/2021</p> <hr/> <p>Direction Photo Taken: Northwest</p> <hr/> <p>Description: ~60-80 degree bank angle; no exposed roots; evidence of scour from rock toe to mid bank upstream of remediation; installed rock toe intact; vegetation established in remediated portion</p>

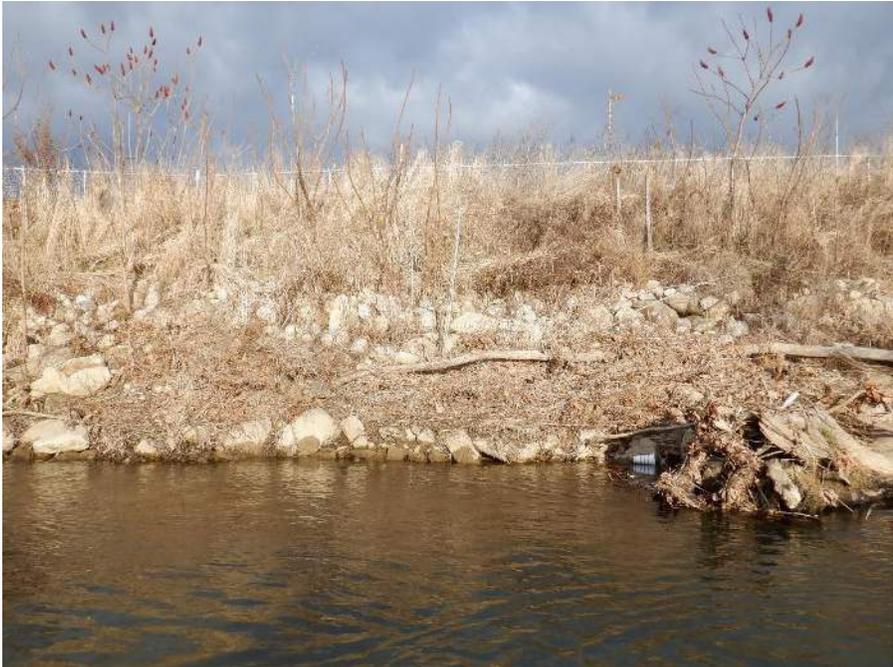
<p>Location: 00+50'</p> <hr/> <p>Photo Number: Date: 5 1/20/2021</p> <hr/> <p>Direction Photo Taken: Northwest</p> <hr/> <p>Description: ~45 degree bank angle; no scour present; installed rock toe intact; vegetation established; LWD intact; sediment deposition behind LWD</p>

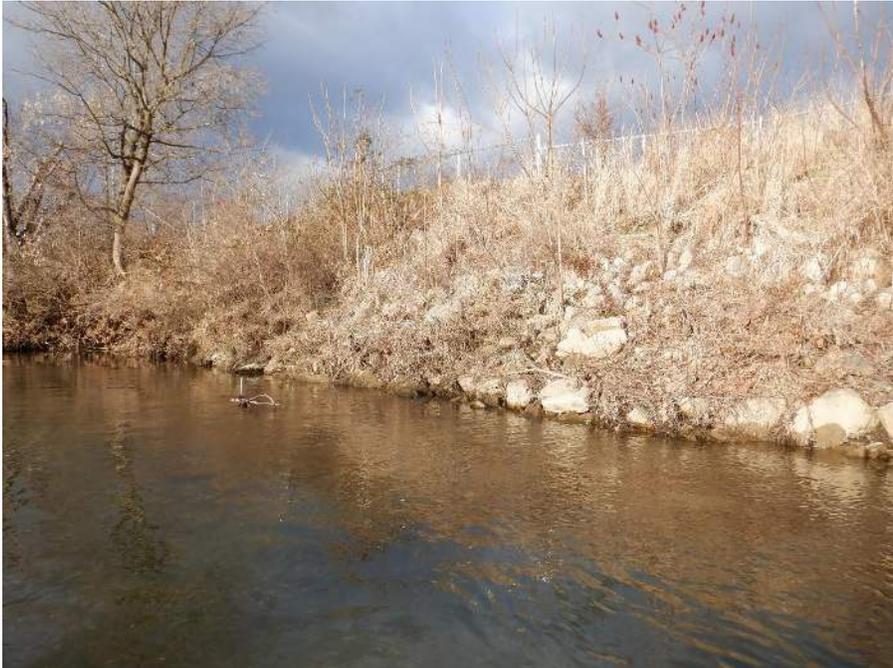
<p>Location: 00+50'</p> <hr/> <p>Photo Title: Date: 6 1/20/2021</p> <hr/> <p>Direction Photo Taken: West</p> <hr/> <p>Description: Upstream view; no scour present; installed rock toe intact; vegetation established in remediated portion</p>

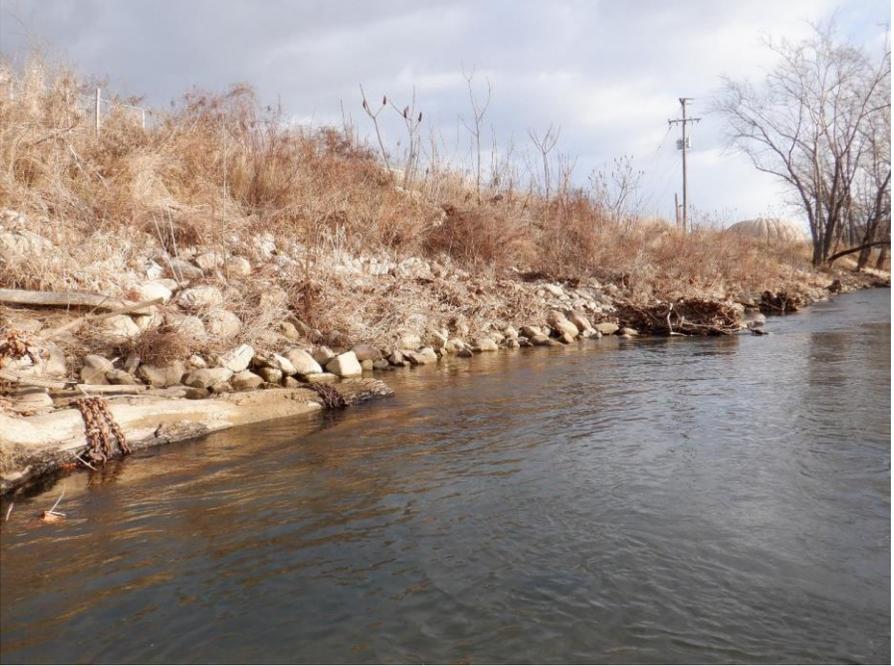
<p>Location: 00+50'</p> <hr/> <p>Photo Number: Date: 7 1/20/2021</p> <hr/> <p>Direction Photo Taken: North</p> <hr/> <p>Description: No scour present; installed rock toe intact; vegetation established; LWD intact; sediment deposition behind LWD</p>

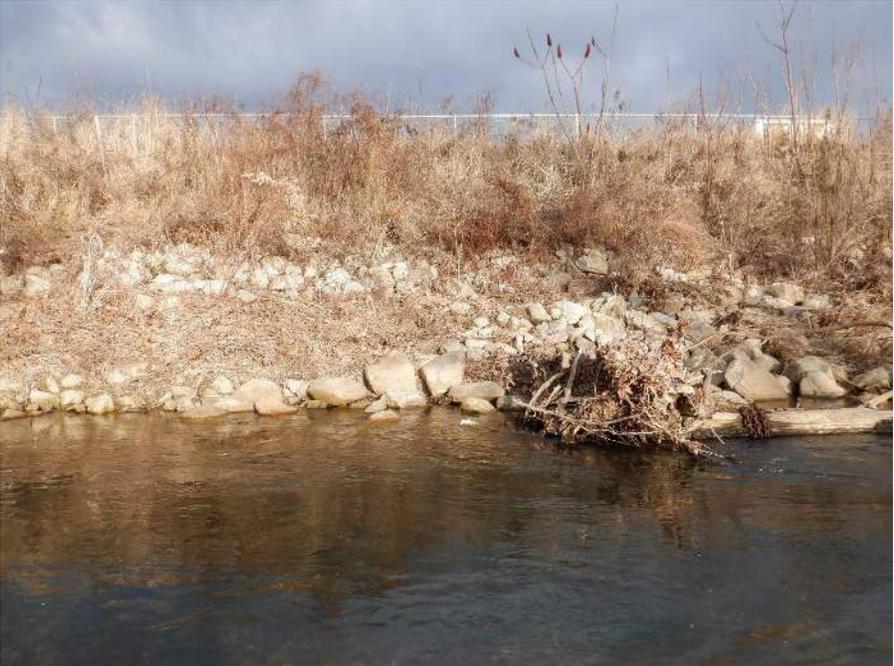
<p>Location: 00+100'</p> <hr/> <p>Photo Title: Date: 8 1/20/2021</p> <hr/> <p>Direction Photo Taken: Northwest</p> <hr/> <p>Description: ~45 degree bank angle; no scour present; installed rock toe intact; vegetation established; LWD intact; sediment deposition behind LWD</p>

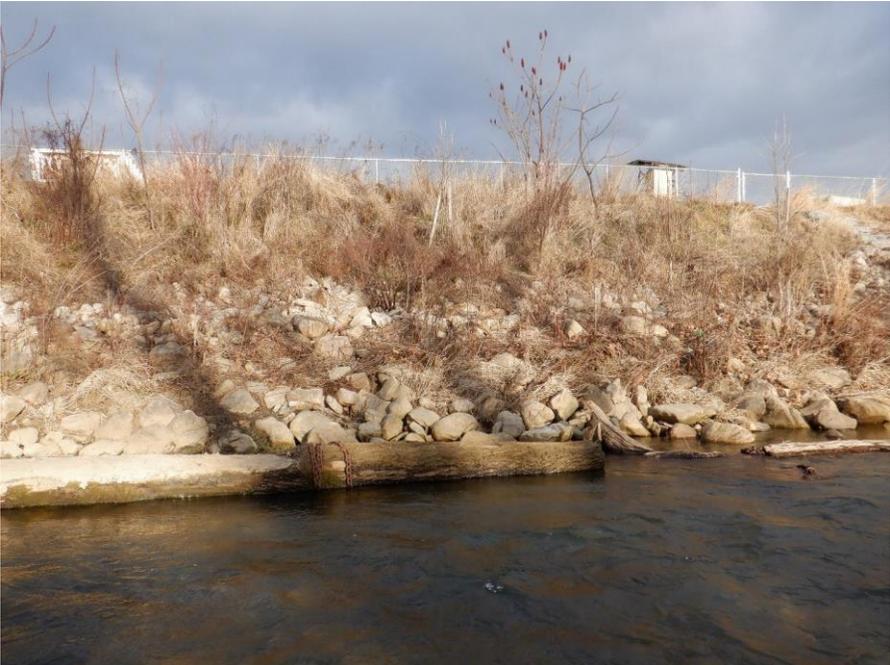
<p>Location: 00+150'</p> <hr/> <p>Photo Number: Date: 9 1/20/2021</p> <hr/> <p>Direction Photo Taken: Northwest</p> <hr/> <p>Description: ~45 degree bank angle; installed rock toe intact, vegetation established; LWD intact; sediment deposition behind LWD</p>

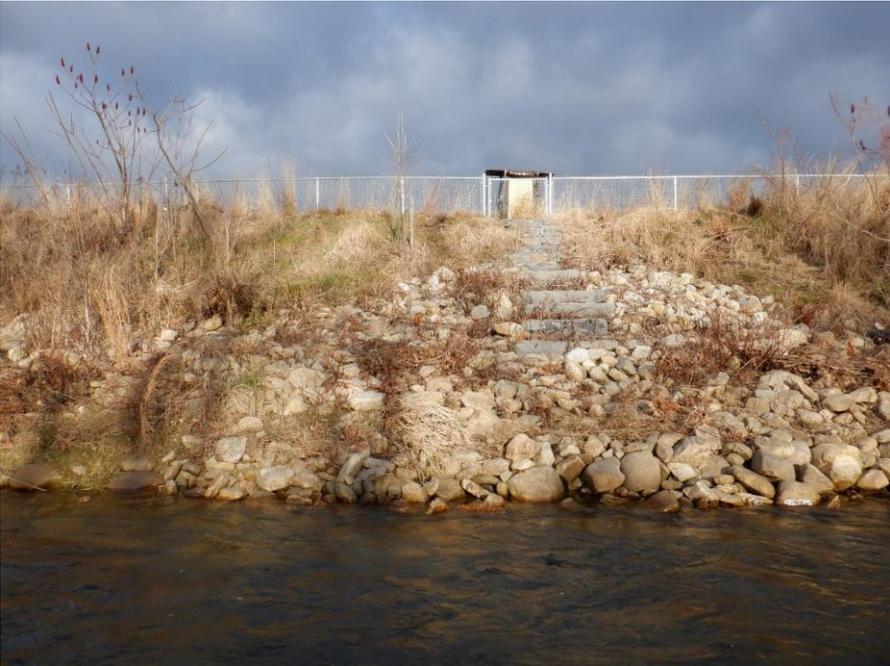
<p>Location: 00+200'</p> <hr/> <p>Photo Title: Date: 10 1/20/2021</p> <hr/> <p>Direction Photo Taken: Northwest</p> <hr/> <p>Description: ~45 degree bank angle; installed rock toe intact; vegetation established; outfall pipe in rock toe and staircase / gate access intact</p>

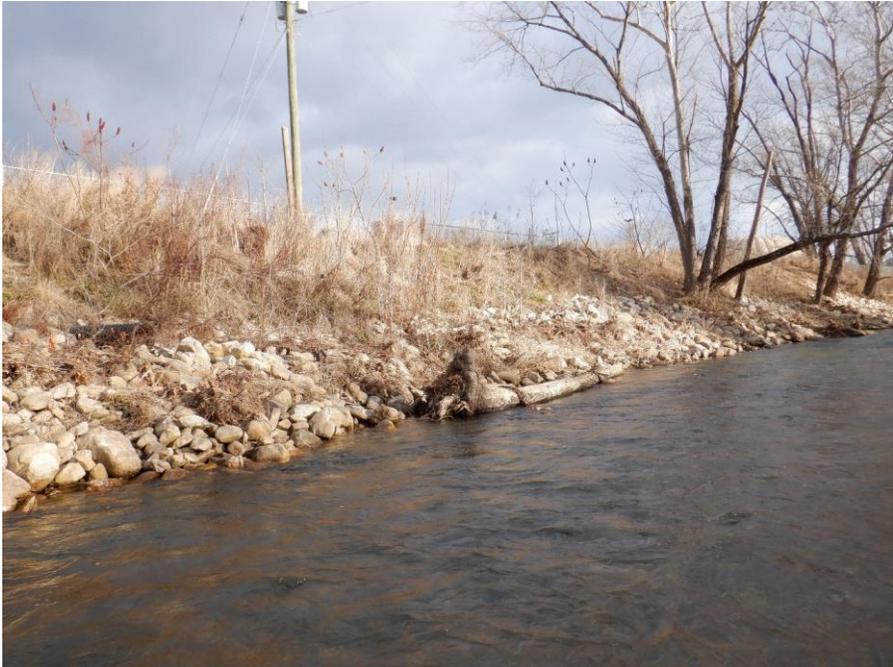
<p>Location: 00+200'</p> <hr/> <p>Photo Number: Date: 11 1/20/2021</p> <hr/> <p>Direction Photo Taken: North</p> <hr/> <p>Description: Outfall pipe intact; installed rock toe intact; predominately native vegetation established</p>

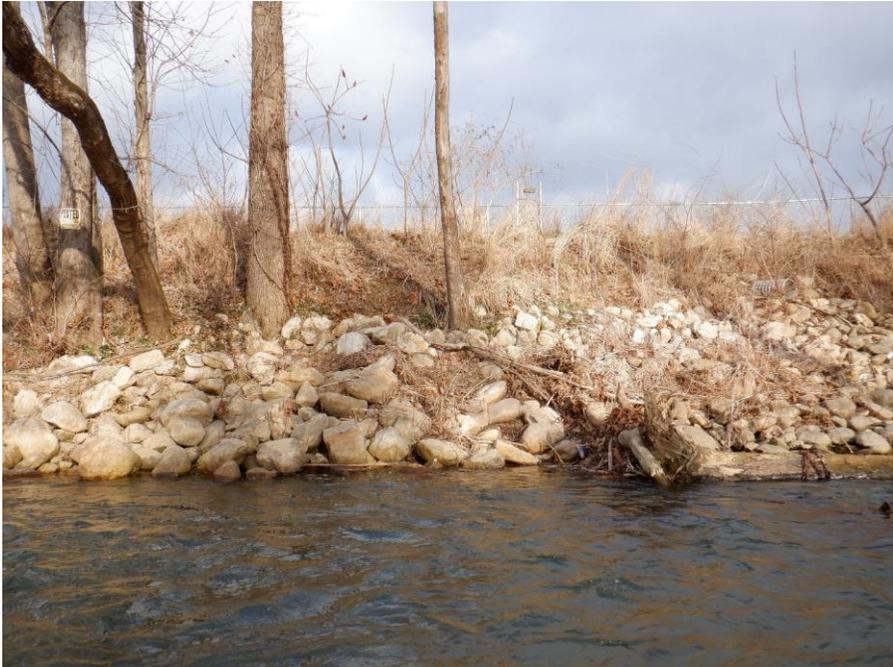
<p>Location: 00+300'</p> <hr/> <p>Photo Number: Date: 13 1/20/2021</p> <hr/> <p>Direction Photo Taken: Northwest</p> <hr/> <p>Description: ~45 degree bank angle; installed rock toe intact; vegetation established; LWD intact</p>

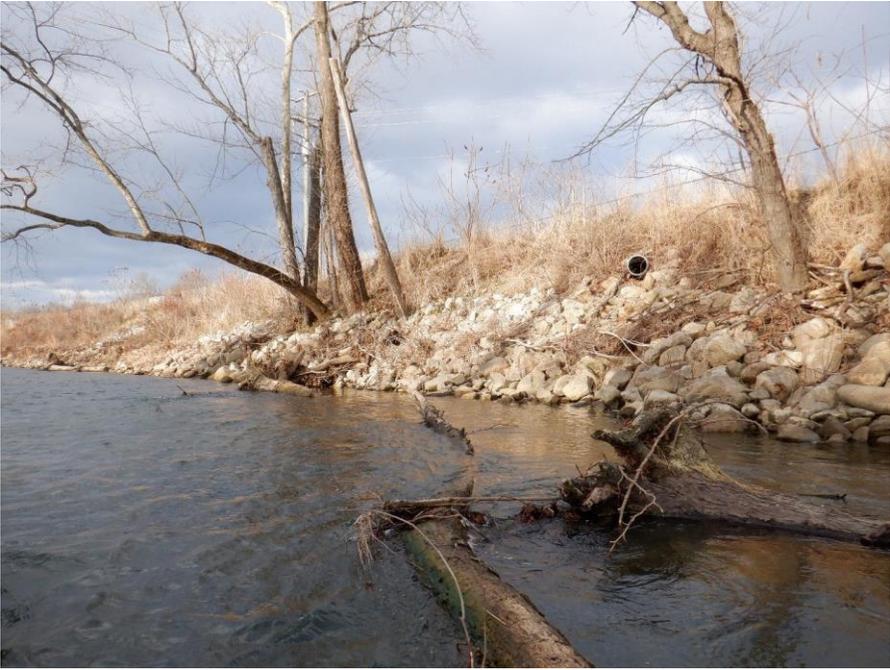
<p>Location: 00+350'</p> <hr/> <p>Photo Number: Date: 15 1/20/2021</p> <hr/> <p>Direction Photo Taken: West</p> <hr/> <p>Description: Installed rock toe intact; upstream outfall pipe intact; vegetation established</p>

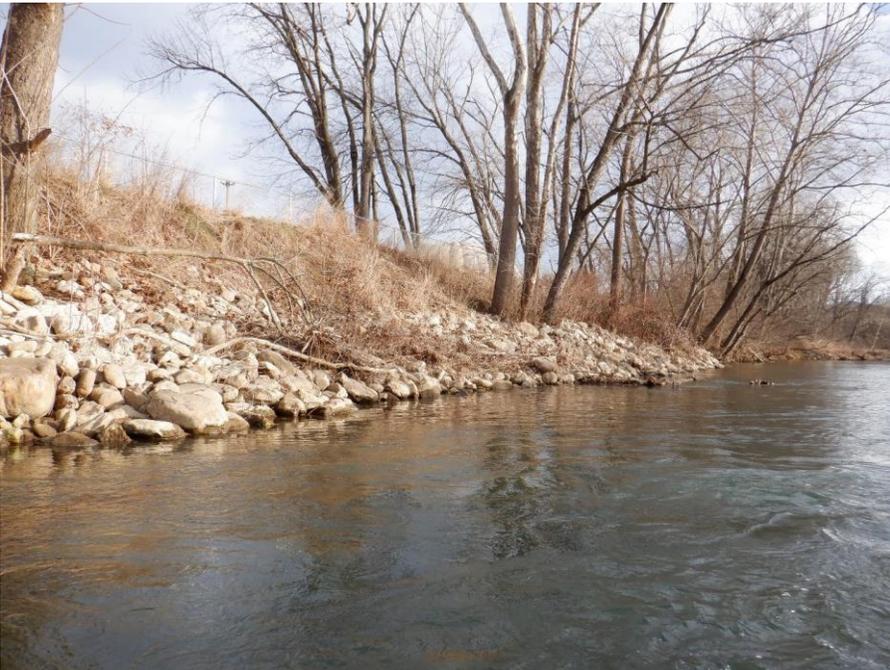
<p>Location: 00+350'</p> <hr/> <p>Photo Title: Date: 16 1/20/2021</p> <hr/> <p>Direction Photo Taken: North</p> <hr/> <p>Description: Installed rock toe intact; vegetation established</p>

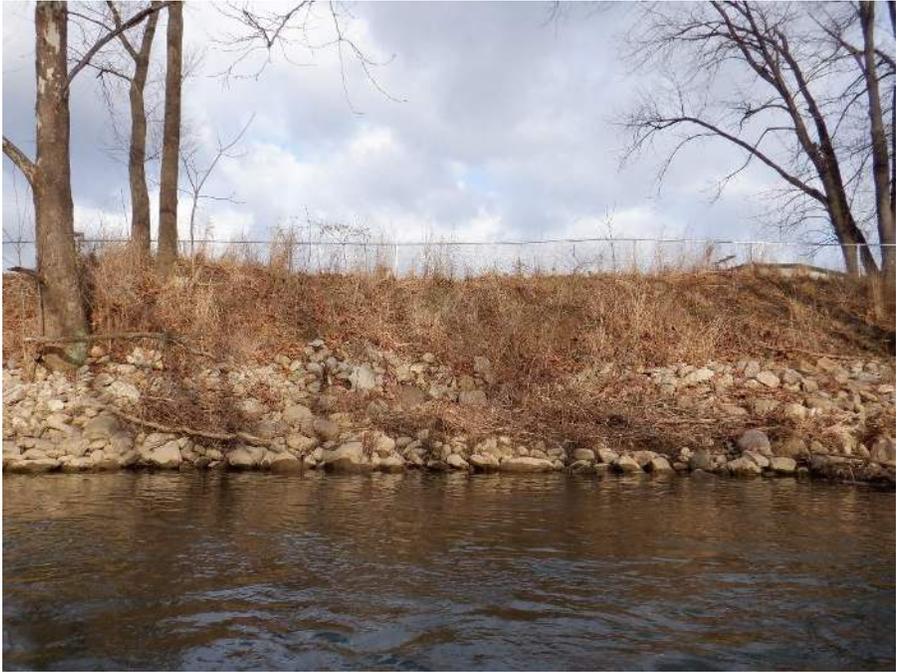
<p>Location: 00+400'</p> <hr/> <p>Photo Title: Date: 18 1/20/2021</p> <hr/> <p>Direction Photo Taken: Northwest</p> <hr/> <p>Description: ~45 degree bank angle; installed rock toe intact with 2 outfall pipes; LWD shifted downstream; vegetation established; 1st outfall pipe has broken hinge and 2nd appears to be blocked; some geocell visible on upper bank</p>

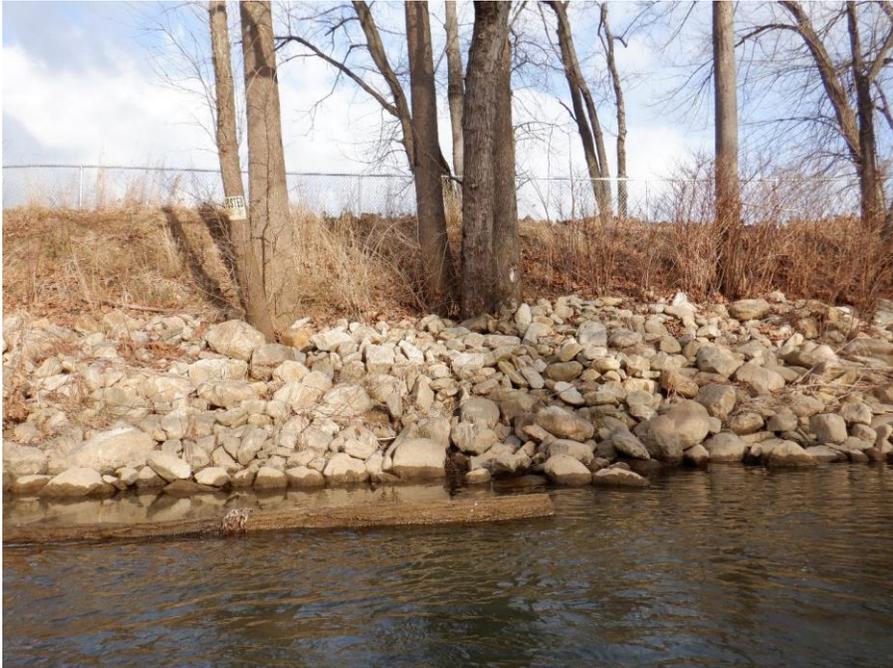
<p>Location: 00+450'</p> <hr/> <p>Photo Title: Date: 20 1/20/2021</p> <hr/> <p>Direction Photo Taken: Northwest</p> <hr/> <p>Description: ~45 degree bank angle; installed rock toe intact; vegetation established; LWD intact; sediment deposition behind LWD; not at risk trees present</p>

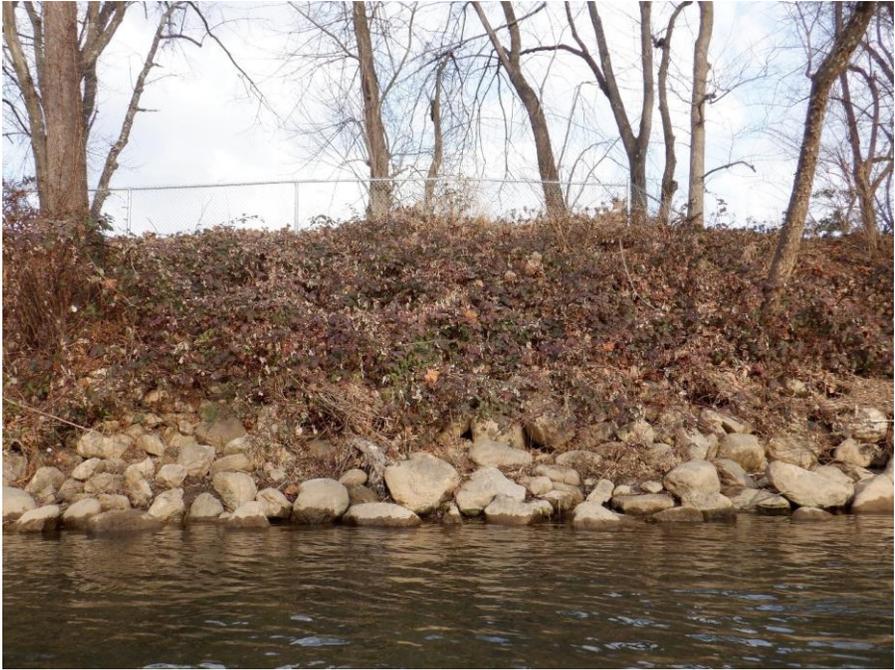
<p>Location: 00+500'</p> <hr/> <p>Photo Number: Date: 21 1/20/2021</p> <hr/> <p>Direction Photo Taken: Northwest</p> <hr/> <p>Description: ~45 degree bank angle; installed rock toe intact; vegetation established; no at risk trees present; minimal sediment deposition in rock toe</p>

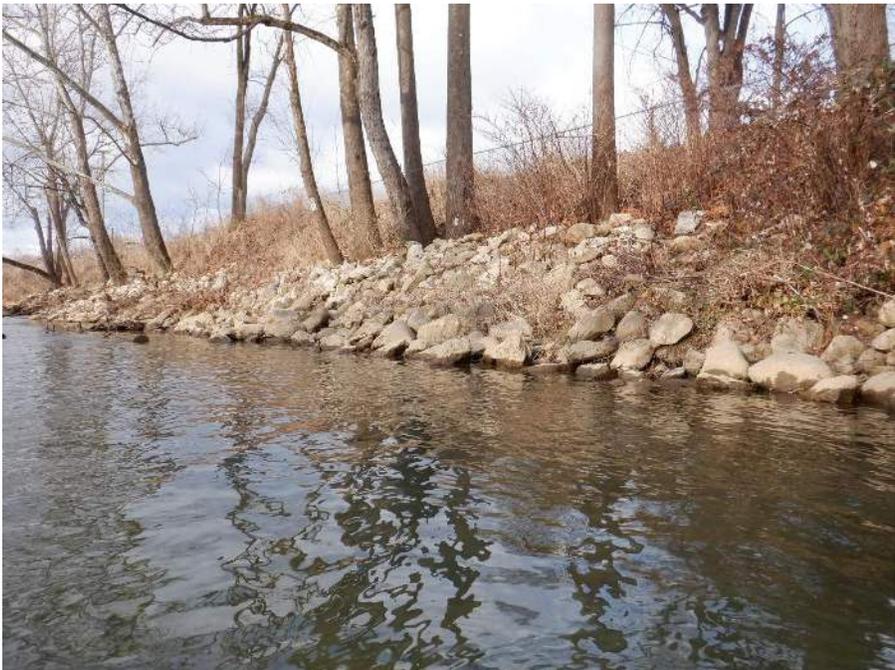
<p>Location: 00+500'</p> <hr/> <p>Photo Title: Date: 22 1/20/2021</p> <hr/> <p>Direction Photo Taken: Northwest</p> <hr/> <p>Description: Installed rock toe intact; vegetation established; no at risk trees present; minimal sediment deposition in rock toe</p>

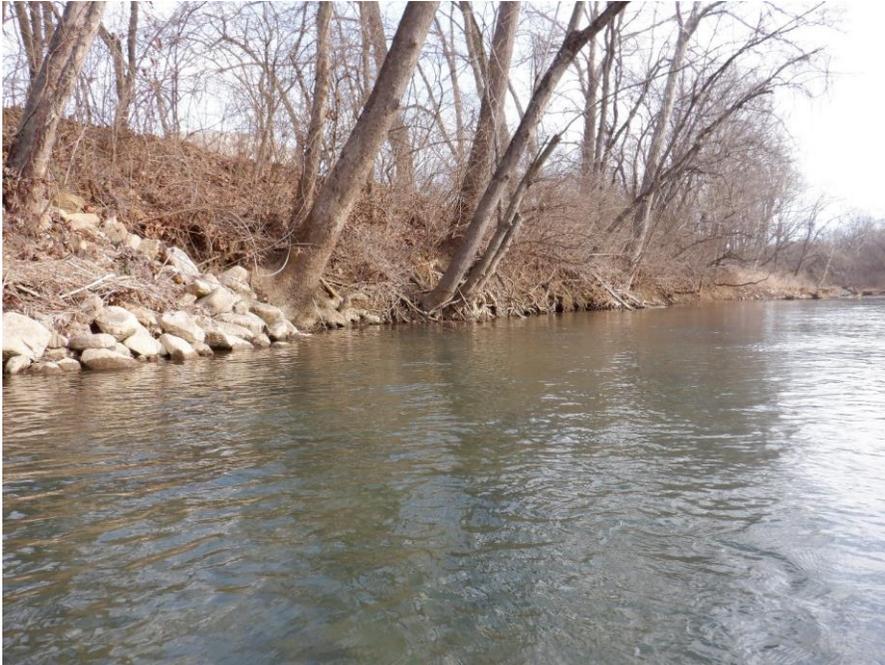
<p>Location: 00+500'</p> <hr/> <p>Photo Number: Date: 23 1/20/2021</p> <hr/> <p>Direction Photo Taken: North</p> <hr/> <p>Description: Installed rock toe intact; shows end of 1st remediated section; at risk trees present in non-remediated section; vegetation established in remediated section</p>

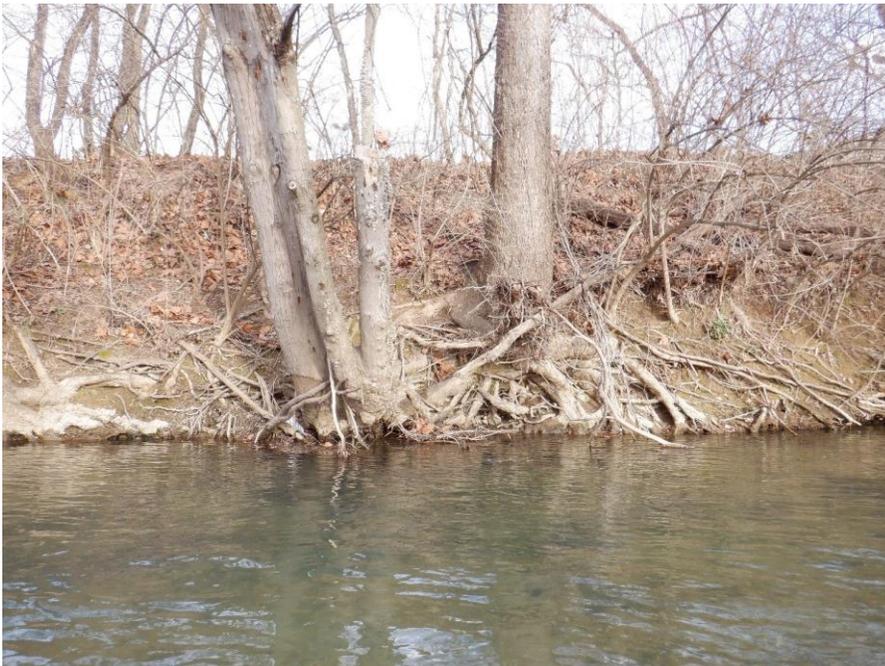
<p>Location: 00+550'</p> <hr/> <p>Photo Title: Date: 24 1/20/2021</p> <hr/> <p>Direction Photo Taken: Northwest</p> <hr/> <p>Description: ~75 degree bank angle; non-remediated section; significant root exposure on lower bank; several at risk trees present; significant scour present</p>
