**Re: 2020 Leaf-on and 2020-2021 Leaf-off Maintenance Inspections
Former DuPont Waynesboro Site AOC 4
Waynesboro, Virginia
EPA ID# VAD003114832**

Subject 2020-2021 Phase 1 BMA Leaf-Off Maintenance Inspection
Former DuPont Waynesboro Site, Area of Concern 4

Date March 24, 2021

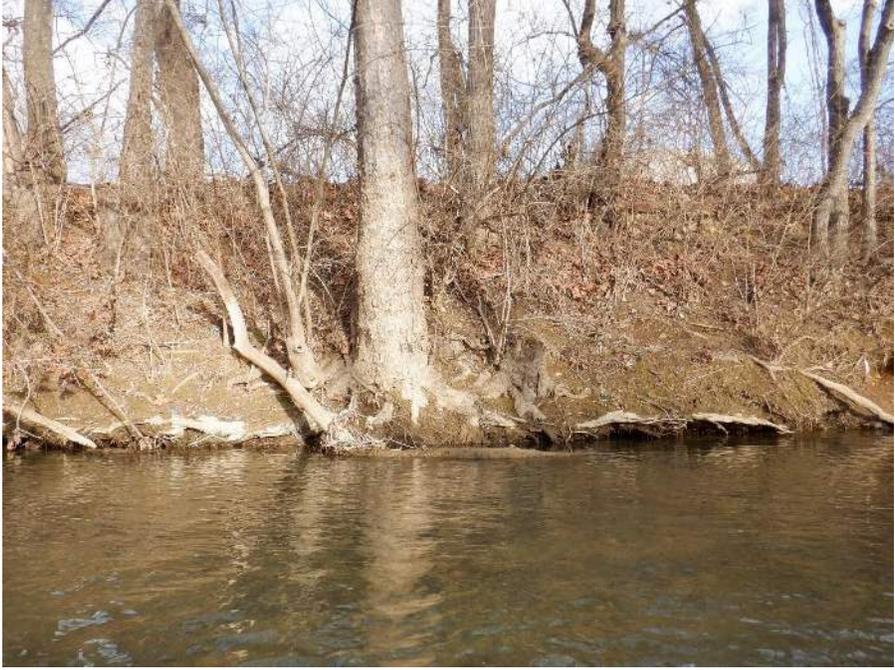
<p>Location: 00+600'</p> <hr/> <p>Photo Number: Date: 25 1/20/2021</p> <hr/> <p>Direction Photo Taken: Northwest</p> <hr/> <p>Description: ~75 degree bank angle; non-remediated section; significant root exposure on lower bank; several at risk trees present; significant scour present</p>

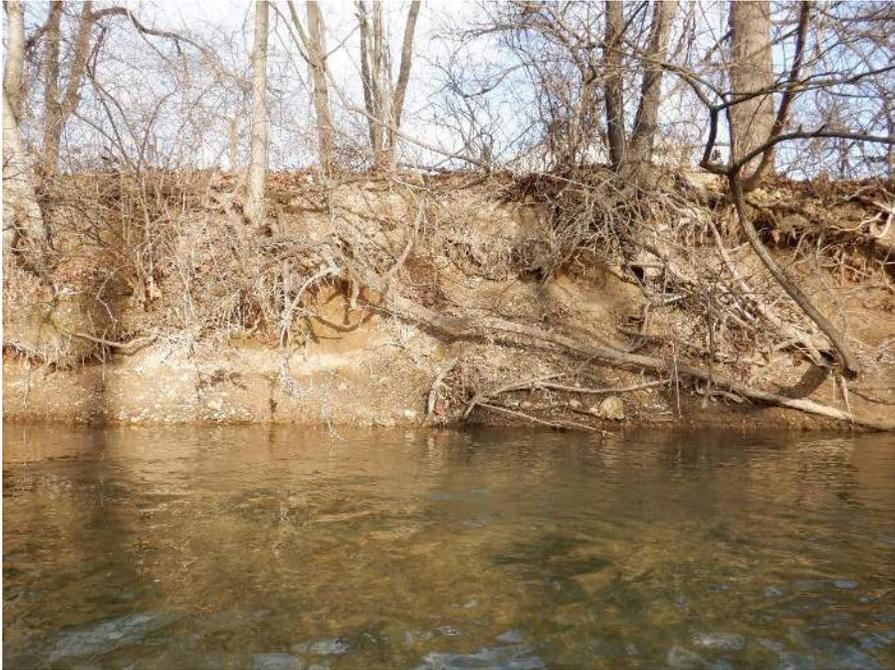
<p>Location: 00+650'</p> <hr/> <p>Photo Title: Date: 26 1/20/2021</p> <hr/> <p>Direction Photo Taken: Northwest</p> <hr/> <p>Description: ~85 degree bank angle; non-remediated section; significant root exposure on lower bank and upper bank; several at risk trees present; significant scour present</p>

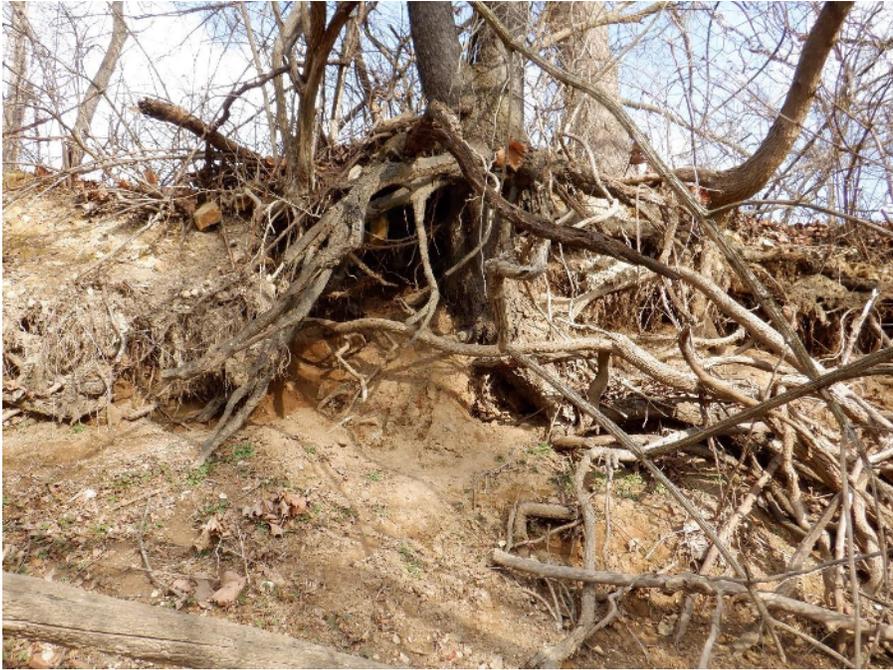
<p>Location: 00+650'</p> <hr/> <p>Photo Number: Date: 27 1/20/2021</p> <hr/> <p>Direction Photo Taken: Northwest</p> <hr/> <p>Description: Significant root exposure on upper bank; several at risk trees present; scour advancing under root masses or at risk trees; significant scour present on lower and mid bank</p>

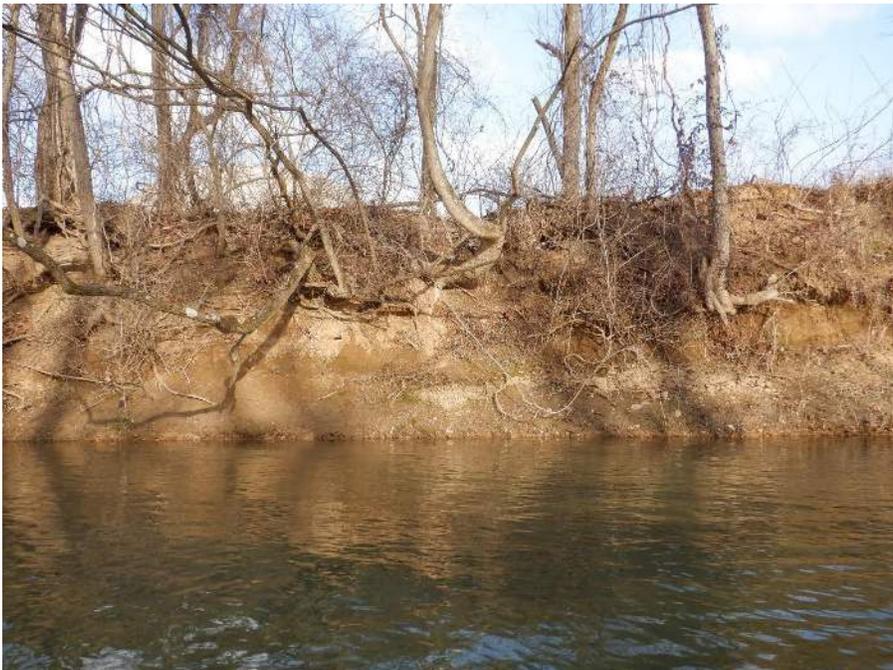
<p>Location: 00+700'</p> <hr/> <p>Photo Title: Date: 28 1/20/2021</p> <hr/> <p>Direction Photo Taken: Northwest</p> <hr/> <p>Description: ~90 degree bank angle; non-remediated section; several at risk trees present on upper bank; significant scour present on lower and mid bank; scour advancing under root masses of at risk trees; scour advancing towards toe of slope</p>

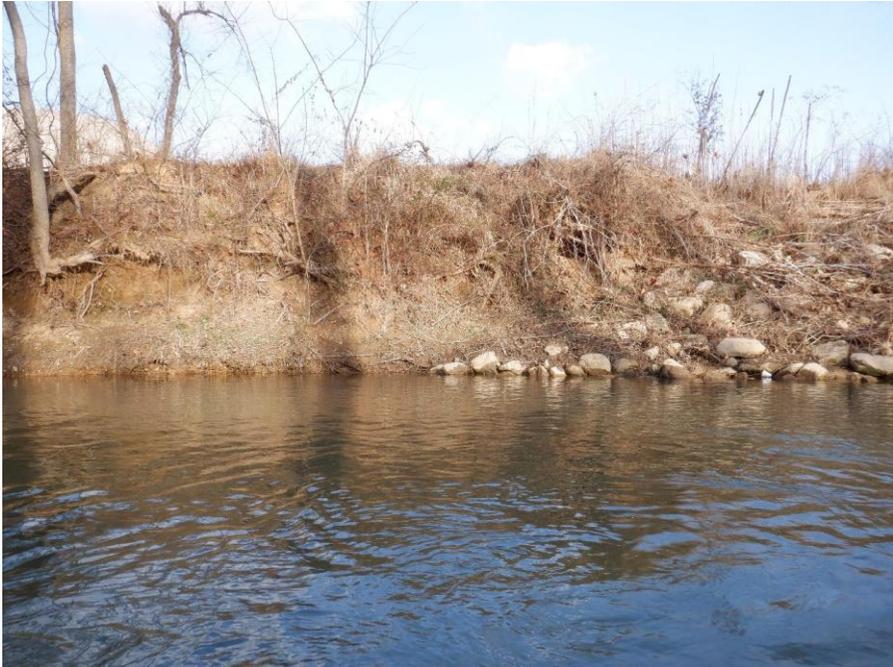
<p>Location: 00+750'</p> <hr/> <p>Photo Number: Date: 29 1/20/2021</p> <hr/> <p>Direction Photo Taken: Northwest</p> <hr/> <p>Description: ~90 degree bank angle in non-remediated section and 45 degree angle in remediated section; significant root exposure and scour upstream of remediation; installed rock toe intact; vegetation established in remediated section</p>

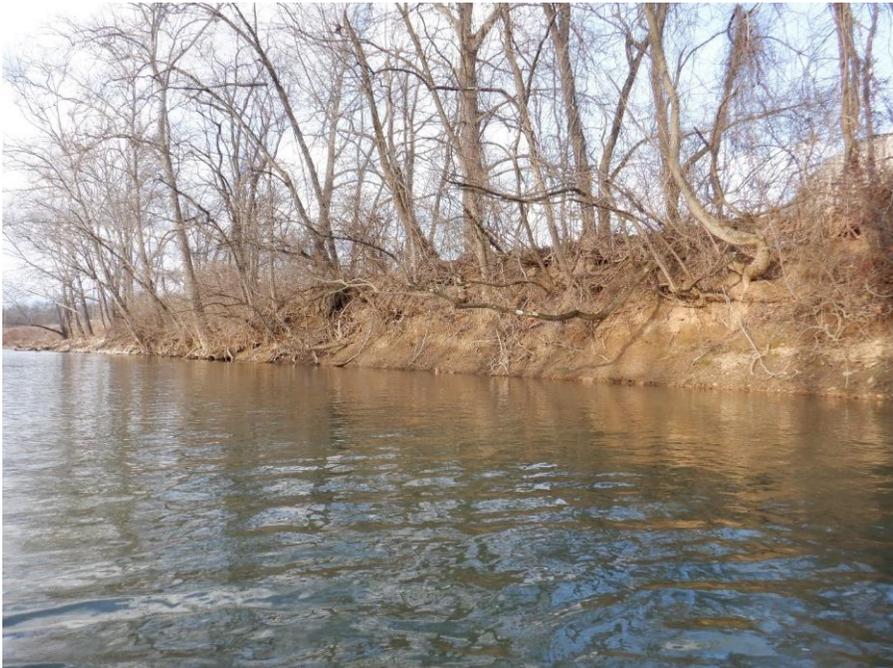
<p>Location: 00+750'</p> <hr/> <p>Photo Title: Date: 30 1/20/2021</p> <hr/> <p>Direction Photo Taken: West</p> <hr/> <p>Description: Significant root exposure and scour, at risk trees, and exposed roots present upstream of remediation</p>

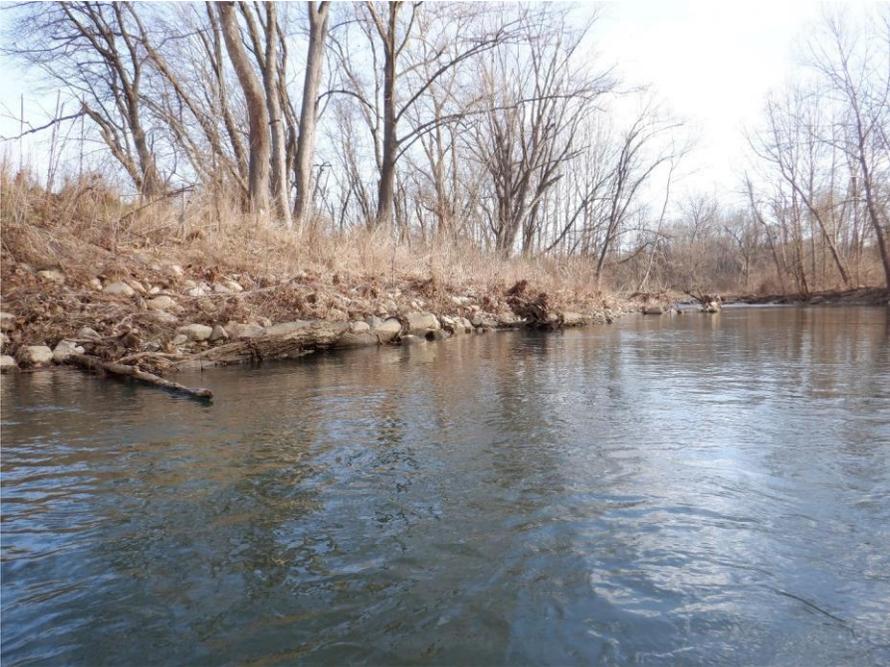
<p>Location: 00+750'</p> <hr/> <p>Photo Number: Date: 31 1/20/2021</p> <hr/> <p>Direction Photo Taken: North</p> <hr/> <p>Description: Downstream view showing extent of 2nd remediated section</p>

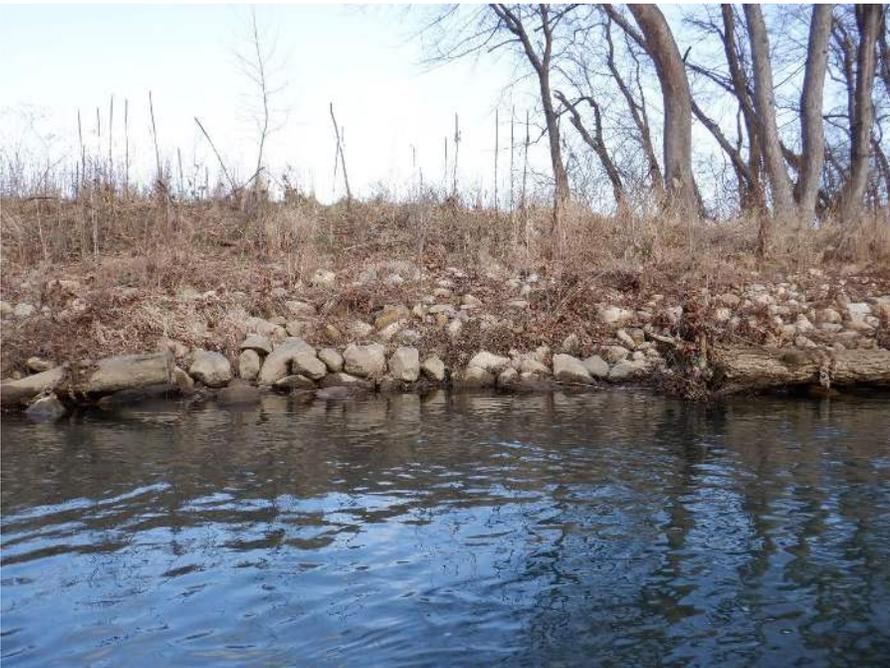
<p>Location: 00+800'</p> <hr/> <p>Photo Title: Date: 32 1/20/2021</p> <hr/> <p>Direction Photo Taken: Northwest</p> <hr/> <p>Description: ~40 degree bank angle; installed rock toe intact; vegetation established; LWD intact</p>

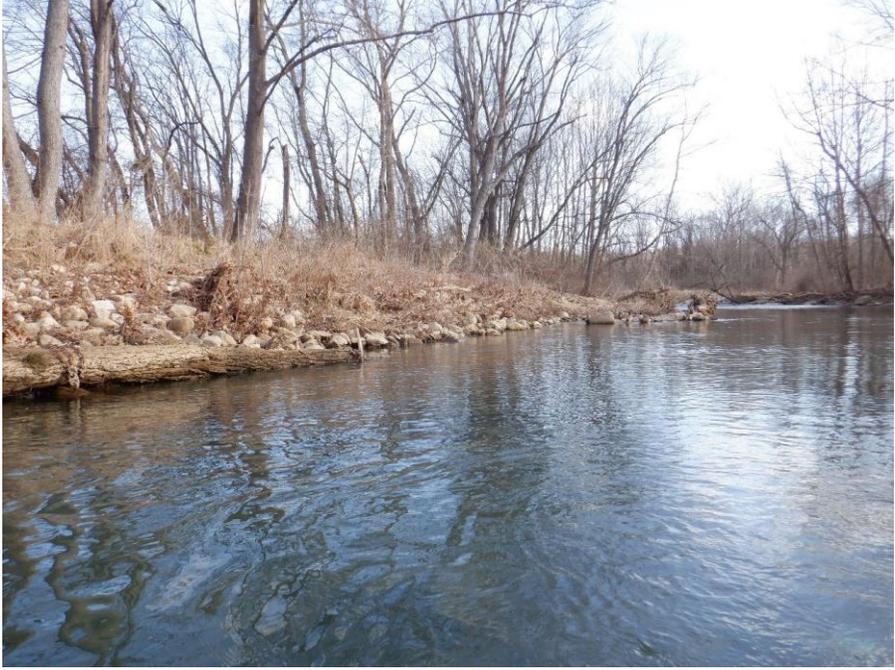
<p>Location: 00+800'</p> <hr/> <p>Photo Number: Date: 33 1/20/2021</p> <hr/> <p>Direction Photo Taken: North</p> <hr/> <p>Description: Installed rock toe intact; vegetation established; LWD intact; sediment deposition behind LWD</p>

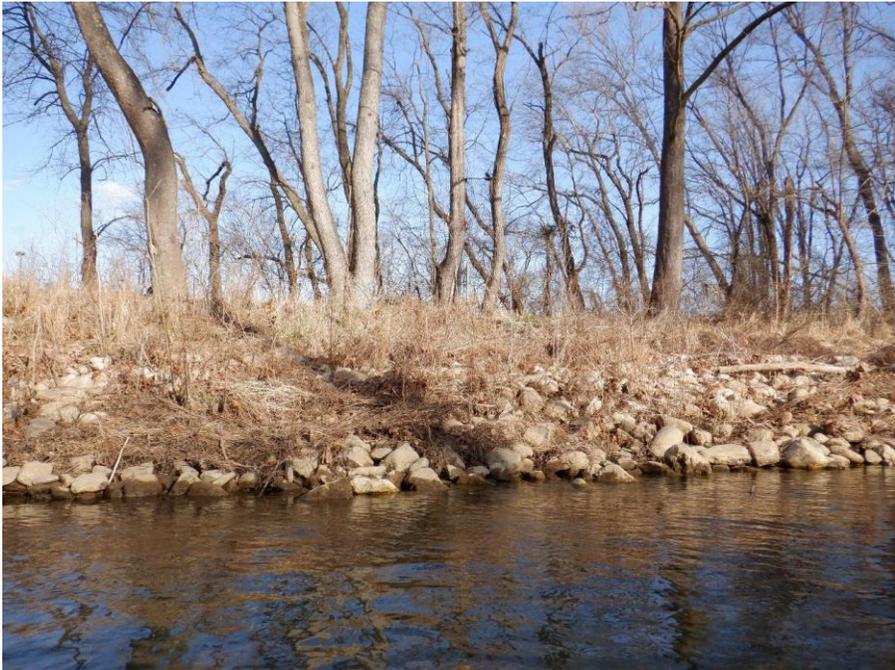
<p>Location: 00+850'</p> <hr/> <p>Photo Title: Date: 34 1/20/2021</p> <hr/> <p>Direction Photo Taken: Northwest</p> <hr/> <p>Description: ~30 degree bank angle; installed rock toe intact; vegetation established; LWD pivoted downstream from original position and angled into river</p>

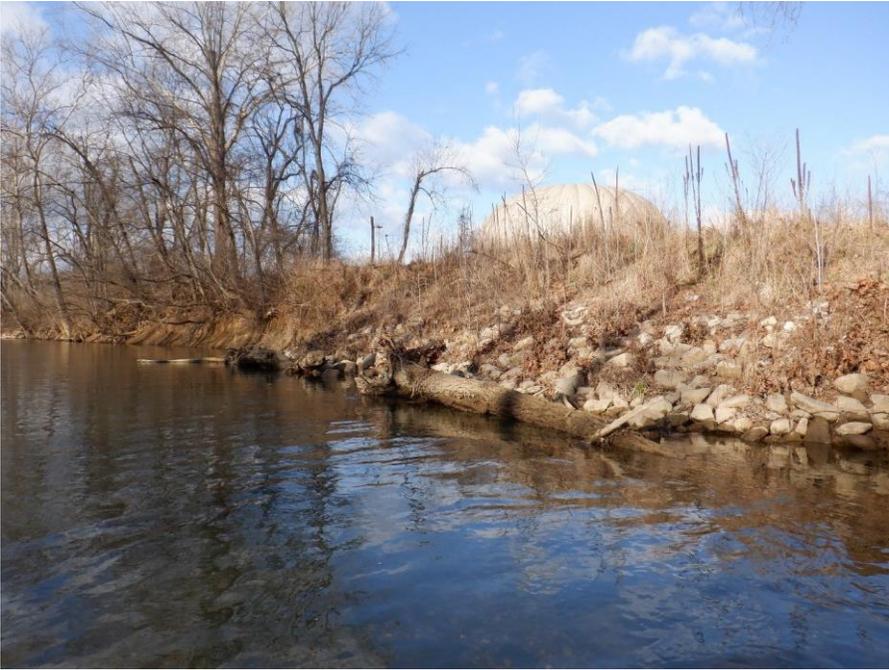
<p>Location: 00+850'</p> <hr/> <p>Photo Number: Date: 35 1/20/2021</p> <hr/> <p>Direction Photo Taken: West</p> <hr/> <p>Description: Installed rock toe intact; vegetation established; upstream LWD intact</p>

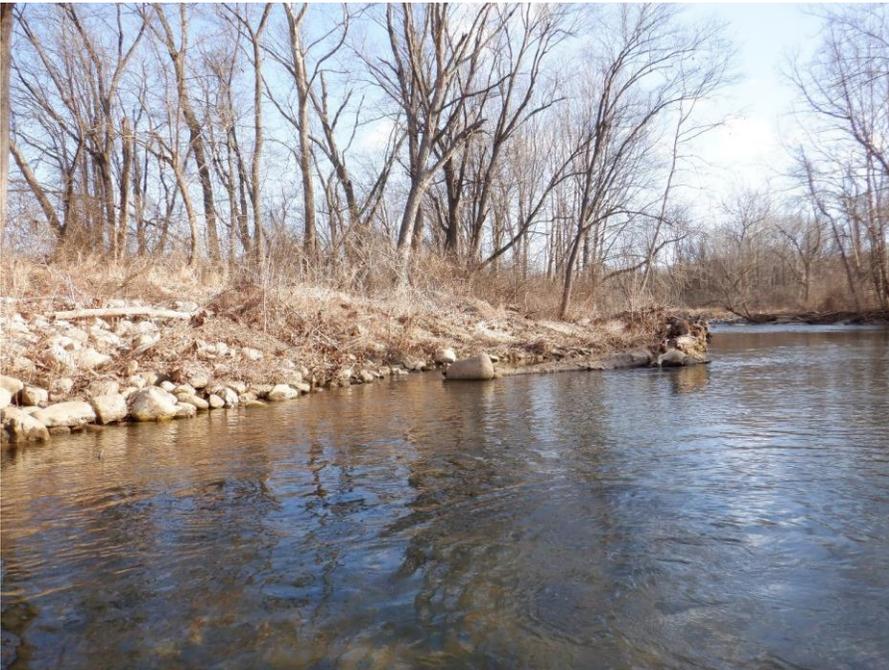
<p>Location: 00+850'</p> <hr/> <p>Photo Title: Date: 36 1/20/2021</p> <hr/> <p>Direction Photo Taken: North</p> <hr/> <p>Description: Installed rock toe intact; LWD pivoted downstream from original position and angled into river</p>

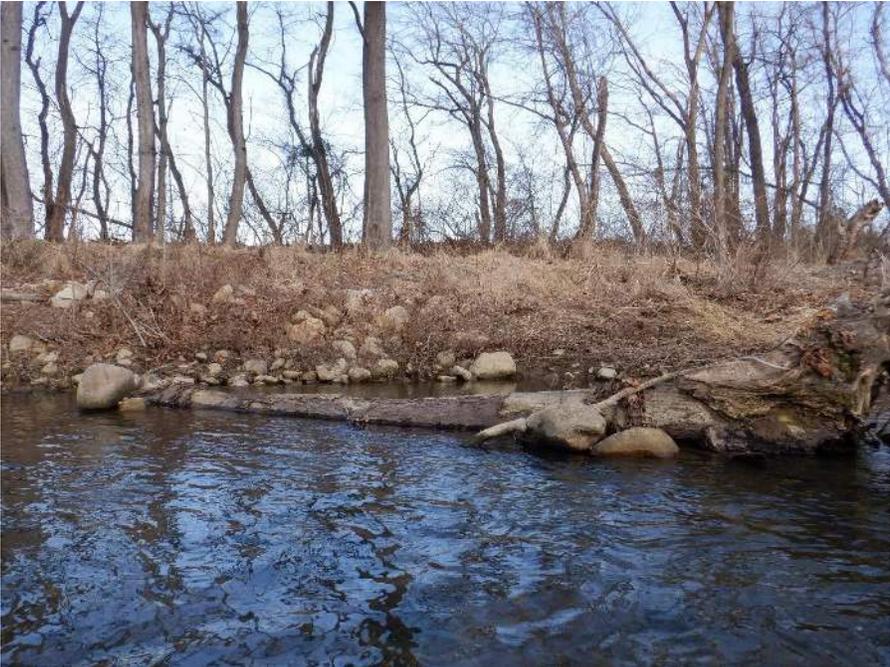
<p>Location: 00+880'</p> <hr/> <p>Photo Number: Date: 37 1/20/2021</p> <hr/> <p>Direction Photo Taken: Northwest</p> <hr/> <p>Description: ~20 degree bank angle; no scour present; installed rock toe intact; vegetation established; shifted LWD intact; sediment deposition behind LWD</p>

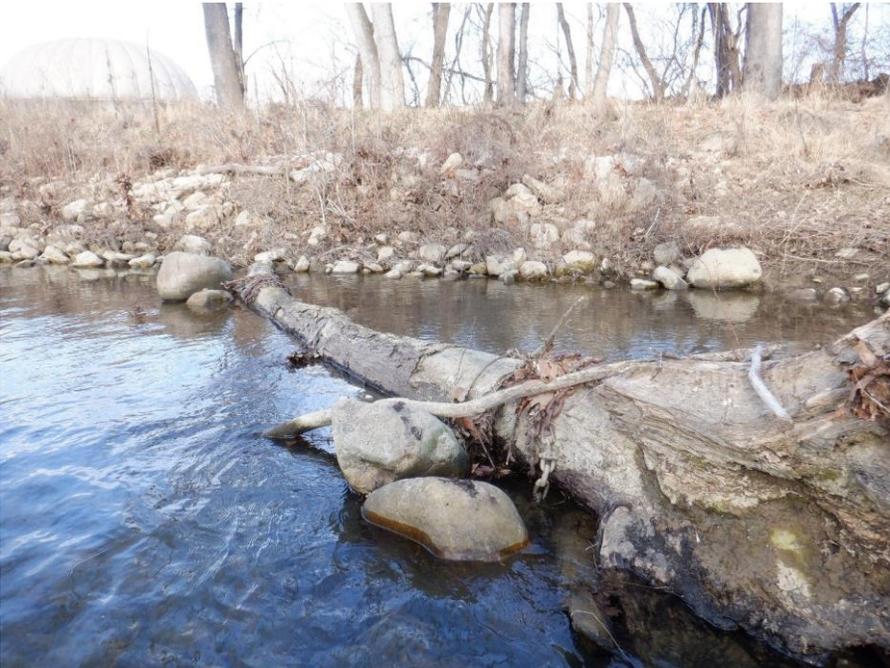
<p>Location: 00+880'</p> <hr/> <p>Photo Title: Date: 38 1/20/2021</p> <hr/> <p>Direction Photo Taken: Northwest</p> <hr/> <p>Description: End of remediation; shifted LWD angled into river; sediment deposition behind LWD; vegetation established; installed rock toe intact</p>

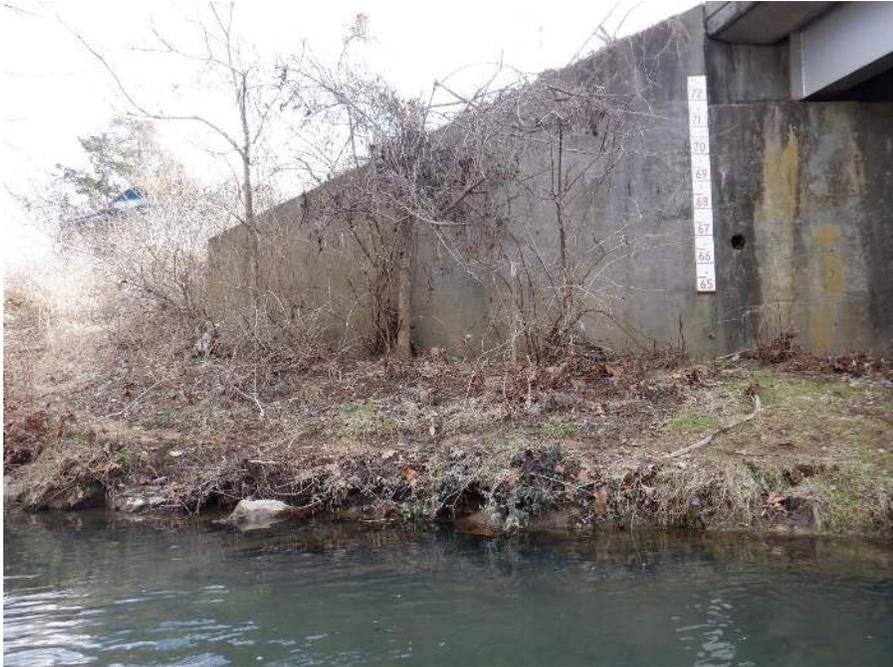
<p>Location: 00-20'</p> <hr/> <p>Photo Number: Date: 1 1/19/2021</p> <hr/> <p>Direction Photo Taken: Southeast</p> <hr/> <p>Description: (non-remediated transect under 2nd Street overpass); ~20 degree bank angle; no at risk trees present; some scour associated with foot traffic along bank</p>

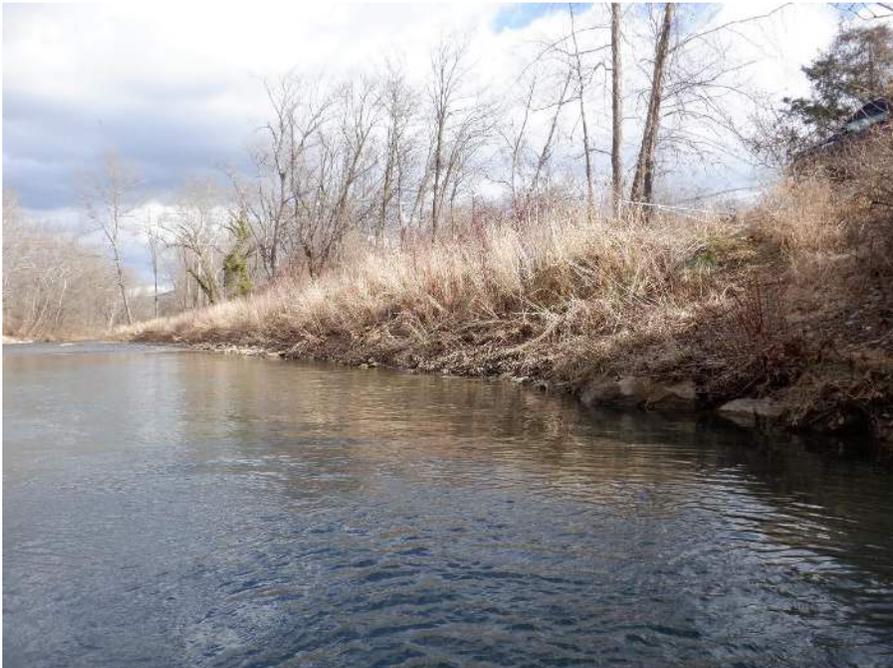
<p>Location: 00-20'</p> <hr/> <p>Photo Title: Date: 2 1/19/2021</p> <hr/> <p>Direction Photo Taken: East</p> <hr/> <p>Description: (non-remediated transect under 2nd Street overpass); ~20 degree bank angle; no at risk trees present; sand deposition above rock toe; improvised access point located downstream; scour associated with foot traffic along bank.</p>

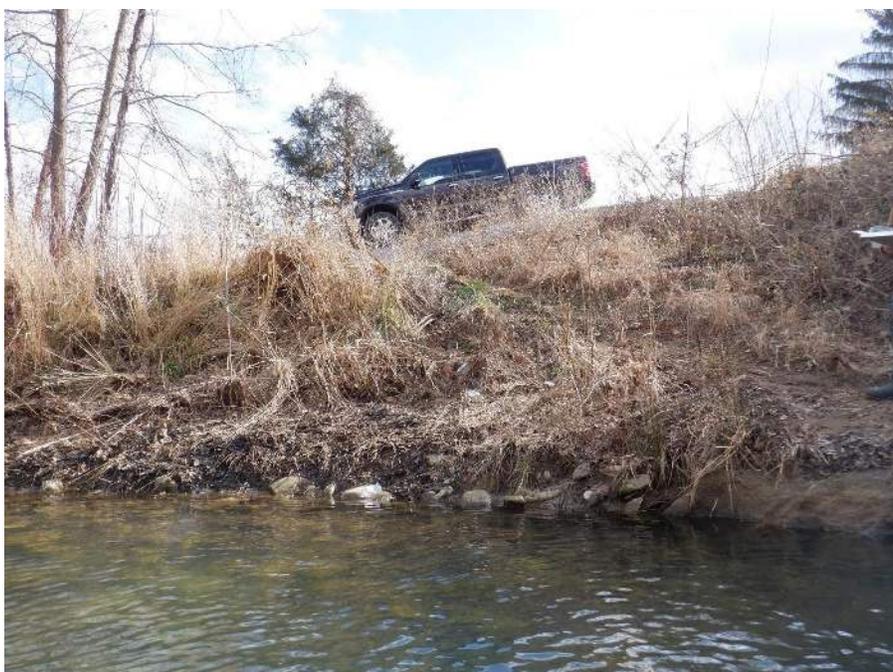
<p>Location: 00+00'</p> <hr/> <p>Photo Number: Date: 3 1/19/2021</p> <hr/> <p>Direction Photo Taken: Southeast</p> <hr/> <p>Description: ~45 degree bank angle; installed rock toe intact; sand deposition above rock toe; vegetation establishing; live stakes minimally established; erosion control fabric minimally exposed; geocell moderately exposed on upper bank as erosion control fabric deteriorated; some scour associated with foot traffic.</p>

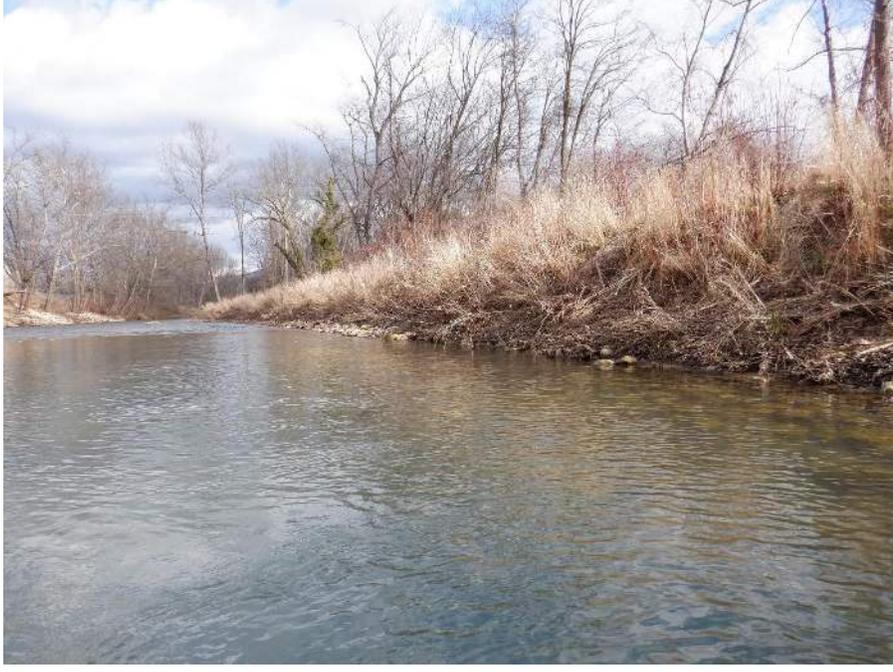
<p>Location: 00+00'</p> <hr/> <p>Photo Title: Date: 4 1/19/2021</p> <hr/> <p>Direction Photo Taken: East</p> <hr/> <p>Description: Installed rock toe intact; sand deposition above rock toe; some scour associated with foot traffic along bank</p>

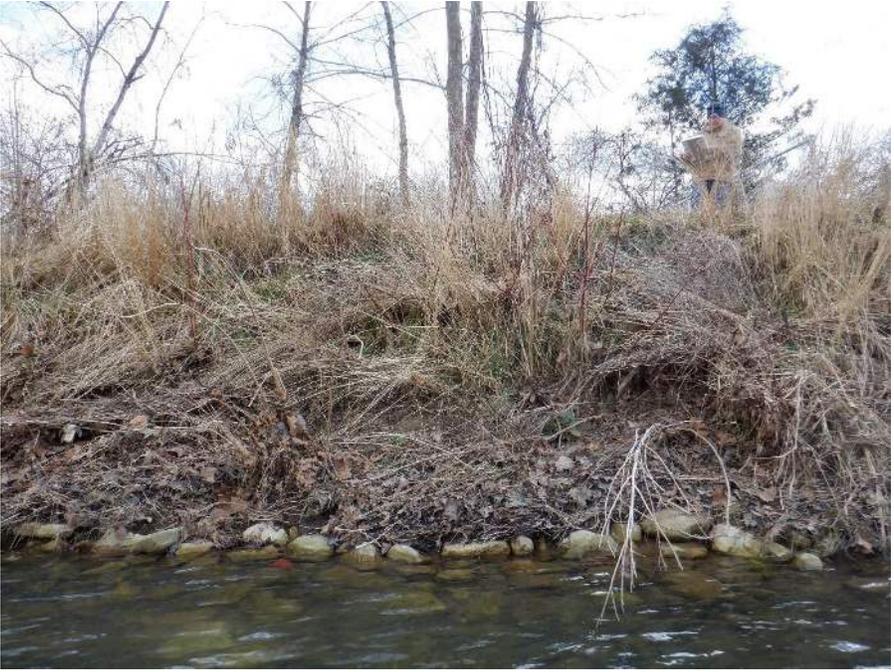
<p>Location: 00+50'</p> <hr/> <p>Photo Number: Date: 5 1/19/2021</p> <hr/> <p>Direction Photo Taken: Southeast</p> <hr/> <p>Description: ~50 degree bank angle; installed rock toe intact; live stakes minimally established; no at risk trees present; geocell minimally exposed mid bank as erosion control fabric is deteriorated; scour present where there is exposed geocell; sand deposition at toe of bank.</p>

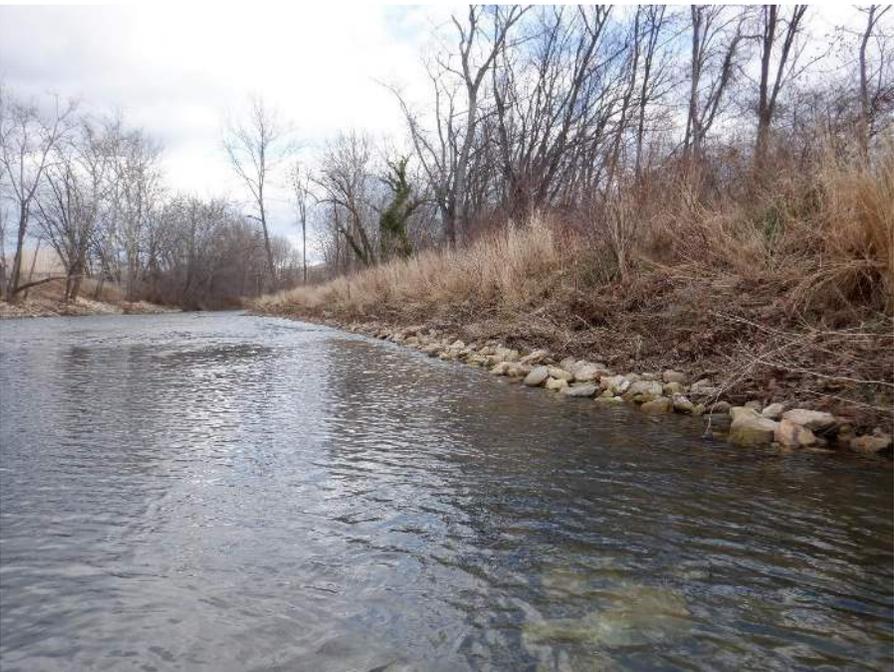
<p>Location: 00+50'</p> <hr/> <p>Photo Title: Date: 6 1/19/2021</p> <hr/> <p>Direction Photo Taken: East</p> <hr/> <p>Description: Installed rock toe intact; live stakes minimally established; no at risk trees present; sand deposition at toe of bank.</p>

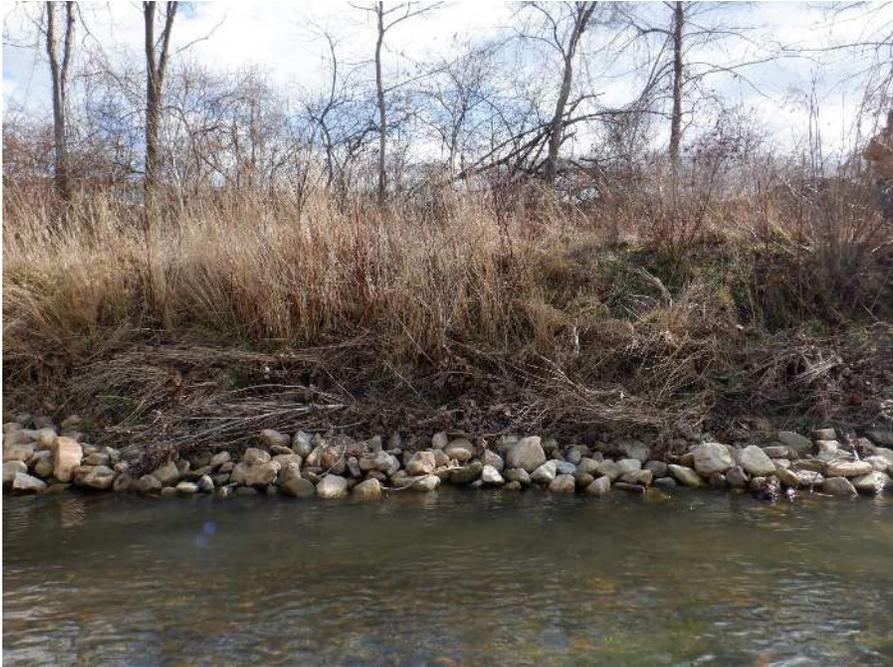
<p>Location: 00+100'</p> <hr/> <p>Photo Number: Date: 7 1/19/2021</p> <hr/> <p>Direction Photo Taken: Southeast</p> <hr/> <p>Description: ~50 degree bank angle; live stakes minimally established; geocell exposed in areas with heavy foot traffic and erosion control fabric disintegrated; rocks from improvised weir moved back to stone toe.</p>

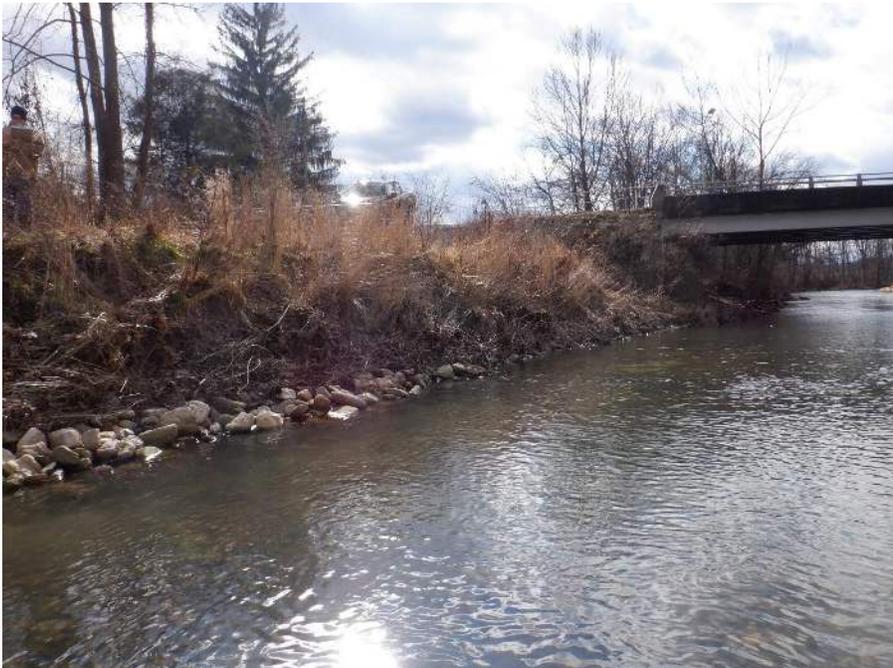
<p>Location: 00+100'</p> <hr/> <p>Photo Title: Date: 8 1/19/2021</p> <hr/> <p>Direction Photo Taken: South</p> <hr/> <p>Description: Geocell exposed at top of bank as erosion control fabric has deteriorated; rocks from improvised weir moved back to stone toe.</p>

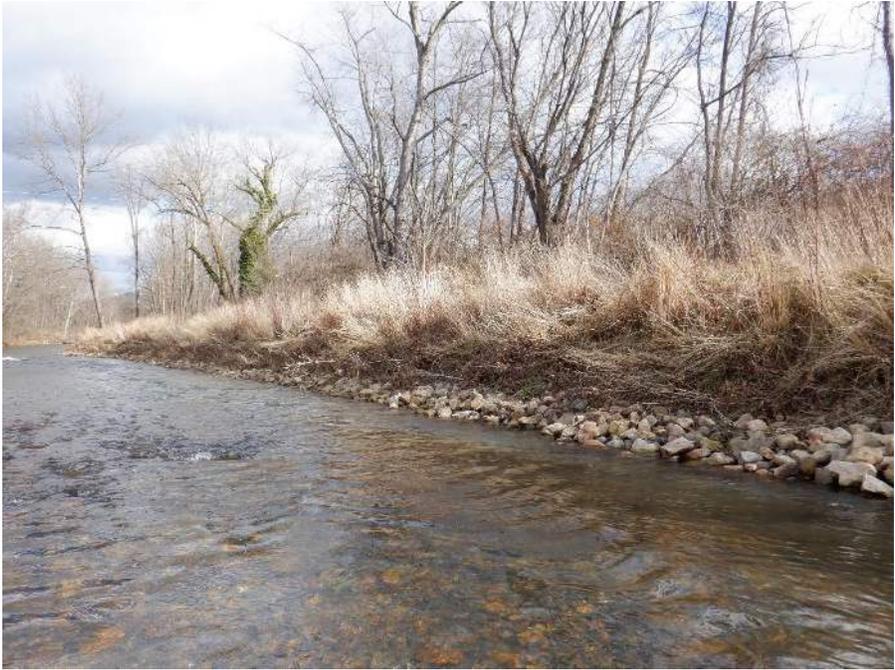
<p>Location: 00+100'</p> <hr/> <p>Photo Number: Date: 9 1/19/2021</p> <hr/> <p>Direction Photo Taken: East</p> <hr/> <p>Description: Vegetation established along bank; improvised weir rocks moved back to stone toe.</p>

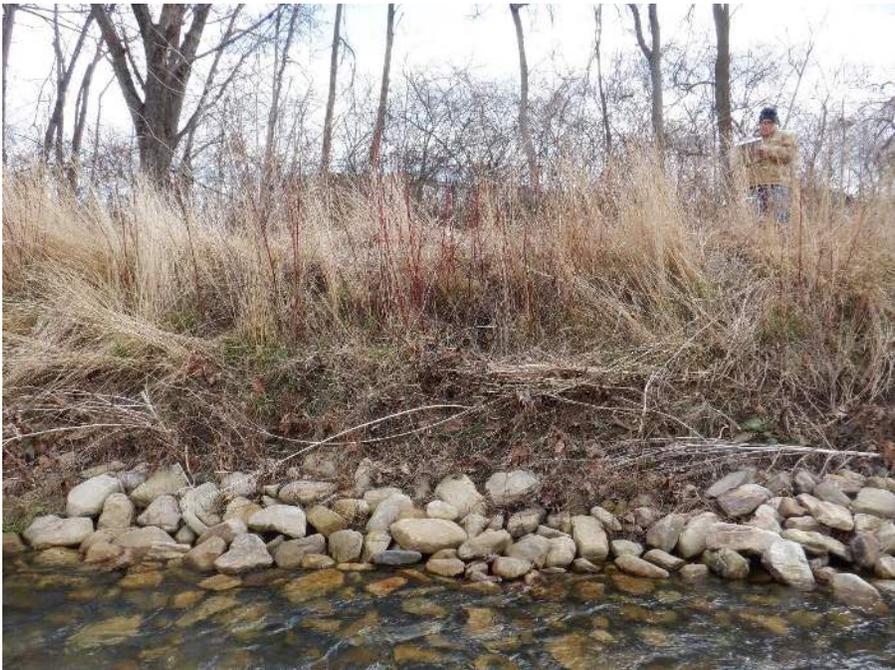
<p>Location: 00+150'</p> <hr/> <p>Photo Title: Date: 10 1/19/2021</p> <hr/> <p>Direction Photo Taken: Southeast</p> <hr/> <p>Description: ~50 degree bank angle; installed rock toe intact; vegetation established; no at risk trees present; 20% erosion control fabric exposed above rock toe; little sediment deposition in rock toe</p>

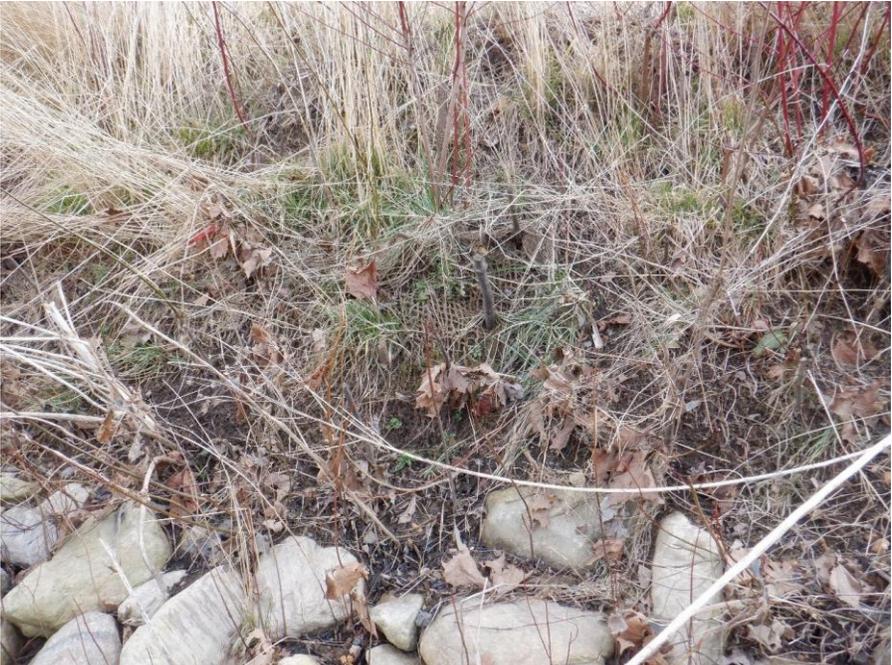
<p>Location: 00+150'</p> <hr/> <p>Photo Number: 11 Date: 1/19/2021</p> <hr/> <p>Direction Photo Taken: N/A</p> <hr/> <p>Description: Erosion control fabric exposed above rock toe.</p>

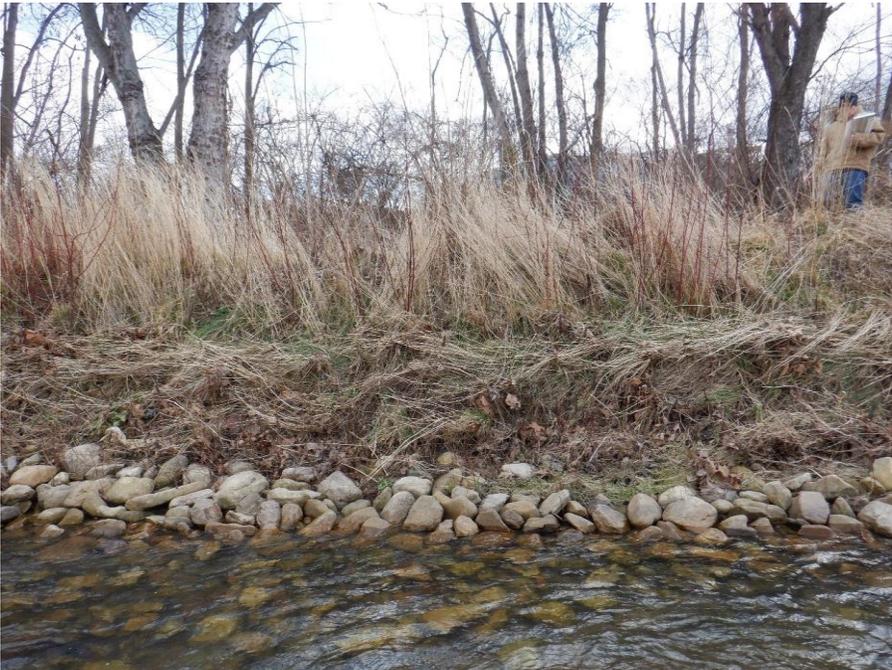
<p>Location: 00+200'</p> <hr/> <p>Photo Title: 12 Date: 1/19/2021</p> <hr/> <p>Direction Photo Taken: Southeast</p> <hr/> <p>Description: ~50 degree bank angle; installed rock toe intact; live stakes minimally established; vegetation established; little sediment deposition at toe of bank</p>

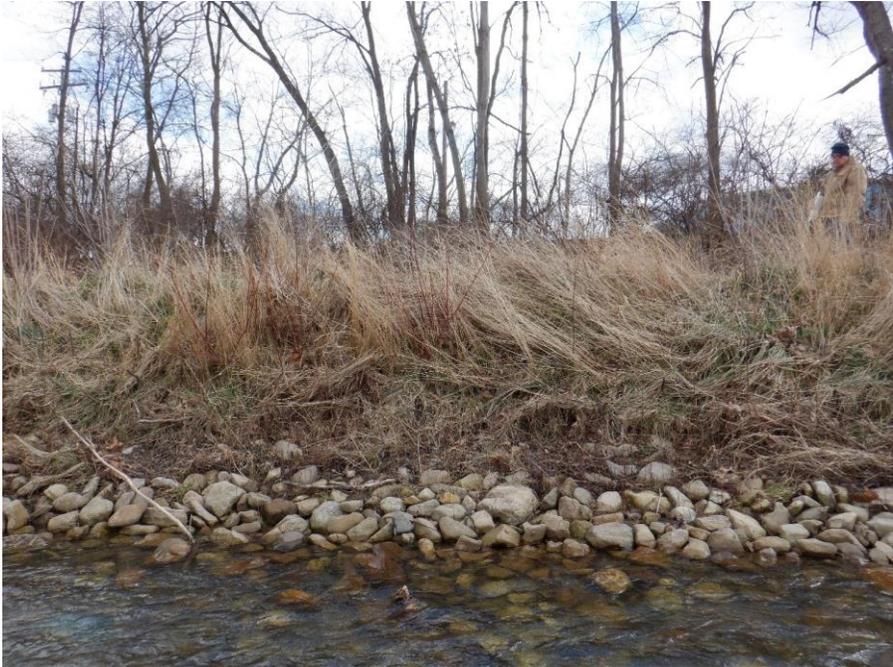
<p>Location: 00+250'</p> <hr/> <p>Photo Number: 13 Date: 1/19/2021</p> <hr/> <p>Direction Photo Taken: Southeast</p> <hr/> <p>Description: ~50 degree bank angle; installed rock toe intact; live stakes minimally established; no at risk trees present; vegetation established; minimal sediment deposition in rock toe</p>

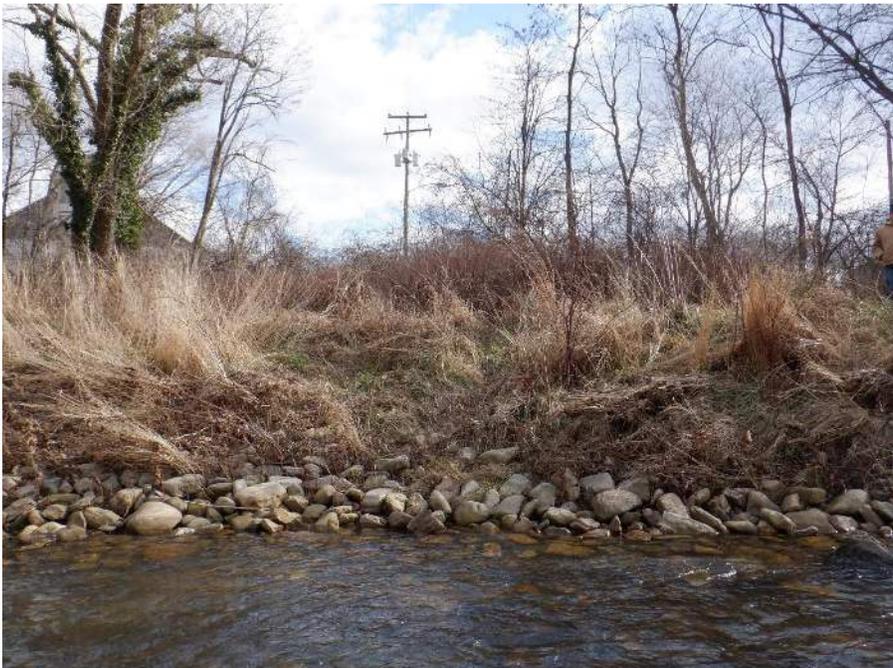
<p>Location: 00+300'</p> <hr/> <p>Photo Title: 14 Date: 1/19/2021</p> <hr/> <p>Direction Photo Taken: Southeast</p> <hr/> <p>Description: ~40 degree bank angle; installed rock toe intact; vegetation established; minimal sediment deposition in rock toe</p>

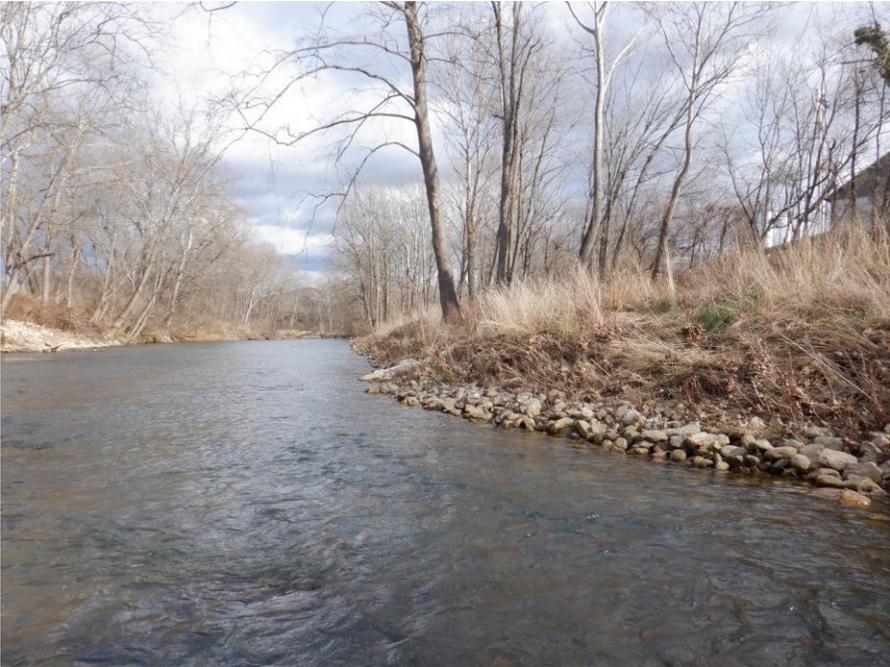
<p>Location: 00+300'</p> <hr/> <p>Photo Number: Date: 15 1/19/2021</p> <hr/> <p>Direction Photo Taken: East</p> <hr/> <p>Description: Installed rock toe intact; minimal sediment deposition in rock toe; vegetation established</p>

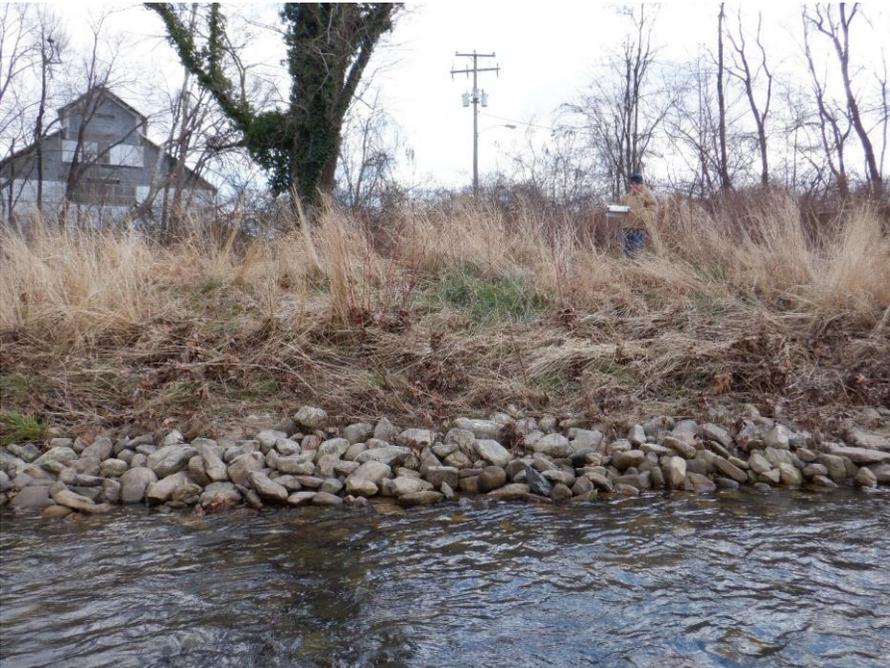
<p>Location: 00+350'</p> <hr/> <p>Photo Title: Date: 16 1/19/2021</p> <hr/> <p>Direction Photo Taken: Southeast</p> <hr/> <p>Description: ~40 degree bank angle; installed rock toe intact; live pushed over from high water events; no at risk trees present; vegetation established; minimal sediment deposition in rock toe</p>

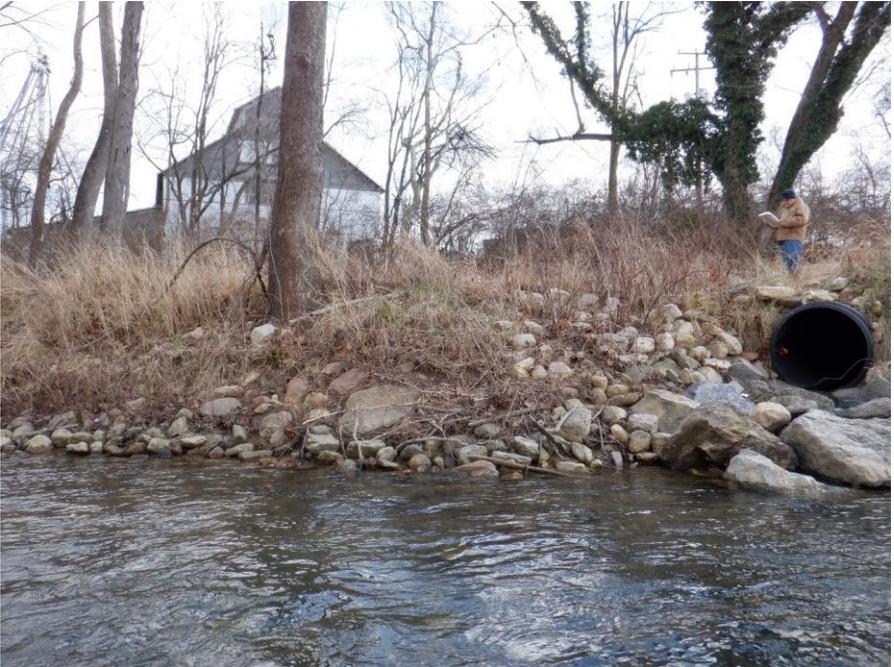
<p>Location: 00+400'</p> <hr/> <p>Photo Number: Date: 17 1/19/2021</p> <hr/> <p>Direction Photo Taken: Southeast</p> <hr/> <p>Description: ~50 degree bank angle; outfall and drainage structure intact; rock toe intact; vegetation established; live stakes not visible; no at risk trees present; minimal sediment deposition in rock toe</p>

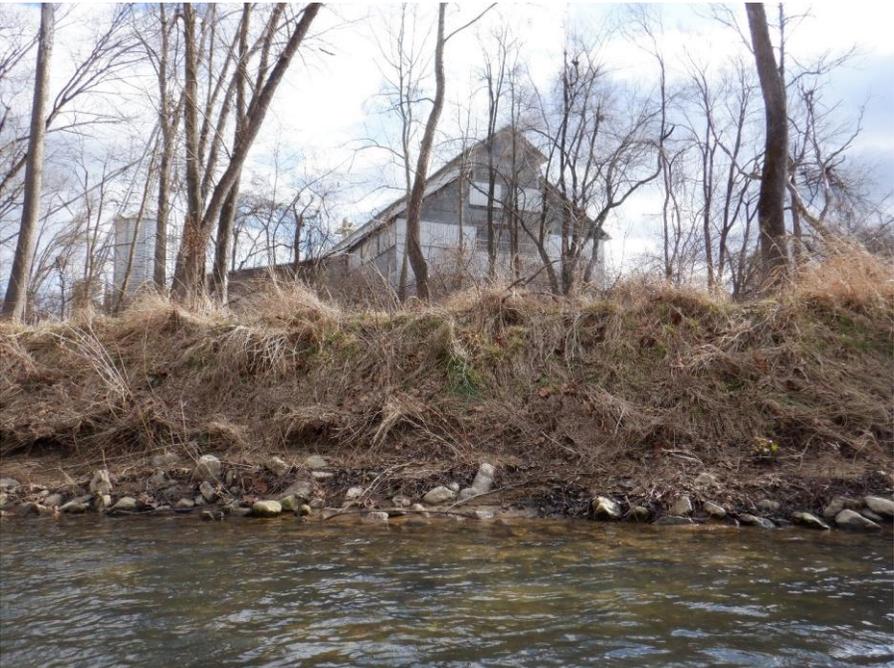
<p>Location: 00+450'</p> <hr/> <p>Photo Title: Date: 18 1/19/2021</p> <hr/> <p>Direction Photo Taken: Southeast</p> <hr/> <p>Description: ~50 degree bank angle; installed rock toe intact; vegetation established; minimal sediment deposition in rock toe</p>

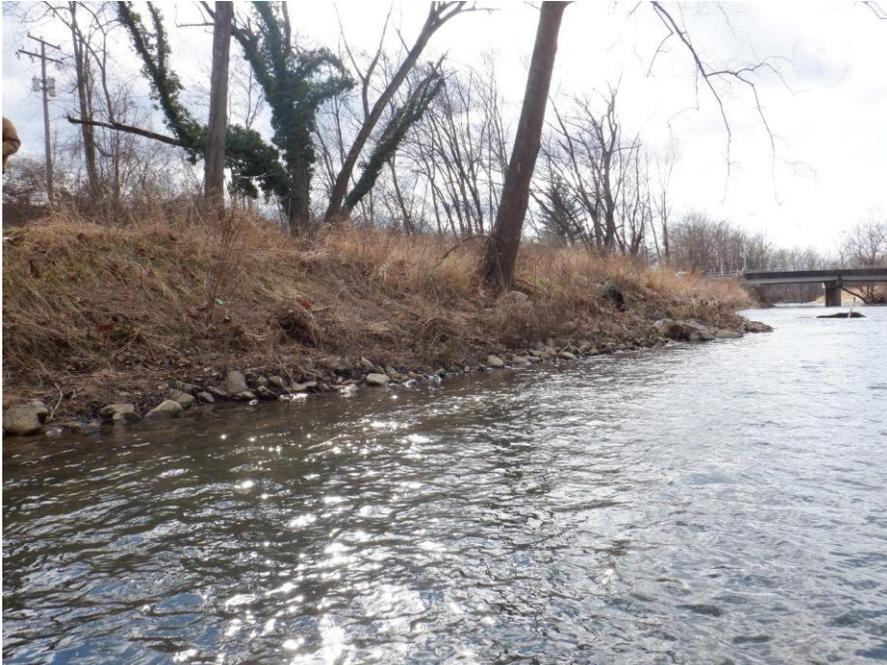
<p>Location: 00+450'</p> <hr/> <p>Photo Number: Date: 19 1/19/2021</p> <hr/> <p>Direction Photo Taken: South</p> <hr/> <p>Description: Vegetation established throughout bank; live stakes pushed over from high water events; sand deposition from high water events above rock toe</p>

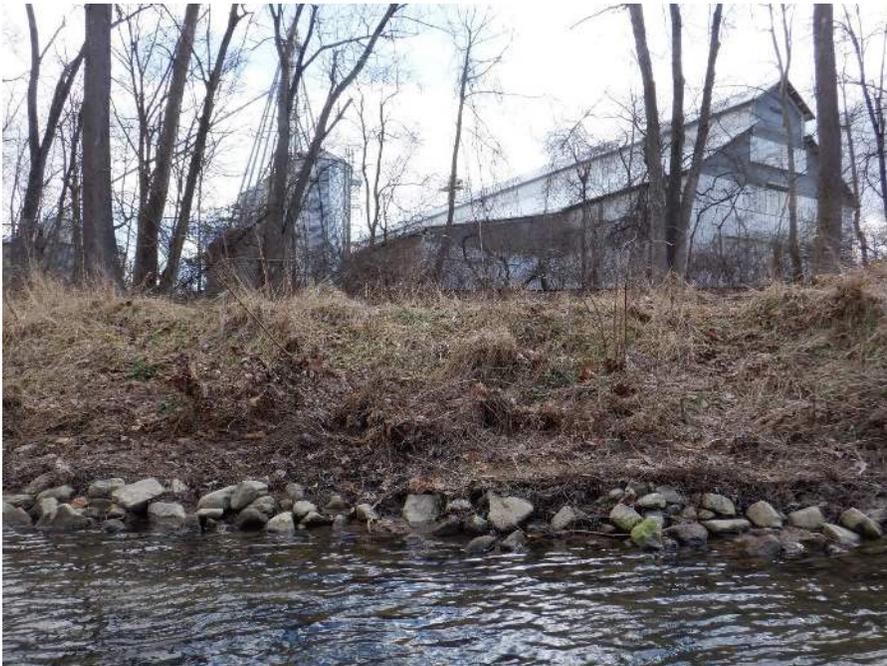
<p>Location: 00+500'</p> <hr/> <p>Photo Title: Date: 20 1/19/2021</p> <hr/> <p>Direction Photo Taken: Southeast</p> <hr/> <p>Description: ~40 degree bank angle; installed rock toe intact; vegetation established throughout bank; live stakes minimally established; sand deposition from high water events above rock toe</p>
