**Re: 2020 Leaf-on and 2020-2021 Leaf-off Maintenance Inspections
Former DuPont Waynesboro Site AOC 4
Waynesboro, Virginia
EPA ID# VAD003114832**

Subject 2020-2021 Phase 1 BMA Leaf-Off Maintenance Inspection
Former DuPont Waynesboro Site, Area of Concern 4

Date March 24, 2021

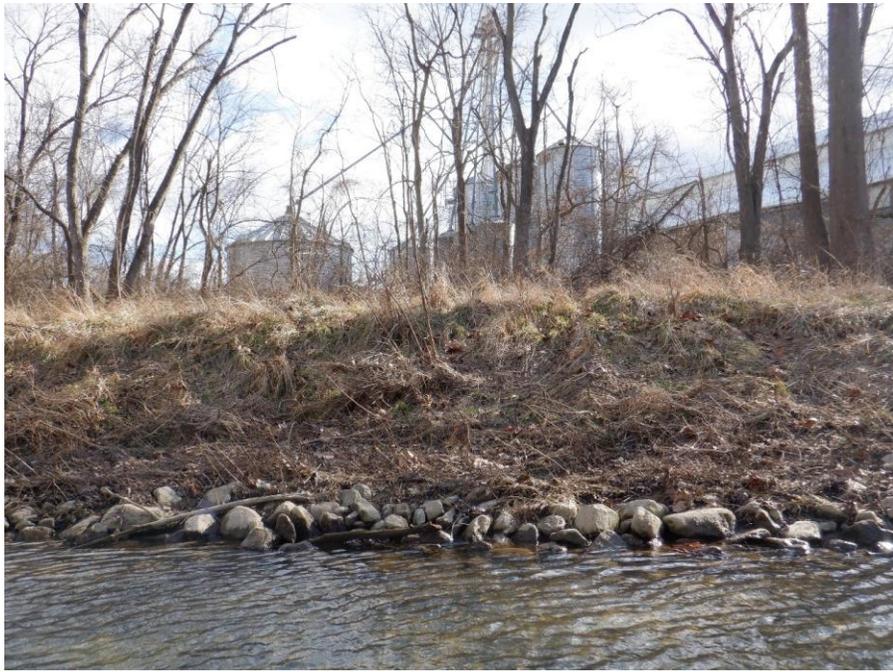
<p>Location: 00+550'</p> <hr/> <p>Photo Number: Date: 21 1/19/2021</p> <hr/> <p>Direction Photo Taken: Southeast</p> <hr/> <p>Description: ~20 degree lower bank angle and 40 degree upper bank angle; installed rock toe intact; live stakes minimally established; vegetation established; sand deposition from high water events above rock toe</p>

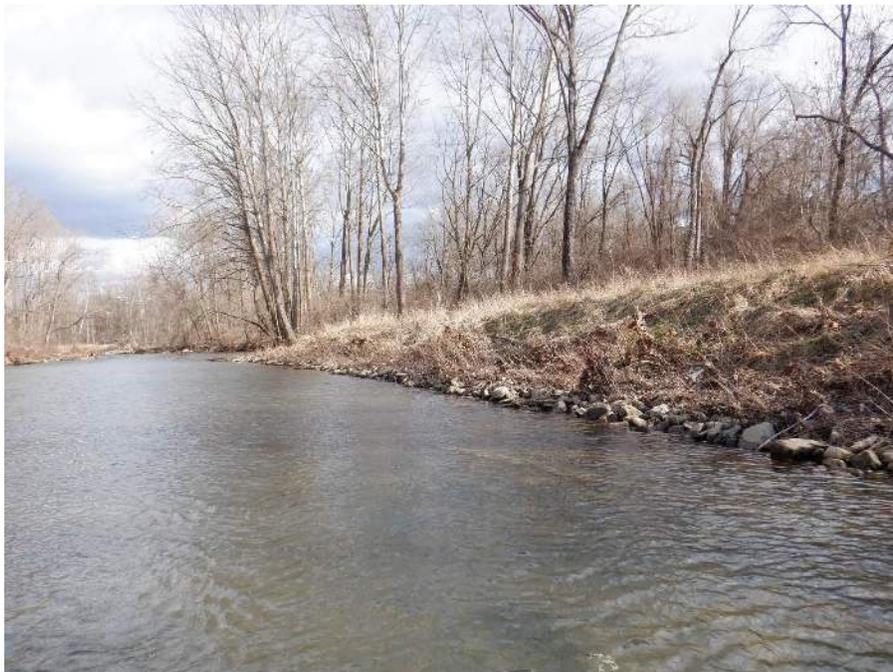
<p>Location: 00+550'</p> <hr/> <p>Photo Title: Date: 22 1/19/2021</p> <hr/> <p>Direction Photo Taken: East</p> <hr/> <p>Description: Installed rock toe intact; vegetation established; sand deposition from high water events above rock toe</p>

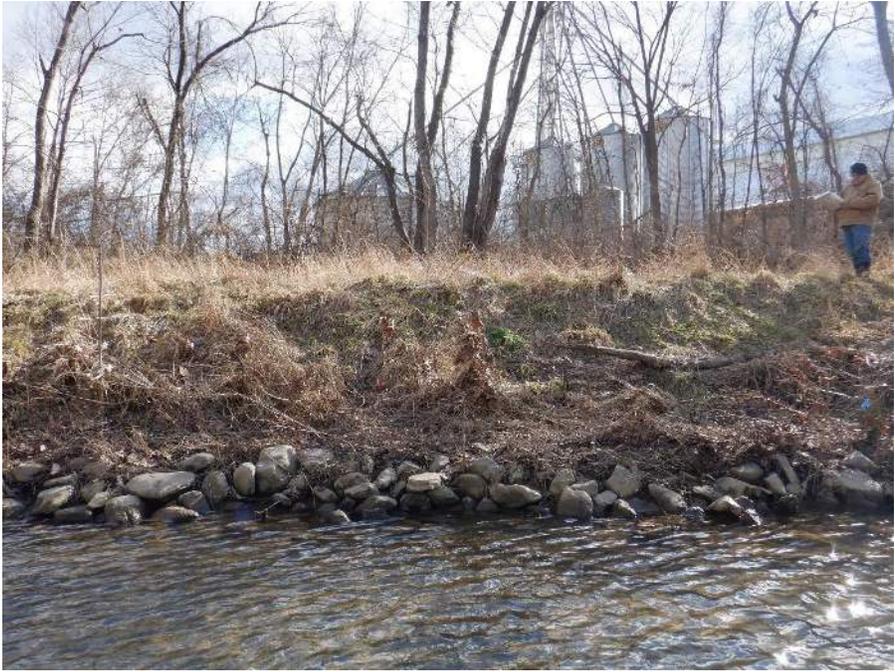
<p>Location: 00+600'</p> <hr/> <p>Photo Number: 23 Date: 1/19/2021</p> <hr/> <p>Direction Photo Taken: Southeast</p> <hr/> <p>Description: ~20 degree lower bank angle and 40 degree upper bank angle; installed rock toe intact; vegetation established; live stakes minimally established; sand deposition from high water events above rock toe; flood debris deposited above rock toe</p>

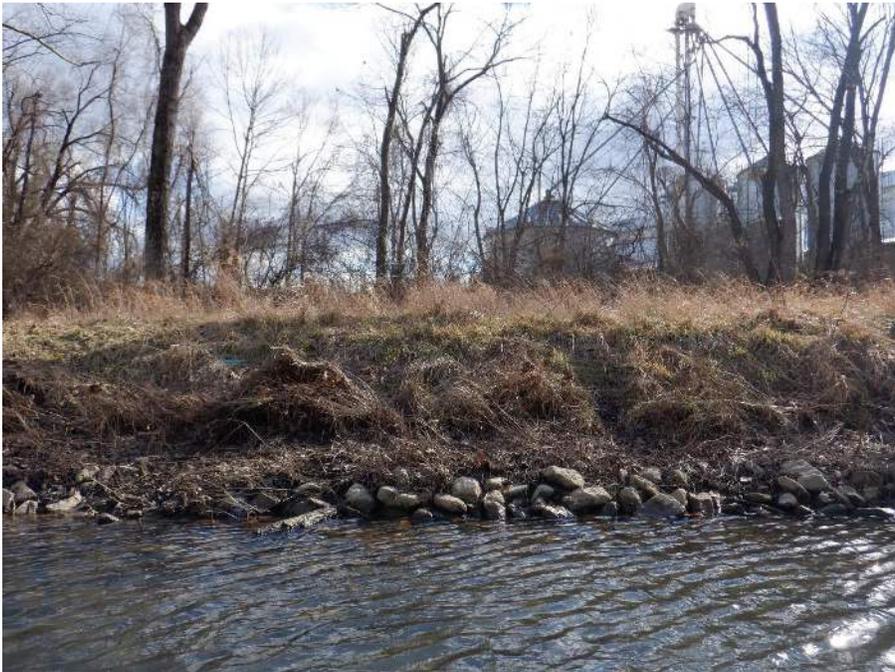
<p>Location: 00+650'</p> <hr/> <p>Photo Title: 24 Date: 1/19/2021</p> <hr/> <p>Direction Photo Taken: Southeast</p> <hr/> <p>Description: ~20 degree lower bank angle and 40 degree upper bank angle; installed rock toe intact; vegetation established; live stakes minimally established; minimal sediment deposition in rock toe</p>

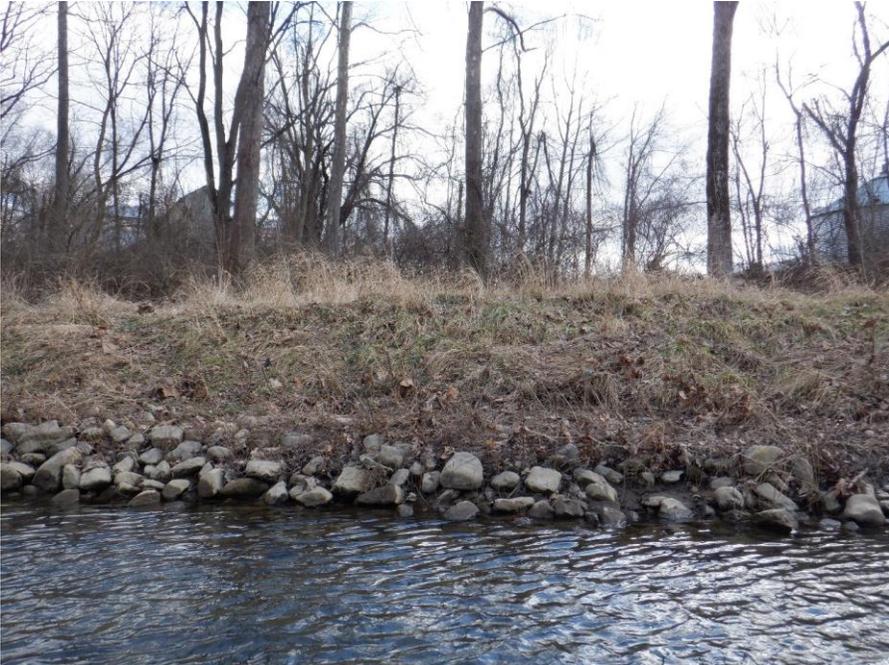
<p>Location: 00+700'</p> <hr/> <p>Photo Number: Date: 25 1/19/2021</p> <hr/> <p>Direction Photo Taken: Southeast</p> <hr/> <p>Description: ~20 degree lower bank angle and 40 degree upper bank angle; installed rock toe intact; vegetation established; live stakes minimally established; minimal sediment deposition in rock toe</p>

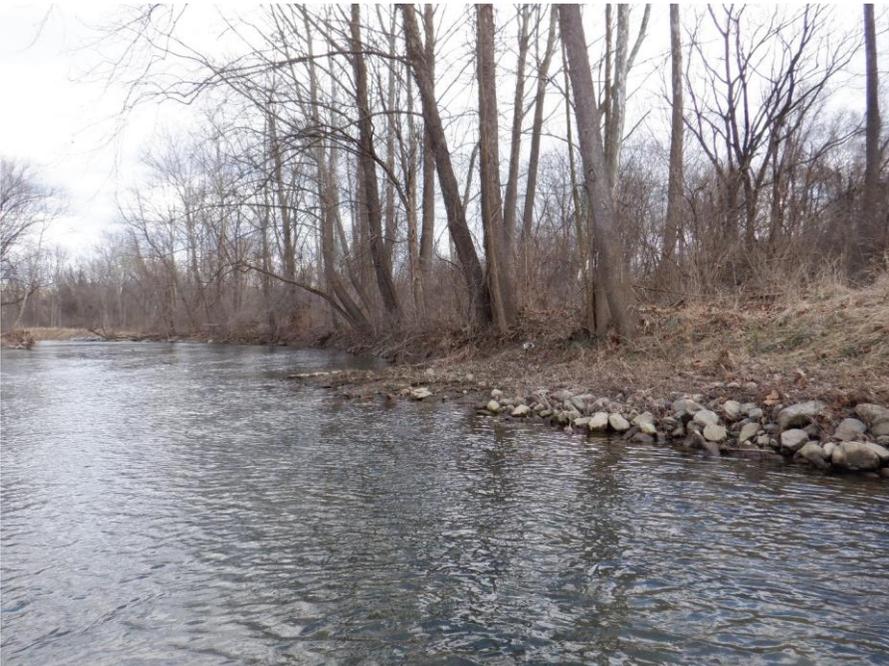
<p>Location: 00+700'</p> <hr/> <p>Photo Title: Date: 26 1/19/2021</p> <hr/> <p>Direction Photo Taken: East</p> <hr/> <p>Description: Downstream end of first remediated section; installed rock toe intact; vegetation established</p>

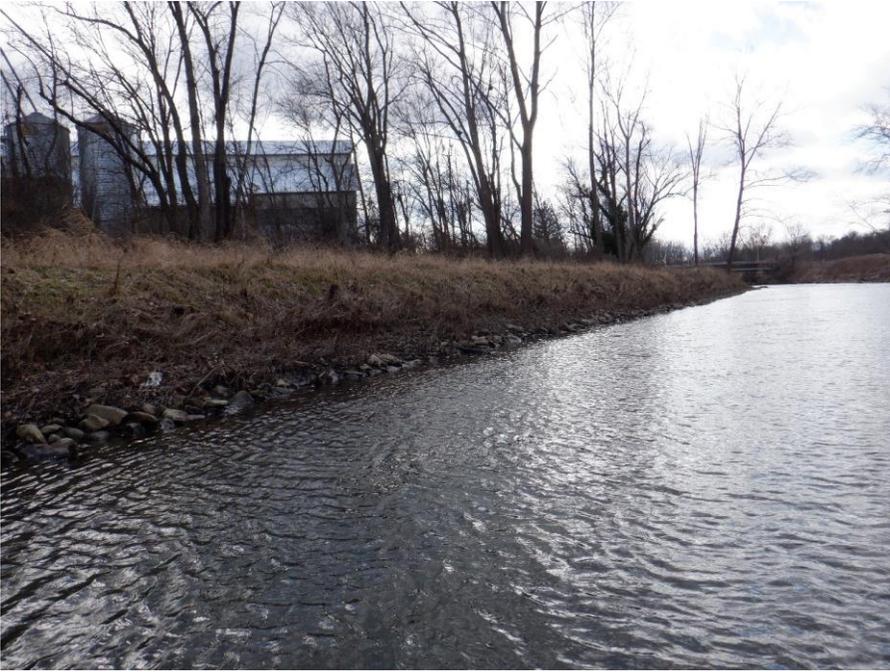
<p>Location: 00+700'</p> <hr/> <p>Photo Number: Date: 27 1/19/2021</p> <hr/> <p>Direction Photo Taken: South</p> <hr/> <p>Description: Installed rock toe intact; vegetation established; live stakes minimally established; minimal sediment deposition in rock toe</p>

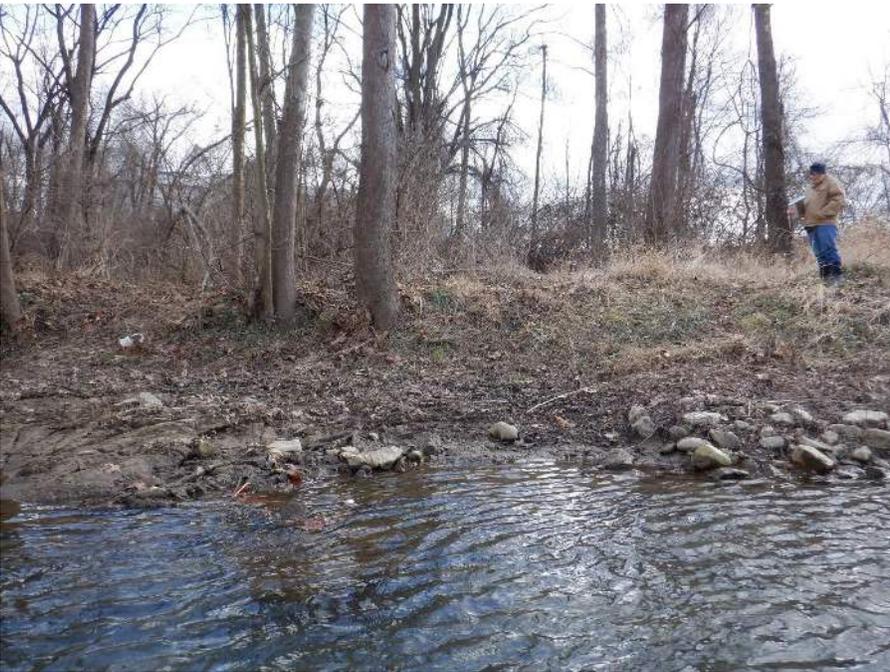
<p>Location: 00+750'</p> <hr/> <p>Photo Title: Date: 28 1/19/2021</p> <hr/> <p>Direction Photo Taken: Southeast</p> <hr/> <p>Description: ~20 degree lower bank angle and 40 degree upper bank angle; installed rock toe intact; no live stakes observed; vegetation established; improvised access path observed; partially exposed roots downstream of BMA</p>

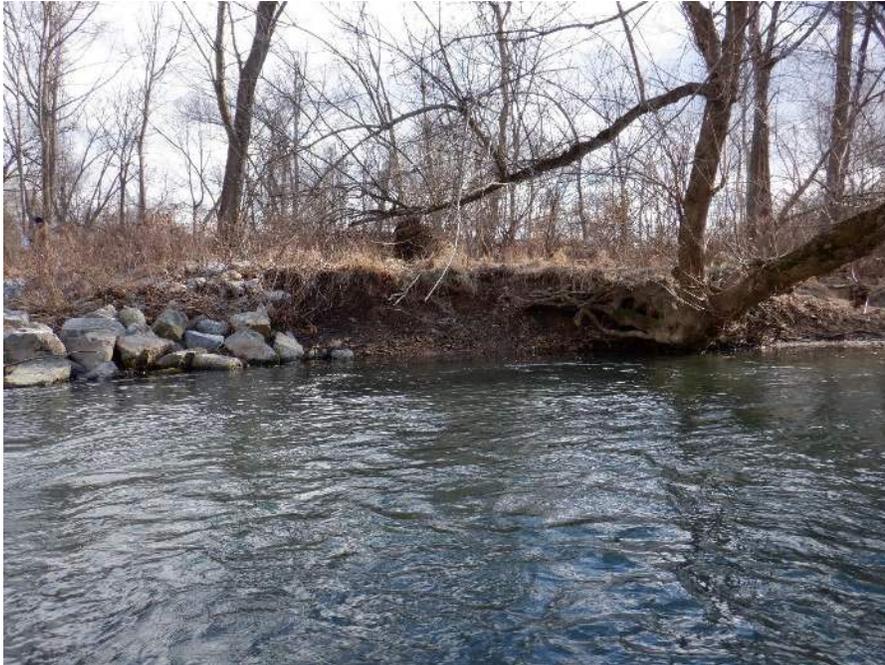
<p>Location: 00+1250'</p>

<p>Photo Number: 29 Date: 1/19/2021</p>	
<p>Direction Photo Taken: Southeast</p>	
<p>Description: ~40 degree bank angle (non-remediated 80 degrees); exposed roots of large at risk trees are present upstream of remediation; heavy scour around roots; significant scour above remediation; installed rock toe intact within remediated section</p>

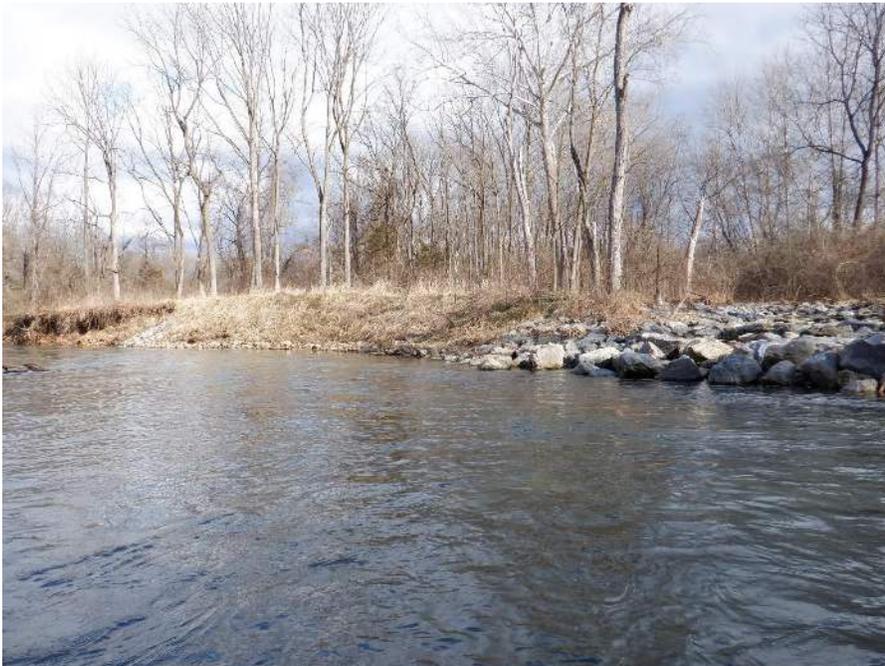
<p>Location: 00+1250'</p>

<p>Photo Title: 30 Date: 1/19/2021</p>	
<p>Direction Photo Taken: East</p>	
<p>Description: Riprap tributary channel downstream with continued bank remediation</p>

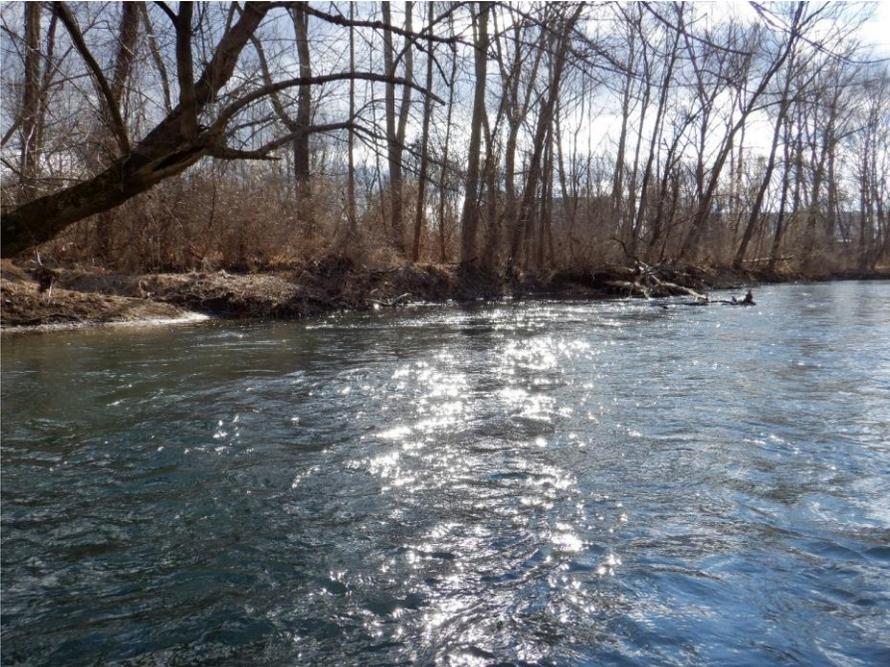
<p>Location: 00+1250'</p> <hr/> <p>Photo Number: Date: 31 1/19/2021</p> <hr/> <p>Direction Photo Taken: South</p> <hr/> <p>Description: Exposed roots of large at risk trees are present upstream of remediation; heavy scour around roots; significant scour above remediation</p>

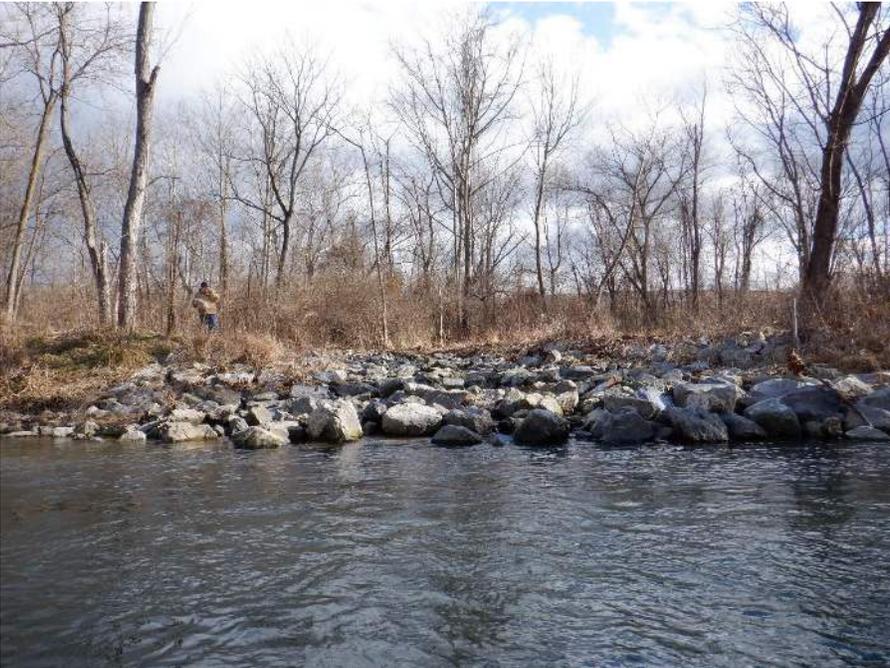
<p>Location: 00+1300'</p> <hr/> <p>Photo Number: Date: 33 1/19/2021</p> <hr/> <p>Direction Photo Taken: East</p> <hr/> <p>Description: Installed rock toe intact downstream; live stakes minimally established; vegetation established throughout bank</p>

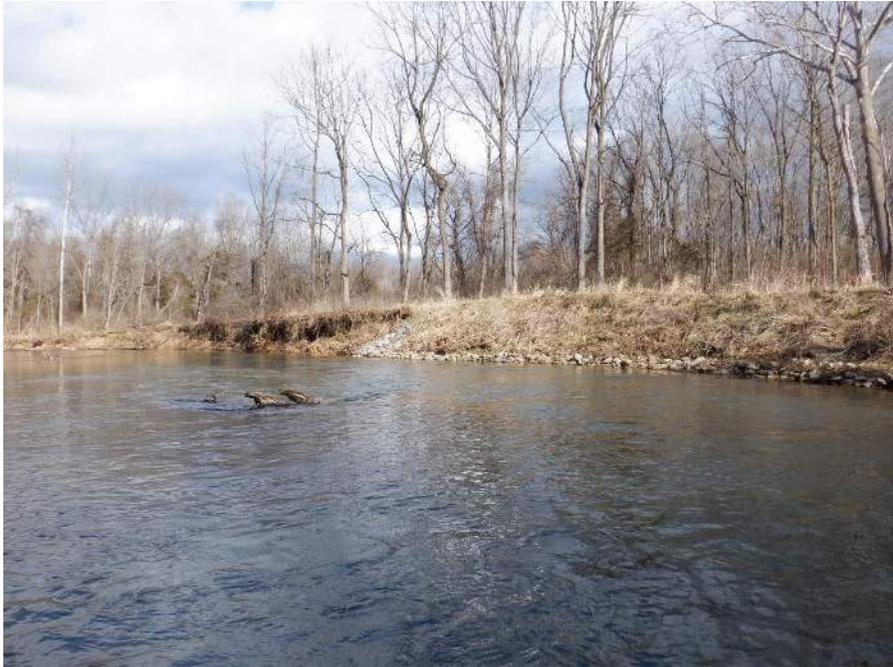
<p>Location: 00+1350'</p> <hr/> <p>Photo Title: Date: 34 1/19/2021</p> <hr/> <p>Direction Photo Taken: Southeast</p> <hr/> <p>Description: ~50 degree bank angle; installed rock toe intact; vegetation established; live stakes minimally established; minimal sediment deposition in rock toe</p>

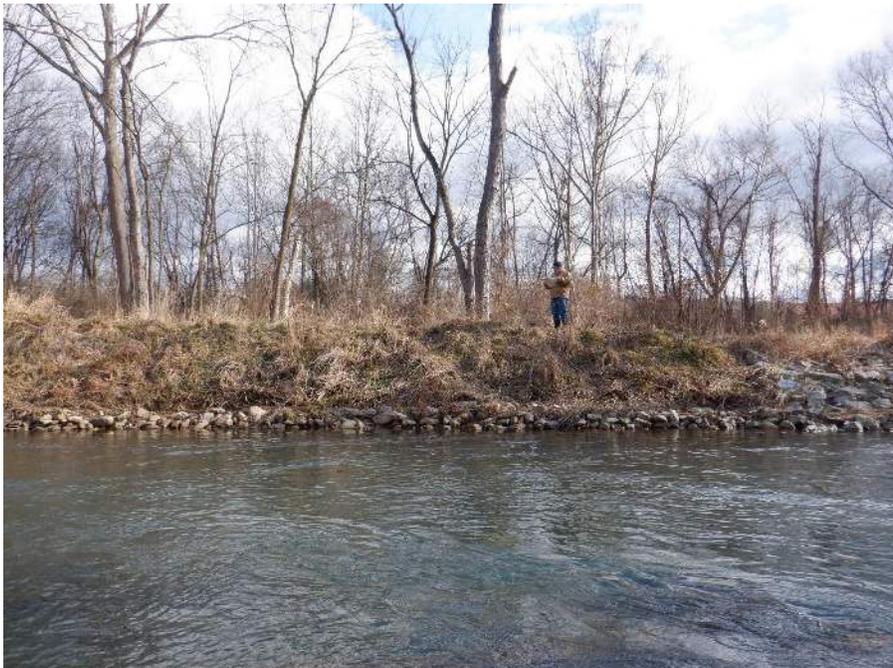
<p>Location: 00+1400'</p> <hr/> <p>Photo Number: Date: 35 1/19/2021</p> <hr/> <p>Direction Photo Taken: Southeast</p> <hr/> <p>Description: ~50 degree bank angle; installed rock toe intact; live stakes minimally established; vegetation established; minimal sediment deposition in rock toe</p>

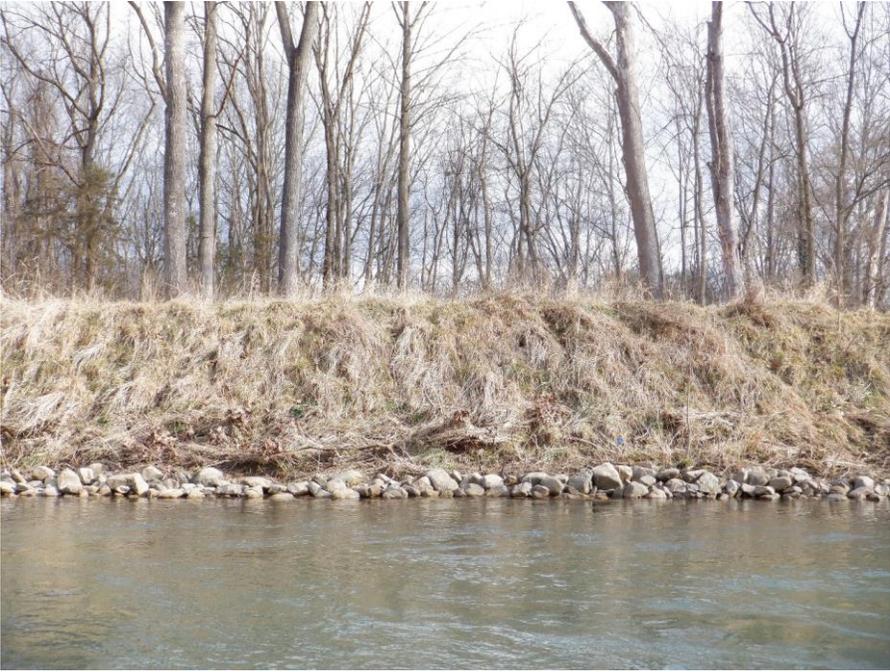
<p>Location: 00+1400'</p> <hr/> <p>Photo Title: Date: 36 1/19/2021</p> <hr/> <p>Direction Photo Taken: East</p> <hr/> <p>Description: Downstream showing end of remediation with rock toe intact; significant erosion after remediation</p>

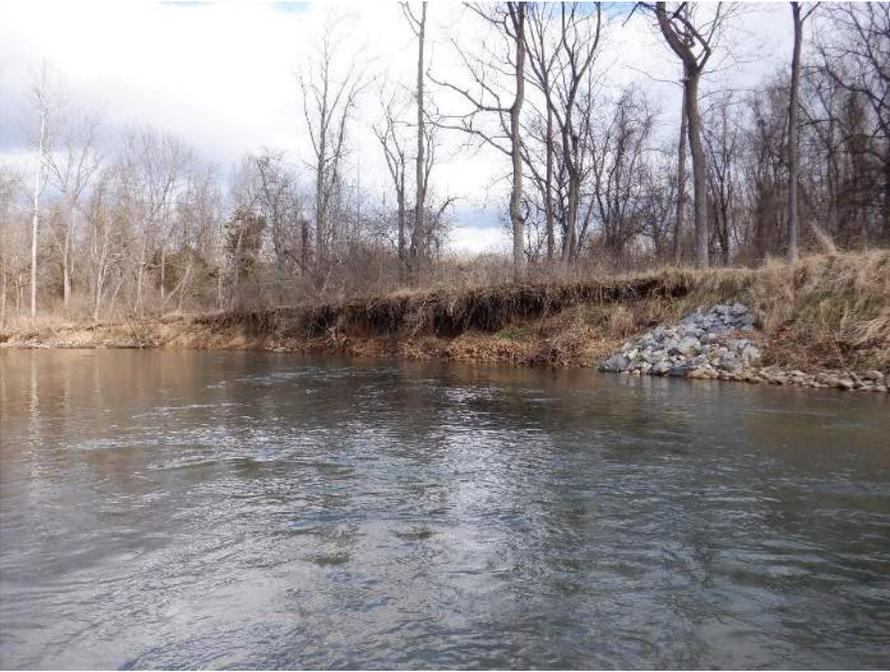
<p>Location: 00+1400'</p> <hr/> <p>Photo Number: Date: 37 1/19/2021</p> <hr/> <p>Direction Photo Taken: South</p> <hr/> <p>Description: Upstream showing fortified riprap bank and tributary channel; vegetation established; installed rock toe intact</p>

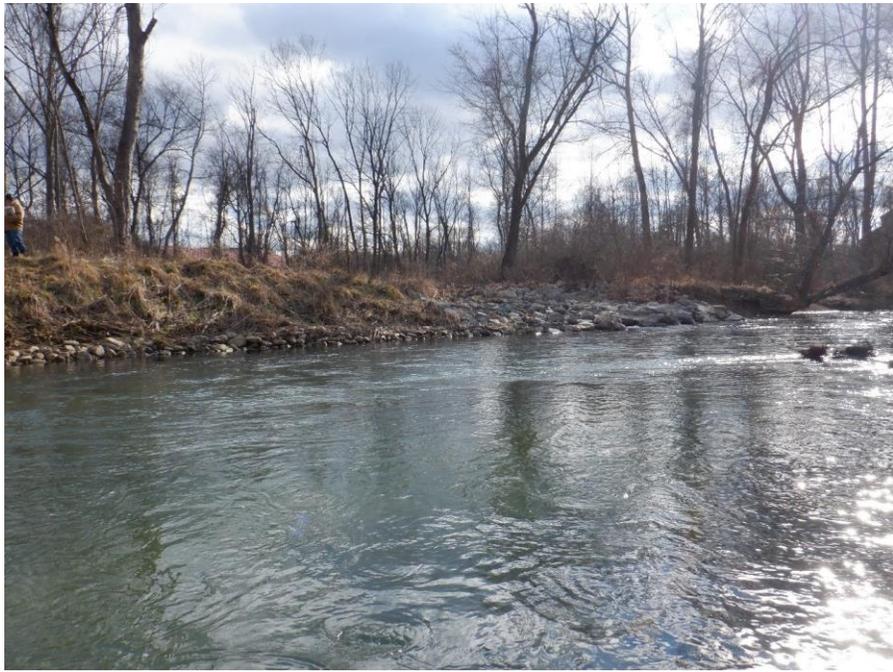
<p>Location: 00+1450'</p> <hr/> <p>Photo Title: Date: 38 1/19/2021</p> <hr/> <p>Direction Photo Taken: Southeast</p> <hr/> <p>Description: ~50 degree bank angle within remediated section and 90 degrees downstream of remediation; end of installed rock toe intact; vegetation established within remediated section; severe erosion downstream of BMA</p>

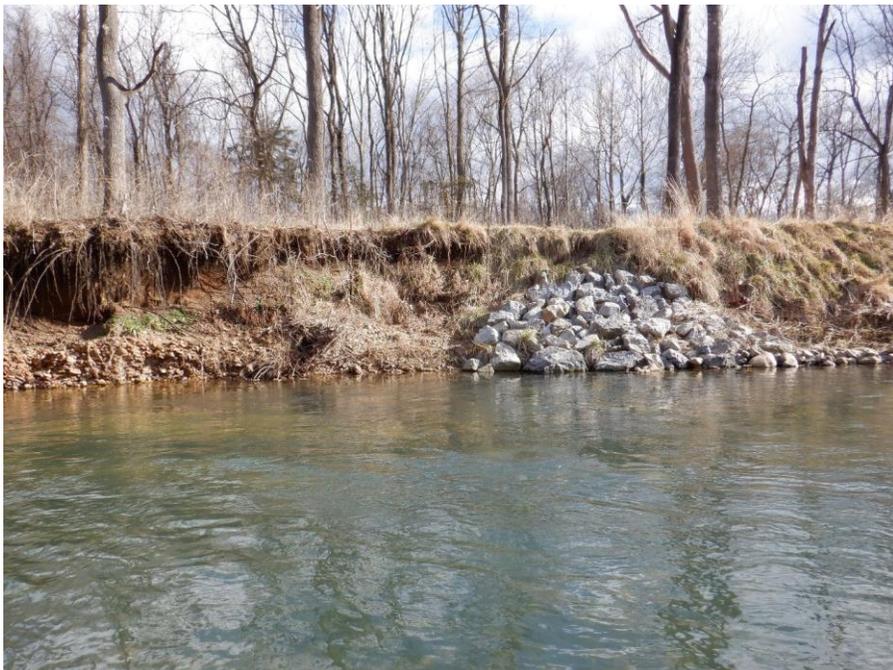
<p>Location: 00+1500'</p> <hr/> <p>Photo Number: Date: 39 1/19/2021</p> <hr/> <p>Direction Photo Taken: Southeast</p> <hr/> <p>Description: ~90 degree bank angle; significant erosion and scour along bank; several exposed roots; several at risk trees; bank heavily undercut</p>

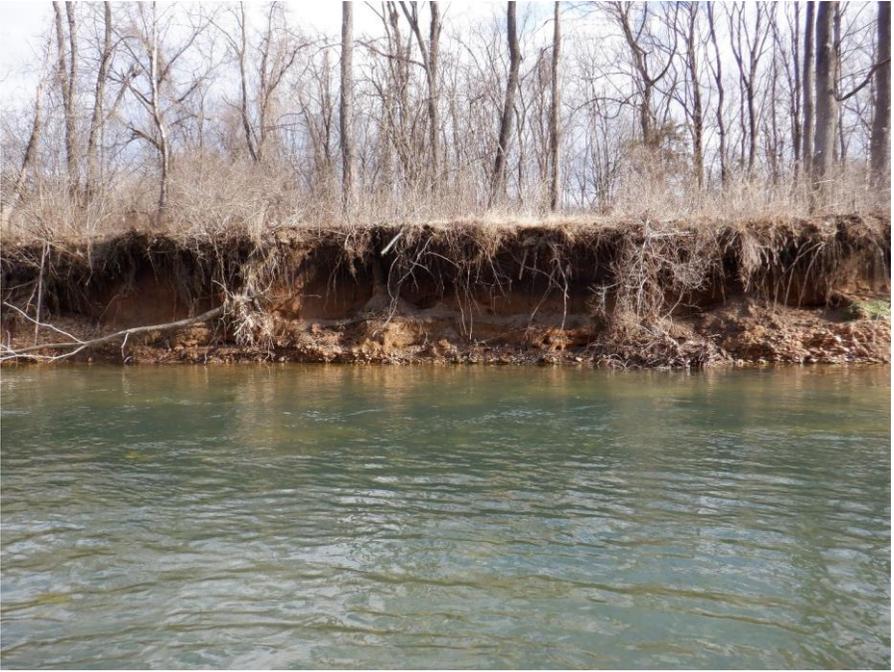
<p>Location: 00+1500'</p> <hr/> <p>Photo Title: Date: 40 1/19/2021</p> <hr/> <p>Direction Photo Taken: East</p> <hr/> <p>Description: Severe erosion downstream of BMA; at risk trees and exposed roots present; bank heavily undercut</p>

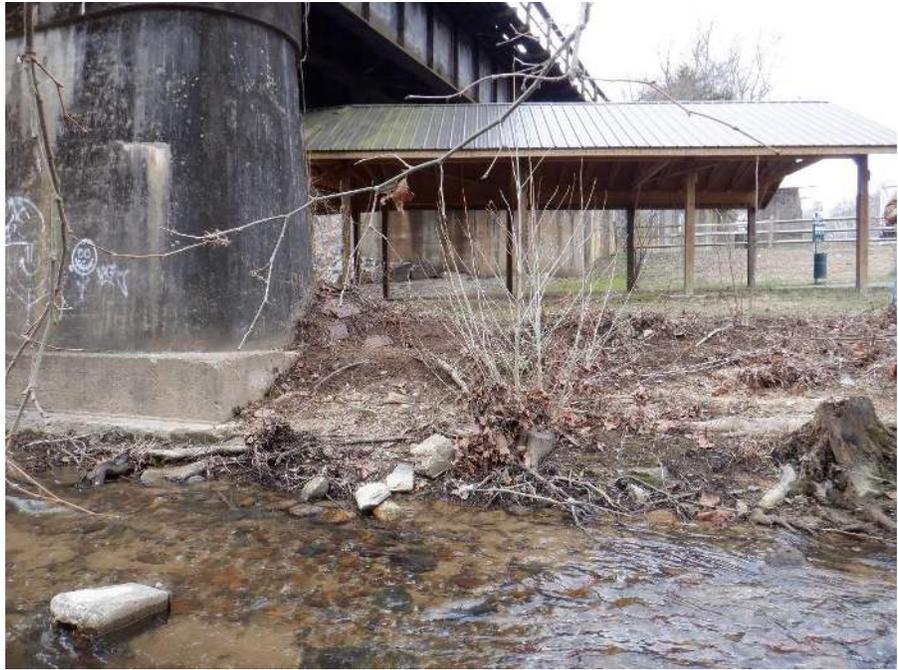
<p>Location: 00+00'</p> <hr/> <p>Photo Title: Date: 2 1/18/2021</p> <hr/> <p>Direction Photo Taken: West</p> <hr/> <p>Description: ~45 degree bank angle; start of remediation; culvert just upstream out of remediation; installed rock toe intact; few installed live stakes observed; vegetation established; no erosion control fabric or geocell exposed; minimal sediment deposition from recent high water events</p>

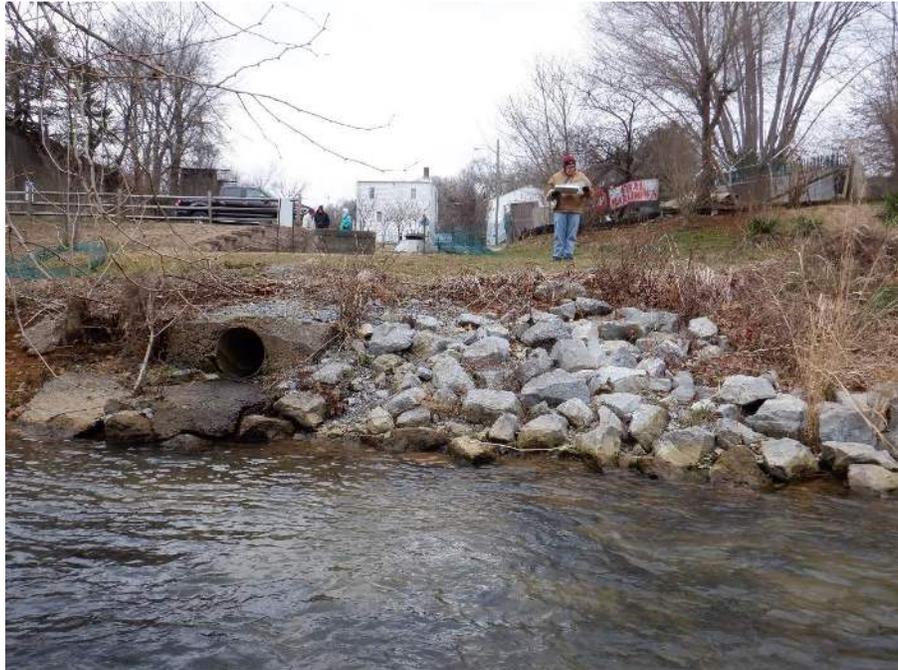
<p>Location: 00+00'</p> <hr/> <p>Photo Number: Date: 3 1/18/2021</p> <hr/> <p>Direction Photo Taken: Southwest</p> <hr/> <p>Description: Upstream of remediation; no at risk trees; access paths to river present</p>

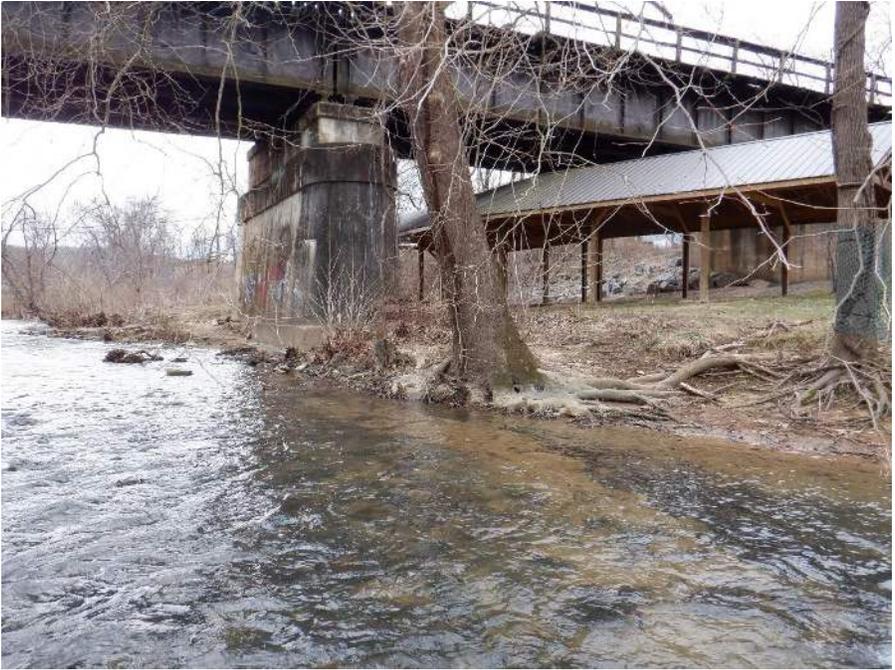
<p>Location: 00+00'</p> <hr/> <p>Photo Title: Date: 4 1/18/2021</p> <hr/> <p>Direction Photo Taken: North</p> <hr/> <p>Description: Upstream extent of BMA; vegetation establishing throughout bank</p>

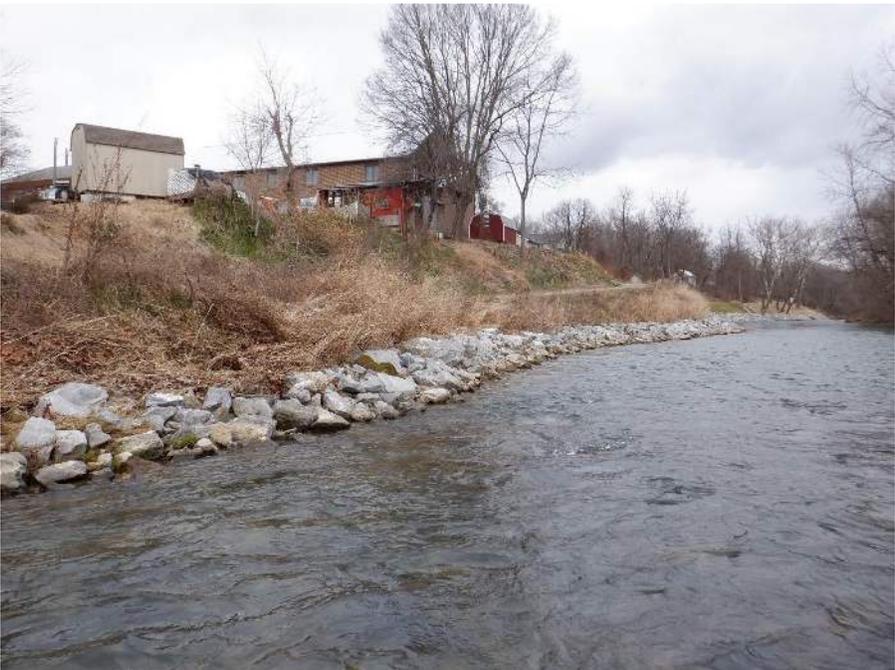
<p>Location: 00+50'</p> <hr/> <p>Photo Number: Date: 5 1/18/2021</p> <hr/> <p>Direction Photo Taken: West</p> <hr/> <p>Description: ~65 degree bank angle; installed rock toe intact; few installed live stakes observed; vegetation established; no erosion control fabric or geocell exposed; minimal sediment deposition from recent high water events</p>

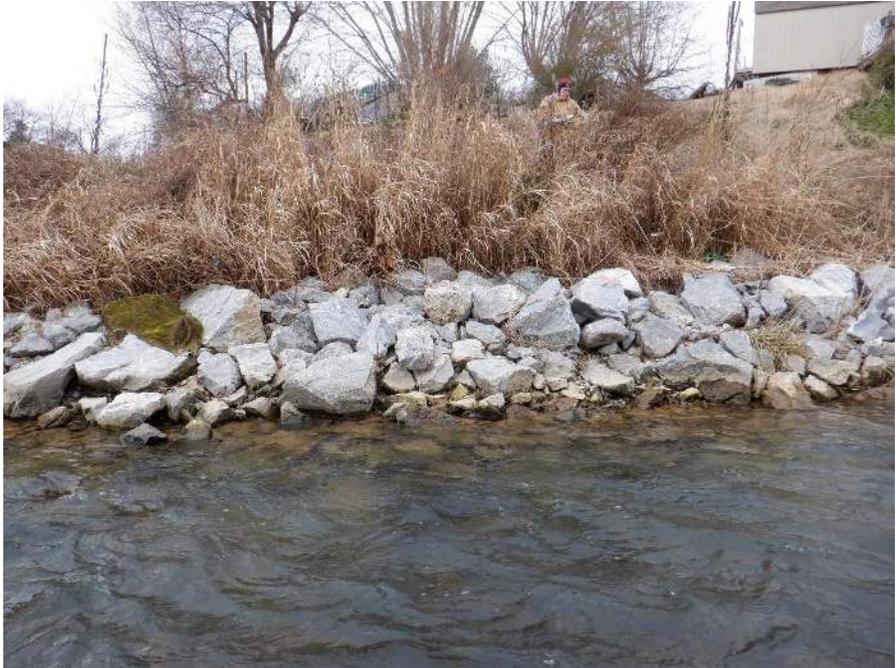
<p>Location: 00+100'</p> <hr/> <p>Photo Title: Date: 6 1/18/2021</p> <hr/> <p>Direction Photo Taken: West</p> <hr/> <p>Description: ~60 degree upper bank angle and 40 degree lower bank angle; no installed live stakes or plantings present after being removed from property owner; vegetation established; sediment deposition from high water events</p>

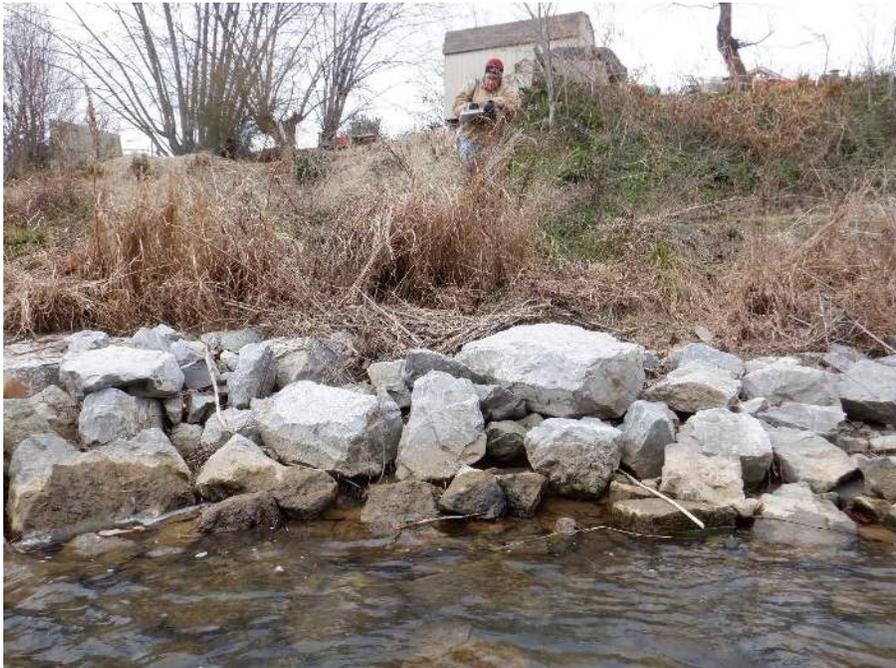
<p>Location: 00+150'</p> <hr/> <p>Photo Number: Date: 7 1/18/2021</p> <hr/> <p>Direction Photo Taken: West</p> <hr/> <p>Description: ~60 degree bank angle and 40 degree upper bank angle; no installed live stakes of plantings present after being removed by nearby property owner; vegetation established; minimal sediment deposition from recent flood events</p>

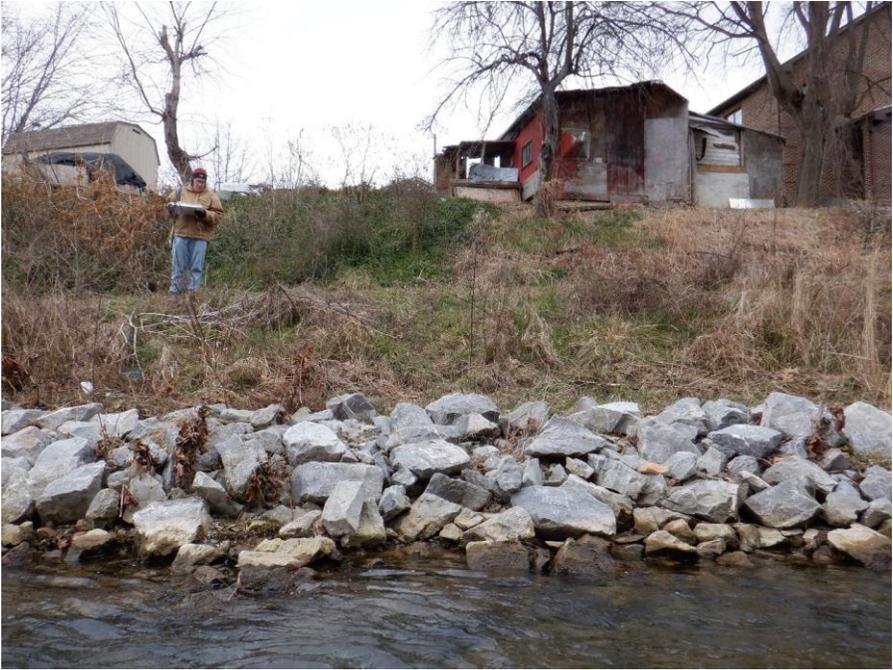
<p>Location: 00+150'</p> <hr/> <p>Photo Title: Date: 8 1/18/2021</p> <hr/> <p>Direction Photo Taken: West</p> <hr/> <p>Description: ~60 degree upper bank angle upslope of Greenway; some evidence of surface runoff; installed plantings removed by property owner; vegetation minimally established</p>

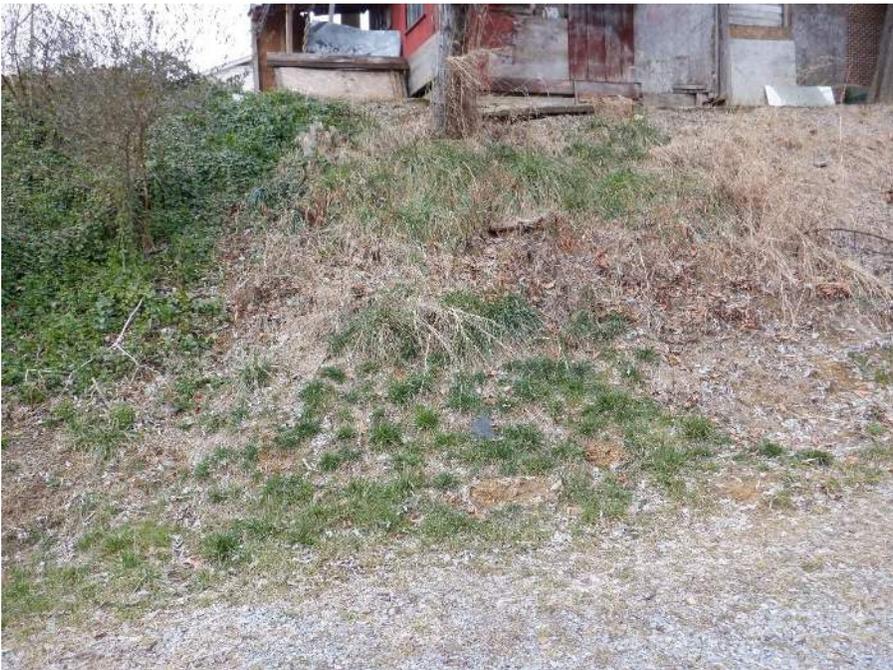
<p>Location: 00+200'</p> <hr/> <p>Photo Number: Date: 9 1/18/2021</p> <hr/> <p>Direction Photo Taken: West</p> <hr/> <p>Description: ~65 degree bank angle; vegetation establishing covering 80%; installed rock toe intact; few live stakes present; erosion control fabric 20% exposed, no geocell exposed</p>

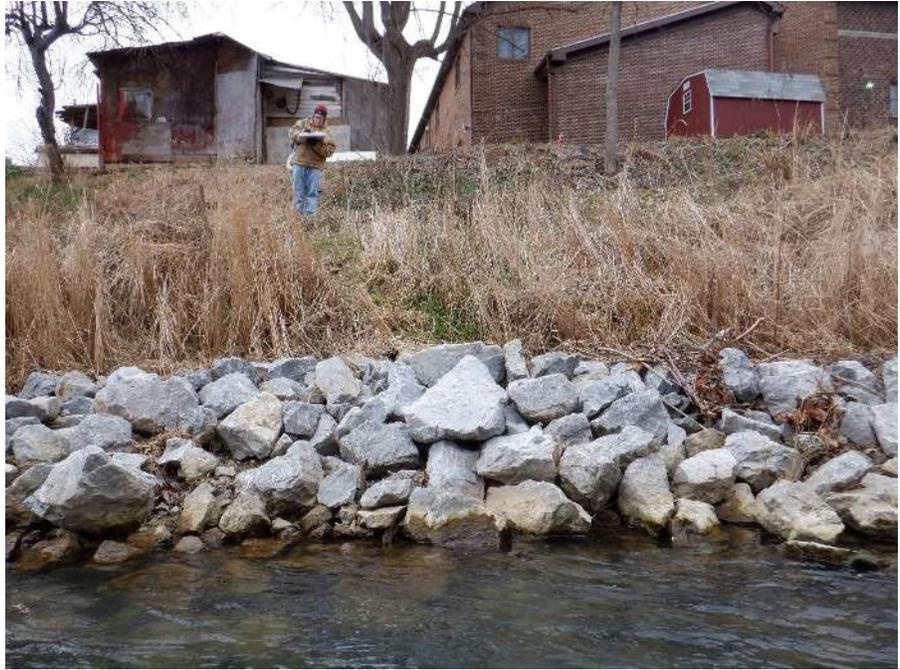
<p>Location: 00+250'</p> <hr/> <p>Photo Title: Date: 10 1/18/2021</p> <hr/> <p>Direction Photo Taken: West</p> <hr/> <p>Description: ~65 degree bank angle; installed rock toe intact; vegetation establishing; erosion control fabric 30% exposed; live stakes and plantings establishing</p>

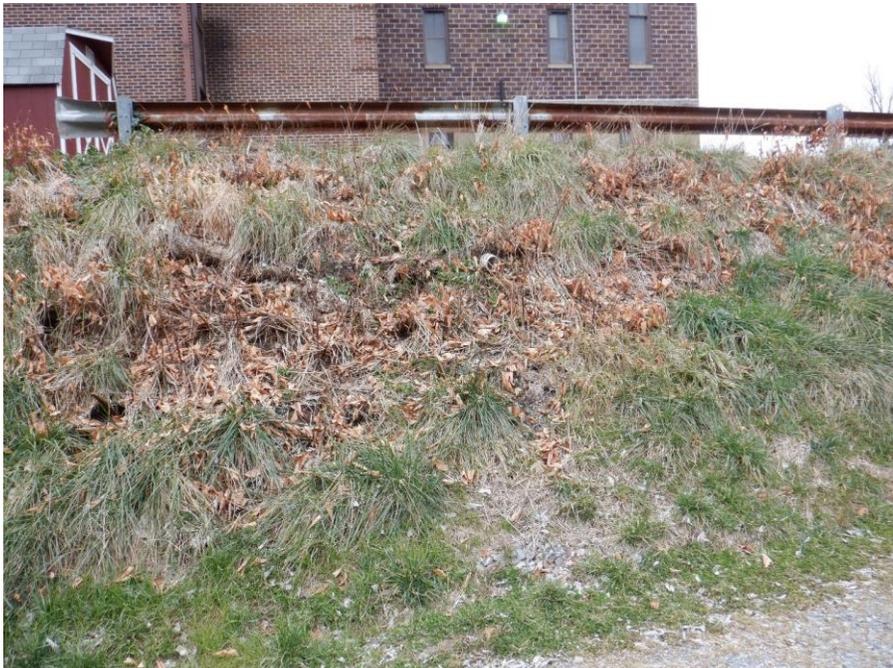
<p>Location: 00+250'</p> <hr/> <p>Photo Title: Date: 12 1/18/2021</p> <hr/> <p>Direction Photo Taken: N/A</p> <hr/> <p>Description: Drainage pipe on upper bank above Greenway and buried under Greenway is damaged</p>

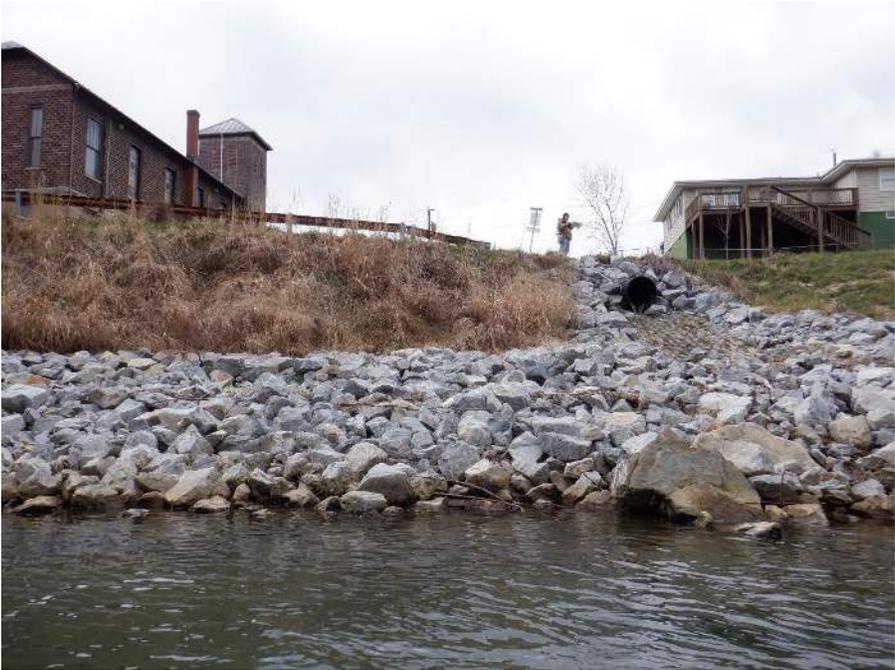
<p>Location: 00+400'</p> <hr/> <p>Photo Number: Date: 17 1/18/2021</p> <hr/> <p>Direction Photo Taken: West</p> <hr/> <p>Description: ~50 degree upper bank angle and 45 degree lower bank angle; no at risk trees present; lives stakes minimally established; plantings establishing; vegetation established; no erosion control fabric or geocell exposed; installed rock toe intact; bank covered by seeded grasses that appear to be dead and no longer establishing</p>

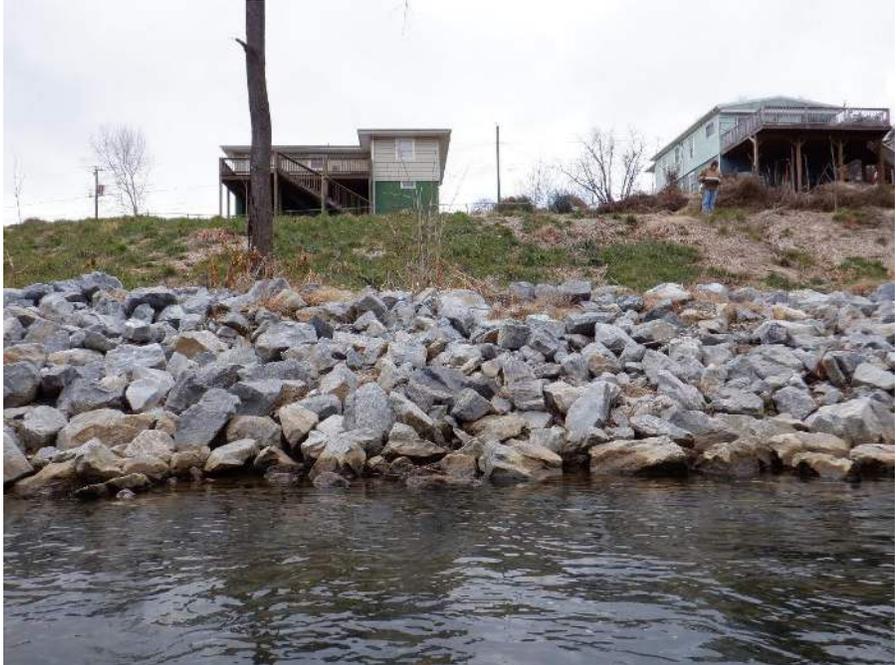
<p>Location: 00+400'</p> <hr/> <p>Photo Title: Date: 18 1/18/2021</p> <hr/> <p>Direction Photo Taken: Northwest</p> <hr/> <p>Description: Vegetation establishing throughout bank; installed rock toe intact</p>

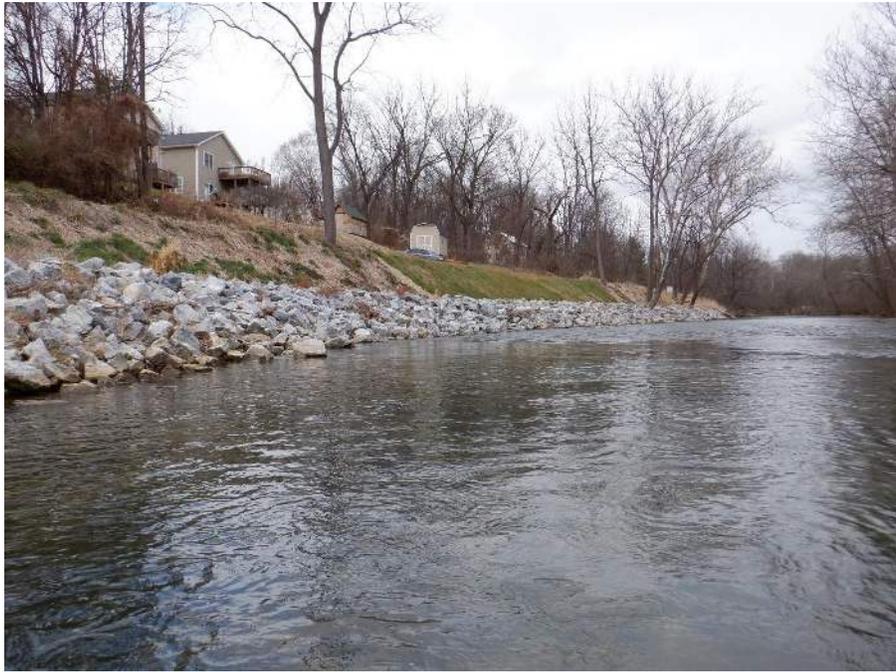
<p>Location: 00+400'</p> <hr/> <p>Photo Number: 19 Date: 1/18/2021</p> <hr/> <p>Direction Photo Taken: Southwest</p> <hr/> <p>Description: Installed rock toe intact; vegetation establishing throughout bank</p>

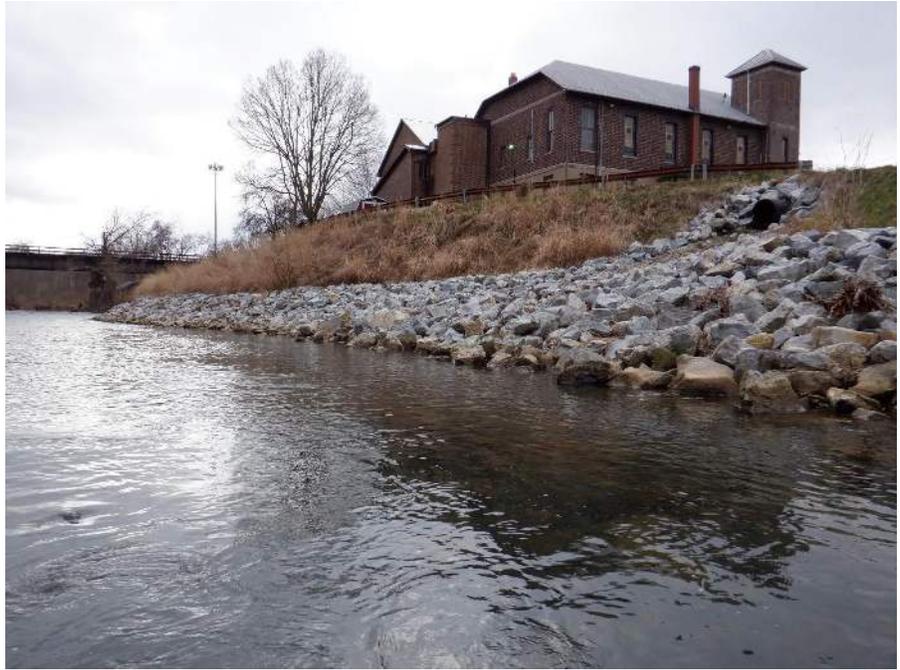
<p>Location: 00+450'</p> <hr/> <p>Photo Title: 20 Date: 1/18/2021</p> <hr/> <p>Direction Photo Taken: West</p> <hr/> <p>Description: ~55 degree upper bank angle and 45 degree lower bank angle; installed live stakes and plantings establishing; installed rock toe intact; vegetation establishing throughout bank; evidence of erosion from surface runoff; bank covered by seeded grasses that appear to be dead and no longer establishing</p>
