**Re: 2020 Leaf-on and 2020-2021 Leaf-off Maintenance Inspections
Former DuPont Waynesboro Site AOC 4
Waynesboro, Virginia
EPA ID# VAD003114832**

Subject 2020-2021 Phase 1 BMA Leaf-Off Maintenance Inspection
Former DuPont Waynesboro Site, Area of Concern 4

Date March 24, 2021

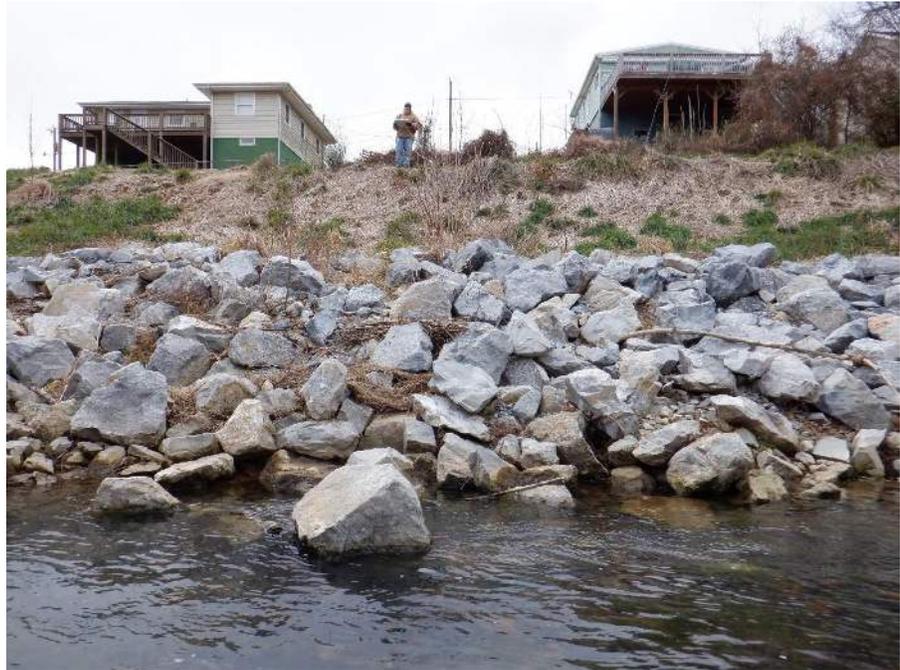
<p>Location: 00+450'</p> <hr/> <p>Photo Number: Date: 21 1/18/2021</p> <hr/> <p>Direction Photo Taken: West</p> <hr/> <p>Description: Surface water runoff on upper bank; vegetation establishing</p>

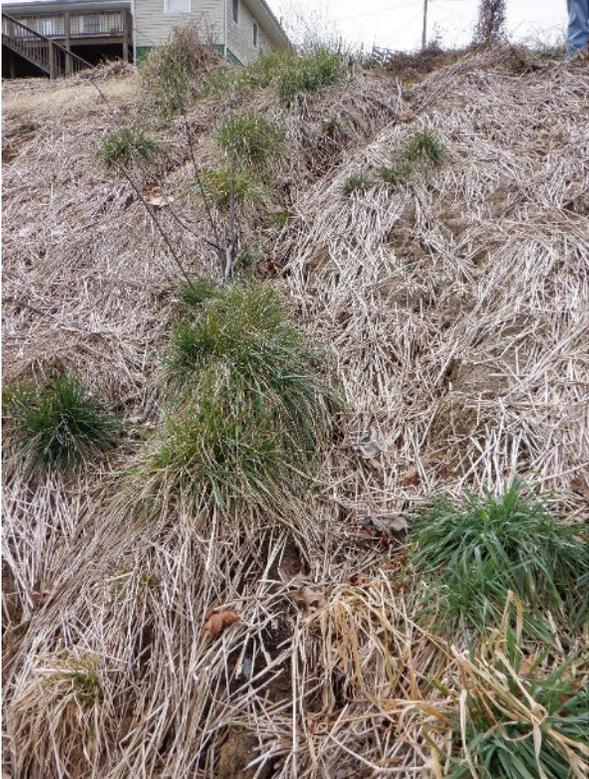
<p>Location: 00+500'</p> <hr/> <p>Photo Title: Date: 22 1/18/2021</p> <hr/> <p>Direction Photo Taken: West</p> <hr/> <p>Description: ~65 degree upper bank angle and 45 degree lower bank angle; no at risk trees present; installed live stakes and plantings establishing; vegetation establishing; bank covered by seeded grasses that appear to be dead and no longer establishing; installed rock toe intact</p>

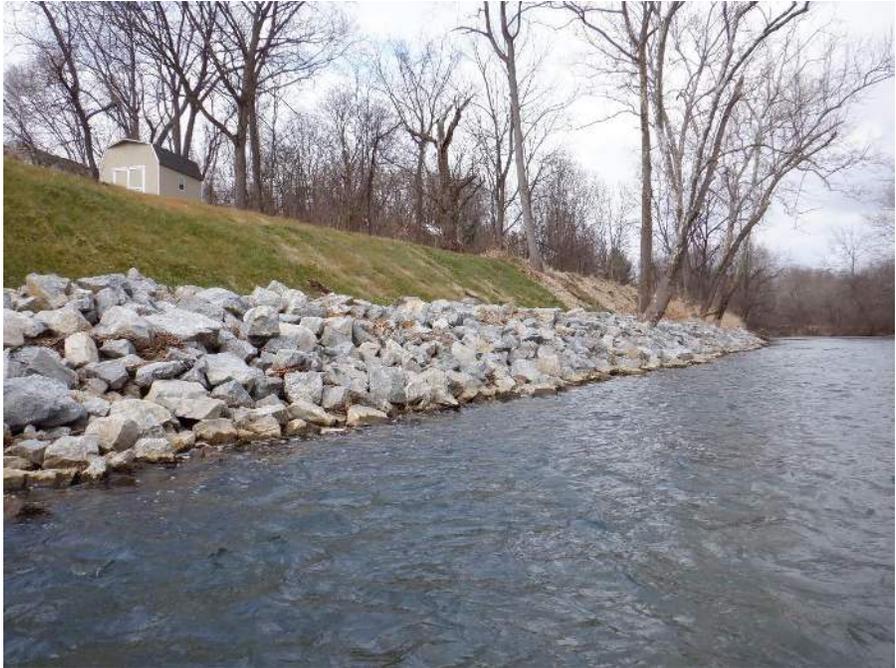
<p>Location: 00+600'</p> <hr/> <p>Photo Title: 26 Date: 1/18/2021</p> <hr/> <p>Direction Photo Taken: West</p> <hr/> <p>Description: ~70 degree upper bank angle and 60 degree lower bank angle; portion of the bank that failed over the summer has been repaired; grasses establishing along repaired portion of bank; installed rock toe intact; erosion control fabric 40% exposed in repaired area</p>

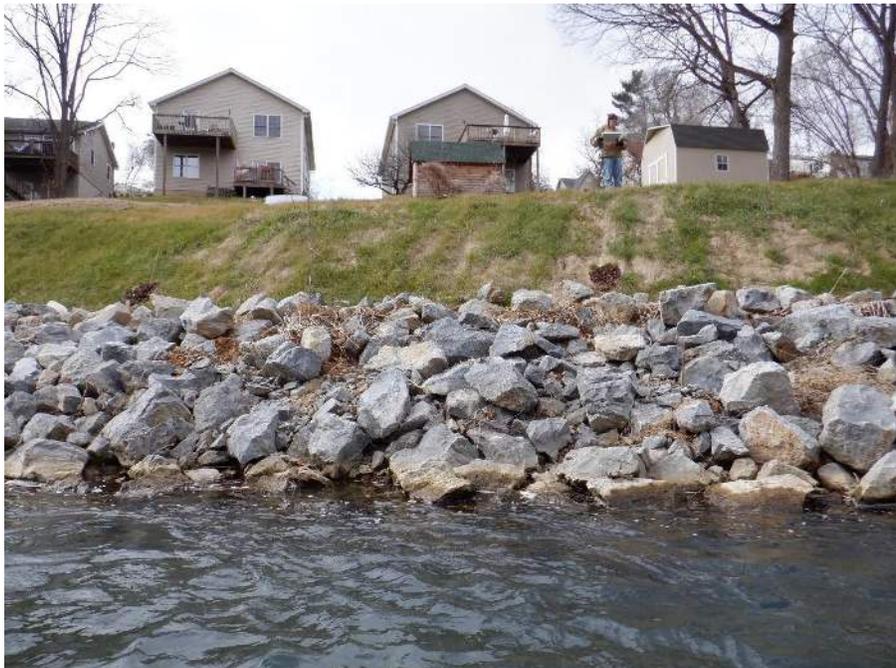
<p>Location: 00+650'</p> <hr/> <p>Photo Number: 27 Date: 1/18/2021</p> <hr/> <p>Direction Photo Taken: West</p> <hr/> <p>Description: ~70 degree upper bank angle and 60 degree lower bank angle; installed live stakes and plantings establishing; vegetation establishing; no at risk trees present; installed rock toe intact; bank covered by seeded grasses that appear to be dead and no longer establishing</p>

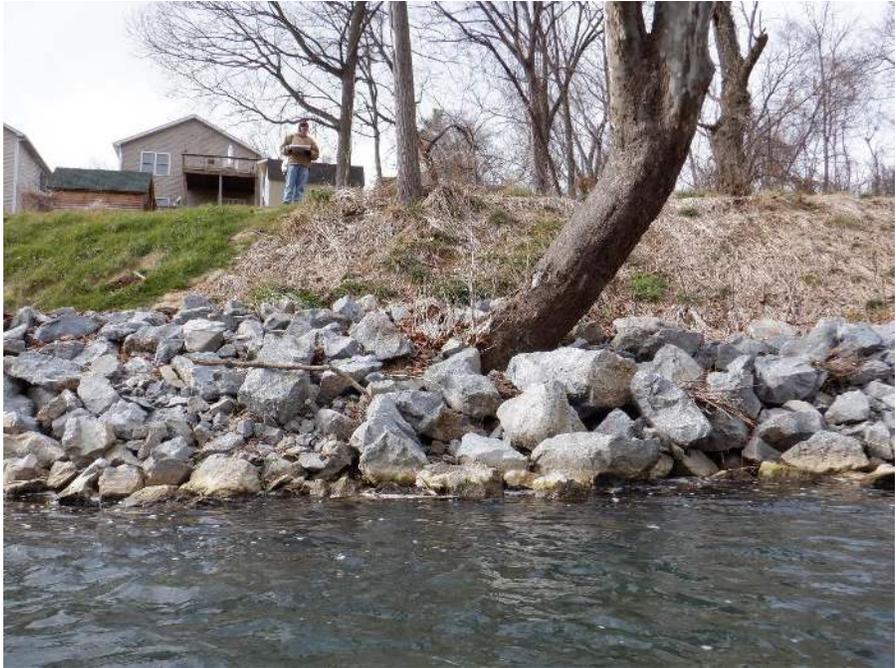
<p>Location: 00+700'</p> <hr/> <p>Photo Title: 28 Date: 1/18/2021</p> <hr/> <p>Direction Photo Taken: West</p> <hr/> <p>Description: ~65 degree bank angle; installed live stakes and plantings establishing; installed rock toe intact; bank covered by seeded grasses that appear to be dead and no longer establishing</p>

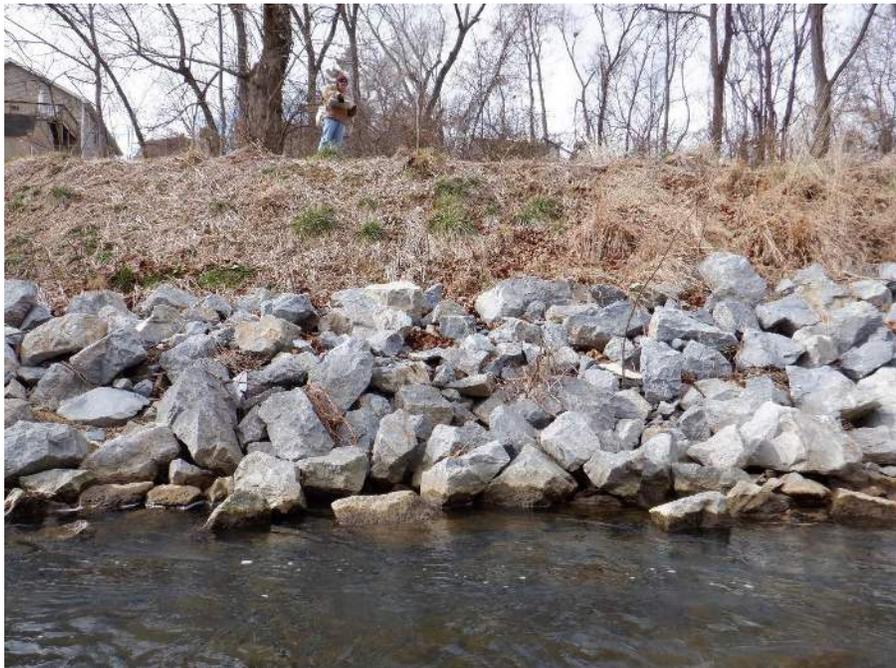
<p>Location: 00+700'</p> <hr/> <p>Photo Number: Date: 29 1/18/2021</p> <hr/> <p>Direction Photo Taken: Southwest</p> <hr/> <p>Description: Installed rock toe intact; vegetation establishing; newly repaired bank upstream</p>

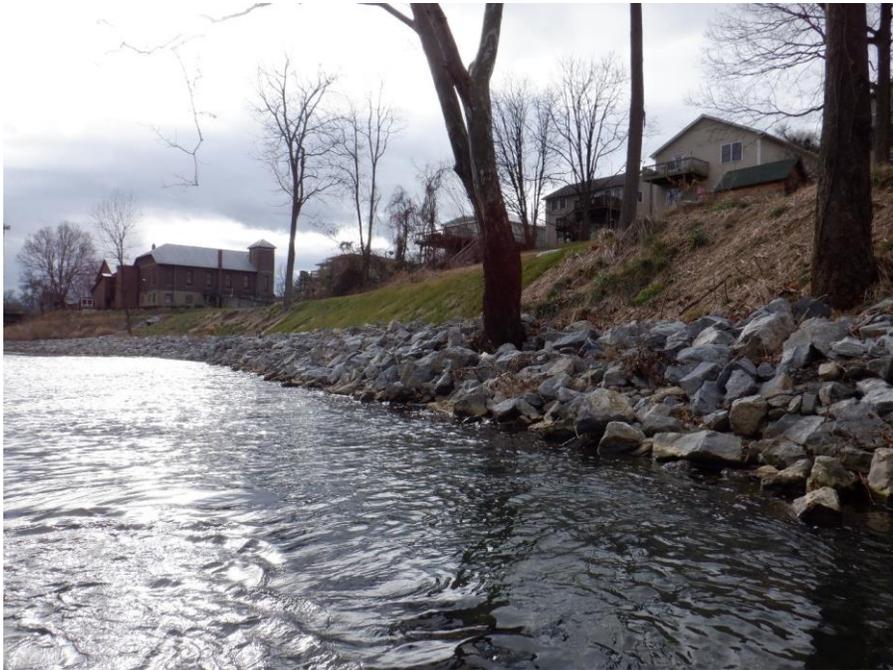
<p>Location: 00+700'</p> <hr/> <p>Photo Title: Date: 30 1/18/2021</p> <hr/> <p>Direction Photo Taken: Northwest</p> <hr/> <p>Description: Installed rock toe intact; vegetation establishing; bank covered by seeded grasses that appear to be dead and no longer establishing</p>

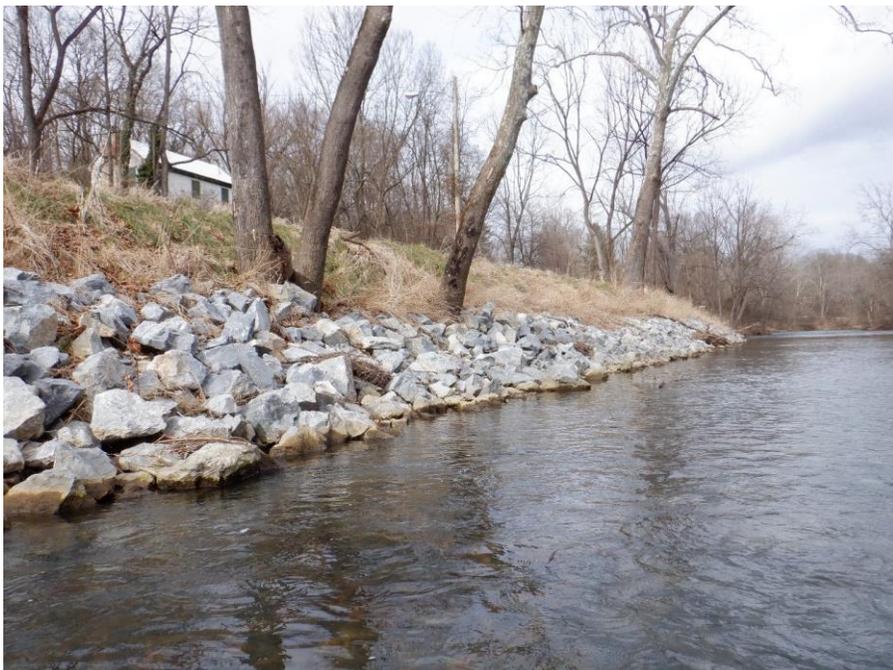
<p>Location: 00+750'</p> <hr/> <p>Photo Number: 31 Date: 1/18/2021</p> <hr/> <p>Direction Photo Taken: West</p> <hr/> <p>Description: ~60 degree bank angle; installed live stakes and plantings establishing; no at risk trees present; installed rock toe intact; vegetation establishing; bank covered by seeded grasses that appear to be dead and no longer establishing</p>

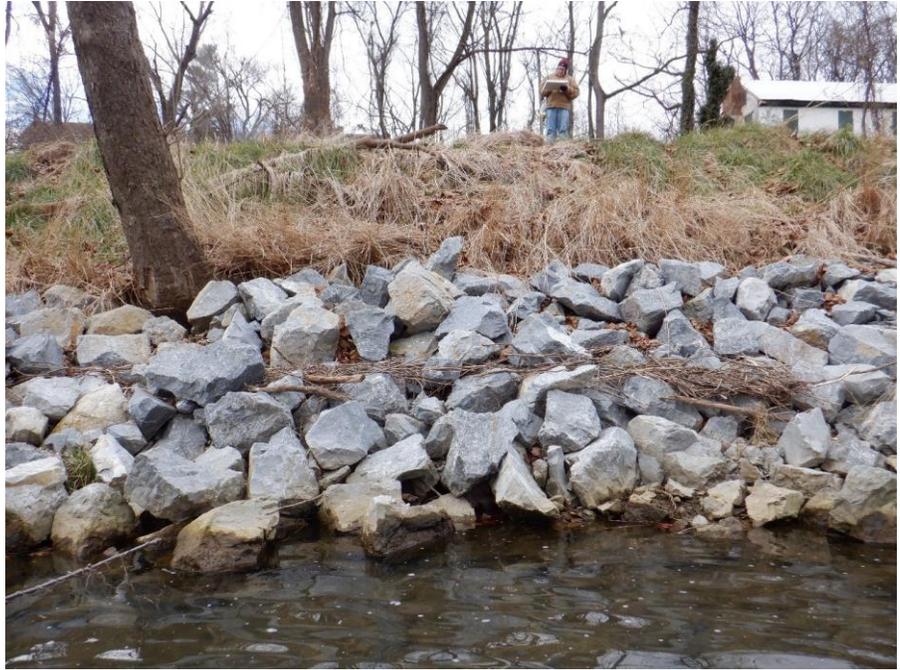
<p>Location: 00+800'</p> <hr/> <p>Photo Title: 32 Date: 1/18/2021</p> <hr/> <p>Direction Photo Taken: West</p> <hr/> <p>Description: ~65 degree bank angle; installed live stakes and plantings establishing; installed rock toe intact; bank covered by seeded grasses that appear to be dead and no longer establishing</p>

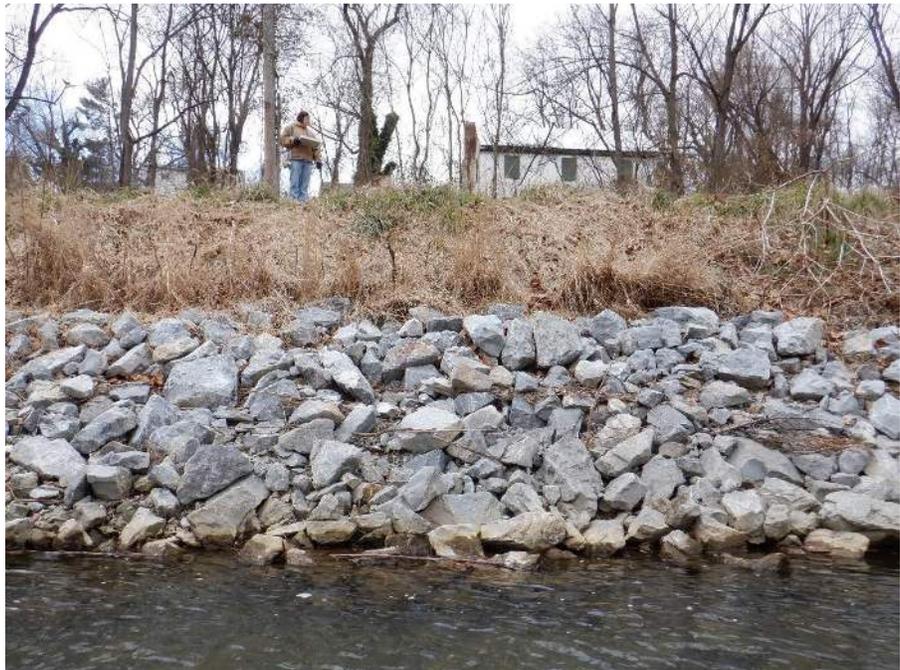
<p>Location: 00+850'</p> <hr/> <p>Photo Number: Date: 33 1/18/2021</p> <hr/> <p>Direction Photo Taken: West</p> <hr/> <p>Description: ~65 degree bank angle; installed live stakes and plantings establishing; vegetation establishing; installed rock toe intact; minimal sediment deposition in rock toe</p>

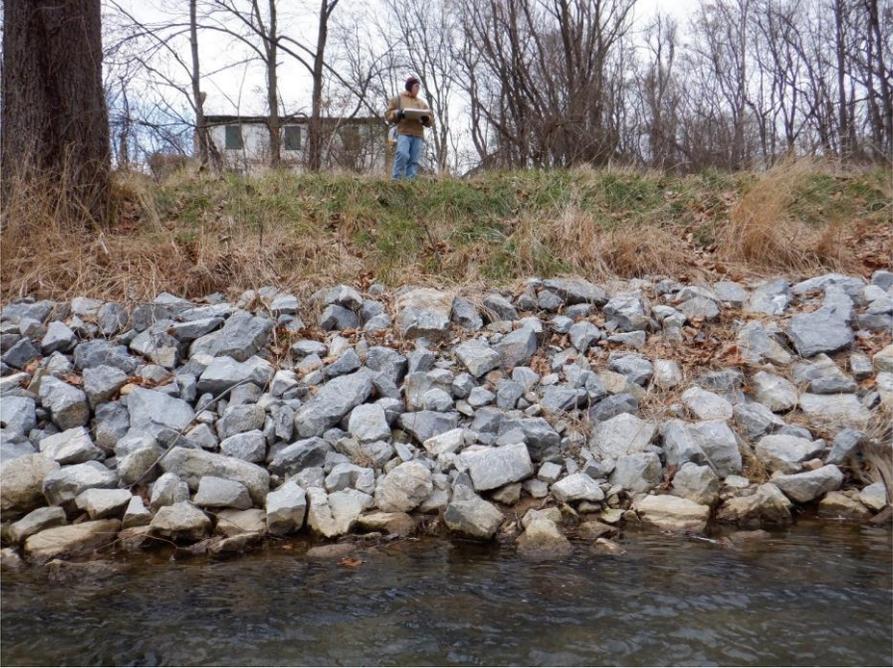
<p>Location: 00+900'</p> <hr/> <p>Photo Title: Date: 34 1/18/2021</p> <hr/> <p>Direction Photo Taken: West</p> <hr/> <p>Description: ~70 degree bank angle; installed live stakes and plantings establishing; installed rock toe intact; minimal sediment deposition in rock toe; bank covered by seeded grasses that appear to be dead and no longer establishing</p>

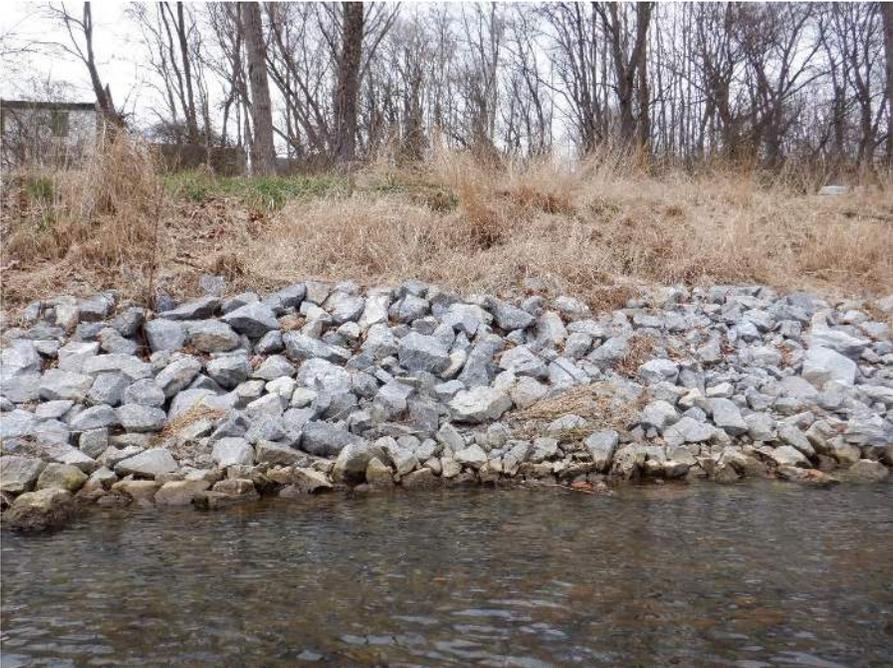
<p>Location: 00+950'</p> <hr/> <p>Photo Number: Date: 35 1/18/2021</p> <hr/> <p>Direction Photo Taken: West</p> <hr/> <p>Description: ~60 degree upper bank angle and 70 degree lower bank angle; no at risk trees present; installed rock toe intact; minimal sediment deposition in rock toe; bank covered by seeded grasses that appear dead and no longer establishing</p>

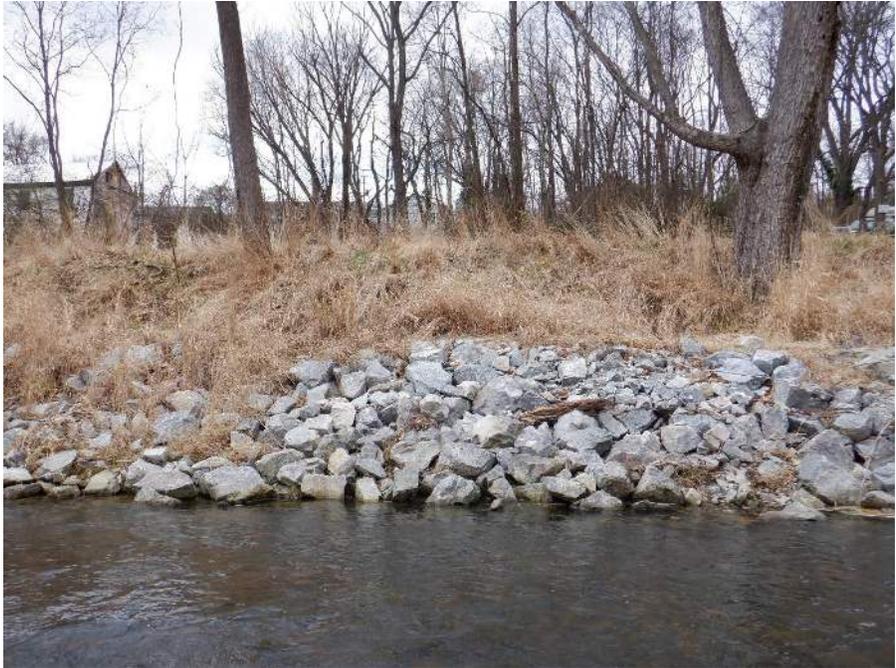
<p>Location: 00+975'</p> <hr/> <p>Photo Title: Date: 36 1/18/2021</p> <hr/> <p>Direction Photo Taken: West</p> <hr/> <p>Description: End of remediation; ~60 degree bank angle; installed rock toe intact; remediated bank portion covered by seeded grasses that appear dead and no longer establishing</p>

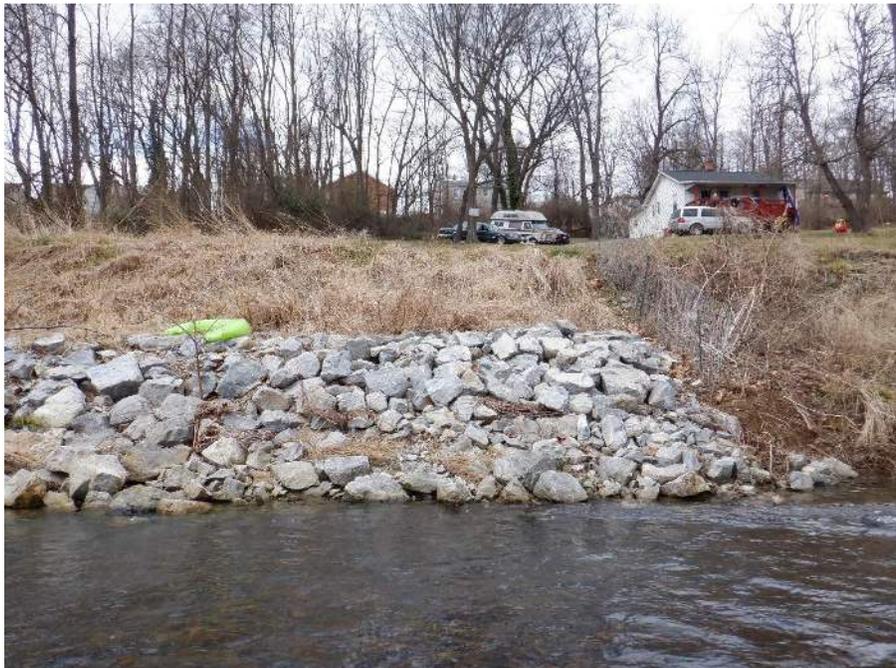
<p>Location: 00+975'</p> <hr/> <p>Photo Number: Date: 37 1/18/2021</p> <hr/> <p>Direction Photo Taken: South</p> <hr/> <p>Description: Installed rock toe intact; bank covered by seeded grasses that appear dead and no longer establishing</p>

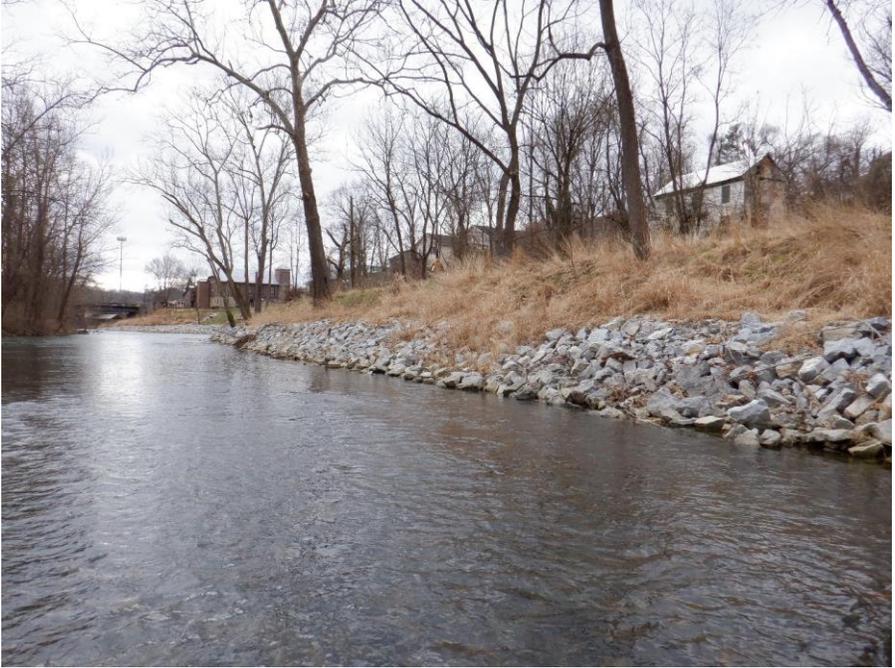
<p>Location: 00+975'</p> <hr/> <p>Photo Title: Date: 38 1/18/2021</p> <hr/> <p>Direction Photo Taken: Northwest</p> <hr/> <p>Description: Non-remediated bank; exposed roots and at risk trees present; scour along lower bank downstream of rock toe</p>

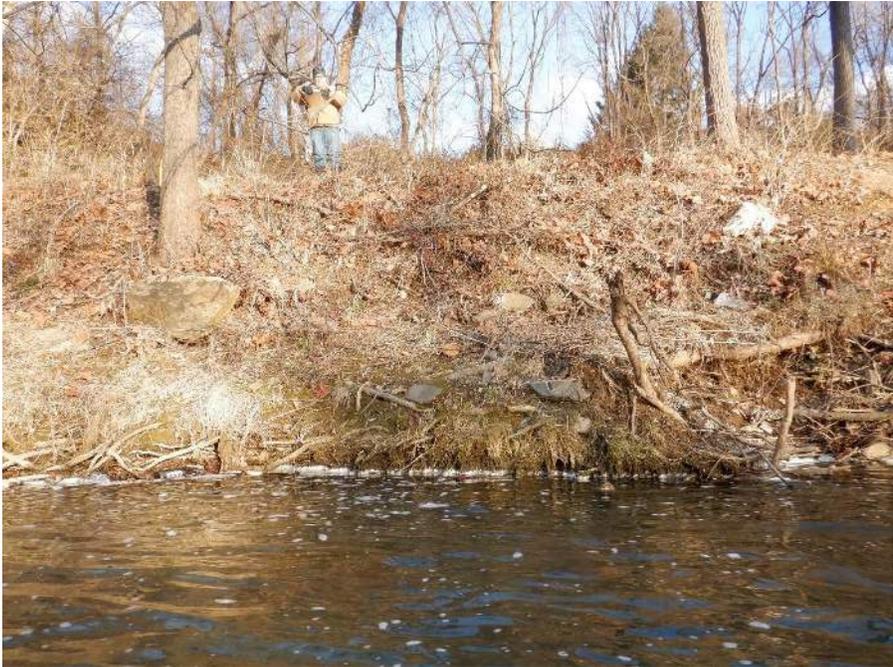
<p>Location: 00-25'</p> <hr/> <p>Photo Number: Date: 1 1/19/2021</p> <hr/> <p>Direction Photo Taken: Northwest</p> <hr/> <p>Description: Upstream of remediation; ~70 degree bank angle; 60% vegetation cover; significant root exposure; no at risk trees; minor erosion and scour around exposed roots; some undercutting at toe of slope</p>

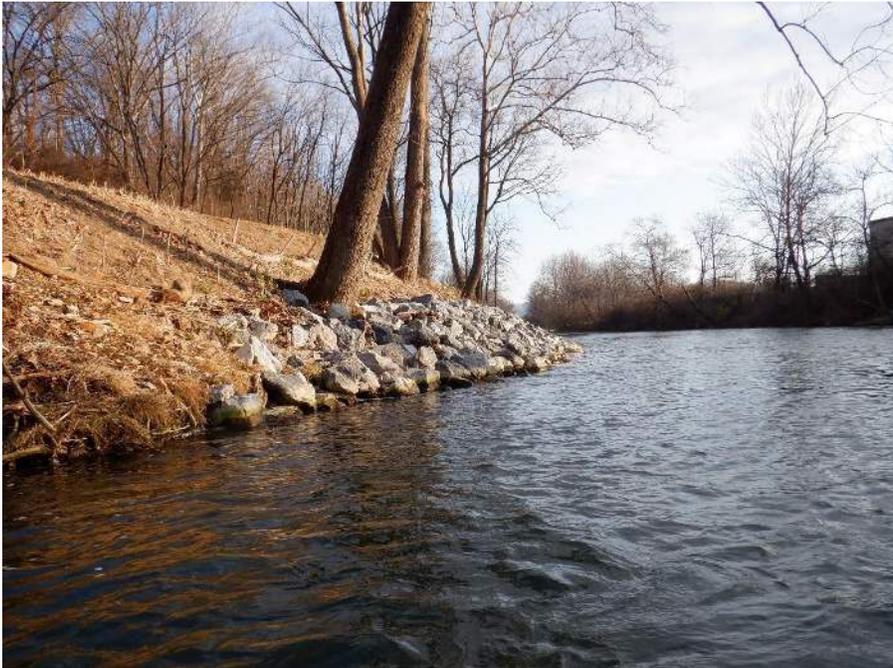
<p>Location: 00-25'</p> <hr/> <p>Photo Title: Date: 2 1/19/2021</p> <hr/> <p>Direction Photo Taken: North</p> <hr/> <p>Description: Downstream view showing start of remediated section; minimal scour and undercutting of slope toe before remediated section</p>

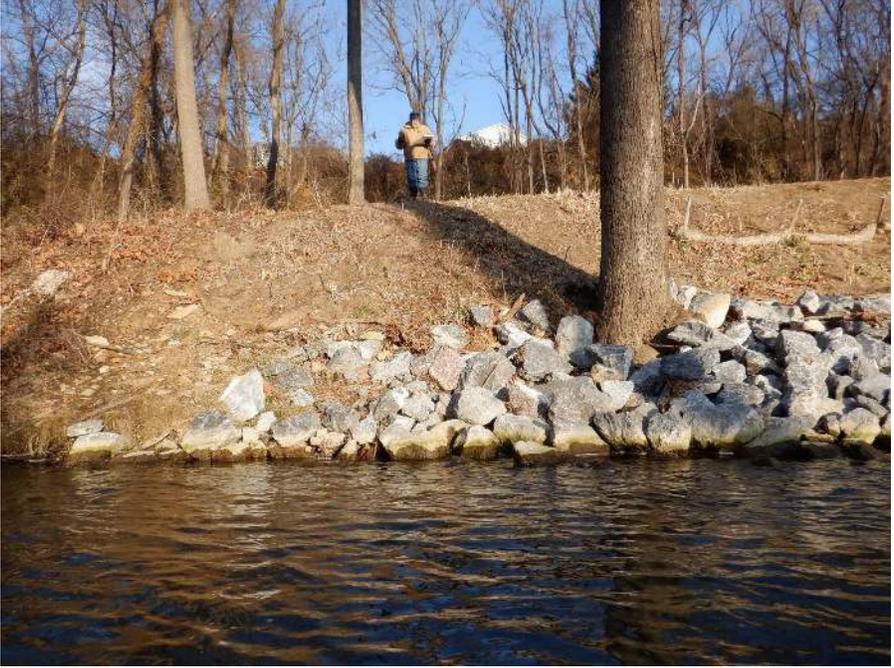
<p>Location: 00+00</p> <hr/> <p>Photo Number: Date: 3 1/19/2021</p> <hr/> <p>Direction Photo Taken: Northwest</p> <hr/> <p>Description: Start of remediation; ~60 degree bank angle; installed rock toe intact; no at risk trees; lives stakes and plantings establishing; minimal vegetation cover; erosion control fabric 90% exposed; no sediment deposition in rock toe</p>

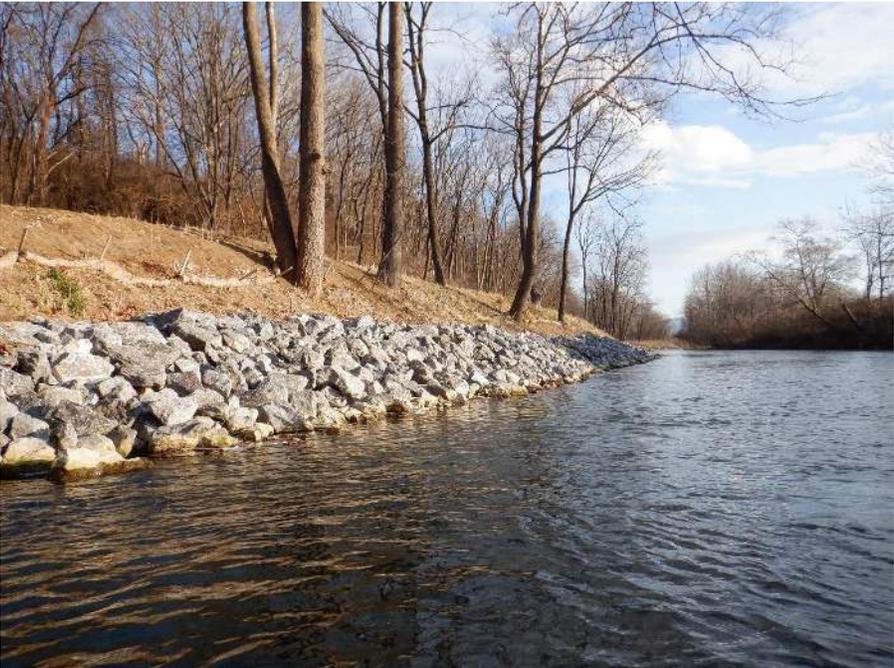
<p>Location: 00+00</p> <hr/> <p>Photo Title: Date: 4 1/19/2021</p> <hr/> <p>Direction Photo Taken: North</p> <hr/> <p>Description: Downstream view showing remediated bank; ~60 degree bank angle; installed rock toe intact; minimal vegetation cover; erosion control fabric 90% exposed</p>

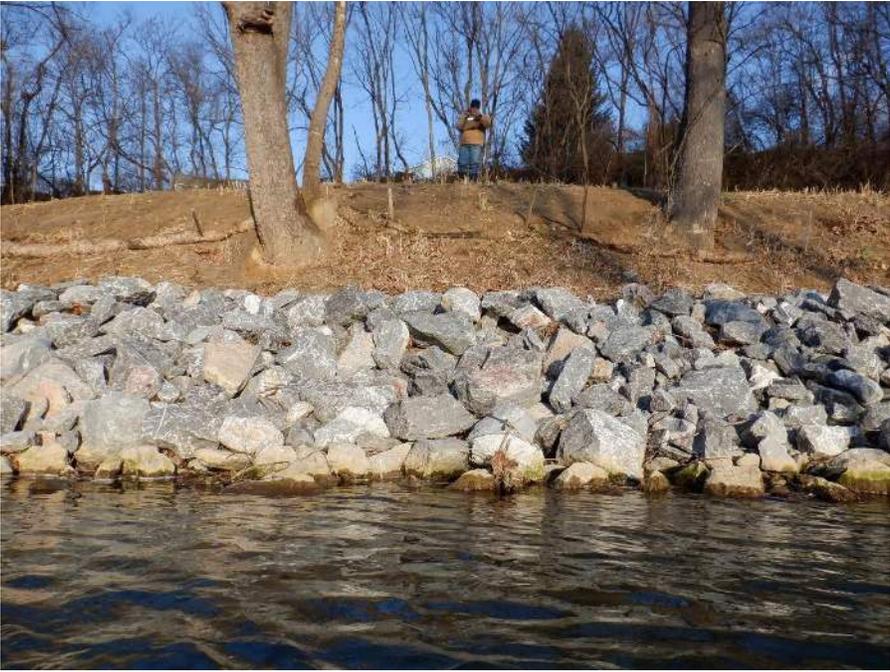
<p>Location: 00+50'</p> <hr/> <p>Photo Number: Date: 5 1/19/2021</p> <hr/> <p>Direction Photo Taken: Northwest</p> <hr/> <p>Description: ~60 degree bank angle; installed rock toe intact; live stakes and plantings establishing; minimal vegetation cover; erosion control fabric 90% exposed; straw wattle in place; minimal fine sediment deposition in rock toe</p>

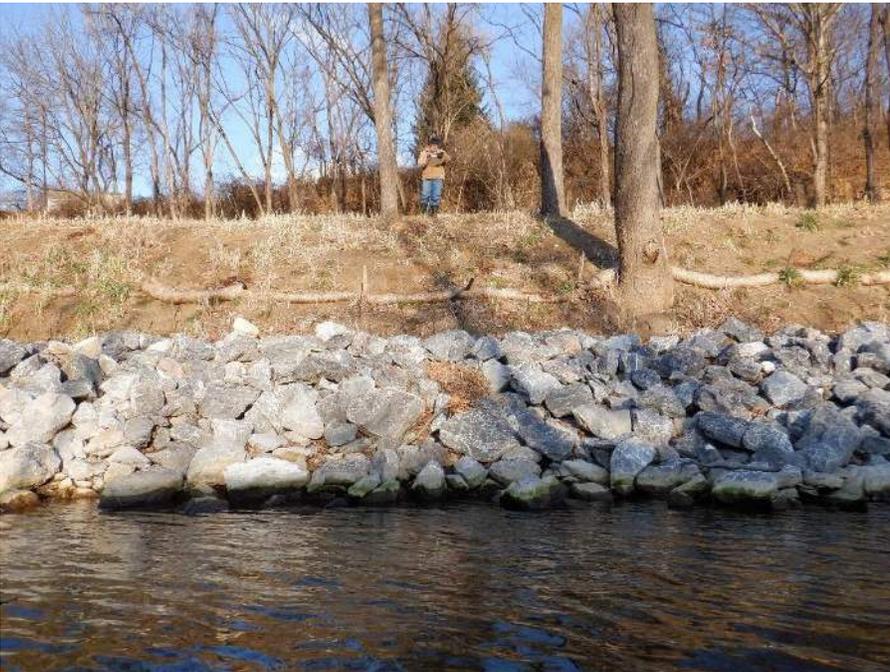
<p>Location: 00+100'</p> <hr/> <p>Photo Title: Date: 6 1/19/2021</p> <hr/> <p>Direction Photo Taken: Northwest</p> <hr/> <p>Description: ~60 degree bank angle; installed rock toe intact; live stakes and plantings establishing; bark damaged on tree on upper bank close to Greenway; minimal vegetation cover; erosion control fabric 90% exposed; sand deposition in rock toe</p>

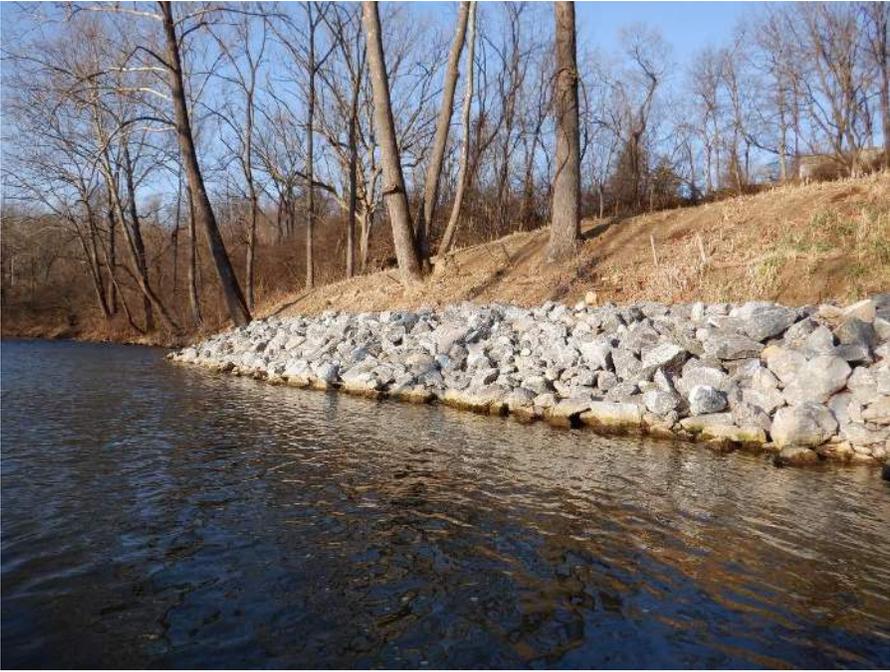
<p>Location: 00+100'</p> <hr/> <p>Photo Number: Date: 7 1/19/2021</p> <hr/> <p>Direction Photo Taken: West</p> <hr/> <p>Description: Upstream view of start of remediation; installed rock toe intact; minimal vegetation established; erosion control fabric significantly exposed</p>

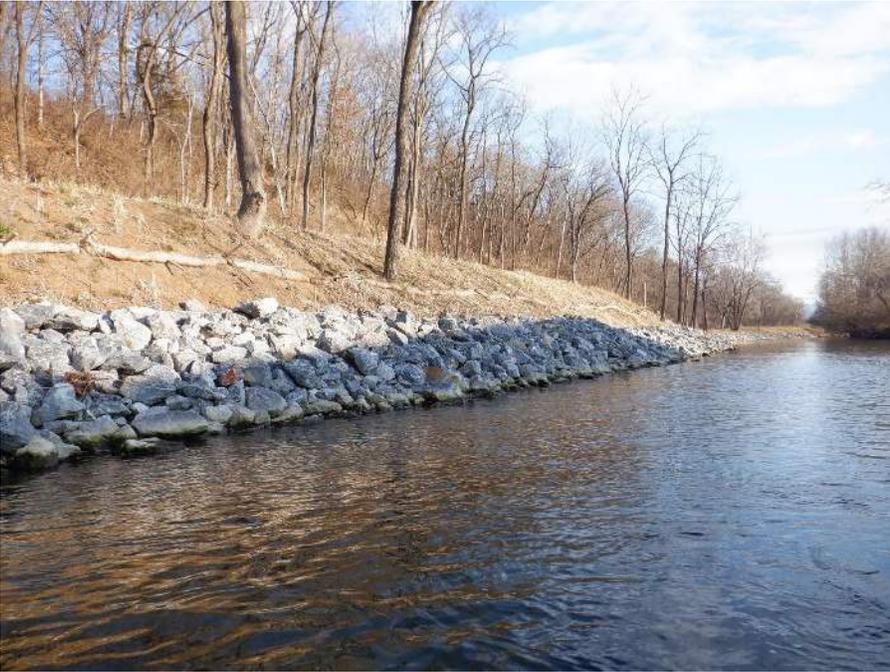
<p>Location: 00+100'</p> <hr/> <p>Photo Title: Date: 8 1/19/2021</p> <hr/> <p>Direction Photo Taken: North</p> <hr/> <p>Description: Downstream view of remediation; installed rock toe intact; minimal vegetation established; erosion control fabric significantly exposed</p>

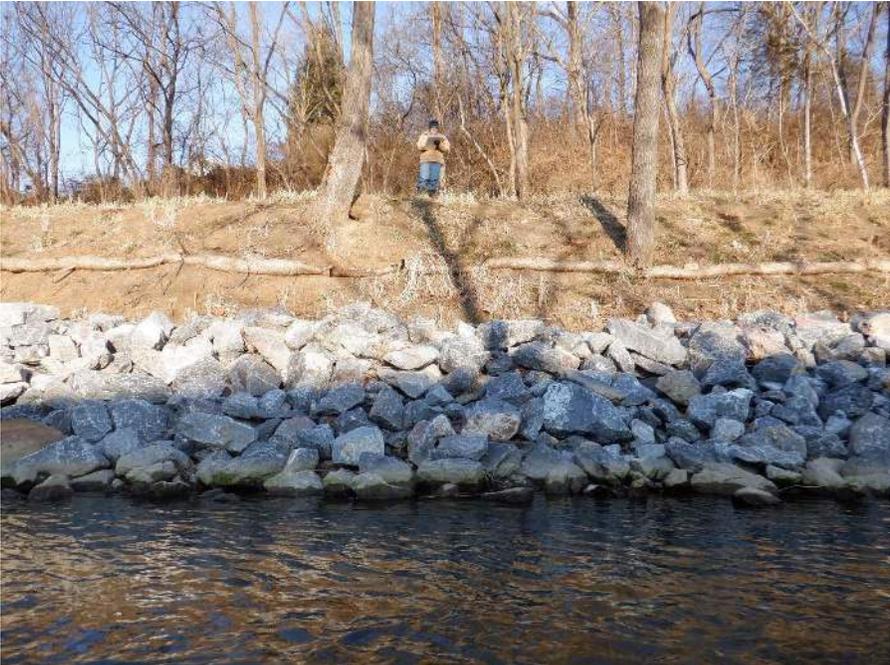
<p>Location: 00+150'</p> <hr/> <p>Photo Number: Date: 9 1/19/2021</p> <hr/> <p>Direction Photo Taken: Northwest</p> <hr/> <p>Description: ~60 degree bank angle; installed rock toe intact; live stakes and plantings establishing; minimal vegetation cover; erosion control fabric 90% exposed; no at risk trees present; some sediment deposition in rock toe</p>

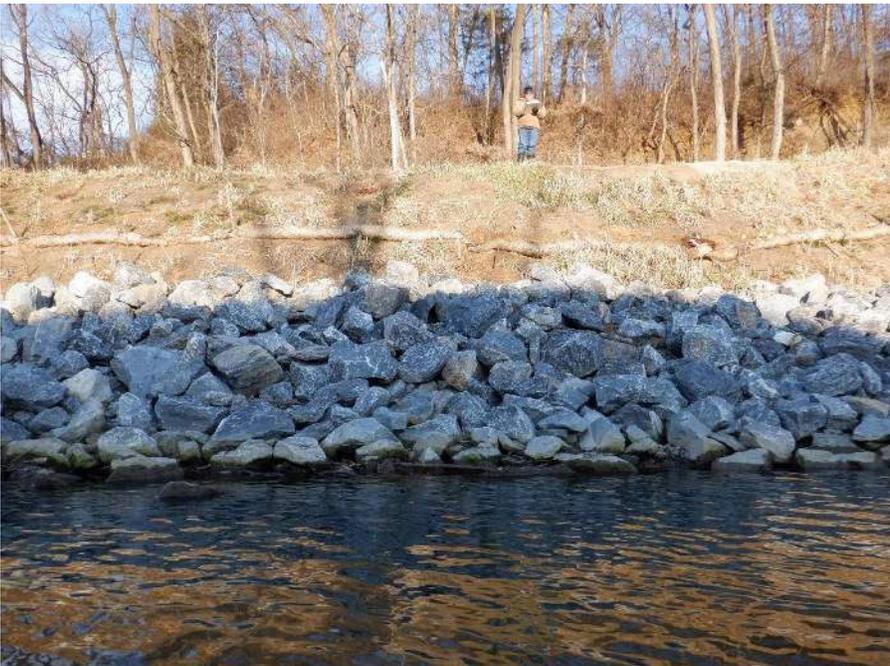
<p>Location: 00+200'</p> <hr/> <p>Photo Title: Date: 10 1/19/2021</p> <hr/> <p>Direction Photo Taken: Northwest</p> <hr/> <p>Description: ~60 degree bank angle; installed rock toe intact; live stakes and plantings establishing; minimal vegetation cover; erosion control fabric 90% exposed; straw wattle intact; sediment deposition in rock toe</p>

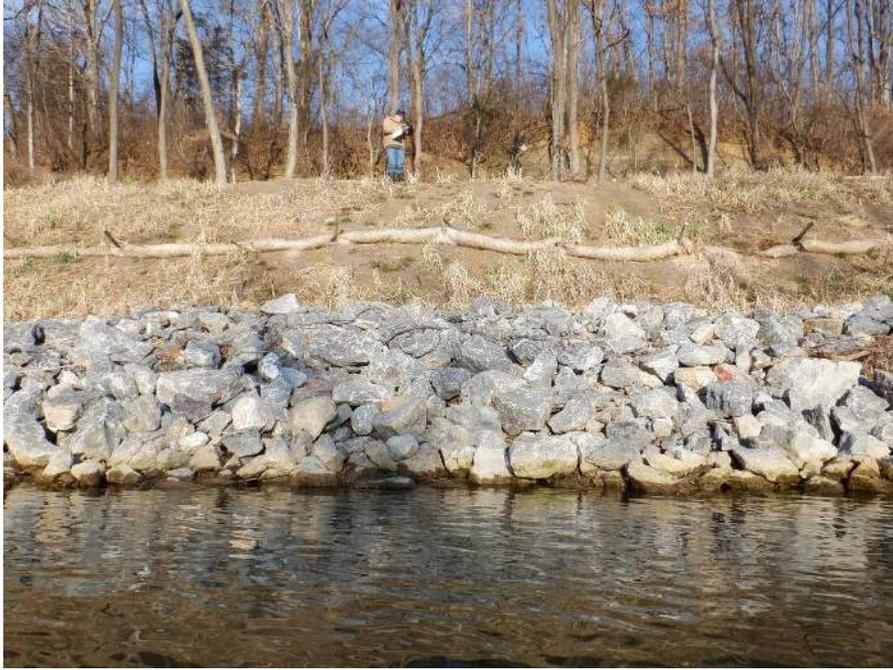
<p>Location: 00+250'</p> <hr/> <p>Photo Number: 11 Date: 1/19/2021</p> <hr/> <p>Direction Photo Taken: Northwest</p> <hr/> <p>Description: ~60 degree bank angle; installed rock toe intact; live stakes and plantings establishing; minimal vegetation cover; erosion control fabric 90% exposed; some sediment deposition in rock toe</p>

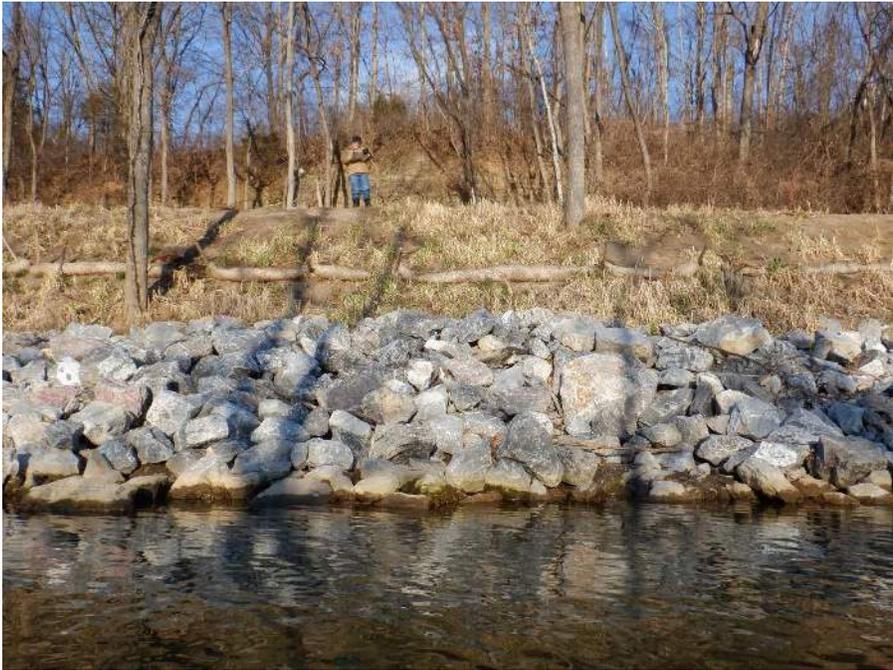
<p>Location: 00+300'</p> <hr/> <p>Photo Title: 12 Date: 1/19/2021</p> <hr/> <p>Direction Photo Taken: Northwest</p> <hr/> <p>Description: ~70 degree bank angle; installed rock toe intact; live stakes and plantings establishing; minimal vegetation cover; erosion control fabric 70% exposed; no at risk trees present; some sediment deposition in rock toe</p>

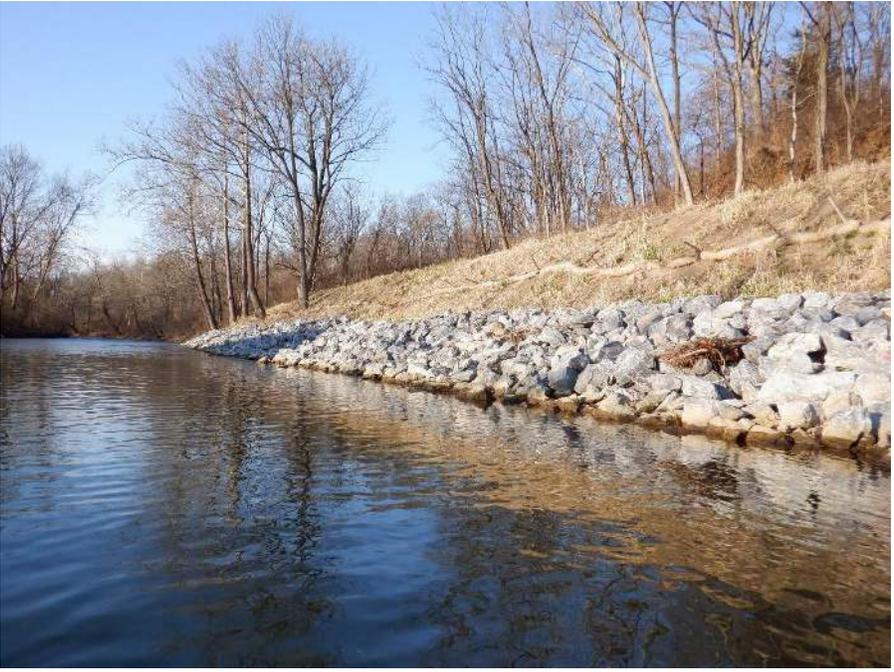
<p>Location: 00+300'</p> <hr/> <p>Photo Number: Date: 13 1/19/2021</p> <hr/> <p>Direction Photo Taken: West</p> <hr/> <p>Description: Upstream view of remediated bank; installed rock toe intact; minimal vegetation cover</p>

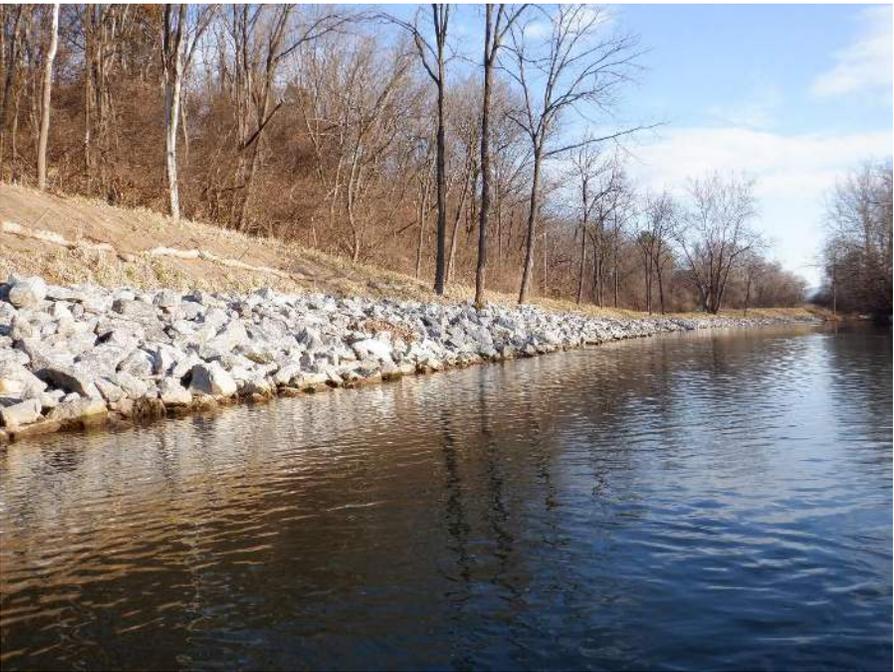
<p>Location: 00+300'</p> <hr/> <p>Photo Title: Date: 14 1/19/2021</p> <hr/> <p>Direction Photo Taken: North</p> <hr/> <p>Description: Downstream view of remediated bank; installed rock toe intact; minimal vegetation cover</p>

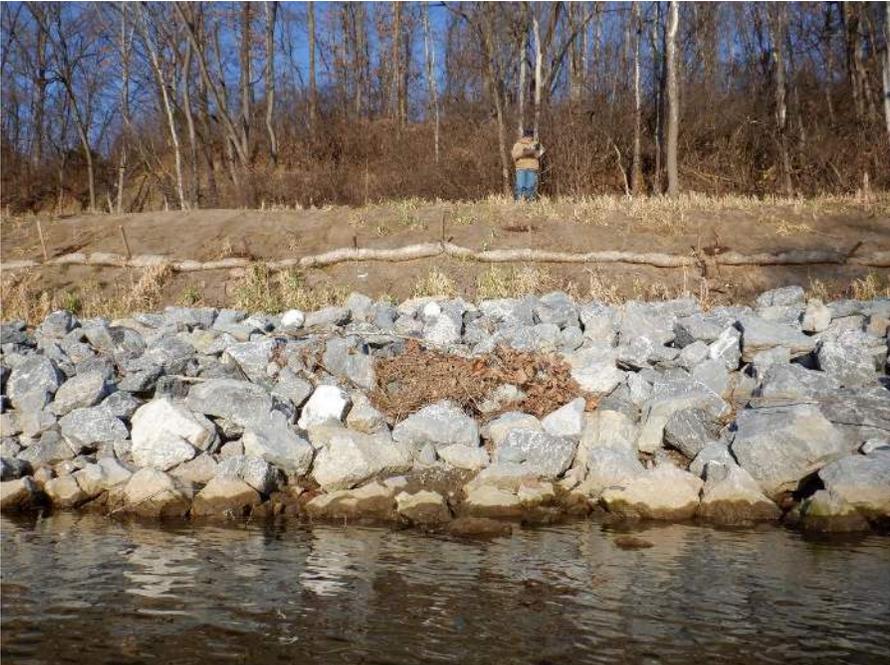
00 + 350	65	Y		15	N/A	no woody vegetation; live stakes and plantings present; vegetation 20% established	15	N	no at-risk trees present	15	Y (rock toe)	N	Y	erosion control fabric 80% exposed; no geocell exposed; coir log intact; straw wattle intact	15	N	Minimal sediment deposition	15	Initial Inspection after Remediation
00 + 400	40	Y		16	N/A	no woody vegetation; live stakes and plantings present; vegetation 20% established	16	N	trees near rock toe in good condition	16	Y (rock toe)	N	Y	erosion control fabric 80% exposed; no geocell exposed; coir log intact; straw wattle intact	16	N	Minimal sediment deposition	16	Initial Inspection after Remediation
00 + 450	40	Y		17	N/A	no woody vegetation; live stakes and plantings present; vegetation 20% established	17	N	no at-risk trees present	17	Y (rock toe)	N	Y	erosion control fabric 80% exposed; no geocell exposed; coir log intact; straw wattle intact	17	N	Minimal sediment deposition	17	Initial Inspection after Remediation

<p>Location: 00+350'</p> <hr/> <p>Photo Number: Date: 15 1/19/2021</p> <hr/> <p>Direction Photo Taken: Northwest</p> <hr/> <p>Description: ~65 degree bank angle; installed rock toe intact; live stakes and plantings establishing; minimal vegetation cover; erosion control fabric 80% exposed; sediment deposition in rock toe</p>

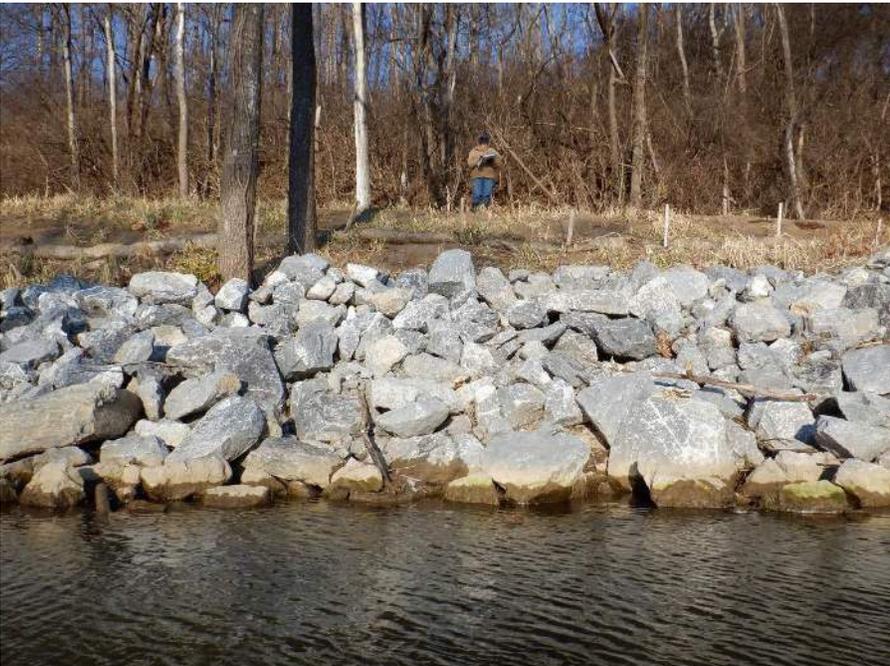
<p>Location: 00+400'</p> <hr/> <p>Photo Title: Date: 16 1/19/2021</p> <hr/> <p>Direction Photo Taken: Northwest</p> <hr/> <p>Description: ~40 degree bank angle; installed rock toe intact; live stakes and plantings establishing; minimal vegetation cover; erosion control fabric 80% exposed; no at risk trees present; some sediment deposition in rock toe</p>

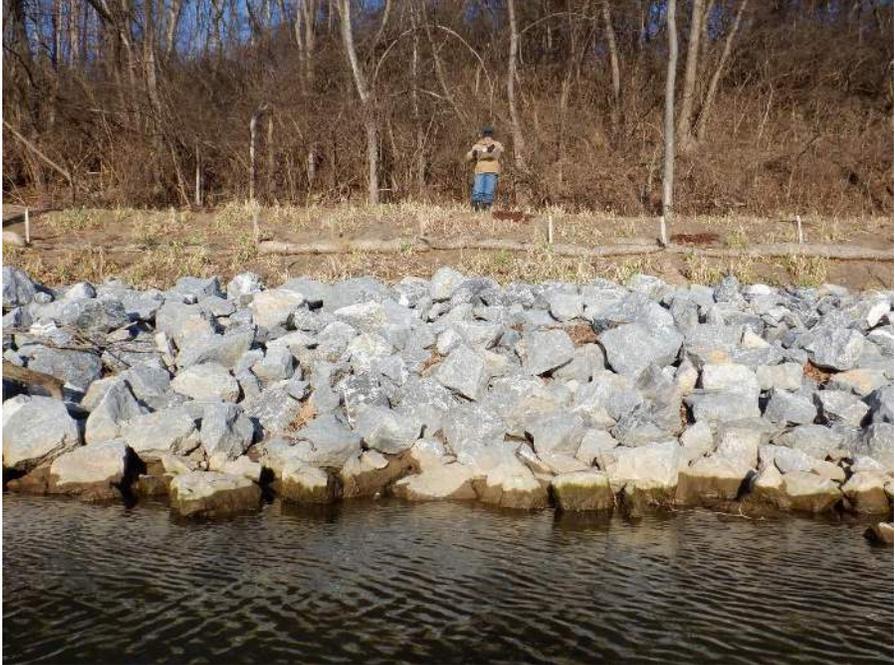
<p>Location: 00+450'</p> <hr/> <p>Photo Number: Date: 17 1/19/2021</p> <hr/> <p>Direction Photo Taken: Northwest</p> <hr/> <p>Description: ~40 degree bank angle; installed rock toe intact; live stakes and plantings establishing; minimal vegetation cover; erosion control fabric 80% exposed; some sediment deposition in rock toe</p>

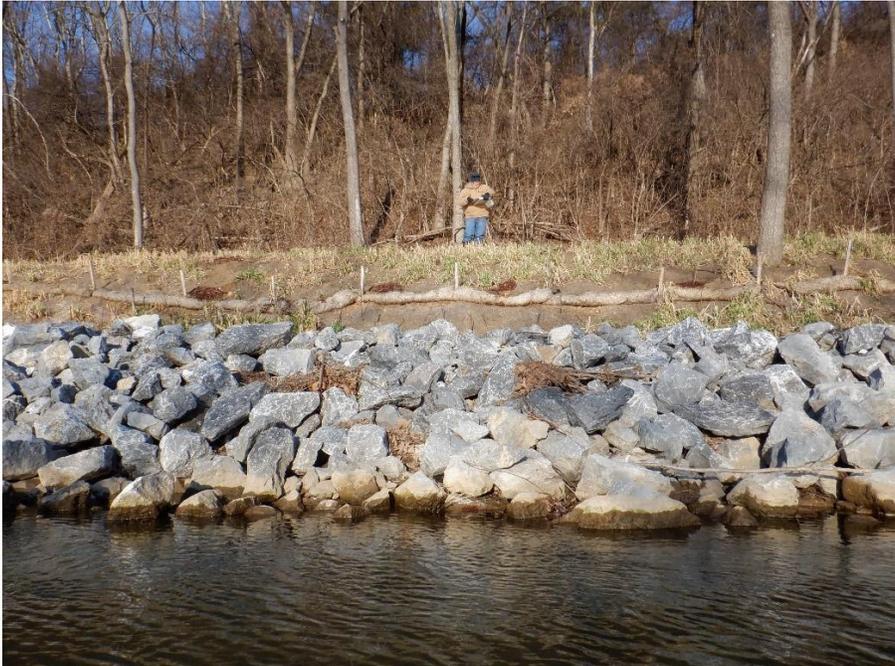
<p>Location: 00+500'</p> <hr/> <p>Photo Title: Date: 18 1/19/2021</p> <hr/> <p>Direction Photo Taken: Northwest</p> <hr/> <p>Description: ~50 degree bank angle; installed rock toe intact; live stakes and plantings establishing; minimal vegetation cover; erosion control fabric 70% exposed; no at risk trees present; no sediment deposition in rock toe</p>
