**Re: 2020 Leaf-on and 2020-2021 Leaf-off Maintenance Inspections
Former DuPont Waynesboro Site AOC 4
Waynesboro, Virginia
EPA ID# VAD003114832**

Subject 2020-2021 Phase 1 BMA Leaf-Off Maintenance Inspection
Former DuPont Waynesboro Site, Area of Concern 4

Date March 24, 2021

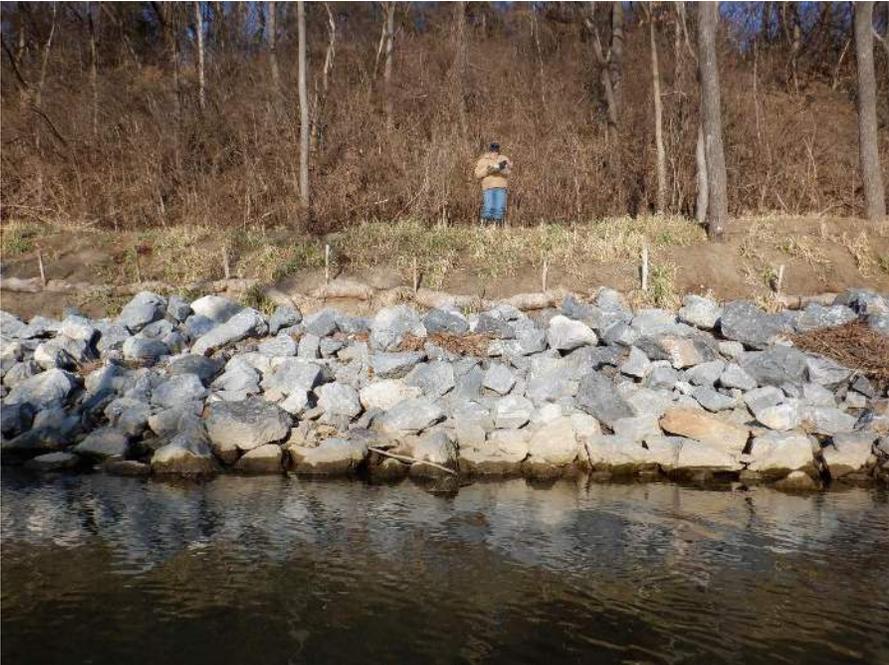
<p>Location: 00+550'</p> <hr/> <p>Photo Number: Date: 19 1/19/2021</p> <hr/> <p>Direction Photo Taken: Northwest</p> <hr/> <p>Description: ~50 degree bank angle; installed rock toe intact; live stakes and plantings establishing; minimal vegetation cover; erosion control fabric 70% exposed; no sediment deposition in rock toe</p>

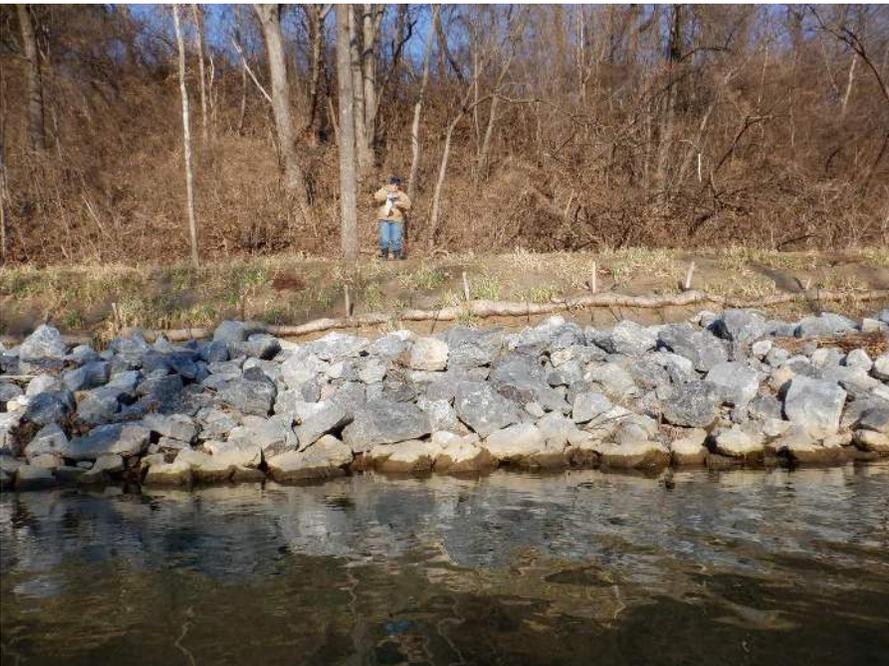
<p>Location: 00+600'</p> <hr/> <p>Photo Title: Date: 20 1/19/2021</p> <hr/> <p>Direction Photo Taken: Northwest</p> <hr/> <p>Description: ~60 degree bank angle; installed rock toe intact; live stakes and plantings establishing; minimal vegetation cover; erosion control fabric 80% exposed; no sediment deposition in rock toe</p>

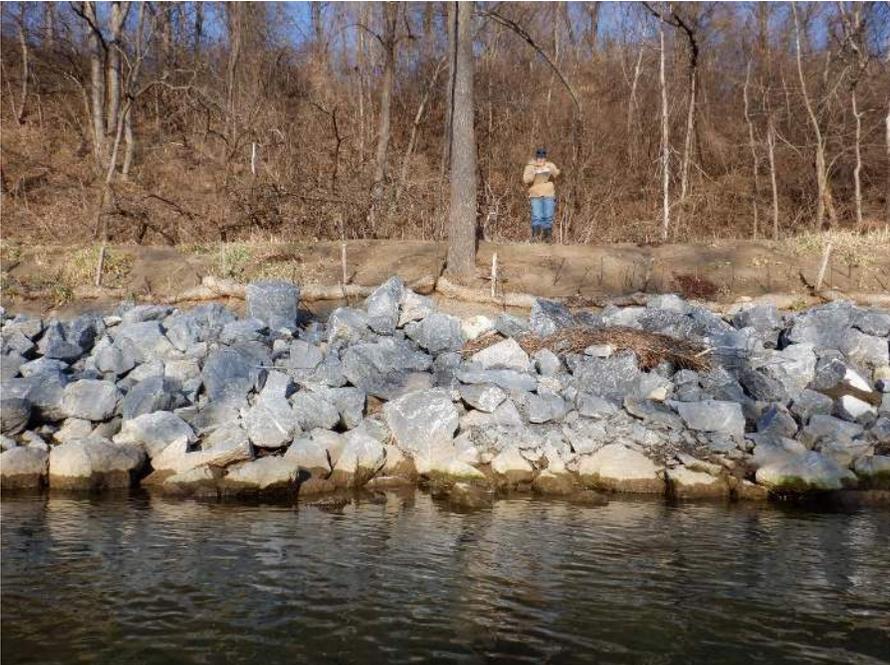
00 + 650	50	Y		21	N/A	live stakes and plantings present; vegetation 5% established	21	N	one tree above rock toe in good condition	21	Y (rock toe)	N	Y	erosion control fabric 95% exposed; no geocell exposed; coir log intact; straw wattle intact	21	N	No sediment deposition	21	Initial Inspection after Remediation
00 + 700	50	Y		22,23,24	N/A	live stakes and plantings present; vegetation 10% established	22,23,24	N	one tree near GW has damaged bark	22,23,24	Y (rock toe)	N	Y	erosion control fabric 90% exposed; no geocell exposed; coir log intact; straw wattle intact	22,23,24	N	No sediment deposition	22,23,24	Initial Inspection after Remediation
00 + 750	40	Y		25	N/A	live stakes and plantings present; vegetation 10% established	25	N	no at-risk trees present	25	Y (rock toe)	N	Y	erosion control fabric 90% exposed; no geocell exposed; coir log intact; straw wattle intact	25	N	No sediment deposition	25	Initial Inspection after Remediation

<p>Location: 00+650</p> <hr/> <p>Photo Number: 21 Date: 1/19/2021</p> <hr/> <p>Direction Photo Taken: Northwest</p> <hr/> <p>Description: ~50 degree bank angle; installed rock toe intact; live stakes and plantings establishing; minimal vegetation cover; erosion control fabric 95% exposed; no at risk trees present; no sediment deposition in rock toe</p>

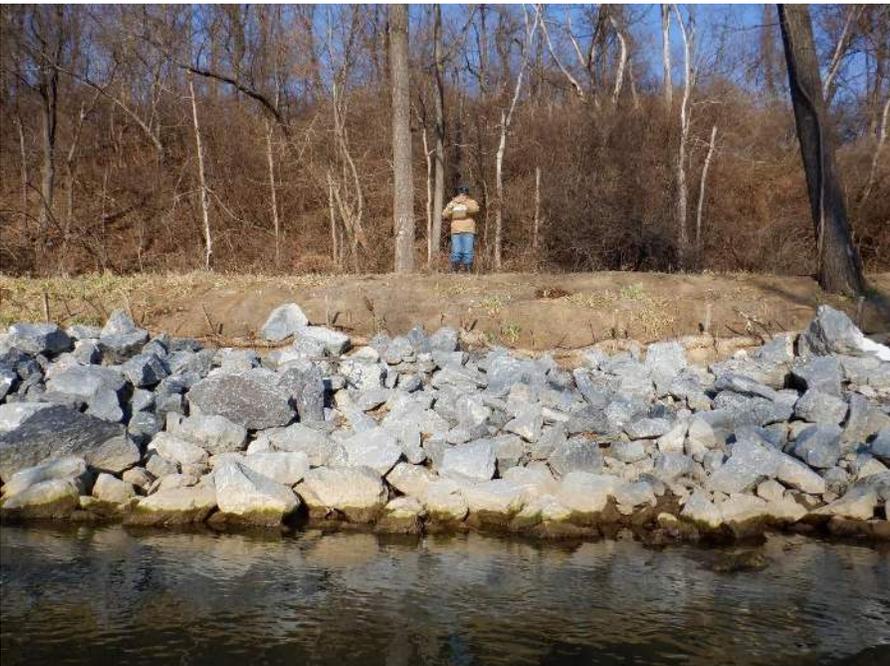
<p>Location: 00+700</p> <hr/> <p>Photo Title: 22 Date: 1/19/2021</p> <hr/> <p>Direction Photo Taken: Northwest</p> <hr/> <p>Description: ~50 degree bank angle; installed rock toe intact; live stakes and plantings establishing; minimal vegetation cover; erosion control fabric 90% exposed; no at risk trees present; no sediment deposition in rock toe</p>

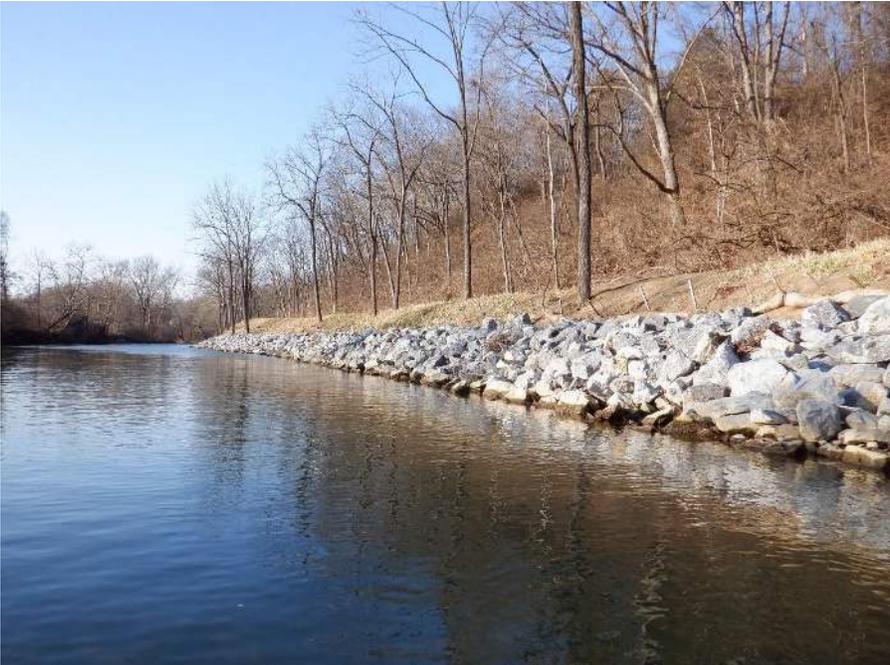
<p>Location: 00+700'</p> <hr/> <p>Photo Number: 23 Date: 1/19/2021</p> <hr/> <p>Direction Photo Taken: West</p> <hr/> <p>Description: Upstream view of 1st section of remediated bank; installed rock toe intact; minimal vegetation cover</p>

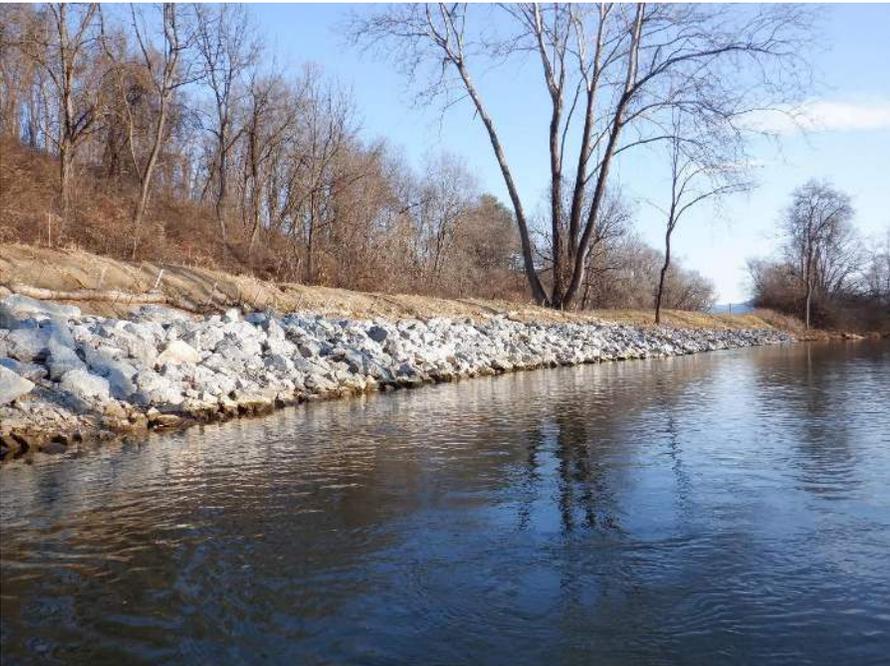
<p>Location: 00+700'</p> <hr/> <p>Photo Title: 24 Date: 1/19/2021</p> <hr/> <p>Direction Photo Taken: North</p> <hr/> <p>Description: Downstream view of 1st remediated bank section; installed rock toe intact; minimal vegetation cover</p>

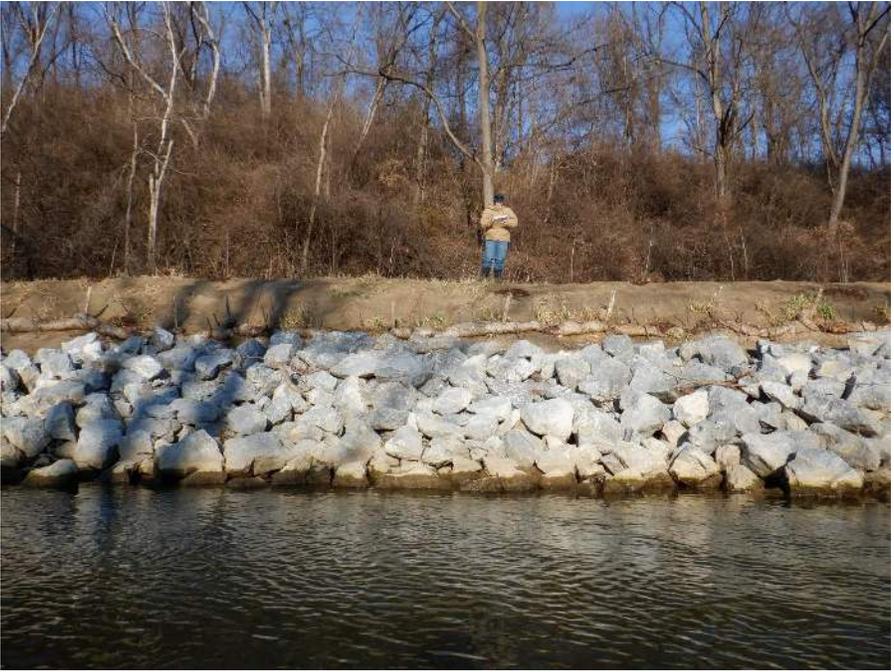
<p>Location: 00+750'</p> <hr/> <p>Photo Number: 25 Date: 1/19/2021</p> <hr/> <p>Direction Photo Taken: Northwest</p> <hr/> <p>Description: ~40 degree bank angle; installed rock toe intact; live stakes and plantings establishing; minimal vegetation cover; erosion control fabric 90% exposed; no sediment deposition in rock toe</p>

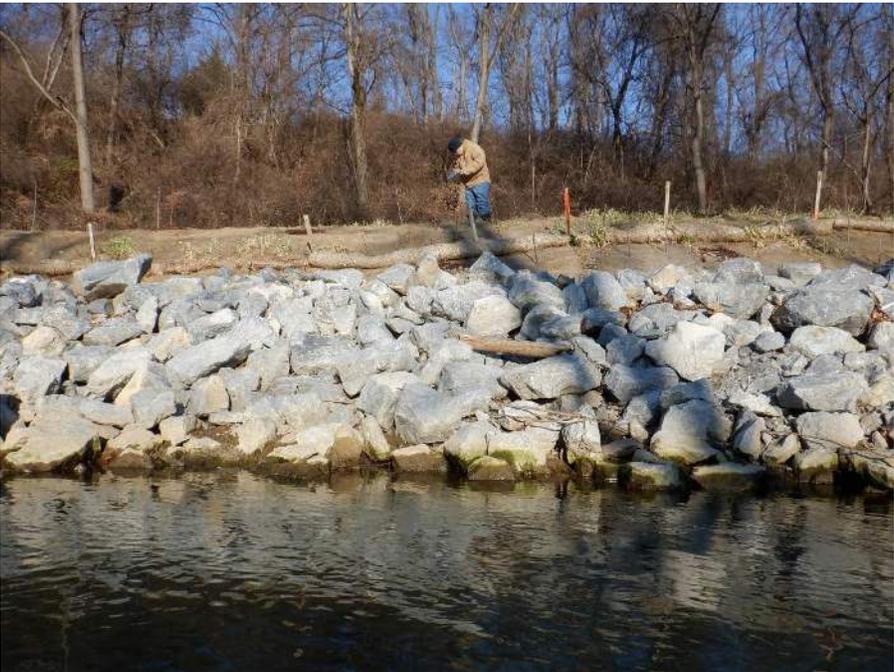
00 + 800	50	Y		26	N/A	live stakes and plantings present; vegetation 10% established	26	N	no at-risk trees present	26	Y (rock toe)	N	Y	erosion control fabric 90% exposed; no geocell exposed; coir log intact; straw wattle intact	26	N	Minimal sediment deposition	26	Initial Inspection after Remediation
00 + 850	20	Y		27	N/A	live stakes and plantings present; vegetation 25% established	27	N	group of 3 trees near top of bank in good condition	27	Y (rock toe)	N	Y	erosion control fabric 75% exposed; no geocell exposed; coir log intact; straw wattle intact	27	N	Minimal sediment deposition	27	Initial Inspection after Remediation
00 + 900	20	Y		28	N/A	live stakes and plantings present; vegetation 25% established	28	N	no at-risk trees present	28	Y (rock toe)	N	Y	erosion control fabric 75% exposed; no geocell exposed; coir log intact; straw wattle intact	28	N	No sediment deposition	28	Initial Inspection after Remediation

<p>Location: 00+800'</p> <hr/> <p>Photo Title: 26 Date: 1/19/2021</p> <hr/> <p>Direction Photo Taken: Northwest</p> <hr/> <p>Description: ~50 degree bank angle; installed rock toe intact; live stakes and plantings establishing; minimal vegetation cover; erosion control fabric 90% exposed; some sediment deposition in rock toe</p>

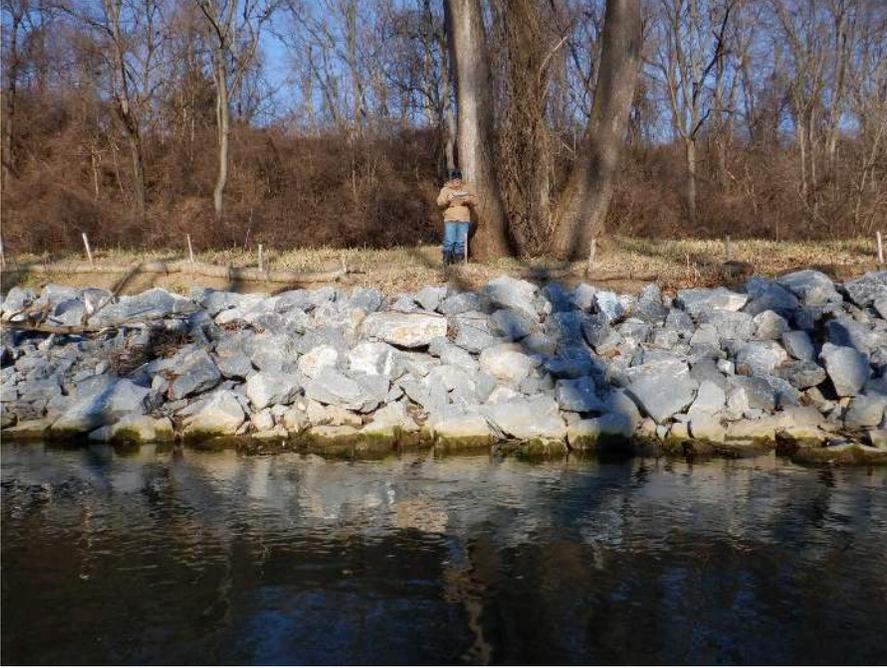
<p>Location: 00+850'</p> <hr/> <p>Photo Number: 27 Date: 1/19/2021</p> <hr/> <p>Direction Photo Taken: Northwest</p> <hr/> <p>Description: ~20 degree bank angle; installed rock toe intact; live stakes and plantings establishing; minimal vegetation cover; erosion control fabric 75% exposed; no at risk trees present; some sediment deposition in rock toe</p>

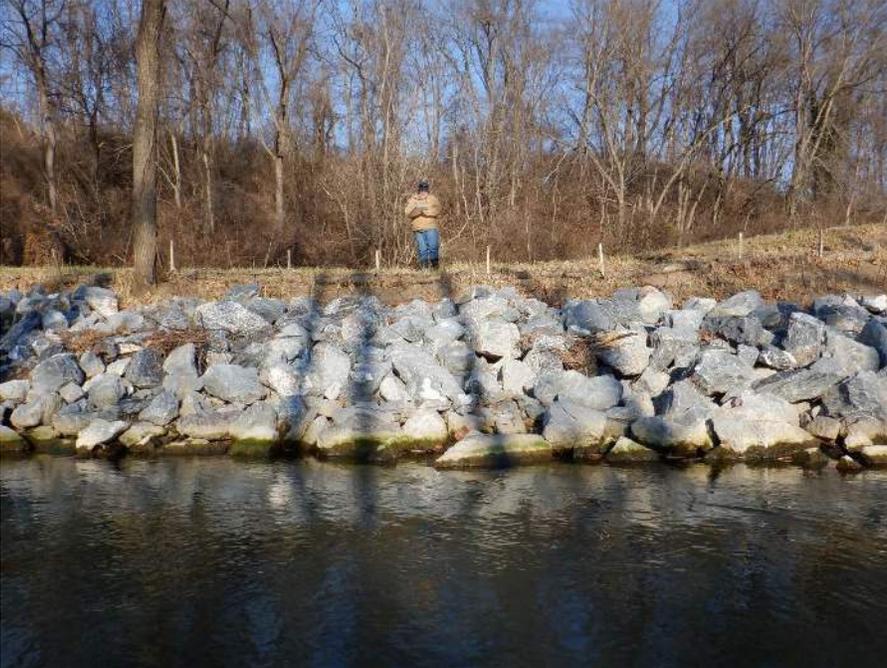
<p>Location: 00+900'</p> <hr/> <p>Photo Title: 28 Date: 1/19/2021</p> <hr/> <p>Direction Photo Taken: Northwest</p> <hr/> <p>Description: ~20 degree bank angle; installed rock toe intact; live stakes and plantings establishing; minimal vegetation cover; erosion control fabric 75% exposed; no at risk trees present; no sediment deposition in rock toe</p>

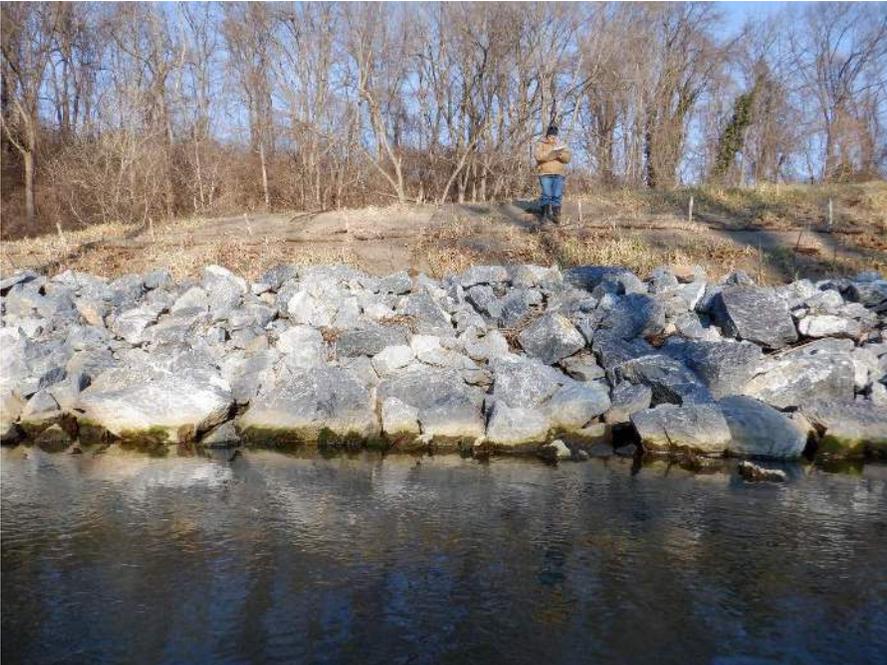
<p>Location: 00+950'</p>

<p>Photo Number: 29 Date: 1/19/2021</p>	
<p>Direction Photo Taken: Northwest</p>	
<p>Description: ~30 degree bank angle; installed rock toe intact; live stakes and plantings establishing; minimal vegetation cover; erosion control fabric 75% exposed; no at risk trees present; no sediment deposition in rock toe</p>

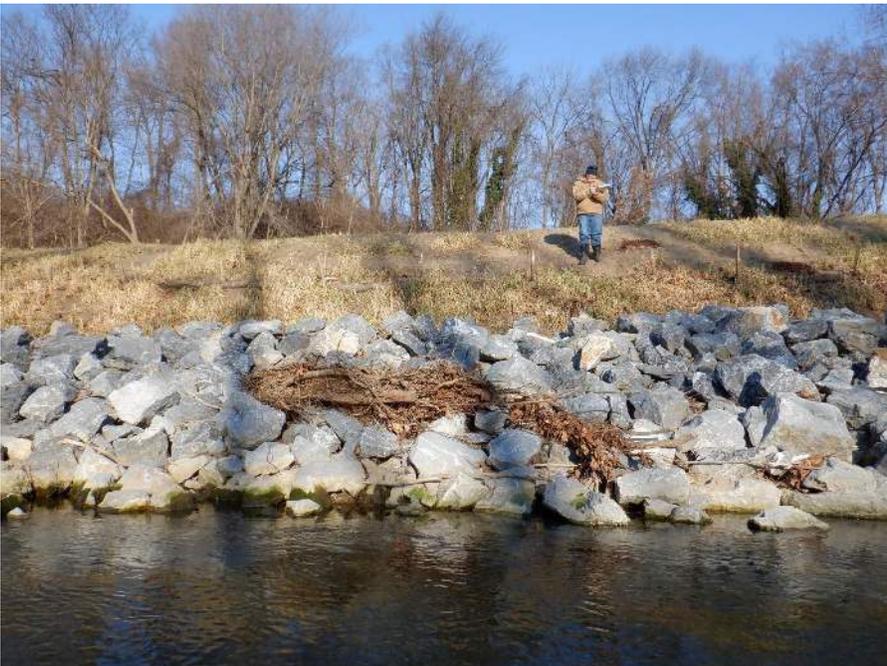
<p>Location: 00+1000'</p>

<p>Photo Title: 30 Date: 1/19/2021</p>	
<p>Direction Photo Taken: Northwest</p>	
<p>Description: ~30 degree bank angle; installed rock toe intact; live stakes and plantings establishing; minimal vegetation cover; erosion control fabric 75% exposed; no at risk trees present; no sediment deposition in rock toe</p>

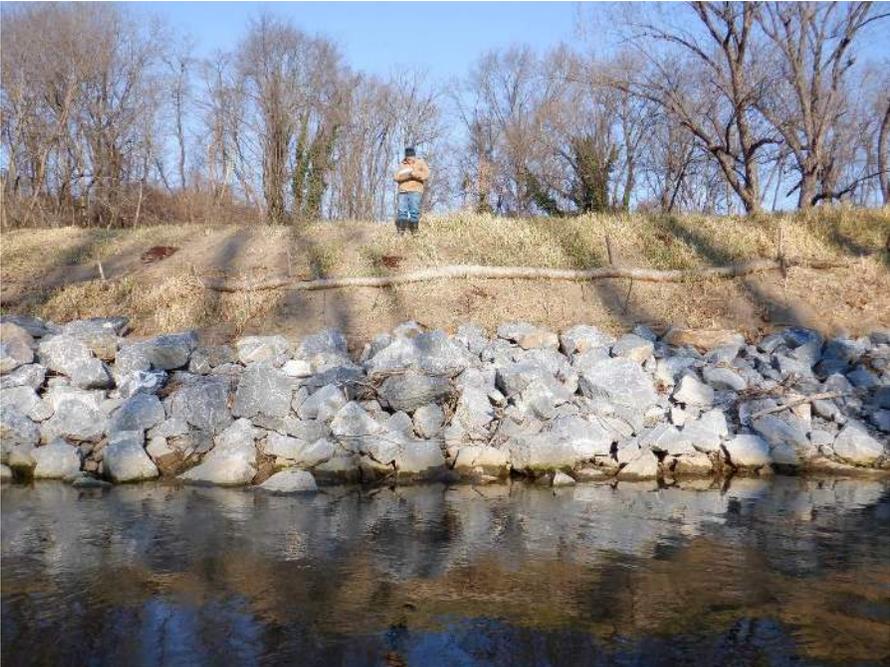
<p>Location: 00+1050'</p> <hr/> <p>Photo Number: Date: 31 1/19/2021</p> <hr/> <p>Direction Photo Taken: Northwest</p> <hr/> <p>Description: Immediately upstream of end of 1st section of remediated bank; ~45 degree bank angle; installed rock toe intact; live stakes and plantings establishing; minimal vegetation cover; erosion control fabric 75% exposed; no at risk trees present; no sediment de</p>

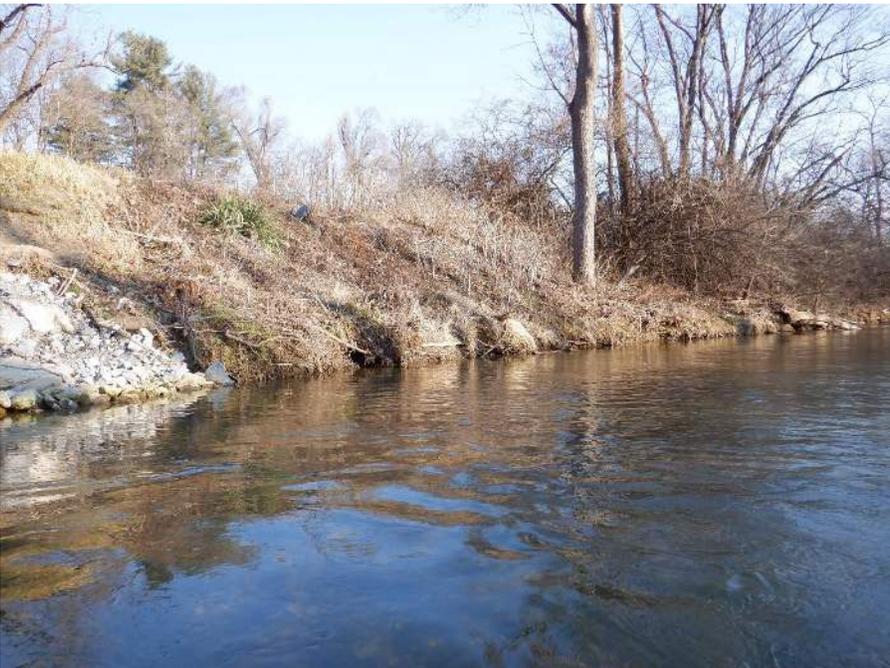
<p>Location: 00+1050'</p> <hr/> <p>Photo Title: Date: 32 1/19/2021</p> <hr/> <p>Direction Photo Taken: North</p> <hr/> <p>Description: Downstream view of end of 1st section of remediation; minimal erosion and scour after remediation</p>

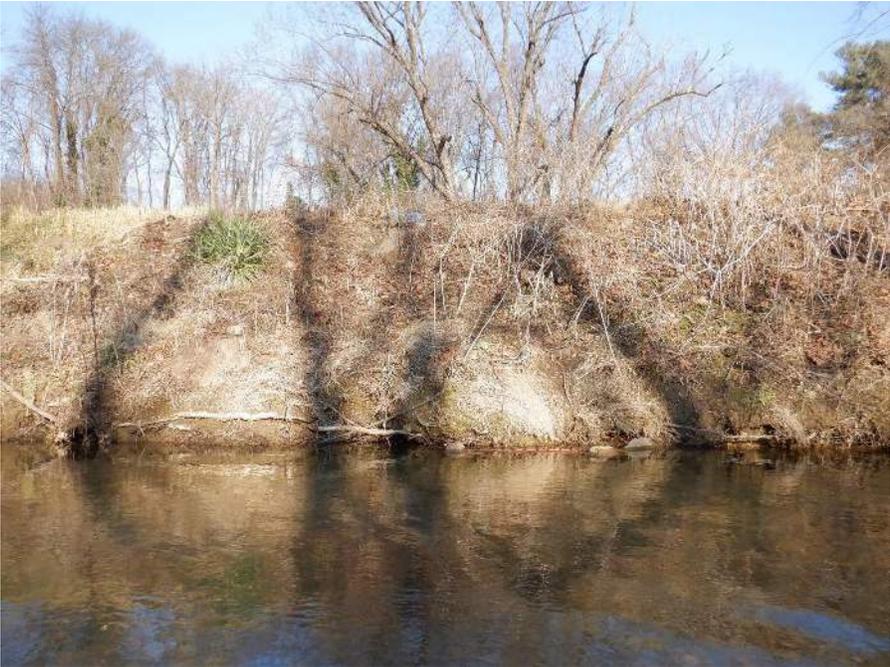
<p>Location: 00+1100'</p> <hr/> <p>Photo Number: Date: 33 1/19/2021</p> <hr/> <p>Direction Photo Taken: Northwest</p> <hr/> <p>Description: ~45 degree bank angle; some vegetation adjacent to waters edge; exposed roots along toe of bank; minimal undercutting at toe of bank; 50% vegetation cover; some shrubs mid to upper bank</p>

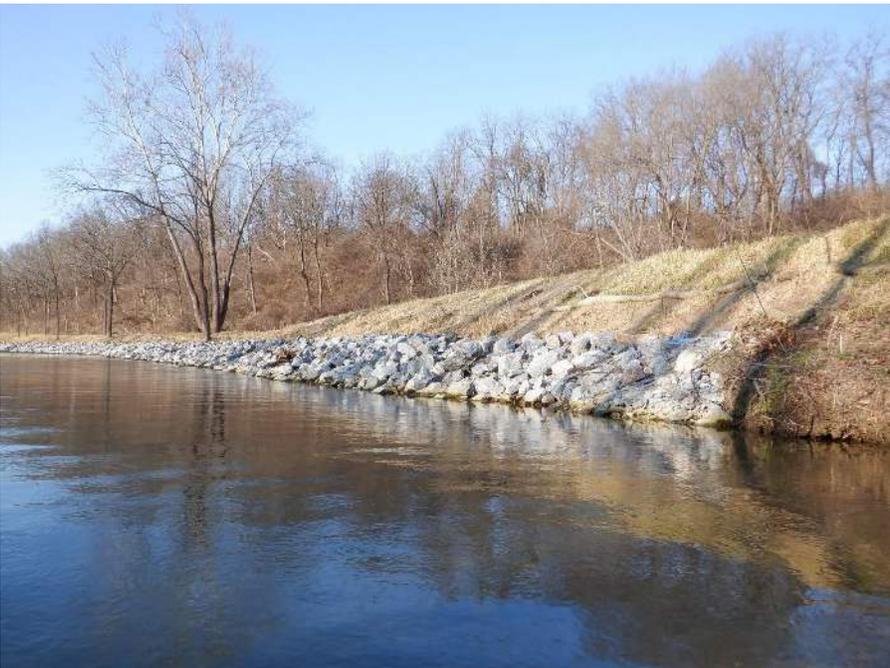
<p>Location: 00+1100'</p> <hr/> <p>Photo Title: Date: 34 1/19/2021</p> <hr/> <p>Direction Photo Taken: West</p> <hr/> <p>Description: Upstream view of end of 1st section of remediation; installed rock toe intact; minimal vegetation cover</p>

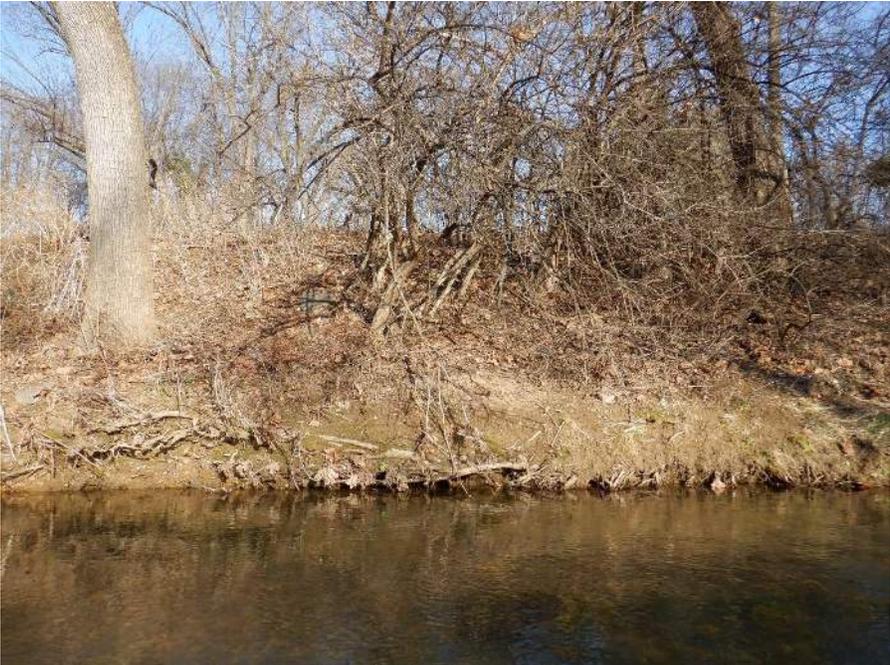
00 + 1150	45	Y		35	M	grass adjacent to water's edge; shrubs mid and upper bank	35	N	one tree mid bank in good condition	35	N/A	N/A	N/A	minimal undercutting at toe of bank	35	N	no scour	35	Initial Inspection after Remediation
00 + 1200	45	Y		36	M	sparse grasses at toe; shrubs on upper bank	36	N	3 trees mid bank in good condition	36	N/A	N/A	N/A	minimal undercutting at toe of bank; LWD present	36	N	no scour	36	Initial Inspection after Remediation
00 + 1250	55	N	Lower bank ~70 degrees Upper bank ~45 degrees	37,38	L	no vegetation at toe; woody vegetation on mid and upper bank	37,38	N	one tree mid bank in good condition	37,38	N/A	N/A	N/A	wooden steps present from top of bank to mid bank then a mostly vertical drop from scour and erosion at the base of steps	37,38	Y	Scour present at base of wooden steps	37,38	Initial Inspection after Remediation
00 + 1300	45	Y		39	M	no vegetation at toe; woody vegetation on mid and upper bank; exposed roots on one tree at toe	39	Y	1 tree at toe and 1 at mid bank; tree mid bank appears to be dead	39	N/A	N/A	N/A	undercutting mostly at tree at toe of bank	39	Y	some scour at exposed roots at toe of bank	39	Initial Inspection after Remediation

<p>Location: 00+1150'</p> <hr/> <p>Photo Number: Date: 35 1/19/2021</p> <hr/> <p>Direction Photo Taken: Northwest</p> <hr/> <p>Description: ~45 degree bank angle; some vegetation adjacent to waters edge; exposed roots along toe of bank; undercutting at toe of bank; scour around exposed roots; 50% vegetation cover; shrubs mid to upper bank; no at risk trees present</p>

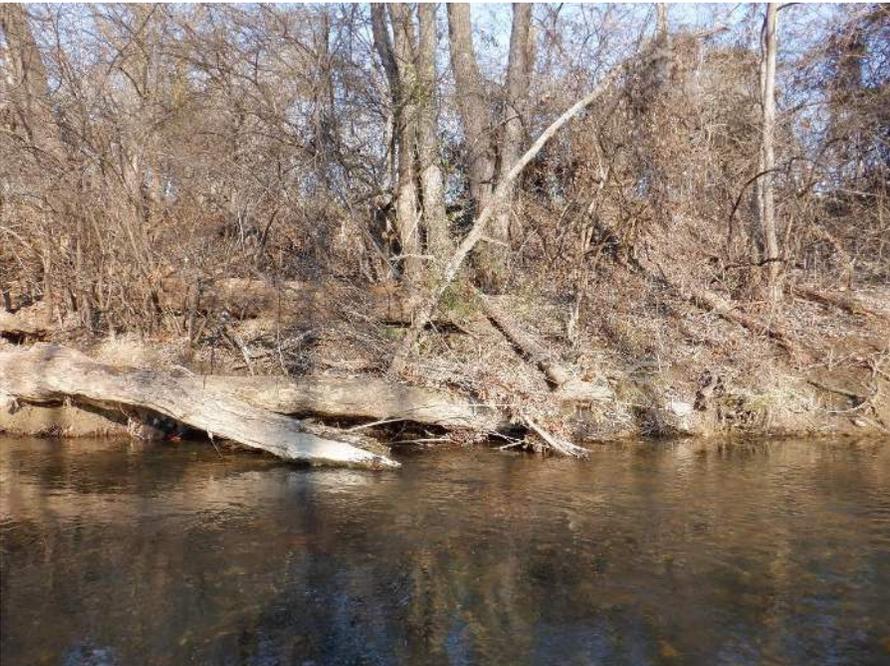
<p>Location: 00+1250'</p> <hr/> <p>Photo Number: Date: 37 1/19/2021</p> <hr/> <p>Direction Photo Taken: Northwest</p> <hr/> <p>Description: ~45 degrees upper bank and 70 degrees lower bank; no vegetation at toe; erosion and scour at bank toe; 20% vegetation cover; shrubs mid to upper bank; no at risk trees present; exposed roots mid bank; some undercutting at toe</p>

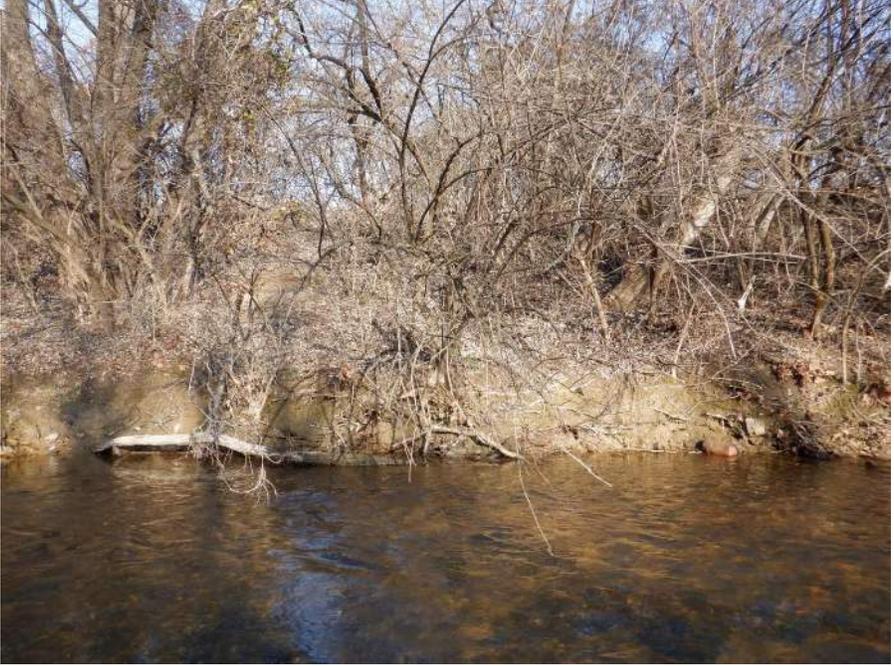
<p>Location: 00+1250'</p> <hr/> <p>Photo Title: Date: 38 1/19/2021</p> <hr/> <p>Direction Photo Taken: Northwest</p> <hr/> <p>Description: Significant erosion and scour and bank edge; most erosion and scour present by manmade pathway to waters edge; cinder blocks placed at erosive edge as steps; upper bank consists of constructed and tiered steps to get to water</p>

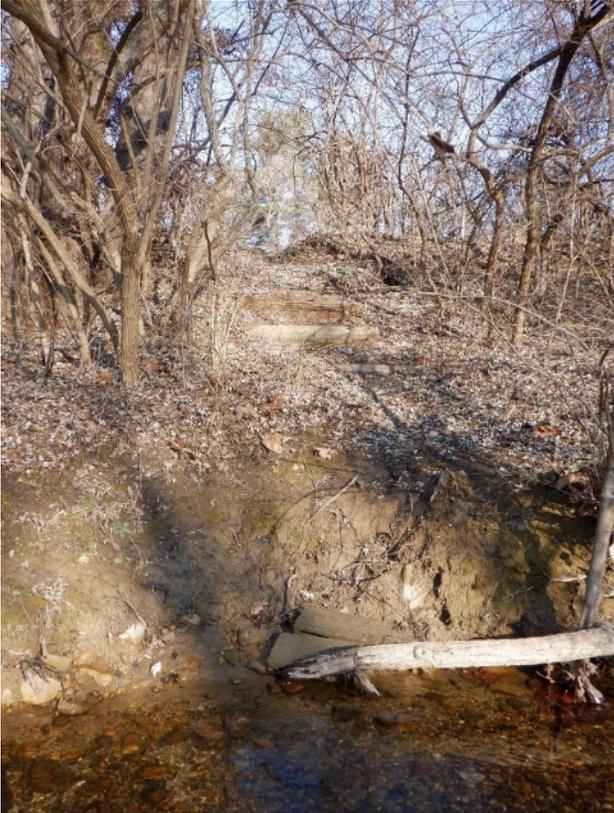
<p>Location: 00+1300'</p> <hr/> <p>Photo Number: 39 Date: 1/19/2021</p> <hr/> <p>Direction Photo Taken: Northwest</p> <hr/> <p>Description: ~45 degree bank angle; exposed roots at waters edge; scour and undercutting at toe of bank especially around exposed roots; several at risk trees present; 30% vegetation cover; no vegetation adjacent to waters edge; shrubs from mid to upper bank</p>

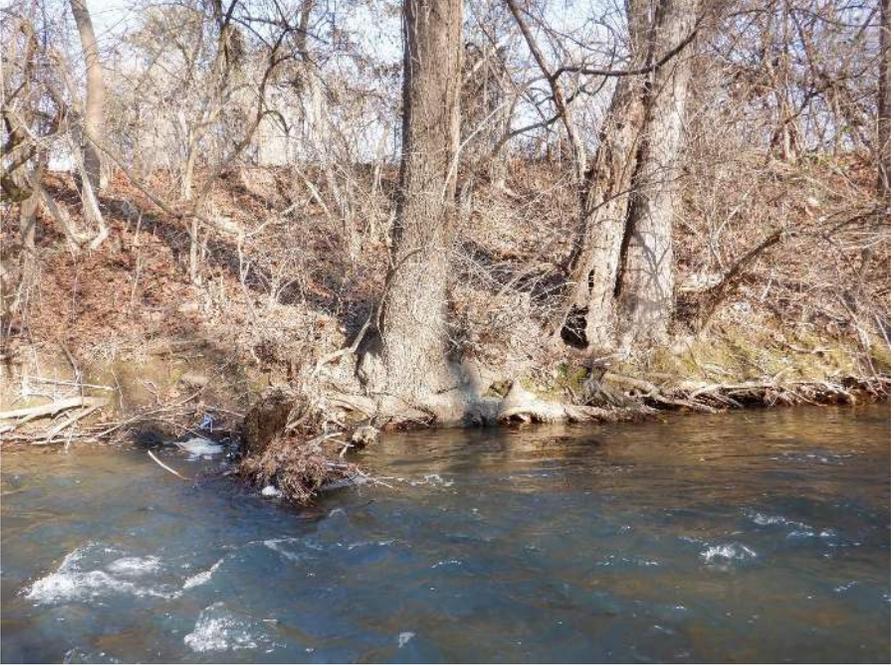
<p>Location: 00+1350'</p> <hr/> <p>Photo Title: 40 Date: 1/19/2021</p> <hr/> <p>Direction Photo Taken: Northwest</p> <hr/> <p>Description: ~45 degree bank angle; exposed roots at waters edge; scour and undercutting at toe of bank mostly around exposed roots; at risk trees present; 20% vegetation cover; minimal vegetation adjacent to waters edge; shrubs throughout bank</p>

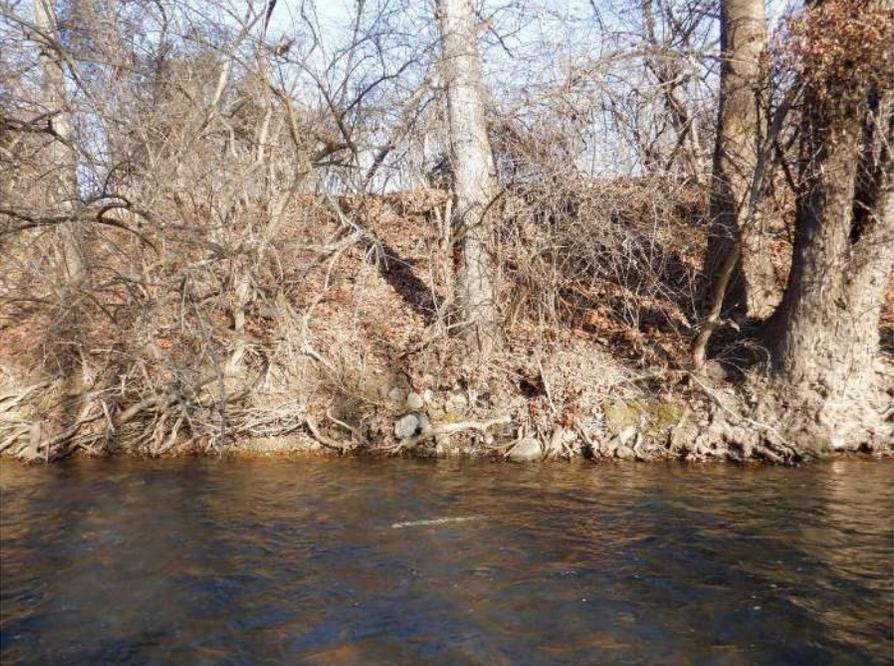
<p>Location: 00+1400'</p> <hr/> <p>Photo Number: Date: 41 1/19/2021</p> <hr/> <p>Direction Photo Taken: Northwest</p> <hr/> <p>Description: ~45 degree bank angle; exposed roots at bank toe; scour and undercutting at bank toe mostly around exposed roots; at risk trees present; 20% vegetation cover; shrubs mid to upper bank</p>

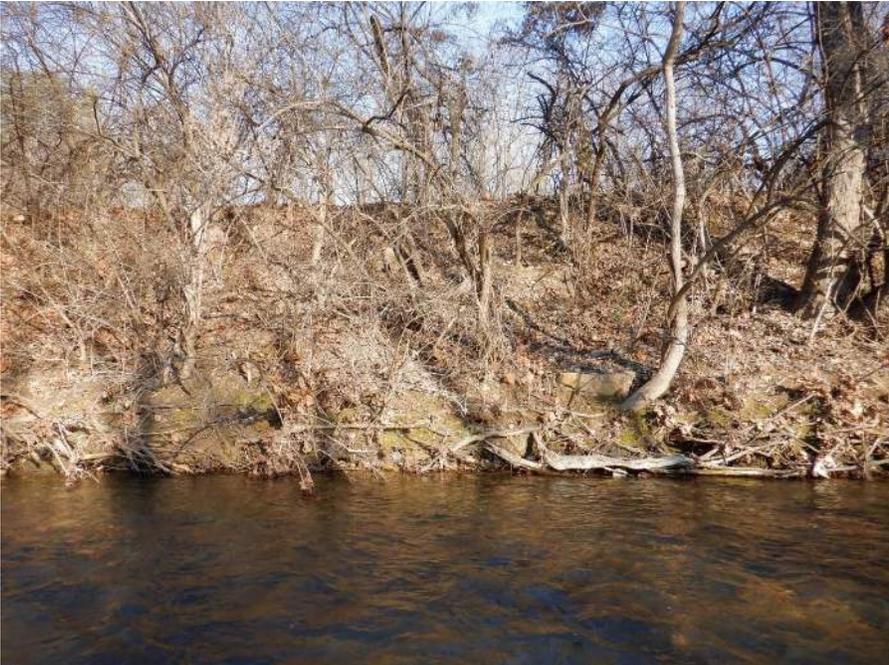
<p>Location: 00+1450'</p> <hr/> <p>Photo Title: Date: 42 1/19/2021</p> <hr/> <p>Direction Photo Taken: Northwest</p> <hr/> <p>Description: ~50 degree bank angle; exposed roots at bank toe; scour and undercutting around roots at bank toe; at risk trees present; 30% vegetation cover; shrubs established throughout bank</p>

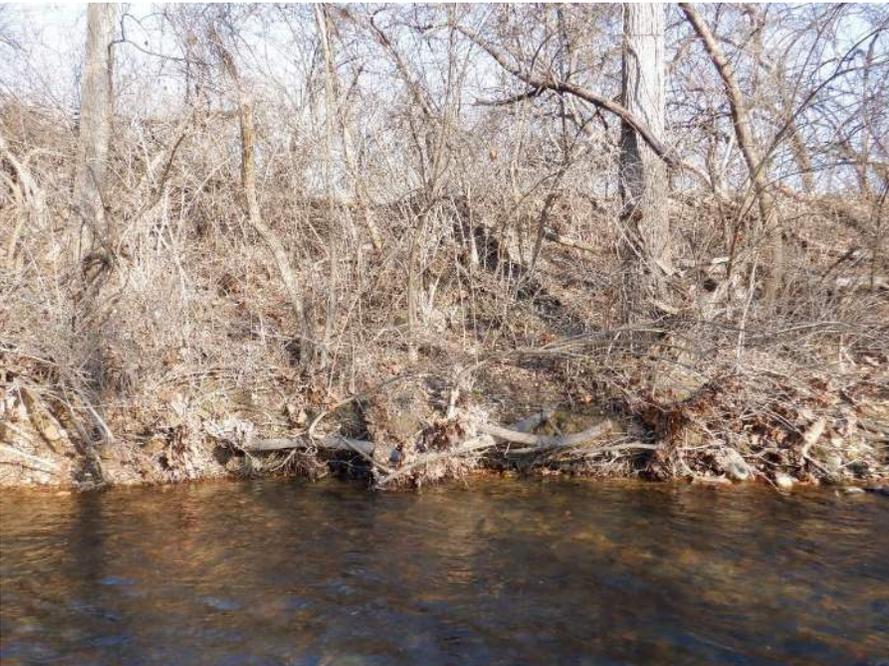
<p>Location: 00+1500'</p> <hr/> <p>Photo Number: Date: 43 1/19/2021</p> <hr/> <p>Direction Photo Taken: Northwest</p> <hr/> <p>Description: Immediately upstream of 2nd remediated bank section; ~60 degree bank angle; exposed roots at bank toe; some scour and undercutting around exposed roots; at risk tree present by waters edge; 20% vegetation cover; shrubs mid to upper bank</p>

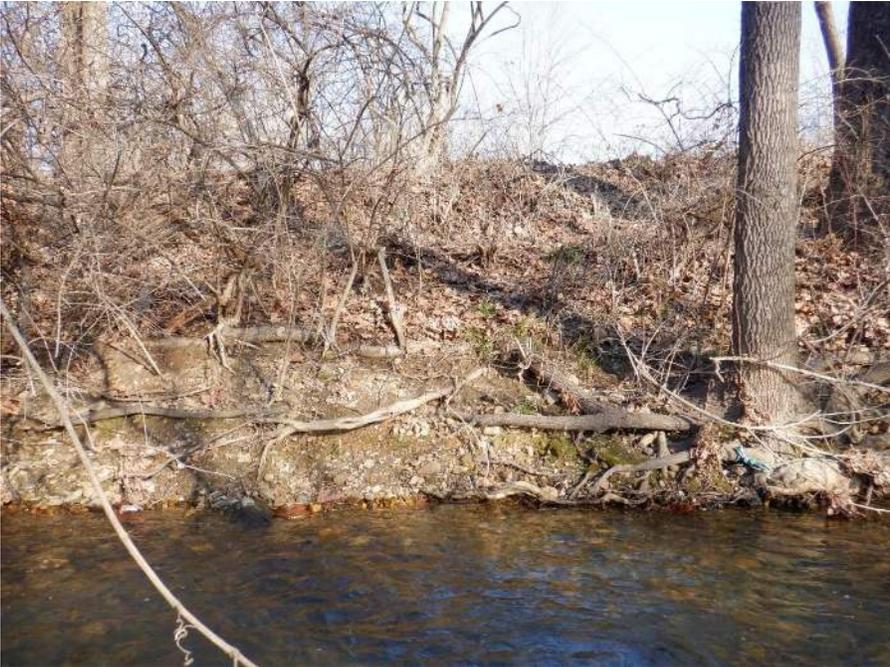
<p>Location: 00+1550'</p> <hr/> <p>Photo Title: Date: 44 1/19/2021</p> <hr/> <p>Direction Photo Taken: Northwest</p> <hr/> <p>Description: Start of 2nd remediated bank section; ~75 degree upper bank angle and 50 degree lower bank angle; undercutting and scour around exposed roots upstream of remediation; installed rock toe intact; minimal vegetation established in remediated section; erosion</p>

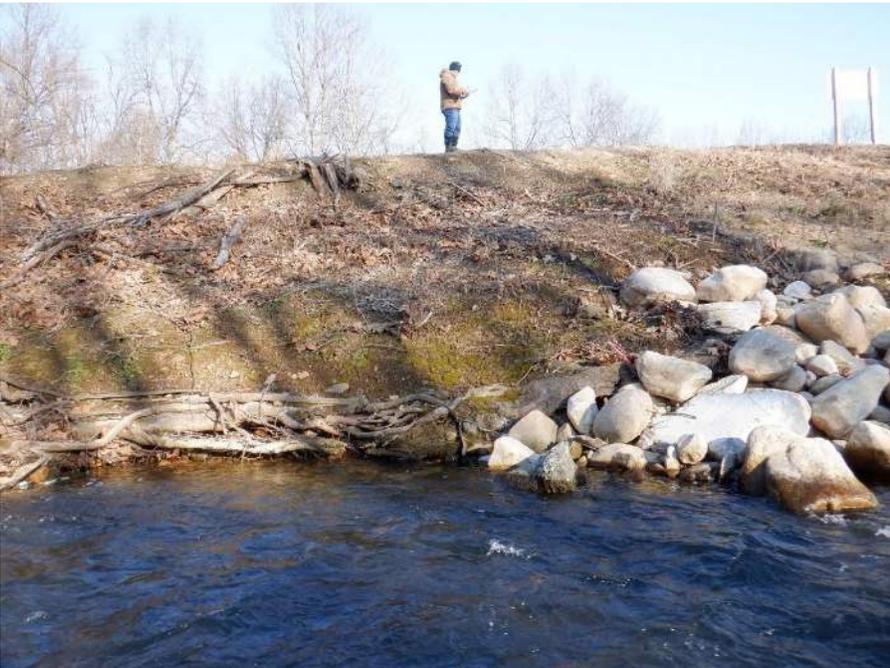
<p>Location: 00+1550'</p> <hr/> <p>Photo Number: Date: 45 1/19/2021</p> <hr/> <p>Direction Photo Taken: West</p> <hr/> <p>Description: Upstream view showing non-remediated section before 2nd remediated bank area; undercutting and scour around exposed roots by bank toe</p>

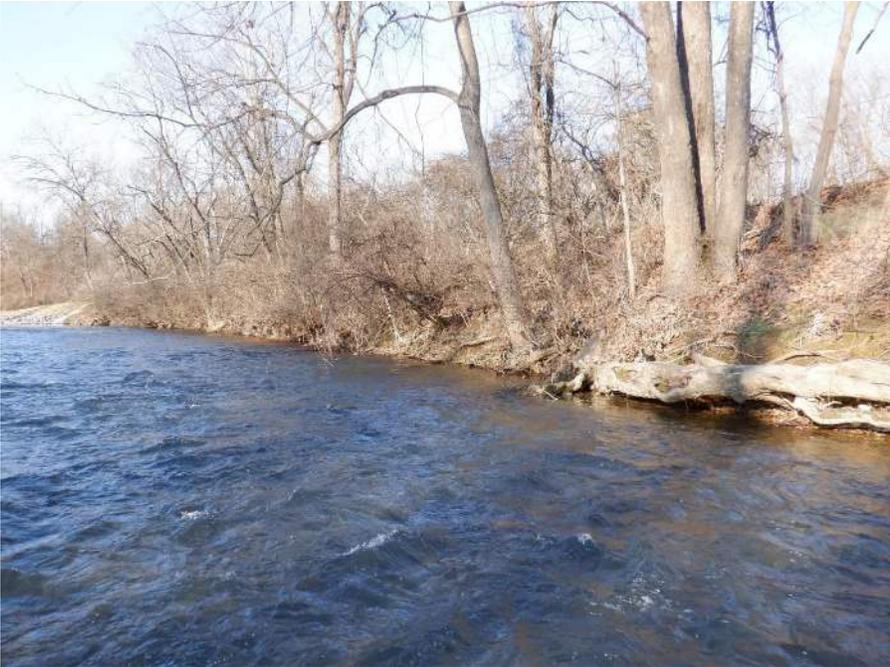
<p>Location: 00+1550'</p> <hr/> <p>Photo Title: Date: 46 1/19/2021</p> <hr/> <p>Direction Photo Taken: North</p> <hr/> <p>Description: Downstream view showing start of 2nd remediated bank section; installed rock toe intact; minimal vegetation cover</p>

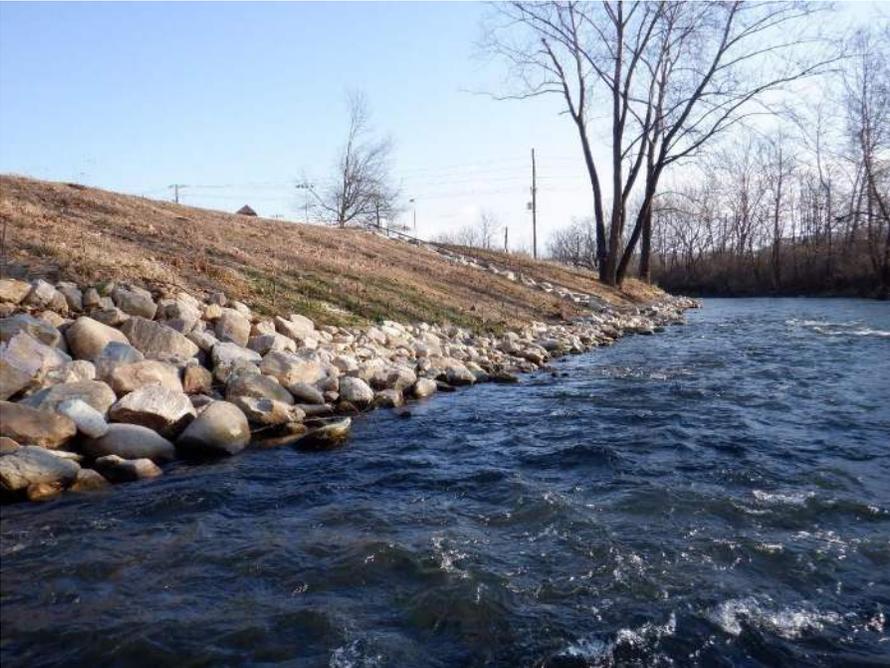
<p>Location: 00+1600'</p> <hr/> <p>Photo Number: 47 Date: 1/19/2021</p> <hr/> <p>Direction Photo Taken: Northwest</p> <hr/> <p>Description: ~50 degree bank angle; installed rock toe intact; installed live stakes and plantings establishing; vegetation establishing; erosion control fabric 30% exposed; no sediment deposition in rock toe</p>

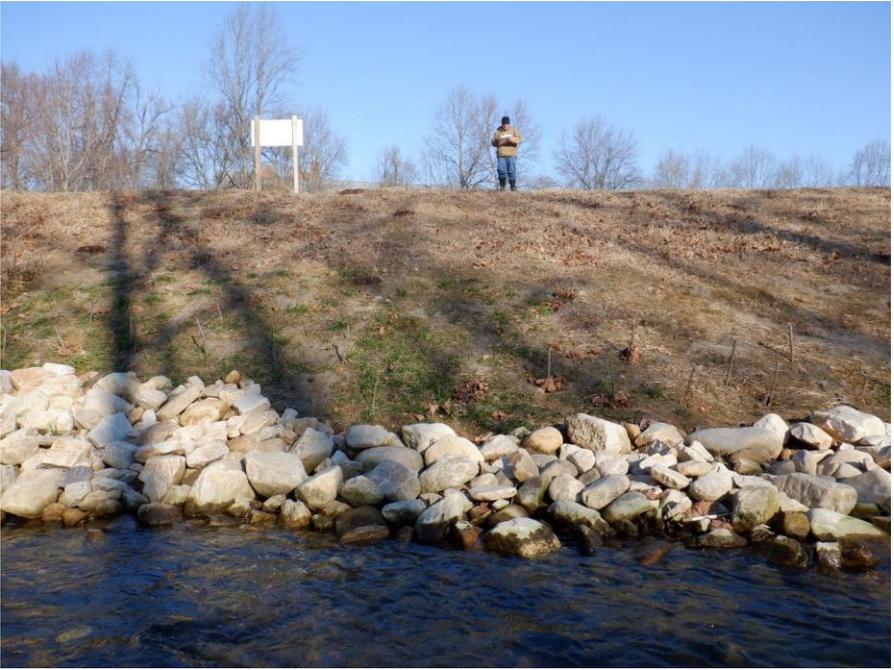
<p>Location: 00+1600'</p> <hr/> <p>Photo Title: 48 Date: 1/19/2021</p> <hr/> <p>Direction Photo Taken: West</p> <hr/> <p>Description: Upstream view of start of 2nd remediated bank section; installed rock toe intact; minimal vegetation cover</p>

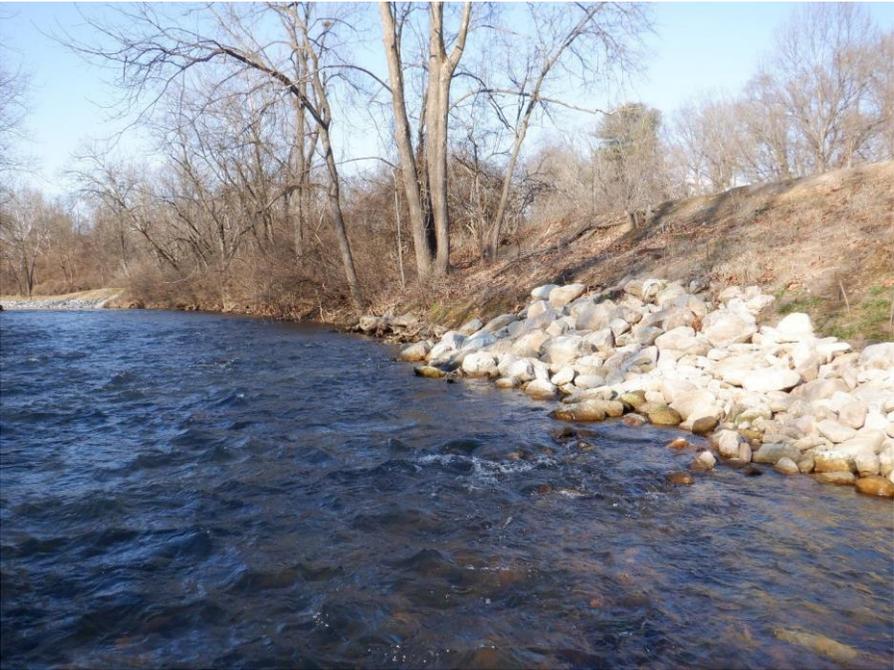
<p>Location: 00+1600'</p> <hr/> <p>Photo Number: Date: 49 1/19/2021</p> <hr/> <p>Direction Photo Taken: North</p> <hr/> <p>Description: Downstream view of 2nd remediated section showing constructed staircase and kayak launch; installed rock toe intact; minimal vegetation established</p>

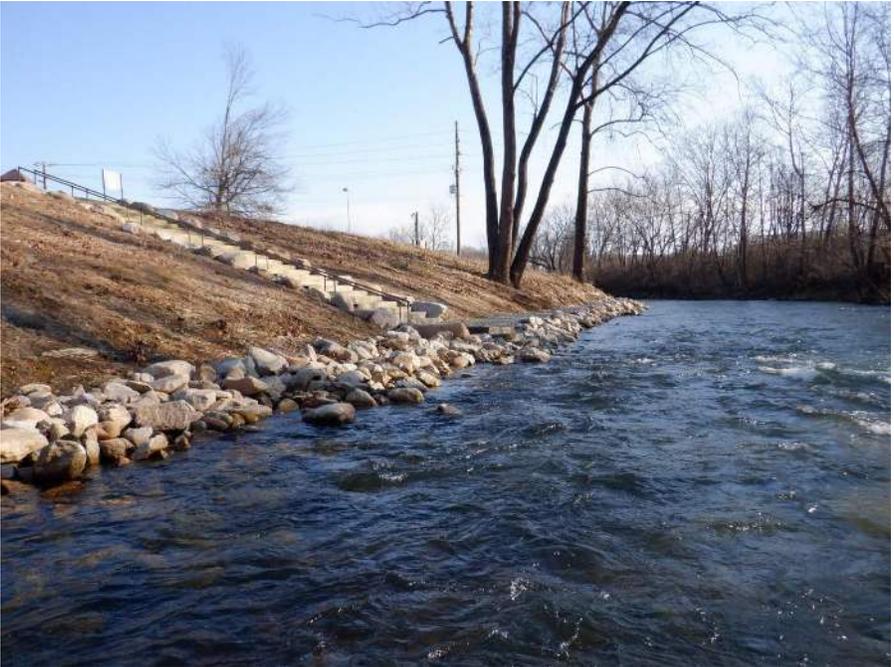
<p>Location: 00+1650'</p> <hr/> <p>Photo Title: Date: 50 1/19/2021</p> <hr/> <p>Direction Photo Taken: Northwest</p> <hr/> <p>Description: ~45 degree bank angle; constructed staircase and kayak launch intact; mild erosion of gravel around large stone slab steps at bottom of staircase; installed rock toe intact; erosion control fabric 30% exposed; no sediment deposition in rock toe; surface w</p>

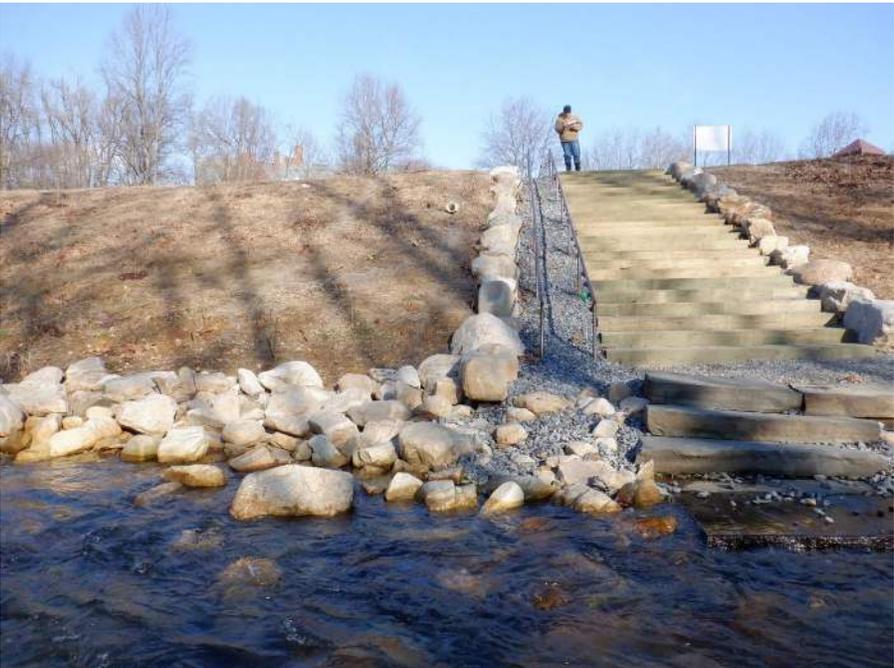
<p>Location: 00+1650'</p> <hr/> <p>Photo Number: 51 Date: 1/19/2021</p> <hr/> <p>Direction Photo Taken: North</p> <hr/> <p>Description: Downstream view of constructed walking path between upstream and downstream constructed staircases withing the 2nd remediated section; installed rock toe in path; walking path intact with some erosion of gravel and stonedust from high water events</p>
