**Re: 2020 Leaf-on and 2020-2021 Leaf-off Maintenance Inspections
Former DuPont Waynesboro Site AOC 4
Waynesboro, Virginia
EPA ID# VAD003114832**

Subject 2020-2021 Phase 1 BMA Leaf-Off Maintenance Inspection
Former DuPont Waynesboro Site, Area of Concern 4

Date March 24, 2021

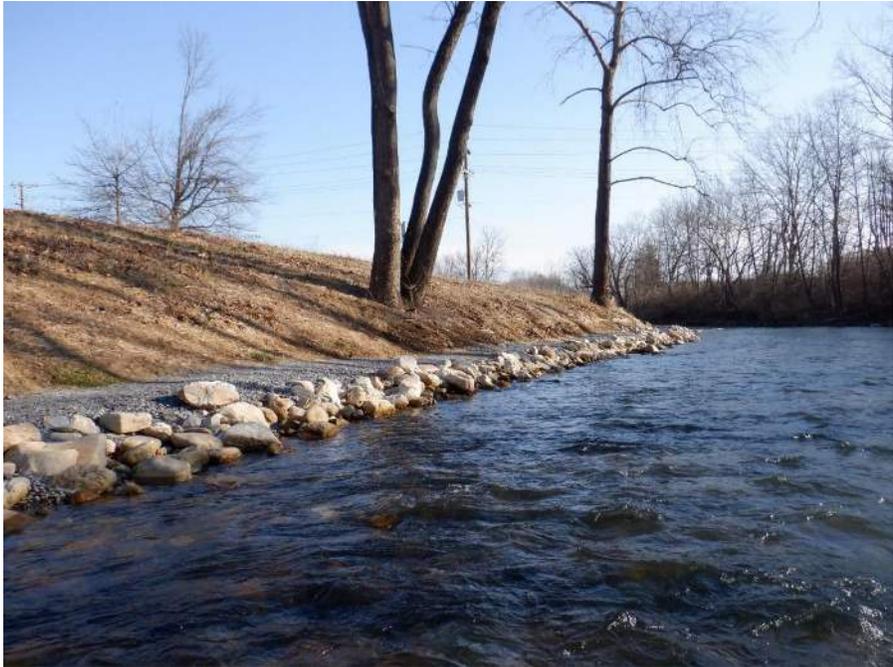
<p>Location: 00+1650'</p> <hr/> <p>Photo Title: 52 Date: 1/19/2021</p> <hr/> <p>Direction Photo Taken: Northeast</p> <hr/> <p>Description: Erosion of gravel behind large stone slab steps at the bottom of constructed staircase</p>

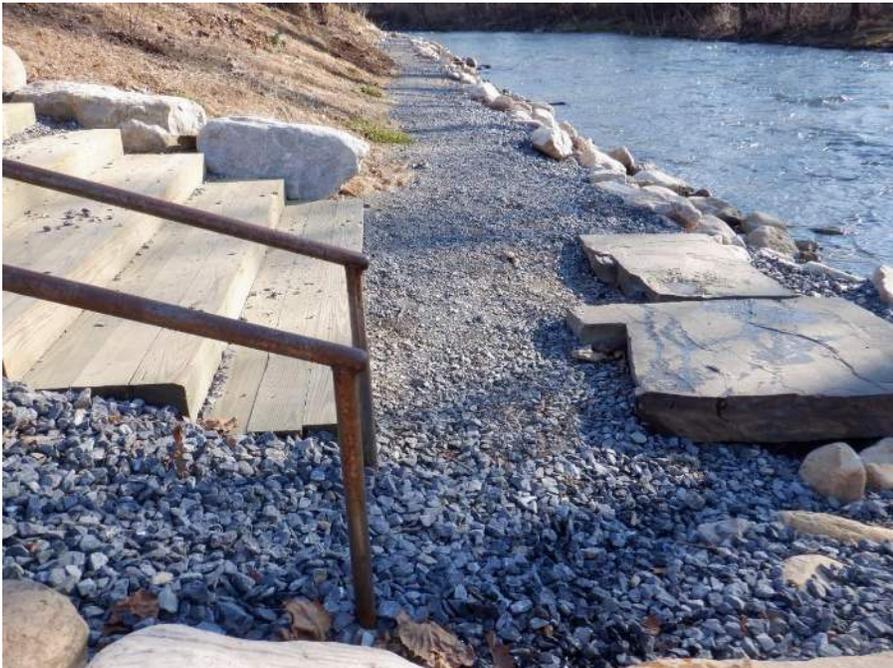
<p>Location: 00+1700'</p> <hr/> <p>Photo Number: Date: 53 1/19/2021</p> <hr/> <p>Direction Photo Taken: Northwest</p> <hr/> <p>Description: ~50 degree bank angle; installed rock toe intact; live stakes and plantings establishing; no at risk trees present; walking path above rock toe intact with minimal erosion of gravel from high water; vegetation establishing; erosion control fabric 50% expo</p>

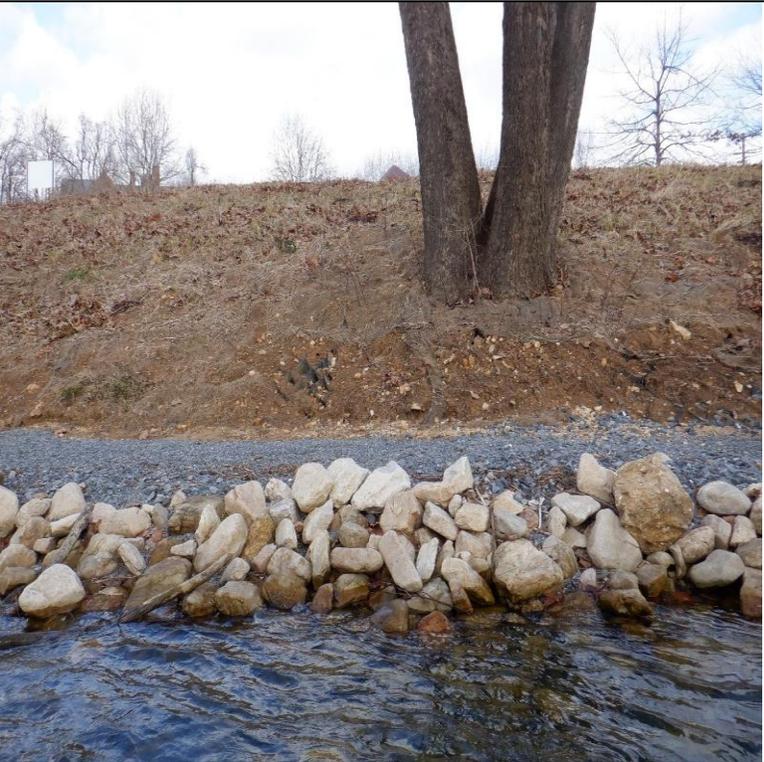
<p>Location: 00+1700'</p> <hr/> <p>Photo Title: Date: 54 1/19/2021</p> <hr/> <p>Direction Photo Taken: West</p> <hr/> <p>Description: Upstream view showing constructed 1st constructed staircase; installed rock toe intact; gravel access path intact; minimal vegetation cover</p>

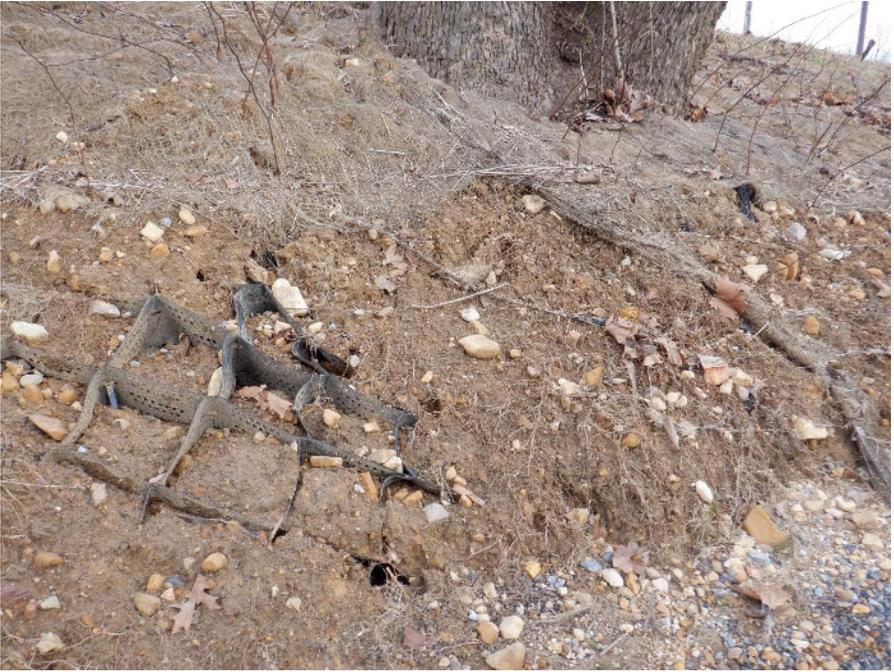
<p>Location: 00+1700'</p> <hr/> <p>Photo Title: Date: 56 1/19/2021</p> <hr/> <p>Direction Photo Taken: Southwest</p> <hr/> <p>Description: Upstream view of gravel access path between staircases and exposed geocell directly above access path</p>

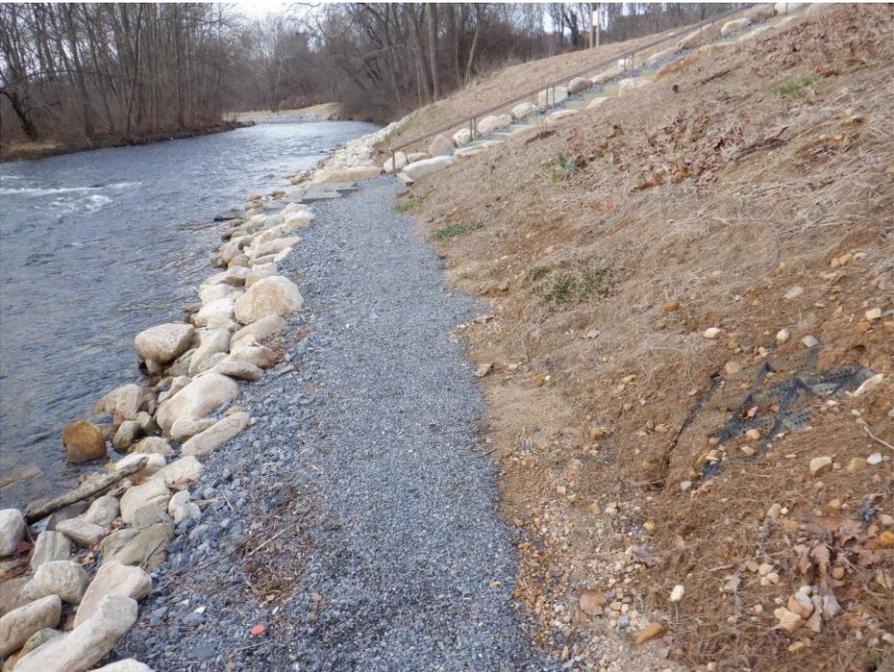
<p>Location: 00+1700'</p> <hr/> <p>Photo Number: 57 Date: 1/19/2021</p> <hr/> <p>Direction Photo Taken: Northeast</p> <hr/> <p>Description: Downstream view of gravel access path between constructed staircases showing exposed geocell throughout the remediated bank directly above access path</p>

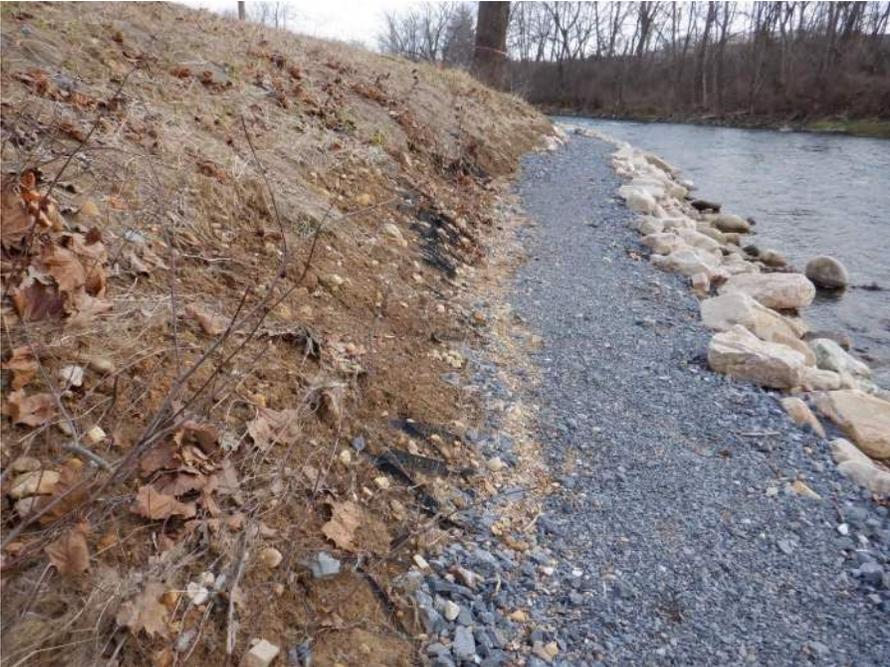
<p>Location: 00+1750'</p> <hr/> <p>Photo Title: 58 Date: 1/19/2021</p> <hr/> <p>Direction Photo Taken: Northwest</p> <hr/> <p>Description: ~50 degree bank angle; installed rock toe intact; live stakes and plantings establishing; walking path above rock toe intact with minimal erosion of gravel from high water; vegetation establishing; erosion control fabric 50% exposed; no sediment depositio</p>

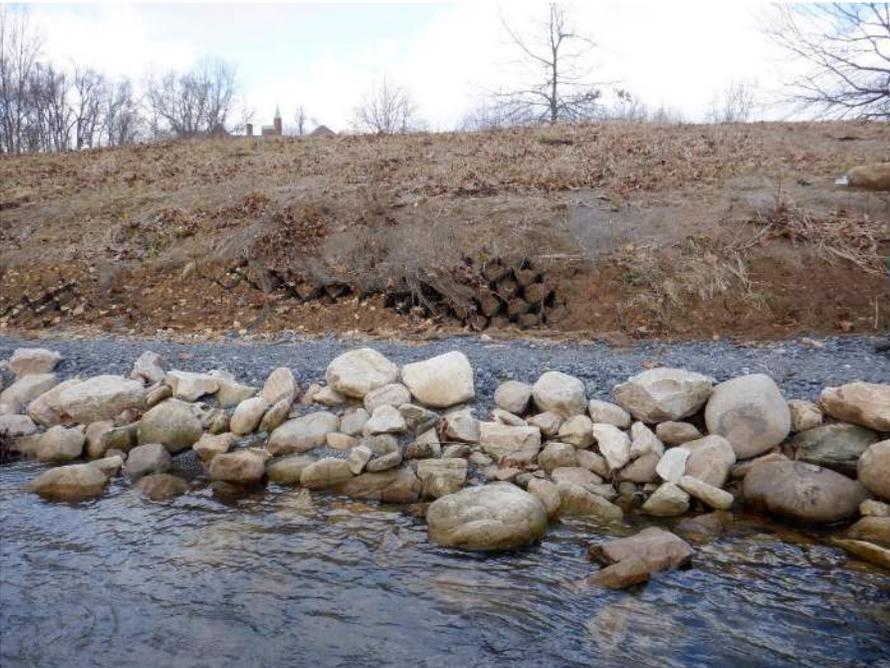
<p>Location: 00+1750'</p> <hr/> <p>Photo Number: Date: 59 1/19/2021</p> <hr/> <p>Direction Photo Taken: West</p> <hr/> <p>Description: Large section of geocell exposed above gravel access path from high water events</p>

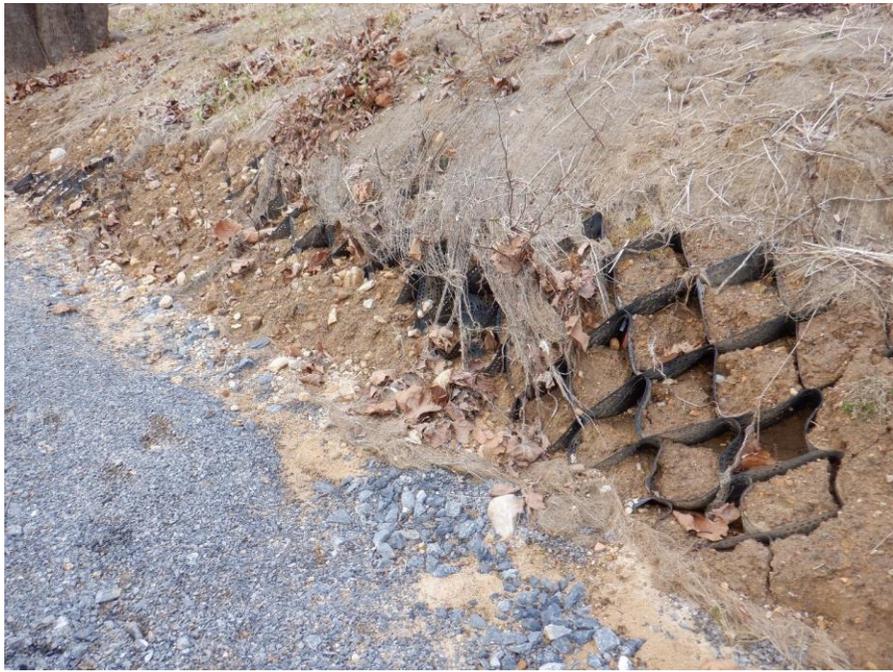
<p>Location: 00+1750'</p> <hr/> <p>Photo Title: Date: 60 1/19/2021</p> <hr/> <p>Direction Photo Taken: North</p> <hr/> <p>Description: Section of remediated bank above gravel access path that is likely to fail with natural erosive tendencies and/or future high water events; edges of geocell exposed from slump in soil along bank</p>

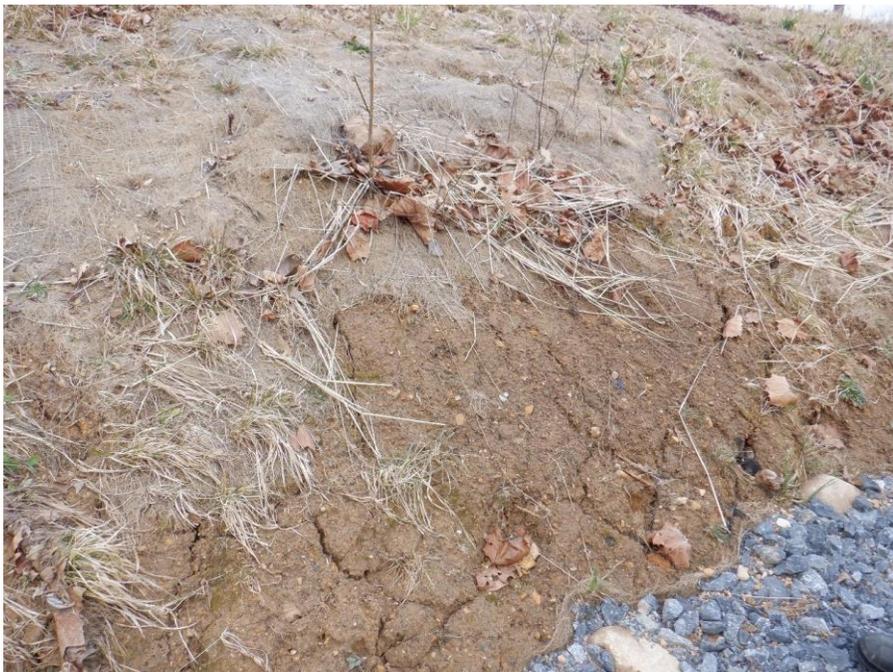
<p>Location: 00+1800'</p> <hr/> <p>Photo Number: Date: 61 1/19/2021</p> <hr/> <p>Direction Photo Taken: Northwest</p> <hr/> <p>Description: ~50 degree bank angle; installed rock toe intact; gravel access path above rock toe intact with minimal erosion of gravel from high water; vegetation establishing; erosion control fabric 20% exposed; no sediment deposition in rock toe; some geocell expose</p>

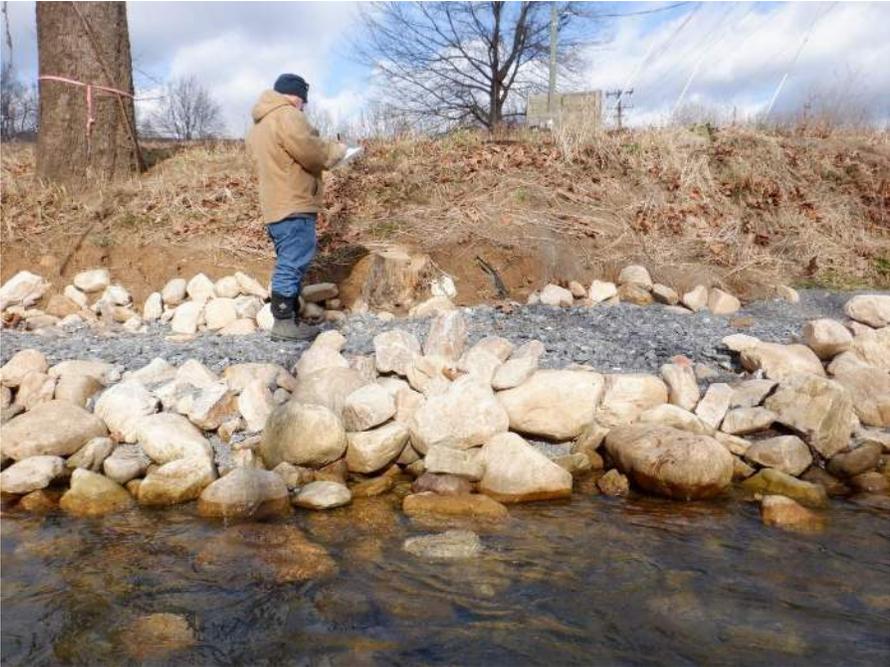
<p>Location: 00+1800'</p> <hr/> <p>Photo Title: Date: 62 1/19/2021</p> <hr/> <p>Direction Photo Taken: Northwest</p> <hr/> <p>Description: Section of geocell exposed above gravel access path; gravel deposition at toe of bank from gravel access path from high water events</p>

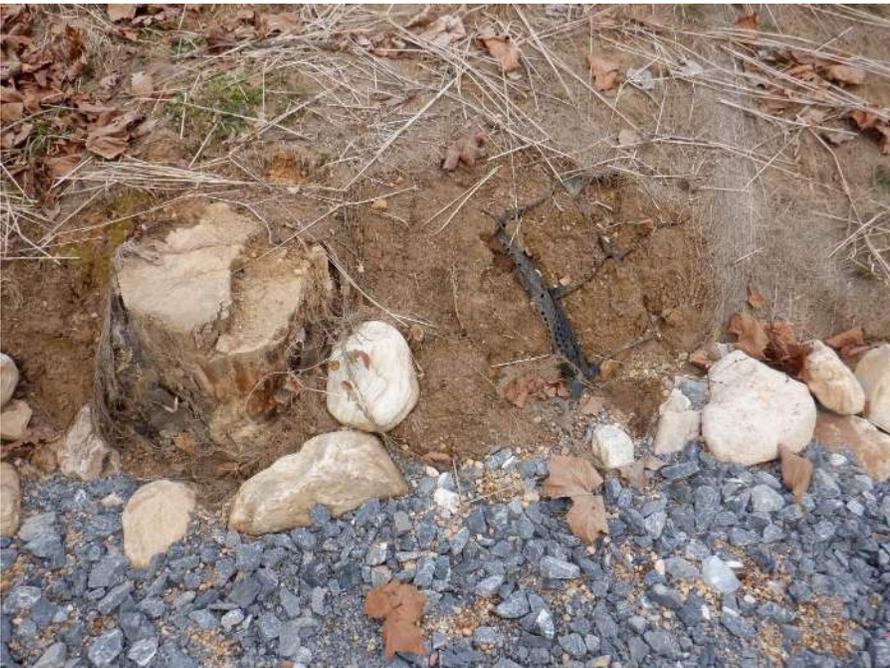
<p>Location: 00+1800'</p>

<p>Photo Number: 63 Date: 1/19/2021</p>	
<p>Direction Photo Taken: Northeast</p>	
<p>Description: Erosion of gravel access path from high water events showing small grade gravel deposited in a mound at upper bank toe and exposing larger grade base gravel along access path</p>

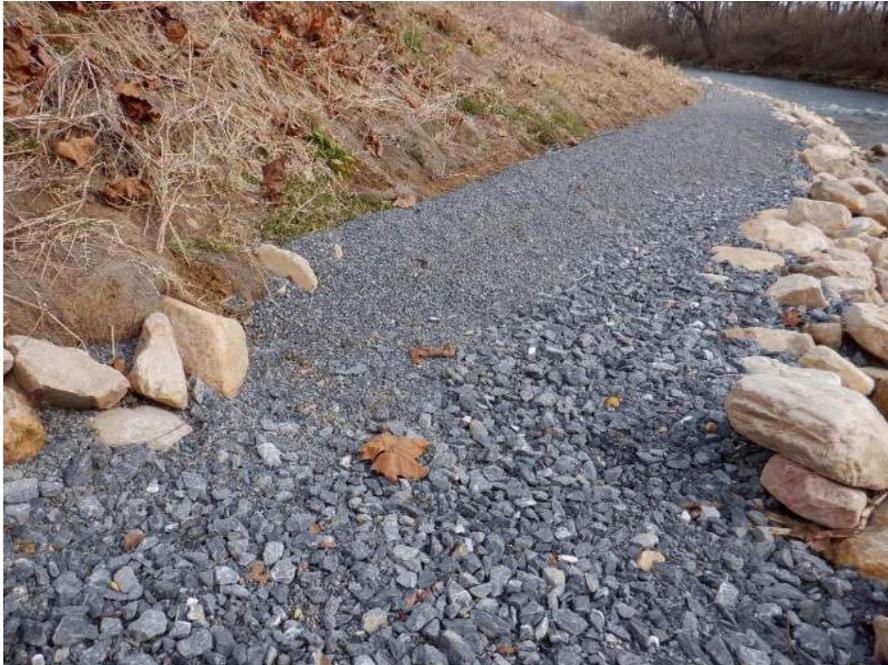
<p>Location: 00+1850'</p>

<p>Photo Title: 64 Date: 1/19/2021</p>	
<p>Direction Photo Taken: Northwest</p>	
<p>Description: ~40 degree bank angle; installed rock toe intact; gravel access path above rock toe intact with minimal erosion of gravel from high water; vegetation establishing; erosion control fabric 25% exposed; no sediment deposition in rock toe</p>

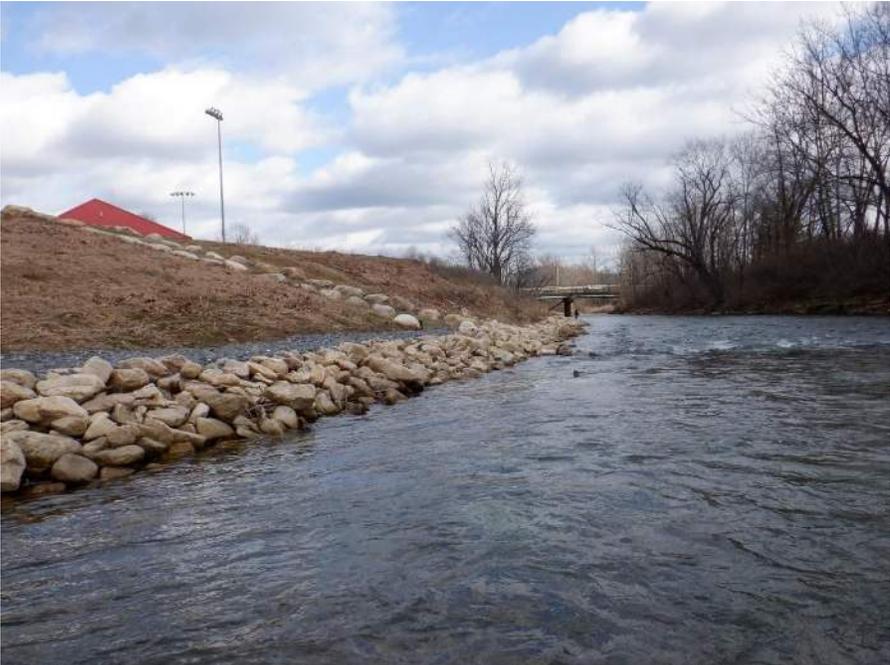
<p>Location: 00+1850'</p> <hr/> <p>Photo Number: 65 Date: 1/19/2021</p> <hr/> <p>Direction Photo Taken: North</p> <hr/> <p>Description: Downstream view showing 2nd constructed staircase in 2nd remediated section; installed rock toe intact; gravel access path between staircases intact with some erosion of gravel from high water events</p>

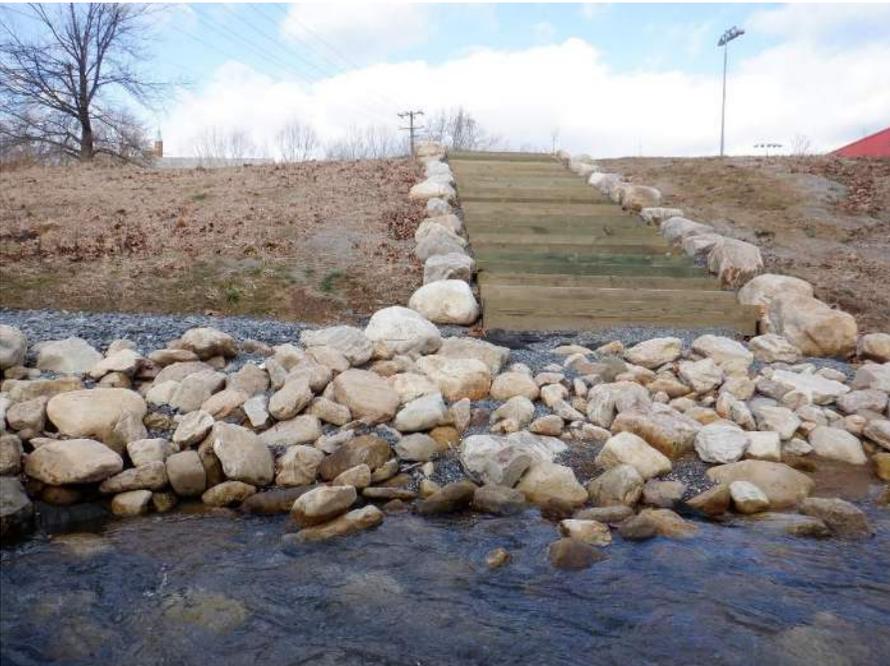
<p>Location: 00+1900'</p> <hr/> <p>Photo Title: 66 Date: 1/19/2021</p> <hr/> <p>Direction Photo Taken: Northwest</p> <hr/> <p>Description: ~45 degree bank angle; constructed staircase intact; erosion control fabric visible at bottom of staircase; installed rock toe intact; vegetation minimally established; erosion control fabric 50% exposed; no sediment deposition in rock toe</p>

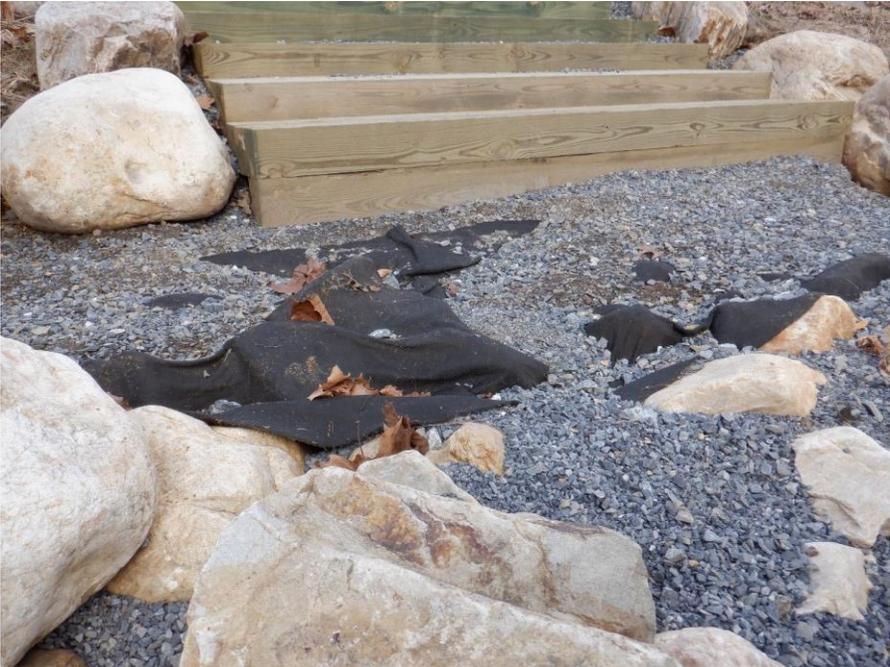
<p>Location: 00+1900'</p> <hr/> <p>Photo Number: Date: 67 1/19/2021</p> <hr/> <p>Direction Photo Taken: North</p> <hr/> <p>Description: Erosion control fabric exposed at bottom of constructed staircase</p>

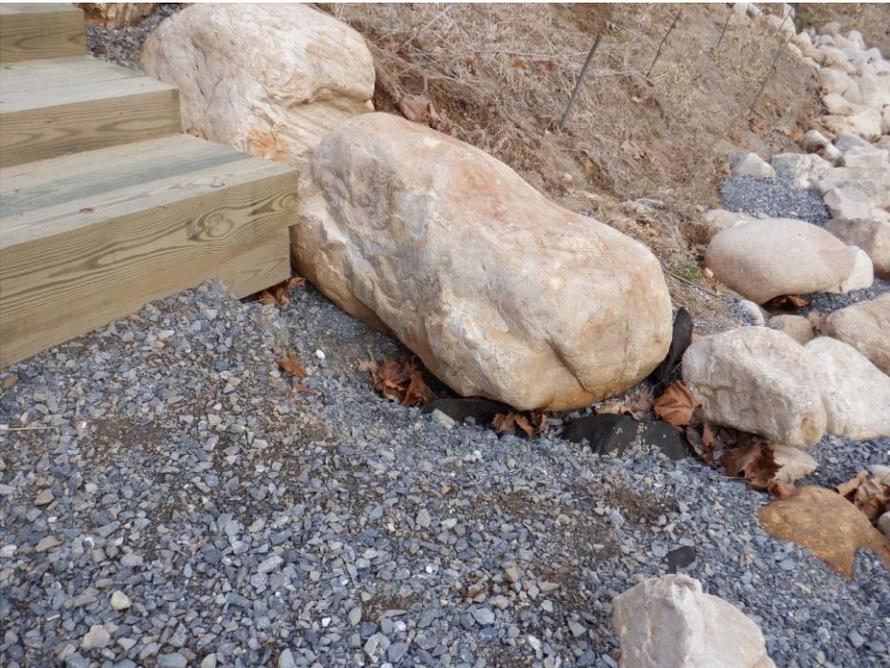
<p>Location: 00+1900'</p> <hr/> <p>Photo Title: Date: 68 1/19/2021</p> <hr/> <p>Direction Photo Taken: North</p> <hr/> <p>Description: Erosion around stones from high water events and some exposed erosion control fabric exposed</p>

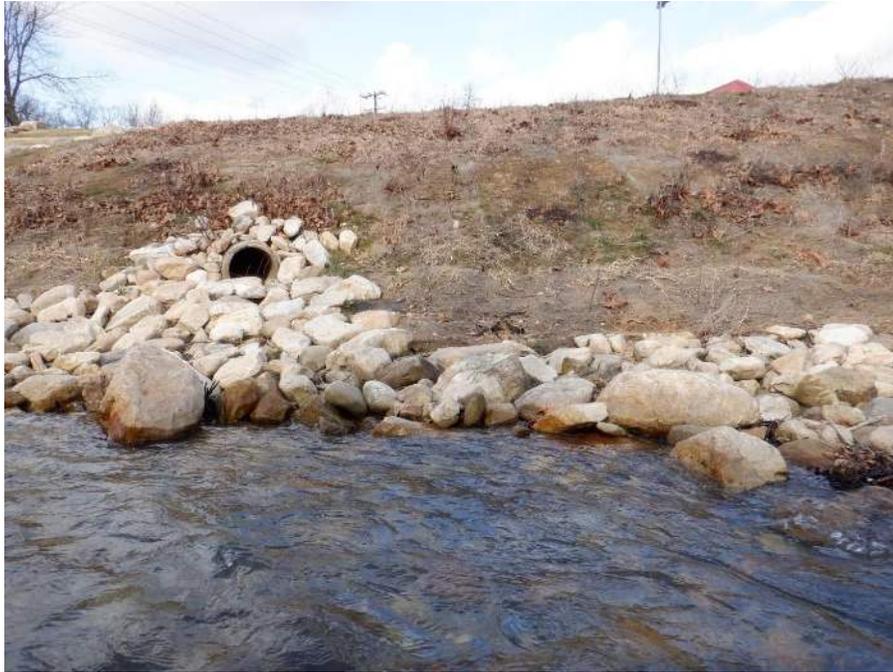
<p>Location: 00+1950'</p> <hr/> <p>Photo Number: 69 Date: 1/19/2021</p> <hr/> <p>Direction Photo Taken: Northwest</p> <hr/> <p>Description: ~60 degree bank angle; installed rock toe intact; live stakes and plantings establishing; outfall pipe with riprap intact; vegetation establishing; erosion control fabric 30% exposed; sections of geocell exposed above rock toe; no sediment deposition in r</p>

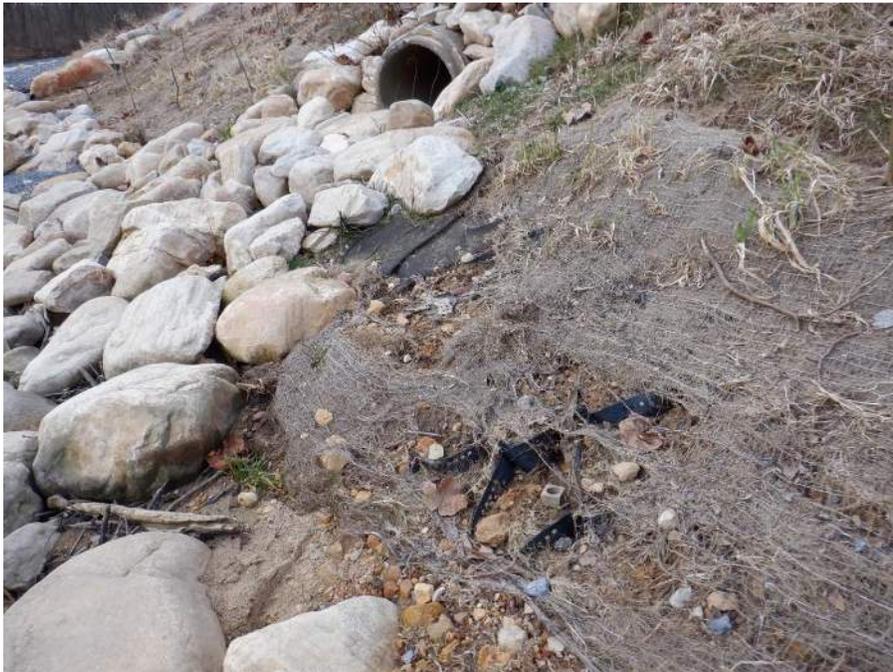
<p>Location: 00+1950'</p> <hr/> <p>Photo Title: 70 Date: 1/19/2021</p> <hr/> <p>Direction Photo Taken: West</p> <hr/> <p>Description: Erosion control fabric torn and geocell exposed above rock toe; fabric exposed around outfall riprap</p>

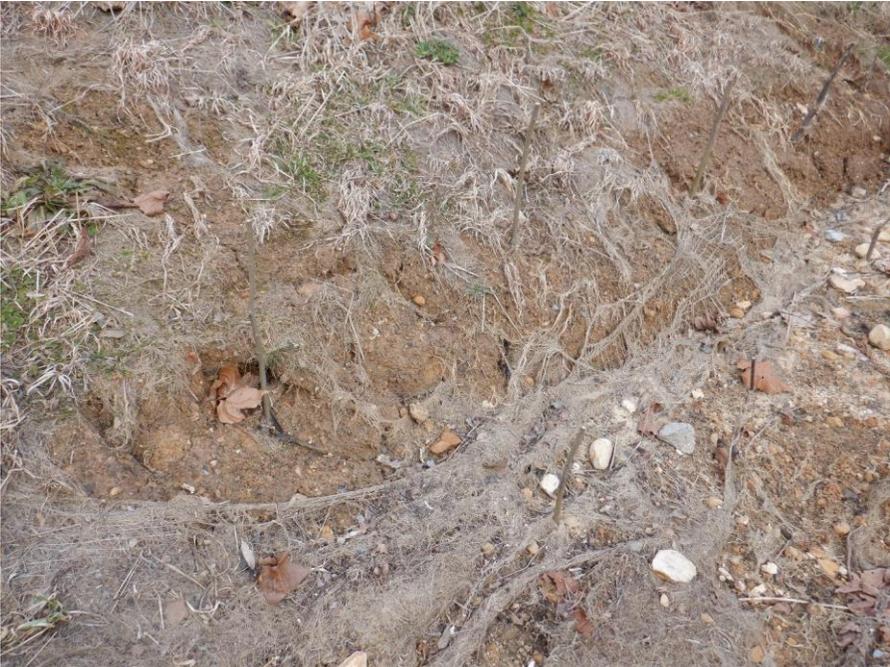
<p>Location: 00+1950'</p> <hr/> <p>Photo Number: Date: 71 1/19/2021</p> <hr/> <p>Direction Photo Taken: North</p> <hr/> <p>Description: Erosion control fabric torn and geocell starting to be exposed from erosion and slump after high water events</p>

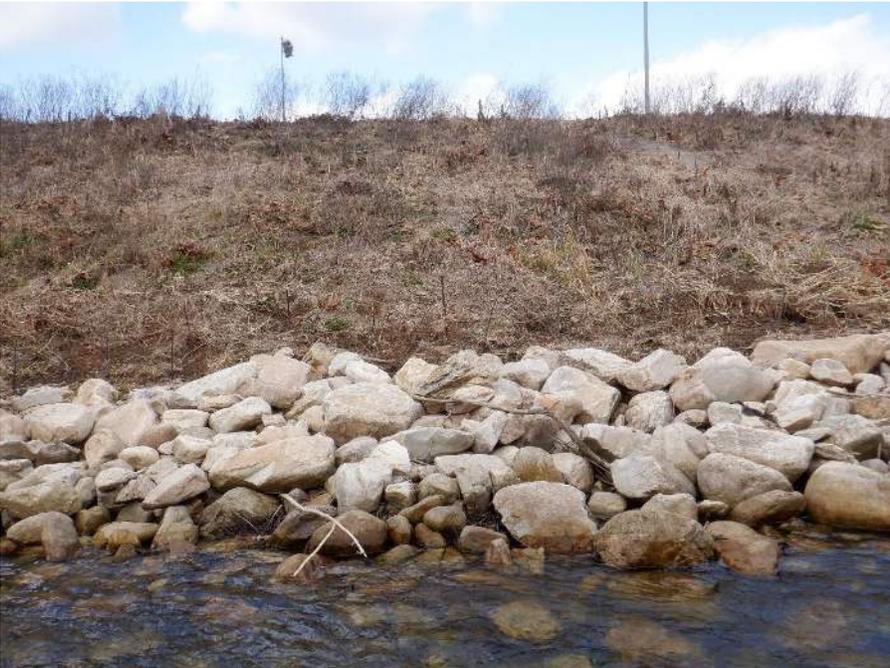
<p>Location: 00+2000'</p> <hr/> <p>Photo Title: Date: 72 1/19/2021</p> <hr/> <p>Direction Photo Taken: Northwest</p> <hr/> <p>Description: ~60 degree bank angle; installed rock toe intact; live stakes and plantings establishing; vegetation establishing; erosion control fabric 20% exposed; geocell exposed above rock toe; no sediment deposition above rock toe</p>

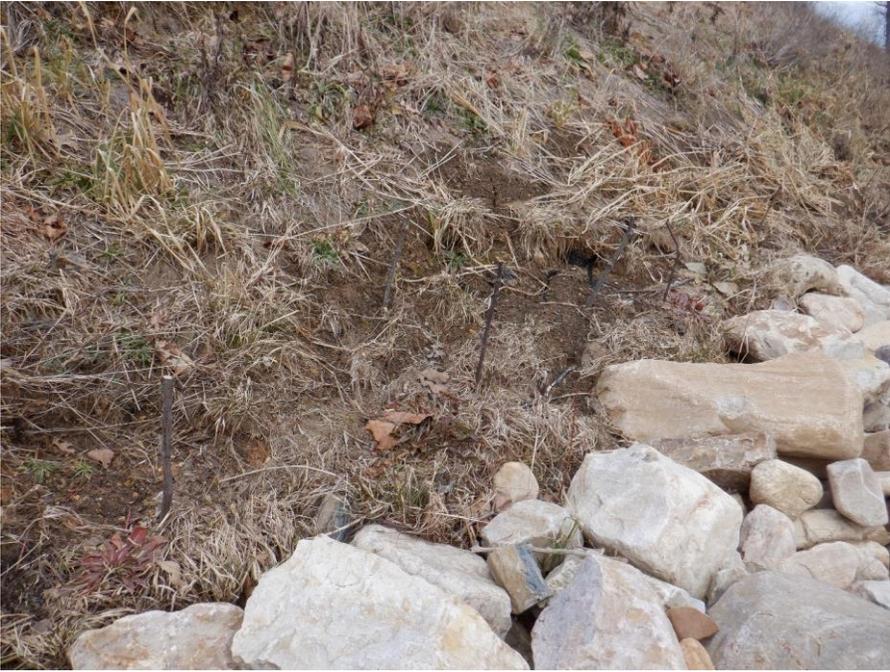
<p>Location: 00+2000'</p> <hr/> <p>Photo Number: Date: 73 1/19/2021</p> <hr/> <p>Direction Photo Taken: North</p> <hr/> <p>Description: Minimal geocell exposed above rock toe from erosion from high water events</p>

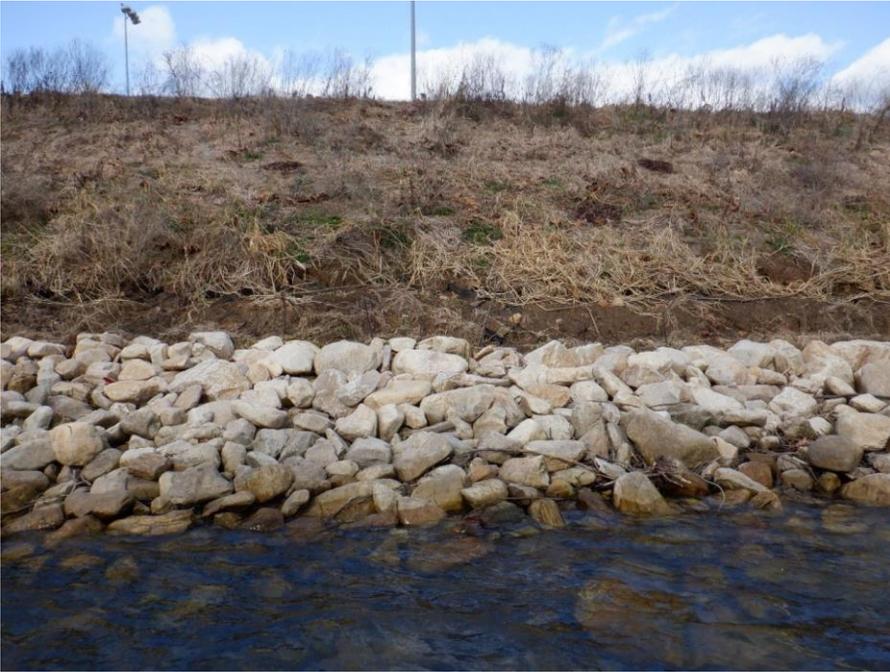
<p>Location: 00+2050'</p> <hr/> <p>Photo Title: Date: 74 1/19/2021</p> <hr/> <p>Direction Photo Taken: Northwest</p> <hr/> <p>Description: ~60 degree bank angle; installed rock toe intact; live stakes and plantings establishing; vegetation establishing; erosion control fabric 20% exposed; geocell significantly exposed above rock toe; no sediment deposition above rock toe</p>

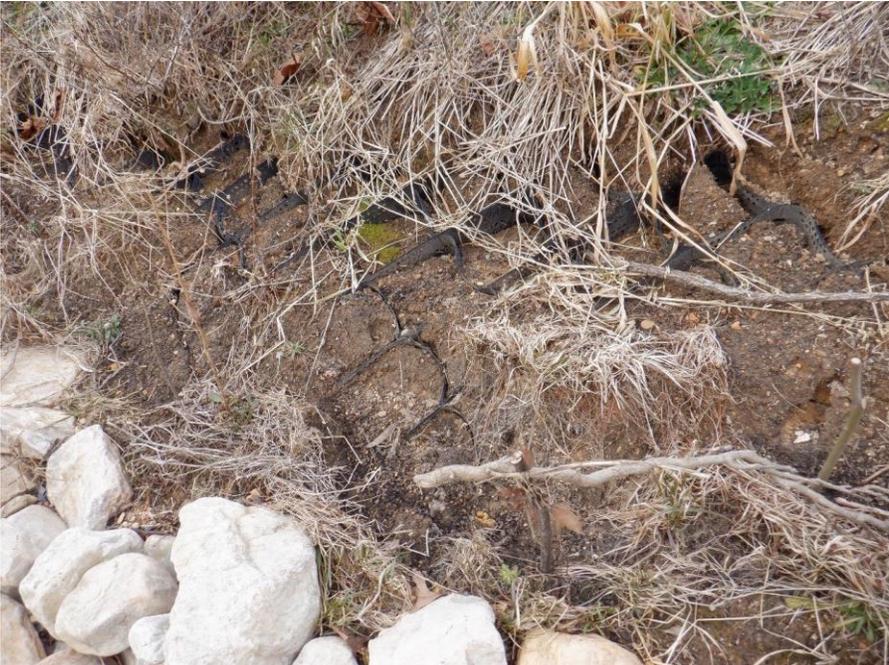
<p>Location: 00+2050'</p> <hr/> <p>Photo Number: Date: 75 1/19/2021</p> <hr/> <p>Direction Photo Taken: Northwest</p> <hr/> <p>Description: Large sections of geocell exposed above rock toe from erosion</p>

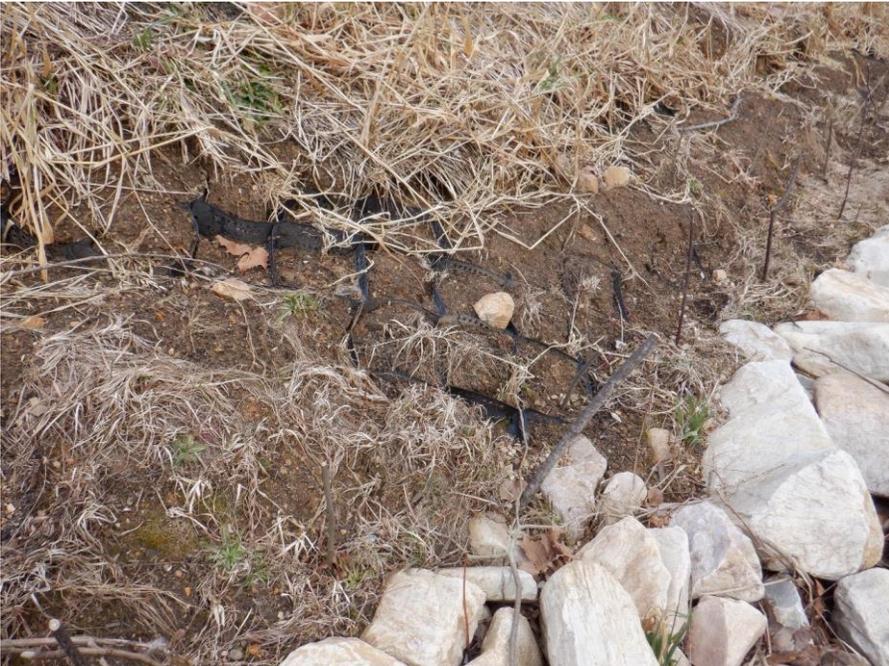
<p>Location: 00+2050'</p> <hr/> <p>Photo Title: Date: 76 1/19/2021</p> <hr/> <p>Direction Photo Taken: North</p> <hr/> <p>Description: Large sections of geocell exposed along remediated bank above rock toe from erosion and soil slump</p>

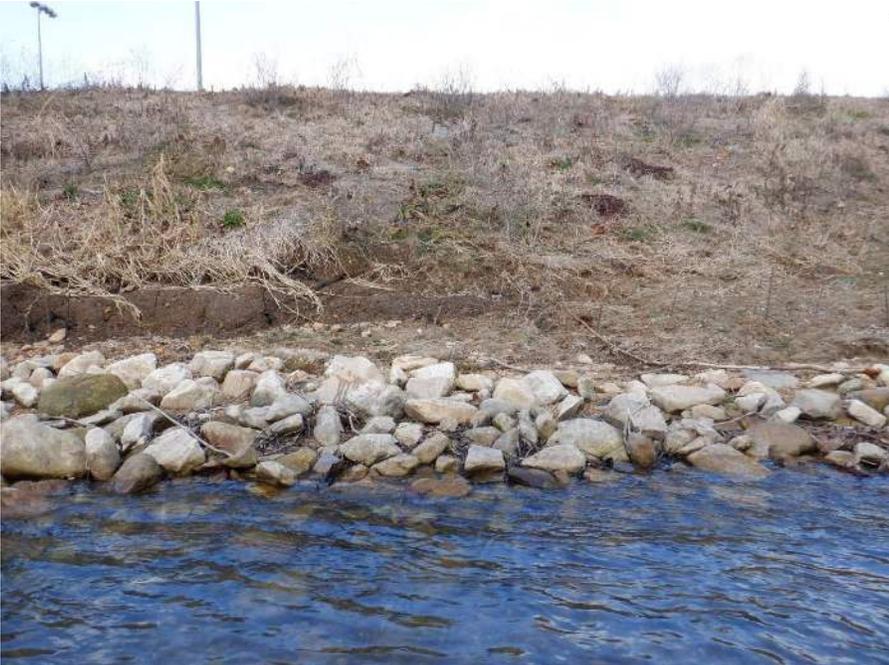
<p>Location: 00+2100'</p> <hr/> <p>Photo Number: Date: 77 1/19/2021</p> <hr/> <p>Direction Photo Taken: Northwest</p> <hr/> <p>Description: ~60 degree bank angle; installed rock toe intact; live stakes and plantings establishing; vegetation establishing; erosion control fabric 10% exposed; geocell exposed above rock toe from erosion and slump; no sediment deposition in rock toe</p>

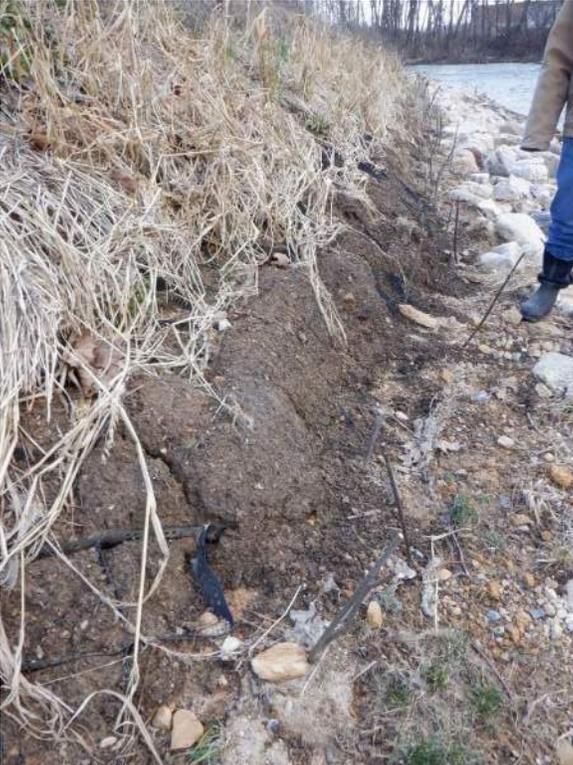
<p>Location: 00+2100'</p> <hr/> <p>Photo Title: Date: 78 1/19/2021</p> <hr/> <p>Direction Photo Taken: Southwest</p> <hr/> <p>Description: Significant sections of geocell exposed above rock toe from erosion and soil slump along length of remediated bank</p>

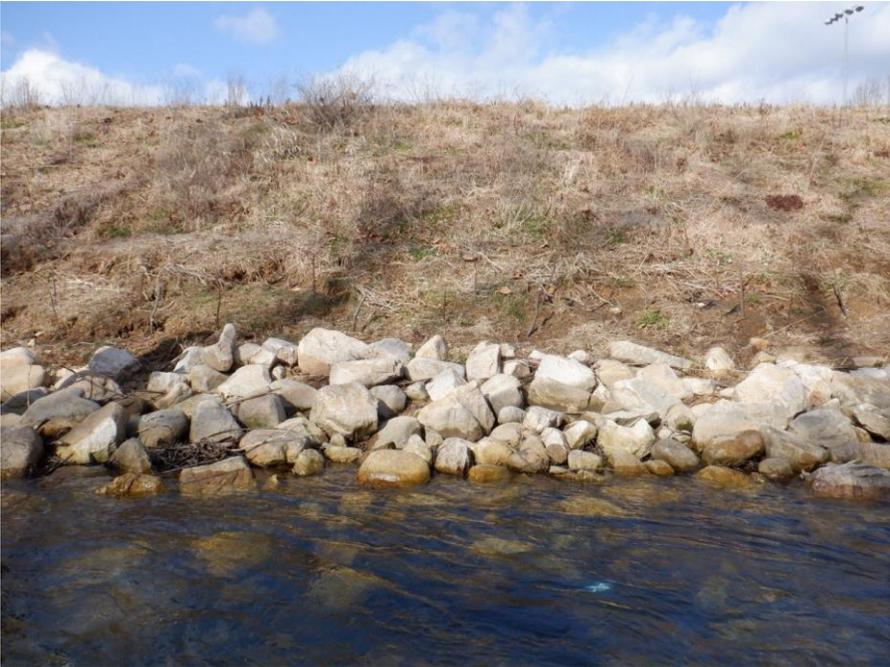
00 + 2150'	60	Y		79,80	N/A	live stakes and plantings present; vegetation 90% established	79,80	N	no at-risk trees present	79,80	Y (rock toe)	Y	Y	erosion control fabric and geocell 10% exposed above rock toe; rock toe intact	79,80	N	No sediment deposition	79,80	Initial Inspection after Remediation
00 + 2200'	60	Y		81,82,83,84	N/A	live stakes and plantings present; vegetation 90% established	81,82,83,84	Y	one tree mid bank in good condition	81,82,83,84	Y (rock toe)	Y	Y	erosion control fabric and geocell 10% exposed above rock toe; rock toe intact	81,82,83,84	N	No sediment deposition	81,82,83,84	Initial Inspection after Remediation
00 + 2250'	60	Y	end of 2nd remediated section	85	N/A	live stakes and plantings present; vegetation 90% established	85	Y	one tree mid bank in good condition	85	Y (rock toe)	N	Y	erosion control fabric 10% exposed; no geocell exposed; rock toe intact; higher rock toe in this section	85	N	No sediment deposition	85	Initial Inspection after Remediation

<p>Location: 00+2150'</p> <hr/> <p>Photo Number: 79 Date: 1/19/2021</p> <hr/> <p>Direction Photo Taken: Northwest</p> <hr/> <p>Description: ~60 degree bank angle; installed rock toe intact; live stakes and plantings establishing; vegetation establishing; erosion control fabric 10% exposed; geocell exposed above rock toe; no sediment deposition in rock toe</p>

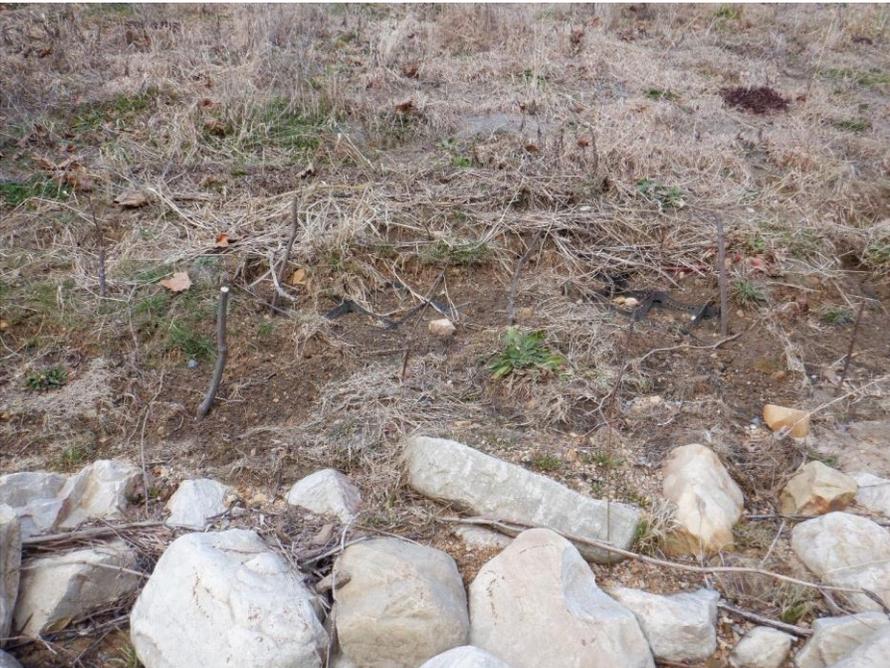
<p>Location: 00+2150'</p> <hr/> <p>Photo Title: 80 Date: 1/19/2021</p> <hr/> <p>Direction Photo Taken: Northwest</p> <hr/> <p>Description: Small sections of geocell exposed above rock toe</p>

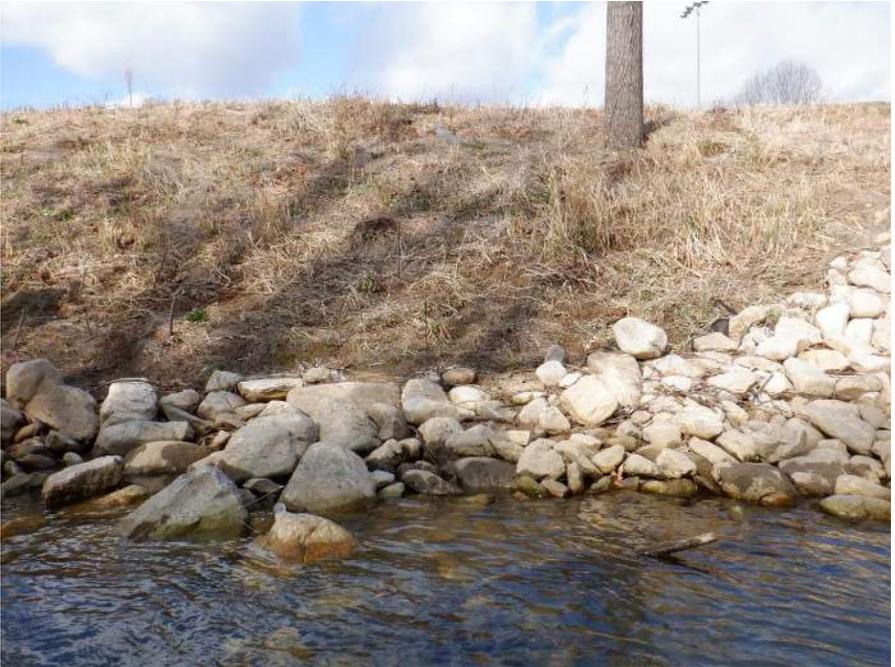
<p>Location: 00+2200'</p> <hr/> <p>Photo Number: Date: 81 1/19/2021</p> <hr/> <p>Direction Photo Taken: Northwest</p> <hr/> <p>Description: ~60 degree bank angle; installed rock toe intact; live stakes and plantings establishing; no at risk trees; vegetation establishing; erosion control fabric 10% exposed; geocell exposed above rock toe; no sediment deposition in rock toe</p>

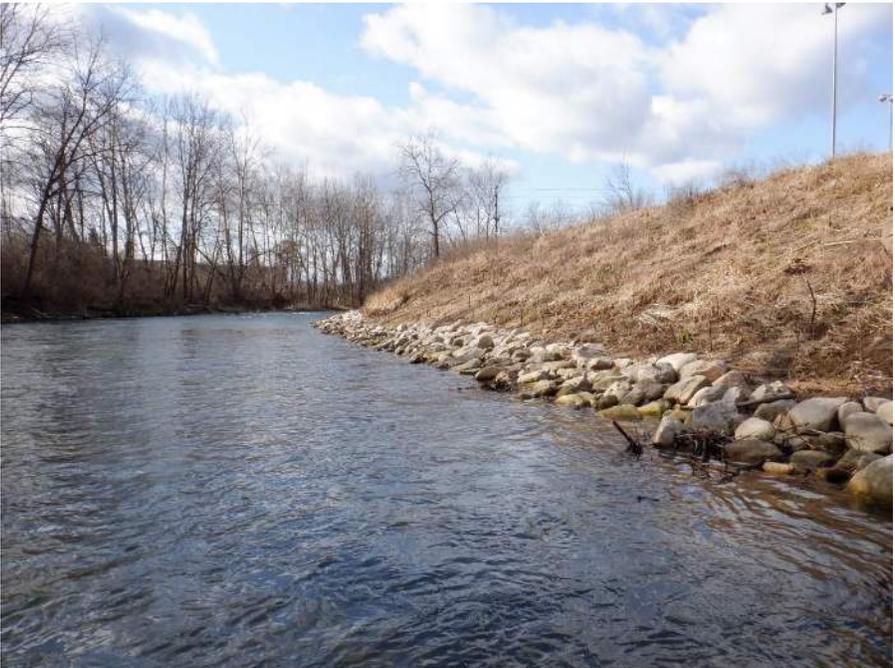
<p>Location: 00+2200'</p> <hr/> <p>Photo Title: Date: 82 1/19/2021</p> <hr/> <p>Direction Photo Taken: West</p> <hr/> <p>Description: Upstream vies showing remediated bank; geocell exposed along length of bank above rock toe; installed rock toe intact</p>

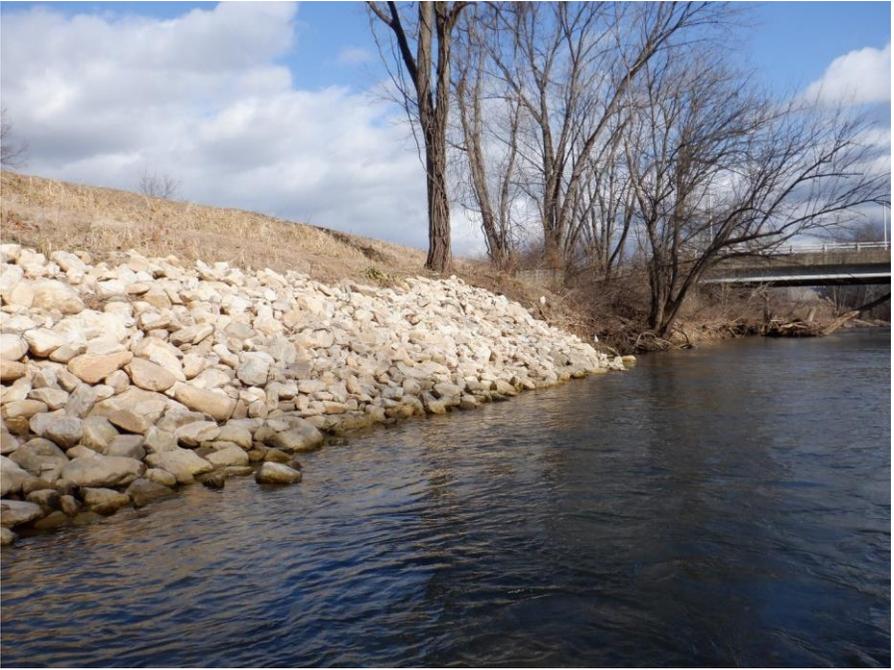
<p>Location: 00+2200'</p> <hr/> <p>Photo Number: Date: 83 1/19/2021</p> <hr/> <p>Direction Photo Taken: North</p> <hr/> <p>Description: Downstream view showing end of remediated bank section; installed rock toe intact</p>

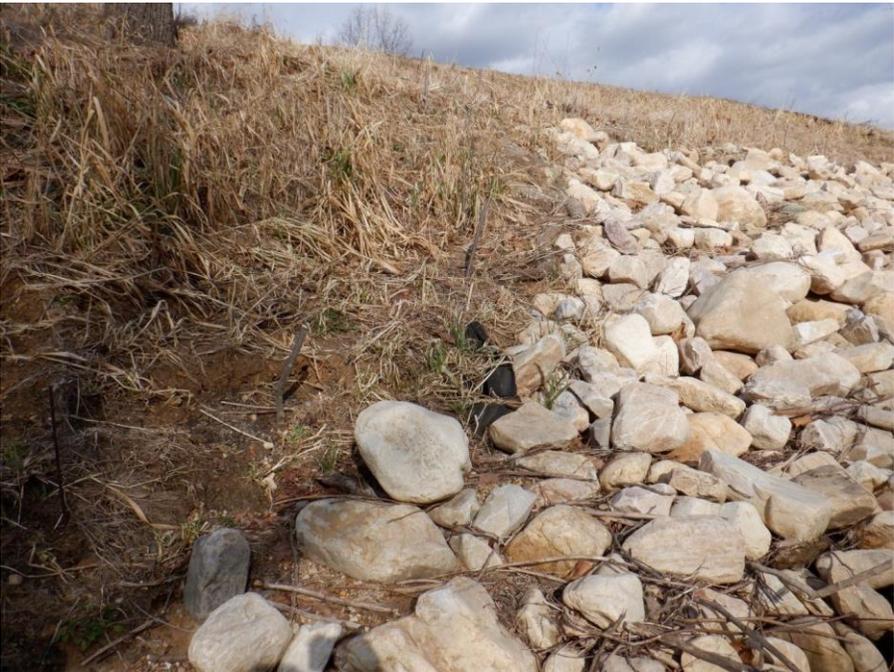
<p>Location: 00+2200'</p> <hr/> <p>Photo Title: Date: 84 1/19/2021</p> <hr/> <p>Direction Photo Taken: North</p> <hr/> <p>Description: Some fabric showing along vertically extended section of rock toe</p>

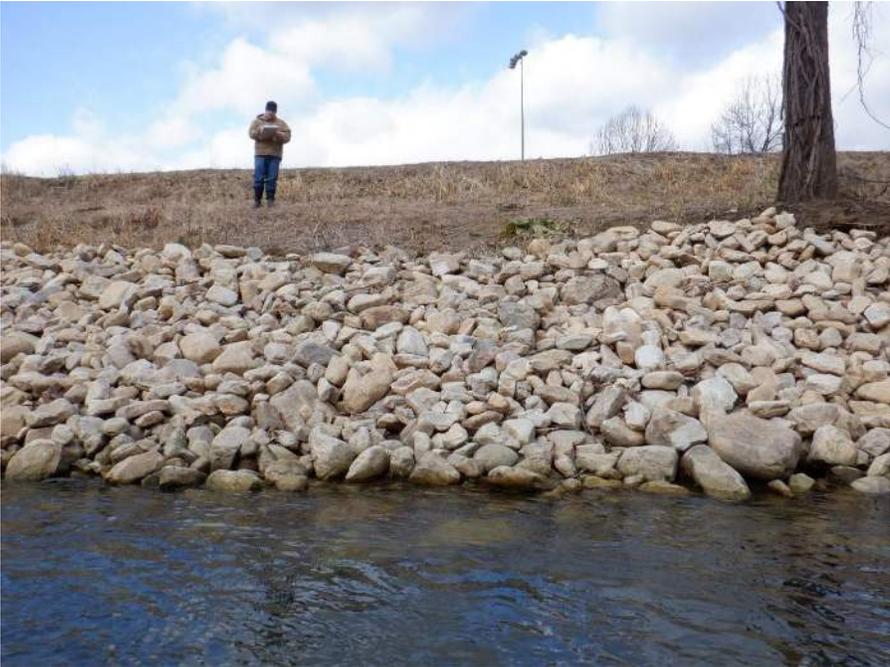
<p>Location: 00+2250'</p> <hr/> <p>Photo Number: Date: 85 1/19/2021</p> <hr/> <p>Direction Photo Taken: Northwest</p> <hr/> <p>Description: ~60 degree bank angle; installed rock toe intact; live stakes and plantings establishing; no at risk trees; vegetation establishing; erosion control fabric 10% exposed; no geocell exposed; no sediment deposition in rock toe</p>
