**Re: 2020 Leaf-on and 2020-2021 Leaf-off Maintenance Inspections
Former DuPont Waynesboro Site AOC 4
Waynesboro, Virginia
EPA ID# VAD003114832**

Subject 2020-2021 Phase 1 BMA Leaf-Off Maintenance Inspection
Former DuPont Waynesboro Site, Area of Concern 4

Date March 24, 2021

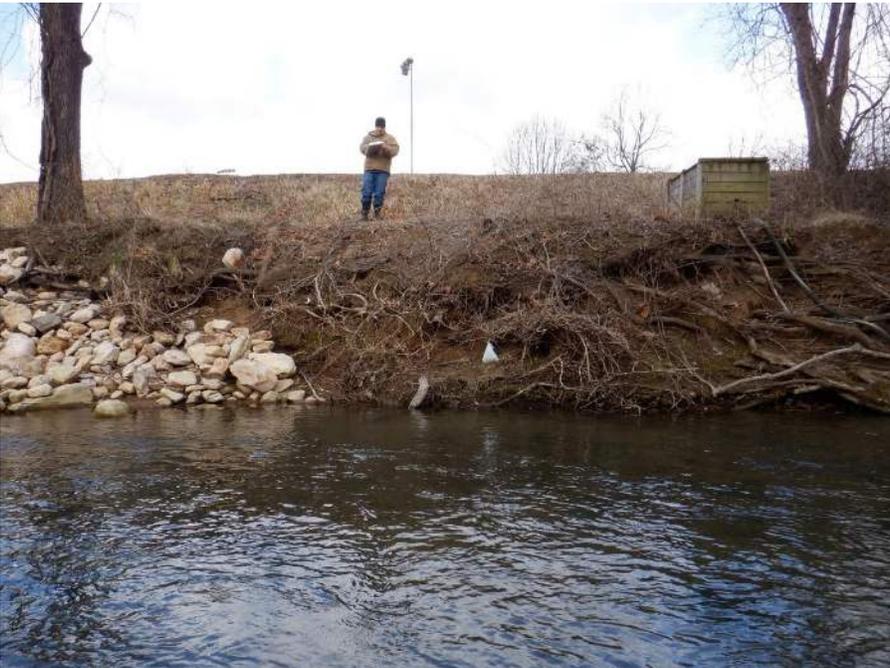
00 + 2300'	65	N	start of non-remediated section lower bank ~90 degrees upper bank ~40 degrees	86	M	woody vegetation throughout bank; medium exposed roots mid to lower bank; sparse vegetation	86	N	no at-risk trees present	86	N/A	N/A	N/A	bank undercutting minimal	86	N	no scour	86	Initial Inspection after Remediation
00 + 2350'	65	N	lower bank ~90 degrees upper bank ~40 degrees	87	H	woody vegetation mid to upper bank; highly exposed roots; no vegetation established adjacent to water's edge	87	Y	several trees on upper bank in good condition	87	N/A	N/A	N/A	significant bank undercutting from mid to lower bank	87	Y	scour mid to lower bank by exposed roots	87	Initial Inspection after Remediation
00 + 2380'	65	N	lower bank ~90 degrees upper bank ~40 degrees	88,89,90	M	woody vegetation throughout bank; medium exposed roots mid to lower bank; sparse vegetation	88,89,90	Y	several trees on upper bank in good condition	88,89,90	N/A	N/A	N/A	minimal undercutting at toe of bank	88,89,90	Y	minimal scour at toe of slope	88,89,90	Initial Inspection after Remediation

<p>Location: 00+2300'</p> <hr/> <p>Photo Title: Date: 86 1/19/2021</p> <hr/> <p>Direction Photo Taken: Northwest</p> <hr/> <p>Description: ~40 degree upper bank angle and 90 degree lower bank angle; downstream of remediated section exposed roots with scour and undercutting around exposed roots; installed rock toe intact at end of remediation; no at risk trees</p>

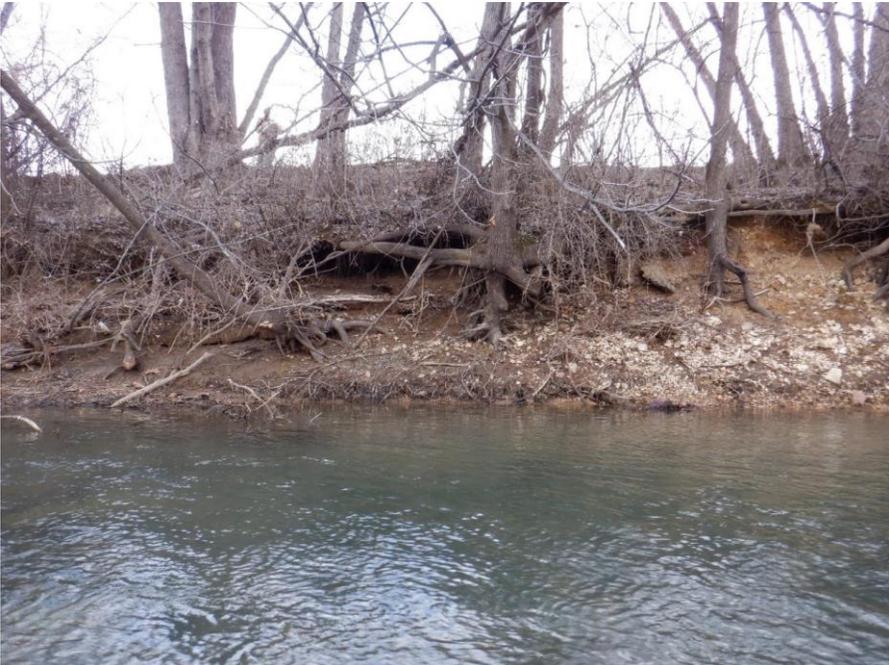
<p>Location: 00+2350'</p> <hr/> <p>Photo Number: Date: 87 1/19/2021</p> <hr/> <p>Direction Photo Taken: Northwest</p> <hr/> <p>Description: ~40 degree upper bank angle and 90 degree lower bank angle; significant exposure of roots with scour and undercutting around exposed roots; several at risk trees; erosion from mid bank to toe</p>

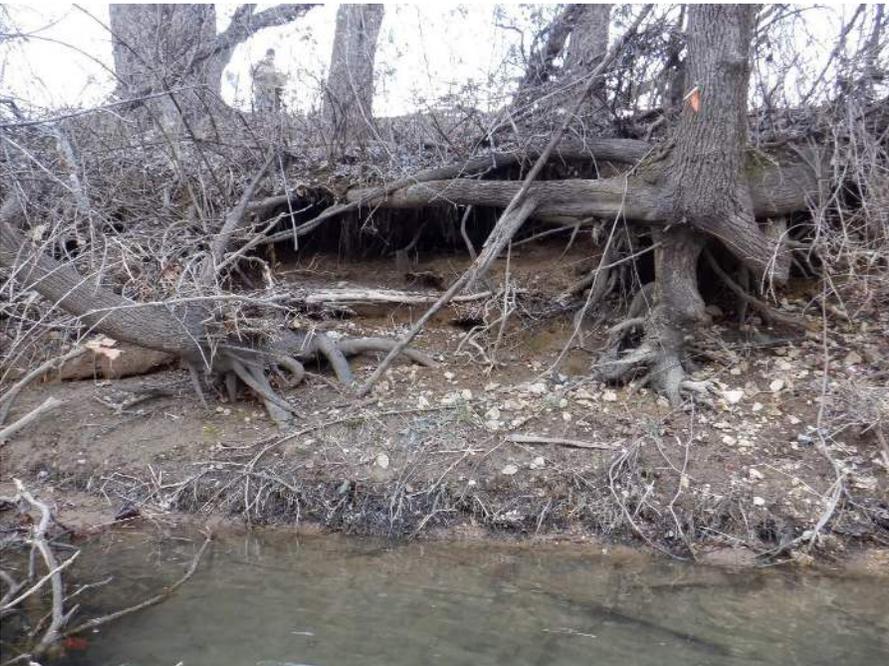
<p>Location: 00+2350'</p> <hr/> <p>Photo Title: Date: 88 1/19/2021</p> <hr/> <p>Direction Photo Taken: Northwest</p> <hr/> <p>Description: Severe erosion and scour around exposed roots; some undercutting at toe of bank</p>

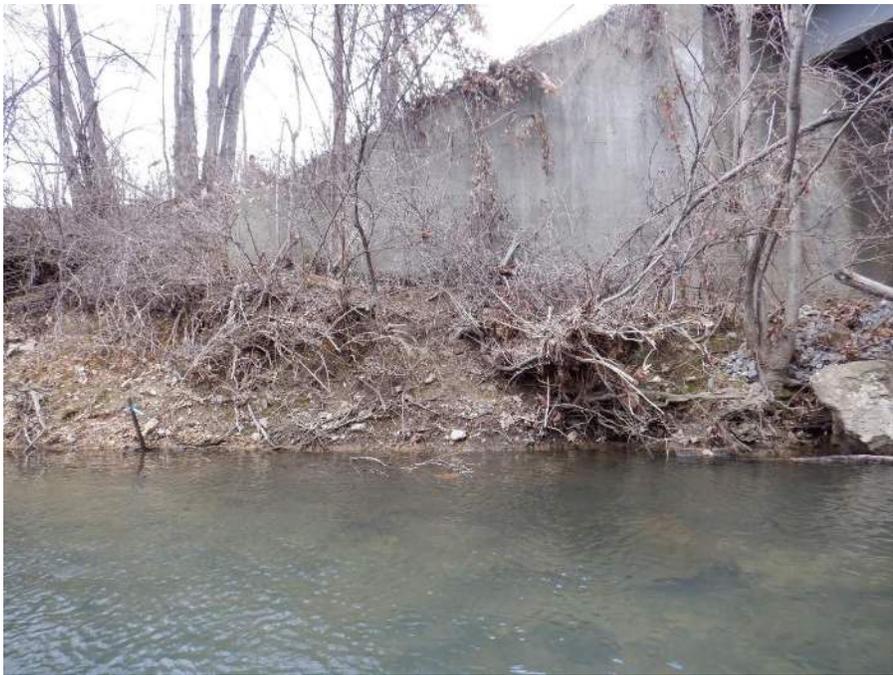
<p>Location: 00+2380'</p> <hr/> <p>Photo Number: Date: 89 1/19/2021</p> <hr/> <p>Direction Photo Taken: Northwest</p> <hr/> <p>Description: ~40 degree upper bank angle and 90 degree lower bank angle; erosion and scour around exposed roots; minimal undercutting at bank toe</p>

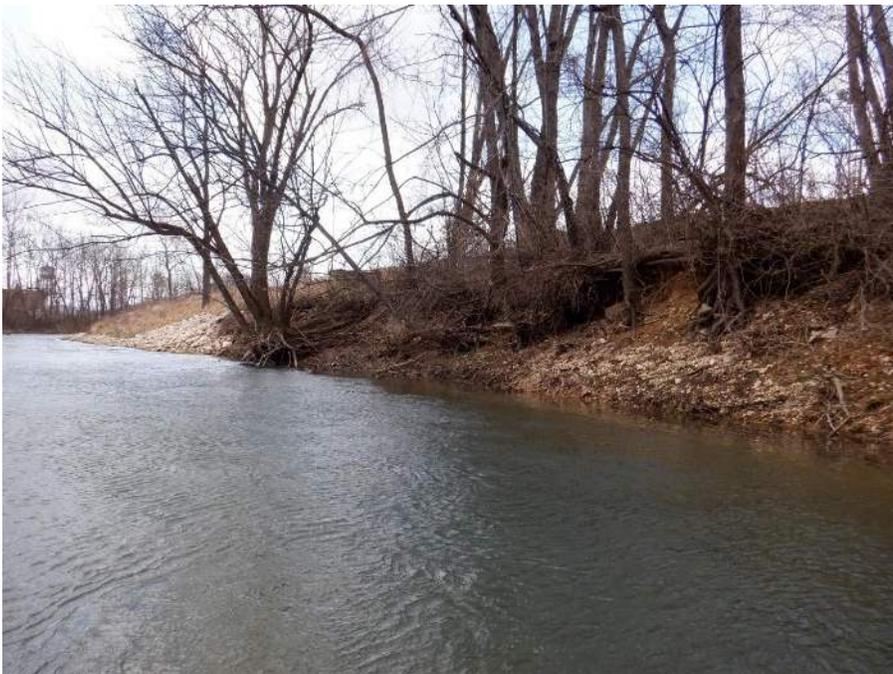
<p>Location: 00+2380'</p> <hr/> <p>Photo Title: Date: 90 1/19/2021</p> <hr/> <p>Direction Photo Taken: West</p> <hr/> <p>Description: Upstream view showing non-remediated section beyond BMA to bridge; significant erosion, scour, and undercutting around exposed roots in non-remediated section</p>

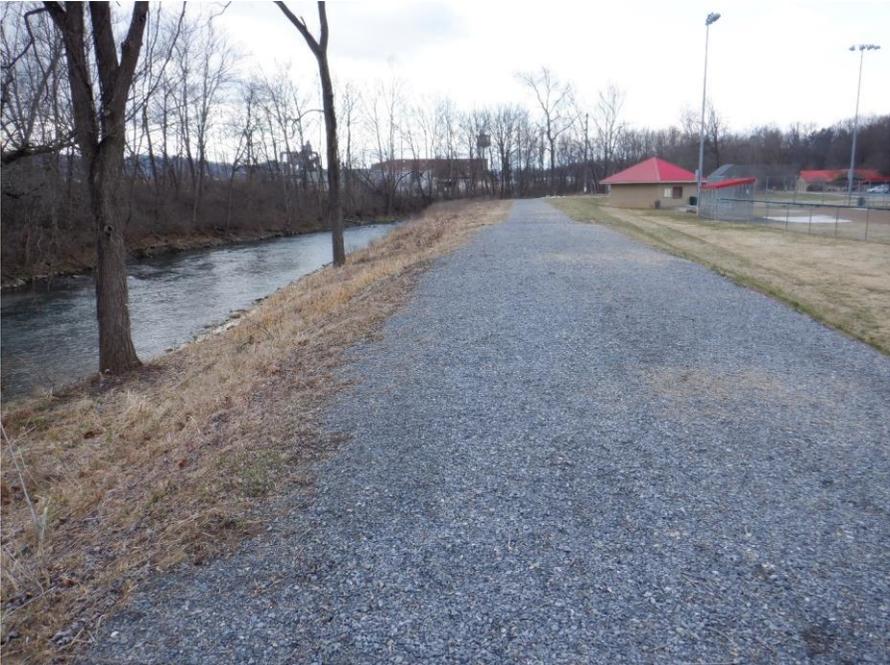
North Park	N/A	N/A	largely flat	91-113	N/A	large trees present across greenspace in North Park in good condition; vegetation minimally established in greenspace; plantings present	91-113	N	no at-risk trees present	91-113	N/A	N/A	N/A	erosion control fabric; highly exposed (50-90%) within North Park; Greenway intact and ready for pavement; some ruts along GW from vehicles	91-113	N	N/A	91-113	Initial Inspection after Remediation

<p>Location: North Park</p> <hr/> <p>Photo Number: 91 Date: 1/19/2021</p> <hr/> <p>Direction Photo Taken: Southwest</p> <hr/> <p>Description: Downstream end of Greenway showing gravel walking path to be paved</p>

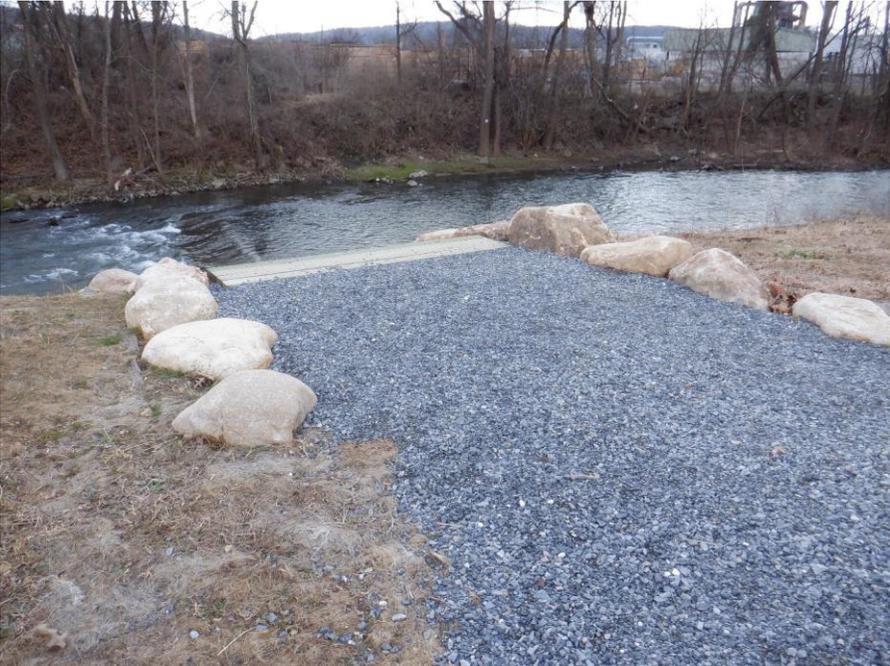
<p>Location: North Park</p> <hr/> <p>Photo Title: 92 Date: 1/19/2021</p> <hr/> <p>Direction Photo Taken: Southeast</p> <hr/> <p>Description: Top of 2nd constructed staircase (downstream) from Greenway</p>

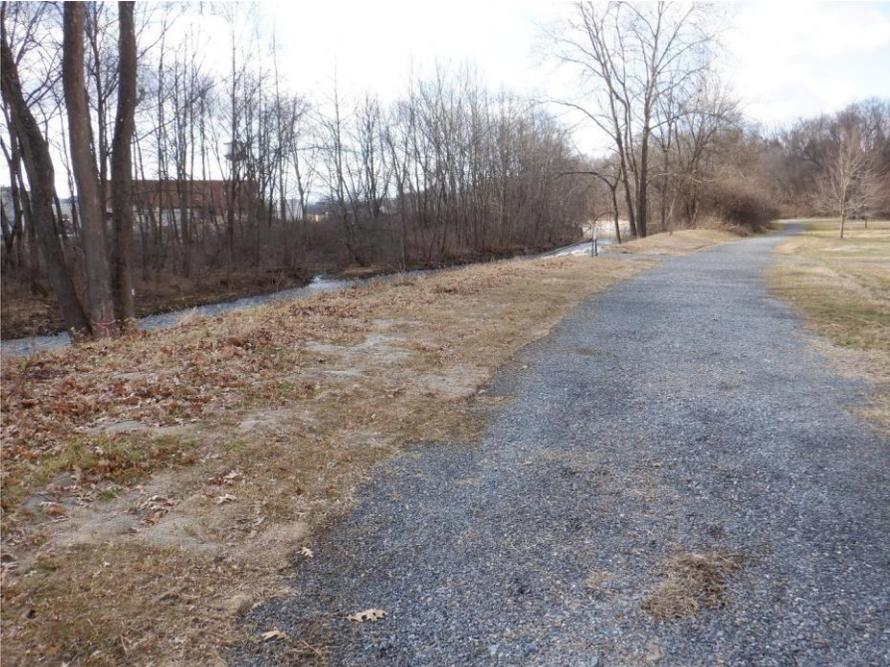
<p>Location: North Park</p> <hr/> <p>Photo Number: 93 Date: 1/19/2021</p> <hr/> <p>Direction Photo Taken: Southwest</p> <hr/> <p>Description: Greenway section between constructed staircases</p>

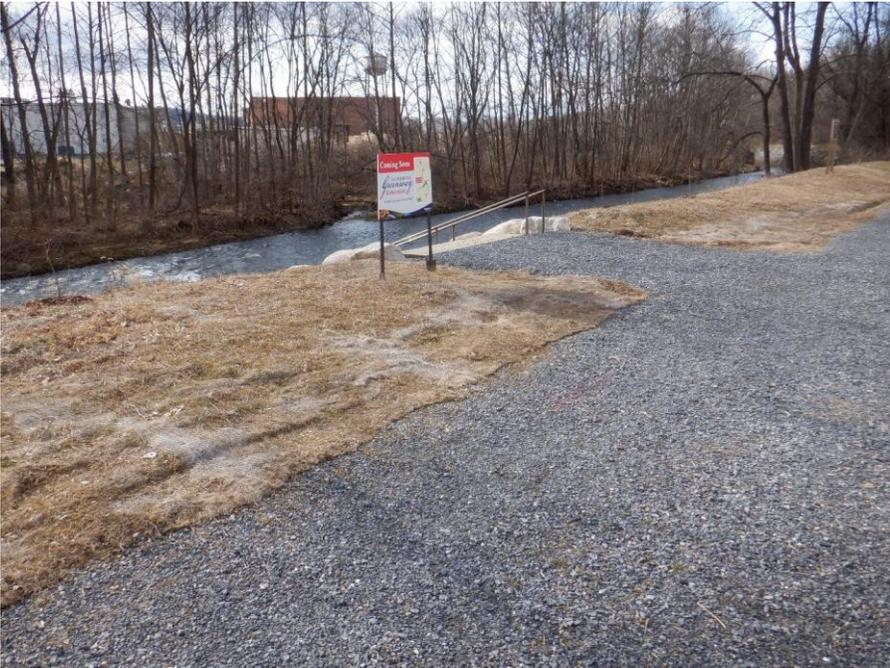
<p>Location: North Park</p> <hr/> <p>Photo Title: 94 Date: 1/19/2021</p> <hr/> <p>Direction Photo Taken: South</p> <hr/> <p>Description: Top of 1st constructed staircase (upstream) for river access with kayak launch ramp</p>

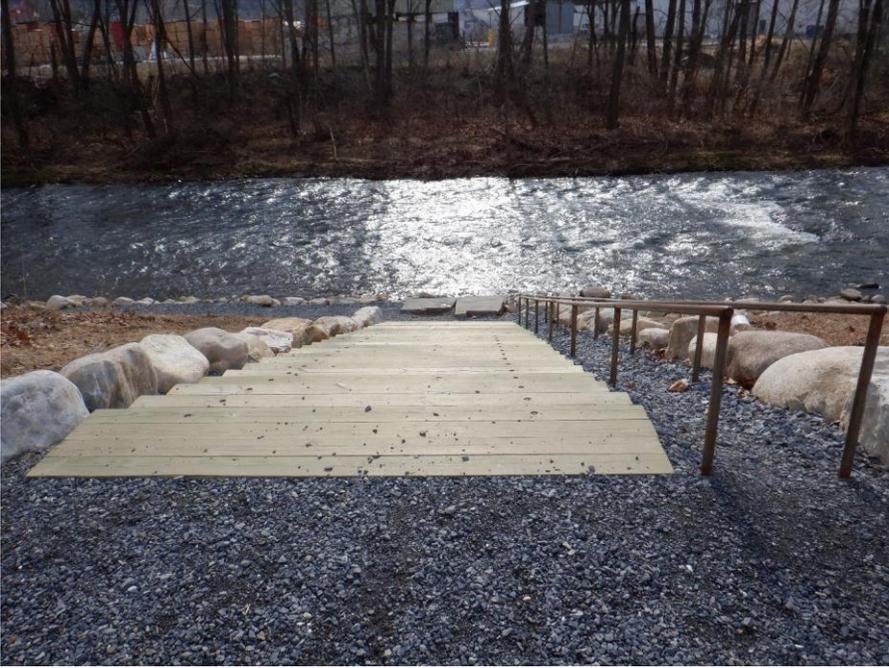
<p>Location: North Park</p> <hr/> <p>Photo Number: 95 Date: 1/19/2021</p> <hr/> <p>Direction Photo Taken: Southeast</p> <hr/> <p>Description: Top view of 1st constructed staircase (upstream) with kayak launch ramp</p>

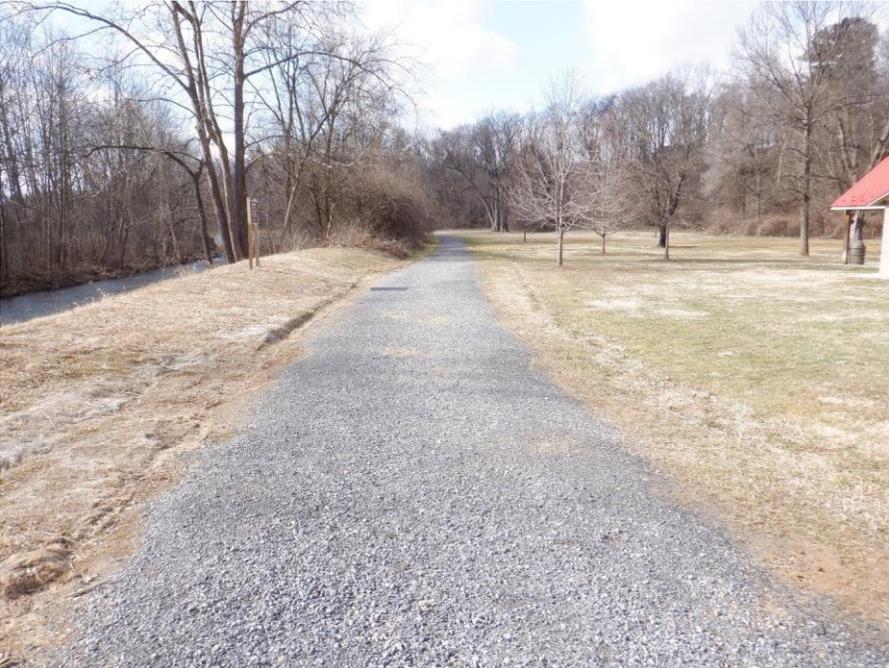
<p>Location: North Park</p> <hr/> <p>Photo Title: 96 Date: 1/19/2021</p> <hr/> <p>Direction Photo Taken: Southwest</p> <hr/> <p>Description: Greenway path upstream of 1st stairway access to river</p>

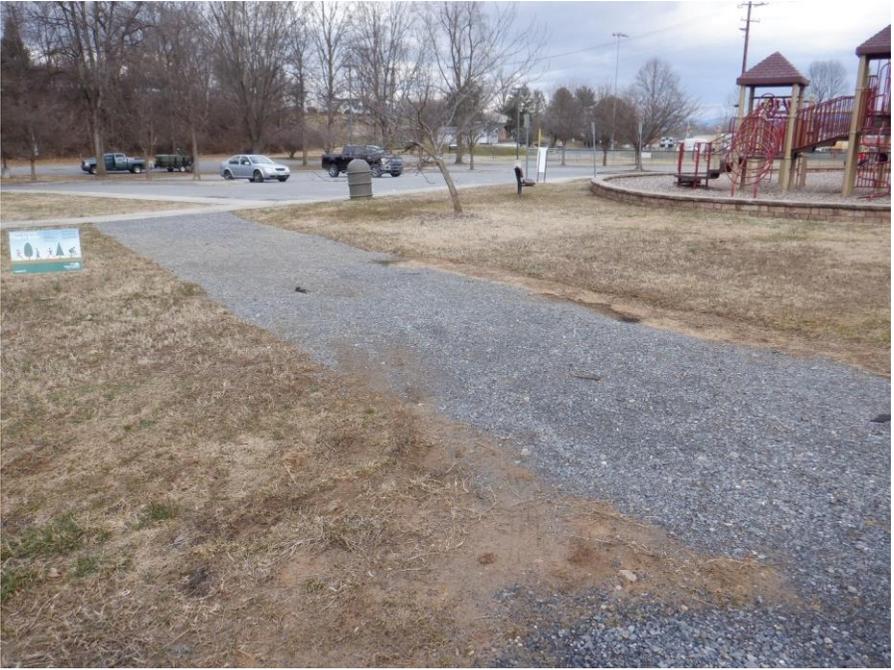
<p>Location: North Park</p> <hr/> <p>Photo Number: 97 Date: 1/19/2021</p> <hr/> <p>Direction Photo Taken: Northwest</p> <hr/> <p>Description: Access path from parking lot to Greenway to be paved</p>

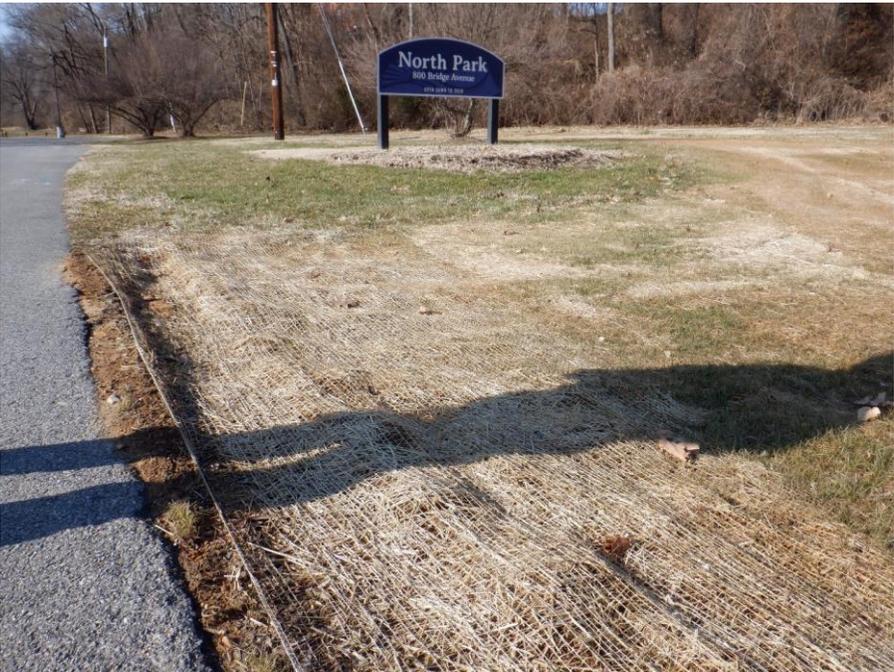
<p>Location: North Park</p> <hr/> <p>Photo Title: 98 Date: 1/19/2021</p> <hr/> <p>Direction Photo Taken: West</p> <hr/> <p>Description: Access pathway for construction equipment for North Park work seeded; vegetation establishing; tire marks along drive</p>

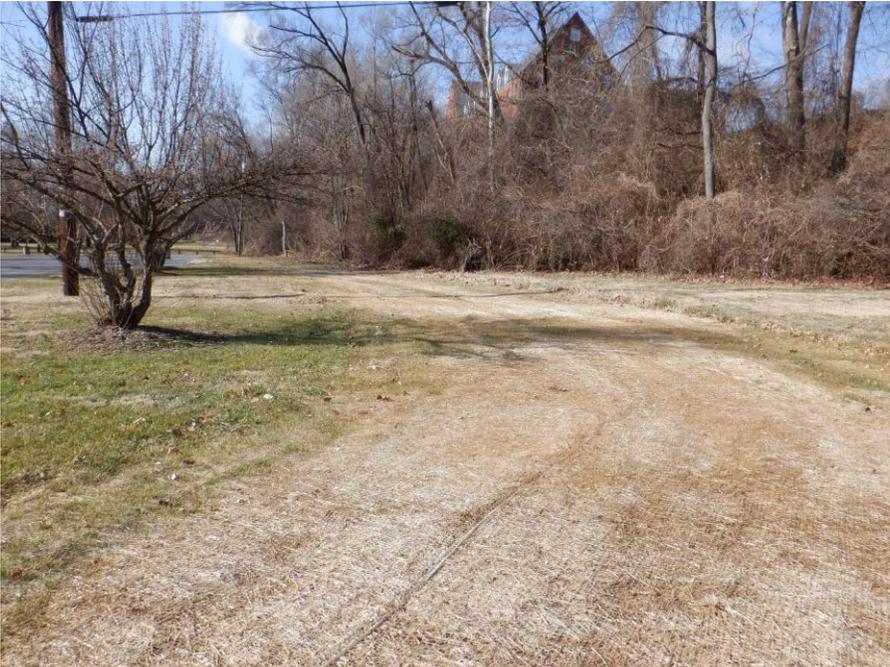
<p>Location: North Park</p> <hr/> <p>Photo Number: 99 Date: 1/19/2021</p> <hr/> <p>Direction Photo Taken: West</p> <hr/> <p>Description: Some vegetation establishing on construction vehicle access path; fabric intact</p>

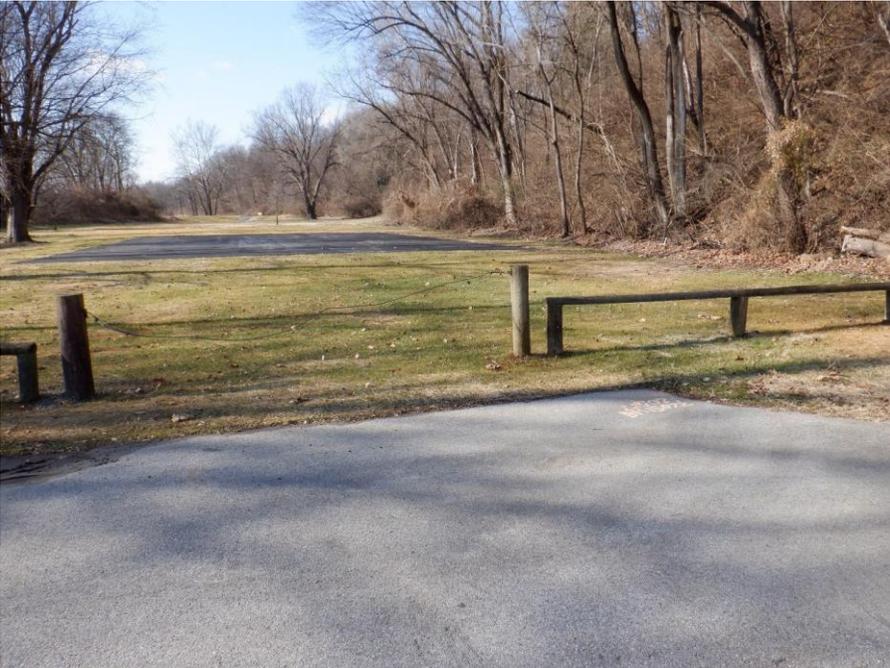
<p>Location: North Park</p> <hr/> <p>Photo Title: 100 Date: 1/19/2021</p> <hr/> <p>Direction Photo Taken: Southwest</p> <hr/> <p>Description: Installed fence and gate to green space in North Park; paved basketball court in background</p>

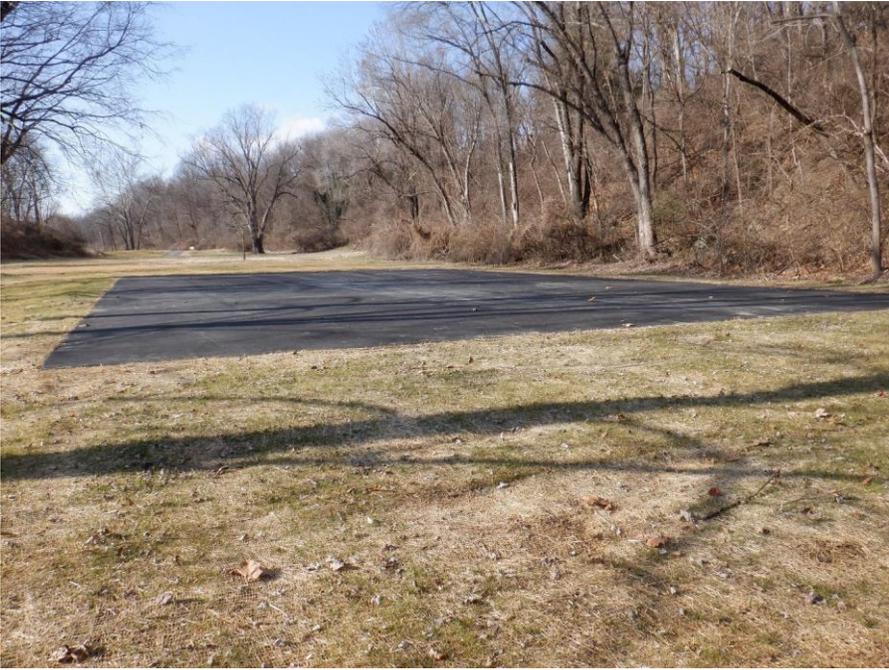
<p>Location: North Park</p> <hr/> <p>Photo Number: 101 Date: 1/19/2021</p> <hr/> <p>Direction Photo Taken: Southwest</p> <hr/> <p>Description: Paved basketball court; vegetation establishing</p>

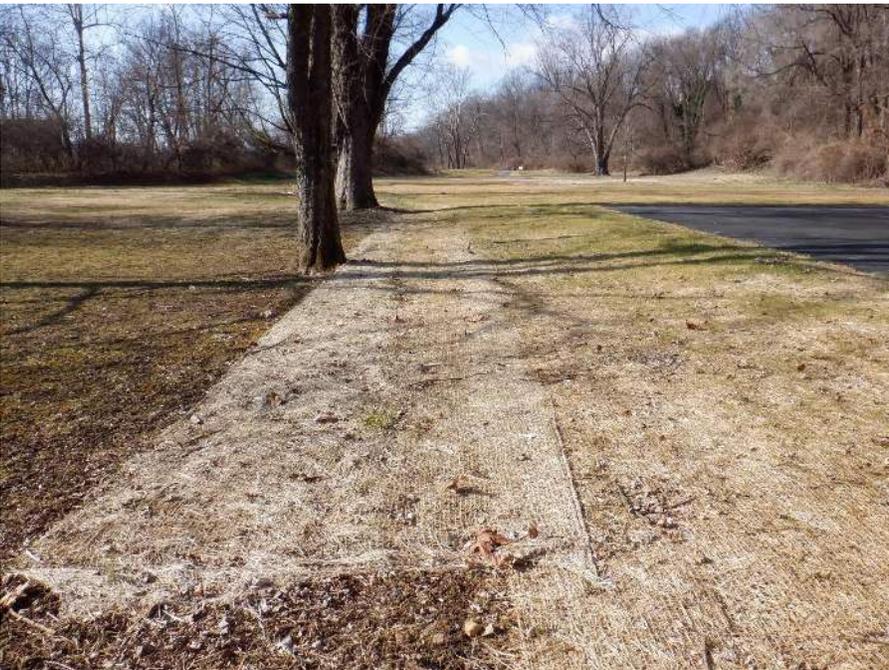
<p>Location: North Park</p> <hr/> <p>Photo Title: 102 Date: 1/19/2021</p> <hr/> <p>Direction Photo Taken: Southwest</p> <hr/> <p>Description: Edge of excavated section; fabric intact; vegetation establishing</p>

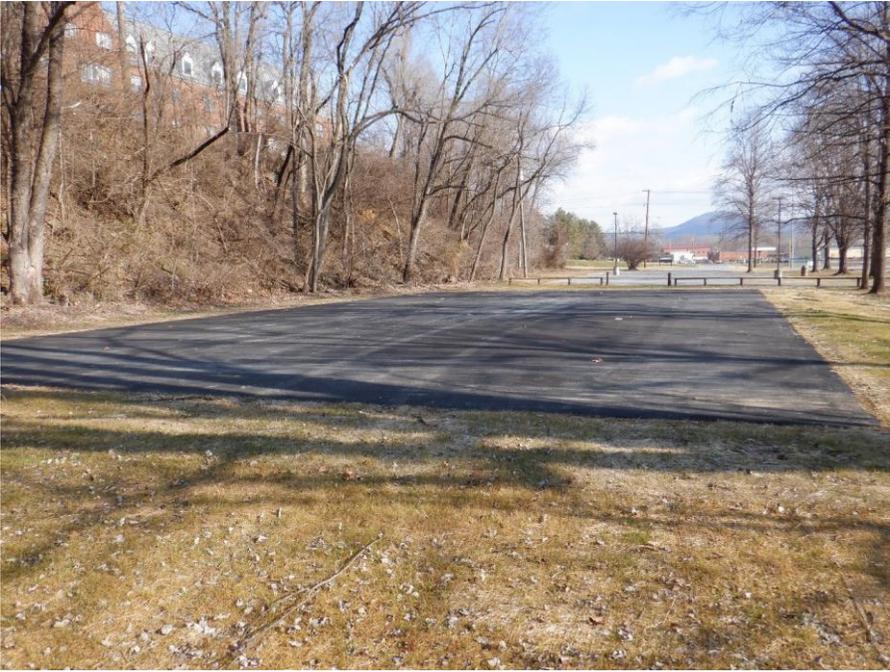
<p>Location: North Park</p> <hr/> <p>Photo Number: 103 Date: 1/19/2021</p> <hr/> <p>Direction Photo Taken: Northeast</p> <hr/> <p>Description: Paved basketball court; vegetation establishing</p>

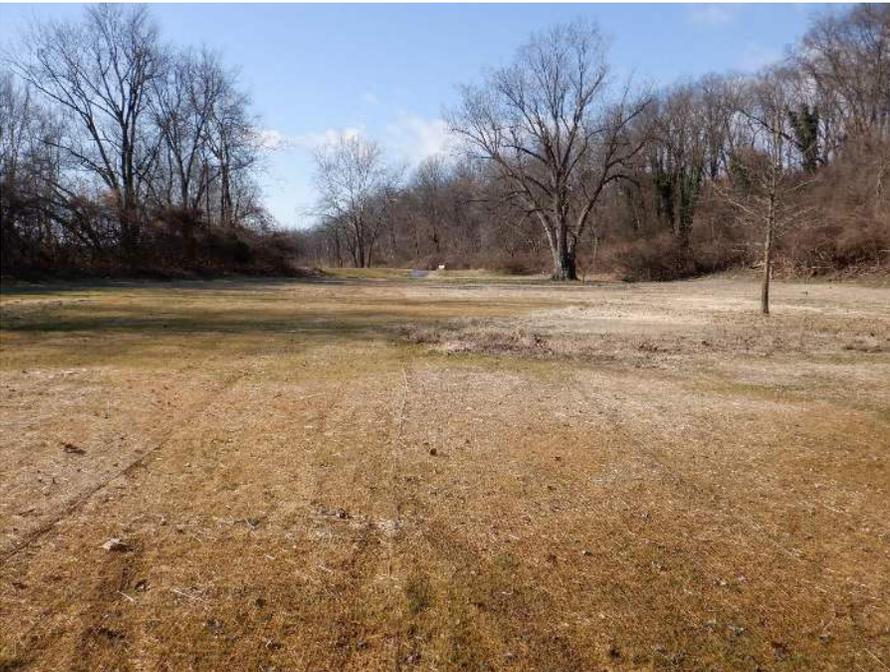
<p>Location: North Park</p> <hr/> <p>Photo Title: 104 Date: 1/19/2021</p> <hr/> <p>Direction Photo Taken: Southwest</p> <hr/> <p>Description: View of excavated green space in North Park; fabric intact; vegetation minimally established</p>

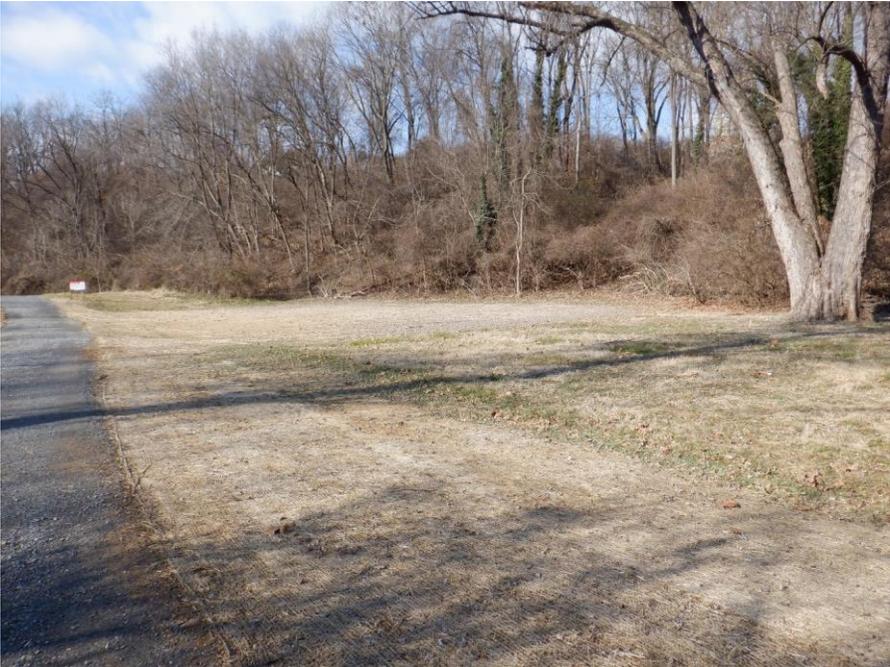
<p>Location: North Park</p> <hr/> <p>Photo Number: Date: 105 1/19/2021</p> <hr/> <p>Direction Photo Taken: West</p> <hr/> <p>Description: Green space along Greenway path; fabric intact; minimal vegetation establishing</p>

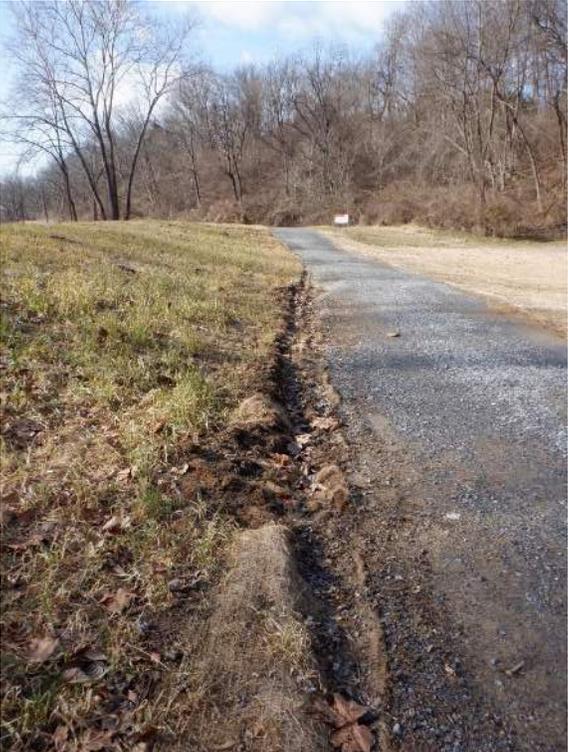
<p>Location: North Park</p> <hr/> <p>Photo Title: Date: 106 1/19/2021</p> <hr/> <p>Direction Photo Taken: Southwest</p> <hr/> <p>Description: Ruts made from vehicle along Greenway; vegetation establishing at top of remediated bank</p>

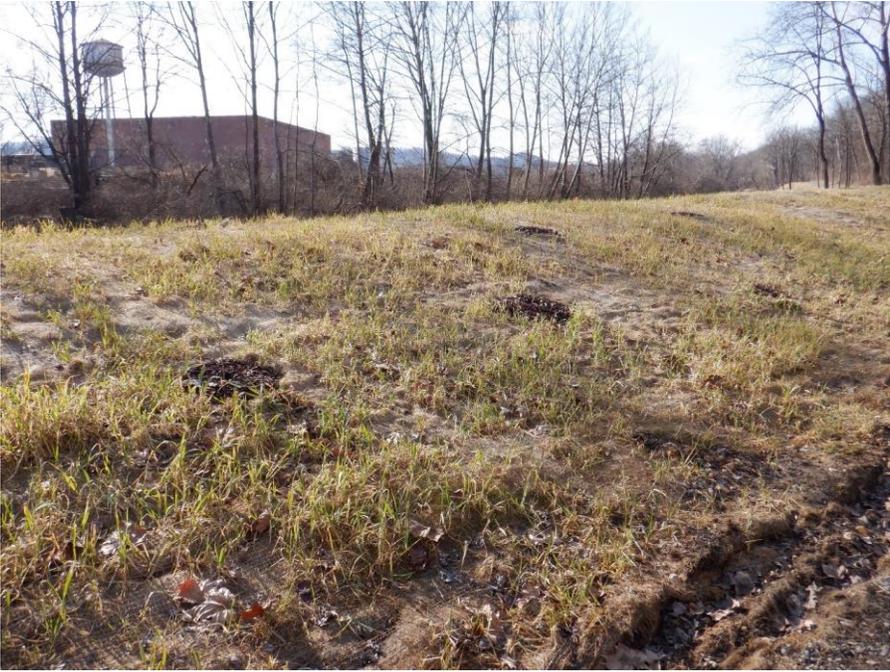
<p>Location: North Park</p> <hr/> <p>Photo Number: 107 Date: 1/19/2021</p> <hr/> <p>Direction Photo Taken: South</p> <hr/> <p>Description: Vegetation and plantings establishing along top of remediated bank next to Greenway</p>

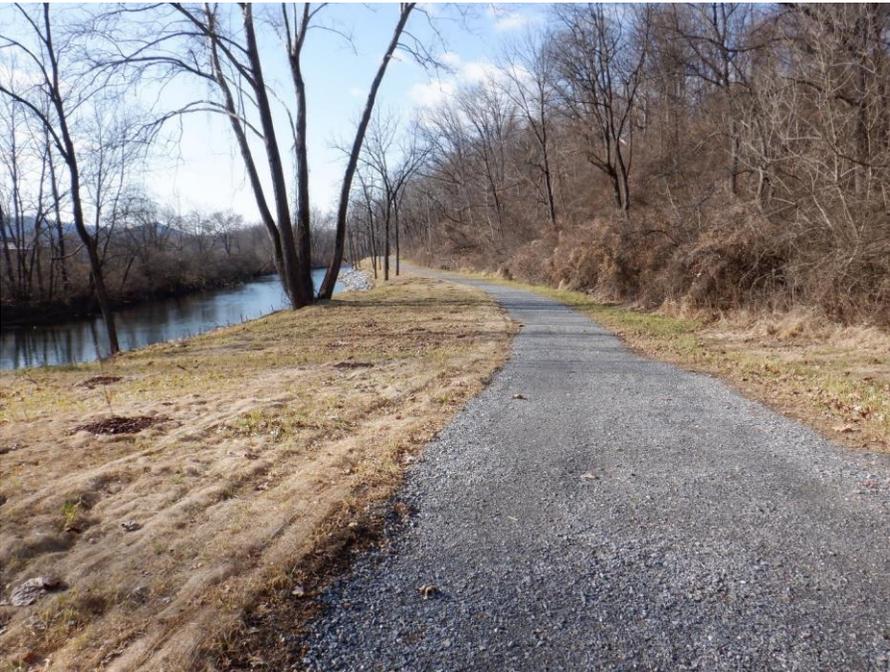
<p>Location: North Park</p> <hr/> <p>Photo Title: 108 Date: 1/19/2021</p> <hr/> <p>Direction Photo Taken: Southwest</p> <hr/> <p>Description: Greenway along 1st remediated bank section of BMA to be paved; fabric intact; vegetation and plantings establishing</p>

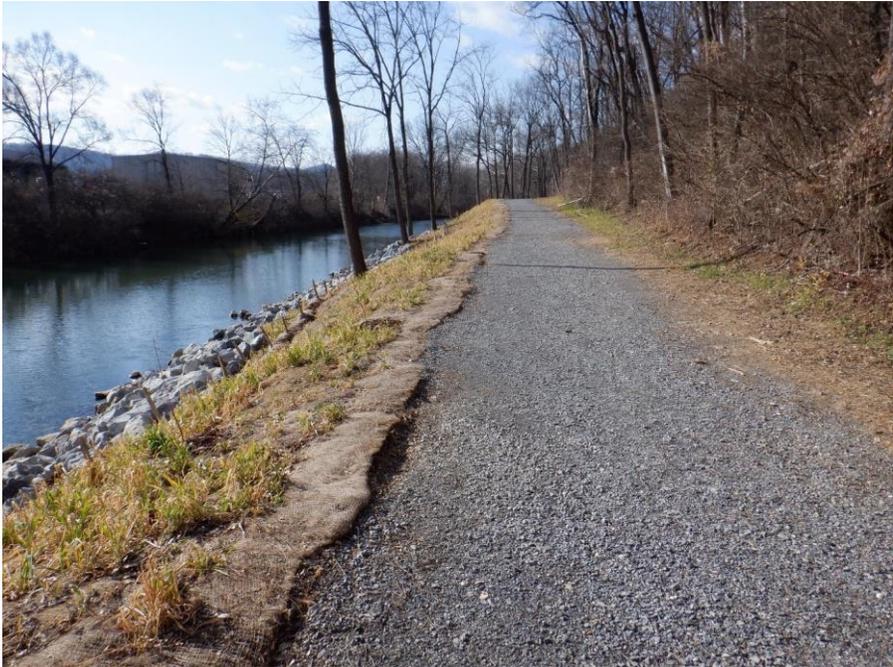
<p>Location: North Park</p> <hr/> <p>Photo Number: Date: 109 1/19/2021</p> <hr/> <p>Direction Photo Taken: Southwest</p> <hr/> <p>Description: Greenway to be paved above 1st remediated bank section; vegetation establishing along Greenway; fabric intact</p>

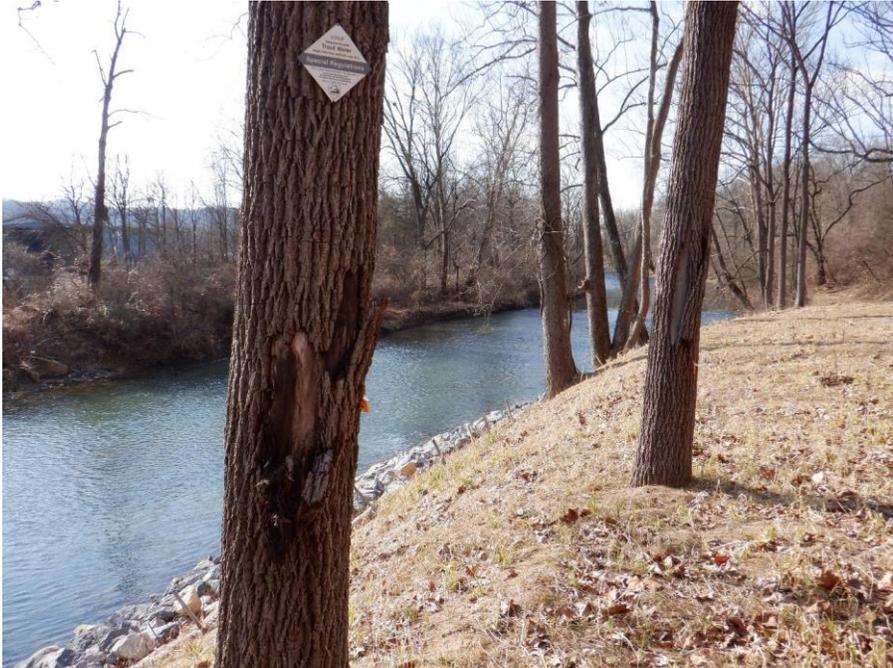
<p>Location: North Park</p> <hr/> <p>Photo Title: Date: 110 1/19/2021</p> <hr/> <p>Direction Photo Taken: South</p> <hr/> <p>Description: Damage to bark to tree along Greenway</p>

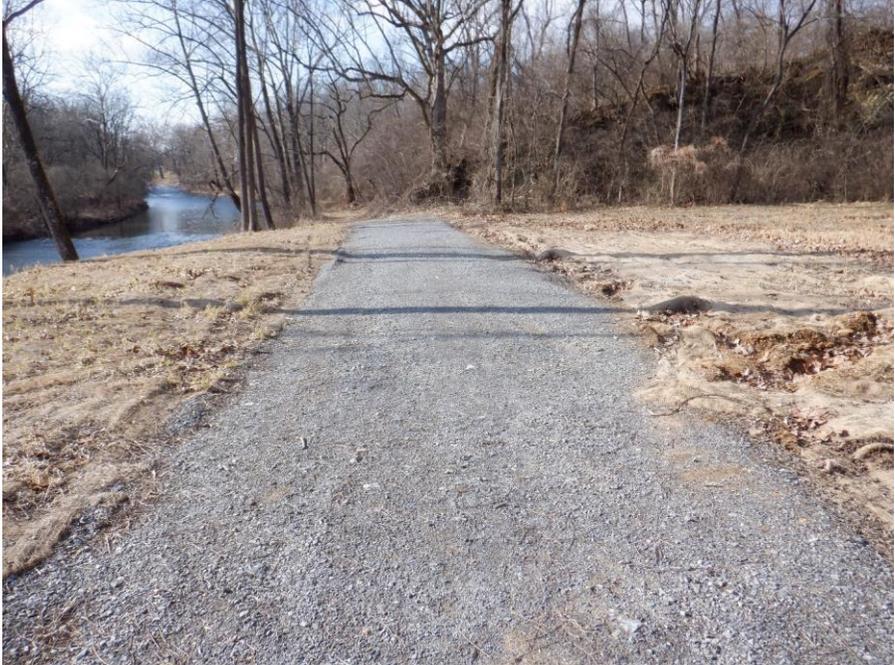
<p>Location: North Park</p> <hr/> <p>Photo Number: Date: 111 1/19/2021</p> <hr/> <p>Direction Photo Taken: Southwest</p> <hr/> <p>Description: Greenway path at upstream portion of BMA to be paved; minimal vegetation establishing; fabric intact</p>

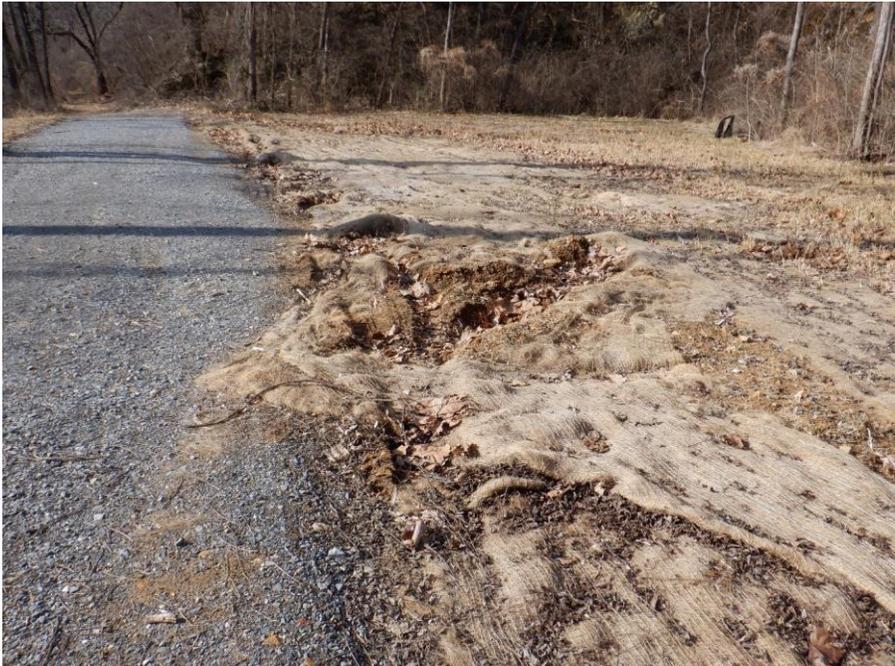
<p>Location: North Park</p> <hr/> <p>Photo Title: Date: 112 1/19/2021</p> <hr/> <p>Direction Photo Taken: Southwest</p> <hr/> <p>Description: Ruts made from vehicle along Greenway path; fabric torn; minimal vegetation establishing</p>

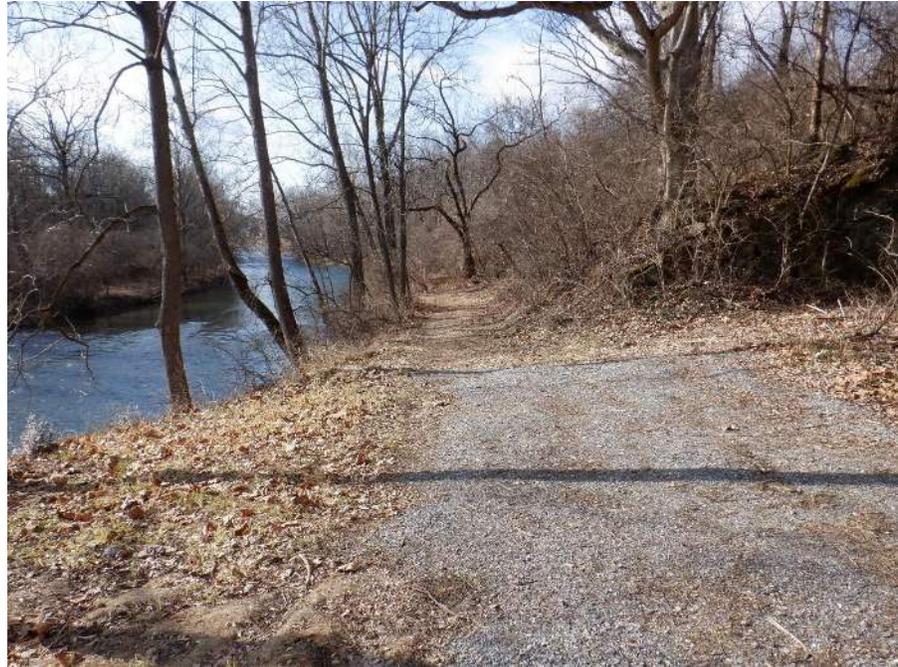
Location:
North Park

Description:
End of top portion of upstream remediated section; vegetation establishing; Greenway to be extended and paved to meet with Shiloh Baptist Church portion of remediation
