**Re: 2021 Leaf-on and Leaf-off Maintenance Inspections  
Former DuPont Waynesboro Site AOC 4  
Waynesboro, Virginia  
EPA ID# VAD003114832**

## Memorandum

Subject 2021 Leaf-on Maintenance Inspection  
Former DuPont Waynesboro Site, Area of Concern 4

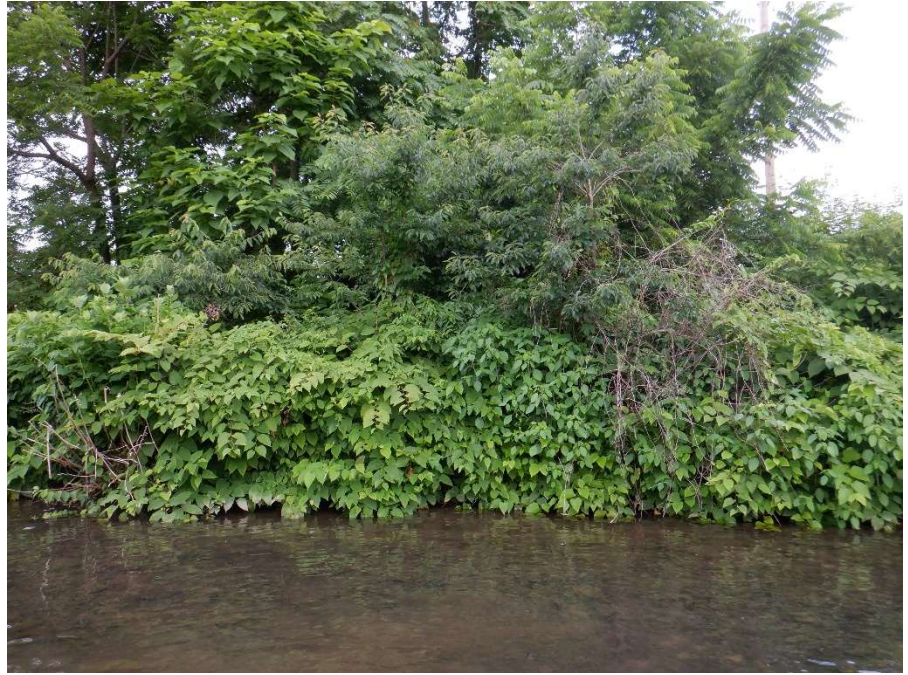
**Location:**  
00-25'

**Description:**  
~20 degree lower bank angle and 55 degree upper bank angle; Persimmon saplings adjacent to water's edge; invasive knotweed has become established; some erosion at water's edge with minimal scour.

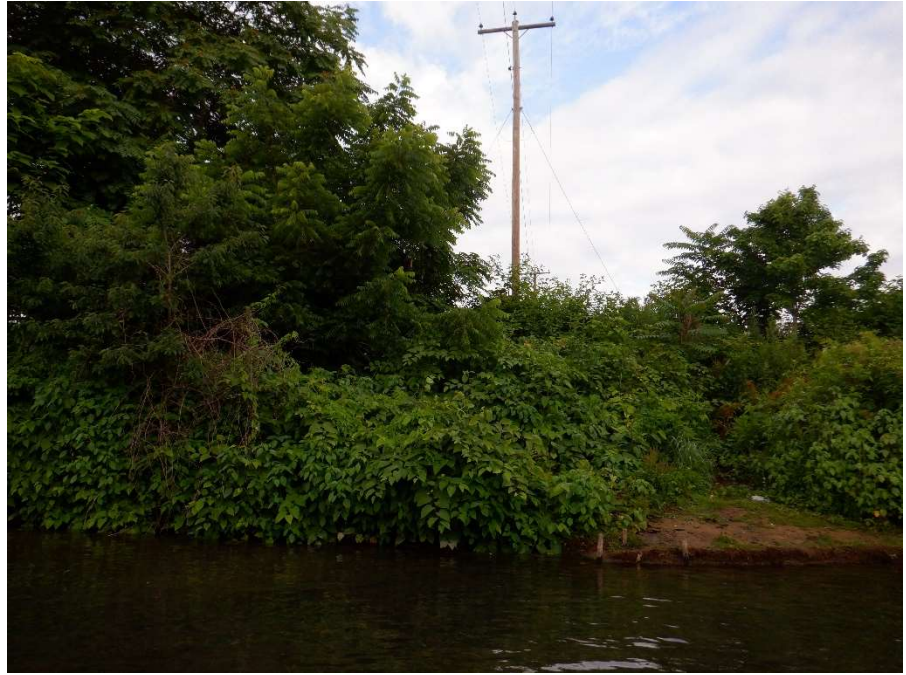
**Location:**  
00+00'

**Description:**  
~30 degree lower bank angle and 55 degree upper bank angle; No live stakes have established; No trees adjacent to water; coir logs intact; some erosion control fabric exposed; vegetation established; exposed geocell at constructed gravel access path.

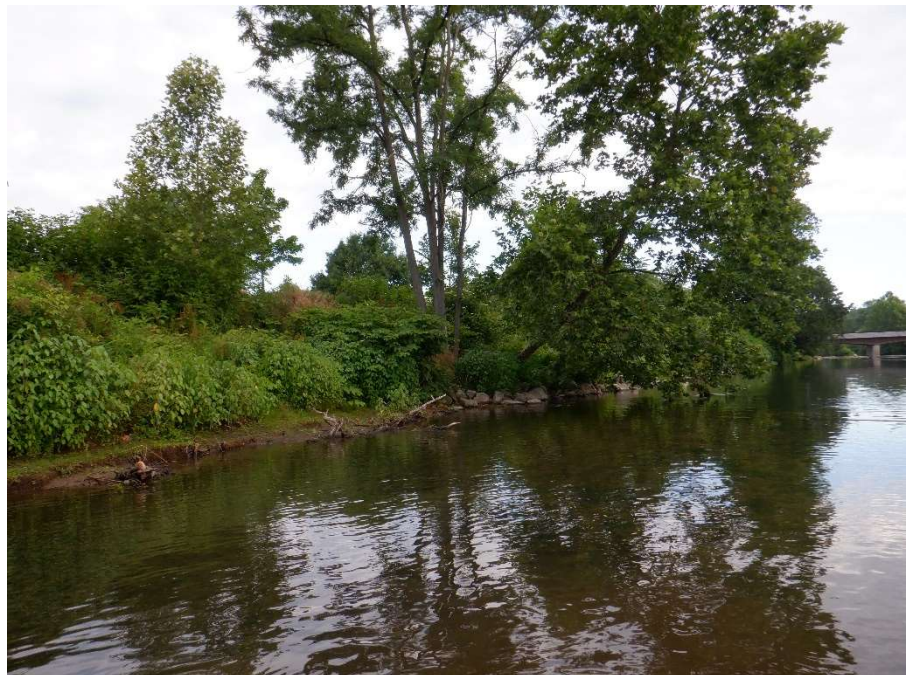
**Description:**  
Slight scour; Exposed geocell along constructed river access path.

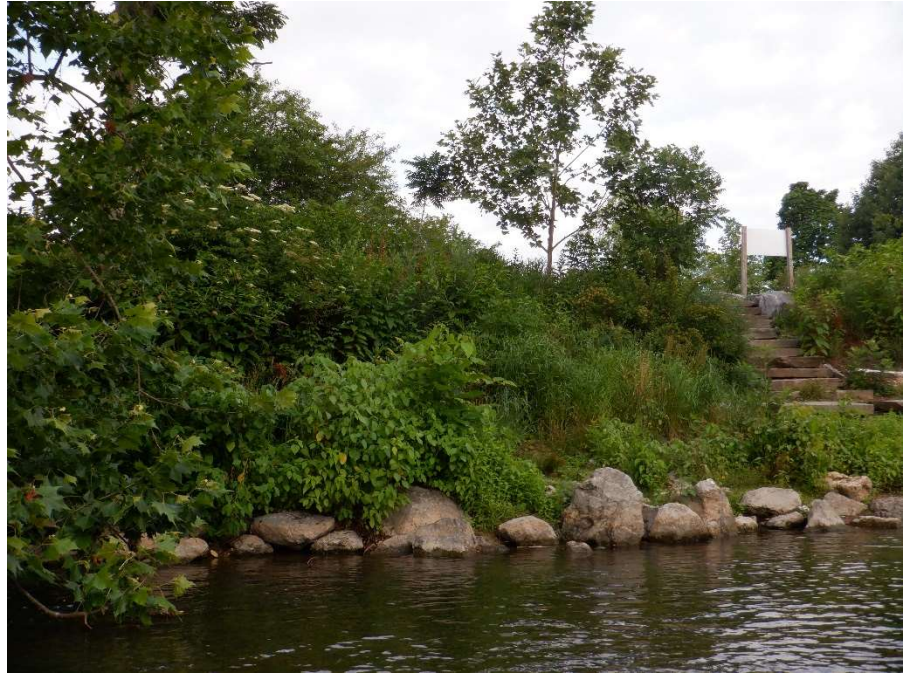
**Location:**  
00+100'

**Description:**  
~45 degree bank angle; no live stakes not visible; plantings establishing- mostly elderberry; vegetation established-mostly jewelweed; staircase intact; sediment deposition around rock toe; installed rock toe intact; no geocell or erosion fabric visible.

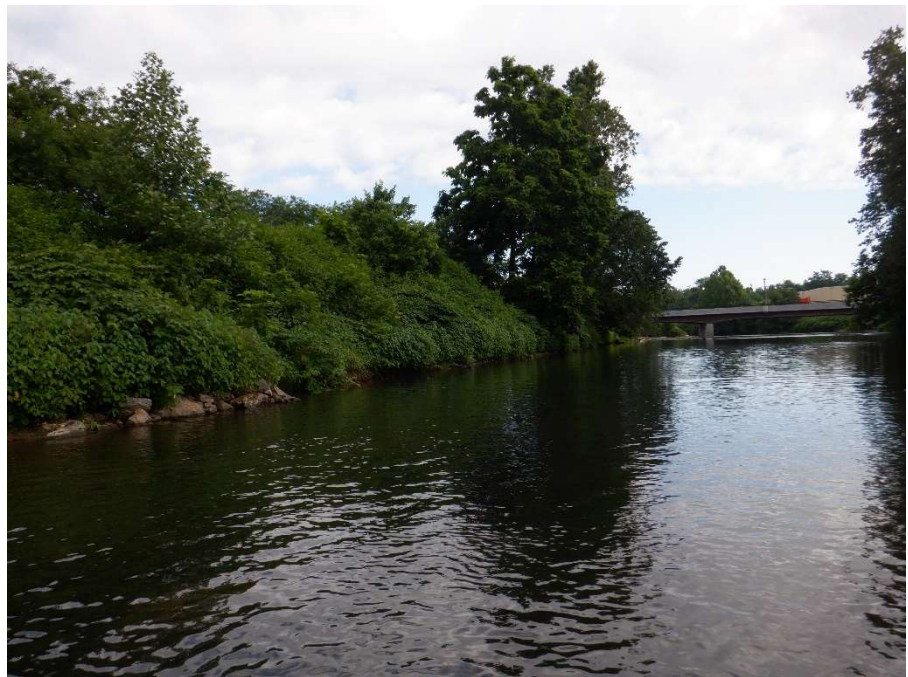
**Description:**  
Downstream view; rock toe, no erosion control fabric or geocell exposed.

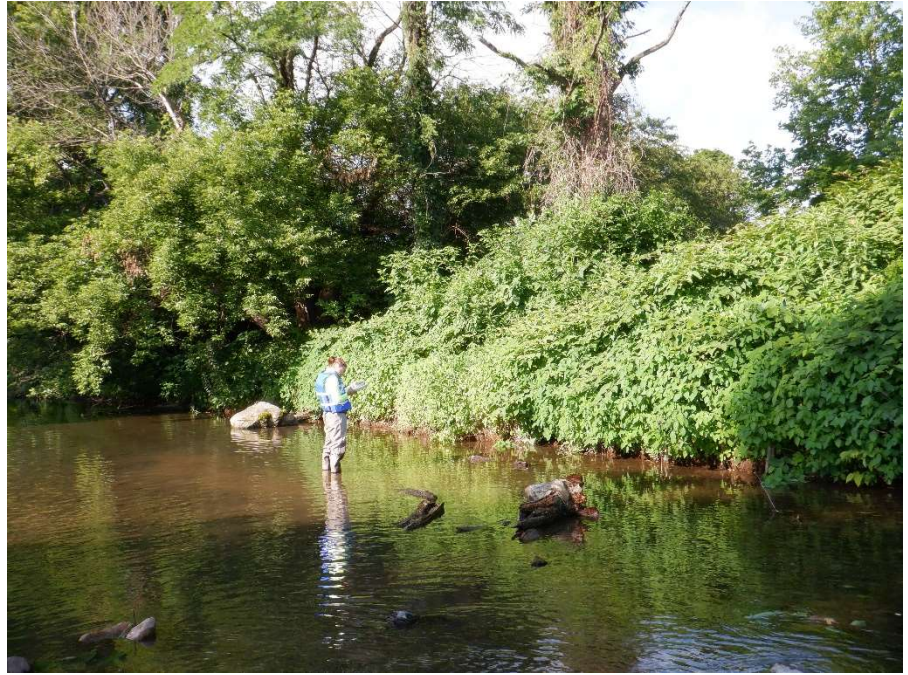
**Location:**  
00+525'

**Description:**  
Invasive knotweed cover  
~40%.

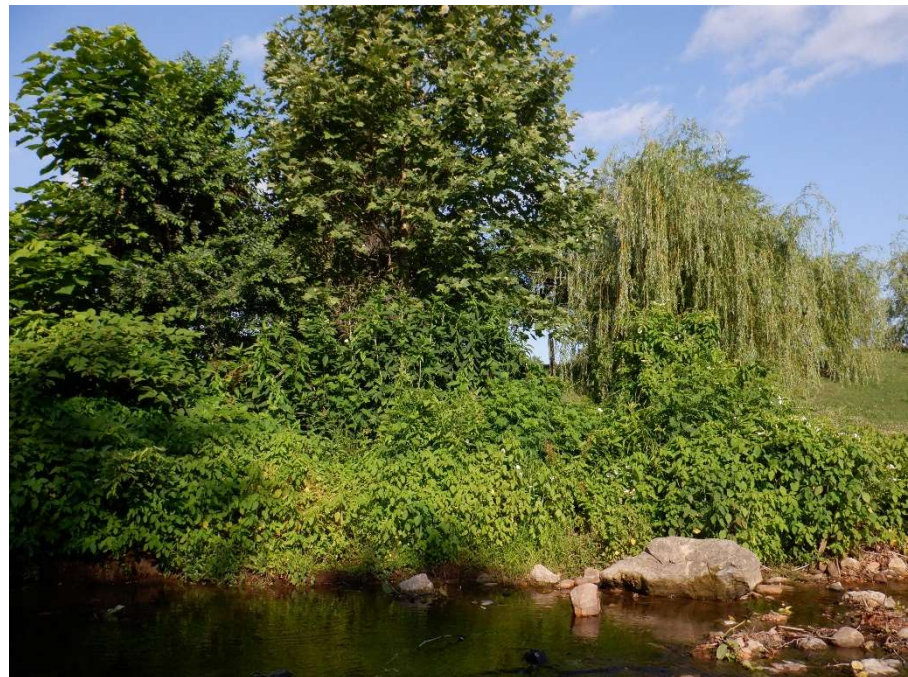
**Description:**  
~15 degree bank angle; no  
exposed roots; native  
vegetation established-  
sycamore, locust, American  
elm, jewelweed, curly dock,  
elderberry; invasive  
knotweed ~5% cover.

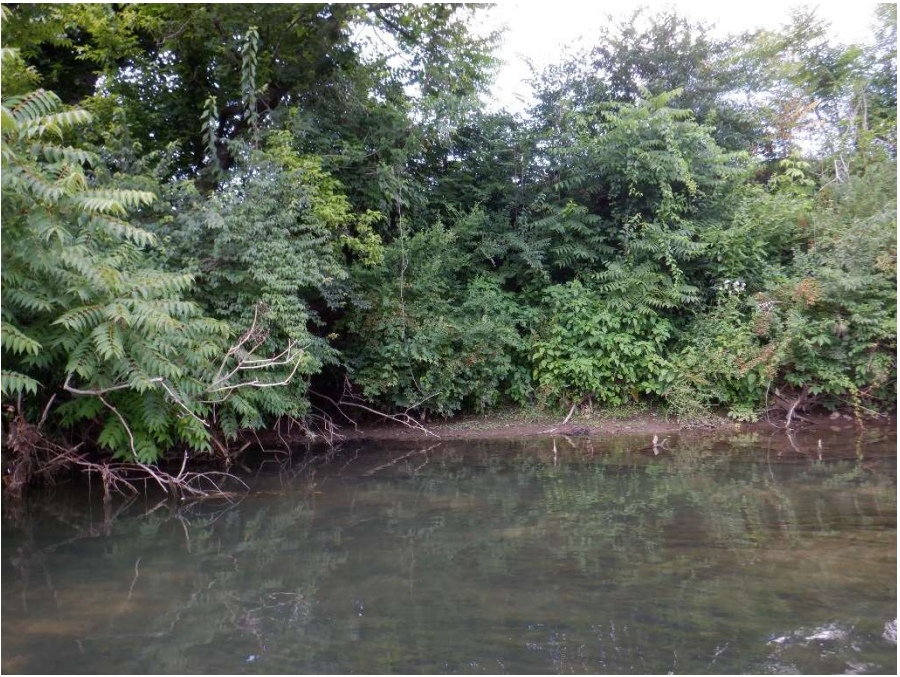
<p><b>Location:</b> Station 00-25'</p> <hr/> <p><b>Photo Number:</b>      <b>Date:</b> 1                              6/22/2021</p> <hr/> <p><b>Direction Photo Taken:</b> Northwest</p> <hr/> <p><b>Description:</b> 85 degree bank angle; at risk trees present - box elder; scour present throughout; 80% vegetated - 50% honeysuckle, Ailanthus saplings.</p>

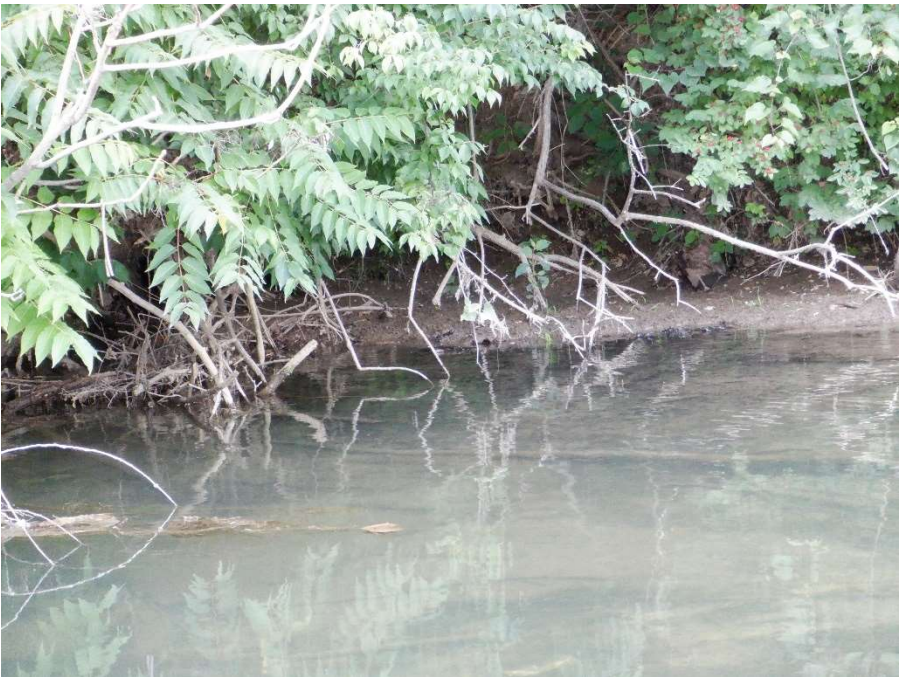
<p><b>Location:</b> Station 00-25'</p> <hr/> <p><b>Photo Title:</b>              <b>Date:</b> 2                              6/22/2021</p> <hr/> <p><b>Direction Photo Taken:</b> Northwest</p> <hr/> <p><b>Description:</b> High quantity of roots exposed on the bank; at risk trees present-box elder; scour present throughout.</p>

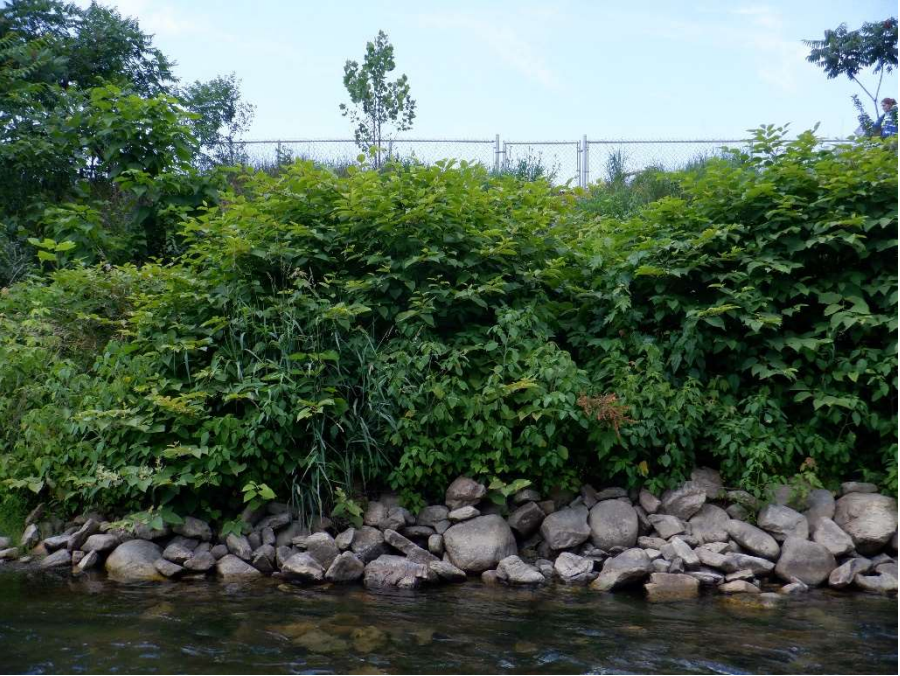
<p><b>Location:</b> Station 00-200'</p> <hr/> <p><b>Photo Title:</b>              <b>Date:</b> 10                              6/22/2021</p> <hr/> <p><b>Direction Photo Taken:</b> Northwest</p> <hr/> <p><b>Description:</b> 45 degree bank angle; predominantly native vegetation along top of rock toe-sumac ~60% cover; large patches of invasive knotweed present ~75% cover. access stairs covered by knotweed; No woody plants adjacent to edge of water; erosion control fabric 20% exposed on upper bank. Rock stairs and gate present on upper half of bank; No scour present along rock toe.</p>

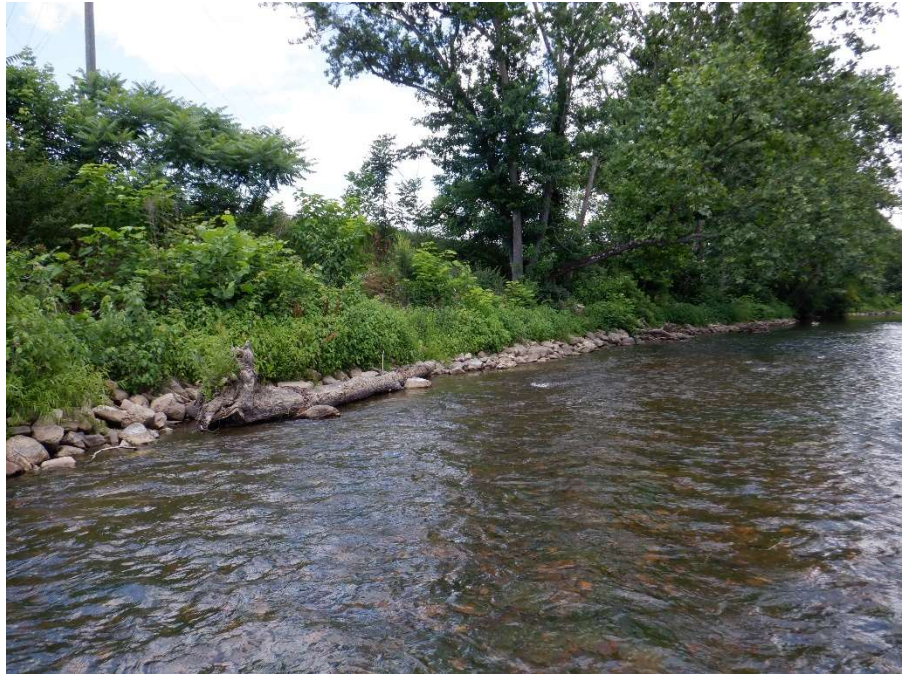
<p><b>Location:</b> Station 00-200'</p> <hr/> <p><b>Photo Number:</b>      <b>Date:</b> 11                              6/22/2021</p> <hr/> <p><b>Direction Photo Taken:</b> North</p> <hr/> <p><b>Description:</b> Downstream view of location; Predominantly native vegetation along top of rock toe; erosion control fabric 20% exposed on upper bank. Rock stairs and gate present on upper half of bank; No scour present along rock toe; outfall pipe present within rock toe.</p>

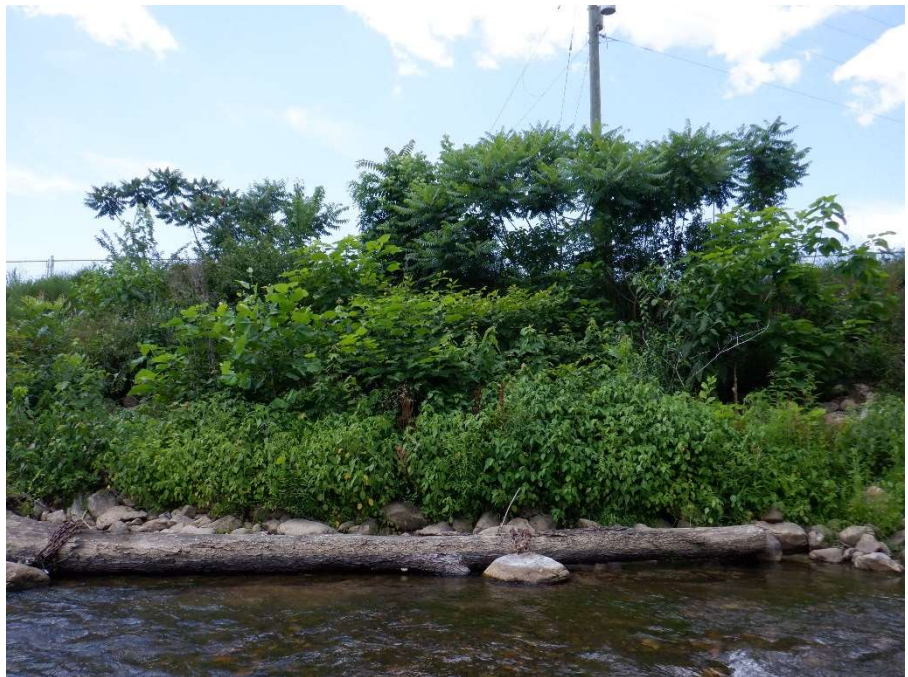
<p><b>Location:</b> Station 00-250'</p> <hr/> <p><b>Photo Title:</b>              <b>Date:</b> 12                              6/22/2021</p> <hr/> <p><b>Direction Photo Taken:</b> Northwest</p> <hr/> <p><b>Description:</b> 45 degree bank angle; Predominantly native vegetation along top of rock toe-sumacs 15-20' tall, pokeberry, jewelweed; invasive knotweed present ~20% cover; no woody plants adjacent to edge of water; erosion control fabric 40% exposed; LWD intact; no scour present along rock toe.</p>

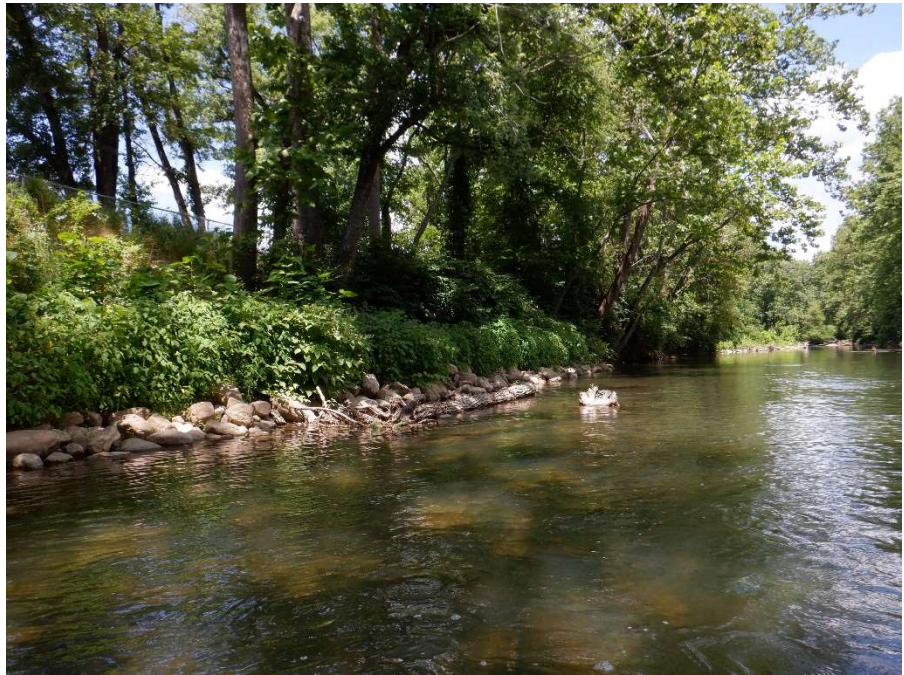
**Description:**  
Downstream view of location; predominantly native vegetation along top of rock toe, erosion control fabric exposed on upper bank; upstream LWD has shifted and is parallel with another piece of installed LWD downstream of 00 +400'; no scour present along rock toe.

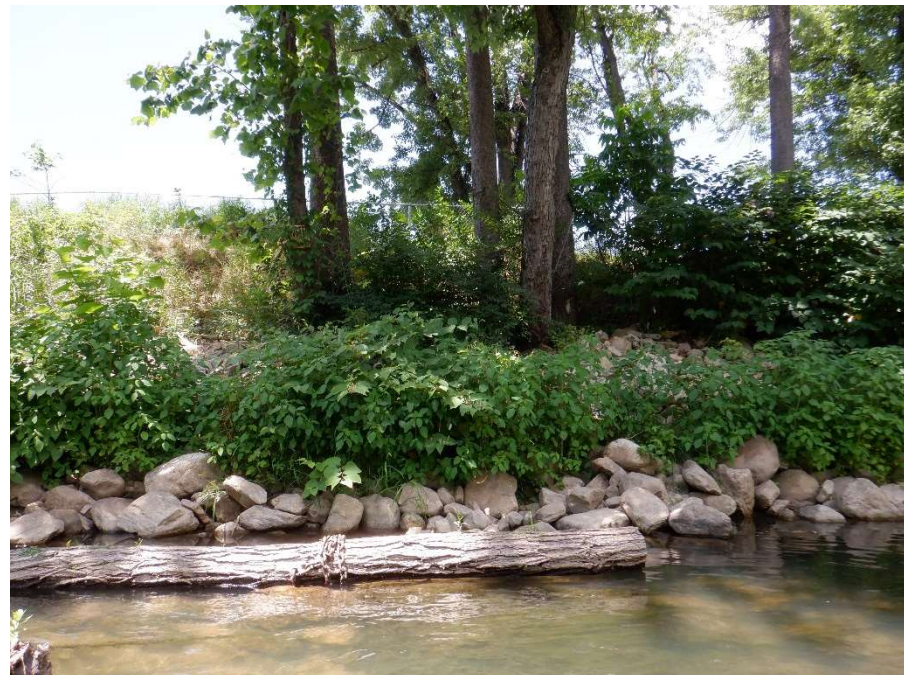
**Description:**  
45 degree bank angle; native vegetation along top of rock toe-4 sycamores, and 1 silver maple; some large trees present; small patches of invasive knotweed present ~25% cover; no at risk trees present; no erosion control fabric exposed at top of bank and around tree bases; no geocell exposed, grasses present; no scour present along rock toe.

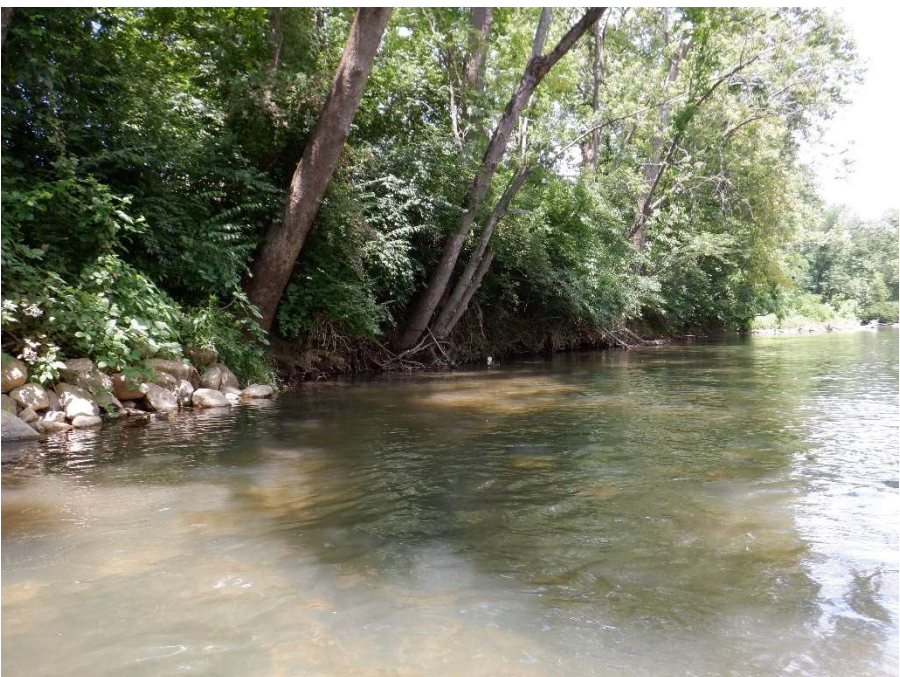
<p><b>Location:</b> Station 00-500'</p> <hr/> <p><b>Photo Title:</b>              <b>Date:</b> 20                              6/22/2021</p> <hr/>

<p><b>Direction Photo Taken:</b> North</p> <hr/>	
<p><b>Description:</b> Downstream view of location; no at risk trees present; no erosion control fabric or geocell exposed ; no scour present along rock toe.</p>

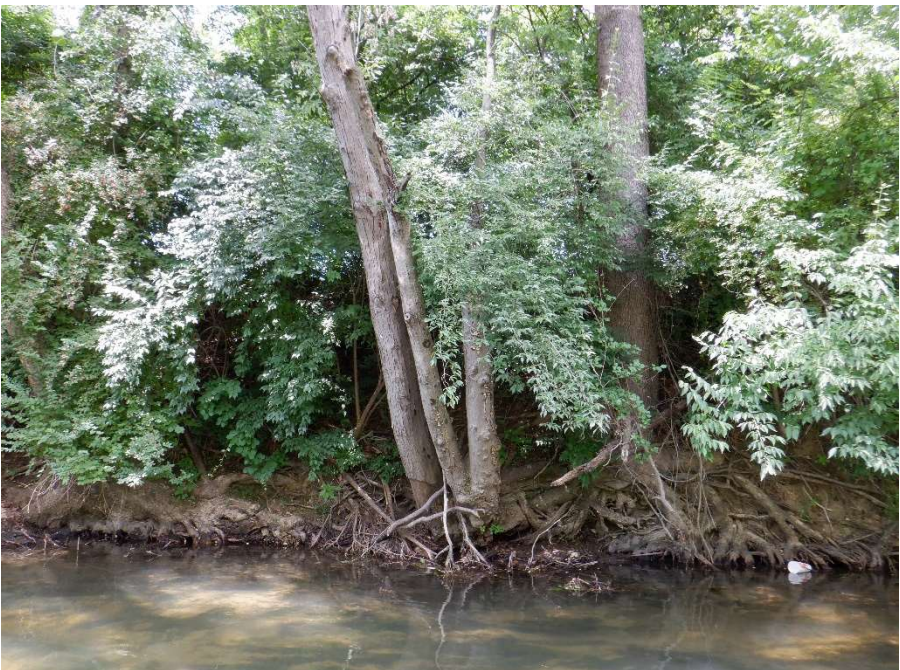
<p><b>Location:</b> Station 00-550'</p> <hr/> <p><b>Photo Title:</b>              <b>Date:</b> 22                      6/22/2021</p> <hr/> <p><b>Direction Photo Taken:</b> Northwest</p> <hr/> <p><b>Description:</b> 70 degree bank angle; lower bank consists mostly of exposed roots; several large trees with exposed roots hanging over the river-silver maple and sycamore, invasive honeysuckle is at risk; section was not remediated; entire lower bank shows large amounts of scour.</p>

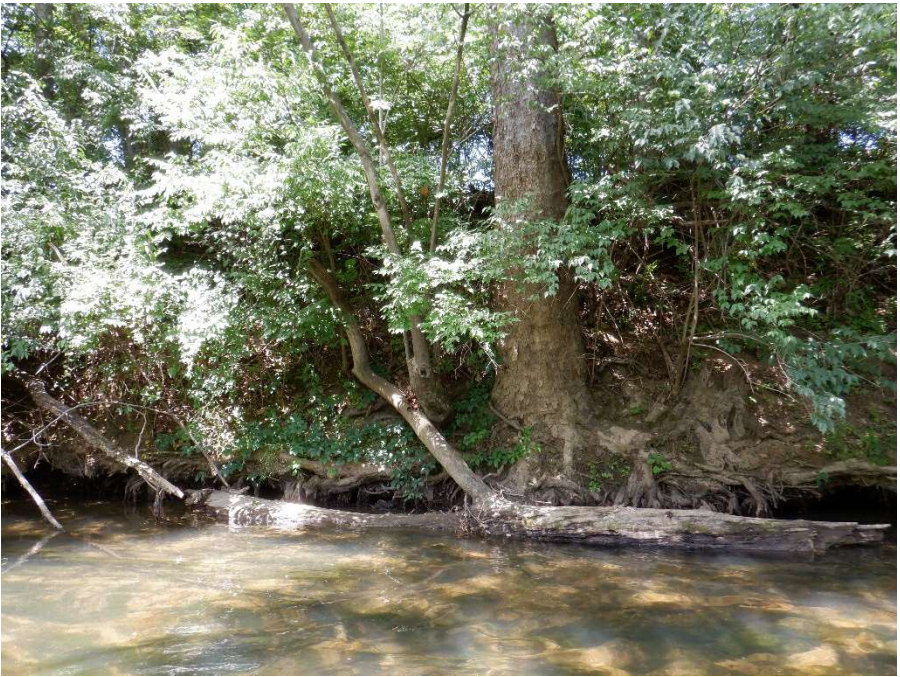
<p><b>Location:</b> Station 00-600'</p> <hr/> <p><b>Photo Number:</b>      <b>Date:</b> 23                              6/22/2021</p> <hr/> <p><b>Direction Photo Taken:</b> Northwest</p> <hr/> <p><b>Description:</b> 75 degree bank angle; lower bank consists mostly of exposed roots; many exposed roots along the lower bank, at risk trees include: silver maple, hackberry, and sycamore; section was not remediated; entire lower bank shows large amounts of scour.</p>

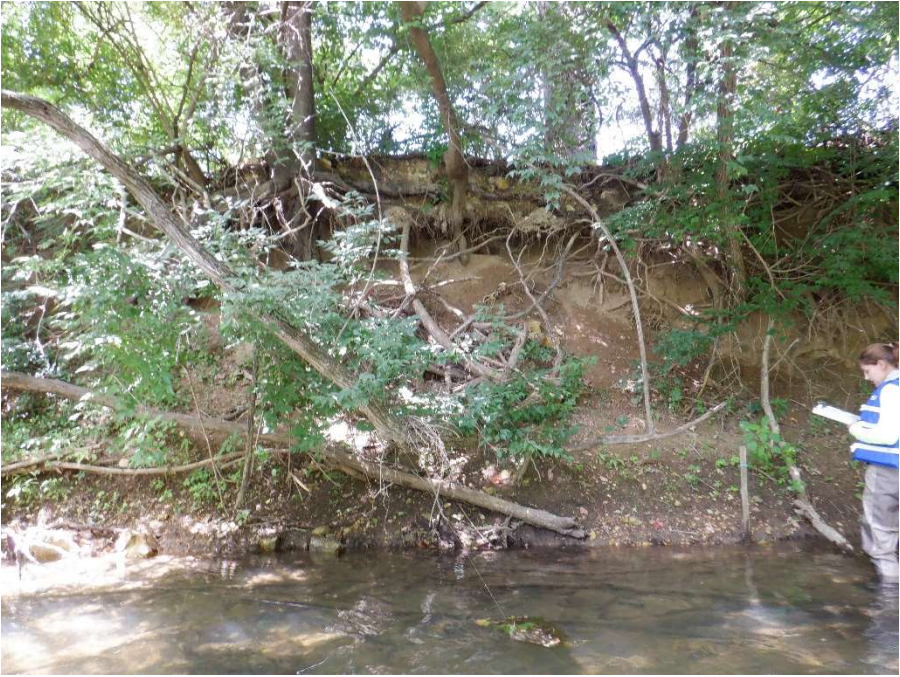
<p><b>Location:</b> Station 00-650'</p> <hr/> <p><b>Photo Title:</b>              <b>Date:</b> 24                              6/22/2021</p> <hr/> <p><b>Direction Photo Taken:</b> Northwest</p> <hr/> <p><b>Description:</b> 85 degree bank angle; Bank consists mostly of exposed roots, strip of jewelweed at toe of slope; at risk trees present along the upper bank- hackberry, invasive honeysuckle and black locust; section was not remediated; entire bank shows large amounts of scour; exposed soil at toe.</p>

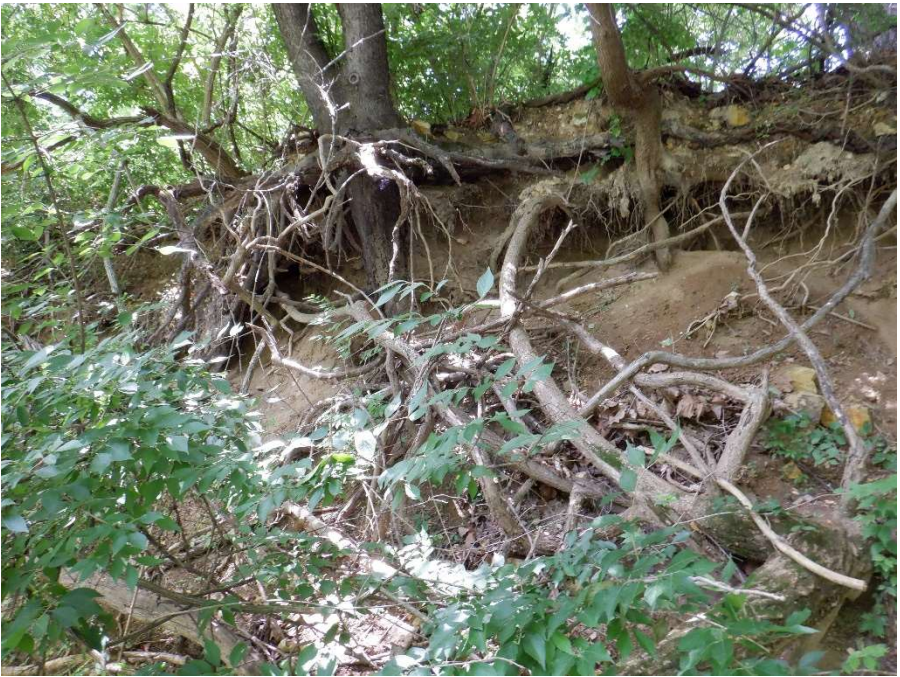
<p><b>Location:</b> Station 00-650'</p> <hr/> <p><b>Photo Number:</b>      <b>Date:</b> 25                      6/22/2021</p> <hr/> <p><b>Direction Photo Taken:</b> Northwest</p> <hr/> <p><b>Description:</b> 85 degree bank angle; bank consists mostly of exposed roots; at risk trees present along the upper bank; section was not remediated.</p>

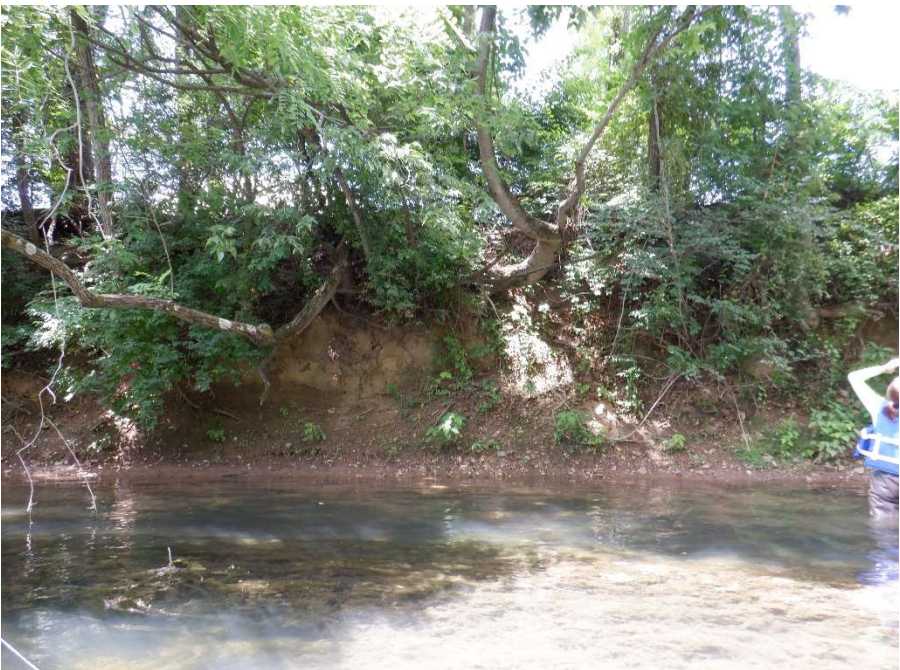
<p><b>Location:</b> Station 00-700'</p> <hr/> <p><b>Photo Title:</b>              <b>Date:</b> 26                      6/22/2021</p> <hr/> <p><b>Direction Photo Taken:</b> Northwest</p> <hr/> <p><b>Description:</b> 90 degree bank angle; bank consists mostly of exposed roots, with some vegetation growing on slope; At risk trees present along the upper bank- hackberry, invasive honeysuckle and black locust; Section was not remediated; Entire bank shows large amounts of scour. Exposed soil at toe.</p>

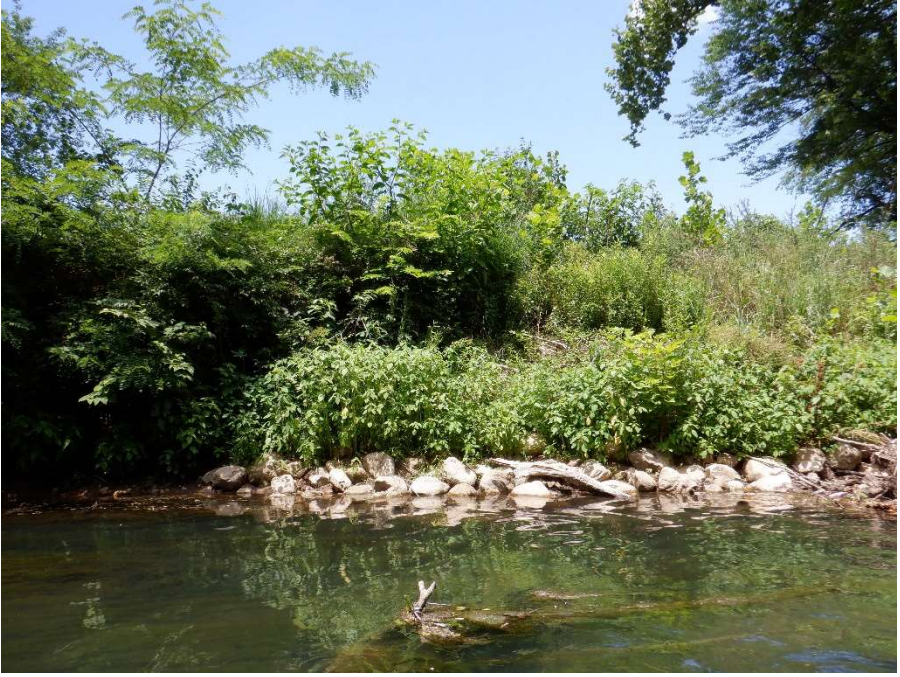
<p><b>Location:</b> Station 00-750'</p> <hr/> <p><b>Photo Number:</b>      <b>Date:</b> 27                      6/22/2021</p> <hr/> <p><b>Direction Photo Taken:</b> Northwest</p> <hr/> <p><b>Description:</b> 90 degree bank angle; Beginning of second remediated area; upstream bank; ~90 degrees, downstream bank; ~45 degrees; upper bank upstream of the remediation consists mostly of exposed roots, invasive Japanese knotweed ~2% cover, also present is black locust, Jewelweed ~10% cover, willow ~25% cover, and pokeweed ~20% cover; at risk trees present upstream of rock toe-Catalpa; large amounts of scour above rock toe.</p>

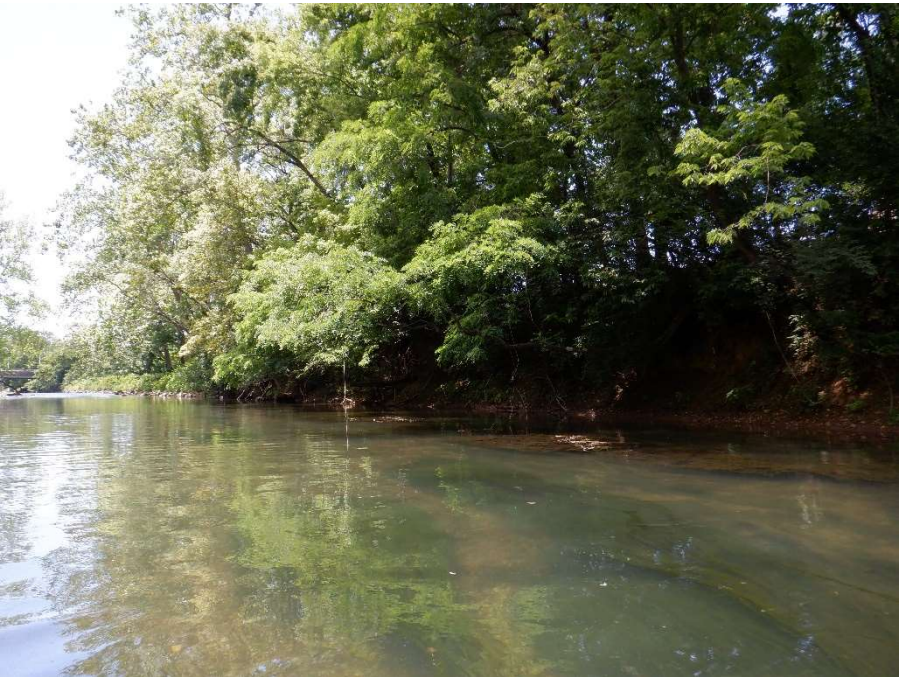
<p><b>Location:</b> Station 00-750'</p> <hr/> <p><b>Photo Title:</b>              <b>Date:</b> 28                      6/22/2021</p> <hr/> <p><b>Direction Photo Taken:</b> West</p> <hr/> <p><b>Description:</b> Upstream view of location; beginning of second remediated area; at risk trees present upstream of rock toe-Catalpa; Beginning of second remediated section; Large amounts of scour above rock toe.</p>

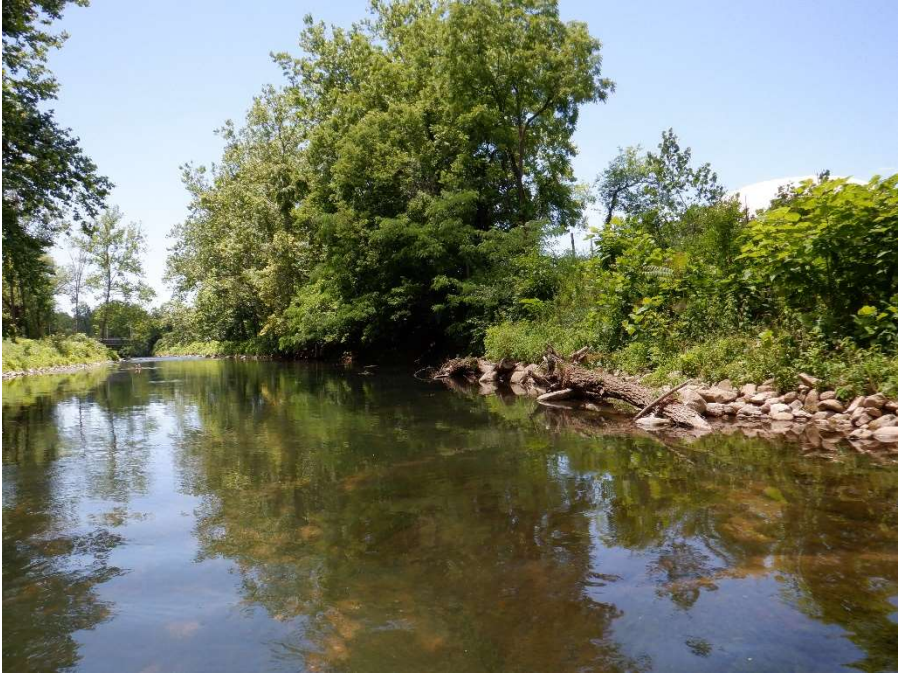
<p><b>Location:</b> Station 00-850'</p> <hr/> <p><b>Photo Number:</b>      <b>Date:</b> 33                      6/22/2021</p> <hr/> <p><b>Direction Photo Taken:</b> West</p> <hr/> <p><b>Description:</b> Upstream view of location; planted vegetation well established above rock toe; no at risk trees present; erosion control fabric primarily covered in vegetation; LWD moved from its installed position. No scour present along rock toe.</p>

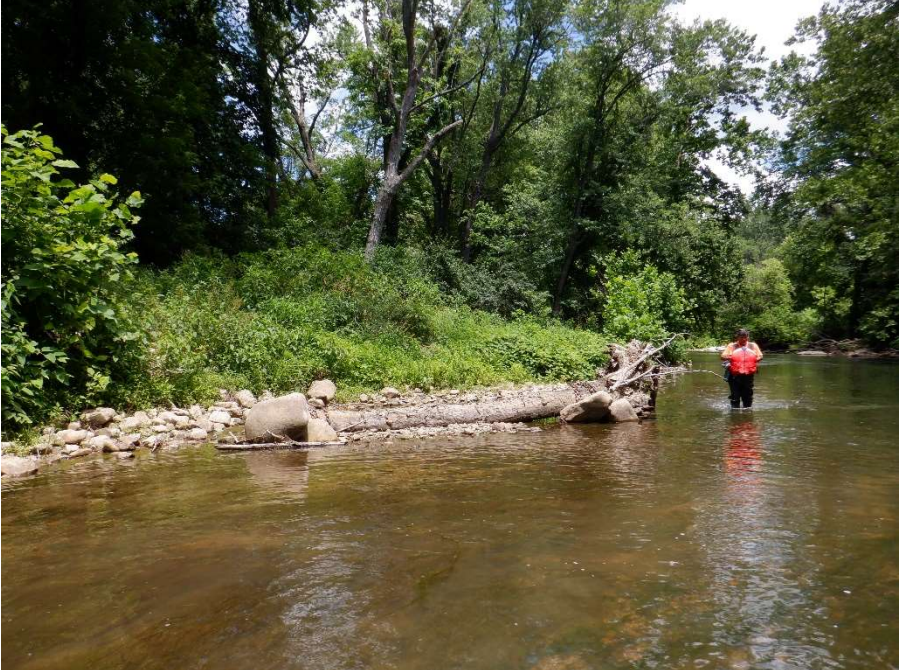
<p><b>Location:</b> Station 00-850'</p> <hr/> <p><b>Photo Title:</b>              <b>Date:</b> 34                      6/22/2021</p> <hr/> <p><b>Direction Photo Taken:</b> Northeast</p> <hr/> <p><b>Description:</b> Downstream view of location; planted vegetation well established above rock toe; no at risk trees present; Erosion control fabric primarily covered in vegetation; LWD moved from its installed position. The root ball side of the installed LWD has pivoted downstream from its original position and is now angled into the river; no scour present along rock toe.</p>

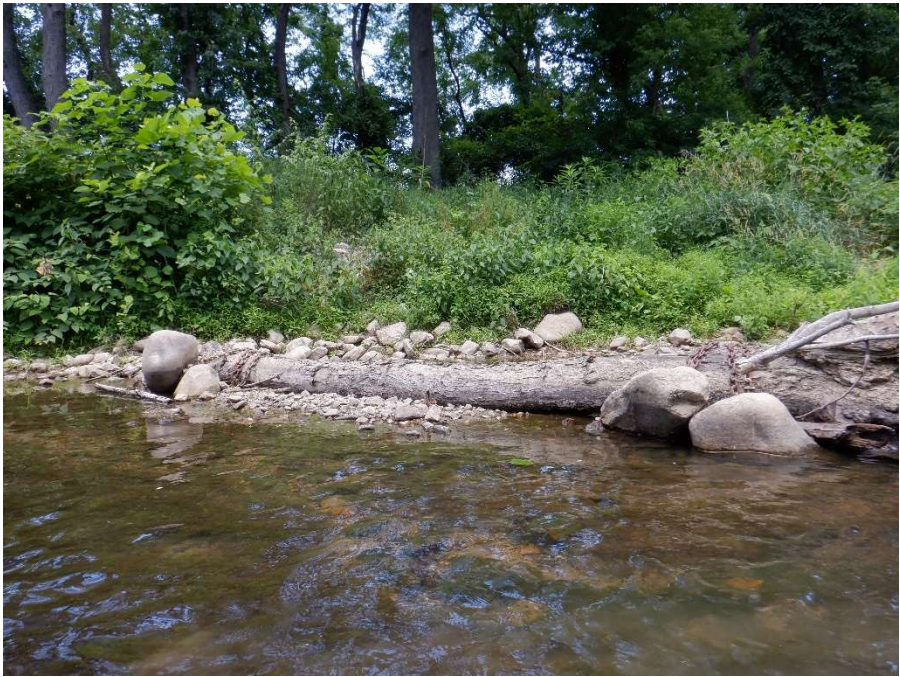
<p><b>Location:</b> Station 00-880'</p> <hr/> <p><b>Photo Number:</b>      <b>Date:</b> 35                              6/22/2021</p> <hr/> <p><b>Direction Photo Taken:</b> Northwest</p> <hr/> <p><b>Description:</b> 20 degree bank angle; Planted vegetation well established above rock toe. Catalpa and sycamore saplings and large sycamore. Invasive knotweed ~ 25% cover; no woody plants adjacent to edge of water; erosion control fabric covered in vegetation; sediment filling around shifted LWD; no scour present along rock toe and lower bank.</p>

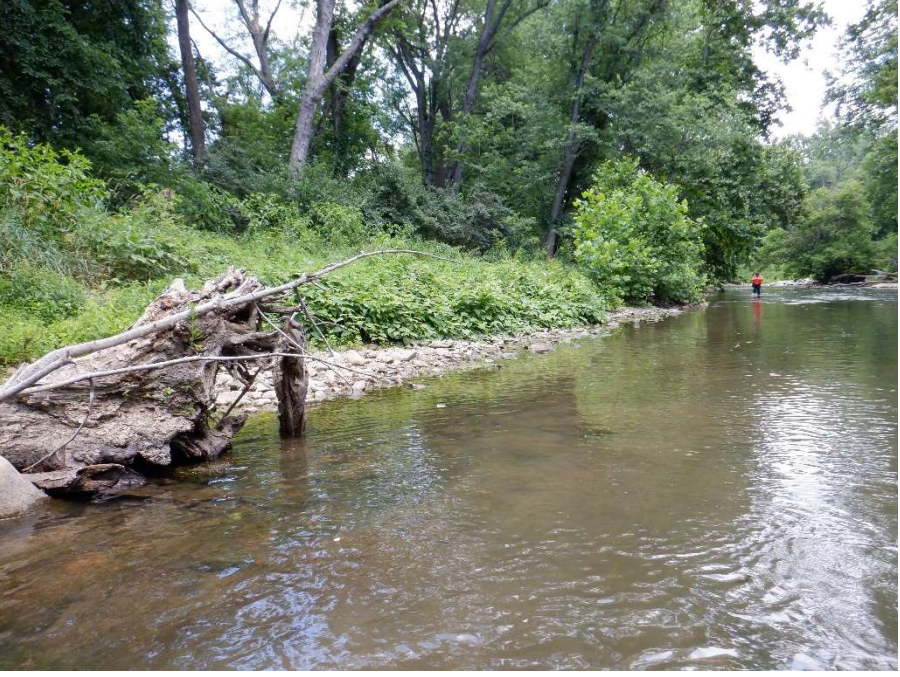
<p><b>Location:</b> Station 00-880'</p> <hr/> <p><b>Photo Title:</b>              <b>Date:</b> 36                              6/22/2021</p> <hr/> <p><b>Direction Photo Taken:</b> North</p> <hr/> <p><b>Description:</b> Downstream view of location; planted vegetation well established above rock toe; no woody plants adjacent to edge of water; erosion control fabric covered in vegetation; downstream end of LWD is at a 45 degree angle from bank about 10-15 feet from the water's edge; no scour present along rock toe and lower bank.</p>

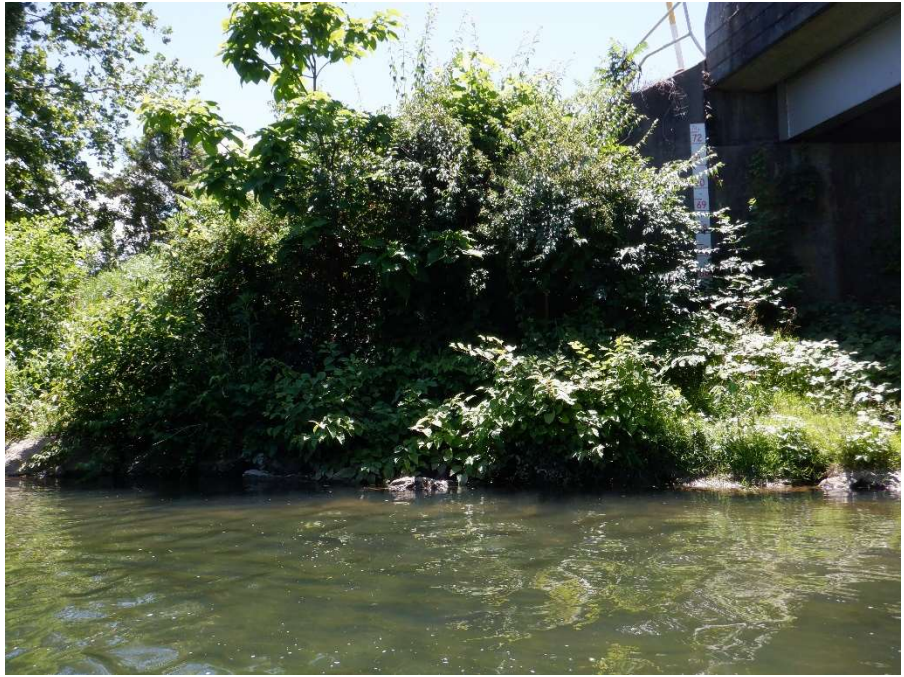
<p><b>Location:</b> 00-20'</p> <hr/> <p><b>Photo Number:</b>      <b>Date:</b> 1                              6/23/2021</p> <hr/> <p><b>Direction Photo Taken:</b> Southeast</p> <hr/> <p><b>Description:</b> ~ 20 degree bank angle; invasive Japanese knotweed - 25% cover; catalpa, pokeweed and invasive honeysuckle also present; no woody plants adjacent to edge of water; no fabric or geocell installed; upstream of remediation; some scour associated with foot traffic along bank.</p>

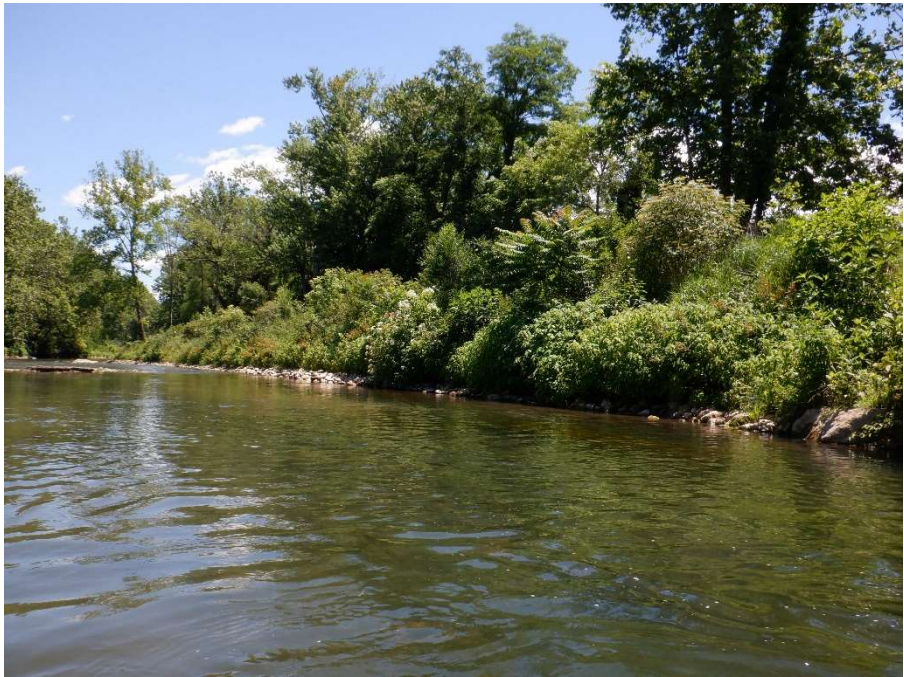
<p><b>Location:</b> 00+00'</p> <hr/> <p><b>Photo Number:</b>      <b>Date:</b> 3                              6/23/2021</p> <hr/> <p><b>Direction Photo Taken:</b> Southeast</p> <hr/> <p><b>Description:</b> ~ 45 degree bank angle; slope hydroseeded Spring 2020; vegetation established on slope; no evidence of live stakes, jewelweed ~30% cover; pokweed, curly dock, large elderberry shrub, grasses ~65% cover; one invasive ailanthus sapling; no at-risk trees present; vegetation too thick to observe fabric or geocell exposure; some scour associated with foot traffic along bank; sand deposition above rock toe.</p>

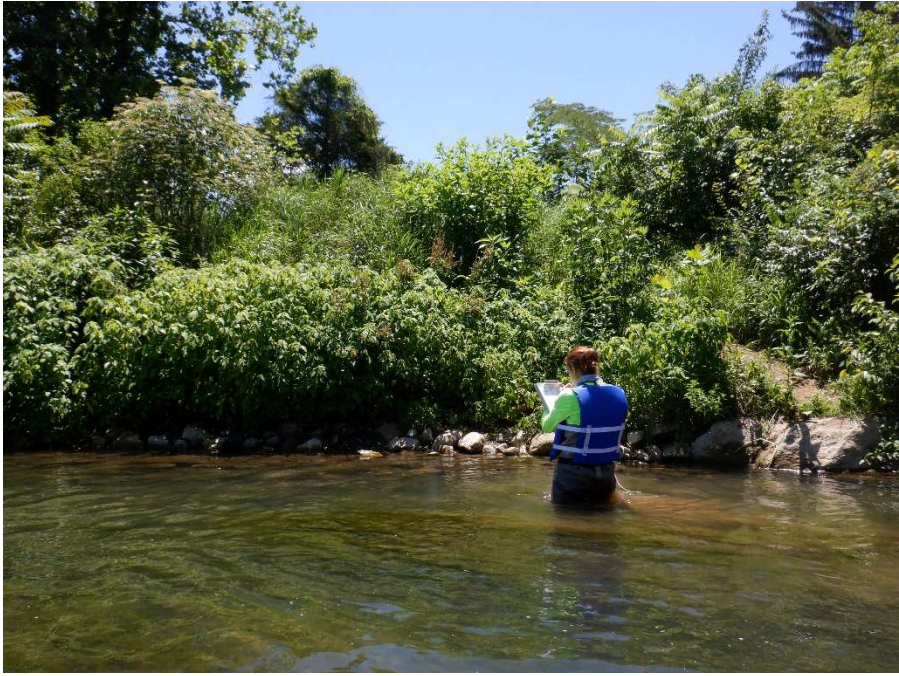
<p><b>Location:</b> 00+00'</p> <hr/> <p><b>Photo Title:</b>              <b>Date:</b> 4                                      6/23/2021</p> <hr/> <p><b>Direction Photo Taken:</b> East</p> <hr/> <p><b>Description:</b> ~ 45 degree bank angle; slope hydroseeded Spring 2020; vegetation established on slope; no evidence of live stakes, no at-risk trees present; vegetation too thick to observe fabric or geocell exposure; some scour associated with foot traffic along bank; sand deposition above rock toe.</p>

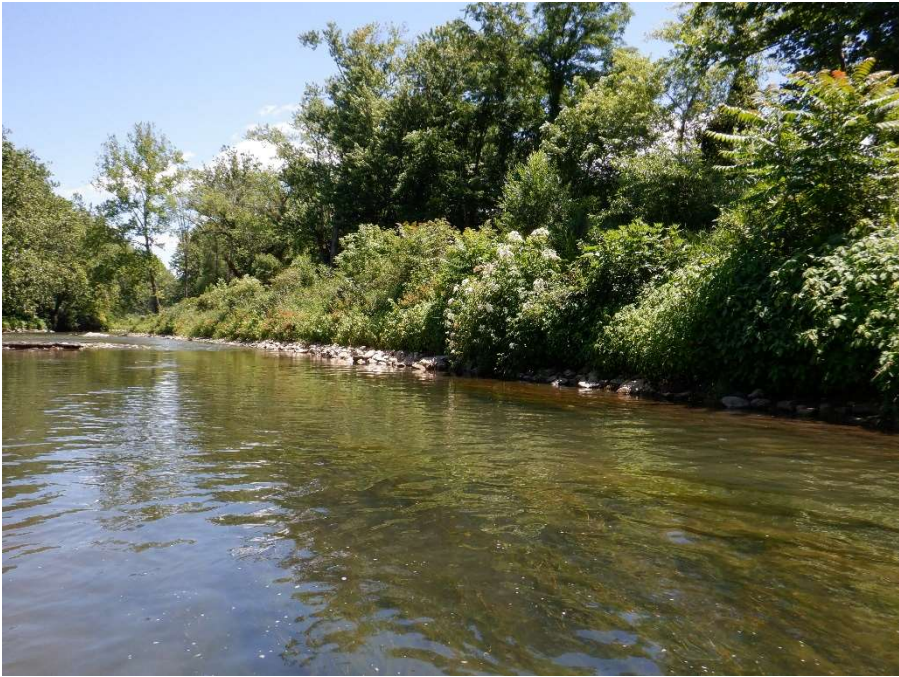
<p><b>Location:</b> 00+50'</p> <hr/> <p><b>Photo Number:</b>      <b>Date:</b> 5                              6/23/2021</p> <hr/> <p><b>Direction Photo Taken:</b> Southeast</p> <hr/> <p><b>Description:</b> ~50 degree bank angle; slope hydroseeded Spring 2020; Minimal vegetation adjacent to water; no evidence of livestakes; elderberry ~25% cover, cutleaf coneflower ~5% cover, jewelweed and dogwoods ~25% cover, grasses ~55% cover; no at-risk trees present; vegetation too thick to observe fabric or geocell exposure; scour present where fabric is torn; sand deposition at toe of bank.</p>

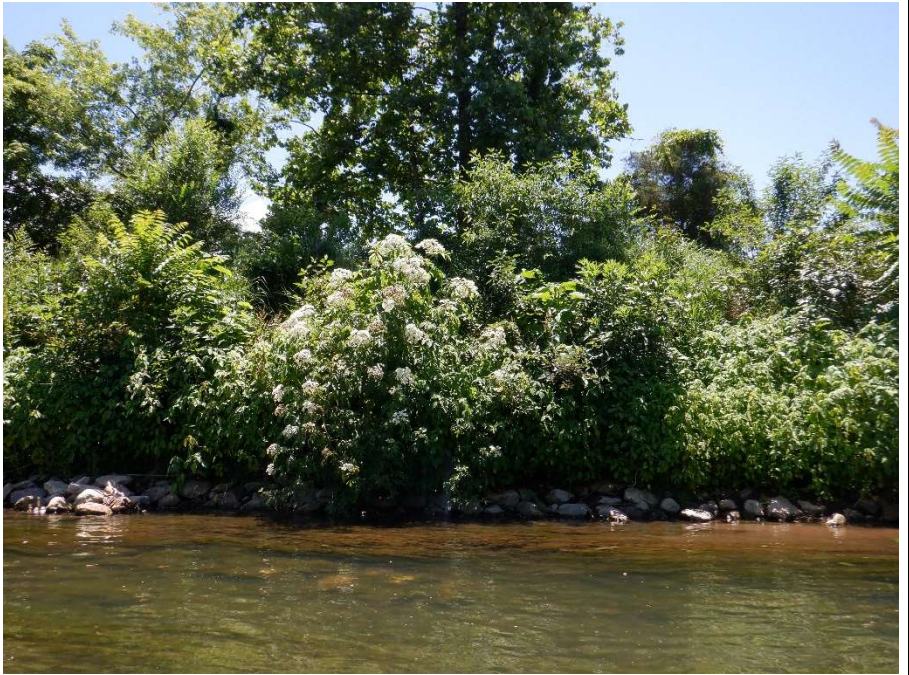
<p><b>Location:</b> 00+50'</p> <hr/> <p><b>Photo Title:</b>              <b>Date:</b> 6                                      6/23/2021</p> <hr/> <p><b>Direction Photo Taken:</b> East</p> <hr/> <p><b>Description:</b> ~50 degree bank angle; slope hydroseeded Spring 2020; Minimal vegetation adjacent to water; no evidence of livestakes; no at-risk trees present; vegetation too thick to observe fabric or geocell exposure; scour present where fabric is torn; sand deposition at toe of bank.</p>
